**The Road Inventory
of
Mammoth Cave National Park
MACA – 5530
Cycle 4**

**Prepared By:
Federal Highway Administration
Road Inventory Program
Cycle 4**

Mammoth Cave National Park in Kentucky

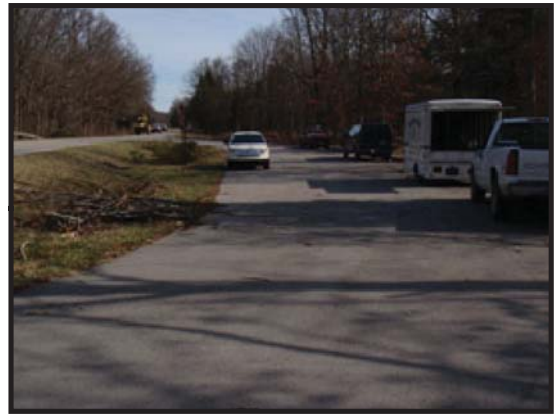
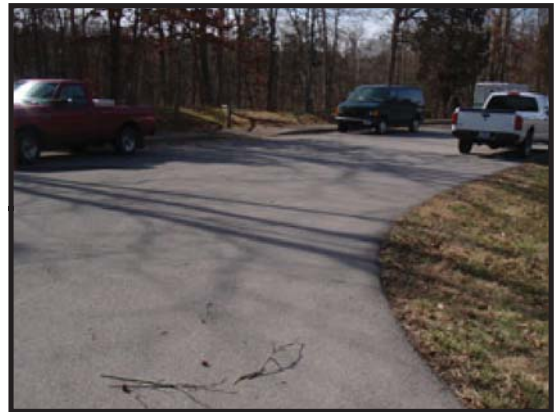
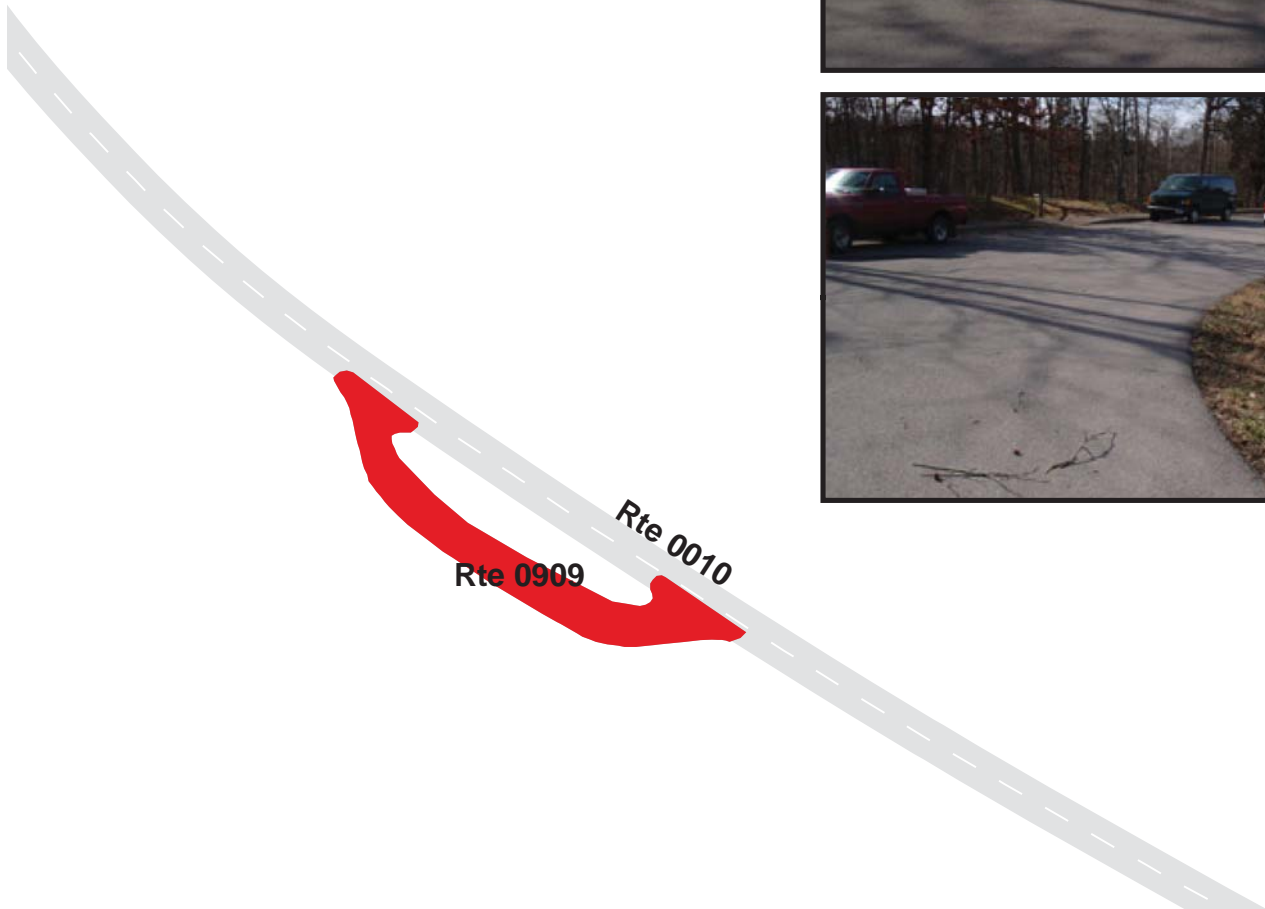
Route Number	Public / NonPublic	Date Visited		Area (sq ft)	Lane Miles *	Surface Type
0909	PUBLIC	3/3/2009		9,382	0.16	AS
Culverts	Drop Inlets	Gates	Fire Hydrants	Curb & Gutter	Curb	PCR
0	2	0	0	CONCRETE CURB AND GUTTER	NO CURB	FAIR/73

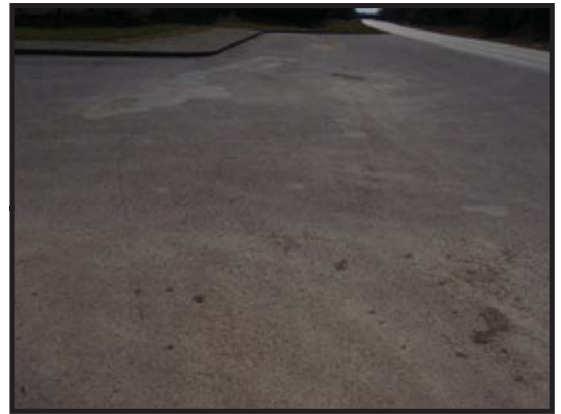
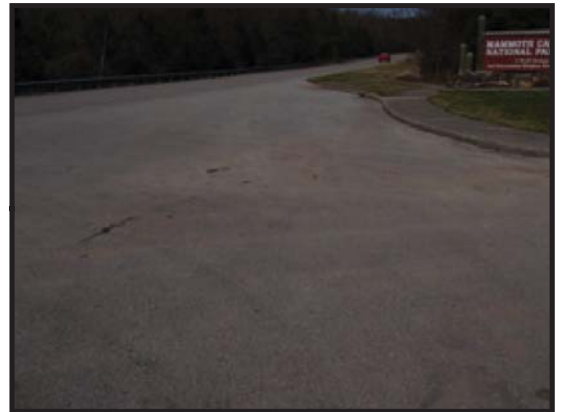
Route Number	Public / NonPublic	Date Visited		Area (sq ft)	Lane Miles *	Surface Type
0911	PUBLIC	3/3/2009		9,746	0.17	AS
Culverts	Drop Inlets	Gates	Fire Hydrants	Curb & Gutter	Curb	PCR
0	1	0	0	NO CURB AND GUTTER	ASPHALT CURB	FAIR/73

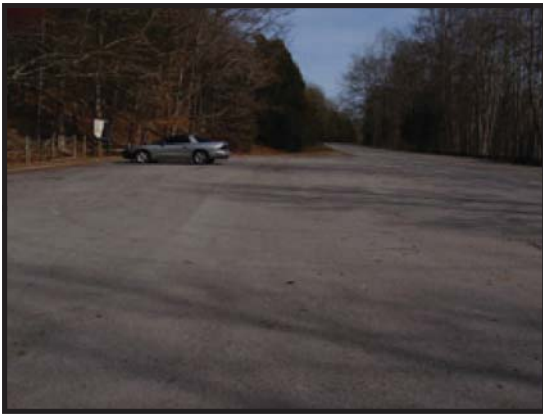
Route Number	Public / NonPublic	Date Visited		Area (sq ft)	Lane Miles *	Surface Type
0912	PUBLIC	3/3/2009		6,046	0.10	AS
Culverts	Drop Inlets	Gates	Fire Hydrants	Curb & Gutter	Curb	PCR
0	0	0	0	NO CURB AND GUTTER	CONCRETE CURB	GOOD/90

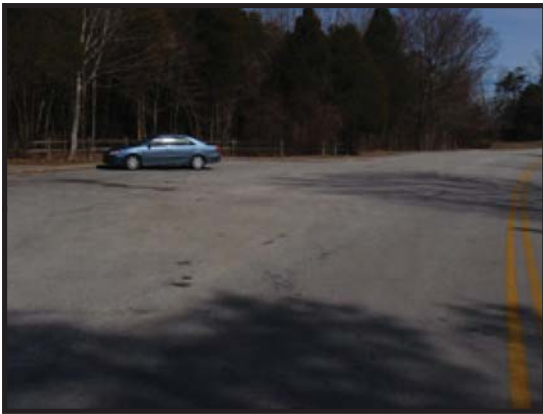
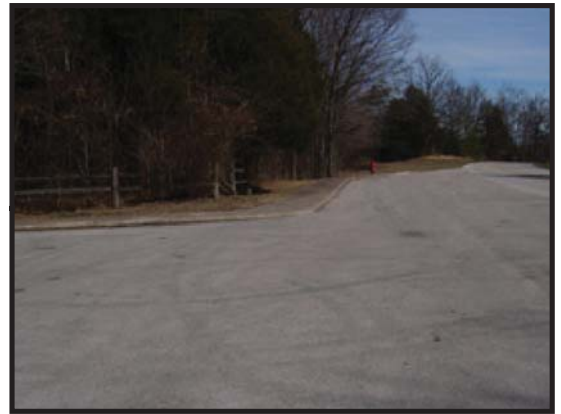
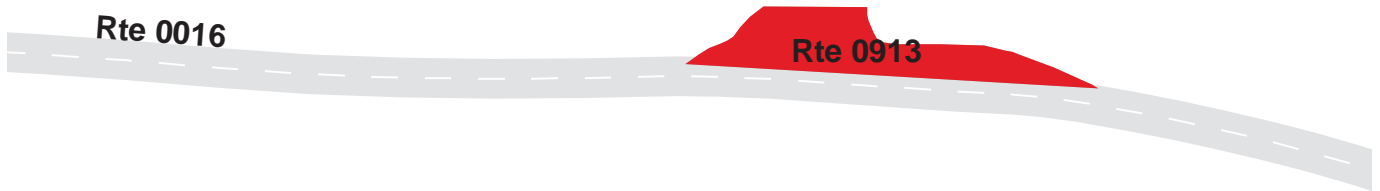
Route Number	Public / NonPublic	Date Visited		Area (sq ft)	Lane Miles *	Surface Type
0913	PUBLIC	3/3/2009		6,310	0.11	AS
Culverts	Drop Inlets	Gates	Fire Hydrants	Curb & Gutter	Curb	PCR
0	1	0	1	NO CURB AND GUTTER	ASPHALT & CONCRETE	FAIR/73

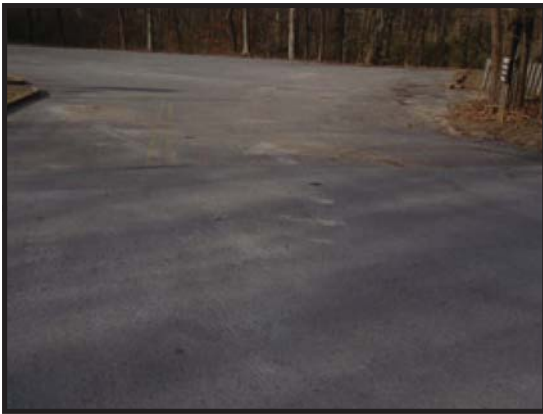
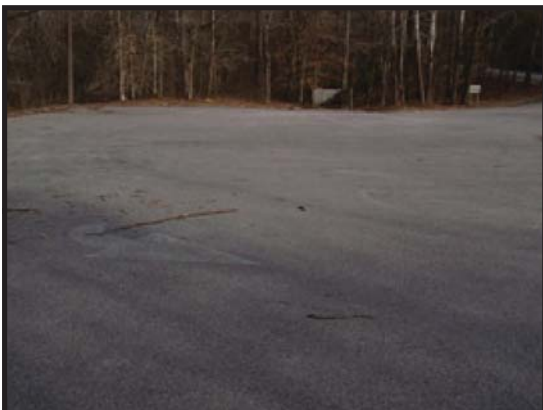
Route Number	Public / NonPublic	Date Visited		Area (sq ft)	Lane Miles *	Surface Type
0915	PUBLIC	3/3/2009		20,639	0.36	AS
Culverts	Drop Inlets	Gates	Fire Hydrants	Curb & Gutter	Curb	PCR
0	0	0	0	NO CURB AND GUTTER	CONCRETE CURB	FAIR/73

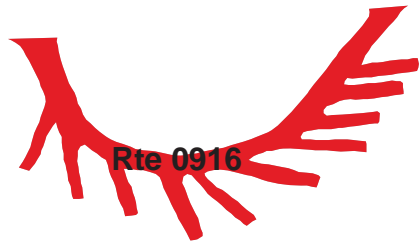
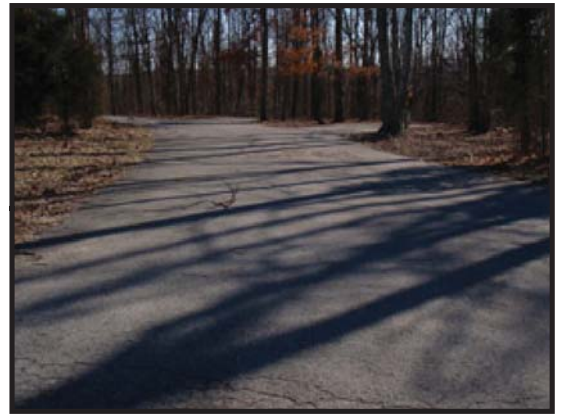
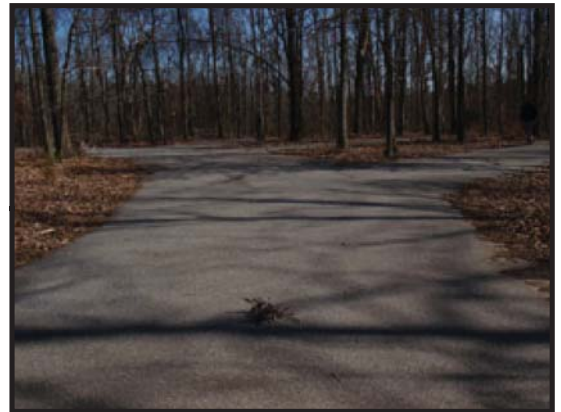
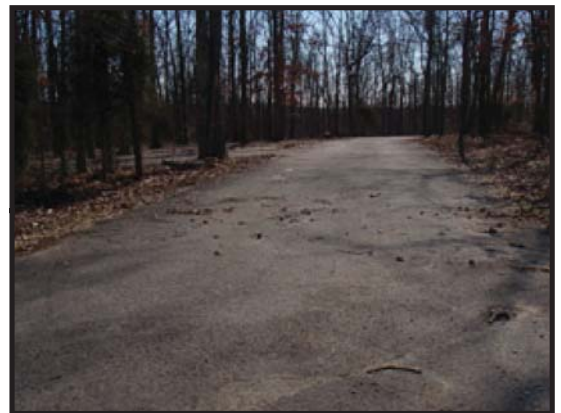
Route Number	Public / NonPublic	Date Visited		Area (sq ft)	Lane Miles *	Surface Type
0916	PUBLIC	3/4/2009		12,926	0.22	AS
Culverts	Drop Inlets	Gates	Fire Hydrants	Curb & Gutter	Curb	PCR
2	0	0	0	NO CURB AND GUTTER	NO CURB	GOOD/90

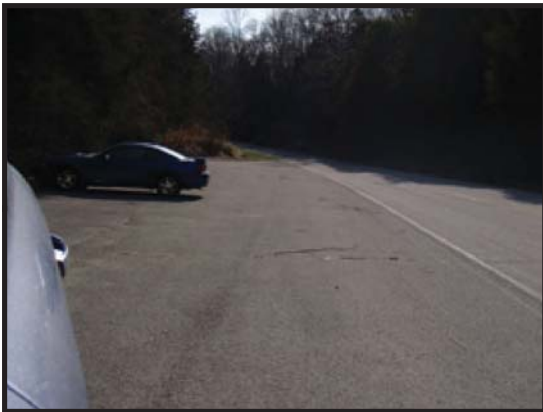
Route Number	Public / NonPublic	Date Visited		Area (sq ft)	Lane Miles *	Surface Type
0919	PUBLIC	3/3/2009		5,795	0.10	AS
Culverts	Drop Inlets	Gates	Fire Hydrants	Curb & Gutter	Curb	PCR
0	1	0	0	NO CURB AND GUTTER	CONCRETE CURB	FAIR/73

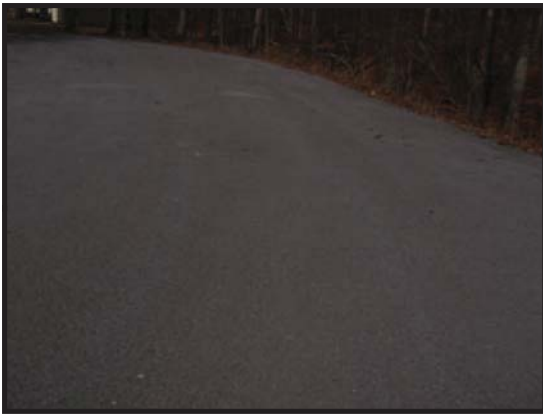
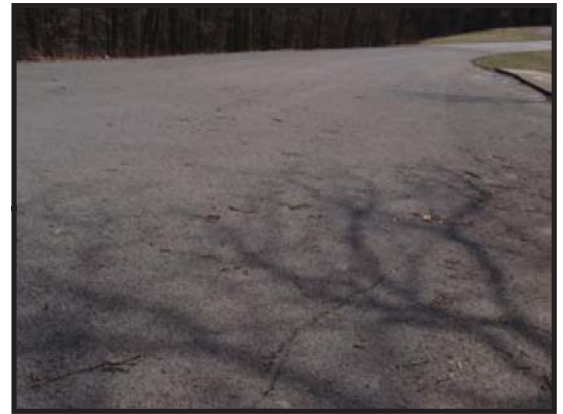
Route Number	Public / NonPublic	Date Visited		Area (sq ft)	Lane Miles *	Surface Type
0920	PUBLIC	3/4/2009		9,692	0.17	AS
Culverts	Drop Inlets	Gates	Fire Hydrants	Curb & Gutter	Curb	PCR
0	0	0	1	NO CURB AND GUTTER	NO CURB	FAIR/73

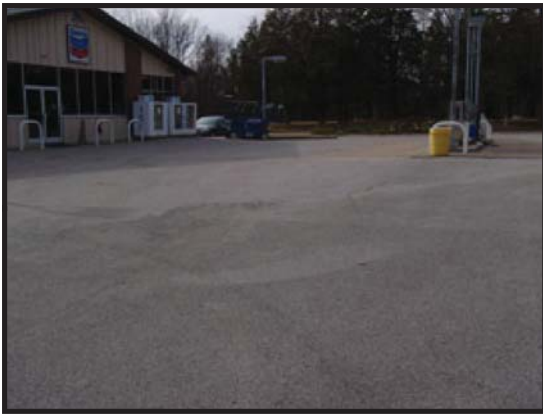
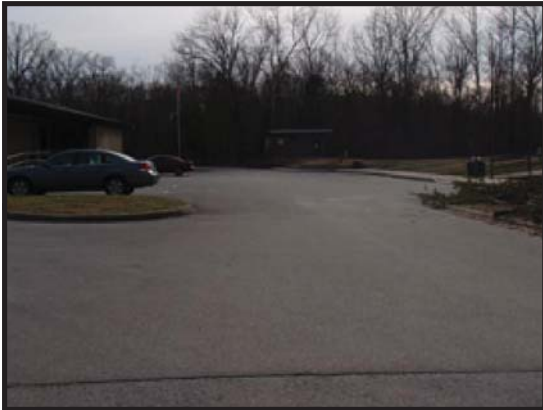
Route 0922

Route Number	Public / NonPublic	Date Visited		Area (sq ft)	Lane Miles *	Surface Type
0922	PUBLIC	3/3/2009		46,174	0.80	AS
Culverts	Drop Inlets	Gates	Fire Hydrants	Curb & Gutter	Curb	PCR
1	4	0	1	NO CURB AND GUTTER	CONCRETE CURB	FAIR/73

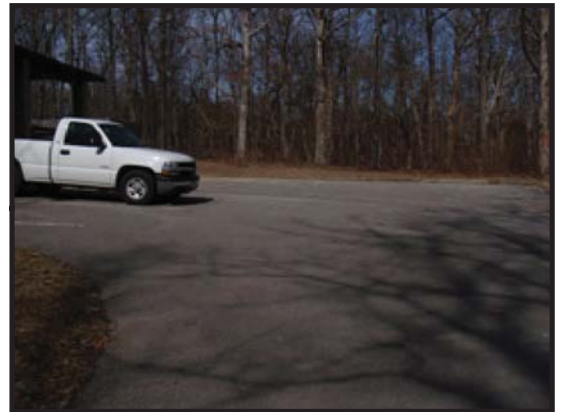
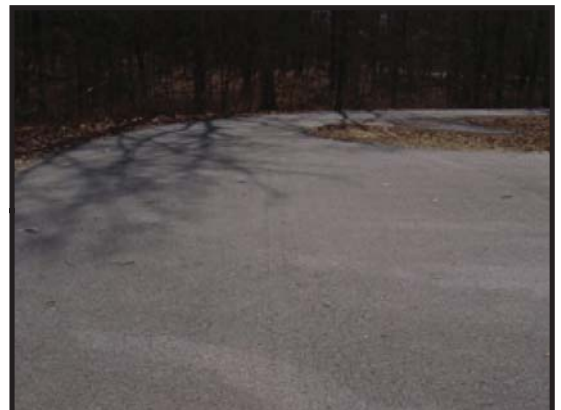
Route 0923

Route Number	Public / NonPublic	Date Visited		Area (sq ft)	Lane Miles *	Surface Type
0923	PUBLIC	3/3/2009		4,631	0.08	AS
Culverts	Drop Inlets	Gates	Fire Hydrants	Curb & Gutter	Curb	PCR
0	0	0	0	NO CURB AND GUTTER	NO CURB	FAIR/73

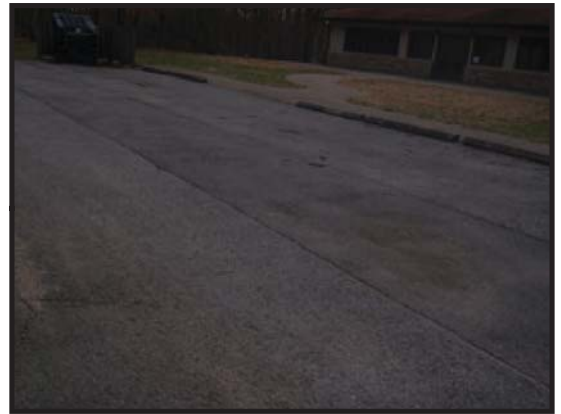
Route Number	Public / NonPublic	Date Visited		Area (sq ft)	Lane Miles *	Surface Type
0931AZ	PUBLIC	3/4/2009		1,147	0.02	AS
Culverts	Drop Inlets	Gates	Fire Hydrants	Curb & Gutter	Curb	PCR
0	0	0	0	NO CURB AND GUTTER	NO CURB	FAIR/73

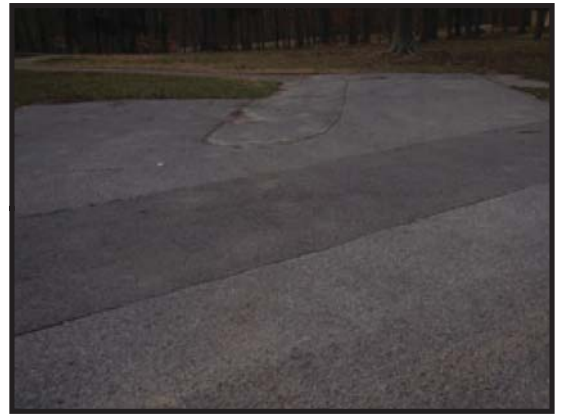
Route 0931BZ

Route Number	Public / NonPublic	Date Visited		Area (sq ft)	Lane Miles *	Surface Type
0931BZ	PUBLIC	3/4/2009		1,039	0.02	AS
Culverts	Drop Inlets	Gates	Fire Hydrants	Curb & Gutter	Curb	PCR
0	0	0	0	NO CURB AND GUTTER	NO CURB	FAIR/73

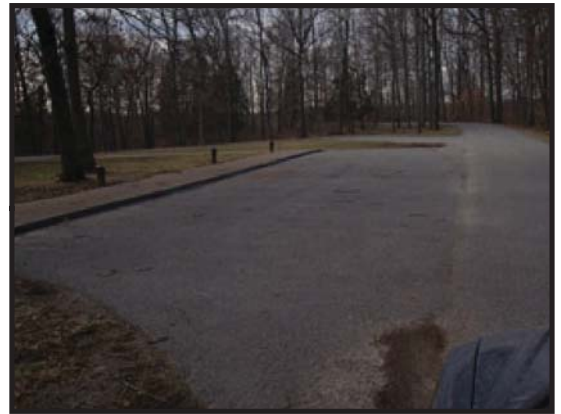
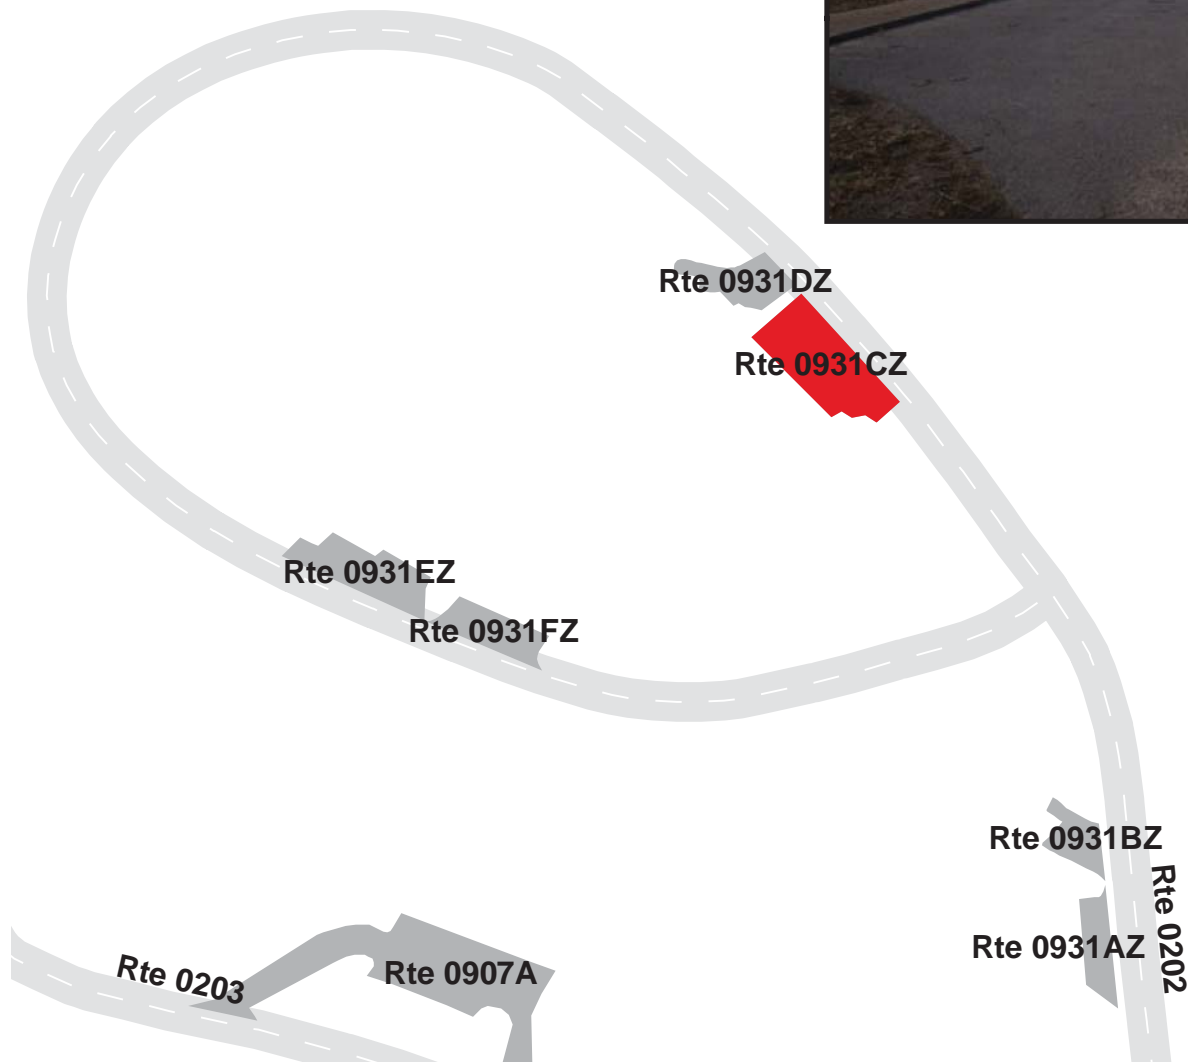
Route 0931CZ

Route Number	Public / NonPublic	Date Visited		Area (sq ft)	Lane Miles *	Surface Type
0931CZ	PUBLIC	3/4/2009		3,452	0.06	AS
Culverts	Drop Inlets	Gates	Fire Hydrants	Curb & Gutter	Curb	PCR
0	0	0	0	NO CURB AND GUTTER	NO CURB	FAIR/73

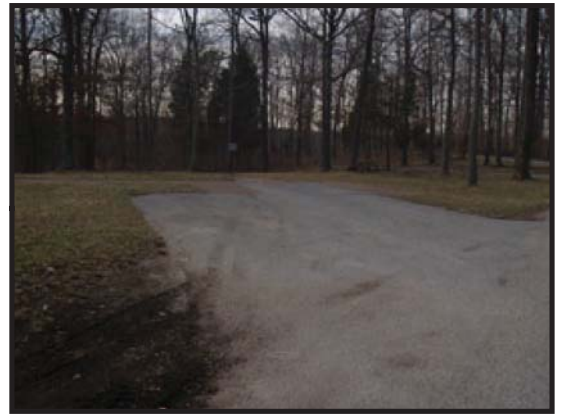
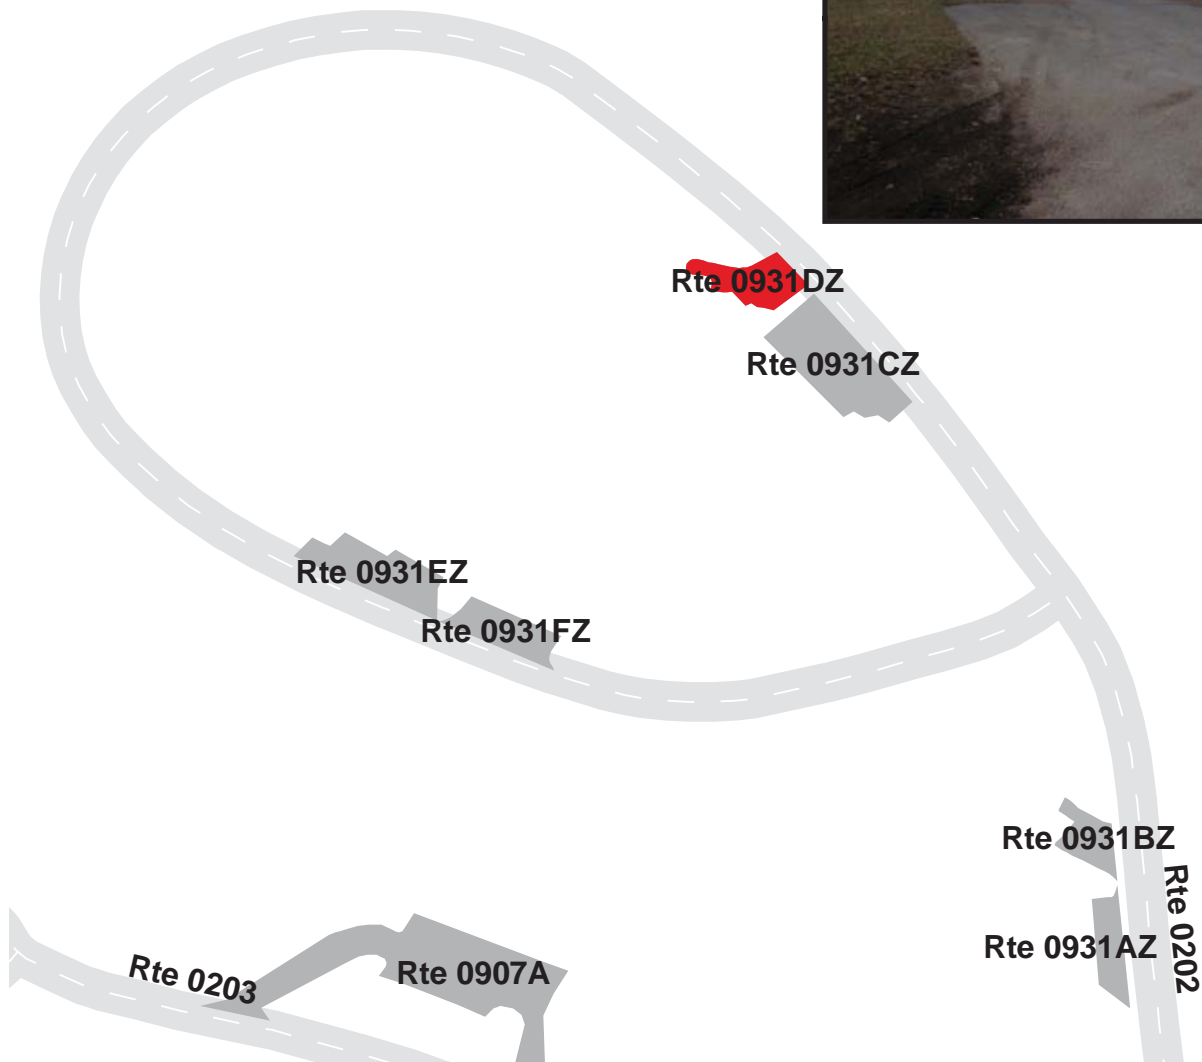
Route 0931DZ

Route Number	Public / NonPublic	Date Visited		Area (sq ft)	Lane Miles *	Surface Type
0931DZ	PUBLIC	3/4/2009		1,478	0.03	AS
Culverts	Drop Inlets	Gates	Fire Hydrants	Curb & Gutter	Curb	PCR
0	0	0	0	NO CURB AND GUTTER	NO CURB	FAIR/73

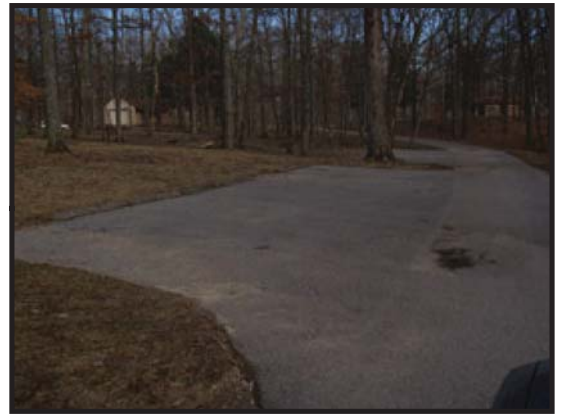
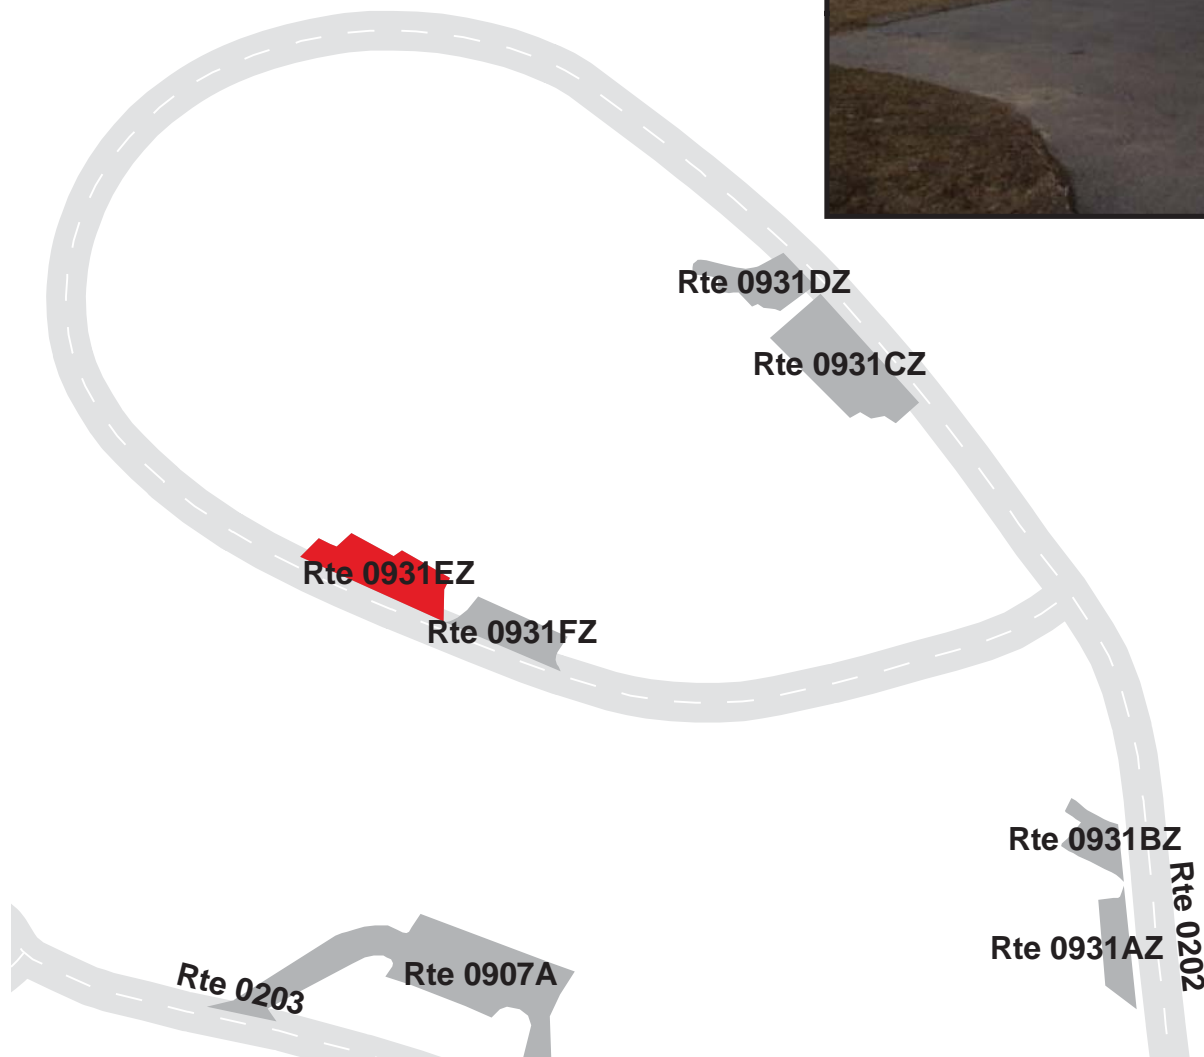
Route 0931EZ

Route Number	Public / NonPublic	Date Visited		Area (sq ft)	Lane Miles *	Surface Type
0931EZ	PUBLIC	3/4/2009		2,276	0.04	AS
Culverts	Drop Inlets	Gates	Fire Hydrants	Curb & Gutter	Curb	PCR
0	0	0	0	NO CURB AND GUTTER	NO CURB	FAIR/73

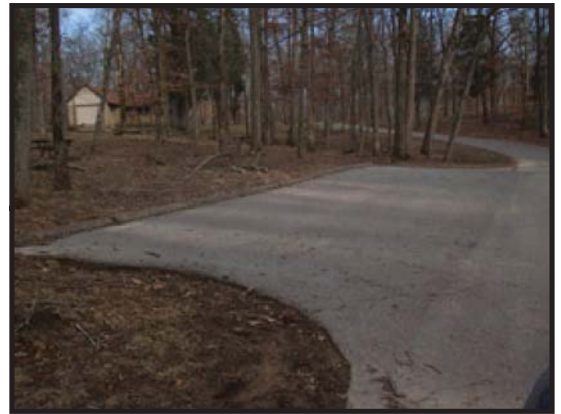
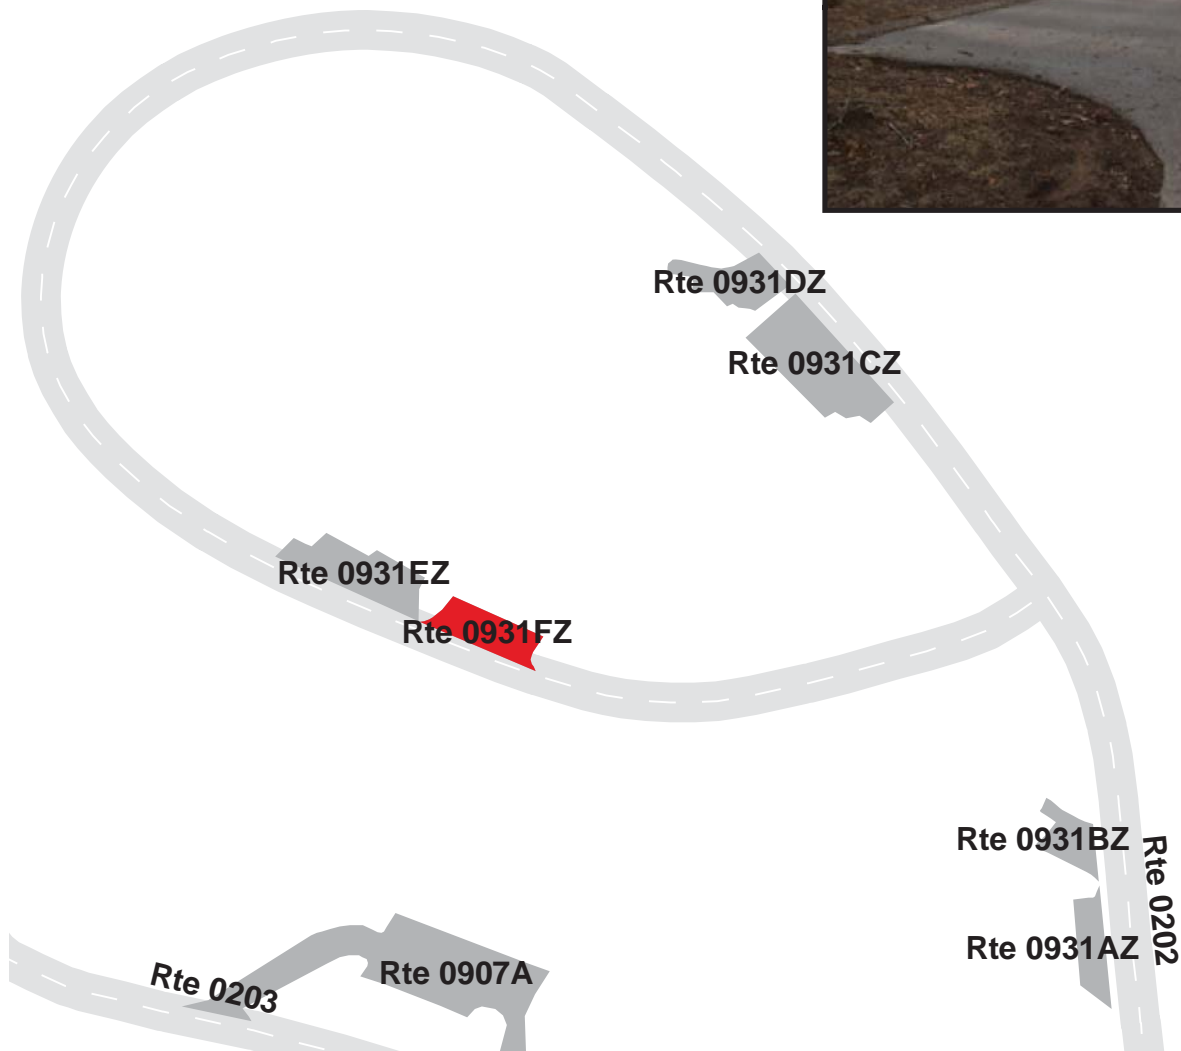
Route 0931FZ

Route Number	Public / NonPublic	Date Visited		Area (sq ft)	Lane Miles *	Surface Type
0931FZ	PUBLIC	3/4/2009		1,458	0.03	AS
Culverts	Drop Inlets	Gates	Fire Hydrants	Curb & Gutter	Curb	PCR
0	0	0	0	NO CURB AND GUTTER	NO CURB	FAIR/73

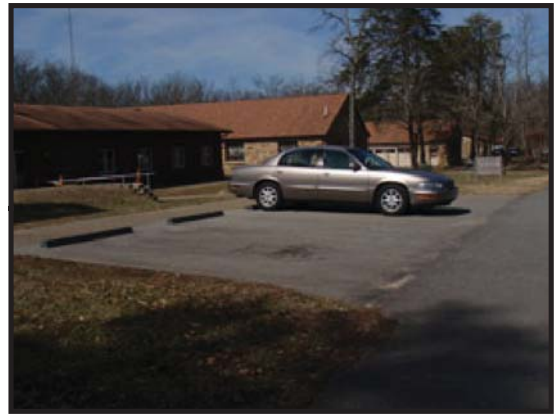
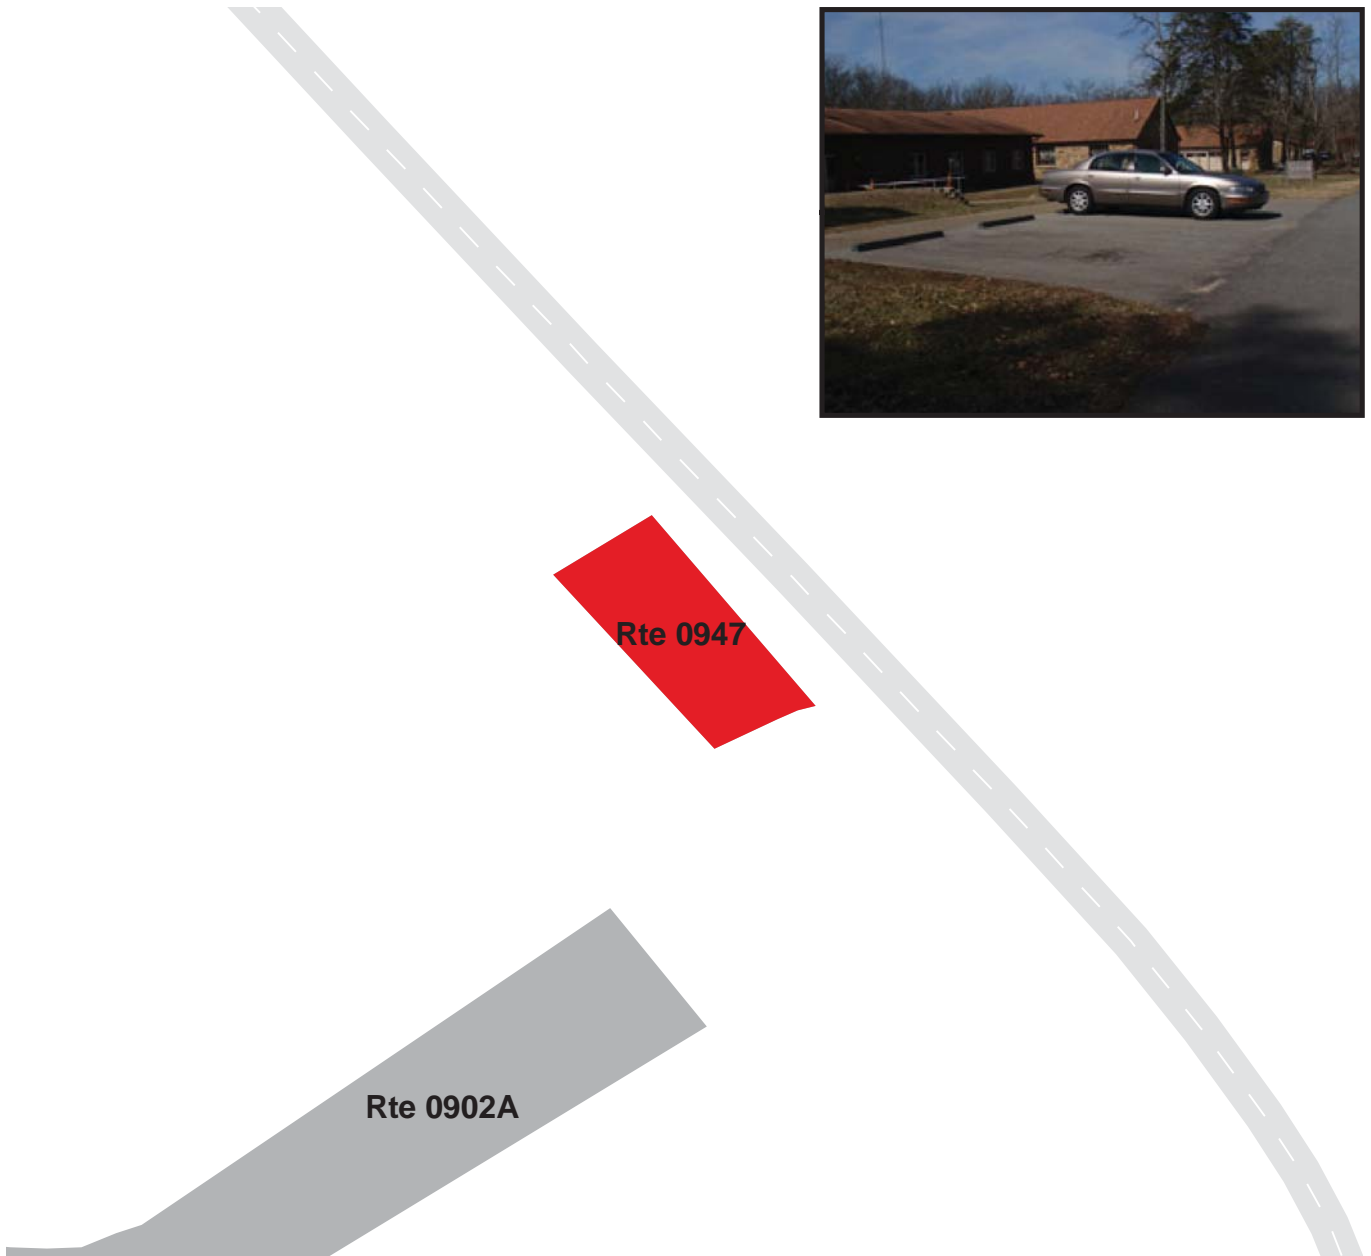
Route 0947

Route Number	Public / NonPublic	Date Visited		Area (sq ft)	Lane Miles *	Surface Type
0947	NONPUBLIC	3/4/2009		748	0.01	AS
Culverts	Drop Inlets	Gates	Fire Hydrants	Curb & Gutter	Curb	PCR
0	0	0	0	NO CURB AND GUTTER	NO CURB	GOOD/90

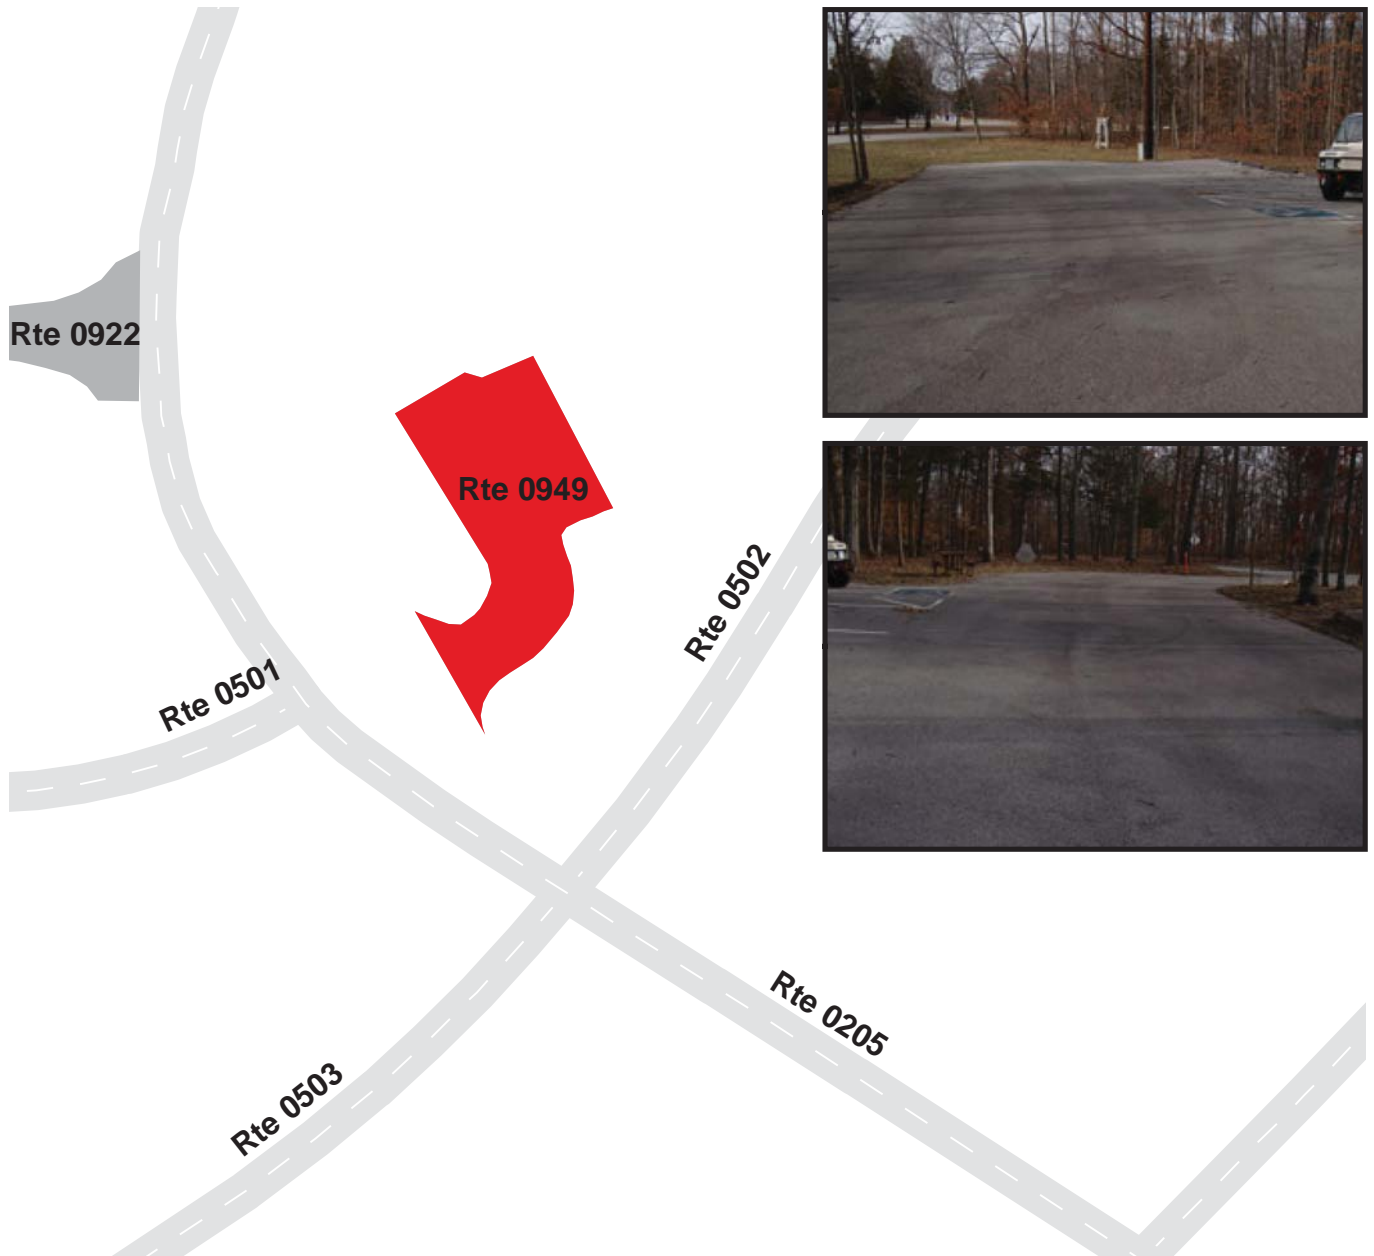
Route 0949

Route Number	Public / NonPublic	Date Visited		Area (sq ft)	Lane Miles *	Surface Type
0949	PUBLIC	3/3/2009		4,032	0.07	AS
Culverts	Drop Inlets	Gates	Fire Hydrants	Curb & Gutter	Curb	PCR
0	0	0	0	NO CURB AND GUTTER	NO CURB	GOOD/90

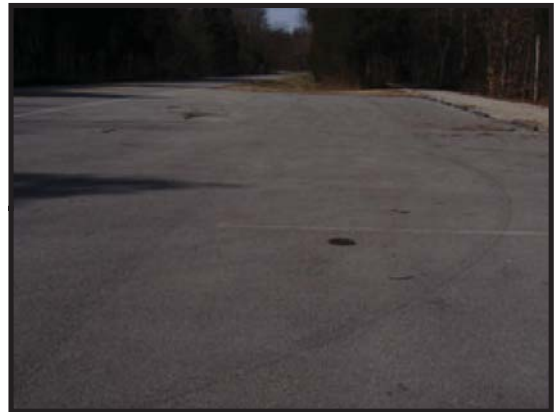
Route 0951

Route Number	Public / NonPublic	Date Visited		Area (sq ft)	Lane Miles *	Surface Type
0951	PUBLIC	3/4/2009		4,552	0.08	AS
Culverts	Drop Inlets	Gates	Fire Hydrants	Curb & Gutter	Curb	PCR
0	0	0	0	NO CURB AND GUTTER	NO CURB	GOOD/90

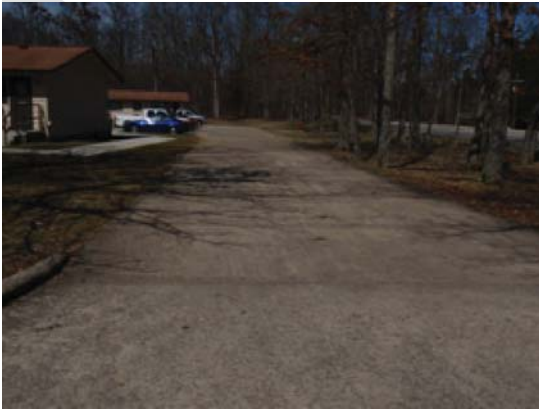
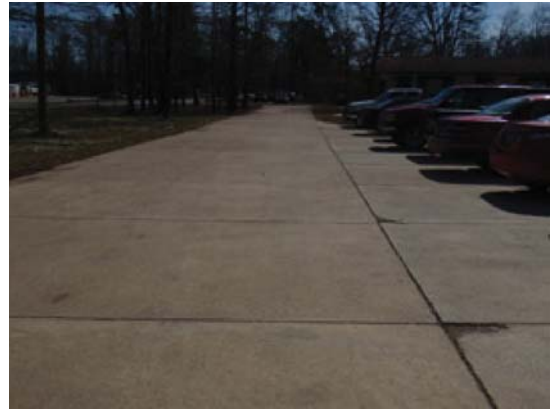
Route 0955

Route Number	Public / NonPublic	Date Visited		Area (sq ft)	Lane Miles *	Surface Type
0955	NONPUBLIC	3/4/2009		6,497	0.11	CO
Culverts	Drop Inlets	Gates	Fire Hydrants	Curb & Gutter	Curb	PCR
0	0	0	0	NO CURB AND GUTTER	CONCRETE CURB	GOOD/90

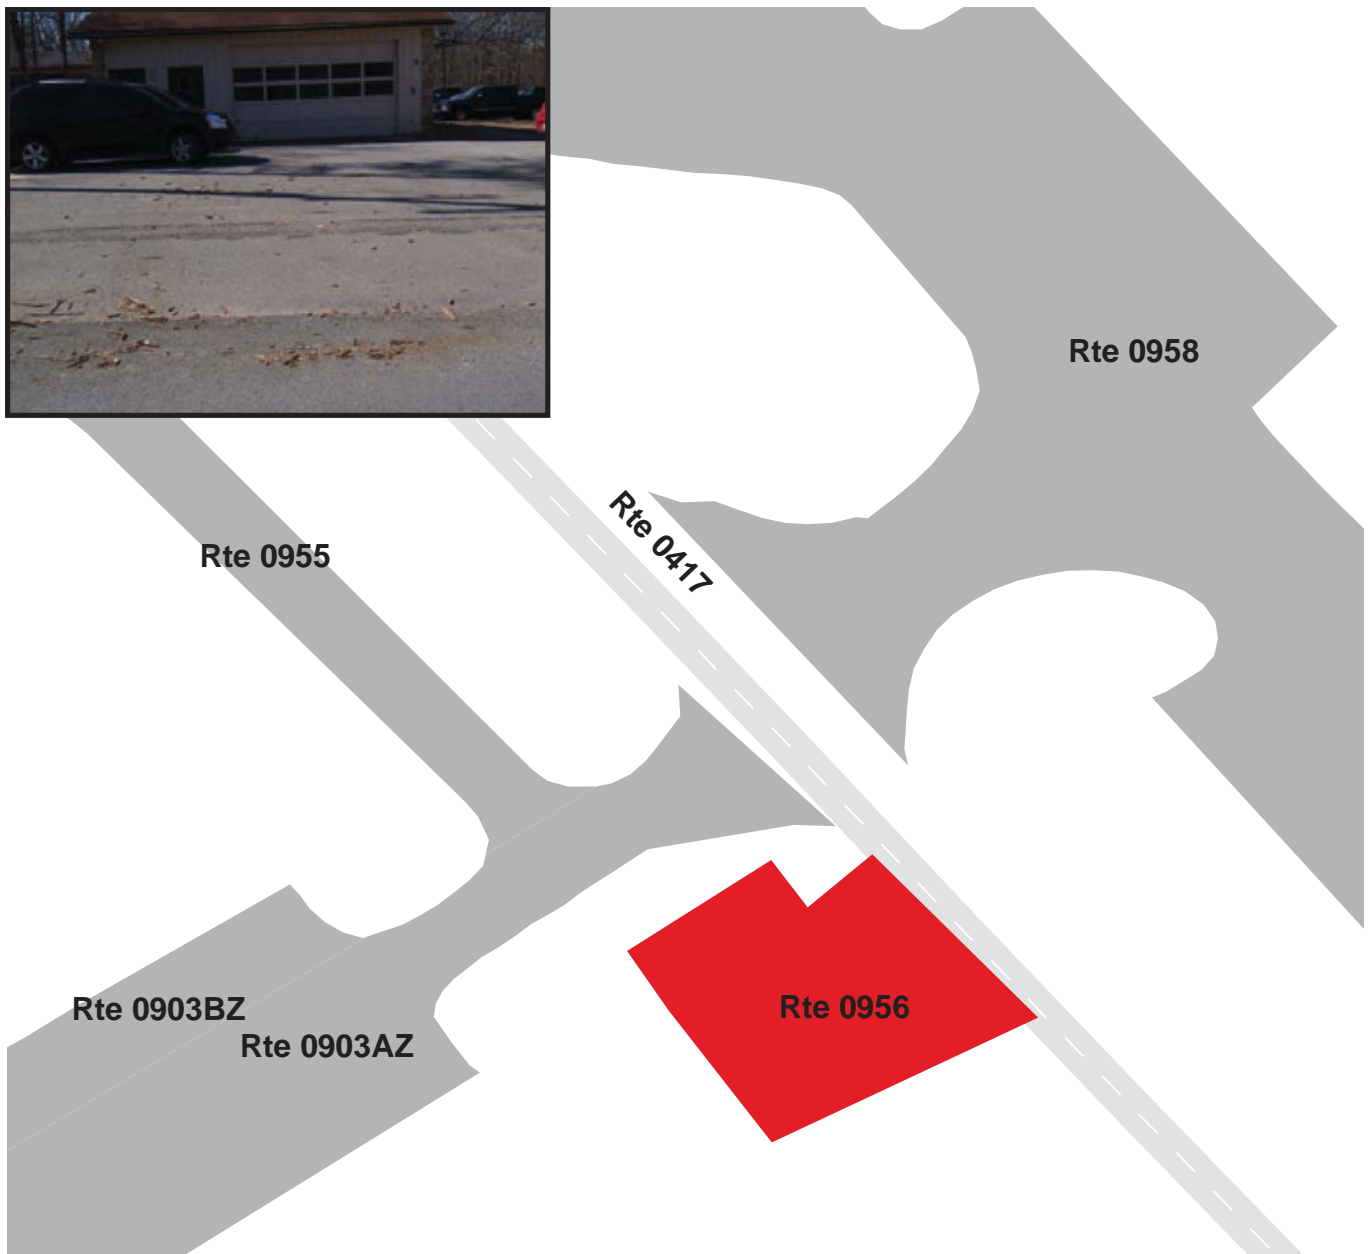
Route 0956

Route Number	Public / NonPublic	Date Visited		Area (sq ft)	Lane Miles *	Surface Type
0956	NONPUBLIC	3/4/2009		2,832	0.05	AS
Culverts	Drop Inlets	Gates	Fire Hydrants	Curb & Gutter	Curb	PCR
0	0	0	0	NO CURB AND GUTTER	CONCRETE CURB	FAIR/73

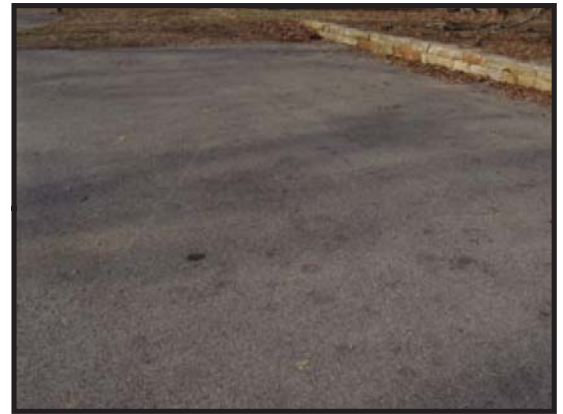
MAMMOTH CAVE NATIONAL PARK
Route 0957
 HERITAGE TRAIL PARKING
 ADJACENT TO ROUTE 0430 (SUNSET LODGE ROAD)

Route Number	Public / NonPublic	Date Visited		Area (sq ft)	Lane Miles *	Surface Type
0957	PUBLIC	3/4/2009		821	0.01	AS
Culverts	Drop Inlets	Gates	Fire Hydrants	Curb & Gutter	Curb	PCR
0	0	0	0	NO CURB AND GUTTER	STONE CURB	GOOD/90

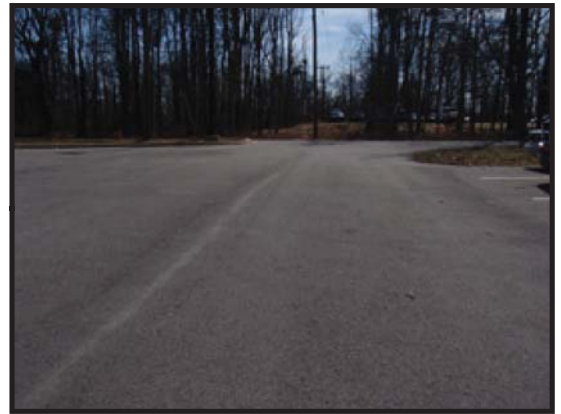
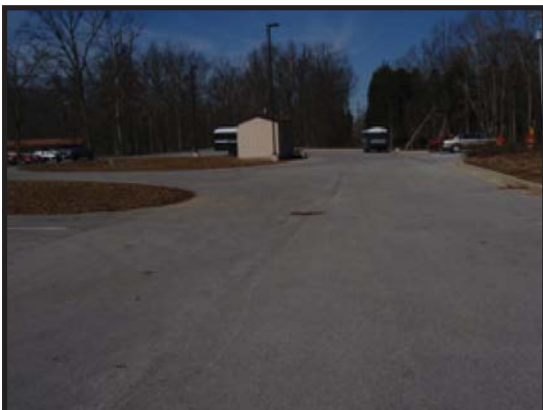
Route 0958

Route Number	Public / NonPublic	Date Visited		Area (sq ft)	Lane Miles *	Surface Type
0958	NONPUBLIC	3/4/2009		36,809	0.63	AS
Culverts	Drop Inlets	Gates	Fire Hydrants	Curb & Gutter	Curb	PCR
0	3	0	0	CONCRETE CURB AND GUTTER	CONCRETE CURB	GOOD/90
