**The Road Inventory  
of  
Mesa Verde National Park  
MEVE – 1490  
Cycle 4**

**Prepared By: Federal Highway Administration  
Road Inventory Program  
Cycle 4**

# Mesa Verde National Park in Colorado

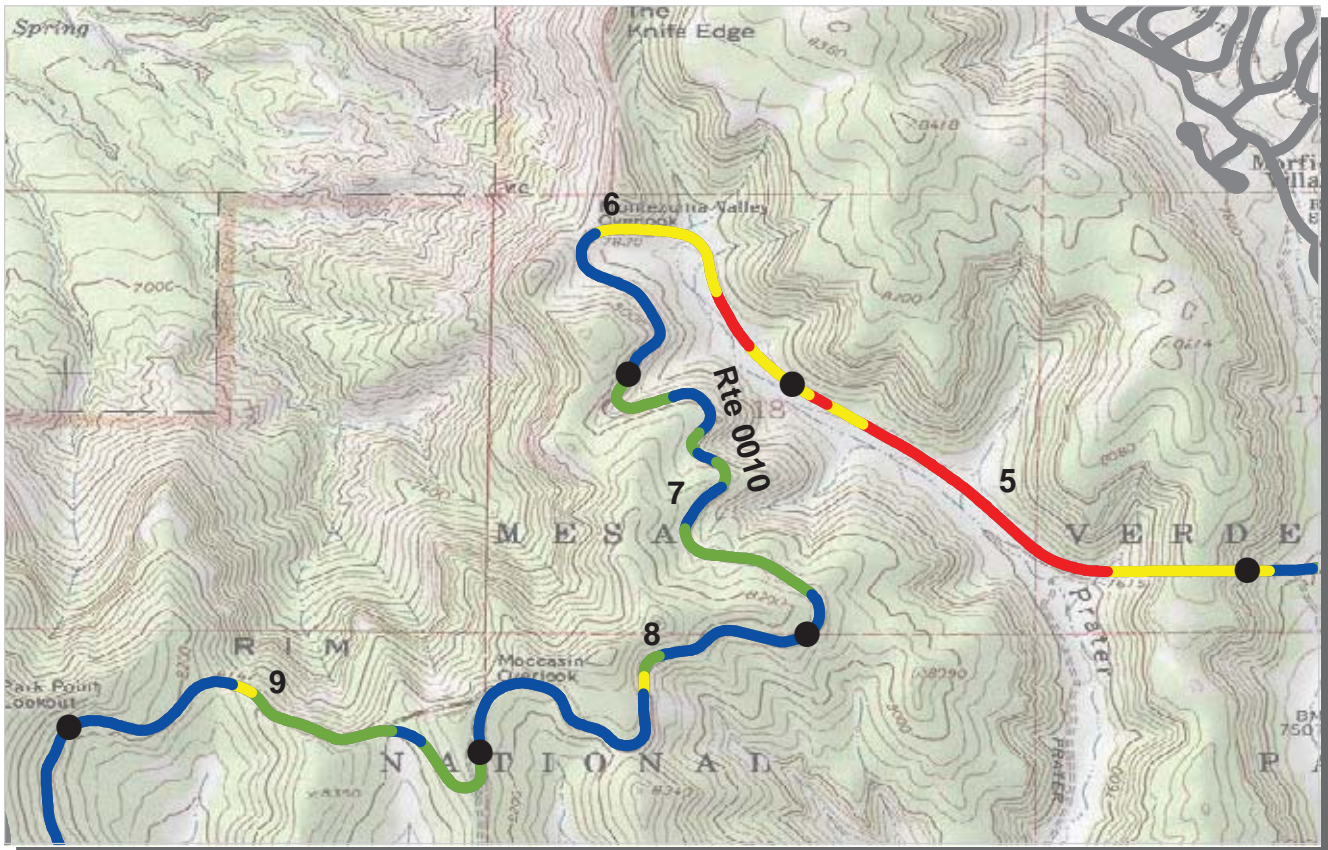
**ROUTE: 0010 CHAPIN MESA ROAD**

<i>Section Number</i>	0	1	2	3	4
<i>Section Length (mi)</i>	1.00	1.00	1.00	1.00	1.00
<i>Traffic</i>	Traffic data may be found at <a href="http://www.efl.fhwa.dot.gov">www.efl.fhwa.dot.gov</a> Click on PROGRAMS / NPS Traffic Data (Note: Not all parks have traffic data)				
<i>Cross Section Information</i>					
Number of Lanes	2	2	2	2	2
Paved Width (ft)	48	27	34	34	36
Lane Width (ft)	13	10	11	10	21
Shoulder Width Right (ft)**	0	0	0	0	0
Shoulder Width Left (ft)**	0	0	0	0	0
<i>Roadway Condition Information</i>					
SCR (Surface Condition Rating)	87	99	81	96	94
PCR (Pavement Condition Rating)	88	95	80	96	96
<i>Distress Index Values</i>					
Alligator Cracking Index	100	100	99	100	100
Longitudinal Cracking Index	96	100	95	99	100
Transverse Cracking Index	96	99	95	100	100
Patching Index	100	100	98	100	100
Rutting Index	95	100	94	97	94
Roughness Condition Index (RCI)	89	89	78	94	99

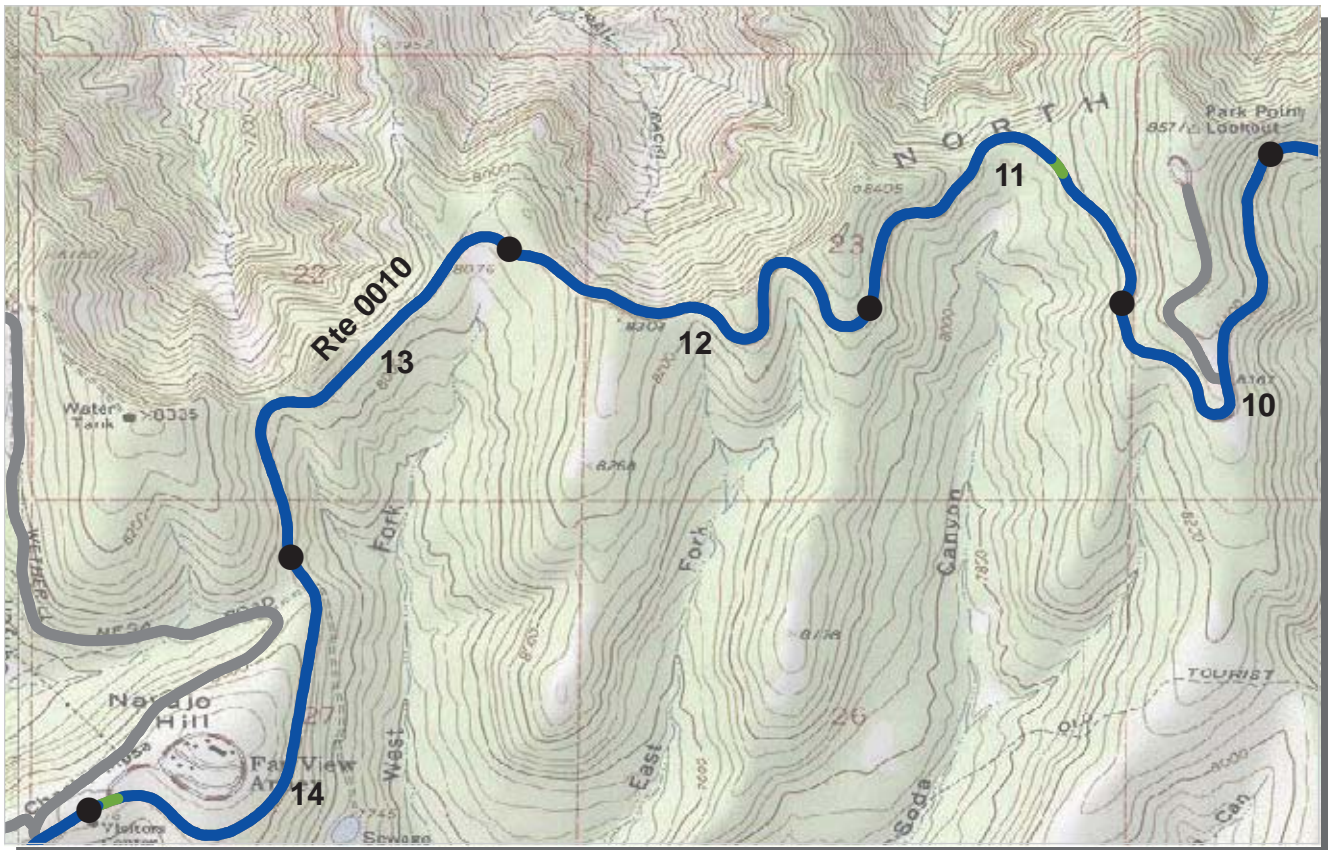
**ROUTE: 0010 CHAPIN MESA ROAD**

Section Number	5	6	7	8	9
Section Length (mi)	1.00	1.00	1.00	1.00	1.00
<b>Traffic</b>	Traffic data may be found at <a href="http://www.efl.fhwa.dot.gov">www.efl.fhwa.dot.gov</a> Click on PROGRAMS / NPS Traffic Data (Note: Not all parks have traffic data)				
<b>Cross Section Information</b>					
Number of Lanes	2	2	2	2	2
Paved Width (ft)	27	32	27	26	29
Lane Width (ft)	11	13	10	10	11
Shoulder Width Right (ft)**	0	0	0	0	0
Shoulder Width Left (ft)**	0	0	0	0	0
<b>Roadway Condition Information</b>					
SCR (Surface Condition Rating)	30	68	95	97	96
PCR (Pavement Condition Rating)	49	80	92	96	94
<b>Distress Index Values</b>					
Alligator Cracking Index	88	88	100	100	100
Longitudinal Cracking Index	87	99	100	100	100
Transverse Cracking Index	92	100	100	100	100
Patching Index	100	100	100	100	100
Rutting Index	60	81	95	97	96
Roughness Condition Index (RCI)	79	97	89	95	90

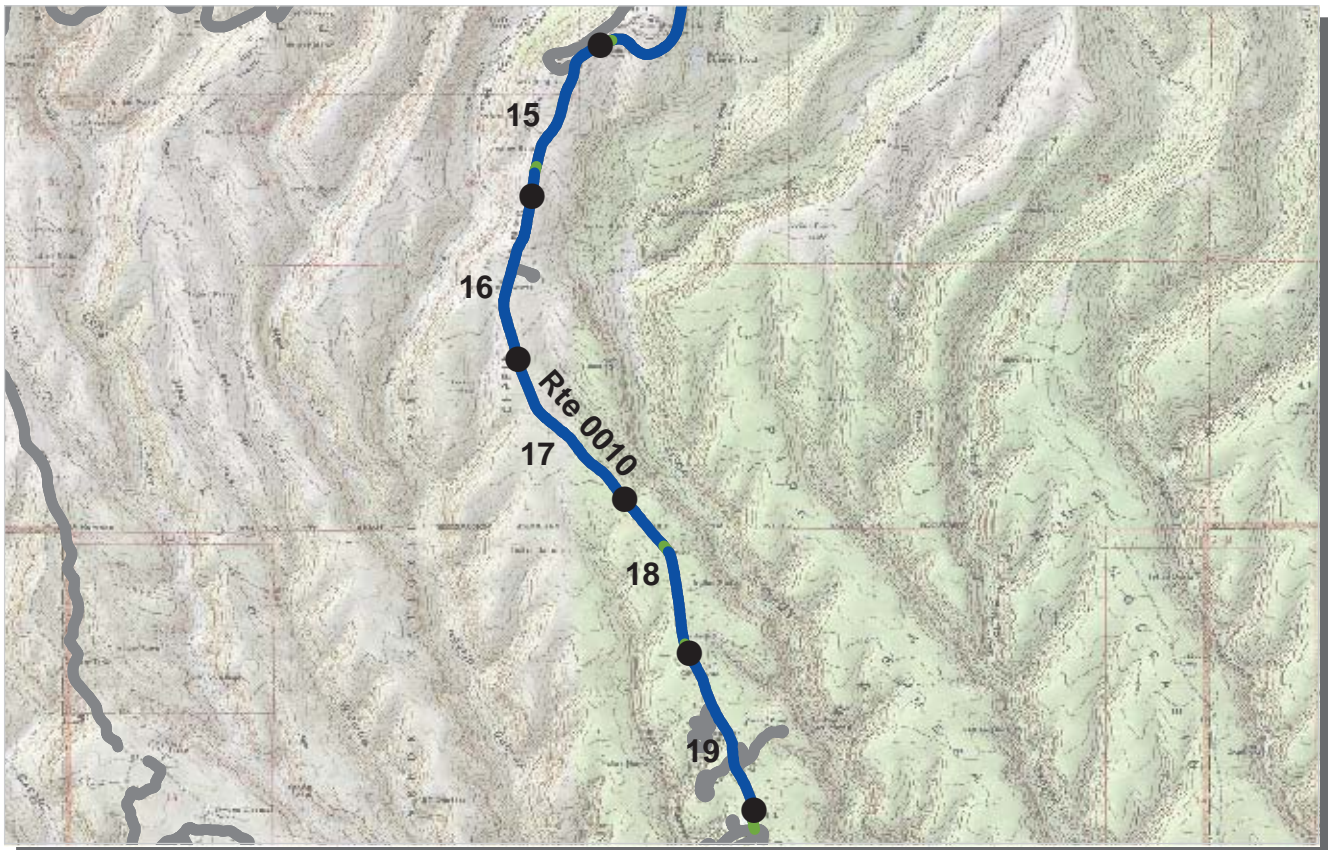
**ROUTE: 0010 CHAPIN MESA ROAD**

Section Number	10	11	12	13	14
Section Length (mi)	1.00	1.00	1.00	1.00	1.00
Traffic	AADT SADT ADT Date Traffic data may be found at <a href="http://www.efl.fhwa.dot.gov">www.efl.fhwa.dot.gov</a> Click on PROGRAMS / NPS Traffic Data (Note: Not all parks have traffic data)				
Cross Section Information					
Number of Lanes	2	2	2	2	2
Paved Width (ft)	28	29	28	27	29
Lane Width (ft)	11	10	10	10	10
Shoulder Width Right (ft)**	0	0	0	0	0
Shoulder Width Left (ft)**	0	0	0	0	0
Roadway Condition Information					
SCR (Surface Condition Rating)	99	99	98	99	98
PCR (Pavement Condition Rating)	99	99	99	99	99
Distress Index Values					
Alligator Cracking Index	100	100	100	100	100
Longitudinal Cracking Index	100	100	100	100	100
Transverse Cracking Index	100	100	100	100	100
Patching Index	100	100	100	100	99
Rutting Index	99	99	99	99	99
Roughness Condition Index (RCI)	99	99	99	100	100

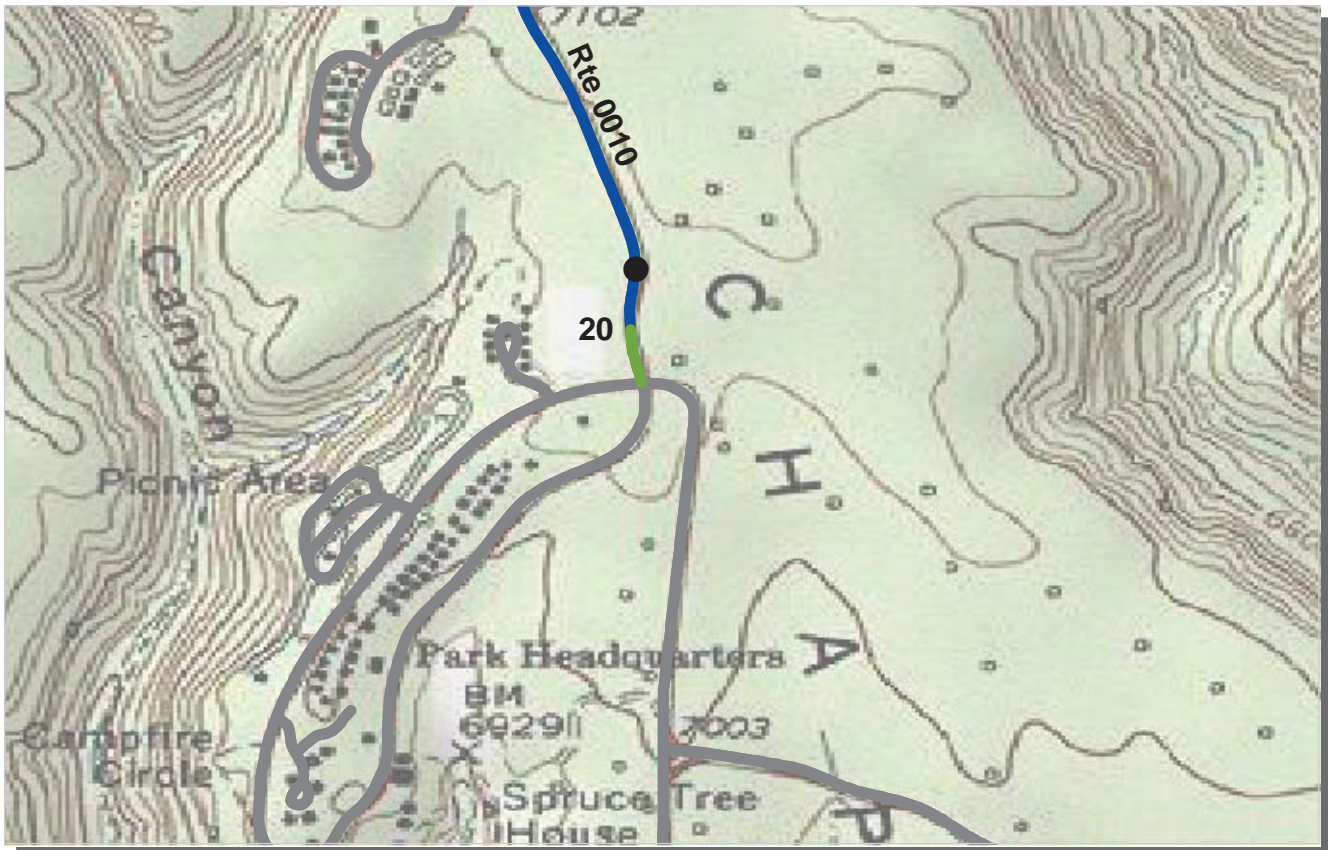
**ROUTE: 0010 CHAPIN MESA ROAD**

<i>Section Number</i>	15	16	17	18	19
<i>Section Length (mi)</i>	1.00	1.00	1.00	1.00	1.00
<i>Traffic</i>	Traffic data may be found at <a href="http://www.efl.fhwa.dot.gov">www.efl.fhwa.dot.gov</a> Click on PROGRAMS / NPS Traffic Data (Note: Not all parks have traffic data)				
<i>Cross Section Information</i>					
Number of Lanes	2	2	2	2	2
Paved Width (ft)	29	24	24	24	24
Lane Width (ft)	10	10	11	10	11
Shoulder Width Right (ft)**	0	0	0	0	0
Shoulder Width Left (ft)**	0	0	0	0	0
<i>Roadway Condition Information</i>					
SCR (Surface Condition Rating)	97	98	98	97	97
PCR (Pavement Condition Rating)	98	99	99	98	98
<i>Distress Index Values</i>					
Alligator Cracking Index	100	100	100	100	100
Longitudinal Cracking Index	100	100	100	100	100
Transverse Cracking Index	100	100	100	100	100
Patching Index	99	100	100	100	99
Rutting Index	98	98	99	97	98
Roughness Condition Index (RCI)	100	100	100	100	100

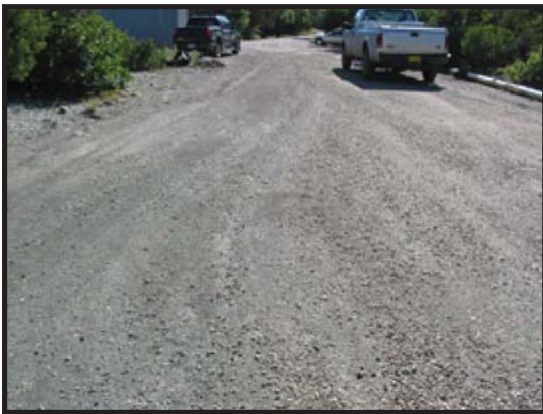
Route Number	Public / NonPublic	Date Visited		Area (sq ft)	Lane Miles *	Surface Type
0406	PUBLIC	9/10/2007		5,031	0.09	AS
Culverts	Drop Inlets	Gates	Fire Hydrants	Curb & Gutter	Curb	PCR
1	0	1	0	NO CURB AND GUTTER	NO CURB	FAIR/73

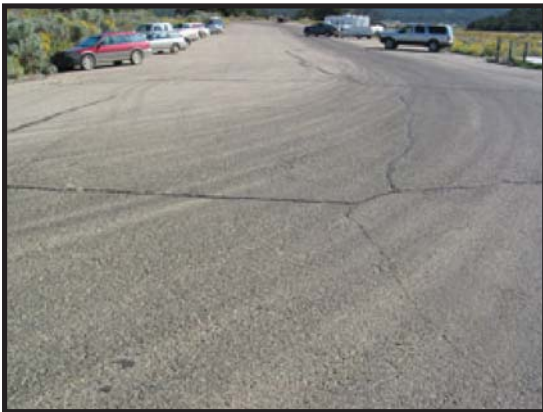
Route Number	Public / NonPublic	Date Visited		Area (sq ft)	Lane Miles *	Surface Type
0900	PUBLIC	9/10/2007		33,986	0.59	AS
Culverts	Drop Inlets	Gates	Fire Hydrants	Curb & Gutter	Curb	PCR
0	0	0	0	NO CURB AND GUTTER	ASPHALT CURB	FAIR/73

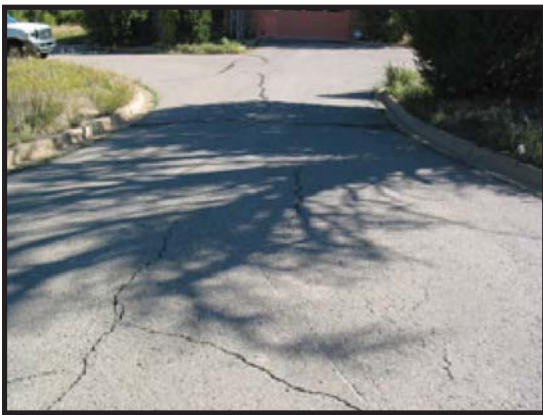
**MESA VERDE NATIONAL PARK**  
**Route 0901**  
**WATER TREATMENT PLANT PARKING AREA**  
**AT END OF ROUTE 0410**

Route Number	Public / NonPublic	Date Visited		Area (sq ft)	Lane Miles *	Surface Type
0901	NONPUBLIC	9/10/2007		4,798	0.08	AS
Culverts	Drop Inlets	Gates	Fire Hydrants	Curb & Gutter	Curb	PCR
0	0	0	1	CONCRETE CURB AND GUTTER	NO CURB	FAIR/73

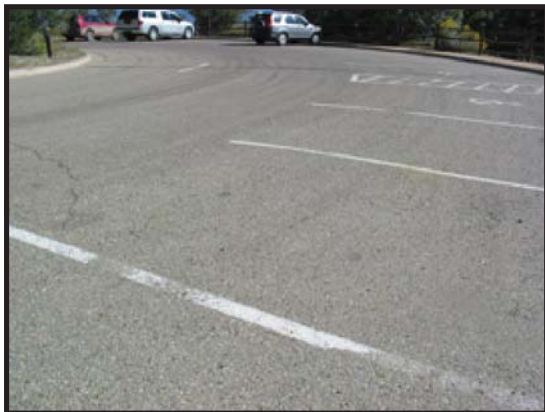
## Route 0902

Route Number	Public / NonPublic	Date Visited		Area (sq ft)	Lane Miles *	Surface Type
0902	PUBLIC	9/10/2007		10,822	0.19	AS
Culverts	Drop Inlets	Gates	Fire Hydrants	Curb & Gutter	Curb	PCR
0	1	0	0	CONCRETE CURB AND GUTTER	ASPHALT CURB	GOOD/90

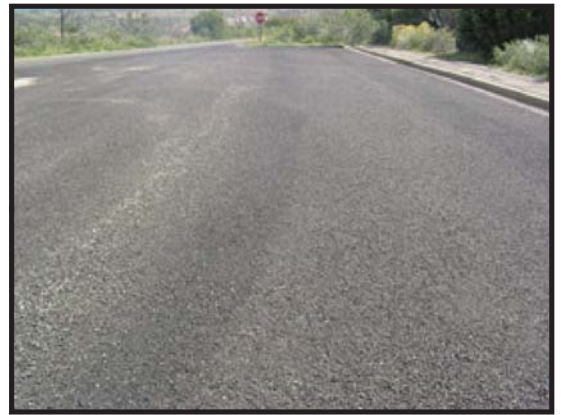
## Route 0903

Route Number	Public / NonPublic	Date Visited		Area (sq ft)	Lane Miles *	Surface Type
0903	PUBLIC	9/11/2007		6,661	0.12	AS
Culverts	Drop Inlets	Gates	Fire Hydrants	Curb & Gutter	Curb	PCR
0	0	0	0	CONCRETE CURB AND GUTTER	NO CURB	GOOD/90

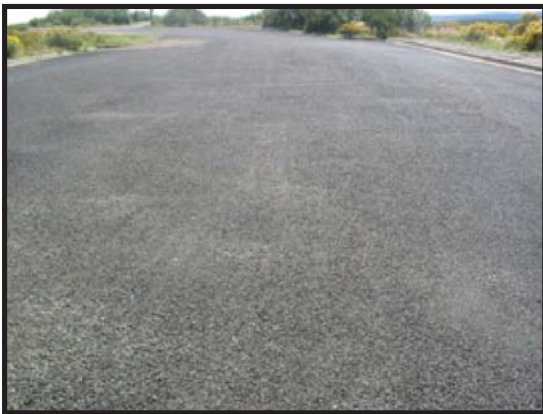
## Route 0904

Route Number	Public / NonPublic	Date Visited		Area (sq ft)	Lane Miles *	Surface Type
0904	PUBLIC	9/11/2007		9,619	0.17	AS
Culverts	Drop Inlets	Gates	Fire Hydrants	Curb & Gutter	Curb	PCR
0	0	0	0	CONCRETE CURB AND GUTTER	NO CURB	GOOD/90

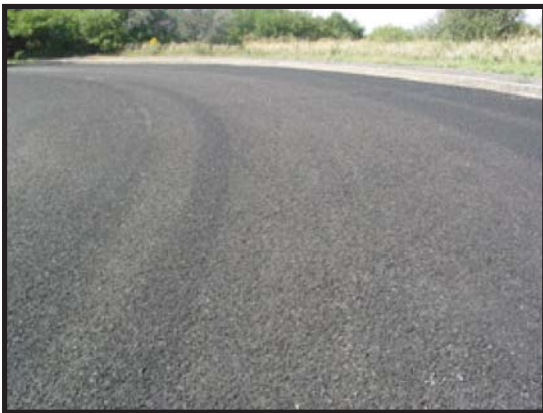
## Route 0905

Route Number	Public / NonPublic	Date Visited		Area (sq ft)	Lane Miles *	Surface Type
0905	PUBLIC	9/11/2007		9,362	0.16	AS
Culverts	Drop Inlets	Gates	Fire Hydrants	Curb & Gutter	Curb	PCR
0	1	0	0	CONCRETE CURB AND GUTTER	NO CURB	GOOD/90

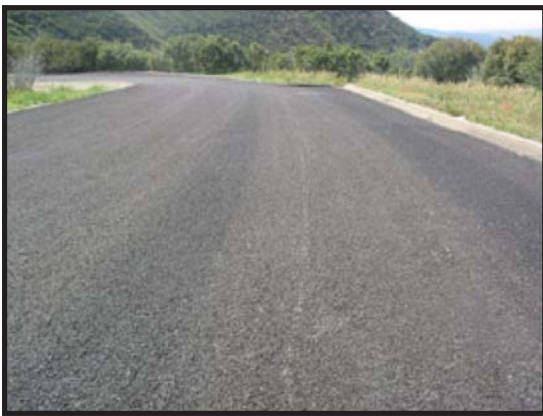
## Route 0906

Route Number	Public / NonPublic	Date Visited		Area (sq ft)	Lane Miles *	Surface Type
0906	PUBLIC	9/11/2007		7,070	0.12	AS
Culverts	Drop Inlets	Gates	Fire Hydrants	Curb & Gutter	Curb	PCR
0	0	0	0	CONCRETE CURB AND GUTTER	NO CURB	GOOD/90

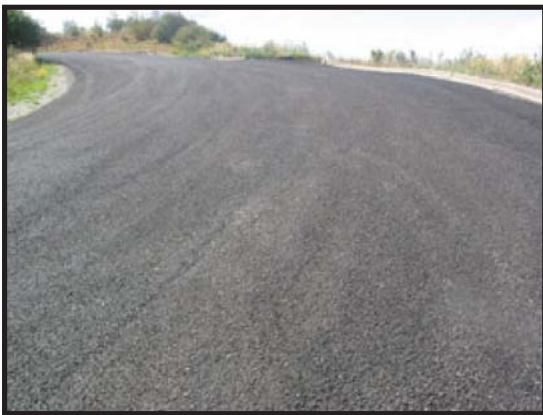
## Route 0907

Route Number	Public / NonPublic	Date Visited		Area (sq ft)	Lane Miles *	Surface Type
0907	PUBLIC	9/11/2007		9,851	0.17	AS
Culverts	Drop Inlets	Gates	Fire Hydrants	Curb & Gutter	Curb	PCR
0	0	0	0	CONCRETE CURB AND GUTTER	NO CURB	GOOD/90

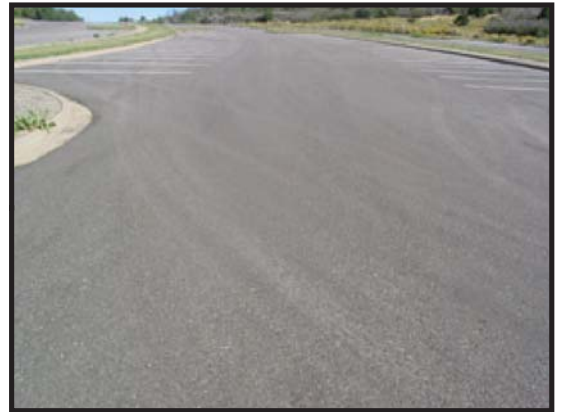
**MESA VERDE NATIONAL PARK**  
**Route 0908**  
**MOREFIELD AMPHITHEATER PARKING AREA**  
**AT END OF ROUTE 0202**

Route Number	Public / NonPublic	Date Visited		Area (sq ft)	Lane Miles *	Surface Type
0908	PUBLIC	9/10/2007		83,992	1.45	AS
Culverts	Drop Inlets	Gates	Fire Hydrants	Curb & Gutter	Curb	PCR
0	7	0	0	NO CURB AND GUTTER	CONCRETE CURB	GOOD/90

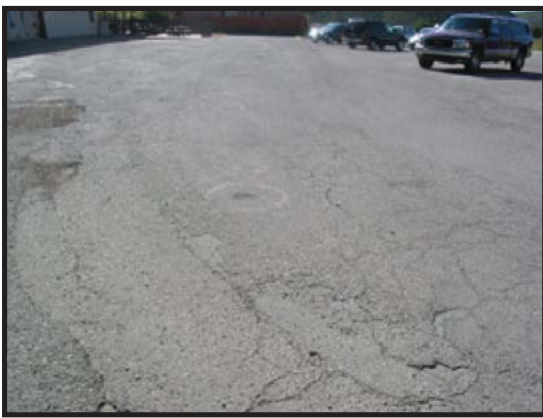
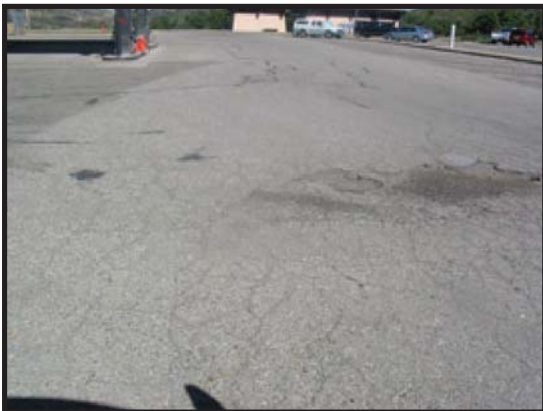
Route Number	Public / NonPublic	Date Visited		Area (sq ft)	Lane Miles *	Surface Type
0910	PUBLIC	9/10/2007		80,052	1.38	AS
Culverts	Drop Inlets	Gates	Fire Hydrants	Curb & Gutter	Curb	PCR
0	7	0	3	CONCRETE CURB AND GUTTER	NO CURB	POOR/45

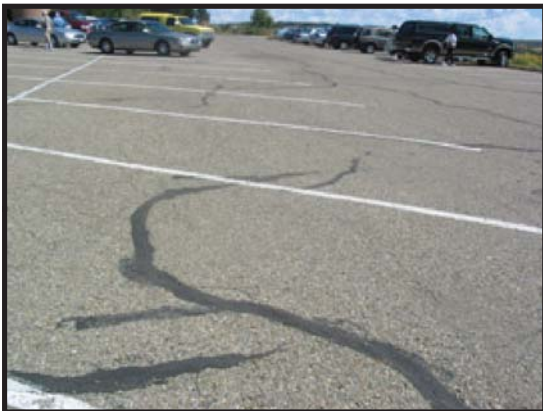
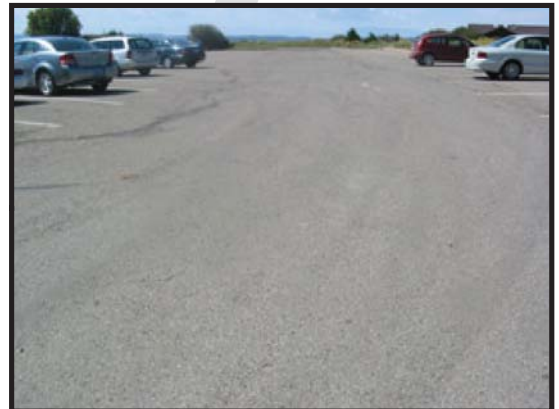
Route Number	Public / NonPublic	Date Visited		Area (sq ft)	Lane Miles *	Surface Type
0912AZ	PUBLIC	9/10/2007		55,395	0.95	AS
Culverts	Drop Inlets	Gates	Fire Hydrants	Curb & Gutter	Curb	PCR
0	1	0	1	CONCRETE CURB AND GUTTER	NO CURB	POOR/45

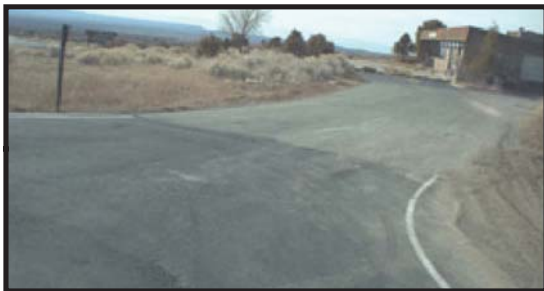
## Route 0912BZ

Route Number	Public / NonPublic	Date Visited		Area (sq ft)	Lane Miles *	Surface Type
0912BZ	PUBLIC	9/10/2007		5,629	0.10	AS
Culverts	Drop Inlets	Gates	Fire Hydrants	Curb & Gutter	Curb	PCR
0	0	0	0	CONCRETE CURB AND GUTTER	NO CURB	POOR/45

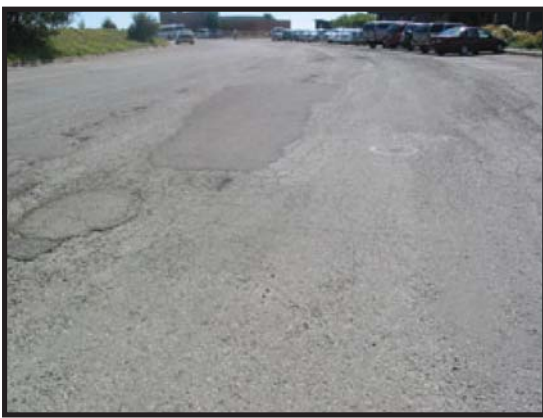
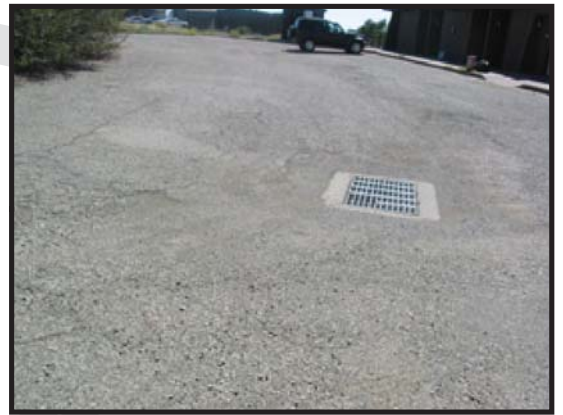
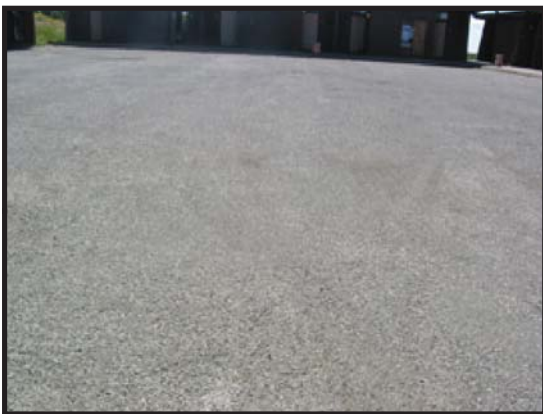
Route Number	Public / NonPublic	Date Visited		Area (sq ft)	Lane Miles *	Surface Type
0913	PUBLIC	9/10/2007		242,442	4.17	AS
Culverts	Drop Inlets	Gates	Fire Hydrants	Curb & Gutter	Curb	PCR
1	13	1	9	CONCRETE CURB AND GUTTER	NO CURB	POOR/45

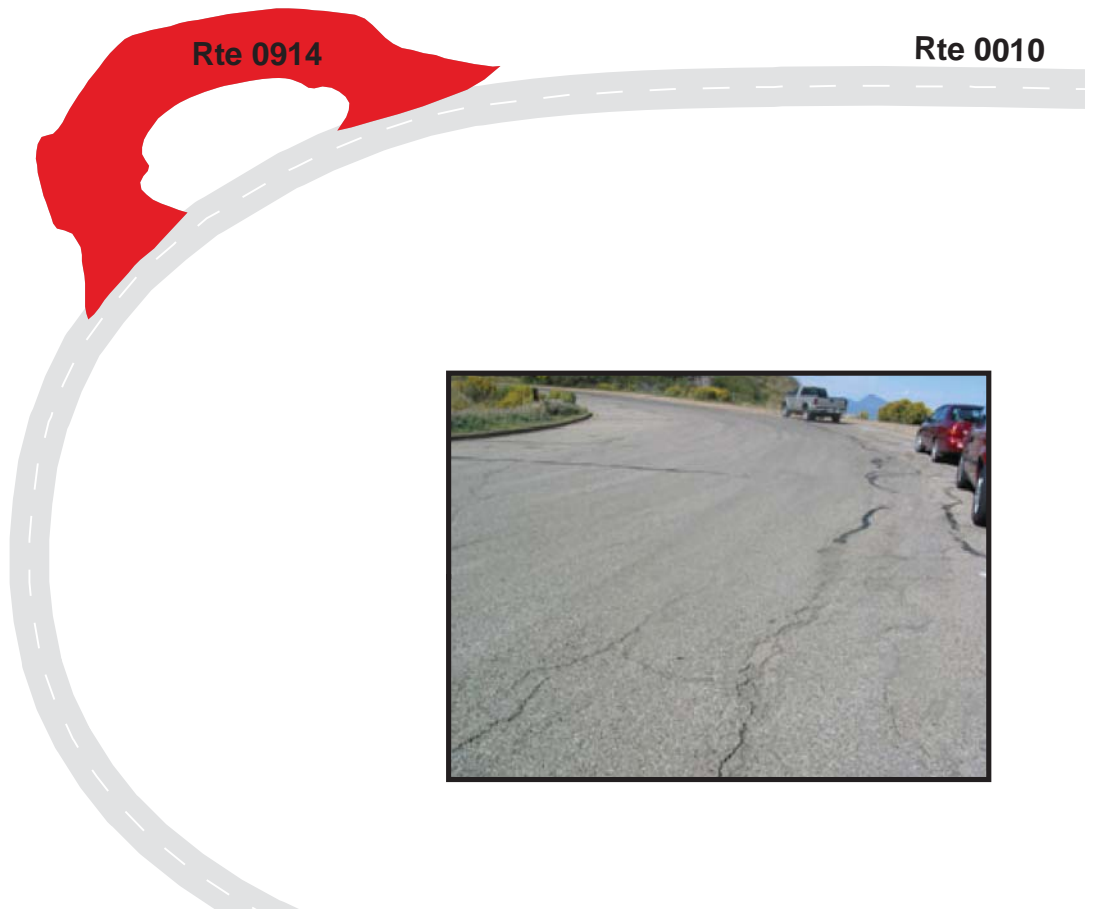
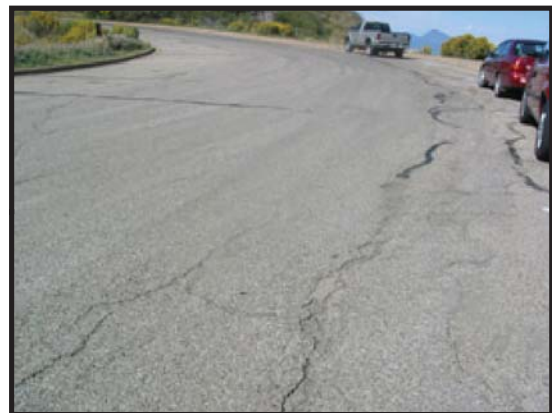
## Route 0914

Route Number	Public / NonPublic	Date Visited		Area (sq ft)	Lane Miles *	Surface Type
0914	PUBLIC	9/10/2007		14,971	0.26	AS
Culverts	Drop Inlets	Gates	Fire Hydrants	Curb & Gutter	Curb	PCR
0	1	0	0	CONCRETE CURB AND GUTTER	NO CURB	FAIR/73

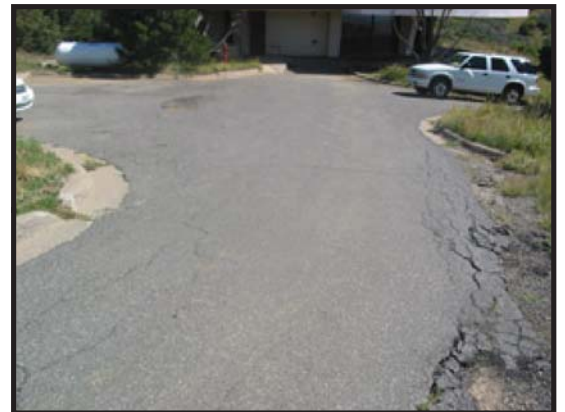
Route Number	Public / NonPublic	Date Visited		Area (sq ft)	Lane Miles *	Surface Type
0917	NONPUBLIC	9/10/2007		3,916	0.07	AS
Culverts	Drop Inlets	Gates	Fire Hydrants	Curb & Gutter	Curb	PCR
0	0	0	0	CONCRETE CURB AND GUTTER	NO CURB	POOR/45

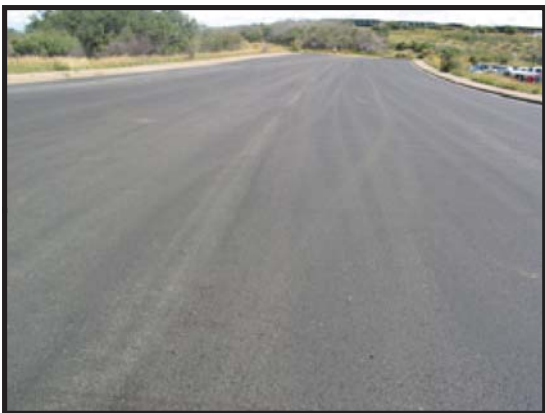
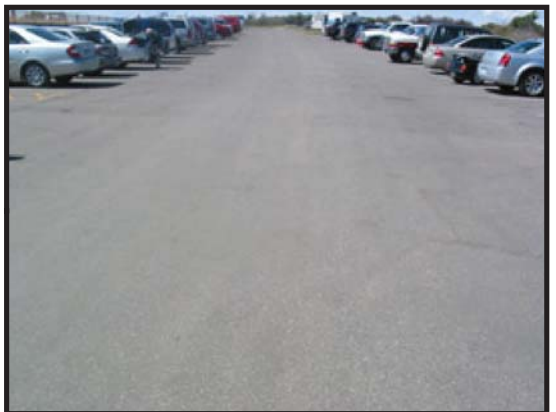
Route Number	Public / NonPublic	Date Visited		Area (sq ft)	Lane Miles *	Surface Type
0918	PUBLIC	9/10/2007		63,219	1.09	AS
Culverts	Drop Inlets	Gates	Fire Hydrants	Curb & Gutter	Curb	PCR
0	3	0	0	CONCRETE CURB AND GUTTER	NO CURB	GOOD/90

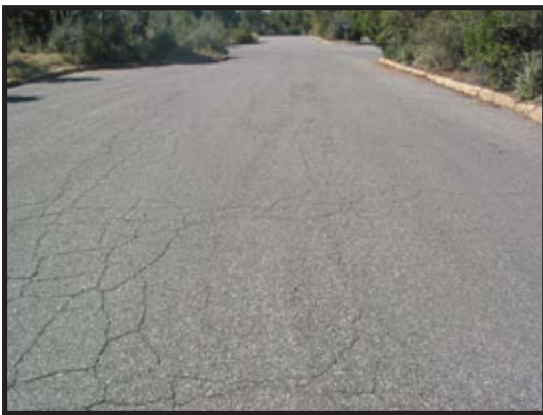
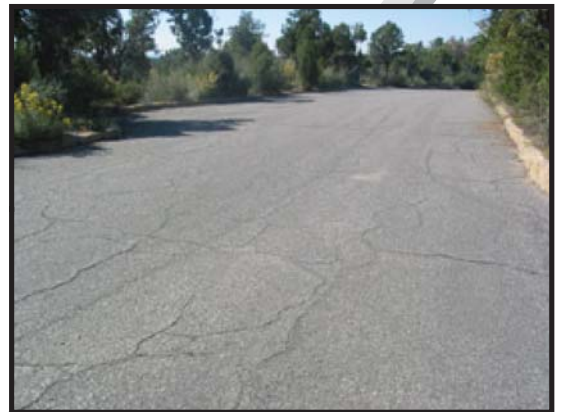
Route Number	Public / NonPublic	Date Visited		Area (sq ft)	Lane Miles *	Surface Type
0919A	PUBLIC	9/11/2007		16,250	0.28	AS
Culverts	Drop Inlets	Gates	Fire Hydrants	Curb & Gutter	Curb	PCR
0	0	0	0	NO CURB AND GUTTER	STONE CURB	POOR/45

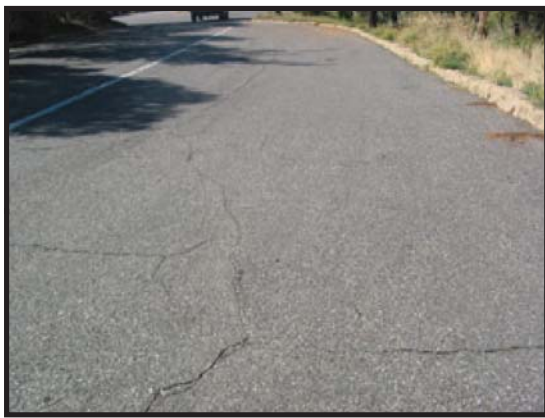
Route Number	Public / NonPublic	Date Visited		Area (sq ft)	Lane Miles *	Surface Type
0919B	PUBLIC	9/11/2007		2,030	0.04	AS
Culverts	Drop Inlets	Gates	Fire Hydrants	Curb & Gutter	Curb	PCR
0	0	0	0	NO CURB AND GUTTER	STONE CURB	FAIR/73

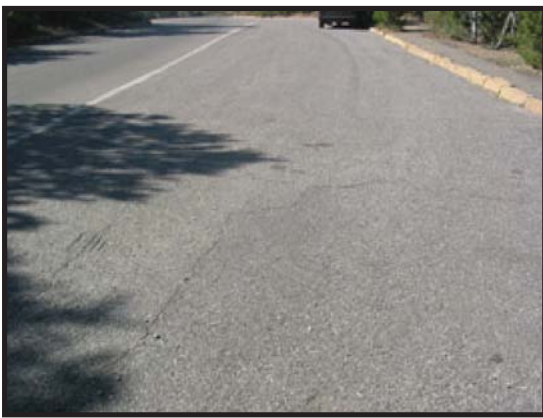
Route Number	Public / NonPublic	Date Visited		Area (sq ft)	Lane Miles *	Surface Type
0919C	PUBLIC	9/11/2007		2,945	0.05	AS
Culverts	Drop Inlets	Gates	Fire Hydrants	Curb & Gutter	Curb	PCR
0	0	0	0	NO CURB AND GUTTER	STONE CURB	FAIR/73

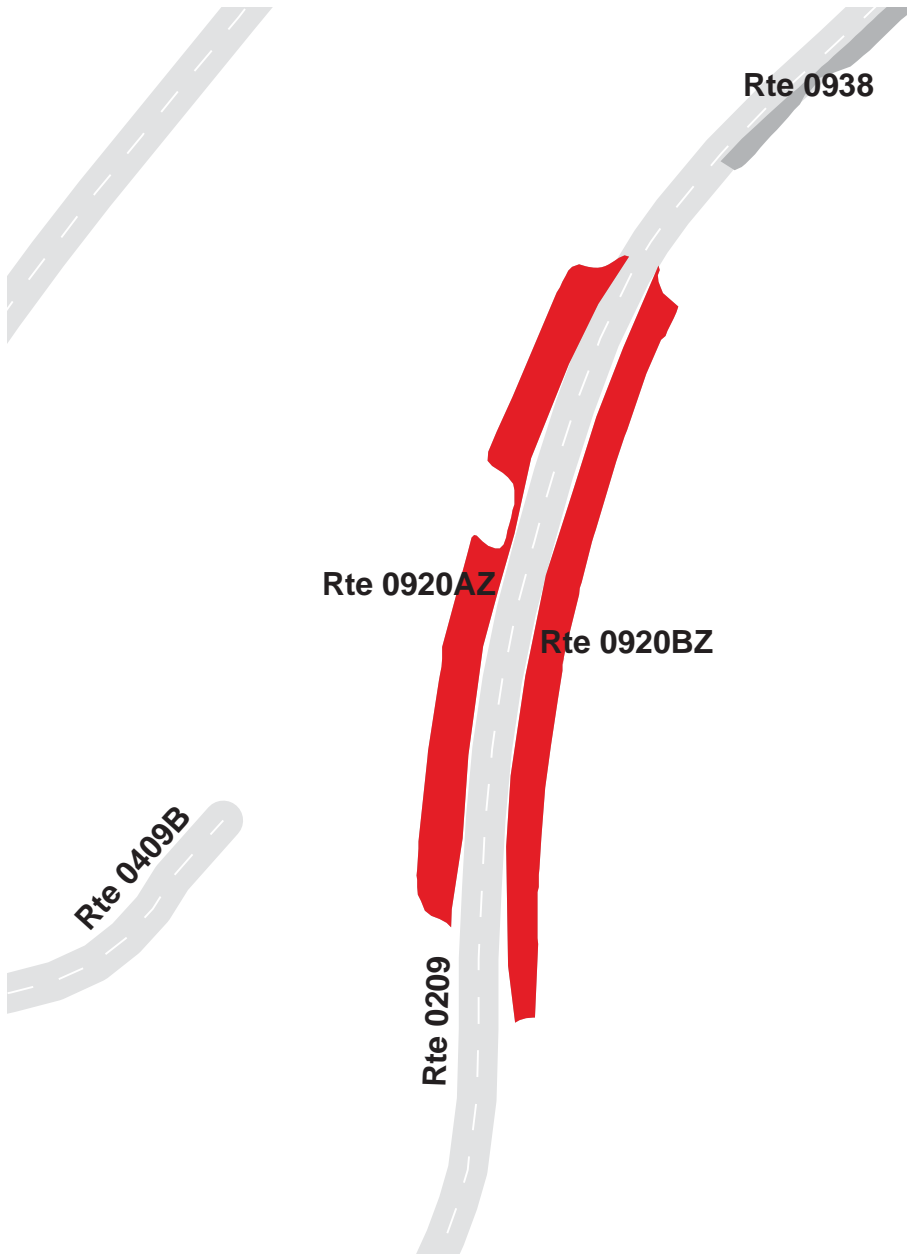
Route Number	Public / NonPublic	Date Visited		Area (sq ft)	Lane Miles *	Surface Type
0920ZZ	PUBLIC	9/11/2007		22,176	0.38	AS
Culverts	Drop Inlets	Gates	Fire Hydrants	Curb & Gutter	Curb	PCR
0	2	0	1	NO CURB AND GUTTER	NO CURB	SUMMARY/73

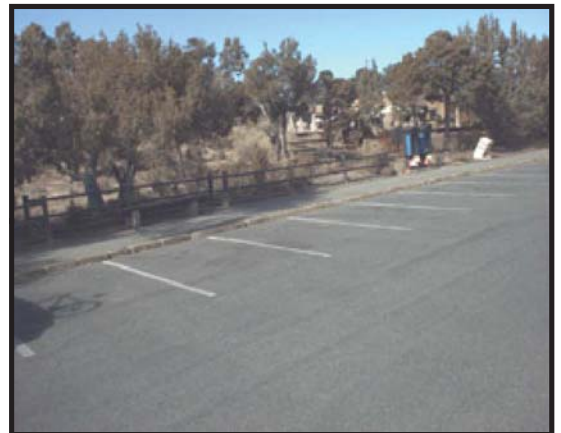
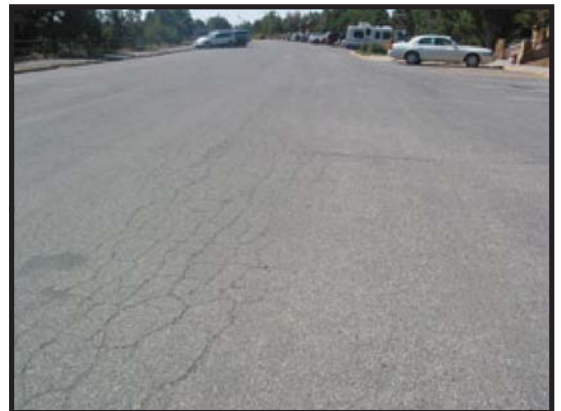
Route Number	Public / NonPublic	Date Visited		Area (sq ft)	Lane Miles *	Surface Type
0920AZ	PUBLIC	9/11/2007		11,169	0.19	AS
Culverts	Drop Inlets	Gates	Fire Hydrants	Curb & Gutter	Curb	PCR
0	2	0	1	NO CURB AND GUTTER	STONE CURB	FAIR/73

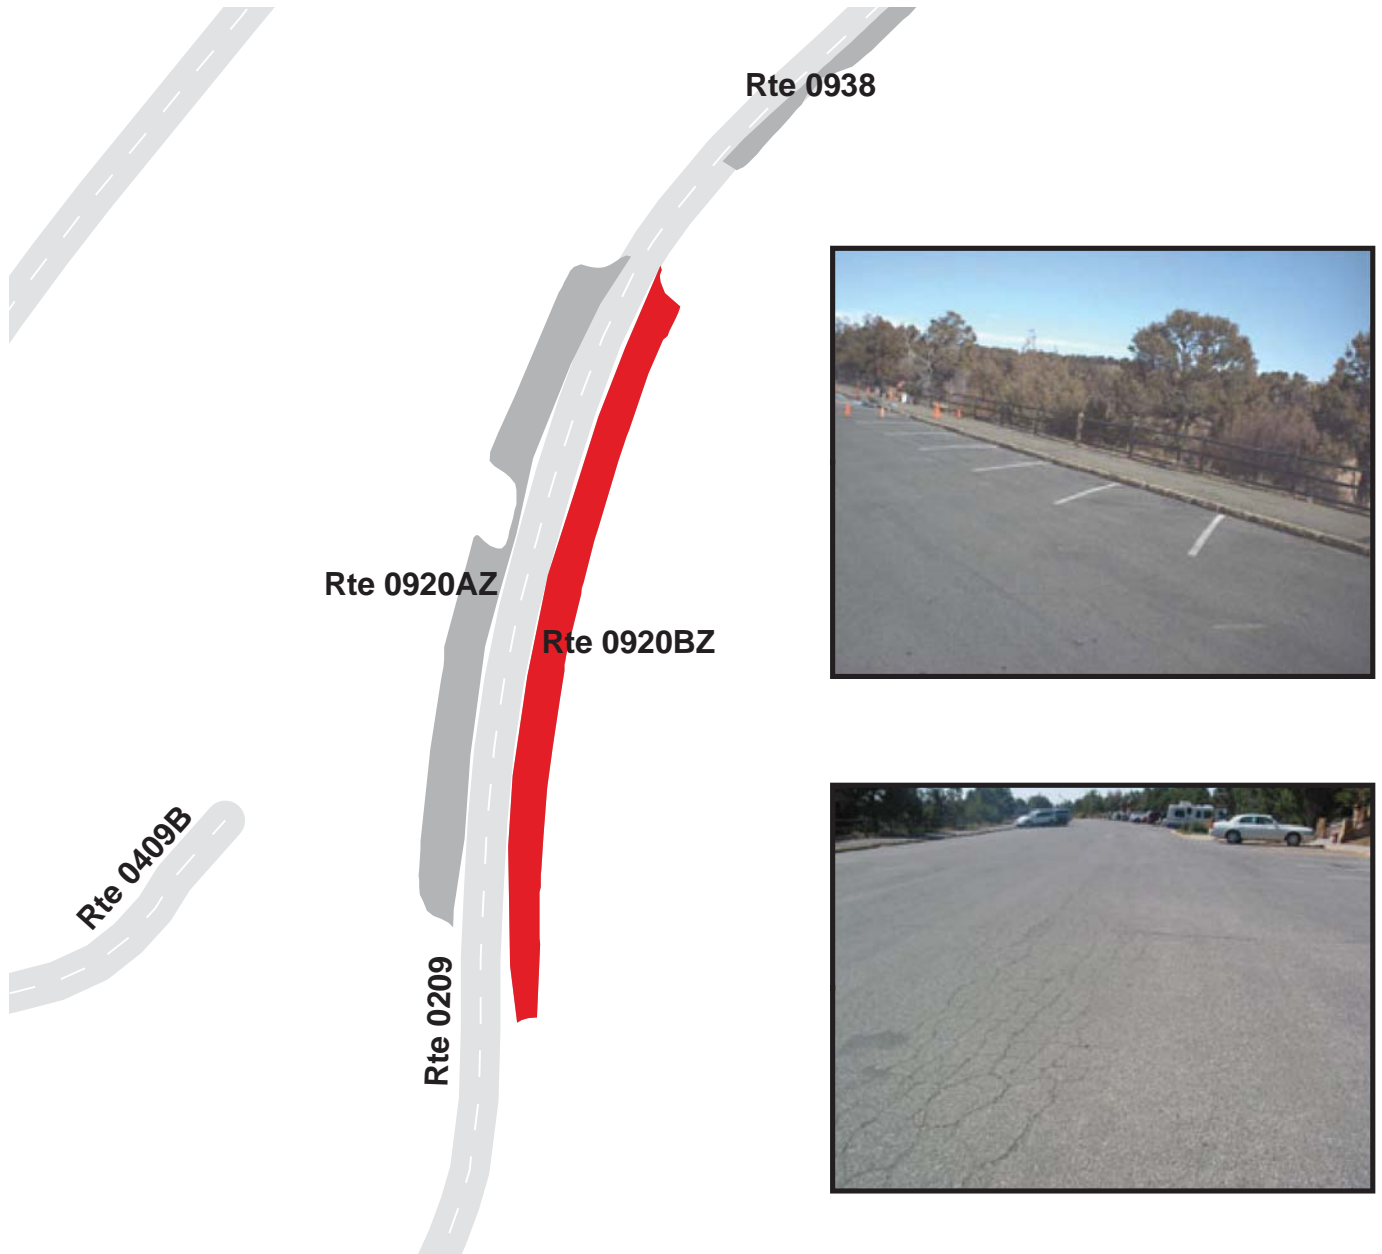
Route Number	Public / NonPublic	Date Visited		Area (sq ft)	Lane Miles *	Surface Type
0920BZ	PUBLIC	9/11/2007		11,007	0.19	AS
Culverts	Drop Inlets	Gates	Fire Hydrants	Curb & Gutter	Curb	PCR
0	0	0	0	NO CURB AND GUTTER	STONE CURB	FAIR/73

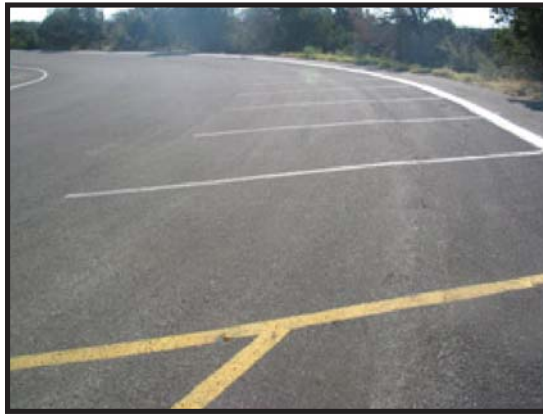
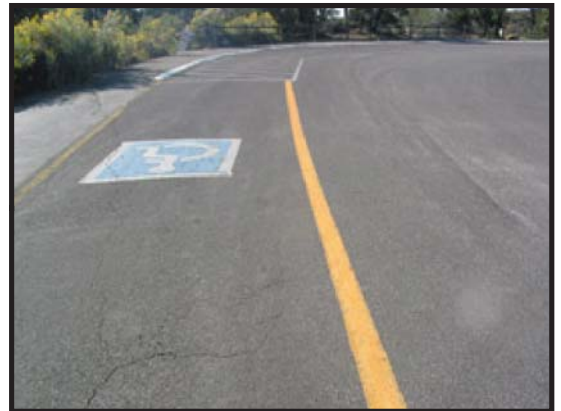
Route Number	Public / NonPublic	Date Visited		Area (sq ft)	Lane Miles *	Surface Type
0921	PUBLIC	9/11/2007		20,977	0.36	AS
Culverts	Drop Inlets	Gates	Fire Hydrants	Curb & Gutter	Curb	PCR
0	0	0	0	NO CURB AND GUTTER	ASPHALT CURB	GOOD/90

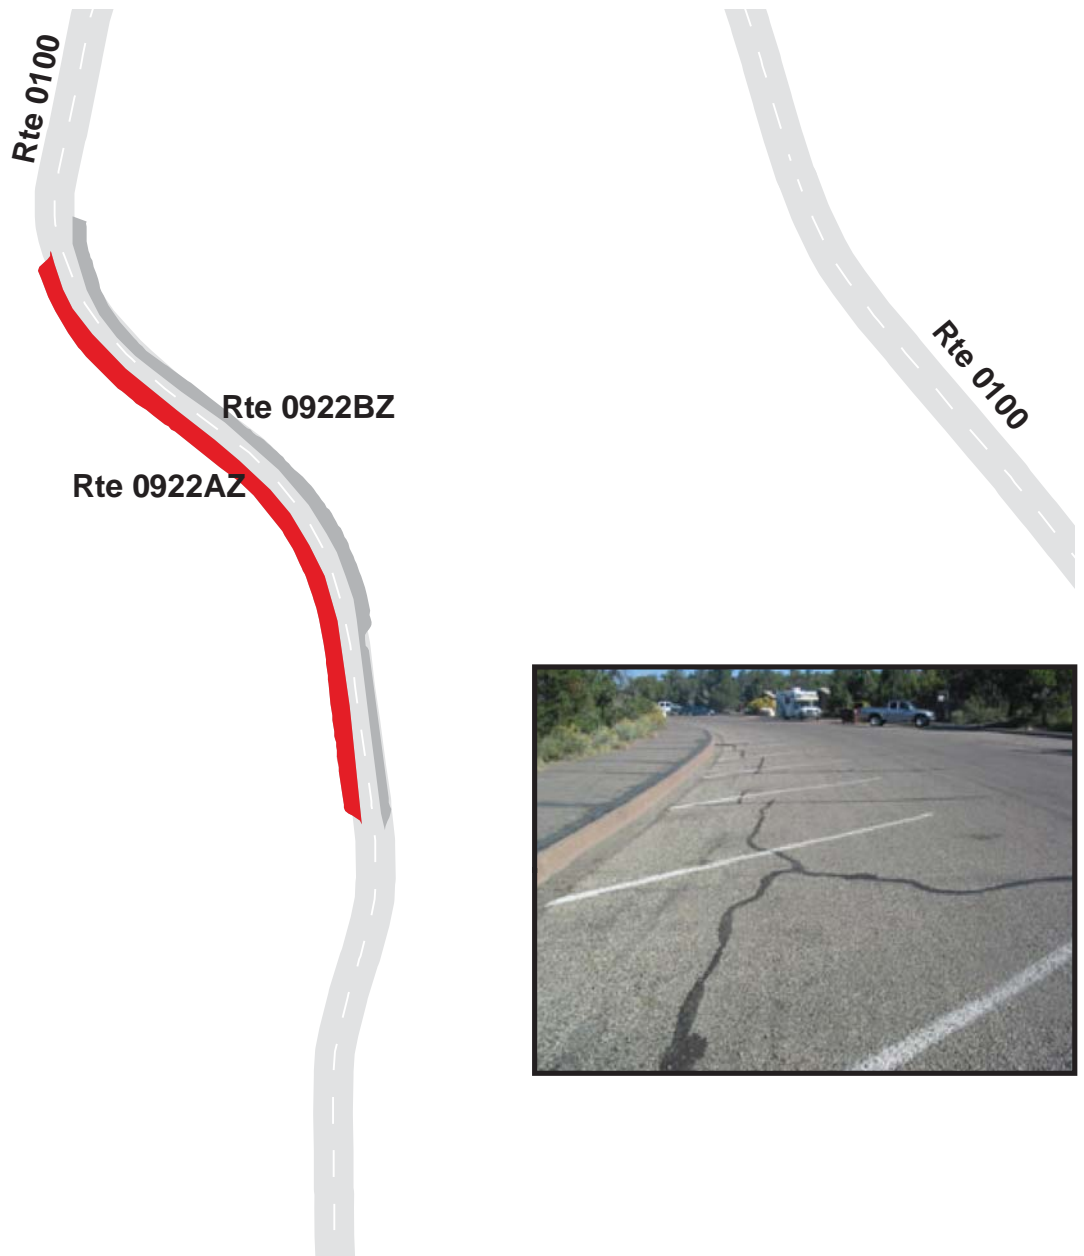
Route Number	Public / NonPublic	Date Visited		Area (sq ft)	Lane Miles *	Surface Type
0922AZ	PUBLIC	9/11/2007		16,843	0.29	AS
Culverts	Drop Inlets	Gates	Fire Hydrants	Curb & Gutter	Curb	PCR
0	3	0	0	CONCRETE CURB AND GUTTER	NO CURB	FAIR/73

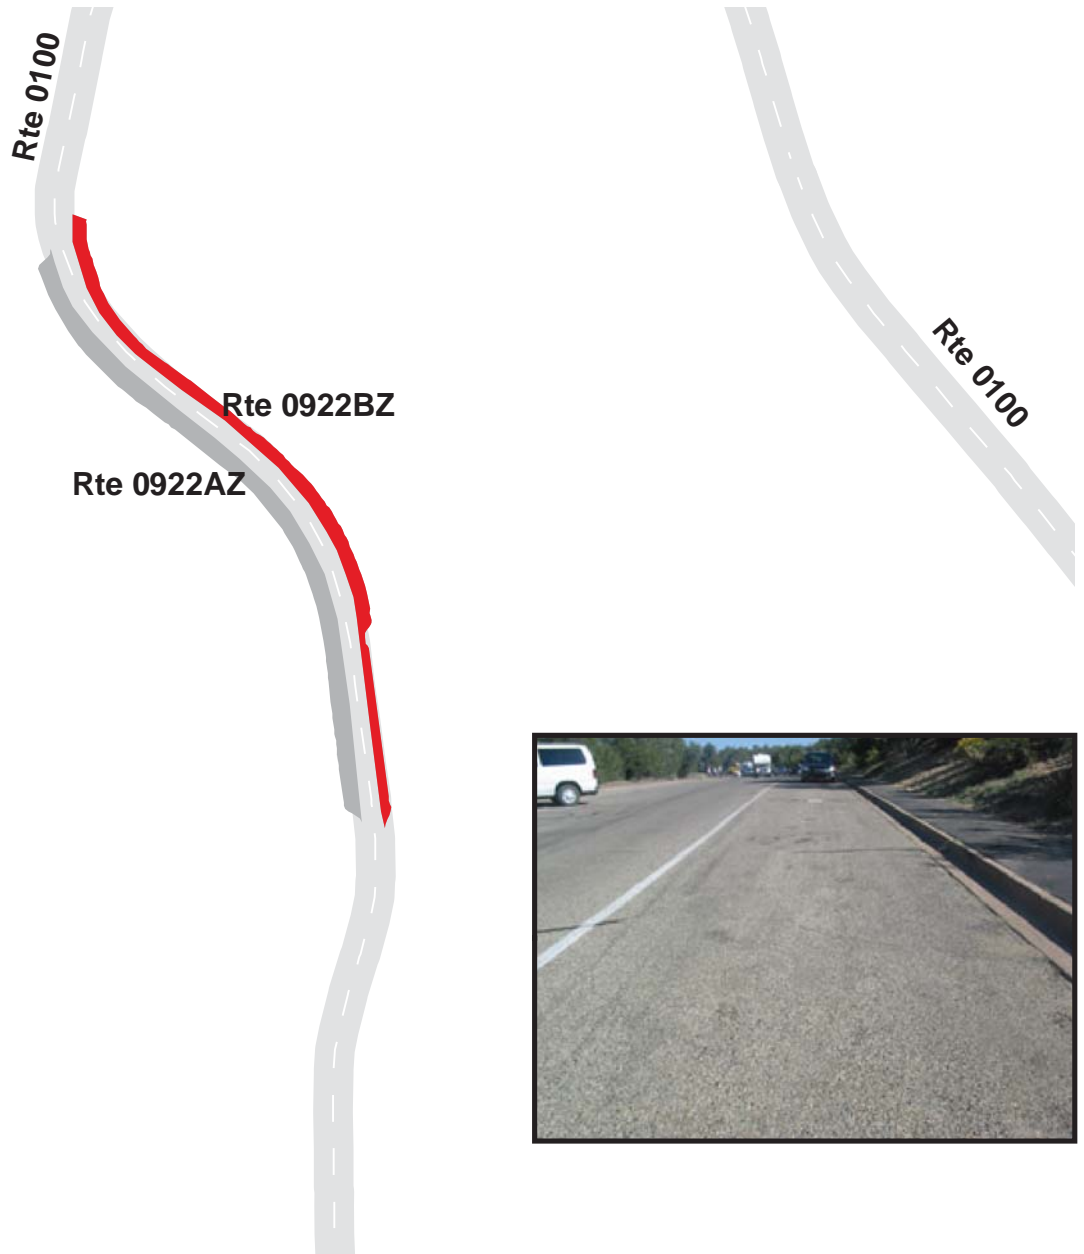
Route Number	Public / NonPublic	Date Visited		Area (sq ft)	Lane Miles *	Surface Type
0922BZ	PUBLIC	9/11/2007		12,062	0.21	AS
Culverts	Drop Inlets	Gates	Fire Hydrants	Curb & Gutter	Curb	PCR
0	0	0	0	CONCRETE CURB AND GUTTER	NO CURB	FAIR/73

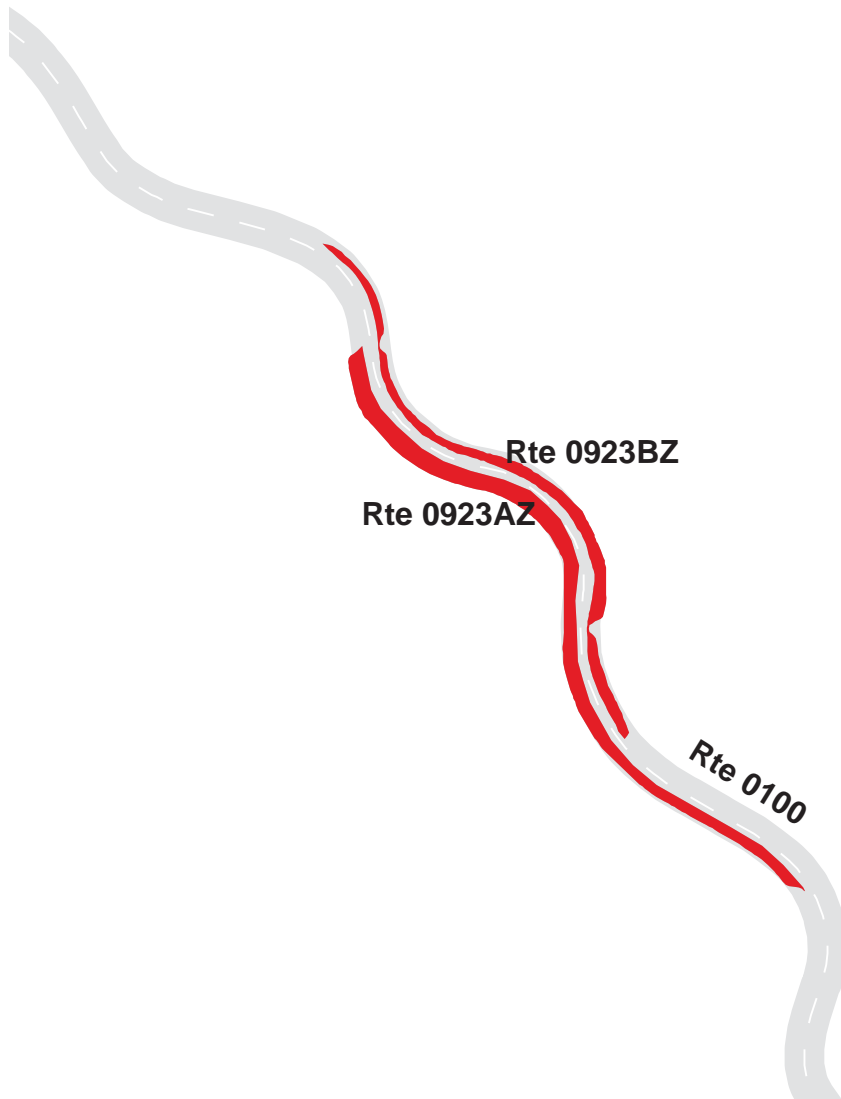
Route Number	Public / NonPublic	Date Visited		Area (sq ft)	Lane Miles *	Surface Type
0923ZZ	PUBLIC	9/11/2007		32,531	0.56	AS
Culverts	Drop Inlets	Gates	Fire Hydrants	Curb & Gutter	Curb	PCR
0	3	0	0	CONCRETE CURB AND GUTTER	NO CURB	SUMMARY/73

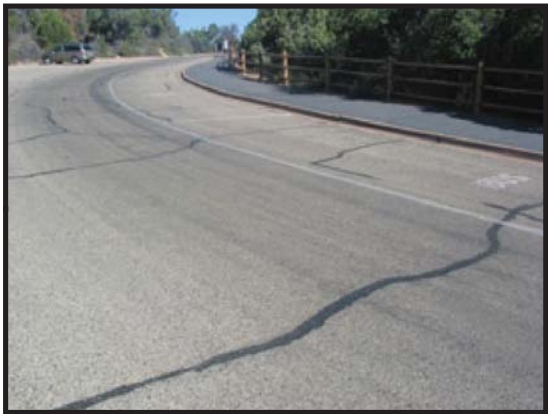
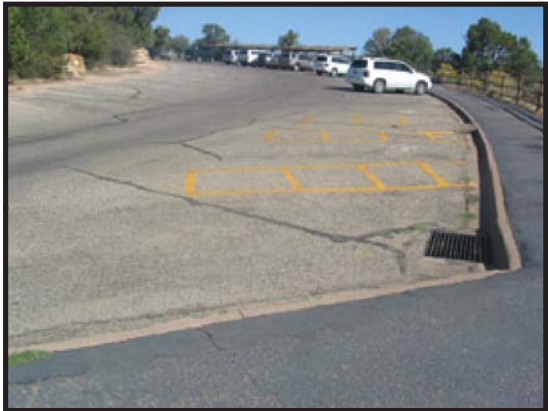
Route Number	Public / NonPublic	Date Visited		Area (sq ft)	Lane Miles *	Surface Type
0923BZ	PUBLIC	9/11/2007		11,536	0.20	AS
Culverts	Drop Inlets	Gates	Fire Hydrants	Curb & Gutter	Curb	PCR
0	3	0	0	CONCRETE CURB AND GUTTER	NO CURB	FAIR/73

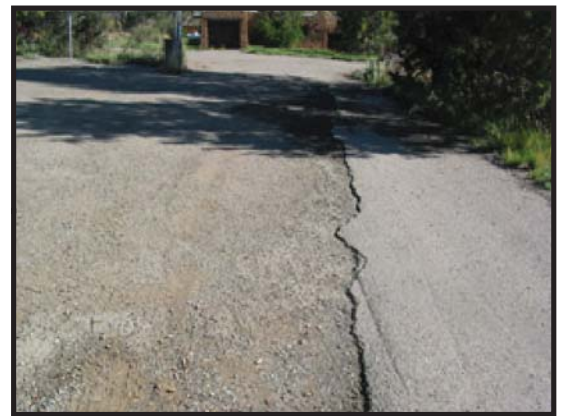
Route Number	Public / NonPublic	Date Visited		Area (sq ft)	Lane Miles *	Surface Type
0924	NONPUBLIC	9/10/2007		6,565	0.11	AS
Culverts	Drop Inlets	Gates	Fire Hydrants	Curb & Gutter	Curb	PCR
0	1	0	1	NO CURB AND GUTTER	NO CURB	FAIR/73

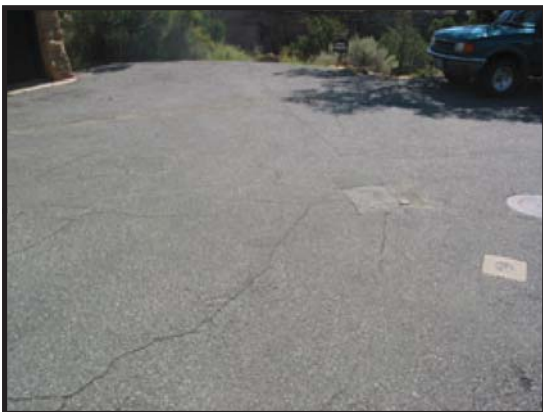
Route Number	Public / NonPublic	Date Visited		Area (sq ft)	Lane Miles *	Surface Type
0925	NONPUBLIC	9/11/2007		4,460	0.08	AS
Culverts	Drop Inlets	Gates	Fire Hydrants	Curb & Gutter	Curb	PCR
1	1	0	1	NO CURB AND GUTTER	NO CURB	FAIR/73
