**The Road Inventory  
of  
Mesa Verde National Park  
MEVE – 1490  
Cycle 4**

**Prepared By: Federal Highway Administration  
Road Inventory Program  
Cycle 4**

# Mesa Verde National Park in Colorado

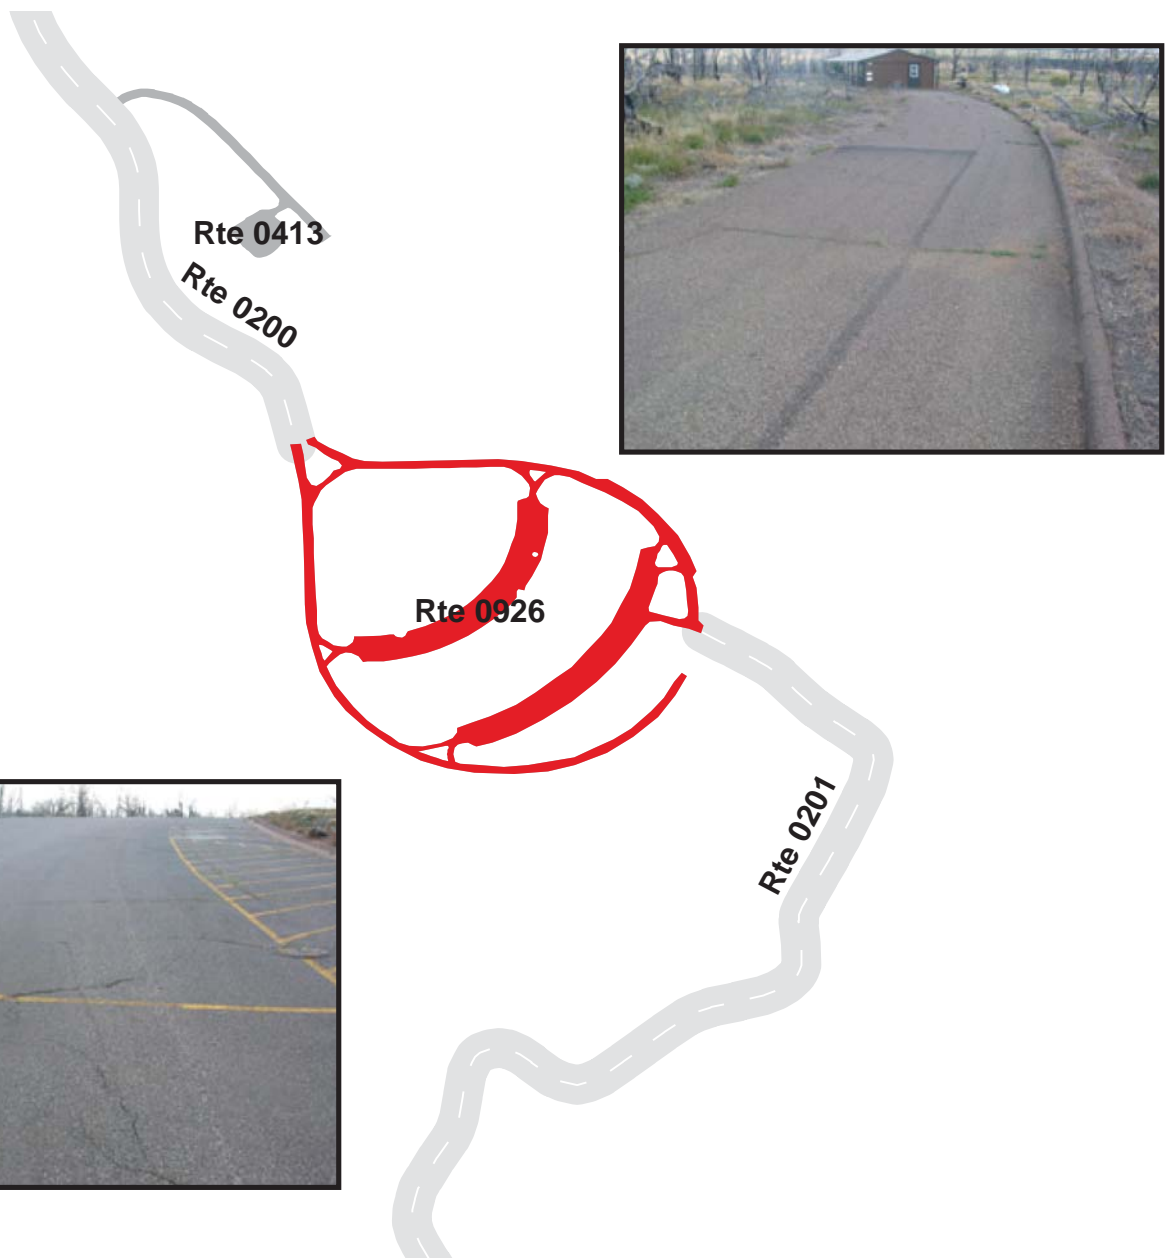
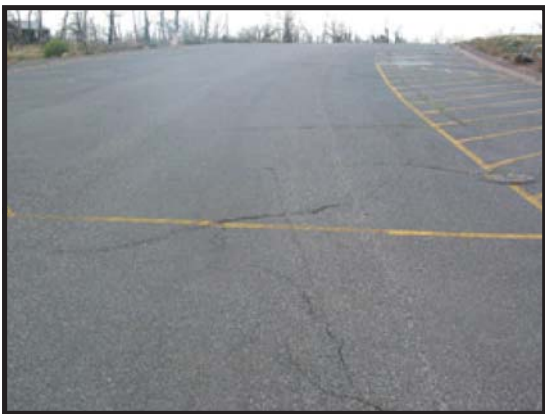
Route Number	Public / NonPublic	Date Visited		Area (sq ft)	Lane Miles *	Surface Type
0926	NONPUBLIC	9/11/2007		119,720	2.06	AS
Culverts	Drop Inlets	Gates	Fire Hydrants	Curb & Gutter	Curb	PCR
0	0	0	0	CONCRETE CURB AND GUTTER	ASPHALT CURB	FAIR/73

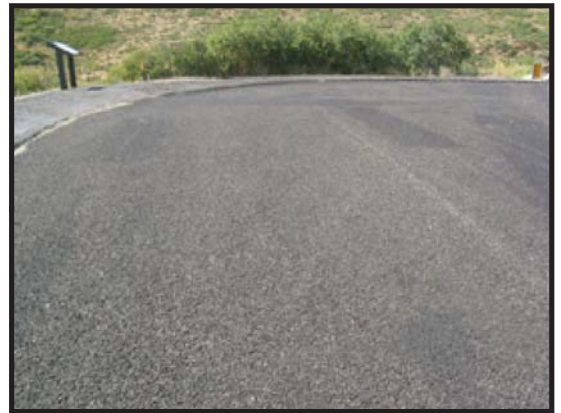
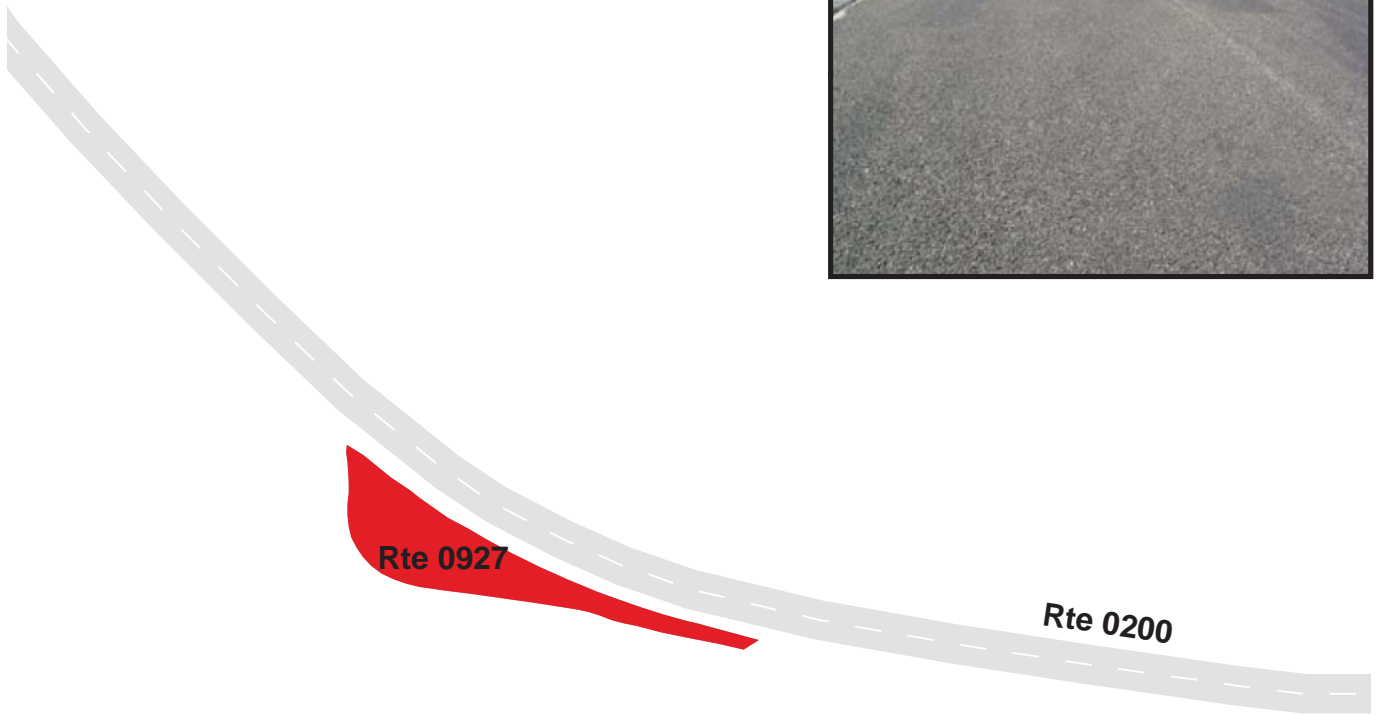
Route Number	Public / NonPublic	Date Visited		Area (sq ft)	Lane Miles *	Surface Type
0927	PUBLIC	9/11/2007		3,236	0.06	AS
Culverts	Drop Inlets	Gates	Fire Hydrants	Curb & Gutter	Curb	PCR
0	0	0	0	NO CURB AND GUTTER	ASPHALT CURB	GOOD/90

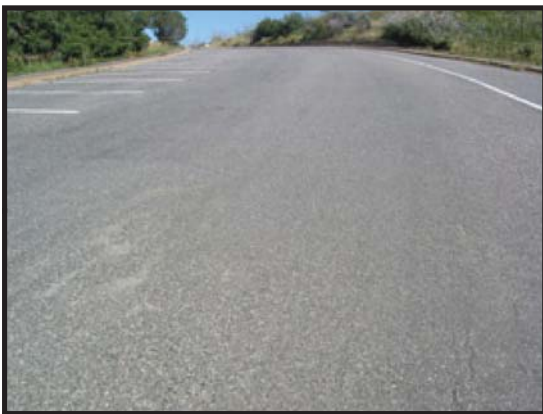
Route Number	Public / NonPublic	Date Visited		Area (sq ft)	Lane Miles *	Surface Type
0929	PUBLIC	9/10/2007		29,108	0.50	AS
Culverts	Drop Inlets	Gates	Fire Hydrants	Curb & Gutter	Curb	PCR
2	1	0	0	CONCRETE CURB AND GUTTER	STONE CURB	FAIR/73

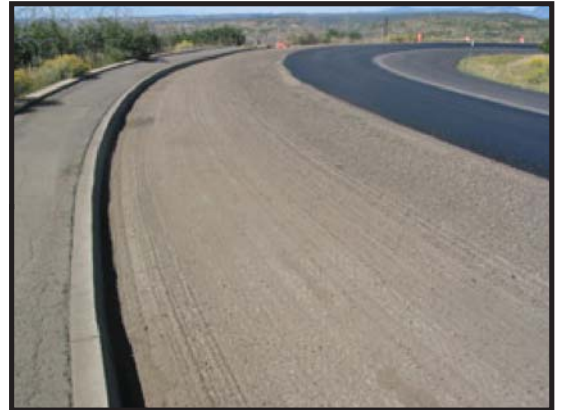
Route Number	Public / NonPublic	Date Visited		Area (sq ft)	Lane Miles *	Surface Type
0930	PUBLIC	N/A		6,136	0.11	AS
Culverts	Drop Inlets	Gates	Fire Hydrants	Curb & Gutter	Curb	PCR
0	0	0	0	N/A	N/A	NC/N/A

**NOTE: C4-UNDER CONSTRUCTION AT TIME OF ROUTE ID VISIT**

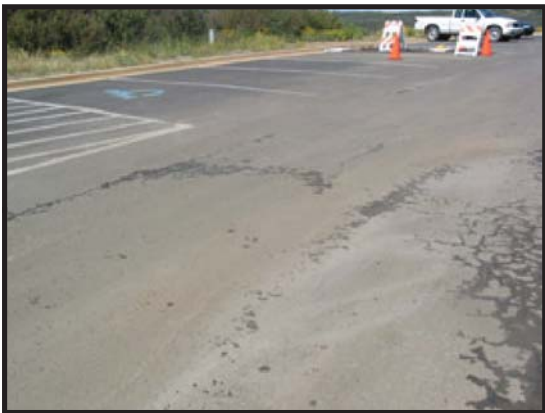
Route Number	Public / NonPublic	Date Visited		Area (sq ft)	Lane Miles *	Surface Type
0931A	NONPUBLIC	9/10/2007		4,097	0.07	AS
Culverts	Drop Inlets	Gates	Fire Hydrants	Curb & Gutter	Curb	PCR
0	0	0	0	CONCRETE CURB AND GUTTER	NO CURB	EXCELLENT/97

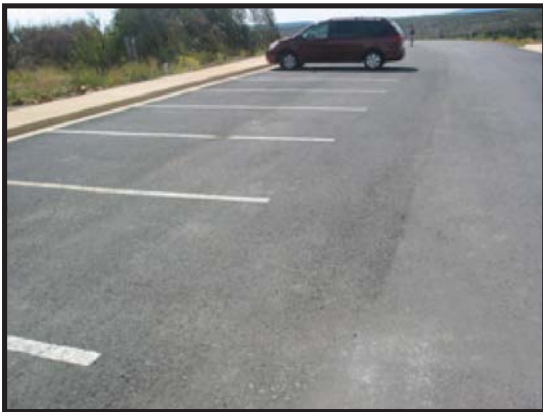
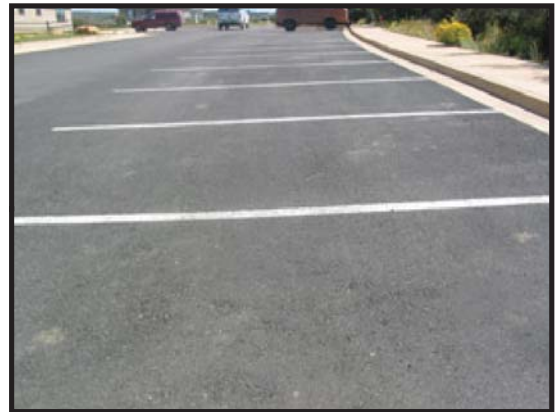
Route Number	Public / NonPublic	Date Visited		Area (sq ft)	Lane Miles *	Surface Type
0931B	NONPUBLIC	9/11/2007		3,348	0.06	AS
Culverts	Drop Inlets	Gates	Fire Hydrants	Curb & Gutter	Curb	PCR
0	0	0	1	CONCRETE CURB AND GUTTER	NO CURB	EXCELLENT/97

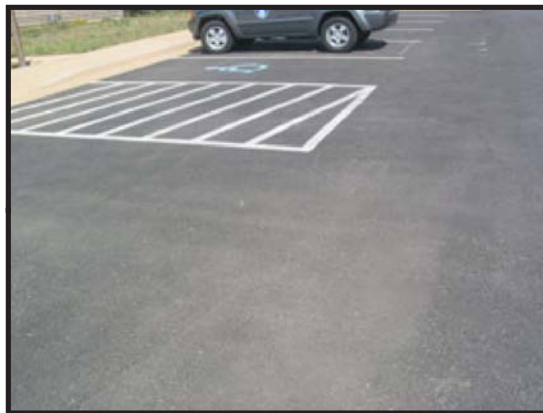
Route Number	Public / NonPublic	Date Visited		Area (sq ft)	Lane Miles *	Surface Type
0931C	NONPUBLIC	9/11/2007		1,594	0.03	AS
Culverts	Drop Inlets	Gates	Fire Hydrants	Curb & Gutter	Curb	PCR
0	0	0	0	CONCRETE CURB AND GUTTER	NO CURB	EXCELLENT/97

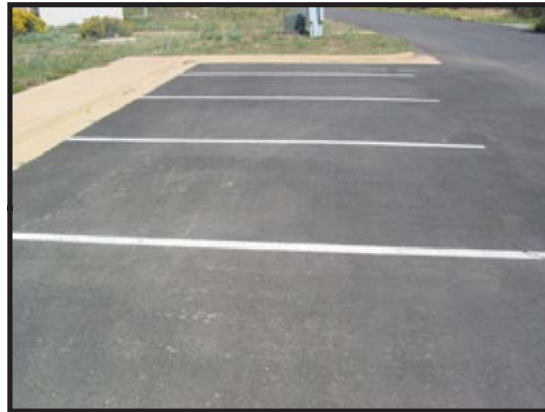
Route Number	Public / NonPublic	Date Visited		Area (sq ft)	Lane Miles *	Surface Type
0931E	NONPUBLIC	9/11/2007		954	0.02	AS
Culverts	Drop Inlets	Gates	Fire Hydrants	Curb & Gutter	Curb	PCR
0	0	0	0	CONCRETE CURB AND GUTTER	NO CURB	EXCELLENT/97

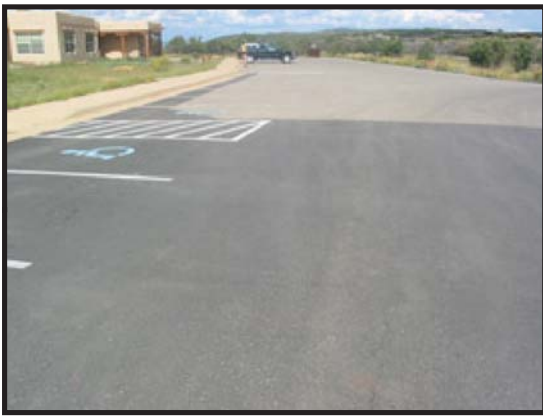
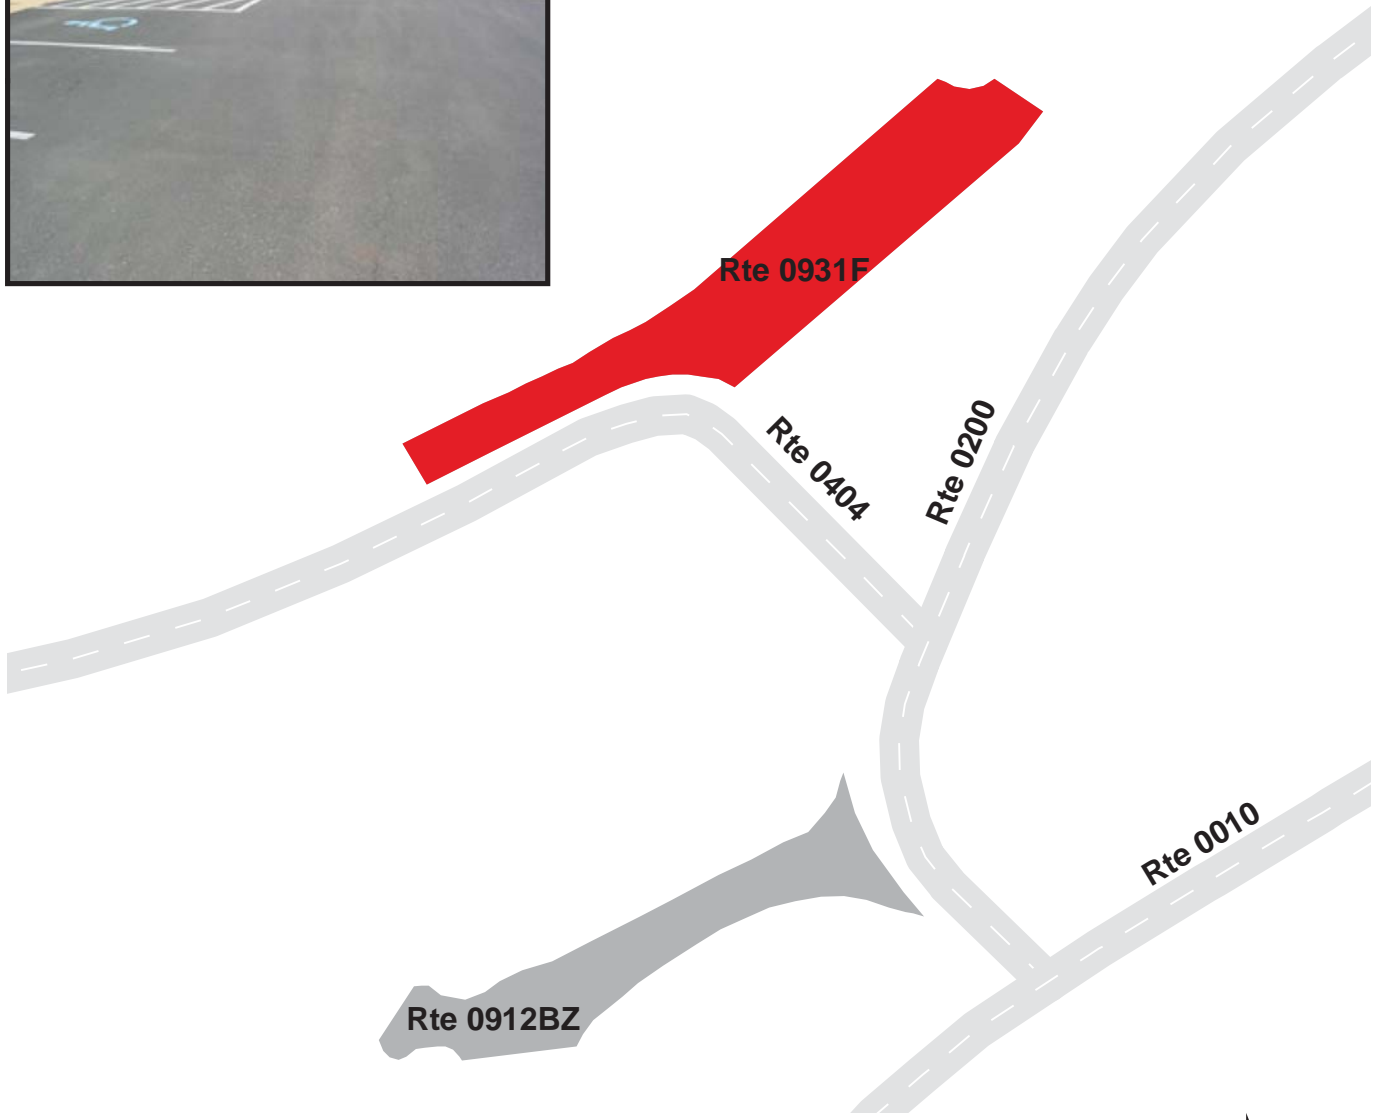
Route Number	Public / NonPublic	Date Visited		Area (sq ft)	Lane Miles *	Surface Type
0931F	NONPUBLIC	9/11/2007		8,844	0.15	AS
Culverts	Drop Inlets	Gates	Fire Hydrants	Curb & Gutter	Curb	PCR
0	0	0	1	CONCRETE CURB AND GUTTER	NO CURB	EXCELLENT/97

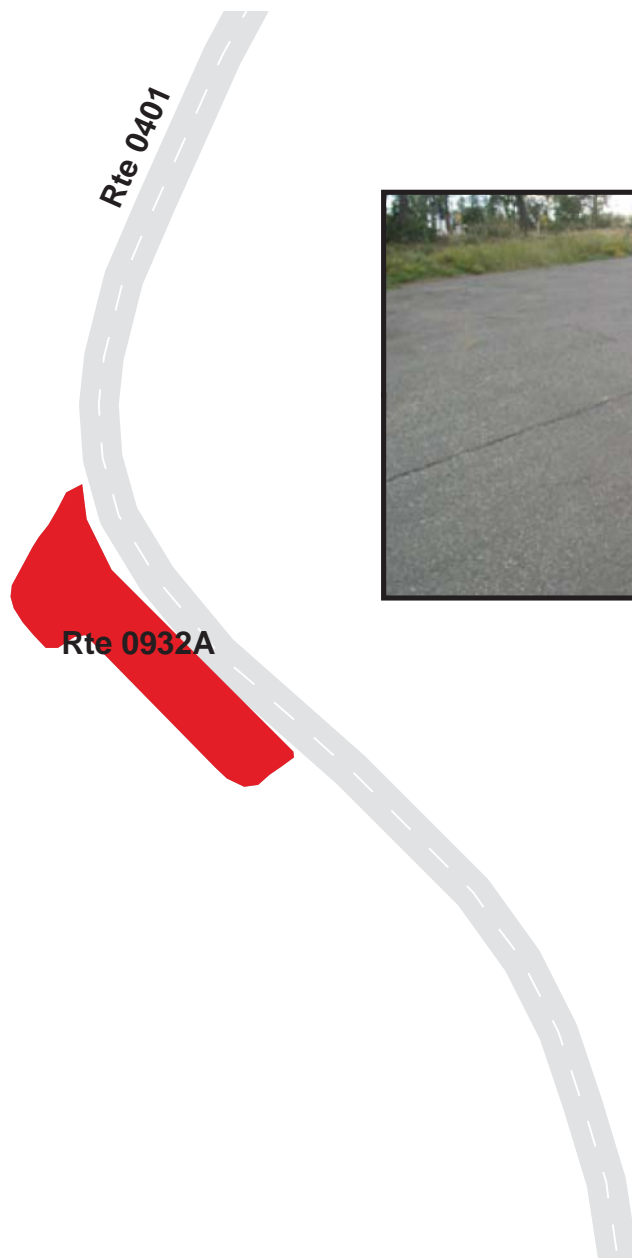
Route Number	Public / NonPublic	Date Visited		Area (sq ft)	Lane Miles *	Surface Type
0932A	NONPUBLIC	9/10/2007		2,273	0.04	AS
Culverts	Drop Inlets	Gates	Fire Hydrants	Curb & Gutter	Curb	PCR
0	1	0	0	NO CURB AND GUTTER	NO CURB	GOOD/90

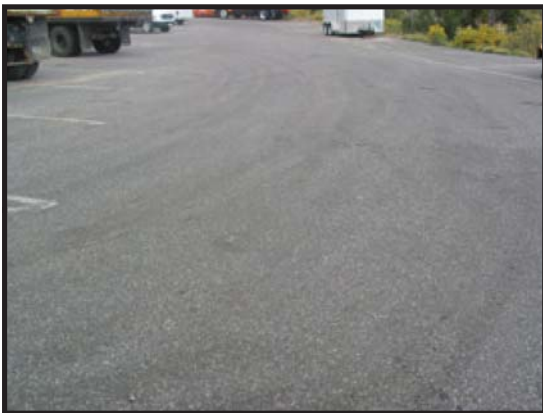
Route Number	Public / NonPublic	Date Visited		Area (sq ft)	Lane Miles *	Surface Type
0933	PUBLIC	9/10/2007		26,421	0.46	AS
Culverts	Drop Inlets	Gates	Fire Hydrants	Curb & Gutter	Curb	PCR
1	1	0	0	NO CURB AND GUTTER	NO CURB	GOOD/90

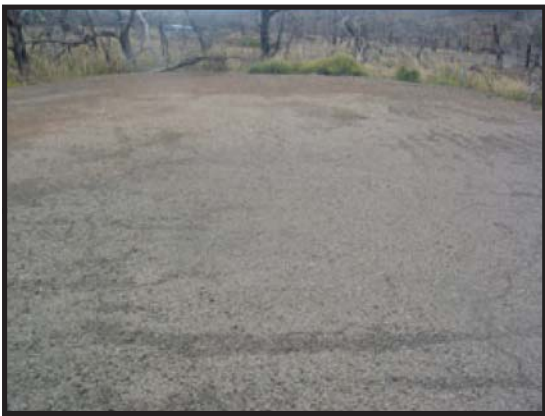
Route Number	Public / NonPublic	Date Visited		Area (sq ft)	Lane Miles *	Surface Type
0935	NONPUBLIC	9/10/2007		685	0.01	AS
Culverts	Drop Inlets	Gates	Fire Hydrants	Curb & Gutter	Curb	PCR
0	0	0	0	NO CURB AND GUTTER	NO CURB	POOR/45

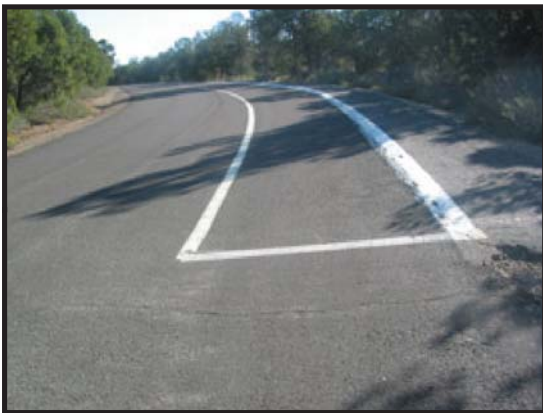
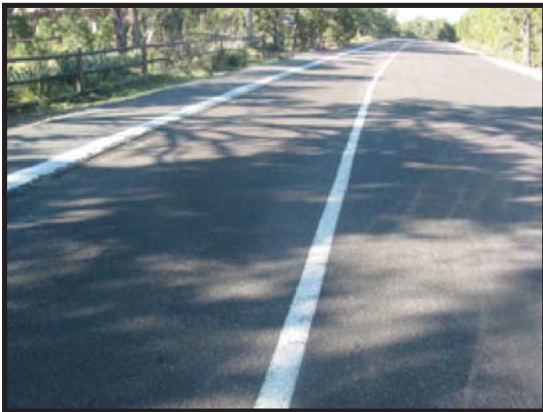
Route Number	Public / NonPublic	Date Visited		Area (sq ft)	Lane Miles *	Surface Type
0939	PUBLIC	9/11/2007		4,652	0.08	AS
Culverts	Drop Inlets	Gates	Fire Hydrants	Curb & Gutter	Curb	PCR
0	0	0	0	NO CURB AND GUTTER	ASPHALT CURB	GOOD/90

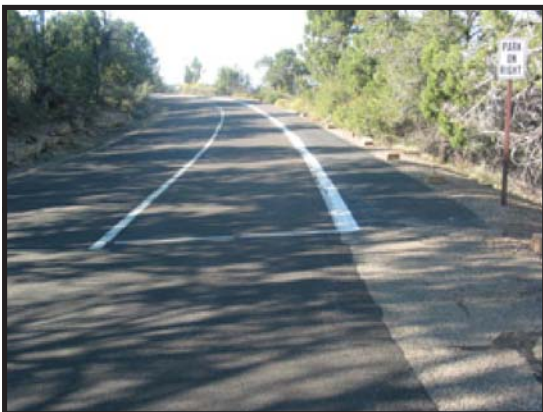
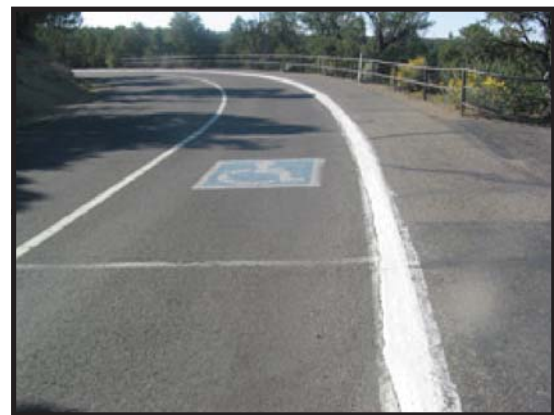
Route Number	Public / NonPublic	Date Visited		Area (sq ft)	Lane Miles *	Surface Type
0940	PUBLIC	9/11/2007		7,580	0.13	AS
Culverts	Drop Inlets	Gates	Fire Hydrants	Curb & Gutter	Curb	PCR
0	0	0	0	NO CURB AND GUTTER	ASPHALT CURB	GOOD/90

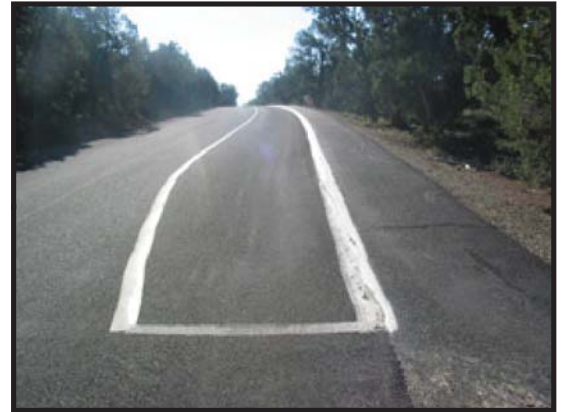
Route Number	Public / NonPublic	Date Visited		Area (sq ft)	Lane Miles *	Surface Type
0941	PUBLIC	9/11/2007		3,217	0.06	AS
Culverts	Drop Inlets	Gates	Fire Hydrants	Curb & Gutter	Curb	PCR
0	0	0	0	NO CURB AND GUTTER	ASPHALT CURB	GOOD/90

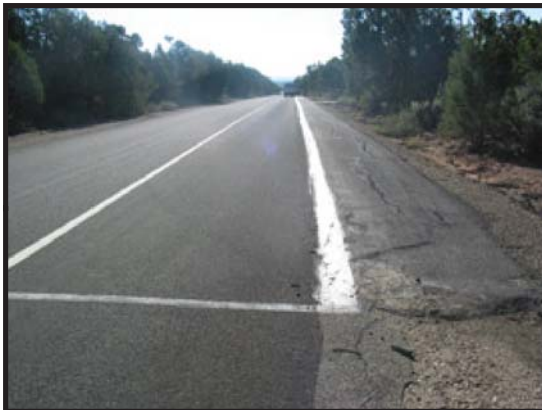
Route Number	Public / NonPublic	Date Visited		Area (sq ft)	Lane Miles *	Surface Type
0942	PUBLIC	9/11/2007		3,396	0.06	AS
Culverts	Drop Inlets	Gates	Fire Hydrants	Curb & Gutter	Curb	PCR
0	0	0	0	NO CURB AND GUTTER	ASPHALT CURB	GOOD/90

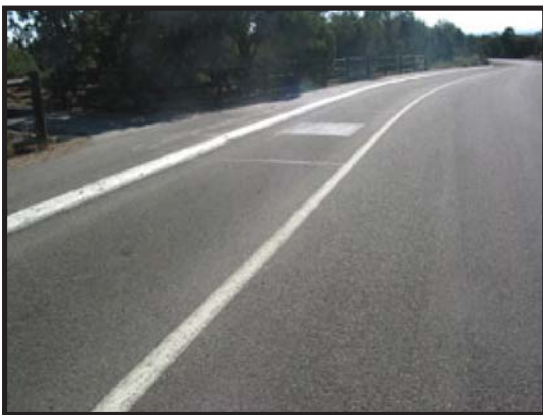
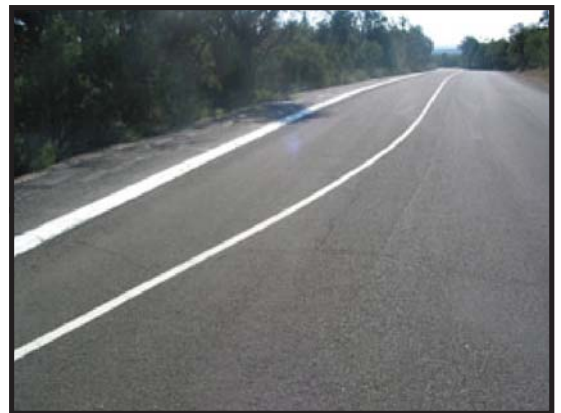
Route Number	Public / NonPublic	Date Visited		Area (sq ft)	Lane Miles *	Surface Type
0943	PUBLIC	9/11/2007		4,464	0.08	AS
Culverts	Drop Inlets	Gates	Fire Hydrants	Curb & Gutter	Curb	PCR
0	0	0	0	NO CURB AND GUTTER	ASPHALT CURB	GOOD/90

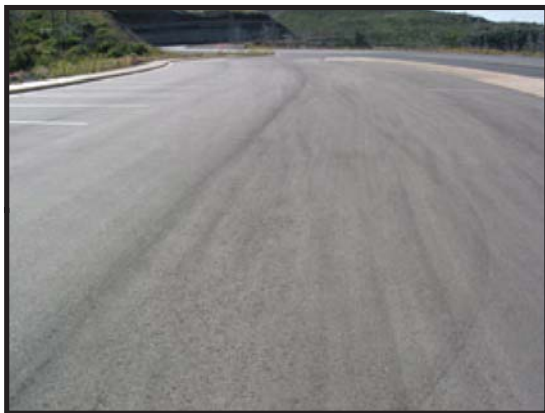
Route Number	Public / NonPublic	Date Visited		Area (sq ft)	Lane Miles *	Surface Type
0947	PUBLIC	9/11/2007		15,320	0.26	AS
Culverts	Drop Inlets	Gates	Fire Hydrants	Curb & Gutter	Curb	PCR
0	0	0	0	CONCRETE CURB AND GUTTER	NO CURB	EXCELLENT/97

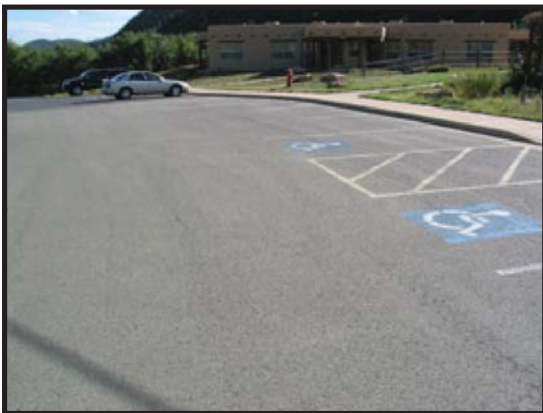
Route Number	Public / NonPublic	Date Visited		Area (sq ft)	Lane Miles *	Surface Type
0948AZ	PUBLIC	9/11/2007		3,395	0.06	AS
Culverts	Drop Inlets	Gates	Fire Hydrants	Curb & Gutter	Curb	PCR
0	0	0	1	CONCRETE CURB AND GUTTER	NO CURB	GOOD/90

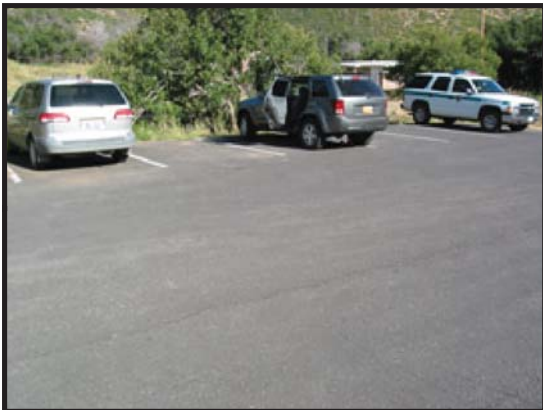
Route Number	Public / NonPublic	Date Visited		Area (sq ft)	Lane Miles *	Surface Type
0948BZ	PUBLIC	9/11/2007		1,042	0.02	AS
Culverts	Drop Inlets	Gates	Fire Hydrants	Curb & Gutter	Curb	PCR
0	0	0	0	NO CURB AND GUTTER	NO CURB	GOOD/90
