**The Road Inventory
of
Mojave National Preserve
MOJA – 8380
Cycle 4**

**Prepared By:
Federal Highway Administration
Road Inventory Program
Cycle 4**

Mojave National Preserve in California

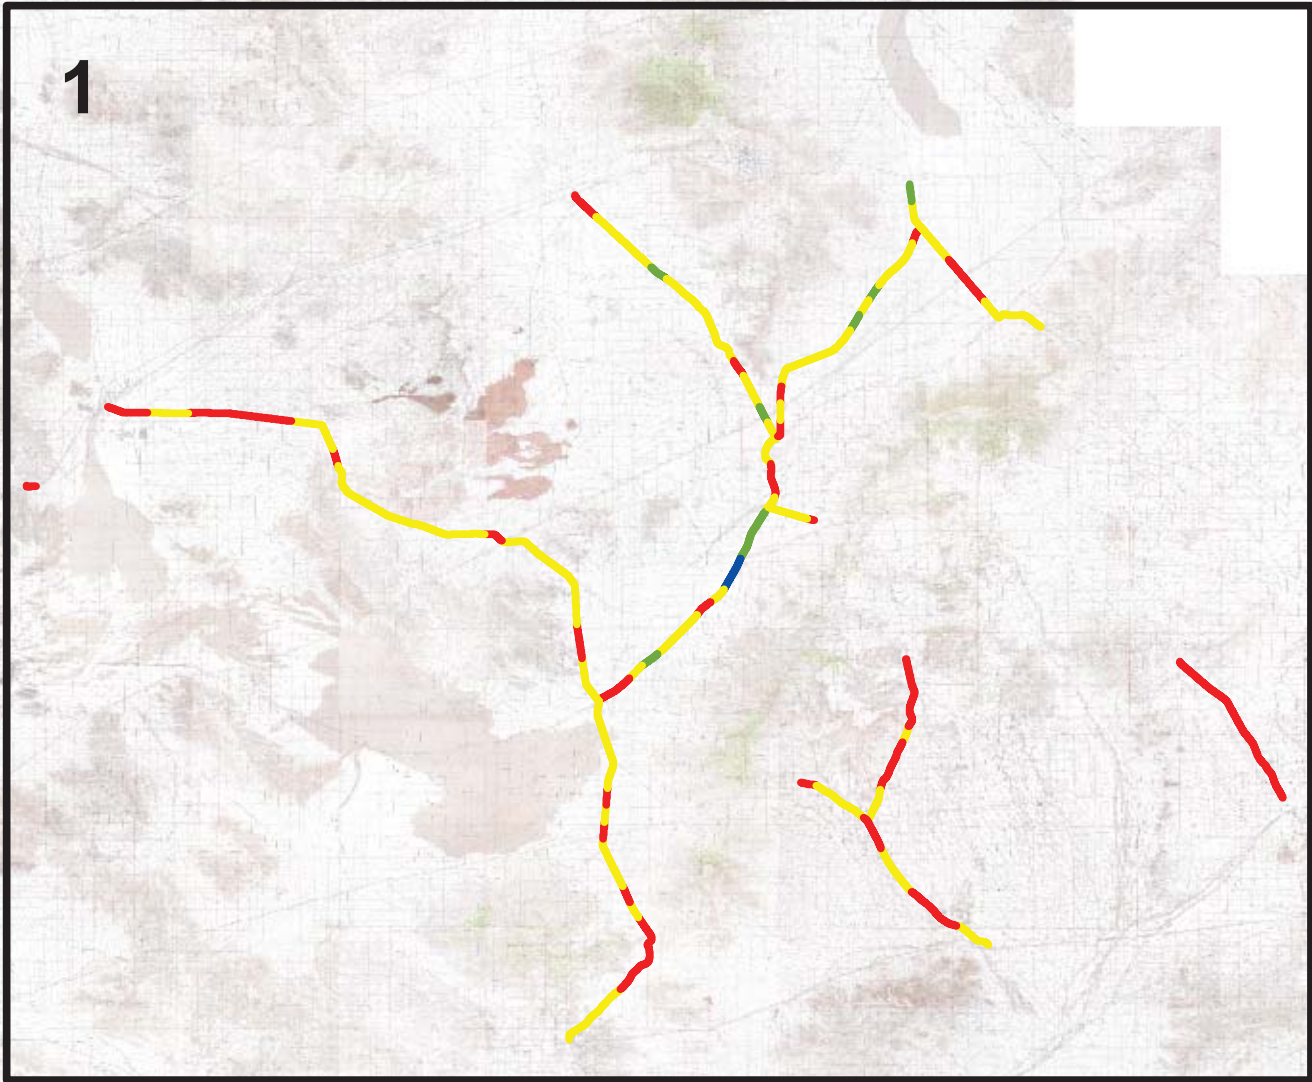
Mojave National Preserve
Route Condition Map
PCR - Mile by Mile
Key Map

PCR Poor ■ Fair ■ Good ■ Excellent ■ No Data ■
 (<=60) (61 - 84) (85 - 94) (95 - 100)

* If the PCR rating is not available for a section, the SCR rating will be displayed. See appendix for definitions and formulas.

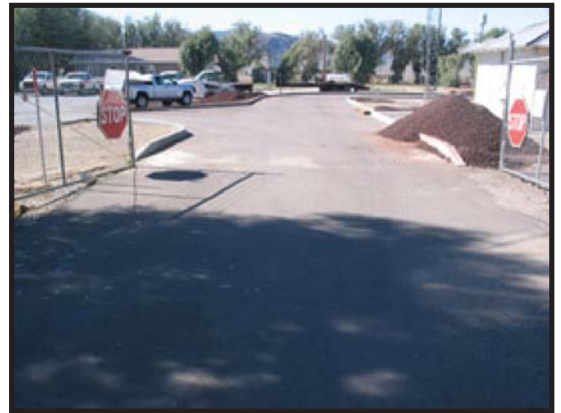
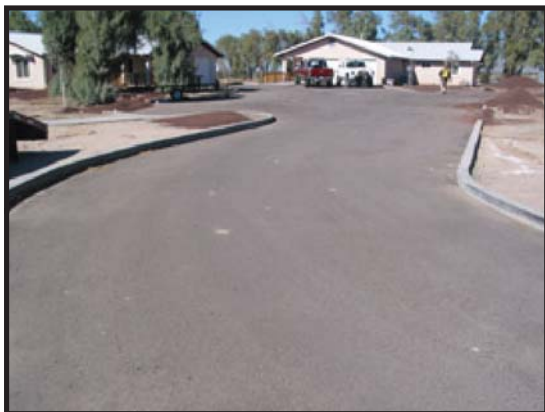
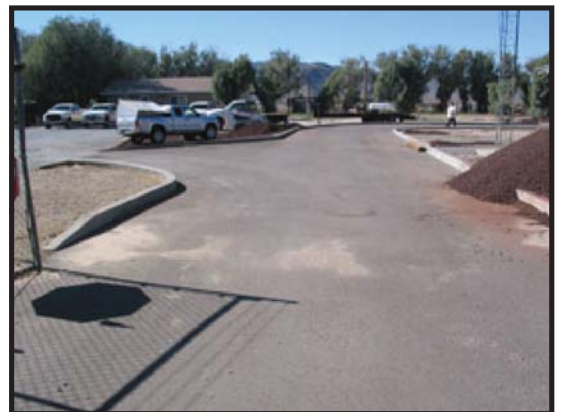
Route Number	Public / NonPublic	Date Visited		Area (sq ft)	Lane Miles *	Surface Type
0402	NONPUBLIC	2/12/2008		6,826	0.12	AS
Culverts	Drop Inlets	Gates	Fire Hydrants	Curb & Gutter	Curb	PCR
0	0	1	0	NO CURB AND GUTTER	CONCRETE CURB	GOOD/90

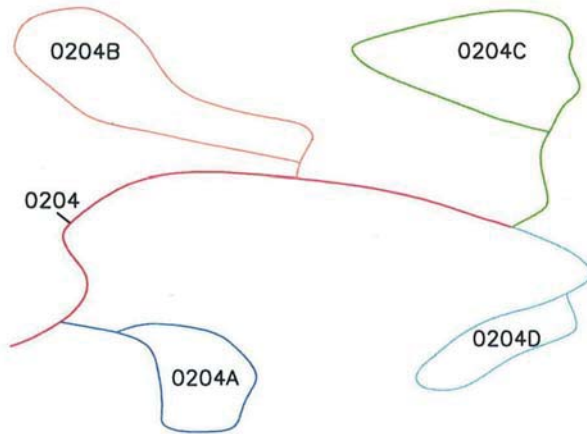
Figure 1: Campground with five routes and five assets

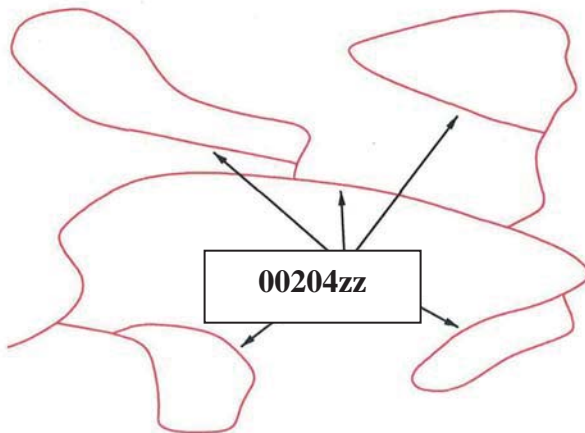
Figure 2: Campground with all loops combined into one route and one asset. This has eliminated four assets.

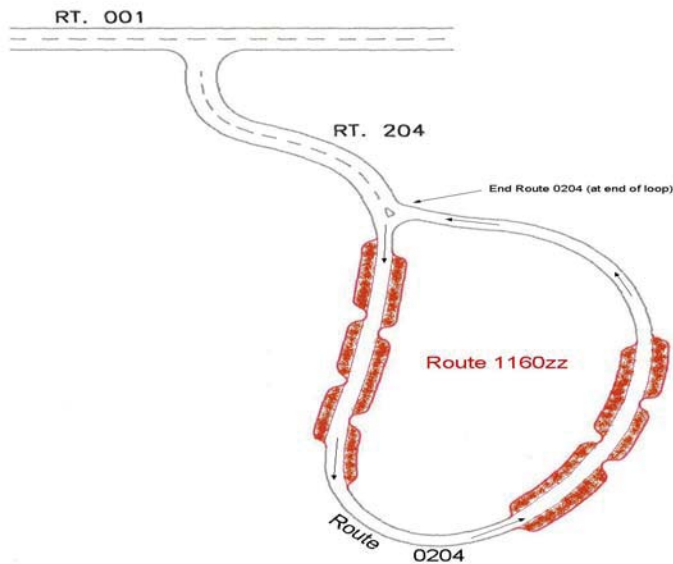
Figure 4: Parking with access route 204 and one parking area 1160zz. Route 204 is assumed longer than 0.25 miles. There are now 2 assets (one 1100 asset, one 1300 asset) instead of 12.

Discrete parking areas may be combined into a single asset where they service the same facility or resource and are within walking distance of each other. These combined areas should be maintained as one asset. There are many instances where small (5-10 space), discrete parking areas have been separated into individual assets even though they provide parking for the same area or facility. These may be combined into a single asset. Figures 3 and 4 shows examples of combining parking areas.

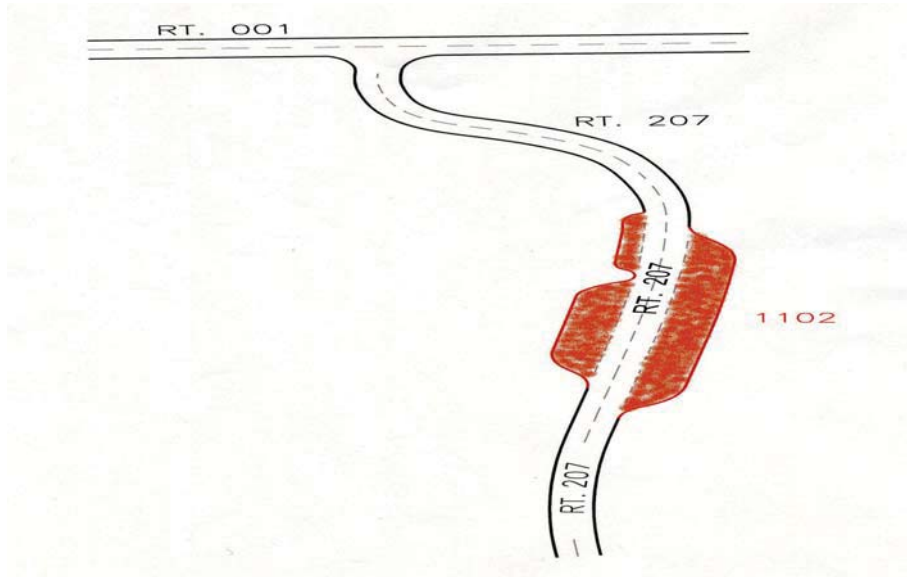
Figure 5: Parking with access route 207 running through and continuing beyond parking 1102. This access route cannot be considered a part of the parking area and two routes and two assets continue to exist.

Parking areas and roads may not be combined. Parking areas and roads are tracked as separate asset types (1300 vs. 1100) in FMSS and as such should not be combined except in situations described by 5g. In Figure 5, Route 207 is a spur road from the main route running through parking area 1102. Since the spur road continues through and beyond the parking area, it will remain a separate route.

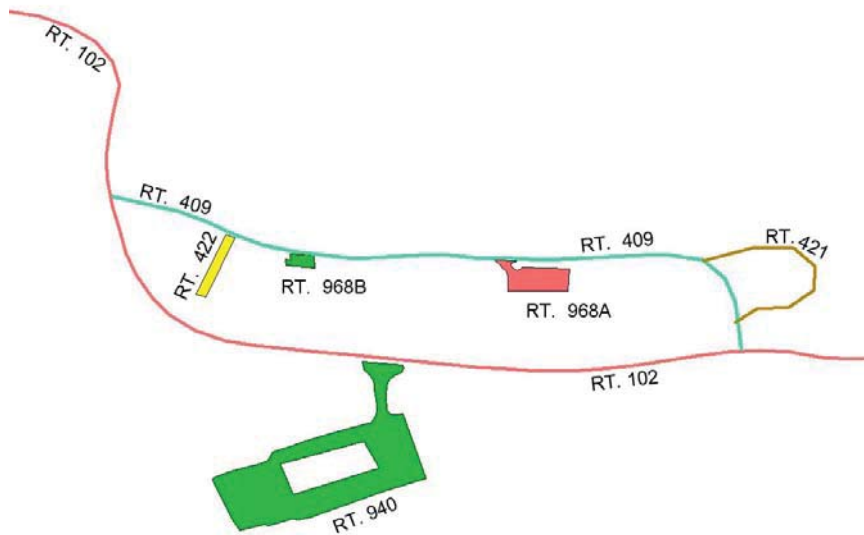
Figure 7 – Current Housing area access configuration. Route 409 is less than 0.25 miles long.

The following example illustrates a complex road system and how the proposed business practice and several of the guidelines could be applied to create fewer assets that are consistent with local management.

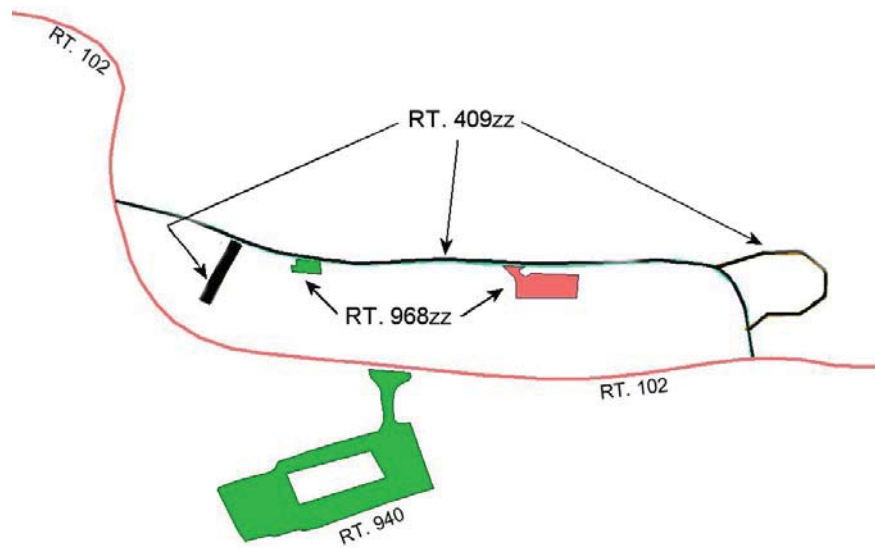
Figure 8 – Combined housing area access configuration – Parking and road assets combined to eliminate 3 assets.

The area serviced by Routes 409, 421, 422, 968A, and 968B is all employee housing. Route 940 provides access to visitor services and not to the housing area. Routes may be combined to create assets that reflect local management. Routes 409, 421, and 422 are all the same functional class, provide access to one type of activity (housing) and are all posted as non-public. These routes may be combined. They should not be combined with any parking areas even though they are all less than 0.25 miles long. This is because their main function is not to provide access to parking. Routes 968A and B provide parking for access to the same facility (housing). Even though these discrete areas may provide parking to different housing units, it's reasonable to manage them as a single asset. They may also be combined.
