**The Road Inventory  
of  
Natural Bridges National Monument  
NABR – 1349  
Cycle 4**

**Prepared By:  
Federal Highway Administration  
Road Inventory Program  
Cycle 4**

# Natural Bridges National Monument in Utah

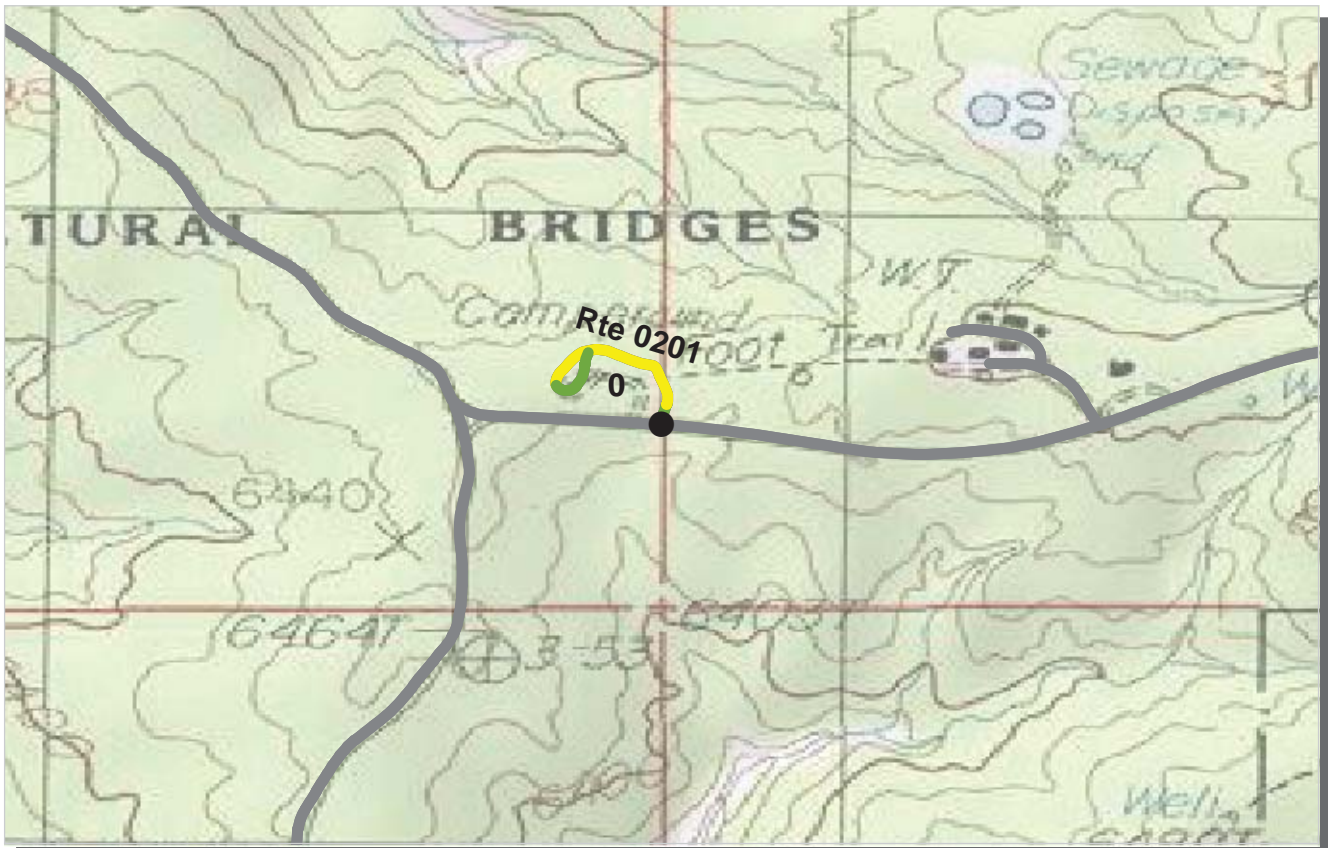
**ROUTE: 0201 CAMPGROUND LOOP**

<i>Section Number</i>	0				
<i>Section Length (mi)</i>	0.21				
<i>Traffic</i>	Traffic data may be found at <a href="http://www.efl.fhwa.dot.gov">www.efl.fhwa.dot.gov</a> Click on PROGRAMS / NPS Traffic Data (Note: Not all parks have traffic data)				
<i>Cross Section Information</i>					
Number of Lanes	2				
Paved Width (ft)	16				
Lane Width (ft)	8				
Shoulder Width Right (ft)**	0				
Shoulder Width Left (ft)**	0				
<i>Roadway Condition Information</i>					
SCR (Surface Condition Rating)	79				
PCR (Pavement Condition Rating)	79				
<i>Distress Index Values</i>					
Alligator Cracking Index	100				
Longitudinal Cracking Index	100				
Transverse Cracking Index	100				
Patching Index	100				
Rutting Index	79				
Roughness Condition Index (RCI)	NC
