**The Road Inventory
of
National Capital Parks - East
NACE – 3500
Cycle 4**

**Prepared By:
Federal Highway Administration
Road Inventory Program
Cycle 4**

National Capital Parks - East in Washington DC / Maryland

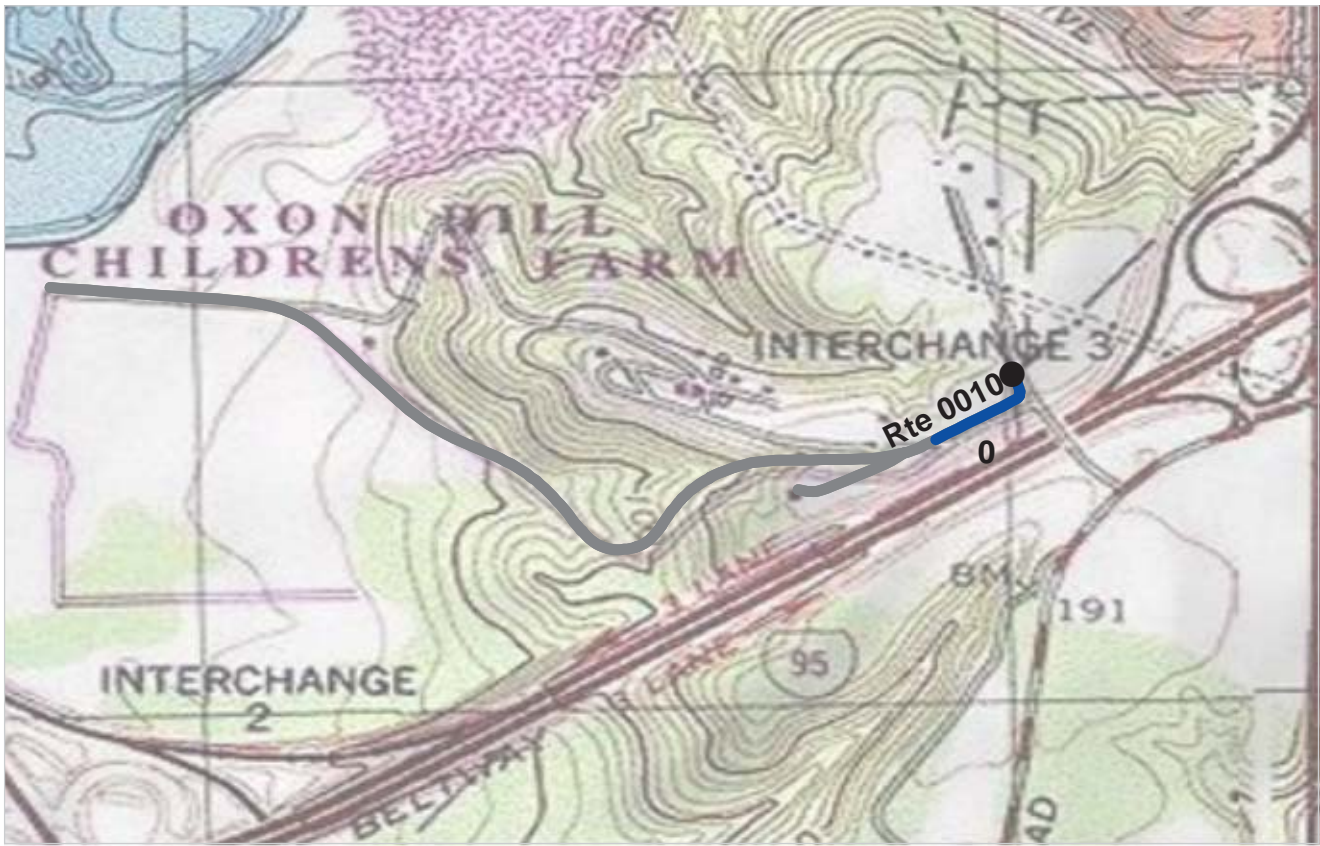
Section Number	0				
Section Length (mi)	0.10				
Traffic	Traffic data may be found at www.efl.fhwa.dot.gov Click on PROGRAMS / NPS Traffic Data (Note: Not all parks have traffic data)				
Cross Section Information					
Number of Lanes	1				
Paved Width (ft)	19				
Lane Width (ft)	13				
Shoulder Width Right (ft)	NC				
Shoulder Width Left (ft)	NC				
Roadway Condition Information					
SCR (Surface Condition Rating)	98				
PCR (Pavement Condition Rating)	98				
Distress Index Values					
Alligator Cracking Index	100				
Longitudinal Cracking Index	100				
Transverse Cracking Index	100				
Patching Index	100				
Rutting Index	98				
Roughness Condition Index (RCI)	NC

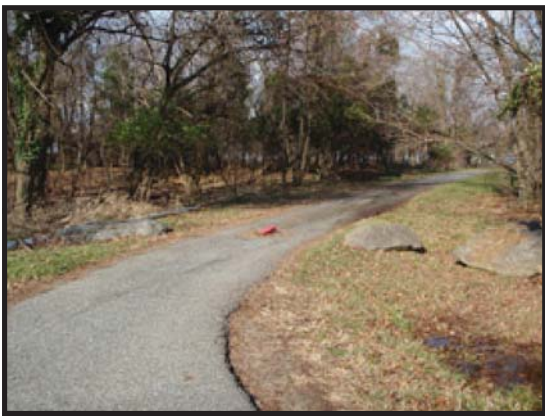
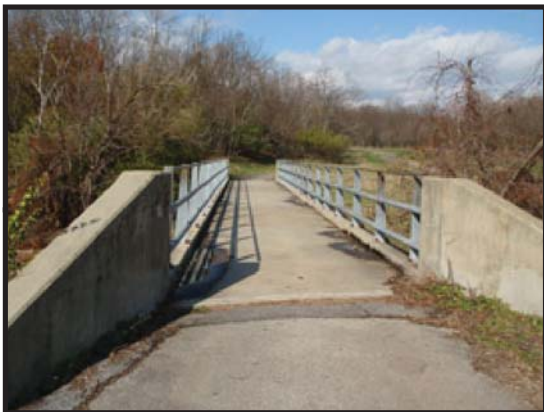
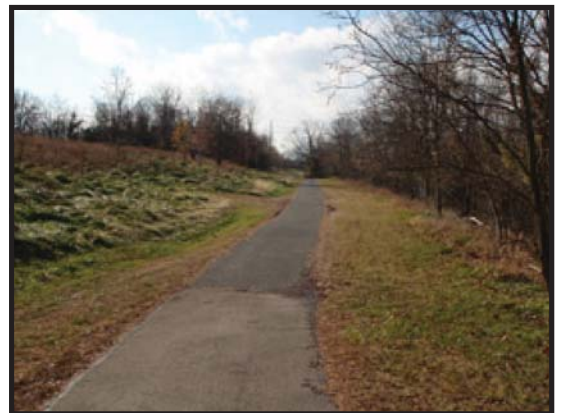
Route 0411

Route Number	Public / NonPublic	Date Visited		Area (sq ft)	Lane Miles *	Surface Type
0411	NONPUBLIC	12/1/2008		46,570	0.80	AS
Culverts	Drop Inlets	Gates	Fire Hydrants	Curb & Gutter	Curb	PCR
0	0	0	0	NO CURB AND GUTTER	NO CURB	POOR/45

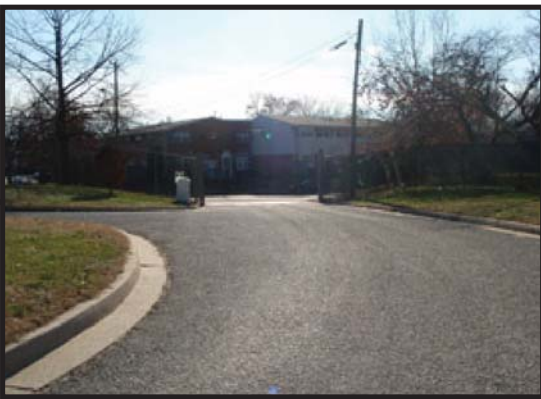
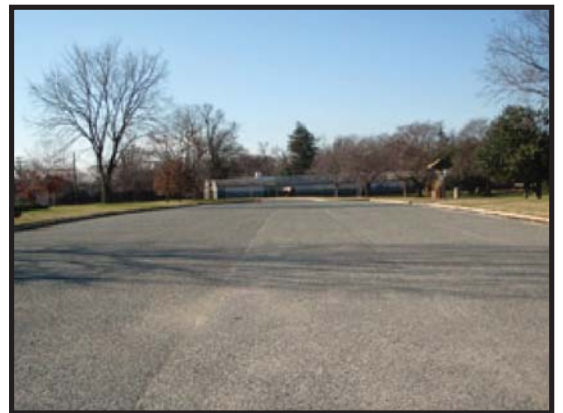
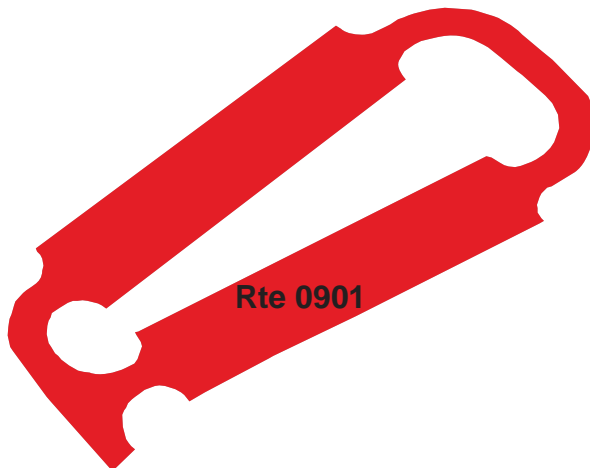
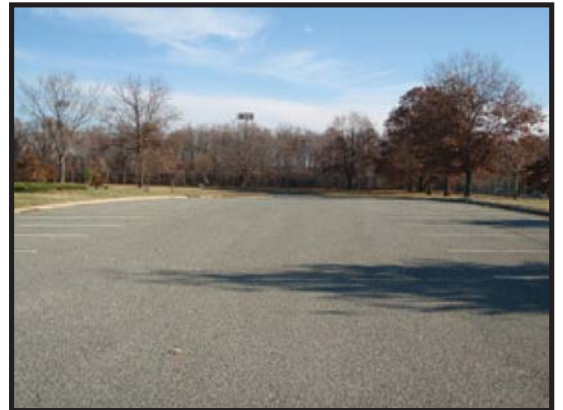
Route Number	Public / NonPublic	Date Visited		Area (sq ft)	Lane Miles *	Surface Type
0901	PUBLIC	12/2/2008		38,114	0.66	AS
Culverts	Drop Inlets	Gates	Fire Hydrants	Curb & Gutter	Curb	PCR
0	4	1	0	CONCRETE CURB AND GUTTER	NO CURB	FAIR/73

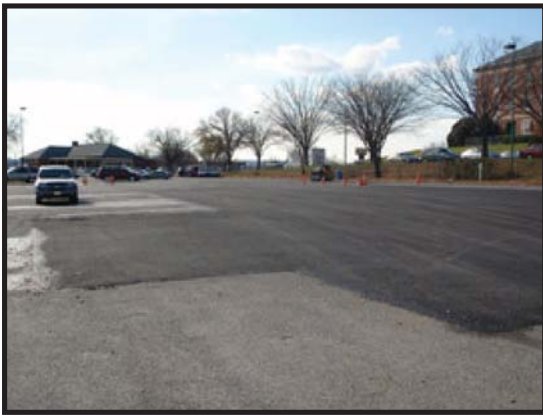
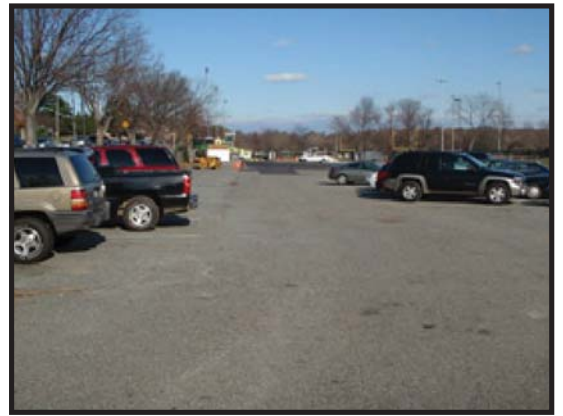
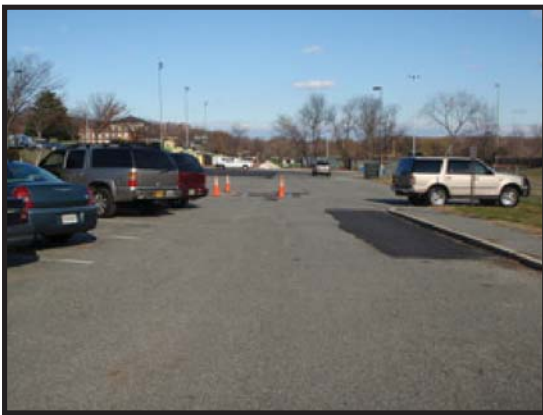
Route 0905

Route Number	Public / NonPublic	Date Visited		Area (sq ft)	Lane Miles *	Surface Type
0905	PUBLIC	12/2/2008		51,390	0.89	AS
Culverts	Drop Inlets	Gates	Fire Hydrants	Curb & Gutter	Curb	PCR
0	0	1	0	NO CURB AND GUTTER	CONCRETE CURB	POOR/45

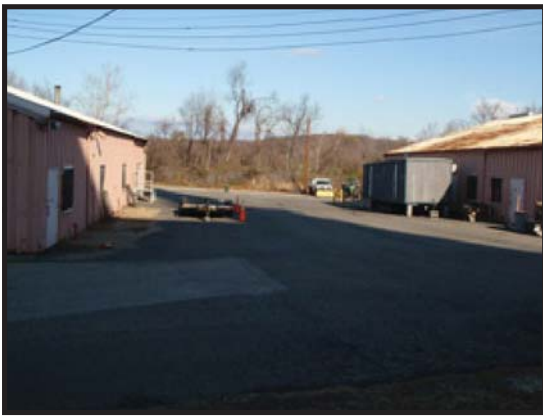
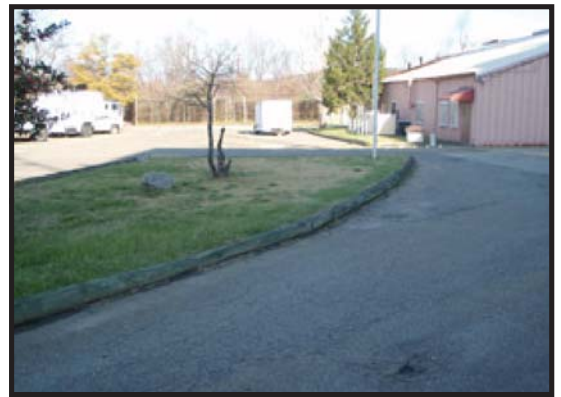
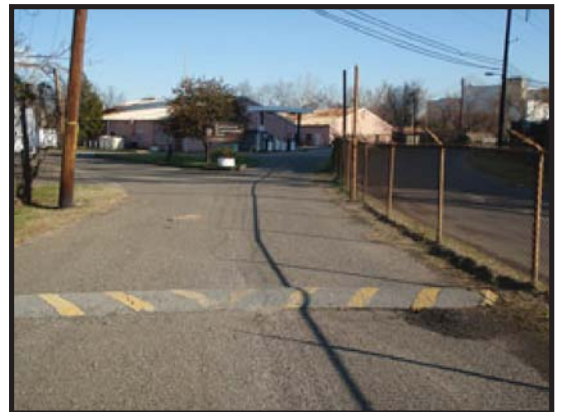
Route 0906

Route Number	Public / NonPublic	Date Visited		Area (sq ft)	Lane Miles *	Surface Type
0906	NONPUBLIC	12/2/2008		47,041	0.81	AS
Culverts	Drop Inlets	Gates	Fire Hydrants	Curb & Gutter	Curb	PCR
0	0	1	1	NO CURB AND GUTTER	ASPHALT CURB	POOR/45

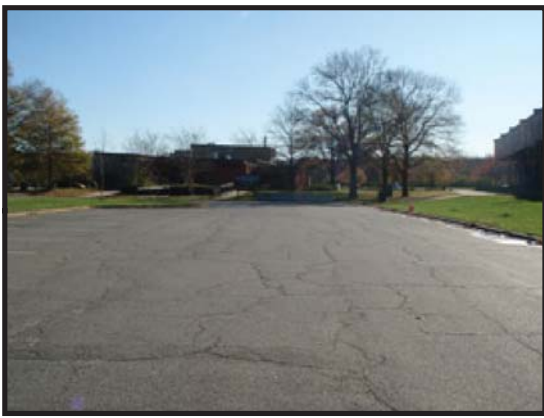
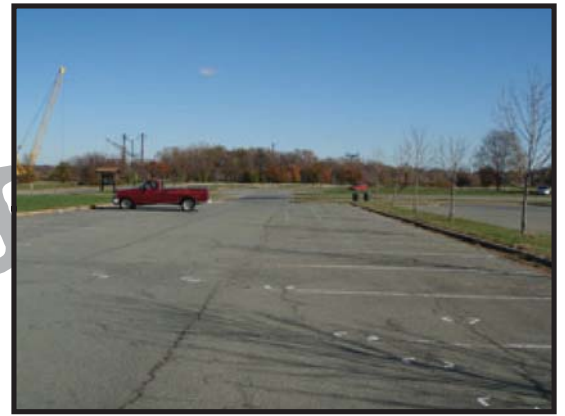
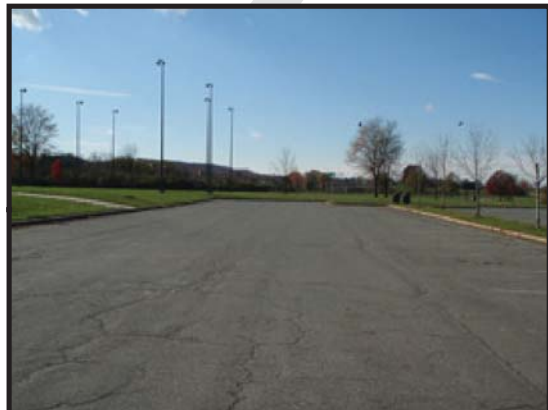
Route 0907

Route Number	Public / NonPublic	Date Visited		Area (sq ft)	Lane Miles *	Surface Type
0907	PUBLIC	11/19/2008		63,169	1.09	AS
Culverts	Drop Inlets	Gates	Fire Hydrants	Curb & Gutter	Curb	PCR
0	5	0	0	CONCRETE CURB AND GUTTER	CONCRETE CURB	FAIR/73

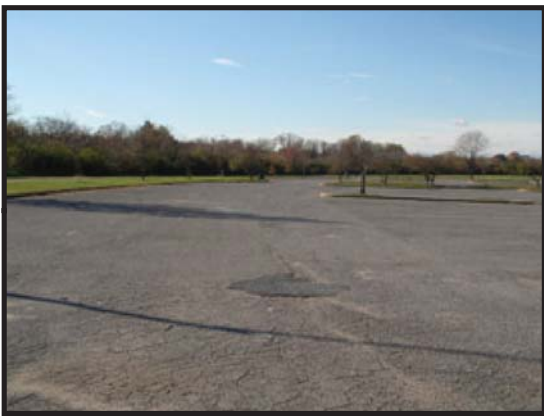
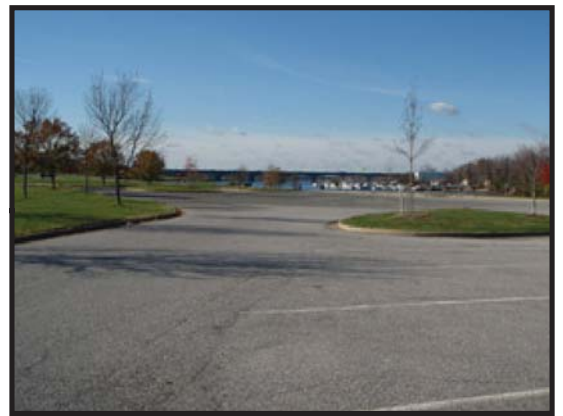
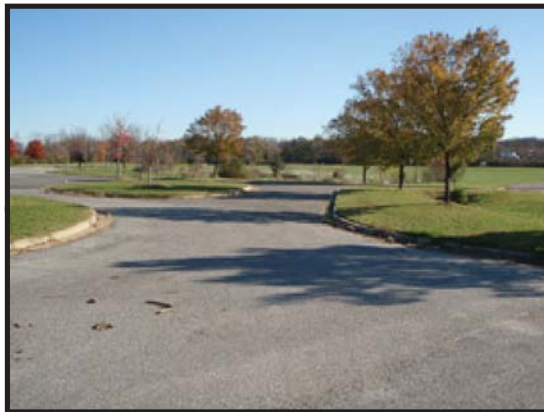
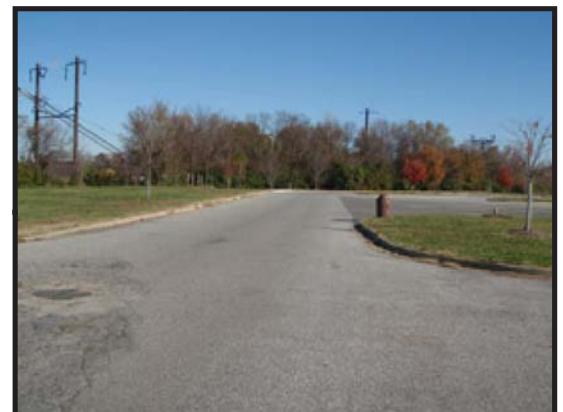
Route 0908

Route Number	Public / NonPublic	Date Visited		Area (sq ft)	Lane Miles *	Surface Type
0908	PUBLIC	11/19/2008		54,059	0.93	AS
Culverts	Drop Inlets	Gates	Fire Hydrants	Curb & Gutter	Curb	PCR
1	2	0	0	CONCRETE CURB AND GUTTER	NO CURB	FAIR/73

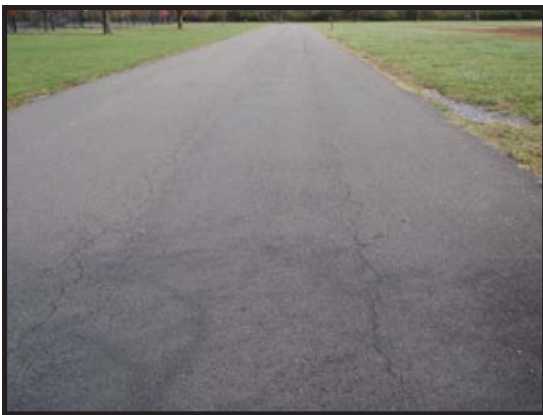
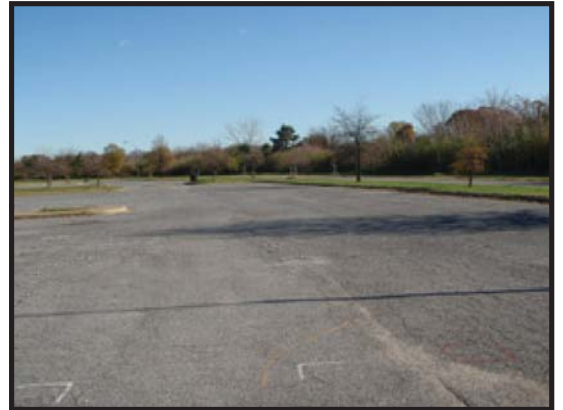
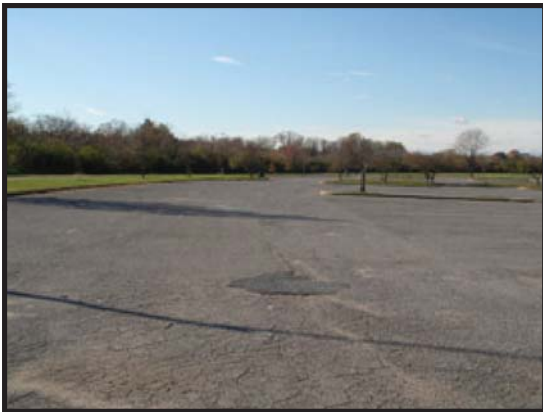
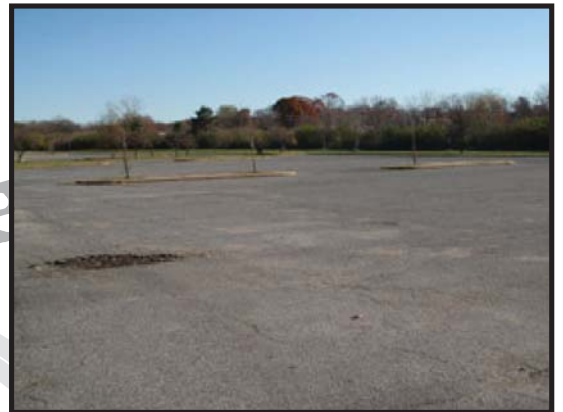
Route Number	Public / NonPublic	Date Visited		Area (sq ft)	Lane Miles *	Surface Type
0909	PUBLIC	11/19/2008		115,510	1.99	AS
Culverts	Drop Inlets	Gates	Fire Hydrants	Curb & Gutter	Curb	PCR
0	2	0	0	CONCRETE CURB AND GUTTER	NO CURB	POOR/45

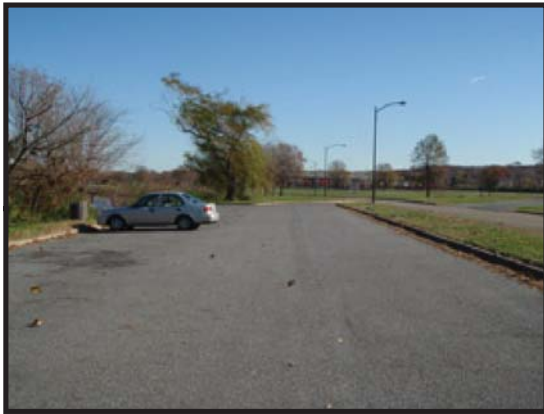
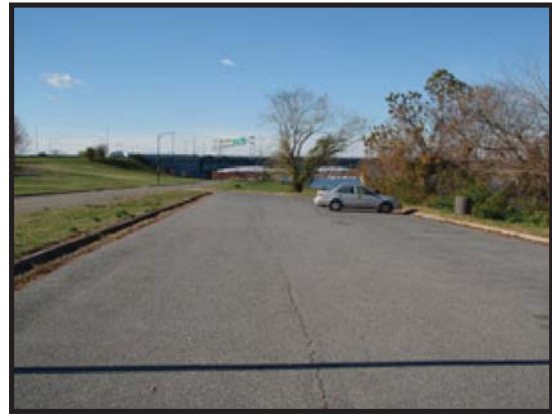
Route 0910

Route Number	Public / NonPublic	Date Visited		Area (sq ft)	Lane Miles *	Surface Type
0910	PUBLIC	11/19/2008		8,021	0.14	AS
Culverts	Drop Inlets	Gates	Fire Hydrants	Curb & Gutter	Curb	PCR
0	1	0	0	CONCRETE CURB AND GUTTER	NO CURB	FAIR/73

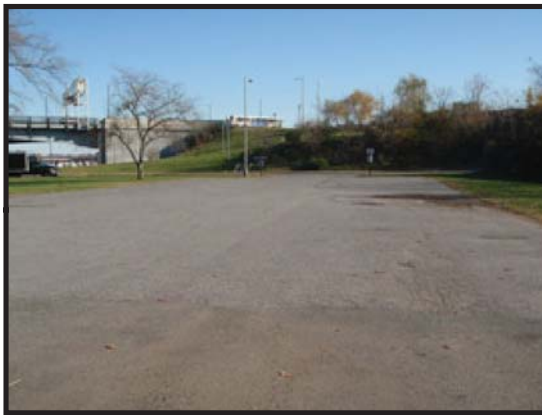
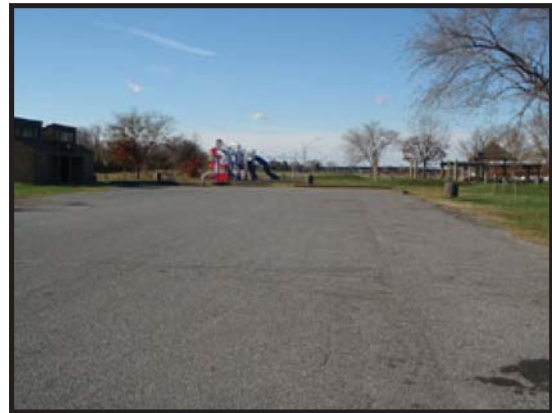
Route 0911

Route Number	Public / NonPublic	Date Visited		Area (sq ft)	Lane Miles *	Surface Type
0911	PUBLIC	11/19/2008		12,249	0.21	AS
Culverts	Drop Inlets	Gates	Fire Hydrants	Curb & Gutter	Curb	PCR
0	0	0	0	NO CURB AND GUTTER	NO CURB	FAIR/73

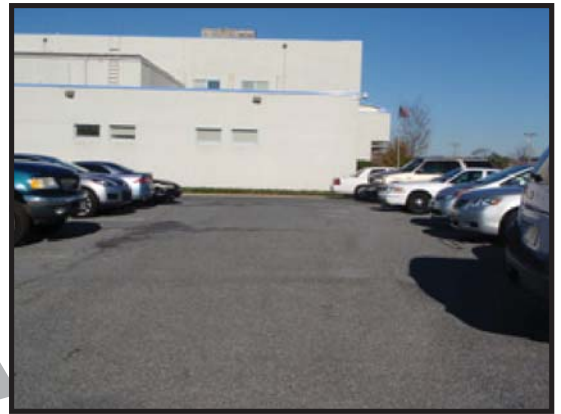
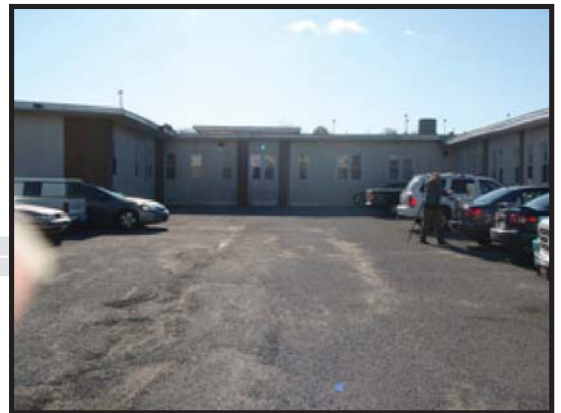
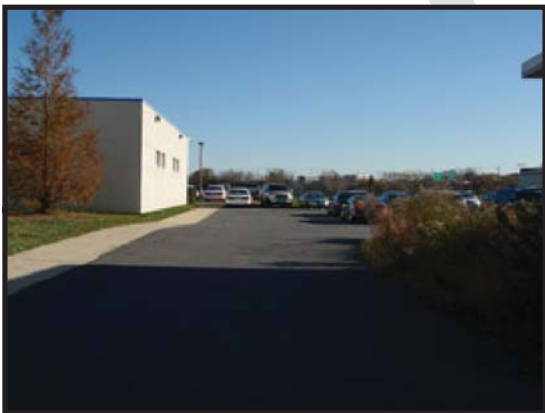
Route Number	Public / NonPublic	Date Visited		Area (sq ft)	Lane Miles *	Surface Type
0913AZ	NONPUBLIC	11/19/2008		17,652	0.30	AS
Culverts	Drop Inlets	Gates	Fire Hydrants	Curb & Gutter	Curb	PCR
0	0	0	0	NO CURB AND GUTTER	NO CURB	FAIR/73

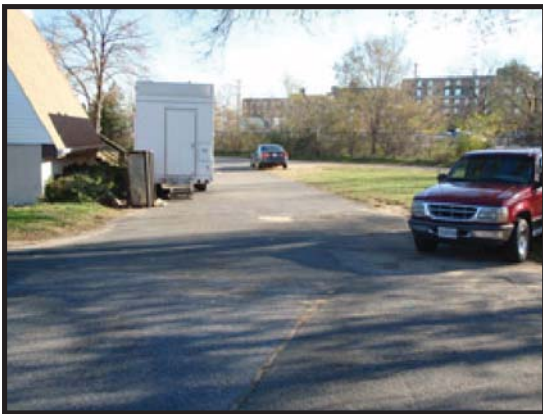
Route Number	Public / NonPublic	Date Visited		Area (sq ft)	Lane Miles *	Surface Type
0915AZ	NONPUBLIC	11/19/2008		8,954	0.15	AS
Culverts	Drop Inlets	Gates	Fire Hydrants	Curb & Gutter	Curb	PCR
0	0	0	0	NO CURB AND GUTTER	CONCRETE CURB	POOR/45

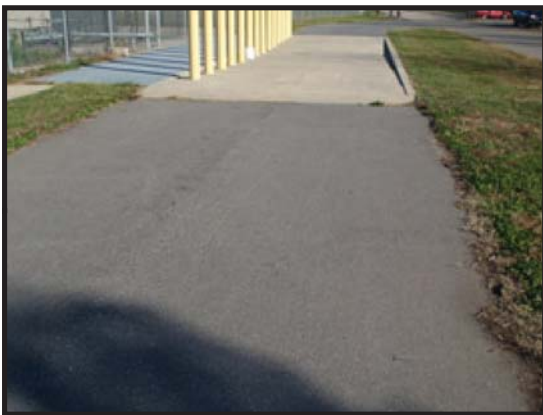
Route 0915BZ

Route Number	Public / NonPublic	Date Visited		Area (sq ft)	Lane Miles *	Surface Type
0915BZ	NONPUBLIC	11/19/2008		5,297	0.09	AS
Culverts	Drop Inlets	Gates	Fire Hydrants	Curb & Gutter	Curb	PCR
0	1	0	1	NO CURB AND GUTTER	CONCRETE CURB	GOOD/90

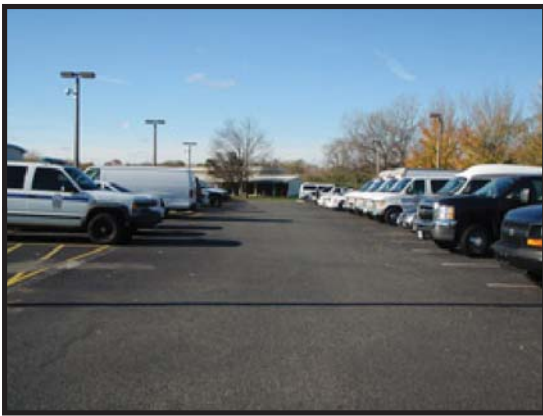
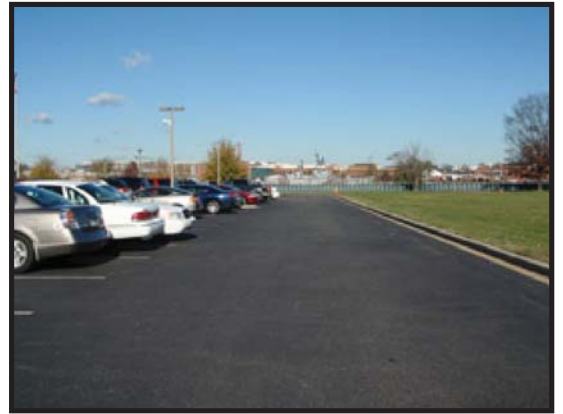
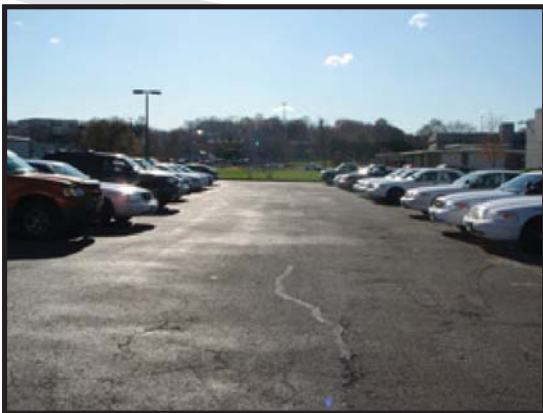
Route 0916

Route Number	Public / NonPublic	Date Visited		Area (sq ft)	Lane Miles *	Surface Type
0916	NONPUBLIC	11/19/2008		53,911	0.93	AS
Culverts	Drop Inlets	Gates	Fire Hydrants	Curb & Gutter	Curb	PCR
0	3	0	1	CONCRETE CURB AND GUTTER	ASPHALT CURB	GOOD/90

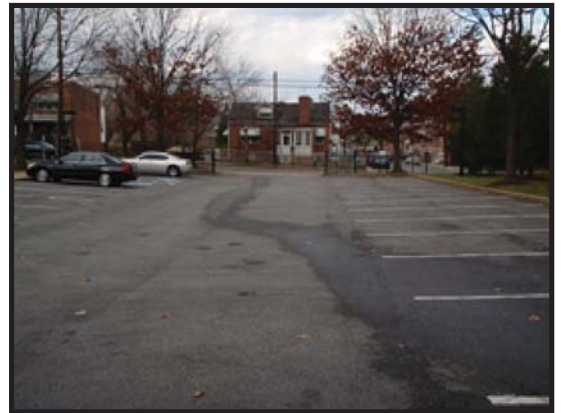
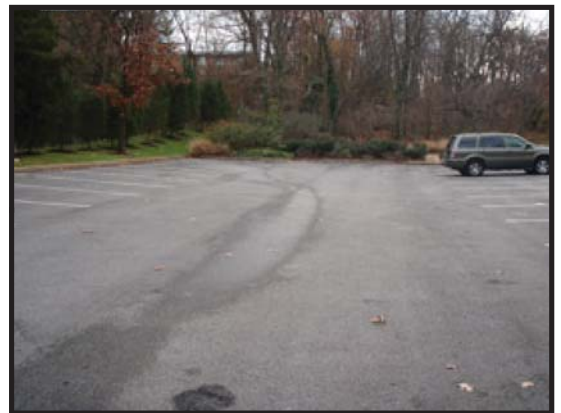
NATIONAL CAPITAL PARKS-EAST
Route 0917
FREDERICK DOUGLAS S HOME PARKING
FROM W STREET SE
TO PARKING

Route Number	Public / NonPublic	Date Visited		Area (sq ft)	Lane Miles *	Surface Type
0917	PUBLIC	12/1/2008		10,077	0.17	AS
Culverts	Drop Inlets	Gates	Fire Hydrants	Curb & Gutter	Curb	PCR
0	1	0	0	NO CURB AND GUTTER	CONCRETE CURB	GOOD/90

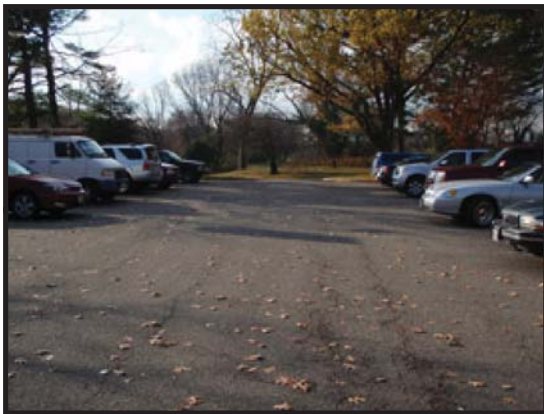
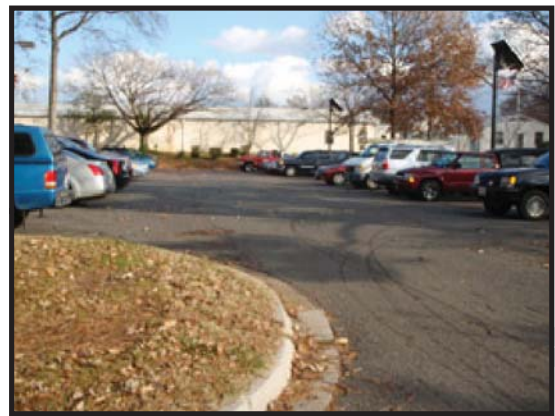
Route 0918

Route Number	Public / NonPublic	Date Visited		Area (sq ft)	Lane Miles *	Surface Type
0918	NONPUBLIC	11/19/2008		8,849	0.15	AS
Culverts	Drop Inlets	Gates	Fire Hydrants	Curb & Gutter	Curb	PCR
0	1	0	0	NO CURB AND GUTTER	CONCRETE CURB	FAIR/73

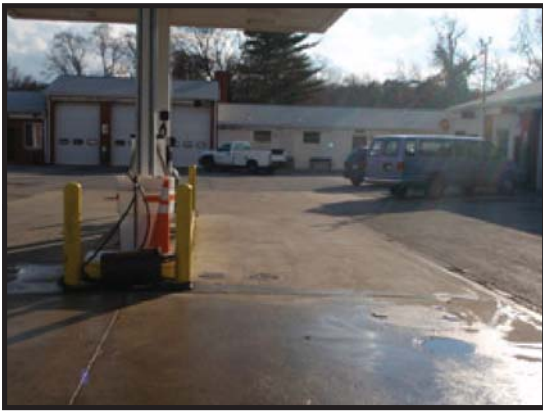
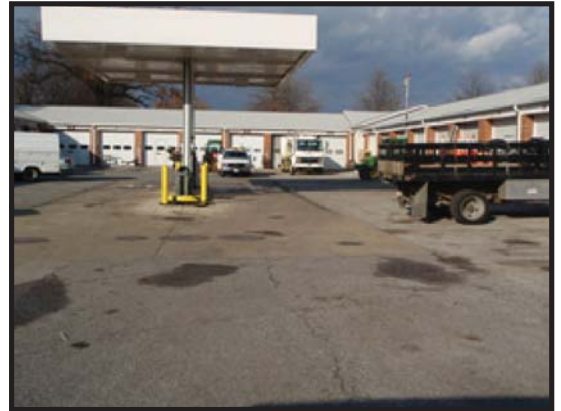
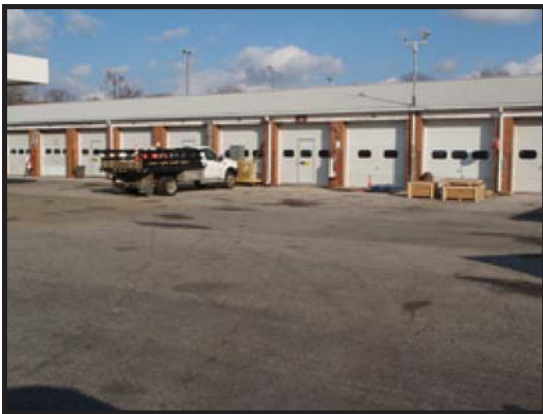
Route 0919A

Route Number	Public / NonPublic	Date Visited		Area (sq ft)	Lane Miles *	Surface Type
0919A	NONPUBLIC	12/1/2008		17,845	0.31	AS
Culverts	Drop Inlets	Gates	Fire Hydrants	Curb & Gutter	Curb	PCR
0	1	0	0	NO CURB AND GUTTER	NO CURB	FAIR/73

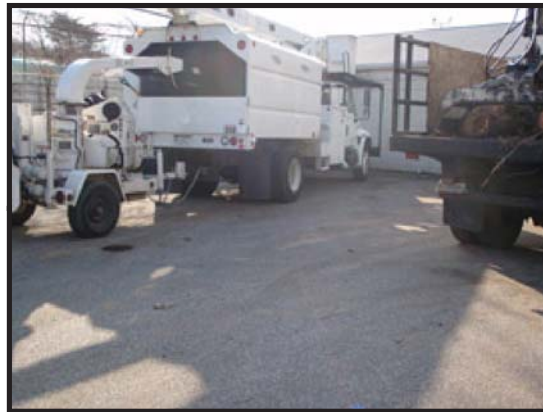
Route 0919B

Route Number	Public / NonPublic	Date Visited		Area (sq ft)	Lane Miles *	Surface Type
0919B	NONPUBLIC	12/1/2008		4,733	0.08	AS
Culverts	Drop Inlets	Gates	Fire Hydrants	Curb & Gutter	Curb	PCR
0	0	0	0	NO CURB AND GUTTER	NO CURB	FAIR/73

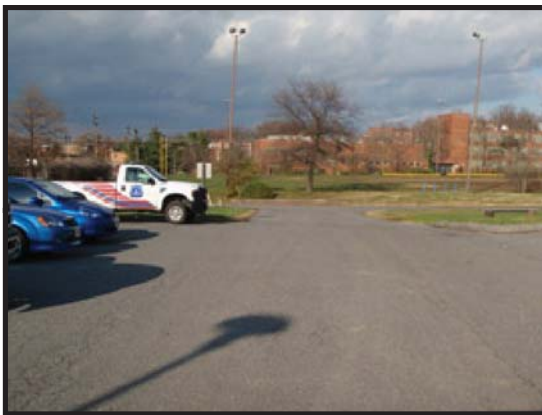
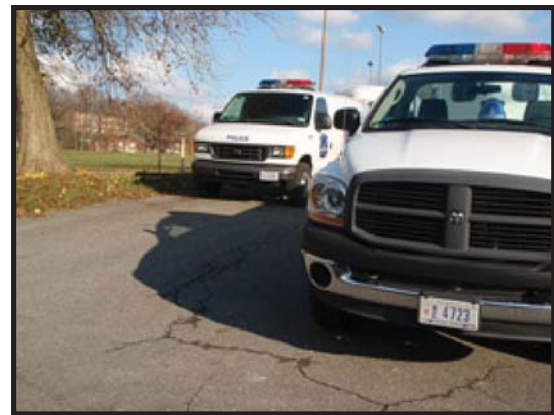
Route 0920

Route Number	Public / NonPublic	Date Visited		Area (sq ft)	Lane Miles *	Surface Type
0920	NONPUBLIC	12/1/2008		10,907	0.19	AS
Culverts	Drop Inlets	Gates	Fire Hydrants	Curb & Gutter	Curb	PCR
0	0	0	0	NO CURB AND GUTTER	NO CURB	POOR/45

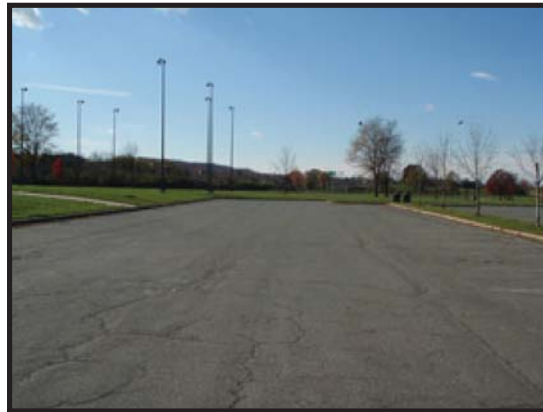
Route 0921

Route Number	Public / NonPublic	Date Visited		Area (sq ft)	Lane Miles *	Surface Type
0921	PUBLIC	12/1/2008		76,687	1.32	AS
Culverts	Drop Inlets	Gates	Fire Hydrants	Curb & Gutter	Curb	PCR
0	4	1	0	CONCRETE CURB AND GUTTER	NO CURB	FAIR/73

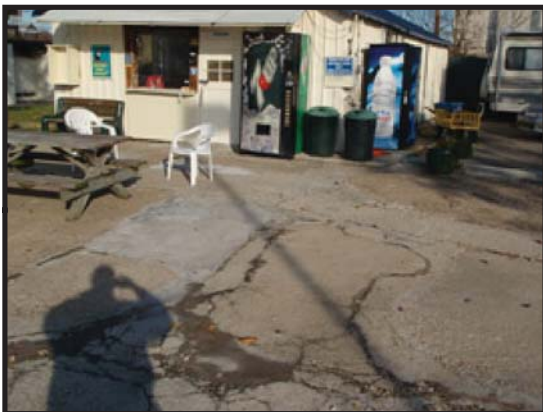
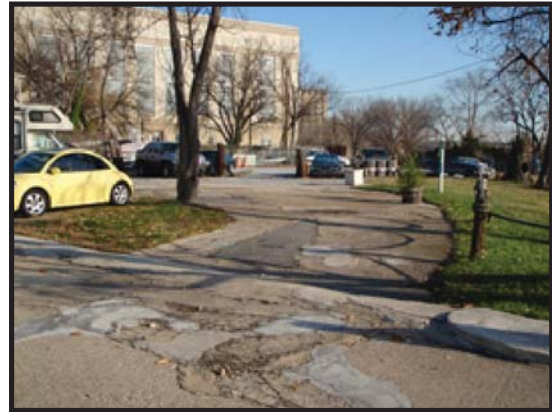
Route Number	Public / NonPublic	Date Visited		Area (sq ft)	Lane Miles *	Surface Type
0923	PUBLIC	12/1/2008		10,489	0.18	CO
Culverts	Drop Inlets	Gates	Fire Hydrants	Curb & Gutter	Curb	PCR
0	0	0	0	NO CURB AND GUTTER	NO CURB	POOR/45

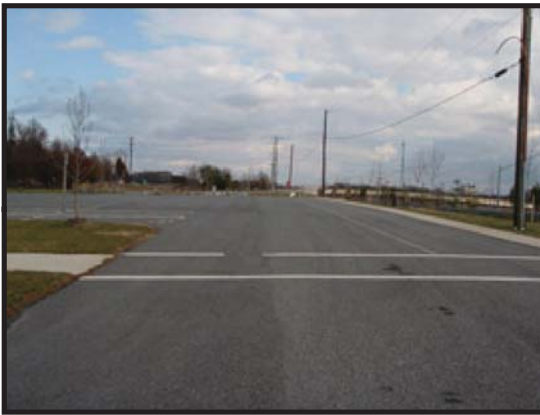
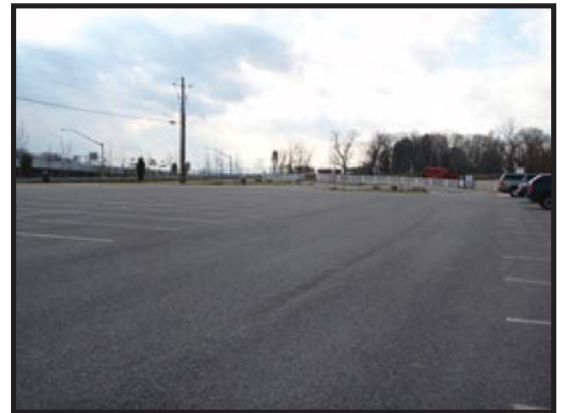
Route 0950

Route Number	Public / NonPublic	Date Visited		Area (sq ft)	Lane Miles *	Surface Type
0950	PUBLIC	12/1/2008		40,185	0.69	AS
Culverts	Drop Inlets	Gates	Fire Hydrants	Curb & Gutter	Curb	PCR
0	1	2	0	NO CURB AND GUTTER	NO CURB	GOOD/90

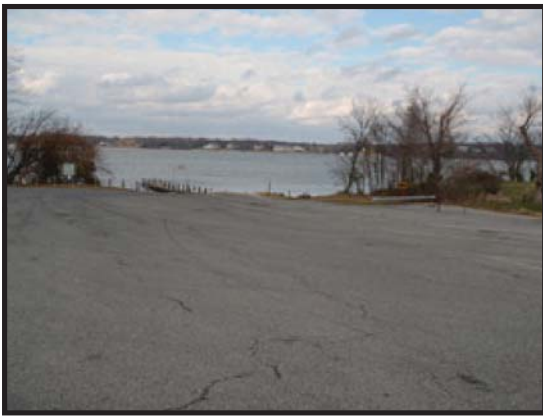
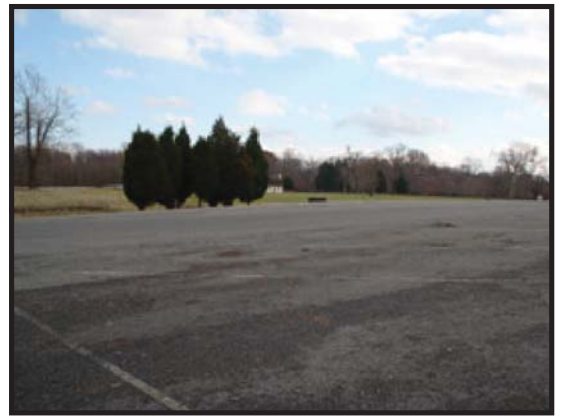
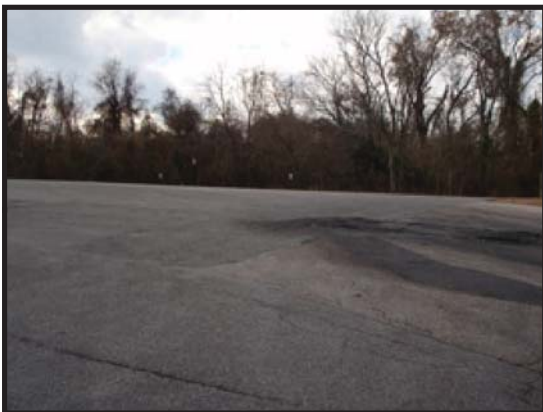
Route 0956

Route Number	Public / NonPublic	Date Visited		Area (sq ft)	Lane Miles *	Surface Type
0956	PUBLIC	12/1/2008		47,568	0.82	AS
Culverts	Drop Inlets	Gates	Fire Hydrants	Curb & Gutter	Curb	PCR
1	0	0	0	NO CURB AND GUTTER	NO CURB	FAIR/73

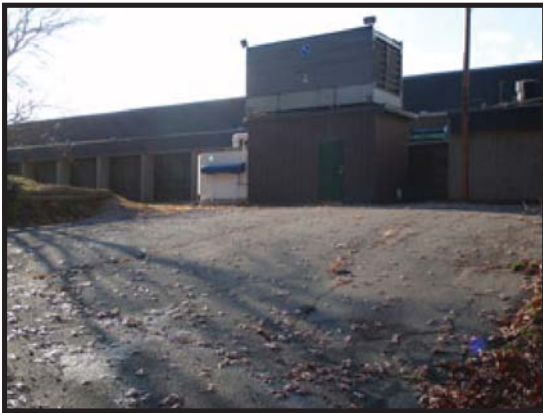
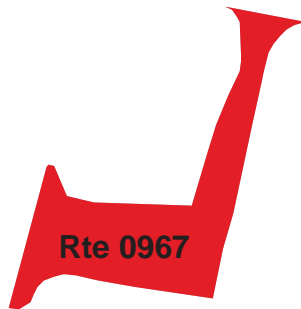
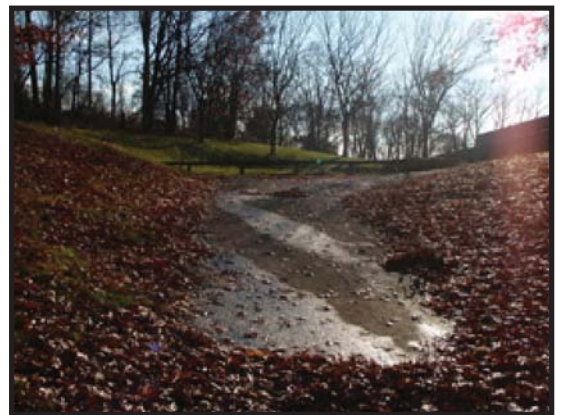
Route Number	Public / NonPublic	Date Visited		Area (sq ft)	Lane Miles *	Surface Type
0967	NONPUBLIC	12/1/2008		3,985	0.07	AS
Culverts	Drop Inlets	Gates	Fire Hydrants	Curb & Gutter	Curb	PCR
0	0	1	0	NO CURB AND GUTTER	NO CURB	POOR/45

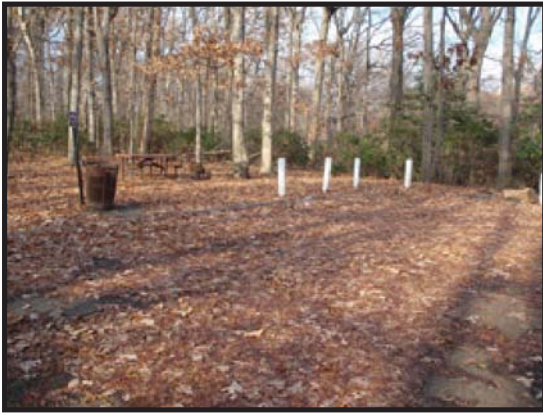
Route 0980

Route Number	Public / NonPublic	Date Visited		Area (sq ft)	Lane Miles *	Surface Type
0980	PUBLIC	12/1/2008		1,297	0.02	AS
Culverts	Drop Inlets	Gates	Fire Hydrants	Curb & Gutter	Curb	PCR
0	0	0	0	NO CURB AND GUTTER	ASPHALT CURB	POOR/45

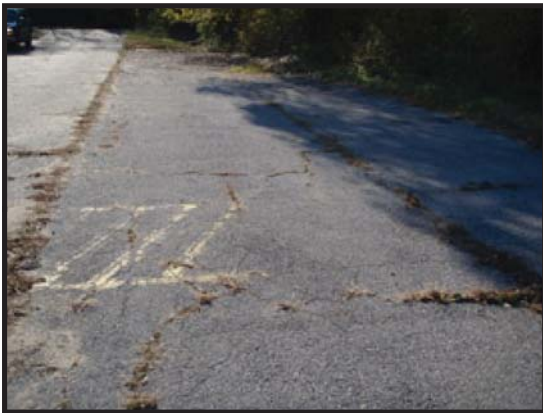
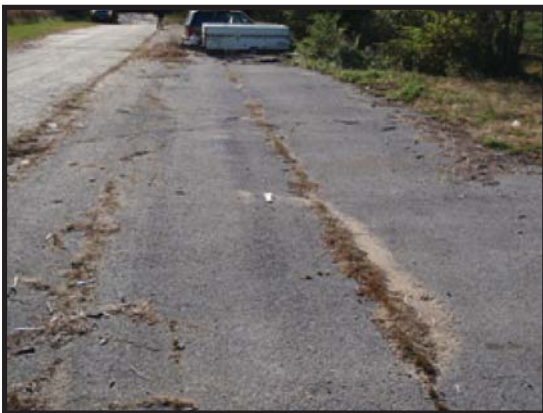
Route 0981

Route Number	Public / NonPublic	Date Visited		Area (sq ft)	Lane Miles *	Surface Type
0981	NONPUBLIC	11/19/2008		22,511	0.39	AS
Culverts	Drop Inlets	Gates	Fire Hydrants	Curb & Gutter	Curb	PCR
0	1	0	0	NO CURB AND GUTTER	NO CURB	POOR/45
