**The Road Inventory
of
Organ Pipe Cactus National Monument
ORPI – 8660
Cycle 4**

**Prepared By:
Federal Highway Administration
Road Inventory Program
Cycle 4**

Organ Pipe Cactus National Monument in Arizona

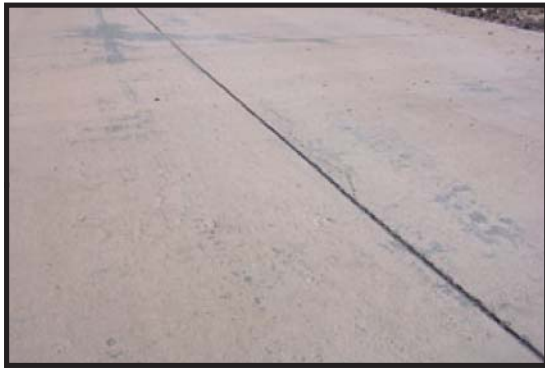
Section 1

Route Number	Public / NonPublic	Date Visited		Area (sq ft)	Lane Miles *	Surface Type
0011	PUBLIC	11/4/2007		1,904	0.02	AS
Culverts	Drop Inlets	Gates	Fire Hydrants	Curb & Gutter	Curb	PCR
0	0	0	0	NO CURB AND GUTTER	NO CURB	GOOD/90

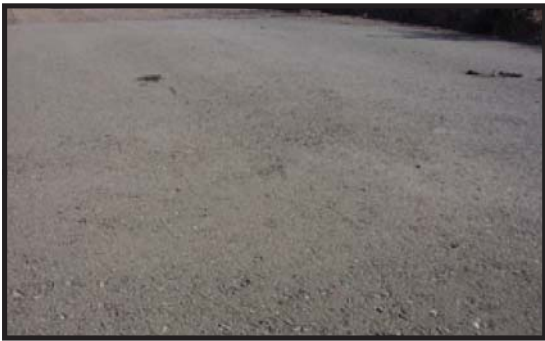
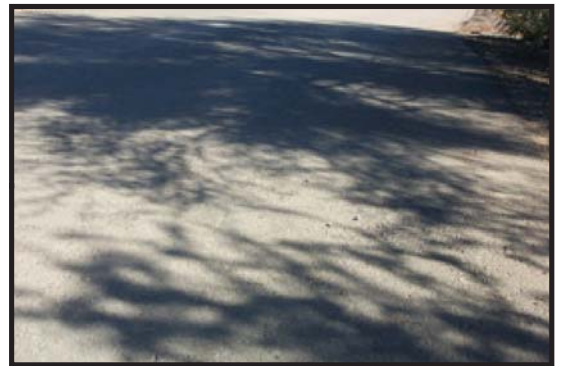
Section 2

Route Number	Public / NonPublic	Date Visited		Area (sq ft)	Lane Miles *	Surface Type
0011	PUBLIC	11/4/2007		2,875	0.03	AS
Culverts	Drop Inlets	Gates	Fire Hydrants	Curb & Gutter	Curb	PCR
0	0	0	0	NO CURB AND GUTTER	NO CURB	GOOD/90

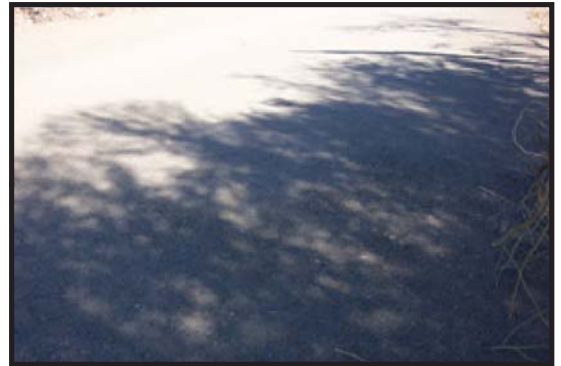
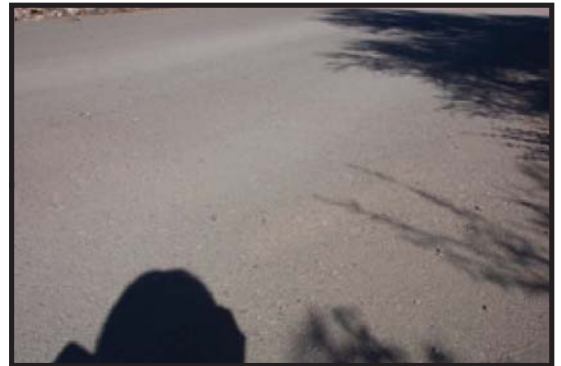
Section 3

Route Number	Public / NonPublic	Date Visited		Area (sq ft)	Lane Miles *	Surface Type
0011	PUBLIC	11/4/2007		4,005	0.04	AS
Culverts	Drop Inlets	Gates	Fire Hydrants	Curb & Gutter	Curb	PCR
0	0	0	0	NO CURB AND GUTTER	NO CURB	GOOD/90

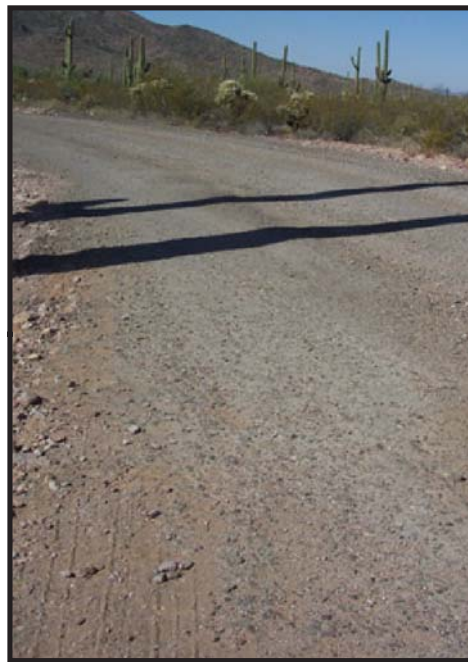
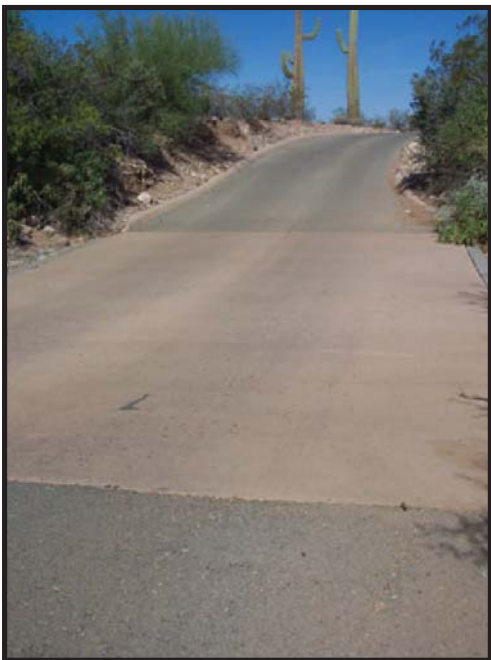
Section 4

Route Number	Public / NonPublic	Date Visited		Area (sq ft)	Lane Miles *	Surface Type
0011	PUBLIC	11/4/2007		201,697	2.18	AS
Culverts	Drop Inlets	Gates	Fire Hydrants	Curb & Gutter	Curb	PCR
0	0	0	0	NO CURB AND GUTTER	CONCRETE CURB	FAIR/73

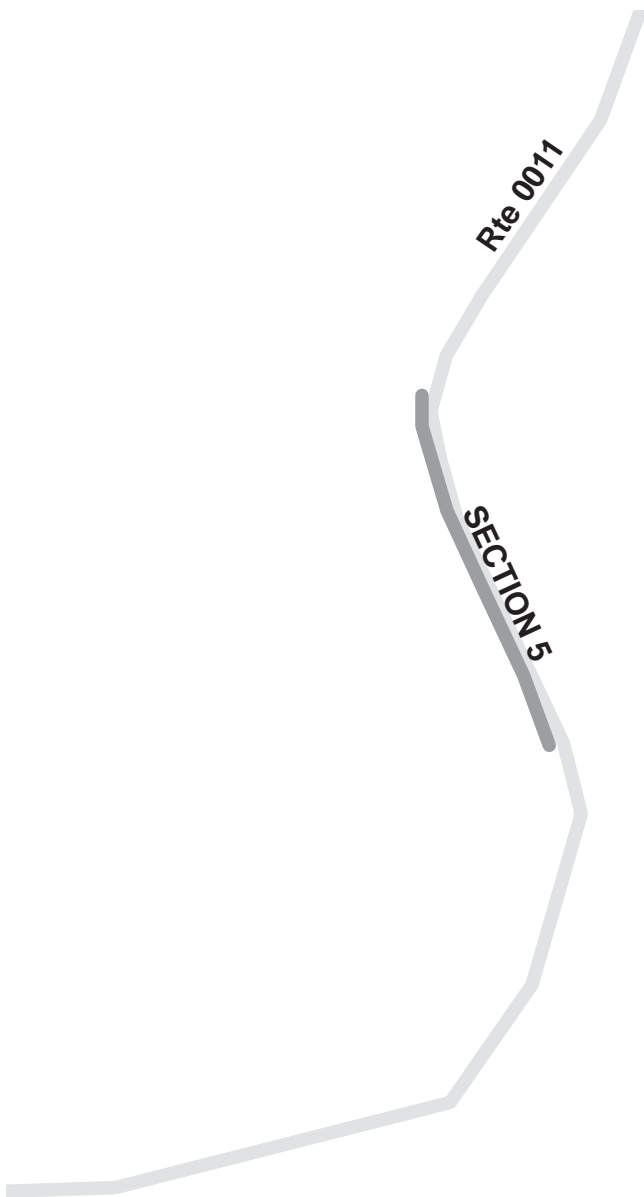
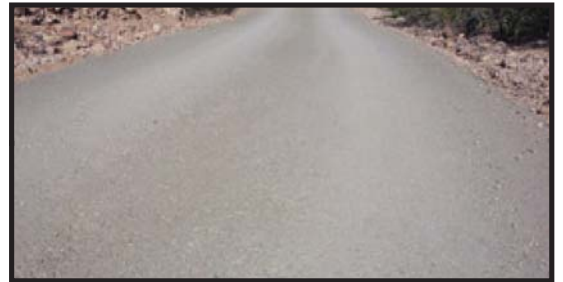
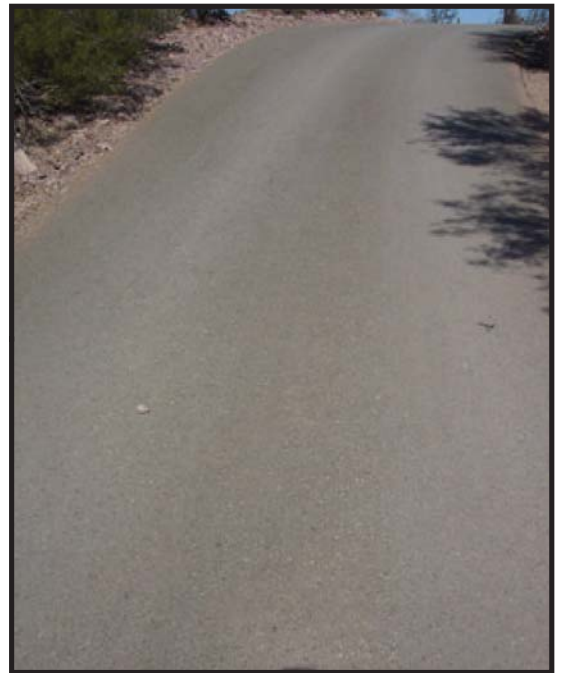
Section 5

Route Number	Public / NonPublic	Date Visited		Area (sq ft)	Lane Miles *	Surface Type
0011	PUBLIC	11/4/2007		2,787	0.03	AS
Culverts	Drop Inlets	Gates	Fire Hydrants	Curb & Gutter	Curb	PCR
0	0	0	0	NO CURB AND GUTTER	NO CURB	GOOD/90

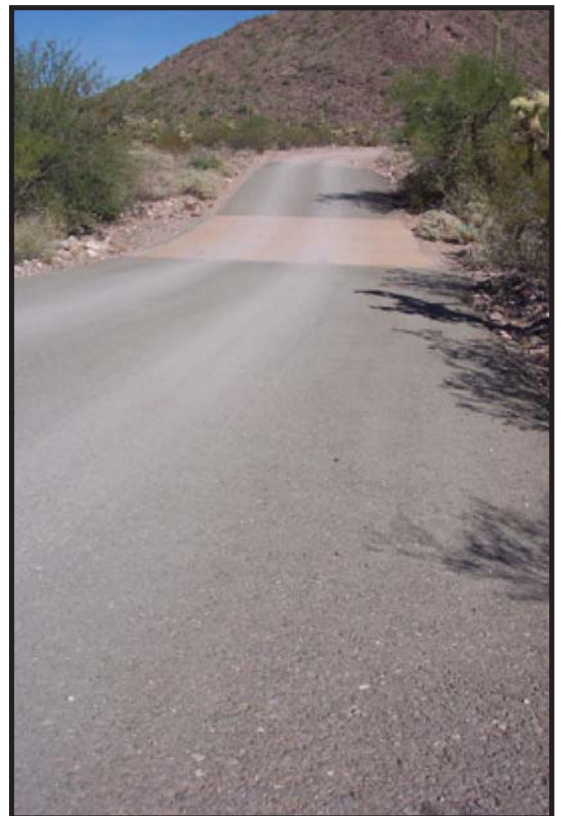
Section 7

Route Number	Public / NonPublic	Date Visited		Area (sq ft)	Lane Miles *	Surface Type
0011	PUBLIC	11/4/2007		2,257	0.02	AS
Culverts	Drop Inlets	Gates	Fire Hydrants	Curb & Gutter	Curb	PCR
0	0	0	0	NO CURB AND GUTTER	NO CURB	GOOD/90

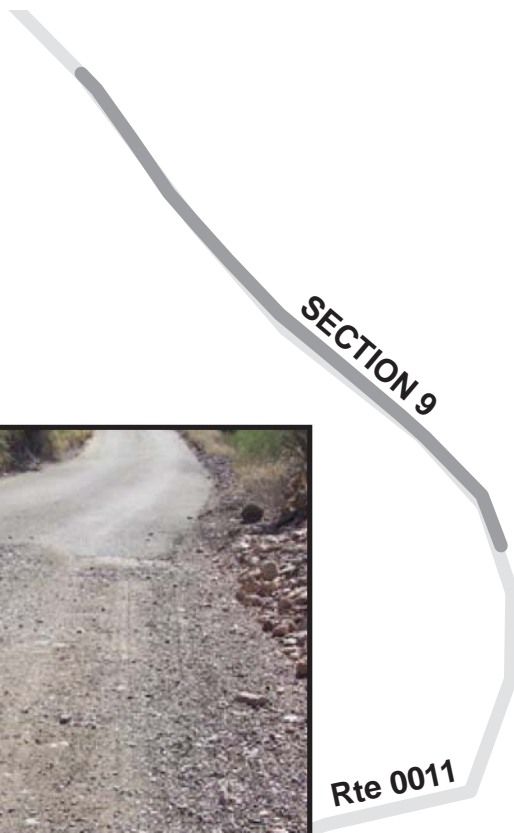
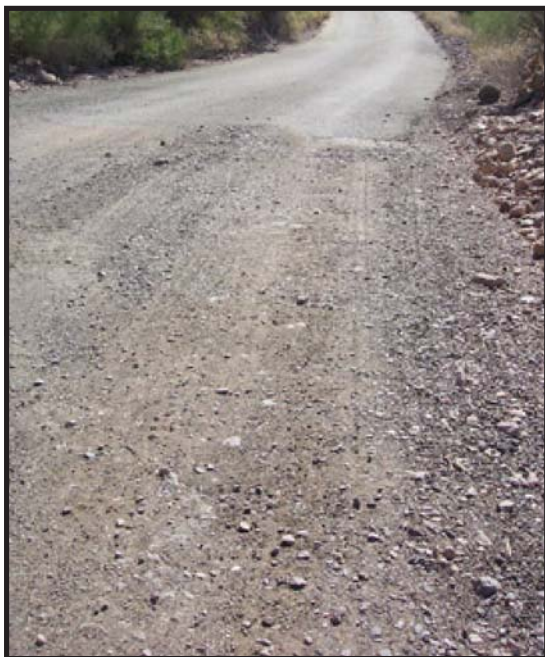
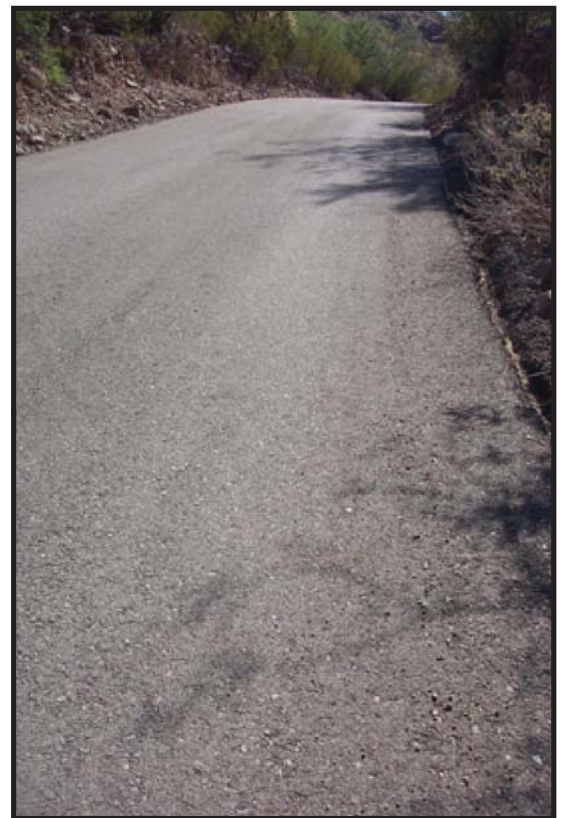
Section 9

Route Number	Public / NonPublic	Date Visited		Area (sq ft)	Lane Miles *	Surface Type
0011	PUBLIC	11/4/2007		6,401	0.07	AS
Culverts	Drop Inlets	Gates	Fire Hydrants	Curb & Gutter	Curb	PCR
0	0	0	0	NO CURB AND GUTTER	NO CURB	GOOD/90

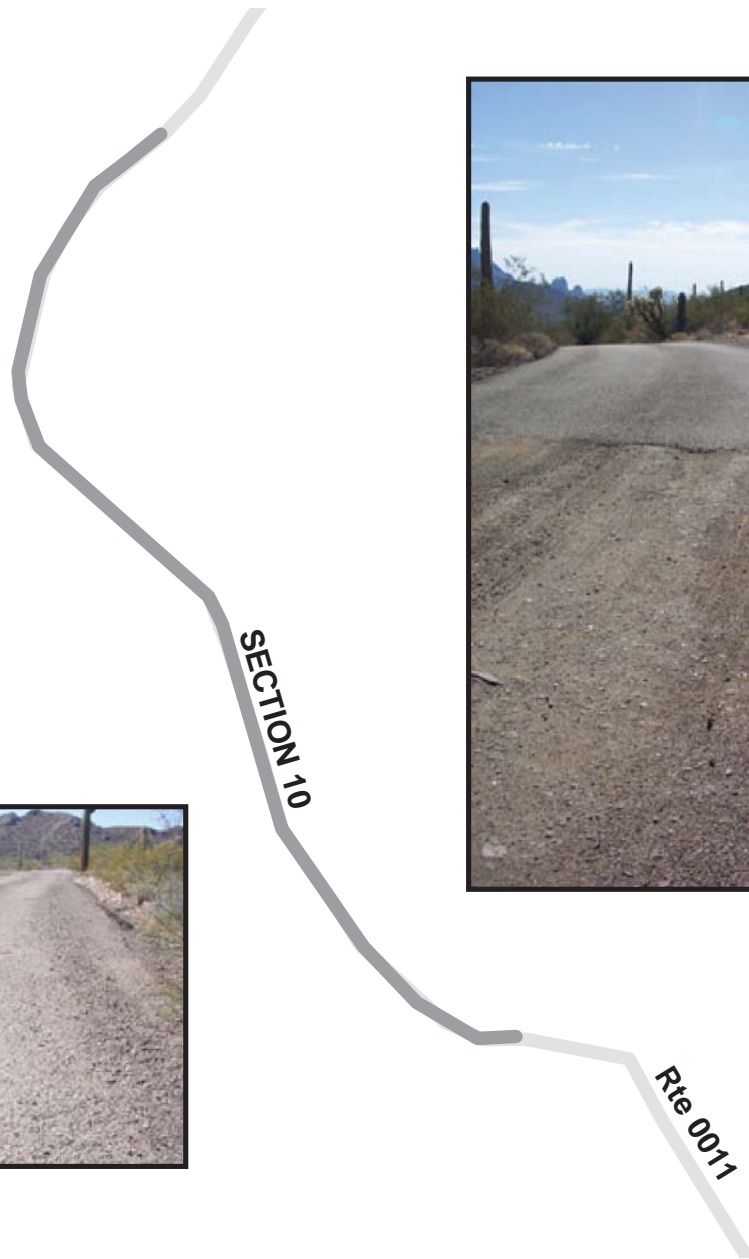
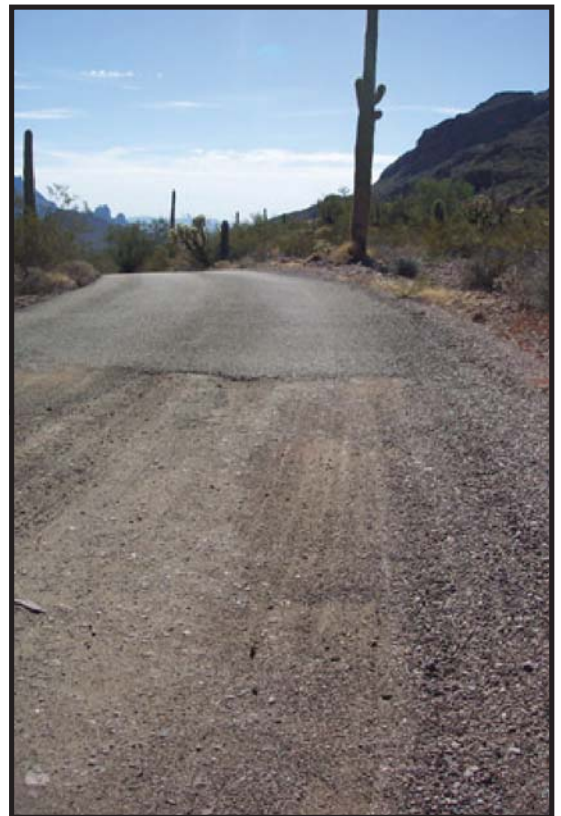
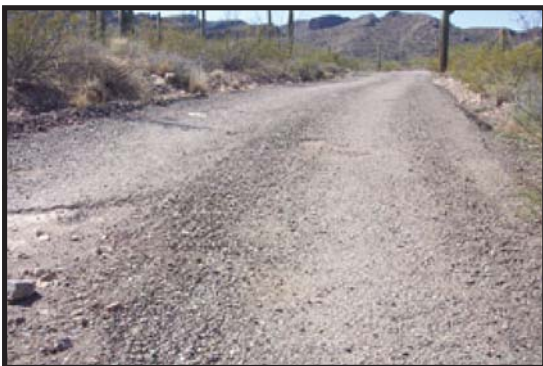
Section 10

Route Number	Public / NonPublic	Date Visited		Area (sq ft)	Lane Miles *	Surface Type
0011	PUBLIC	11/4/2007		31,697	0.34	AS
Culverts	Drop Inlets	Gates	Fire Hydrants	Curb & Gutter	Curb	PCR
0	0	0	0	NO CURB AND GUTTER	NO CURB	GOOD/90

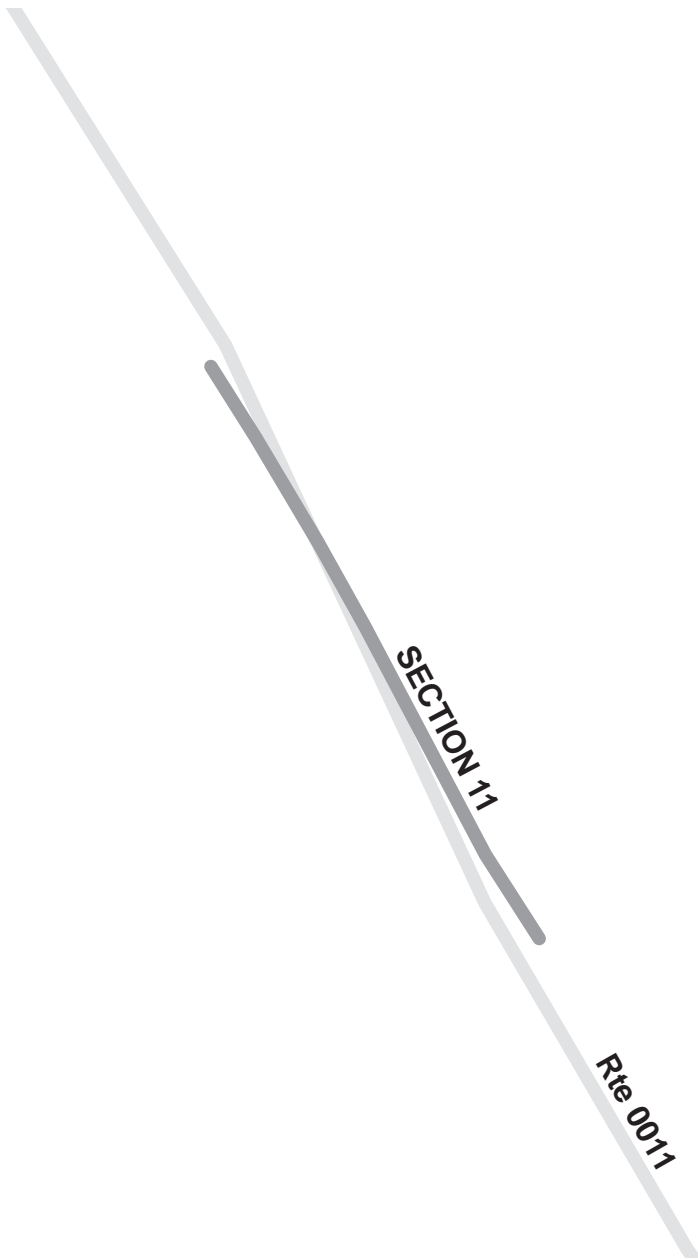
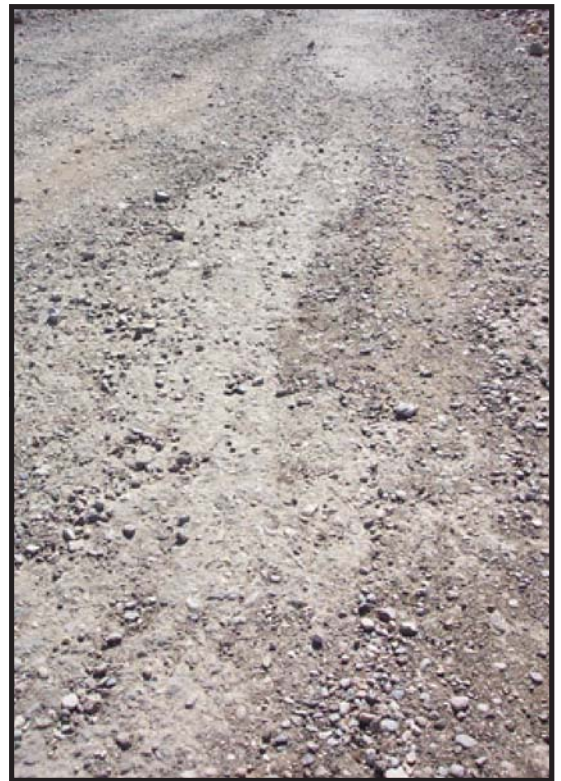
Section 11

Route Number	Public / NonPublic	Date Visited		Area (sq ft)	Lane Miles *	Surface Type
0011	PUBLIC	11/4/2007		2,068	0.02	AS
Culverts	Drop Inlets	Gates	Fire Hydrants	Curb & Gutter	Curb	PCR
0	0	0	0	NO CURB AND GUTTER	NO CURB	POOR/45

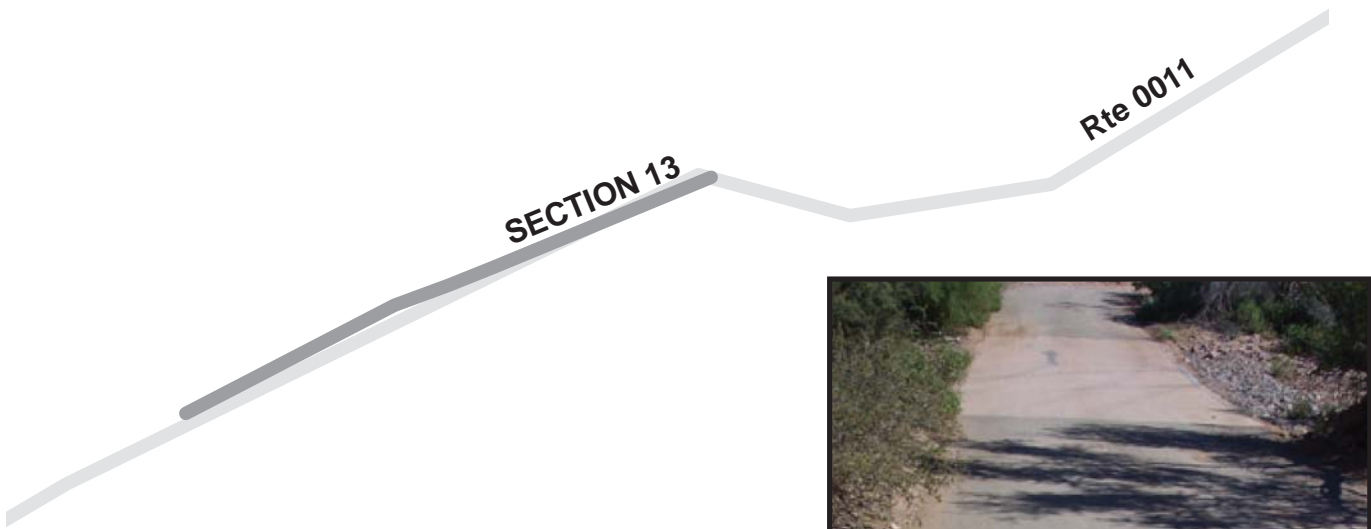
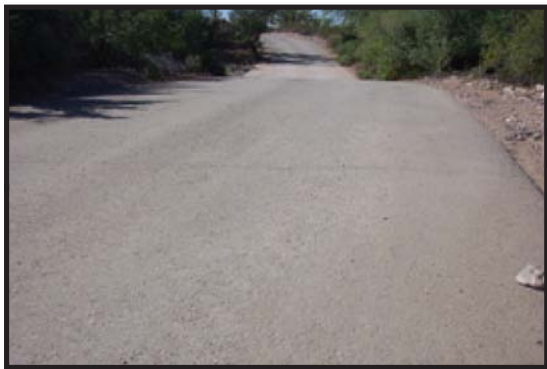
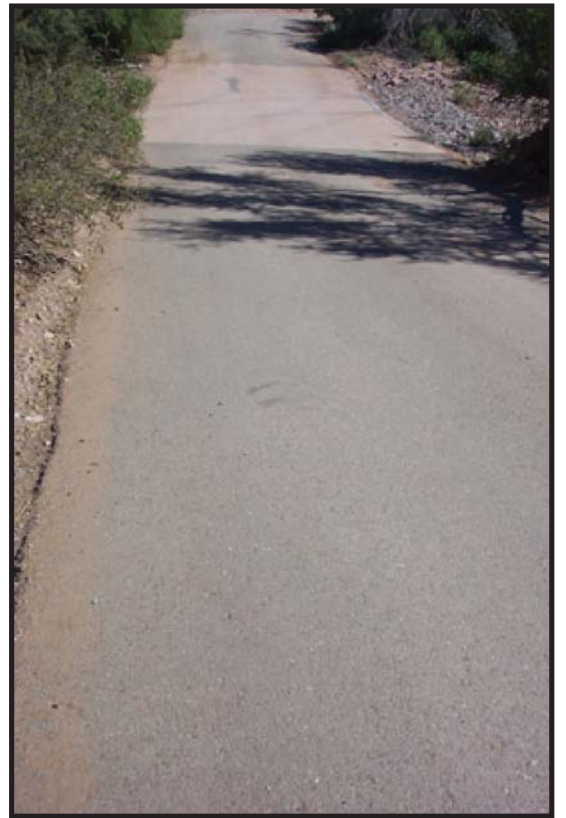
Section 13

Route Number	Public / NonPublic	Date Visited		Area (sq ft)	Lane Miles *	Surface Type
0011	PUBLIC	11/4/2007		3,346	0.04	AS
Culverts	Drop Inlets	Gates	Fire Hydrants	Curb & Gutter	Curb	PCR
0	0	0	0	NO CURB AND GUTTER	NO CURB	GOOD/90

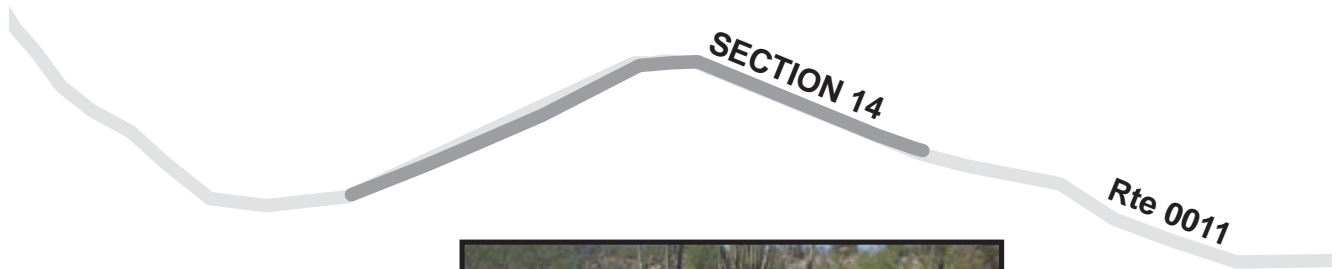
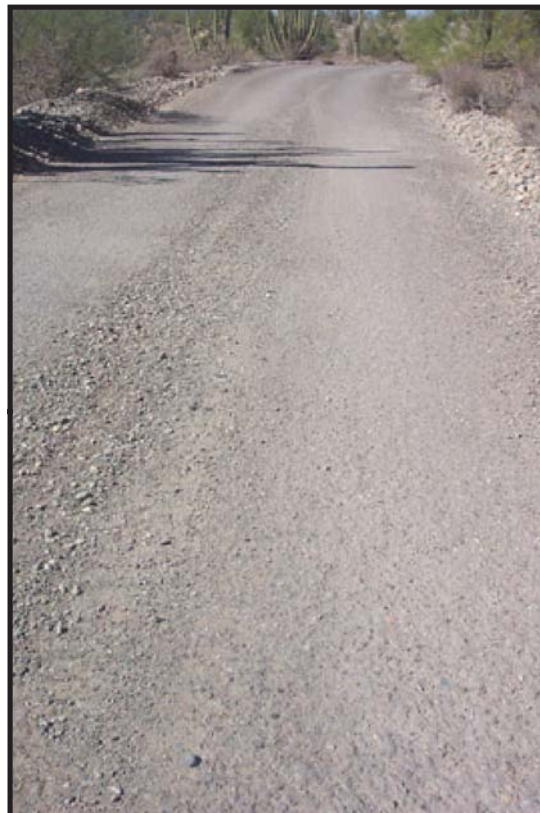
Section 14

Route Number	Public / NonPublic	Date Visited		Area (sq ft)	Lane Miles *	Surface Type
0011	PUBLIC	11/4/2007		17,018	0.18	AS
Culverts	Drop Inlets	Gates	Fire Hydrants	Curb & Gutter	Curb	PCR
0	0	0	0	NO CURB AND GUTTER	NO CURB	POOR/45

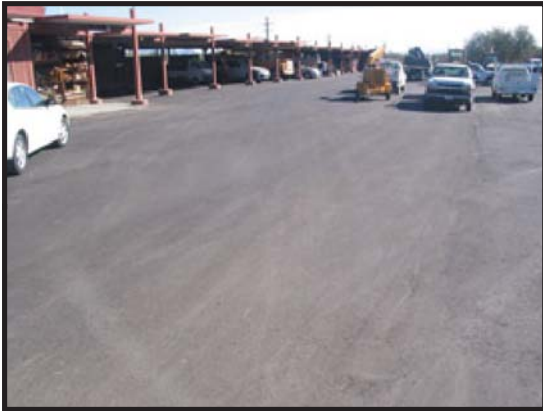
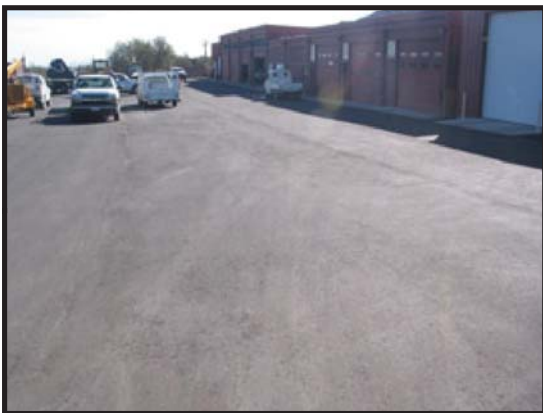
Route Number	Public / NonPublic	Date Visited		Area (sq ft)	Lane Miles *	Surface Type
0903	NONPUBLIC	12/7/2006		25,728	0.44	AS
Culverts	Drop Inlets	Gates	Fire Hydrants	Curb & Gutter	Curb	PCR
0	0	1	1	NO CURB AND GUTTER	NO CURB	GOOD/90

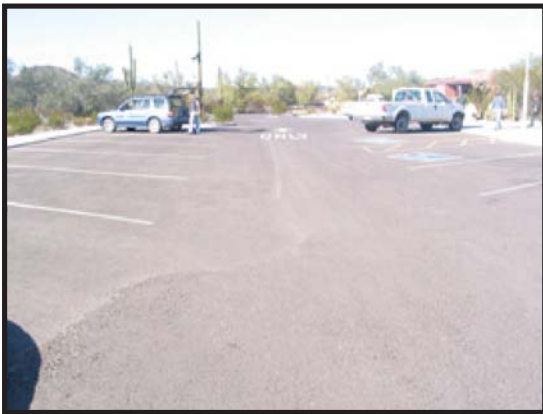
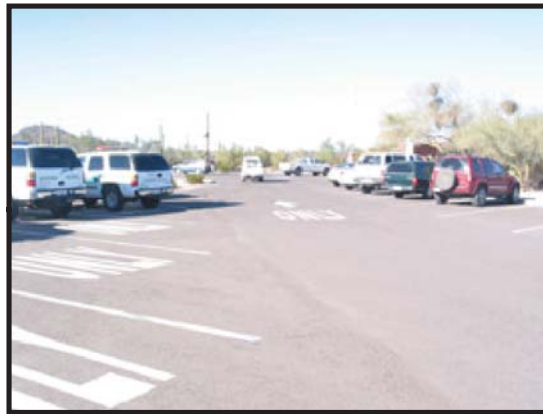
Route 0904A

Route Number	Public / NonPublic	Date Visited		Area (sq ft)	Lane Miles *	Surface Type
0904A	PUBLIC	12/7/2006		36,360	0.63	AS
Culverts	Drop Inlets	Gates	Fire Hydrants	Curb & Gutter	Curb	PCR
0	0	0	1	NO CURB AND GUTTER	CONCRETE CURB	EXCELLENT/97

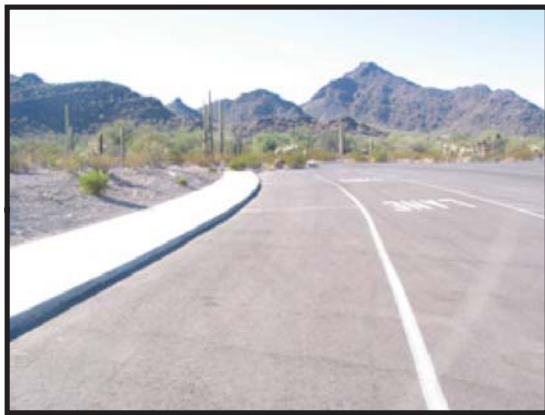
Route 0904B

Route Number	Public / NonPublic	Date Visited		Area (sq ft)	Lane Miles *	Surface Type
0904B	PUBLIC	12/7/2006		8,246	0.14	AS
Culverts	Drop Inlets	Gates	Fire Hydrants	Curb & Gutter	Curb	PCR
0	0	0	0	NO CURB AND GUTTER	NO CURB	EXCELLENT/97

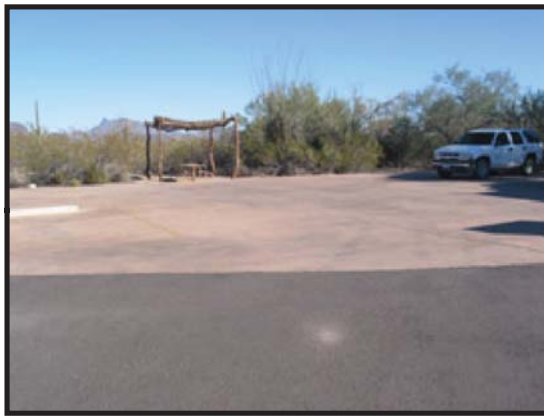
Route 0905

Route Number	Public / NonPublic	Date Visited		Area (sq ft)	Lane Miles *	Surface Type
0905	NONPUBLIC	12/7/2006		7,927	0.14	AS
Culverts	Drop Inlets	Gates	Fire Hydrants	Curb & Gutter	Curb	PCR
0	0	0	1	NO CURB AND GUTTER	NO CURB	EXCELLENT/97

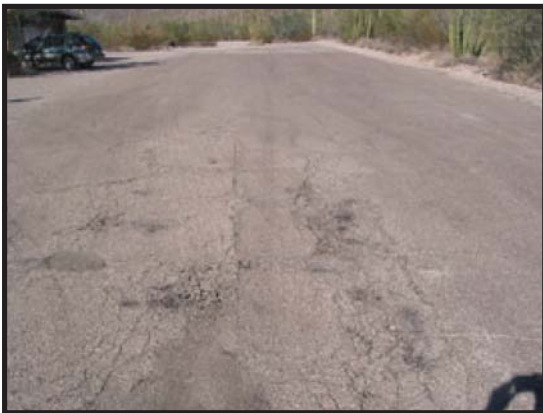
Route Number	Public / NonPublic	Date Visited		Area (sq ft)	Lane Miles *	Surface Type
0906	PUBLIC	12/7/2006		10,652	0.18	AS
Culverts	Drop Inlets	Gates	Fire Hydrants	Curb & Gutter	Curb	PCR
0	0	0	0	NO CURB AND GUTTER	NO CURB	POOR/45

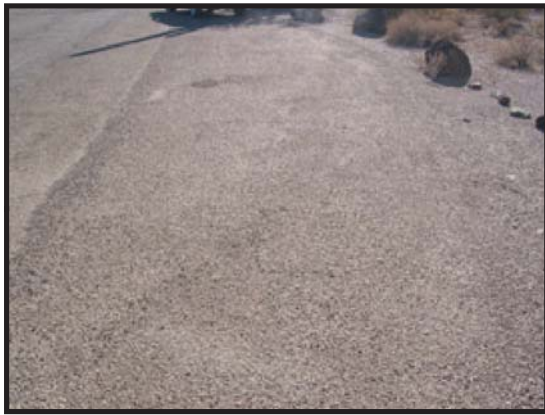
Route 0907

Route Number	Public / NonPublic	Date Visited		Area (sq ft)	Lane Miles *	Surface Type
0907	PUBLIC	12/7/2006		902	0.02	AS
Culverts	Drop Inlets	Gates	Fire Hydrants	Curb & Gutter	Curb	PCR
0	0	0	0	NO CURB AND GUTTER	NO CURB	POOR/45

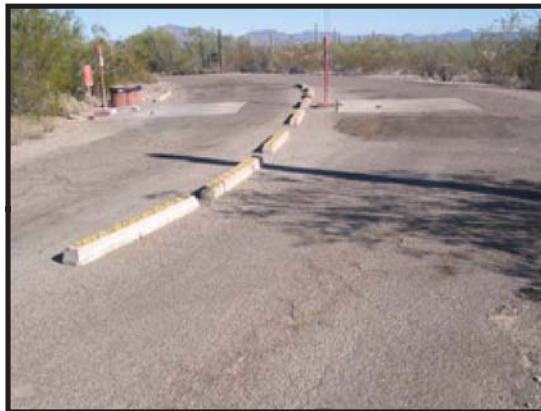
Route 0908

Route Number	Public / NonPublic	Date Visited		Area (sq ft)	Lane Miles *	Surface Type
0908	PUBLIC	12/7/2006		7,147	0.12	AS
Culverts	Drop Inlets	Gates	Fire Hydrants	Curb & Gutter	Curb	PCR
0	0	0	0	NO CURB AND GUTTER	NO CURB	POOR/45

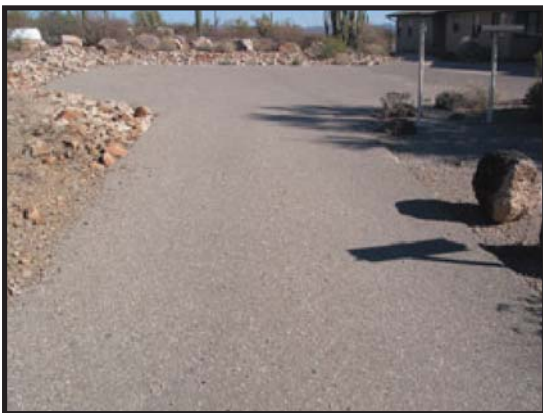
Route 0909

Route Number	Public / NonPublic	Date Visited		Area (sq ft)	Lane Miles *	Surface Type
0909	NONPUBLIC	12/7/2006		2,639	0.05	AS
Culverts	Drop Inlets	Gates	Fire Hydrants	Curb & Gutter	Curb	PCR
0	0	1	0	NO CURB AND GUTTER	NO CURB	EXCELLENT/97

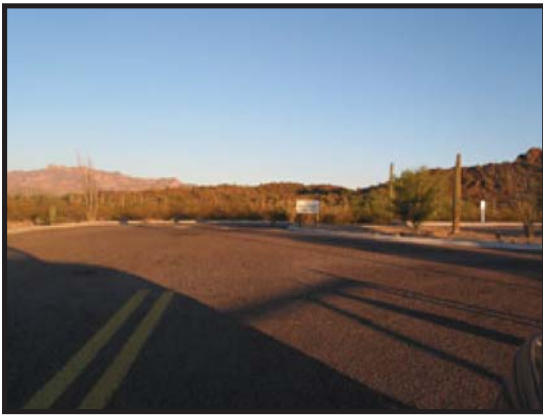
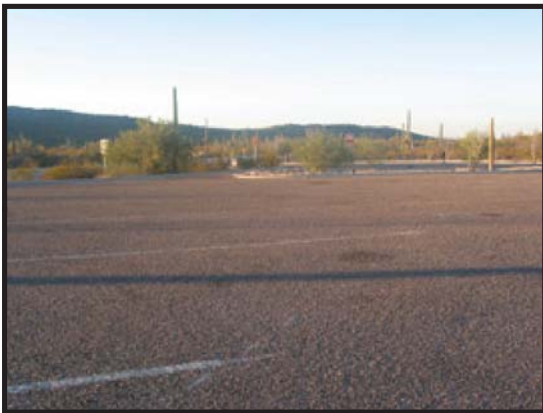
Route 0910

Route Number	Public / NonPublic	Date Visited		Area (sq ft)	Lane Miles *	Surface Type
0910	PUBLIC	12/7/2006		28,797	0.50	AS
Culverts	Drop Inlets	Gates	Fire Hydrants	Curb & Gutter	Curb	PCR
0	0	1	0	NO CURB AND GUTTER	ASPHALT CURB	EXCELLENT/97
