**The Road Inventory
of
Ozark National Scenic Riverways
OZAR – 6640
Cycle 4**

**Prepared By:
Federal Highway Administration
Road Inventory Program
Cycle 4**

Ozark National Scenic Riverways in Missouri

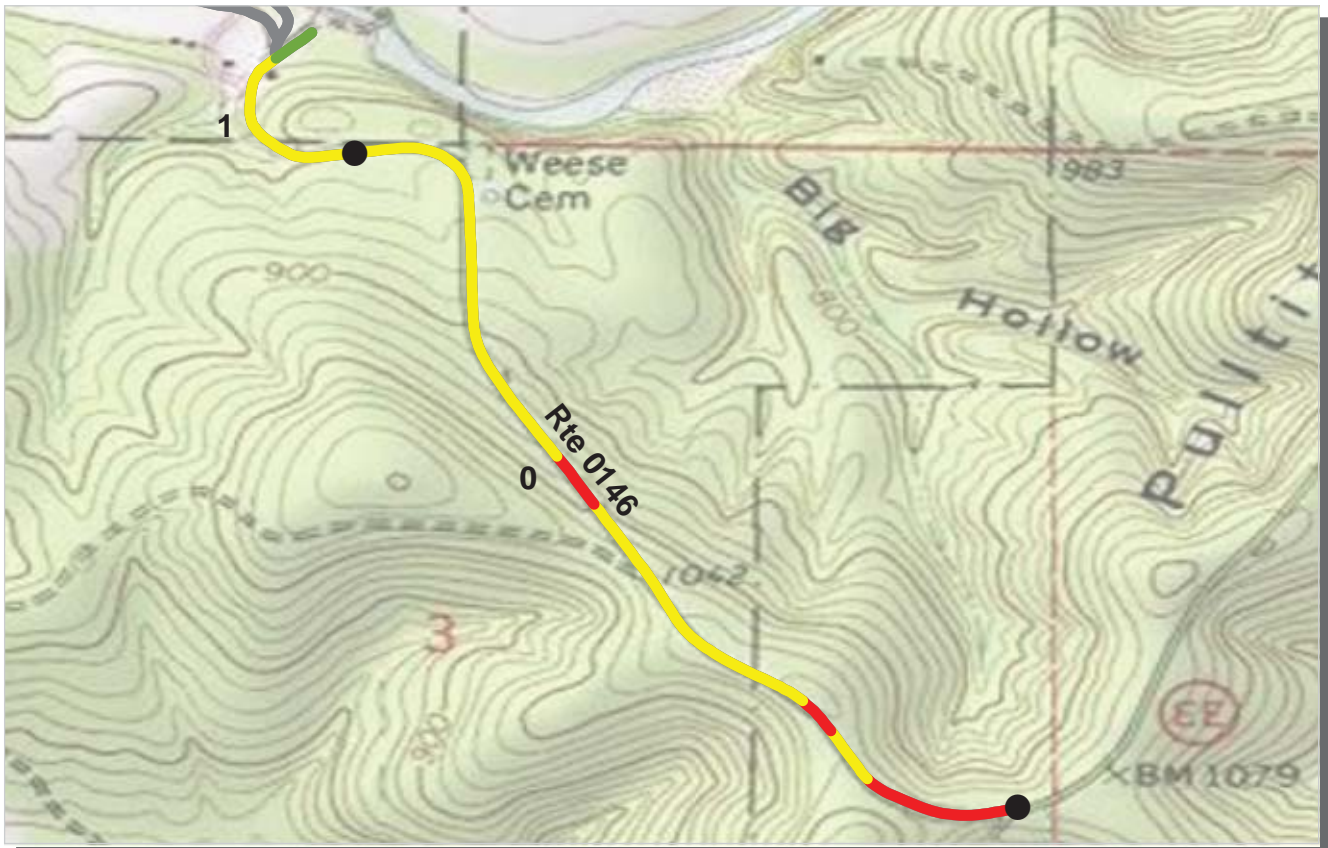
ROUTE: 0131 OLD STATE 106 WEST

Section Number	0	1			
Section Length (mi)	1.00	0.22			
Traffic	Traffic data may be found at www.efl.fhwa.dot.gov Click on PROGRAMS / NPS Traffic Data (Note: Not all parks have traffic data)				
Cross Section Information					
Number of Lanes	2	2			
Paved Width (ft)	18	23			
Lane Width (ft)	8	9			
Shoulder Width Right (ft)	NC	NC			
Shoulder Width Left (ft)	NC	NC			
Roadway Condition Information					
SCR (Surface Condition Rating)	71	86			
PCR (Pavement Condition Rating)	69	84			
Distress Index Values					
Alligator Cracking Index	94	100			
Longitudinal Cracking Index	91	96			
Transverse Cracking Index	95	97			
Patching Index	100	100			
Rutting Index	90	93			
Roughness Condition Index (RCI)	66	80

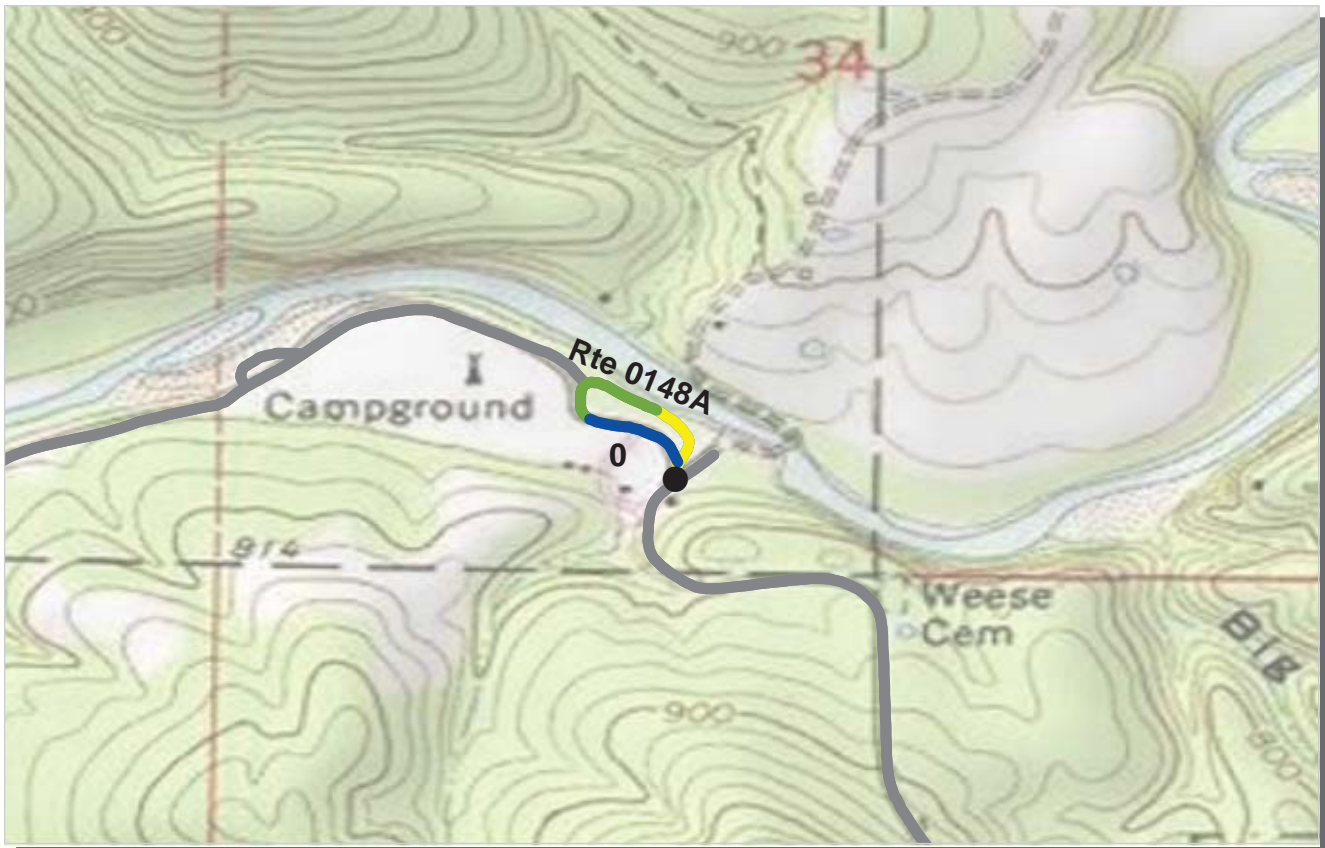
ROUTE: 0146 PULLTITE ROAD

Section Number	0				
Section Length (mi)	0.26				
Traffic	Traffic data may be found at www.efl.fhwa.dot.gov Click on PROGRAMS / NPS Traffic Data (Note: Not all parks have traffic data)				
Cross Section Information					
Number of Lanes	1				
Paved Width (ft)	13				
Lane Width (ft)	13				
Shoulder Width Right (ft)	NC				
Shoulder Width Left (ft)	NC				
Roadway Condition Information					
SCR (Surface Condition Rating)	94				
PCR (Pavement Condition Rating)	93				
Distress Index Values					
Alligator Cracking Index	100				
Longitudinal Cracking Index	99				
Transverse Cracking Index	100				
Patching Index	100				
Rutting Index	95				
Roughness Condition Index (RCI)	59

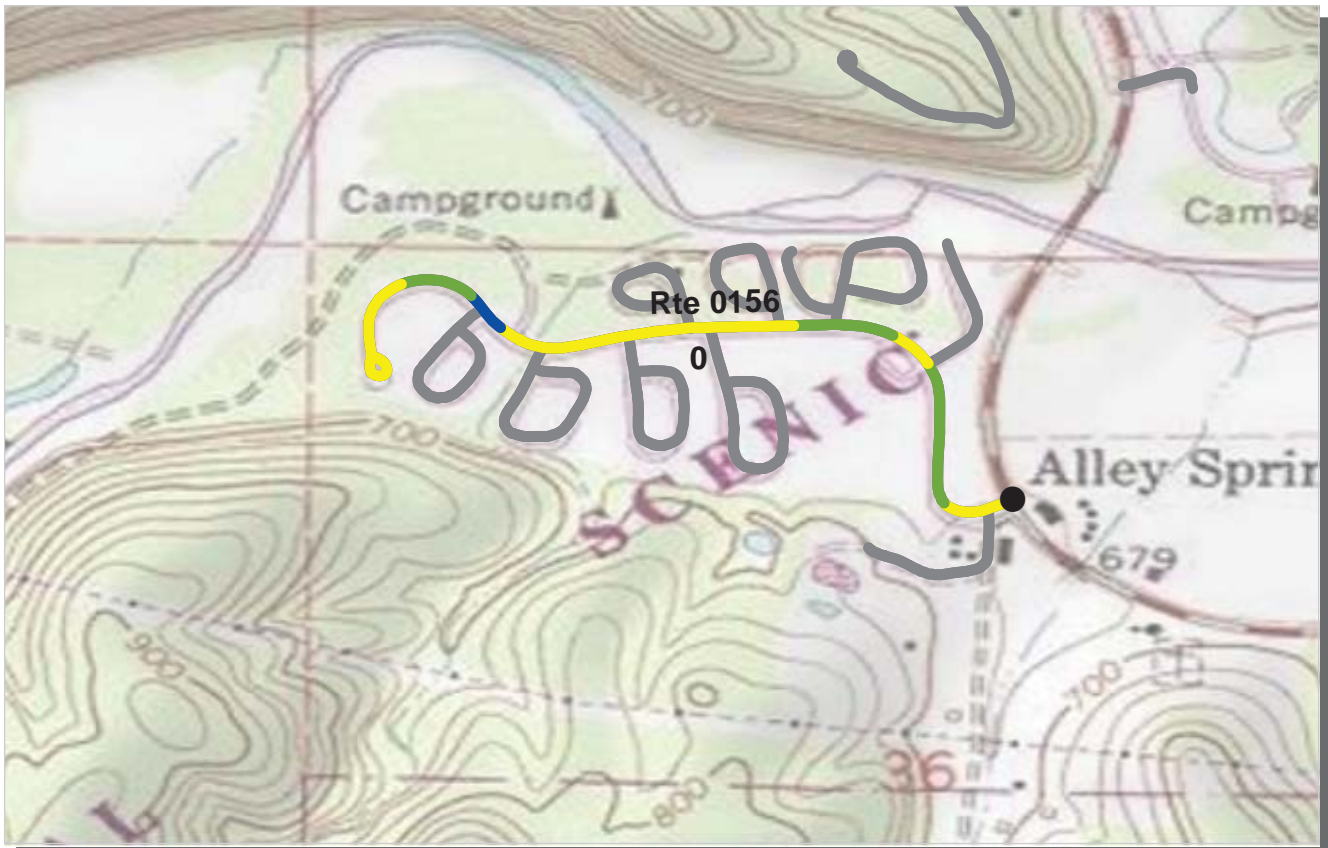
ROUTE: 0148B PULLTITE CAMPGROUND ROAD B

Section Number	0				
Section Length (mi)	0.79				
Traffic	Traffic data may be found at www.efl.fhwa.dot.gov Click on PROGRAMS / NPS Traffic Data (Note: Not all parks have traffic data)				
Cross Section Information					
Number of Lanes	2				
Paved Width (ft)	21				
Lane Width (ft)	9				
Shoulder Width Right (ft)	NC				
Shoulder Width Left (ft)	NC				
Roadway Condition Information					
SCR (Surface Condition Rating)	75				
PCR (Pavement Condition Rating)	78				
Distress Index Values					
Alligator Cracking Index	100				
Longitudinal Cracking Index	94				
Transverse Cracking Index	89				
Patching Index	99				
Rutting Index	93				
Roughness Condition Index (RCI)	86

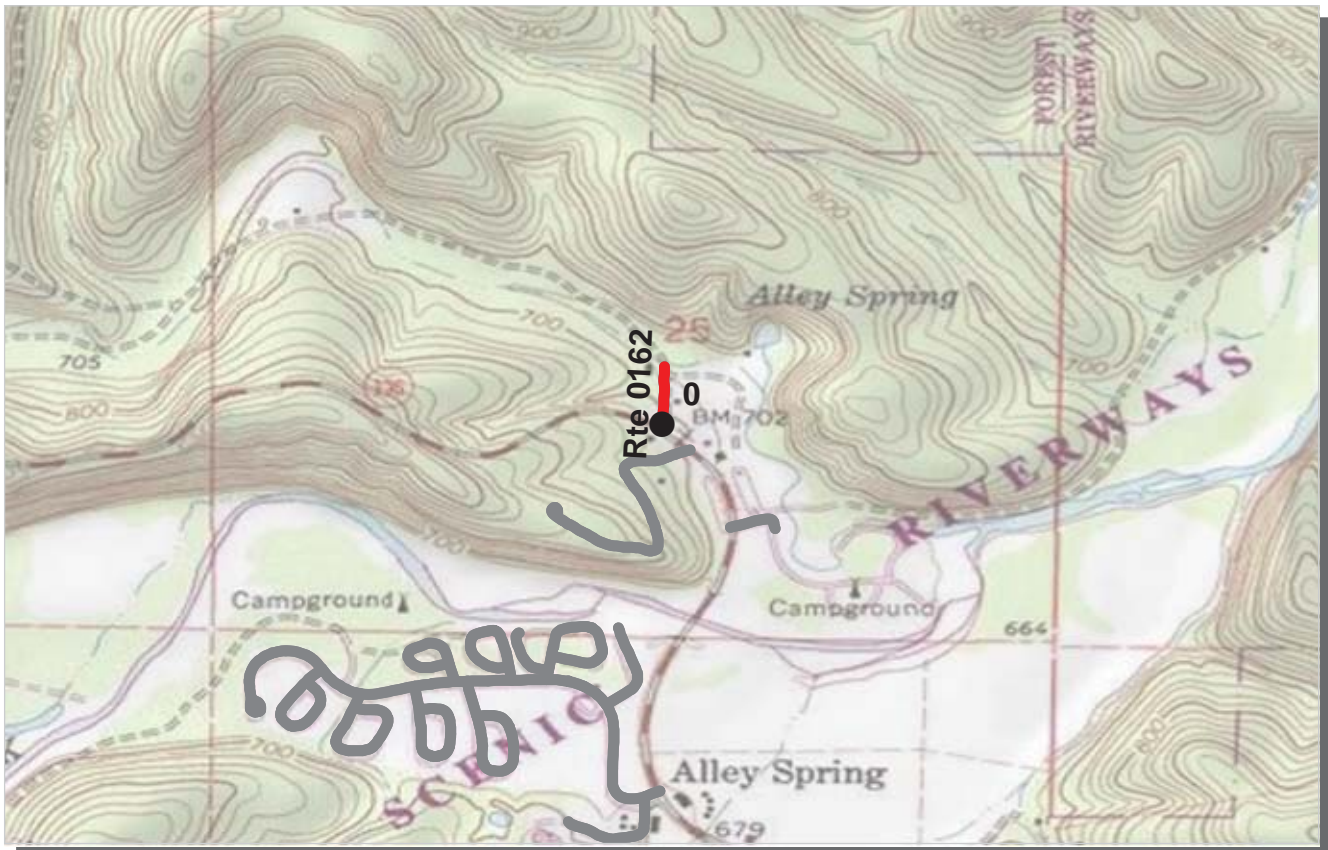
ROUTE: 0161 ALLEY SPRING PICNIC AREA ROAD

Section Number	0				
Section Length (mi)	0.09				
Traffic	Traffic data may be found at www.efl.fhwa.dot.gov Click on PROGRAMS / NPS Traffic Data (Note: Not all parks have traffic data)				
Cross Section Information					
Number of Lanes	2				
Paved Width (ft)	19				
Lane Width (ft)	9				
Shoulder Width Right (ft)	NC				
Shoulder Width Left (ft)	NC				
Roadway Condition Information					
SCR (Surface Condition Rating)	24				
PCR (Pavement Condition Rating)	24				
Distress Index Values					
Alligator Cracking Index	89				
Longitudinal Cracking Index	88				
Transverse Cracking Index	85				
Patching Index	99				
Rutting Index	61				
Roughness Condition Index (RCI)	NC

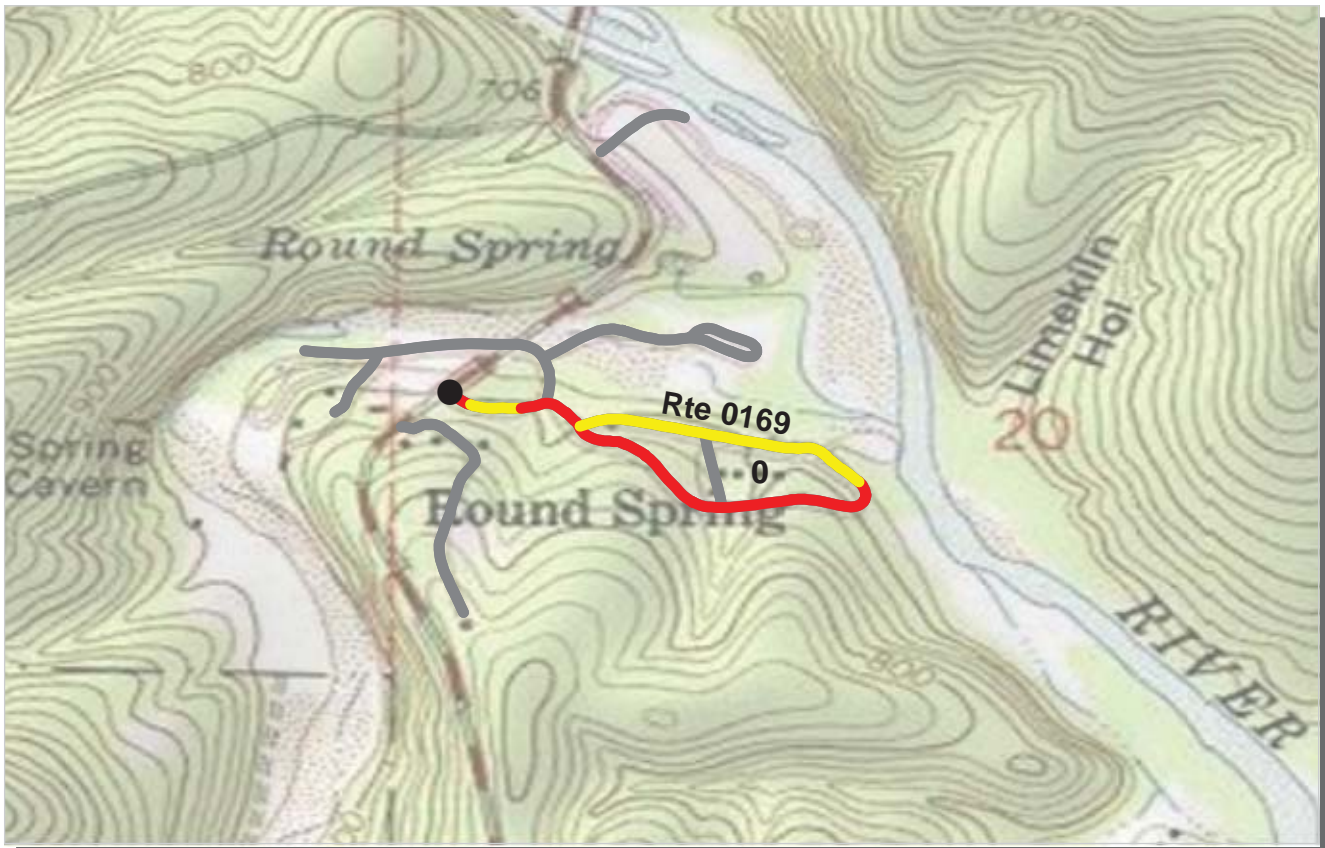
ROUTE: 0162 ALLEY HOLLOW ROAD

Section Number	0				
Section Length (mi)	0.63				
Traffic	Traffic data may be found at www.efl.fhwa.dot.gov Click on PROGRAMS / NPS Traffic Data (Note: Not all parks have traffic data)				
Cross Section Information					
Number of Lanes	2				
Paved Width (ft)	17				
Lane Width (ft)	12				
Shoulder Width Right (ft)	NC				
Shoulder Width Left (ft)	NC				
Roadway Condition Information					
SCR (Surface Condition Rating)	64				
PCR (Pavement Condition Rating)	58				
Distress Index Values					
Alligator Cracking Index	99				
Longitudinal Cracking Index	94				
Transverse Cracking Index	95				
Patching Index	99				
Rutting Index	78				
Roughness Condition Index (RCI)	26

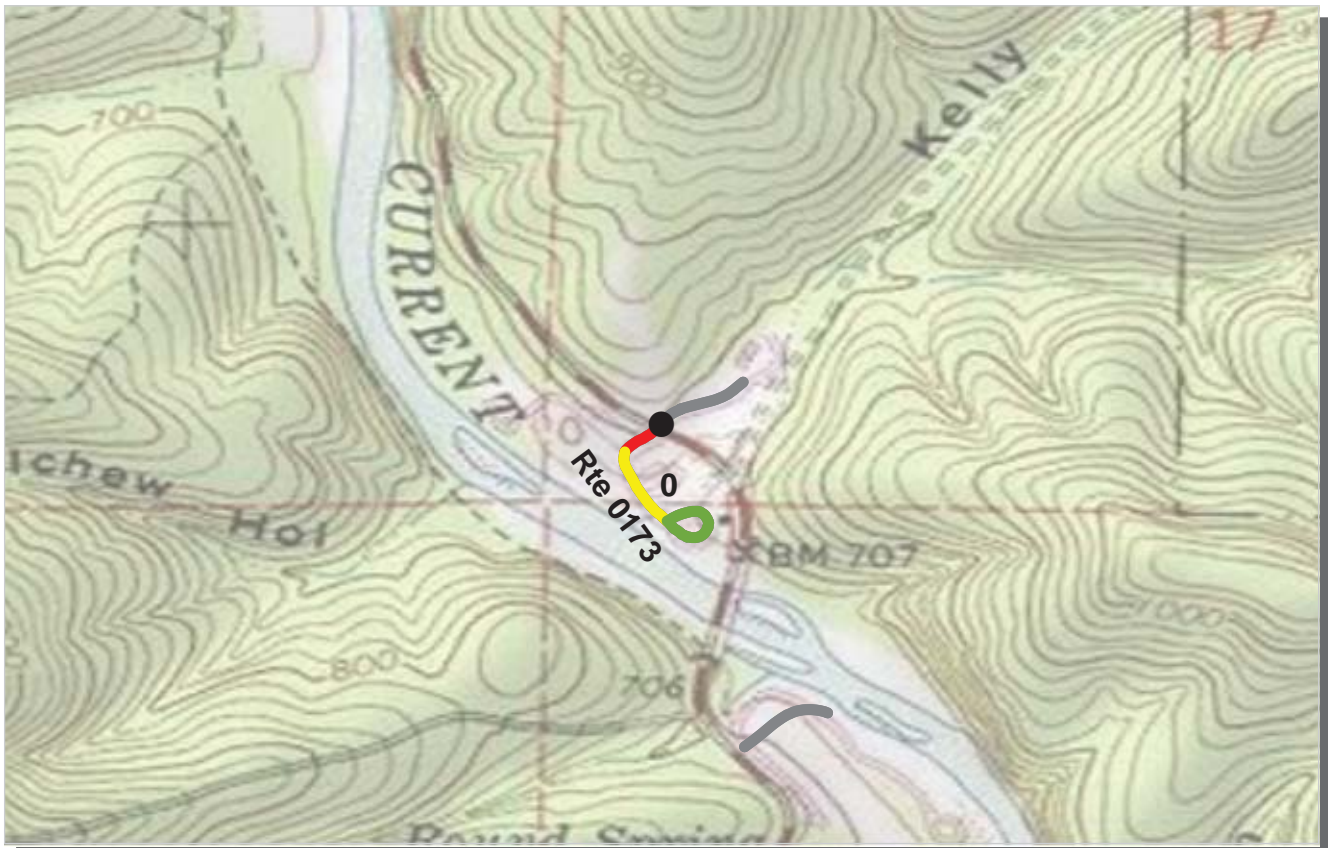
ROUTE: 0172 ROUND SPRING CLUSTER CAMPGROUND ROAD

Section Number	0				
Section Length (mi)	0.20				
Traffic	Traffic data may be found at www.efl.fhwa.dot.gov Click on PROGRAMS / NPS Traffic Data (Note: Not all parks have traffic data)				
Cross Section Information					
Number of Lanes	2				
Paved Width (ft)	19				
Lane Width (ft)	13				
Shoulder Width Right (ft)	NC				
Shoulder Width Left (ft)	NC				
Roadway Condition Information					
SCR (Surface Condition Rating)	73				
PCR (Pavement Condition Rating)	73				
Distress Index Values					
Alligator Cracking Index	96				
Longitudinal Cracking Index	96				
Transverse Cracking Index	91				
Patching Index	100				
Rutting Index	91				
Roughness Condition Index (RCI)	70

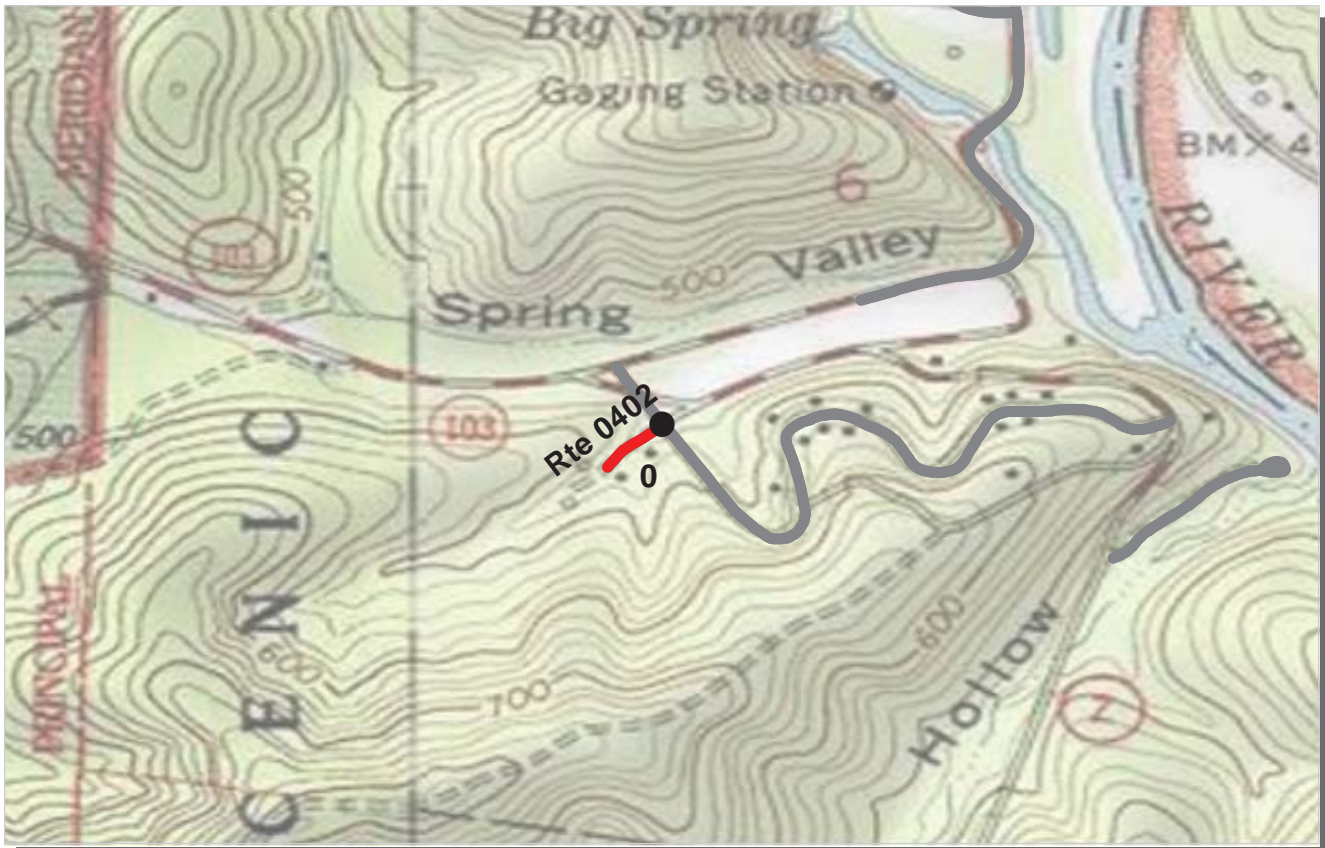
ROUTE: 0211 POWDER MILL VISITOR CENTER ROAD

Section Number	0				
Section Length (mi)	0.06				
Traffic	Traffic data may be found at www.efl.fhwa.dot.gov Click on PROGRAMS / NPS Traffic Data (Note: Not all parks have traffic data)				
Cross Section Information					
Number of Lanes	1				
Paved Width (ft)	12				
Lane Width (ft)	12				
Shoulder Width Right (ft)	NC				
Shoulder Width Left (ft)	NC				
Roadway Condition Information					
SCR (Surface Condition Rating)	32				
PCR (Pavement Condition Rating)	32				
Distress Index Values					
Alligator Cracking Index	100				
Longitudinal Cracking Index	99				
Transverse Cracking Index	99				
Patching Index	100				
Rutting Index	34				
Roughness Condition Index (RCI)	NC

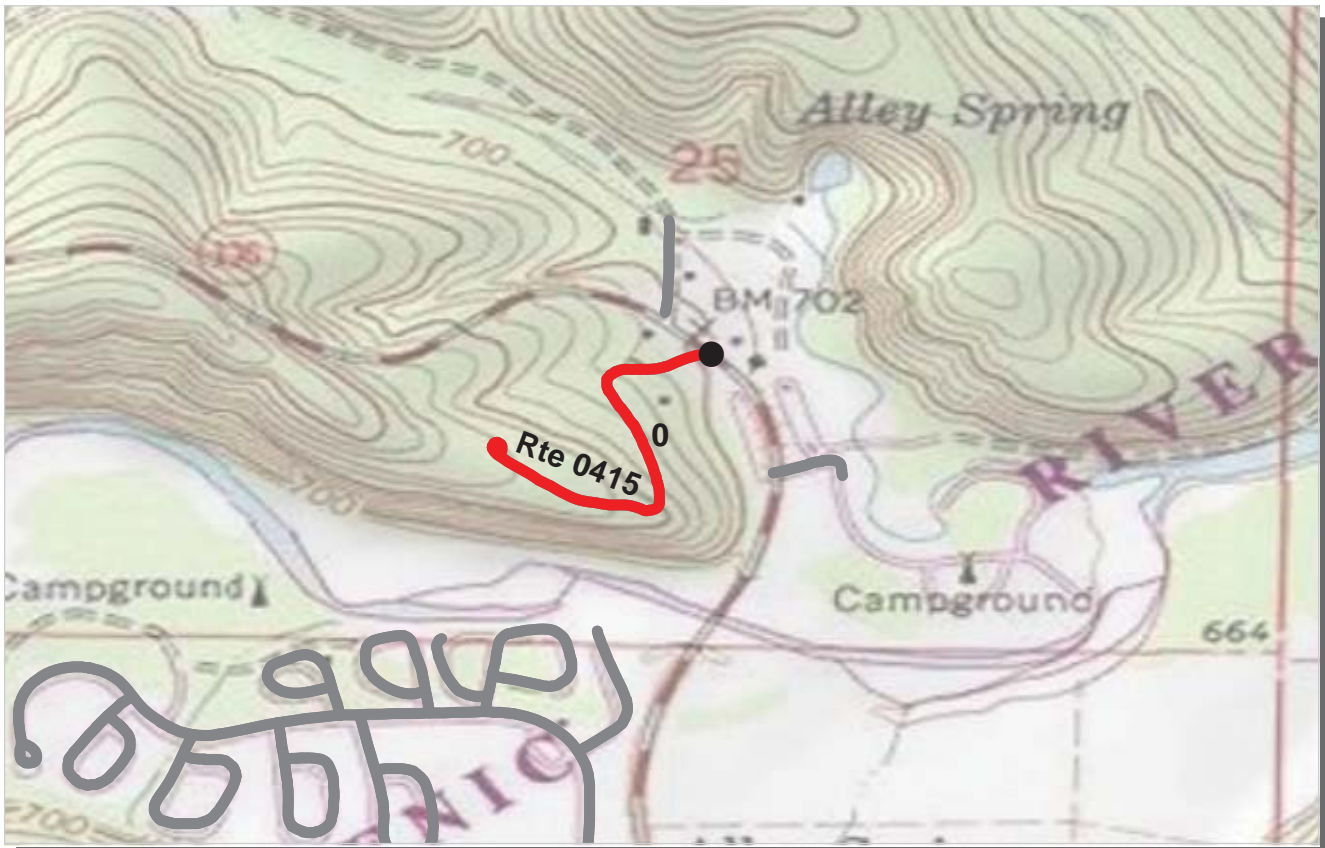
ROUTE: 0414 ALLEY SPRING RESIDENCE ROAD

Section Number	0				
Section Length (mi)	0.40				
Traffic	Traffic data may be found at www.efl.fhwa.dot.gov Click on PROGRAMS / NPS Traffic Data (Note: Not all parks have traffic data)				
Cross Section Information					
Number of Lanes	2				
Paved Width (ft)	10				
Lane Width (ft)	9				
Shoulder Width Right (ft)	NC				
Shoulder Width Left (ft)	NC				
Roadway Condition Information					
SCR (Surface Condition Rating)	18				
PCR (Pavement Condition Rating)	19				
Distress Index Values					
Alligator Cracking Index	90				
Longitudinal Cracking Index	89				
Transverse Cracking Index	93				
Patching Index	100				
Rutting Index	44				
Roughness Condition Index (RCI)	38

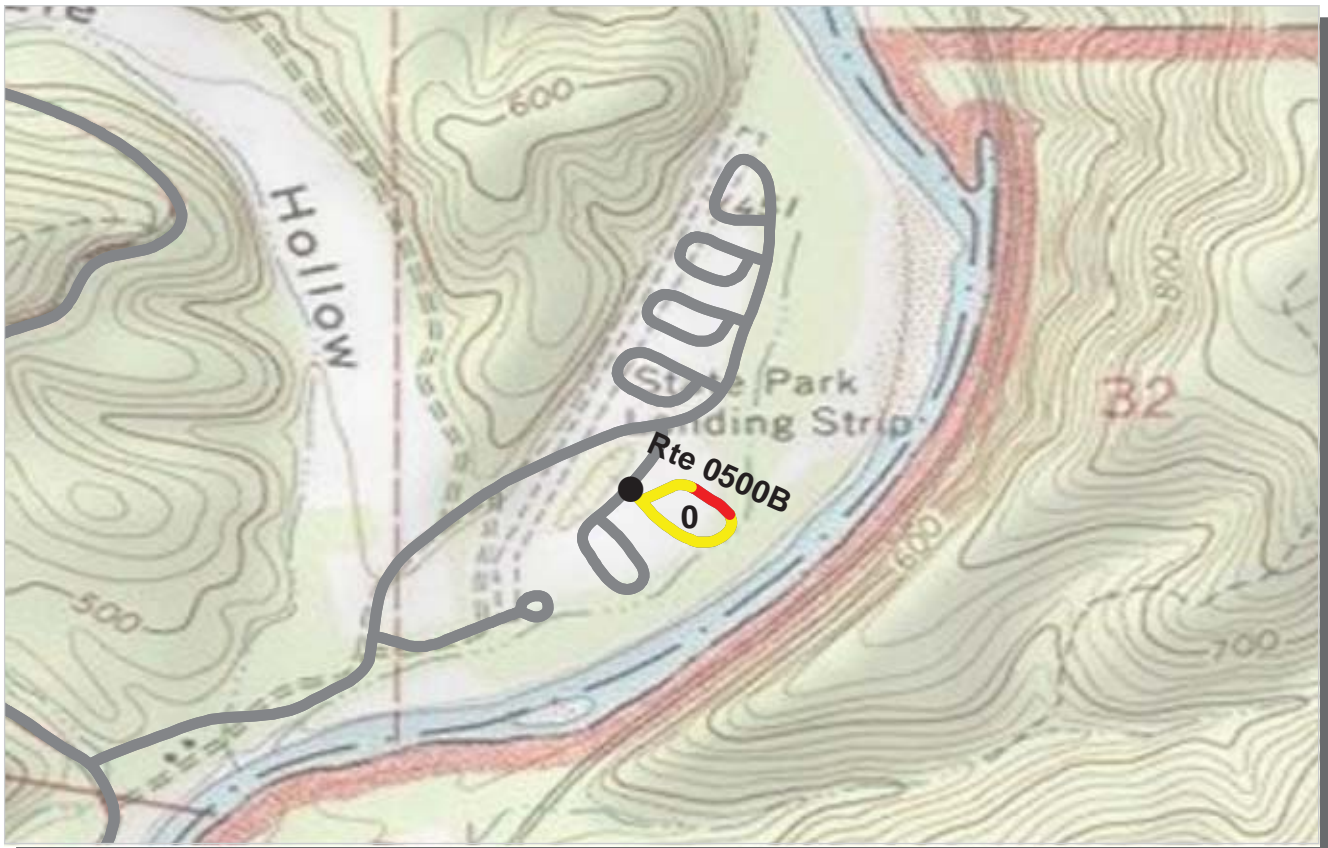
ROUTE: 0500A BIG SPRING CAMPGROUND LOOP A (SITES 101-124)

Section Number	0				
Section Length (mi)	0.28				
Traffic	Traffic data may be found at www.efl.fhwa.dot.gov Click on PROGRAMS / NPS Traffic Data (Note: Not all parks have traffic data)				
Cross Section Information					
Number of Lanes	1				
Paved Width (ft)	16				
Lane Width (ft)	12				
Shoulder Width Right (ft)	NC				
Shoulder Width Left (ft)	NC				
Roadway Condition Information					
SCR (Surface Condition Rating)	78				
PCR (Pavement Condition Rating)	73				
Distress Index Values					
Alligator Cracking Index	100				
Longitudinal Cracking Index	95				
Transverse Cracking Index	98				
Patching Index	100				
Rutting Index	85				
Roughness Condition Index (RCI)	63

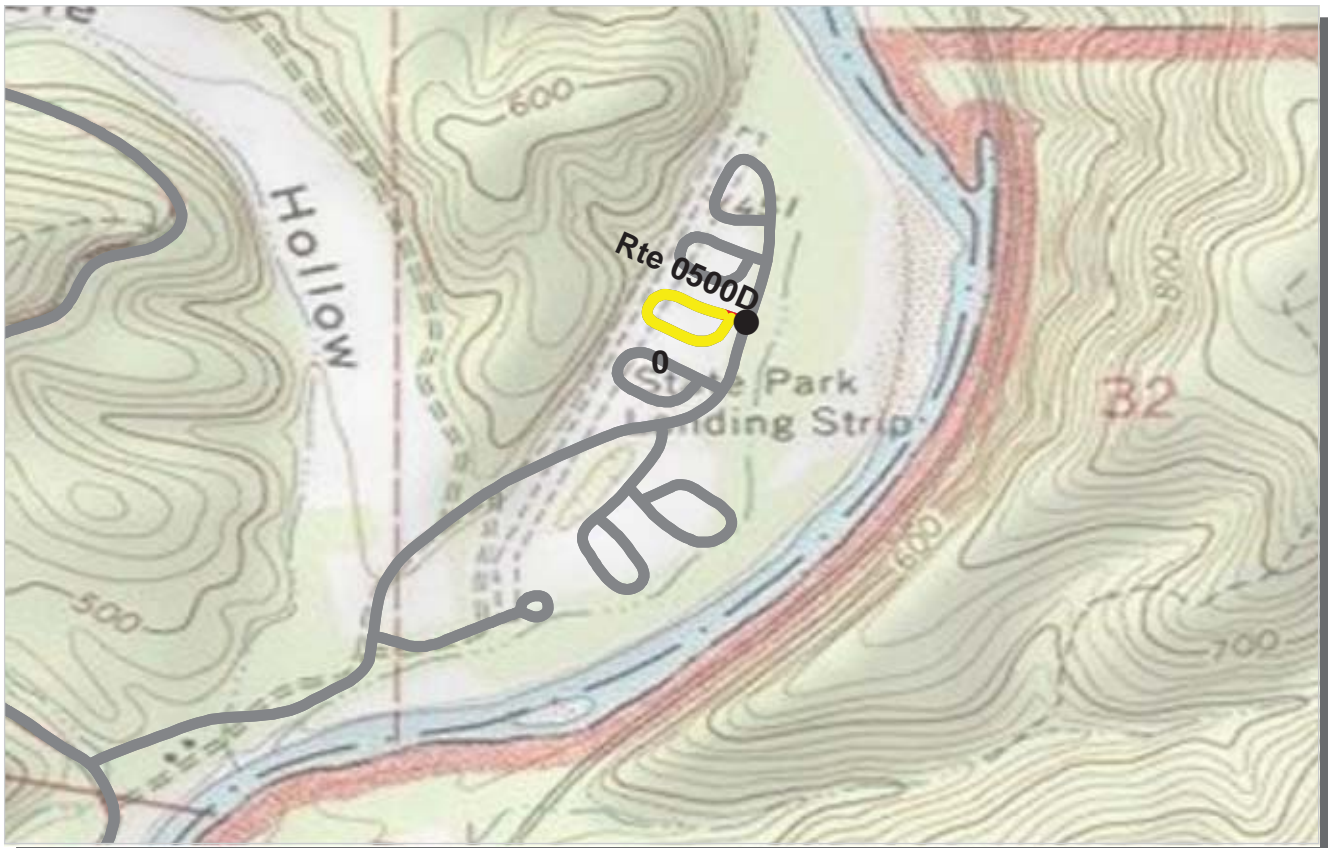
ROUTE: 0500B BIG SPRING CAMPGROUND LOOP B (SITES 201-229)

Section Number	0				
Section Length (mi)	0.20				
Traffic	Traffic data may be found at www.efl.fhwa.dot.gov Click on PROGRAMS / NPS Traffic Data (Note: Not all parks have traffic data)				
Cross Section Information					
Number of Lanes	1				
Paved Width (ft)	12				
Lane Width (ft)	12				
Shoulder Width Right (ft)	NC				
Shoulder Width Left (ft)	NC				
Roadway Condition Information					
SCR (Surface Condition Rating)	69				
PCR (Pavement Condition Rating)	69				
Distress Index Values					
Alligator Cracking Index	100				
Longitudinal Cracking Index	94				
Transverse Cracking Index	97				
Patching Index	99				
Rutting Index	79				
Roughness Condition Index (RCI)	NC

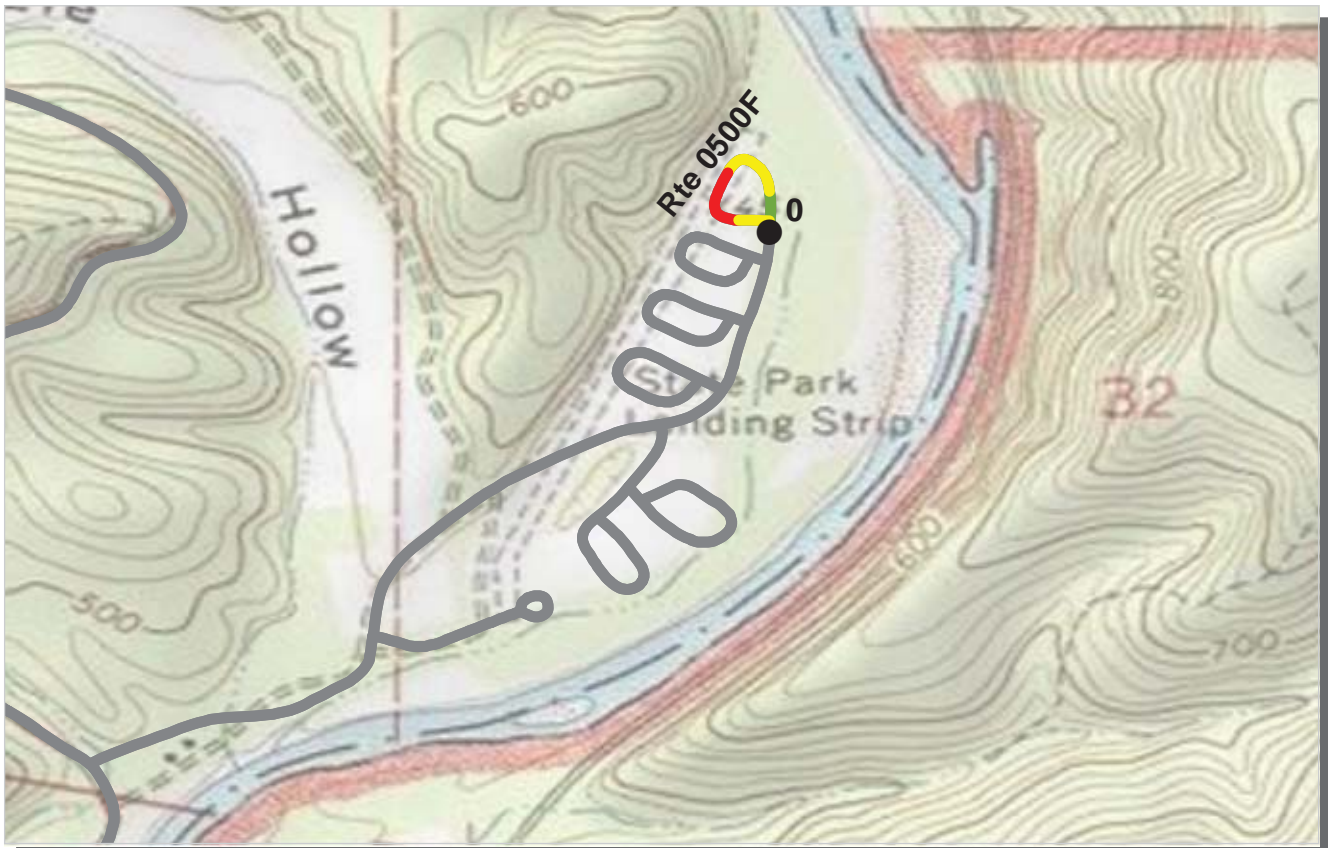
ROUTE: 0500E BIG SPRING CAMPGROUND LOOPE

Section Number	0				
Section Length (mi)	0.16				
Traffic	Traffic data may be found at www.efl.fhwa.dot.gov Click on PROGRAMS / NPS Traffic Data (Note: Not all parks have traffic data)				
Cross Section Information					
Number of Lanes	1				
Paved Width (ft)	11				
Lane Width (ft)	11				
Shoulder Width Right (ft)	NC				
Shoulder Width Left (ft)	NC				
Roadway Condition Information					
SCR (Surface Condition Rating)	63				
PCR (Pavement Condition Rating)	63				
Distress Index Values					
Alligator Cracking Index	98				
Longitudinal Cracking Index	91				
Transverse Cracking Index	86				
Patching Index	100				
Rutting Index	88				
Roughness Condition Index (RCI)	50

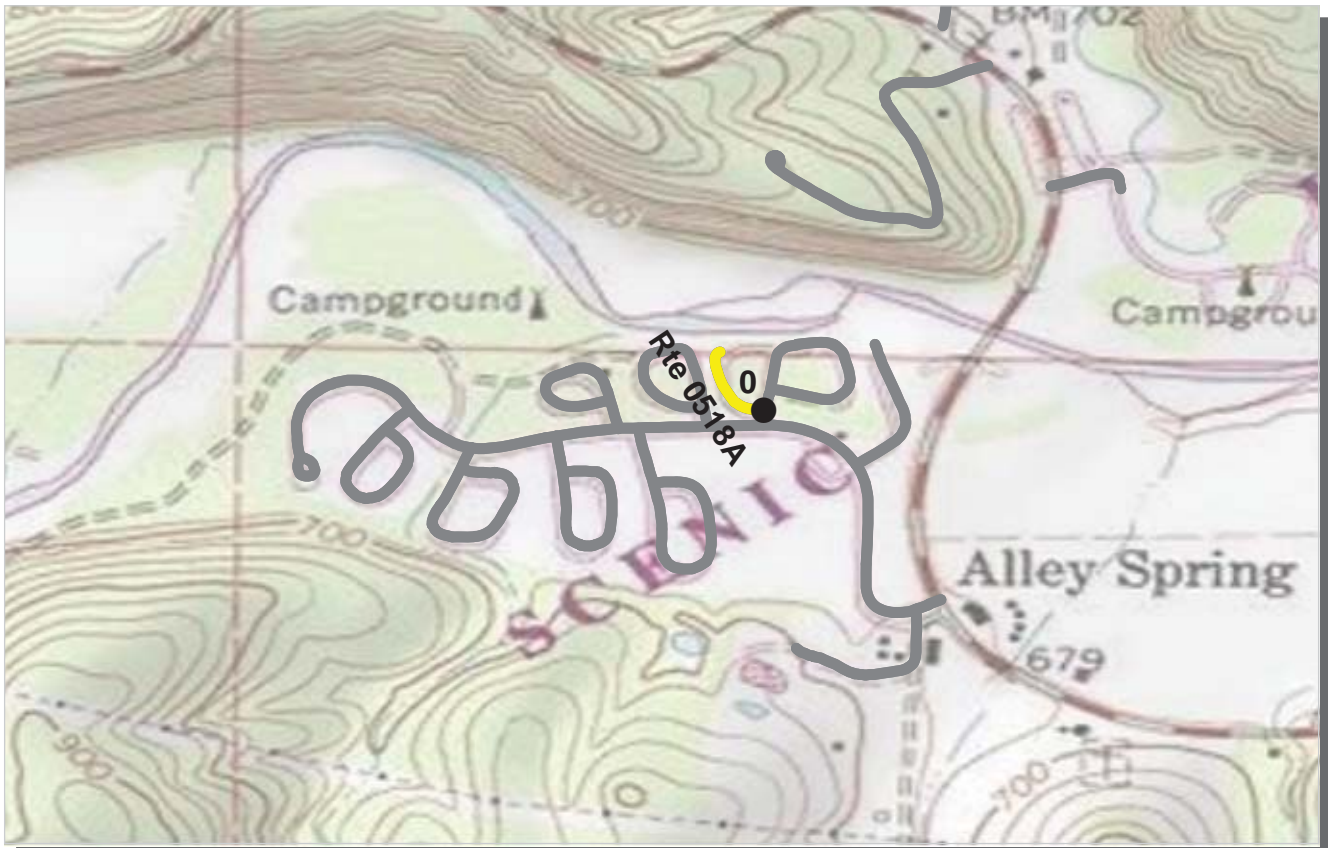
ROUTE: 0500F BIG SPRING CAMPGROUND LOOP F (SITES 801-821)

Section Number	0				
Section Length (mi)	0.18				
Traffic	Traffic data may be found at www.efl.fhwa.dot.gov Click on PROGRAMS / NPS Traffic Data (Note: Not all parks have traffic data)				
Cross Section Information					
Number of Lanes	1				
Paved Width (ft)	14				
Lane Width (ft)	14				
Shoulder Width Right (ft)	NC				
Shoulder Width Left (ft)	NC				
Roadway Condition Information					
SCR (Surface Condition Rating)	61				
PCR (Pavement Condition Rating)	61				
Distress Index Values					
Alligator Cracking Index	98				
Longitudinal Cracking Index	87				
Transverse Cracking Index	83				
Patching Index	100				
Rutting Index	93				
Roughness Condition Index (RCI)	50

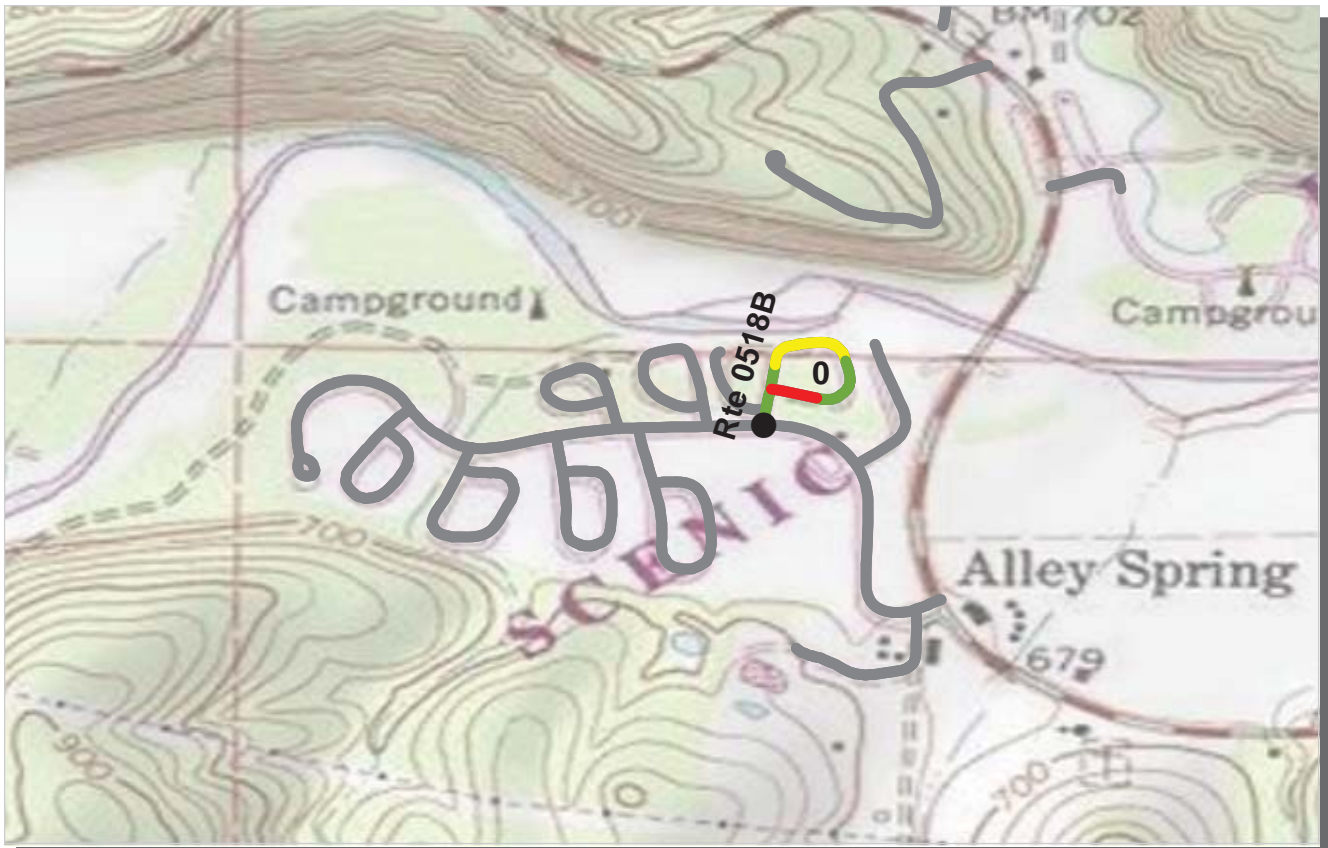
ROUTE: 0518A ALLEY SPRING CAMPGROUND LOOP A

Section Number	0				
Section Length (mi)	0.08				
Traffic	Traffic data may be found at www.efl.fhwa.dot.gov Click on PROGRAMS / NPS Traffic Data (Note: Not all parks have traffic data)				
Cross Section Information					
Number of Lanes	1				
Paved Width (ft)	12				
Lane Width (ft)	12				
Shoulder Width Right (ft)	NC				
Shoulder Width Left (ft)	NC				
Roadway Condition Information					
SCR (Surface Condition Rating)	77				
PCR (Pavement Condition Rating)	77				
Distress Index Values					
Alligator Cracking Index	100				
Longitudinal Cracking Index	98				
Transverse Cracking Index	96				
Patching Index	100				
Rutting Index	83				
Roughness Condition Index (RCI)	NC

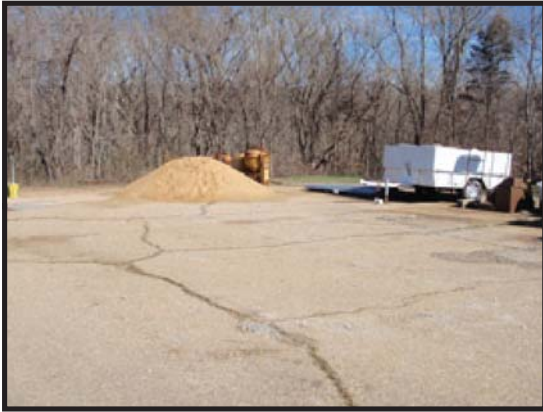
Route Number	Public / NonPublic	Date Visited		Area (sq ft)	Lane Miles *	Surface Type
0900	PUBLIC	3/19/2009		2,955	0.05	AS
Culverts	Drop Inlets	Gates	Fire Hydrants	Curb & Gutter	Curb	PCR
0	0	0	0	NO CURB AND GUTTER	NO CURB	POOR/45

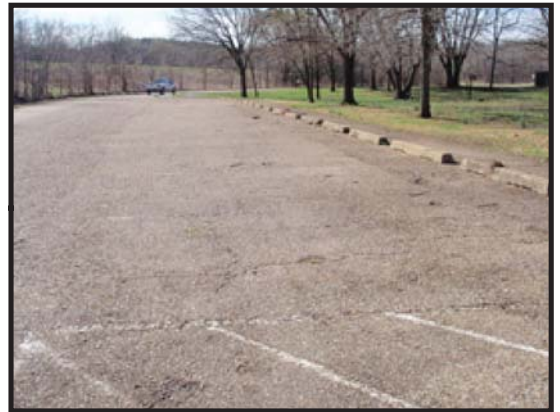
Route 0901

Route Number	Public / NonPublic	Date Visited		Area (sq ft)	Lane Miles *	Surface Type
0901	PUBLIC	3/19/2009		5,135	0.09	AS
Culverts	Drop Inlets	Gates	Fire Hydrants	Curb & Gutter	Curb	PCR
0	0	0	0	NO CURB AND GUTTER	NO CURB	FAIR/73

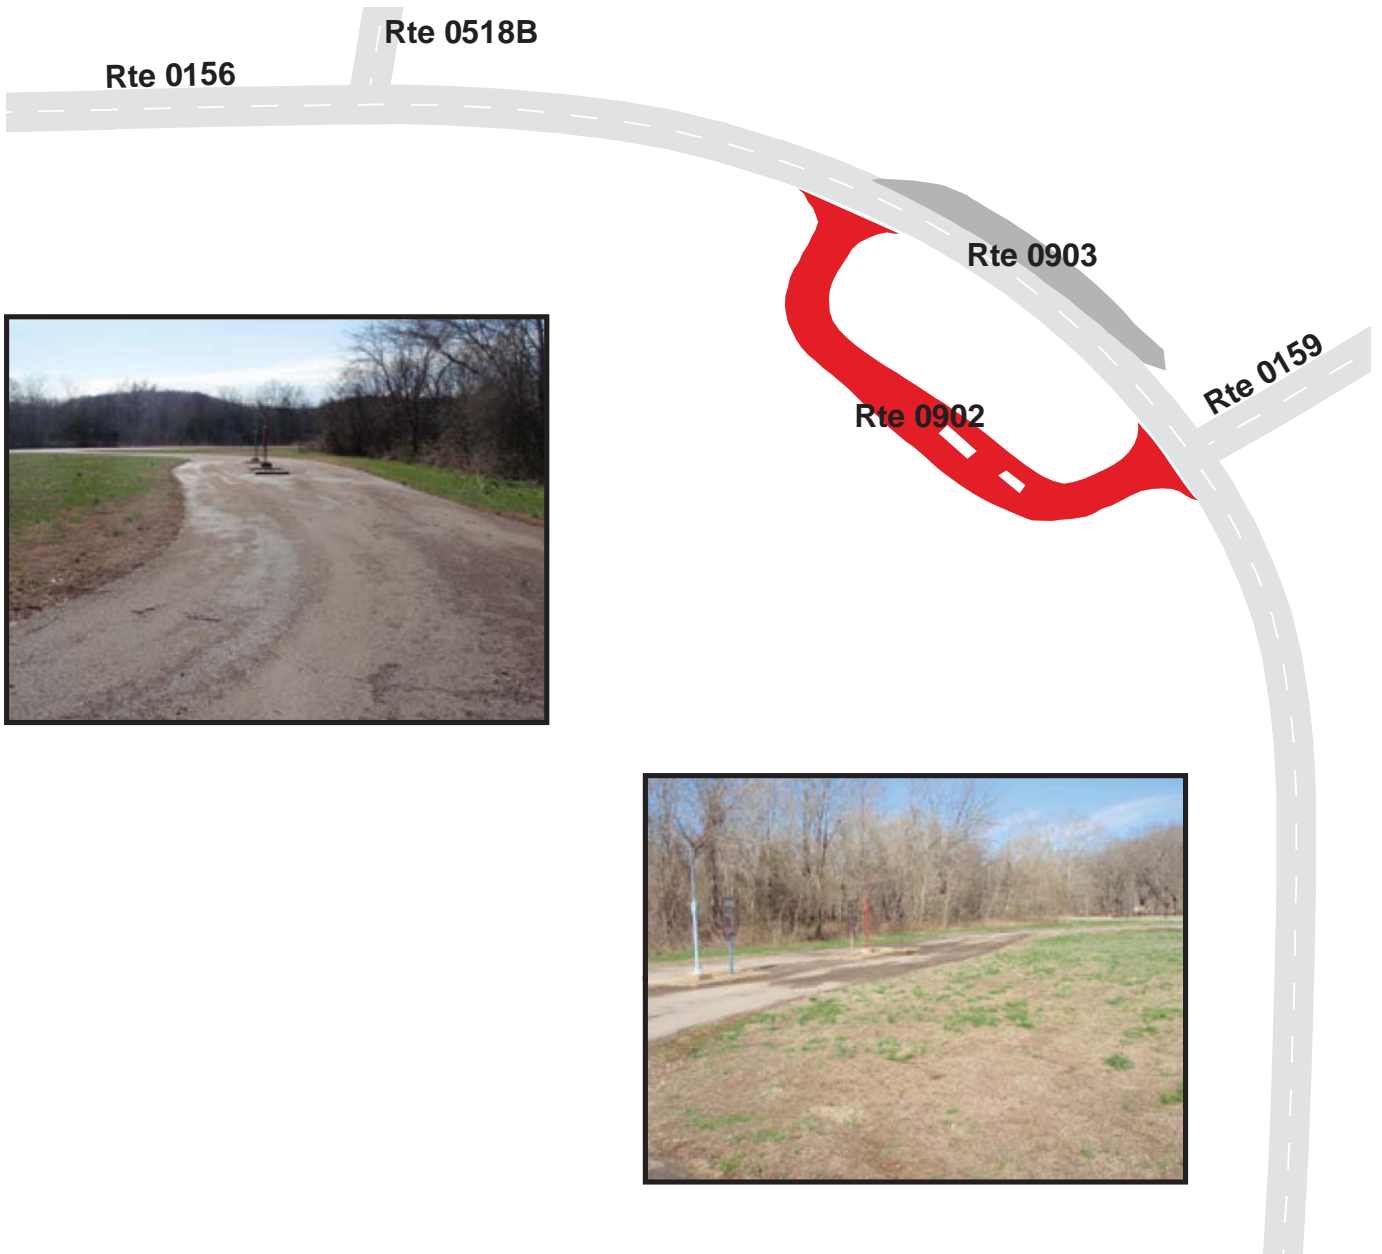
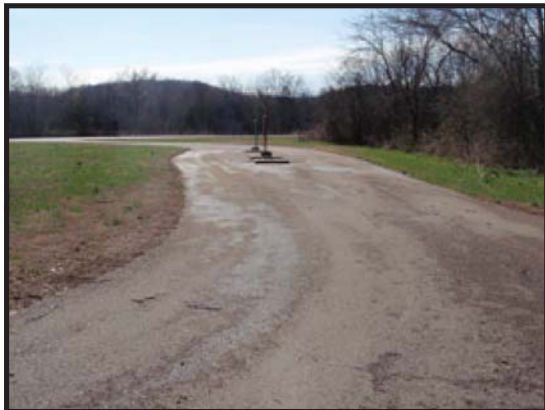
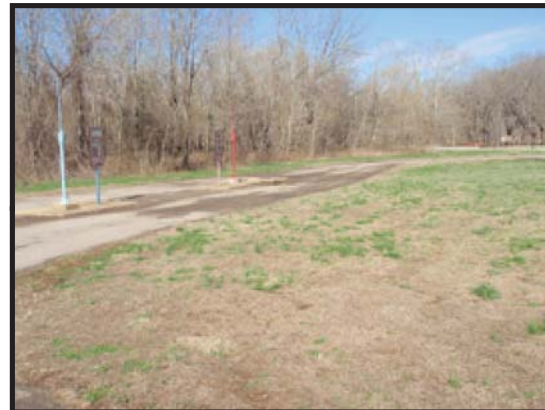
Route 0902

Route Number	Public / NonPublic	Date Visited		Area (sq ft)	Lane Miles *	Surface Type
0902	PUBLIC	3/19/2009		6,809	0.12	AS
Culverts	Drop Inlets	Gates	Fire Hydrants	Curb & Gutter	Curb	PCR
1	0	0	0	NO CURB AND GUTTER	NO CURB	FAIR/73

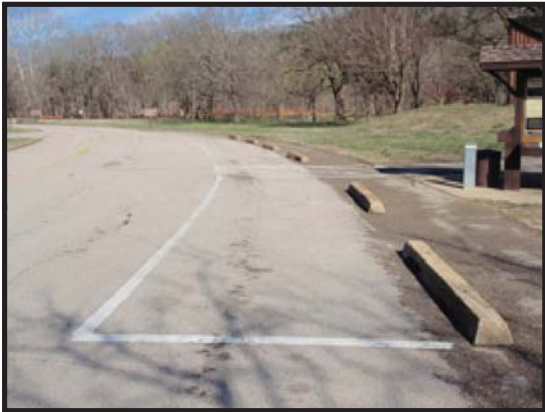
Route 0903

Route Number	Public / NonPublic	Date Visited		Area (sq ft)	Lane Miles *	Surface Type
0903	NONPUBLIC	3/19/2009		2,455	0.04	AS
Culverts	Drop Inlets	Gates	Fire Hydrants	Curb & Gutter	Curb	PCR
0	0	0	0	NO CURB AND GUTTER	NO CURB	FAIR/73

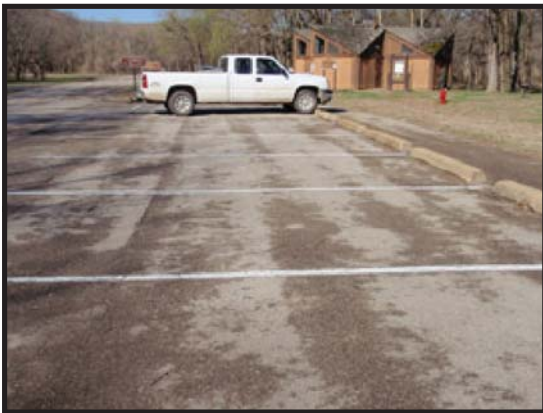
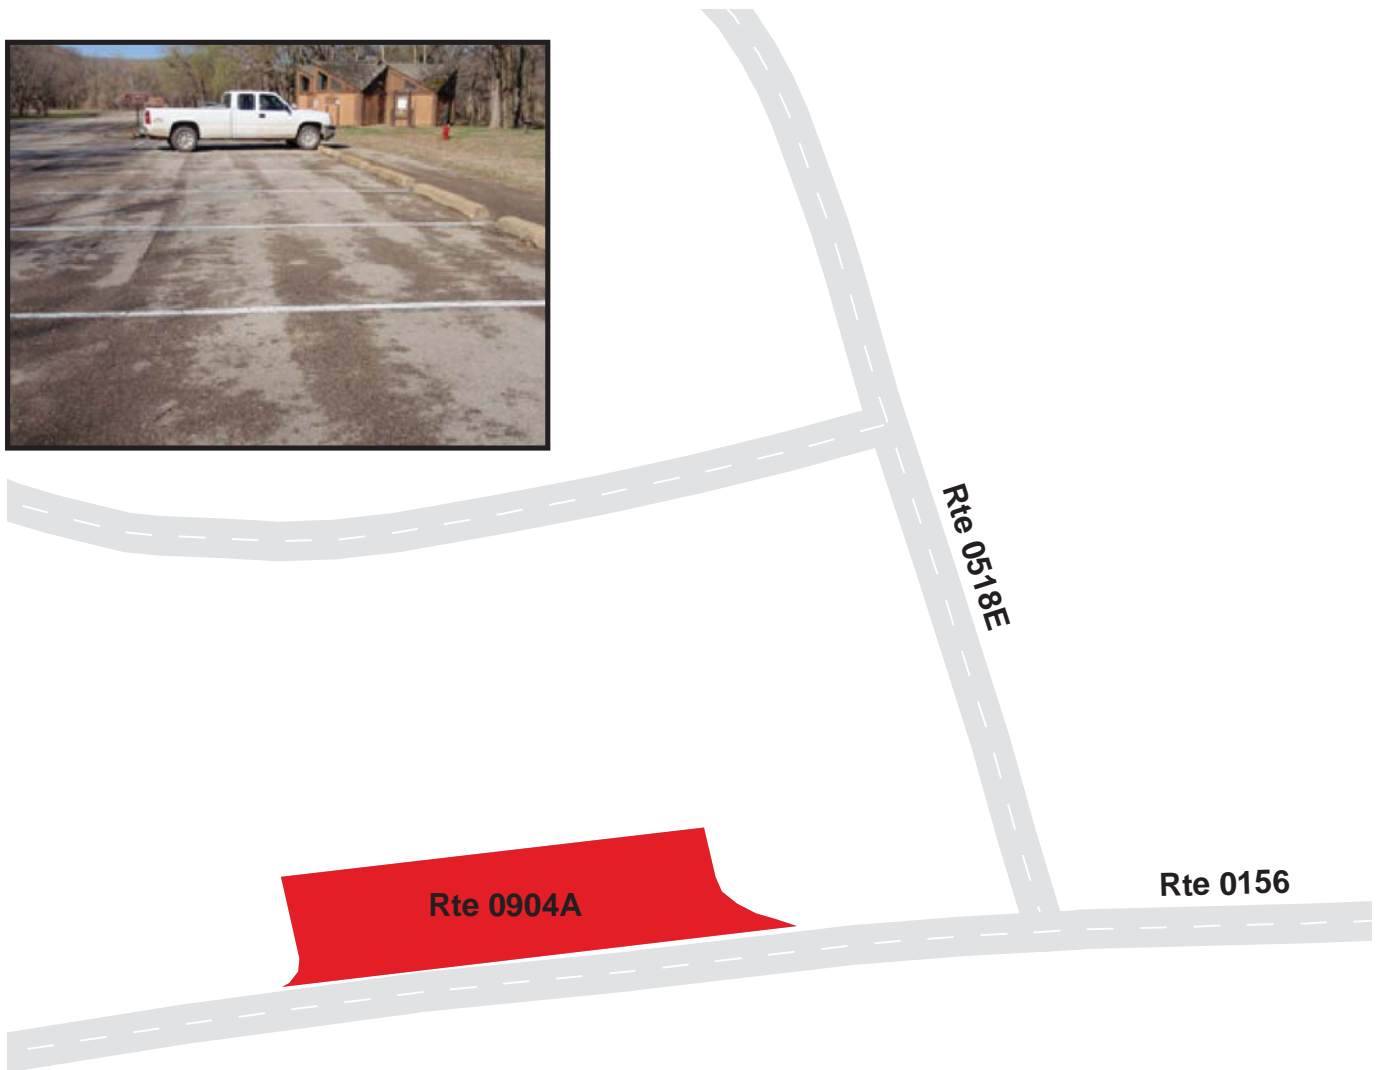
Route 0904A

Route Number	Public / NonPublic	Date Visited		Area (sq ft)	Lane Miles *	Surface Type
0904A	PUBLIC	3/19/2009		3,326	0.06	AS
Culverts	Drop Inlets	Gates	Fire Hydrants	Curb & Gutter	Curb	PCR
0	0	0	1	NO CURB AND GUTTER	NO CURB	FAIR/73

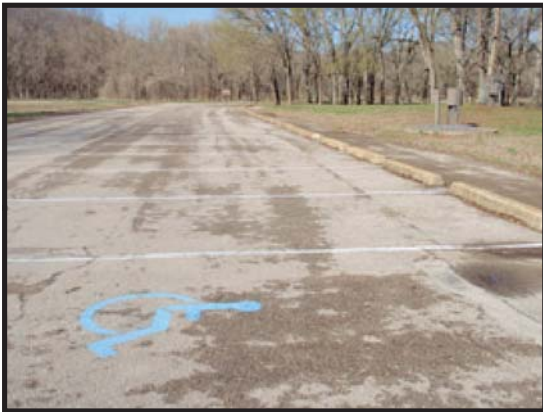
Route 0904B

Route Number	Public / NonPublic	Date Visited		Area (sq ft)	Lane Miles *	Surface Type
0904B	PUBLIC	3/19/2009		7,041	0.12	AS
Culverts	Drop Inlets	Gates	Fire Hydrants	Curb & Gutter	Curb	PCR
0	0	0	0	NO CURB AND GUTTER	NO CURB	FAIR/73

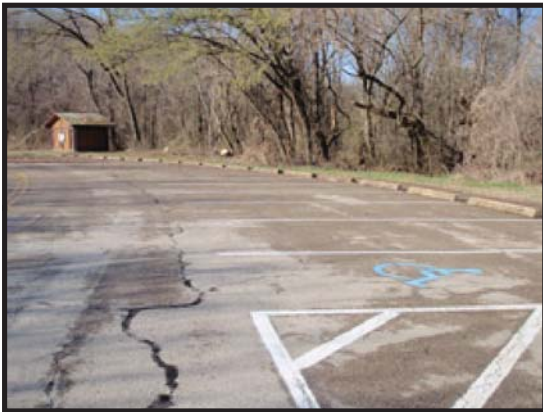
Route 0904C

Route Number	Public / NonPublic	Date Visited		Area (sq ft)	Lane Miles *	Surface Type
0904C	PUBLIC	3/19/2009		5,426	0.09	AS
Culverts	Drop Inlets	Gates	Fire Hydrants	Curb & Gutter	Curb	PCR
0	0	0	0	NO CURB AND GUTTER	NO CURB	FAIR/73

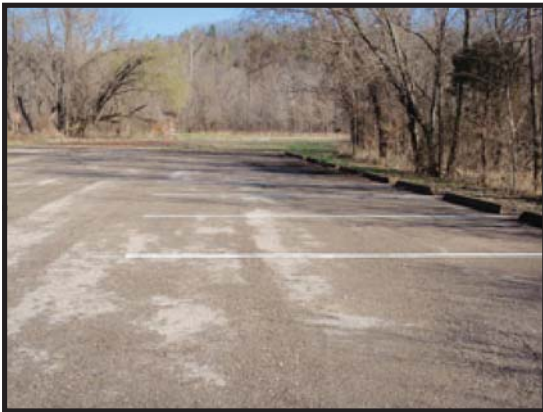
Route 0904D

Route Number	Public / NonPublic	Date Visited		Area (sq ft)	Lane Miles *	Surface Type
0904D	PUBLIC	3/19/2009		2,899	0.05	AS
Culverts	Drop Inlets	Gates	Fire Hydrants	Curb & Gutter	Curb	PCR
0	0	0	0	NO CURB AND GUTTER	NO CURB	FAIR/73
