**The Road Inventory
of
Ozark National Scenic Riverways
OZAR – 6640
Cycle 4**

**Prepared By:
Federal Highway Administration
Road Inventory Program
Cycle 4**

Ozark National Scenic Riverways in Missouri

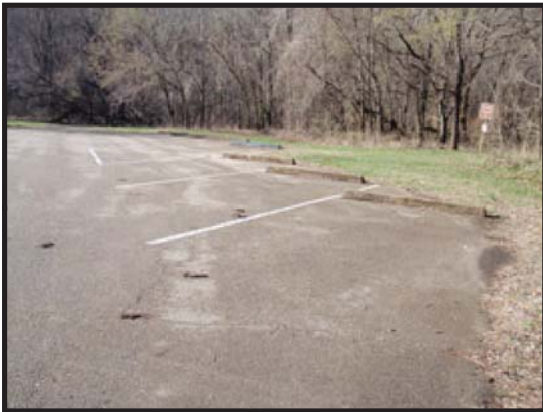
Route 0904E

Route Number	Public / NonPublic	Date Visited		Area (sq ft)	Lane Miles *	Surface Type
0904E	PUBLIC	3/19/2009		2,962	0.05	AS
Culverts	Drop Inlets	Gates	Fire Hydrants	Curb & Gutter	Curb	PCR
0	0	0	0	NO CURB AND GUTTER	NO CURB	FAIR/73

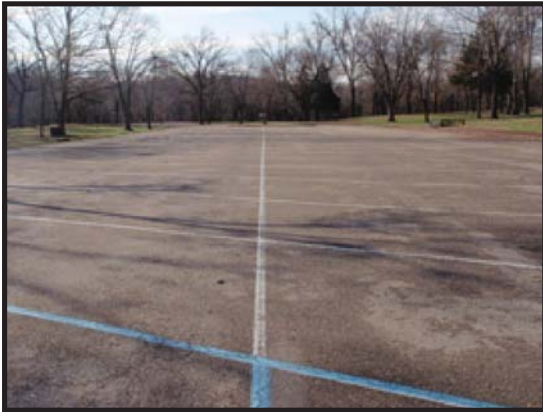
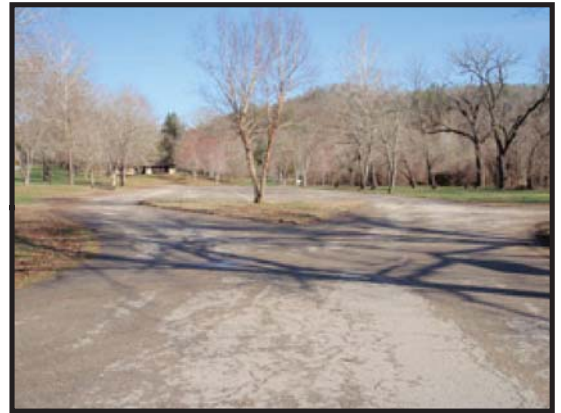
Route 0905

Route Number	Public / NonPublic	Date Visited		Area (sq ft)	Lane Miles *	Surface Type
0905	PUBLIC	3/19/2009		32,205	0.55	AS
Culverts	Drop Inlets	Gates	Fire Hydrants	Curb & Gutter	Curb	PCR
1	0	0	0	NO CURB AND GUTTER	CONCRETE CURB	FAIR/73

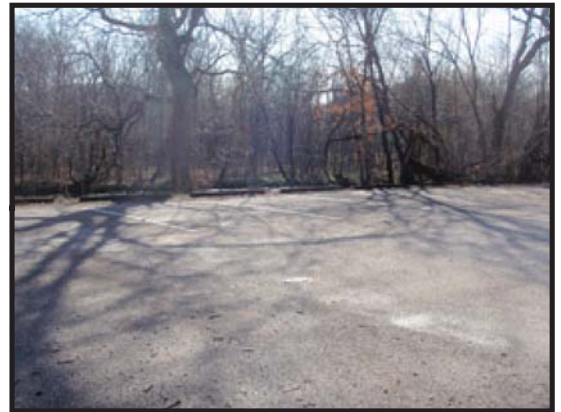
Route 0906

Route Number	Public / NonPublic	Date Visited		Area (sq ft)	Lane Miles *	Surface Type
0906	PUBLIC	3/19/2009		4,273	0.07	AS
Culverts	Drop Inlets	Gates	Fire Hydrants	Curb & Gutter	Curb	PCR
0	0	0	0	NO CURB AND GUTTER	NO CURB	FAIR/73

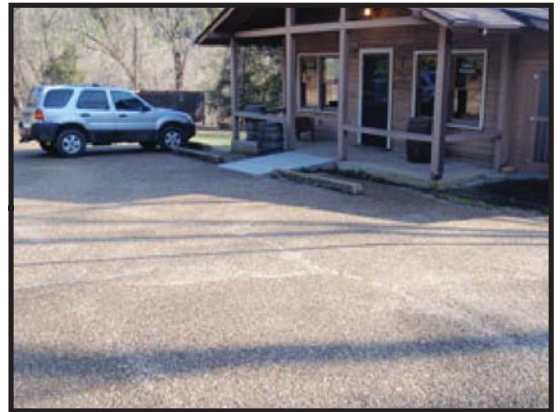
Route 0907

Route Number	Public / NonPublic	Date Visited		Area (sq ft)	Lane Miles *	Surface Type
0907	PUBLIC	3/19/2009		2,264	0.04	AS
Culverts	Drop Inlets	Gates	Fire Hydrants	Curb & Gutter	Curb	PCR
0	0	0	0	NO CURB AND GUTTER	NO CURB	FAIR/73

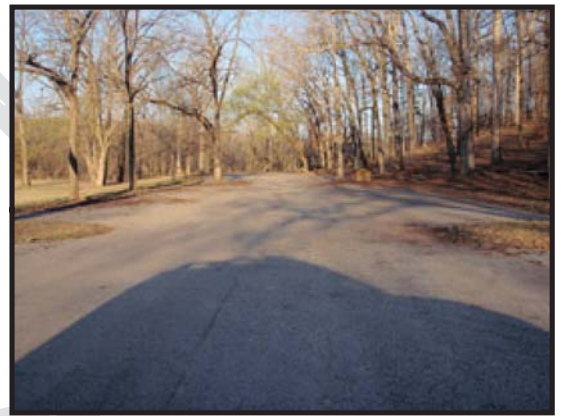
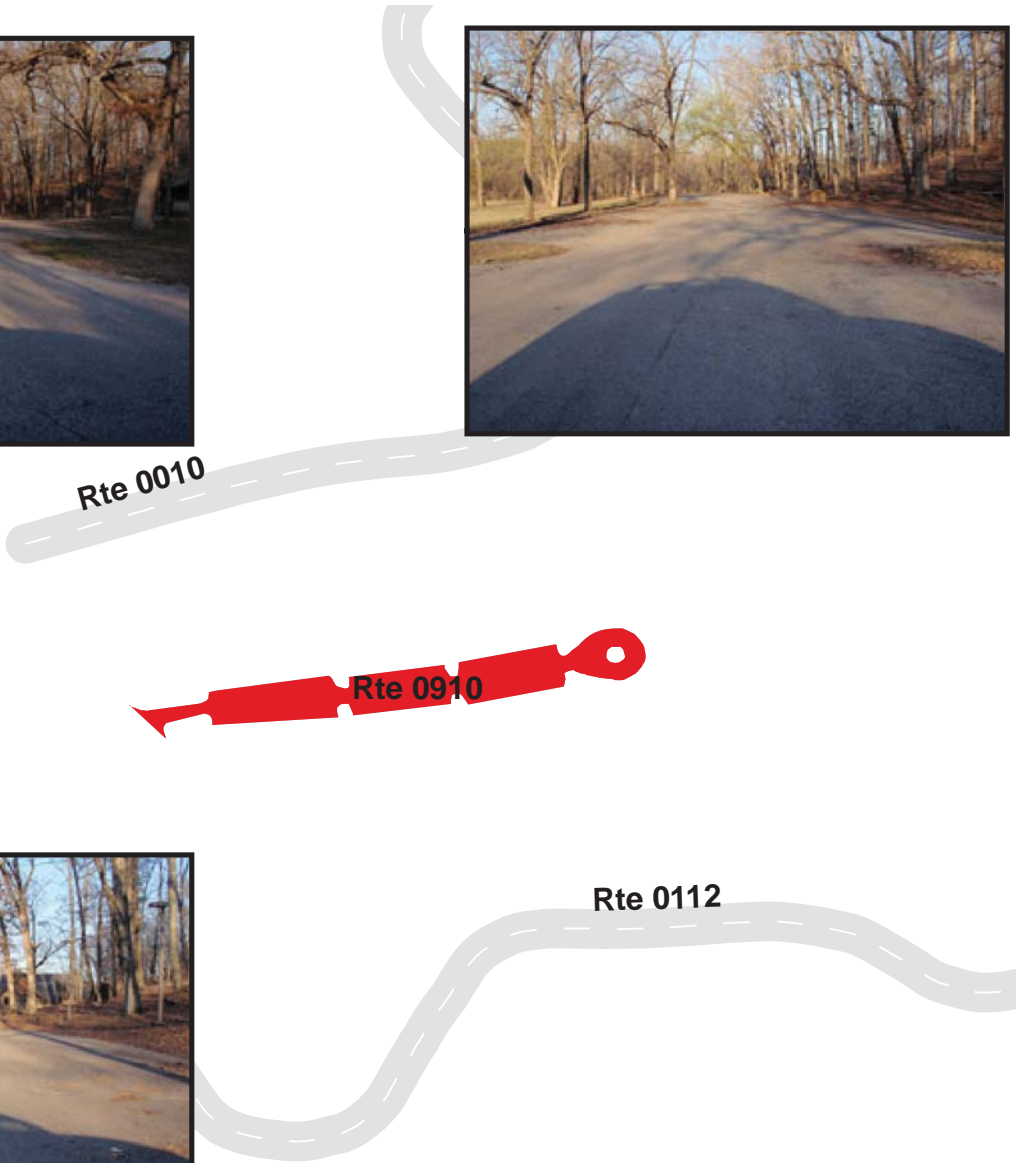
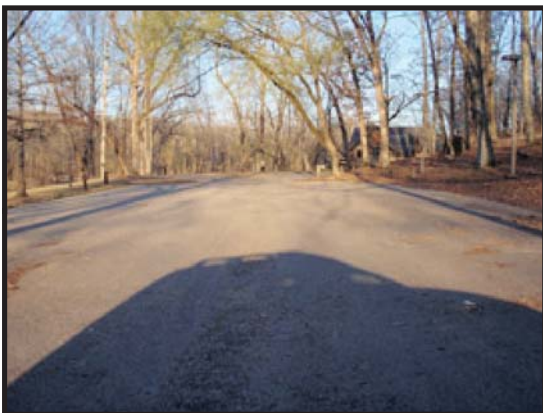
Route 0910

Route Number	Public / NonPublic	Date Visited		Area (sq ft)	Lane Miles *	Surface Type
0910	PUBLIC	3/19/2009		31,504	0.54	AS
Culverts	Drop Inlets	Gates	Fire Hydrants	Curb & Gutter	Curb	PCR
0	0	0	1	NO CURB AND GUTTER	STONE CURB	GOOD/90

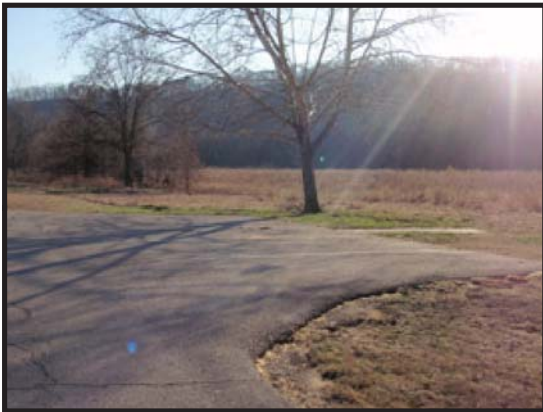
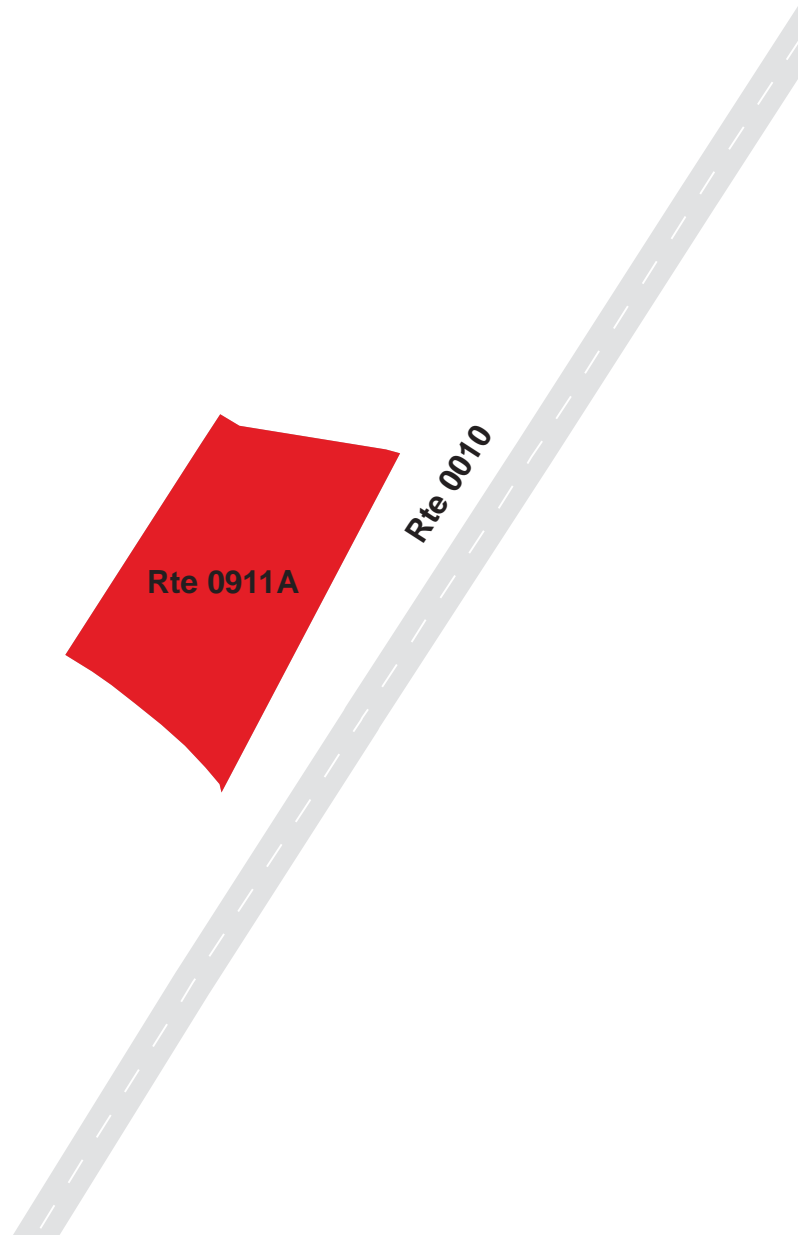
Route 0911A

Route Number	Public / NonPublic	Date Visited		Area (sq ft)	Lane Miles *	Surface Type
0911A	PUBLIC	3/17/2009		1,502	0.03	AS
Culverts	Drop Inlets	Gates	Fire Hydrants	Curb & Gutter	Curb	PCR
0	0	0	0	NO CURB AND GUTTER	NO CURB	GOOD/90

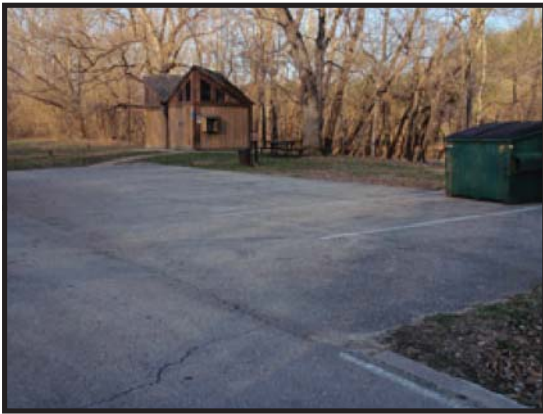
Route 0911B

Route Number	Public / NonPublic	Date Visited		Area (sq ft)	Lane Miles *	Surface Type
0911B	PUBLIC	3/17/2009		2,055	0.04	AS
Culverts	Drop Inlets	Gates	Fire Hydrants	Curb & Gutter	Curb	PCR
0	0	0	0	NO CURB AND GUTTER	NO CURB	FAIR/73

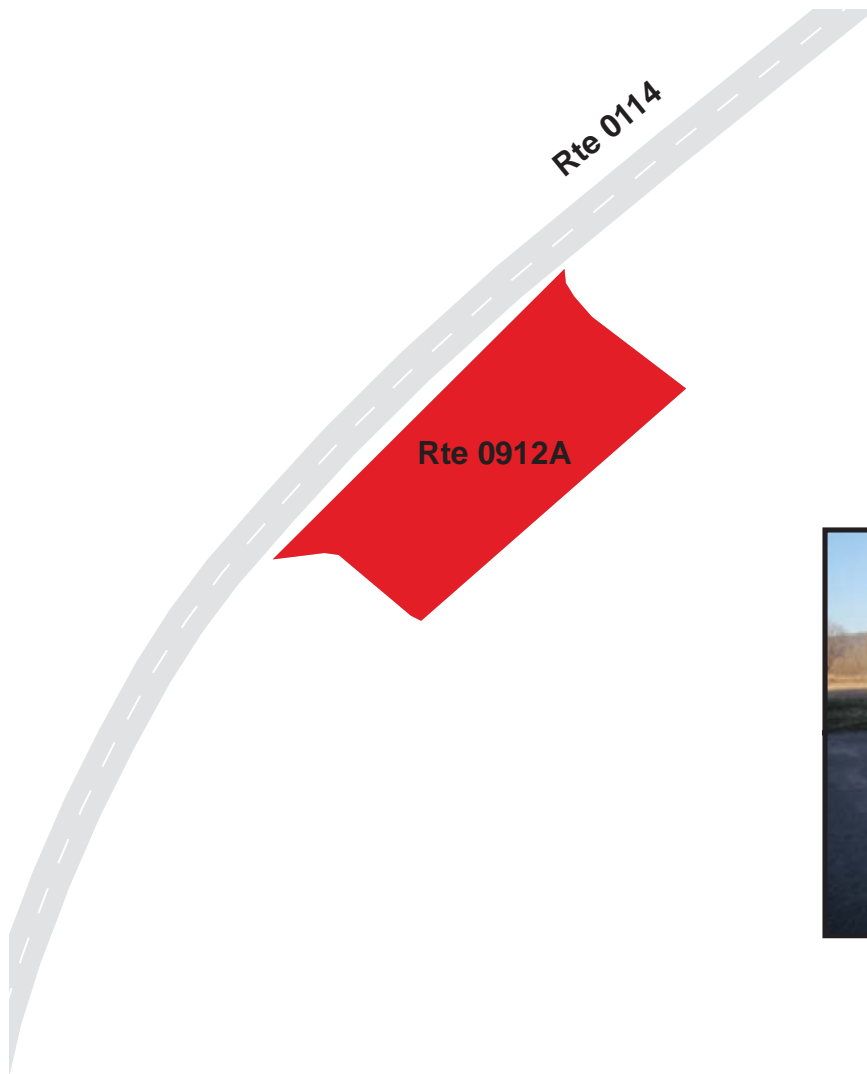
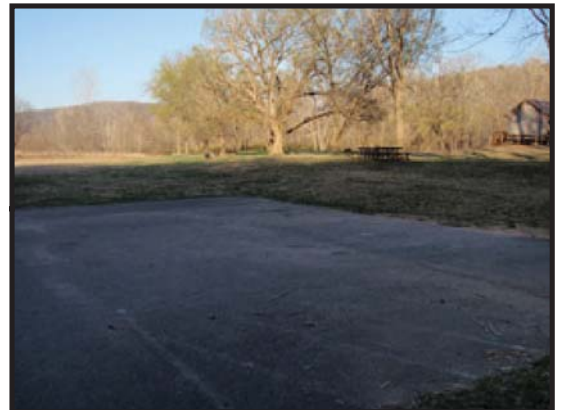
Route Number	Public / NonPublic	Date Visited		Area (sq ft)	Lane Miles *	Surface Type
0912A	PUBLIC	3/17/2009		1,300	0.02	AS
Culverts	Drop Inlets	Gates	Fire Hydrants	Curb & Gutter	Curb	PCR
0	0	0	0	NO CURB AND GUTTER	NO CURB	FAIR/73

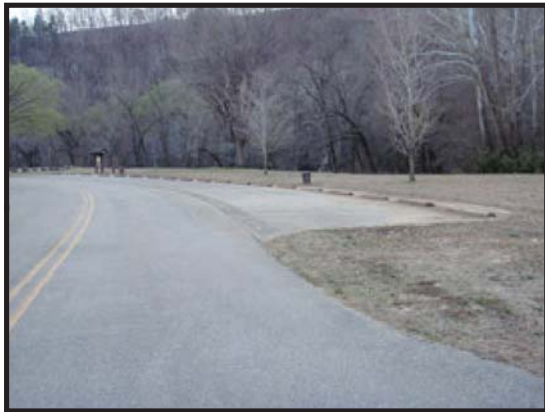
Route 0912E

Route Number	Public / NonPublic	Date Visited		Area (sq ft)	Lane Miles *	Surface Type
0912E	PUBLIC	3/17/2009		20,942	0.36	AS
Culverts	Drop Inlets	Gates	Fire Hydrants	Curb & Gutter	Curb	PCR
0	0	0	0	NO CURB AND GUTTER	NO CURB	FAIR/73

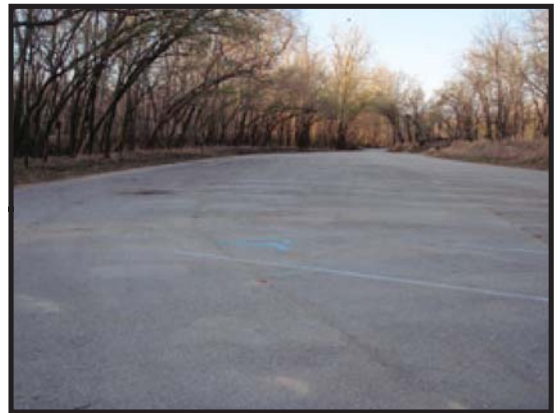
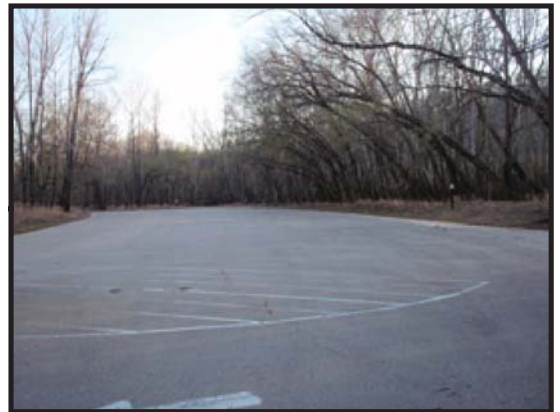
Route 0914

Route Number	Public / NonPublic	Date Visited		Area (sq ft)	Lane Miles *	Surface Type
0914	PUBLIC	3/17/2009		9,414	0.16	AS
Culverts	Drop Inlets	Gates	Fire Hydrants	Curb & Gutter	Curb	PCR
1	0	0	0	NO CURB AND GUTTER	NO CURB	FAIR/73

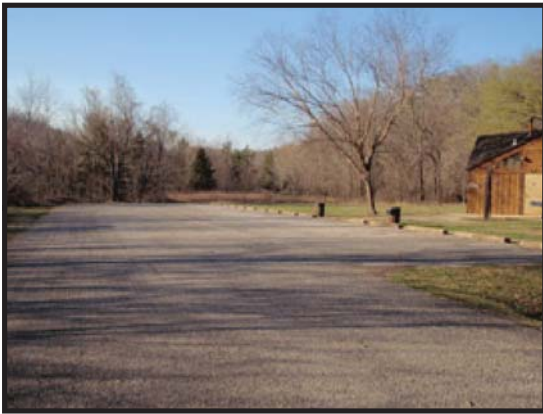
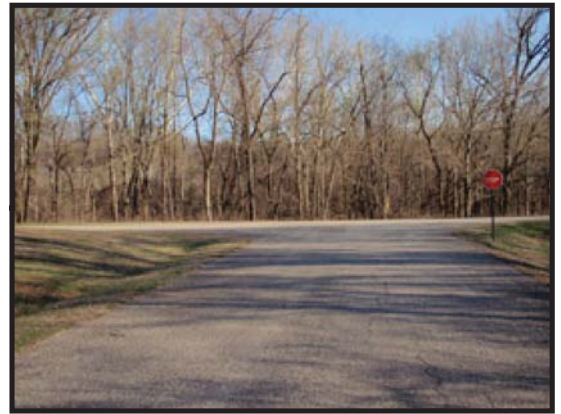
Route 0915

Route Number	Public / NonPublic	Date Visited		Area (sq ft)	Lane Miles *	Surface Type
0915	PUBLIC	3/17/2009		8,021	0.14	AS
Culverts	Drop Inlets	Gates	Fire Hydrants	Curb & Gutter	Curb	PCR
1	0	0	0	NO CURB AND GUTTER	NO CURB	FAIR/73

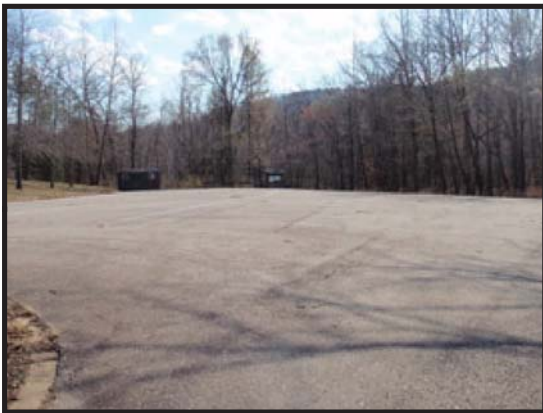
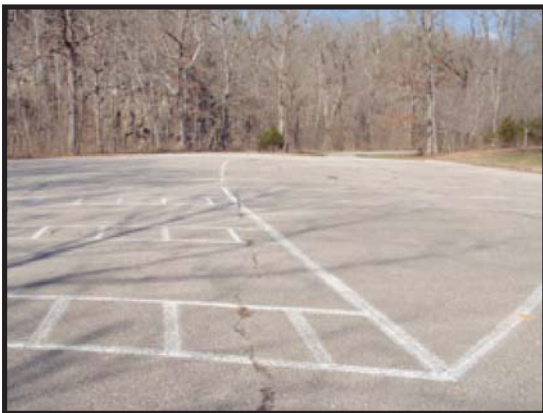
Route 0931A

Route Number	Public / NonPublic	Date Visited		Area (sq ft)	Lane Miles *	Surface Type
0931A	PUBLIC	3/18/2009		8,402	0.15	AS
Culverts	Drop Inlets	Gates	Fire Hydrants	Curb & Gutter	Curb	PCR
0	0	0	0	NO CURB AND GUTTER	CONCRETE CURB	FAIR/73

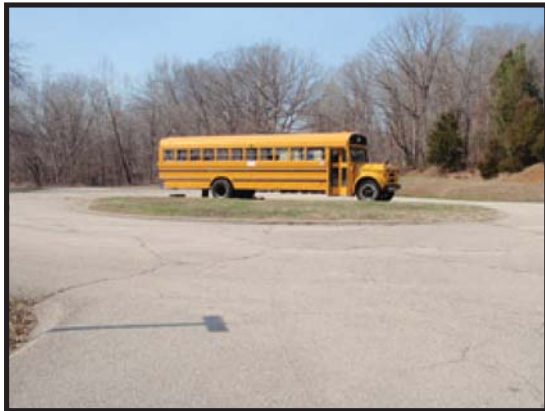
Route 0935A

Route Number	Public / NonPublic	Date Visited		Area (sq ft)	Lane Miles *	Surface Type
0935A	PUBLIC	3/18/2009		484	0.01	AS
Culverts	Drop Inlets	Gates	Fire Hydrants	Curb & Gutter	Curb	PCR
0	0	0	0	NO CURB AND GUTTER	NO CURB	POOR/45

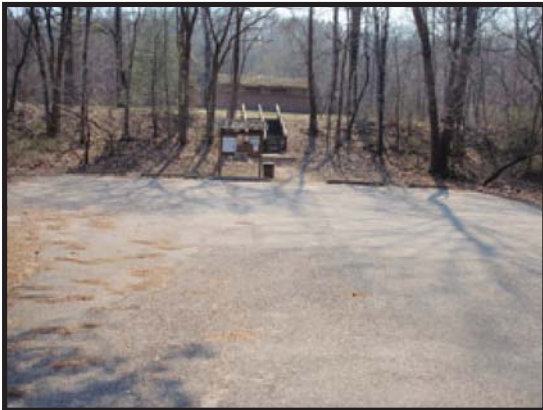
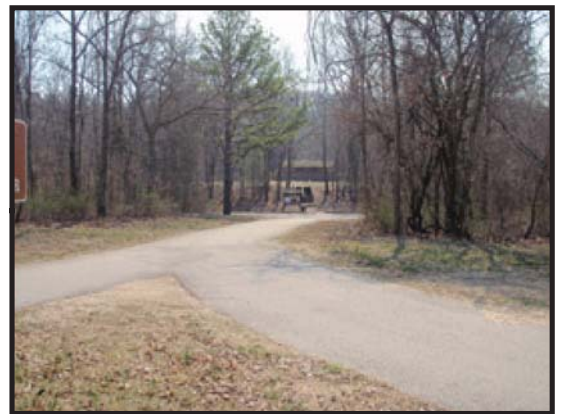
Route Number	Public / NonPublic	Date Visited		Area (sq ft)	Lane Miles *	Surface Type
0990	PUBLIC	3/17/2009		5,698	0.10	AS
Culverts	Drop Inlets	Gates	Fire Hydrants	Curb & Gutter	Curb	PCR
0	0	0	0	NO CURB AND GUTTER	NO CURB	FAIR/73
