**The Road Inventory
of
Petrified Forest National Park
PEFO – 8430
Cycle 4**

**Prepared By:
Federal Highway Administration
Road Inventory Program
Cycle 4**

Petrified Forest National Park in Arizona

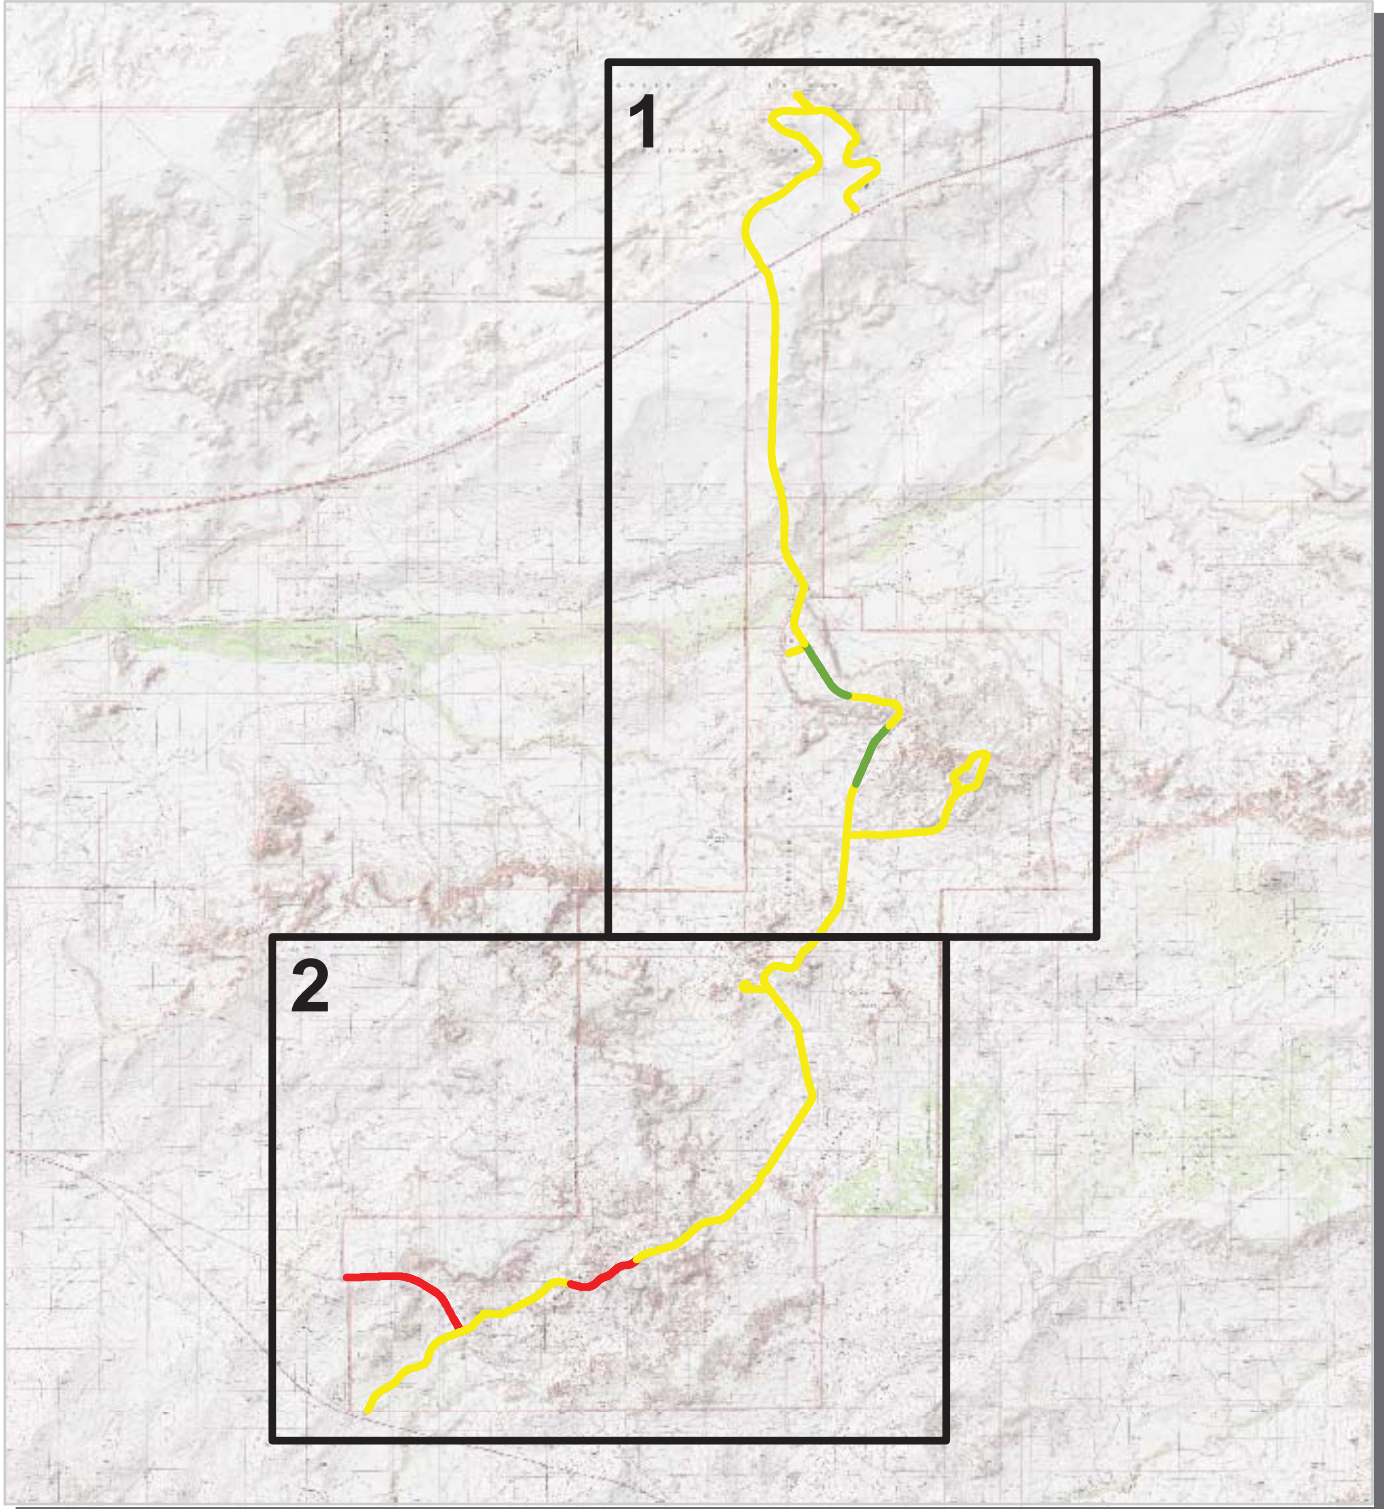
**Petrified Forest National Park
Route Condition Map
PCR - Mile by Mile
Key Map**

PCR	Poor	Fair	Good	Excellent	No Data
	(≤60)	(61 - 84)	(85 - 94)	(95 - 100)

* If the PCR rating is not available for a section, the SCR rating will be displayed. See appendix for definitions and formulas.

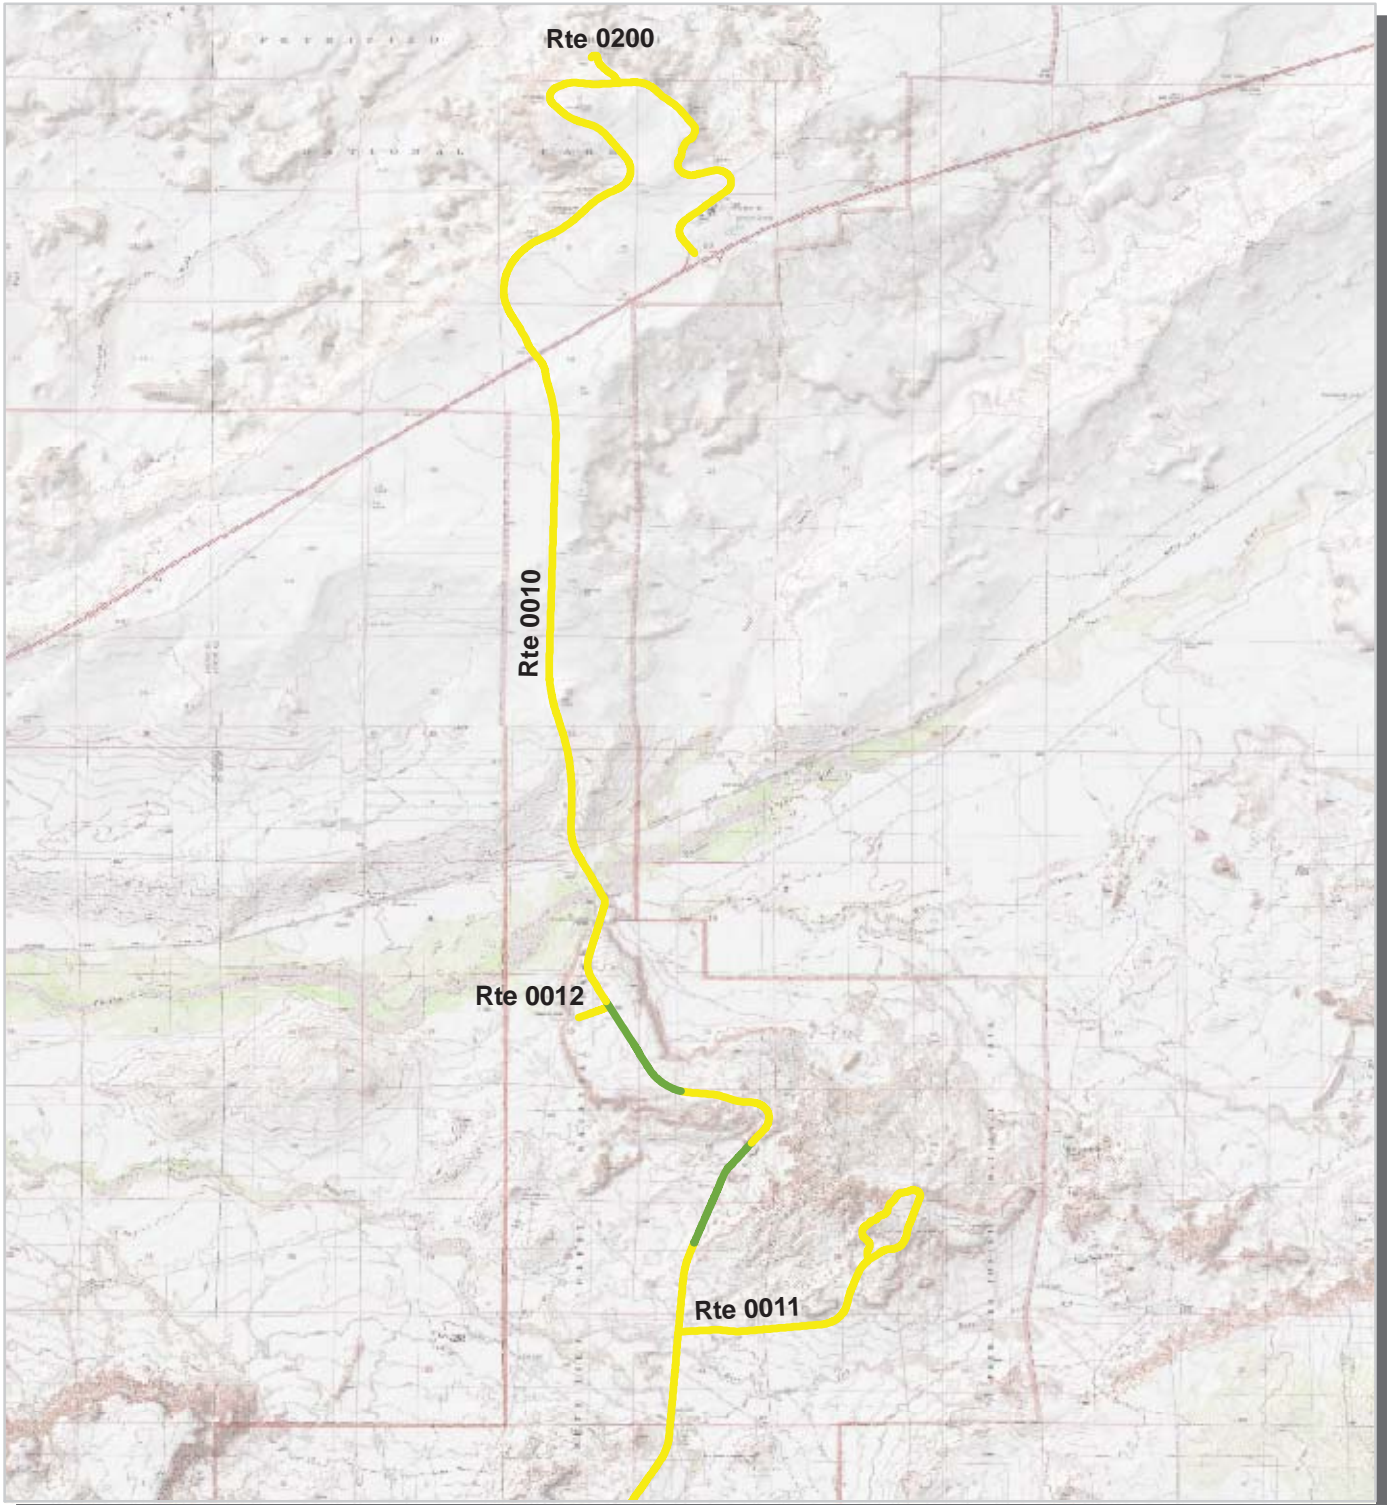
**Petrified Forest National Park
Route Condition Map
PCR - Mile by Mile
Area 1**

PCR	Poor	Fair	Good	Excellent	No Data
	(≤ 60)	(61 - 84)	(85 - 94)	(95 - 100)

* If the PCR rating is not available for a section, the SCR rating will be displayed. See appendix for definitions and formulas.

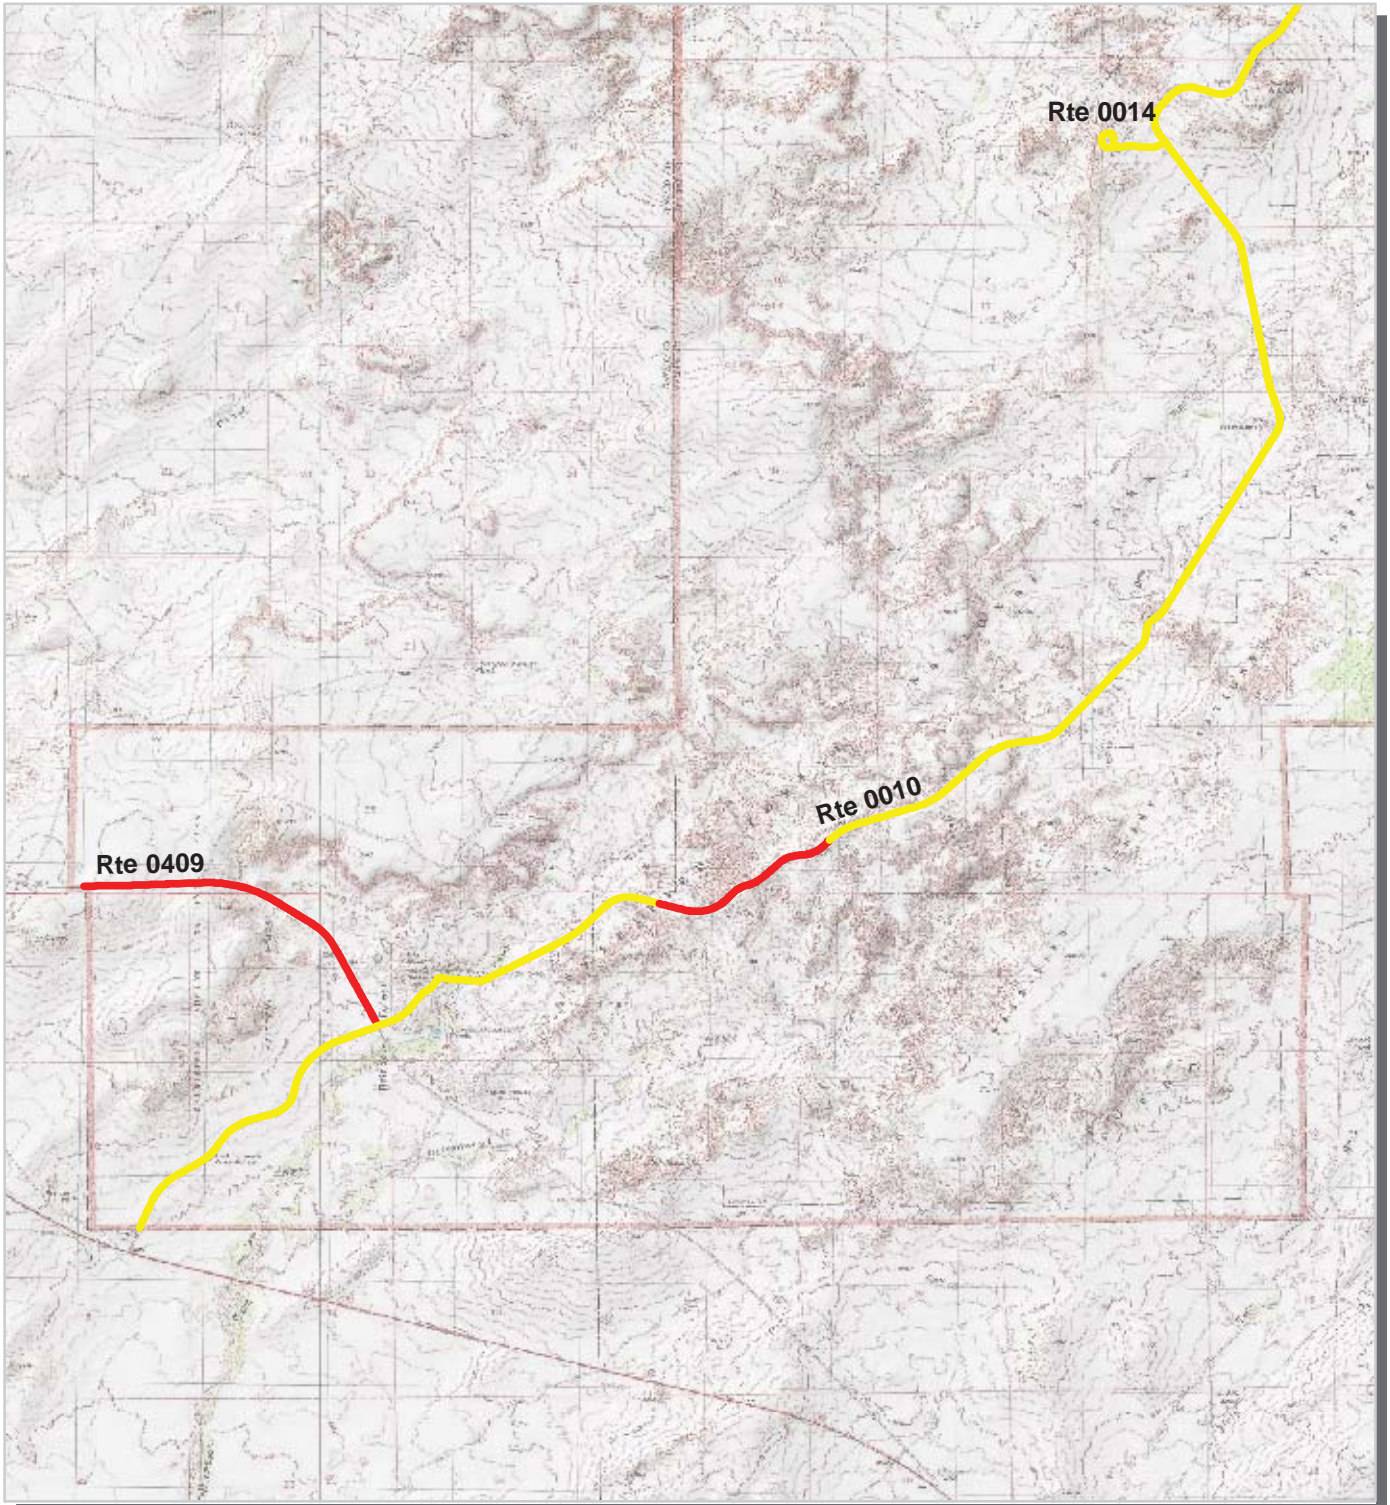
**Petrified Forest National Park
Route Condition Map
PCR - Mile by Mile
Area 2**

PCR	Poor	Fair	Good	Excellent	No Data
	(≤ 60)	(61 - 84)	(85 - 94)	(95 - 100)

* If the PCR rating is not available for a section, the SCR rating will be displayed. See appendix for definitions and formulas.

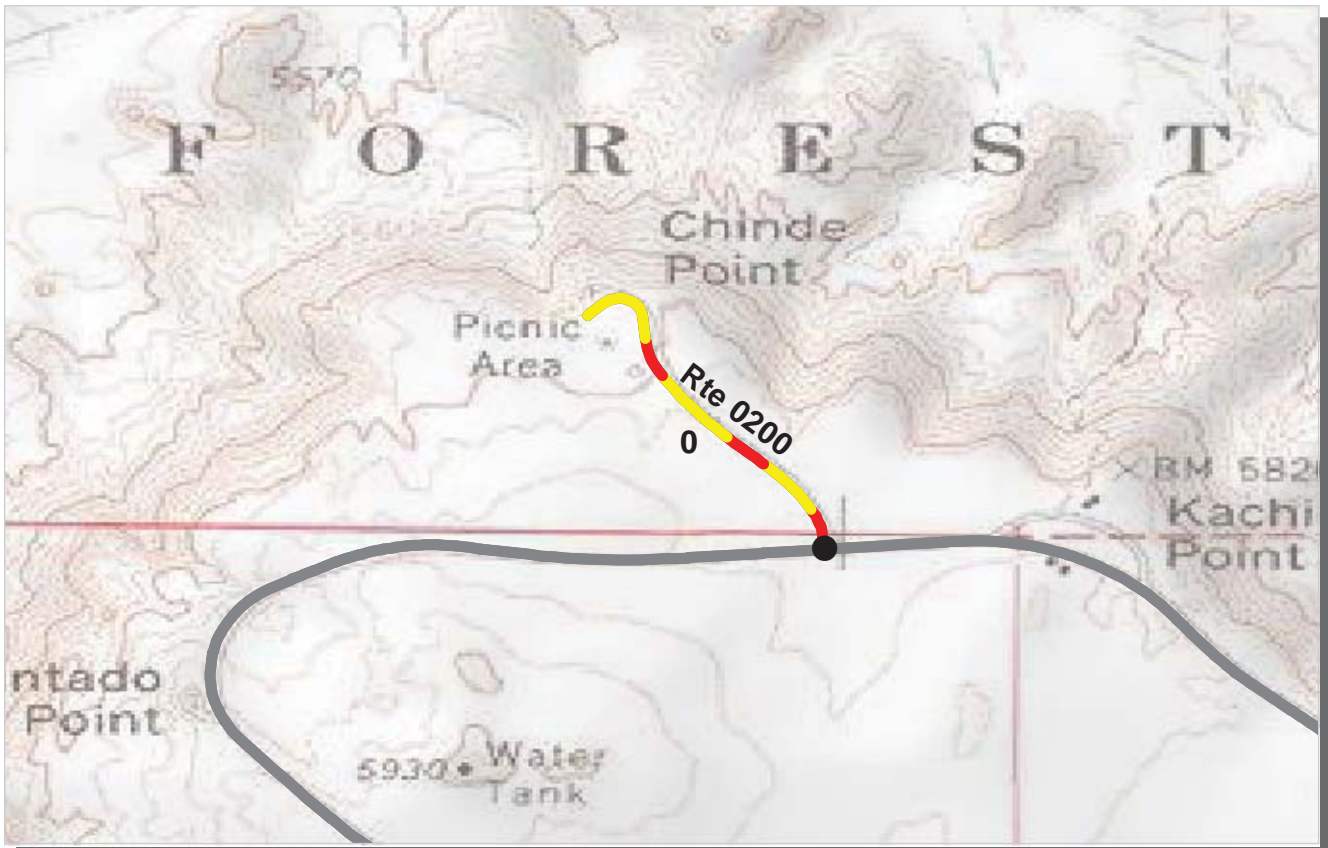
ROUTE: 0014 JASPER FOREST ROAD

Section Number	0				
Section Length (mi)	0.51				
Traffic	Traffic data may be found at www.efl.fhwa.dot.gov Click on PROGRAMS / NPS Traffic Data (Note: Not all parks have traffic data)				
Cross Section Information					
Number of Lanes	2				
Paved Width (ft)	19				
Lane Width (ft)	10				
Shoulder Width Right (ft)	NC				
Shoulder Width Left (ft)	NC				
Roadway Condition Information					
SCR (Surface Condition Rating)	79				
PCR (Pavement Condition Rating)	75				
Distress Index Values					
Alligator Cracking Index	100				
Longitudinal Cracking Index	100				
Transverse Cracking Index	100				
Patching Index	100				
Rutting Index	79				
Roughness Condition Index (RCI)	66

PCR	Poor	Fair	Good	Excellent	No Data
	(≤60)	(61 - 84)	(85 - 94)	(95 - 100)

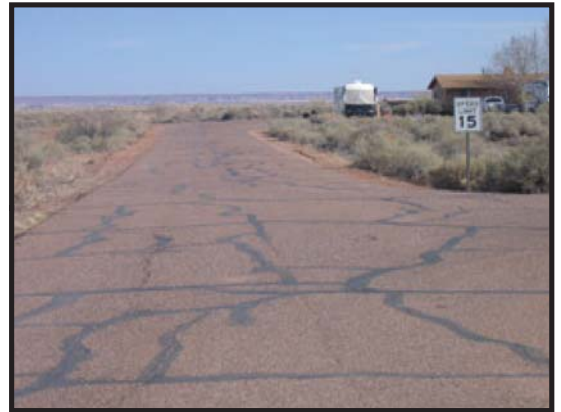
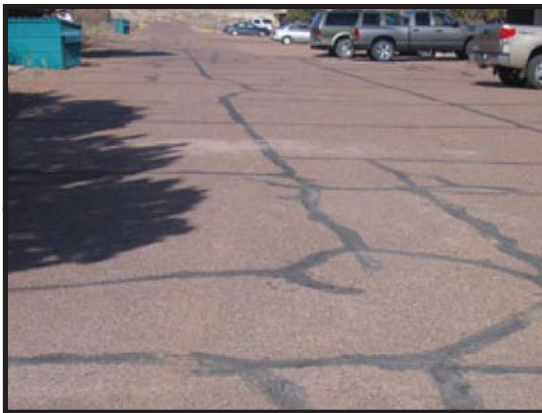
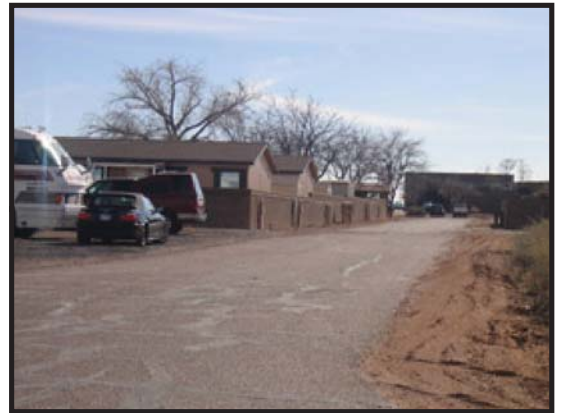
Route Number	Public / NonPublic	Date Visited		Area (sq ft)	Lane Miles *	Surface Type
0415	NONPUBLIC	3/19/2008		81,309	1.40	AS
Culverts	Drop Inlets	Gates	Fire Hydrants	Curb & Gutter	Curb	PCR
0	2	0	5	NO CURB AND GUTTER	NO CURB	POOR/45

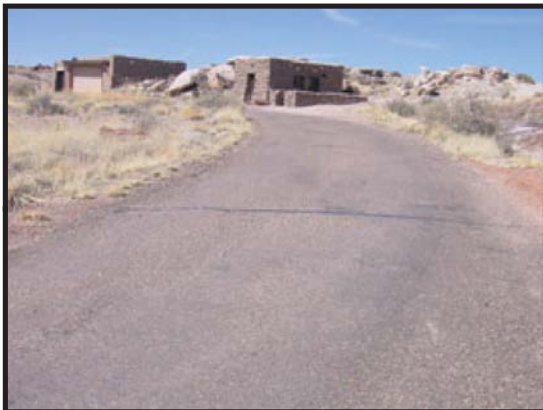
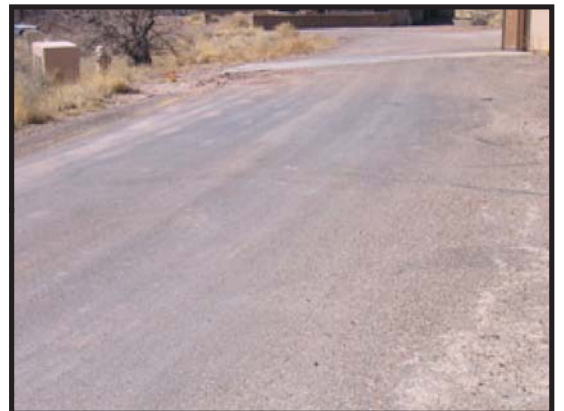
Route 0416

Route Number	Public / NonPublic	Date Visited		Area (sq ft)	Lane Miles *	Surface Type
0416	NONPUBLIC	3/19/2008		19,771	0.34	AS
Culverts	Drop Inlets	Gates	Fire Hydrants	Curb & Gutter	Curb	PCR
0	0	0	3	NO CURB AND GUTTER	STONE CURB	POOR/45

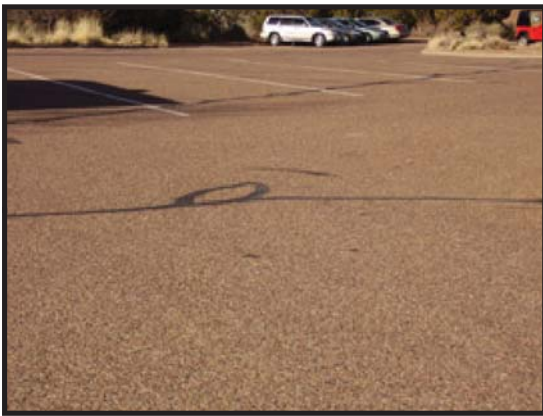
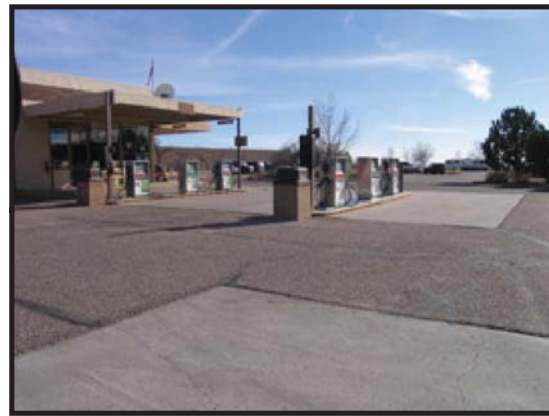
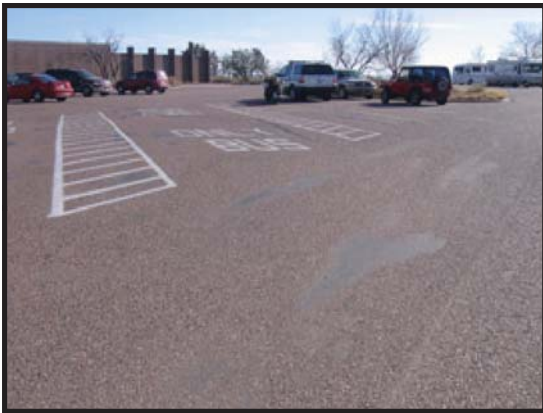
Route Number	Public / NonPublic	Date Visited		Area (sq ft)	Lane Miles *	Surface Type
0900	PUBLIC	3/19/2008		105,133	1.81	AS
Culverts	Drop Inlets	Gates	Fire Hydrants	Curb & Gutter	Curb	PCR
0	0	0	1	CONCRETE CURB AND GUTTER	CONCRETE CURB	FAIR/73

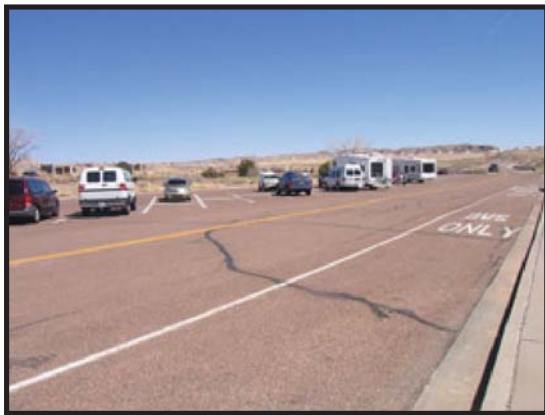
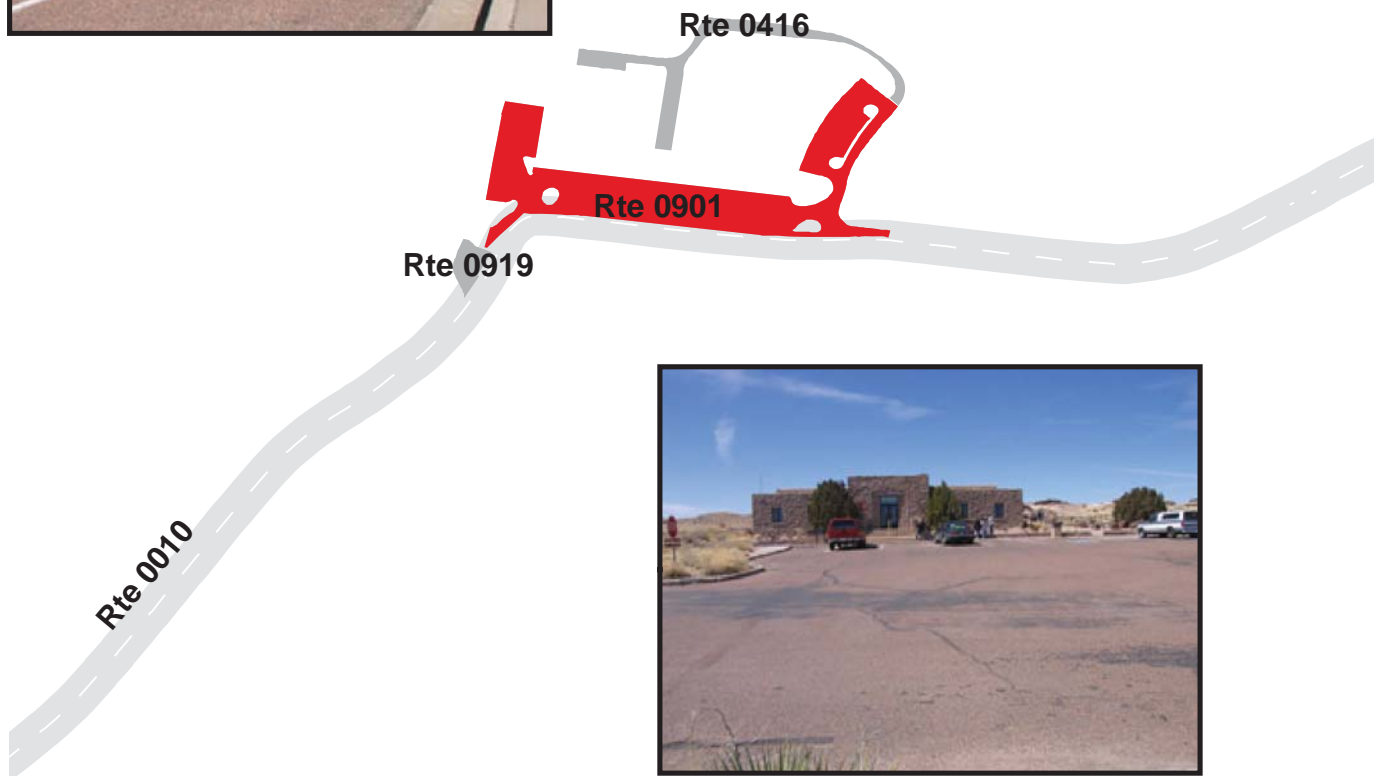
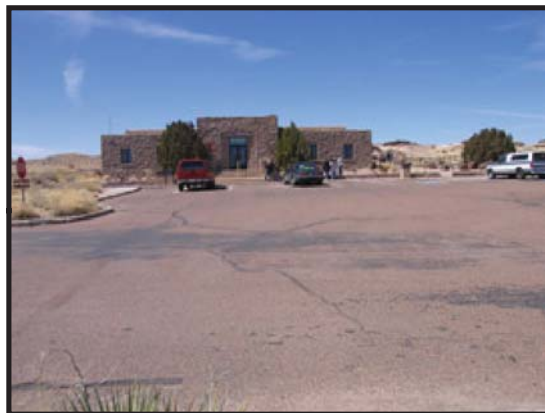
Route 0901

Route Number	Public / NonPublic	Date Visited		Area (sq ft)	Lane Miles *	Surface Type
0901	PUBLIC	3/19/2008		83,228	1.43	AS
Culverts	Drop Inlets	Gates	Fire Hydrants	Curb & Gutter	Curb	PCR
0	0	0	1	NO CURB AND GUTTER	STONE CURB	FAIR/73

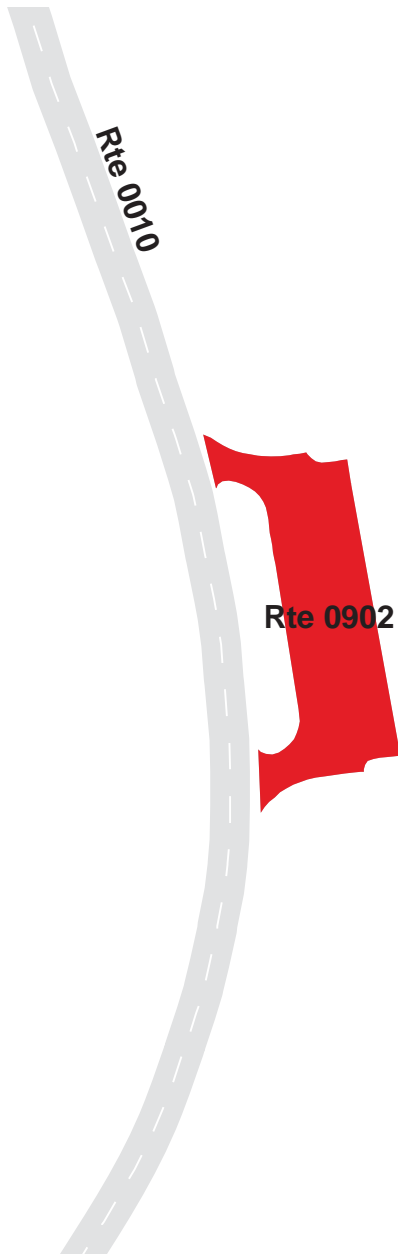
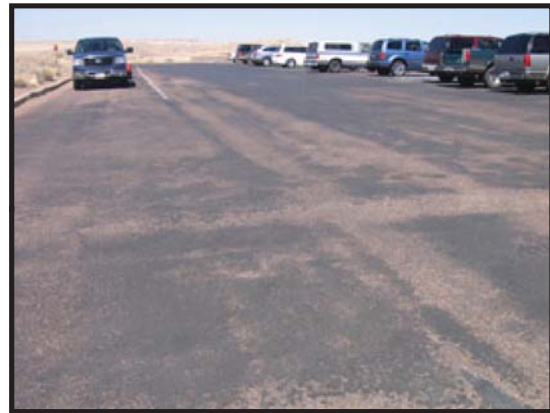
Route 0902

Route Number	Public / NonPublic	Date Visited		Area (sq ft)	Lane Miles *	Surface Type
0902	PUBLIC	3/19/2008		19,349	0.33	AS
Culverts	Drop Inlets	Gates	Fire Hydrants	Curb & Gutter	Curb	PCR
0	0	0	0	NO CURB AND GUTTER	STONE CURB	FAIR/73

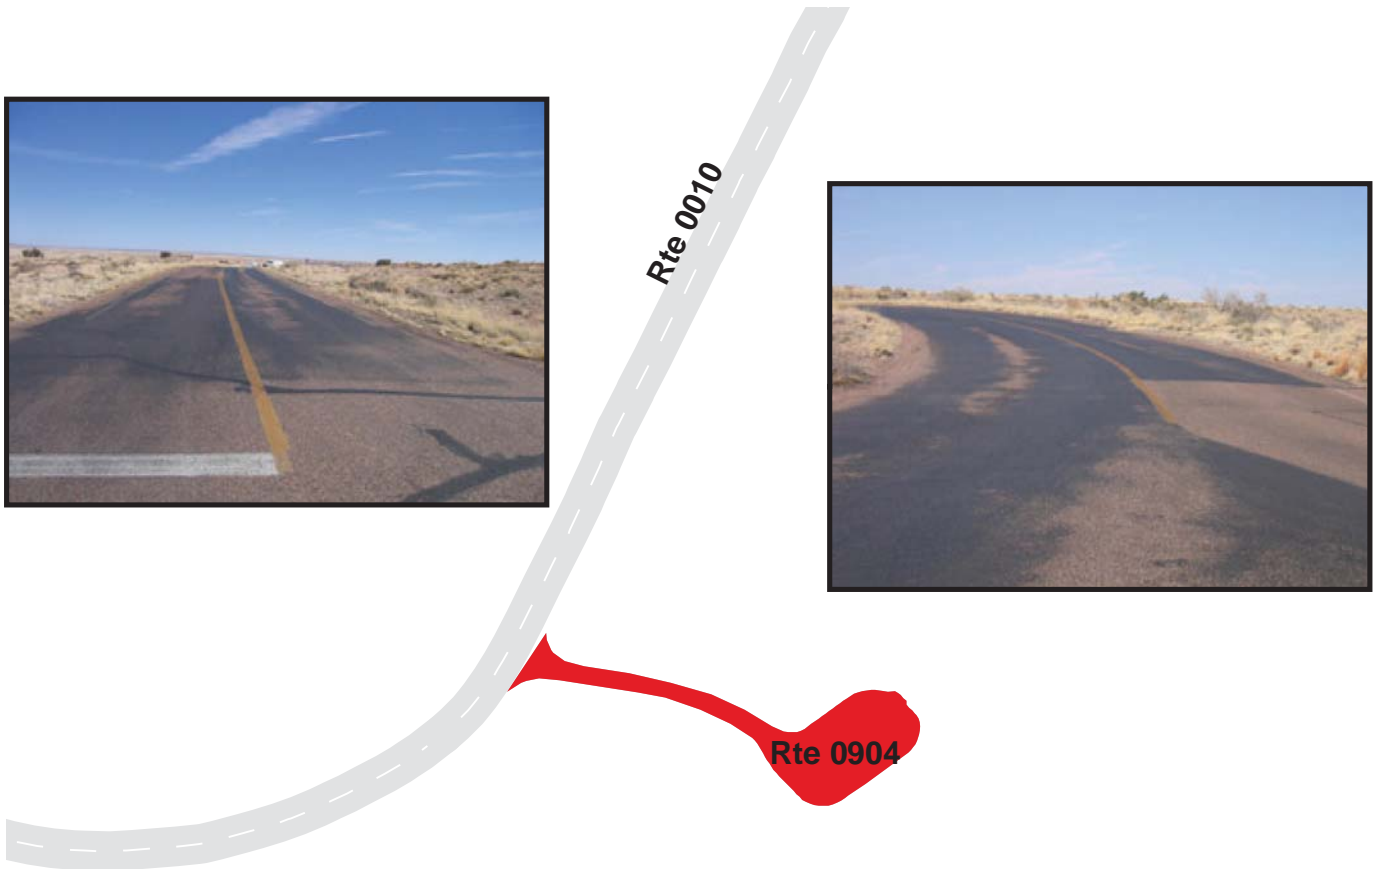
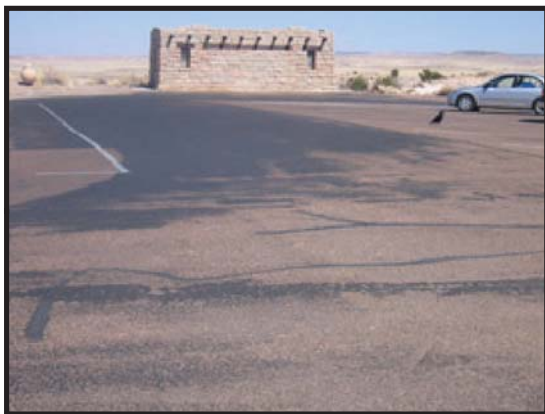
Route 0904

Route Number	Public / NonPublic	Date Visited		Area (sq ft)	Lane Miles *	Surface Type
0904	PUBLIC	3/19/2008		26,375	0.45	AS
Culverts	Drop Inlets	Gates	Fire Hydrants	Curb & Gutter	Curb	PCR
0	0	0	0	CONCRETE CURB AND GUTTER	STONE CURB	FAIR/73

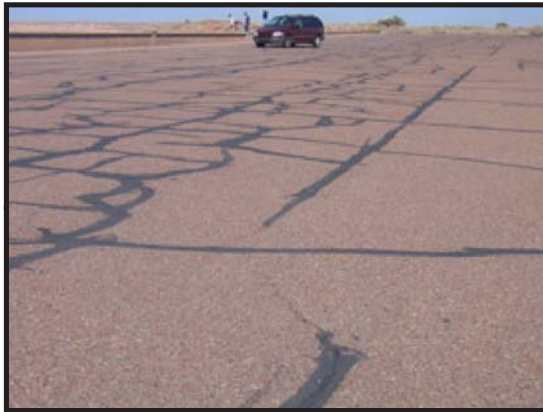
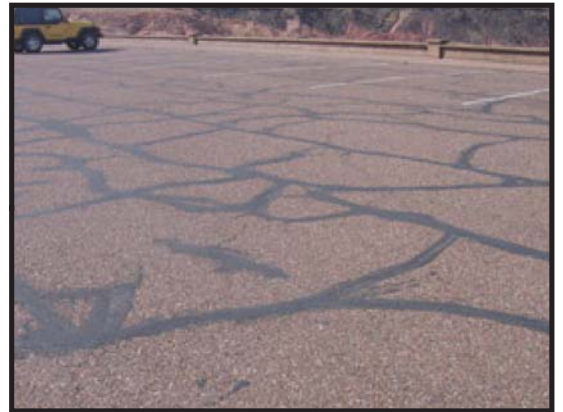
Route 0905

Route Number	Public / NonPublic	Date Visited		Area (sq ft)	Lane Miles *	Surface Type
0905	PUBLIC	3/19/2008		39,014	0.67	AS
Culverts	Drop Inlets	Gates	Fire Hydrants	Curb & Gutter	Curb	PCR
0	1	0	0	ASPHALT CURB AND GUTTER	ASPHALT CURB	POOR/45

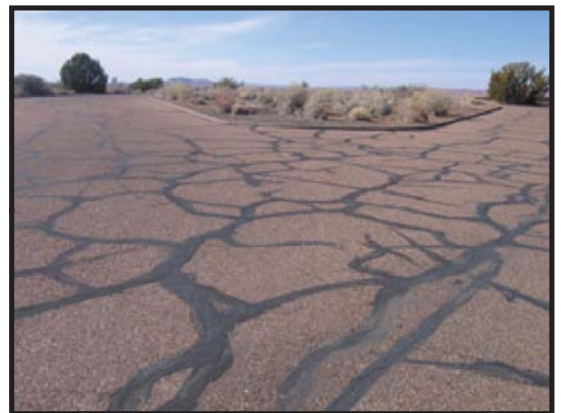
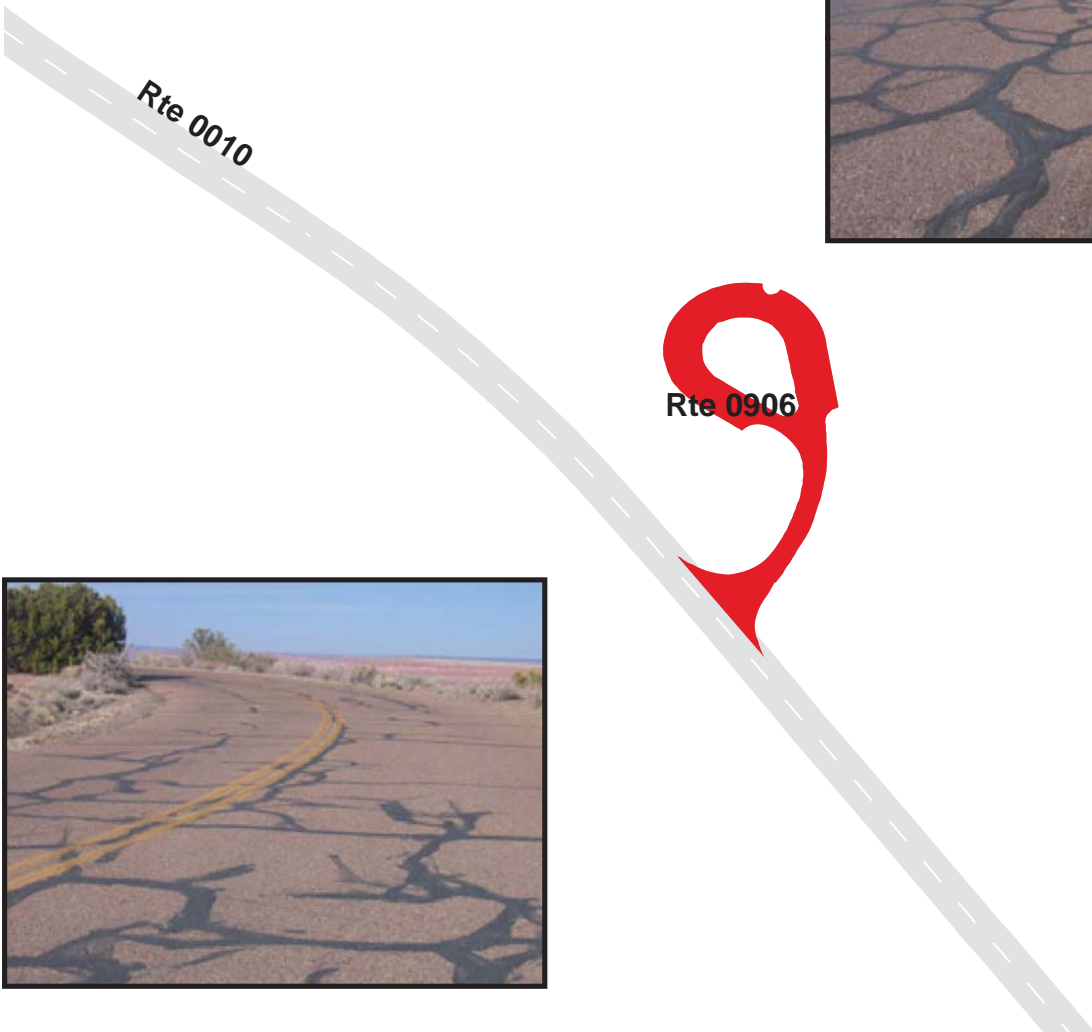
Route 0906

Route Number	Public / NonPublic	Date Visited		Area (sq ft)	Lane Miles *	Surface Type
0906	PUBLIC	3/19/2008		30,335	0.52	AS
Culverts	Drop Inlets	Gates	Fire Hydrants	Curb & Gutter	Curb	PCR
0	1	0	0	ASPHALT CURB AND GUTTER	ASPHALT CURB	POOR/45

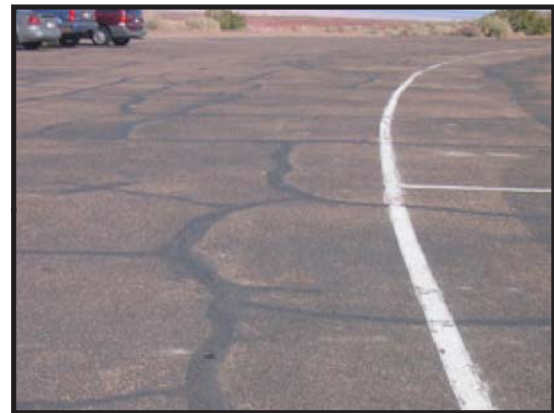
Route 0907

Route Number	Public / NonPublic	Date Visited		Area (sq ft)	Lane Miles *	Surface Type
0907	PUBLIC	3/19/2008		38,324	0.66	AS
Culverts	Drop Inlets	Gates	Fire Hydrants	Curb & Gutter	Curb	PCR
0	0	0	1	ASPHALT CURB AND GUTTER	ASPHALT CURB	POOR/45

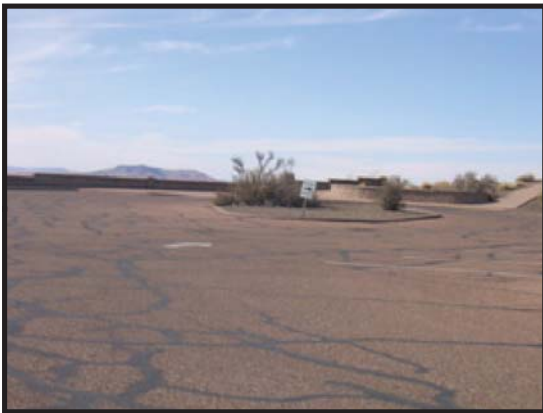
Route 0908

Route Number	Public / NonPublic	Date Visited		Area (sq ft)	Lane Miles *	Surface Type
0908	PUBLIC	3/19/2008		16,846	0.29	AS
Culverts	Drop Inlets	Gates	Fire Hydrants	Curb & Gutter	Curb	PCR
0	0	0	0	ASPHALT CURB AND GUTTER	ASPHALT CURB	POOR/45

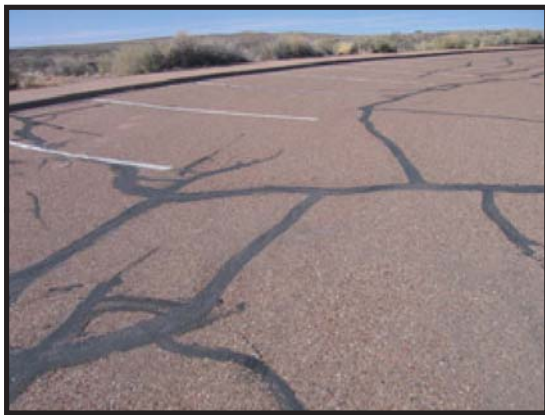
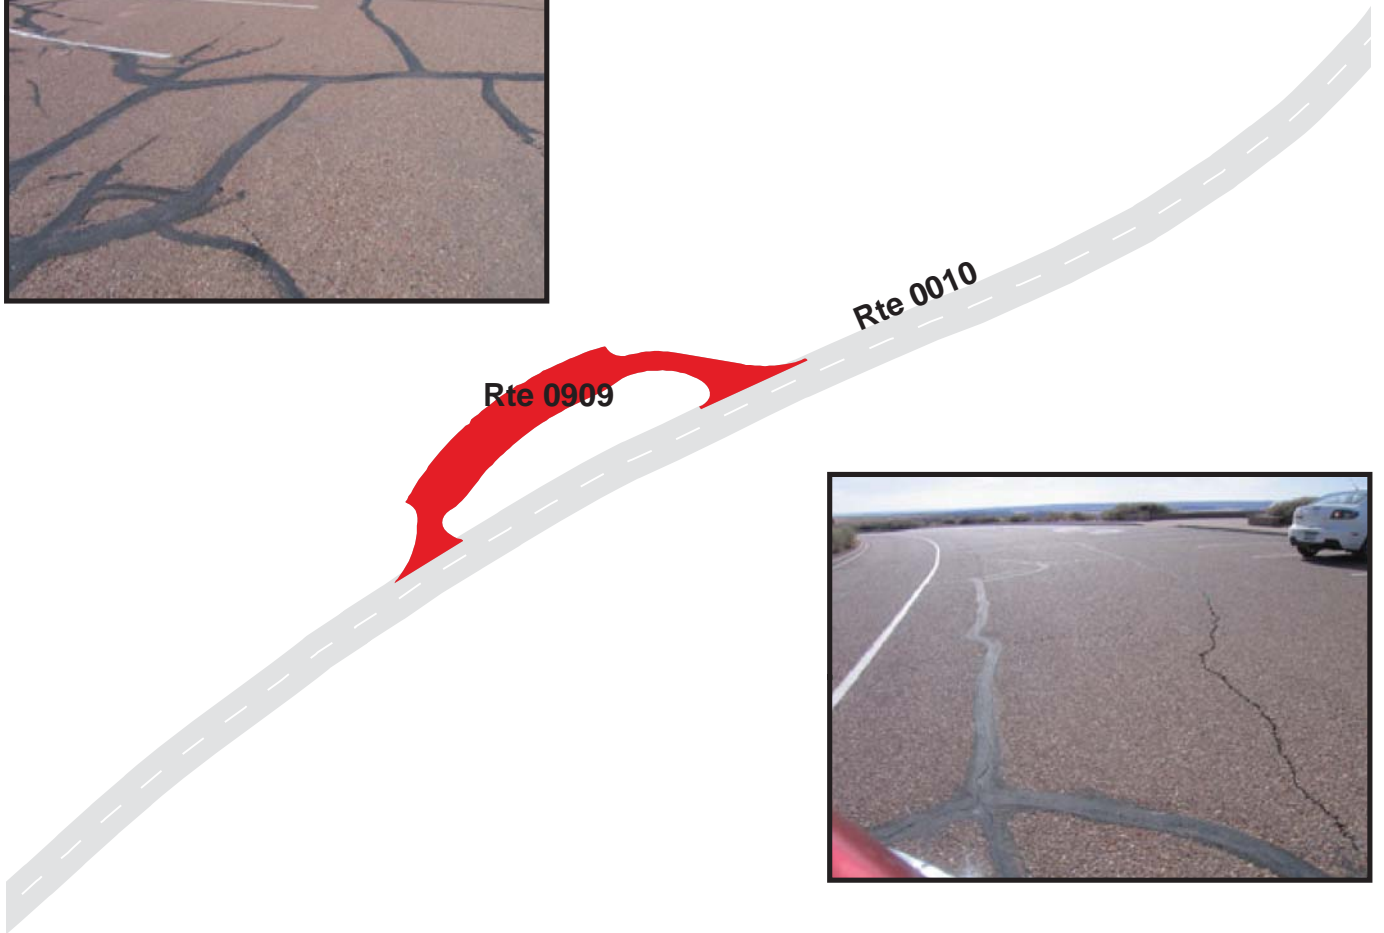
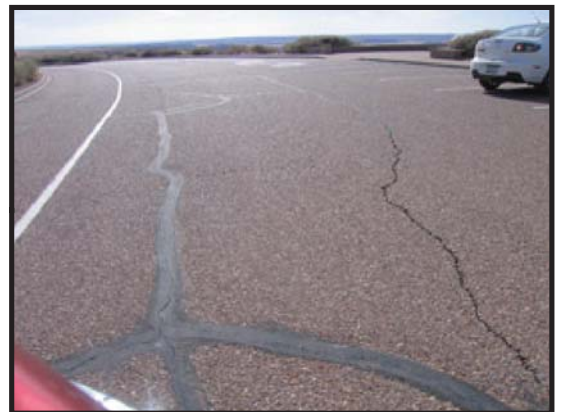
Route 0909

Route Number	Public / NonPublic	Date Visited		Area (sq ft)	Lane Miles *	Surface Type
0909	PUBLIC	3/19/2008		23,123	0.40	AS
Culverts	Drop Inlets	Gates	Fire Hydrants	Curb & Gutter	Curb	PCR
0	1	0	0	ASPHALT CURB AND GUTTER	ASPHALT CURB	POOR/45

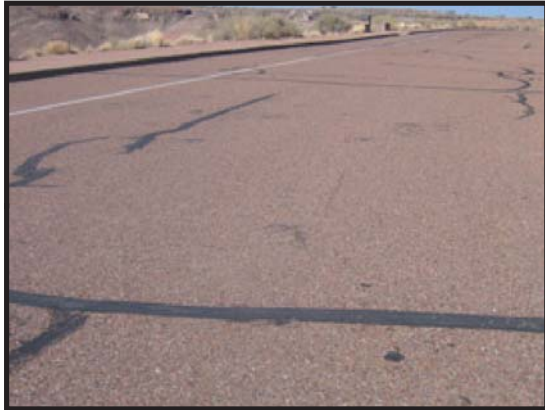
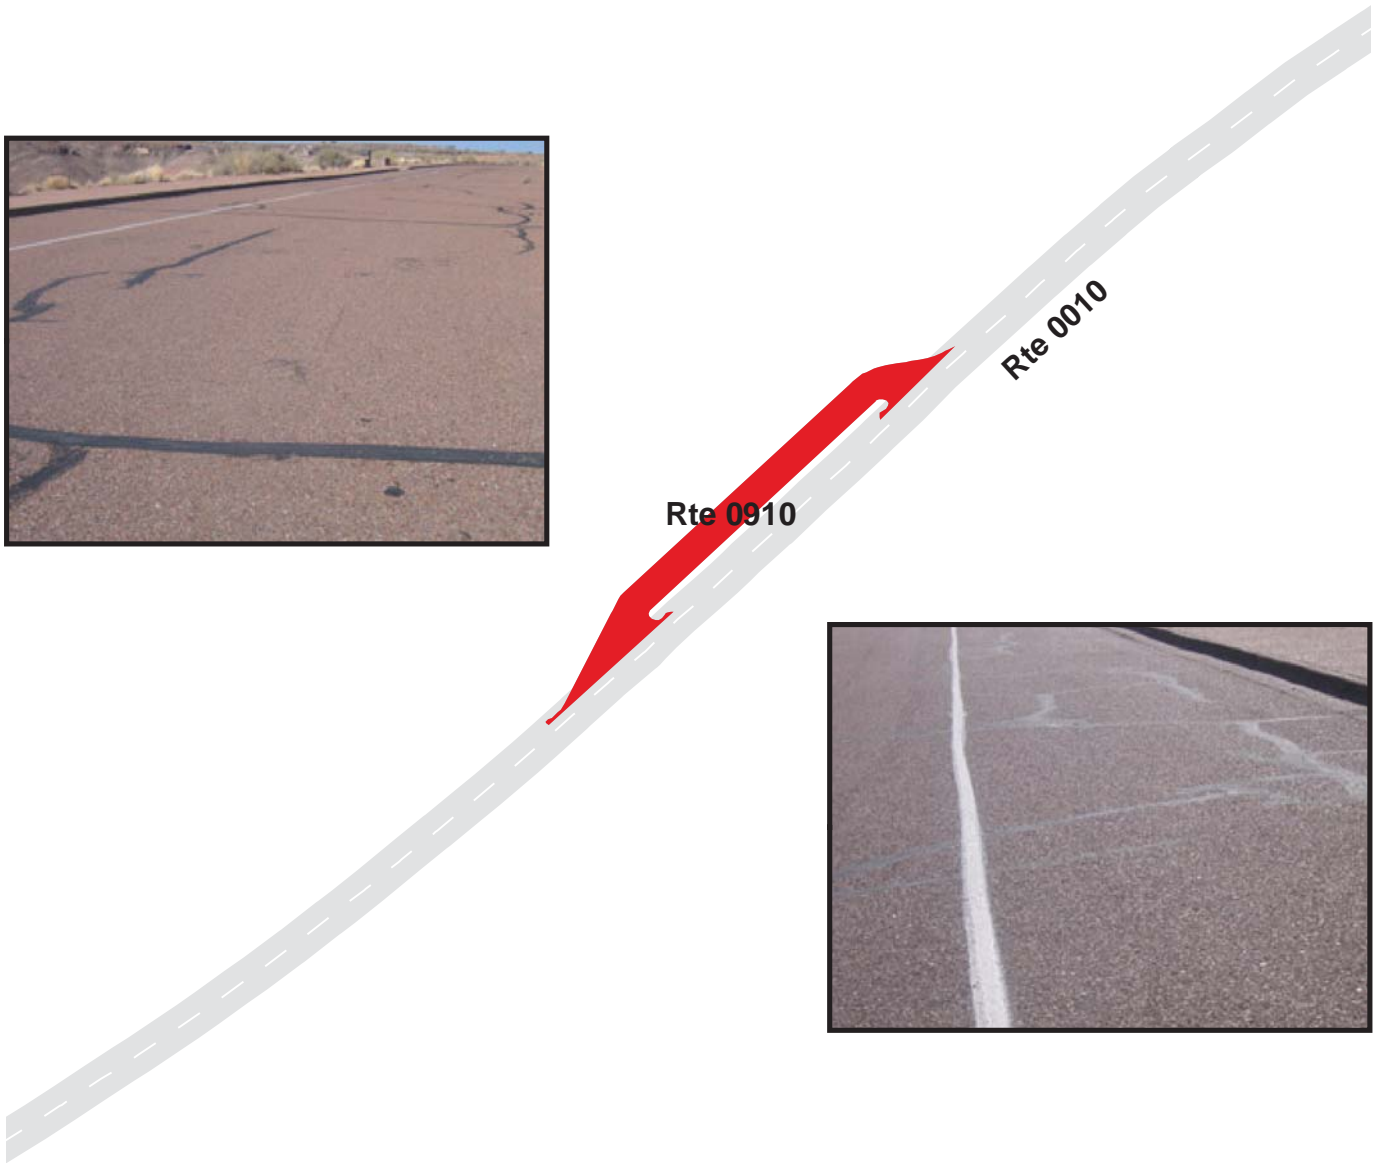
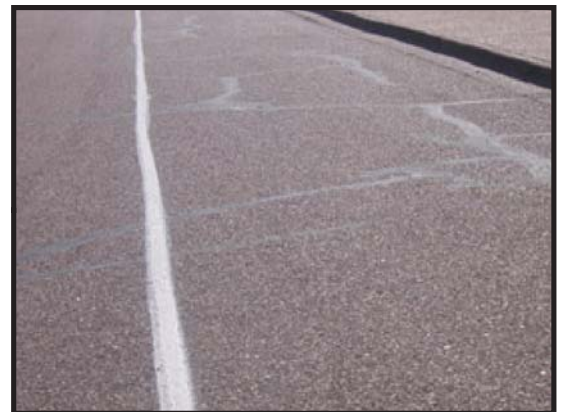
Route 0910

Route Number	Public / NonPublic	Date Visited		Area (sq ft)	Lane Miles *	Surface Type
0910	PUBLIC	3/19/2008		20,464	0.35	AS
Culverts	Drop Inlets	Gates	Fire Hydrants	Curb & Gutter	Curb	PCR
0	0	0	0	ASPHALT CURB AND GUTTER	ASPHALT CURB	POOR/45

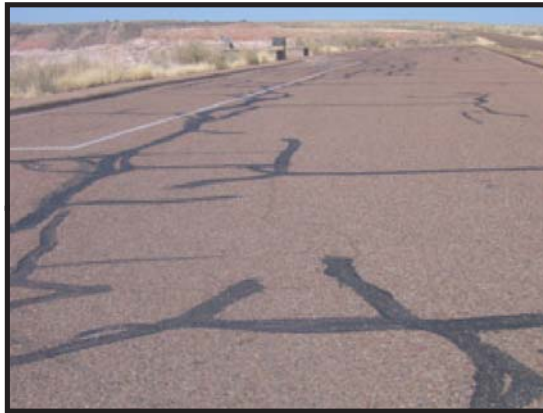
Route 0911

Route Number	Public / NonPublic	Date Visited		Area (sq ft)	Lane Miles *	Surface Type
0911	PUBLIC	3/19/2008		14,638	0.25	AS
Culverts	Drop Inlets	Gates	Fire Hydrants	Curb & Gutter	Curb	PCR
0	0	0	0	ASPHALT CURB AND GUTTER	ASPHALT CURB	FAIR/73

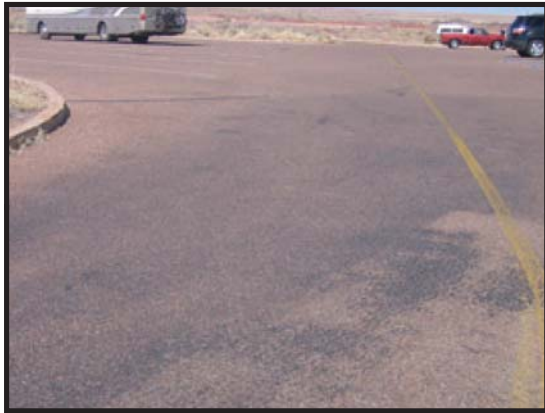
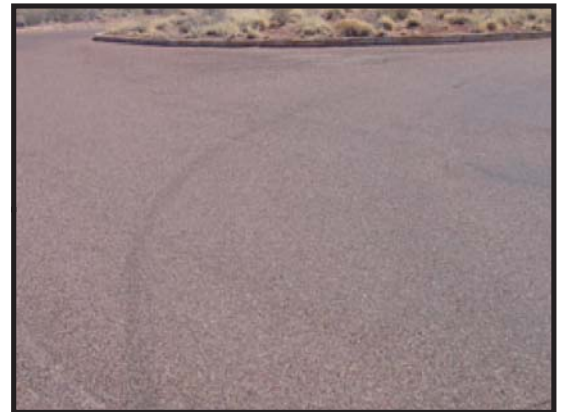
Route 0912

Route Number	Public / NonPublic	Date Visited		Area (sq ft)	Lane Miles *	Surface Type
0912	PUBLIC	3/19/2008		32,434	0.56	AS
Culverts	Drop Inlets	Gates	Fire Hydrants	Curb & Gutter	Curb	PCR
0	2	0	0	NO CURB AND GUTTER	STONE CURB	FAIR/73

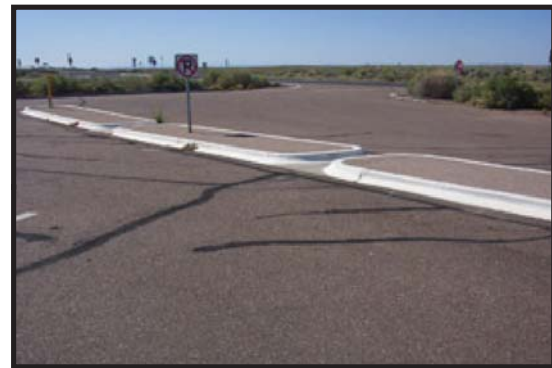
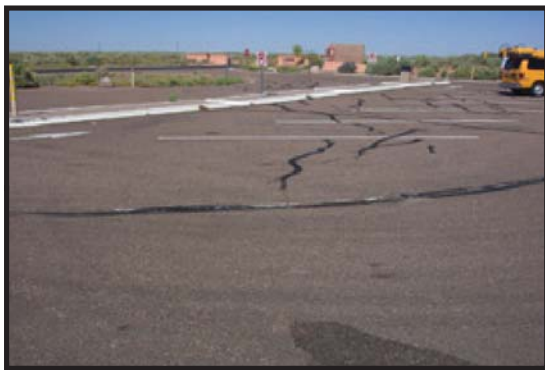
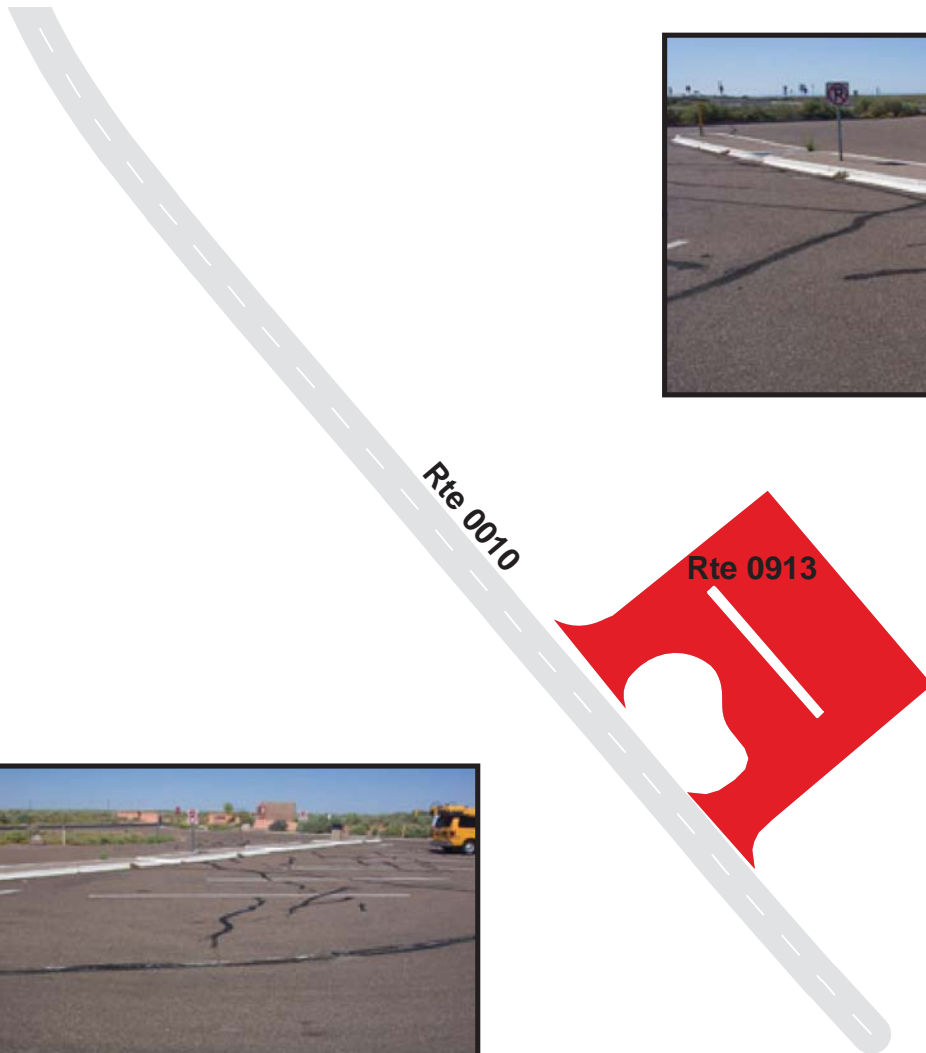
Route Number	Public / NonPublic	Date Visited		Area (sq ft)	Lane Miles *	Surface Type
0913	PUBLIC	9/14/2008		26,277	0.45	AS
Culverts	Drop Inlets	Gates	Fire Hydrants	Curb & Gutter	Curb	PCR
1	0	0	0	CONCRETE CURB AND GUTTER	CONCRETE CURB	FAIR/73

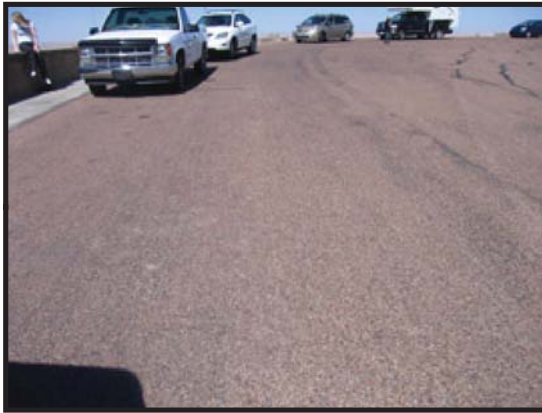
Route 0914

Route Number	Public / NonPublic	Date Visited		Area (sq ft)	Lane Miles *	Surface Type
0914	PUBLIC	3/19/2008		5,126	0.09	AS
Culverts	Drop Inlets	Gates	Fire Hydrants	Curb & Gutter	Curb	PCR
0	0	0	0	NO CURB AND GUTTER	ASPHALT CURB	FAIR/73
