**The Road Inventory
of
Petrified Forest National Park
PEFO – 8430
Cycle 4**

**Prepared By:
Federal Highway Administration
Road Inventory Program
Cycle 4**

Petrified Forest National Park in Arizona

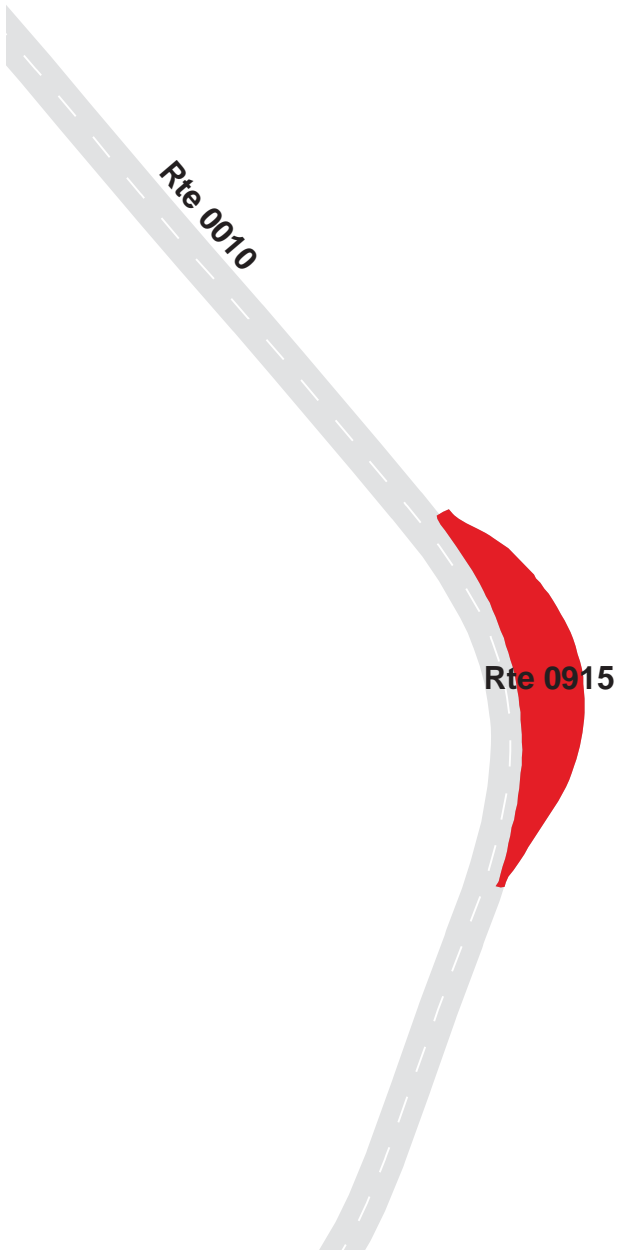
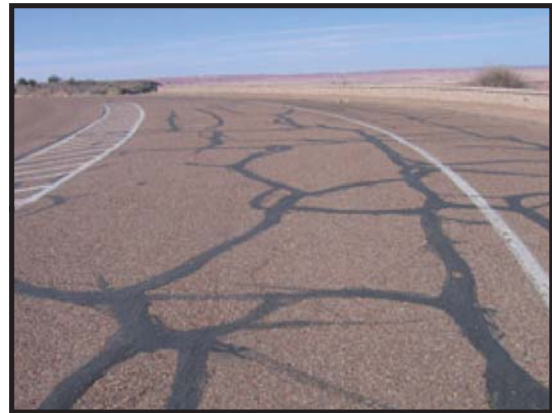
Route 0915

Route Number	Public / NonPublic	Date Visited		Area (sq ft)	Lane Miles *	Surface Type
0915	PUBLIC	3/19/2008		7,315	0.13	AS
Culverts	Drop Inlets	Gates	Fire Hydrants	Curb & Gutter	Curb	PCR
0	0	0	0	ASPHALT CURB AND GUTTER	ASPHALT CURB	POOR/45

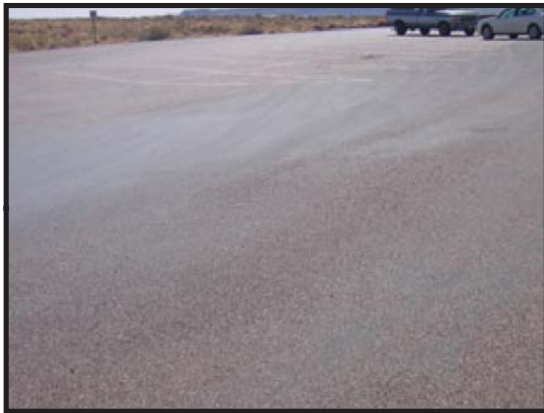
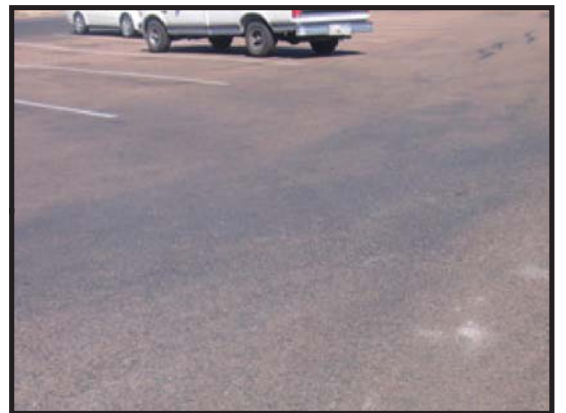
Route 0916

Route Number	Public / NonPublic	Date Visited		Area (sq ft)	Lane Miles *	Surface Type
0916	PUBLIC	3/19/2008		24,368	0.42	AS
Culverts	Drop Inlets	Gates	Fire Hydrants	Curb & Gutter	Curb	PCR
0	0	0	0	NO CURB AND GUTTER	STONE CURB	FAIR/73

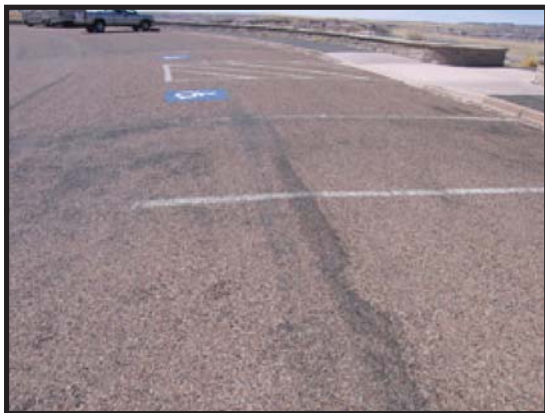
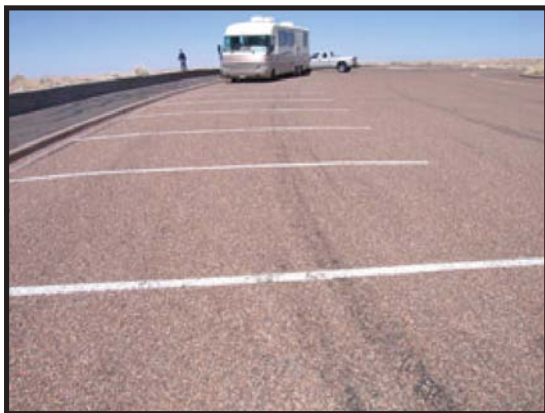
Route Number	Public / NonPublic	Date Visited		Area (sq ft)	Lane Miles *	Surface Type
0917AZ	PUBLIC	3/19/2008		11,173	0.19	AS
Culverts	Drop Inlets	Gates	Fire Hydrants	Curb & Gutter	Curb	PCR
0	0	0	0	CONCRETE CURB AND GUTTER	CONCRETE CURB	FAIR/73

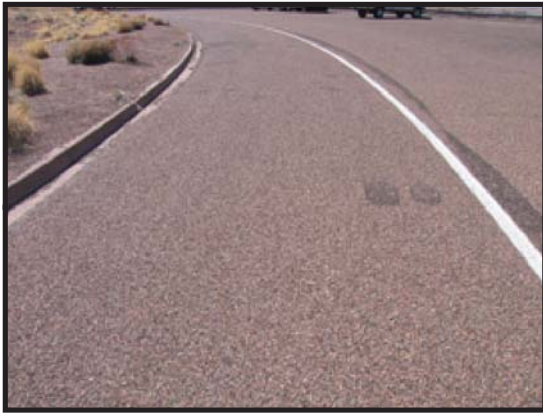
Route 0917BZ

Route Number	Public / NonPublic	Date Visited		Area (sq ft)	Lane Miles *	Surface Type
0917BZ	PUBLIC	3/19/2008		6,571	0.11	AS
Culverts	Drop Inlets	Gates	Fire Hydrants	Curb & Gutter	Curb	PCR
0	1	0	0	CONCRETE CURB AND GUTTER	CONCRETE CURB	GOOD/90

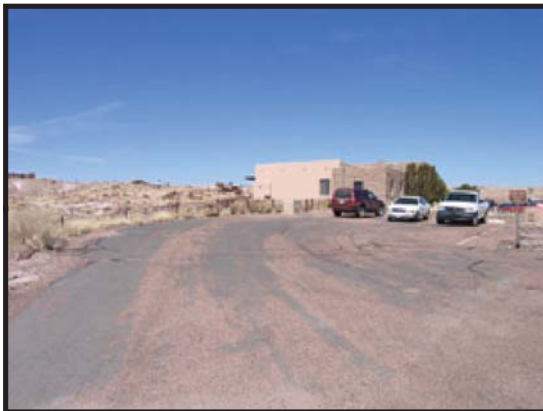
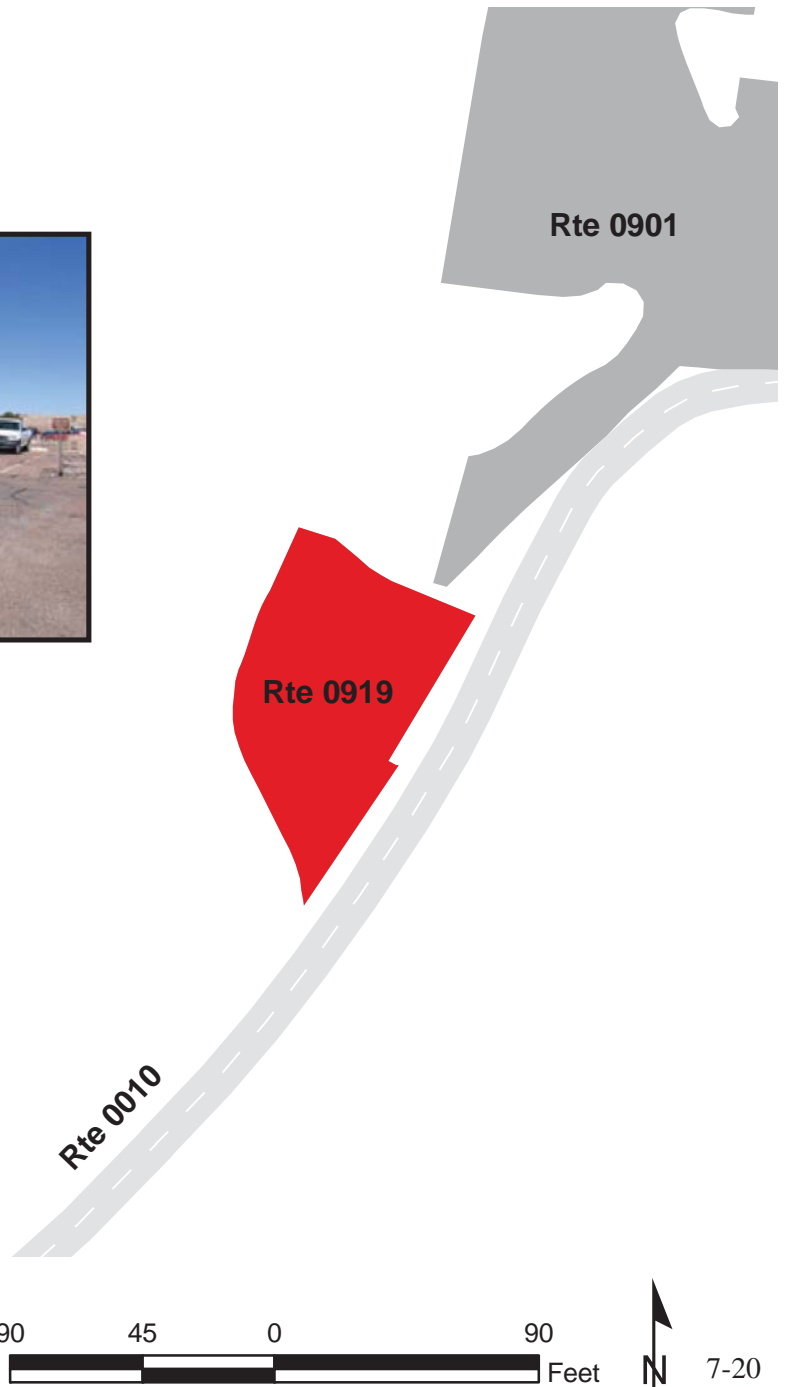
Route 0919

Route Number	Public / NonPublic	Date Visited		Area (sq ft)	Lane Miles *	Surface Type
0919	PUBLIC	3/19/2008		4,522	0.08	AS
Culverts	Drop Inlets	Gates	Fire Hydrants	Curb & Gutter	Curb	PCR
0	0	0	1	NO CURB AND GUTTER	NO CURB	FAIR/73

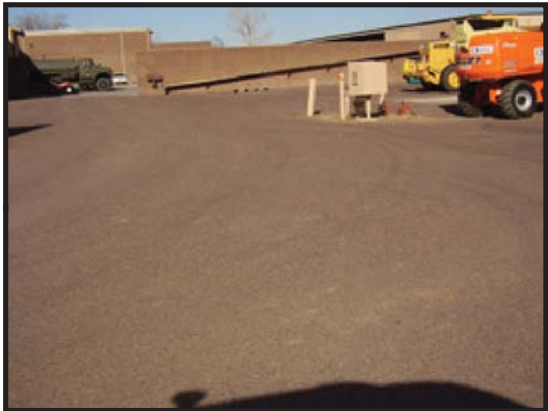
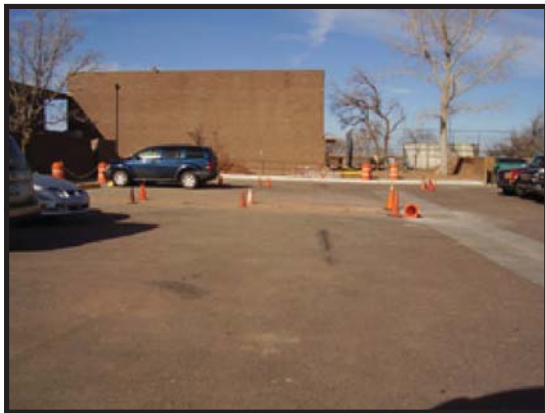
Route 0920

Route Number	Public / NonPublic	Date Visited		Area (sq ft)	Lane Miles *	Surface Type
0920	PUBLIC	3/19/2008		41,829	0.72	AS
Culverts	Drop Inlets	Gates	Fire Hydrants	Curb & Gutter	Curb	PCR
0	2	0	2	NO CURB AND GUTTER	CONCRETE CURB	POOR/45

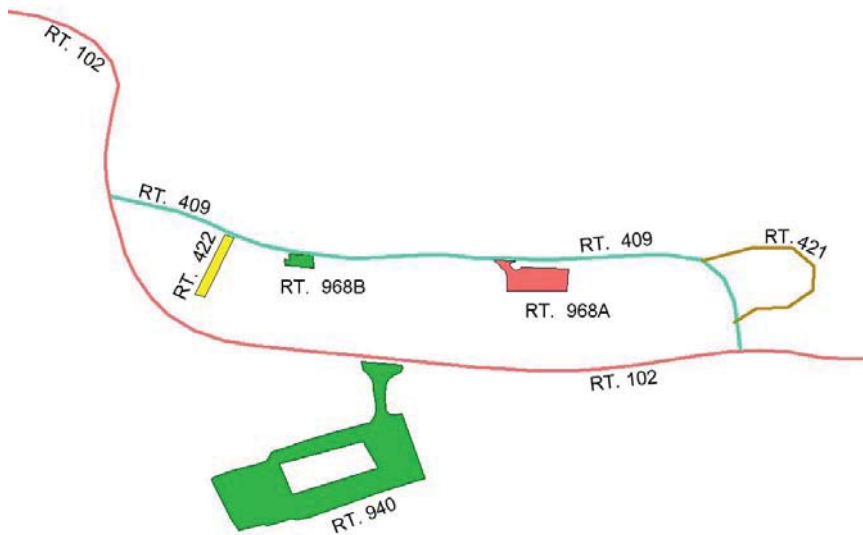
Figure 7 – Current Housing area access configuration. Route 409 is less than 0.25 miles long.

The area serviced by Routes 409, 421, 422, 968A, and 968B is all employee housing. Route 940 provides access to visitor services and not to the housing area. Routes may be combined to create assets that reflect local management. Routes 409, 421, and 422 are all the same functional class, provide access to one type of activity (housing) and are all posted as non-public. These routes may be combined. They should not be combined with any parking areas even though they are all less than 0.25 miles long. This is because their main function is not to provide access to parking. Routes 968A and B provide parking for access to the same facility (housing). Even though these discrete areas may provide parking to different housing units, it's reasonable to manage them as a single asset. They may also be combined.
