**The Road Inventory
of
Point Reyes National Seashore
PORE – 8530
Cycle 4**

**Prepared By:
Federal Highway Administration
Road Inventory Program
Cycle 4**

Point Reyes National Seashore in California

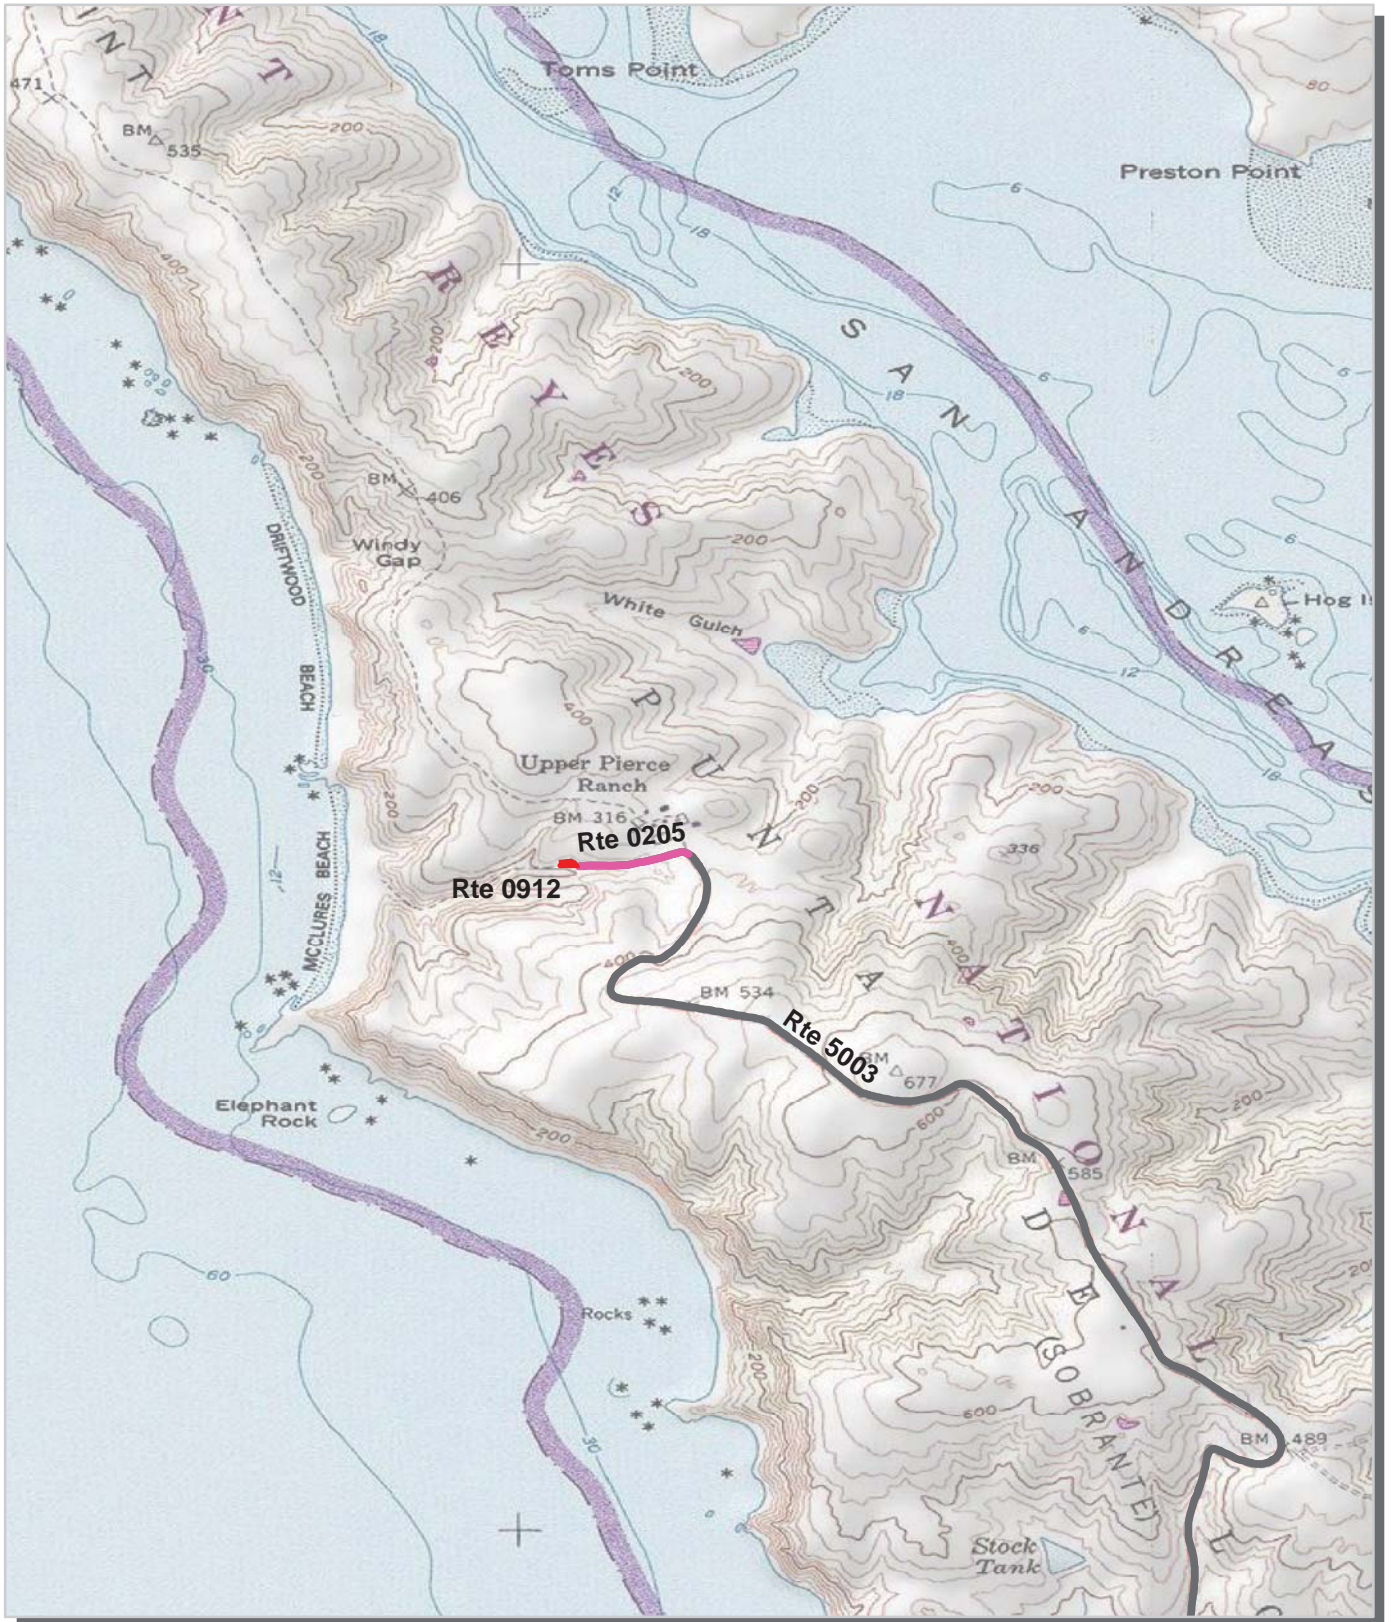
Point Reyes National Seashore Route Location Map Area 1

Unique colors used to differentiate routes

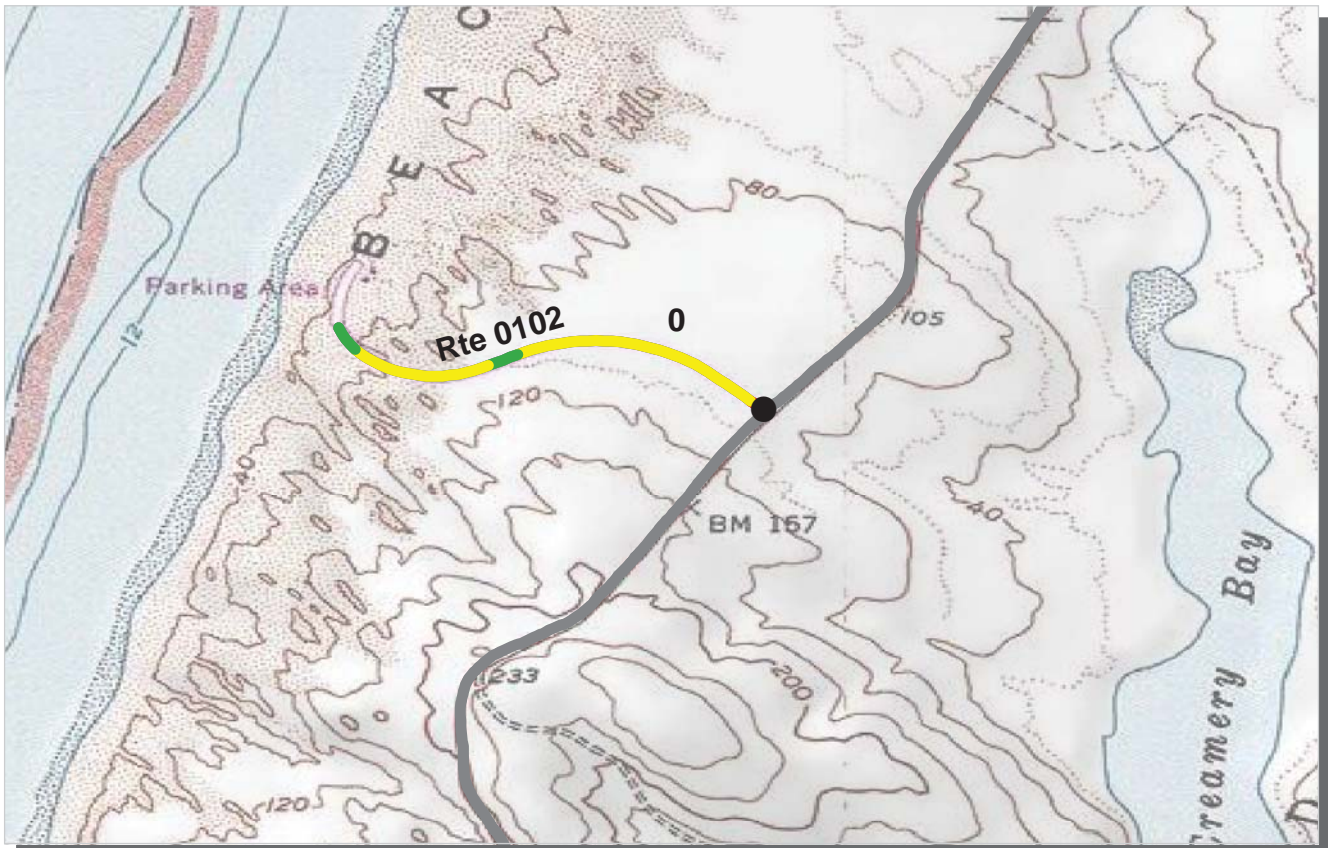
Section Number	0				
Section Length (mi)	0.60				
Traffic	Traffic data may be found at www.efl.fhwa.dot.gov Click on NPS Traffic Data (Note: Not all parks have traffic data)				
Cross Section Information					
Number of Lanes	2				
Paved Width (ft)	33				
Lane Width (ft)	15				
Shoulder Width Right (ft)**	2				
Shoulder Width Left (ft)**	3				
Roadway Condition Information					
SCR (Surface Condition Rating)	67				
PCR (Pavement Condition Rating)	79				
Distress Index Values					
Alligator Cracking Index	100				
Longitudinal Cracking Index	99				
Transverse Cracking Index	96				
Patching Index	100				
Rutting Index	73				
Roughness Condition Index (RCI)	98

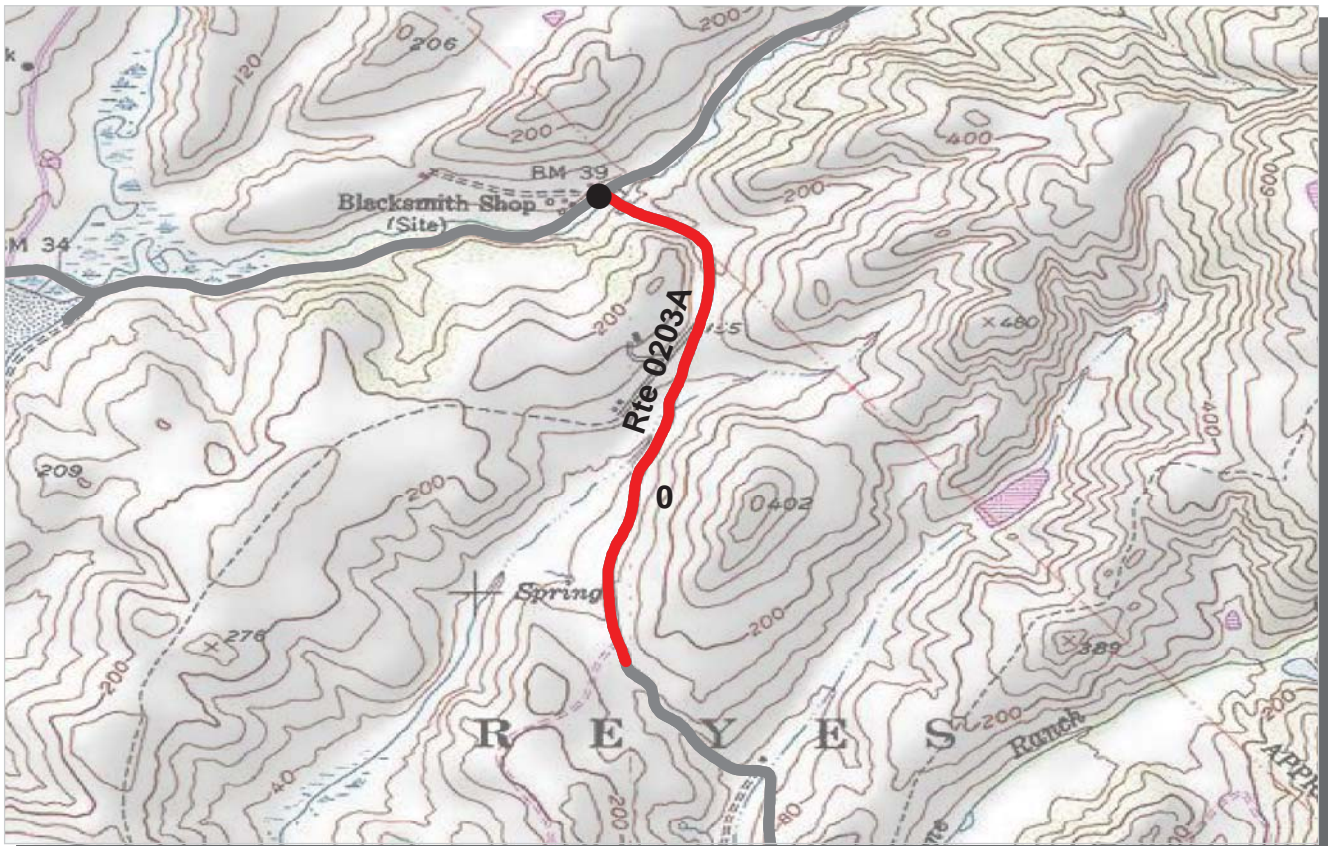
Section Number	0				
Section Length (mi)	0.97				
Traffic	Traffic data may be found at www.efl.fhwa.dot.gov Click on NPS Traffic Data (Note: Not all parks have traffic data)				
Cross Section Information					
Number of Lanes	1				
Paved Width (ft)	11				
Lane Width (ft)	11				
Shoulder Width Right (ft)**	0				
Shoulder Width Left (ft)**	3				
Roadway Condition Information					
SCR (Surface Condition Rating)	30				
PCR (Pavement Condition Rating)	28				
Distress Index Values					
Alligator Cracking Index	85				
Longitudinal Cracking Index	95				
Transverse Cracking Index	92				
Patching Index	97				
Rutting Index	54				
Roughness Condition Index (RCI)	25

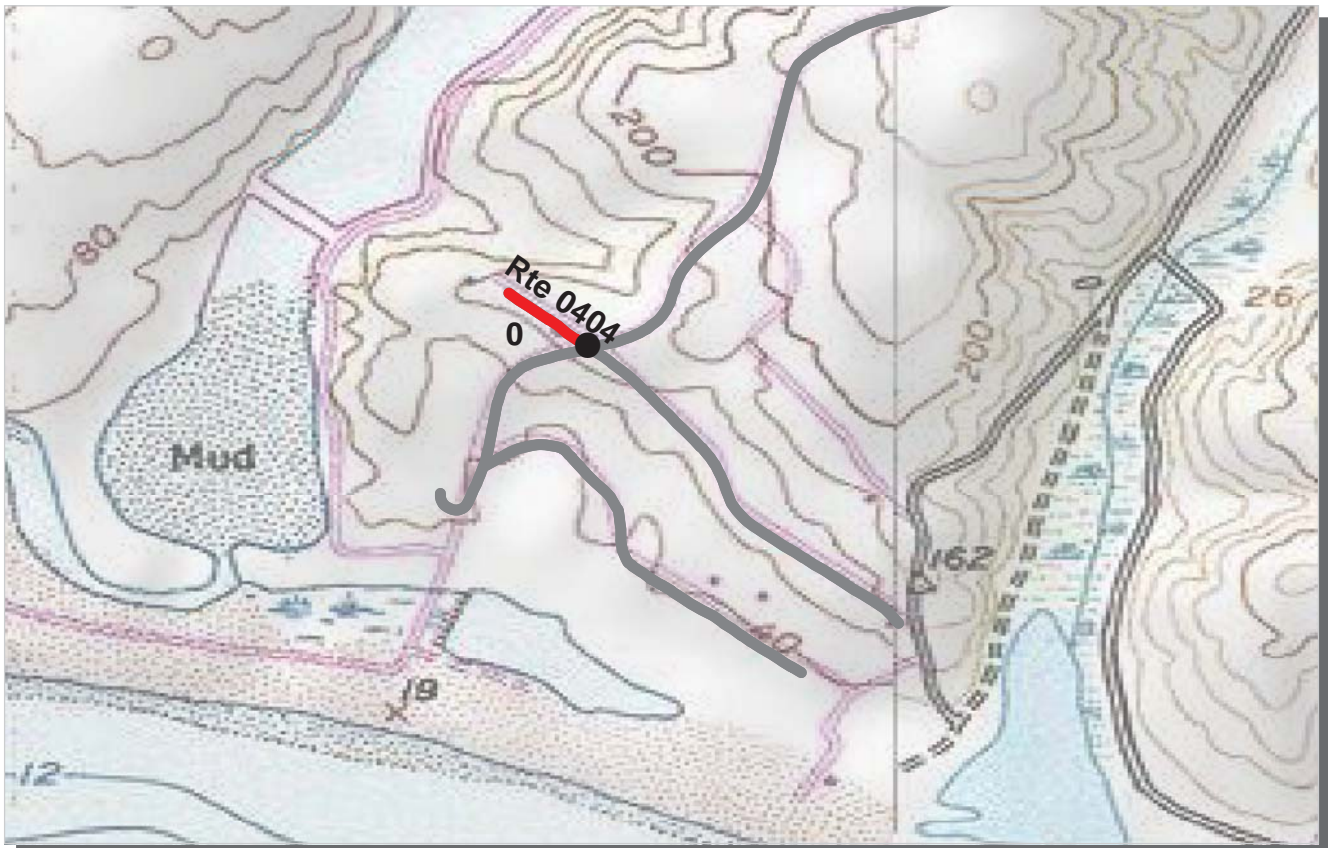
Section Number	0				
Section Length (mi)	0.08				
Traffic	Traffic data may be found at www.efl.fhwa.dot.gov Click on NPS Traffic Data (Note: Not all parks have traffic data)				
Cross Section Information					
Number of Lanes	1				
Paved Width (ft)	13				
Lane Width (ft)	12				
Shoulder Width Right (ft)**	6				
Shoulder Width Left (ft)**	12				
Roadway Condition Information					
SCR (Surface Condition Rating)	37				
PCR (Pavement Condition Rating)	41				
Distress Index Values					
Alligator Cracking Index	100				
Longitudinal Cracking Index	100				
Transverse Cracking Index	99				
Patching Index	100				
Rutting Index	38				
Roughness Condition Index (RCI)	54

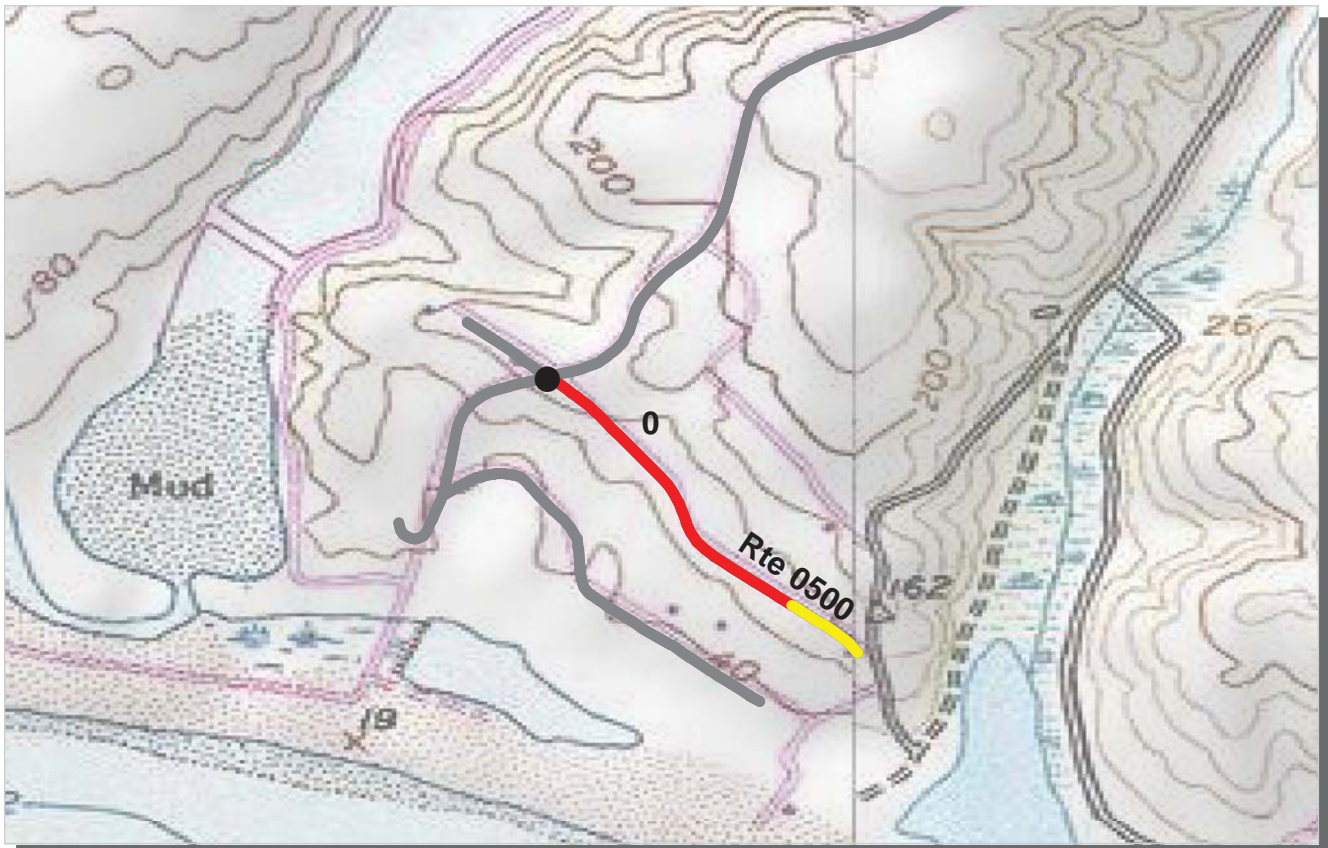
Section Number	0				
Section Length (mi)	0.37				
Traffic	Traffic data may be found at www.efl.fhwa.dot.gov Click on NPS Traffic Data (Note: Not all parks have traffic data)				
Cross Section Information					
Number of Lanes	1				
Paved Width (ft)	15				
Lane Width (ft)	13				
Shoulder Width Right (ft)**	7				
Shoulder Width Left (ft)**	3				
Roadway Condition Information					
SCR (Surface Condition Rating)	45				
PCR (Pavement Condition Rating)	46				
Distress Index Values					
Alligator Cracking Index	100				
Longitudinal Cracking Index	99				
Transverse Cracking Index	98				
Patching Index	100				
Rutting Index	48				
Roughness Condition Index (RCI)	50

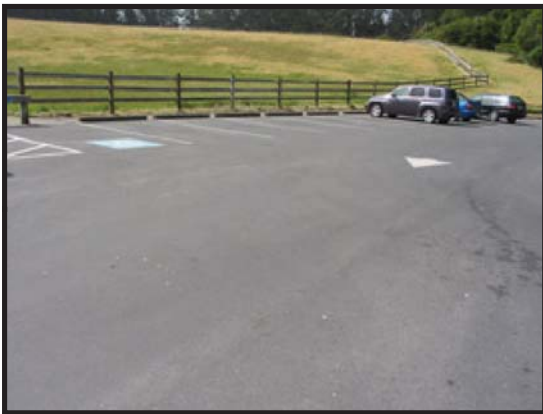
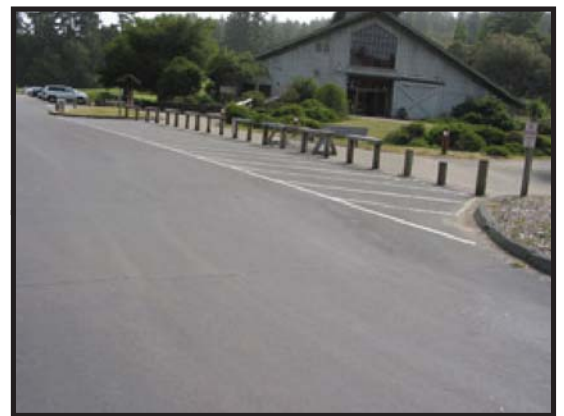
POINT REYES NATIONAL SEASHORE
Route 0902B
BEAR VALLEY R AND T EQUIPMENT PARKING
AT END OF ROUTE 0410

Route Number	Public / NonPublic	Date Visited	Area (sq ft)	Lane Miles *	Surface Type
0902B	NONPUBLIC	5/12/2006	22408	0.39	AS
Culverts	Drop Inlets	Gates	Curb & Gutter	Curb	PCR
0	0	1	NO CURB AND GUTTER	ASPHALT CURB	POOR/45

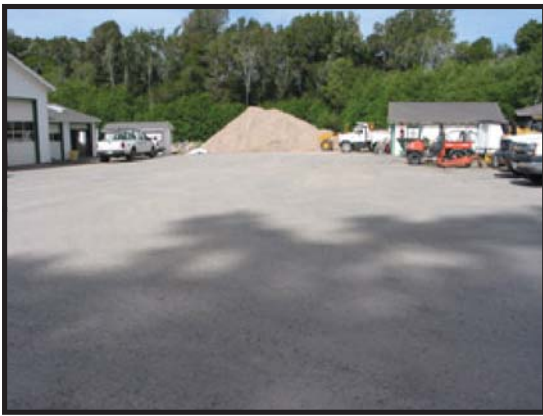
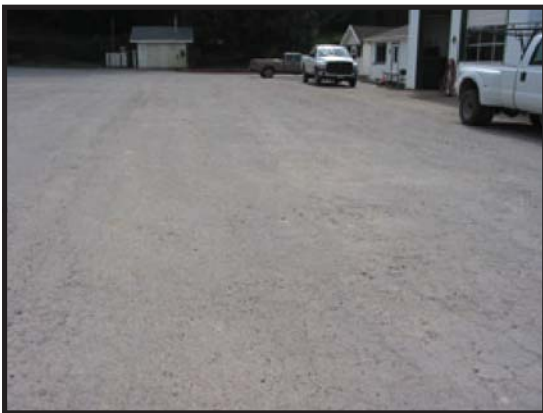
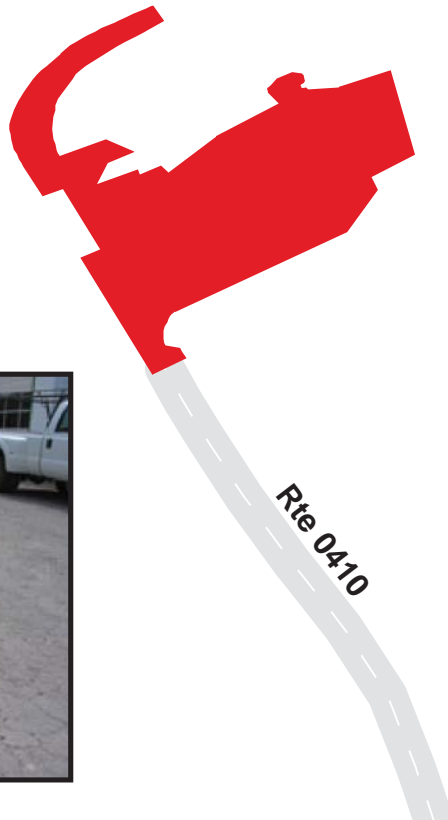
Route 0902C

Route Number	Public / NonPublic	Date Visited	Area (sq ft)	Lane Miles *	Surface Type
0902C	PUBLIC	5/12/2006	5761	0.10	AS
Culverts	Drop Inlets	Gates	Curb & Gutter	Curb	PCR
0	2	0	CONCRETE CURB AND GUTTER	CONCRETE CURB	GOOD/90

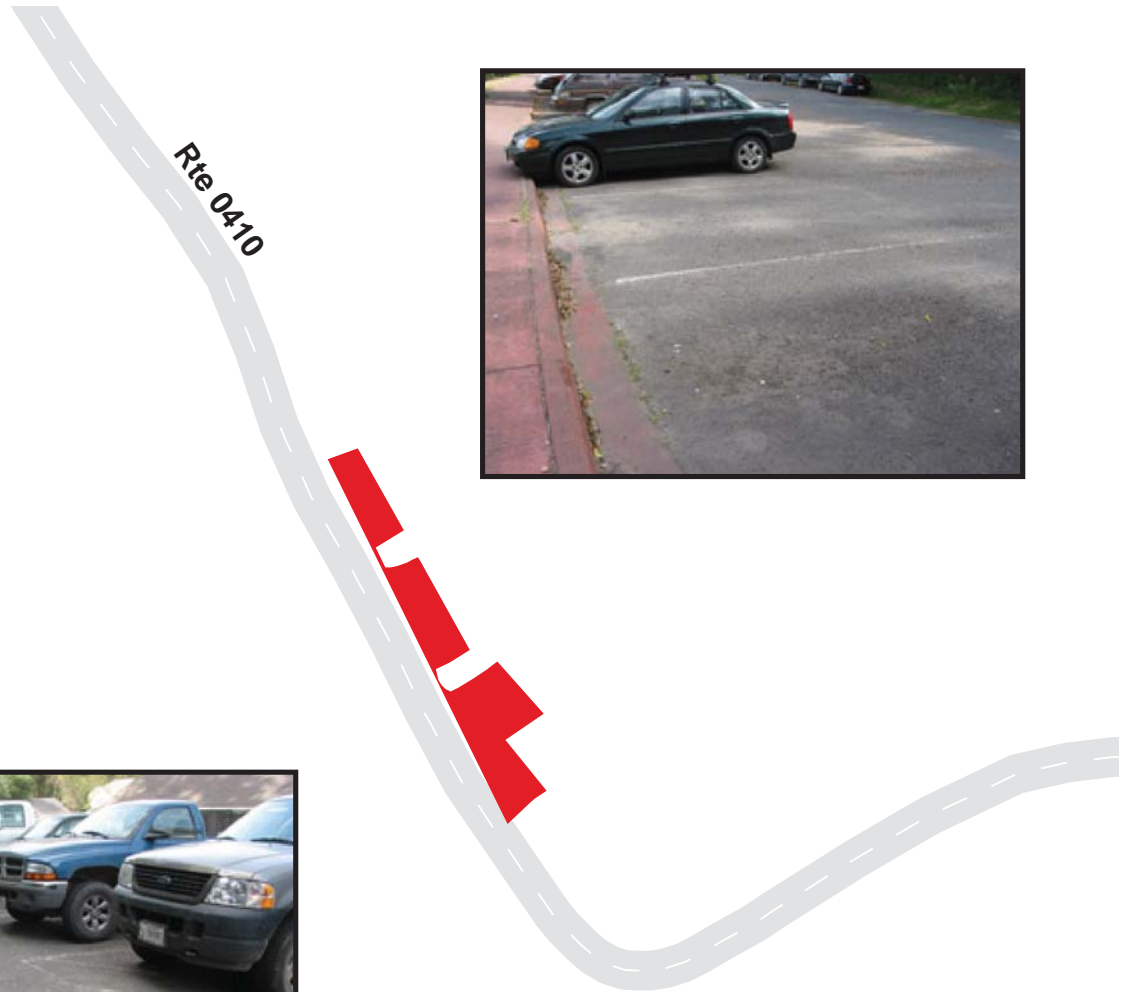
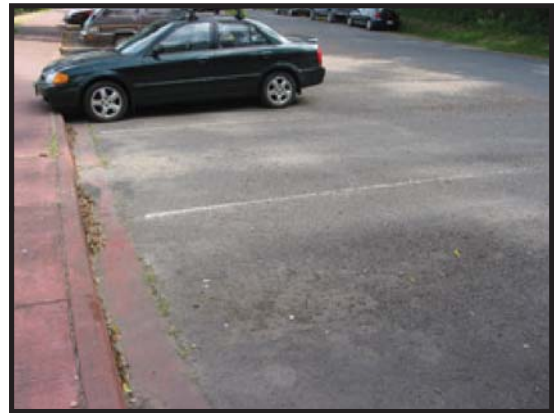
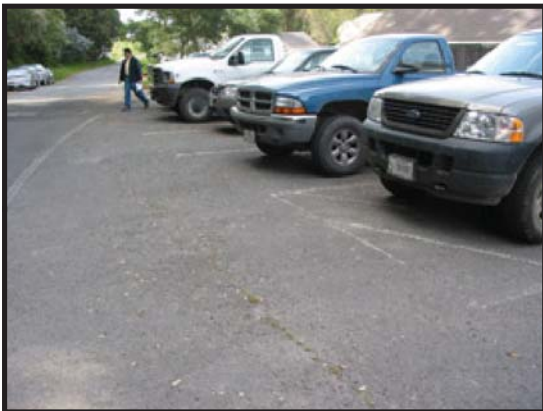
Route 0902D

Route Number	Public / NonPublic	Date Visited	Area (sq ft)	Lane Miles *	Surface Type
0902D	PUBLIC	5/12/2006	12602	0.22	AS
Culverts	Drop Inlets	Gates	Curb & Gutter	Curb	PCR
0	1	0	NO CURB AND GUTTER	NO CURB	FAIR/73

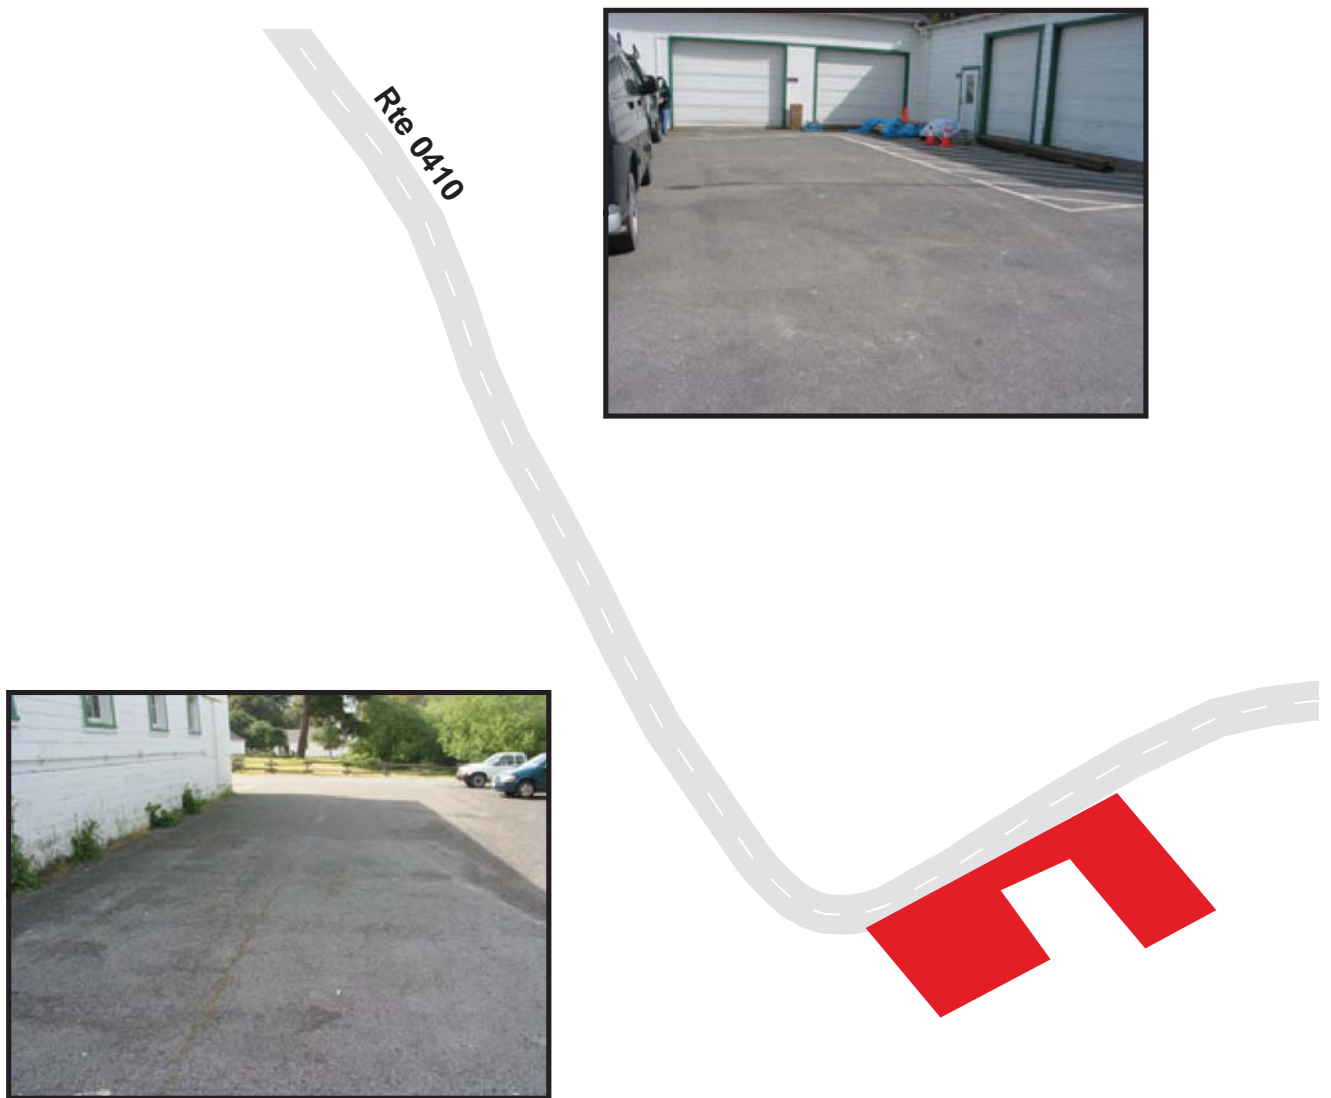
Route 0903

Route Number	Public / NonPublic	Date Visited	Area (sq ft)	Lane Miles *	Surface Type
0903	NONPUBLIC	5/11/2006	1056	0.02	AS
Culverts	Drop Inlets	Gates	Curb & Gutter	Curb	PCR
0	0	0	NO CURB AND GUTTER	NO CURB	FAIR/73

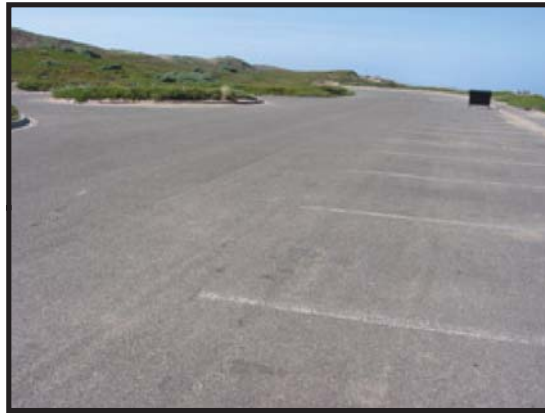
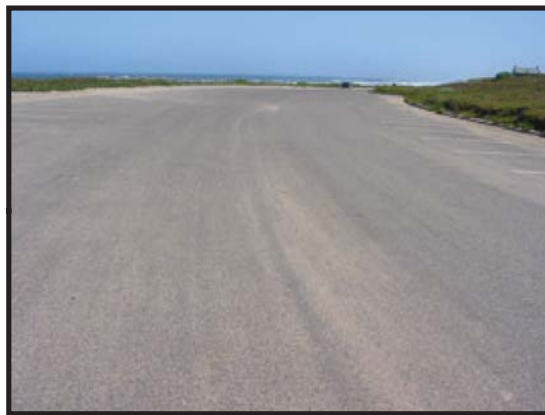
Route 0911

Route Number	Public / NonPublic	Date Visited	Area (sq ft)	Lane Miles *	Surface Type
0911	PUBLIC	5/11/2006	202486	3.49	AS
Culverts	Drop Inlets	Gates	Curb & Gutter	Curb	PCR
0	11	0	CONCRETE CURB AND GUTTER	CONCRETE CURB	GOOD/90

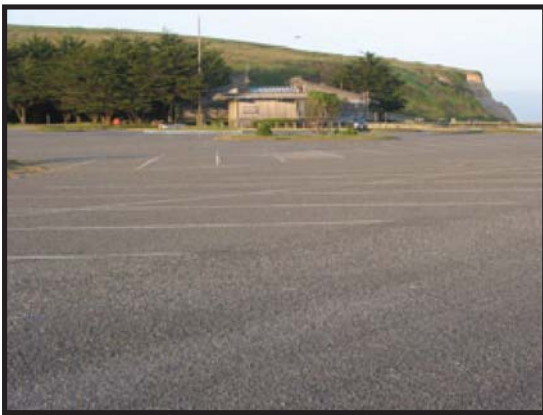
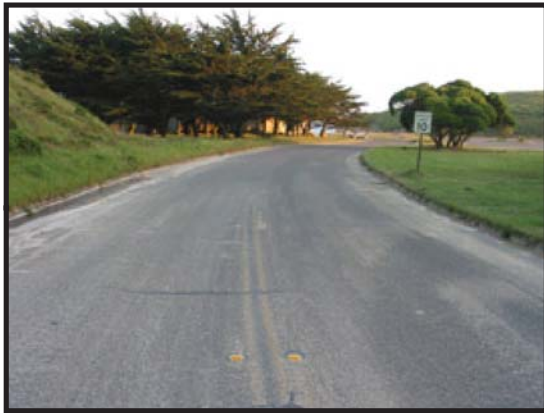
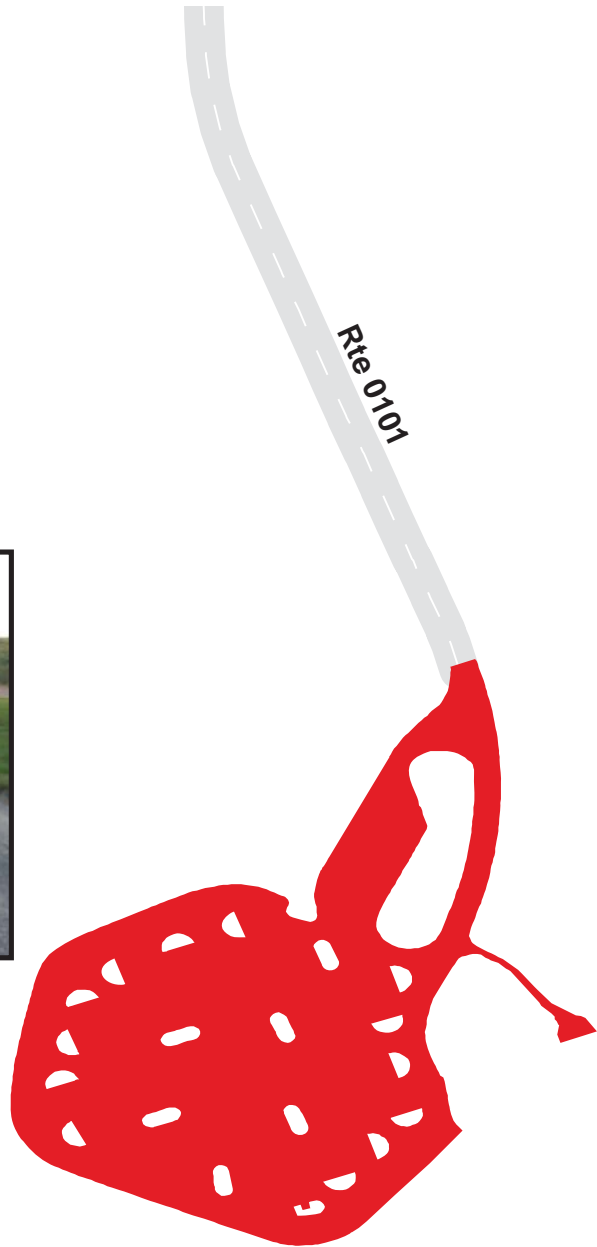
Route 0912

Route Number	Public / NonPublic	Date Visited	Area (sq ft)	Lane Miles *	Surface Type
0912	PUBLIC	5/11/2006	15649	0.27	AS
Culverts	Drop Inlets	Gates	Curb & Gutter	Curb	PCR
0	0	0	NO CURB AND GUTTER	ASPHALT CURB	GOOD/90

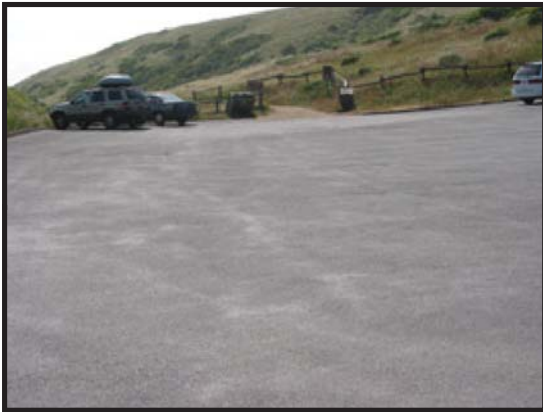
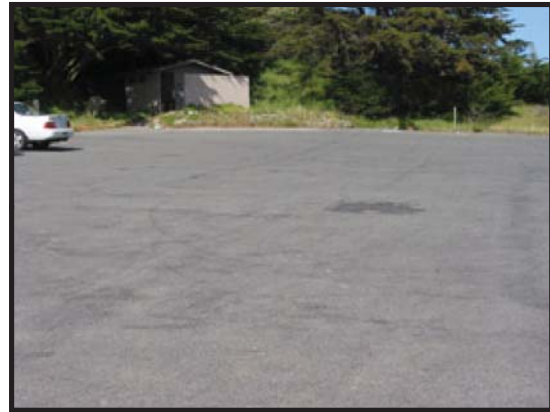
Route 0915

Route Number	Public / NonPublic	Date Visited	Area (sq ft)	Lane Miles *	Surface Type
0915	PUBLIC	5/12/2006	6891	0.12	AS
Culverts	Drop Inlets	Gates	Curb & Gutter	Curb	PCR
0	0	0	NO CURB AND GUTTER	NO CURB	POOR/45

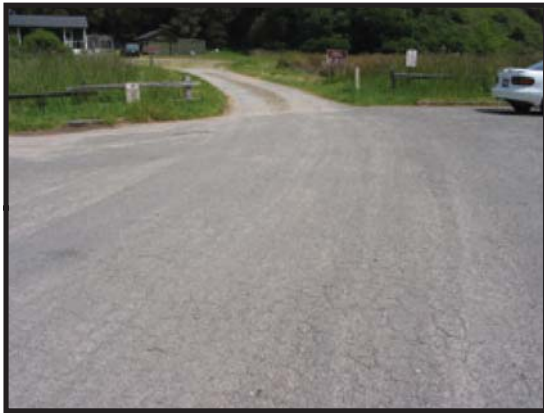
POINT REYES NATIONAL SEASHORE
Route 0925
MORGAN HORSE RANCH HANDICAP PARKING
ADJACENT TO ROUTE 0408 AT MP 0.1

Route Number	Public / NonPublic	Date Visited	Area (sq ft)	Lane Miles *	Surface Type
0925	PUBLIC	5/12/2006	674	0.01	AS
Culverts	Drop Inlets	Gates	Curb & Gutter	Curb	PCR
0	0	0	NO CURB AND GUTTER	WOOD	GOOD/90

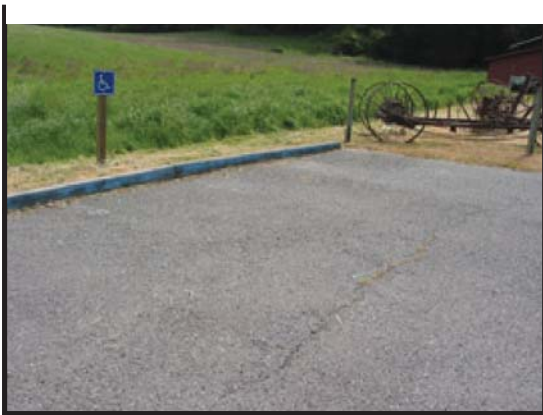
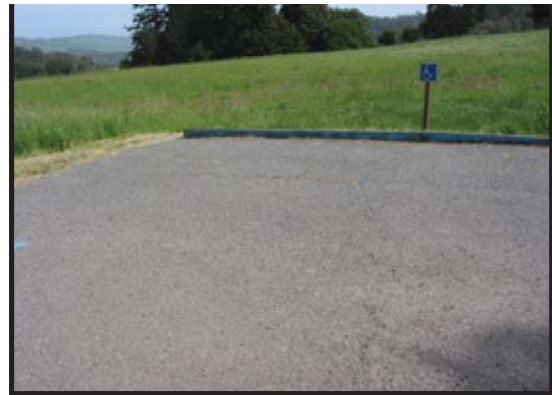
Route 0927

Route Number	Public / NonPublic	Date Visited	Area (sq ft)	Lane Miles *	Surface Type
0927	PUBLIC	5/12/2006	4634	0.08	AS
Culverts	Drop Inlets	Gates	Curb & Gutter	Curb	PCR
0	0	0	NO CURB AND GUTTER	NO CURB	GOOD/90

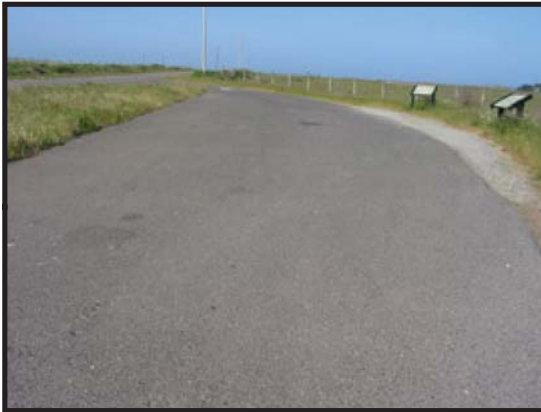
Route 0930

Route Number	Public / NonPublic	Date Visited	Area (sq ft)	Lane Miles *	Surface Type
0930	PUBLIC	5/11/2006	17118	0.29	AS
Culverts	Drop Inlets	Gates	Curb & Gutter	Curb	PCR
0	0	0	NO CURB AND GUTTER	ASPHALT CURB	GOOD/90

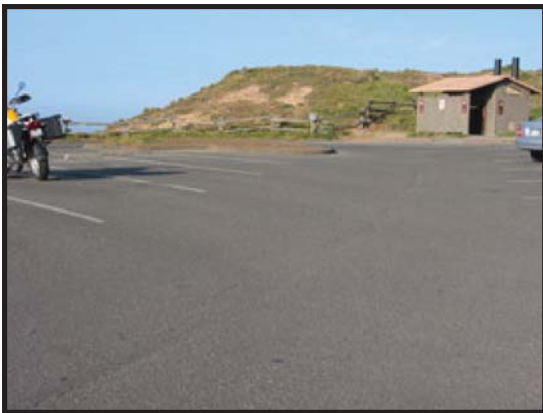
Route 0931

Route Number	Public / NonPublic	Date Visited	Area (sq ft)	Lane Miles *	Surface Type
0931	NONPUBLIC	5/12/2006	21351	0.37	AS
Culverts	Drop Inlets	Gates	Curb & Gutter	Curb	PCR
0	5	0	NO CURB AND GUTTER	CONCRETE CURB	FAIR/73
