**The Road Inventory  
of  
Puukohola Heiau National Historic Site  
PUHE – 8310  
Cycle 4**

**Prepared By:  
Federal Highway Administration  
Road Inventory Program  
Cycle 4**

# Puukohola Heiau National Historic Site in Hawaii

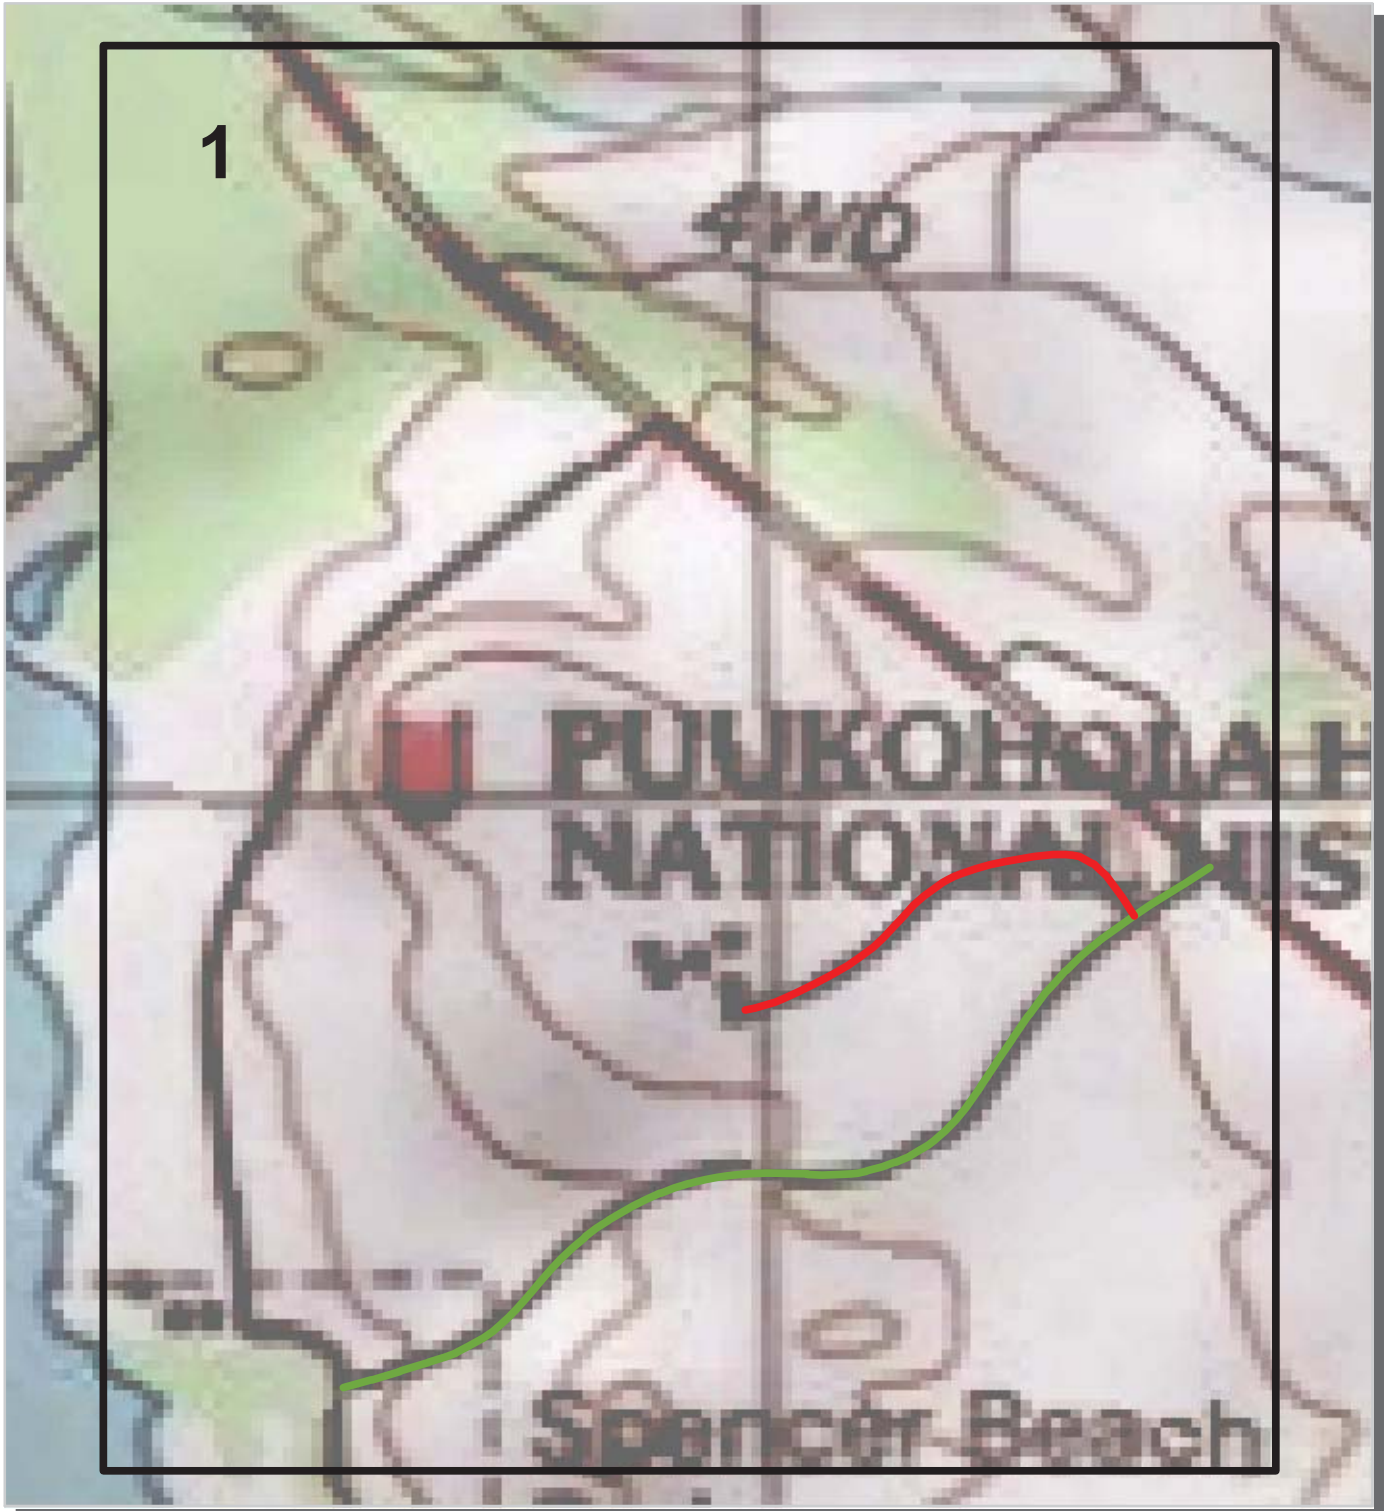
**Puukohola Heiau National Historic Site  
Route Condition Map  
PCR - Mile by Mile  
Key Map**

| PCR | Poor | Fair | Good | Excellent | No Data |
| | (≤60) | (61 - 84) | (85 - 94) | (95 - 100) | |

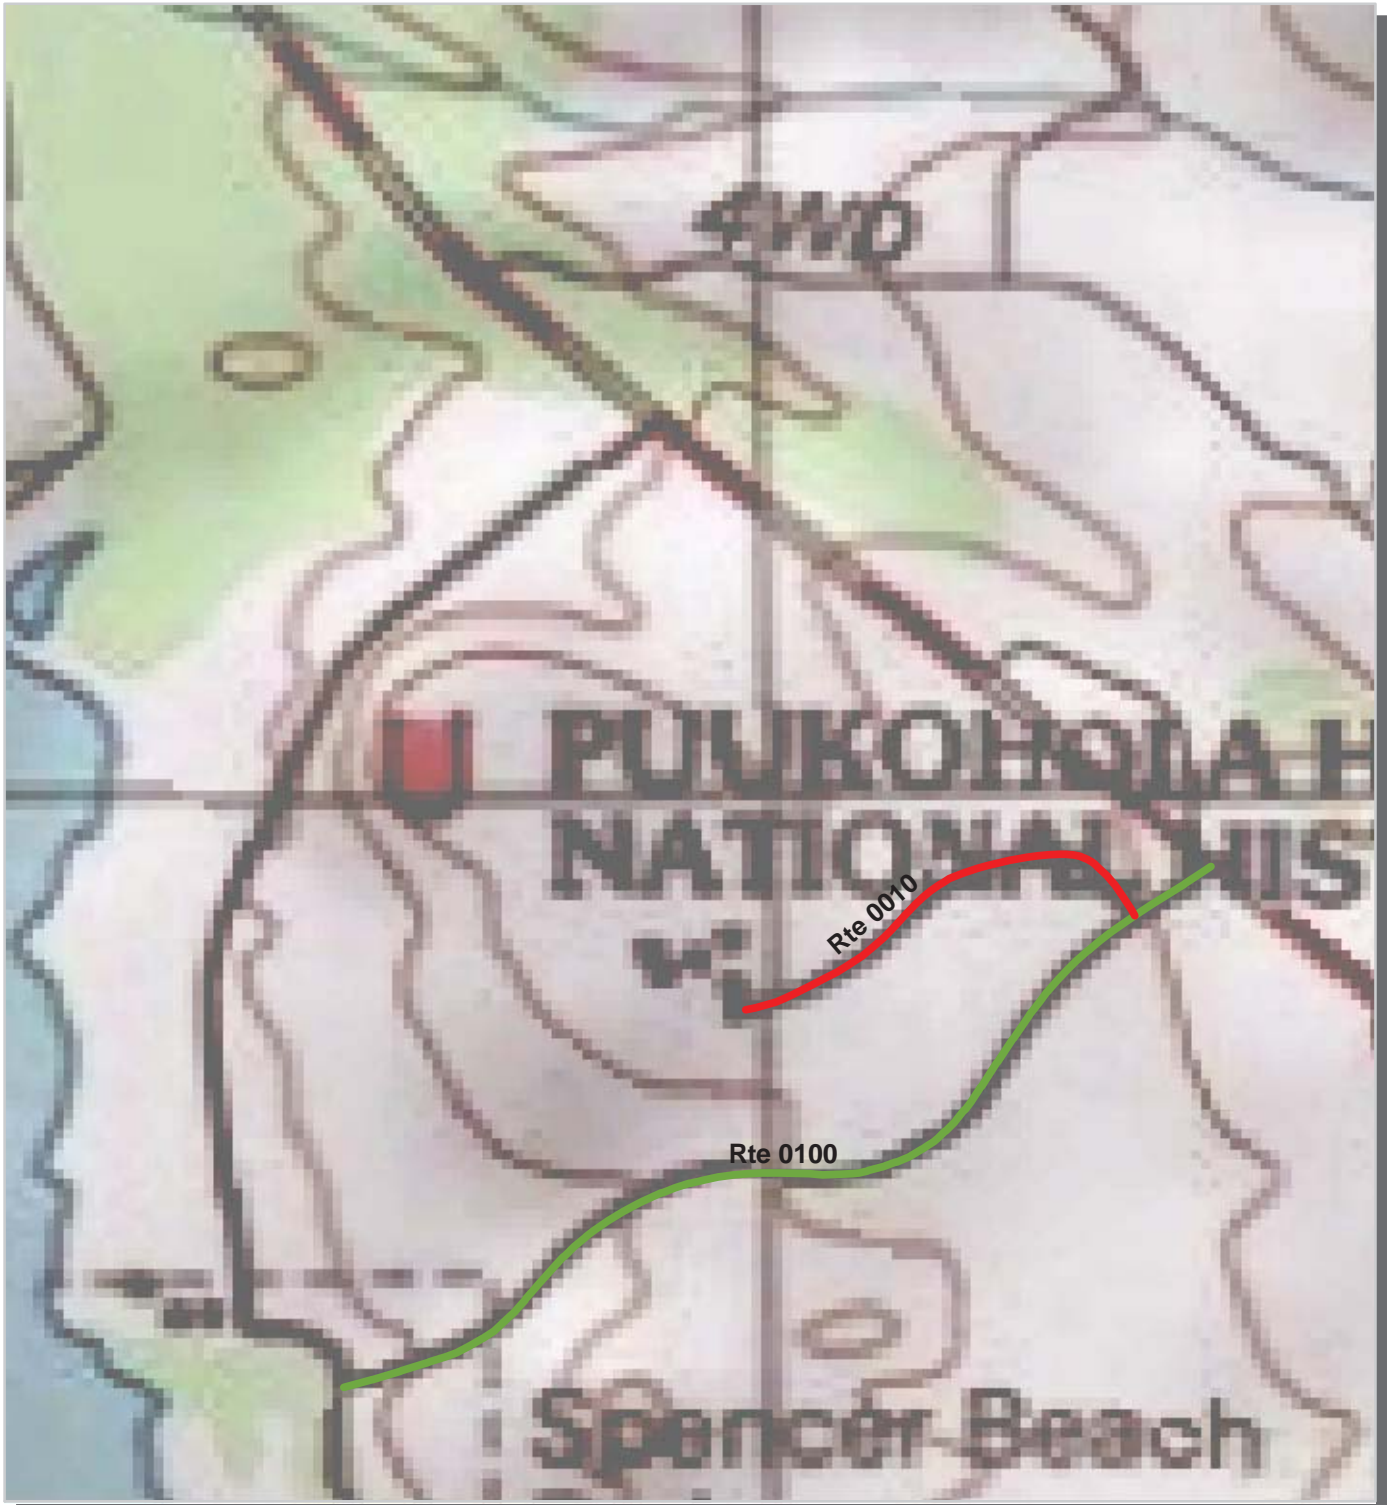
**Puukohola Heiau National Historic Site  
Route Condition Map  
PCR - Mile by Mile  
Area 1**

| PCR | Poor | Fair | Good | Excellent | No Data |
| | (≤60) | (61 - 84) | (85 - 94) | (95 - 100) | |

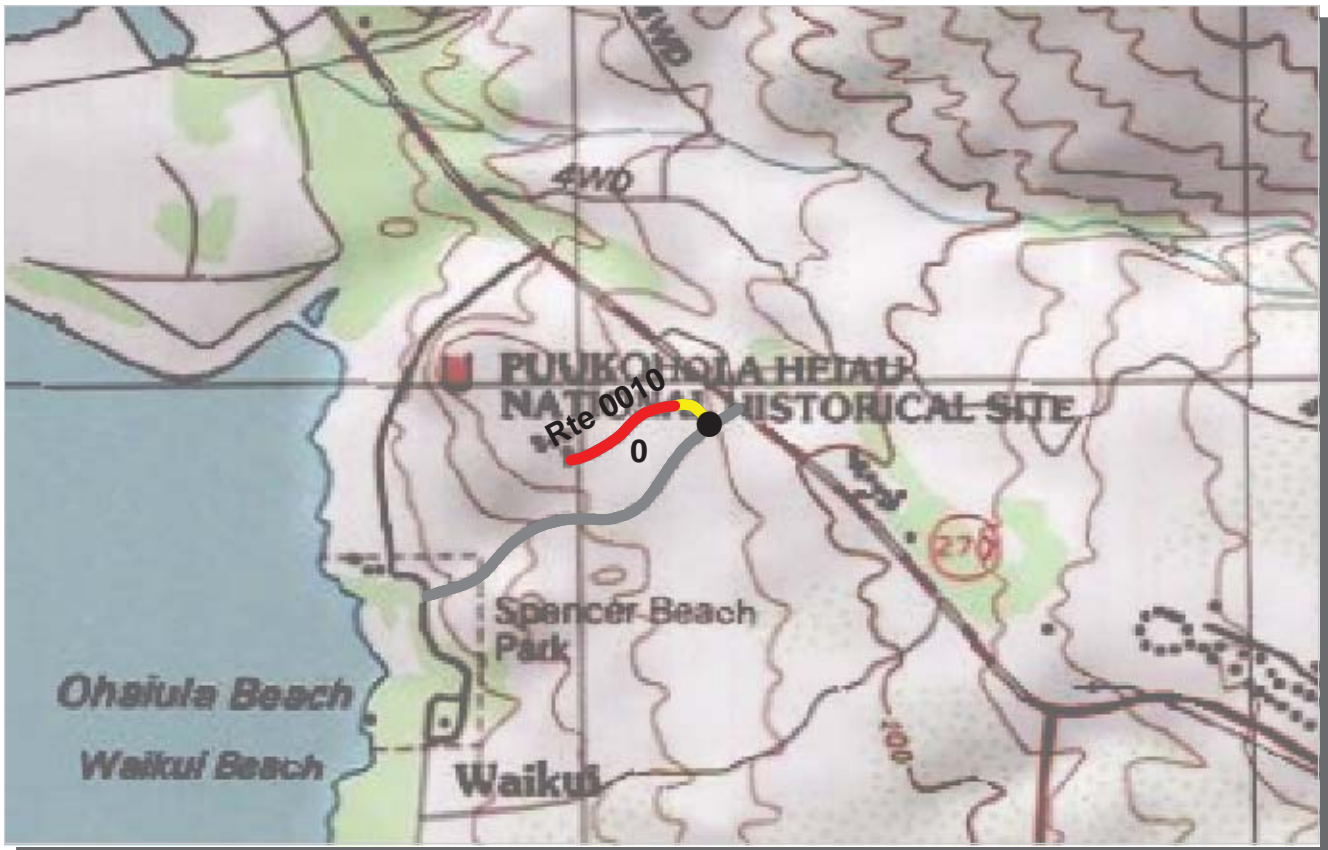
**ROUTE: 0010 PARK HEADQUARTERS ENTRANCE ROAD**

| SCR (Surface Condition Rating) | 27 | | | | |
| PCR (Pavement Condition Rating) | 30 | | | | |
| Longitudinal Cracking Index | 71 | | | | |
| Transverse Cracking Index | 65 | | | | |
| Roughness Condition Index (RCI) | 31 | | | | |

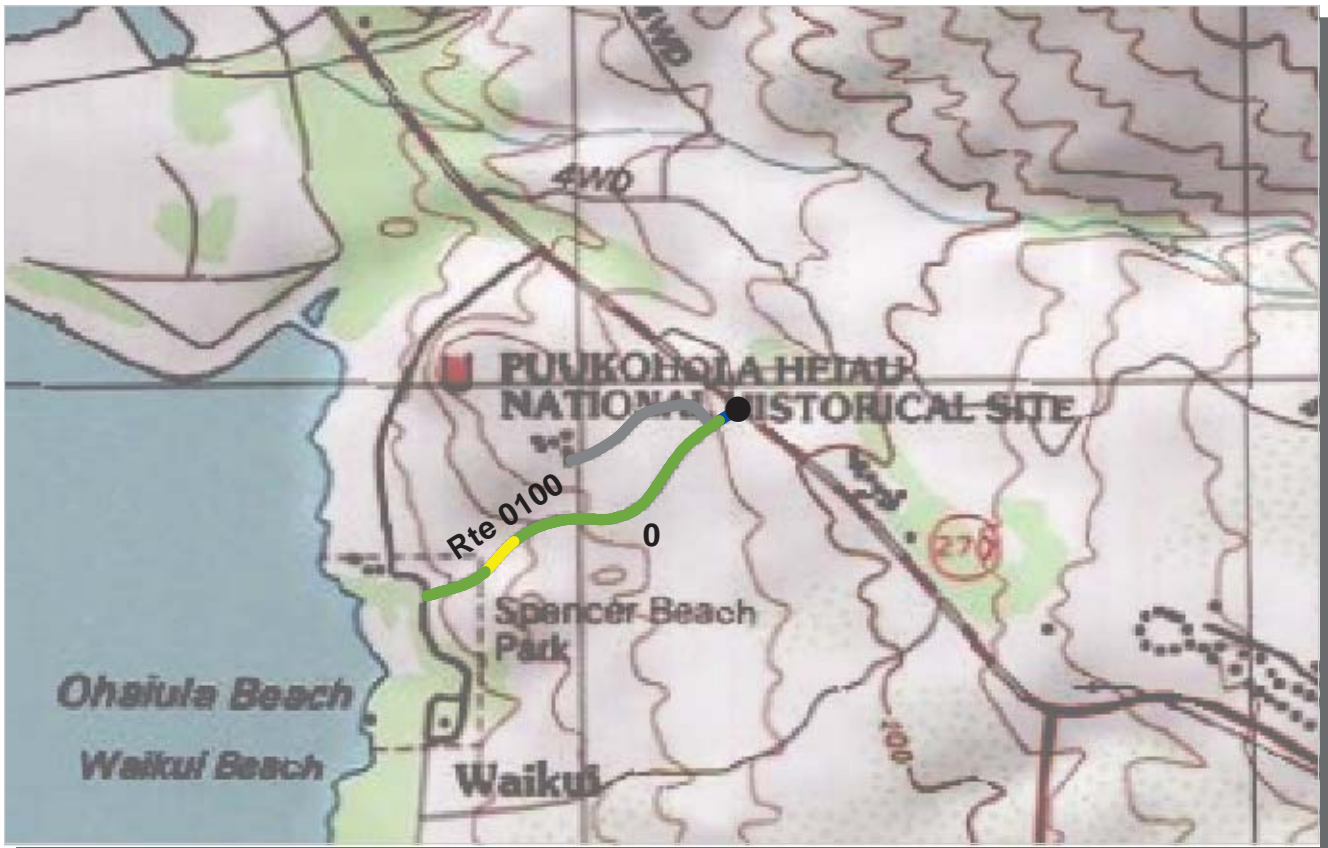
**ROUTE: 0100 NEW SPENCER BEACH PARK ROAD**

| SCR (Surface Condition Rating) | 85 | | | | |
| PCR (Pavement Condition Rating) | 86 | | | | |
| Roughness Condition Index (RCI) | 92 | | | | |
