**The Road Inventory
of
Pu'uhonua o Honaunau National Historical Park
PUHO - 8280
Cycle 4**

**Prepared By:
Federal Highway Administration
Road Inventory Program
Cycle 4**

Pu'uhonua o Honaunau National Historical Park in Hawaii

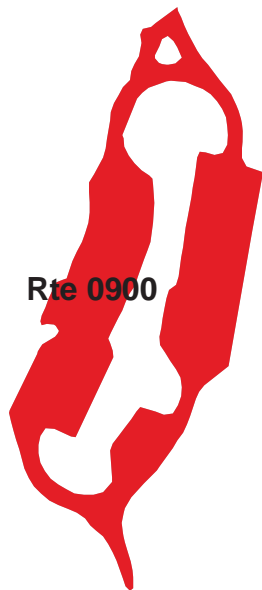
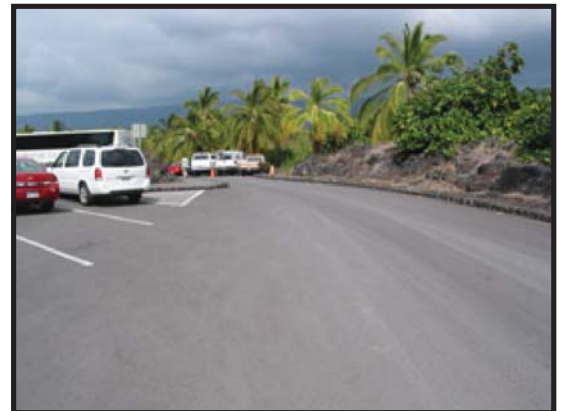
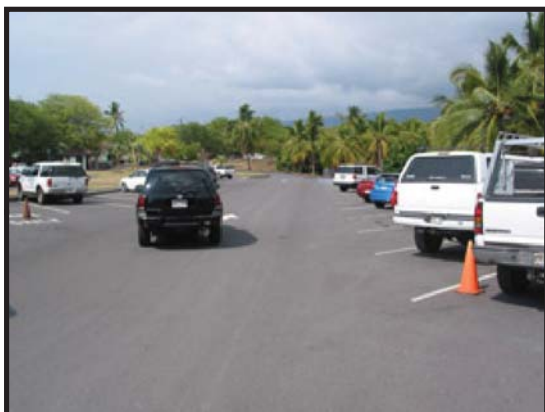
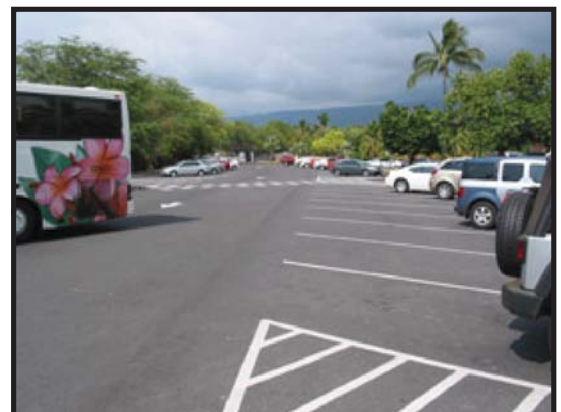
Route 0900

Route Number	Public / NonPublic	Date Visited		Area (sq ft)	Lane Miles *	Surface Type
0900	PUBLIC	3/6/2008		51,268	0.88	AS
Culverts	Drop Inlets	Gates	Fire Hydrants	Curb & Gutter	Curb	PCR
0	4	1	0	NO CURB AND GUTTER	STONE CURB	EXCELLENT/97
