**The Road Inventory  
of  
Redwood National Park  
REDW – 8480  
Cycle 4**

**Prepared By:  
Federal Highway Administration  
Road Inventory Program  
Cycle 4**

# Redwood National Park in California

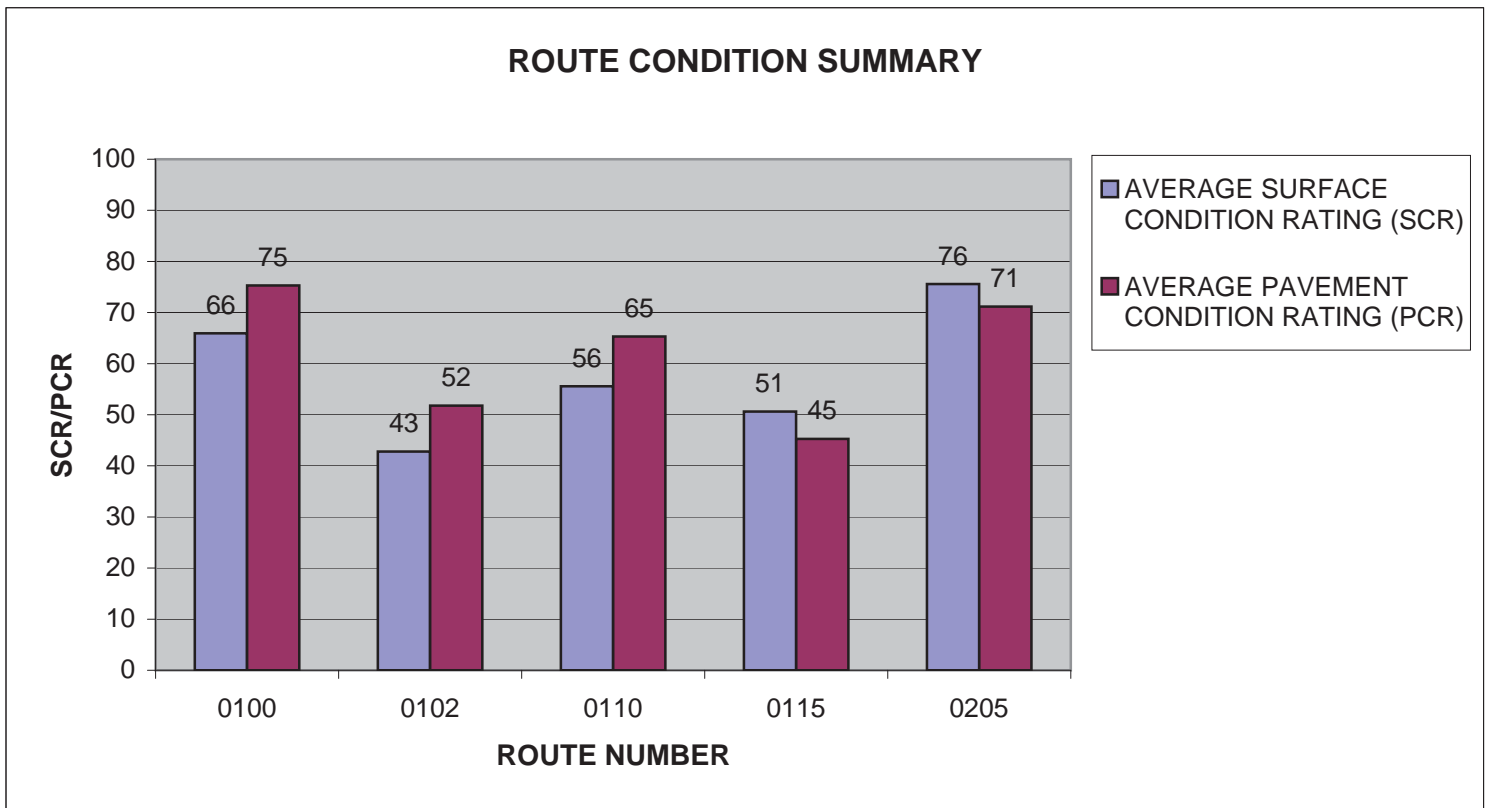
# REDW: ROUTE CONDITION SUMMARY

ROUTE NUMBER	ROUTE NAME	FUNCT CLASS	ROUTE LENGTH	SURFACE TYPE	AVERAGE SURFACE CONDITION RATING (SCR)	AVERAGE PAVEMENT CONDITION RATING (PCR)
0100	ENDERTS BEACH ROAD	2	1.77	ASPHALT	66	75
0102	ALDER CAMP ROAD	2	2.09	ASPHALT	43	52
0110	RED ALDER ROAD	2	1.26	ASPHALT	56	65
0115	DAVISON ROAD	2	0.36	ASPHALT	51	45
0205	LOST MAN CREEK ROAD	3	0.90	ASPHALT	76	71

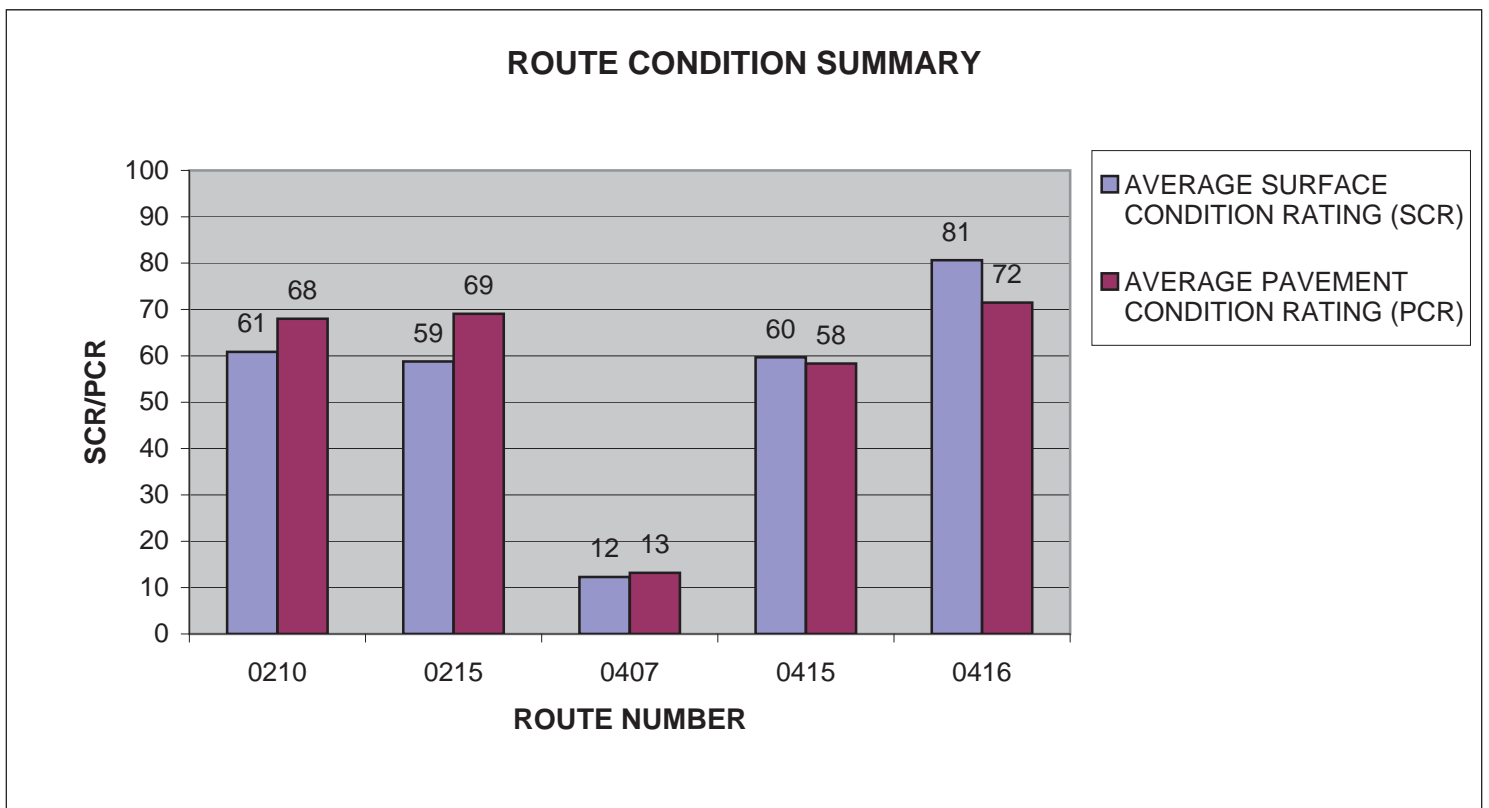
# REDW: ROUTE CONDITION SUMMARY

ROUTE NUMBER	ROUTE NAME	FUNCT CLASS	ROUTE LENGTH	SURFACE TYPE	AVERAGE SURFACE CONDITION RATING (SCR)	AVERAGE PAVEMENT CONDITION RATING (PCR)
0210	REDWOOD CREEK TRAILHEAD ROAD	3	0.43	ASPHALT	61	68
0215	KUCHEL VISITOR CENTER ACCESS ROAD	3	0.26	ASPHALT	59	69
0407	RESIDENCE ROAD	5	0.4	ASPHALT	12	13
0415	KUCHEL VISITOR CENTER SERVICE ROAD	5	0.06	ASPHALT	60	58
0416	OFF HIGHWAY ROAD	6	1.03	ASPHALT	81	72

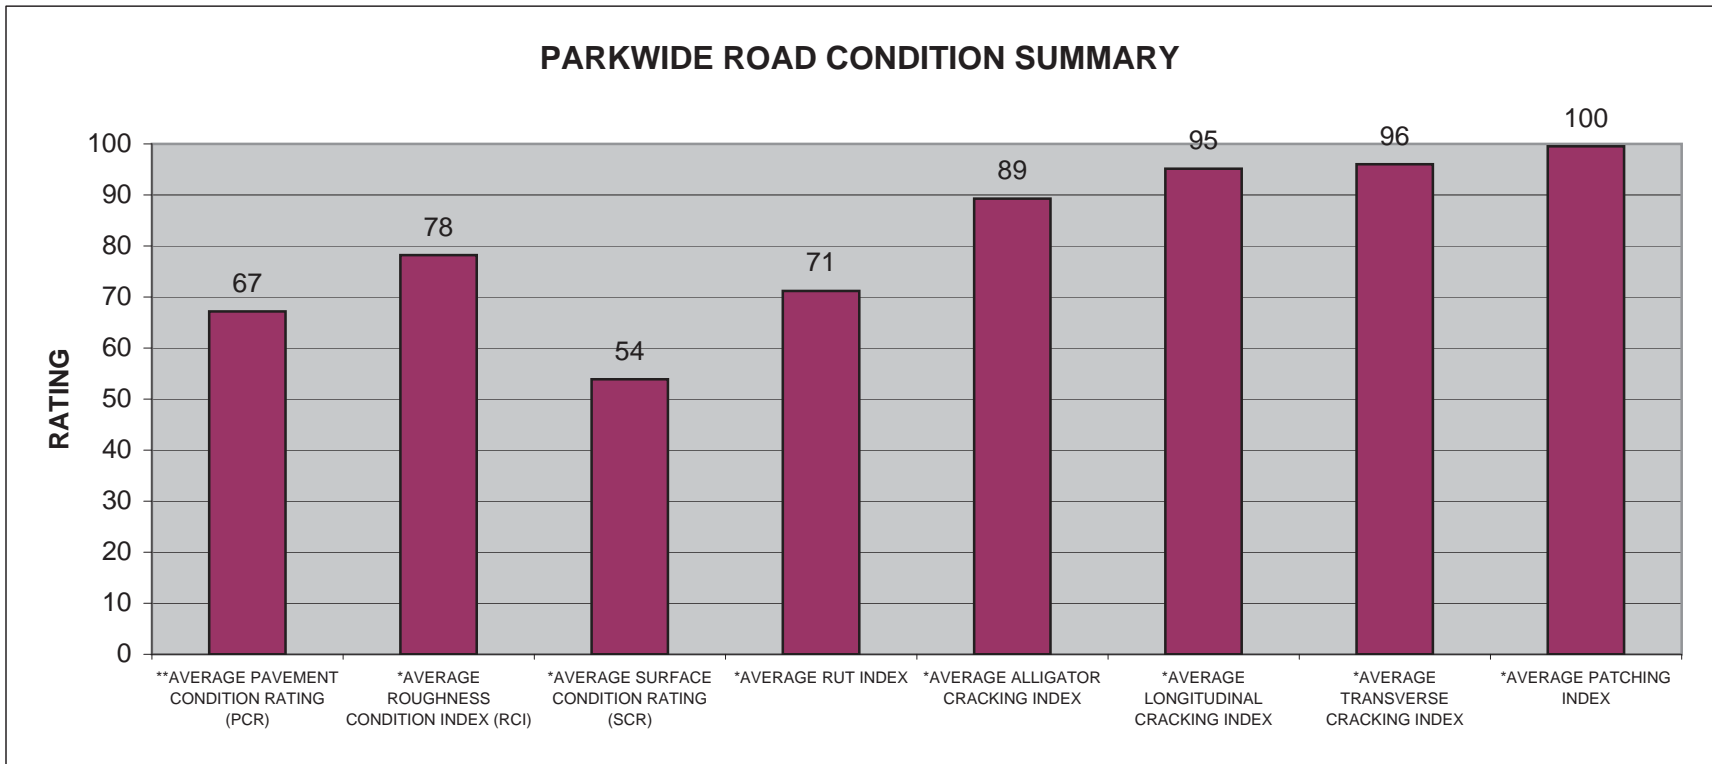
# REDW: PARKWIDE ROAD CONDITION SUMMARY

**AVERAGE PAVEMENT CONDITION RATING (PCR)	*AVERAGE ROUGHNESS CONDITION INDEX (RCI)	*AVERAGE SURFACE CONDITION RATING (SCR)	*AVERAGE RUT INDEX	*AVERAGE ALLIGATOR CRACKING INDEX	*AVERAGE LONGITUDINAL CRACKING INDEX	*AVERAGE TRANSVERSE CRACKING INDEX	*AVERAGE PATCHING INDEX
67	78	54	71	89	95	96	100

\* Index values are based on ARAN-driven roads only.

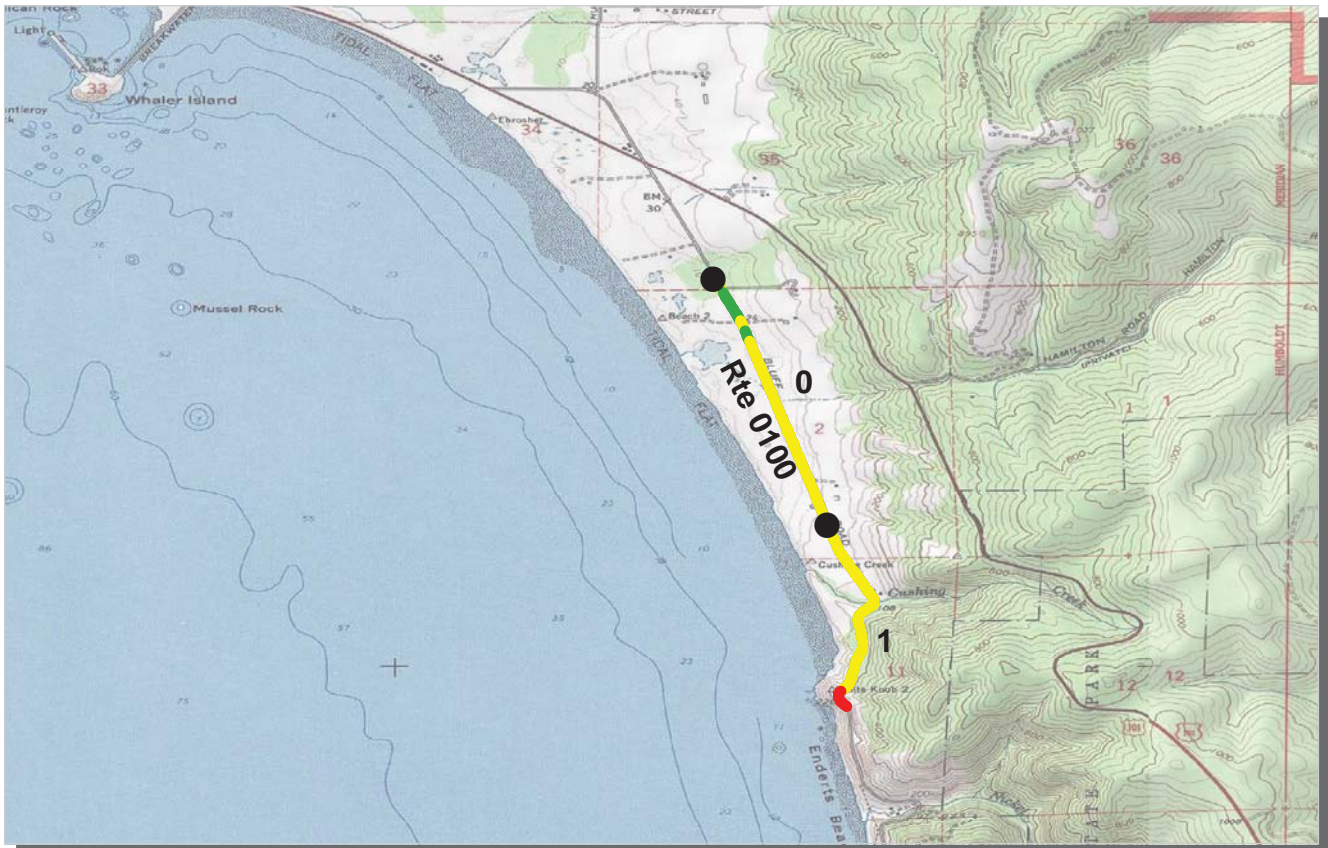
Section Number	0	1			
Section Length (mi)	1.00	0.77			
<b>Traffic</b>	Traffic data may be found at <a href="http://www.efl.fhwa.dot.gov">www.efl.fhwa.dot.gov</a> Click on NPS Traffic Data (Note: Not all parks have traffic data)				
<b>Cross Section Information</b>					
Number of Lanes	2	2			
Paved Width (ft)	25	23			
Lane Width (ft)	11	11			
Shoulder Width Right (ft)**	0	0			
Shoulder Width Left (ft)**	4	5			
<b>Roadway Condition Information</b>					
SCR (Surface Condition Rating)	68	64			
PCR (Pavement Condition Rating)	78	72			
<b>Distress Index Values</b>					
Alligator Cracking Index	100	100			
Longitudinal Cracking Index	99	99			
Transverse Cracking Index	100	99			
Patching Index	100	100			
Rutting Index	70	65			
Roughness Condition Index (RCI)	92	85

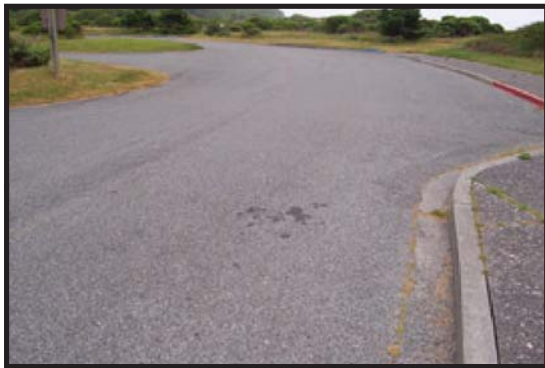
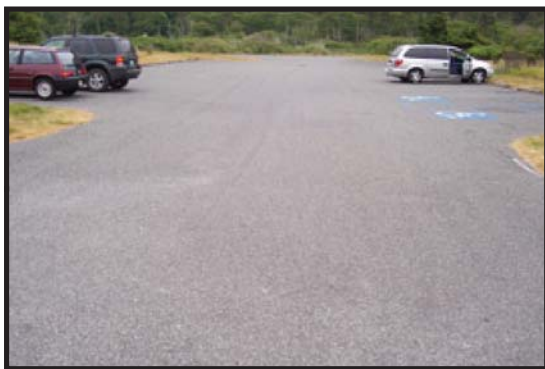
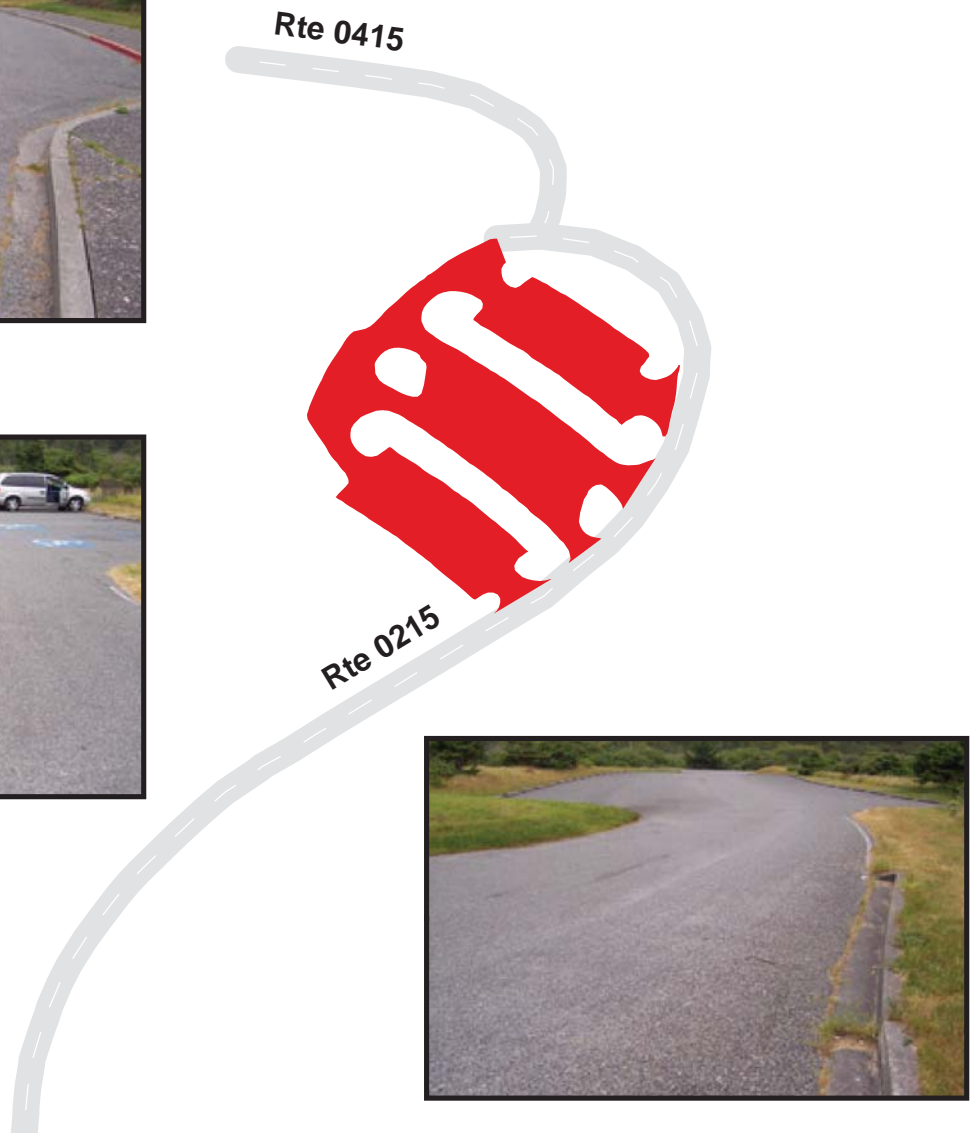
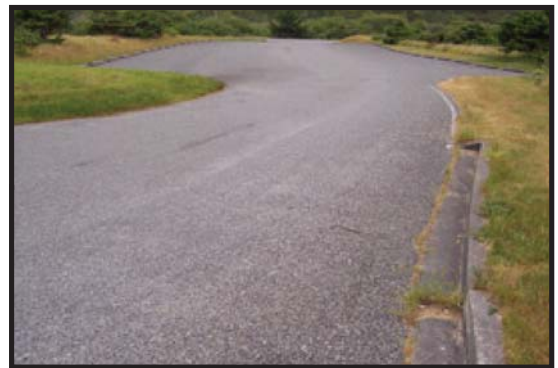
Route Number	Public / NonPublic	Date Visited	Area (sq ft)	Lane Miles *	Surface Type
0900	PUBLIC	5/17/2006	46546	0.80	AS
Culverts	Drop Inlets	Gates	Curb & Gutter	Curb	PCR
0	3	0	CONCRETE CURB AND GUTTER	NO CURB	GOOD/90

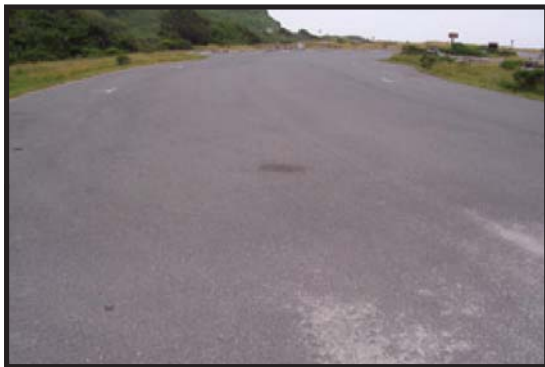
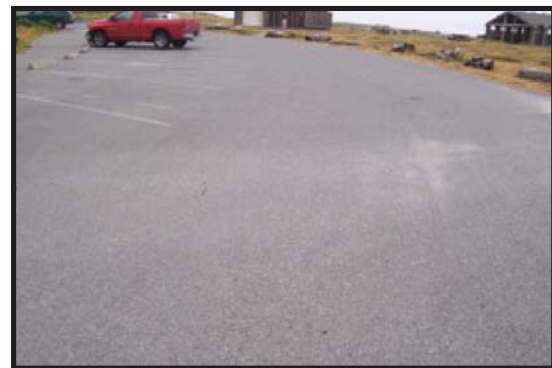
## Route 0901

Route Number	Public / NonPublic	Date Visited	Area (sq ft)	Lane Miles *	Surface Type
0901	PUBLIC	5/17/2006	25635	0.44	AS
Culverts	Drop Inlets	Gates	Curb & Gutter	Curb	PCR
0	0	0	NO CURB AND GUTTER	NO CURB	GOOD/90

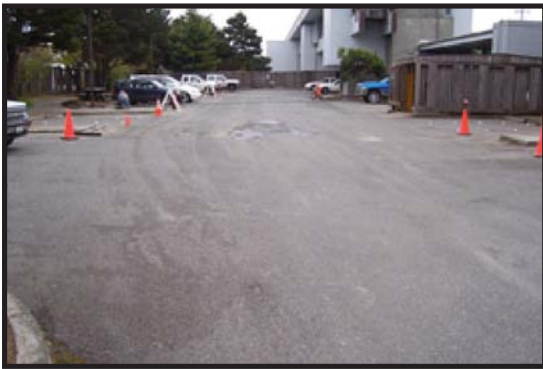
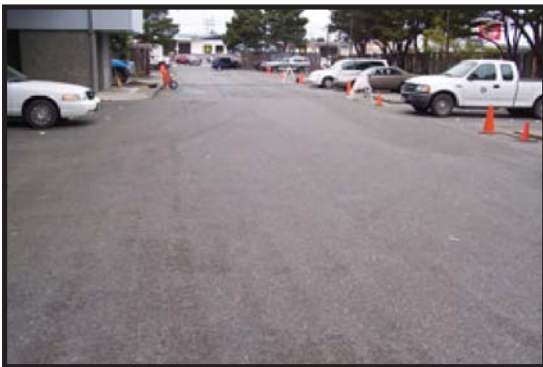
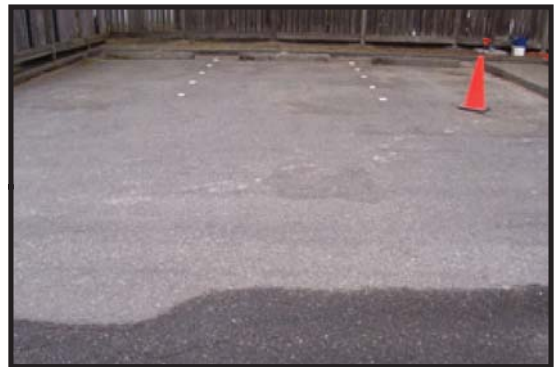
## Route 0902

Route Number	Public / NonPublic	Date Visited	Area (sq ft)	Lane Miles *	Surface Type
0902	PUBLIC	5/17/2006	11506	0.20	AS
Culverts	Drop Inlets	Gates	Curb & Gutter	Curb	PCR
0	3	0	CONCRETE CURB AND GUTTER	CONCRETE CURB	GOOD/90

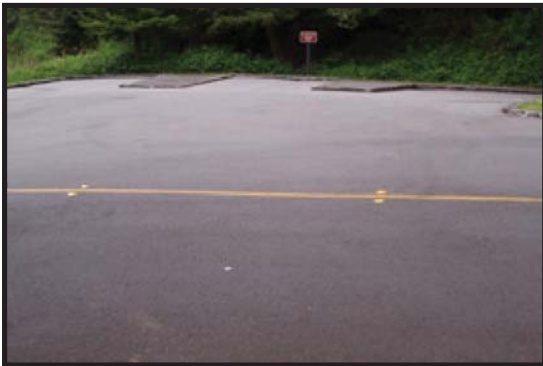
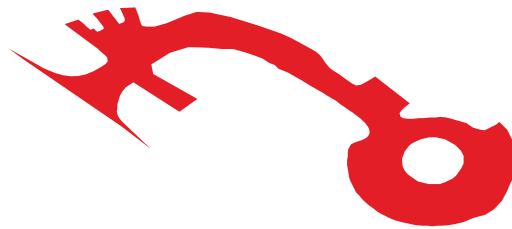
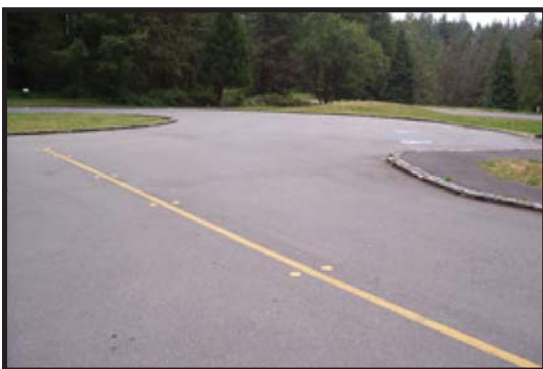
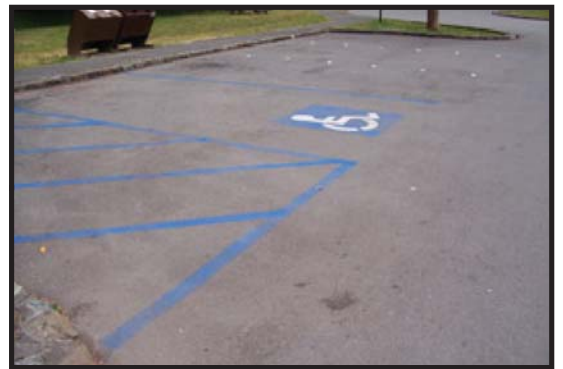
## Route 0903

Route Number	Public / NonPublic	Date Visited	Area (sq ft)	Lane Miles *	Surface Type
0903	PUBLIC	5/17/2006	29898	0.51	AS
Culverts	Drop Inlets	Gates	Curb & Gutter	Curb	PCR
0	0	0	NO CURB AND GUTTER	STONE CURB	EXCELLENT/97

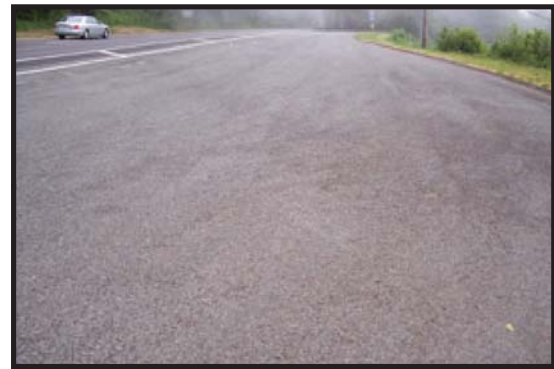
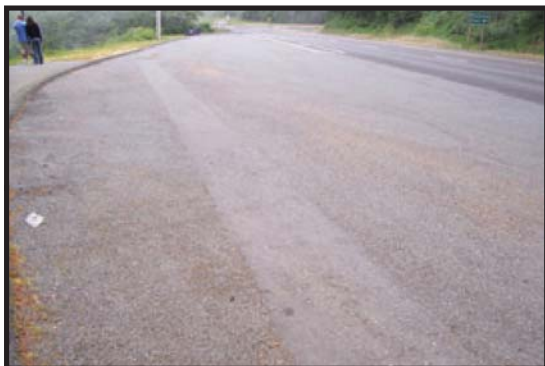
## Route 0904

Route Number	Public / NonPublic	Date Visited	Area (sq ft)	Lane Miles *	Surface Type
0904	PUBLIC	5/18/2006	19132	0.33	AS
Culverts	Drop Inlets	Gates	Curb & Gutter	Curb	PCR
0	0	0	NO CURB AND GUTTER	ASPHALT CURB	GOOD/90

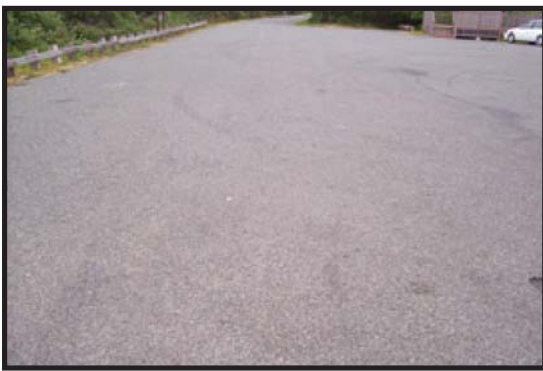
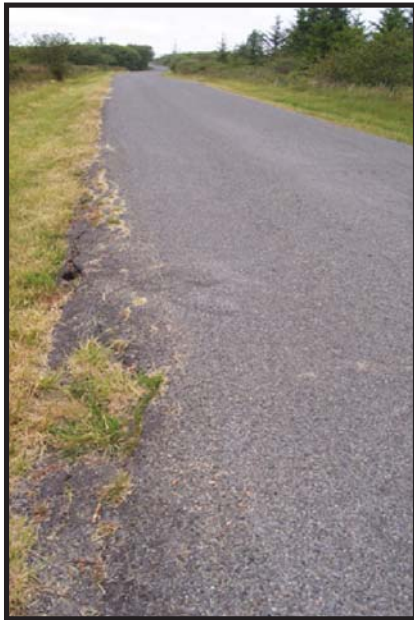
**REDWOOD NATIONAL PARK**  
**Route 0905**  
**CRESCENT BEACH DAY USE PARKING**  
**ADJACENT TO ROUTE 0100 AT MP 0.17**

Route Number	Public / NonPublic	Date Visited	Area (sq ft)	Lane Miles *	Surface Type
0905	PUBLIC	5/17/2006	41096	0.71	AS
Culverts	Drop Inlets	Gates	Curb & Gutter	Curb	PCR
2	0	0	NO CURB AND GUTTER	NO CURB	GOOD/90

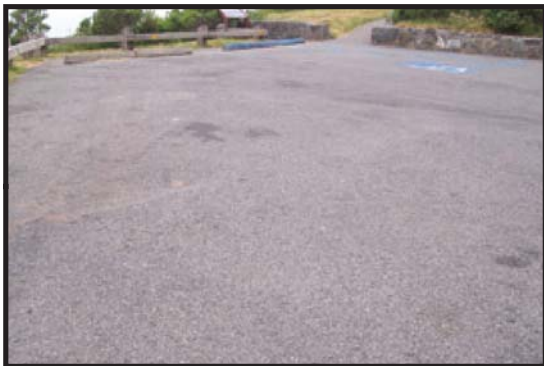
**REDWOOD NATIONAL PARK**  
**Route 0906**  
**CRESCENT BEACH OVERLOOK PARKING**  
**ADJACENT TO ROUTE 0100 AT MP 1.74**

Route Number	Public / NonPublic	Date Visited	Area (sq ft)	Lane Miles *	Surface Type
0906	PUBLIC	5/17/2006	2795	0.05	AS
Culverts	Drop Inlets	Gates	Curb & Gutter	Curb	PCR
0	0	0	NO CURB AND GUTTER	NO CURB	GOOD/90

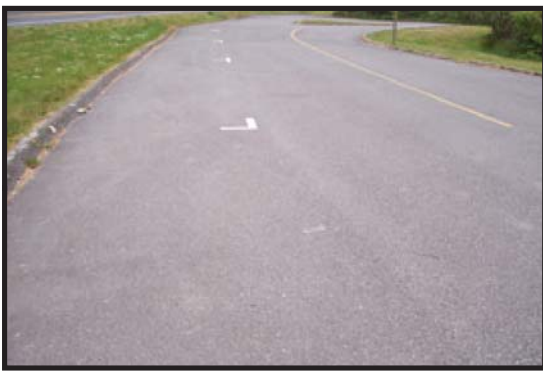
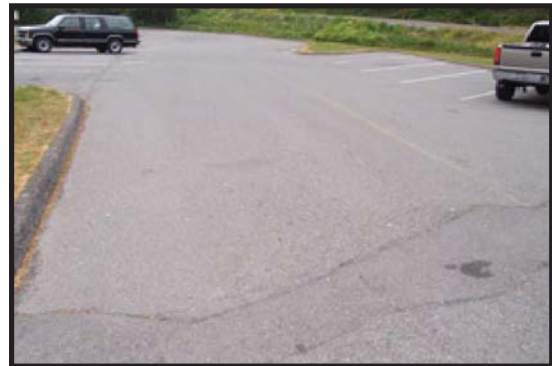
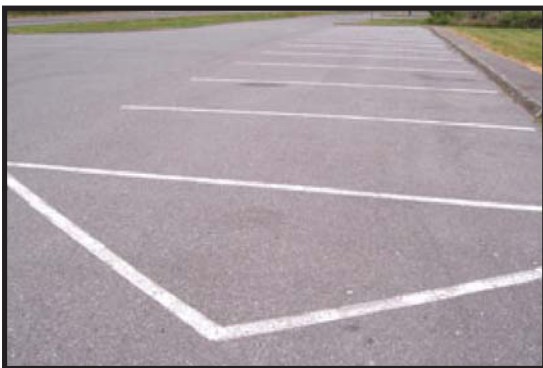
## Route 0907

Route Number	Public / NonPublic	Date Visited	Area (sq ft)	Lane Miles *	Surface Type
0907	PUBLIC	5/18/2006	36683	0.63	AS
Culverts	Drop Inlets	Gates	Curb & Gutter	Curb	PCR
0	5	0	NO CURB AND GUTTER	ASPHALT CURB	GOOD/90

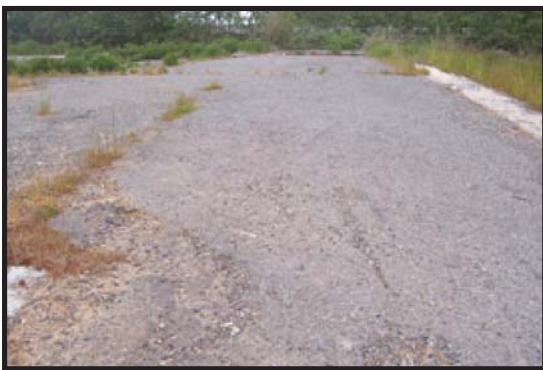
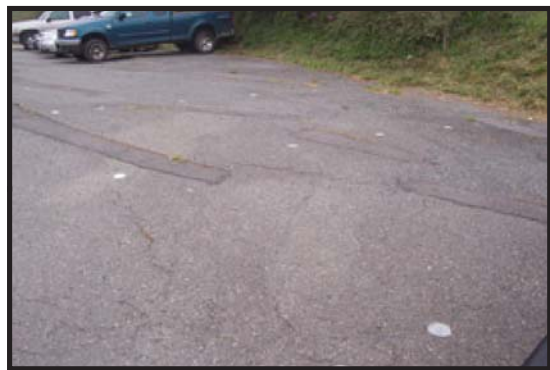
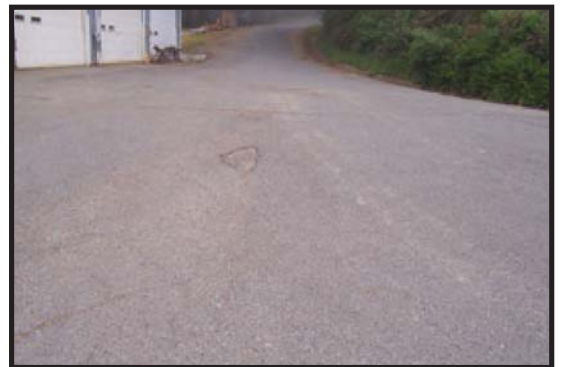
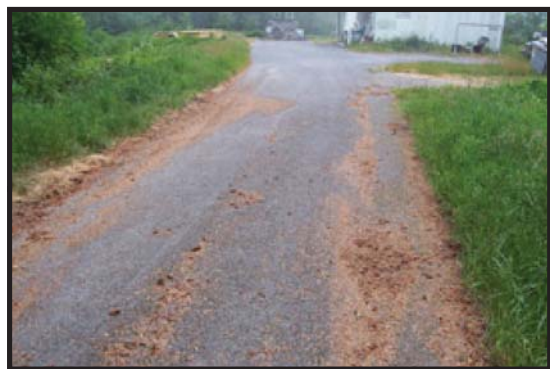
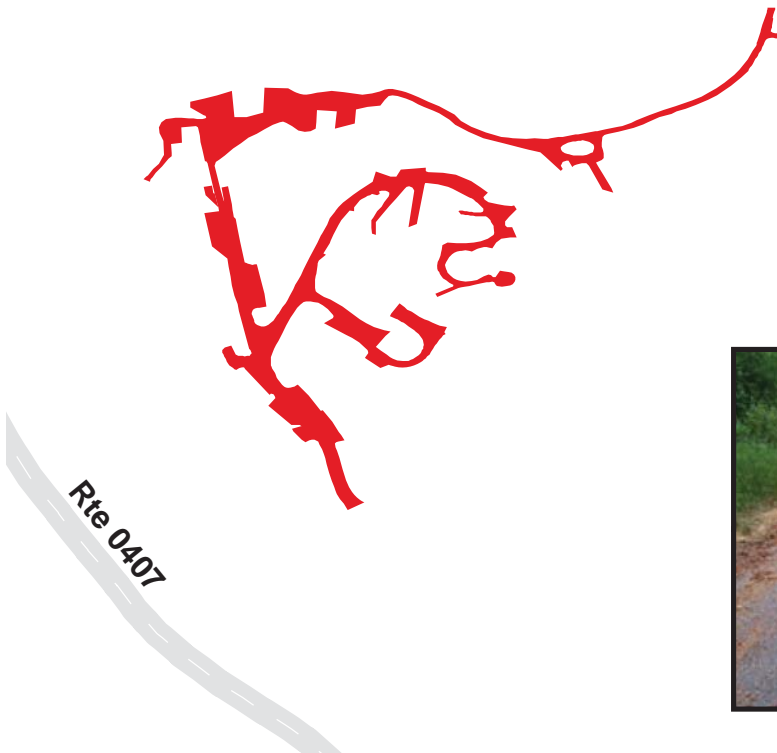
## Route 0908

Route Number	Public / NonPublic	Date Visited	Area (sq ft)	Lane Miles *	Surface Type
0908	NONPUBLIC	5/18/2006	138493	2.38	AS
Culverts	Drop Inlets	Gates	Curb & Gutter	Curb	PCR
7	3	2	NO CURB AND GUTTER	ASPHALT CURB	POOR/45

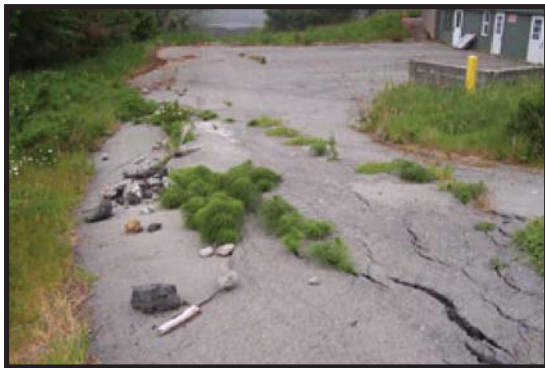
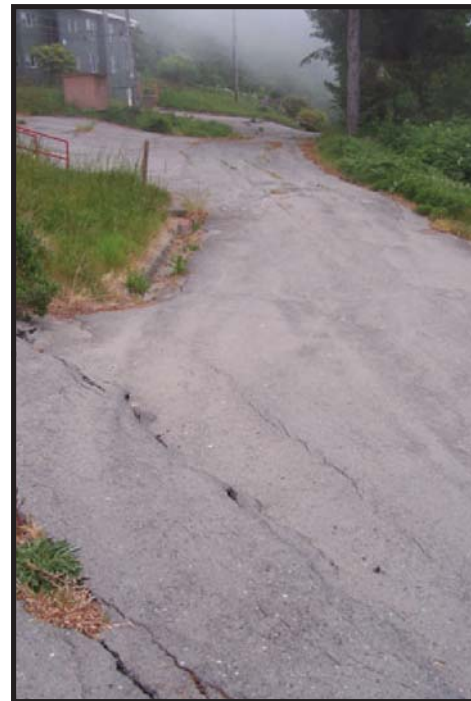
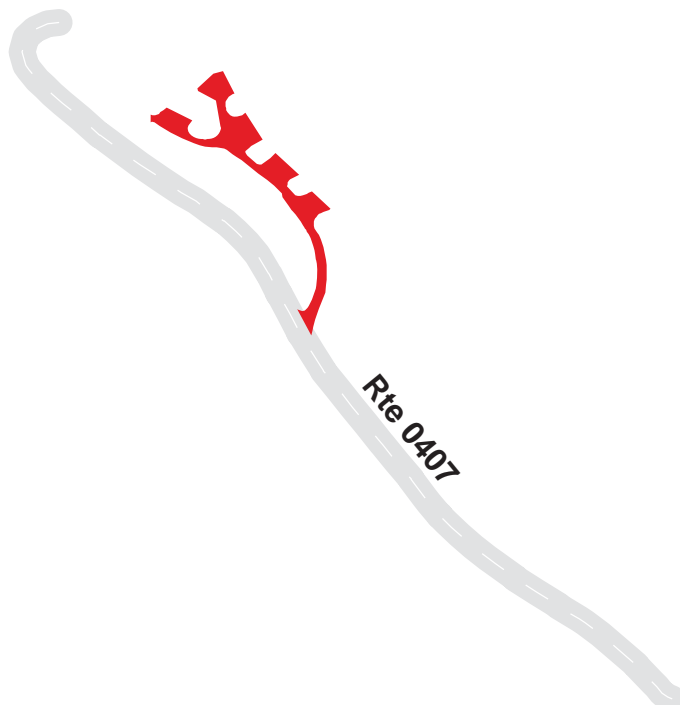
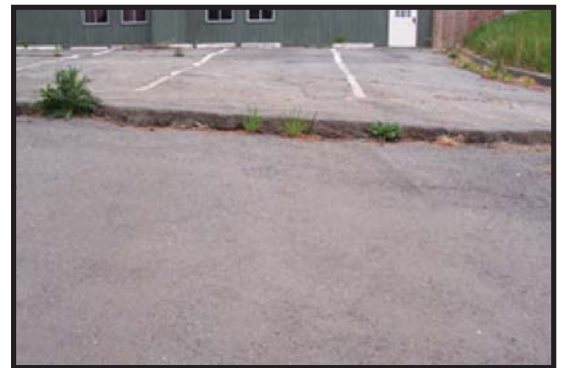
Route Number	Public / NonPublic	Date Visited	Area (sq ft)	Lane Miles *	Surface Type
0909	NONPUBLIC	5/18/2006	27958	0.48	AS
Culverts	Drop Inlets	Gates	Curb & Gutter	Curb	PCR
2	4	1	CONCRETE CURB AND GUTTER	STONE CURB	POOR/45

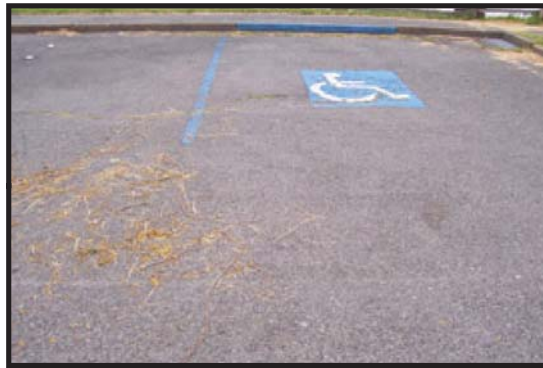
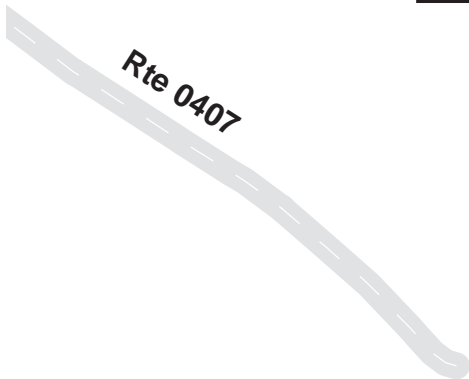
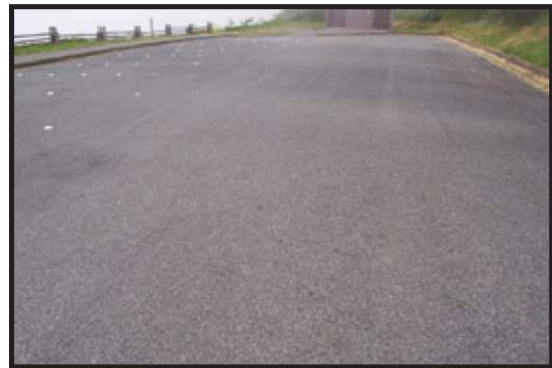
## Route 0910

Route Number	Public / NonPublic	Date Visited	Area (sq ft)	Lane Miles *	Surface Type
0910	PUBLIC	5/18/2006	11086	0.19	AS
Culverts	Drop Inlets	Gates	Curb & Gutter	Curb	PCR
0	1	0	CONCRETE CURB AND GUTTER	NO CURB	FAIR/73

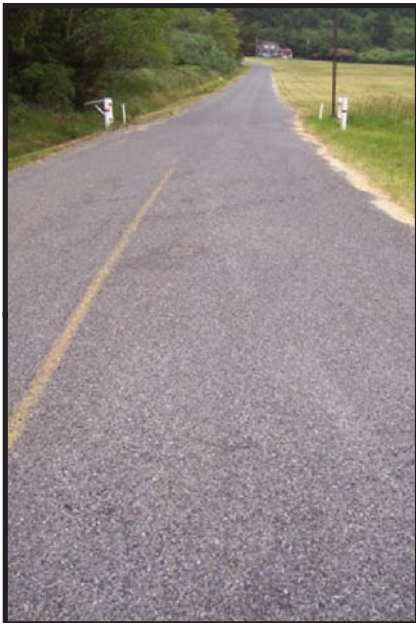
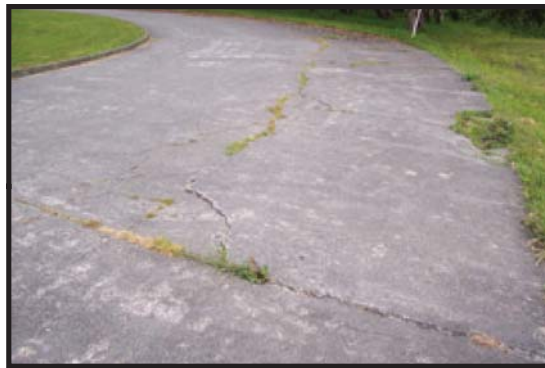
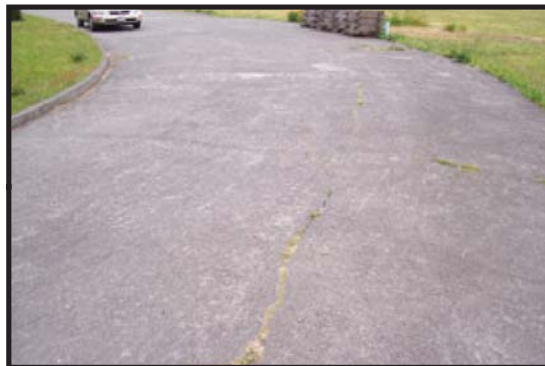
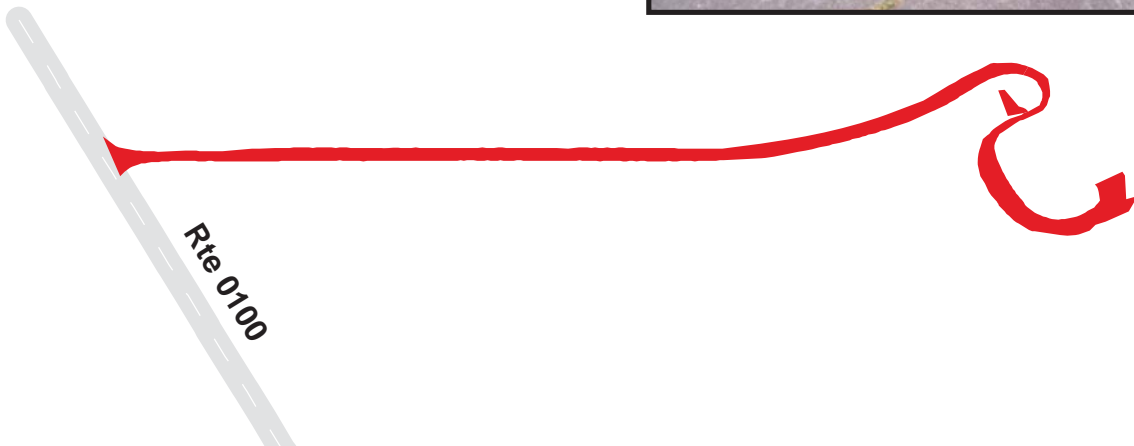
## Route 0911

Route Number	Public / NonPublic	Date Visited	Area (sq ft)	Lane Miles *	Surface Type
0911	PUBLIC	5/17/2006	32065	0.55	AS
Culverts	Drop Inlets	Gates	Curb & Gutter	Curb	PCR
0	0	1	NO CURB AND GUTTER	CONCRETE CURB	GOOD/90

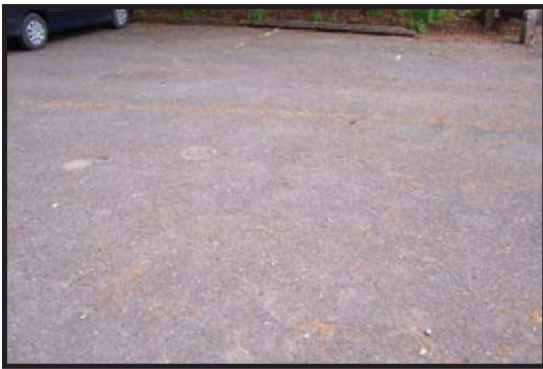
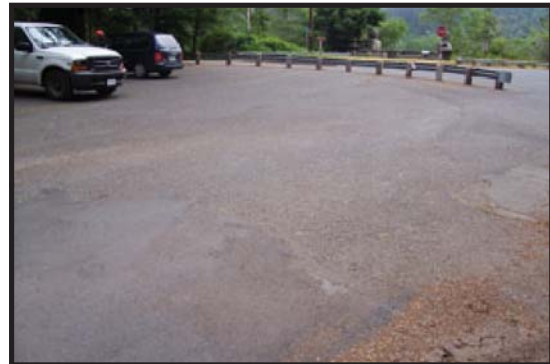
## Route 0912

Route Number	Public / NonPublic	Date Visited	Area (sq ft)	Lane Miles *	Surface Type
0912	PUBLIC	5/18/2006	9985	0.17	AS
Culverts	Drop Inlets	Gates	Curb & Gutter	Curb	PCR
0	1	0	NO CURB AND GUTTER	CONCRETE CURB	FAIR/73

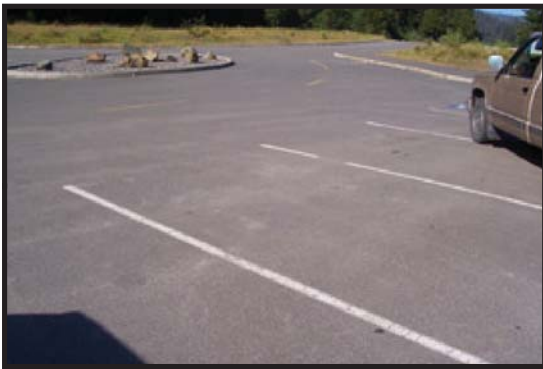
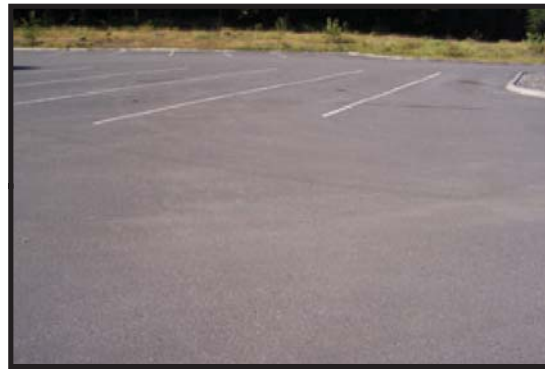
## Route 0913

Route Number	Public / NonPublic	Date Visited	Area (sq ft)	Lane Miles *	Surface Type
0913	PUBLIC	5/17/2006	45095	0.78	AS
Culverts	Drop Inlets	Gates	Curb & Gutter	Curb	PCR
0	1	0	NO CURB AND GUTTER	CONCRETE CURB	EXCELLENT/97

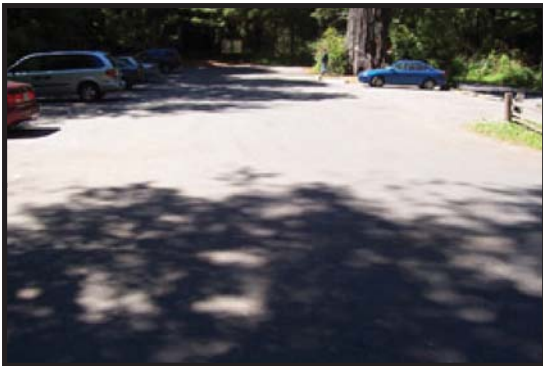
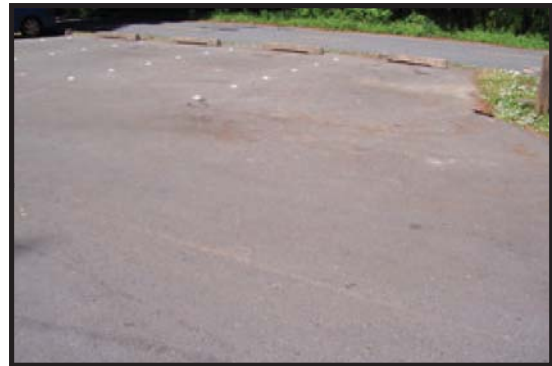
## Route 0914

Route Number	Public / NonPublic	Date Visited	Area (sq ft)	Lane Miles *	Surface Type
0914	PUBLIC	5/17/2006	13524	0.23	AS
Culverts	Drop Inlets	Gates	Curb & Gutter	Curb	PCR
0	0	0	NO CURB AND GUTTER	ASPHALT CURB	GOOD/90

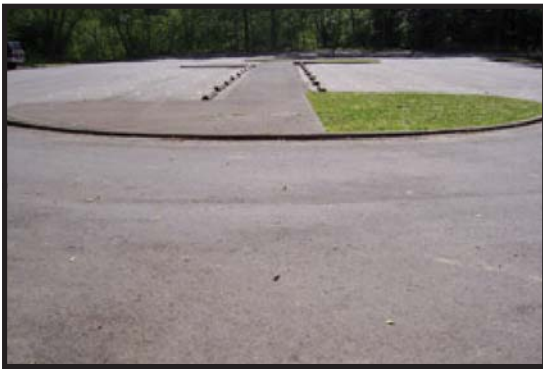
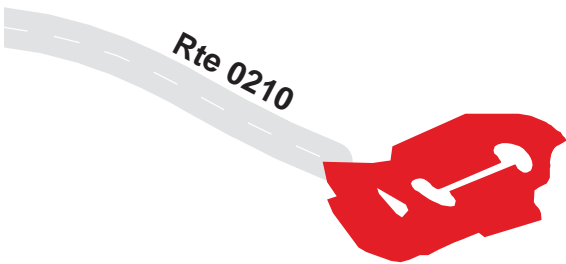
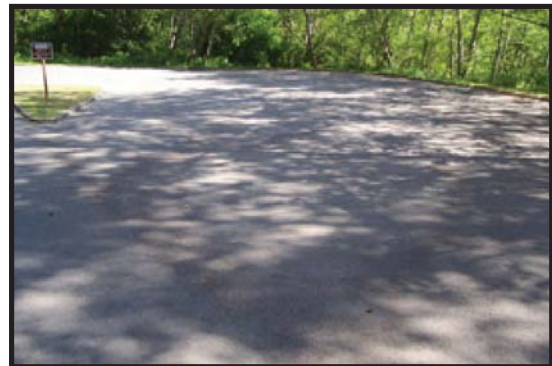
**REDWOOD NATIONAL PARK**  
**Route 0915**  
**REDWOOD CREEK TRAILHEAD PARKING**  
 AT END OF ROUTE 0210 AT MP 0.43

Route Number	Public / NonPublic	Date Visited	Area (sq ft)	Lane Miles *	Surface Type
0915	PUBLIC	5/17/2006	23609	0.41	AS
Culverts	Drop Inlets	Gates	Curb & Gutter	Curb	PCR
1	2	0	CONCRETE CURB AND GUTTER	ASPHALT CURB	EXCELLENT/97

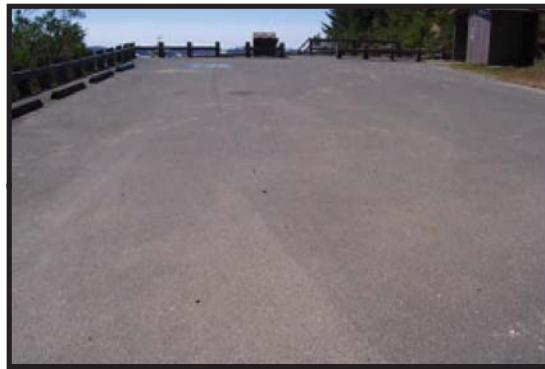
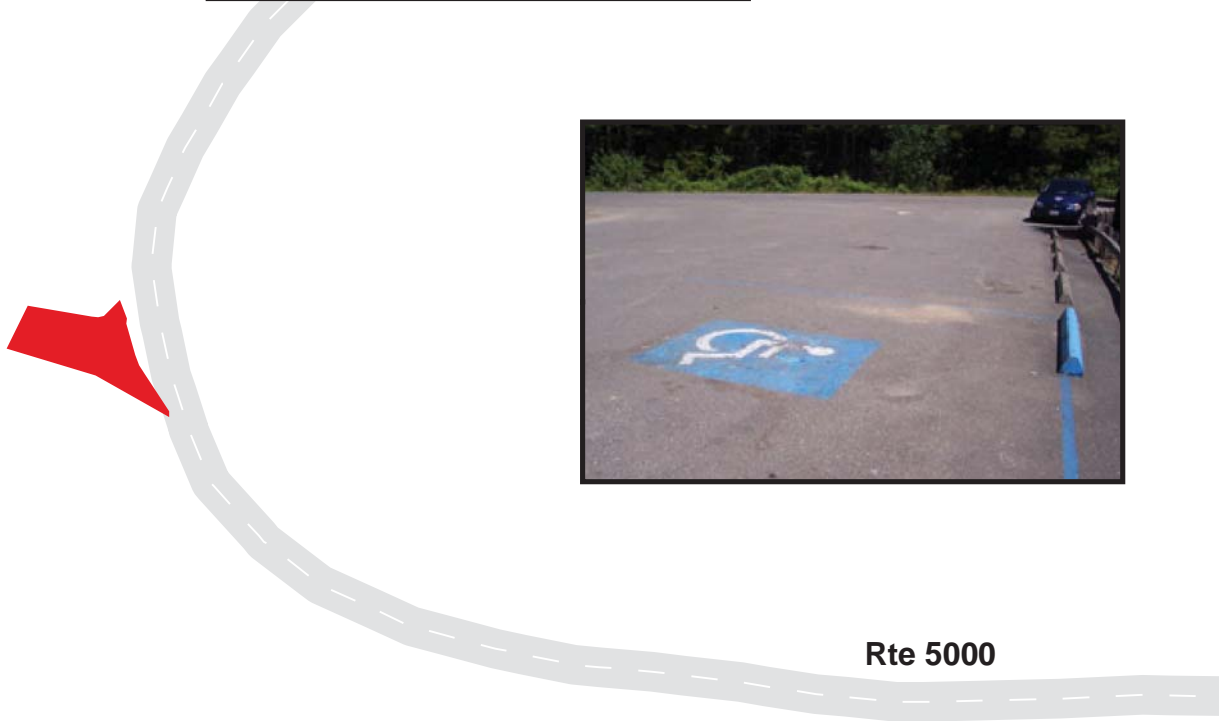
**REDWOOD NATIONAL PARK**  
**Route 0916**  
**REDWOOD CREEK OVERLOOK PARKING**  
**ADJACENT TO ROUTE 5000**

Route Number	Public / NonPublic	Date Visited	Area (sq ft)	Lane Miles *	Surface Type
0916	PUBLIC	5/17/2006	4119	0.07	AS
Culverts	Drop Inlets	Gates	Curb & Gutter	Curb	PCR
0	0	0	NO CURB AND GUTTER	NO CURB	GOOD/90

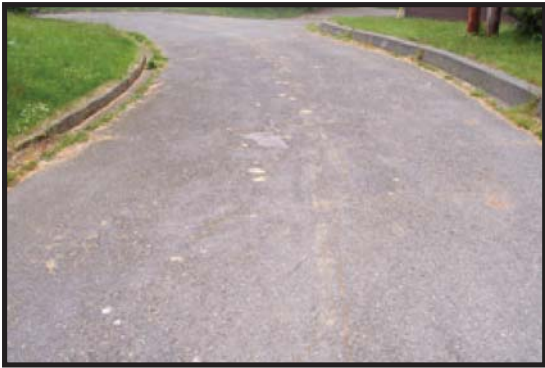
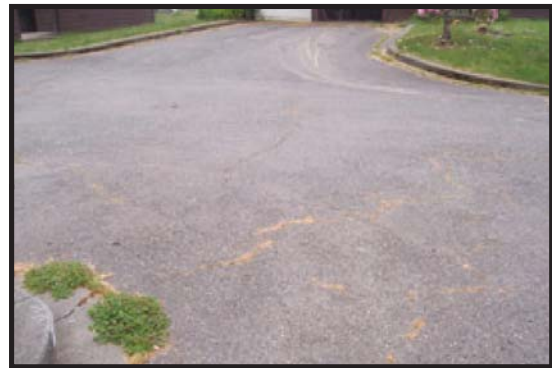
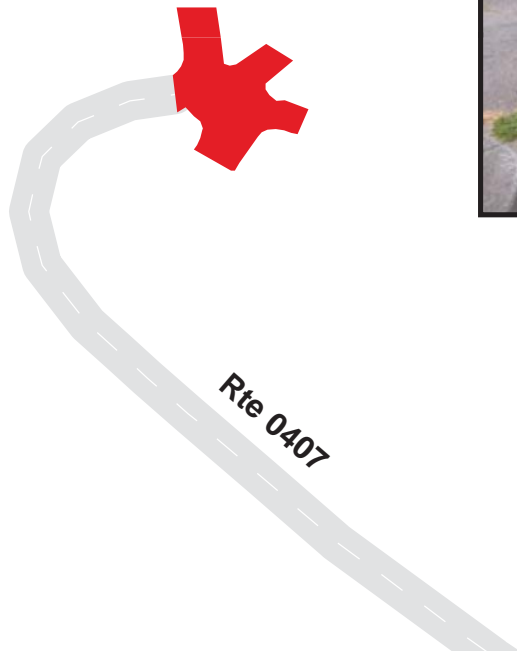
## Route 0917

Route Number	Public / NonPublic	Date Visited	Area (sq ft)	Lane Miles *	Surface Type
0917	NONPUBLIC	5/18/2006	3359	0.06	AS
Culverts	Drop Inlets	Gates	Curb & Gutter	Curb	PCR
0	0	0	CONCRETE CURB AND GUTTER	NO CURB	FAIR/73

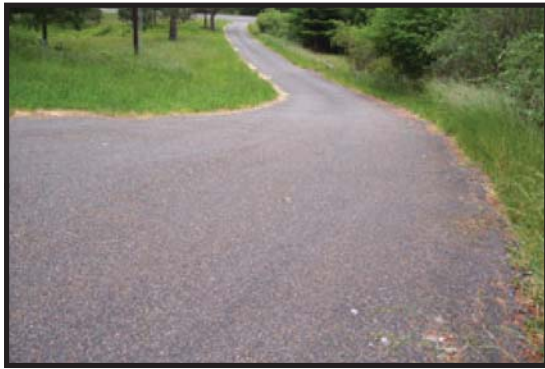
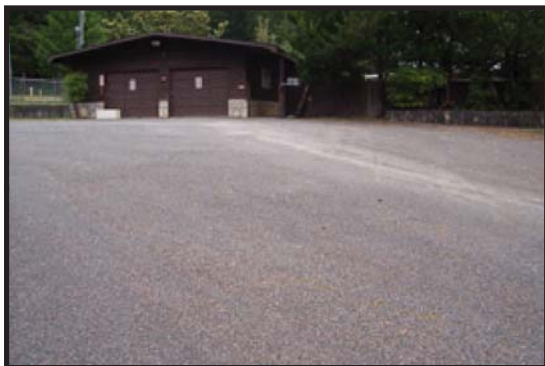
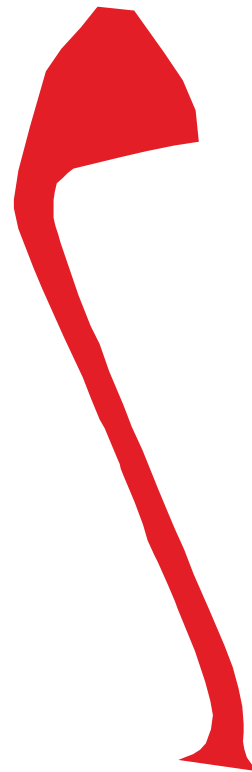
## Route 0918

Route Number	Public / NonPublic	Date Visited	Area (sq ft)	Lane Miles *	Surface Type
0918	NONPUBLIC	5/17/2006	9511	0.16	AS
Culverts	Drop Inlets	Gates	Curb & Gutter	Curb	PCR
0	0	0	NO CURB AND GUTTER	NO CURB	GOOD/90

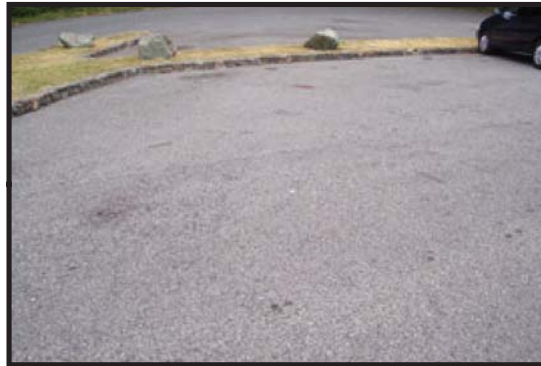
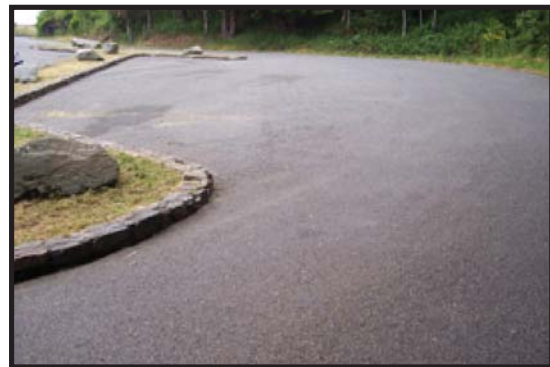
## Route 0919

Route Number	Public / NonPublic	Date Visited	Area (sq ft)	Lane Miles *	Surface Type
0919	PUBLIC	5/17/2006	8671	0.15	AS
Culverts	Drop Inlets	Gates	Curb & Gutter	Curb	PCR
1	0	0	NO CURB AND GUTTER	STONE CURB	GOOD/90

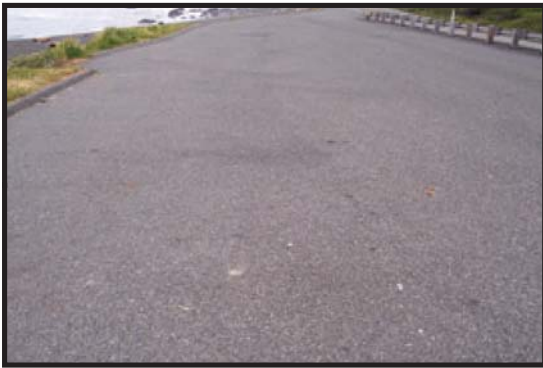
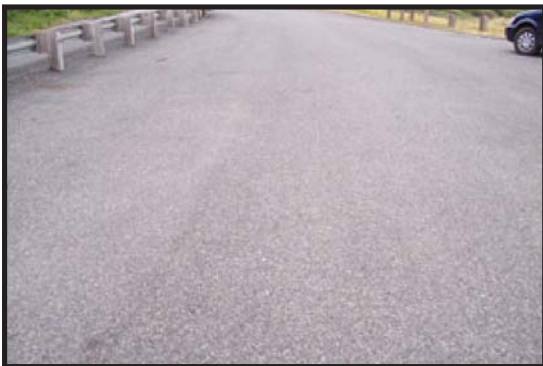
## Route 0920

Route Number	Public / NonPublic	Date Visited	Area (sq ft)	Lane Miles *	Surface Type
0920	PUBLIC	5/18/2006	9652	0.17	AS
Culverts	Drop Inlets	Gates	Curb & Gutter	Curb	PCR
0	0	0	NO CURB AND GUTTER	ASPHALT CURB	EXCELLENT/97

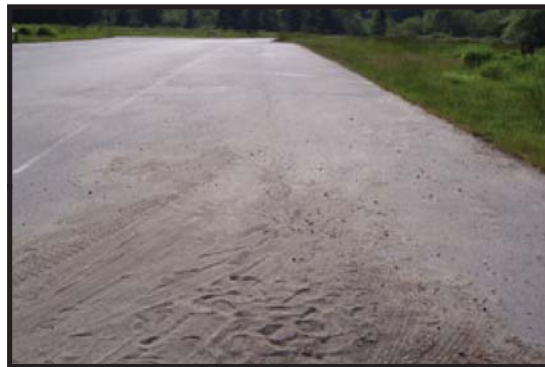
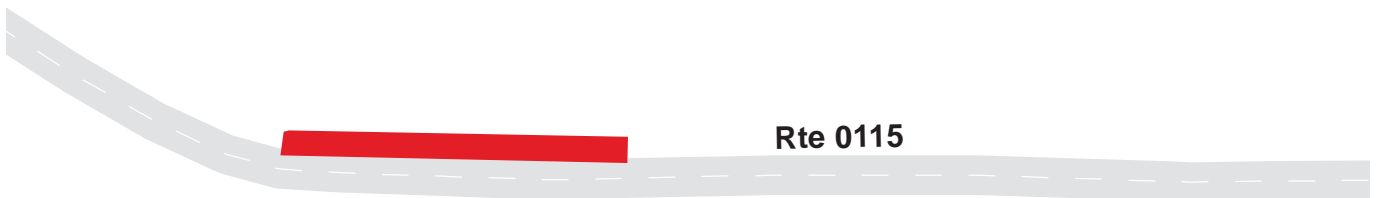
## Route 0921ZZ

Route Number	Public / NonPublic	Date Visited	Area (sq ft)	Lane Miles *	Surface Type
0921AZ	PUBLIC	5/17/2006	2988	0.05	AS
Culverts	Drop Inlets	Gates	Curb & Gutter	Curb	PCR
0	0	0	NO CURB AND GUTTER	NO CURB	EXCELLENT/97

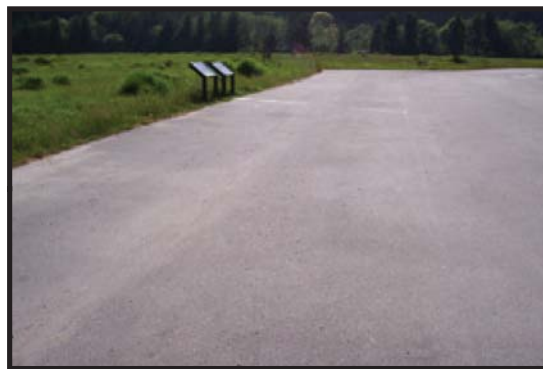
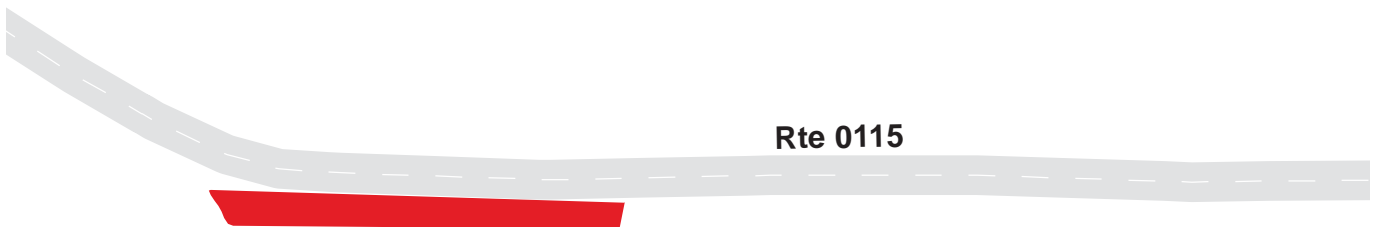
## Route 0921BZ

Route Number	Public / NonPublic	Date Visited	Area (sq ft)	Lane Miles *	Surface Type
0921BZ	PUBLIC	5/17/2006	4224	0.07	AS
Culverts	Drop Inlets	Gates	Curb & Gutter	Curb	PCR
0	0	0	NO CURB AND GUTTER	NO CURB	EXCELLENT/97

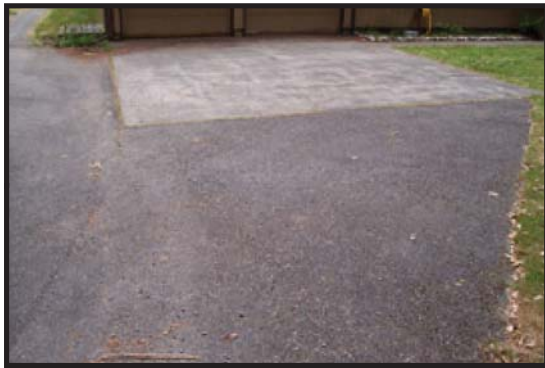
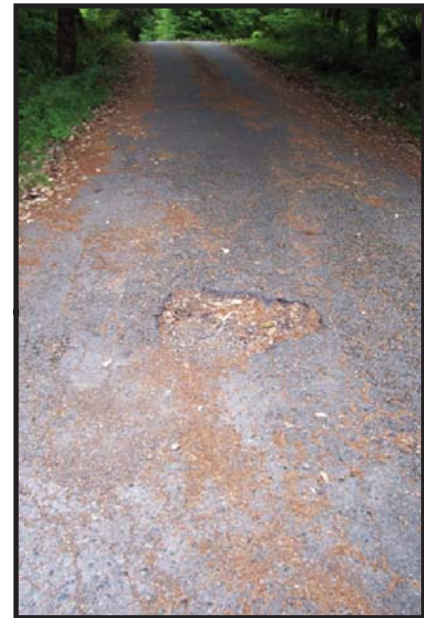
## Route 0922

Route Number	Public / NonPublic	Date Visited	Area (sq ft)	Lane Miles *	Surface Type
0922	NONPUBLIC	5/17/2006	12288	0.21	AS
Culverts	Drop Inlets	Gates	Curb & Gutter	Curb	PCR
0	0	0	NO CURB AND GUTTER	NO CURB	FAIR/73
