**The Road Inventory
of
Saguaro National Park
SAGU – 8670
Cycle 4**

**Prepared By:
Federal Highway Administration
Road Inventory Program
Cycle 4**

Saguaro National Park in Arizona

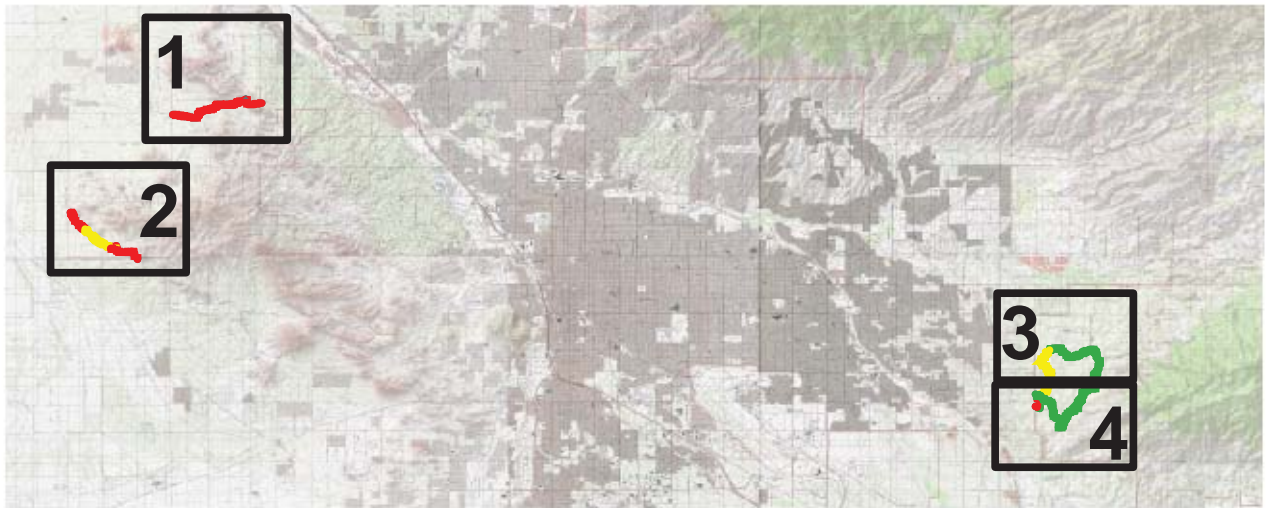
**Saguaro National Park
Route Condition Map
PCR - Mile by Mile
Key Map**

PCR	Poor		Fair		Good		Excellent	
		(<=60)		(61 - 84)		(85 - 94)		(95 - 100)

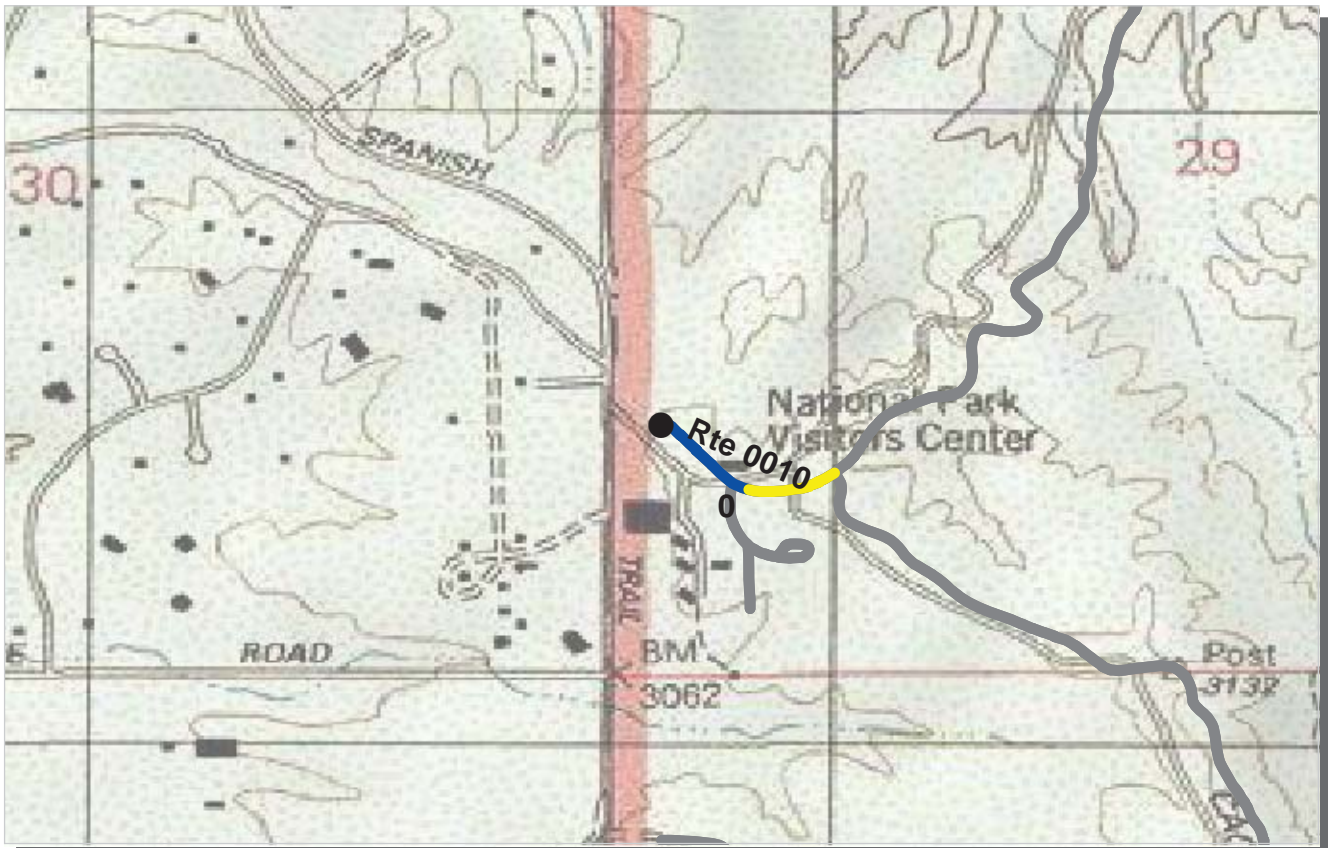
ROUTE: 0010 RINCON MOUNTAIN DISTRICT ENTRANCE ROAD

Section Number	0				
Section Length (mi)	0.17				
Traffic	Traffic data may be found at www.efl.fhwa.dot.gov Click on PROGRAMS / NPS Traffic Data (Note: Not all parks have traffic data)				
Cross Section Information					
Number of Lanes	2				
Paved Width (ft)	24				
Lane Width (ft)	11				
Shoulder Width Right (ft)**	2				
Shoulder Width Left (ft)**	0				
Roadway Condition Information					
SCR (Surface Condition Rating)	95				
PCR (Pavement Condition Rating)	88				
Distress Index Values					
Alligator Cracking Index	99				
Longitudinal Cracking Index	100				
Transverse Cracking Index	100				
Patching Index	100				
Rutting Index	96				
Roughness Condition Index (RCI)	62

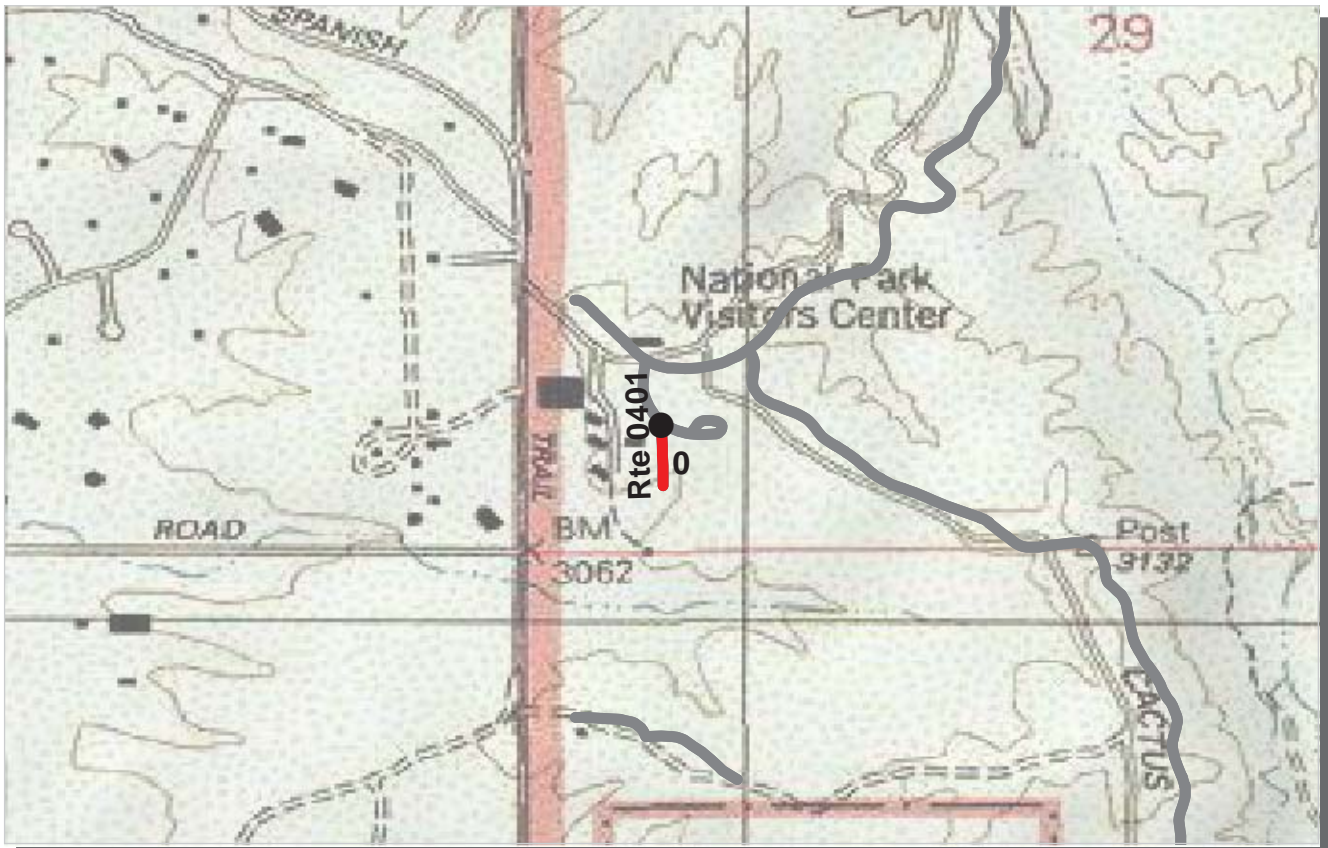
ROUTE: 0401 RESIDENCE ACCESS ROAD

Section Number	0				
Section Length (mi)	0.06				
Traffic	Traffic data may be found at www.efl.fhwa.dot.gov Click on PROGRAMS / NPS Traffic Data (Note: Not all parks have traffic data)				
Cross Section Information					
Number of Lanes	2				
Paved Width (ft)	17				
Lane Width (ft)	8				
Shoulder Width Right (ft)**	4				
Shoulder Width Left (ft)**	3				
Roadway Condition Information					
SCR (Surface Condition Rating)	5				
PCR (Pavement Condition Rating)	5				
Distress Index Values					
Alligator Cracking Index	99				
Longitudinal Cracking Index	76				
Transverse Cracking Index	56				
Patching Index	100				
Rutting Index	59				
Roughness Condition Index (RCI)	NC

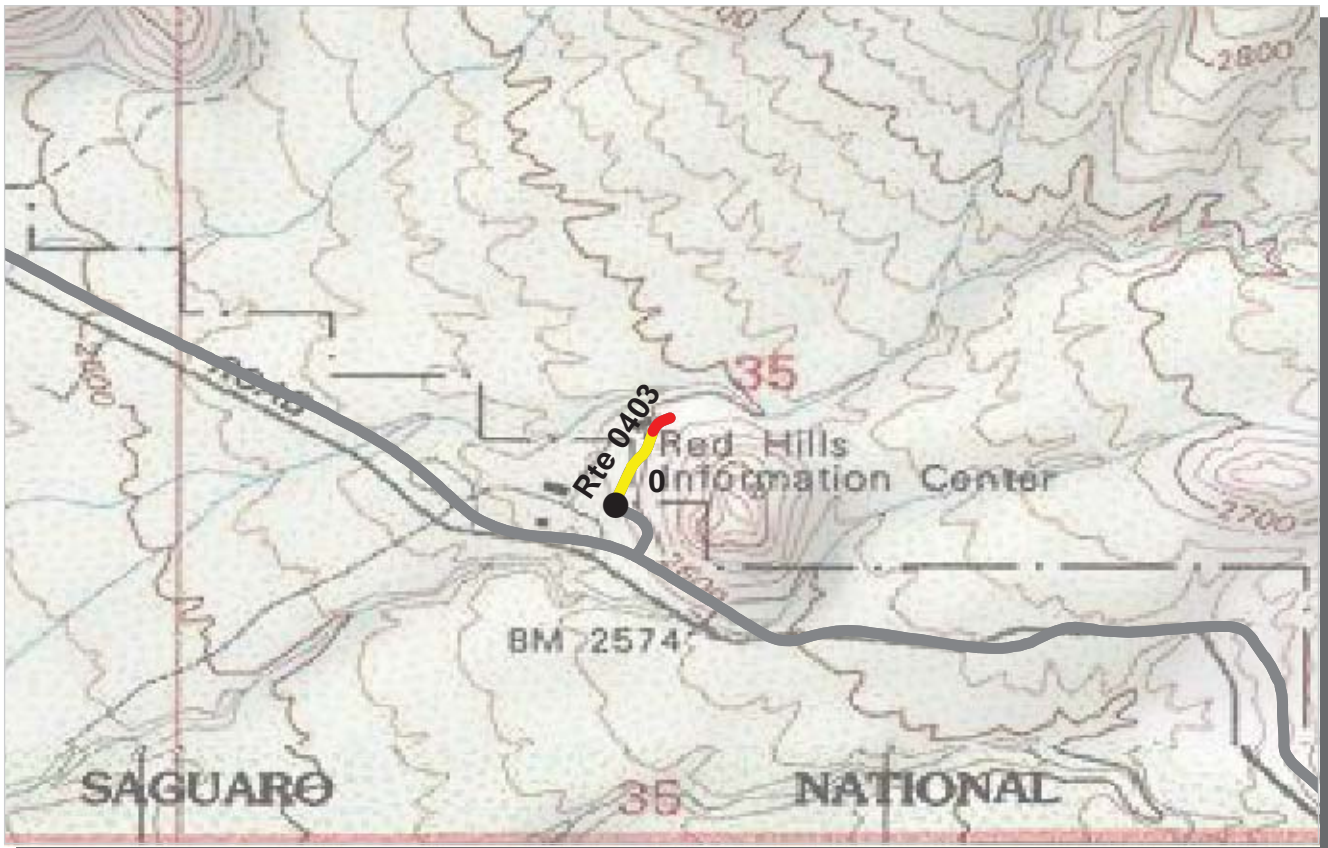
ROUTE: 0403 RED HILLS MAINTENANCE AREA ACCESS ROAD

Section Number	0				
Section Length (mi)	0.10				
Traffic	Traffic data may be found at www.efl.fhwa.dot.gov Click on PROGRAMS / NPS Traffic Data (Note: Not all parks have traffic data)				
Cross Section Information					
Number of Lanes	2				
Paved Width (ft)	23				
Lane Width (ft)	11				
Shoulder Width Right (ft)**	4				
Shoulder Width Left (ft)**	0				
Roadway Condition Information					
SCR (Surface Condition Rating)	60				
PCR (Pavement Condition Rating)	60				
Distress Index Values					
Alligator Cracking Index	100				
Longitudinal Cracking Index	100				
Transverse Cracking Index	97				
Patching Index	100				
Rutting Index	63				
Roughness Condition Index (RCI)	53

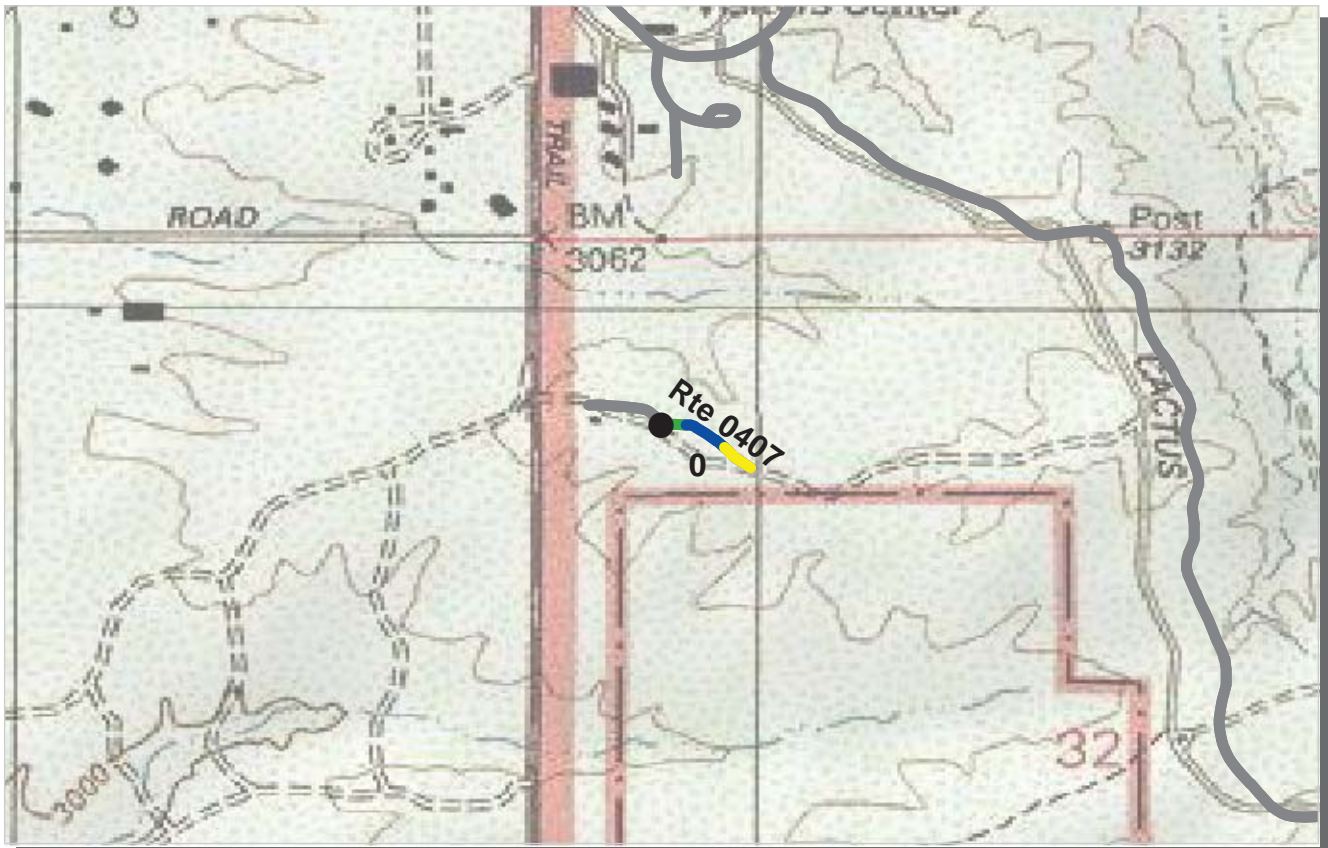
ROUTE: 0407 HELI-BASE FLIGHTLINE ACCESS ROAD

Section Number	0				
Section Length (mi)	0.09				
Traffic	Traffic data may be found at www.efl.fhwa.dot.gov Click on PROGRAMS / NPS Traffic Data (Note: Not all parks have traffic data)				
Cross Section Information					
Number of Lanes	2				
Paved Width (ft)	14				
Lane Width (ft)	7				
Shoulder Width Right (ft)**	2				
Shoulder Width Left (ft)**	0				
Roadway Condition Information					
SCR (Surface Condition Rating)	92				
PCR (Pavement Condition Rating)	89				
Distress Index Values					
Alligator Cracking Index	100				
Longitudinal Cracking Index	99				
Transverse Cracking Index	98				
Patching Index	100				
Rutting Index	95				
Roughness Condition Index (RCI)	68

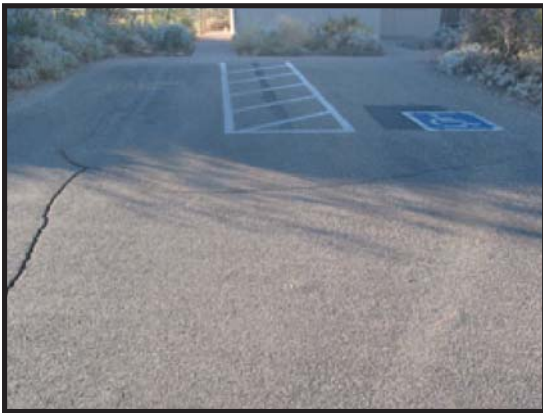
Route Number	Public / NonPublic	Date Visited		Area (sq ft)	Lane Miles *	Surface Type
0900AZ	NONPUBLIC	12/5/2006		683	0.01	AS
Culverts	Drop Inlets	Gates	Fire Hydrants	Curb & Gutter	Curb	PCR
0	0	0	0	NO CURB AND GUTTER	NO CURB	FAIR/73

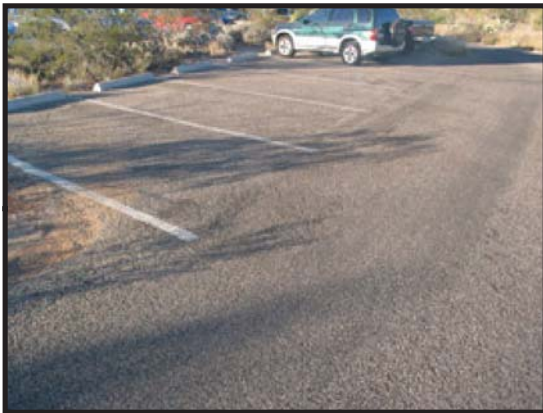
Route Number	Public / NonPublic	Date Visited		Area (sq ft)	Lane Miles *	Surface Type
0900CZ	NONPUBLIC	12/5/2006		1,057	0.02	AS
Culverts	Drop Inlets	Gates	Fire Hydrants	Curb & Gutter	Curb	PCR
0	0	0	0	NO CURB AND GUTTER	NO CURB	FAIR/73

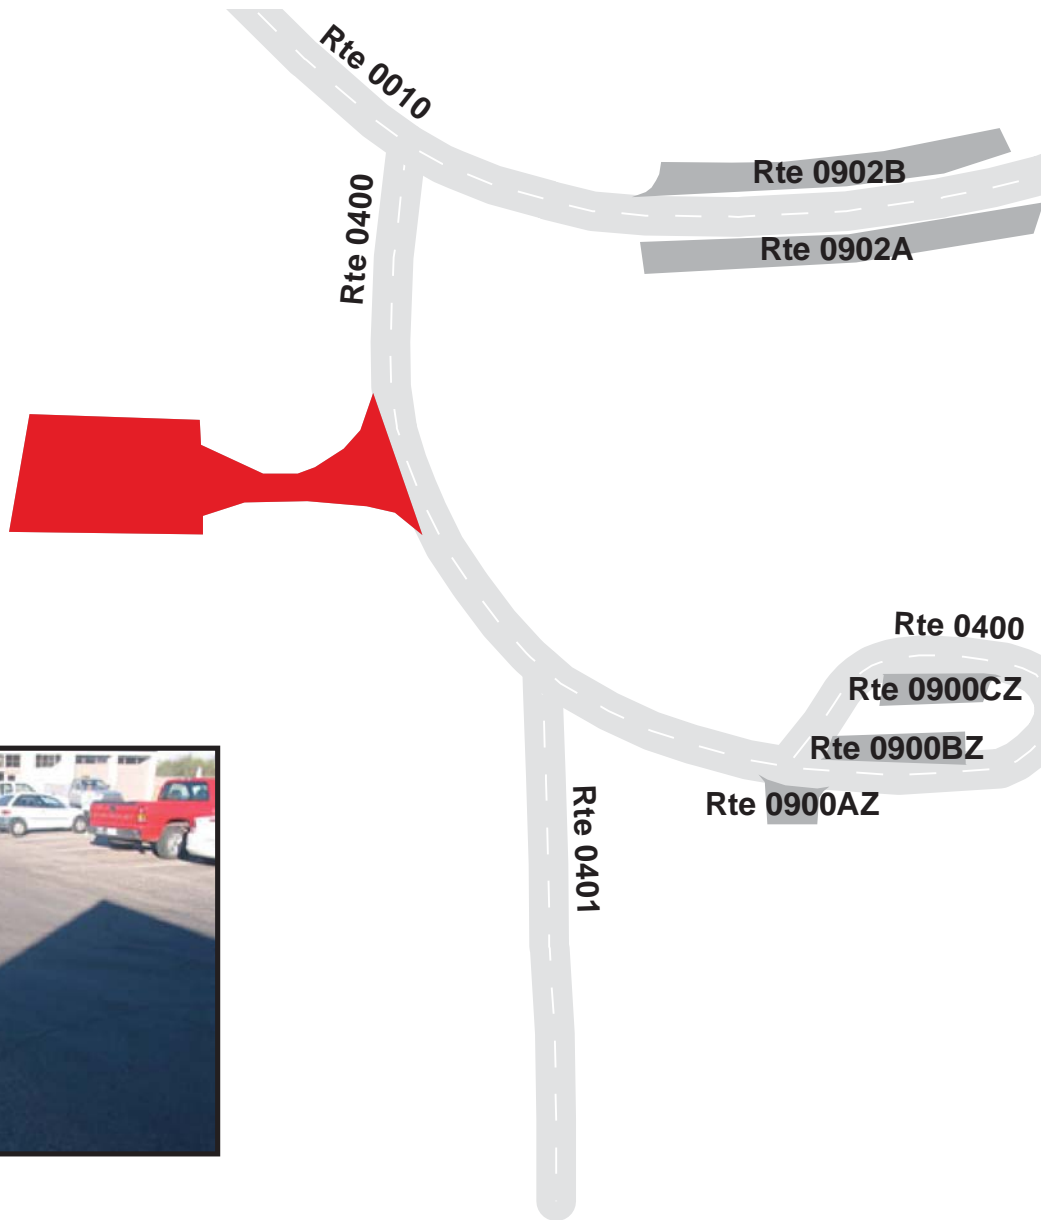
Route 0901

Route Number	Public / NonPublic	Date Visited		Area (sq ft)	Lane Miles *	Surface Type
0901	NONPUBLIC	12/5/2006		10,333	0.18	AS
Culverts	Drop Inlets	Gates	Fire Hydrants	Curb & Gutter	Curb	PCR
0	0	0	0	NO CURB AND GUTTER	NO CURB	FAIR/73

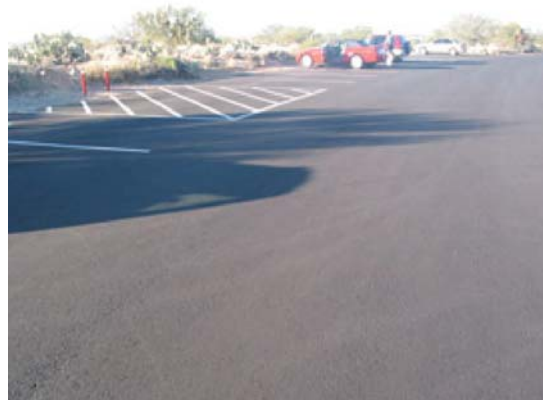
Route 0902A

Route Number	Public / NonPublic	Date Visited		Area (sq ft)	Lane Miles *	Surface Type
0902A	PUBLIC	12/5/2006		3,907	0.07	AS
Culverts	Drop Inlets	Gates	Fire Hydrants	Curb & Gutter	Curb	PCR
0	0	0	0	NO CURB AND GUTTER	NO CURB	EXCELLENT/97

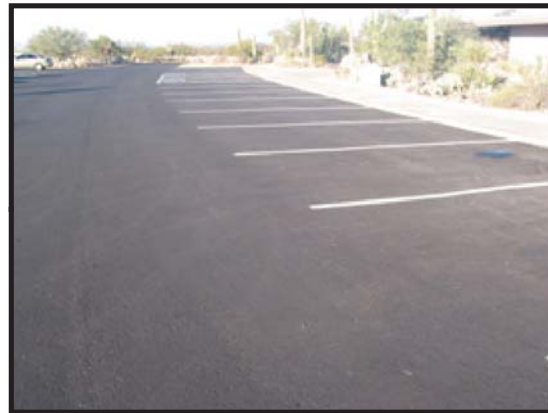
Route 0902B

Route Number	Public / NonPublic	Date Visited		Area (sq ft)	Lane Miles *	Surface Type
0902B	PUBLIC	12/5/2006		3,503	0.06	AS
Culverts	Drop Inlets	Gates	Fire Hydrants	Curb & Gutter	Curb	PCR
0	0	0	0	NO CURB AND GUTTER	CONCRETE CURB	EXCELLENT/97

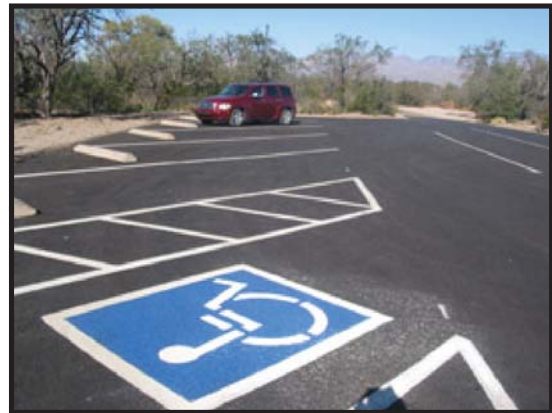
Route 0903

Route Number	Public / NonPublic	Date Visited		Area (sq ft)	Lane Miles *	Surface Type
0903	PUBLIC	12/5/2006		4,227	0.07	AS
Culverts	Drop Inlets	Gates	Fire Hydrants	Curb & Gutter	Curb	PCR
0	0	0	0	NO CURB AND GUTTER	NO CURB	EXCELLENT/97

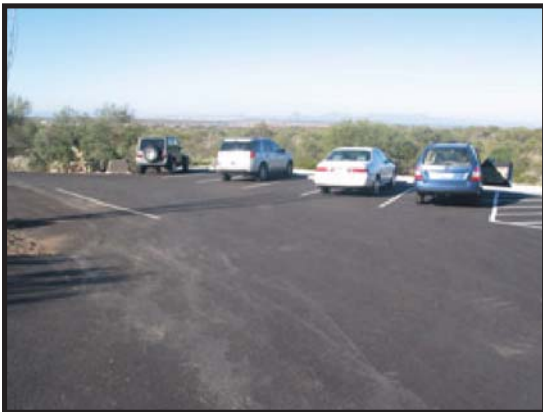
Route 0904

Route Number	Public / NonPublic	Date Visited		Area (sq ft)	Lane Miles *	Surface Type
0904	PUBLIC	12/5/2006		4,948	0.09	AS
Culverts	Drop Inlets	Gates	Fire Hydrants	Curb & Gutter	Curb	PCR
0	0	0	0	NO CURB AND GUTTER	NO CURB	EXCELLENT/97

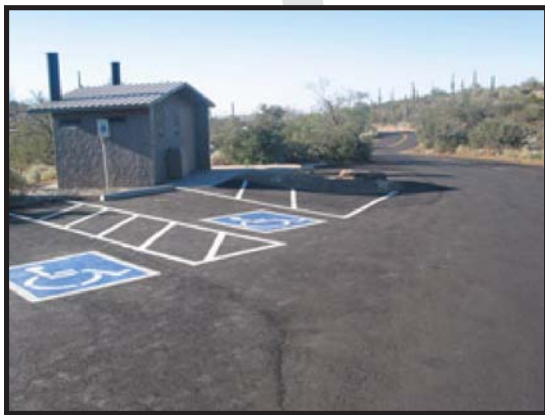
Route 0906

Route Number	Public / NonPublic	Date Visited		Area (sq ft)	Lane Miles *	Surface Type
0906	PUBLIC	12/5/2006		15,307	0.26	AS
Culverts	Drop Inlets	Gates	Fire Hydrants	Curb & Gutter	Curb	PCR
0	0	0	0	NO CURB AND GUTTER	NO CURB	EXCELLENT/97

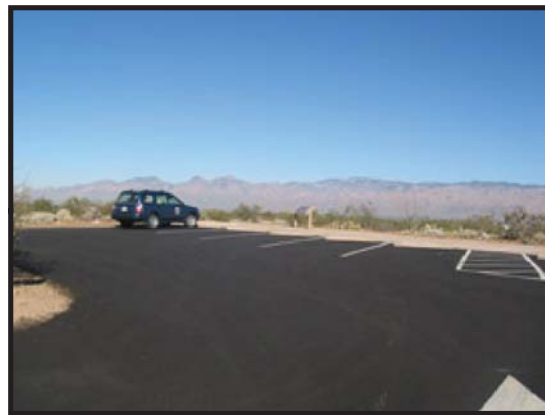
Route 0907

Route Number	Public / NonPublic	Date Visited		Area (sq ft)	Lane Miles *	Surface Type
0907	PUBLIC	12/5/2006		4,175	0.07	AS
Culverts	Drop Inlets	Gates	Fire Hydrants	Curb & Gutter	Curb	PCR
0	0	0	0	NO CURB AND GUTTER	NO CURB	EXCELLENT/97

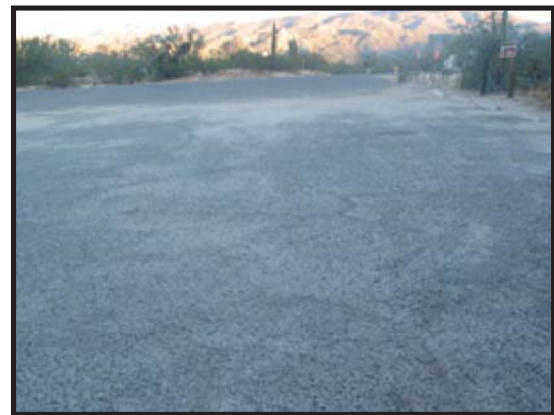
Route 0908

Route Number	Public / NonPublic	Date Visited		Area (sq ft)	Lane Miles *	Surface Type
0908	PUBLIC	12/5/2006		7,644	0.13	AS
Culverts	Drop Inlets	Gates	Fire Hydrants	Curb & Gutter	Curb	PCR
0	0	0	0	NO CURB AND GUTTER	NO CURB	POOR/45

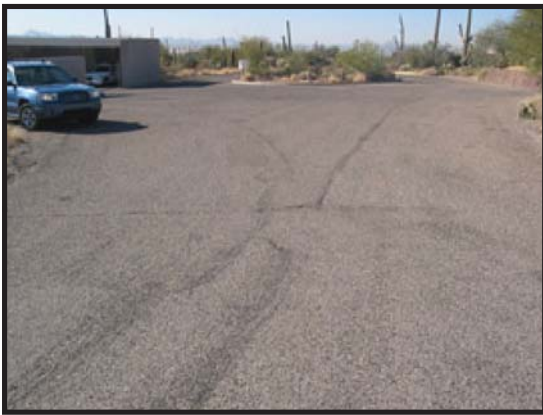
Route 0909

Route Number	Public / NonPublic	Date Visited		Area (sq ft)	Lane Miles *	Surface Type
0909	NONPUBLIC	12/5/2006		14,984	0.26	AS
Culverts	Drop Inlets	Gates	Fire Hydrants	Curb & Gutter	Curb	PCR
0	0	0	0	NO CURB AND GUTTER	CONCRETE CURB	GOOD/90

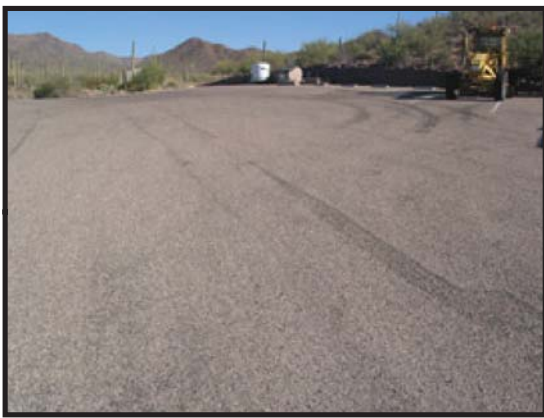
Route 0910

Route Number	Public / NonPublic	Date Visited		Area (sq ft)	Lane Miles *	Surface Type
0910	NONPUBLIC	12/5/2006		31,983	0.55	AS
Culverts	Drop Inlets	Gates	Fire Hydrants	Curb & Gutter	Curb	PCR
0	0	0	0	NO CURB AND GUTTER	NO CURB	GOOD/90

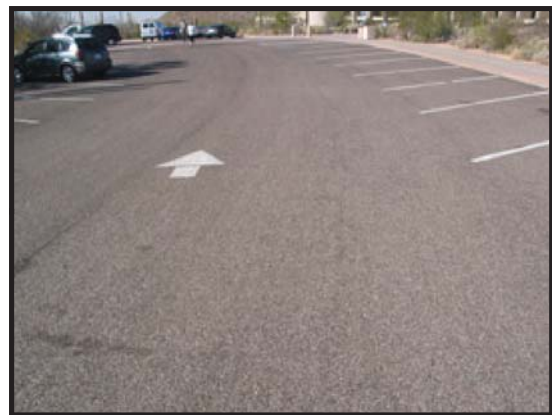
Route 0911

Route Number	Public / NonPublic	Date Visited		Area (sq ft)	Lane Miles *	Surface Type
0911	PUBLIC	12/5/2006		44,782	0.77	AS
Culverts	Drop Inlets	Gates	Fire Hydrants	Curb & Gutter	Curb	PCR
0	0	0	0	NO CURB AND GUTTER	NO CURB	GOOD/90

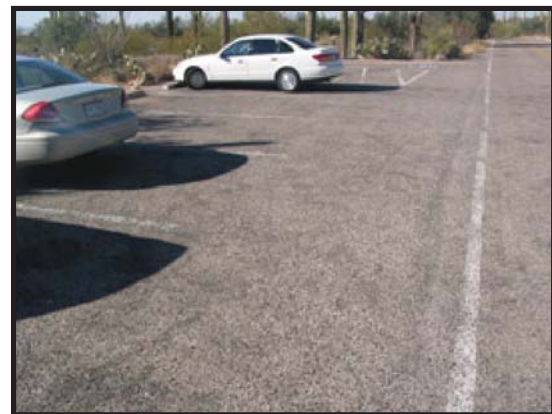
Route 0912

Route Number	Public / NonPublic	Date Visited		Area (sq ft)	Lane Miles *	Surface Type
0912	PUBLIC	12/5/2006		2,296	0.04	AS
Culverts	Drop Inlets	Gates	Fire Hydrants	Curb & Gutter	Curb	PCR
0	0	0	0	NO CURB AND GUTTER	NO CURB	FAIR/73

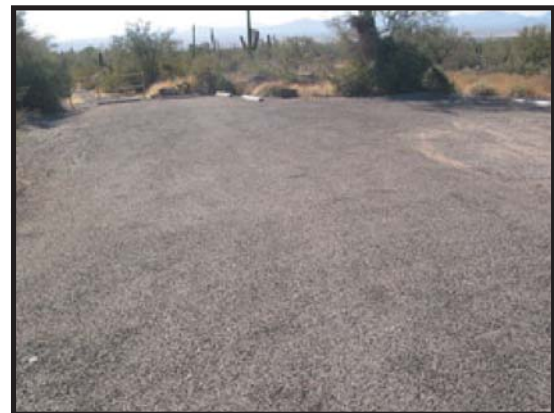
Route 0913

Route Number	Public / NonPublic	Date Visited		Area (sq ft)	Lane Miles *	Surface Type
0913	PUBLIC	12/5/2006		2,996	0.05	AS
Culverts	Drop Inlets	Gates	Fire Hydrants	Curb & Gutter	Curb	PCR
0	0	0	0	NO CURB AND GUTTER	NO CURB	FAIR/73

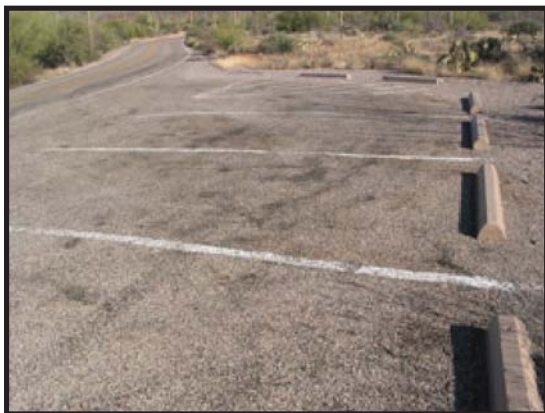
Route 0921

Route Number	Public / NonPublic	Date Visited		Area (sq ft)	Lane Miles *	Surface Type
0921	PUBLIC	12/5/2006		1,500	0.03	AS
Culverts	Drop Inlets	Gates	Fire Hydrants	Curb & Gutter	Curb	PCR
0	0	0	0	NO CURB AND GUTTER	NO CURB	FAIR/73

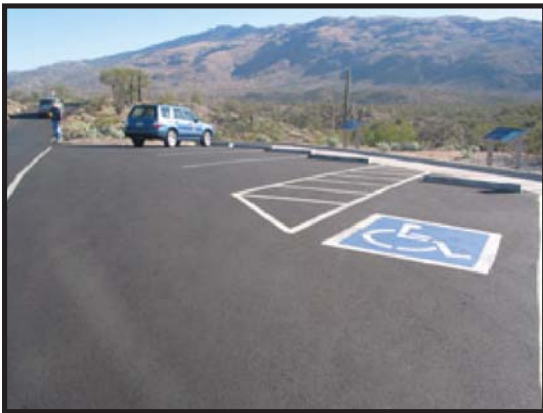
Route 0922

Route Number	Public / NonPublic	Date Visited		Area (sq ft)	Lane Miles *	Surface Type
0922	PUBLIC	12/5/2006		2,151	0.04	AS
Culverts	Drop Inlets	Gates	Fire Hydrants	Curb & Gutter	Curb	PCR
0	0	0	0	NO CURB AND GUTTER	NO CURB	EXCELLENT/97

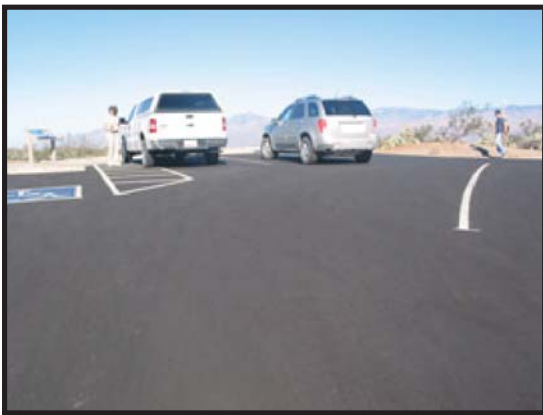
Route 0923

Route Number	Public / NonPublic	Date Visited		Area (sq ft)	Lane Miles *	Surface Type
0923	PUBLIC	12/5/2006		3,834	0.07	AS
Culverts	Drop Inlets	Gates	Fire Hydrants	Curb & Gutter	Curb	PCR
0	0	0	0	NO CURB AND GUTTER	NO CURB	EXCELLENT/97

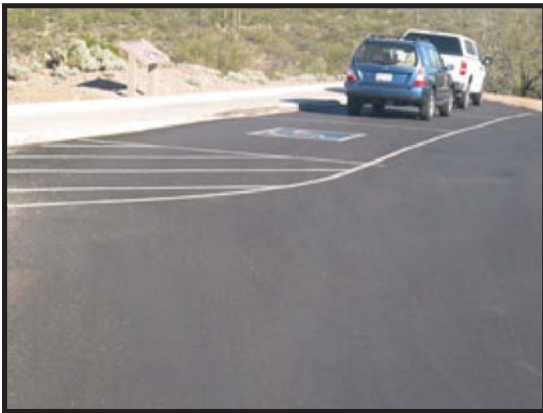
Route 0924

Route Number	Public / NonPublic	Date Visited		Area (sq ft)	Lane Miles *	Surface Type
0924	PUBLIC	12/5/2006		1,945	0.03	AS
Culverts	Drop Inlets	Gates	Fire Hydrants	Curb & Gutter	Curb	PCR
0	0	0	0	NO CURB AND GUTTER	CONCRETE CURB	EXCELLENT/97

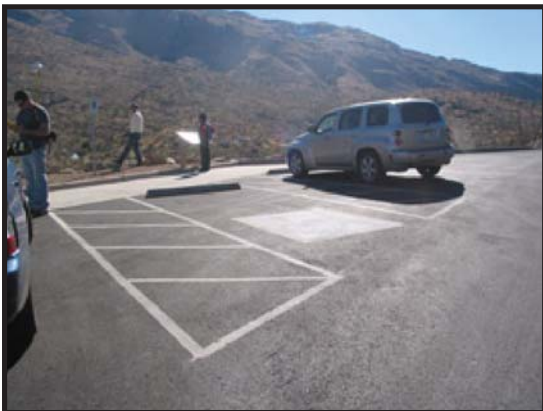
Route Number	Public / NonPublic	Date Visited		Area (sq ft)	Lane Miles *	Surface Type
0927	PUBLIC	12/5/2006		2,002	0.03	AS
Culverts	Drop Inlets	Gates	Fire Hydrants	Curb & Gutter	Curb	PCR
0	0	0	0	NO CURB AND GUTTER	NO CURB	EXCELLENT/97

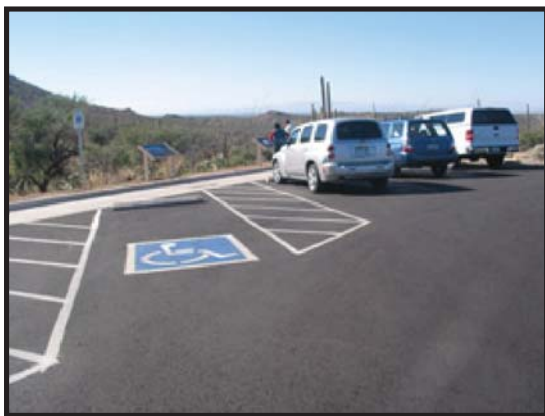
Route 0928

Route Number	Public / NonPublic	Date Visited		Area (sq ft)	Lane Miles *	Surface Type
0928	PUBLIC	12/5/2006		2,933	0.05	AS
Culverts	Drop Inlets	Gates	Fire Hydrants	Curb & Gutter	Curb	PCR
0	0	0	0	NO CURB AND GUTTER	NO CURB	EXCELLENT/97
