**The Road Inventory
of
Sunset Crater Volcano National Monument
SUCR – 7460
Cycle 4**

**Prepared By:
Federal Highway Administration
Road Inventory Program
Cycle 4**

Sunset Crater Volcano National Monument in Arizona

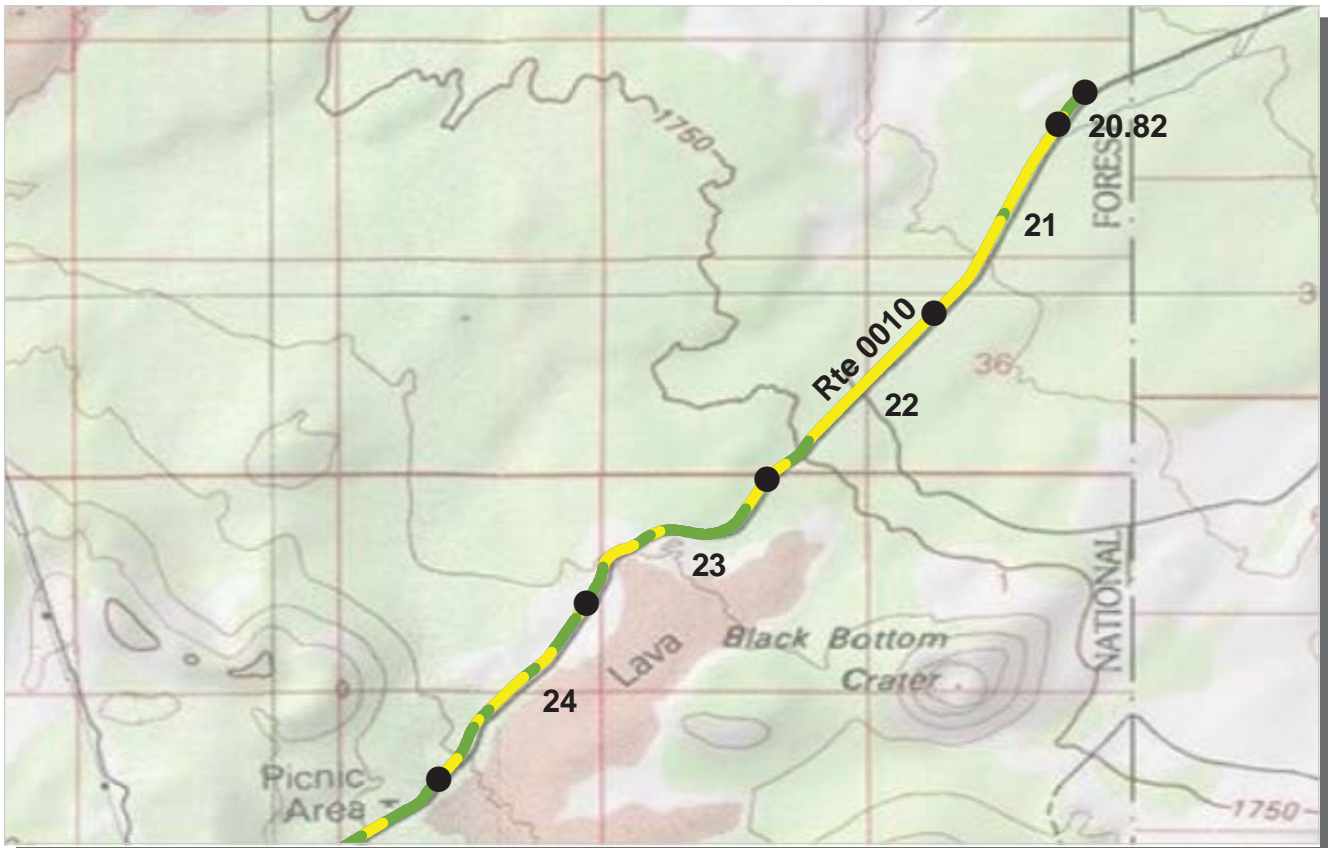
ROUTE: 0010 WUPATKI-SUNSET CRATER SCENIC LOOP ROAD

Section Number	20.82	21	22	23	24
Section Length (mi)	0.18	1.00	1.00	1.00	1.00
Traffic	Traffic data may be found at www.efl.fhwa.dot.gov Click on PROGRAMS / NPS Traffic Data (Note: Not all parks have traffic data)				
Cross Section Information					
Number of Lanes	2	2	2	2	2
Paved Width (ft)	25	27	26	26	26
Lane Width (ft)	10	11	11	10	10
Shoulder Width Right (ft)	NC	NC	NC	NC	NC
Shoulder Width Left (ft)	NC	NC	NC	NC	NC
Roadway Condition Information					
SCR (Surface Condition Rating)	75	70	71	76	73
PCR (Pavement Condition Rating)	85	82	83	85	84
Distress Index Values					
Alligator Cracking Index	100	100	100	100	100
Longitudinal Cracking Index	100	100	100	100	100
Transverse Cracking Index	100	100	100	100	100
Patching Index	100	100	100	100	100
Rutting Index	75	70	71	76	73
Roughness Condition Index (RCI)	100	100	100	100	100

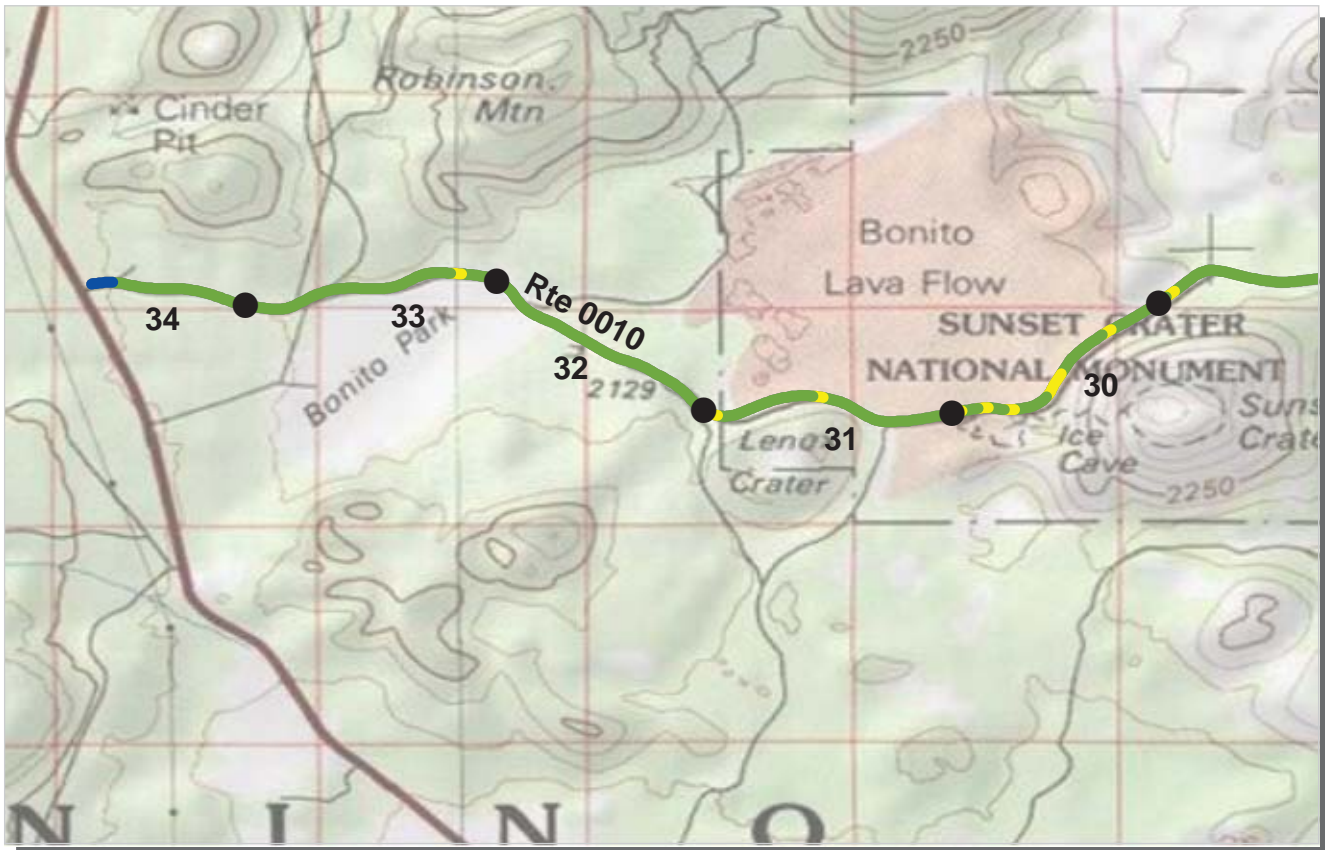
ROUTE: 0010 WUPATKI-SUNSET CRATER SCENIC LOOP ROAD

Section Number	30	31	32	33	34
Section Length (mi)	1.00	1.00	1.00	1.00	0.60
Traffic	Traffic data may be found at www.efl.fhwa.dot.gov Click on PROGRAMS / NPS Traffic Data (Note: Not all parks have traffic data)				
Cross Section Information					
Number of Lanes	2	2	2	2	2
Paved Width (ft)	25	25	25	25	26
Lane Width (ft)	10	10	10	11	10
Shoulder Width Right (ft)	NC	NC	NC	NC	NC
Shoulder Width Left (ft)	NC	NC	NC	NC	NC
Roadway Condition Information					
SCR (Surface Condition Rating)	77	81	81	83	85
PCR (Pavement Condition Rating)	86	88	88	90	91
Distress Index Values					
Alligator Cracking Index	100	100	100	100	100
Longitudinal Cracking Index	100	100	100	100	100
Transverse Cracking Index	100	100	100	100	100
Patching Index	100	100	100	100	100
Rutting Index	77	81	81	83	85
Roughness Condition Index (RCI)	100	99	100	100	100
