**The Road Inventory
of
Suitland Parkway
SUIT – 3564
Cycle 4**

**Prepared By:
Federal Highway Administration
Road Inventory Program
Cycle 4**

Suitland Parkway in Maryland

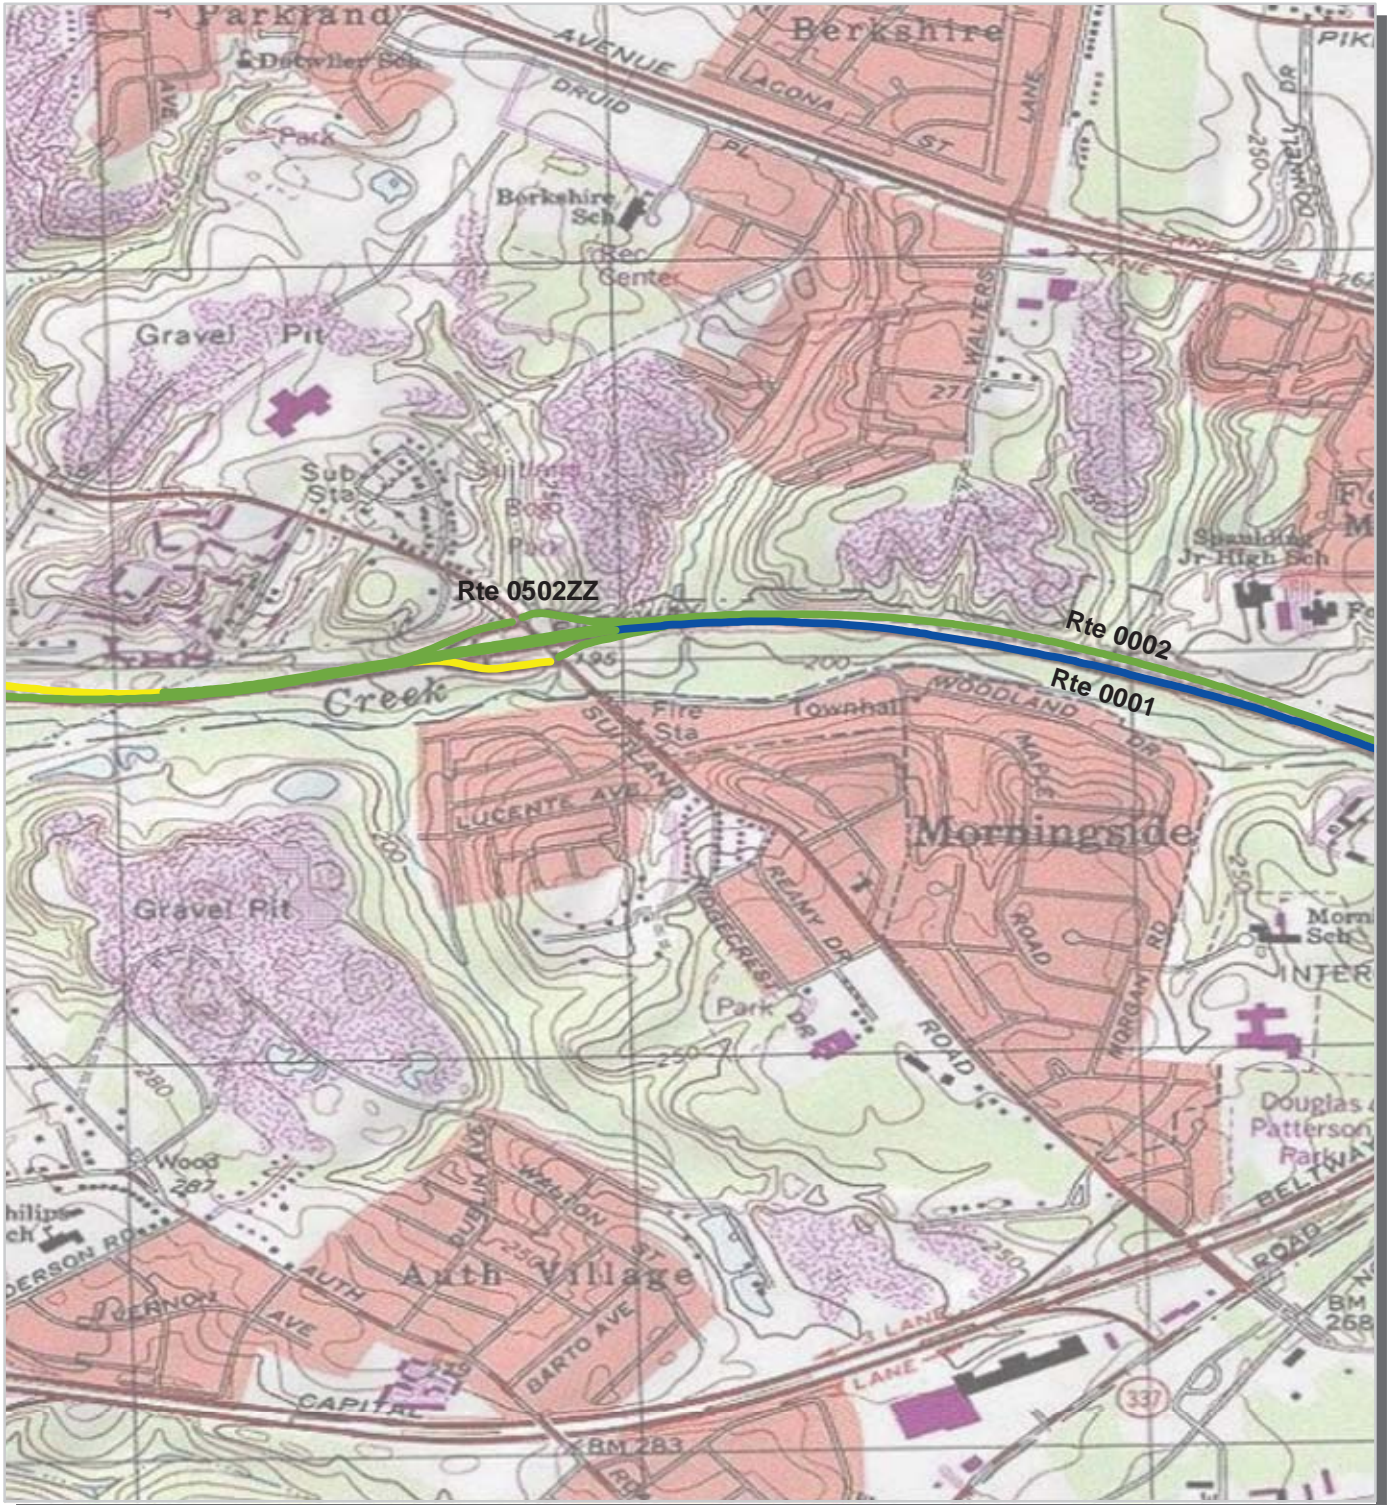
Suitland Parkway Route Condition Map PCR - Mile by Mile Area 3

PCR	Poor	Fair	Good	Excellent	No Data
	(≤60)	(61 - 84)	(85 - 94)	(95 - 100)

* If the PCR rating is not available for a section, the SCR rating will be displayed. See appendix for definitions and formulas.

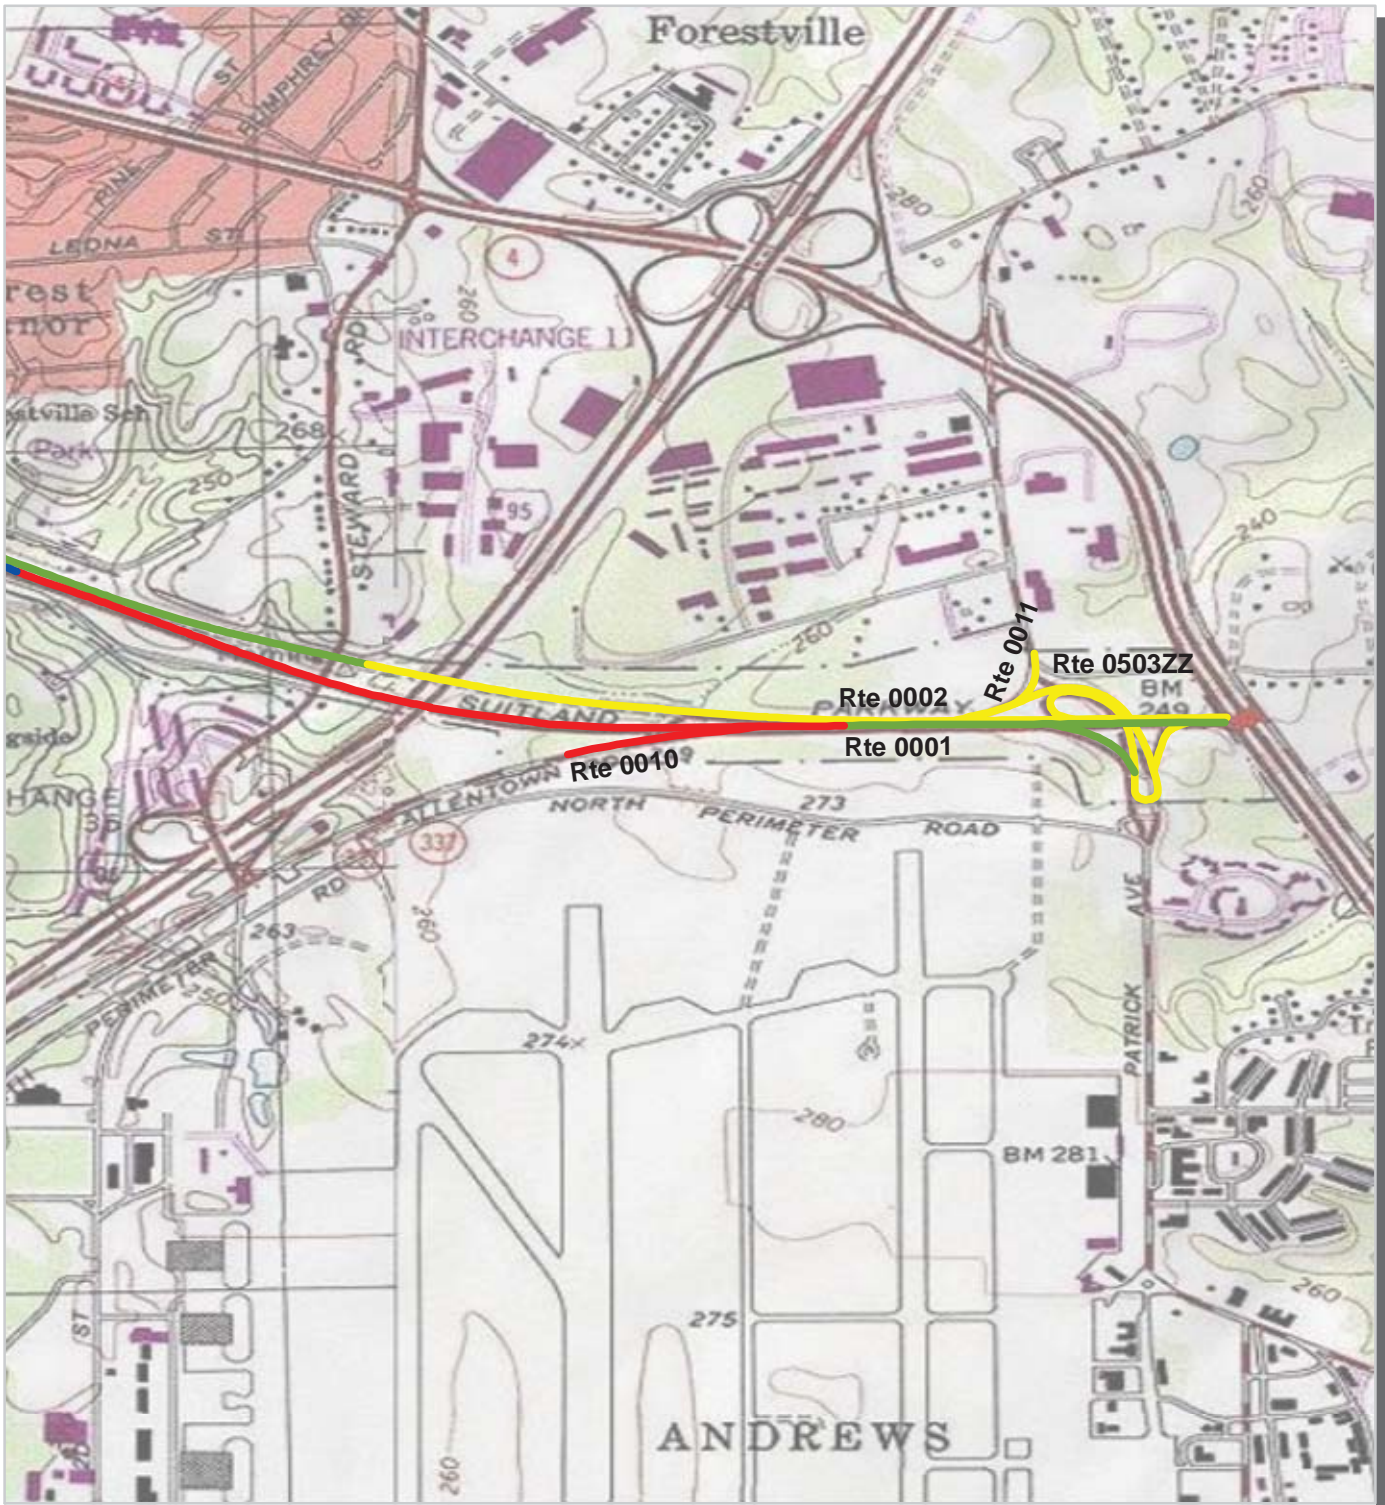
Suitland Parkway Route Condition Map PCR - Mile by Mile Area 4

PCR	Poor	Fair	Good	Excellent	No Data
	(≤60)	(61 - 84)	(85 - 94)	(95 - 100)

* If the PCR rating is not available for a section, the SCR rating will be displayed. See appendix for definitions and formulas.

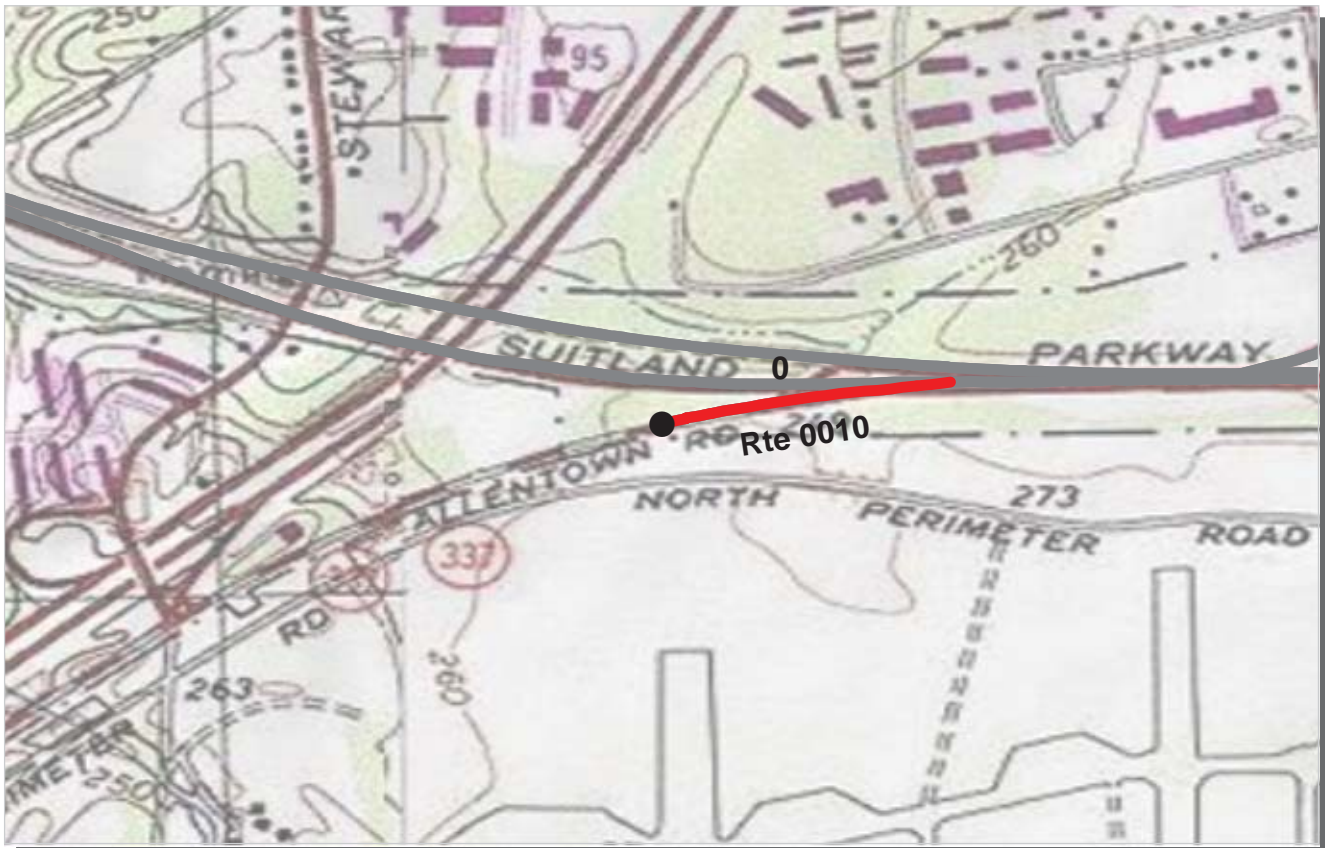
ROUTE: 0002 SUITLAND PARKWAY (WB)

PCR	Poor	Fair	Good	Excellent	No Data
	(≤60)	(61 - 84)	(85 - 94)	(95 - 100)

* If the PCR rating is not available for a section, the SCR rating will be displayed. See appendix for definitions and formulas.

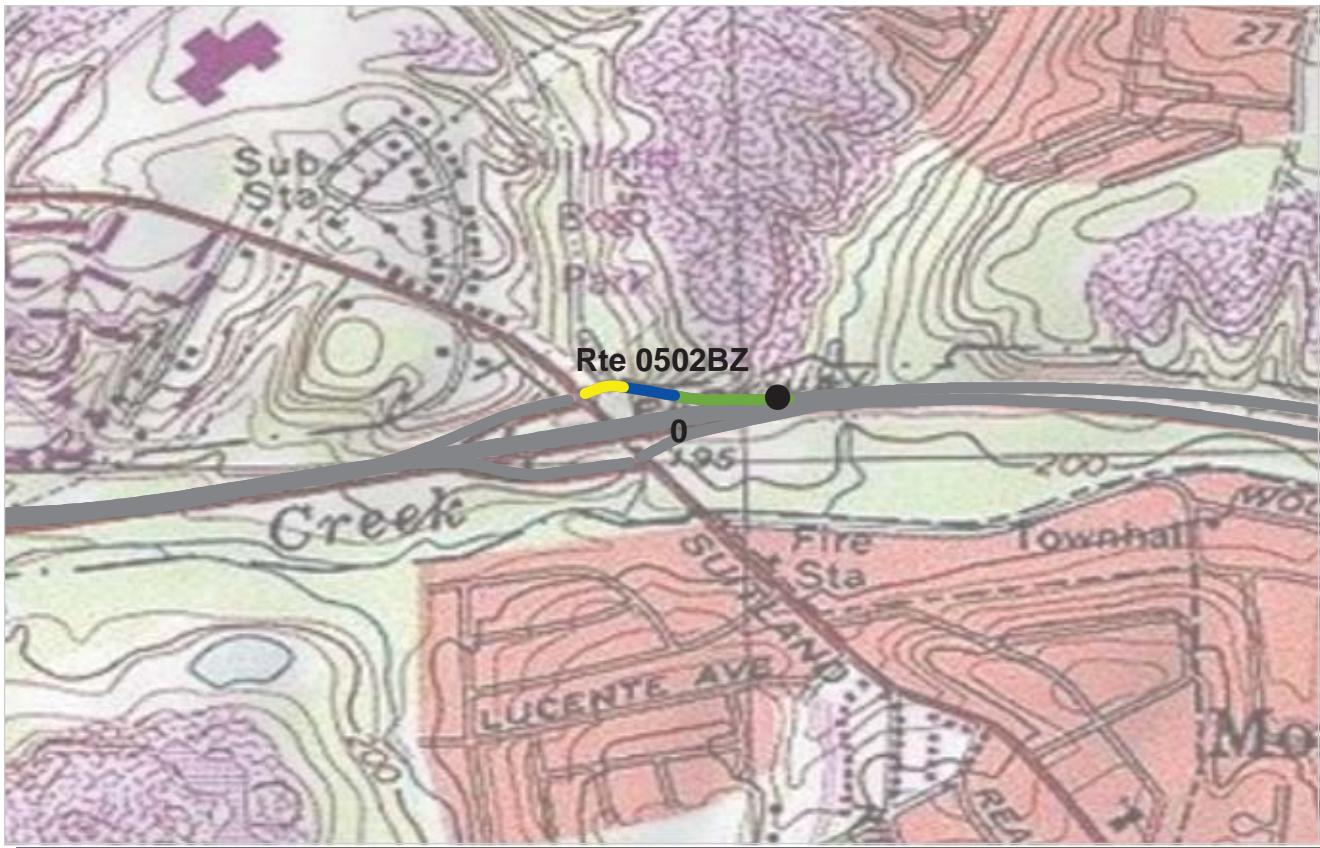
ROUTE: 0501GZ SILVER HILL ROAD INTERCHANGE RAMP G

PCR Poor ■ Fair ■ Good ■ Excellent ■ No Data ■
 (<=60) (61 - 84) (85 - 94) (95 - 100)

* If the PCR rating is not available for a section, the SCR rating will be displayed. See appendix for definitions and formulas.

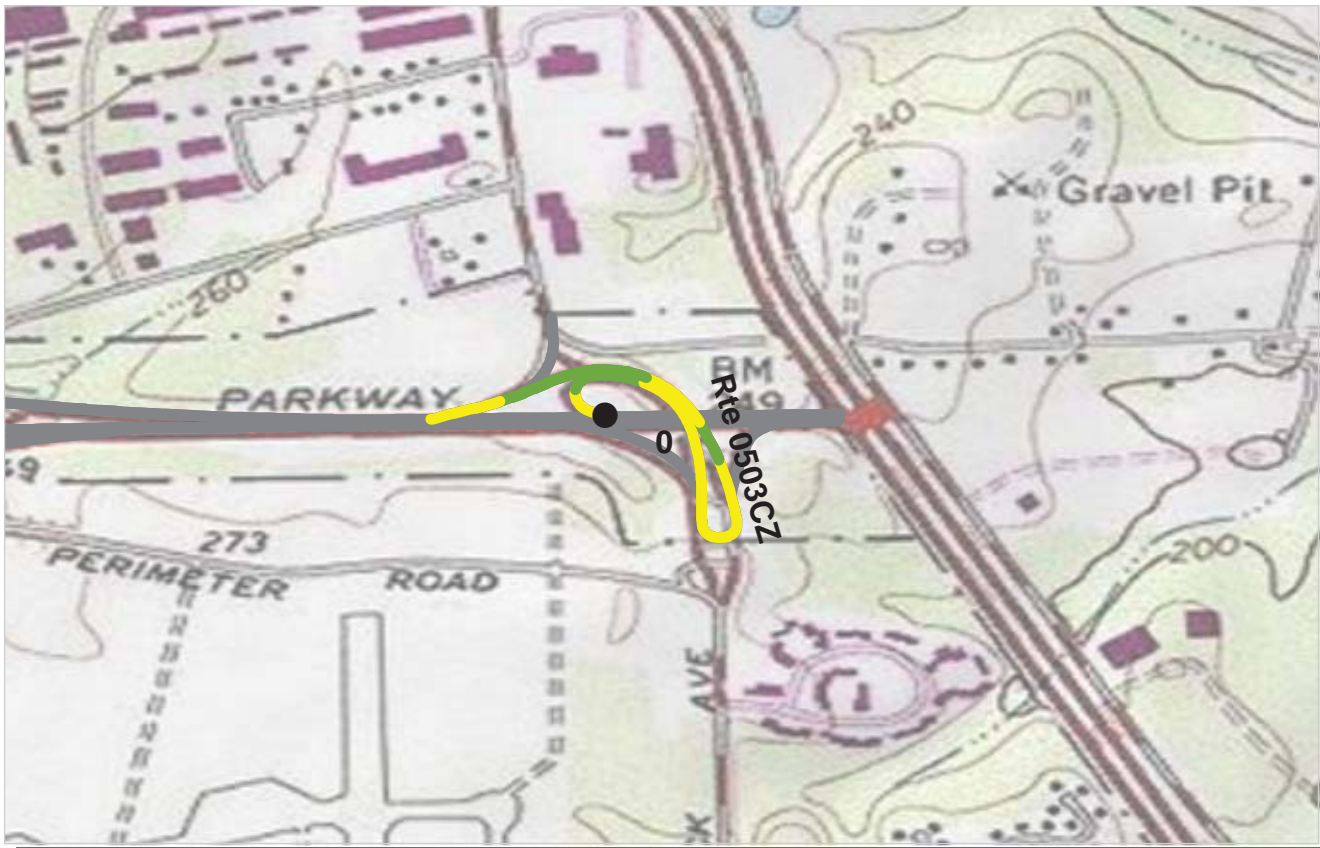
ROUTE: 0503AZ ANDREWS AFB NORTH GATE AND MARLBORO PIKE, MD 4 RAMP A

PCR	Poor	Fair	Good	Excellent	No Data
	(≤60)	(61 - 84)	(85 - 94)	(95 - 100)

* If the PCR rating is not available for a section, the SCR rating will be displayed. See appendix for definitions and formulas.

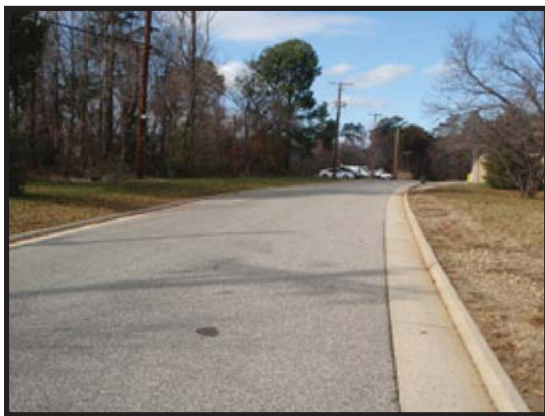
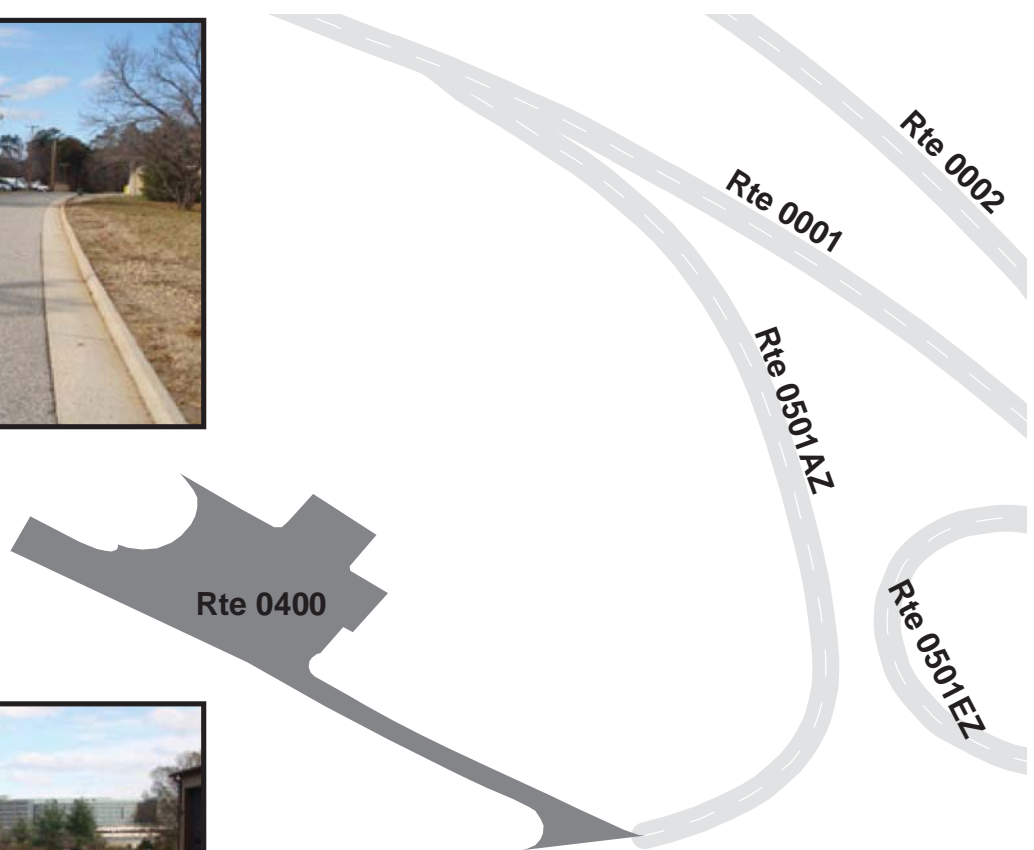
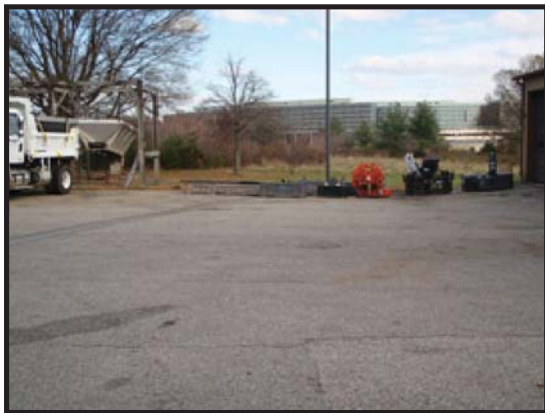
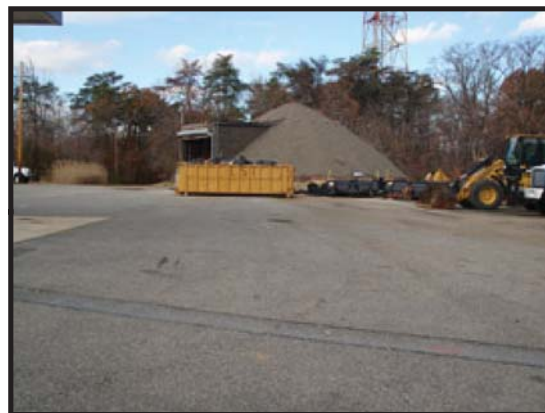
Route Number	Public / NonPublic	Date Visited		Area (sq ft)	Lane Miles *	Surface Type
0400	NONPUBLIC	12/2/2008		38,041	0.66	AS
Culverts	Drop Inlets	Gates	Fire Hydrants	Curb & Gutter	Curb	PCR
0	2	0	0	CONCRETE CURB AND GUTTER	NO CURB	FAIR/73

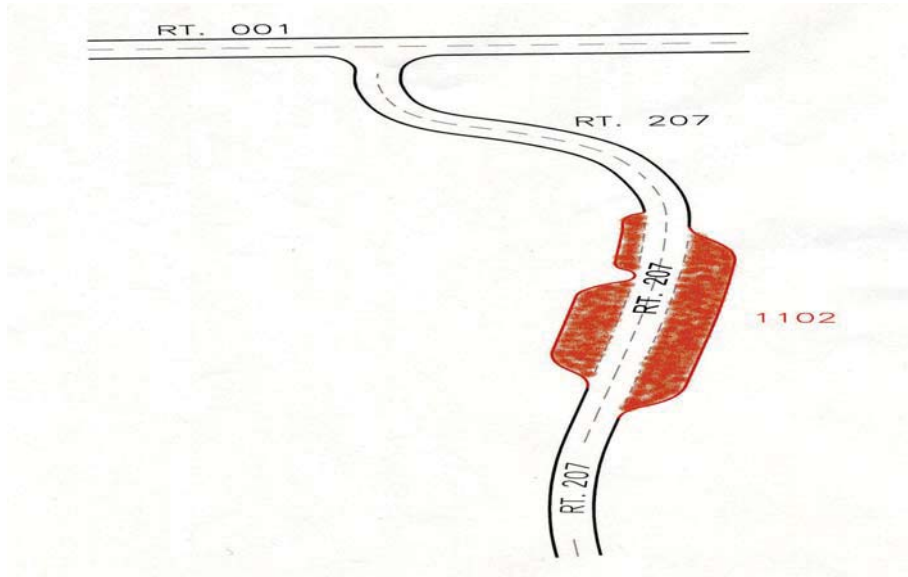
Figure 5: Parking with access route 207 running through and continuing beyond parking 1102. This access route cannot be considered a part of the parking area and two routes and two assets continue to exist.

Parking areas and roads may not be combined. Parking areas and roads are tracked as separate asset types (1300 vs. 1100) in FMSS and as such should not be combined except in situations described by 5g. In Figure 5, Route 207 is a spur road from the main route running through parking area 1102. Since the spur road continues through and beyond the parking area, it will remain a separate route.
