**The Road Inventory
of
Theodore Roosevelt National Park
THRO – 1540
Cycle 4**

**Prepared By:
Federal Highway Administration
Road Inventory Program
Cycle 4**

Theodore Roosevelt National Park in North Dakota

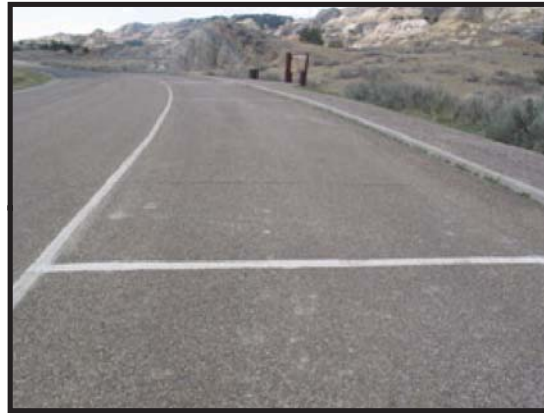
Route 0927

Route Number	Public / NonPublic	Date Visited		Area (sq ft)	Lane Miles *	Surface Type
0927	PUBLIC	5/15/2008		3,550	0.06	AS
Culverts	Drop Inlets	Gates	Fire Hydrants	Curb & Gutter	Curb	PCR
0	0	0	0	NO CURB AND GUTTER	CONCRETE CURB	GOOD/90

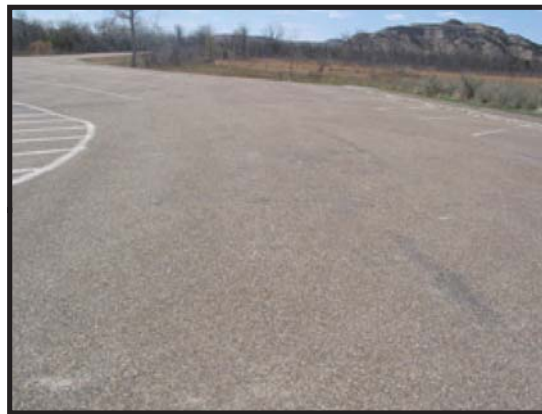
Route 0928

Route Number	Public / NonPublic	Date Visited		Area (sq ft)	Lane Miles *	Surface Type
0928	PUBLIC	5/15/2008		13,638	0.24	AS
Culverts	Drop Inlets	Gates	Fire Hydrants	Curb & Gutter	Curb	PCR
0	0	0	0	NO CURB AND GUTTER	CONCRETE CURB	FAIR/73

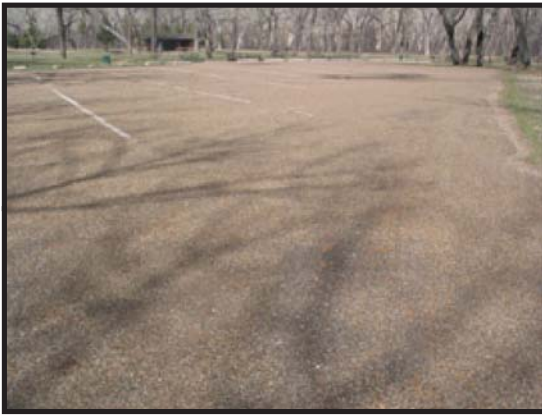
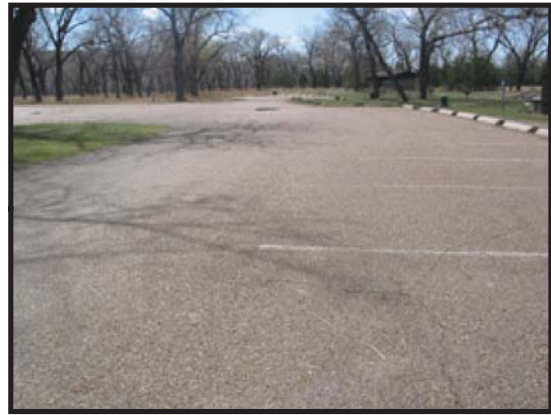
Route 0930

Route Number	Public / NonPublic	Date Visited		Area (sq ft)	Lane Miles *	Surface Type
0930	PUBLIC	5/15/2008		26,355	0.45	AS
Culverts	Drop Inlets	Gates	Fire Hydrants	Curb & Gutter	Curb	PCR
0	0	0	0	NO CURB AND GUTTER	NO CURB	GOOD/90

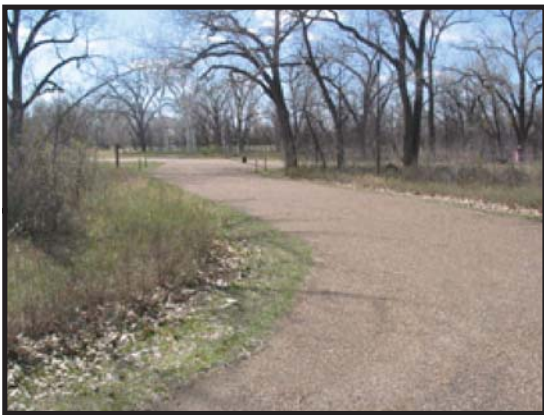
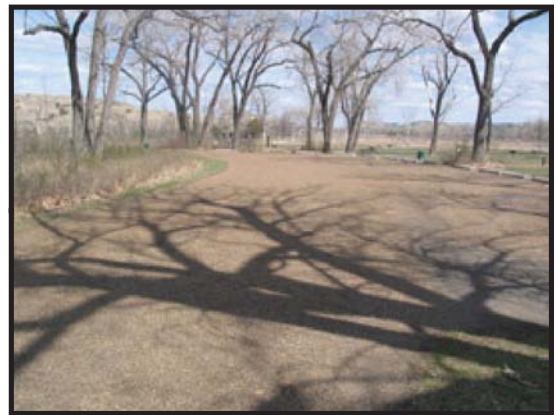
Route 0931

Route Number	Public / NonPublic	Date Visited		Area (sq ft)	Lane Miles *	Surface Type
0931	PUBLIC	5/15/2008		17,488	0.30	AS
Culverts	Drop Inlets	Gates	Fire Hydrants	Curb & Gutter	Curb	PCR
0	0	2	0	NO CURB AND GUTTER	NO CURB	GOOD/90

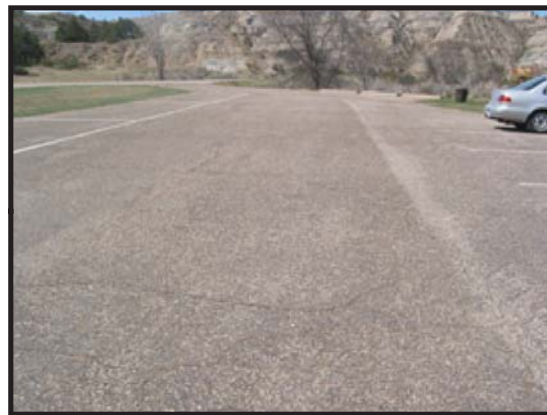
Route 0933

Route Number	Public / NonPublic	Date Visited		Area (sq ft)	Lane Miles *	Surface Type
0933	PUBLIC	5/15/2008		9,125	0.16	AS
Culverts	Drop Inlets	Gates	Fire Hydrants	Curb & Gutter	Curb	PCR
0	0	0	0	NO CURB AND GUTTER	NO CURB	FAIR/73

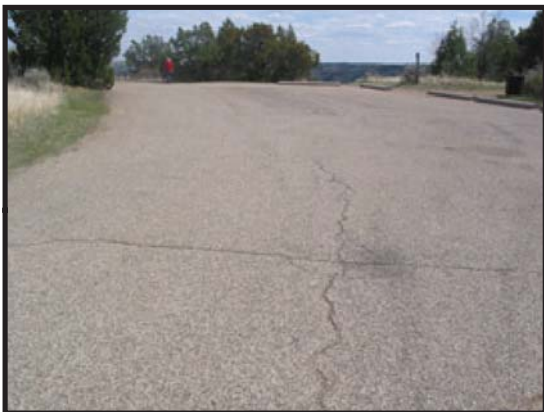
Route 0934

Route Number	Public / NonPublic	Date Visited		Area (sq ft)	Lane Miles *	Surface Type
0934	PUBLIC	5/15/2008		13,654	0.24	AS
Culverts	Drop Inlets	Gates	Fire Hydrants	Curb & Gutter	Curb	PCR
0	0	0	0	NO CURB AND GUTTER	NO CURB	FAIR/73

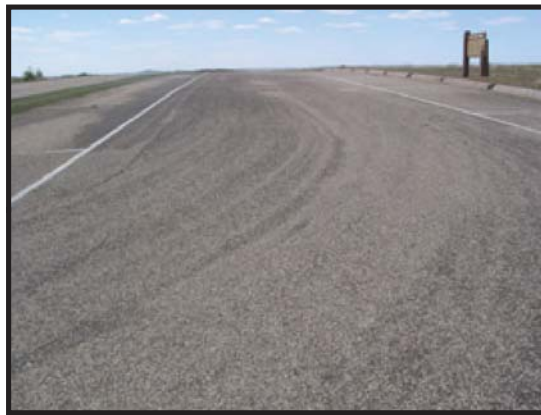
Route 0936

Route Number	Public / NonPublic	Date Visited		Area (sq ft)	Lane Miles *	Surface Type
0936	PUBLIC	5/15/2008		8,379	0.14	AS
Culverts	Drop Inlets	Gates	Fire Hydrants	Curb & Gutter	Curb	PCR
0	0	0	0	NO CURB AND GUTTER	NO CURB	FAIR/73

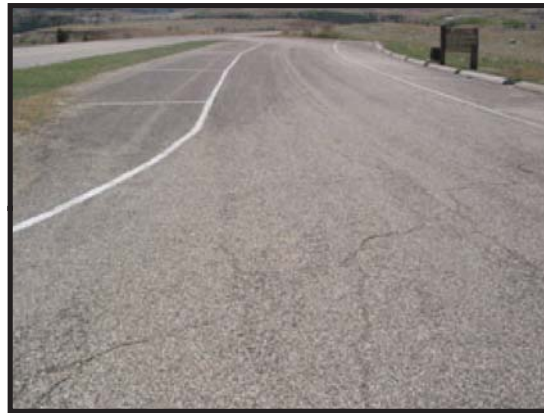
Route 0937

Route Number	Public / NonPublic	Date Visited		Area (sq ft)	Lane Miles *	Surface Type
0937	PUBLIC	5/15/2008		7,310	0.13	AS
Culverts	Drop Inlets	Gates	Fire Hydrants	Curb & Gutter	Curb	PCR
0	0	0	0	NO CURB AND GUTTER	NO CURB	FAIR/73

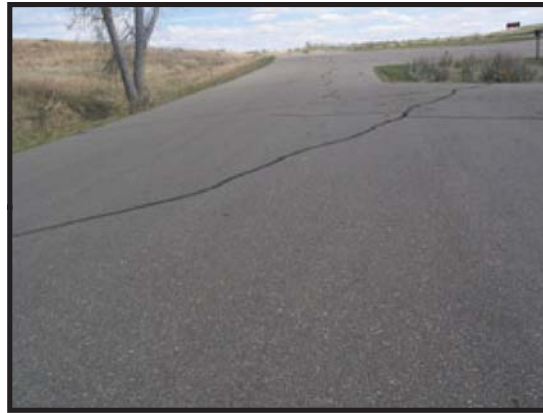
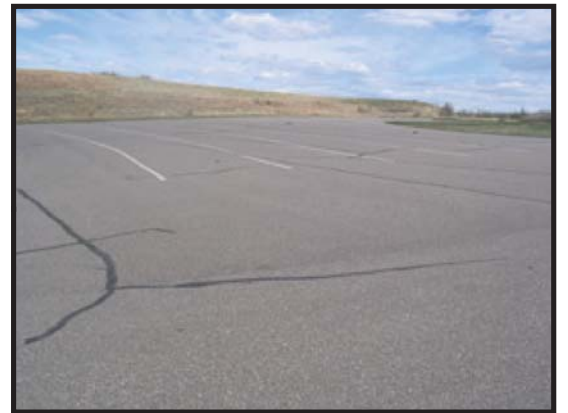
Route 0938

Route Number	Public / NonPublic	Date Visited		Area (sq ft)	Lane Miles *	Surface Type
0938	PUBLIC	5/15/2008		29,365	0.51	AS
Culverts	Drop Inlets	Gates	Fire Hydrants	Curb & Gutter	Curb	PCR
1	0	0	0	NO CURB AND GUTTER	NO CURB	FAIR/73

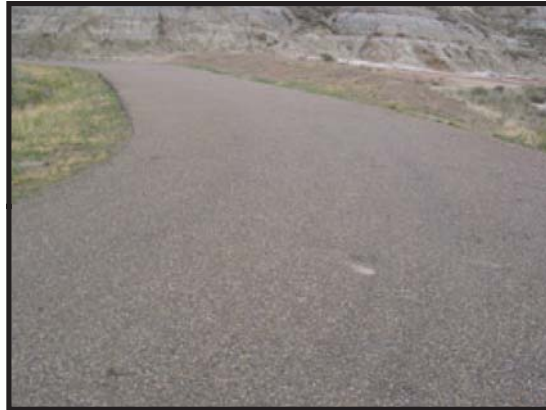
Route Number	Public / NonPublic	Date Visited		Area (sq ft)	Lane Miles *	Surface Type
0941	PUBLIC	5/15/2008		8,016	0.14	AS
Culverts	Drop Inlets	Gates	Fire Hydrants	Curb & Gutter	Curb	PCR
0	0	0	0	NO CURB AND GUTTER	NO CURB	GOOD/90

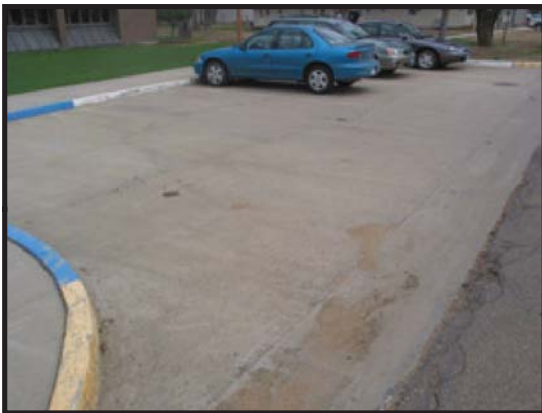
Route 0944

Route Number	Public / NonPublic	Date Visited		Area (sq ft)	Lane Miles *	Surface Type
0944	PUBLIC	5/15/2008		1,373	0.02	CO
Culverts	Drop Inlets	Gates	Fire Hydrants	Curb & Gutter	Curb	PCR
0	0	0	0	NO CURB AND GUTTER	CONCRETE CURB	FAIR/73

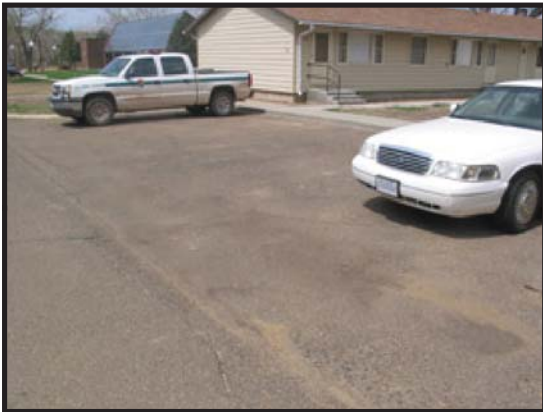
Route Number	Public / NonPublic	Date Visited		Area (sq ft)	Lane Miles *	Surface Type
0945CZ	NONPUBLIC	5/15/2008		1,219	0.02	AS
Culverts	Drop Inlets	Gates	Fire Hydrants	Curb & Gutter	Curb	PCR
0	0	0	0	NO CURB AND GUTTER	CONCRETE CURB	FAIR/73

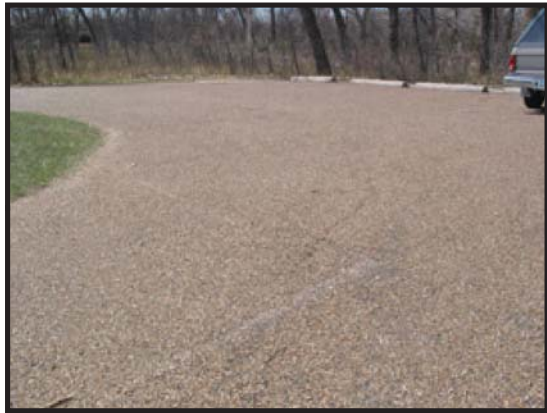
Route 0946

Route Number	Public / NonPublic	Date Visited		Area (sq ft)	Lane Miles *	Surface Type
0946	PUBLIC	5/15/2008		7,192	0.12	AS
Culverts	Drop Inlets	Gates	Fire Hydrants	Curb & Gutter	Curb	PCR
0	0	0	0	NO CURB AND GUTTER	NO CURB	FAIR/73

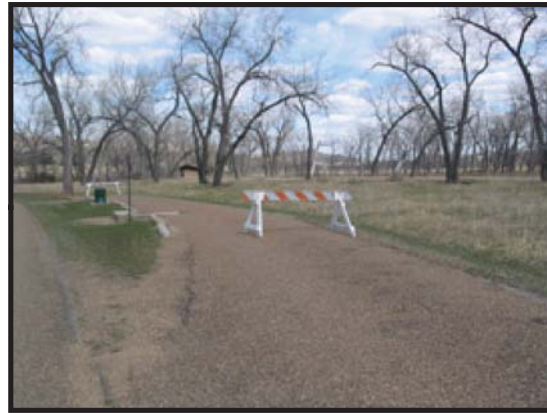
Route 0947

Route Number	Public / NonPublic	Date Visited		Area (sq ft)	Lane Miles *	Surface Type
0947	PUBLIC	5/15/2008		2,545	0.04	AS
Culverts	Drop Inlets	Gates	Fire Hydrants	Curb & Gutter	Curb	PCR
0	0	0	0	NO CURB AND GUTTER	NO CURB	GOOD/90

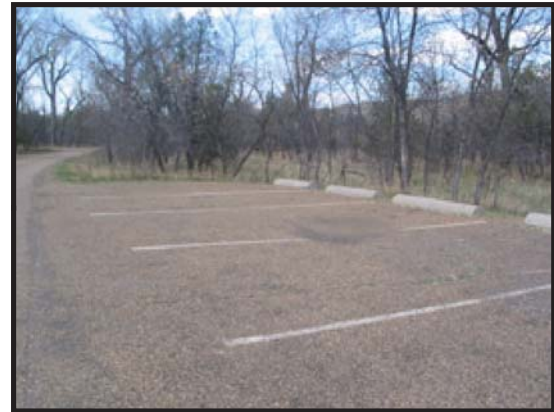
Route 0948

Route Number	Public / NonPublic	Date Visited		Area (sq ft)	Lane Miles *	Surface Type
0948	PUBLIC	5/15/2008		1,296	0.02	AS
Culverts	Drop Inlets	Gates	Fire Hydrants	Curb & Gutter	Curb	PCR
0	0	0	0	NO CURB AND GUTTER	NO CURB	FAIR/73
