**The Road Inventory
of
Tuzigoot National Monument
TUZI – 8700
Cycle 4**

**Prepared By:
Federal Highway Administration
Road Inventory Program
Cycle 4**

Tuzigoot National Monument in Arizona

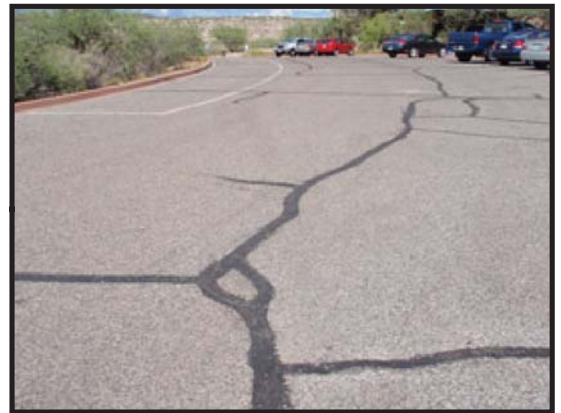
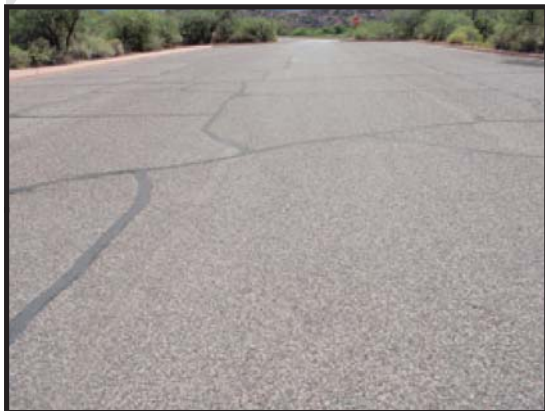
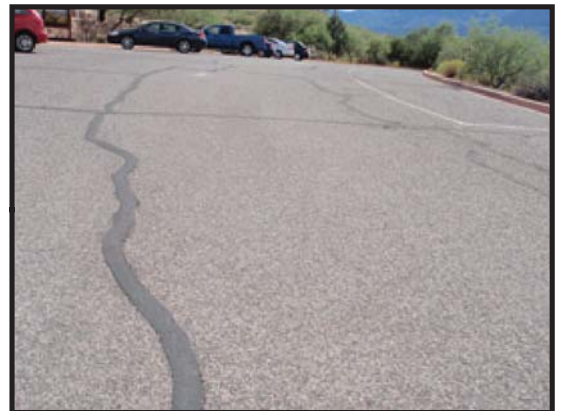
Route 0900

Route Number	Public / NonPublic	Date Visited		Area (sq ft)	Lane Miles *	Surface Type
0900	PUBLIC	9/11/2009		35,521	0.61	AS
Culverts	Drop Inlets	Gates	Fire Hydrants	Curb & Gutter	Curb	PCR
1	0	0	0	CONCRETE CURB AND GUTTER	NO CURB	FAIR/73

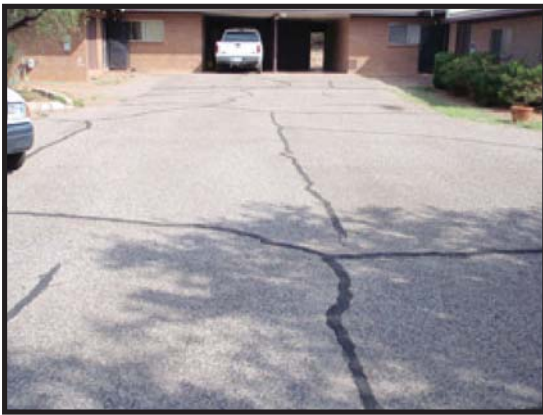
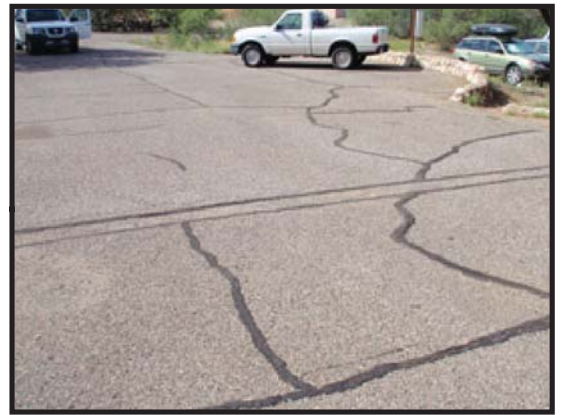
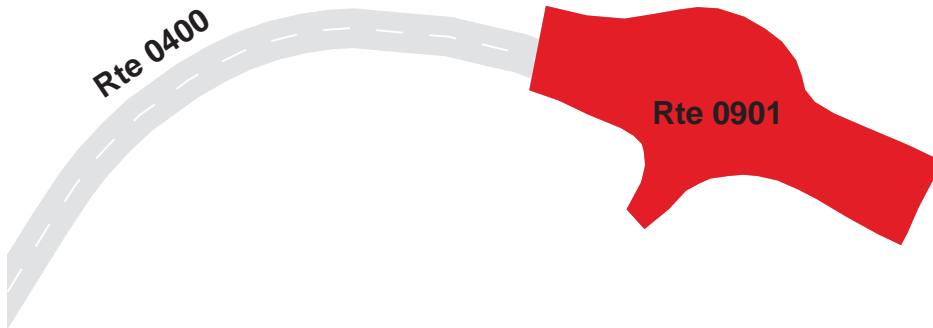
Route 0901

Route Number	Public / NonPublic	Date Visited		Area (sq ft)	Lane Miles *	Surface Type
0901	NONPUBLIC	9/11/2009		3,204	0.06	AS
Culverts	Drop Inlets	Gates	Fire Hydrants	Curb & Gutter	Curb	PCR
0	0	0	0	NO CURB AND GUTTER	STONE CURB	FAIR/73
