**The Road Inventory
of
Wind Cave National Park
WICA – 1560
Cycle 4**

**Prepared By:
Federal Highway Administration
Road Inventory Program
Cycle 4**

Wind Cave National Park in South Dakota

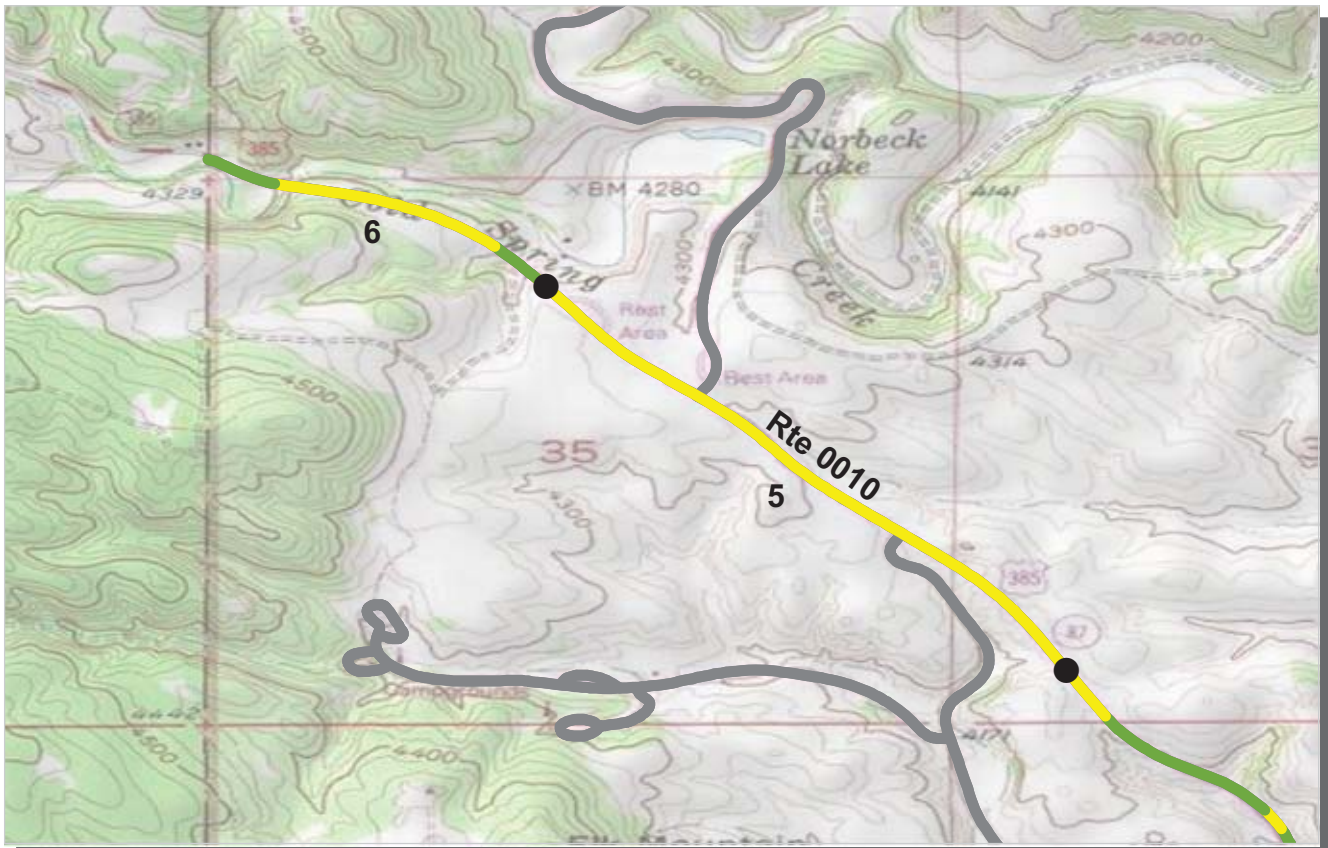
ROUTE: 0010 WIND CAVE HIGHWAY (U.S. 385)

PCR	Poor	Fair	Good	Excellent	No Data
	(≤60)	(61 - 84)	(85 - 94)	(95 - 100)

Section Number	5	6			
Section Length (mi)	1.00	0.52			
Traffic	Traffic data may be found at www.efl.fhwa.dot.gov Click on PROGRAMS / NPS Traffic Data (Note: Not all parks have traffic data)				
Cross Section Information					
Number of Lanes	2	2			
Paved Width (ft)	35	31			
Lane Width (ft)	11	11			
Shoulder Width Right (ft)	NC	NC			
Shoulder Width Left (ft)	NC	NC			
Roadway Condition Information					
SCR (Surface Condition Rating)	67	67			
PCR (Pavement Condition Rating)	80	80			
Distress Index Values					
Alligator Cracking Index	100	100			
Longitudinal Cracking Index	100	100			
Transverse Cracking Index	100	100			
Patching Index	100	100			
Rutting Index	67	68			
Roughness Condition Index (RCI)	100	100

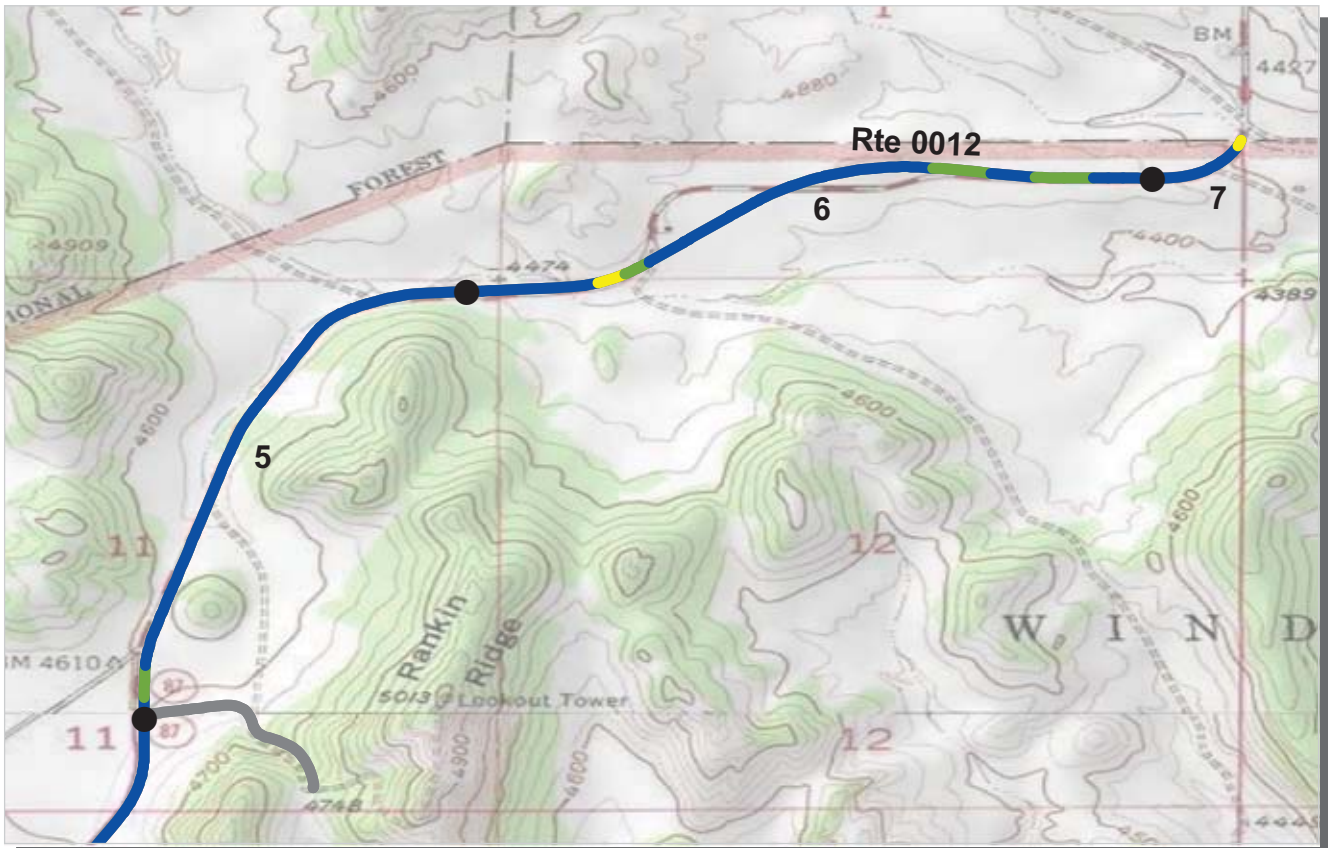
ROUTE: 0012 NORTH ENTRANCE ROAD (HWY 87)

PCR Poor ■ Fair ■ Good ■ Excellent ■ No Data ■
 (<=60) (61 - 84) (85 - 94) (95 - 100)

Section Number	5	6	7		
Section Length (mi)	1.00	1.00	0.15		
Traffic	Traffic data may be found at www.efl.fhwa.dot.gov Click on PROGRAMS / NPS Traffic Data (Note: Not all parks have traffic data)				
Cross Section Information					
Number of Lanes	2	2	2		
Paved Width (ft)	22	22	22		
Lane Width (ft)	9	9	10		
Shoulder Width Right (ft)	NC	NC	NC		
Shoulder Width Left (ft)	NC	NC	NC		
Roadway Condition Information					
SCR (Surface Condition Rating)	96	93	98		
PCR (Pavement Condition Rating)	98	96	96		
Distress Index Values					
Alligator Cracking Index	100	100	100		
Longitudinal Cracking Index	100	100	100		
Transverse Cracking Index	100	100	100		
Patching Index	100	100	100		
Rutting Index	96	93	98		
Roughness Condition Index (RCI)	100	100	94

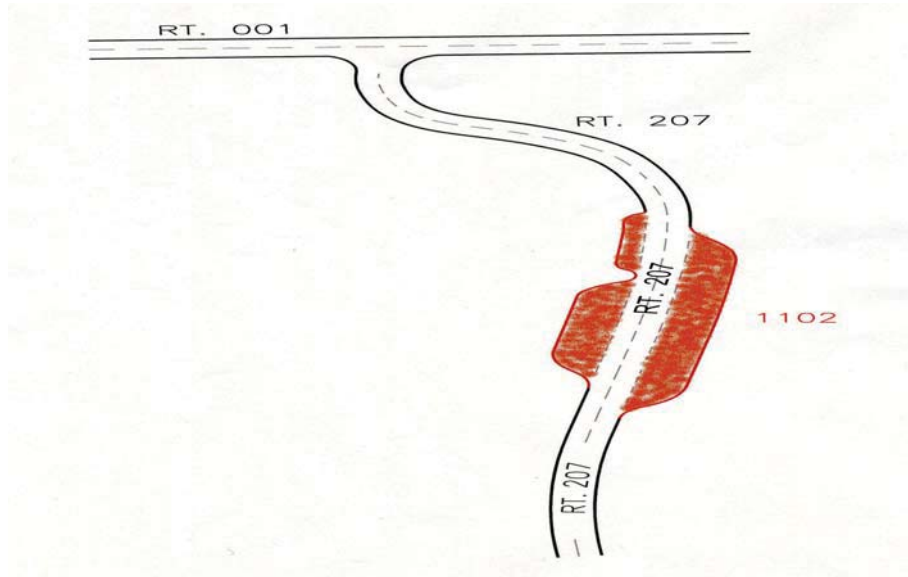
Figure 5: Parking with access route 207 running through and continuing beyond parking 1102. This access route cannot be considered a part of the parking area and two routes and two assets continue to exist.

Parking areas and roads may not be combined. Parking areas and roads are tracked as separate asset types (1300 vs. 1100) in FMSS and as such should not be combined except in situations described by 5g. In Figure 5, Route 207 is a spur road from the main route running through parking area 1102. Since the spur road continues through and beyond the parking area, it will remain a separate route.
