Federal Lands Highway Road Inventory Program

Road Inventory and Condition Assessment

Agate Fossil Beds National Monument

Cycle 5 Report

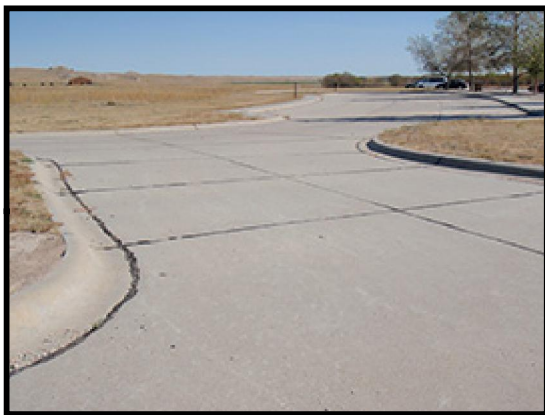
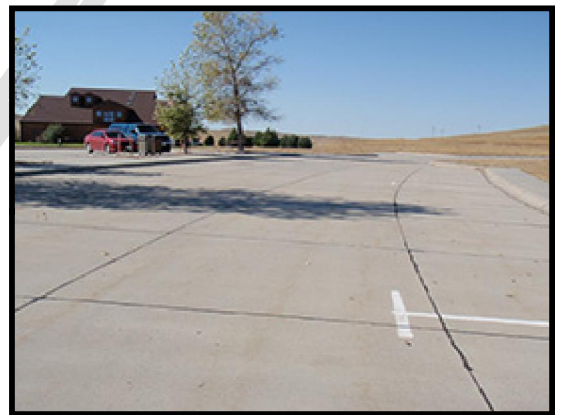
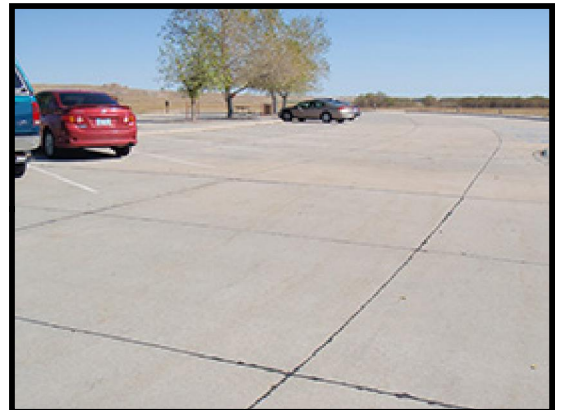
Route 0900

Route Number	Public / NonPublic	Date Visited	Area (sq ft)	Lane Miles *	Surface Type
0900	PUBLIC	10/1/2010	42,421	0.73	CO
Culverts	Drop Inlets	Gates	Curb & Gutter	Curb	PCR
0	3	0	CONCRETE CURB AND GUTTER	NO CURB	GOOD/90

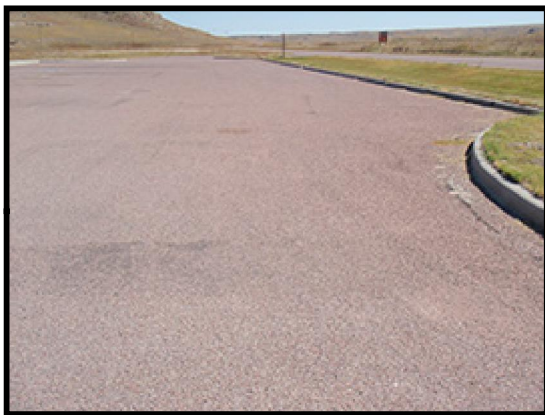
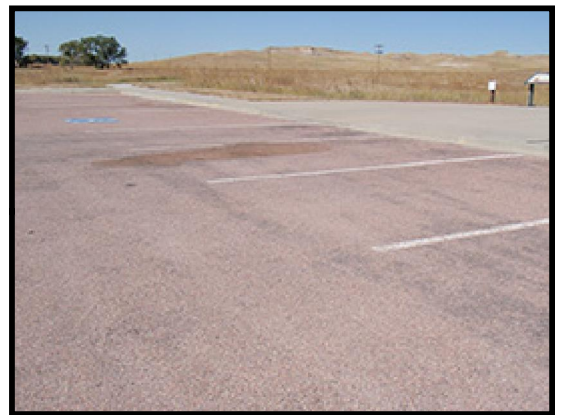
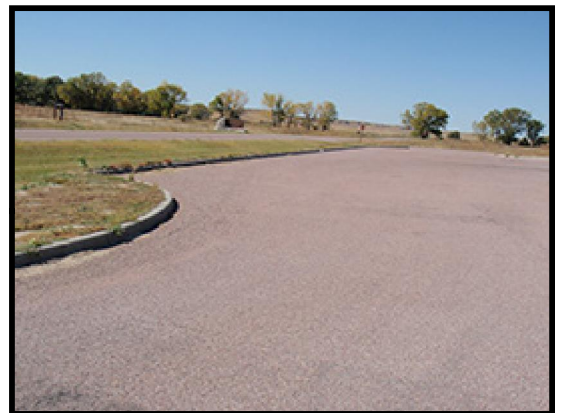
Route Number	Public / NonPublic	Date Visited	Area (sq ft)	Lane Miles *	Surface Type
0901	PUBLIC	10/1/2010	15,699	0.27	AS
Culverts	Drop Inlets	Gates	Curb & Gutter	Curb	PCR
0	0	0	CONCRETE CURB AND GUTTER	NO CURB	GOOD/90

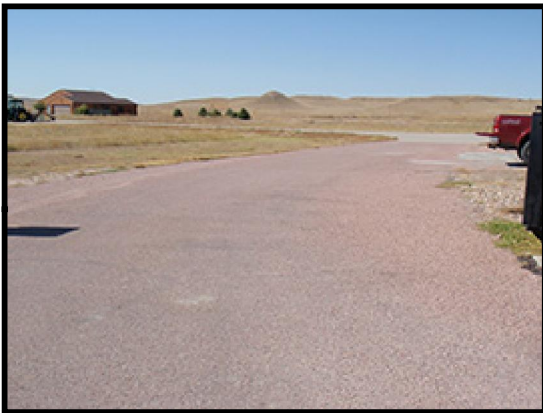
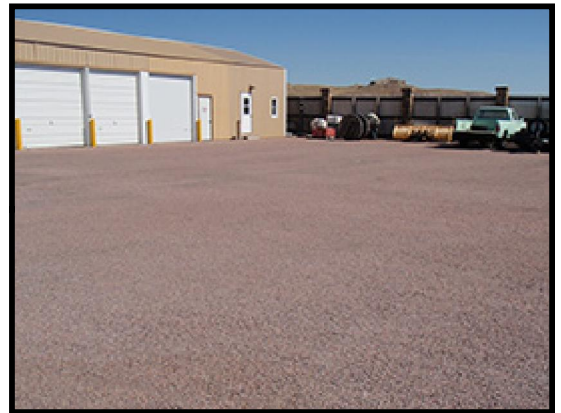
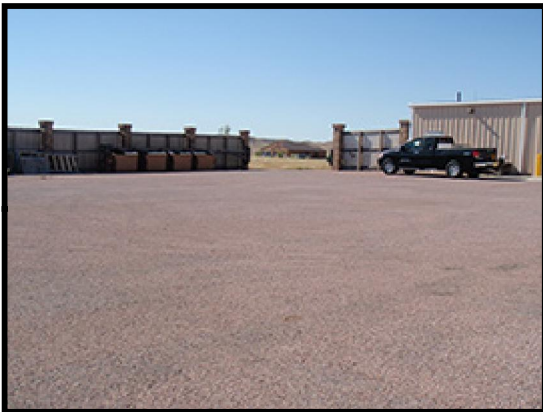
Route Number	Public / NonPublic	Date Visited	Area (sq ft)	Lane Miles *	Surface Type
0902	PUBLIC	10/1/2010	25,909	0.45	AS
Culverts	Drop Inlets	Gates	Curb & Gutter	Curb	PCR
1	0	1	NO CURB AND GUTTER	NO CURB	GOOD/90
