Federal Lands Highway Road Inventory Program

Road Inventory and Condition Assessment

Allegheny Portage Railroad National Historic Site ALPO

Cycle 5 Report

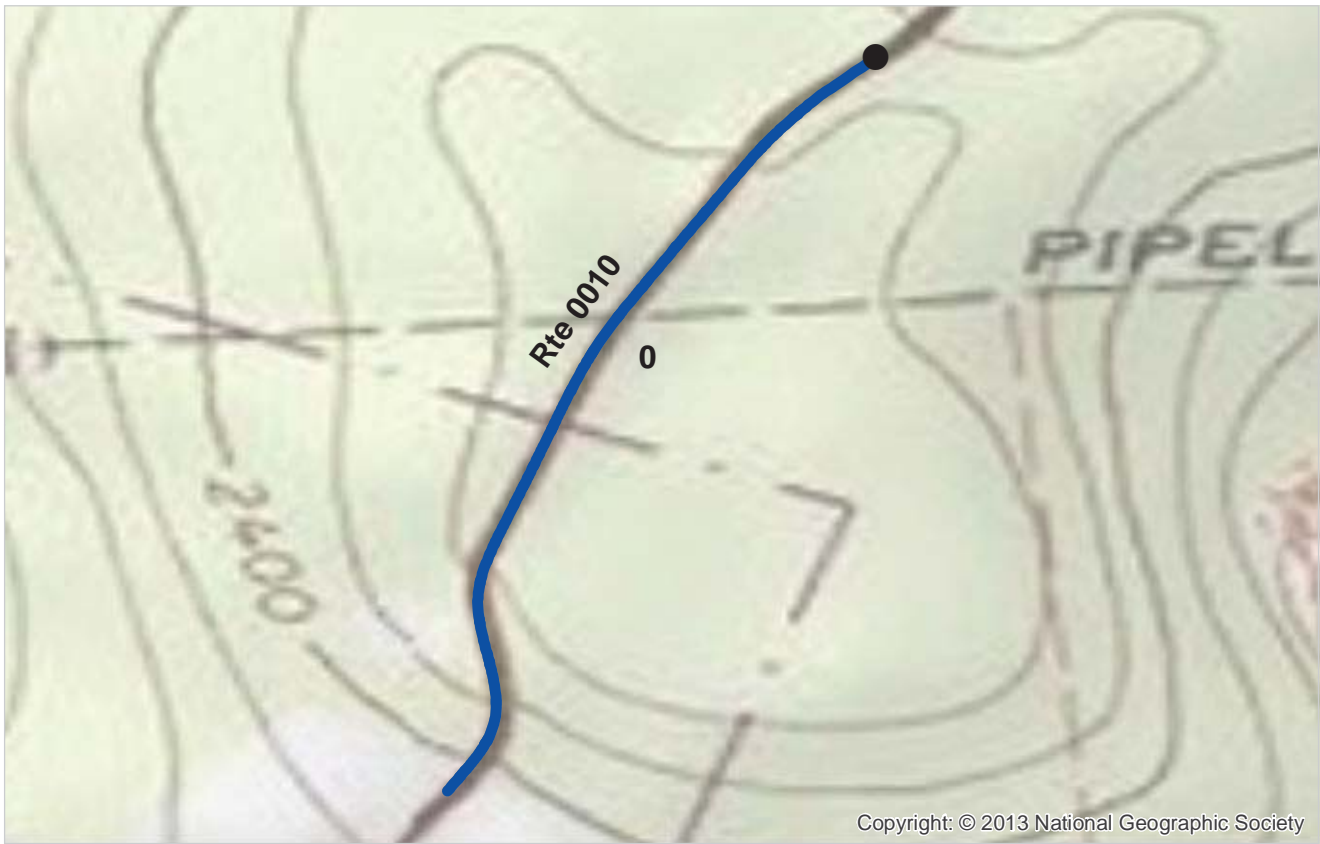
ROUTE: 0010 VISITOR CENTER ROAD

Section Number	0				
Section Length (mi)	0.41				
Cross Section Information					
Number of Lanes	2				
Paved Width (ft)	23				
Lane Width (ft)	11				
Roadway Condition Information					
SCR (Surface Condition Rating)	99				
PCR (Pavement Condition Rating)	99				
Distress Index Values					
Structural Crack Index	100				
Transverse Cracking Index	100				
Patching Index	100				
Rutting Index	99				
Roughness Condition Index (RCI)	NC

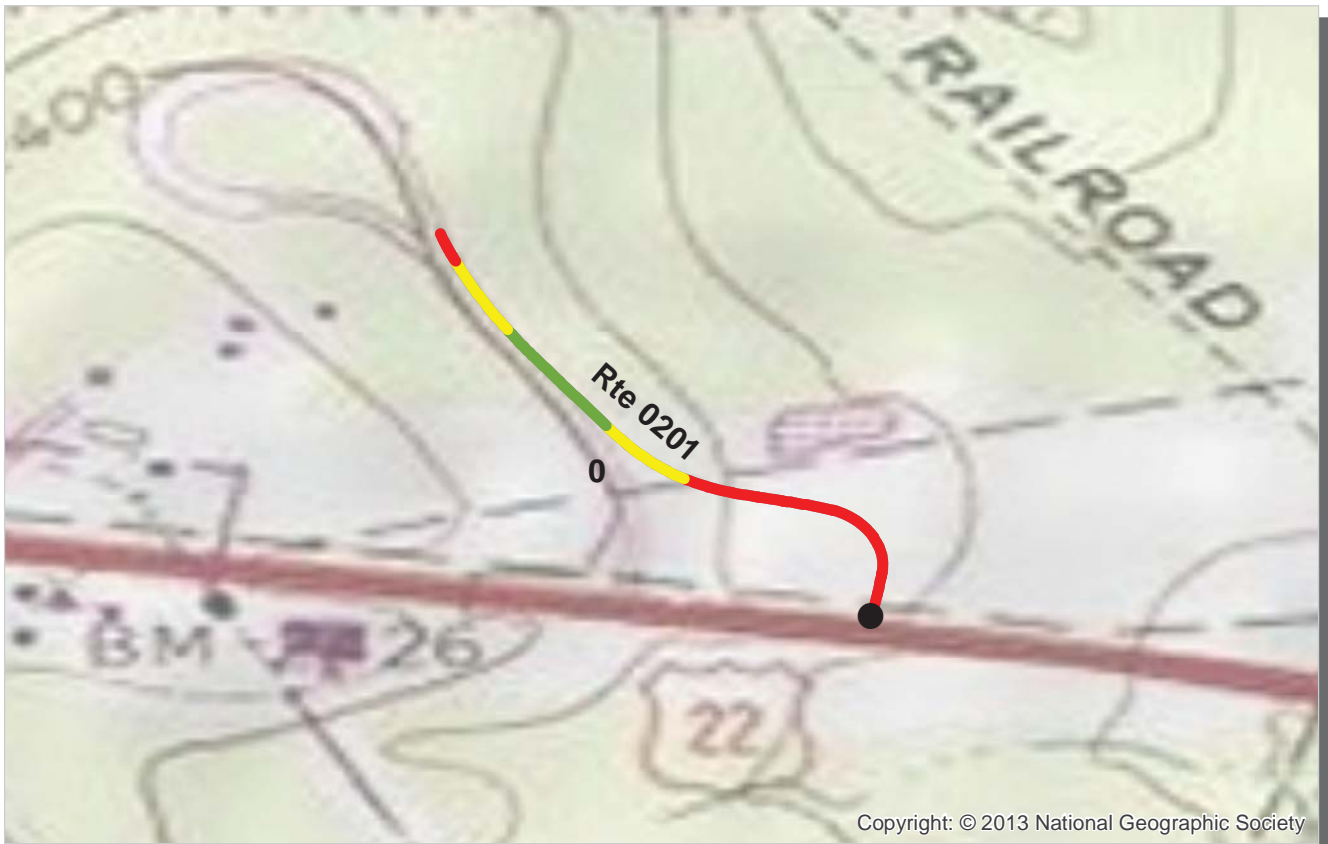
ROUTE: 0201 SUMMIT PICNIC AREA ROAD

Section Number	0				
Section Length (mi)	0.27				
Cross Section Information					
Number of Lanes	2				
Paved Width (ft)	19				
Lane Width (ft)	10				
Roadway Condition Information					
SCR (Surface Condition Rating)	68				
PCR (Pavement Condition Rating)	68				
Distress Index Values					
Structural Crack Index	68				
Transverse Cracking Index	88				
Patching Index	95				
Rutting Index	94				
Roughness Condition Index (RCI)	NC

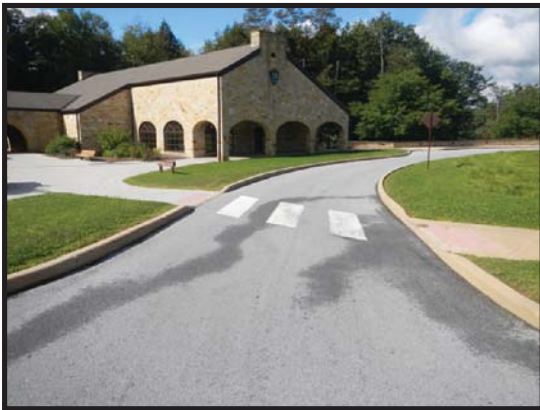
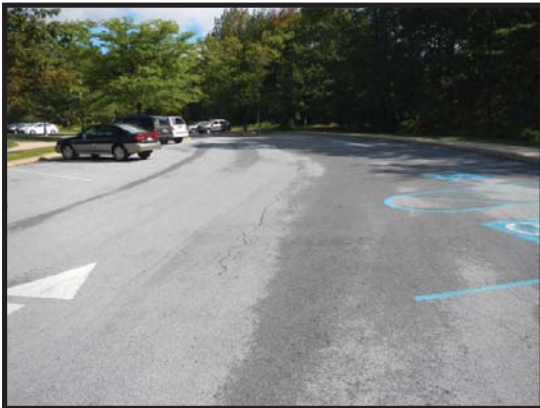
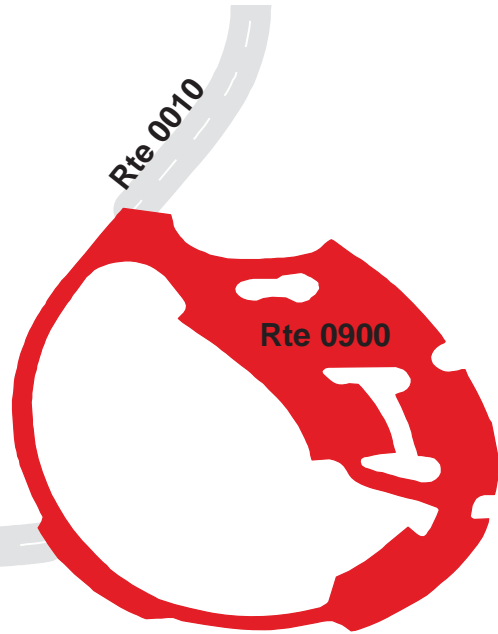
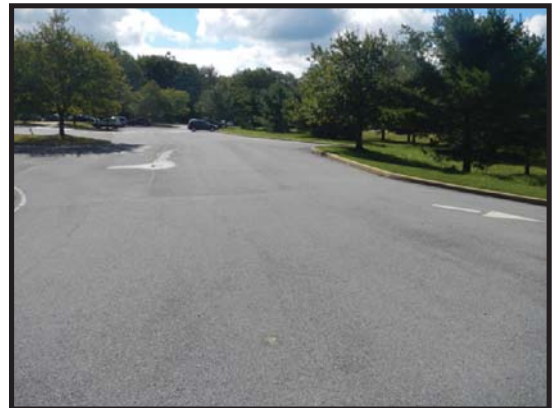
Route Number	Public / NonPublic	Date Visited	Area (sq ft)	Lane Miles *	Surface Type
0900	PUBLIC	9/16/2013	59,732	1.03	AS
Culverts	Drop Inlets	Gates	Curb & Gutter	Curb	PCR
2	7	0	NO CURB AND GUTTER	CONCRETE CURB	GOOD/90

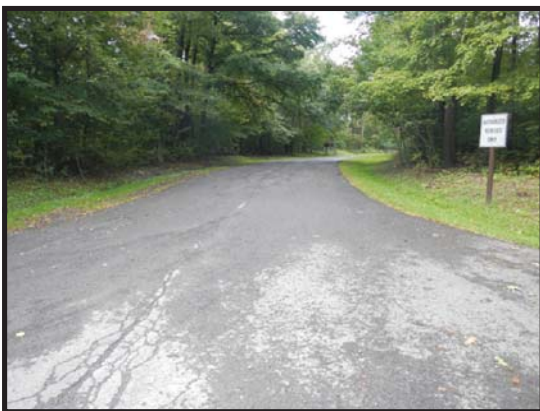
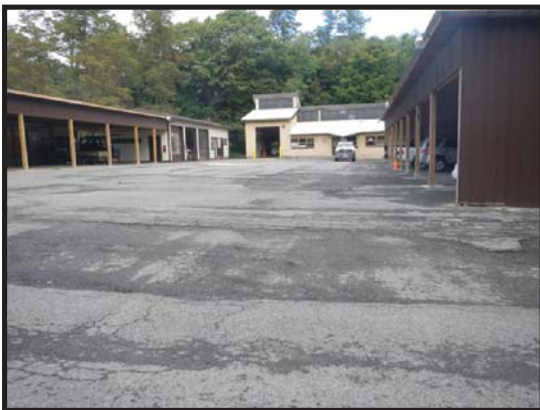
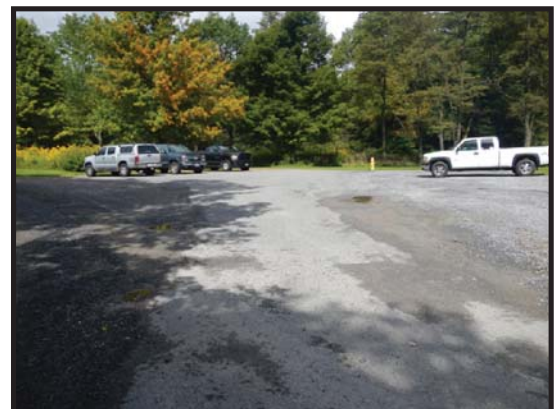
Route 0902

Route Number	Public / NonPublic	Date Visited	Area (sq ft)	Lane Miles *	Surface Type
0902	NONPUBLIC	9/16/2013	23,392	0.40	AS
Culverts	Drop Inlets	Gates	Curb & Gutter	Curb	PCR
0	0	1	NO CURB AND GUTTER	NO CURB	POOR/45

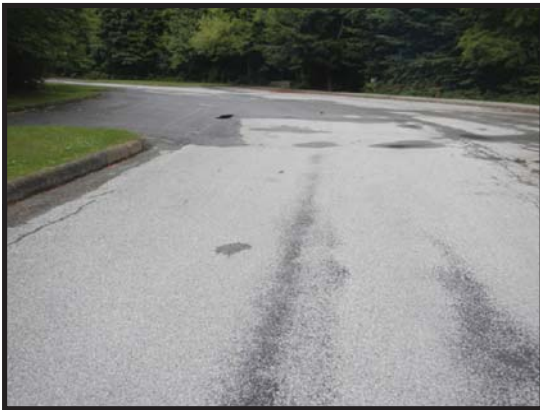
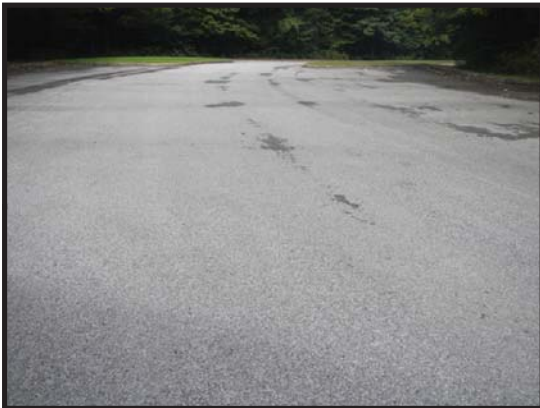
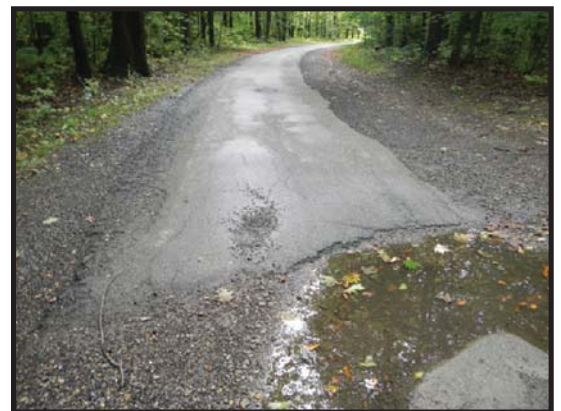
Route 0903

Route Number	Public / NonPublic	Date Visited	Area (sq ft)	Lane Miles *	Surface Type
0903	PUBLIC	9/16/2013	60,848	1.05	AS
Culverts	Drop Inlets	Gates	Curb & Gutter	Curb	PCR
0	9	0	NO CURB AND GUTTER	CONCRETE CURB	POOR/45

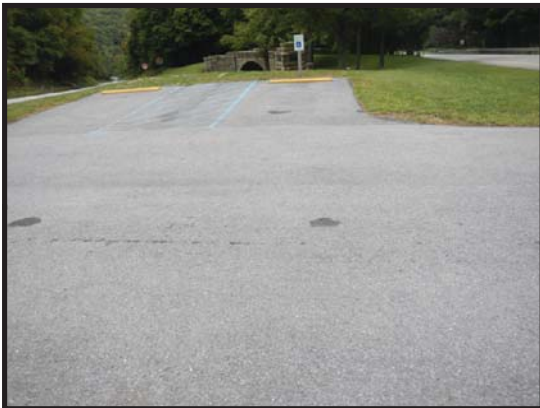
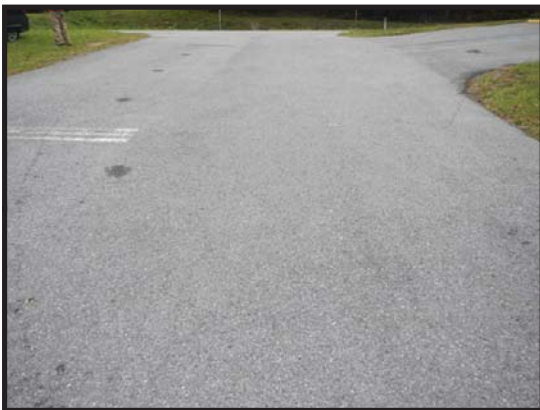
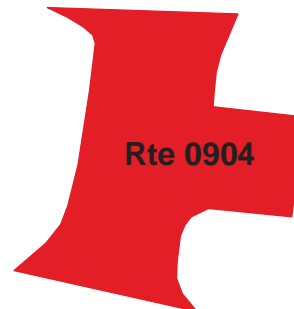
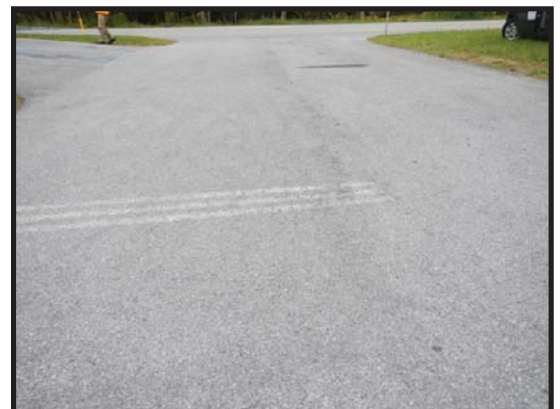
Route 0904

Route Number	Public / NonPublic	Date Visited	Area (sq ft)	Lane Miles *	Surface Type
0904	PUBLIC	9/16/2013	2,432	0.04	AS
Culverts	Drop Inlets	Gates	Curb & Gutter	Curb	PCR
0	0	0	NO CURB AND GUTTER	NO CURB	GOOD/90

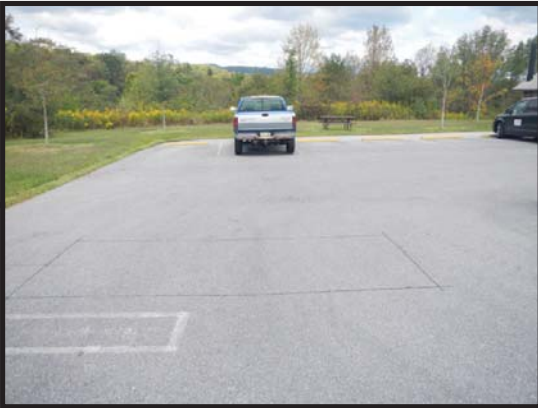
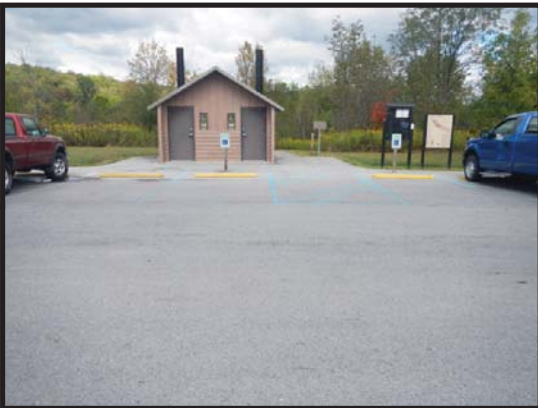
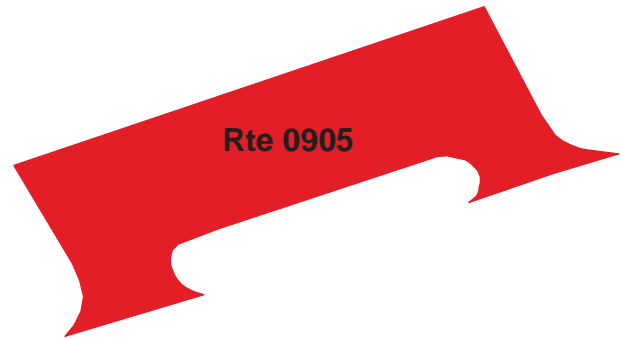
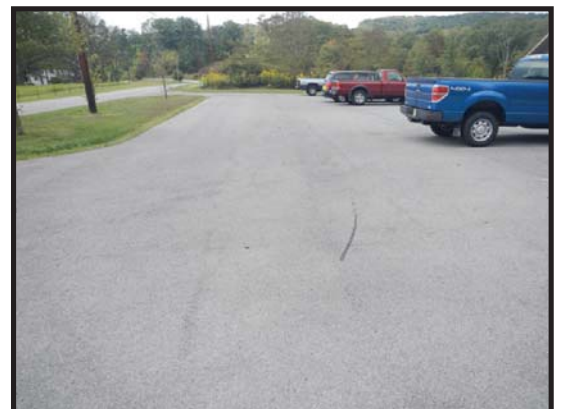
Route 0905

Route Number	Public / NonPublic	Date Visited	Area (sq ft)	Lane Miles *	Surface Type
0905	PUBLIC	9/16/2013	6,777	0.12	AS
Culverts	Drop Inlets	Gates	Curb & Gutter	Curb	PCR
0	0	0	NO CURB AND GUTTER	NO CURB	GOOD/90

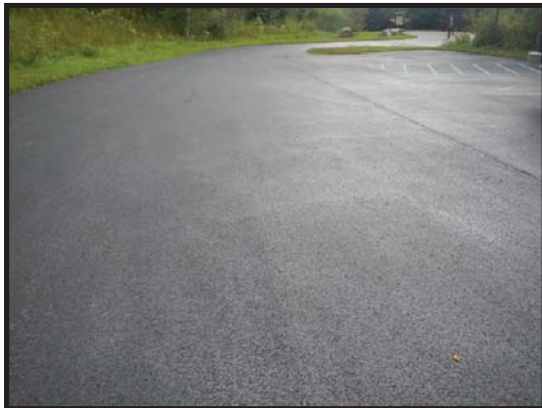
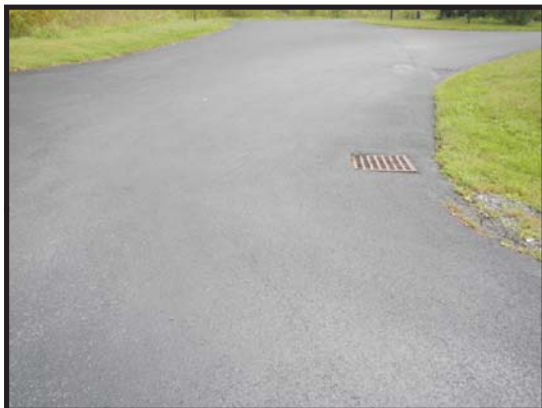
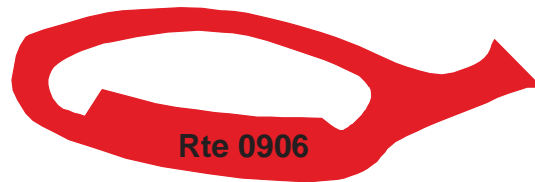
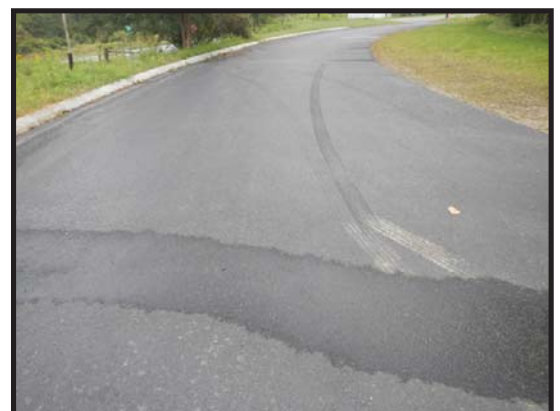
Route 0906

Route Number	Public / NonPublic	Date Visited	Area (sq ft)	Lane Miles *	Surface Type
0906	PUBLIC	9/16/2013	17,745	0.31	AS
Culverts	Drop Inlets	Gates	Curb & Gutter	Curb	PCR
0	3	0	NO CURB AND GUTTER	STONE CURB	GOOD/90

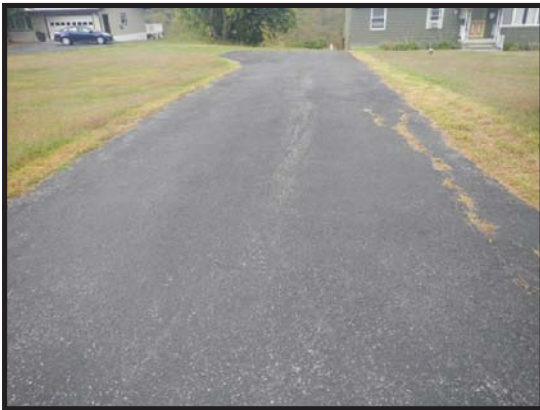
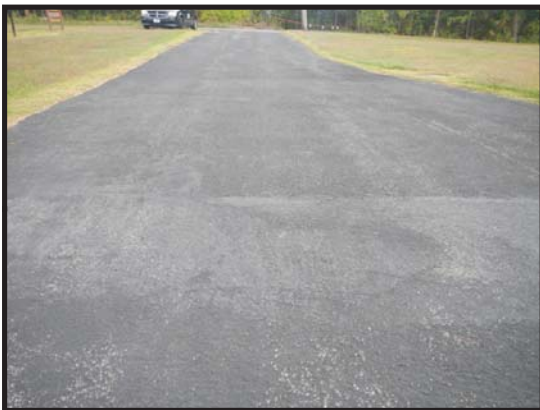
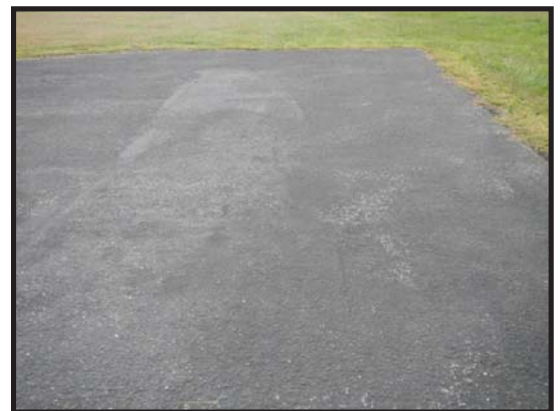
Route 0907

Route Number	Public / NonPublic	Date Visited	Area (sq ft)	Lane Miles *	Surface Type
0907	NONPUBLIC	9/16/2013	1,711	0.03	AS
Culverts	Drop Inlets	Gates	Curb & Gutter	Curb	PCR
0	0	0	NO CURB AND GUTTER	NO CURB	FAIR/73
