Federal Lands Highway Road Inventory Program

Road Inventory and Condition Assessment

Andersonville National Historic Site ANDE

Cycle 5 Report

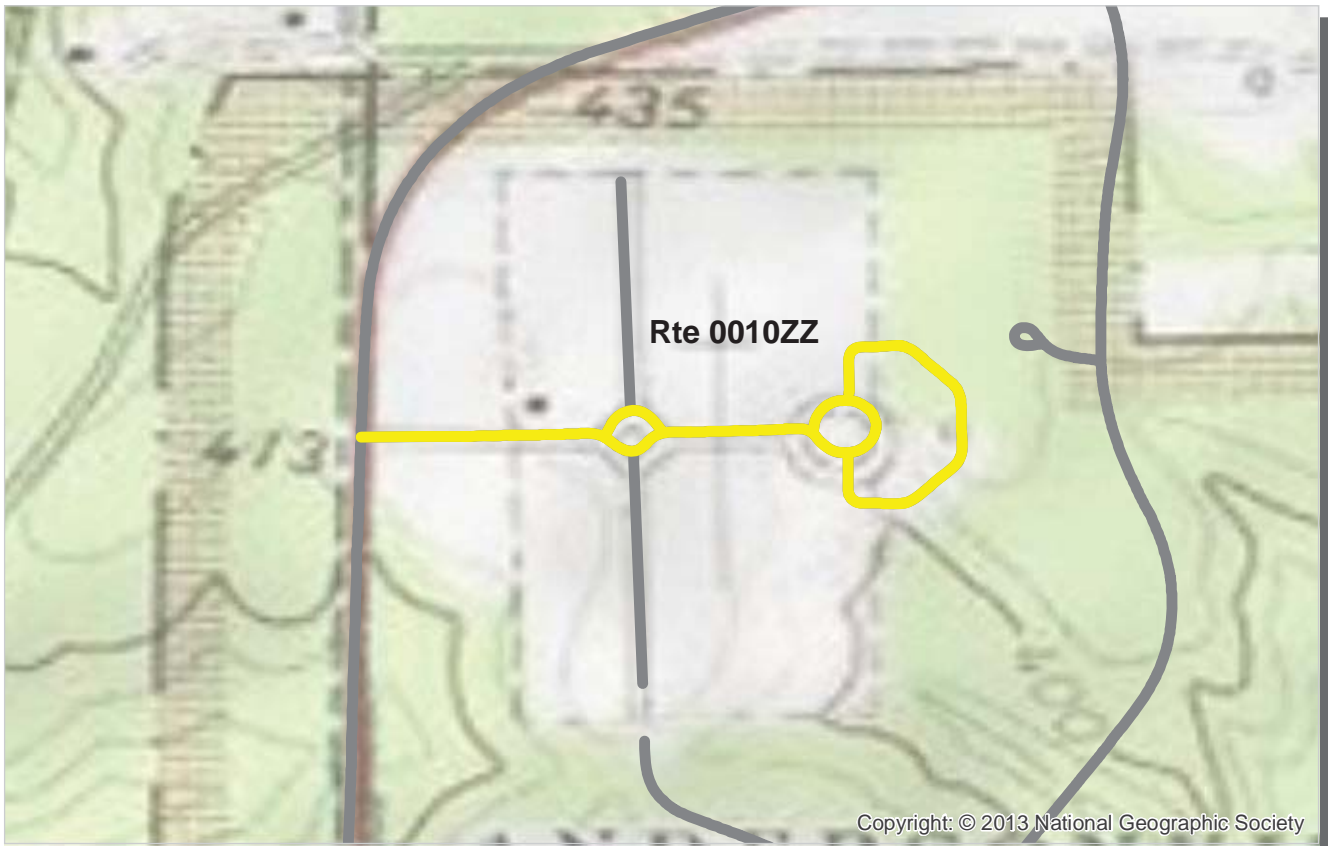
ROUTE: 0010ZZ CEMETERY ROADS

Section Number					
Section Length (mi)					
Cross Section Information					
Number of Lanes	N/A				
Paved Width (ft)	N/A				
Lane Width (ft)	N/A				
Roadway Condition Information					
SCR (Surface Condition Rating)	68				
PCR (Pavement Condition Rating)	68				
Distress Index Values					
Structural Crack Index	N/A				
Transverse Cracking Index	N/A				
Patching Index	N/A				
Rutting Index	N/A				
Roughness Condition Index (RCI)	N/A

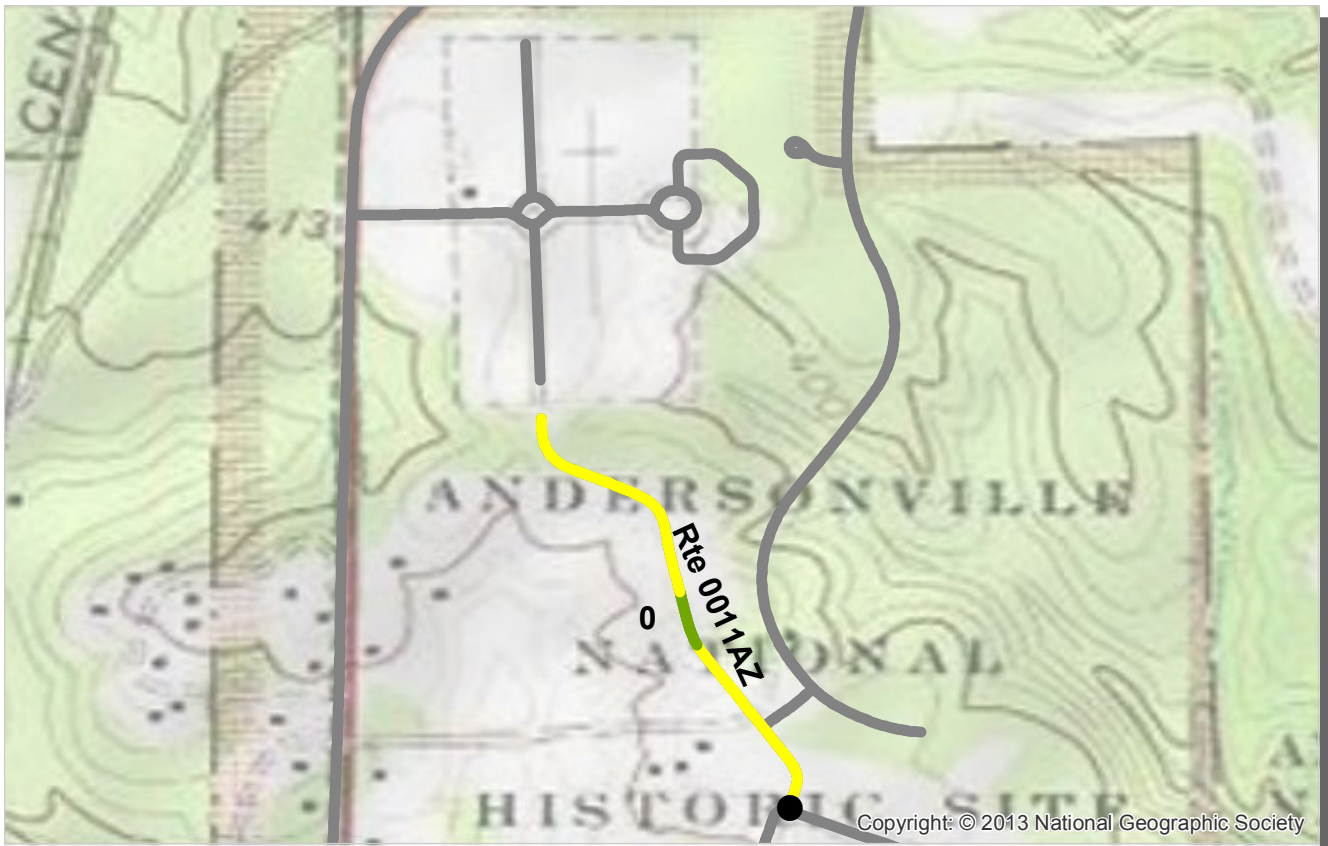
ROUTE: 0011AZ PERIMETER ROAD ACCESS A

Section Number	0				
Section Length (mi)	0.35				
Cross Section Information					
Number of Lanes	2				
Paved Width (ft)	19				
Lane Width (ft)	10				
Roadway Condition Information					
SCR (Surface Condition Rating)	71				
PCR (Pavement Condition Rating)	71				
Distress Index Values					
Structural Crack Index	71				
Transverse Cracking Index	88				
Patching Index	100				
Rutting Index	95				
Roughness Condition Index (RCI)	NC

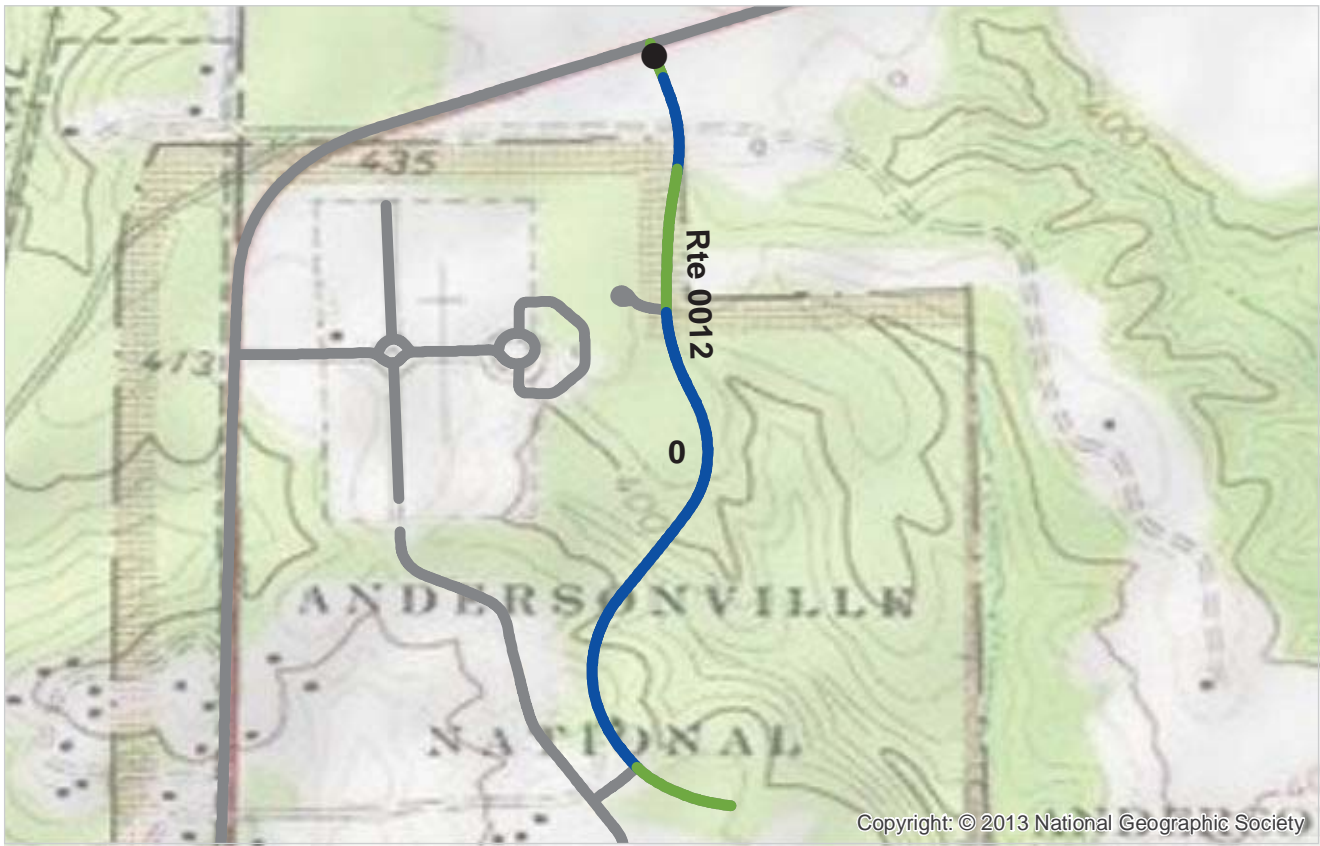
ROUTE: 0012 P.O.W. ROAD

Section Number	0				
Section Length (mi)	0.71				
Cross Section Information					
Number of Lanes	2				
Paved Width (ft)	23				
Lane Width (ft)	11				
Roadway Condition Information					
SCR (Surface Condition Rating)	96				
PCR (Pavement Condition Rating)	96				
Distress Index Values					
Structural Crack Index	99				
Transverse Cracking Index	99				
Patching Index	100				
Rutting Index	96				
Roughness Condition Index (RCI)	NC

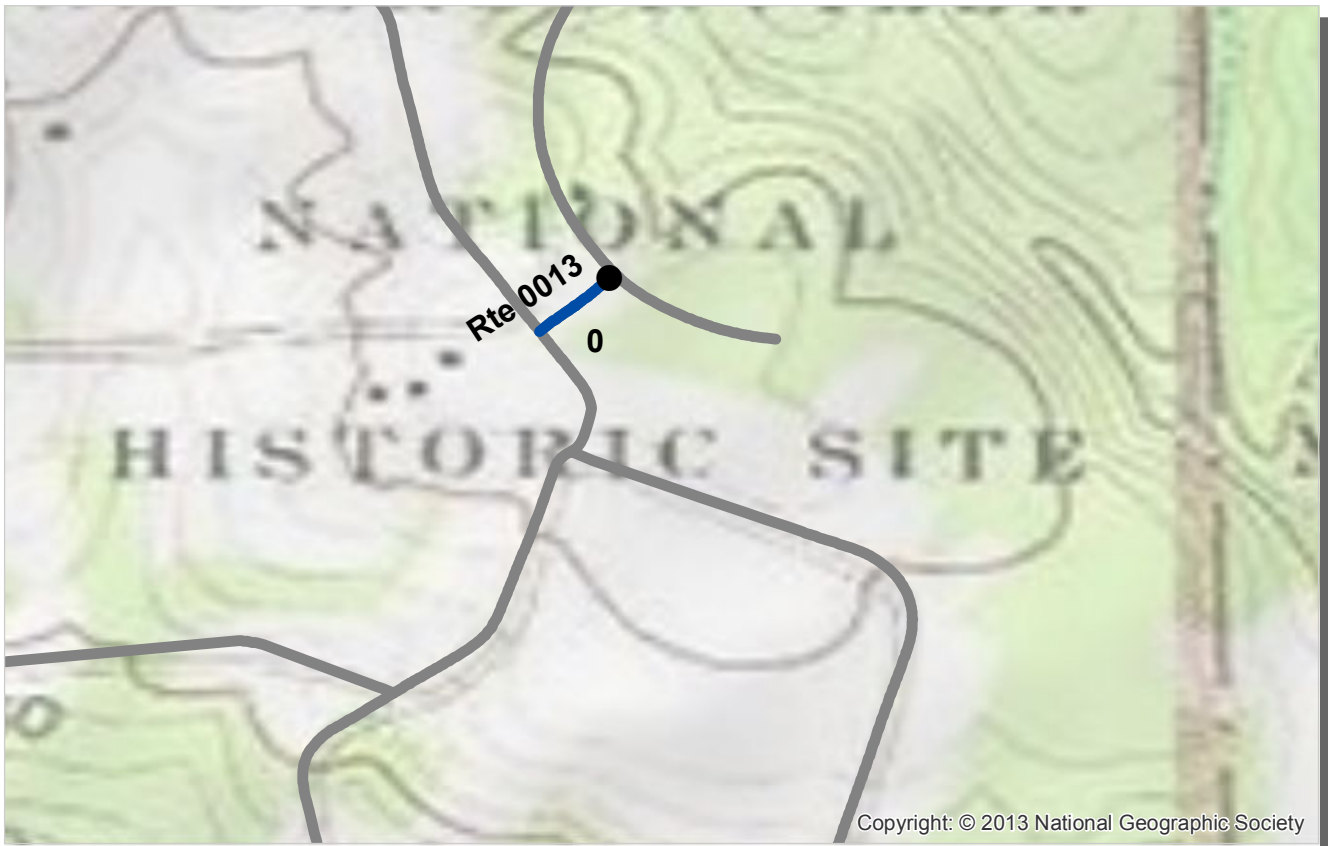
ROUTE: 0013 CONNECTOR ROAD

Section Number	0				
Section Length (mi)	0.03				
Cross Section Information					
Number of Lanes	2				
Paved Width (ft)	21				
Lane Width (ft)	10				
Roadway Condition Information					
SCR (Surface Condition Rating)	95				
PCR (Pavement Condition Rating)	95				
Distress Index Values					
Structural Crack Index	100				
Transverse Cracking Index	100				
Patching Index	100				
Rutting Index	95				
Roughness Condition Index (RCI)	NC

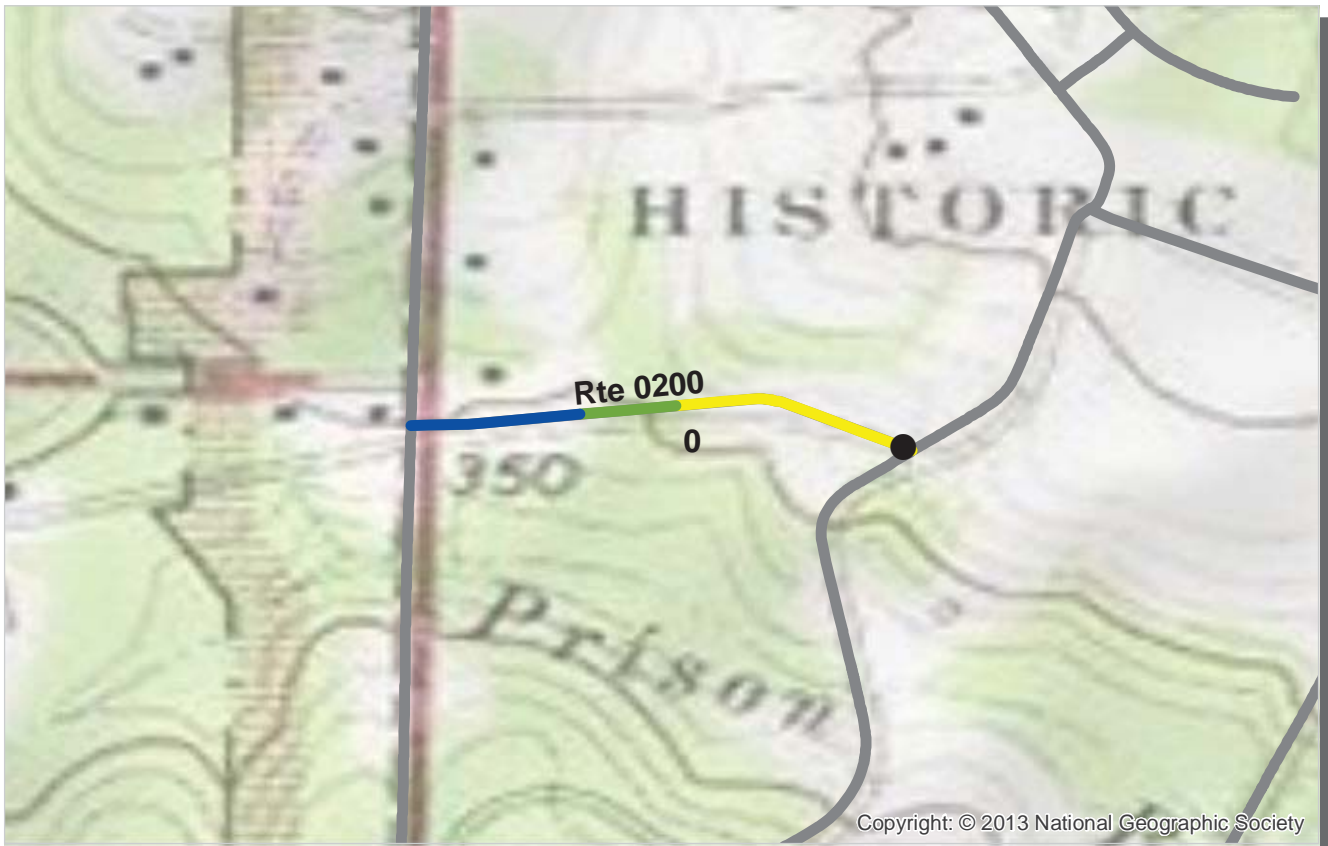
ROUTE: 0200 PECAN LANE

Section Number	0				
Section Length (mi)	0.21				
Cross Section Information					
Number of Lanes	1				
Paved Width (ft)	16				
Lane Width (ft)	16				
Roadway Condition Information					
SCR (Surface Condition Rating)	91				
PCR (Pavement Condition Rating)	91				
Distress Index Values					
Structural Crack Index	92				
Transverse Cracking Index	91				
Patching Index	100				
Rutting Index	95				
Roughness Condition Index (RCI)	NC

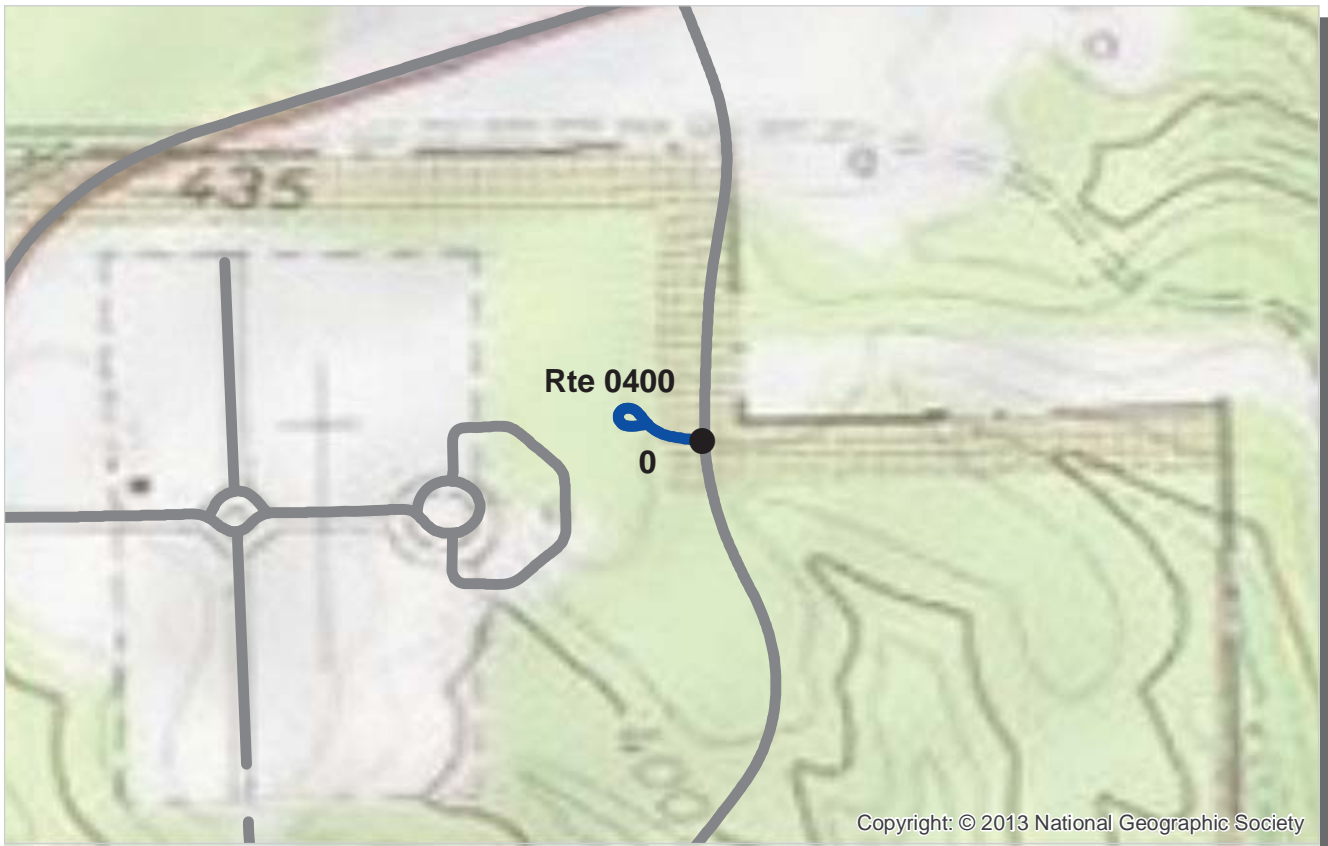
ROUTE: 0400 MAINTENANCE SERVICE ROAD

Section Number	0				
Section Length (mi)	0.06				
Cross Section Information					
Number of Lanes	2				
Paved Width (ft)	18				
Lane Width (ft)	9				
Roadway Condition Information					
SCR (Surface Condition Rating)	95				
PCR (Pavement Condition Rating)	95				
Distress Index Values					
Structural Crack Index	100				
Transverse Cracking Index	100				
Patching Index	99				
Rutting Index	95				
Roughness Condition Index (RCI)	NC

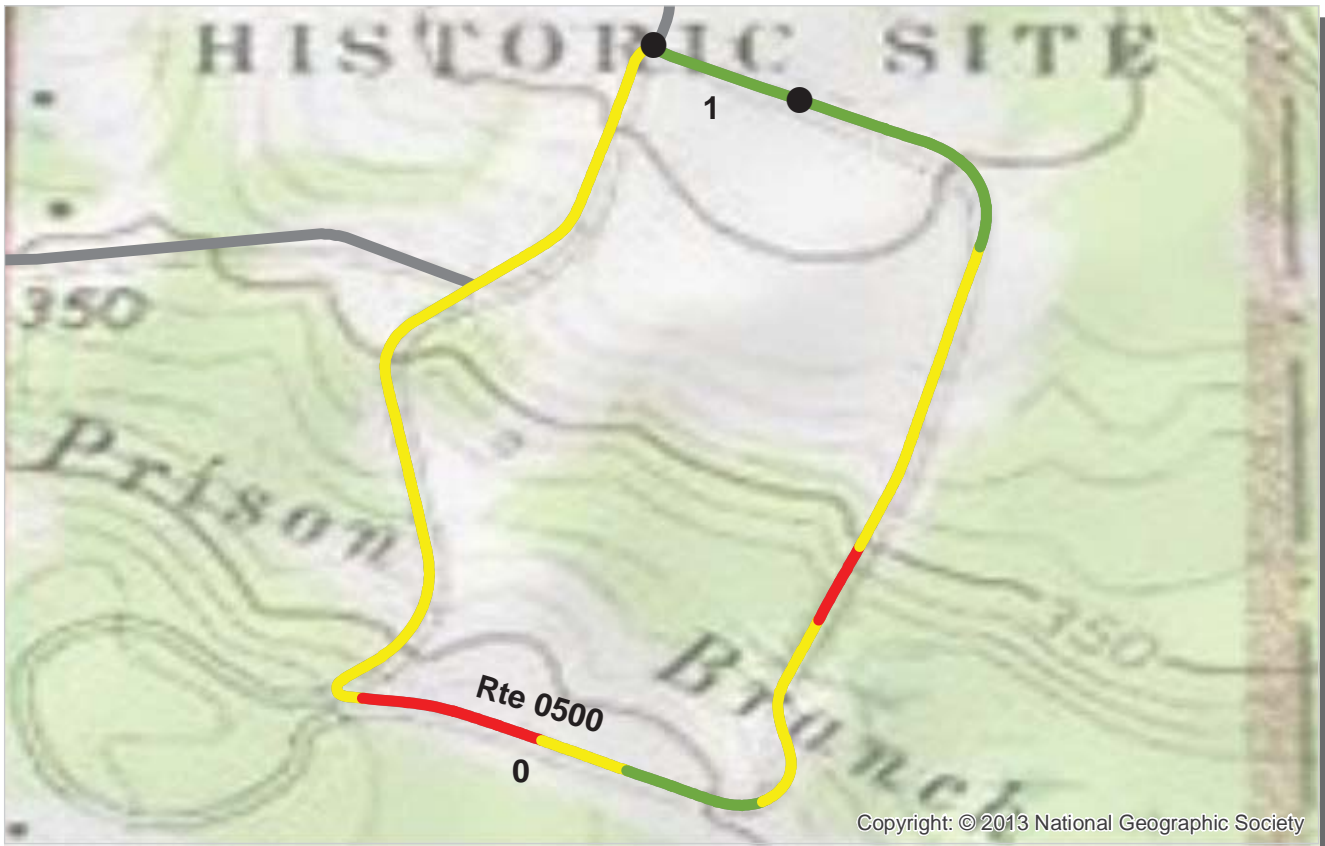
ROUTE: 0500 PRISON SITE PERIMETER ROAD

Section Number	0	1			
Section Length (mi)	1.00	0.06			
Cross Section Information					
Number of Lanes	1	1			
Paved Width (ft)	16	16			
Lane Width (ft)	16	16			
Roadway Condition Information					
SCR (Surface Condition Rating)	77	88			
PCR (Pavement Condition Rating)	77	88			
Distress Index Values					
Structural Crack Index	82	98			
Transverse Cracking Index	77	88			
Patching Index	100	100			
Rutting Index	97	98			
Roughness Condition Index (RCI)	NC	NC

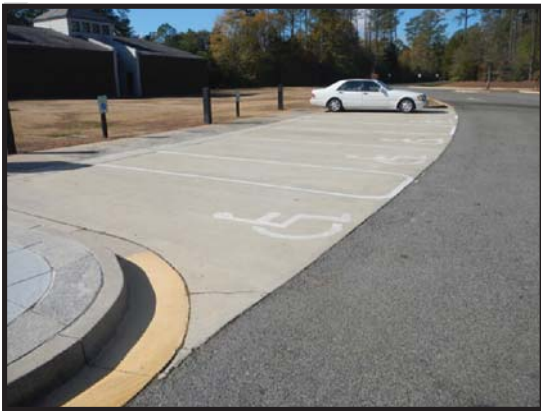
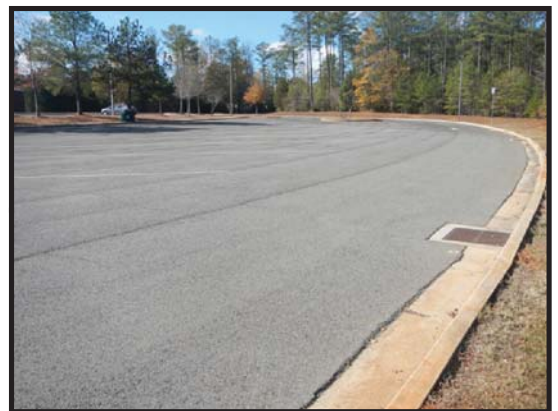
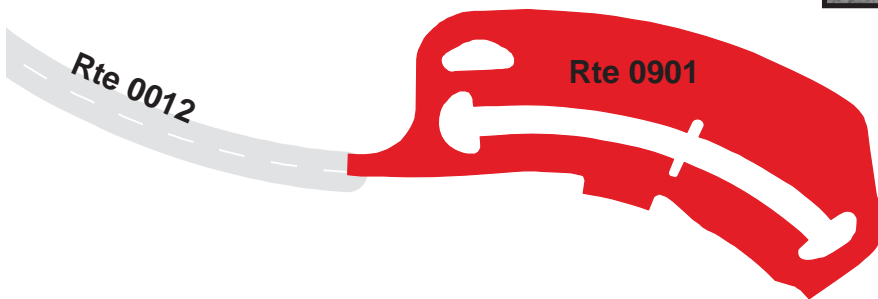
Route 0902

Route Number	Public / NonPublic	Date Visited	Area (sq ft)	Lane Miles *	Surface Type
0902	PUBLIC	12/2/2012	1,561	0.03	AS
Culverts	Drop Inlets	Gates	Curb & Gutter	Curb	PCR
0	0	0	NO CURB AND GUTTER	CONCRETE CURB	POOR/45

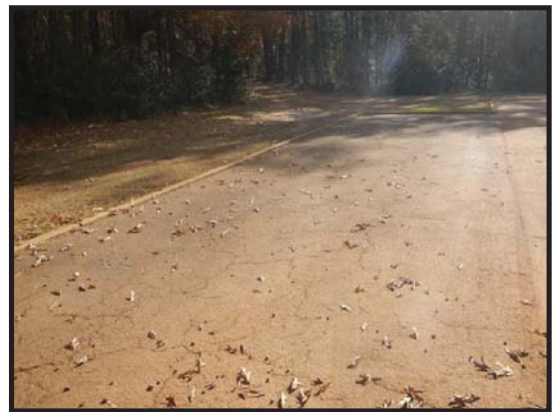
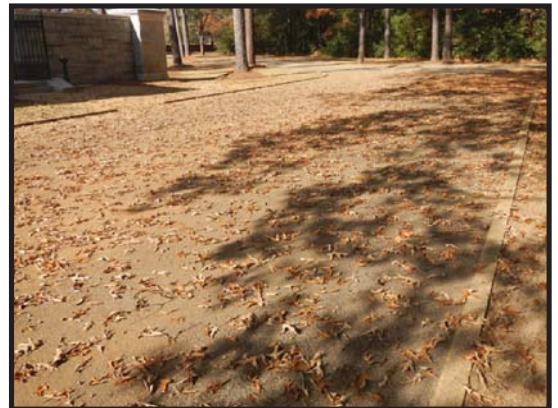
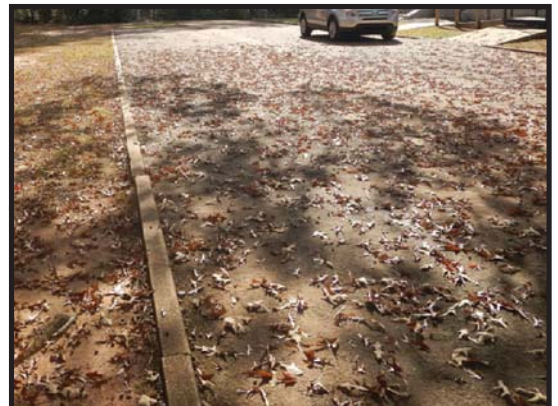
Route 0903

Route Number	Public / NonPublic	Date Visited	Area (sq ft)	Lane Miles *	Surface Type
0903	NONPUBLIC	12/2/2012	14,182	0.24	AS
Culverts	Drop Inlets	Gates	Curb & Gutter	Curb	PCR
0	1	0	NO CURB AND GUTTER	CONCRETE CURB	FAIR/73

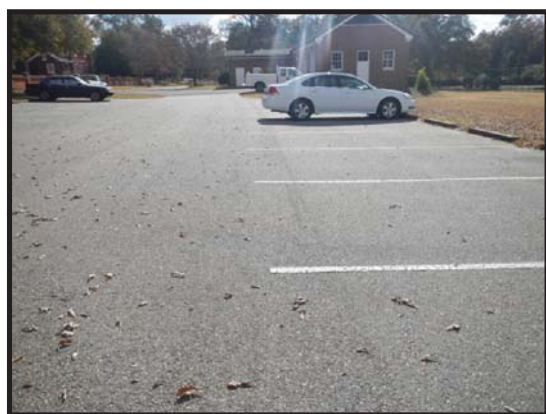
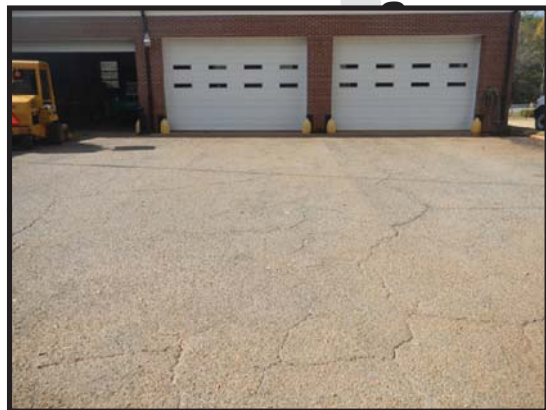
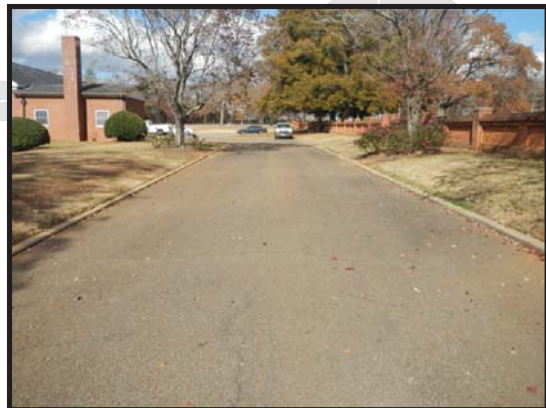
Route 0904

Route Number	Public / NonPublic	Date Visited	Area (sq ft)	Lane Miles *	Surface Type
0904	PUBLIC	12/2/2012	6,782	0.12	AS
Culverts	Drop Inlets	Gates	Curb & Gutter	Curb	PCR
0	0	0	NO CURB AND GUTTER	CONCRETE CURB	POOR/45

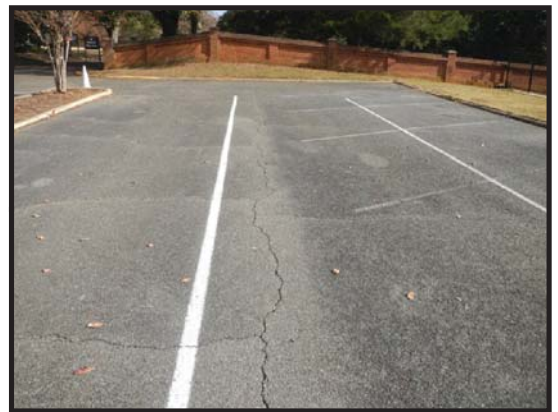
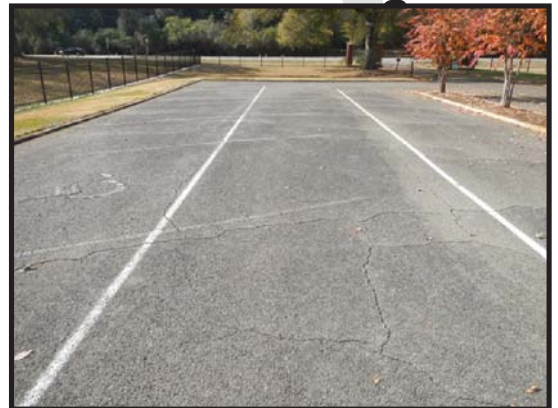
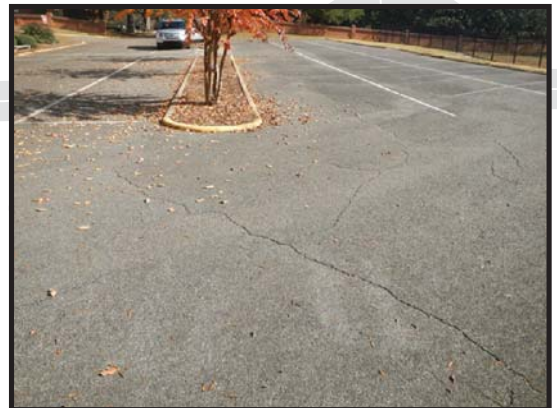
Route 0905

Route Number	Public / NonPublic	Date Visited	Area (sq ft)	Lane Miles *	Surface Type
0905	PUBLIC	12/2/2012	8,771	0.15	AS
Culverts	Drop Inlets	Gates	Curb & Gutter	Curb	PCR
0	0	0	NO CURB AND GUTTER	CONCRETE CURB	POOR/45

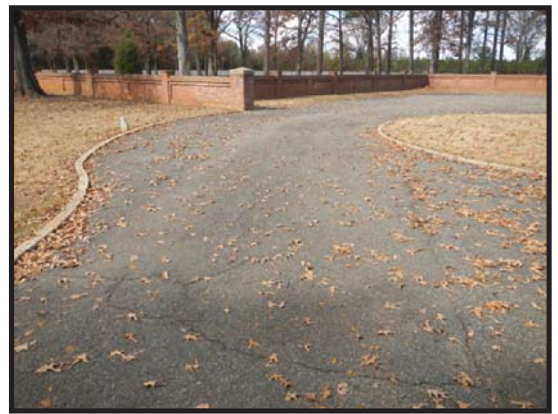
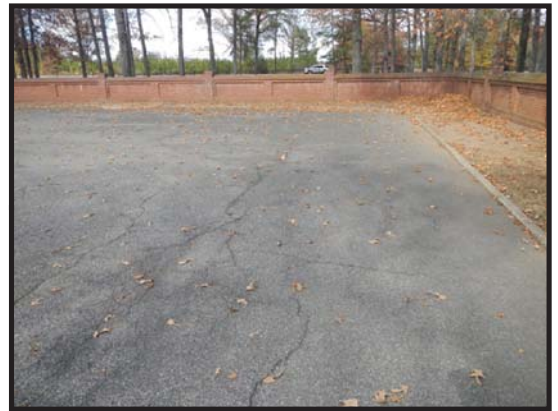
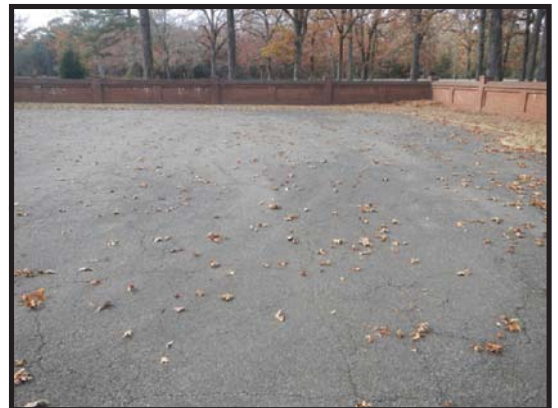
Route 0906

Route Number	Public / NonPublic	Date Visited	Area (sq ft)	Lane Miles *	Surface Type
0906	PUBLIC	12/2/2012	9,037	0.16	AS
Culverts	Drop Inlets	Gates	Curb & Gutter	Curb	PCR
0	0	0	NO CURB AND GUTTER	CONCRETE CURB	POOR/45
