# Federal Lands Highway Road Inventory Program

Road Inventory and Condition Assessment

## Andrew Johnson National Historic Site ANJO

### Cycle 5 Report

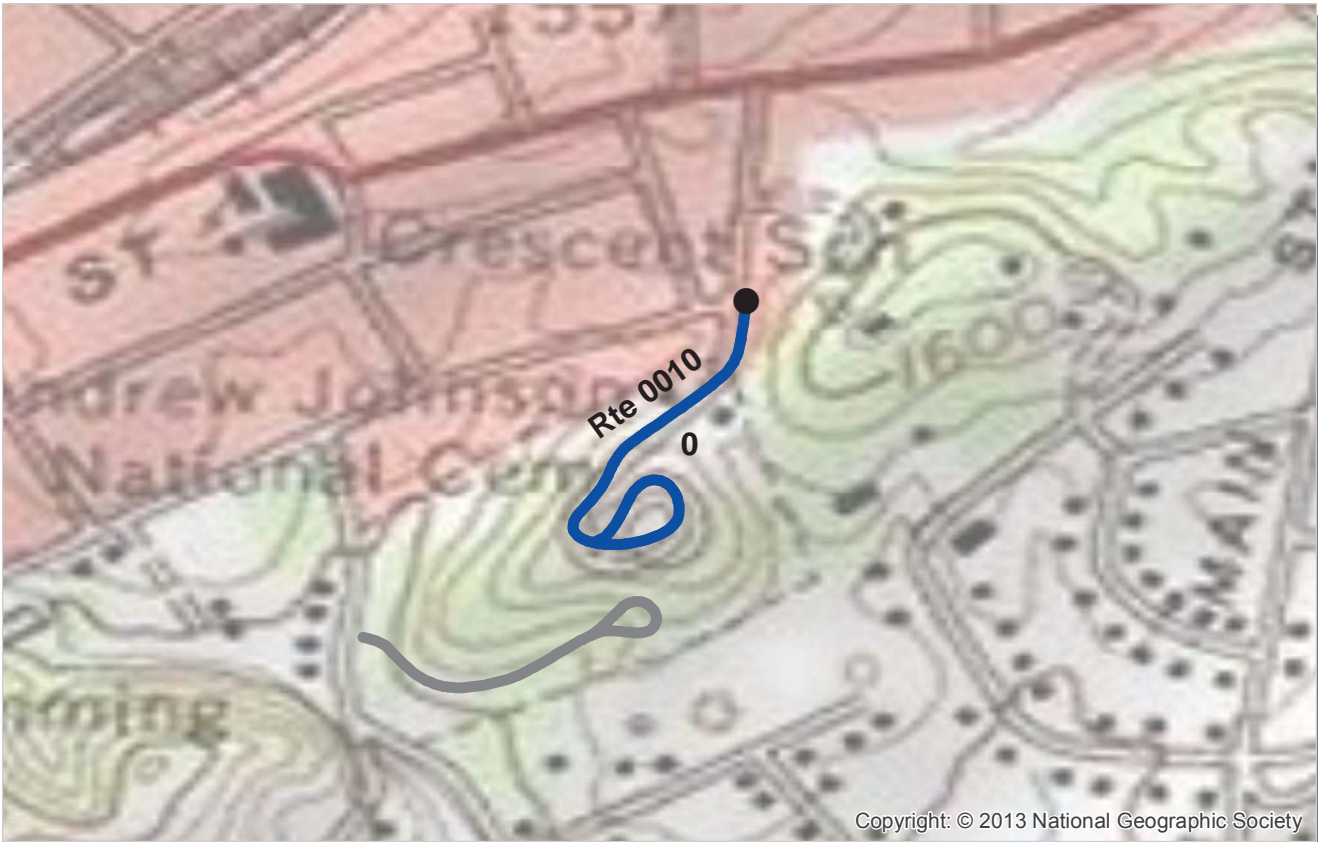
**ROUTE: 0010 MONUMENT AVENUE**

<b>Section Number</b>	0				
<b>Section Length (mi)</b>	0.25				
<b>Cross Section Information</b>					
Number of Lanes	2				
Paved Width (ft)	19				
Lane Width (ft)	10				
<b>Roadway Condition Information</b>					
SCR (Surface Condition Rating)	99				
PCR (Pavement Condition Rating)	99				
<b>Distress Index Values</b>					
Structural Crack Index	100				
Transverse Cracking Index	100				
Patching Index	100				
Rutting Index	99				
Roughness Condition Index (RCI)	NC

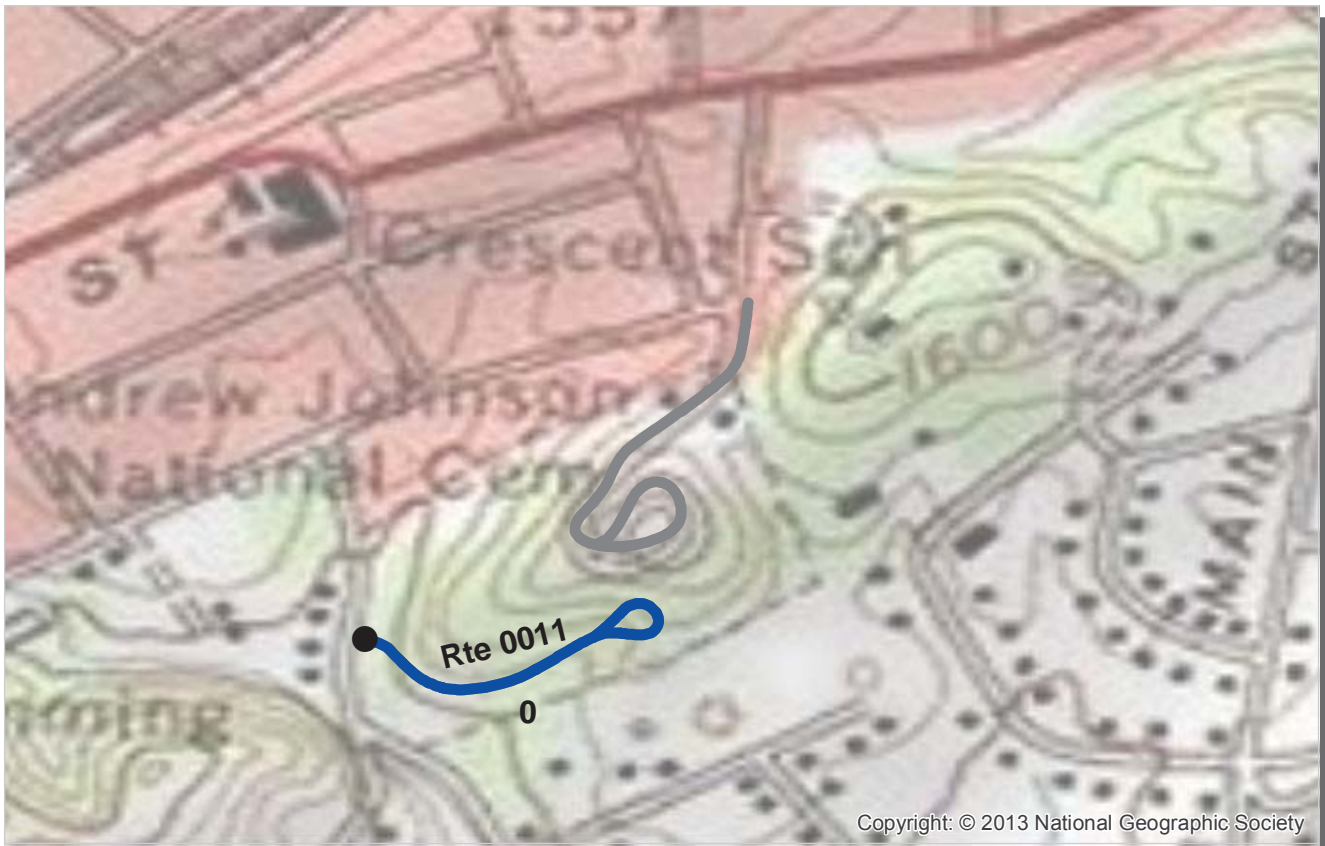
**ROUTE: 0011 LOWER CEMETERY ROAD**

<b>Section Number</b>	0				
<b>Section Length (mi)</b>	0.17				
<b>Cross Section Information</b>					
Number of Lanes	2				
Paved Width (ft)	17				
Lane Width (ft)	9				
<b>Roadway Condition Information</b>					
SCR (Surface Condition Rating)	99				
PCR (Pavement Condition Rating)	99				
<b>Distress Index Values</b>					
Structural Crack Index	100				
Transverse Cracking Index	99				
Patching Index	100				
Rutting Index	99				
Roughness Condition Index (RCI)	NC

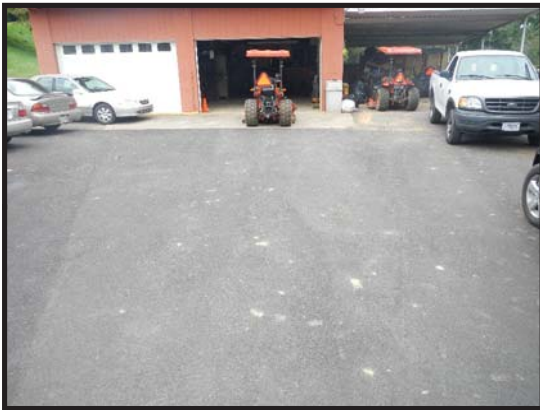
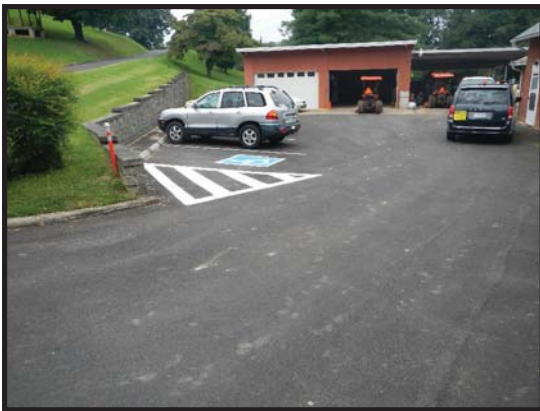
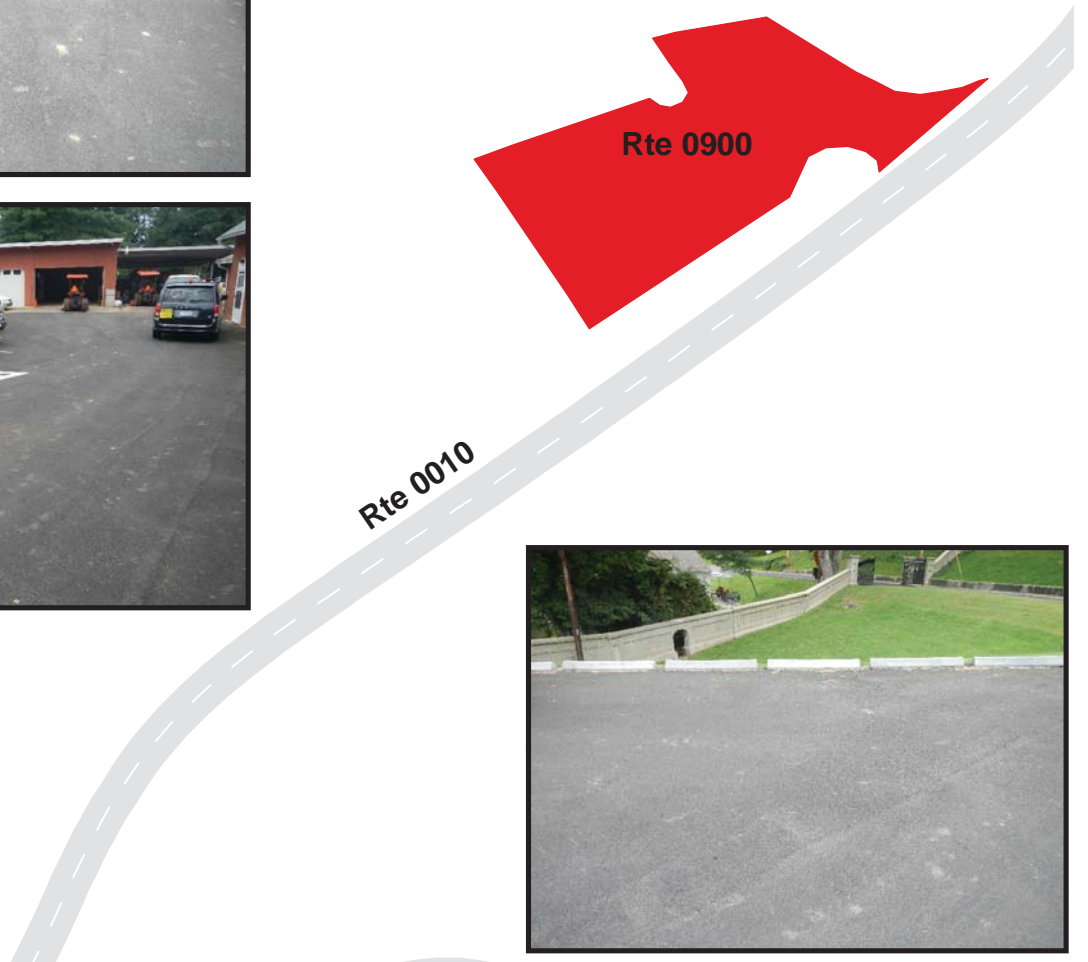
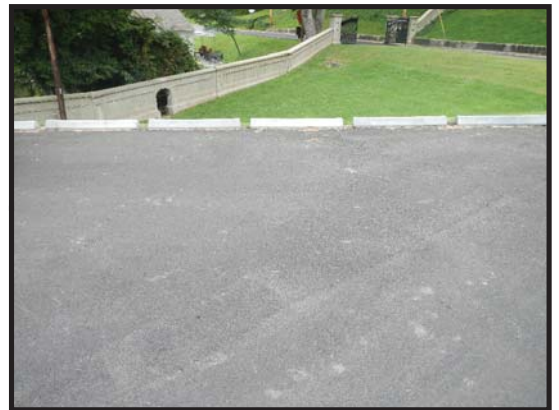
Route Number	Public / NonPublic	Date Visited	Area (sq ft)	Lane Miles *	Surface Type
0900	NONPUBLIC	8/7/2013	4,872	0.08	AS
Culverts	Drop Inlets	Gates	Curb & Gutter	Curb	PCR
0	0	0	NO CURB AND GUTTER	CONCRETE CURB	EXCELLENT/97

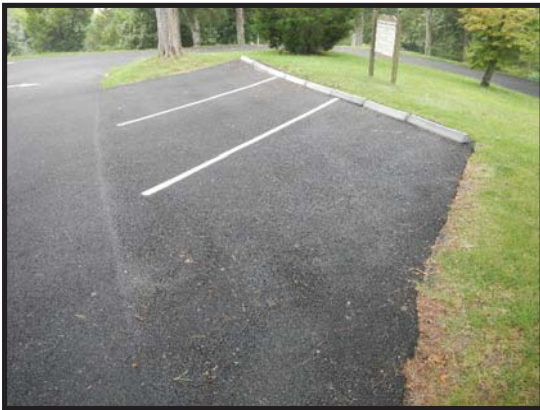
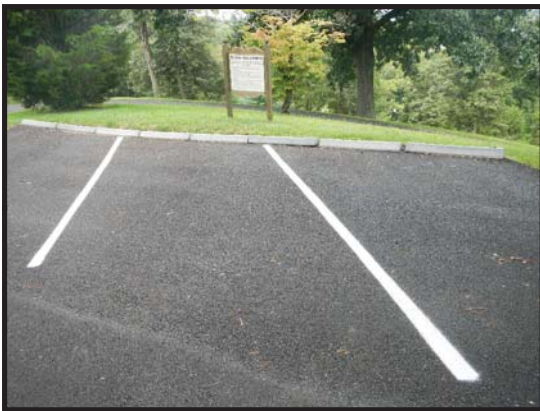
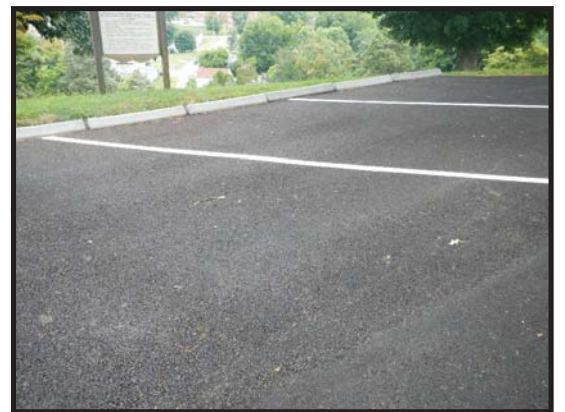
## Route 0901

Route Number	Public / NonPublic	Date Visited	Area (sq ft)	Lane Miles *	Surface Type
0901	PUBLIC	8/7/2013	501	0.01	AS
Culverts	Drop Inlets	Gates	Curb & Gutter	Curb	PCR
0	0	0	NO CURB AND GUTTER	NO CURB	EXCELLENT/97

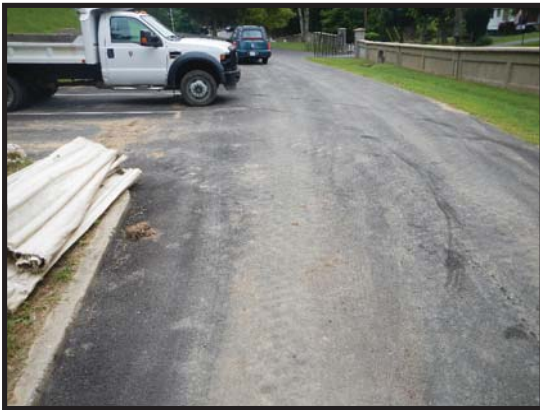
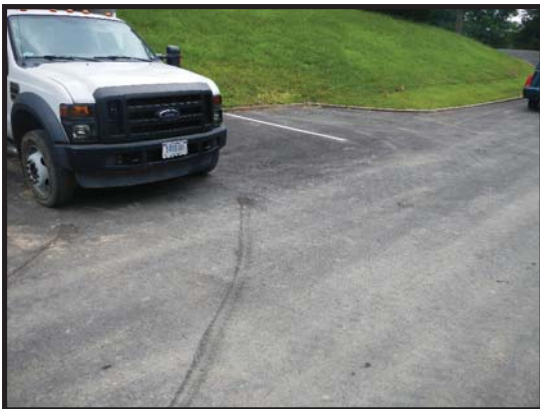
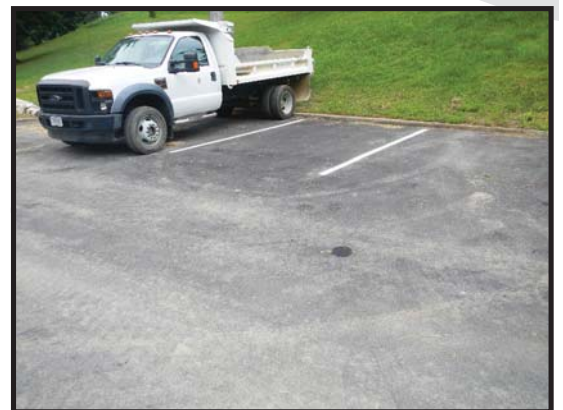
## Route 0902

Route Number	Public / NonPublic	Date Visited	Area (sq ft)	Lane Miles *	Surface Type
0902	PUBLIC	8/7/2013	2,939	0.05	AS
Culverts	Drop Inlets	Gates	Curb & Gutter	Curb	PCR
1	0	0	NO CURB AND GUTTER	CONCRETE CURB	EXCELLENT/97

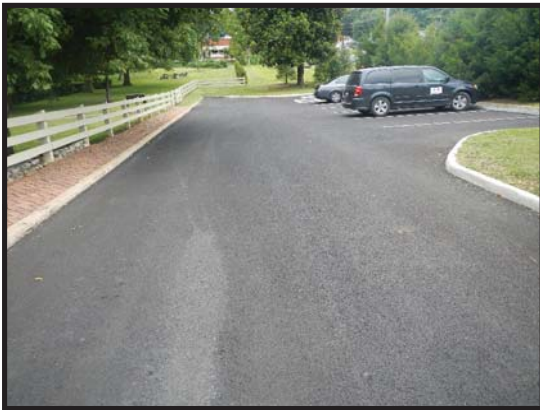
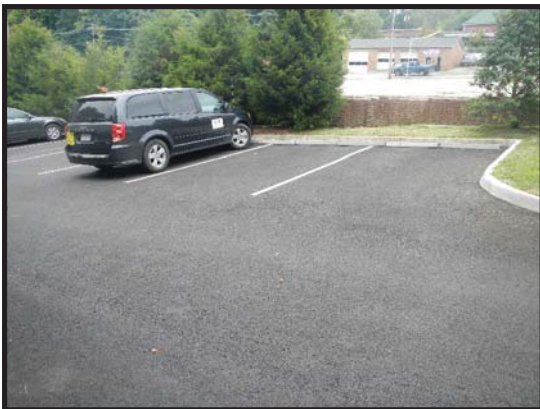
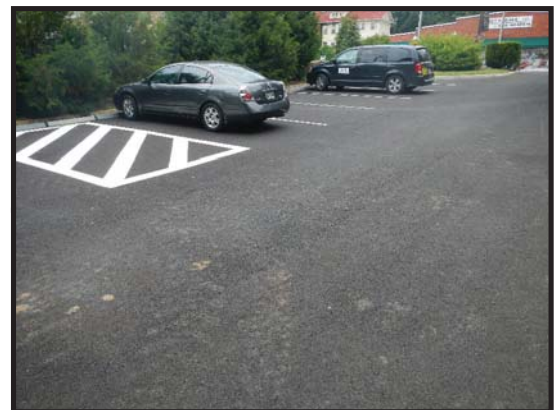
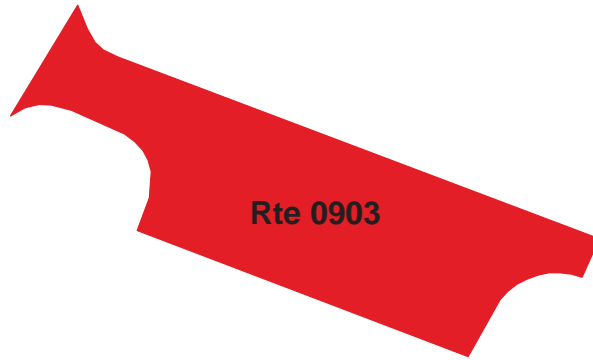
## Route 0903

Route Number	Public / NonPublic	Date Visited	Area (sq ft)	Lane Miles *	Surface Type
0903	PUBLIC	8/7/2013	3,939	0.07	AS
Culverts	Drop Inlets	Gates	Curb & Gutter	Curb	PCR
0	3	0	NO CURB AND GUTTER	CONCRETE CURB	EXCELLENT/97

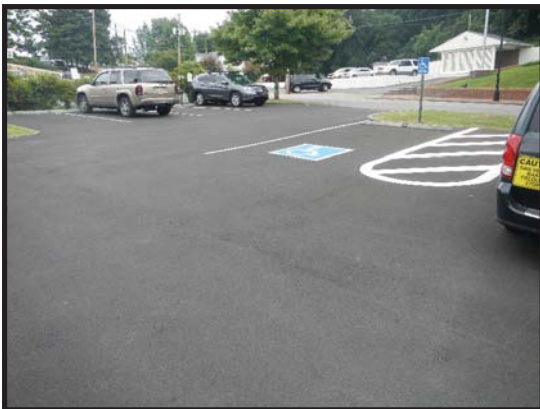
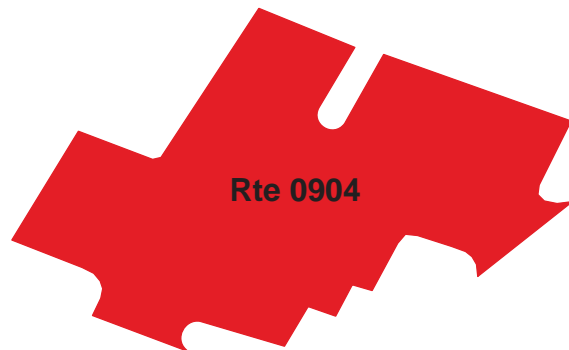
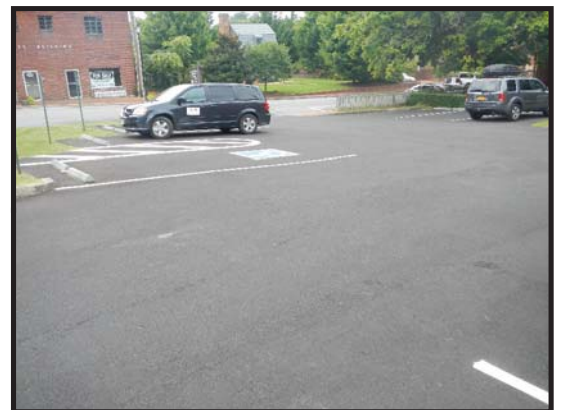
## Route 0904

Route Number	Public / NonPublic	Date Visited	Area (sq ft)	Lane Miles *	Surface Type
0904	PUBLIC	8/7/2013	5,620	0.10	AS
Culverts	Drop Inlets	Gates	Curb & Gutter	Curb	PCR
0	1	0	NO CURB AND GUTTER	CONCRETE CURB	EXCELLENT/97
