Federal Lands Highway Road Inventory Program

Road Inventory and Condition Assessment

Antietam National Battlefield ANTI

Cycle 5 Report

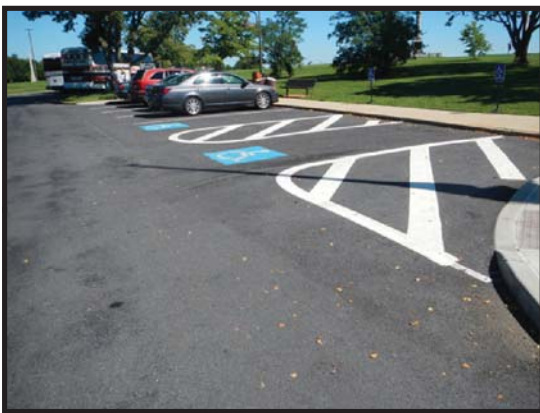
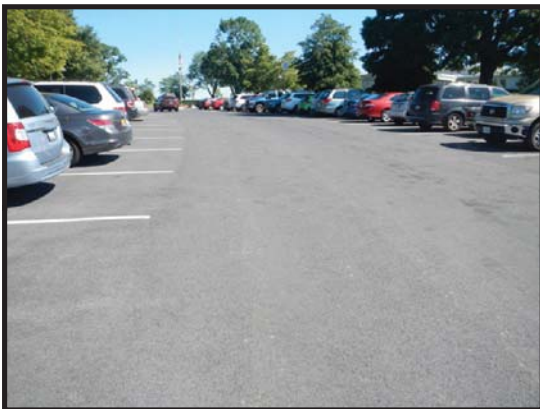
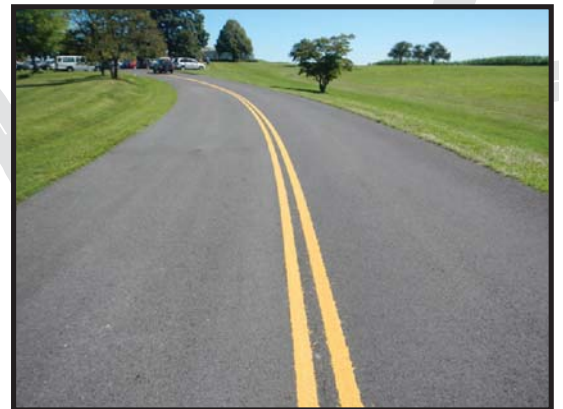
Route Number	Public / NonPublic	Date Visited	Area (sq ft)	Lane Miles *	Surface Type
0900	PUBLIC	7/25/2012	41,358	0.71	AS
Culverts	Drop Inlets	Gates	Curb & Gutter	Curb	PCR
1	2	0	NO CURB AND GUTTER	CONCRETE CURB	GOOD/90

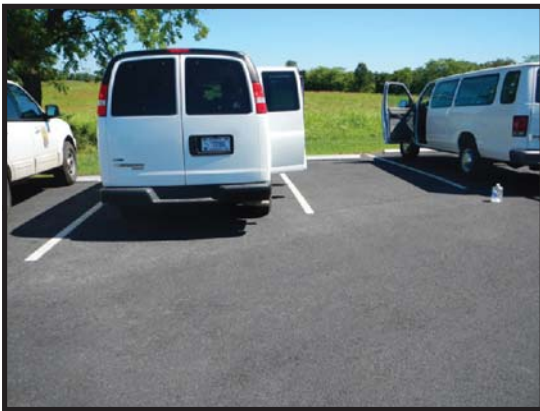
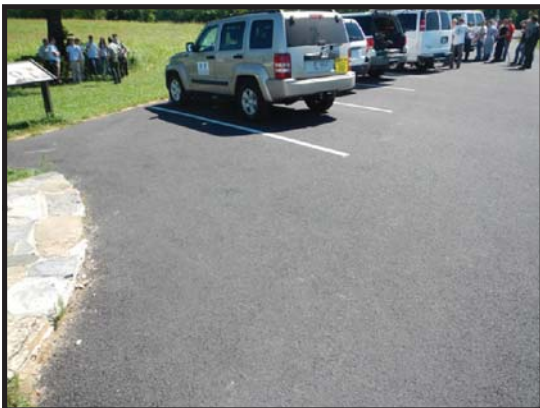
Route 0901

Route Number	Public / NonPublic	Date Visited	Area (sq ft)	Lane Miles *	Surface Type
0901	PUBLIC	7/25/2012	2,822	0.05	AS
Culverts	Drop Inlets	Gates	Curb & Gutter	Curb	PCR
0	0	0	NO CURB AND GUTTER	NO CURB	GOOD/90

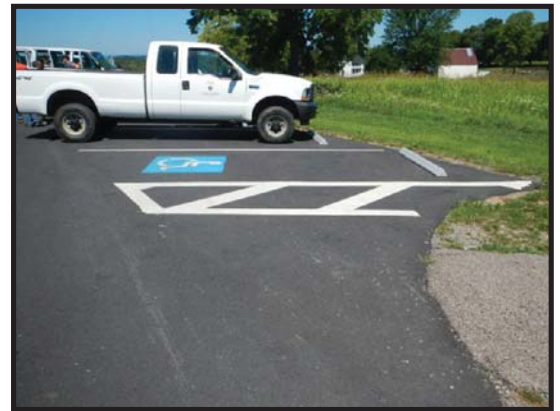
Route 0902A

Route Number	Public / NonPublic	Date Visited	Area (sq ft)	Lane Miles *	Surface Type
0902A	PUBLIC	7/25/2012	1,612	0.03	AS
Culverts	Drop Inlets	Gates	Curb & Gutter	Curb	PCR
0	0	0	NO CURB AND GUTTER	NO CURB	GOOD/90

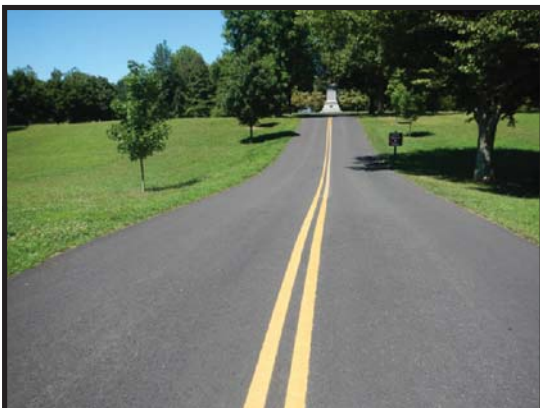
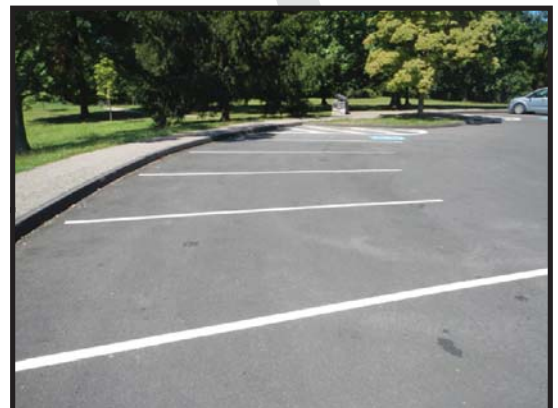
Route 0903

Route Number	Public / NonPublic	Date Visited	Area (sq ft)	Lane Miles *	Surface Type
0903	PUBLIC	7/25/2012	19,806	0.34	AS
Culverts	Drop Inlets	Gates	Curb & Gutter	Curb	PCR
2	1	0	NO CURB AND GUTTER	ASPHALT CURB	GOOD/90

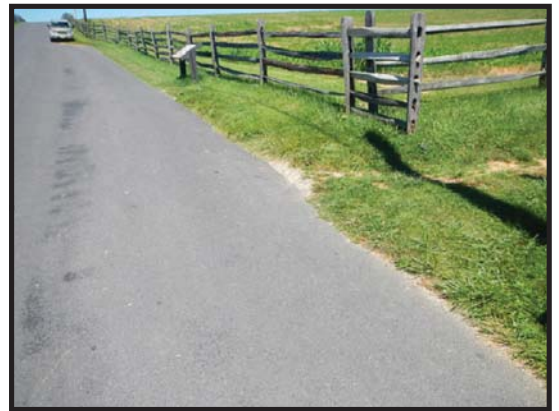
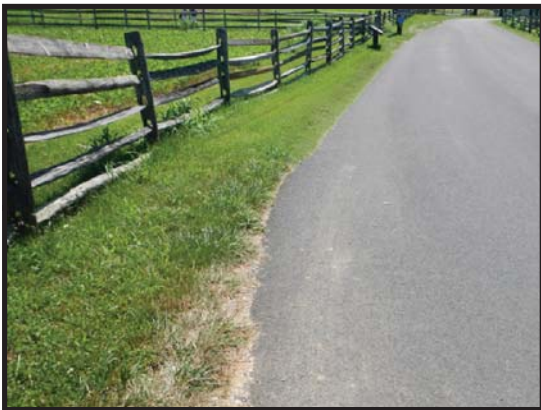
Route 0904

Route Number	Public / NonPublic	Date Visited	Area (sq ft)	Lane Miles *	Surface Type
0904	PUBLIC	7/25/2012	1,318	0.02	AS
Culverts	Drop Inlets	Gates	Curb & Gutter	Curb	PCR
0	0	0	NO CURB AND GUTTER	NO CURB	GOOD/90

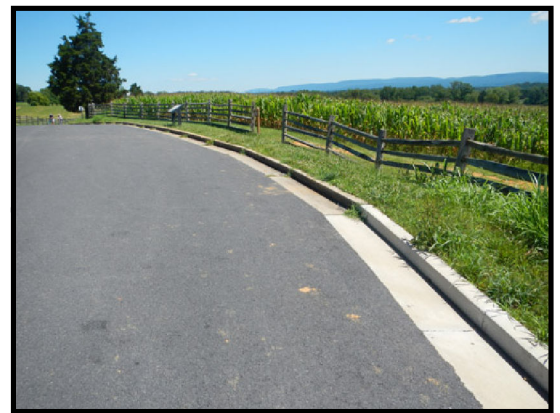
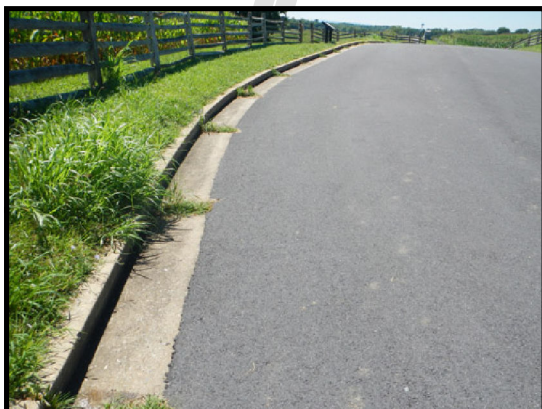
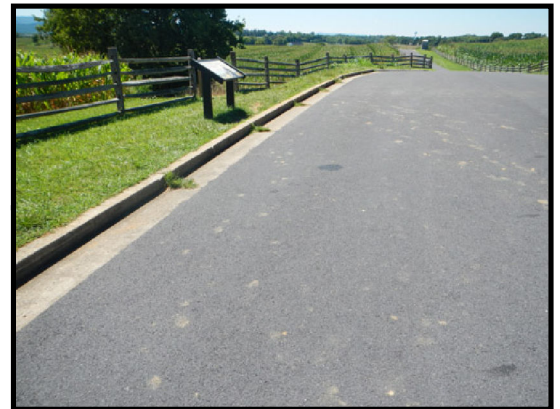
Route 0905

Route Number	Public / NonPublic	Date Visited	Area (sq ft)	Lane Miles *	Surface Type
0905	PUBLIC	7/25/2012	2,388	0.04	AS
Culverts	Drop Inlets	Gates	Curb & Gutter	Curb	PCR
0	0	0	CONCRETE CURB AND GUTTER	NO CURB	GOOD/90

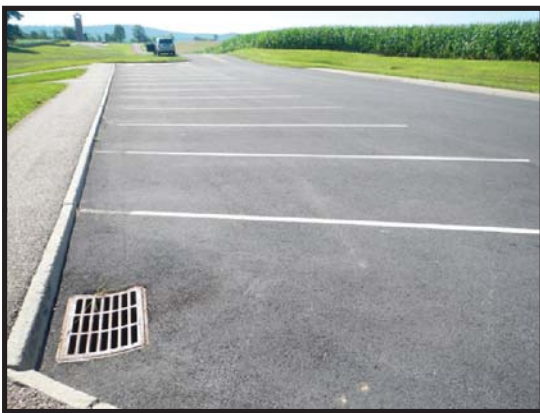
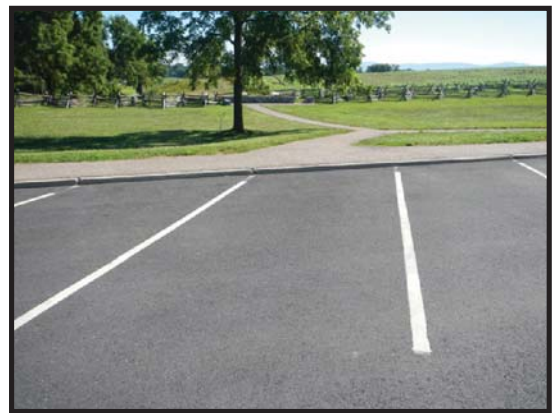
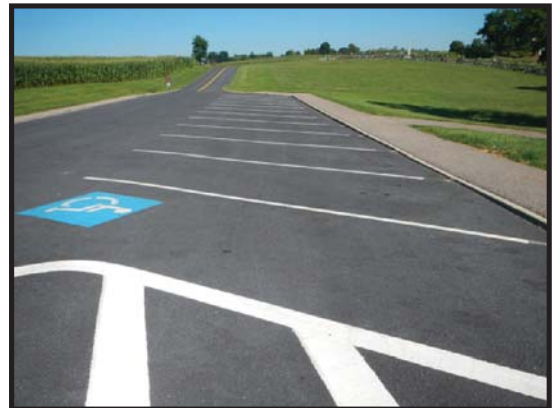
Route 0906A

Route Number	Public / NonPublic	Date Visited	Area (sq ft)	Lane Miles *	Surface Type
0906A	PUBLIC	7/25/2012	3,155	0.05	AS
Culverts	Drop Inlets	Gates	Curb & Gutter	Curb	PCR
0	1	0	NO CURB AND GUTTER	CONCRETE CURB	GOOD/90

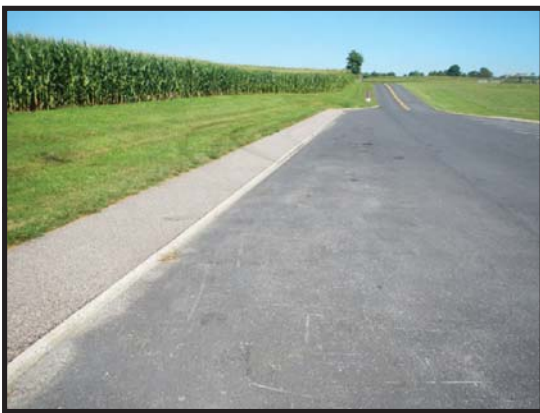
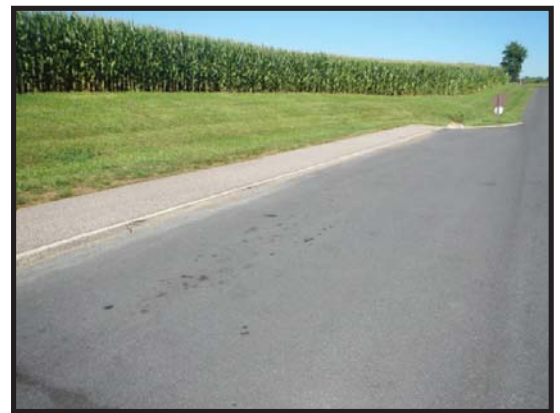
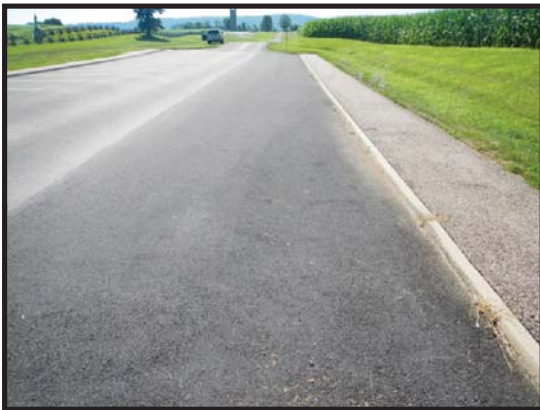
Route 0906B

Route Number	Public / NonPublic	Date Visited	Area (sq ft)	Lane Miles *	Surface Type
0906B	PUBLIC	7/25/2012	1,722	0.03	AS
Culverts	Drop Inlets	Gates	Curb & Gutter	Curb	PCR
0	0	0	NO CURB AND GUTTER	CONCRETE CURB	GOOD/90

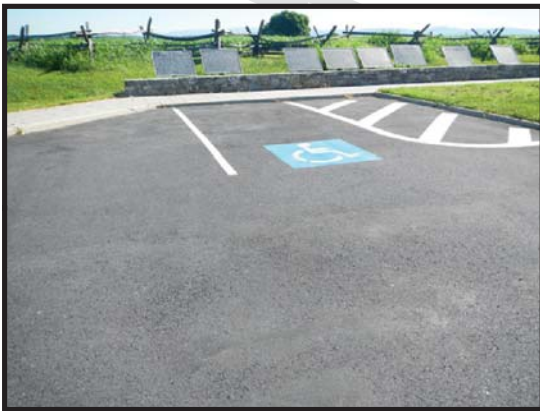
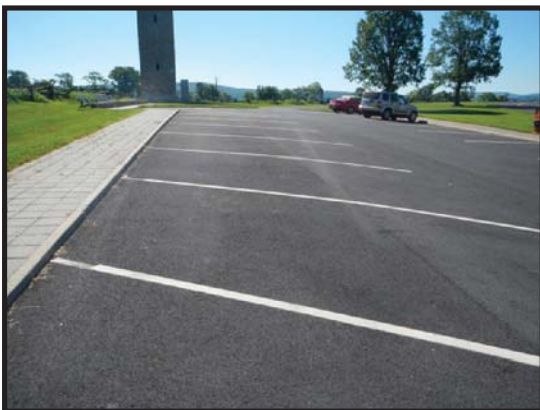
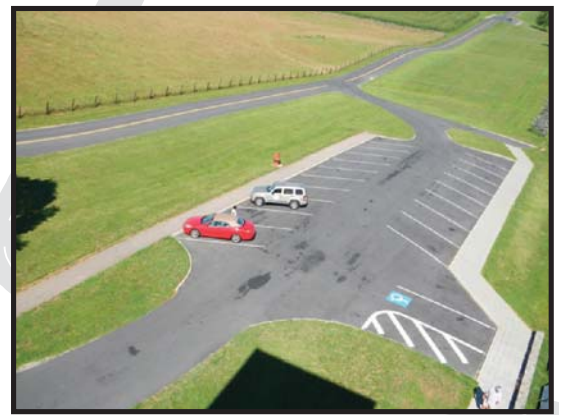
Route 0907

Route Number	Public / NonPublic	Date Visited	Area (sq ft)	Lane Miles *	Surface Type
0907	PUBLIC	7/25/2012	15,489	0.27	AS
Culverts	Drop Inlets	Gates	Curb & Gutter	Curb	PCR
0	3	0	NO CURB AND GUTTER	CONCRETE CURB	GOOD/90

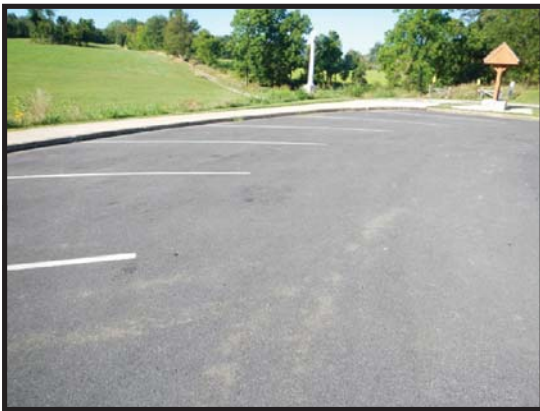
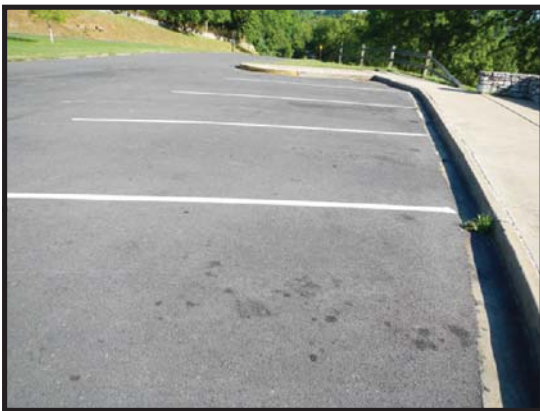
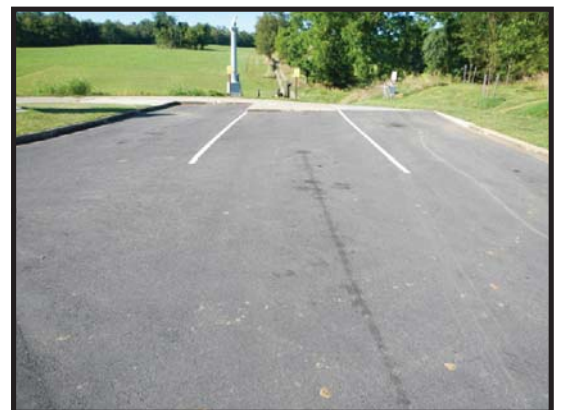
BURNSIDE BRIDGE PARKING

FROM END OF ROUTE 0310 (OLD BURNSIDE BRIDGE ROAD)
TO PARKING

Route Number	Public / NonPublic	Date Visited	Area (sq ft)	Lane Miles *	Surface Type
0908	PUBLIC	7/25/2012	15,141	0.26	AS
Culverts	Drop Inlets	Gates	Curb & Gutter	Curb	PCR
0	4	1	CONCRETE CURB AND GUTTER	NO CURB	GOOD/90

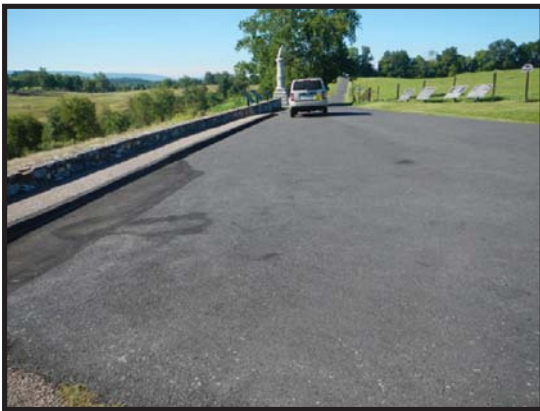
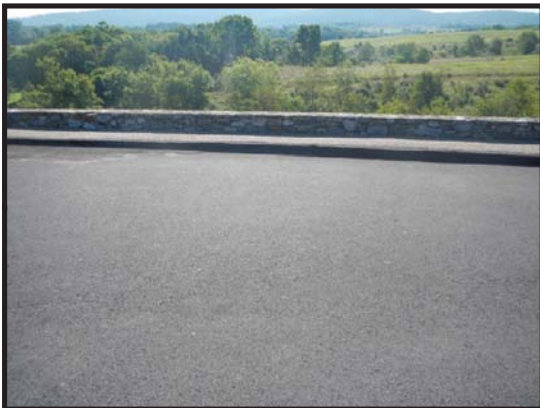
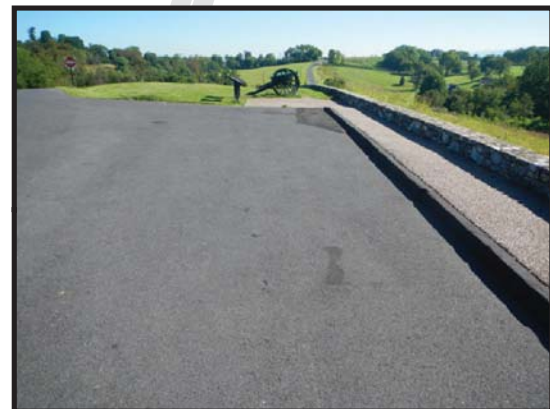
Route 0909

Route Number	Public / NonPublic	Date Visited	Area (sq ft)	Lane Miles *	Surface Type
0909	PUBLIC	7/25/2012	1,643	0.03	AS
Culverts	Drop Inlets	Gates	Curb & Gutter	Curb	PCR
0	0	0	NO CURB AND GUTTER	ASPHALT CURB	GOOD/90

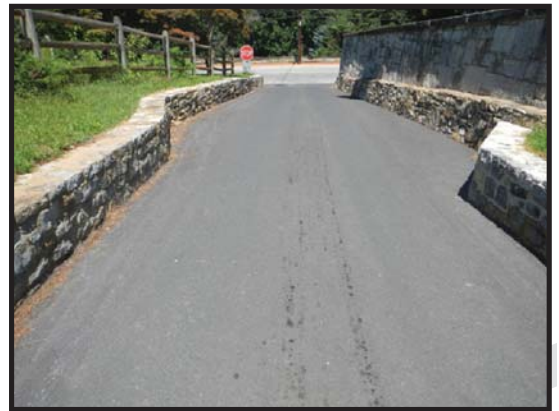
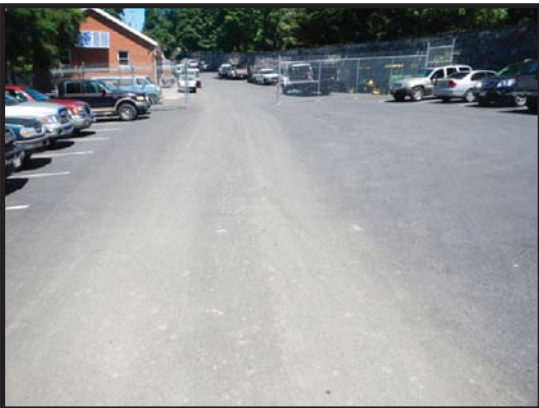
Route 0910

Route Number	Public / NonPublic	Date Visited	Area (sq ft)	Lane Miles *	Surface Type
0910	NONPUBLIC	7/25/2012	33,597	0.58	AS
Culverts	Drop Inlets	Gates	Curb & Gutter	Curb	PCR
0	0	4	NO CURB AND GUTTER	ASPHALT CURB	GOOD/90

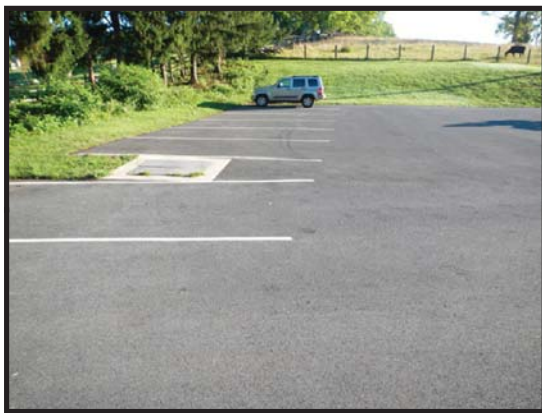
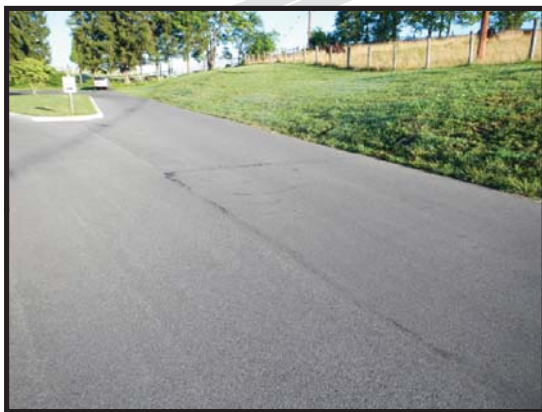
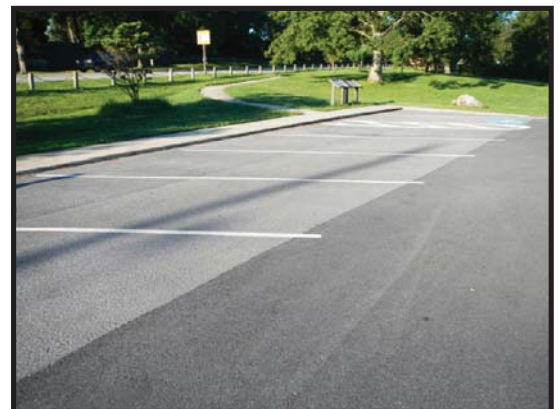
Route 0913

Route Number	Public / NonPublic	Date Visited	Area (sq ft)	Lane Miles *	Surface Type
0913	PUBLIC	7/25/2012	14,095	0.24	AS
Culverts	Drop Inlets	Gates	Curb & Gutter	Curb	PCR
1	0	1	NO CURB AND GUTTER	CONCRETE CURB	GOOD/90

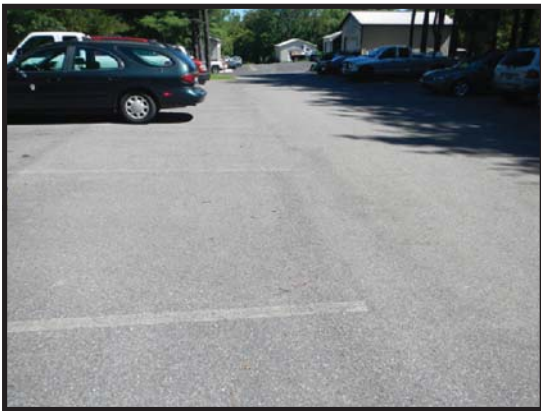
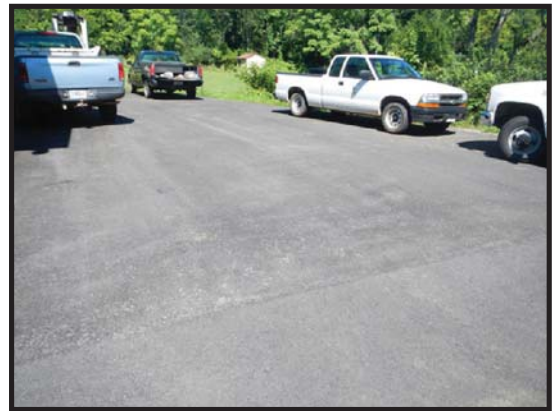
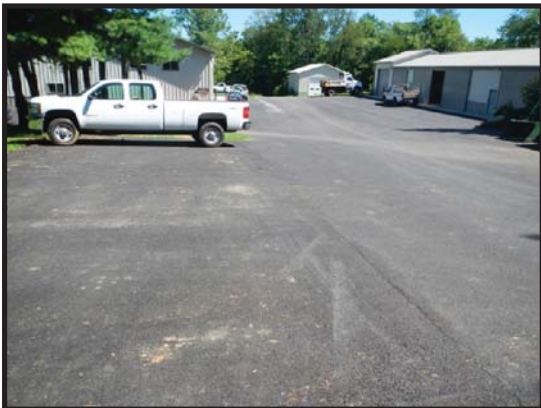
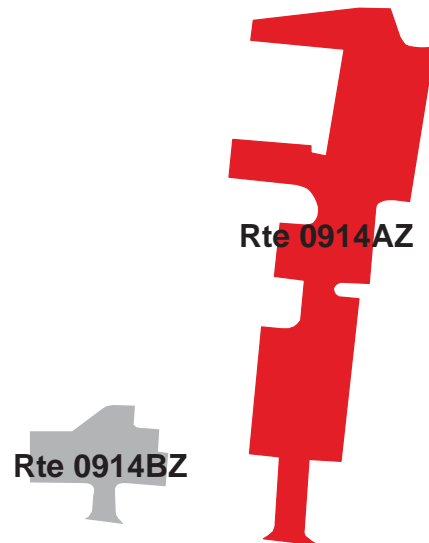
Route Number	Public / NonPublic	Date Visited	Area (sq ft)	Lane Miles *	Surface Type
0914AZ	NONPUBLIC	7/25/2012	26,760	0.46	AS
Culverts	Drop Inlets	Gates	Curb & Gutter	Curb	PCR
0	0	0	NO CURB AND GUTTER	NO CURB	GOOD/90

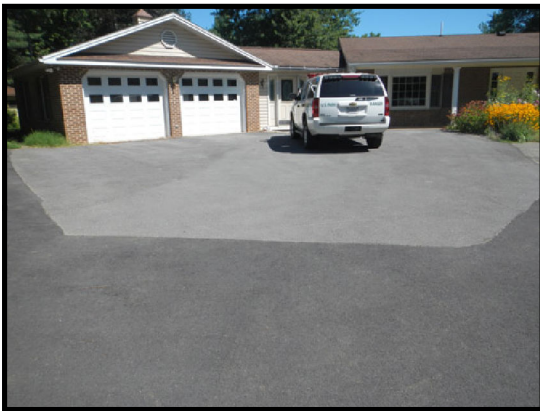
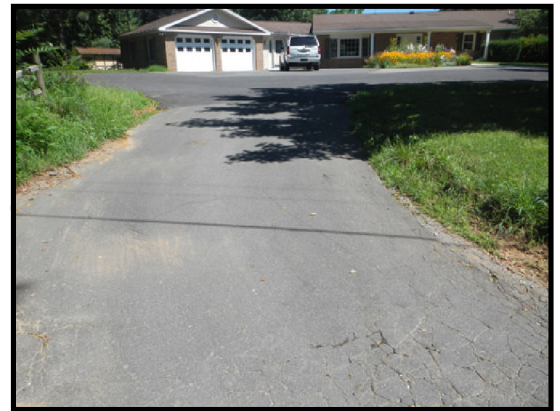
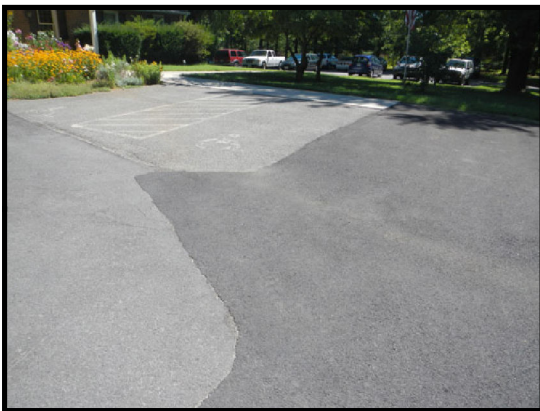
Route 0914BZ

Route Number	Public / NonPublic	Date Visited	Area (sq ft)	Lane Miles *	Surface Type
0914BZ	NONPUBLIC	7/25/2012	5,335	0.09	AS
Culverts	Drop Inlets	Gates	Curb & Gutter	Curb	PCR
0	0	0	NO CURB AND GUTTER	NO CURB	GOOD/90

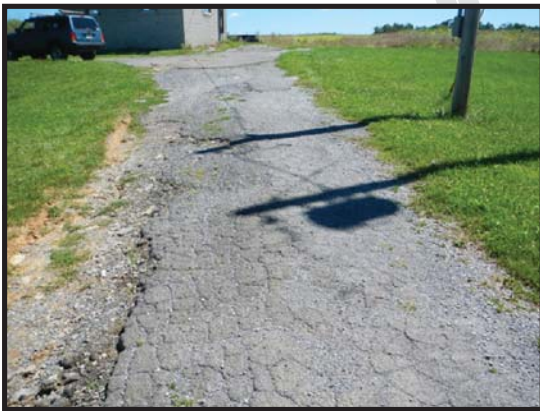
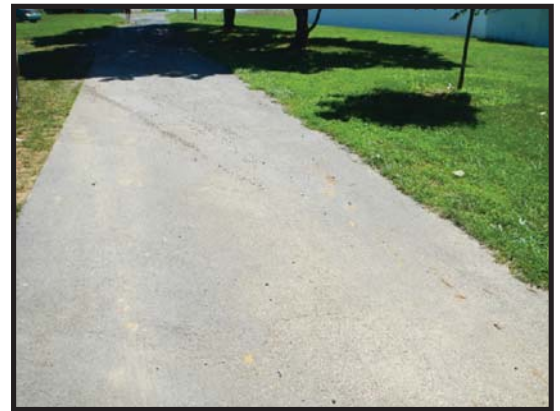
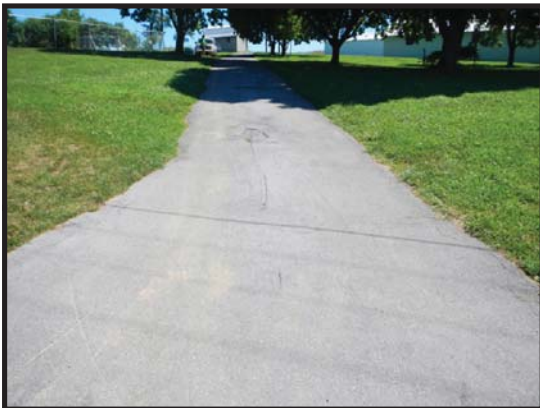
Route 0916

Route Number	Public / NonPublic	Date Visited	Area (sq ft)	Lane Miles *	Surface Type
0916	NONPUBLIC	7/25/2012	4,568	0.08	AS
Culverts	Drop Inlets	Gates	Curb & Gutter	Curb	PCR
1	0	0	NO CURB AND GUTTER	NO CURB	POOR/45

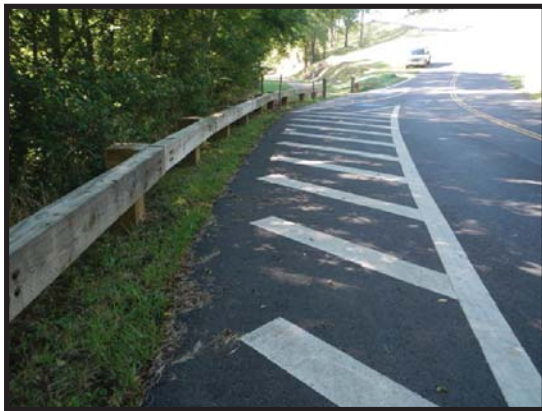
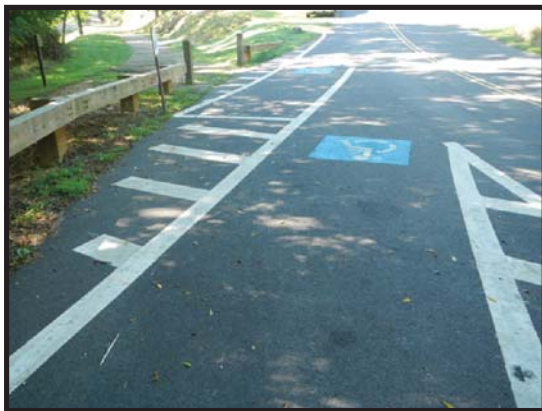
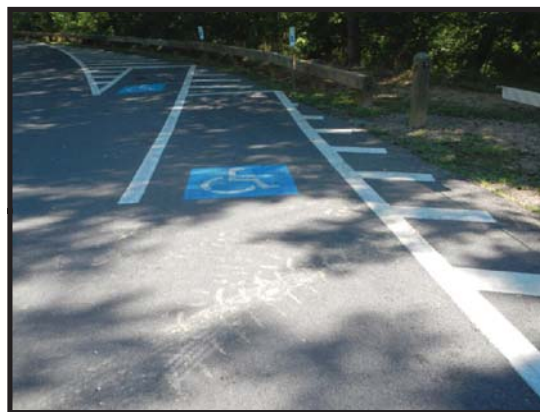
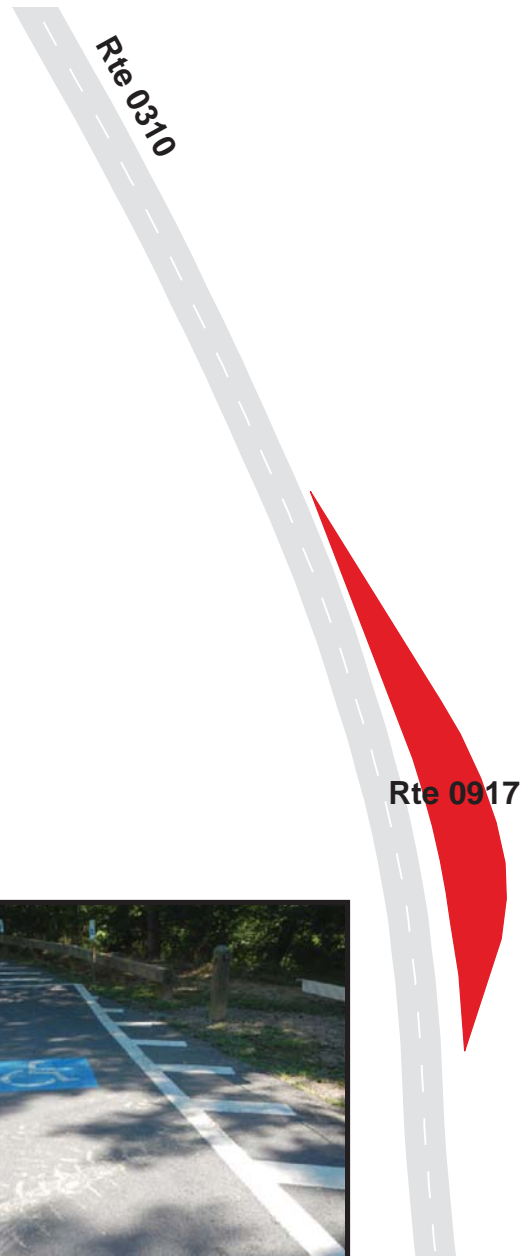
Route 0917

BURNSIDE BRIDGE HANDICAPPED PARKING
ADJACENT TO ROUTE 0310 (OLD BURNSIDE BRIDGE ROAD)

Route Number	Public / NonPublic	Date Visited	Area (sq ft)	Lane Miles *	Surface Type
0917	PUBLIC	7/25/2012	1,147	0.02	AS
Culverts	Drop Inlets	Gates	Curb & Gutter	Curb	PCR
0	0	1	NO CURB AND GUTTER	NO CURB	GOOD/90

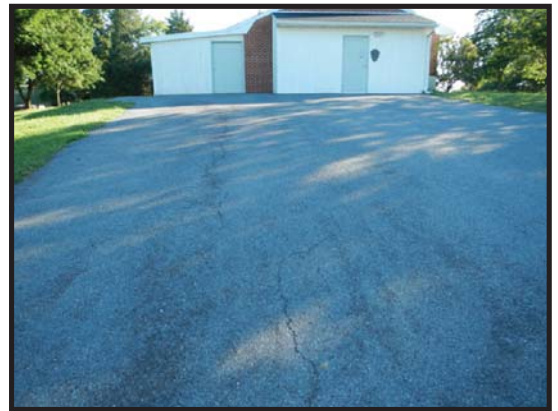
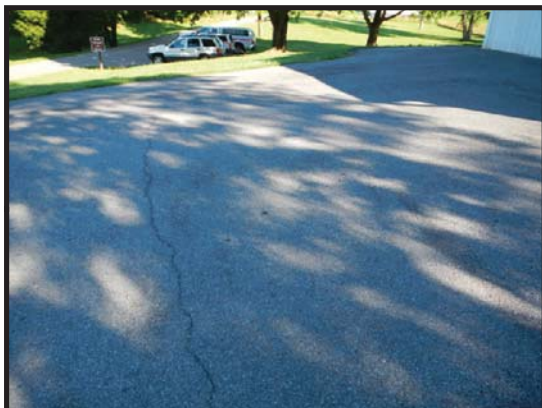
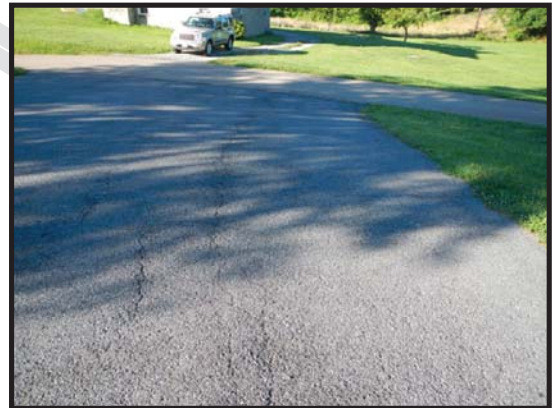
Route Number	Public / NonPublic	Date Visited	Area (sq ft)	Lane Miles *	Surface Type
0918AZ	NONPUBLIC	7/25/2012	1,955	0.03	AS
Culverts	Drop Inlets	Gates	Curb & Gutter	Curb	PCR
0	0	0	NO CURB AND GUTTER	NO CURB	FAIR/73

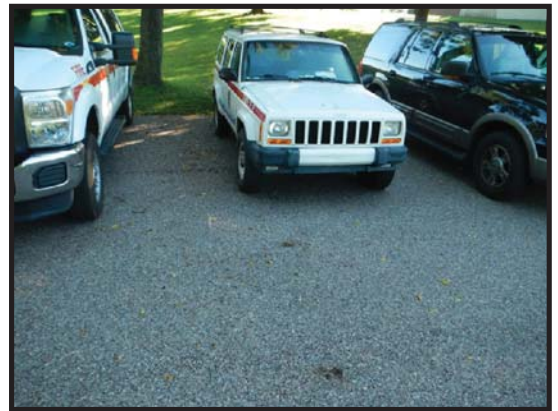
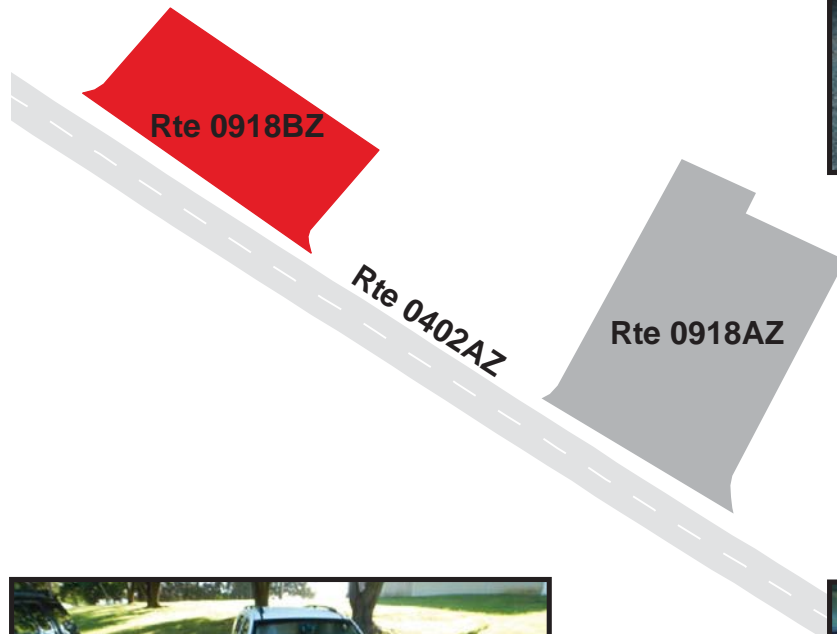
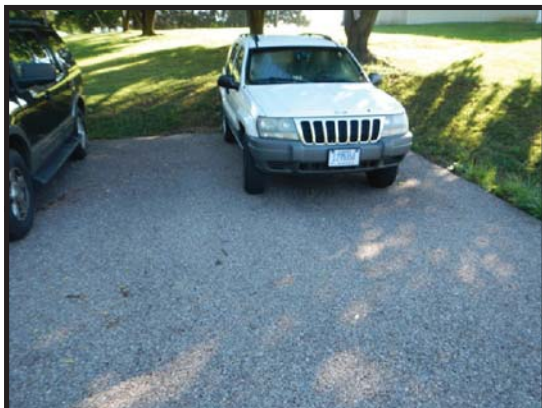
Route 0918BZ

Route Number	Public / NonPublic	Date Visited	Area (sq ft)	Lane Miles *	Surface Type
0918BZ	NONPUBLIC	7/25/2012	1,127	0.02	AS
Culverts	Drop Inlets	Gates	Curb & Gutter	Curb	PCR
0	0	0	NO CURB AND GUTTER	NO CURB	GOOD/90

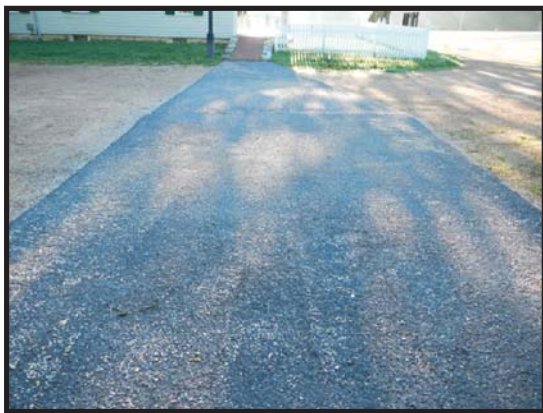
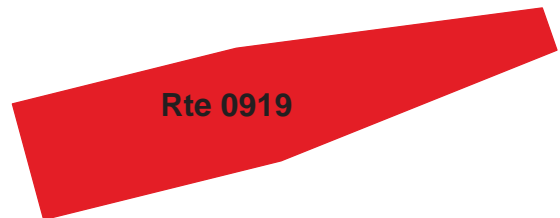
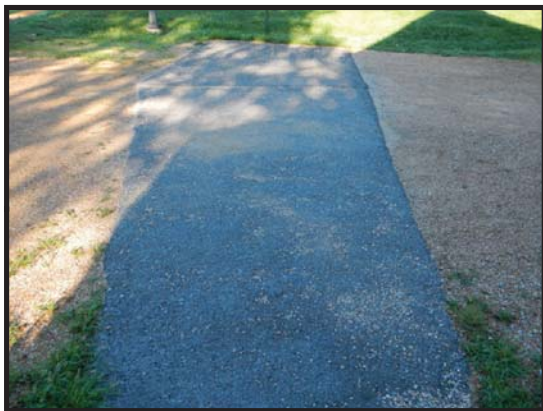
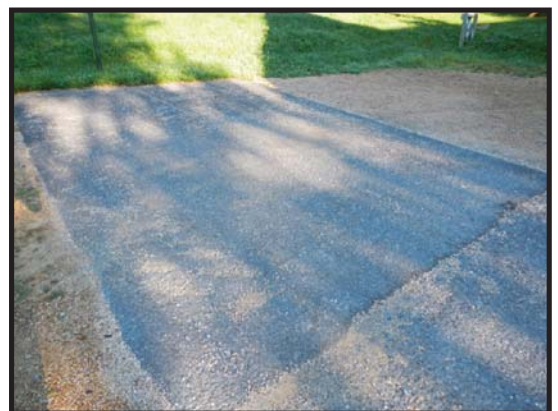
Route 0919

Route Number	Public / NonPublic	Date Visited	Area (sq ft)	Lane Miles *	Surface Type
0919	PUBLIC	7/25/2012	486	0.01	AS
Culverts	Drop Inlets	Gates	Curb & Gutter	Curb	PCR
0	0	0	NO CURB AND GUTTER	NO CURB	FAIR/73

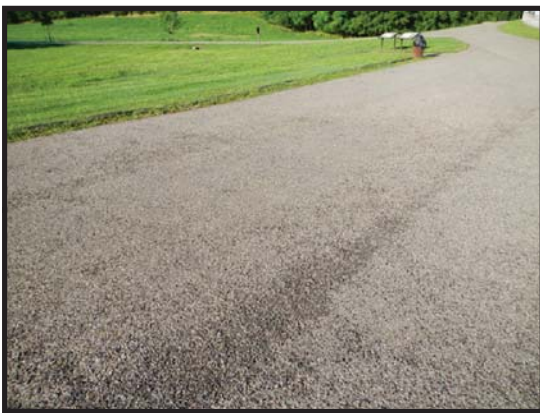
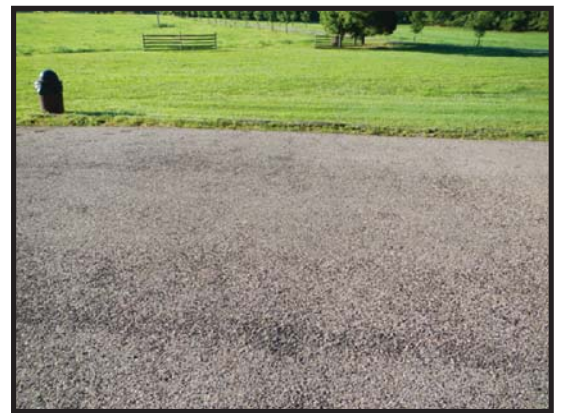
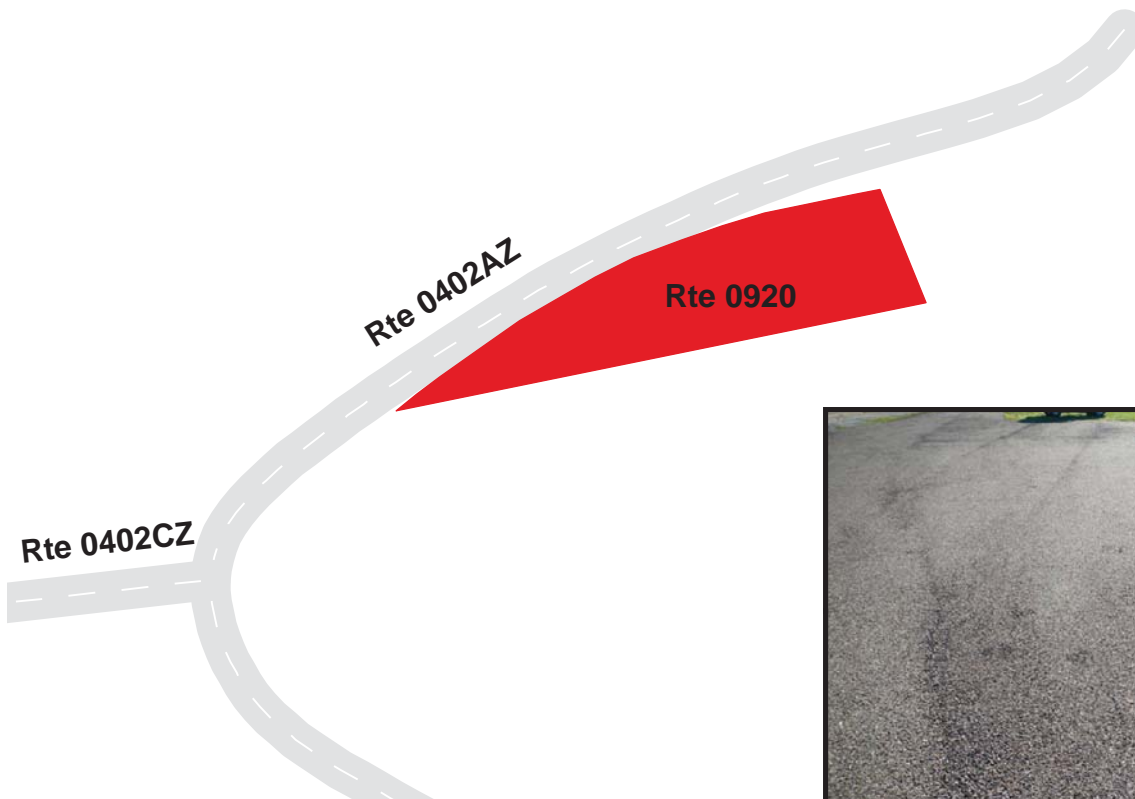
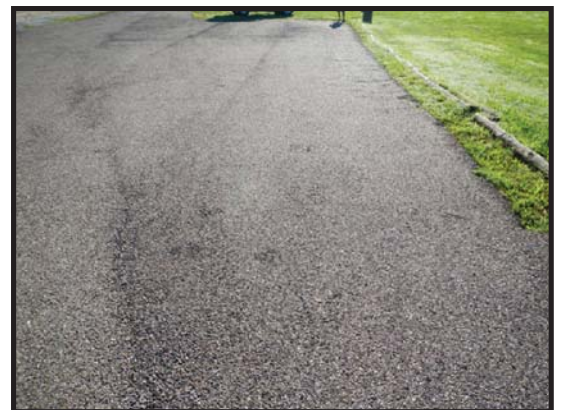
Route 0920

Route Number	Public / NonPublic	Date Visited	Area (sq ft)	Lane Miles *	Surface Type
0920	PUBLIC	7/25/2012	1,673	0.03	AS
Culverts	Drop Inlets	Gates	Curb & Gutter	Curb	PCR
0	0	0	NO CURB AND GUTTER	WOOD CURB	GOOD/90

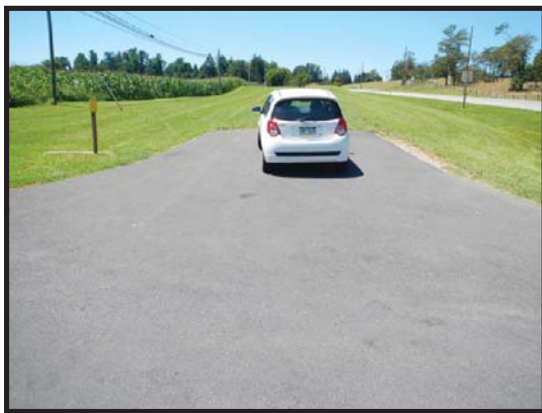
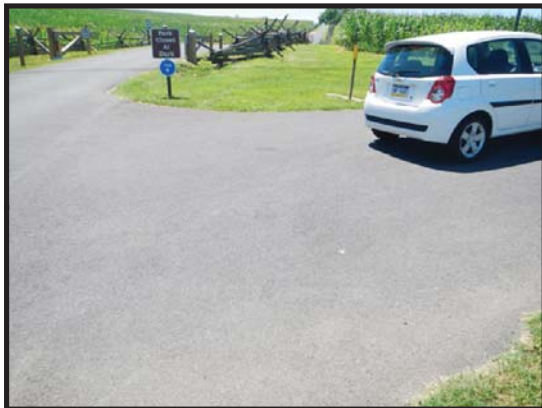
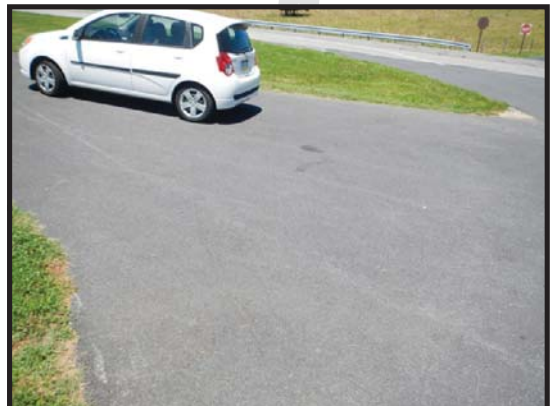
Route Number	Public / NonPublic	Date Visited	Area (sq ft)	Lane Miles *	Surface Type
0921	PUBLIC	7/25/2012	853	0.02	AS
Culverts	Drop Inlets	Gates	Curb & Gutter	Curb	PCR
0	0	0	NO CURB AND GUTTER	NO CURB	GOOD/90

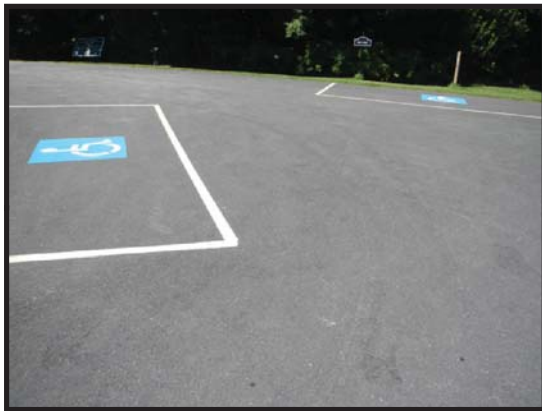
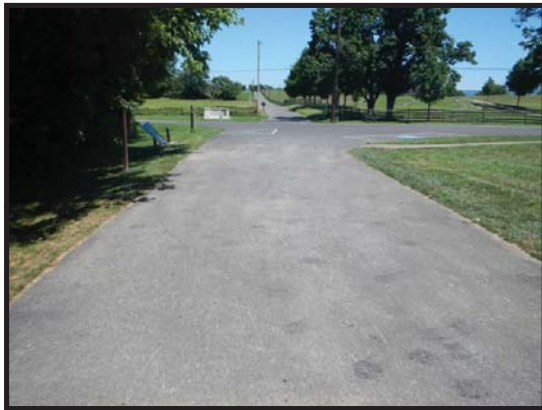
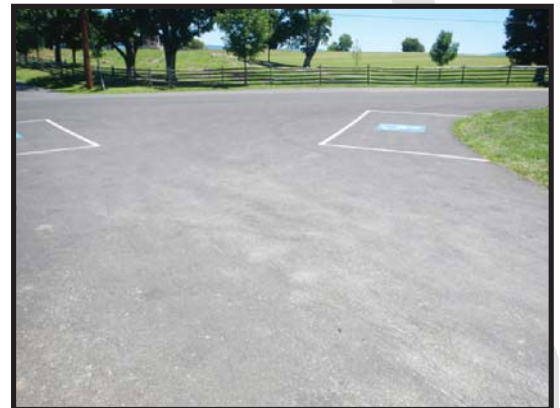
Route 0922

Route Number	Public / NonPublic	Date Visited	Area (sq ft)	Lane Miles *	Surface Type
0922	PUBLIC	7/25/2012	2,539	0.04	AS
Culverts	Drop Inlets	Gates	Curb & Gutter	Curb	PCR
1	0	0	NO CURB AND GUTTER	NO CURB	GOOD/90
