Federal Lands Highway Road Inventory Program

Road Inventory and Condition Assessment

Appomattox Court House National Historical Park APCO

Cycle 5 Report

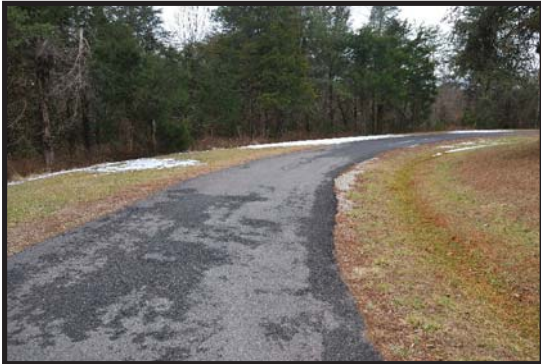
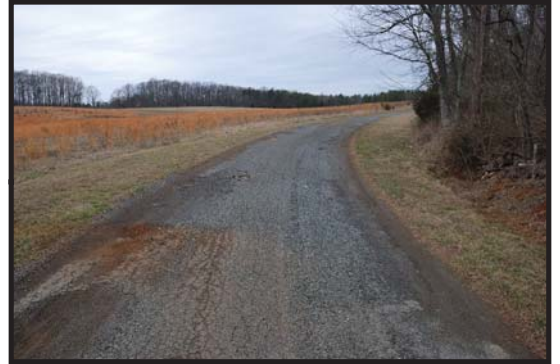
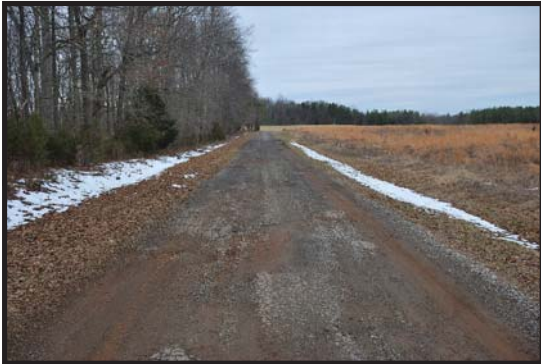
Route Number	Public / NonPublic	Date Visited	Area (sq ft)	Lane Miles *	Paved Length (mi)	Paved Width (ft)
0200	PUBLIC	2/22/2013	58,344	1.01	0.85	13
Culverts	Drop Inlets	Gates	Curb & Gutter	Curb	PCR	Surface Type
1	0	1	NO CURB AND GUTTER	NO CURB	POOR/45	AS

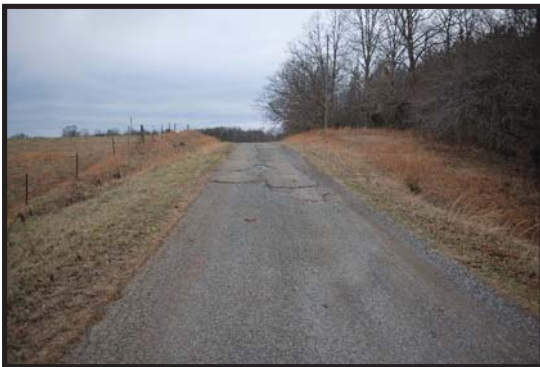
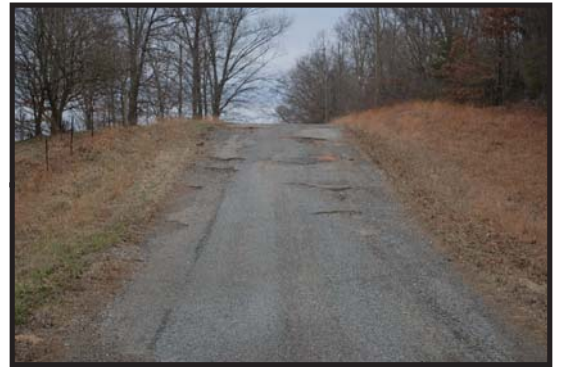
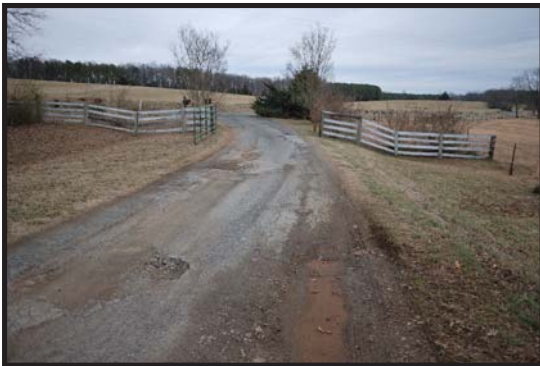
Route 0201

Route Number	Public / NonPublic	Date Visited	Area (sq ft)	Lane Miles *	Paved Length (mi)	Paved Width (ft)
0201	PUBLIC	2/22/2013	26,701	0.46	0.39	13
Culverts	Drop Inlets	Gates	Curb & Gutter	Curb	PCR	Surface Type
3	0	2	NO CURB AND GUTTER	NO CURB	POOR/45	AS

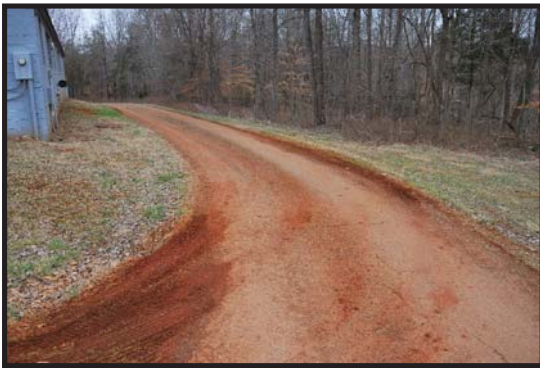
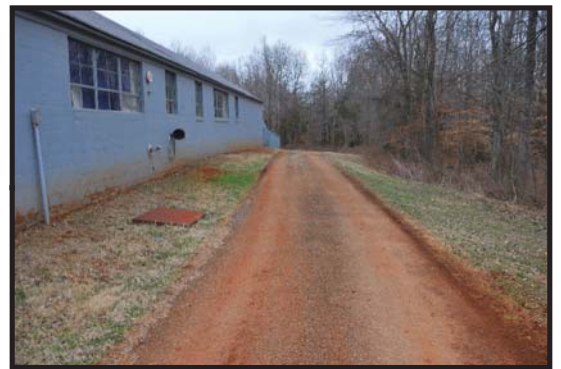
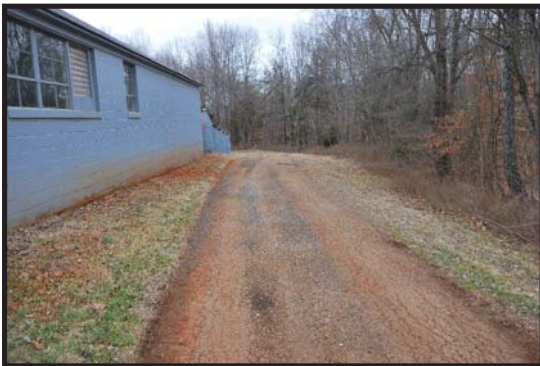
Route 0408

Route Number	Public / NonPublic	Date Visited	Area (sq ft)	Lane Miles *	Surface Type
0408	PUBLIC	2/22/2013	5,029	0.09	AS
Culverts	Drop Inlets	Gates	Curb & Gutter	Curb	PCR
1	0	0	NO CURB AND GUTTER	NO CURB	POOR/45

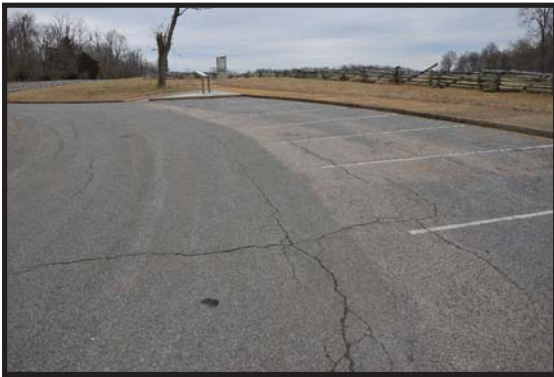
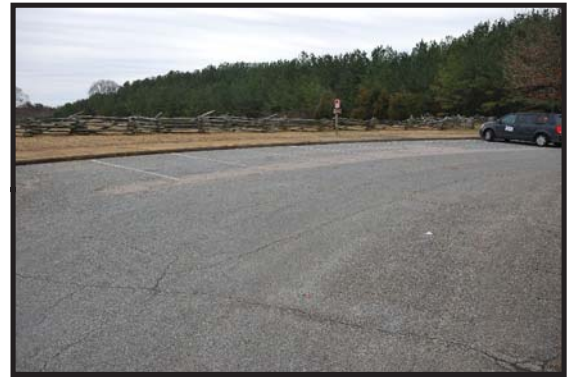
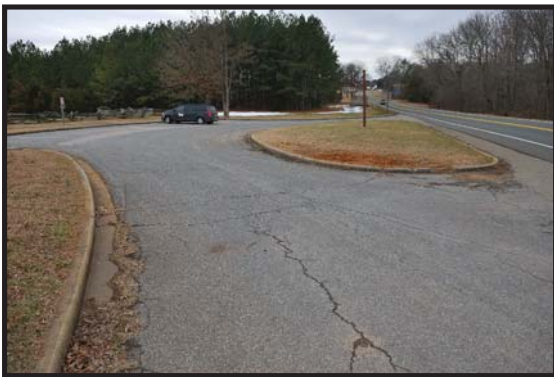
Route Number	Public / NonPublic	Date Visited	Area (sq ft)	Lane Miles *	Surface Type
0900	PUBLIC	2/22/2013	9,161	0.16	AS
Culverts	Drop Inlets	Gates	Curb & Gutter	Curb	PCR
0	0	0	CONCRETE CURB AND GUTTER	CONCRETE CURB	POOR/45

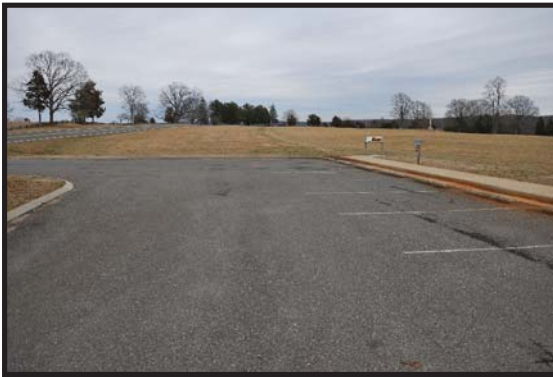
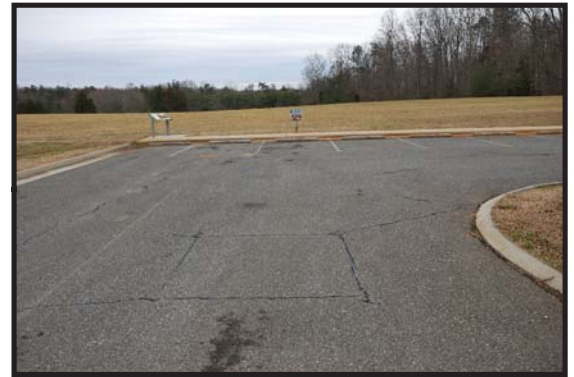
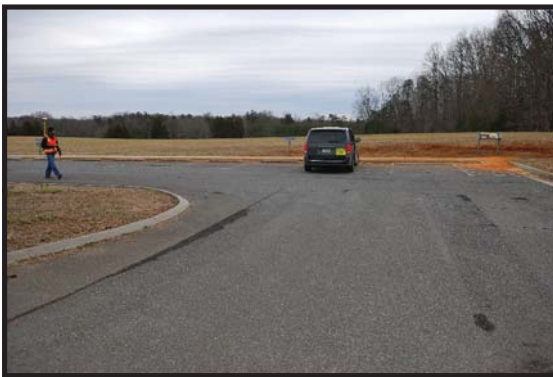
Route 0901

Route Number	Public / NonPublic	Date Visited	Area (sq ft)	Lane Miles *	Surface Type
0901	PUBLIC	2/22/2013	7,922	0.14	AS
Culverts	Drop Inlets	Gates	Curb & Gutter	Curb	PCR
0	0	0	CONCRETE CURB AND GUTTER	CONCRETE CURB	FAIR/73

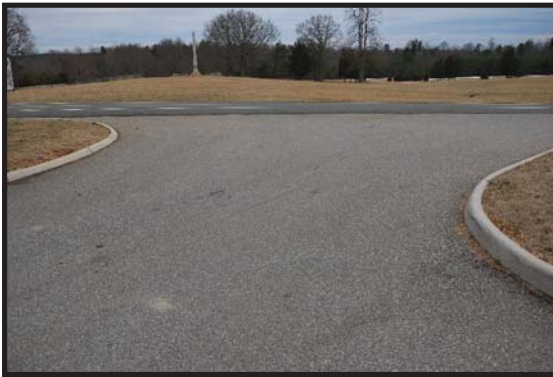
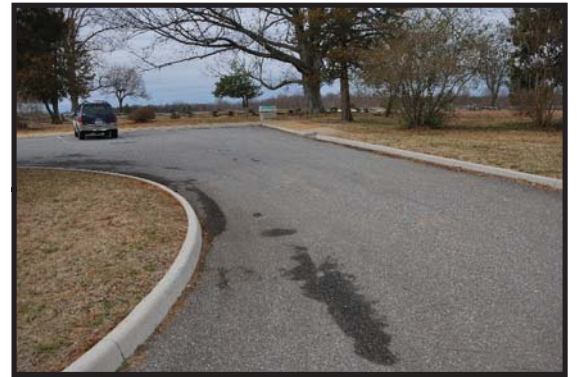
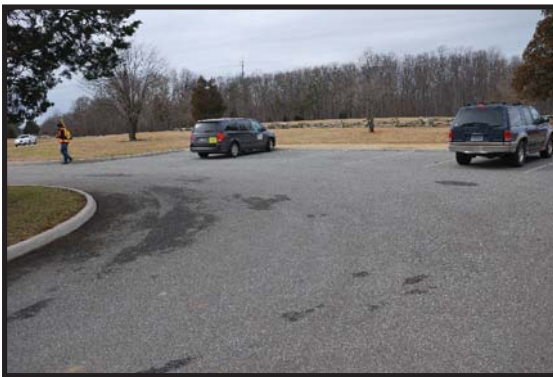
Route 0902

Route Number	Public / NonPublic	Date Visited	Area (sq ft)	Lane Miles *	Surface Type
0902	PUBLIC	2/22/2013	7,589	0.13	AS
Culverts	Drop Inlets	Gates	Curb & Gutter	Curb	PCR
0	1	0	NO CURB AND GUTTER	CONCRETE CURB	GOOD/90

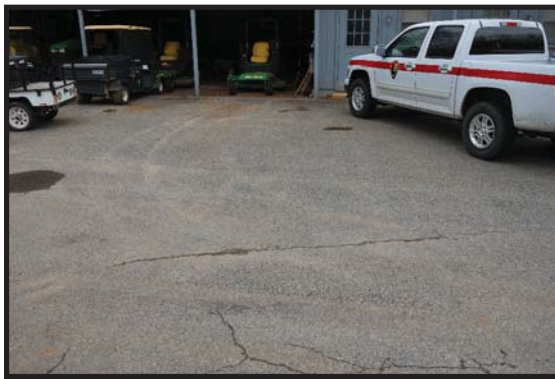
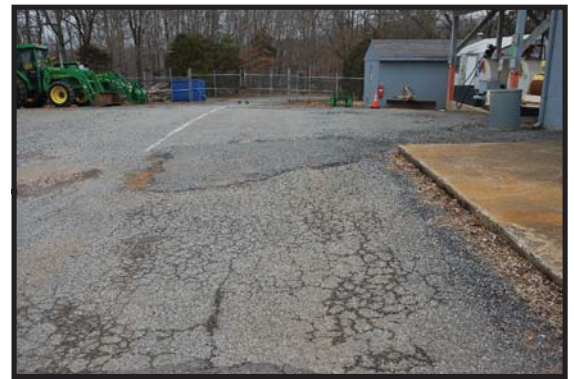
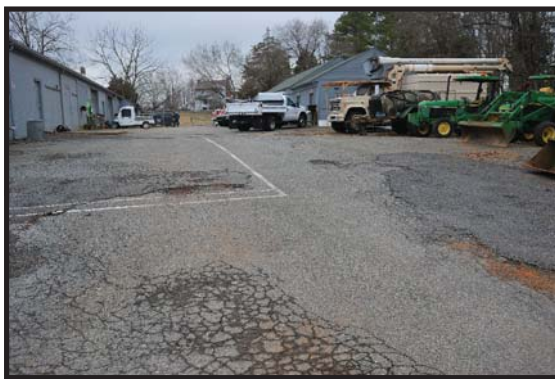
Route 0903

Route Number	Public / NonPublic	Date Visited	Area (sq ft)	Lane Miles *	Surface Type
0903	NONPUBLIC	2/22/2013	13,242	0.23	AS
Culverts	Drop Inlets	Gates	Curb & Gutter	Curb	PCR
0	0	2	NO CURB AND GUTTER	NO CURB	POOR/45

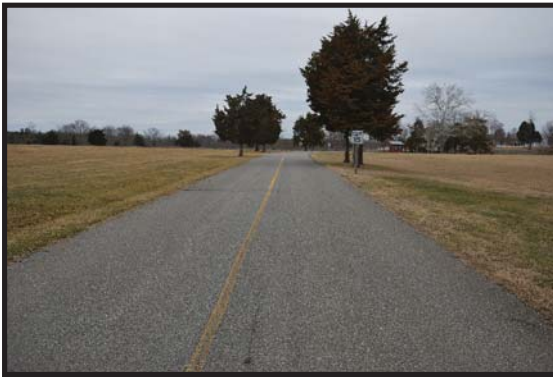
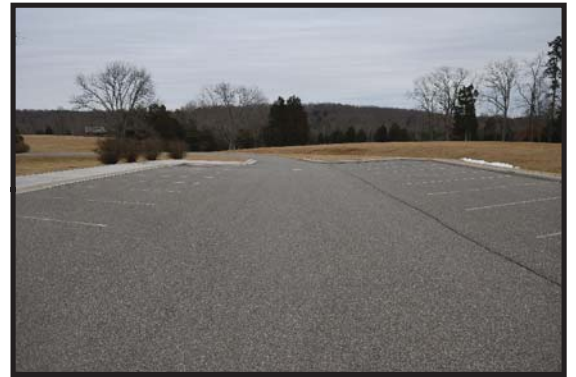
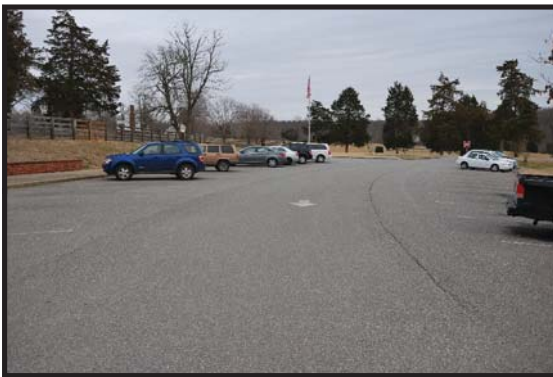
Route 0904

Route Number	Public / NonPublic	Date Visited	Area (sq ft)	Lane Miles *	Surface Type
0904	PUBLIC	2/22/2013	49,450	0.85	AS
Culverts	Drop Inlets	Gates	Curb & Gutter	Curb	PCR
3	8	1	CONCRETE CURB AND GUTTER	CONCRETE CURB	GOOD/90

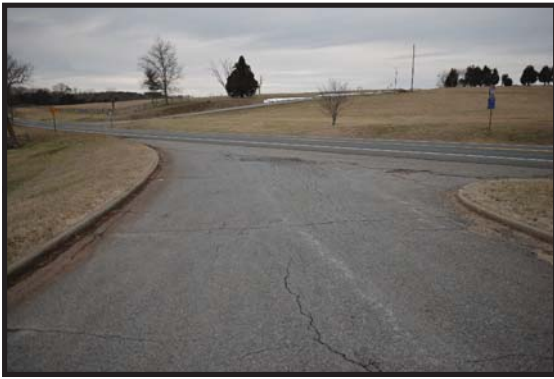
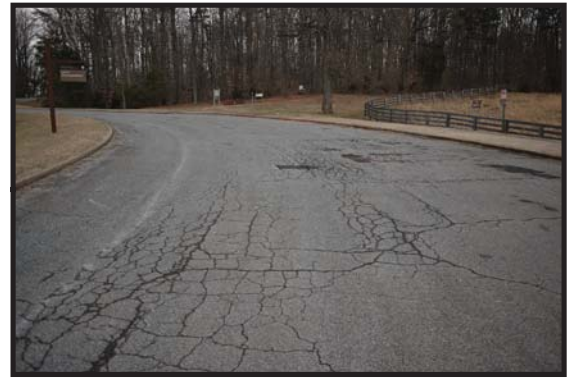
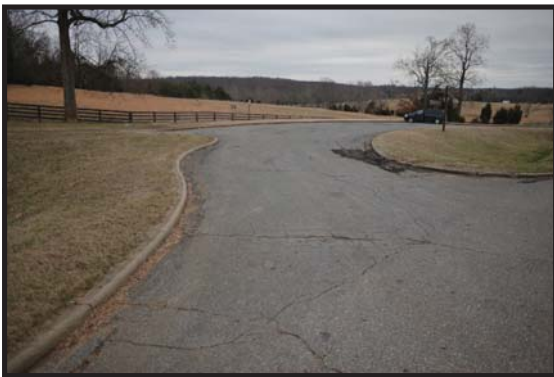
Route 0905

Route Number	Public / NonPublic	Date Visited	Area (sq ft)	Lane Miles *	Surface Type
0905	PUBLIC	2/22/2013	9,280	0.16	AS
Culverts	Drop Inlets	Gates	Curb & Gutter	Curb	PCR
2	0	0	NO CURB AND GUTTER	CONCRETE CURB	POOR/45

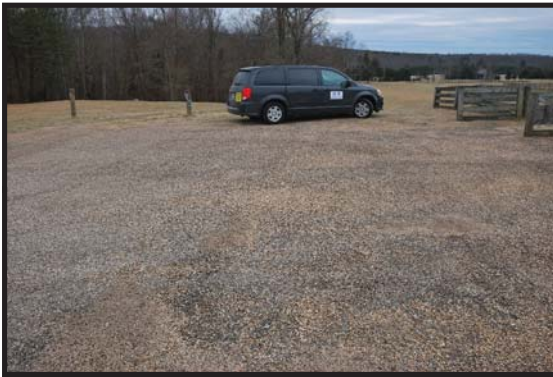
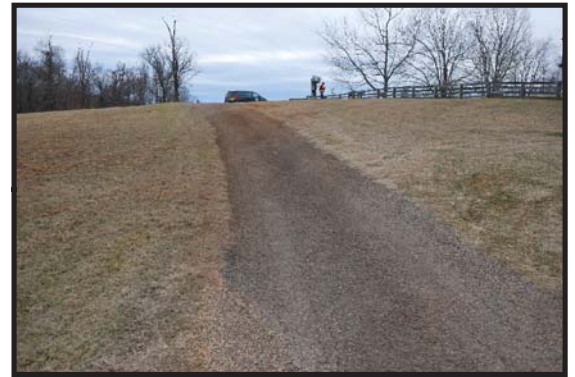
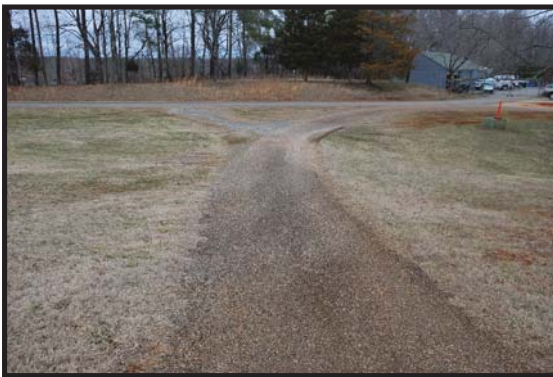
Route 0906

Route Number	Public / NonPublic	Date Visited	Area (sq ft)	Lane Miles *	Surface Type
0906	NONPUBLIC	2/22/2013	4,487	0.08	AS
Culverts	Drop Inlets	Gates	Curb & Gutter	Curb	PCR
0	0	2	NO CURB AND GUTTER	NO CURB	POOR/45
