Federal Lands Highway Road Inventory Program

Road Inventory and Condition Assessment

Arches National Park

Cycle 5 Report

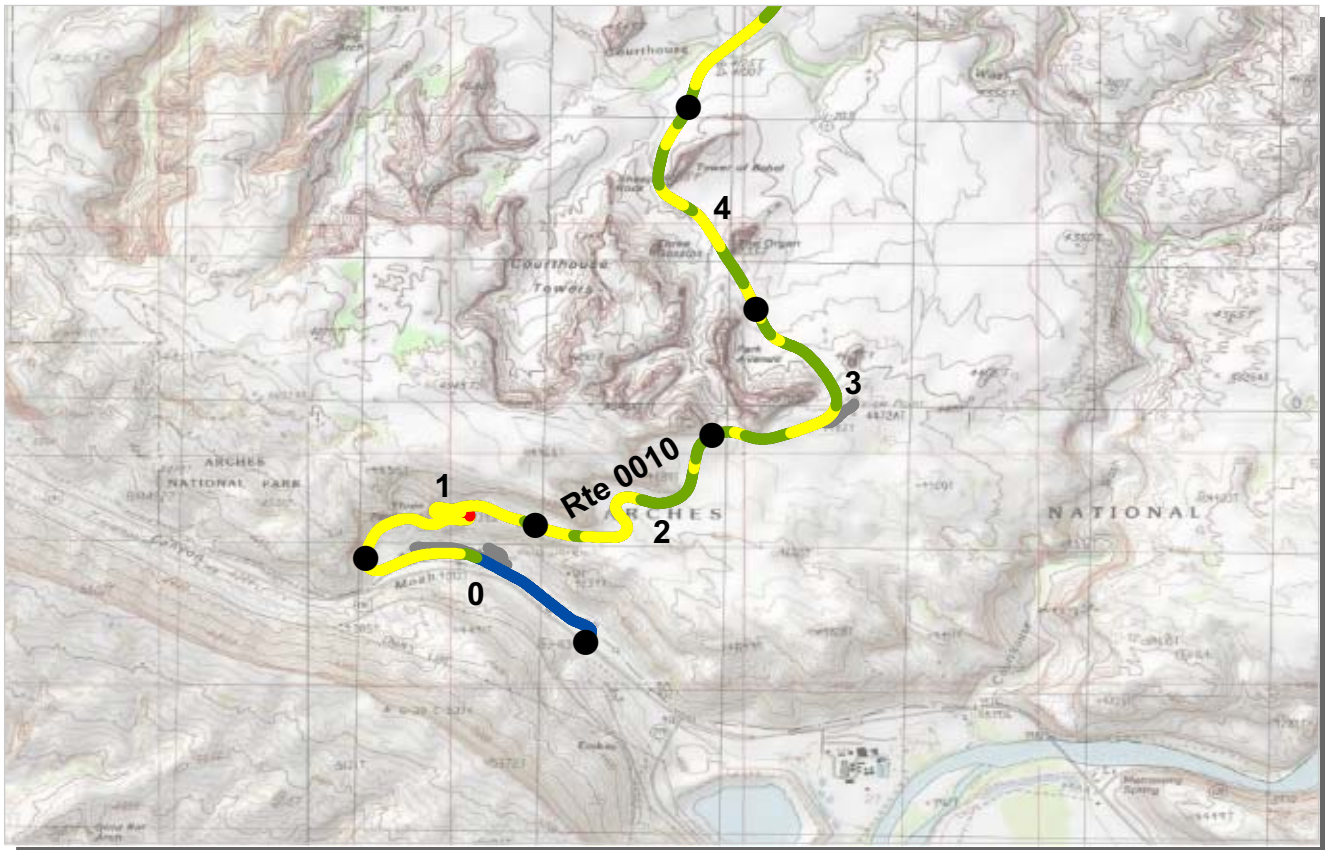
| <i>Section Number</i> | 0 | 1 | 2 | 3 | 4 |
|---|---|---|---|---|---|
| SCR (Surface Condition Rating) | 92 | 72 | 82 | 85 | 83 |
| PCR (Pavement Condition Rating) | 91 | 72 | 84 | 85 | 84 |
| Structural Crack Index | 92 | 77 | 85 | 89 | 85 |
| Transverse Cracking Index | 93 | 72 | 82 | 85 | 83 |
| Roughness Condition Index (RCI) | 89 | 71 | 87 | 86 | 86 |

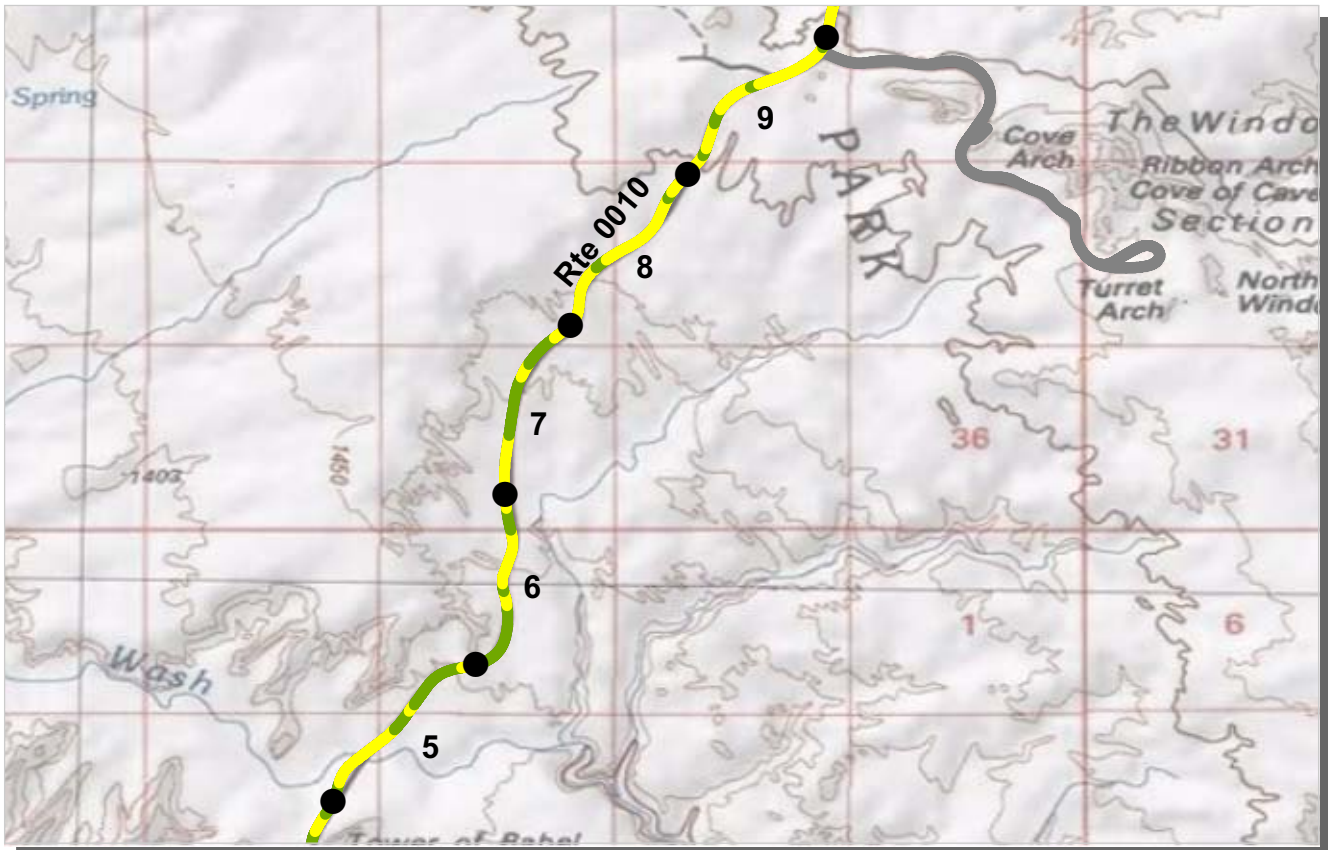
ROUTE: 0010 MAIN PARK ROAD

| <i>Section Number</i> | 5 | 6 | 7 | 8 | 9 |
|---|---|---|---|---|---|
| SCR (Surface Condition Rating) | 84 | 82 | 84 | 79 | 78 |
| PCR (Pavement Condition Rating) | 84 | 85 | 85 | 82 | 82 |
| Structural Crack Index | 88 | 85 | 84 | 82 | 83 |
| Transverse Cracking Index | 84 | 82 | 84 | 79 | 78 |
| Roughness Condition Index (RCI) | 83 | 89 | 86 | 87 | 89 |

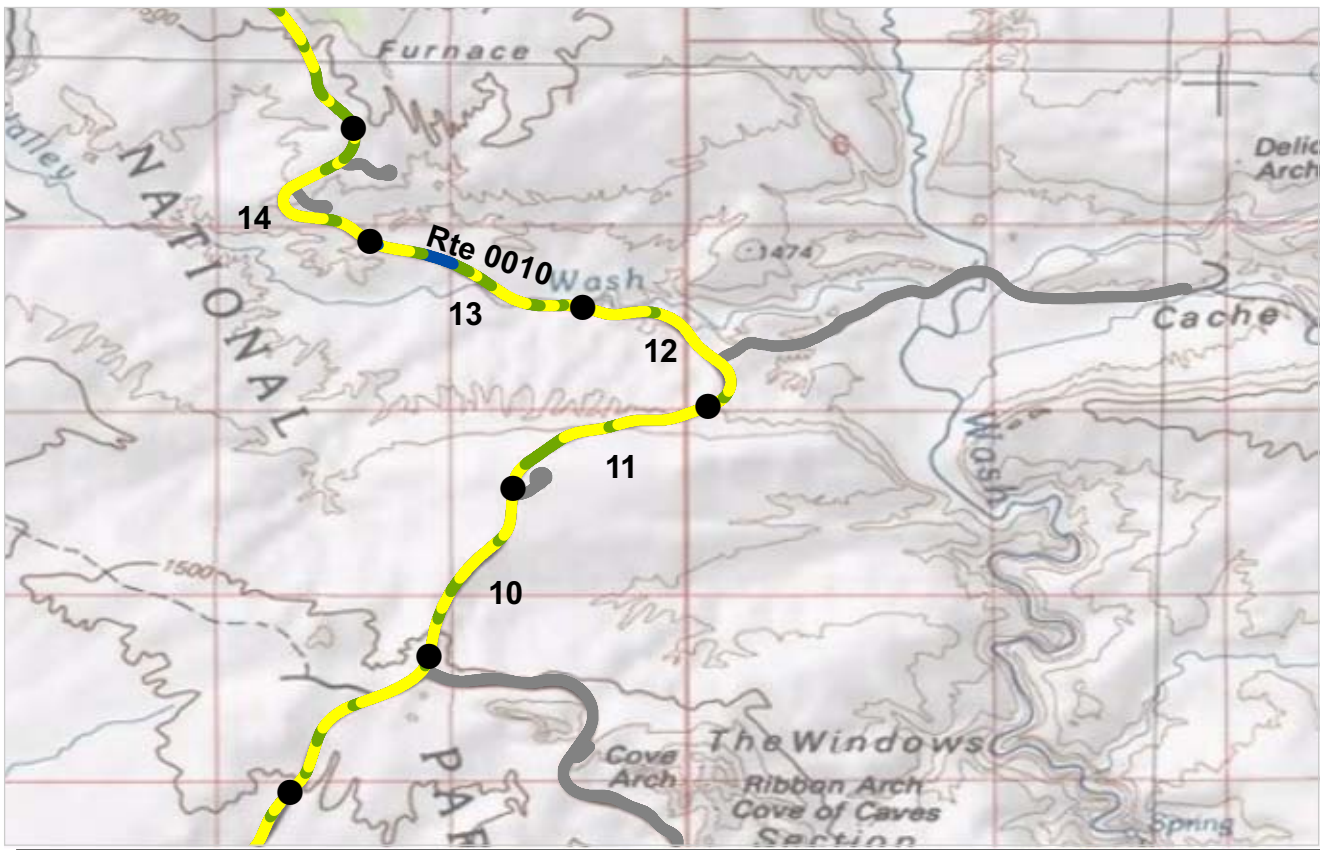
ROUTE: 0010 MAIN PARK ROAD

| <i>Section Number</i> | 10 | 11 | 12 | 13 | 14 |
|---|---|---|---|---|---|
| SCR (Surface Condition Rating) | 79 | 81 | 82 | 87 | 81 |
| PCR (Pavement Condition Rating) | 81 | 83 | 77 | 86 | 80 |
| Structural Crack Index | 82 | 81 | 83 | 87 | 83 |
| Transverse Cracking Index | 79 | 81 | 82 | 91 | 81 |
| Roughness Condition Index (RCI) | 85 | 86 | 69 | 85 | 78 |

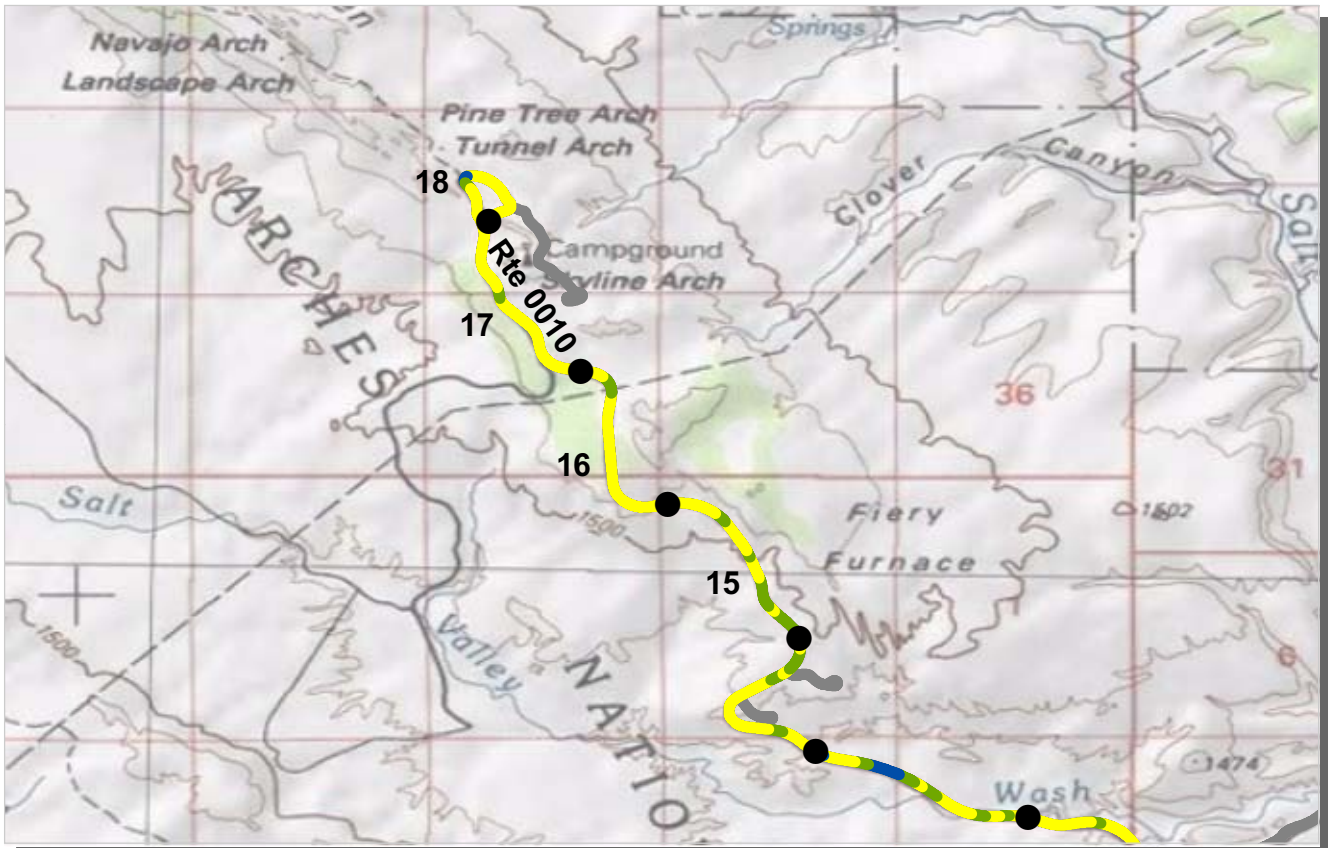
ROUTE: 0010 MAIN PARK ROAD

| Section Number | 15 | 16 | 17 | 18 | |
|---|---|---|---|---|--|
| SCR (Surface Condition Rating) | 81 | 77 | 78 | 78 | |
| PCR (Pavement Condition Rating) | 84 | 80 | 82 | 78 | |
| Structural Crack Index | 85 | 80 | 83 | 81 | |
| Transverse Cracking Index | 81 | 77 | 78 | 78 | |
| Roughness Condition Index (RCI) | 88 | 84 | 88 | 77 | |

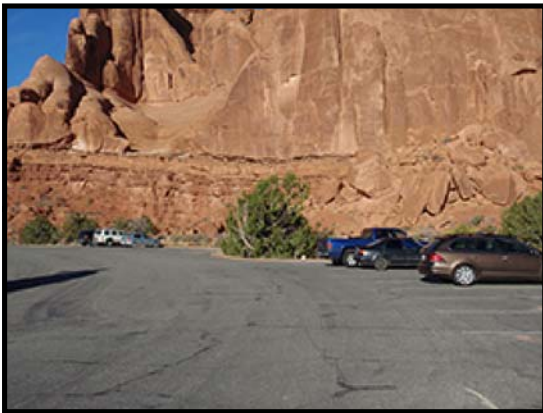
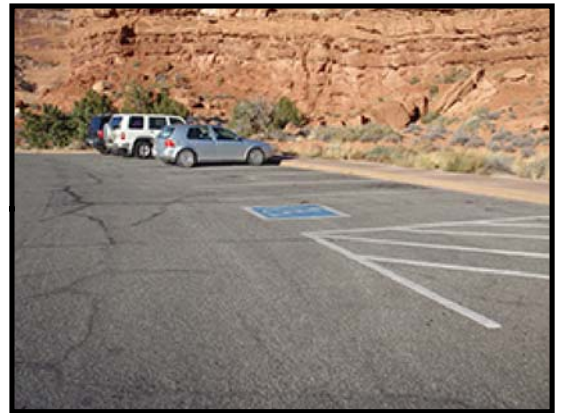
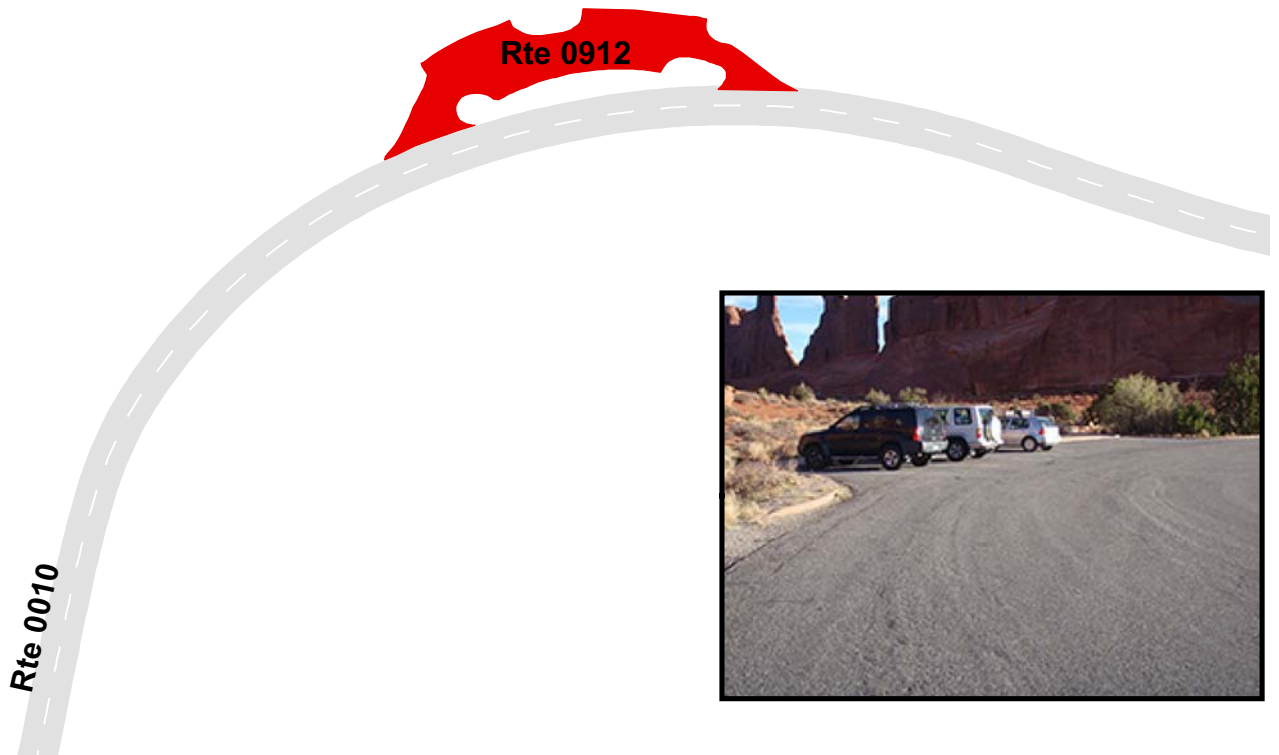
Route 0912

| Route Number | Public / NonPublic | Date Visited | Area (sq ft) | Lane Miles * | Surface Type |
|---|---|---|---|---|---|
| 0 | 0 | 0 | CONCRETE CURB AND GUTTER | NO CURB | FAIR/73 |

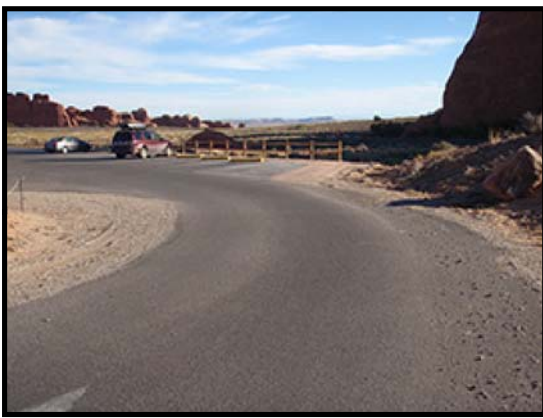
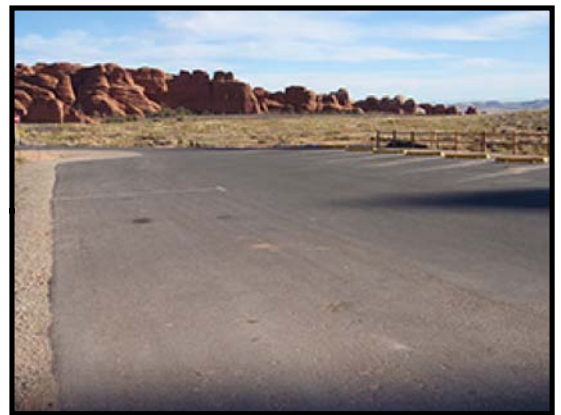
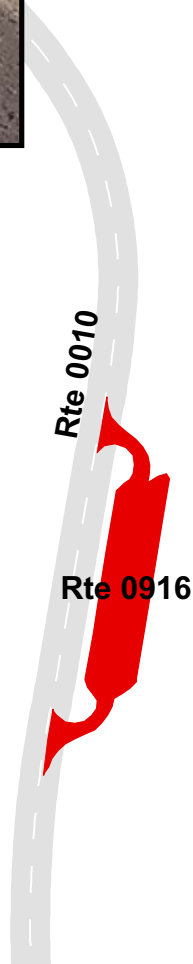
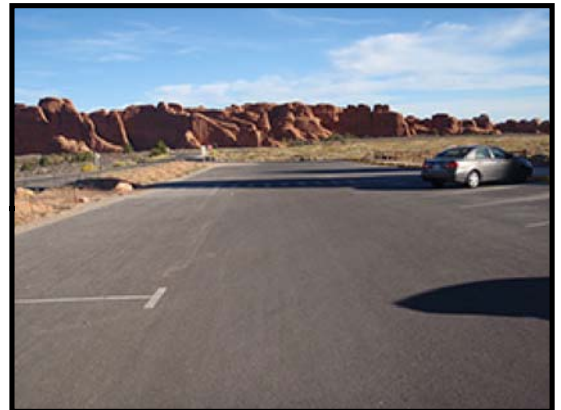
Route 0916

| Route Number | Public / NonPublic | Date Visited | Area (sq ft) | Lane Miles * | Surface Type |
|---|---|---|---|---|---|
| 0 | 1 | 0 | NO CURB AND GUTTER | NO CURB | GOOD/90 |
