# Federal Lands Highway Road Inventory Program

Road Inventory and Condition Assessment

**National Capital Parks – East  
Baltimore-Washington Parkway  
BAWA**

**Cycle 5 Report**

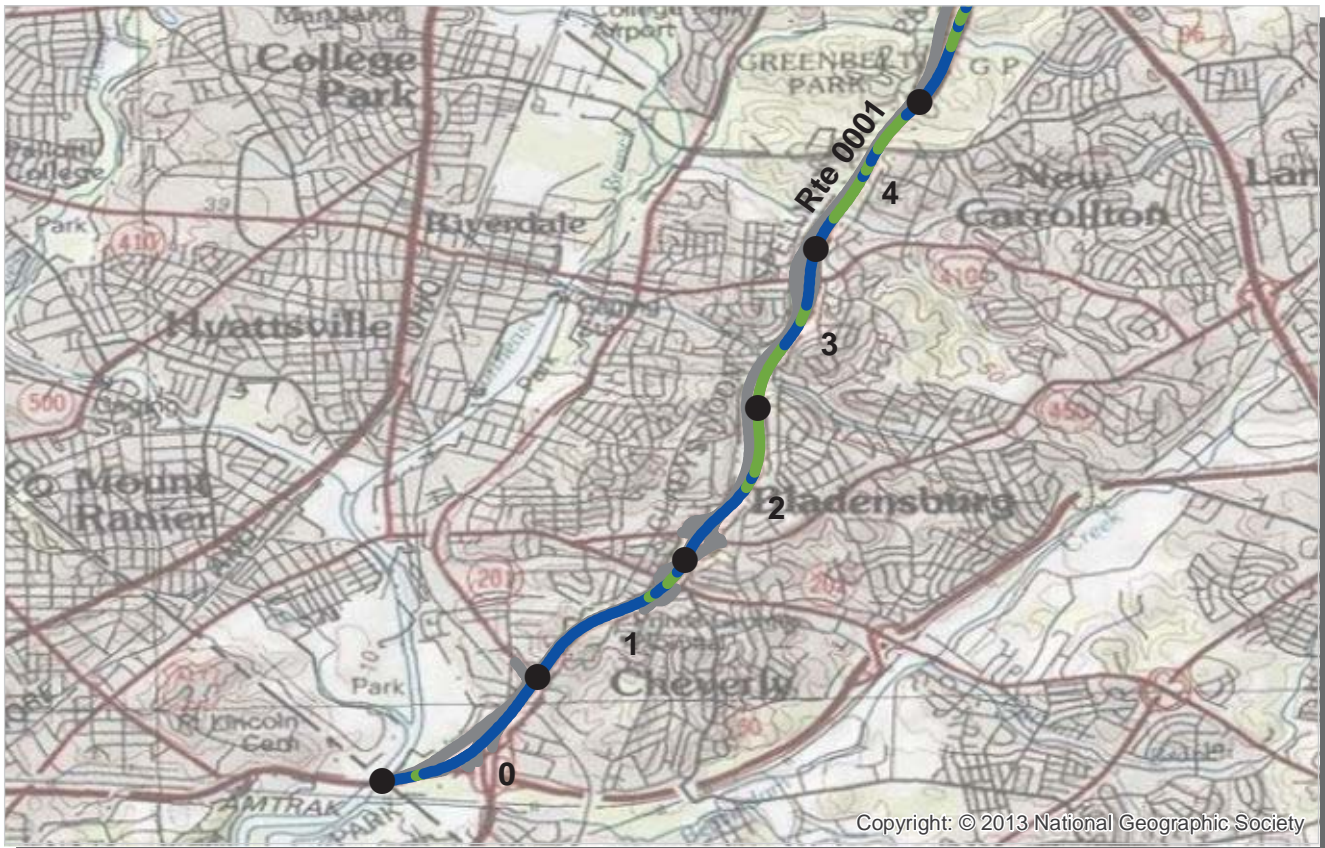
**ROUTE: 0001 BALTIMORE-WASHINGTON PARKWAY (NB)**

Section Number	0	1	2	3	4
Section Length (mi)	1.00	1.00	1.00	1.00	1.00
<b>Cross Section Information</b>					
Number of Lanes	2	3	2	2	2
Paved Width (ft)	40	48	38	35	34
Lane Width (ft)	12	12	14	12	13
<b>Roadway Condition Information</b>					
SCR (Surface Condition Rating)	99	97	93	92	93
PCR (Pavement Condition Rating)	99	98	96	95	96
<b>Distress Index Values</b>					
Structural Crack Index	99	97	98	99	98
Transverse Cracking Index	100	100	93	92	93
Patching Index	100	100	100	100	100
Rutting Index	100	100	98	97	95
Roughness Condition Index (RCI)	100	100	100	100	100

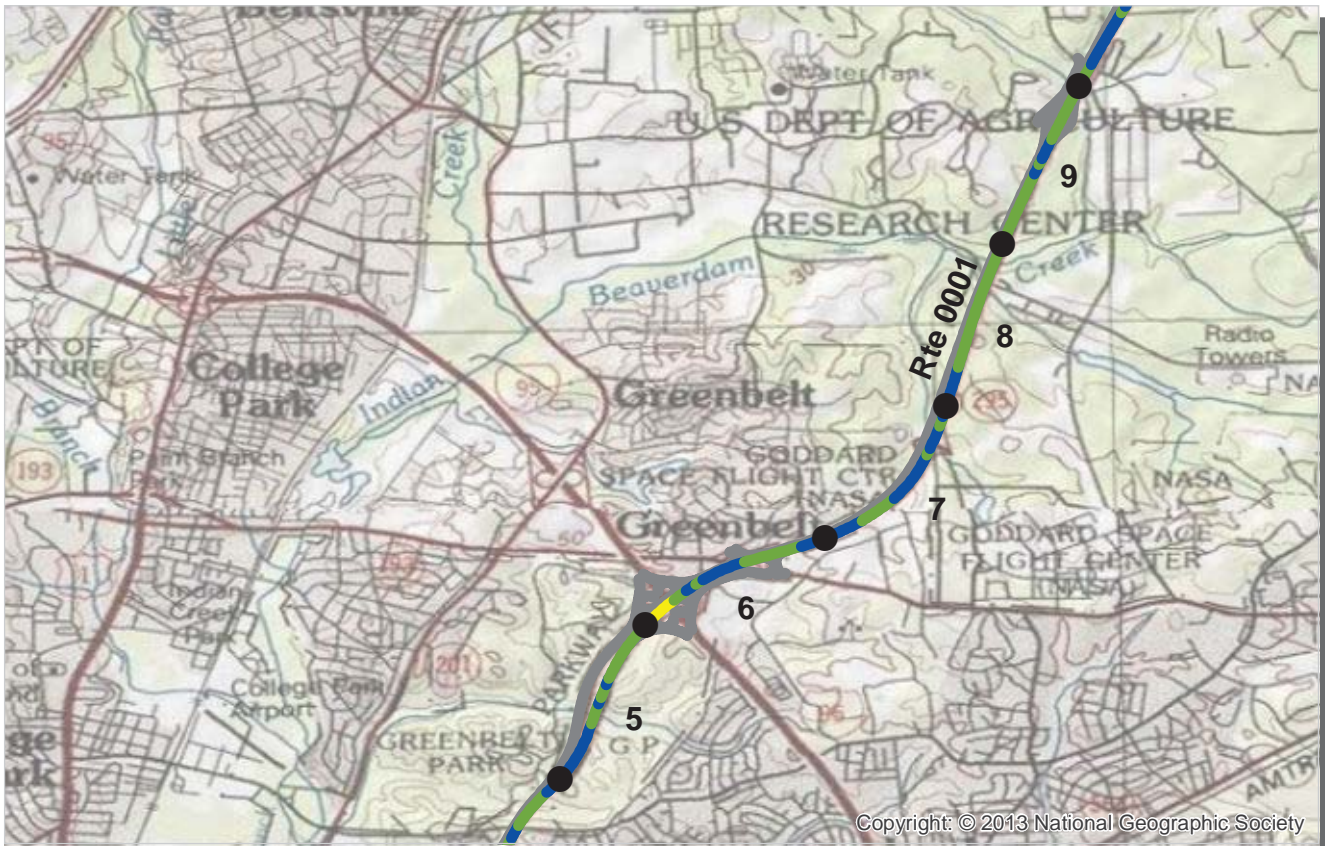
**ROUTE: 0001 BALTIMORE-WASHINGTON PARKWAY (NB)**

<i>Section Number</i>	5	6	7	8	9
<i>Section Length (mi)</i>	1.00	1.00	1.00	1.00	1.00
<i>Cross Section Information</i>					
Number of Lanes	2	2	2	2	2
Paved Width (ft)	34	42	35	33	34
Lane Width (ft)	12	13	12	13	12
<i>Roadway Condition Information</i>					
SCR (Surface Condition Rating)	91	93	93	90	90
PCR (Pavement Condition Rating)	95	96	96	94	94
<i>Distress Index Values</i>					
Structural Crack Index	98	96	100	100	98
Transverse Cracking Index	91	96	98	99	98
Patching Index	100	100	100	100	100
Rutting Index	96	93	93	90	90
Roughness Condition Index (RCI)	100	100	100	100	100

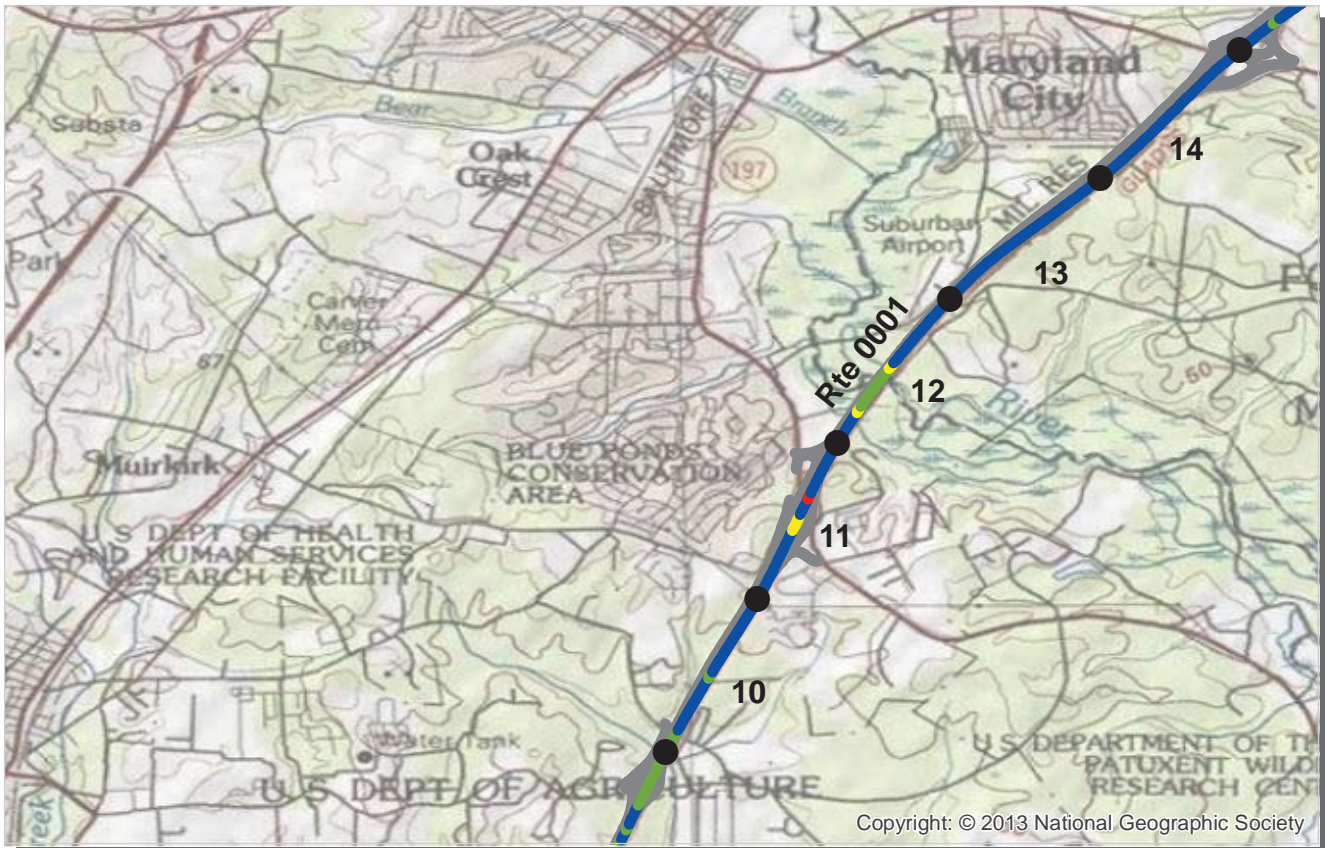
**ROUTE: 0001 BALTIMORE-WASHINGTON PARKWAY (NB)**

<i>Section Number</i>	10	11	12	13	14
<i>Section Length (mi)</i>	1.00	1.00	1.00	1.00	1.00
<i>Cross Section Information</i>					
Number of Lanes	2	2	2	2	2
Paved Width (ft)	39	37	33	32	35
Lane Width (ft)	13	13	12	12	12
<i>Roadway Condition Information</i>					
SCR (Surface Condition Rating)	97	96	95	97	97
PCR (Pavement Condition Rating)	98	98	97	98	98
<i>Distress Index Values</i>					
Structural Crack Index	97	100	99	99	99
Transverse Cracking Index	97	98	95	98	98
Patching Index	100	100	100	100	100
Rutting Index	97	96	97	97	97
Roughness Condition Index (RCI)	100	100	100	100	100

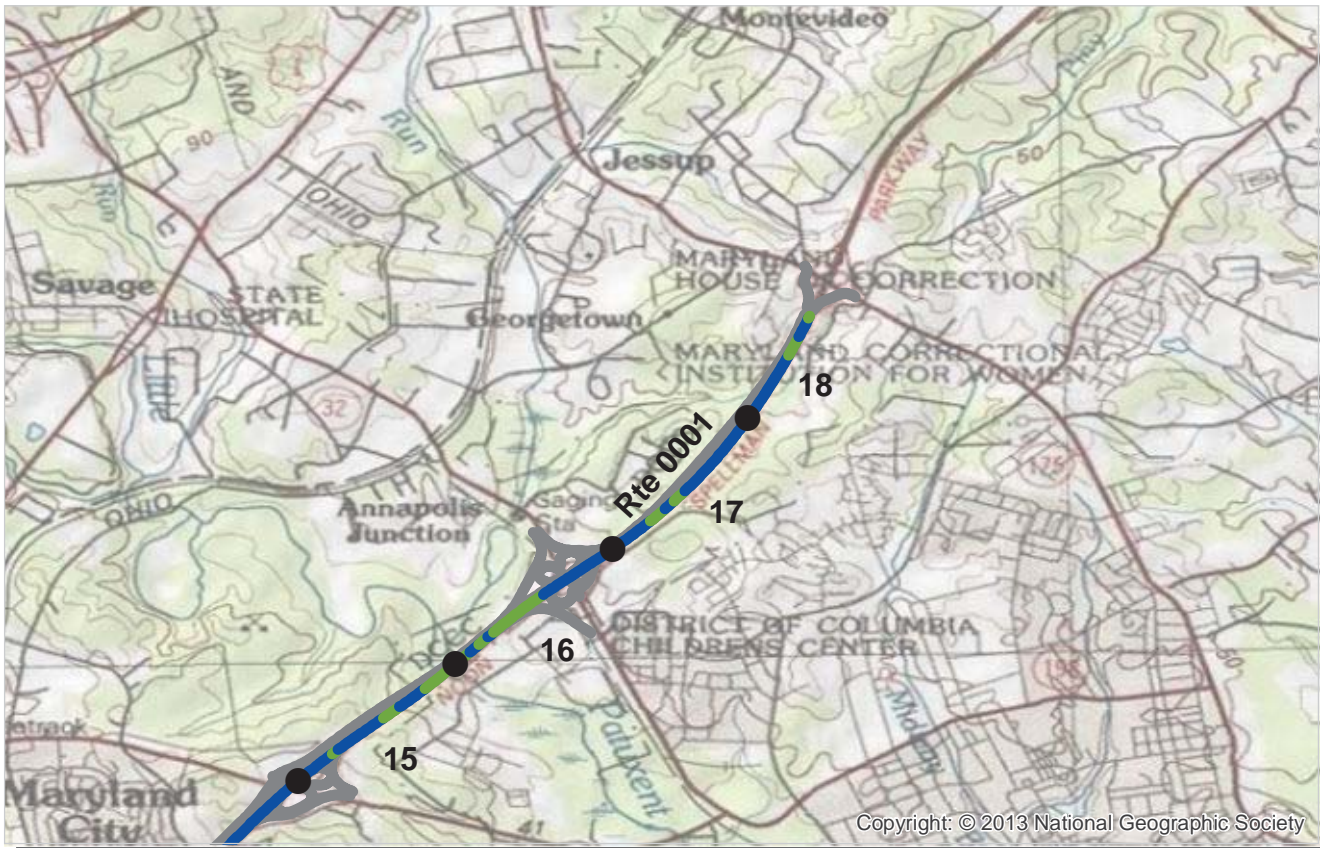
Section Number	15	16	17	18
Section Length (mi)	1.00	1.00	1.00	0.67
<b>Cross Section Information</b>				
Number of Lanes	2	2	2	2
Paved Width (ft)	38	40	35	33
Lane Width (ft)	13	12	14	12
<b>Roadway Condition Information</b>				
SCR (Surface Condition Rating)	93	92	97	94
PCR (Pavement Condition Rating)	96	95	98	96
<b>Distress Index Values</b>				
Structural Crack Index	100	99	98	100
Transverse Cracking Index	98	98	100	97
Patching Index	100	100	100	100
Rutting Index	93	92	97	94
Roughness Condition Index (RCI)	100	100	100	100

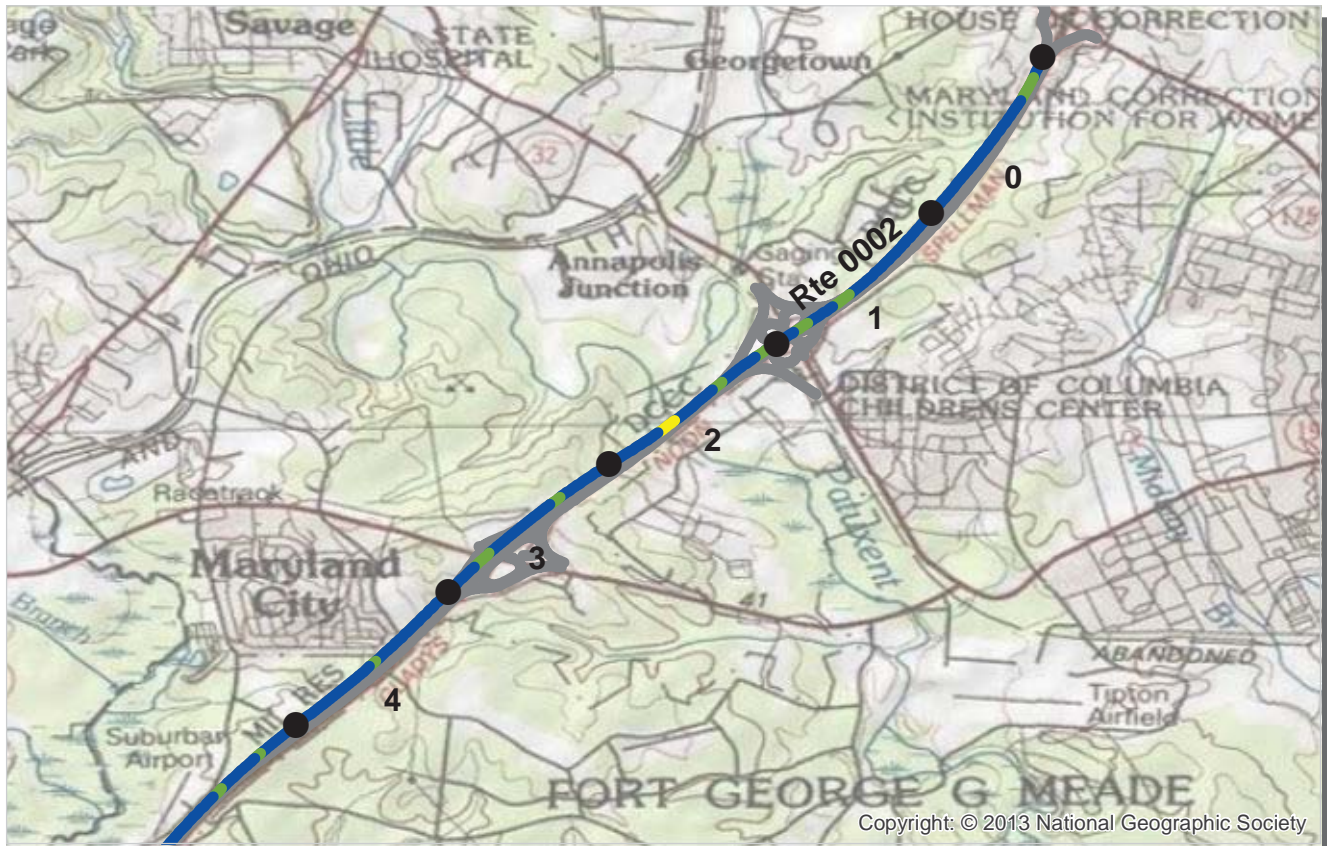
**ROUTE: 0002 BALTIMORE-WASHINGTON PARKWAY (SB)**

<i>Section Number</i>	0	1	2	3	4
<i>Section Length (mi)</i>	1.00	1.00	1.00	1.00	1.00
<i>Cross Section Information</i>					
Number of Lanes	2	2	2	2	2
Paved Width (ft)	33	38	37	33	34
Lane Width (ft)	13	12	13	12	13
<i>Roadway Condition Information</i>					
SCR (Surface Condition Rating)	96	94	94	97	98
PCR (Pavement Condition Rating)	98	96	96	98	99
<i>Distress Index Values</i>					
Structural Crack Index	99	99	99	98	99
Transverse Cracking Index	98	98	97	98	98
Patching Index	100	100	100	100	100
Rutting Index	96	94	94	97	98
Roughness Condition Index (RCI)	100	100	100	100	100

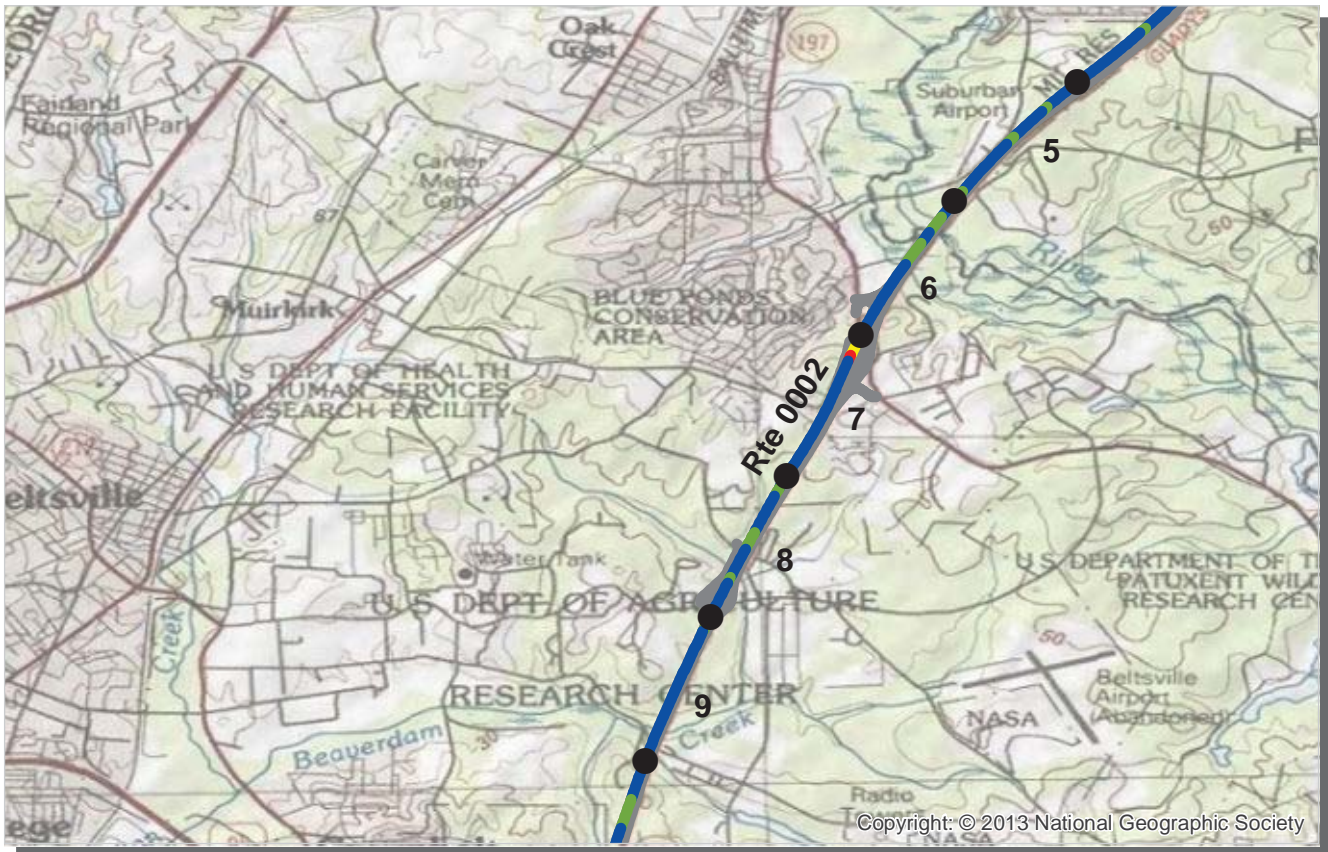
**ROUTE: 0002 BALTIMORE-WASHINGTON PARKWAY (SB)**

Section Number	5	6	7	8	9
Section Length (mi)	1.00	1.00	1.00	1.00	1.00
<b>Cross Section Information</b>					
Number of Lanes	2	2	2	2	2
Paved Width (ft)	32	38	35	34	34
Lane Width (ft)	12	12	14	12	13
<b>Roadway Condition Information</b>					
SCR (Surface Condition Rating)	97	96	97	94	93
PCR (Pavement Condition Rating)	98	98	98	96	96
<b>Distress Index Values</b>					
Structural Crack Index	98	99	99	100	100
Transverse Cracking Index	97	96	97	97	99
Patching Index	100	100	100	100	100
Rutting Index	97	97	99	94	93
Roughness Condition Index (RCI)	100	100	100	100	100

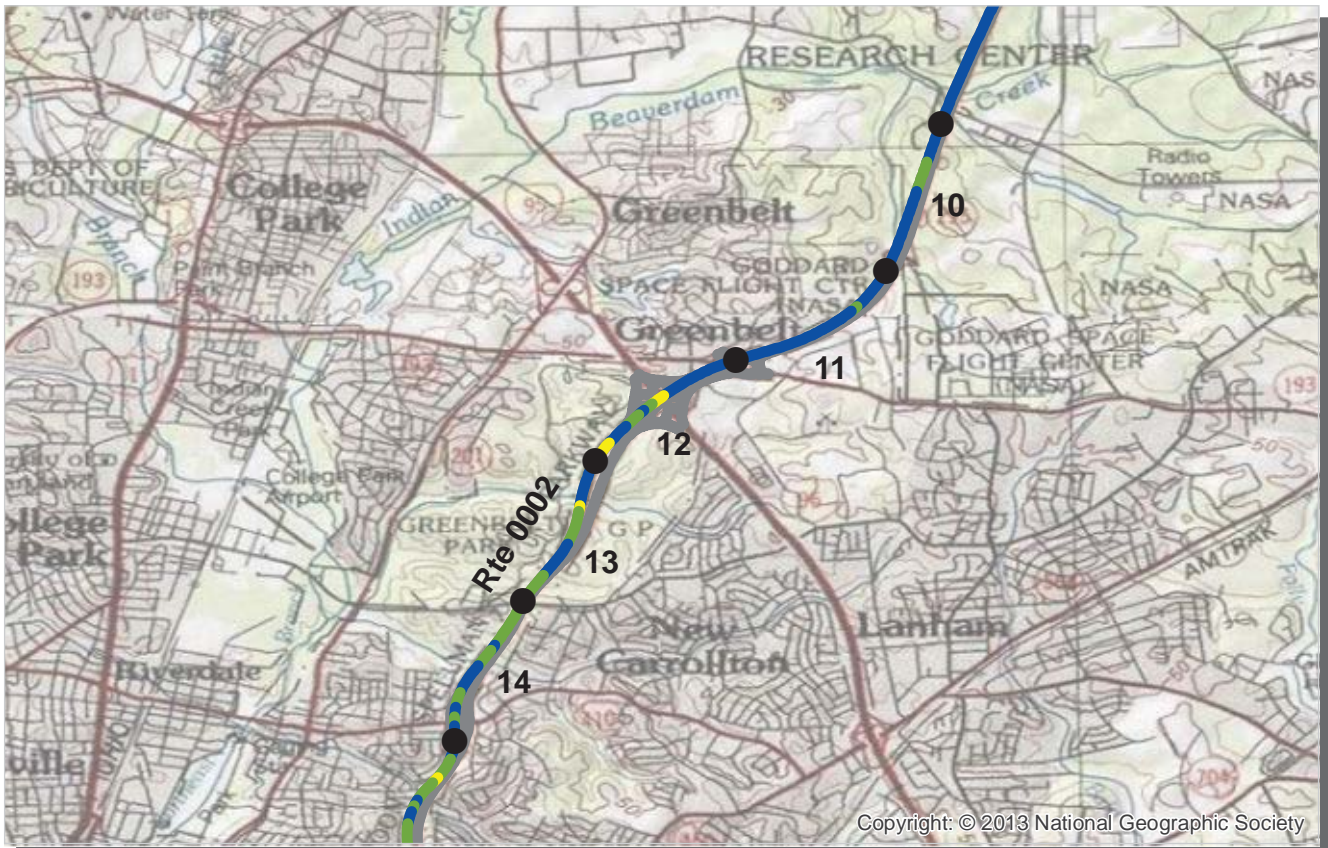
**ROUTE: 0002 BALTIMORE-WASHINGTON PARKWAY (SB)**

Section Number	10	11	12	13	14
Section Length (mi)	1.00	1.00	1.00	1.00	1.00
<b>Cross Section Information</b>					
Number of Lanes	2	2	3	2	2
Paved Width (ft)	34	36	43	35	35
Lane Width (ft)	12	14	11	14	12
<b>Roadway Condition Information</b>					
SCR (Surface Condition Rating)	95	97	88	91	93
PCR (Pavement Condition Rating)	97	98	93	95	96
<b>Distress Index Values</b>					
Structural Crack Index	99	97	88	91	93
Transverse Cracking Index	99	97	96	93	94
Patching Index	100	100	100	100	100
Rutting Index	95	97	99	99	95
Roughness Condition Index (RCI)	100	100	100	100	100

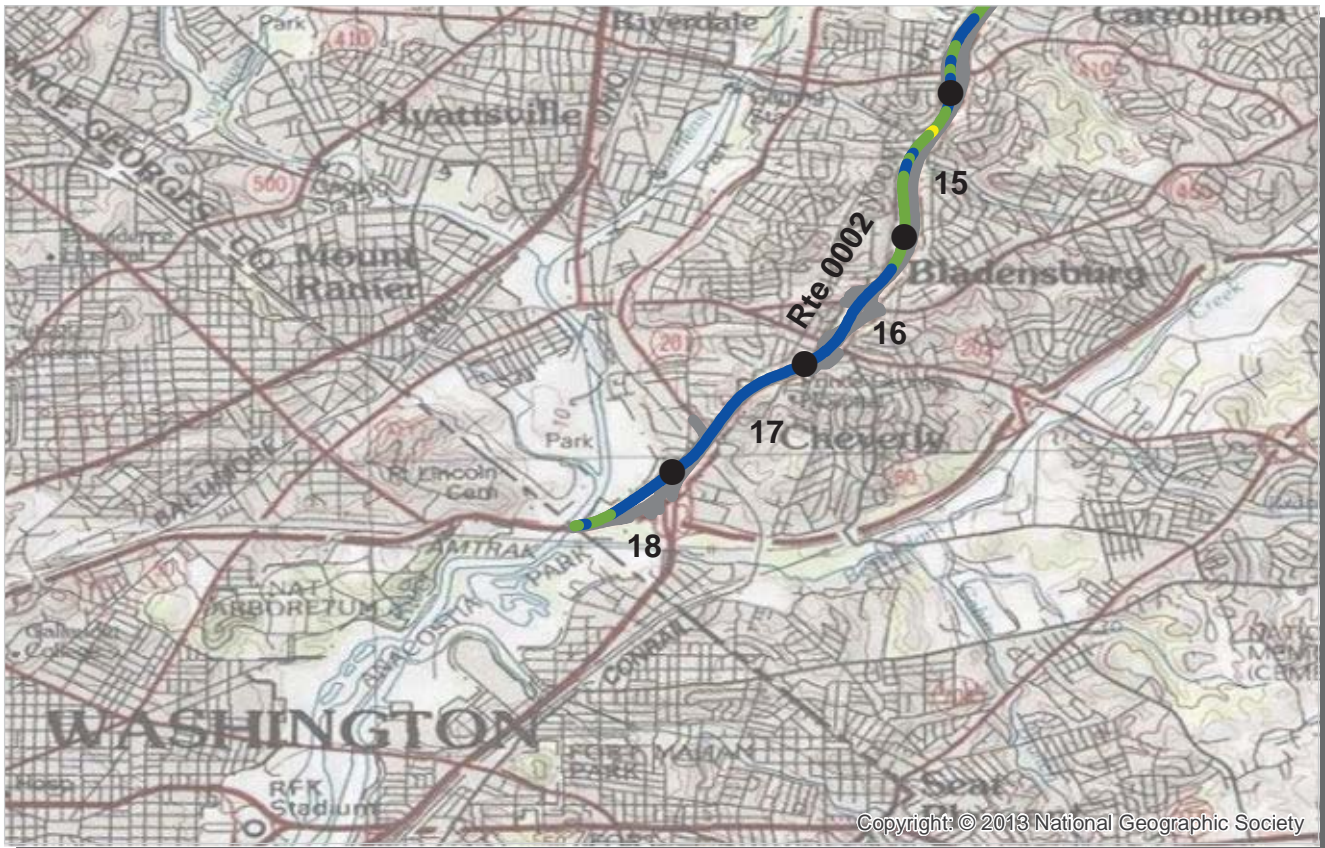
**ROUTE: 0002 BALTIMORE-WASHINGTON PARKWAY (SB)**

Section Number	15	16	17	18	
Section Length (mi)	1.00	1.00	1.00	0.62	
<b>Cross Section Information</b>					
Number of Lanes	2	2	3	2	
Paved Width (ft)	35	45	44	35	
Lane Width (ft)	13	12	12	13	
<b>Roadway Condition Information</b>					
SCR (Surface Condition Rating)	91	97	100	100	
PCR (Pavement Condition Rating)	95	98	100	100	
<b>Distress Index Values</b>					
Structural Crack Index	95	97	100	100	
Transverse Cracking Index	91	98	100	100	
Patching Index	100	100	100	100	
Rutting Index	97	99	100	100	
Roughness Condition Index (RCI)	100	100	100	100

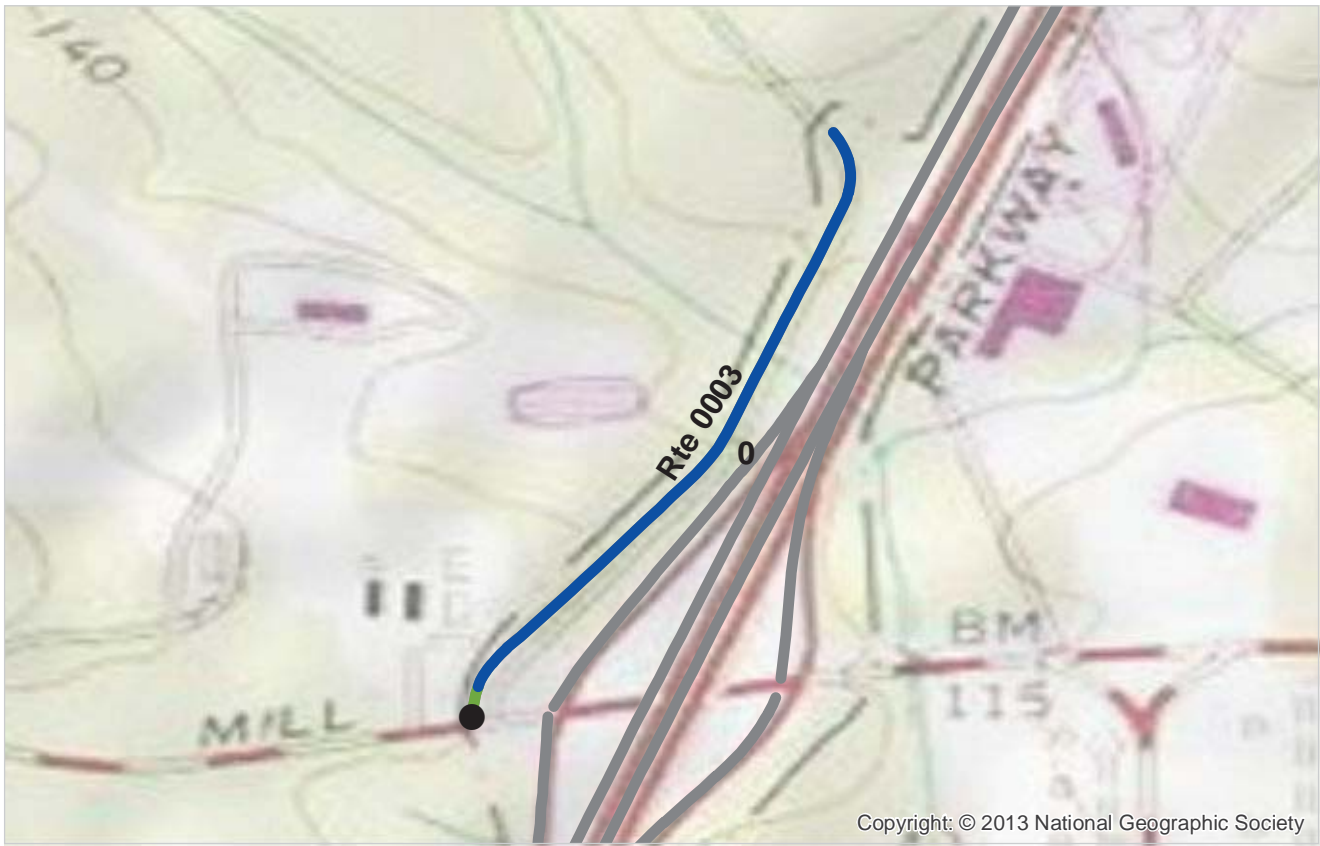
**ROUTE: 0003 SPRINGFIELD ROAD WEST**

<b>Section Number</b>	0				
<b>Section Length (mi)</b>	0.44				
<b>Cross Section Information</b>					
Number of Lanes	2				
Paved Width (ft)	21				
Lane Width (ft)	11				
<b>Roadway Condition Information</b>					
SCR (Surface Condition Rating)	99				
PCR (Pavement Condition Rating)	99				
<b>Distress Index Values</b>					
Structural Crack Index	99				
Transverse Cracking Index	100				
Patching Index	100				
Rutting Index	100				
Roughness Condition Index (RCI)	NC

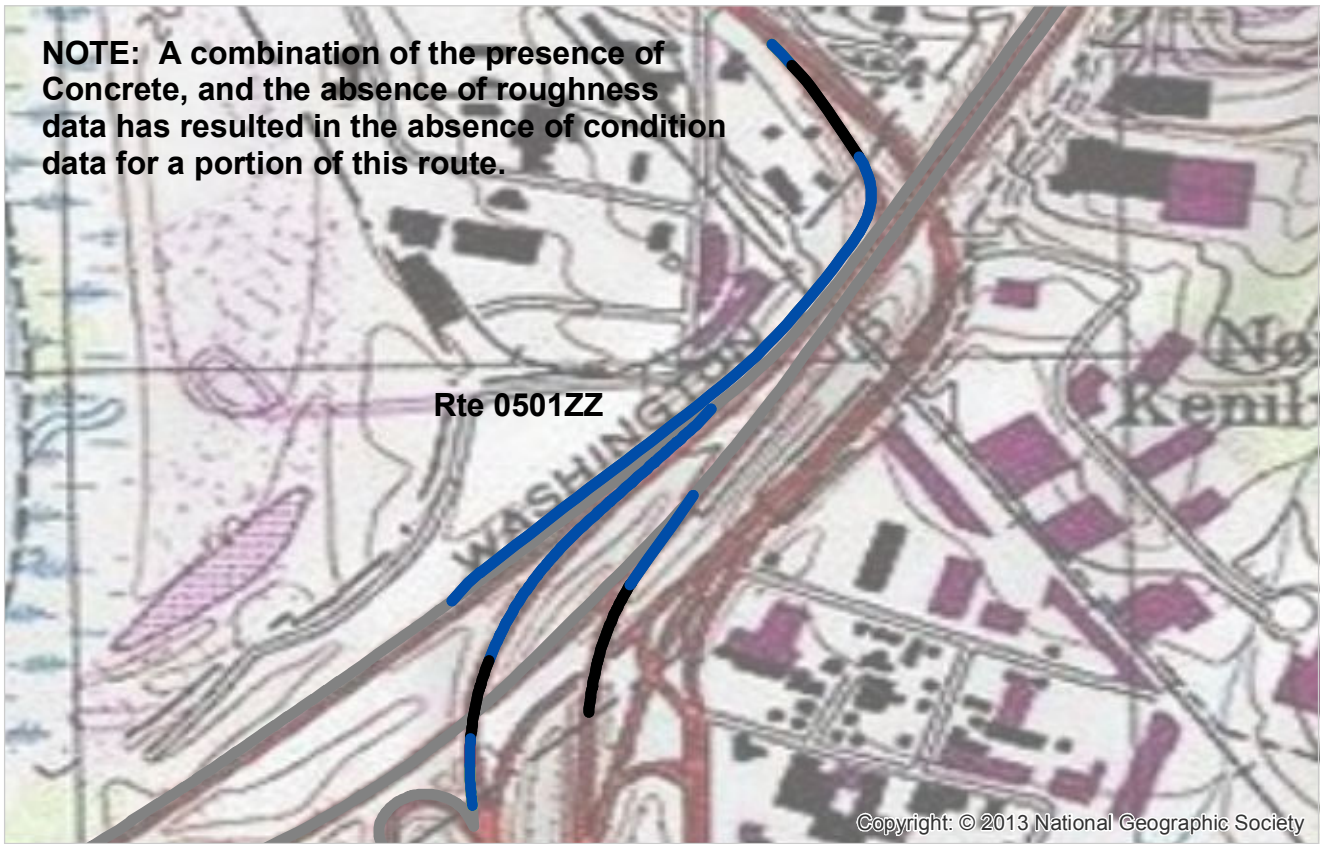
ROUTE: 0501ZZ KENILWORTH AVENUE INTERCHANGE RAMPS

**NOTE: A combination of the presence of Concrete, and the absence of roughness data has resulted in the absence of condition data for a portion of this route.**

PCR	Poor (0 - 60)	Fair (61 - 84)	Good (85 - 94)	Excellent (95 - 100)	No Data

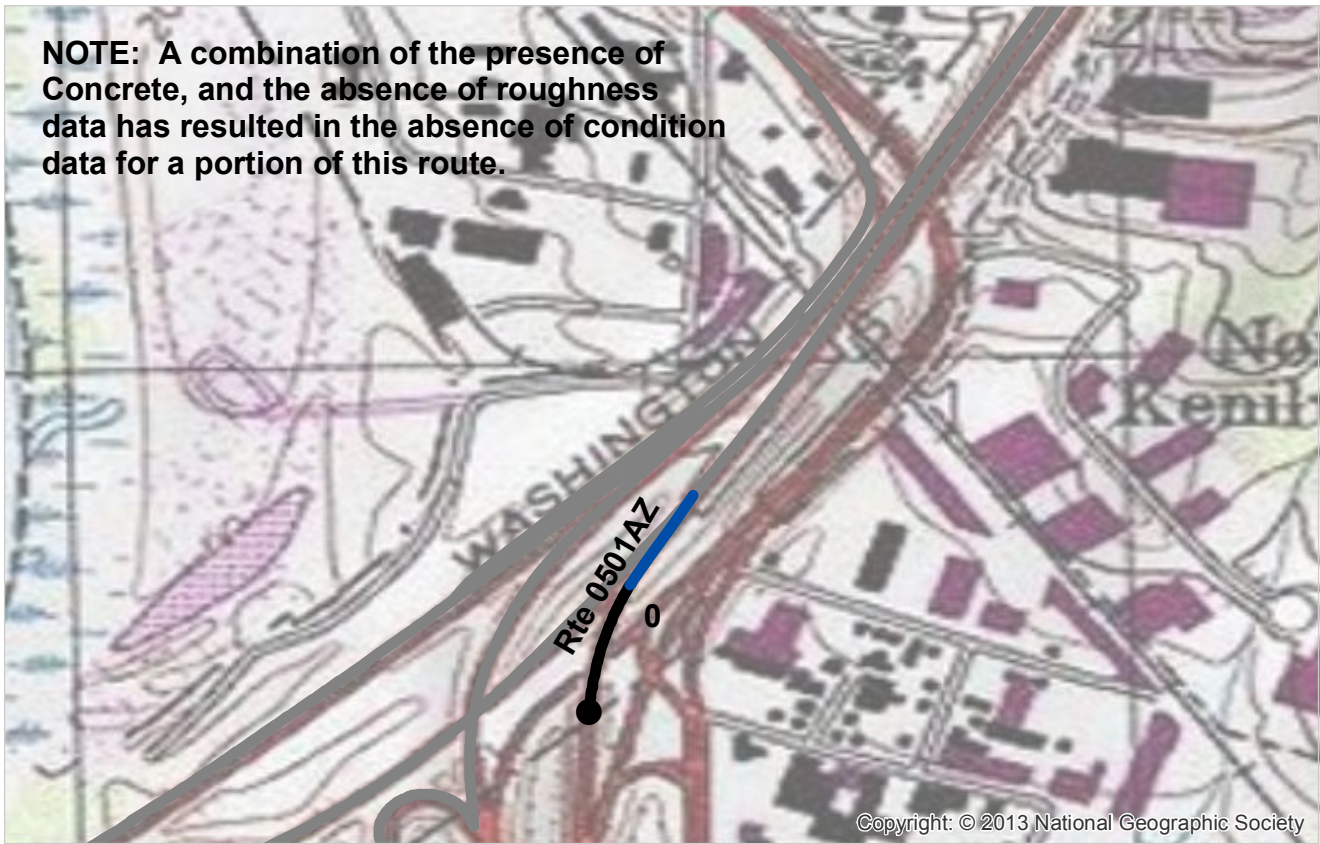
**NOTE: A combination of the presence of Concrete, and the absence of roughness data has resulted in the absence of condition data for a portion of this route.**

PCR    Poor ■    Fair ■    Good ■    Excellent ■    No Data ■  
 (0 - 60)    (61 - 84)    (85 - 94)    (95 - 100)

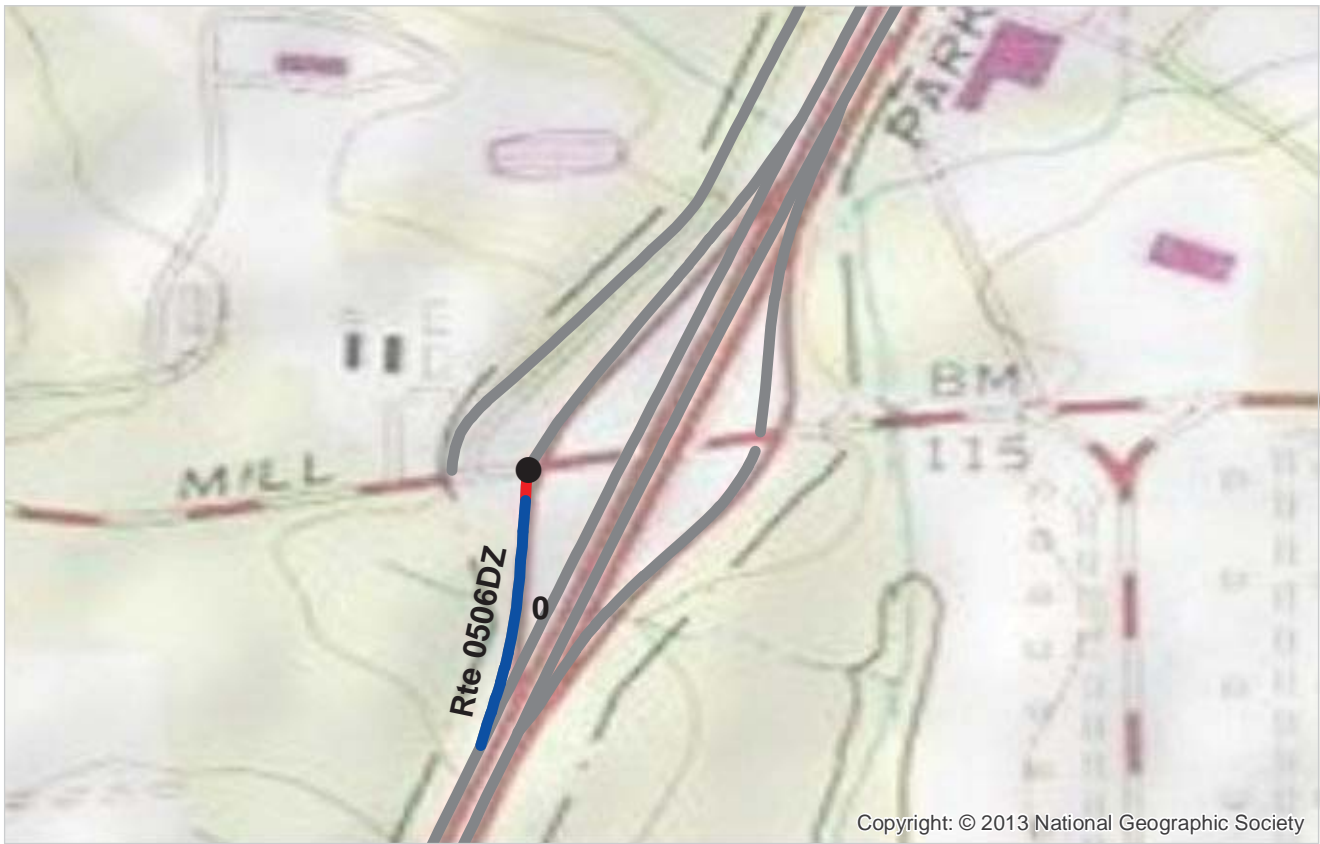
ROUTE: 0506BZ S/B BW PARKWAY RAMP TO POWDER MILL ROAD (ROUTE 212)

PCR    Poor ■    Fair ■    Good ■    Excellent ■    No Data ■  
           (0 - 60)           (61 - 84)           (85 - 94)           (95 - 100)

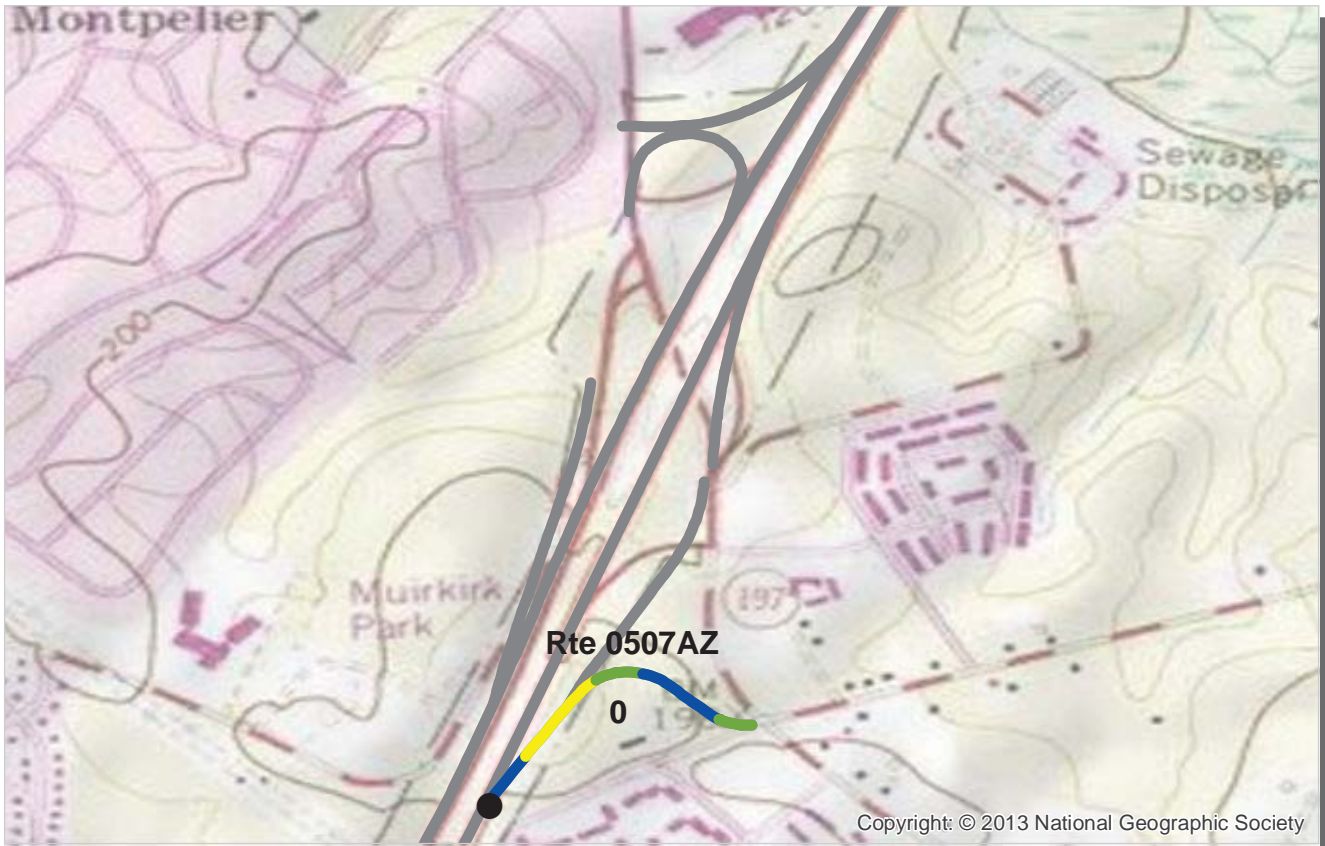
ROUTE: 0506DZ RAMP FROM POWDER MILL ROAD (ROUTE 212) TO S/B BW PARKWAY

PCR	Poor	<span style="color: red;">■</span>	Fair	<span style="color: yellow;">■</span>	Good	<span style="color: green;">■</span>	Excellent	<span style="color: blue;">■</span>	No Data	<span style="background-color: black; color: black;">■</span>
		(0 - 60)		(61 - 84)		(85 - 94)		(95 - 100)

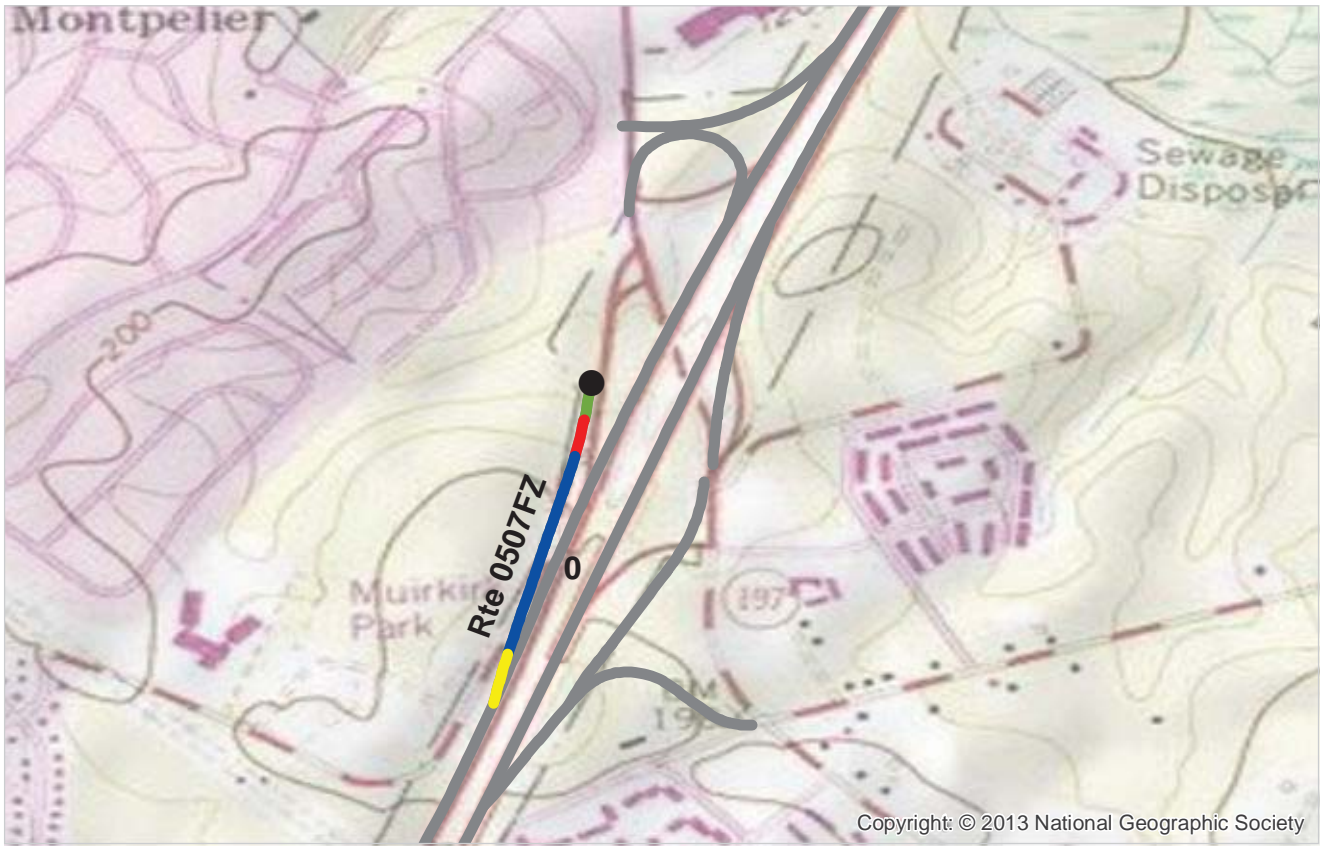
ROUTE: 0507AZ N/B BW PARKWAY RAMP TO S/B ROUTE 197

PCR	Poor	Fair	Good	Excellent	No Data
	(0 - 60)	(61 - 84)	(85 - 94)	(95 - 100)
