Federal Lands Highway Road Inventory Program

Road Inventory and Condition Assessment

Bent's Old Fort National Historic Site BEOL - 1310

Cycle 5 Report

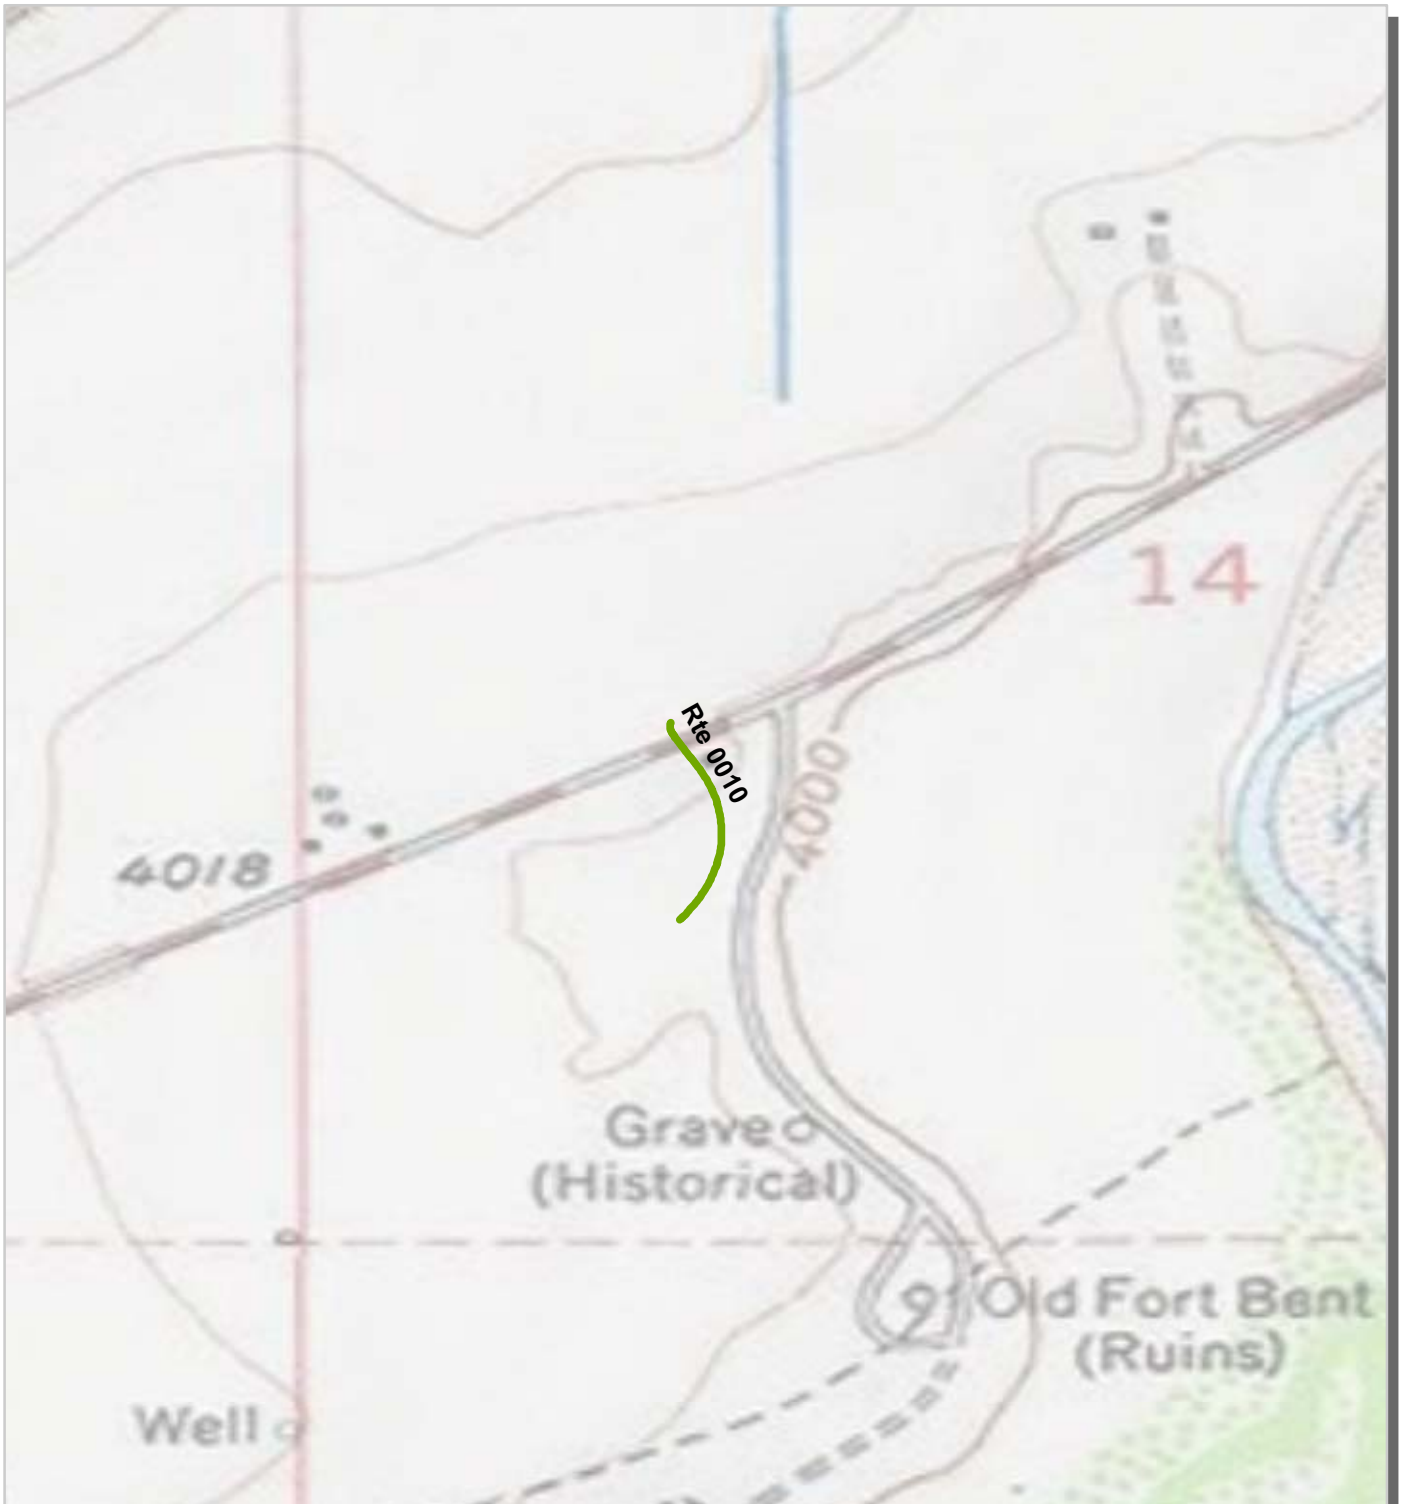
**Bent's Old Fort National Historic Site
Route Condition Map
PCR - Mile by Mile
Area 1**

PCR	Poor	Fair	Good	Excellent	No Data
	(0 - 60)	(61 - 84)	(85 - 94)	(95 - 100)

* If the PCR rating is not available for a section, the SCR rating will be displayed. See appendix for definitions and formulas.

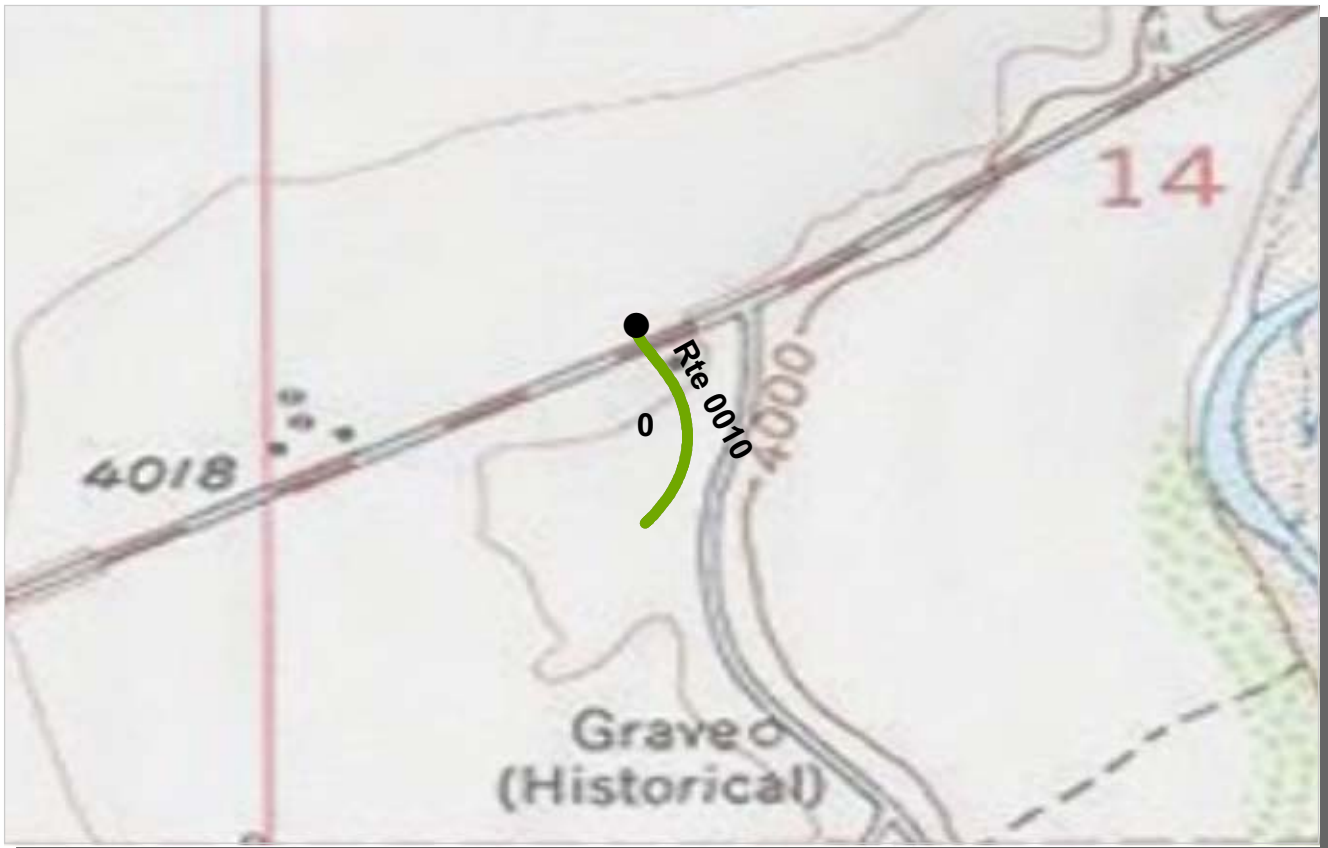
ROUTE: 0010 ENTRANCE ROAD

PCR	Poor	Fair	Good	Excellent	No Data
	(0 - 60)	(61 - 84)	(85 - 94)	(95 - 100)

* If the PCR rating is not available for a section, the SCR rating will be displayed. See appendix for definitions and formulas.

Section Number	0				
Section Length (mi)	0.14				
Cross Section Information					
Number of Lanes	2				
Paved Width (ft)	18				
Lane Width (ft)	9				
Roadway Condition Information					
SCR (Surface Condition Rating)	88				
PCR (Pavement Condition Rating)	88				
Distress Index Values					
Structural Crack Index	97				
Transverse Cracking Index	91				
Patching Index	100				
Rutting Index	88				
Roughness Condition Index (RCI)	NC

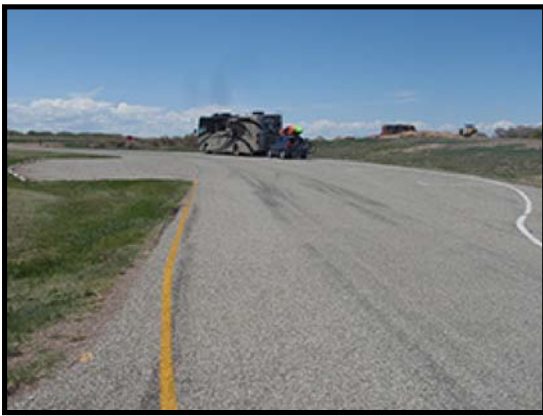
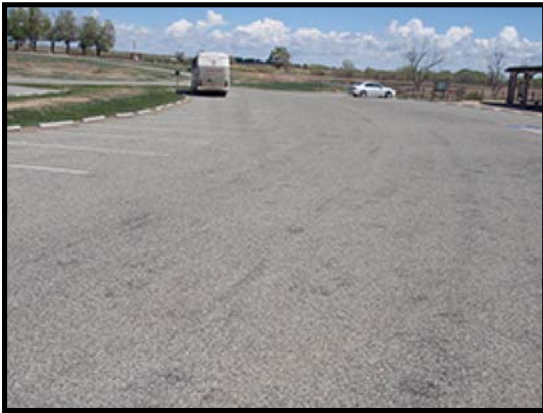
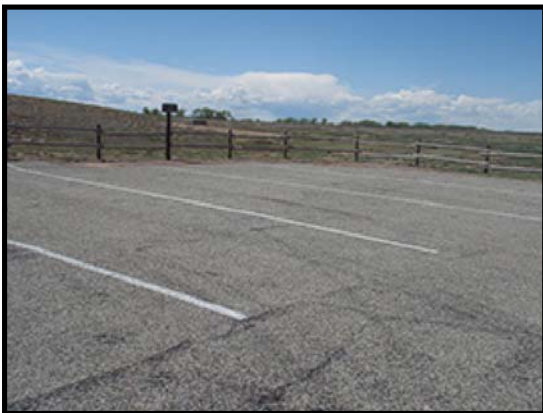
Route Number	Public / NonPublic	Date Visited	Area (sq ft)	Lane Miles *	Surface Type
0900	PUBLIC	4/16/2012	34,773	0.60	AS
Culverts	Drop Inlets	Gates	Curb & Gutter	Curb	PCR
2	0	0	NO CURB AND GUTTER	NO CURB	GOOD/90
