Federal Lands Highway Road Inventory Program

Road Inventory and Condition Assessment

Big Cypress National Preserve BICY

Cycle 5 Report

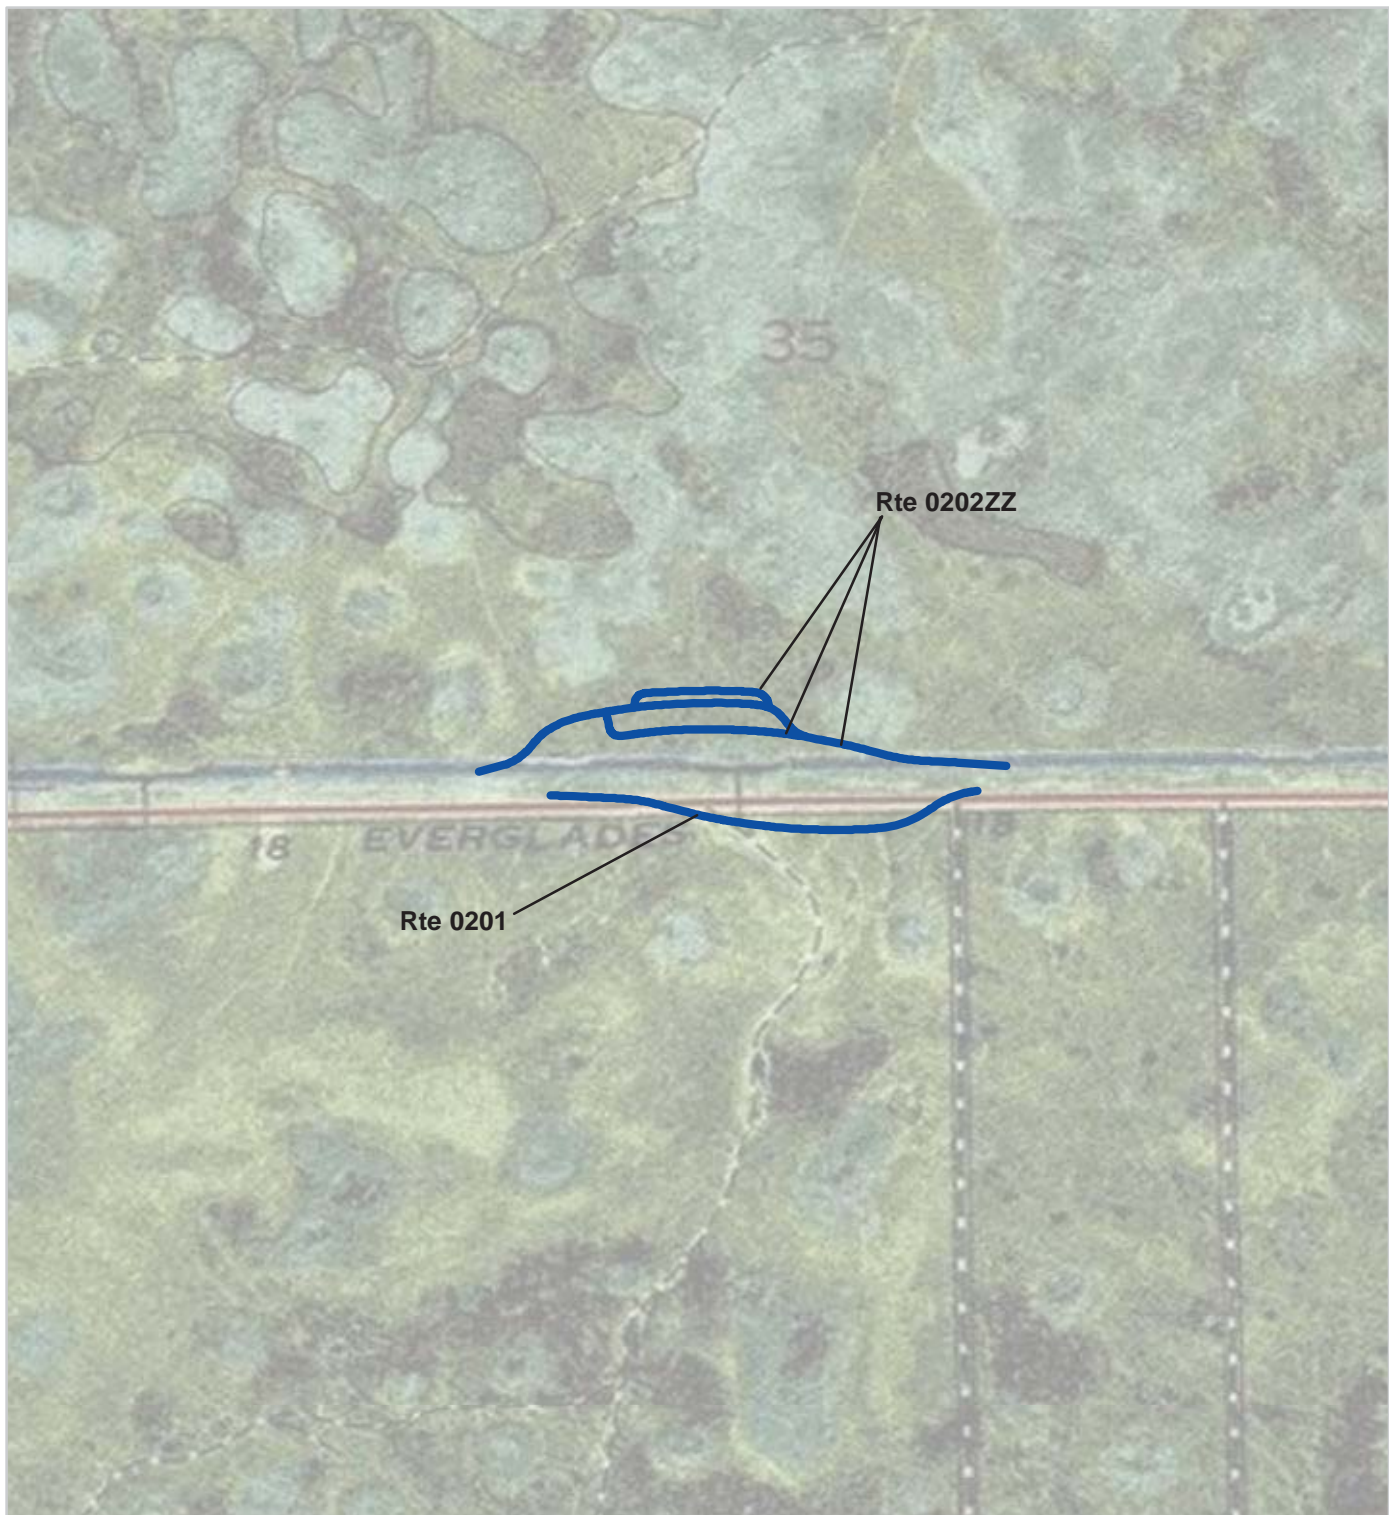
Big Cypress National Preserve Route Condition Map PCR - Mile by Mile Area 1

PCR	Poor		Fair		Good		Excellent		No Data	
	(0 - 60)		(61 - 84)	(85 - 94)		(95 - 100)

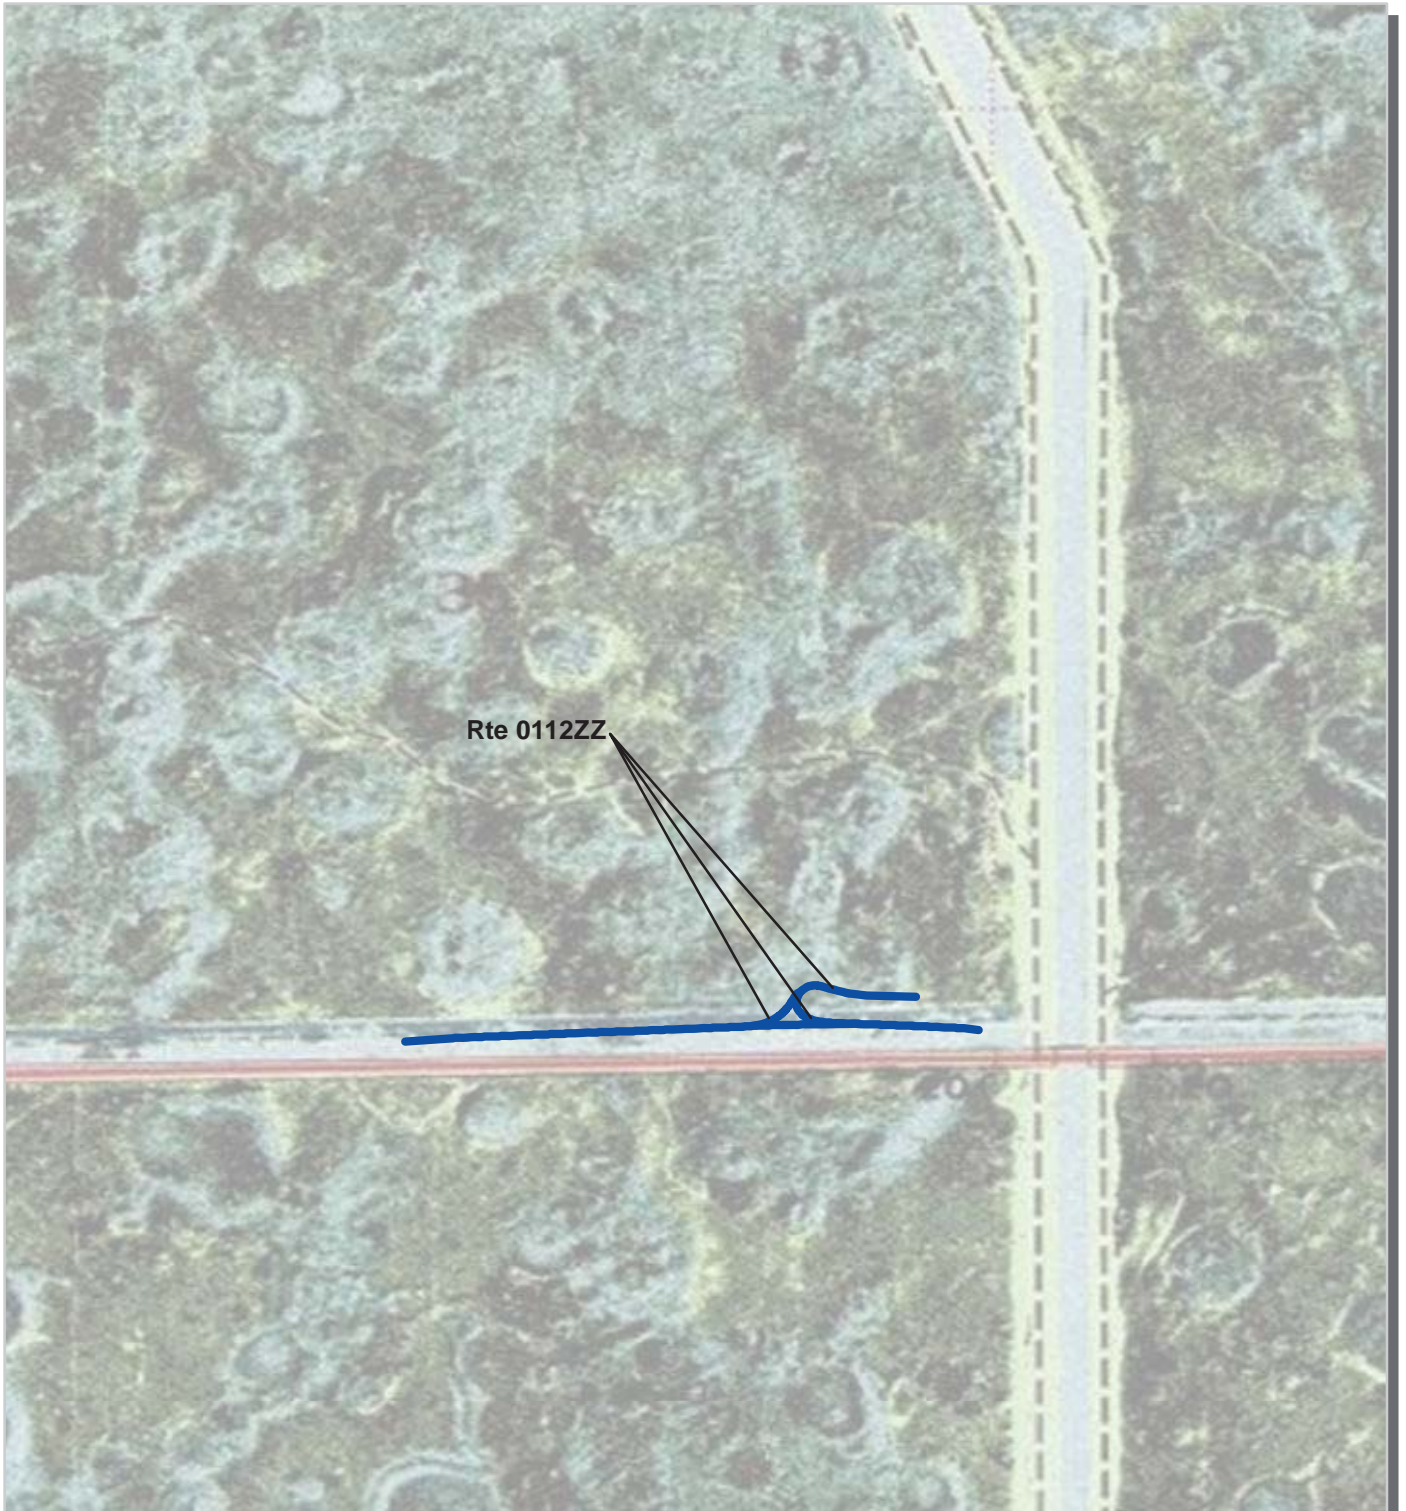
**Big Cypress National Preserve
Route Condition Map
PCR - Mile by Mile
Area 2**

PCR	Poor	Fair	Good	Excellent	No Data
	(0 - 60)	(61 - 84)	(85 - 94)	(95 - 100)

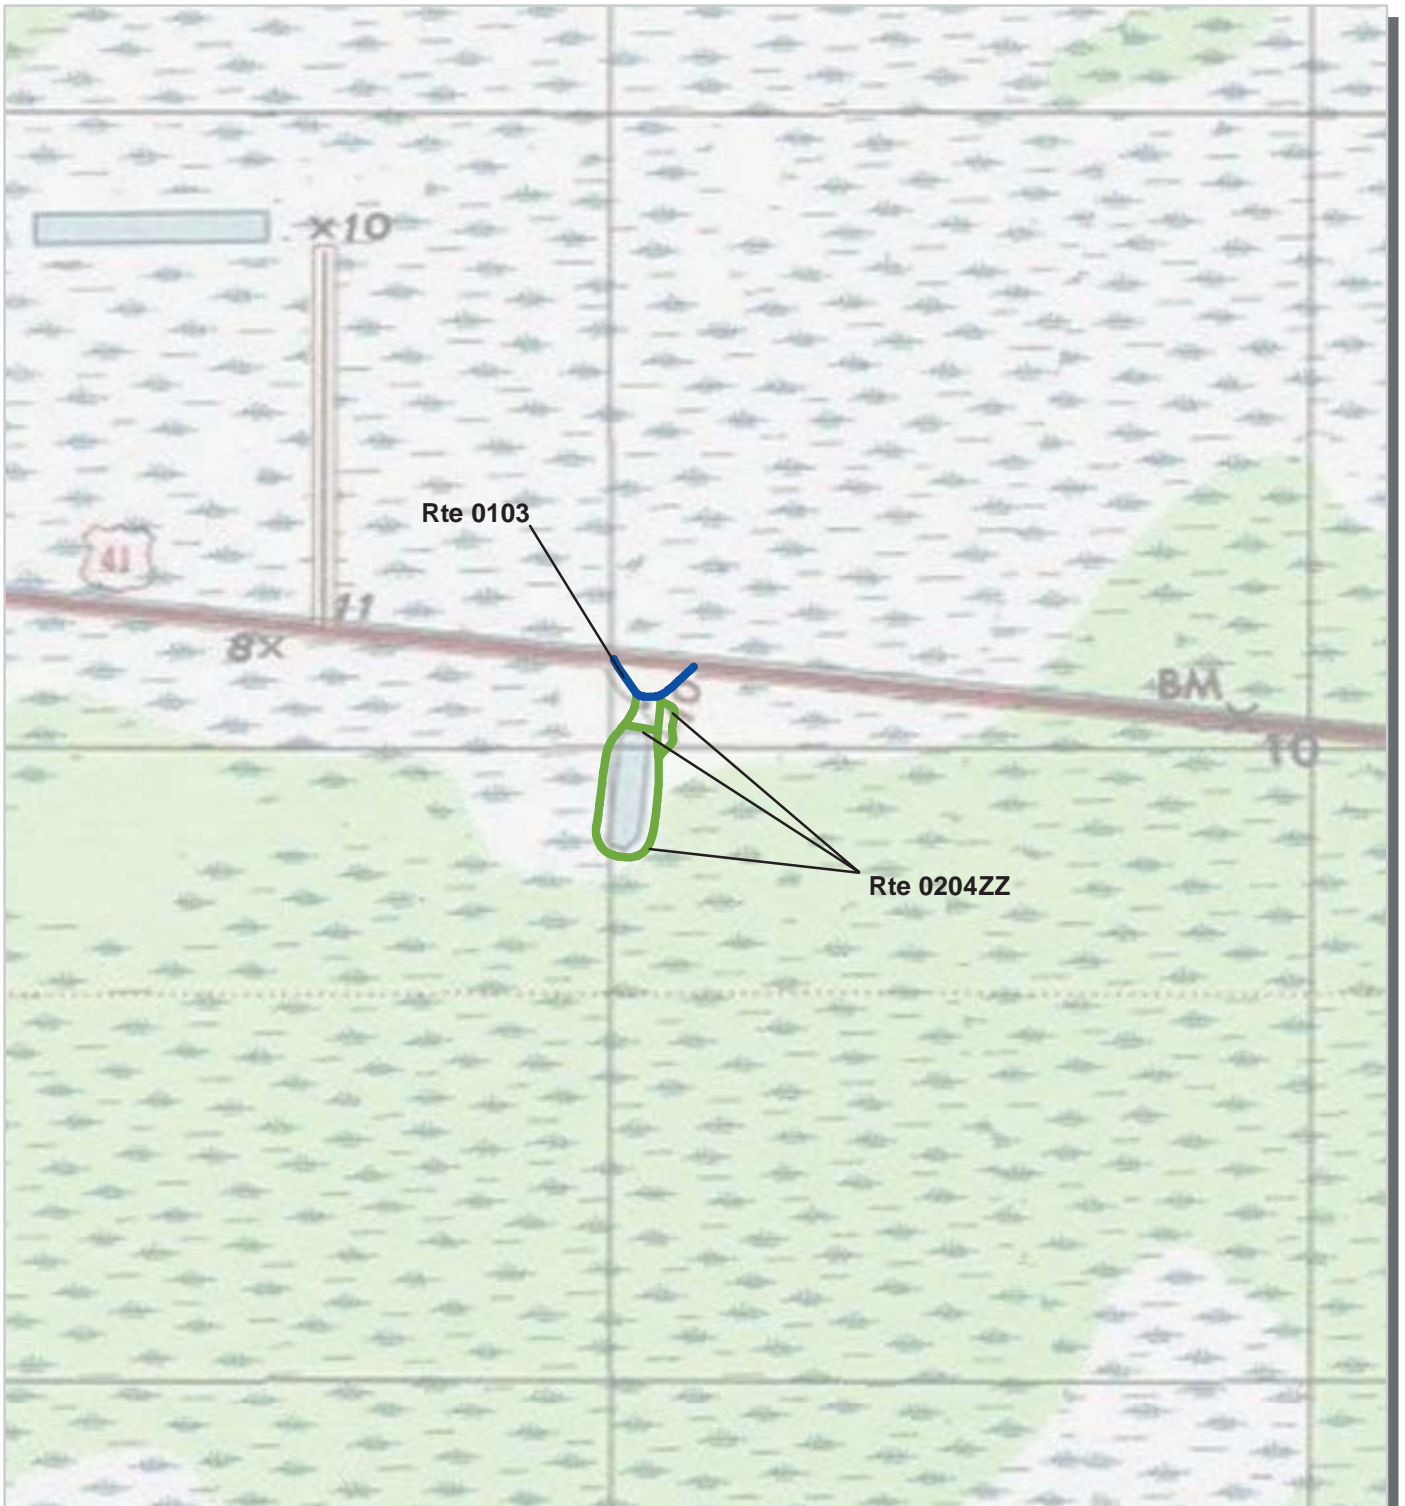
Big Cypress National Preserve Route Condition Map PCR - Mile by Mile Area 7

PCR	Poor		Fair		Good		Excellent		No Data	
	(0 - 60)		(61 - 84)	(85 - 94)		(95 - 100)

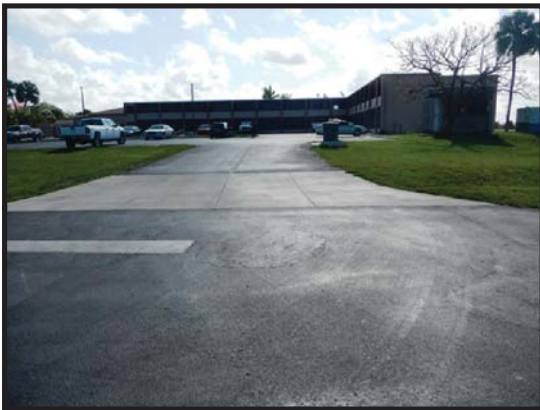
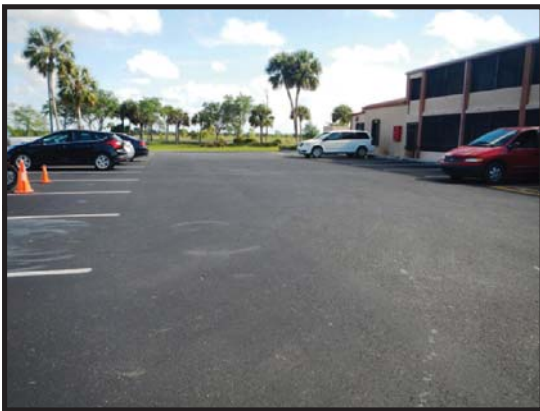
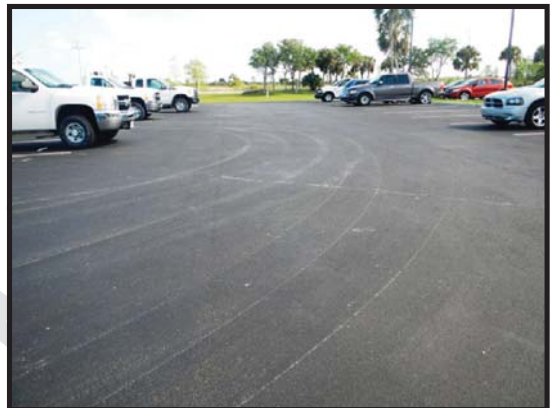
Route Number	Public / NonPublic	Date Visited	Area (sq ft)	Lane Miles *	Surface Type
0900A	NONPUBLIC	4/19/2013	26,790	0.46	AS
Culverts	Drop Inlets	Gates	Curb & Gutter	Curb	PCR
0	0	1	NO CURB AND GUTTER	CONCRETE CURB	EXCELLENT/97

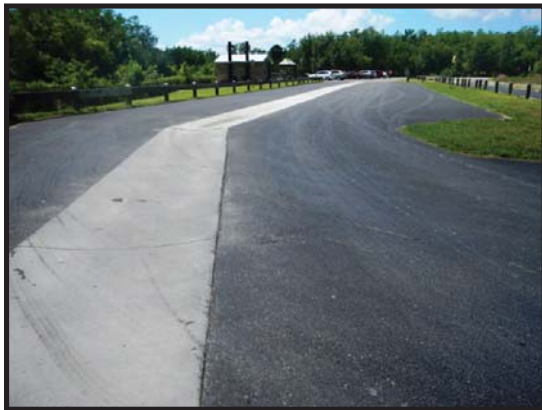
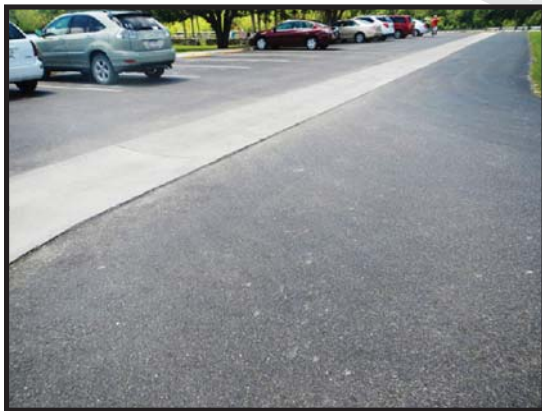
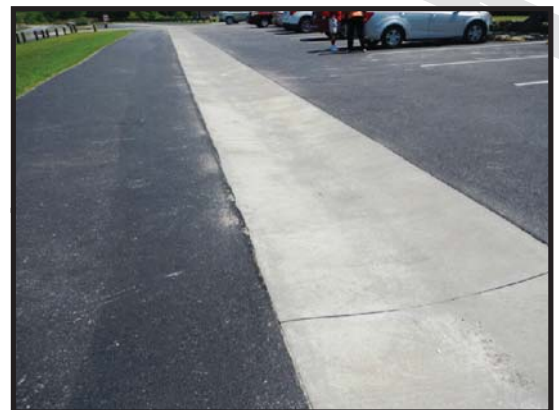
Route Number	Public / NonPublic	Date Visited	Area (sq ft)	Lane Miles *	Surface Type
0901	PUBLIC	4/19/2013	18,427	0.32	AS
Culverts	Drop Inlets	Gates	Curb & Gutter	Curb	PCR
0	0	0	NO CURB AND GUTTER	NO CURB	EXCELLENT/97

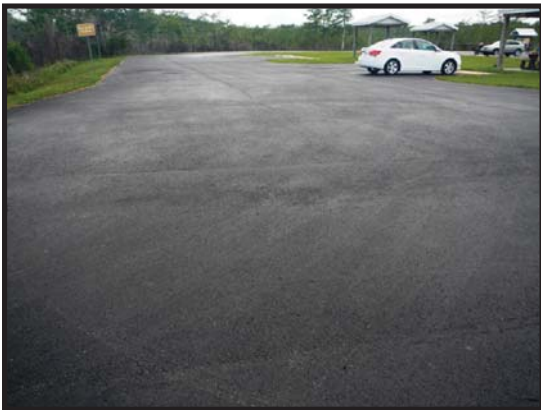
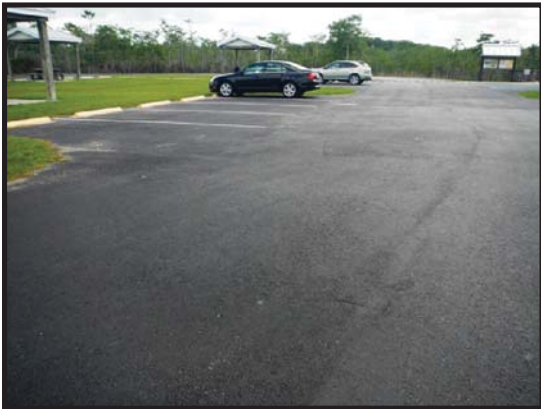
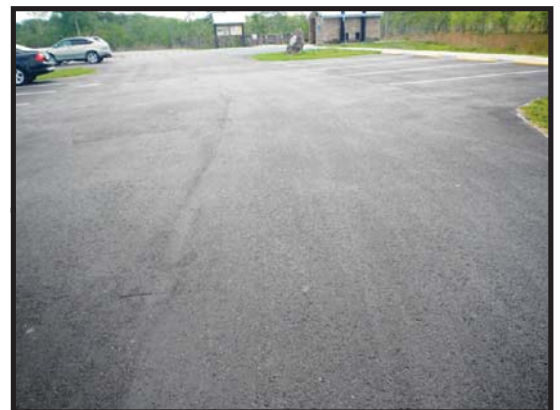
Route 0902

Route Number	Public / NonPublic	Date Visited	Area (sq ft)	Lane Miles *	Surface Type
0902	PUBLIC	4/19/2013	32,381	0.56	AS
Culverts	Drop Inlets	Gates	Curb & Gutter	Curb	PCR
1	1	0	NO CURB AND GUTTER	NO CURB	EXCELLENT/97

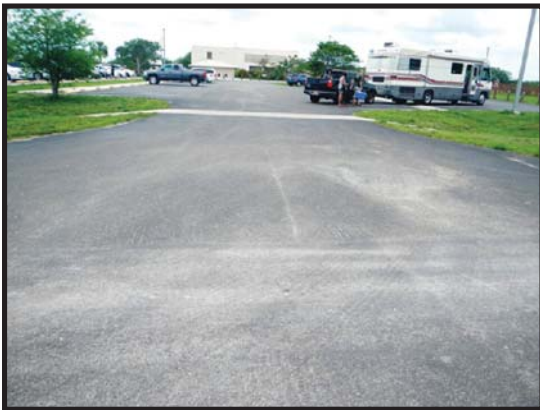
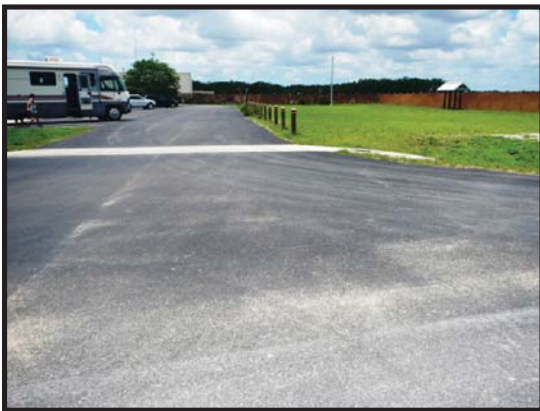
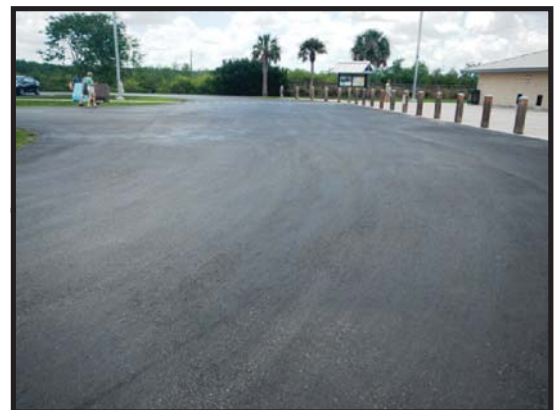
Route 0904

Route Number	Public / NonPublic	Date Visited	Area (sq ft)	Lane Miles *	Surface Type
0904	PUBLIC	4/19/2013	48,526	0.84	AS
Culverts	Drop Inlets	Gates	Curb & Gutter	Curb	PCR
5	4	1	NO CURB AND GUTTER	NO CURB	EXCELLENT/97

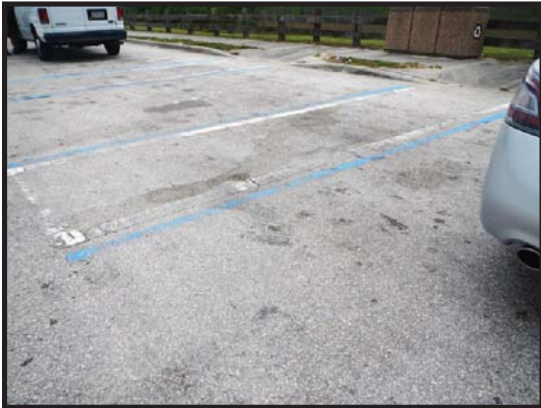
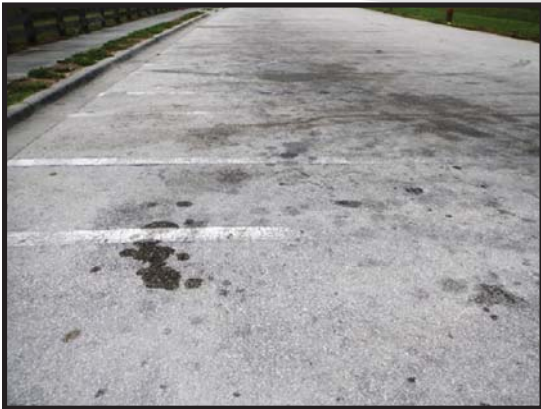
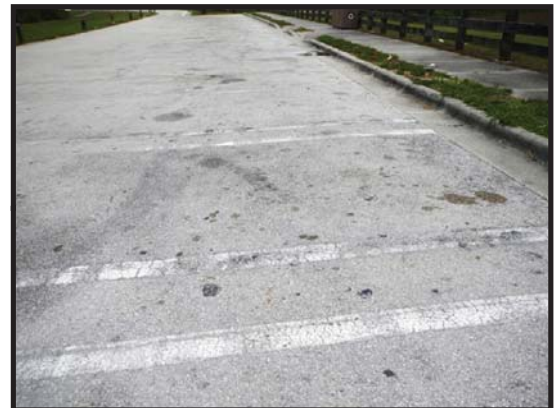
Route 0905

Route Number	Public / NonPublic	Date Visited	Area (sq ft)	Lane Miles *	Surface Type
0905	PUBLIC	4/18/2013	4,166	0.07	AS
Culverts	Drop Inlets	Gates	Curb & Gutter	Curb	PCR
0	0	0	CONCRETE CURB AND GUTTER	NO CURB	GOOD/90

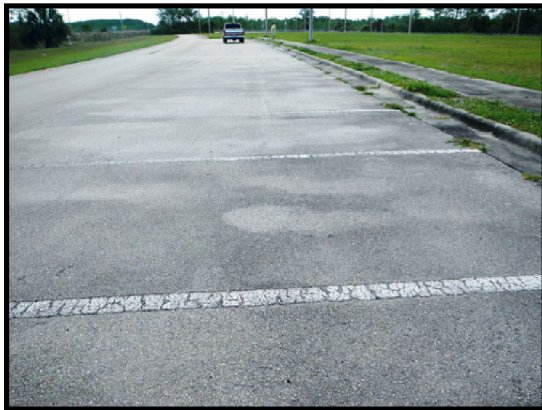
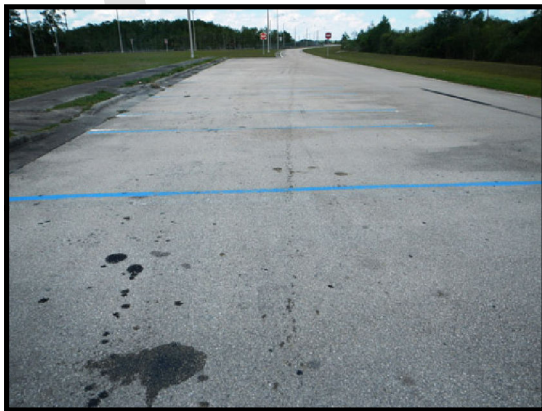
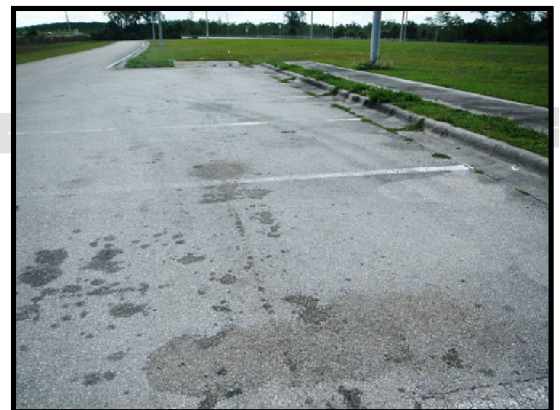
Route 0906AZ

Route Number	Public / NonPublic	Date Visited	Area (sq ft)	Lane Miles *	Surface Type
0906AZ	PUBLIC	4/18/2013	5,277	0.09	AS
Culverts	Drop Inlets	Gates	Curb & Gutter	Curb	PCR
0	0	0	CONCRETE CURB AND GUTTER	NO CURB	GOOD/90

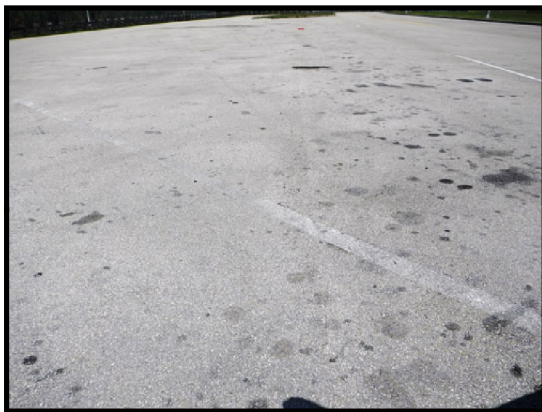
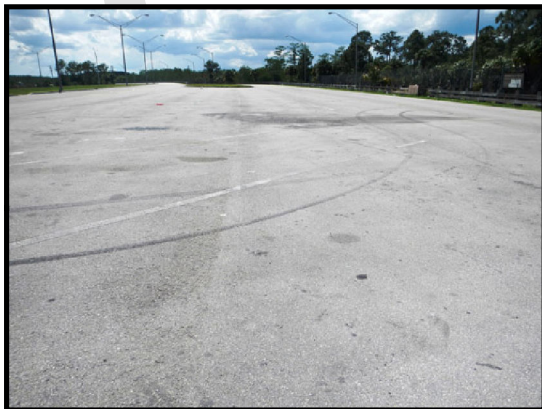
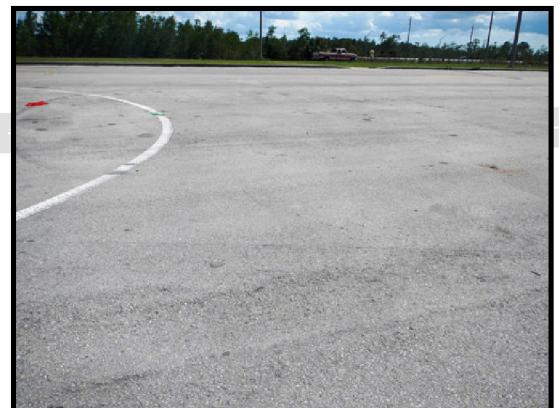
Route Number	Public / NonPublic	Date Visited	Area (sq ft)	Lane Miles *	Surface Type
0906BZ	PUBLIC	4/18/2013	11,991	0.21	AS
Culverts	Drop Inlets	Gates	Curb & Gutter	Curb	PCR
0	0	0	NO CURB AND GUTTER	CONCRETE CURB	GOOD/90

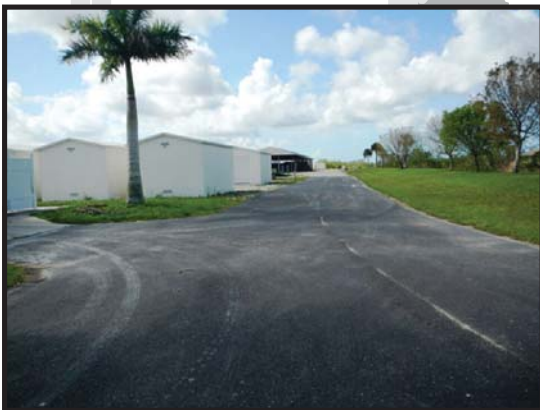
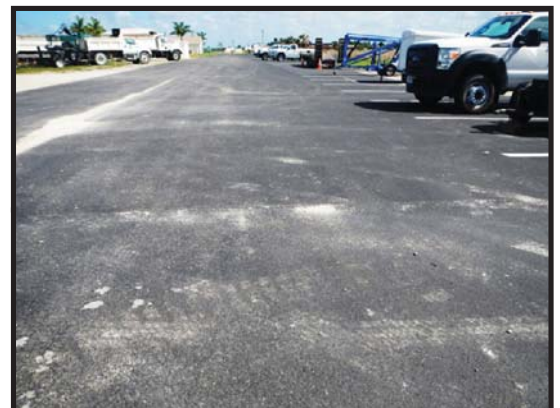
Route 0907

Route Number	Public / NonPublic	Date Visited	Area (sq ft)	Lane Miles *	Surface Type
0907	NONPUBLIC	4/19/2013	57,201	0.99	AS
Culverts	Drop Inlets	Gates	Curb & Gutter	Curb	PCR
0	0	1	NO CURB AND GUTTER	NO CURB	EXCELLENT/97

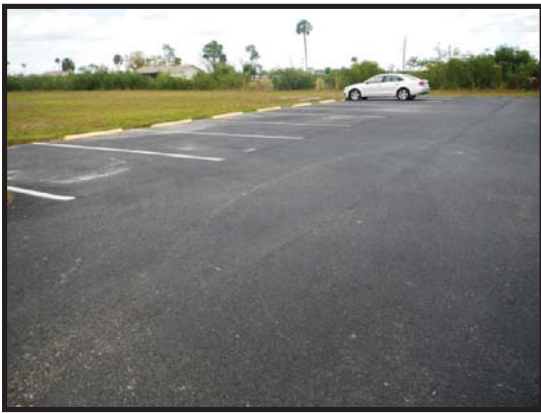
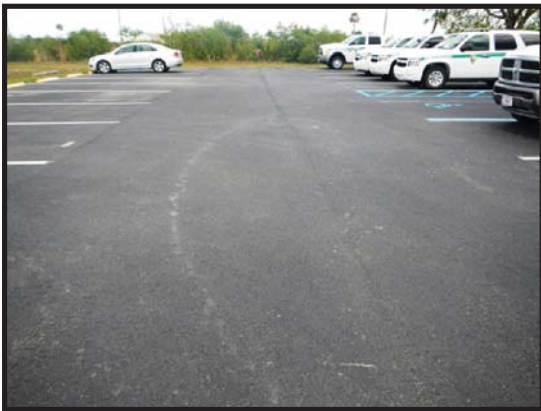
Route 0908

Route Number	Public / NonPublic	Date Visited	Area (sq ft)	Lane Miles *	Surface Type
0908	PUBLIC	4/18/2013	5,663	0.10	AS
Culverts	Drop Inlets	Gates	Curb & Gutter	Curb	PCR
0	0	0	NO CURB AND GUTTER	NO CURB	EXCELLENT/97

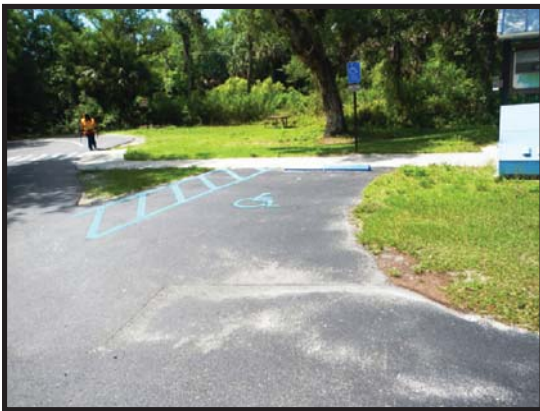
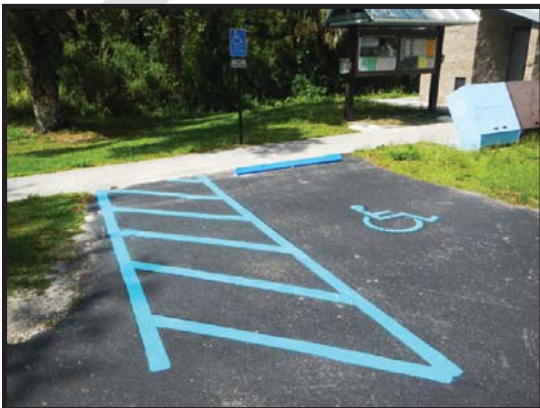
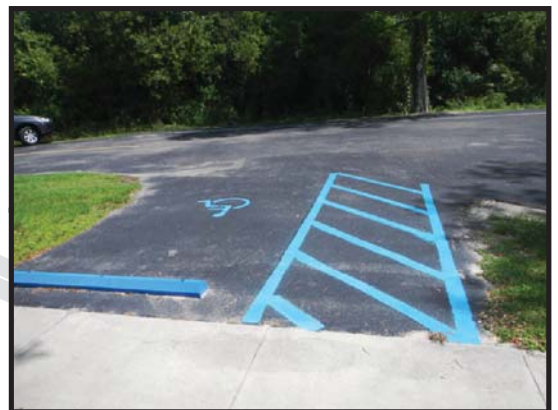
Route Number	Public / NonPublic	Date Visited	Area (sq ft)	Lane Miles *	Surface Type
0909AZ	PUBLIC	4/19/2013	238	0.00	AS
Culverts	Drop Inlets	Gates	Curb & Gutter	Curb	PCR
0	0	0	NO CURB AND GUTTER	NO CURB	EXCELLENT/97

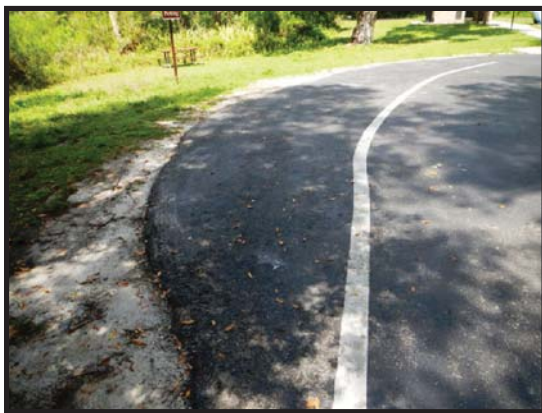
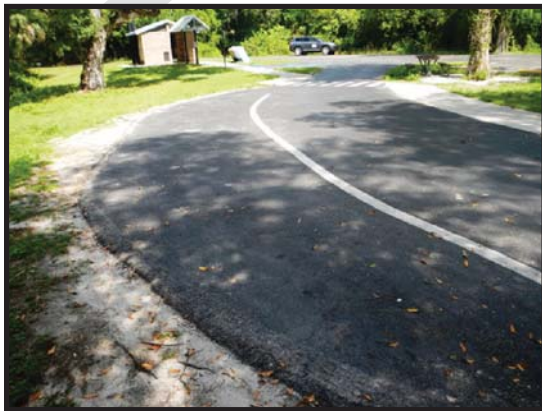
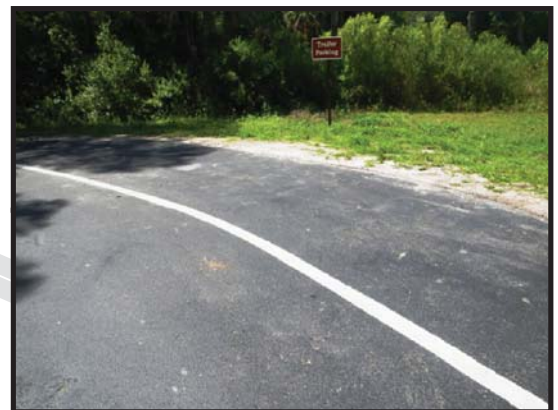
Route Number	Public / NonPublic	Date Visited	Area (sq ft)	Lane Miles *	Surface Type
0909BZ	PUBLIC	4/19/2013	357	0.01	AS
Culverts	Drop Inlets	Gates	Curb & Gutter	Curb	PCR
0	0	0	NO CURB AND GUTTER	NO CURB	EXCELLENT/97

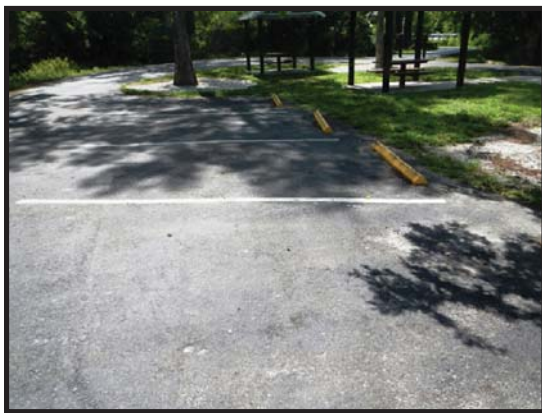
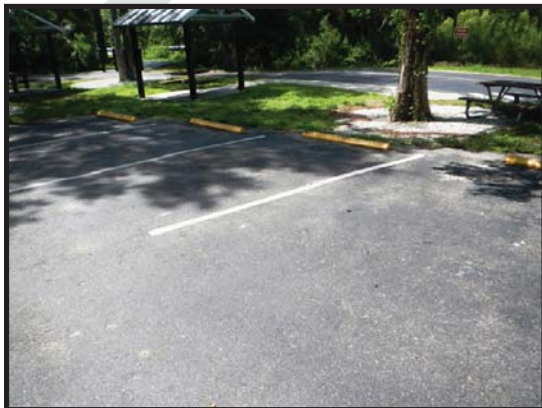
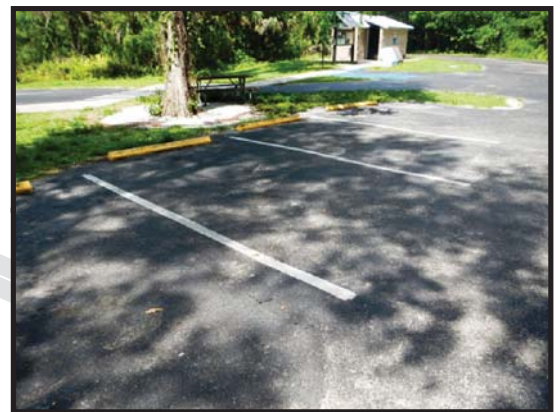
Route 0909CZ

Route Number	Public / NonPublic	Date Visited	Area (sq ft)	Lane Miles *	Surface Type
0909CZ	PUBLIC	4/19/2013	418	0.01	AS
Culverts	Drop Inlets	Gates	Curb & Gutter	Curb	PCR
0	0	0	NO CURB AND GUTTER	NO CURB	EXCELLENT/97

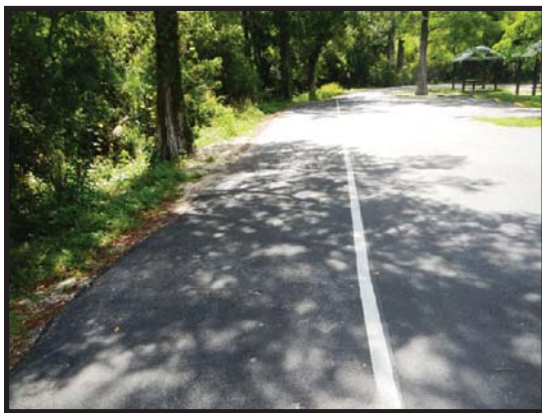
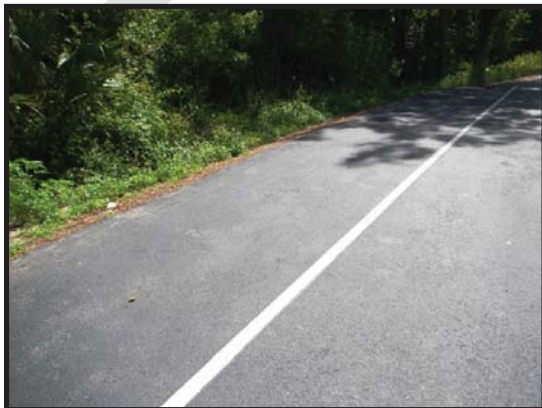
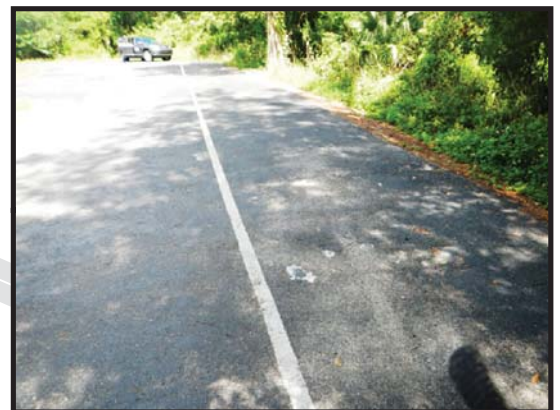
Route 0909DZ

Route Number	Public / NonPublic	Date Visited	Area (sq ft)	Lane Miles *	Surface Type
0909DZ	PUBLIC	4/19/2013	1,206	0.02	AS
Culverts	Drop Inlets	Gates	Curb & Gutter	Curb	PCR
0	0	0	NO CURB AND GUTTER	NO CURB	EXCELLENT/97

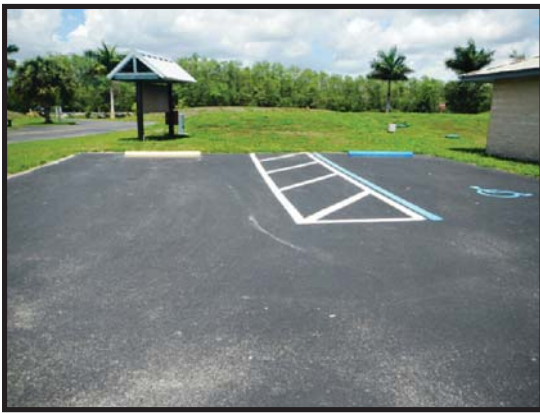
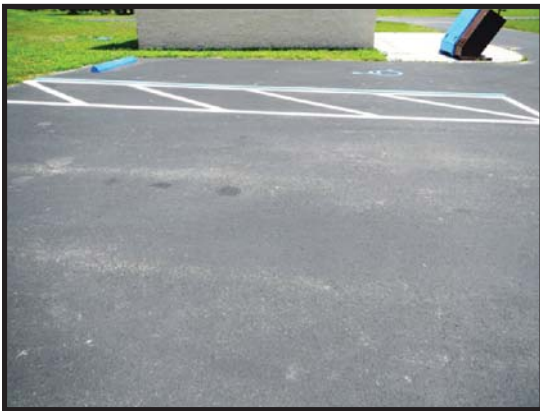
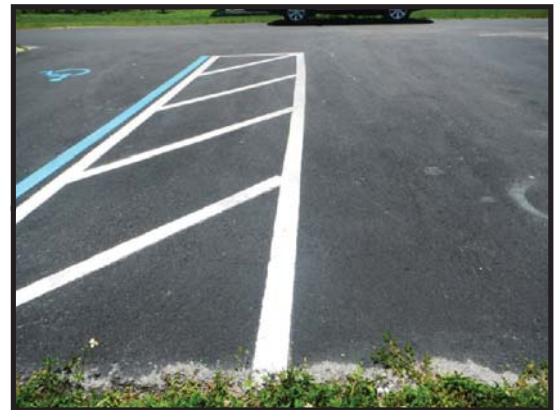
Route Number	Public / NonPublic	Date Visited	Area (sq ft)	Lane Miles *	Surface Type
0910	PUBLIC	4/19/2013	1,027	0.02	AS
Culverts	Drop Inlets	Gates	Curb & Gutter	Curb	PCR
0	0	0	NO CURB AND GUTTER	NO CURB	EXCELLENT/97

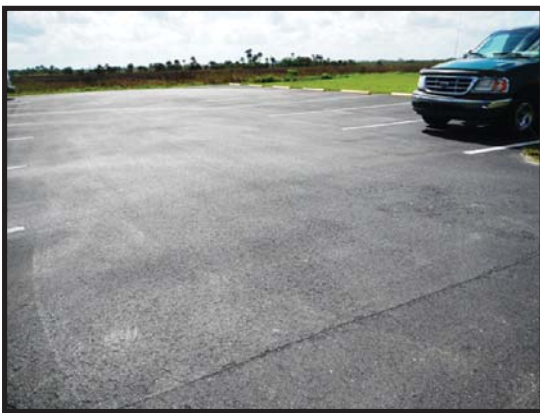
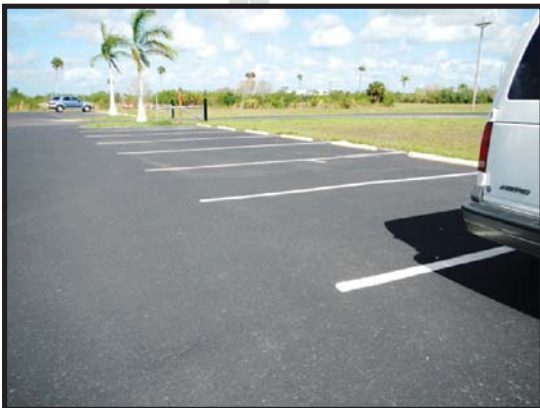
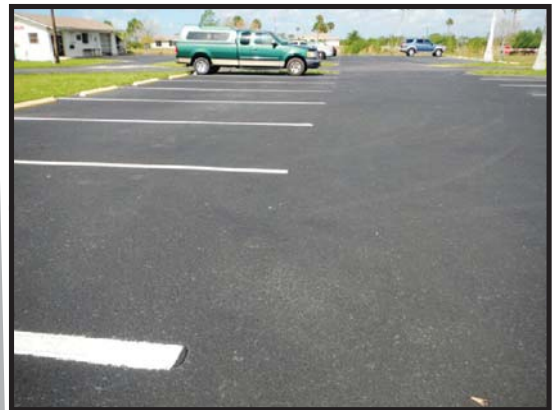
Route 0911

Route Number	Public / NonPublic	Date Visited	Area (sq ft)	Lane Miles *	Surface Type
0911	PUBLIC	4/19/2013	5,091	0.09	AS
Culverts	Drop Inlets	Gates	Curb & Gutter	Curb	PCR
0	0	0	NO CURB AND GUTTER	NO CURB	EXCELLENT/97

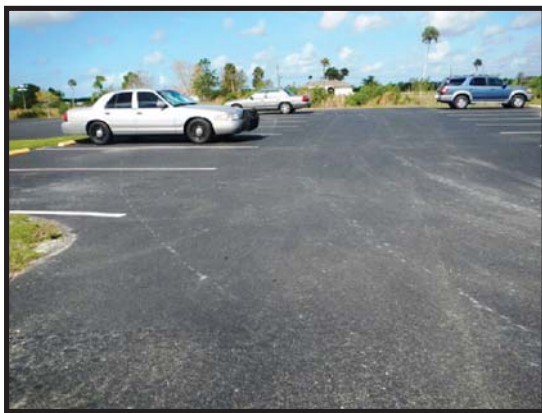
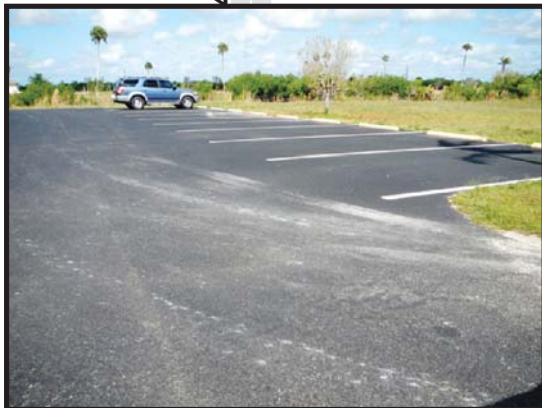
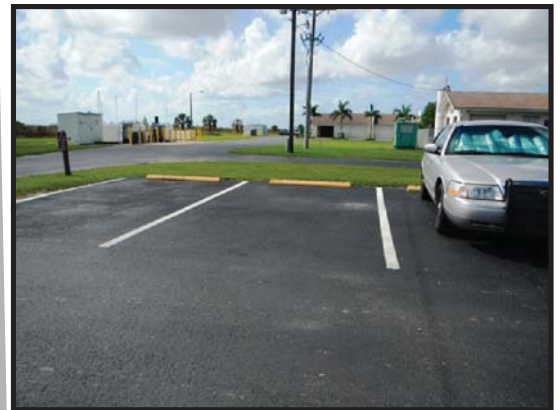
Route 0915

Route Number	Public / NonPublic	Date Visited	Area (sq ft)	Lane Miles *	Surface Type
0915	NONPUBLIC	4/19/2013	5,587	0.10	AS
Culverts	Drop Inlets	Gates	Curb & Gutter	Curb	PCR
0	0	0	NO CURB AND GUTTER	NO CURB	EXCELLENT/97

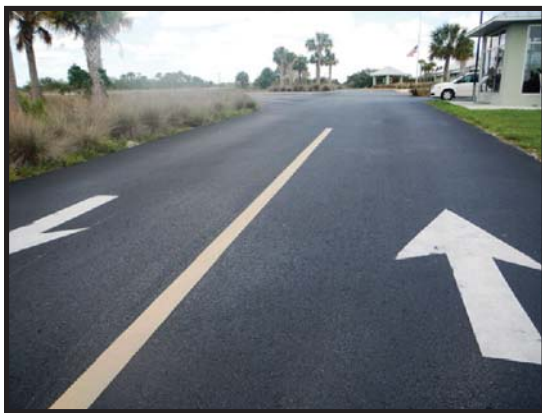
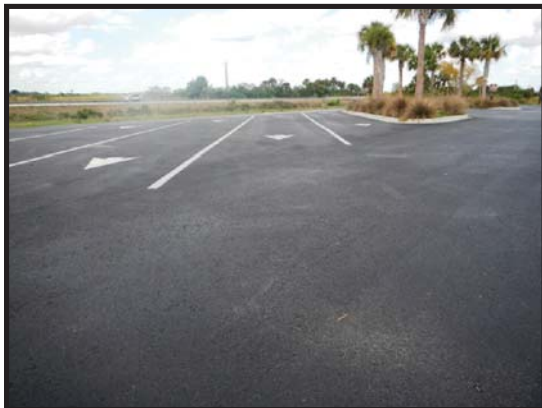
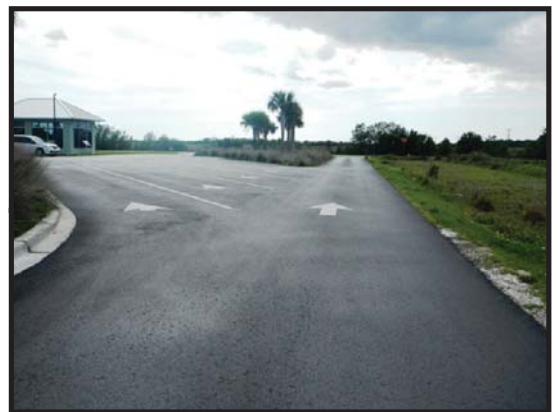
Route 0918

Route Number	Public / NonPublic	Date Visited	Area (sq ft)	Lane Miles *	Surface Type
0918	PUBLIC	4/19/2013	19,749	0.34	AS
Culverts	Drop Inlets	Gates	Curb & Gutter	Curb	PCR
0	1	0	CONCRETE CURB AND GUTTER	NO CURB	EXCELLENT/97

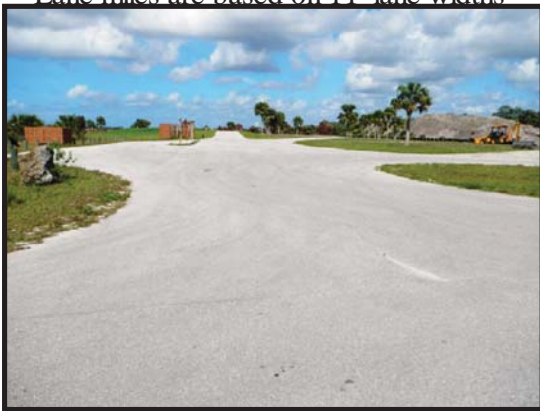
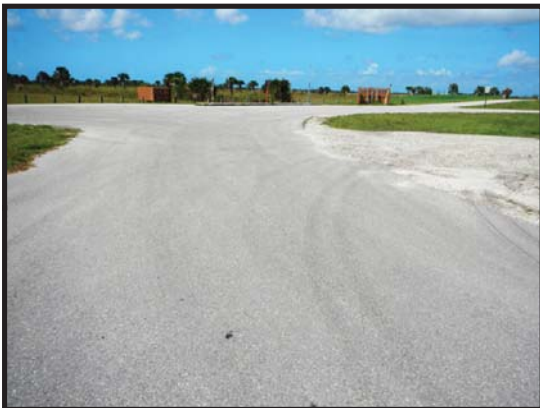
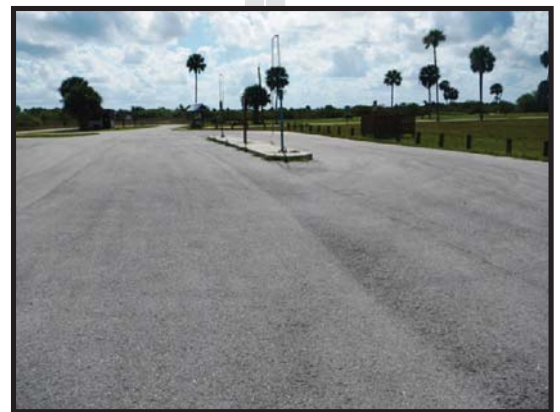
Route Number	Public / NonPublic	Date Visited	Area (sq ft)	Lane Miles *	Surface Type
0919	PUBLIC	4/19/2013	18,094	0.31	AS
Culverts	Drop Inlets	Gates	Curb & Gutter	Curb	PCR
0	0	0	NO CURB AND GUTTER	NO CURB	EXCELLENT/97

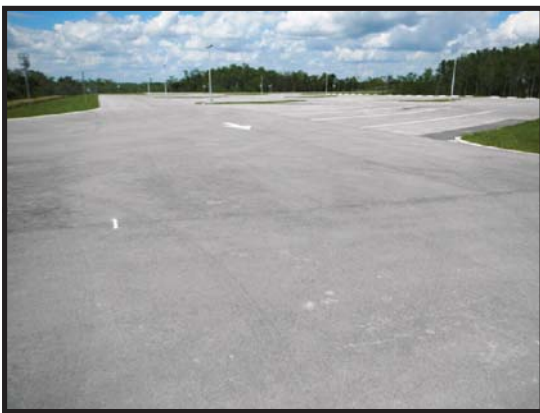
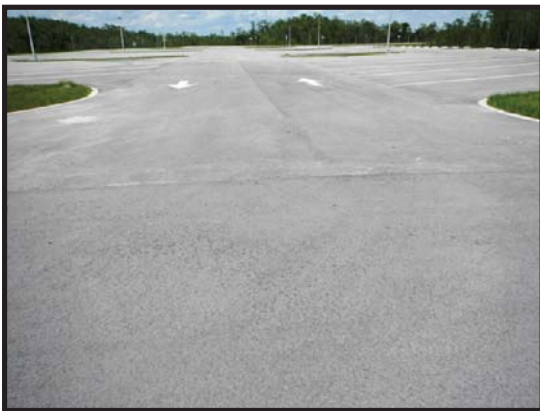
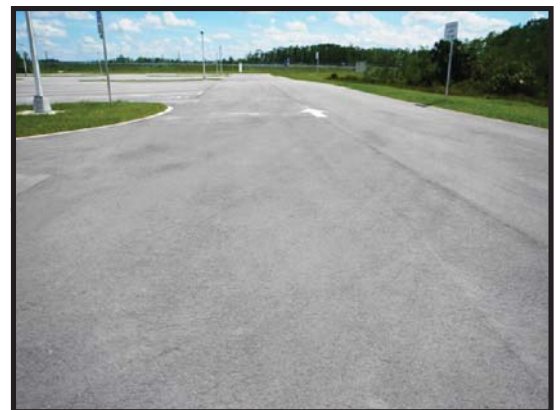
Route 0920

Route Number	Public / NonPublic	Date Visited	Area (sq ft)	Lane Miles *	Surface Type
0920	PUBLIC	4/18/2013	135,727	2.34	AS
Culverts	Drop Inlets	Gates	Curb & Gutter	Curb	PCR
2	8	1	NO CURB AND GUTTER	NO CURB	EXCELLENT/97

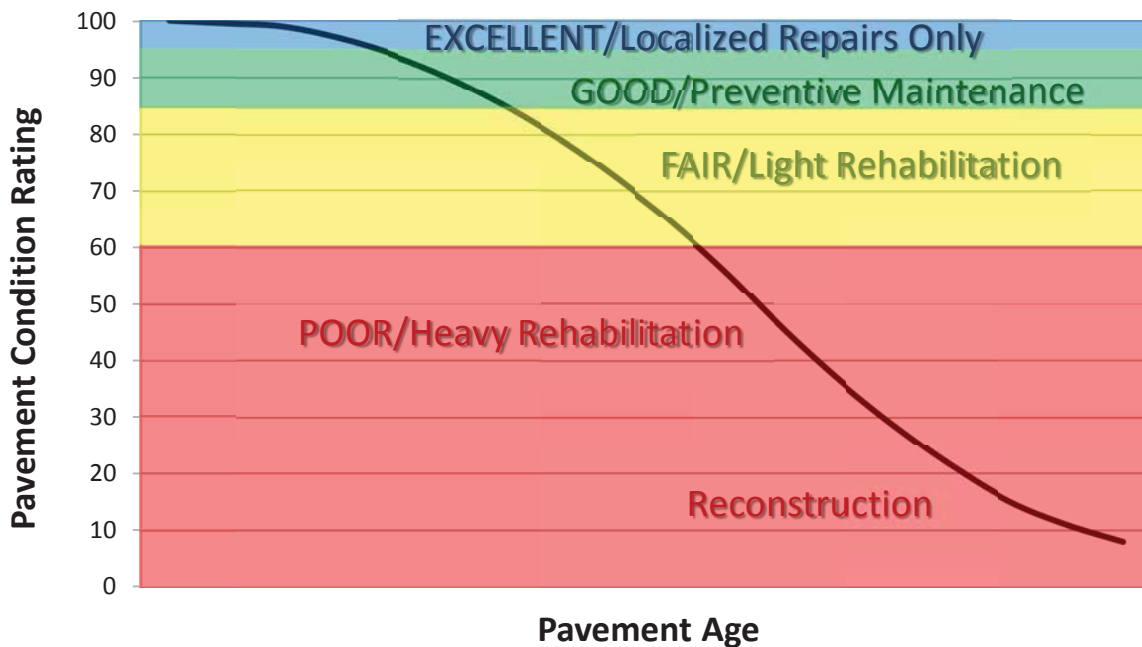
Condition Categories and Treatments

- Excellent/New: PCR of 95-100. Pavements in this range will require only spot repairs
- Good: PCR of 85-94. Pavements in this range will likely be candidates for Preventive Maintenance. Examples include Chip and Slurry Seals, Micro Surfacing and Thin Overlays.
- Fair: PCR of 61-84. Pavements in this range will likely be candidates of Light Rehabilitation (L3R). Examples include single-lift overlays up to 2.5 inches in total thickness, milling and overlays.
- Poor: PCR of 0-60. Pavements in this range will likely be candidates of Heavy Rehabilitation or Reconstruction (H3R or 4R). Examples include Pulverization, Multiple Lift Overlays, and Reconstruction.
