# Federal Lands Highway Road Inventory Program

Road Inventory and Condition Assessment

**Biscayne National Park**  
**BISC**

**Cycle 5 Report**

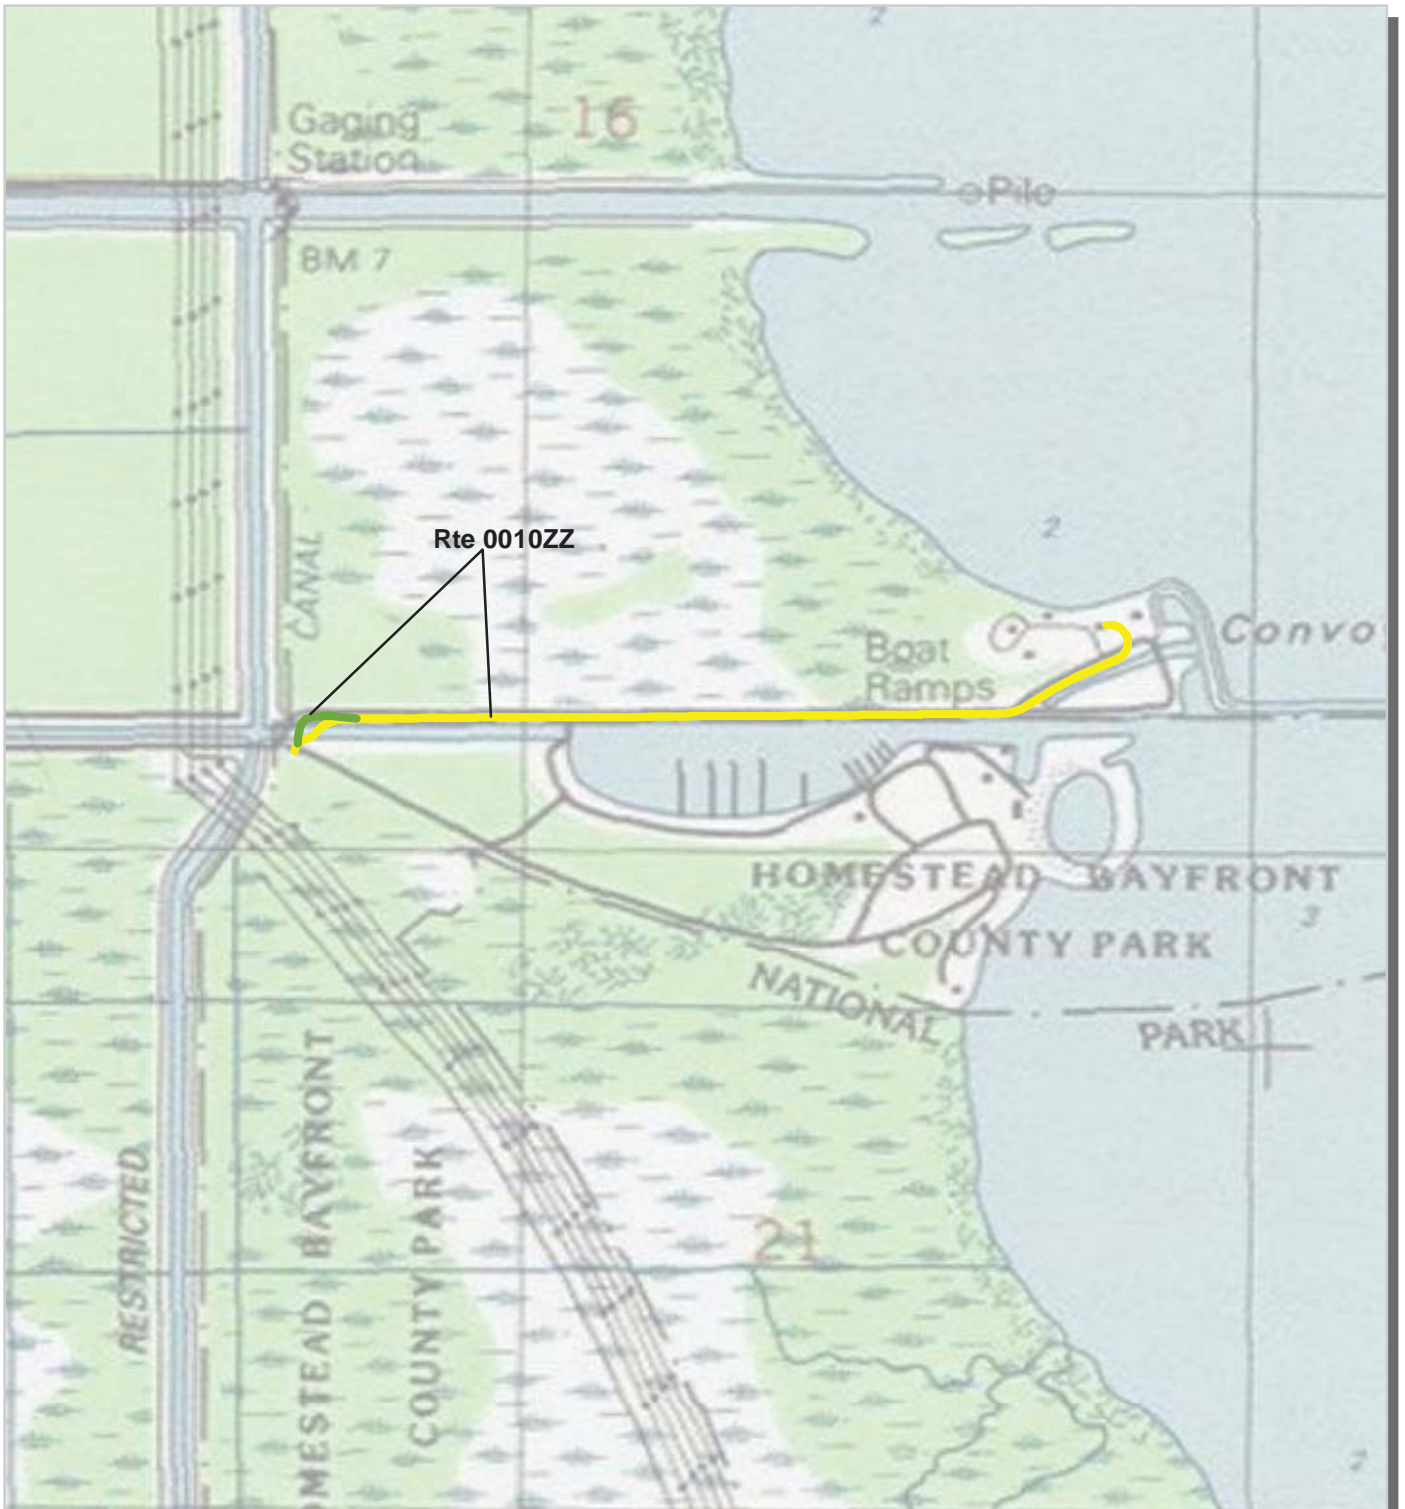
**Biscayne National Park  
Route Condition Map  
PCR - Mile by Mile  
Area 1**

PCR	Poor	Fair	Good	Excellent	No Data
	(0 - 60)	(61 - 84)	(85 - 94)	(95 - 100)

\* If the PCR rating is not available for a section, the SCR rating will be displayed. See appendix for definitions and formulas.

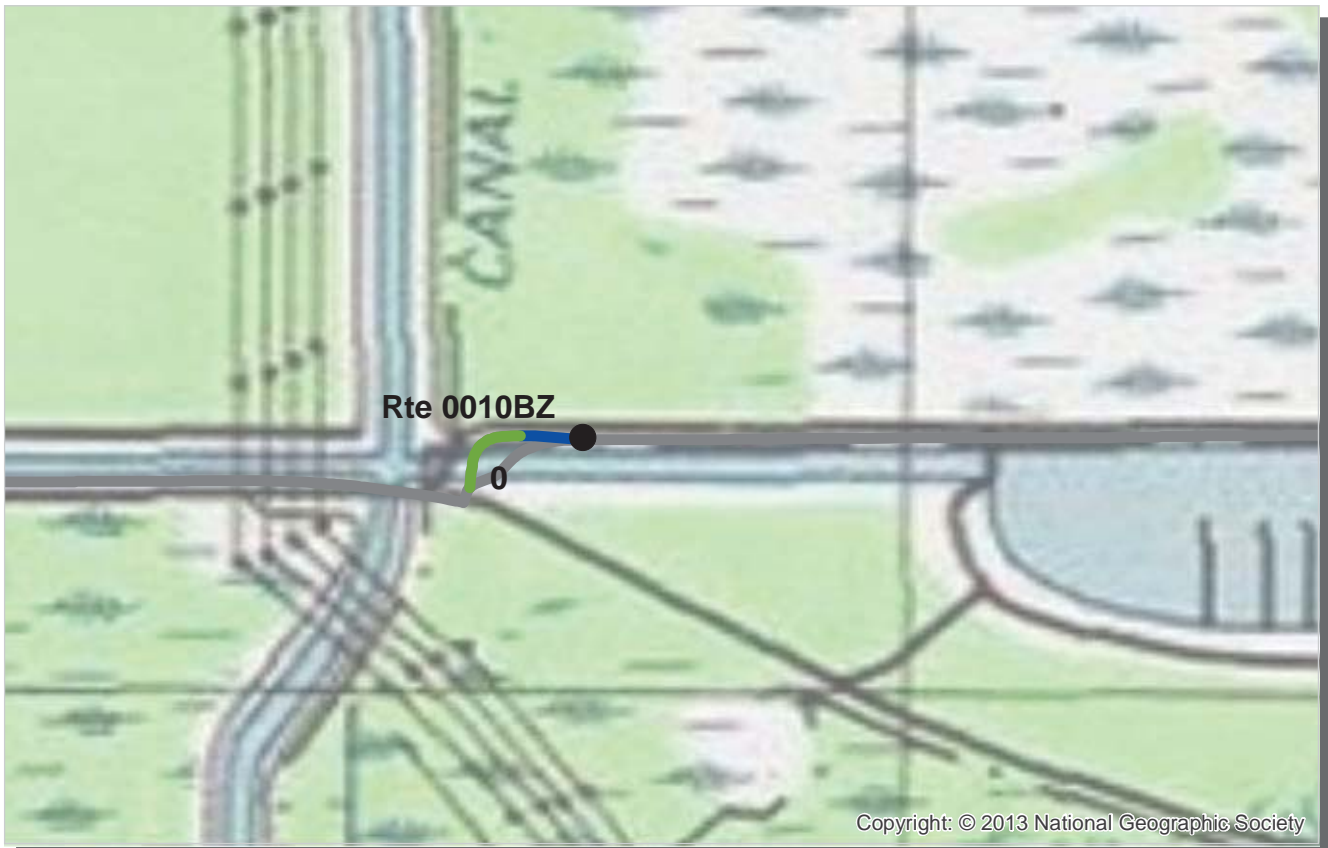
**ROUTE: 0010BZ ENTRANCE ROAD EXIT SPUR**

<b>Section Number</b>	0				
<b>Section Length (mi)</b>	0.05				
<b>Cross Section Information</b>					
Number of Lanes	1				
Paved Width (ft)	12				
Lane Width (ft)	12				
<b>Roadway Condition Information</b>					
SCR (Surface Condition Rating)	94				
PCR (Pavement Condition Rating)	94				
<b>Distress Index Values</b>					
Structural Crack Index	100				
Transverse Cracking Index	99				
Patching Index	100				
Rutting Index	94				
Roughness Condition Index (RCI)	NC
