Federal Lands Highway Road Inventory Program

Road Inventory and Condition Assessment

Big South Fork National River and Recreation Area BISO

Cycle 5 Report

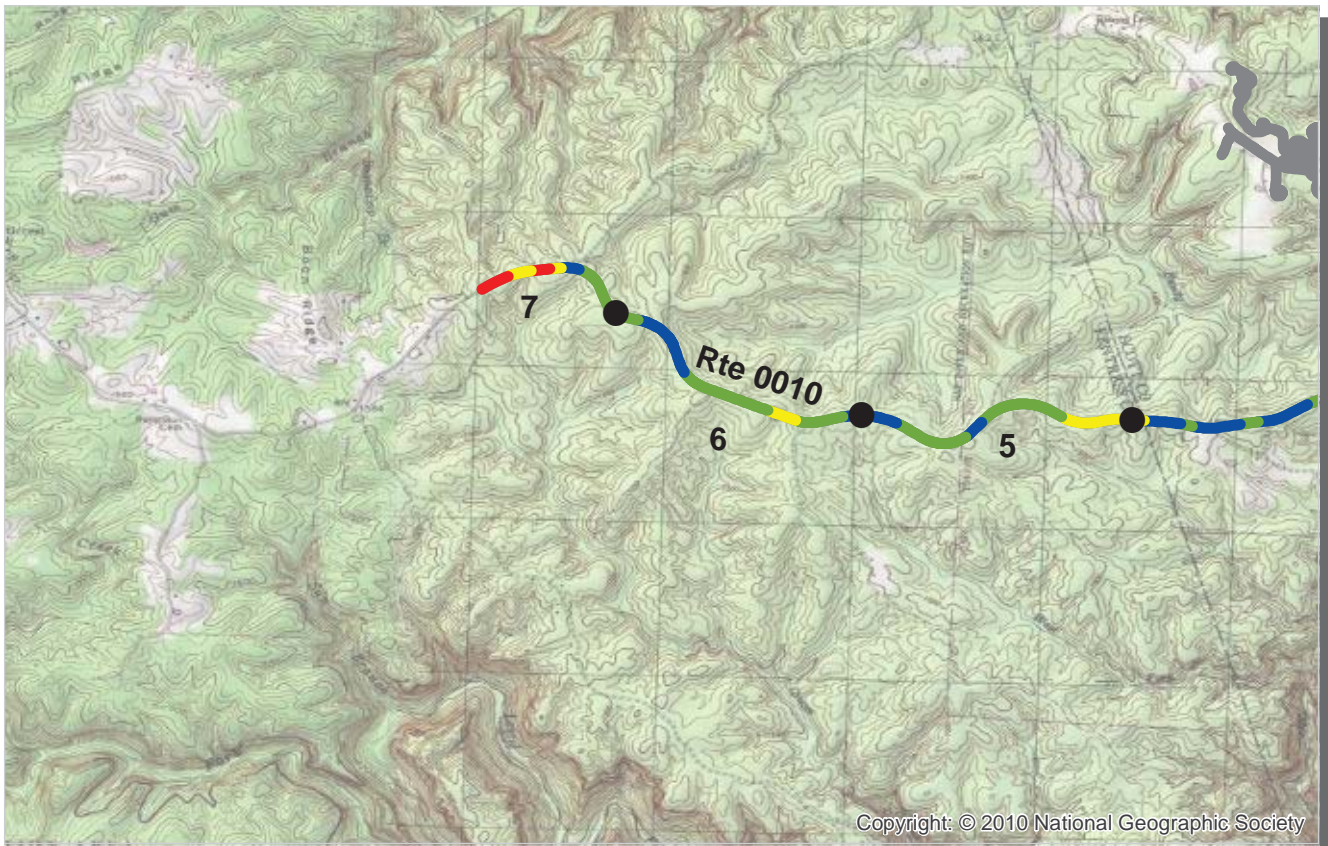
ROUTE: 0010 LEATHERWOOD FORD ROAD (STATE HIGHWAY 297)

<i>Section Number</i>	5	6	7		
<i>Section Length (mi)</i>	1.00	1.00	0.56		
<i>Cross Section Information</i>					
Number of Lanes	2	2	2		
Paved Width (ft)	29	29	29		
Lane Width (ft)	10	10	10		
<i>Roadway Condition Information</i>					
SCR (Surface Condition Rating)	82	86	42		
PCR (Pavement Condition Rating)	89	92	65		
<i>Distress Index Values</i>					
Structural Crack Index	82	86	42		
Transverse Cracking Index	94	96	93		
Patching Index	100	100	100		
Rutting Index	100	100	100		
Roughness Condition Index (RCI)	100	100	100

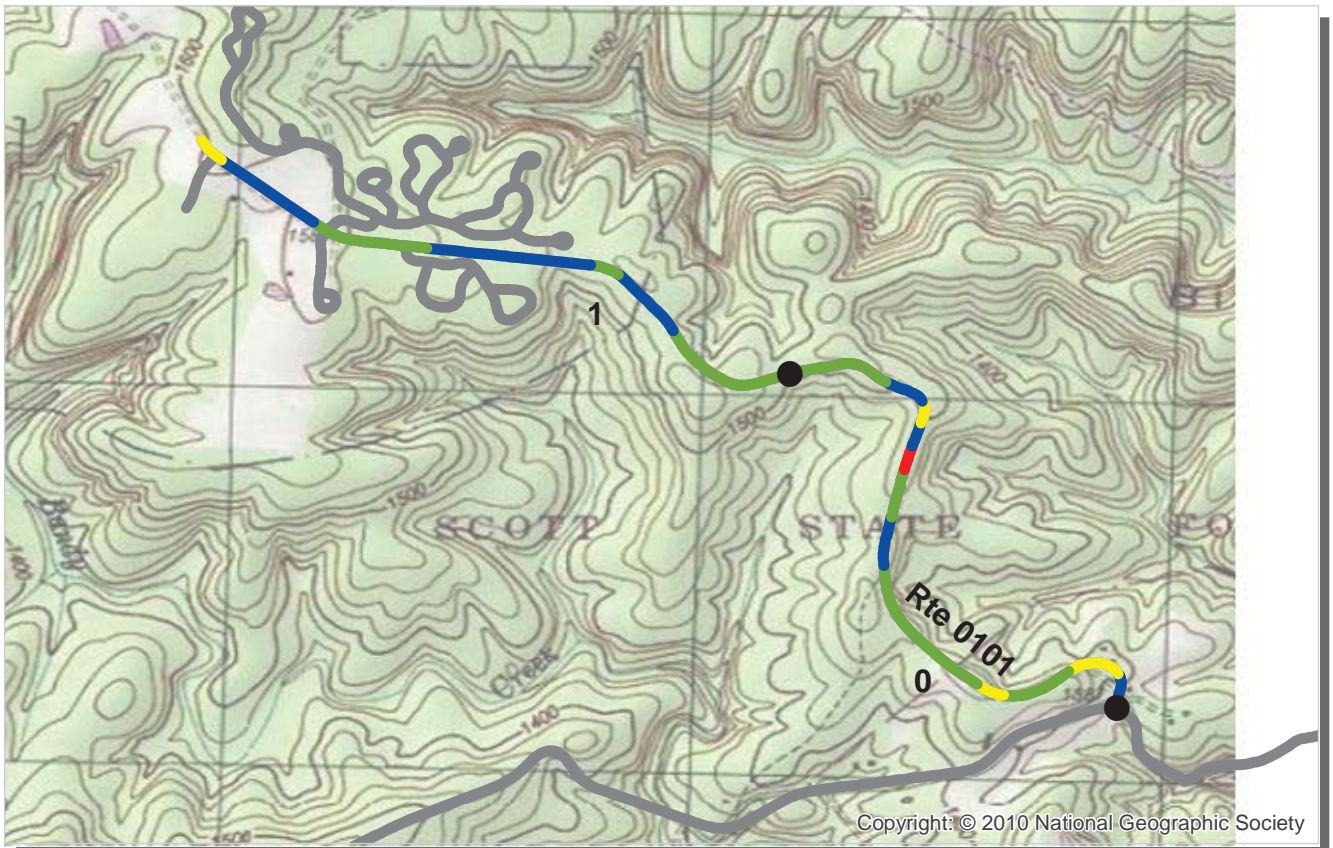
ROUTE: 0101 BANDY CREEK ROAD

Section Number	0	1			
Section Length (mi)	1.00	0.94			
Cross Section Information					
Number of Lanes	2	2			
Paved Width (ft)	30	29			
Lane Width (ft)	12	12			
Roadway Condition Information					
SCR (Surface Condition Rating)	86	93			
PCR (Pavement Condition Rating)	90	95			
Distress Index Values					
Structural Crack Index	86	93			
Transverse Cracking Index	90	95			
Patching Index	100	100			
Rutting Index	99	99			
Roughness Condition Index (RCI)	95	97

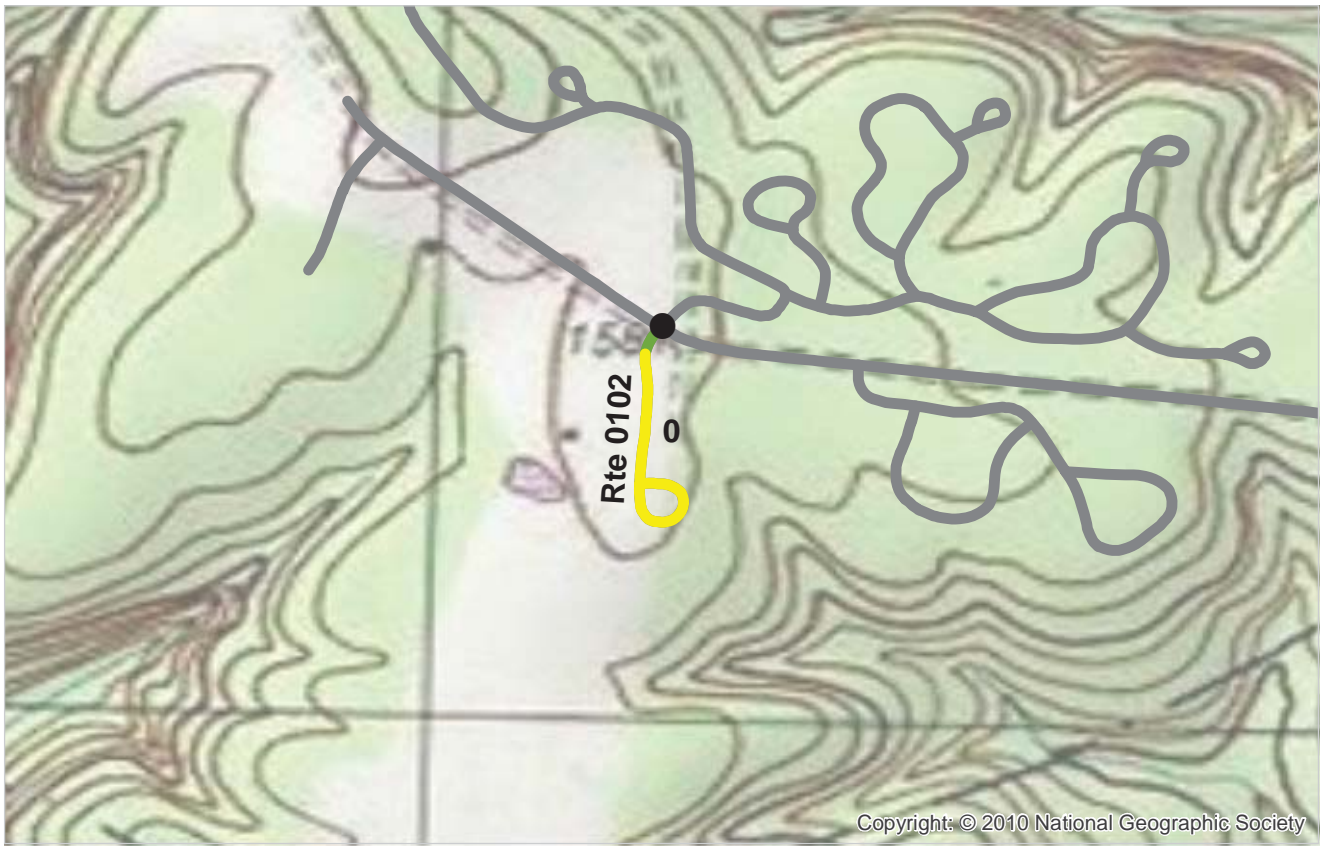
ROUTE: 0102 STABLE ROAD

Section Number	0				
Section Length (mi)	0.18				
Cross Section Information					
Number of Lanes	2				
Paved Width (ft)	19				
Lane Width (ft)	12				
Roadway Condition Information					
SCR (Surface Condition Rating)	79				
PCR (Pavement Condition Rating)	79				
Distress Index Values					
Structural Crack Index	79				
Transverse Cracking Index	85				
Patching Index	100				
Rutting Index	94				
Roughness Condition Index (RCI)	NC

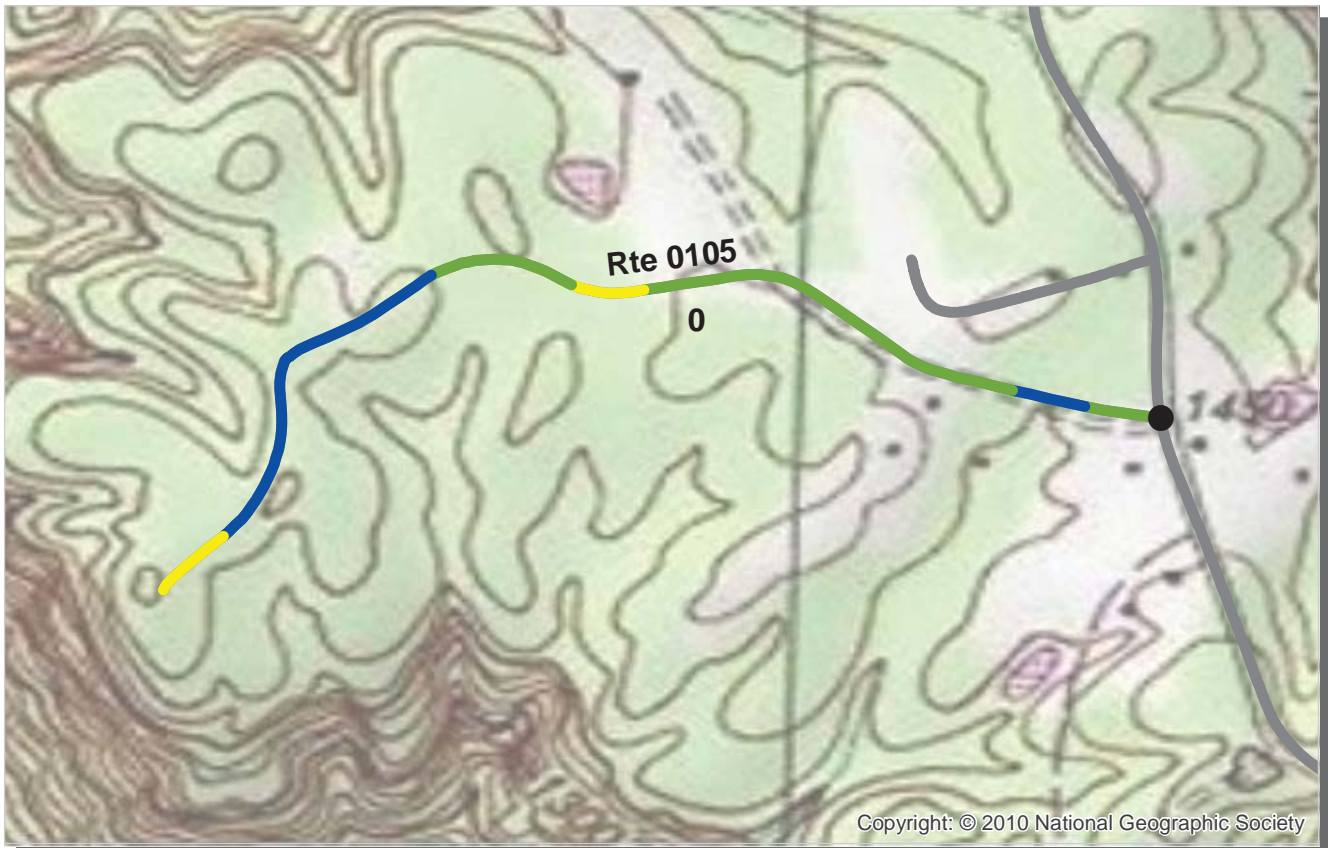
ROUTE: 0105 EAST RIM OVERLOOK ROAD

Section Number	0				
Section Length (mi)	0.69				
Cross Section Information					
Number of Lanes	2				
Paved Width (ft)	20				
Lane Width (ft)	9				
Roadway Condition Information					
SCR (Surface Condition Rating)	96				
PCR (Pavement Condition Rating)	90				
Distress Index Values					
Structural Crack Index	100				
Transverse Cracking Index	100				
Patching Index	100				
Rutting Index	96				
Roughness Condition Index (RCI)	82

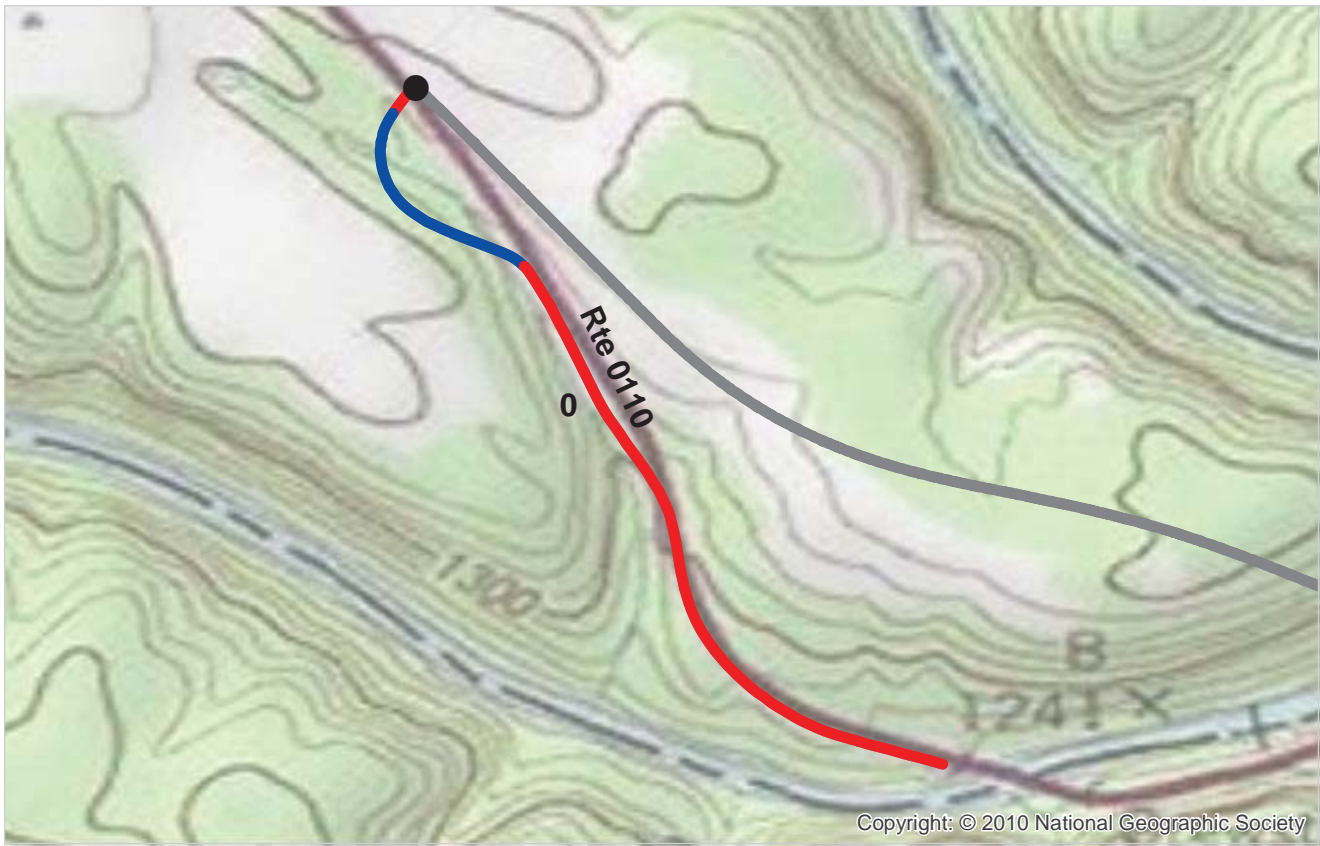
ROUTE: 0110 BREWSTER BRIDGE ROAD

Section Number	0				
Section Length (mi)	0.58				
Cross Section Information					
Number of Lanes	2				
Paved Width (ft)	24				
Lane Width (ft)	10				
Roadway Condition Information					
SCR (Surface Condition Rating)	0				
PCR (Pavement Condition Rating)	36				
Distress Index Values					
Structural Crack Index	0				
Transverse Cracking Index	99				
Patching Index	100				
Rutting Index	94				
Roughness Condition Index (RCI)	90

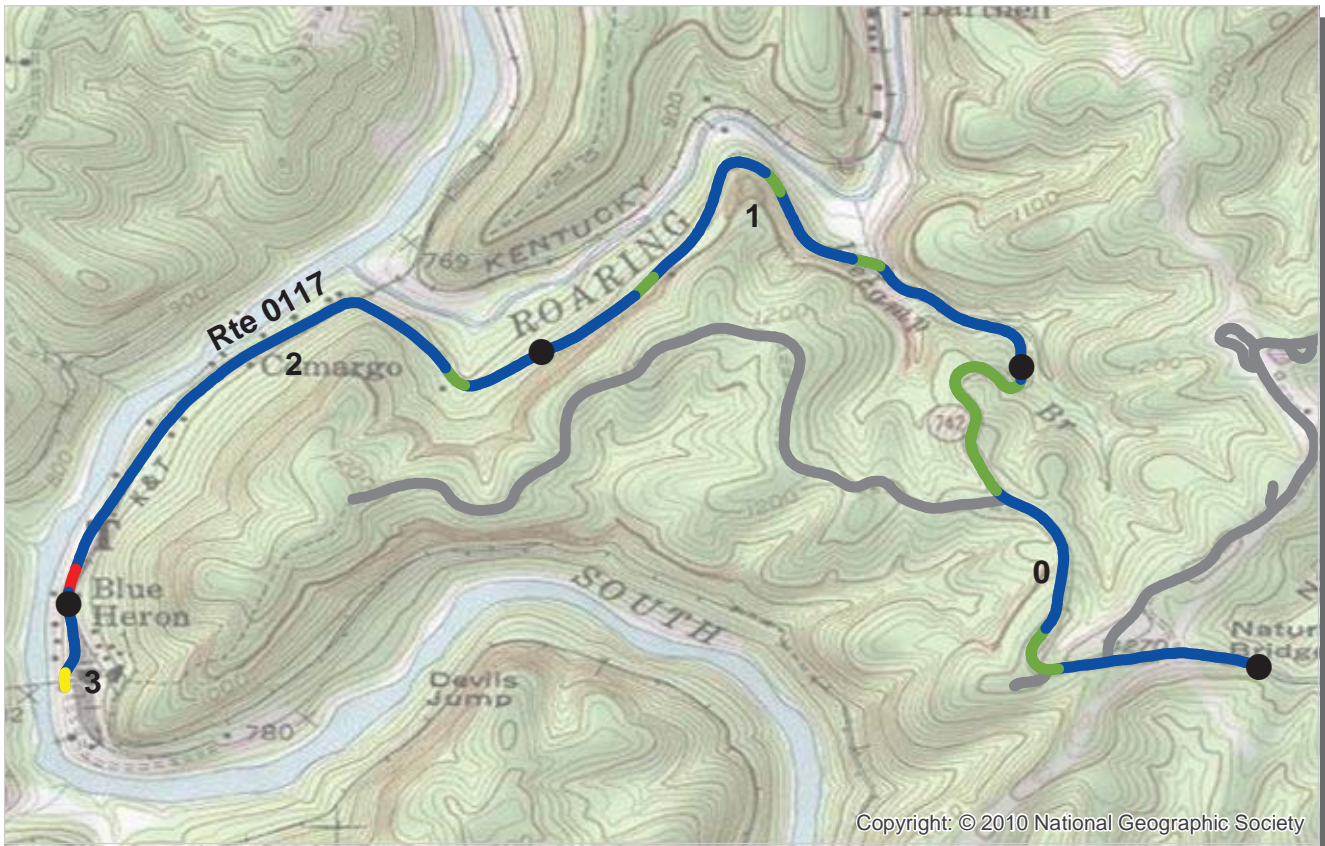
ROUTE: 0117 BLUE HERON ROAD (HWY 742)

Section Number	0	1	2	3
Section Length (mi)	1.00	1.00	1.00	0.14
Cross Section Information				
Number of Lanes	2	2	2	2
Paved Width (ft)	26	27	25	22
Lane Width (ft)	12	11	11	11
Roadway Condition Information				
SCR (Surface Condition Rating)	97	98	98	97
PCR (Pavement Condition Rating)	97	98	98	88
Distress Index Values				
Structural Crack Index	97	98	98	100
Transverse Cracking Index	100	100	100	100
Patching Index	100	100	100	97
Rutting Index	99	99	98	99
Roughness Condition Index (RCI)	97	98	98	74

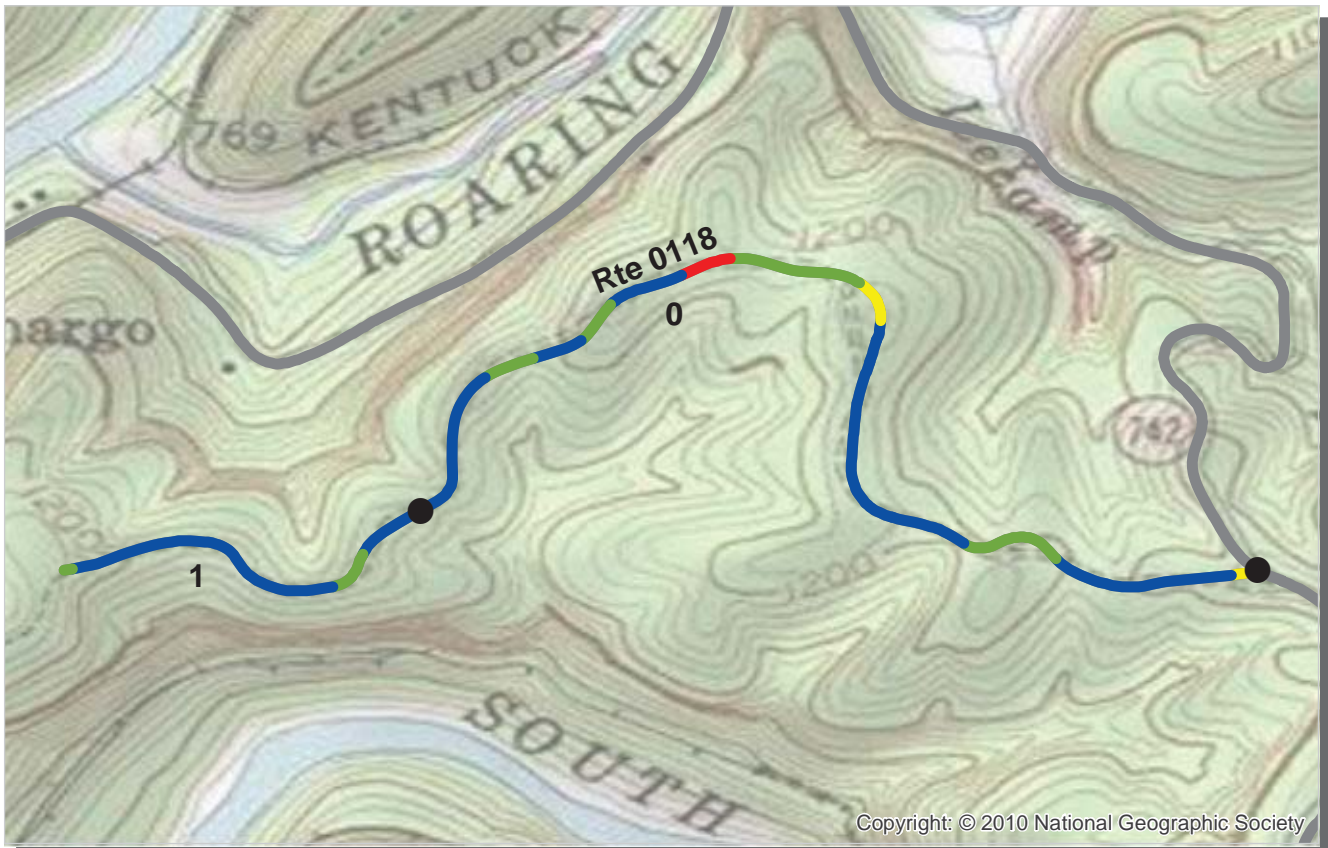
ROUTE: 0118 BLUE HERON OVERLOOK ROAD

<i>Section Number</i>	0	1			
<i>Section Length (mi)</i>	1.00	0.33			
<i>Cross Section Information</i>					
Number of Lanes	2	2			
Paved Width (ft)	20	20			
Lane Width (ft)	10	10			
<i>Roadway Condition Information</i>					
SCR (Surface Condition Rating)	91	99			
PCR (Pavement Condition Rating)	91	97			
<i>Distress Index Values</i>					
Structural Crack Index	91	99			
Transverse Cracking Index	100	100			
Patching Index	100	100			
Rutting Index	99	99			
Roughness Condition Index (RCI)	91	93

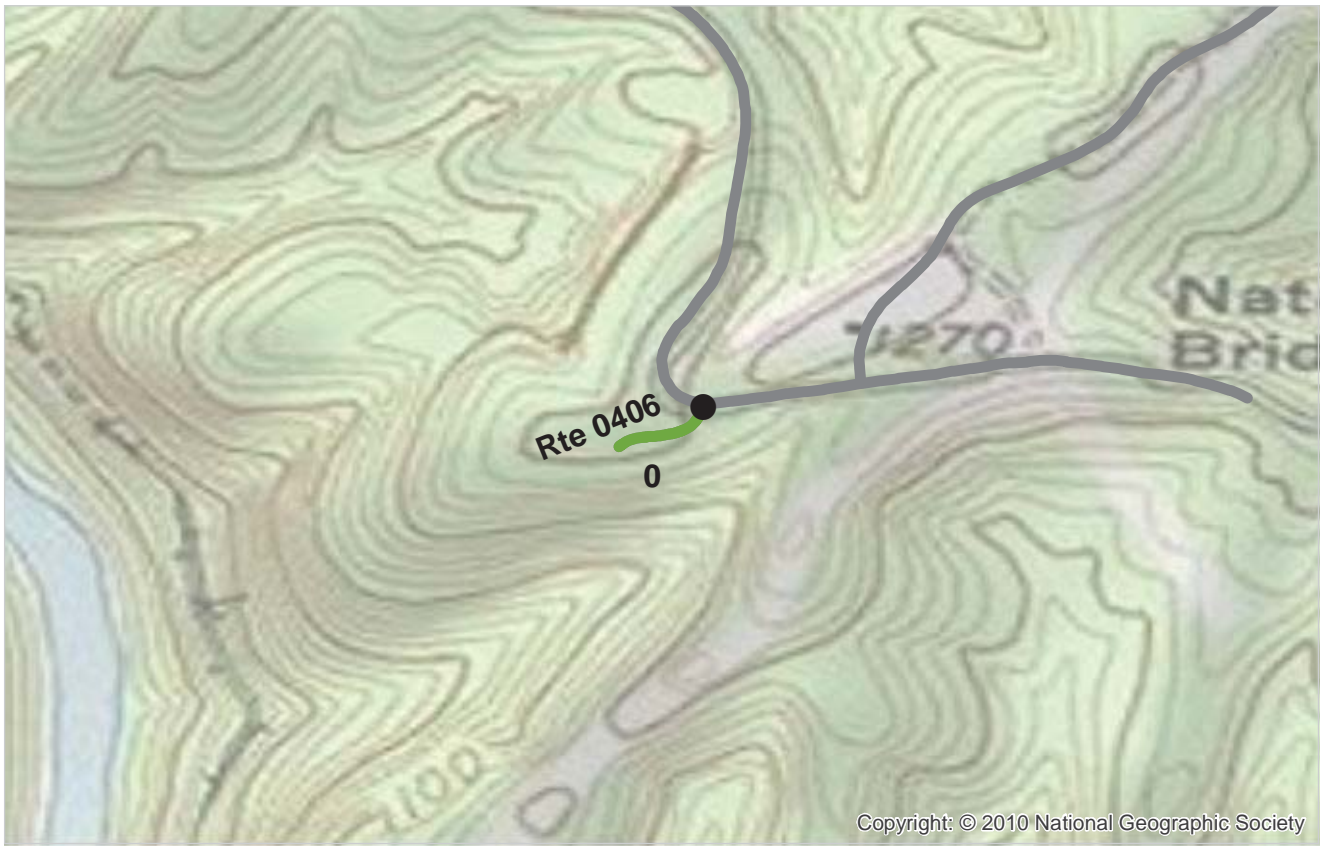
ROUTE: 0406 BLUE HERON RESIDENCE ACCESS ROAD

Section Number	0				
Section Length (mi)	0.06				
Cross Section Information					
Number of Lanes	1				
Paved Width (ft)	13				
Lane Width (ft)	13				
Roadway Condition Information					
SCR (Surface Condition Rating)	91				
PCR (Pavement Condition Rating)	91				
Distress Index Values					
Structural Crack Index	97				
Transverse Cracking Index	100				
Patching Index	100				
Rutting Index	91				
Roughness Condition Index (RCI)	NC

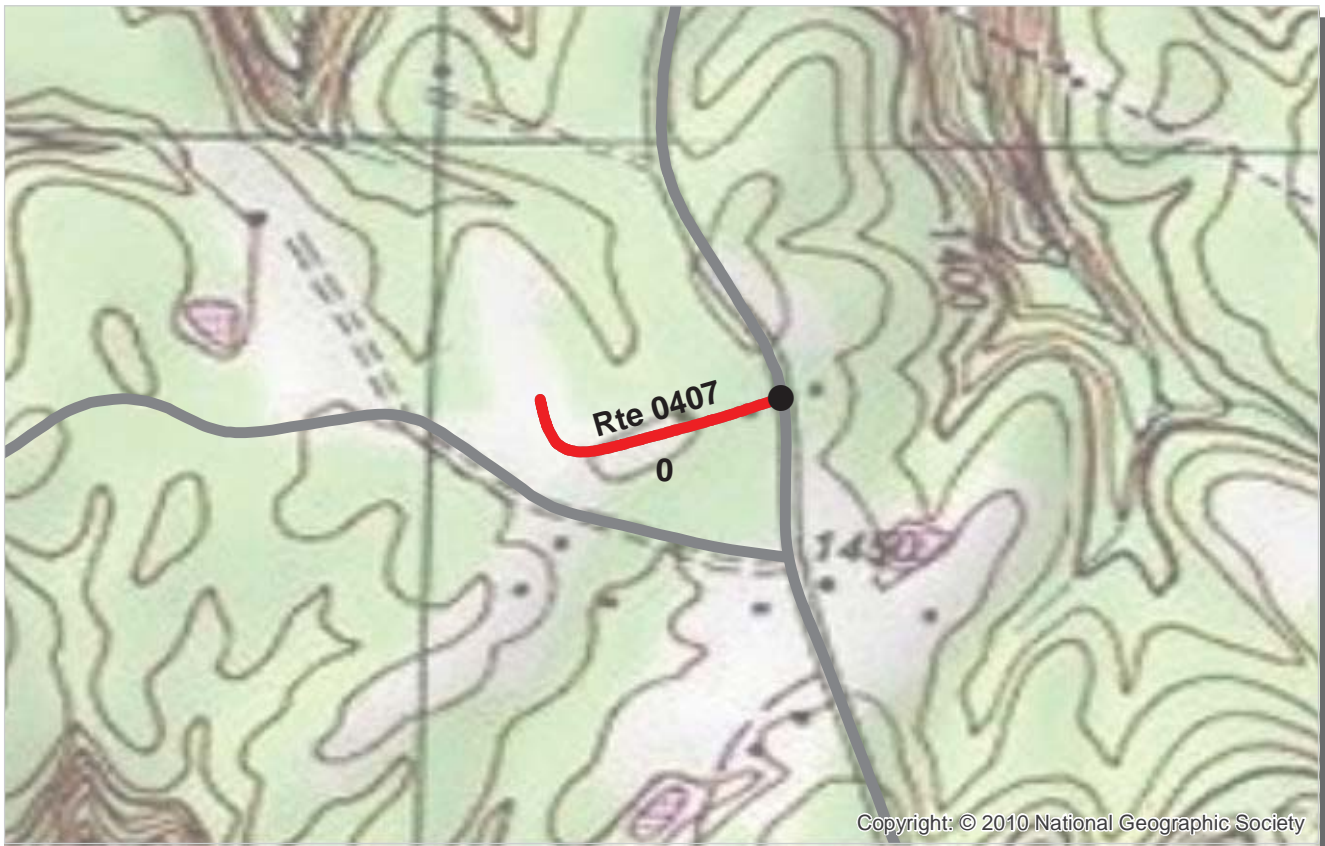
ROUTE: 0407 EAST RIM MAINTENANCE AREA ROAD

Section Number	0				
Section Length (mi)	0.16				
Cross Section Information					
Number of Lanes	1				
Paved Width (ft)	13				
Lane Width (ft)	13				
Roadway Condition Information					
SCR (Surface Condition Rating)	0				
PCR (Pavement Condition Rating)	0				
Distress Index Values					
Structural Crack Index	0				
Transverse Cracking Index	100				
Patching Index	100				
Rutting Index	71				
Roughness Condition Index (RCI)	NC

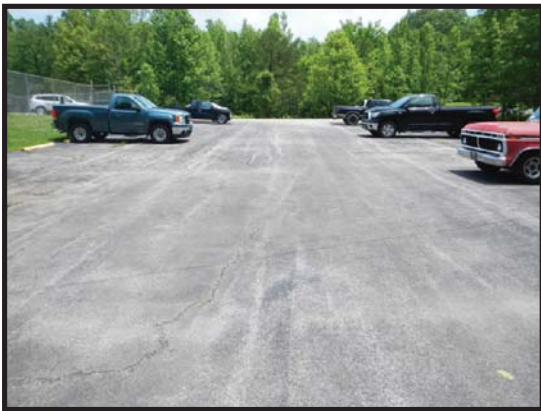
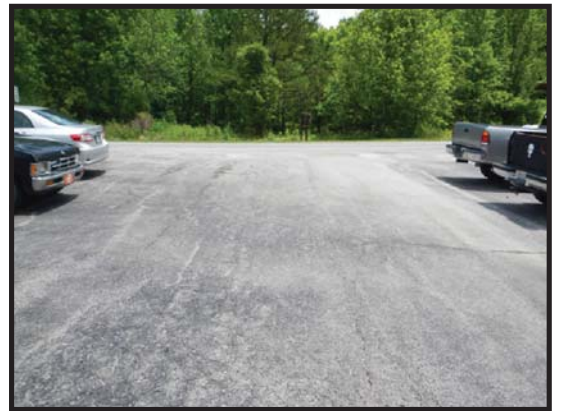
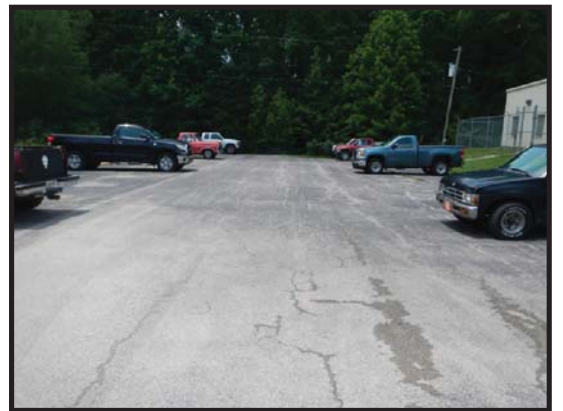
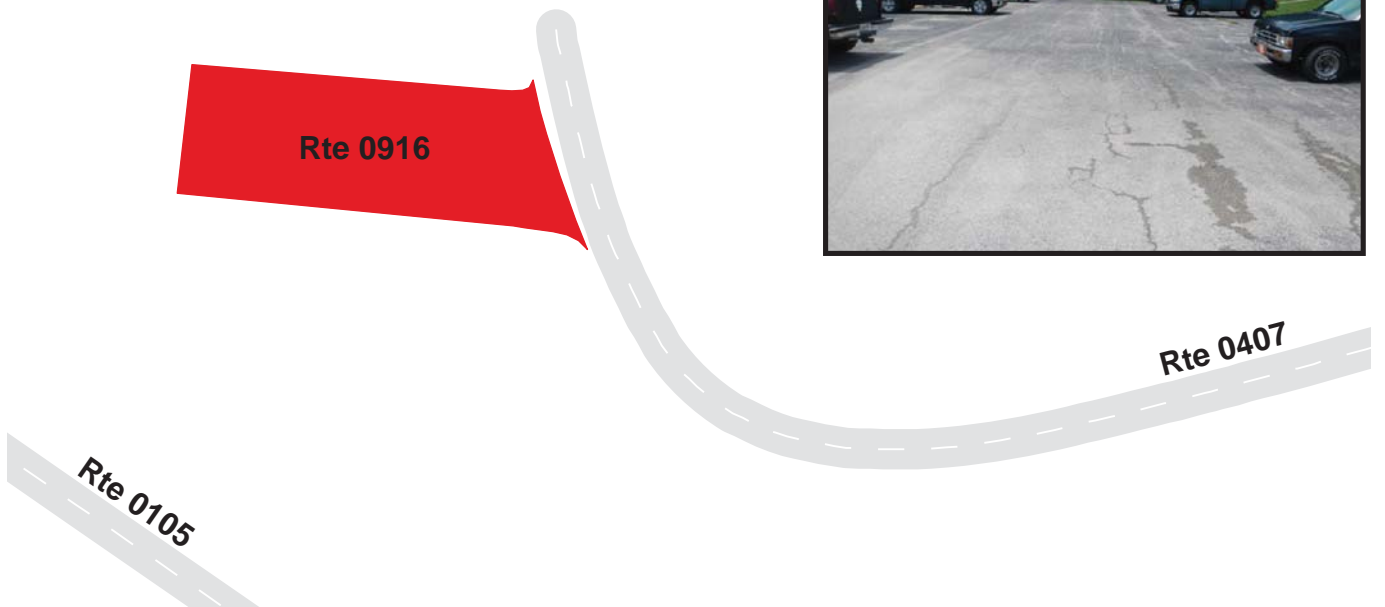
Route Number	Public / NonPublic	Date Visited	Area (sq ft)	Lane Miles *	Surface Type
0916	NONPUBLIC	5/23/2012	7,527	0.13	AS
Culverts	Drop Inlets	Gates	Curb & Gutter	Curb	PCR
0	0	0	NO CURB AND GUTTER	NO CURB	POOR/45
