# Federal Lands Highway Road Inventory Program

Road Inventory and Condition Assessment

## Black Canyon of the Gunnison National Park BLCA - 1377

### Cycle 5 Report

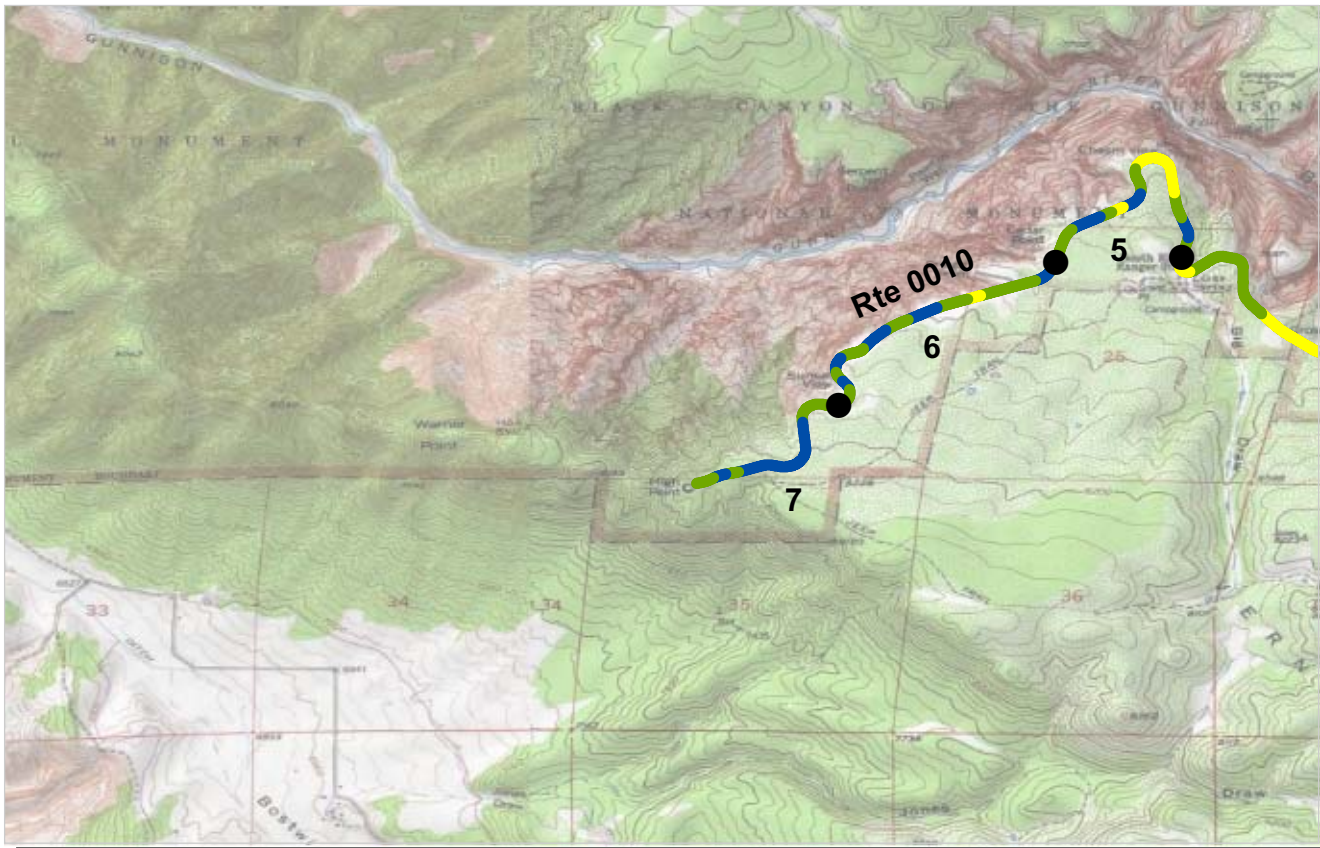
**ROUTE: 0010 SOUTH RIM DRIVE**

<i>Section Number</i>	5	6	7		
<i>Section Length (mi)</i>	1.00	1.00	0.66		
<i>Cross Section Information</i>					
Number of Lanes	2	2	2		
Paved Width (ft)	25	25	24		
Lane Width (ft)	11	10	11		
<i>Roadway Condition Information</i>					
SCR (Surface Condition Rating)	97	98	99		
PCR (Pavement Condition Rating)	87	92	94		
<i>Distress Index Values</i>					
Structural Crack Index	100	100	100		
Transverse Cracking Index	100	100	100		
Patching Index	100	100	100		
Rutting Index	97	98	99		
Roughness Condition Index (RCI)	73	83	86

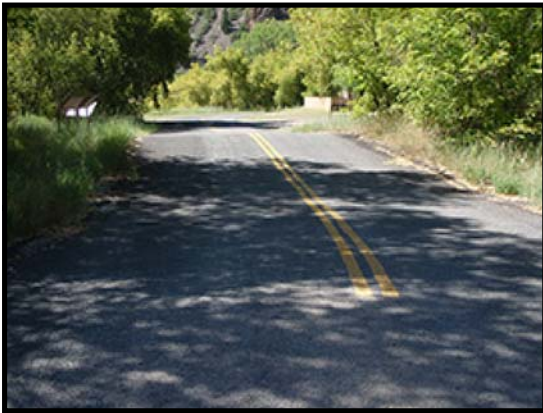
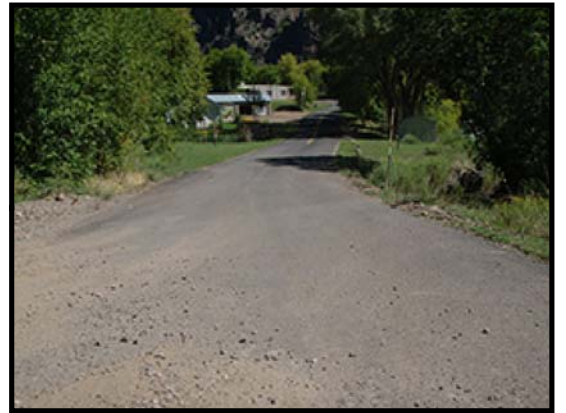
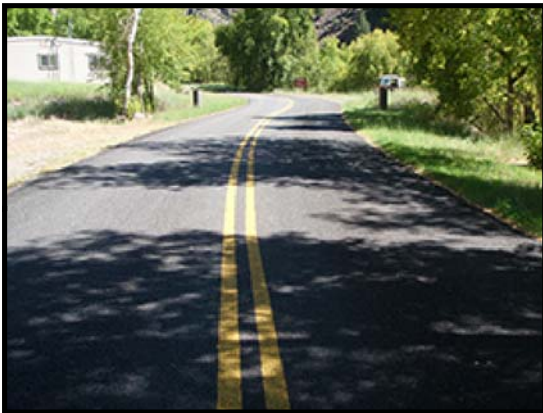
Route Number	Public / NonPublic	Date Visited	Area (sq ft)	Lane Miles *	Paved Length (mi)	Paved Width (ft)
0222	PUBLIC	8/10/2011	13,944	0.24	0.14	19
Culverts	Drop Inlets	Gates	Curb & Gutter	Curb	PCR	Surface Type
1	0	1	NO CURB AND GUTTER	NO CURB	GOOD/90	AS

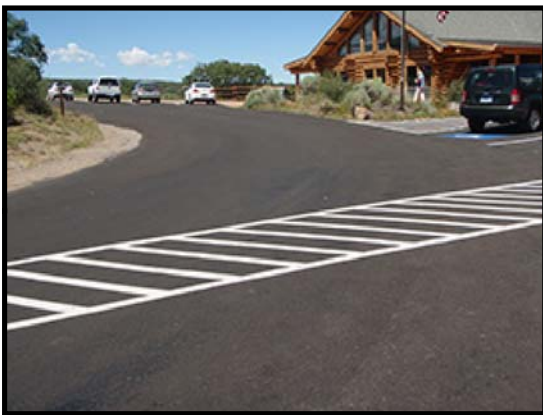
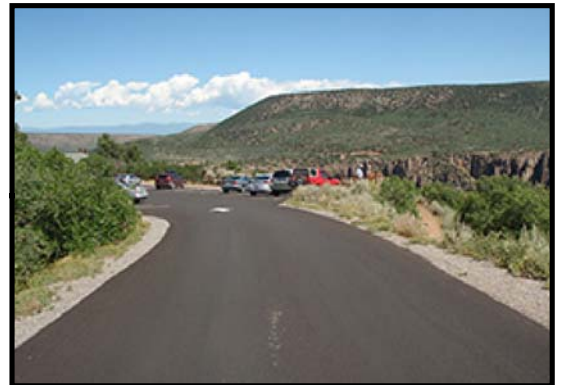
Route Number	Public / NonPublic	Date Visited	Area (sq ft)	Lane Miles *	Surface Type
0900	PUBLIC	8/10/2011	29,123	0.50	AS
Culverts	Drop Inlets	Gates	Curb & Gutter	Curb	PCR
0	2	0	CONCRETE CURB AND GUTTER	NO CURB	GOOD/90

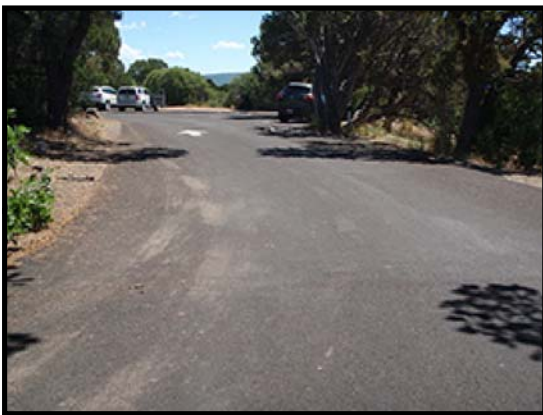
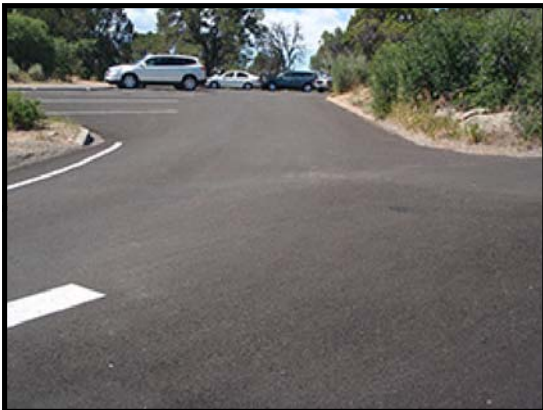
## Route 0901

Route Number	Public / NonPublic	Date Visited	Area (sq ft)	Lane Miles *	Surface Type
0901	PUBLIC	8/10/2011	16,356	0.28	AS
Culverts	Drop Inlets	Gates	Curb & Gutter	Curb	PCR
0	0	0	CONCRETE CURB AND GUTTER	NO CURB	GOOD/90

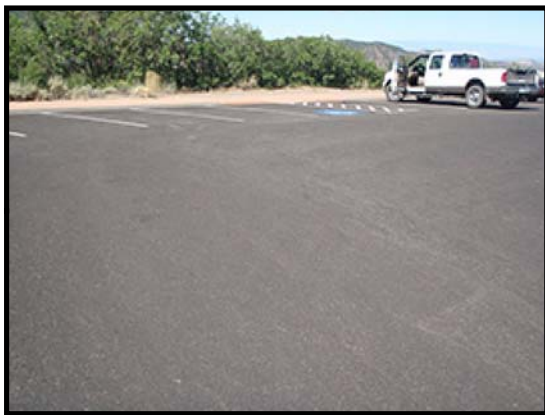
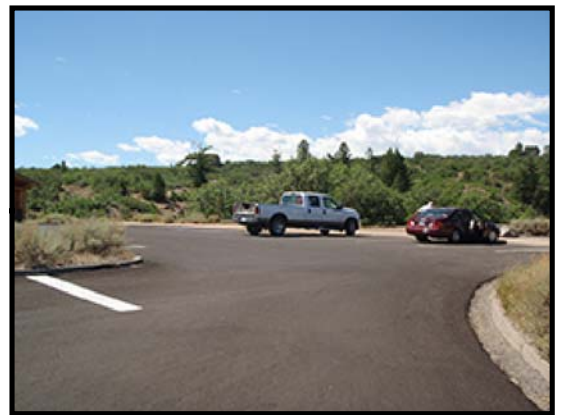
## Route 0902

Route Number	Public / NonPublic	Date Visited	Area (sq ft)	Lane Miles *	Surface Type
0902	PUBLIC	8/10/2011	7,692	0.13	AS
Culverts	Drop Inlets	Gates	Curb & Gutter	Curb	PCR
0	1	0	CONCRETE CURB AND GUTTER	CONCRETE CURB	GOOD/90

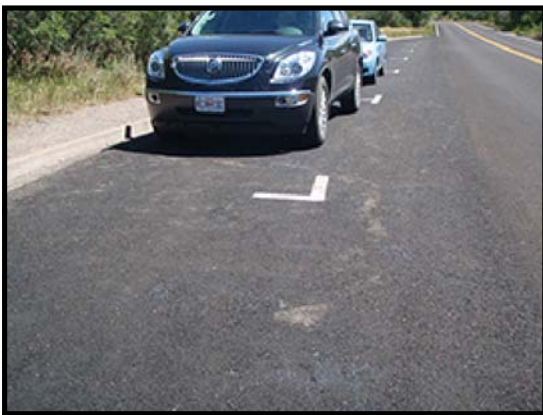
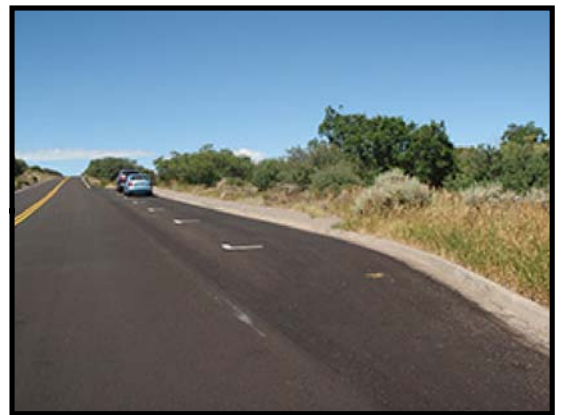
Route Number	Public / NonPublic	Date Visited	Area (sq ft)	Lane Miles *	Surface Type
0903	PUBLIC	8/10/2011	2,221	0.04	AS
Culverts	Drop Inlets	Gates	Curb & Gutter	Curb	PCR
0	0	0	CONCRETE CURB AND GUTTER	NO CURB	GOOD/90

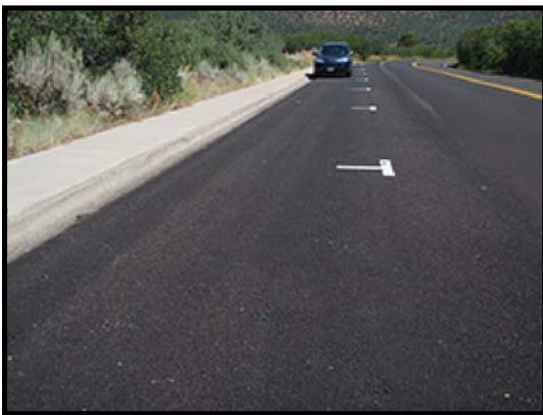
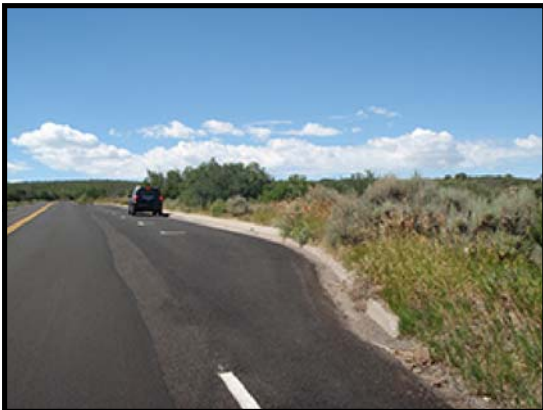
## Route 0904

Route Number	Public / NonPublic	Date Visited	Area (sq ft)	Lane Miles *	Surface Type
0904	PUBLIC	8/10/2011	2,984	0.05	AS
Culverts	Drop Inlets	Gates	Curb & Gutter	Curb	PCR
0	0	0	CONCRETE CURB AND GUTTER	NO CURB	GOOD/90

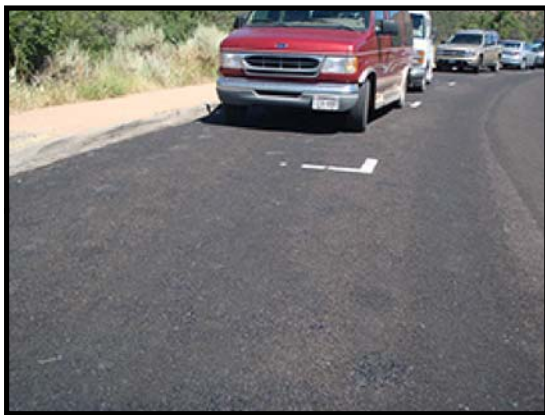
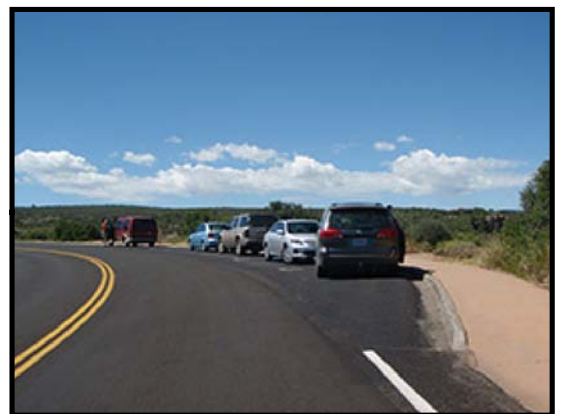
## Route 0905

Route Number	Public / NonPublic	Date Visited	Area (sq ft)	Lane Miles *	Surface Type
0905	PUBLIC	8/10/2011	2,344	0.04	AS
Culverts	Drop Inlets	Gates	Curb & Gutter	Curb	PCR
0	0	0	CONCRETE CURB AND GUTTER	NO CURB	GOOD/90

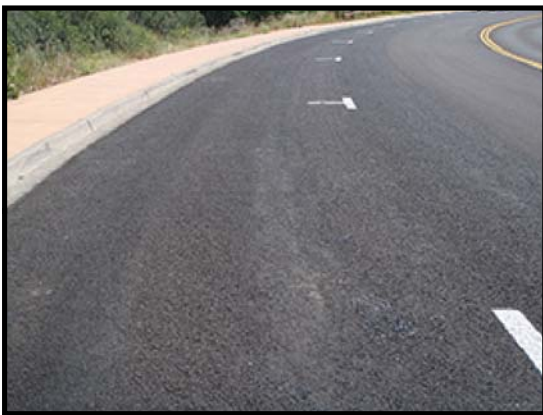
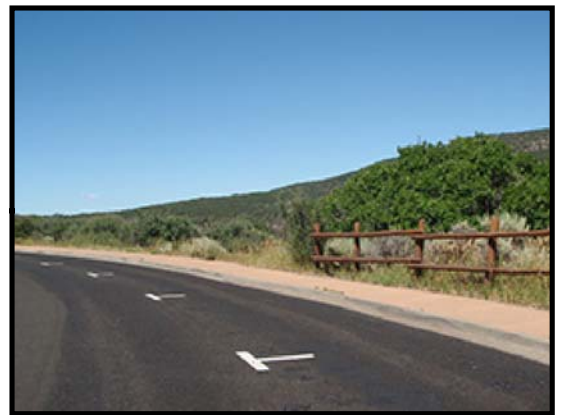
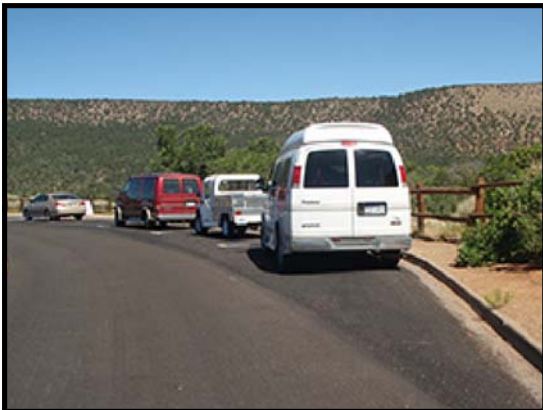
## Route 0906

Route Number	Public / NonPublic	Date Visited	Area (sq ft)	Lane Miles *	Surface Type
0906	PUBLIC	8/10/2011	5,994	0.10	AS
Culverts	Drop Inlets	Gates	Curb & Gutter	Curb	PCR
0	0	0	CONCRETE CURB AND GUTTER	NO CURB	GOOD/90

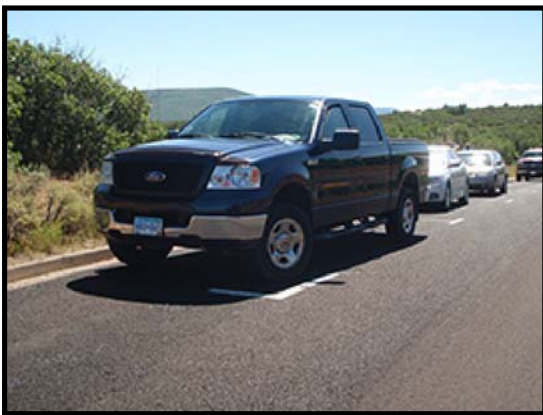
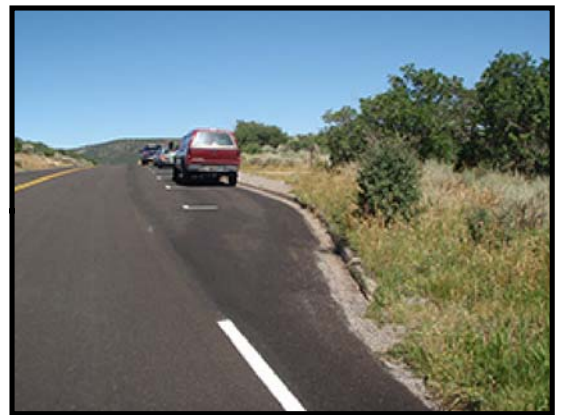
## Route 0907

Route Number	Public / NonPublic	Date Visited	Area (sq ft)	Lane Miles *	Surface Type
0907	PUBLIC	8/10/2011	2,802	0.05	AS
Culverts	Drop Inlets	Gates	Curb & Gutter	Curb	PCR
0	0	0	CONCRETE CURB AND GUTTER	NO CURB	GOOD/90

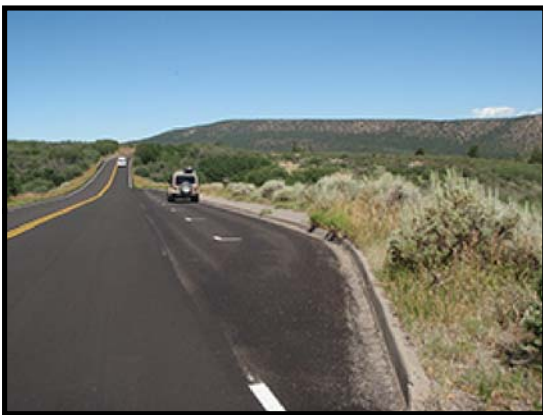
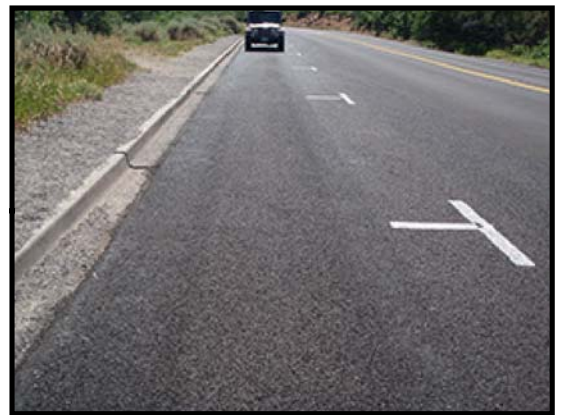
## Route 0908

Route Number	Public / NonPublic	Date Visited	Area (sq ft)	Lane Miles *	Surface Type
0908	PUBLIC	8/10/2011	3,086	0.05	AS
Culverts	Drop Inlets	Gates	Curb & Gutter	Curb	PCR
0	0	0	CONCRETE CURB AND GUTTER	NO CURB	GOOD/90

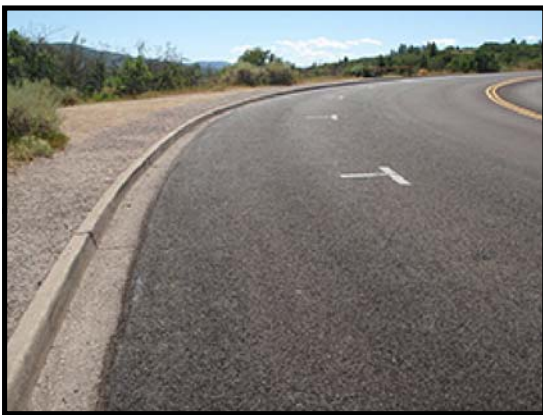
## Route 0909

CROSS FISSURES OVERLOOK  
ADJACENT TO ROUTE 0010 (SOUTH RIM DRIVE)

Route Number	Public / NonPublic	Date Visited	Area (sq ft)	Lane Miles *	Surface Type
0909	PUBLIC	8/10/2011	3,264	0.06	AS
Culverts	Drop Inlets	Gates	Curb & Gutter	Curb	PCR
0	0	0	CONCRETE CURB AND GUTTER	NO CURB	GOOD/90

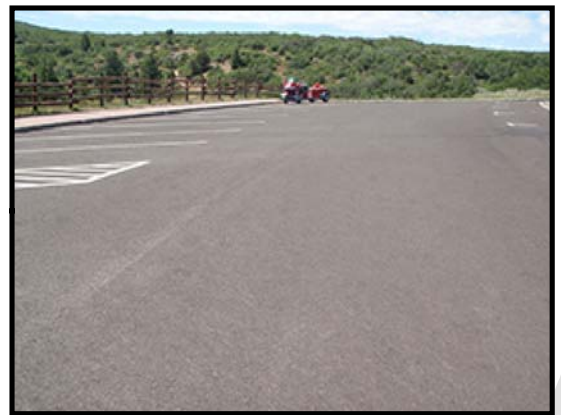
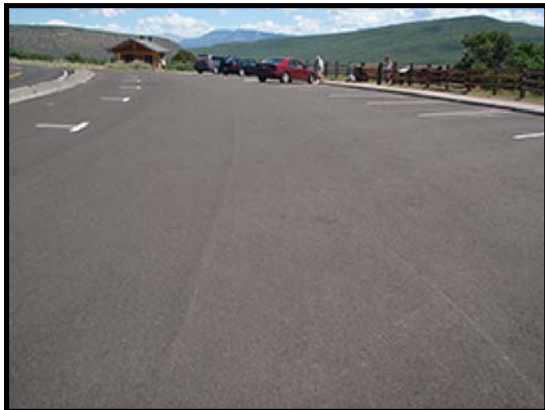
Route Number	Public / NonPublic	Date Visited	Area (sq ft)	Lane Miles *	Surface Type
0911	PUBLIC	8/10/2011	10,467	0.18	AS
Culverts	Drop Inlets	Gates	Curb & Gutter	Curb	PCR
0	0	0	CONCRETE CURB AND GUTTER	CONCRETE CURB	GOOD/90

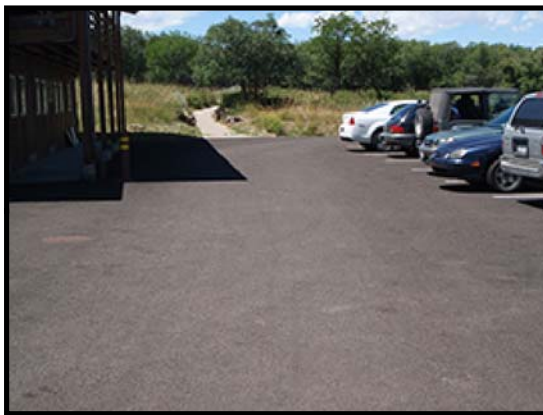
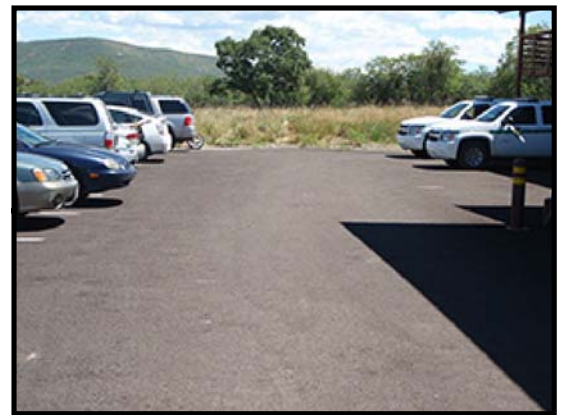
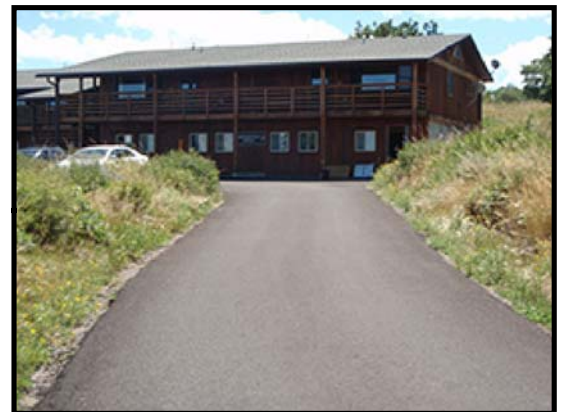
## Route 0912

Route Number	Public / NonPublic	Date Visited	Area (sq ft)	Lane Miles *	Surface Type
0912	PUBLIC	8/10/2011	5,958	0.10	AS
Culverts	Drop Inlets	Gates	Curb & Gutter	Curb	PCR
0	0	0	CONCRETE CURB AND GUTTER	NO CURB	GOOD/90

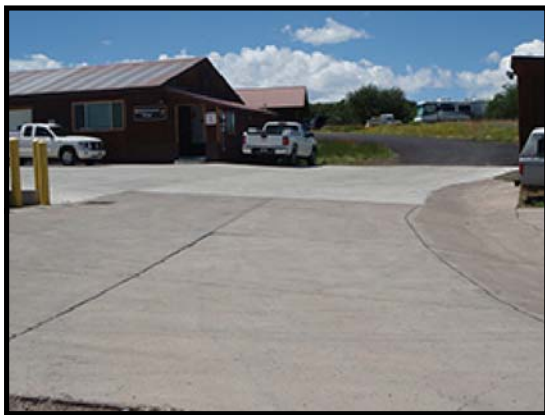
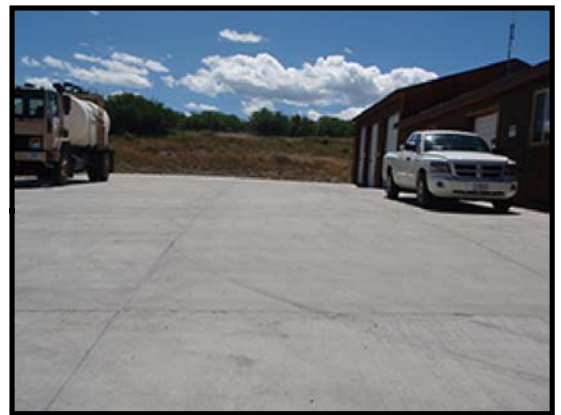
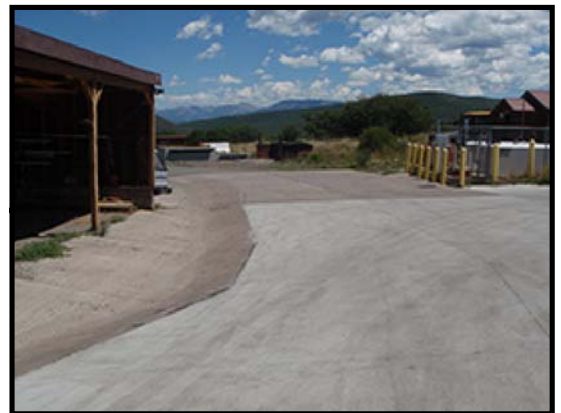
## Route 0913

Route Number	Public / NonPublic	Date Visited	Area (sq ft)	Lane Miles *	Surface Type
0913	NONPUBLIC	8/10/2011	11,320	0.20	CO
Culverts	Drop Inlets	Gates	Curb & Gutter	Curb	PCR
0	1	0	NO CURB AND GUTTER	NO CURB	GOOD/90
