Federal Lands Highway Road Inventory Program

Road Inventory and Condition Assessment

Blue Ridge Parkway BLRI

Cycle 5 Report

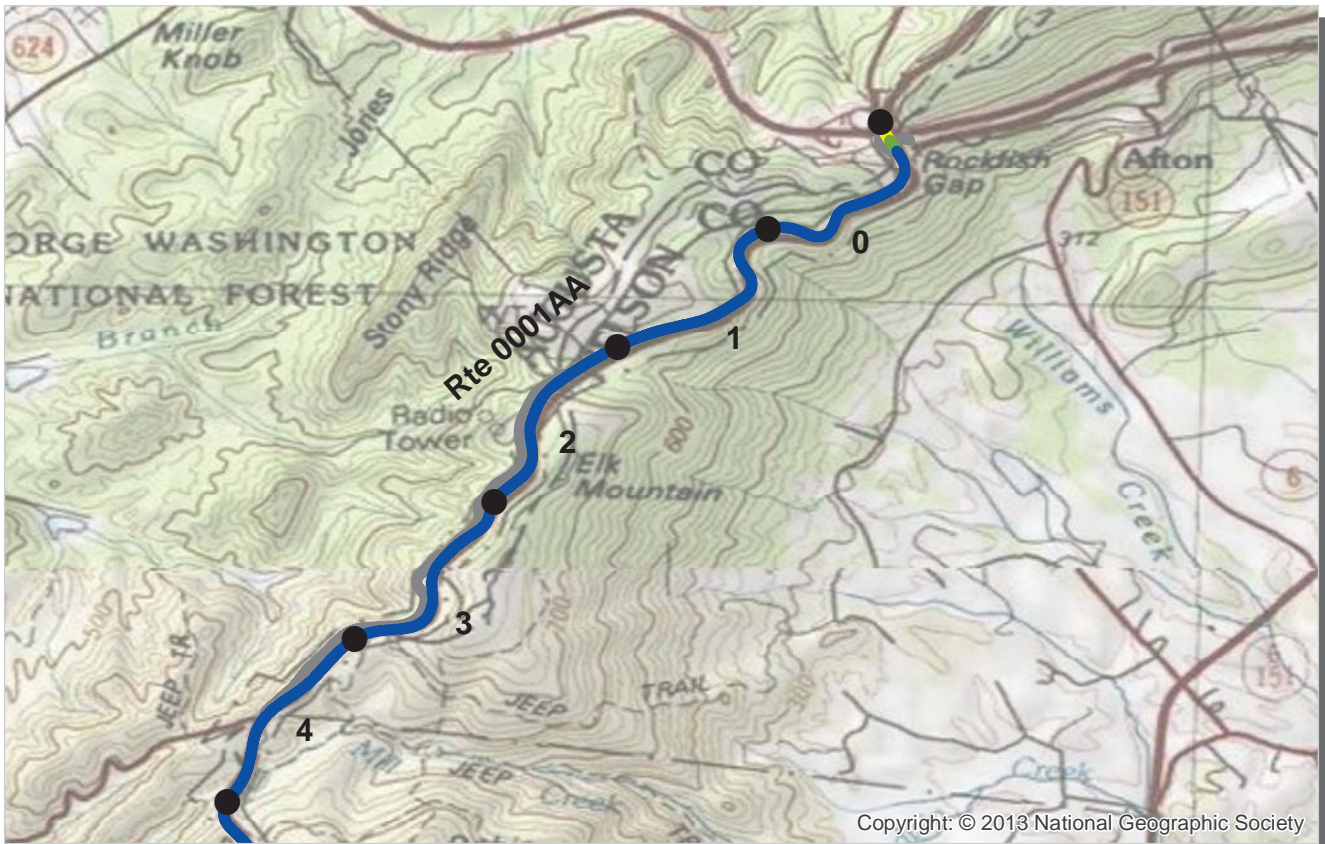
ROUTE: 0001AA BLUE RIDGE PARKWAY - MONTEBELLO SUB-DISTRICT

PCR Poor ■ Fair ■ Good ■ Excellent ■ No Data ■
 (0 - 60) (61 - 84) (85 - 94) (95 - 100)

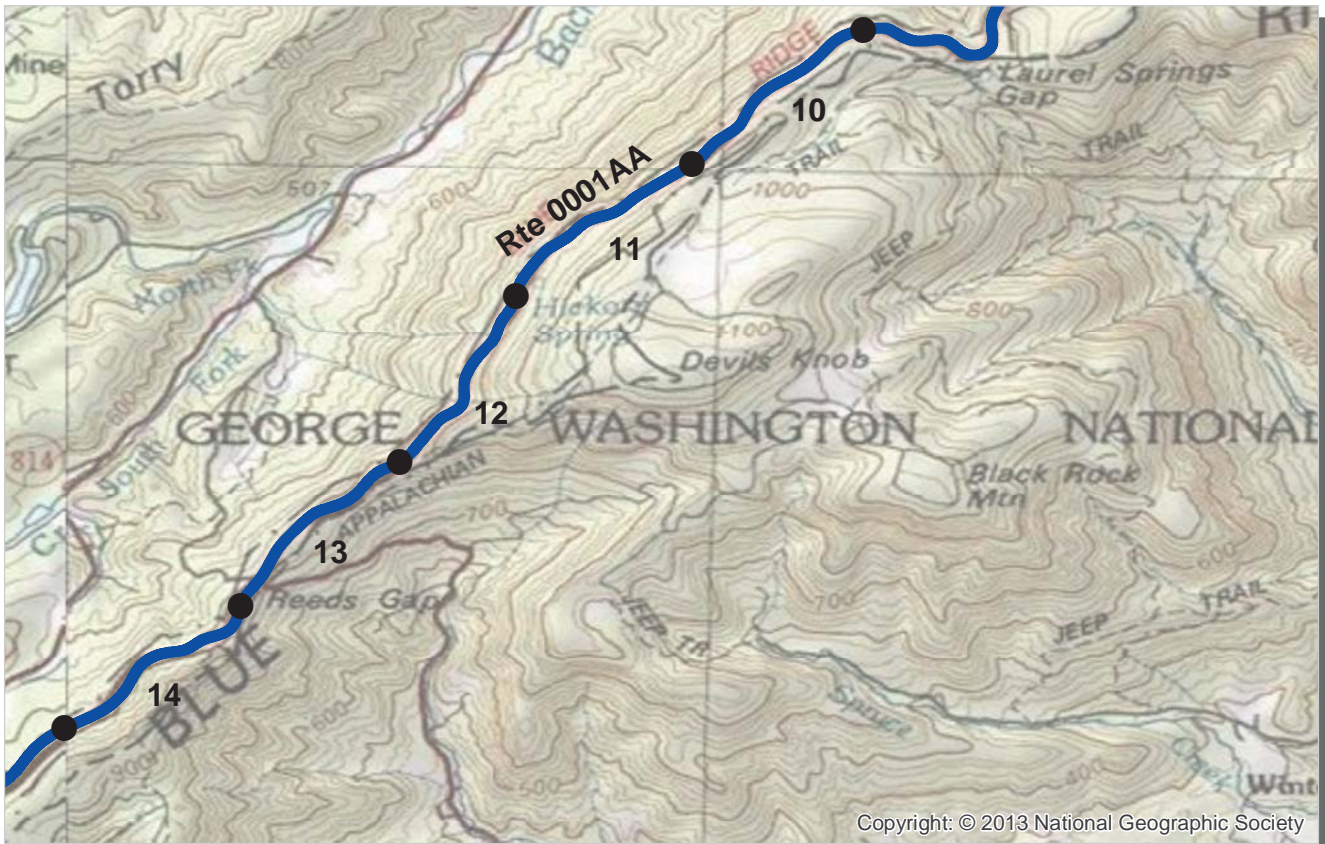
ROUTE: 0001AA BLUE RIDGE PARKWAY - MONTEBELLO SUB-DISTRICT

PCR	Poor	Fair	Good	Excellent	No Data
	(0 - 60)	(61 - 84)	(85 - 94)	(95 - 100)

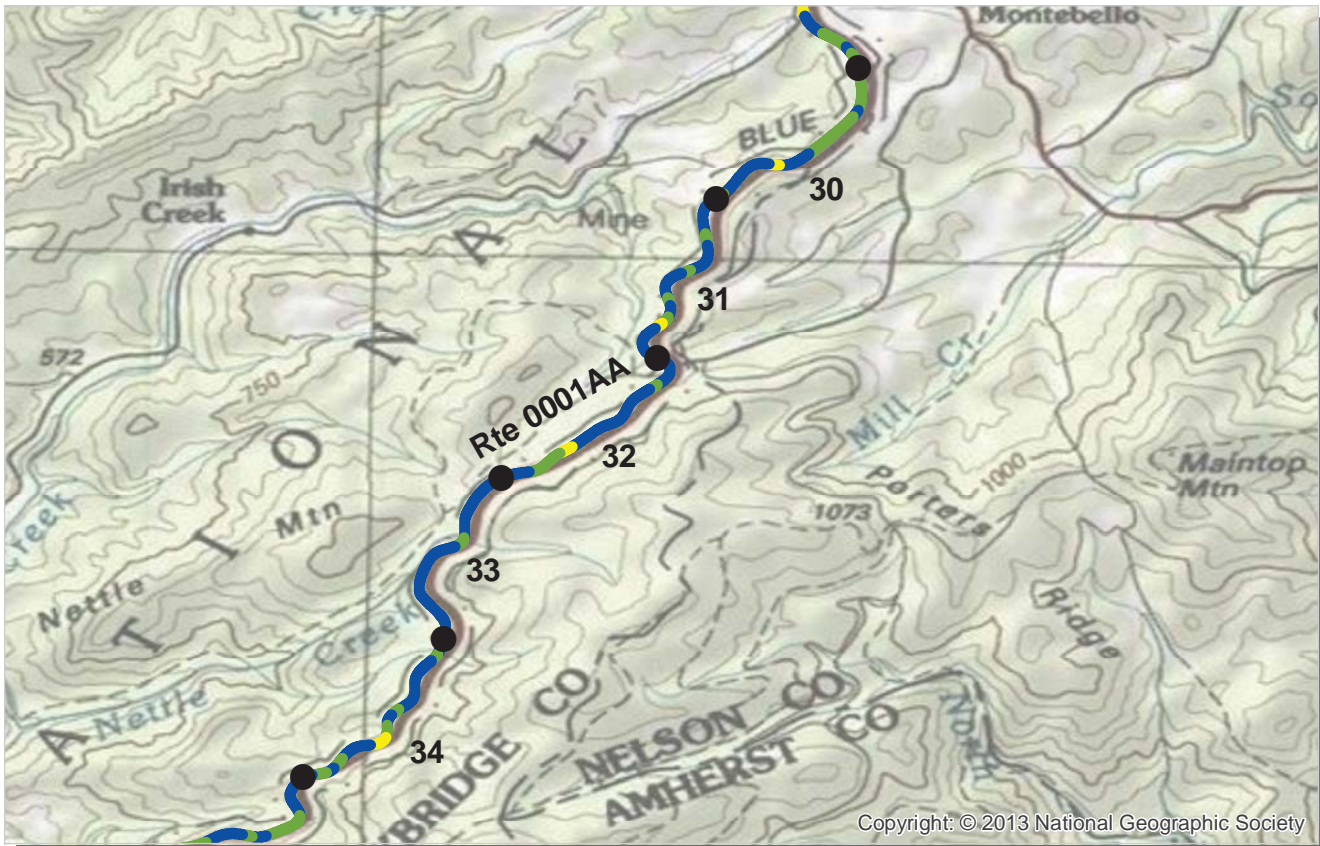
ROUTE: 0001AB BLUE RIDGE PARKWAY - JAMES RIVER SUB-DISTRICT

PCR Poor ■ Fair ■ Good ■ Excellent ■ No Data ■
 (0 - 60) (61 - 84) (85 - 94) (95 - 100)

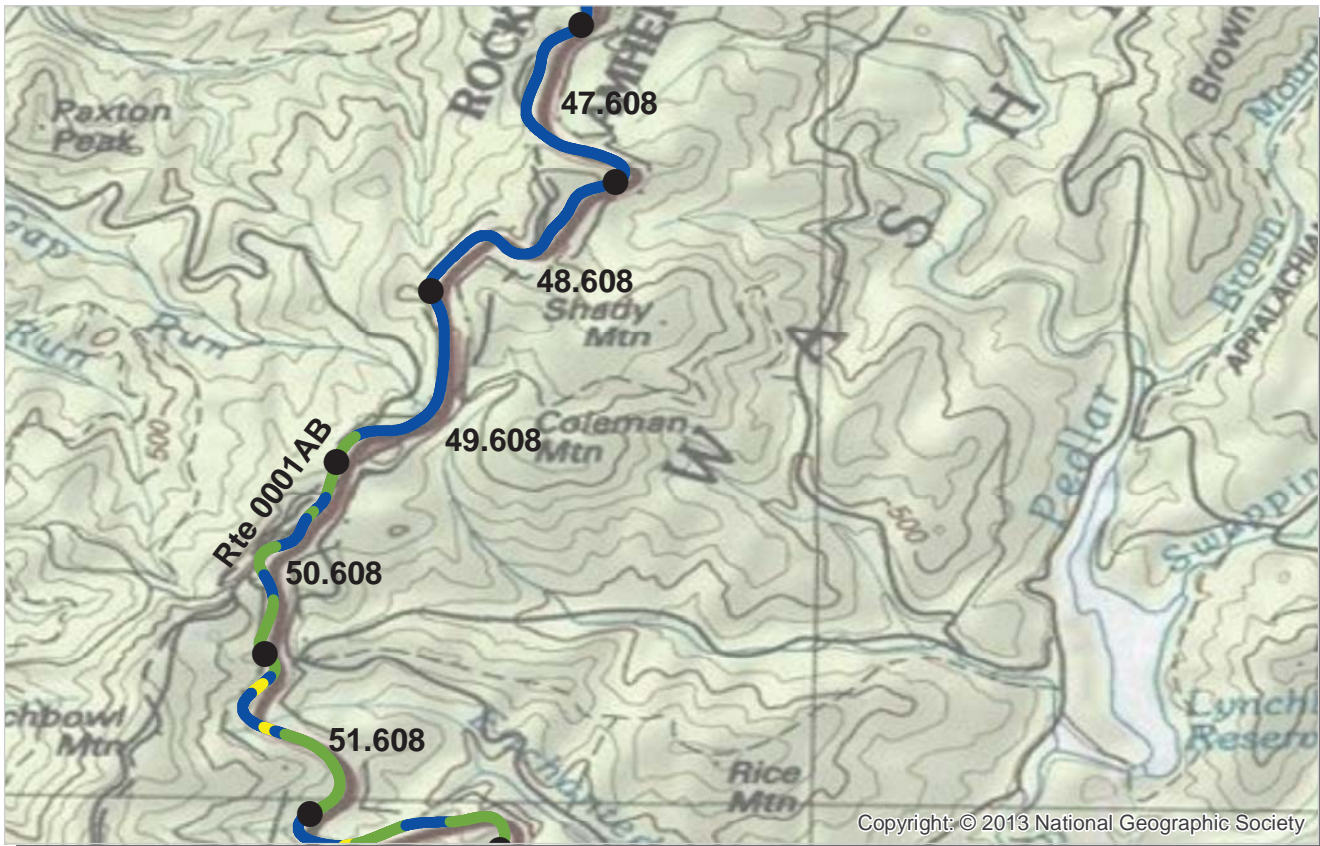
ROUTE: 0001AB BLUE RIDGE PARKWAY - JAMES RIVER SUB-DISTRICT

PCR Poor ■ Fair ■ Good ■ Excellent ■ No Data ■
 (0 - 60) (61 - 84) (85 - 94) (95 - 100)

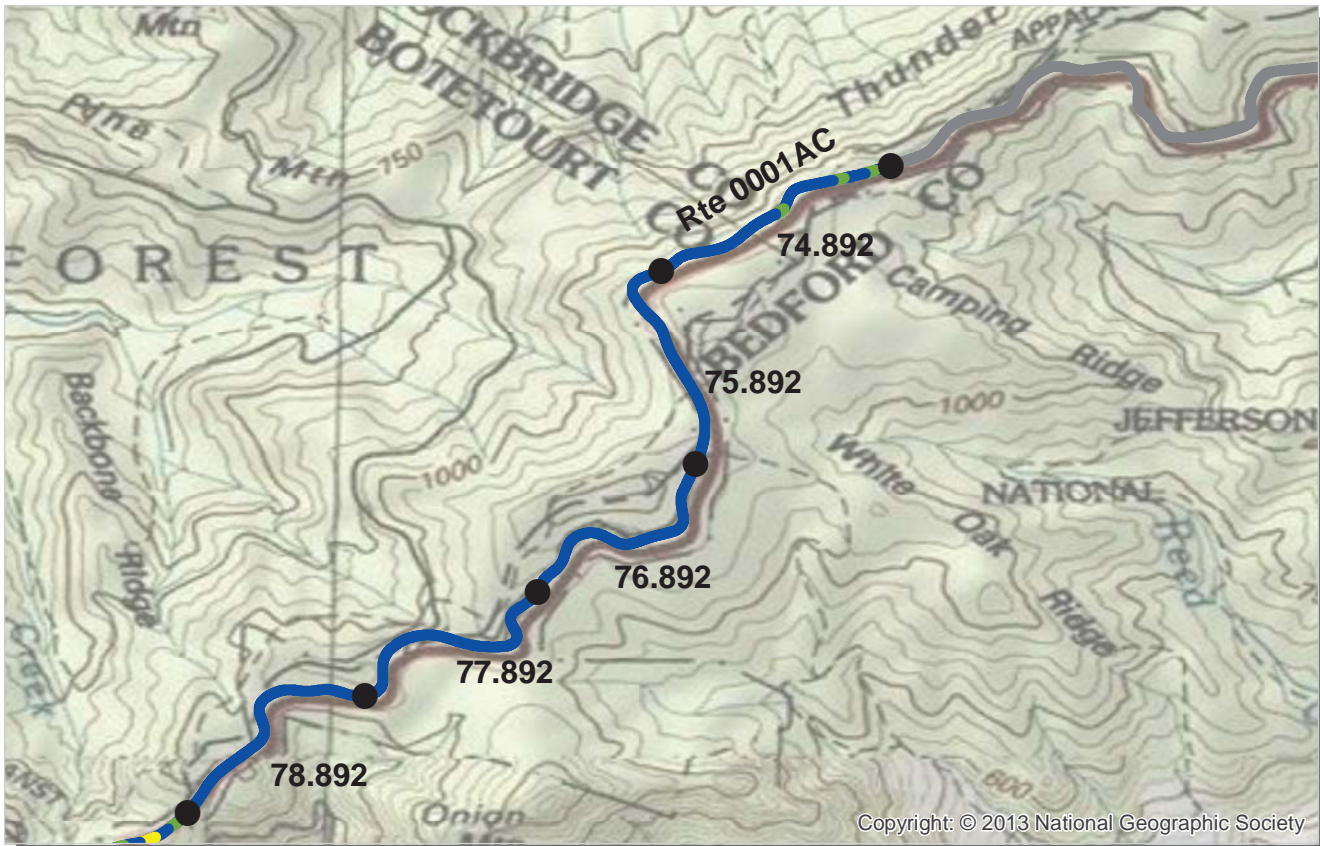
ROUTE: 0001AC BLUE RIDGE PARKWAY - PEAKS OF OTTER SUB-DISTRICT

PCR Poor ■ (0 - 60) Fair ■ (61 - 84) Good ■ (85 - 94) Excellent ■ (95 - 100) No Data ■

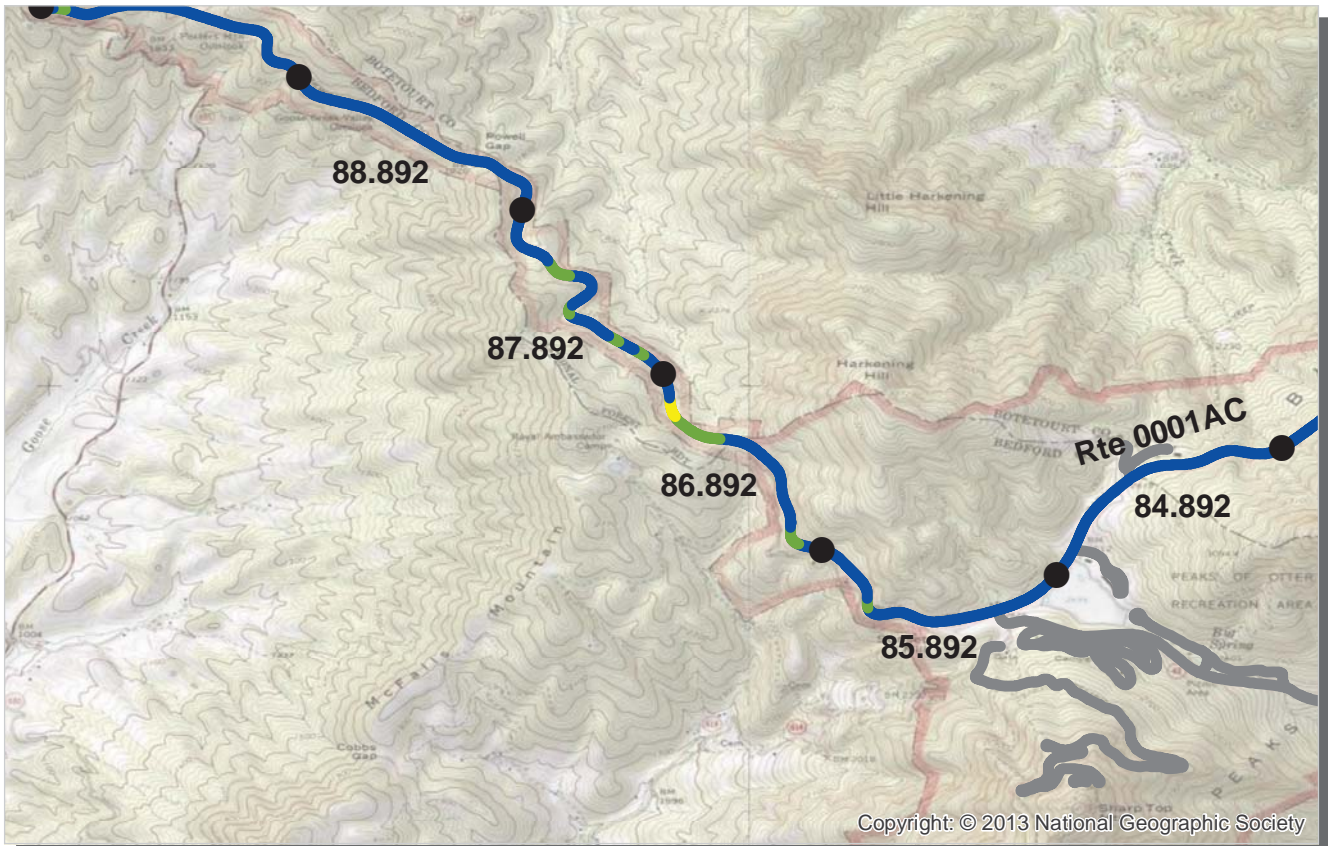
ROUTE: 0001AC BLUE RIDGE PARKWAY - PEAKS OF OTTER SUB-DISTRICT

PCR Poor ■ Fair ■ Good ■ Excellent ■ No Data ■
 (0 - 60) (61 - 84) (85 - 94) (95 - 100)

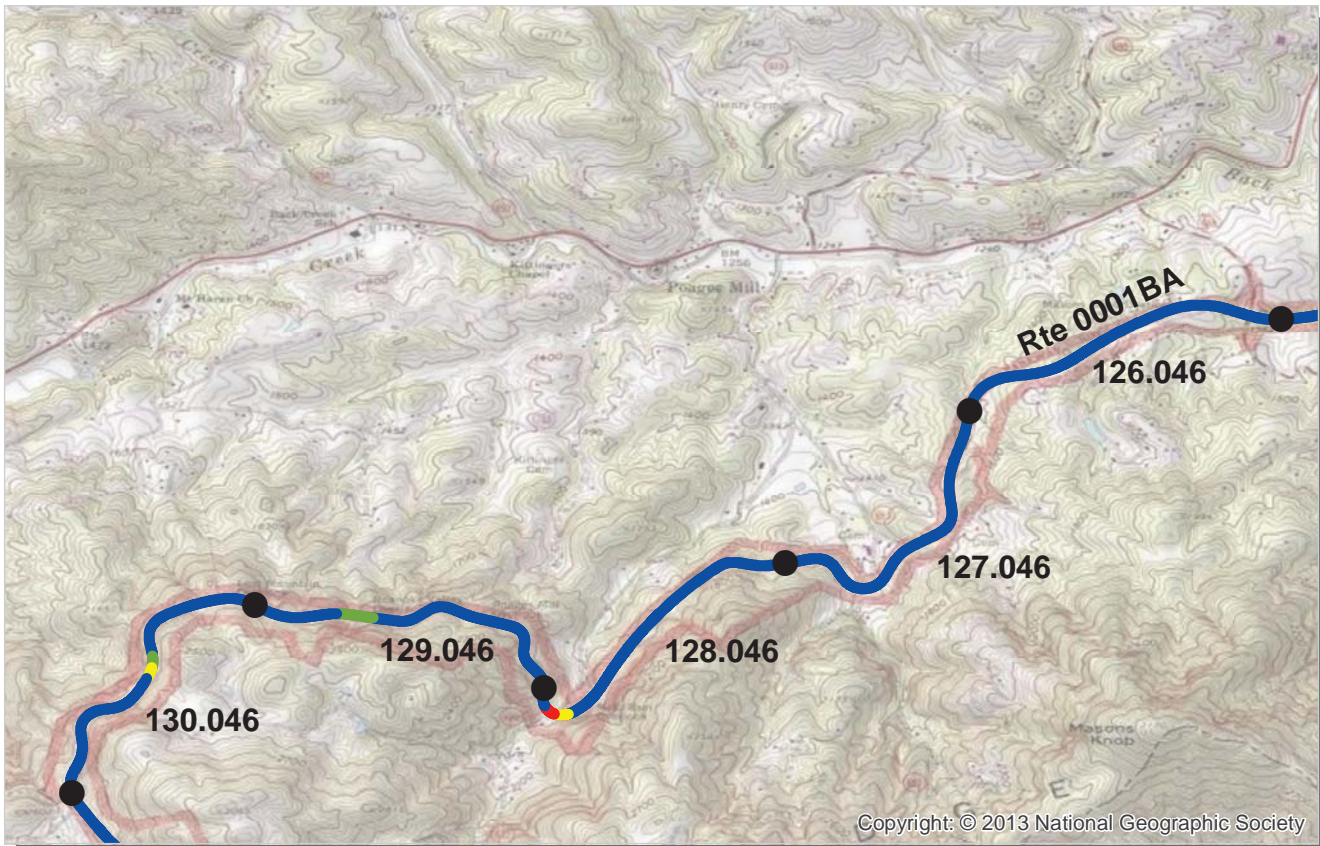
ROUTE: 0001BB BLUE RIDGE PARKWAY - ROCKY KNOB SUB-DISTRICT

PCR Poor (0 - 60) Fair (61 - 84) Good (85 - 94) Excellent (95 - 100) No Data

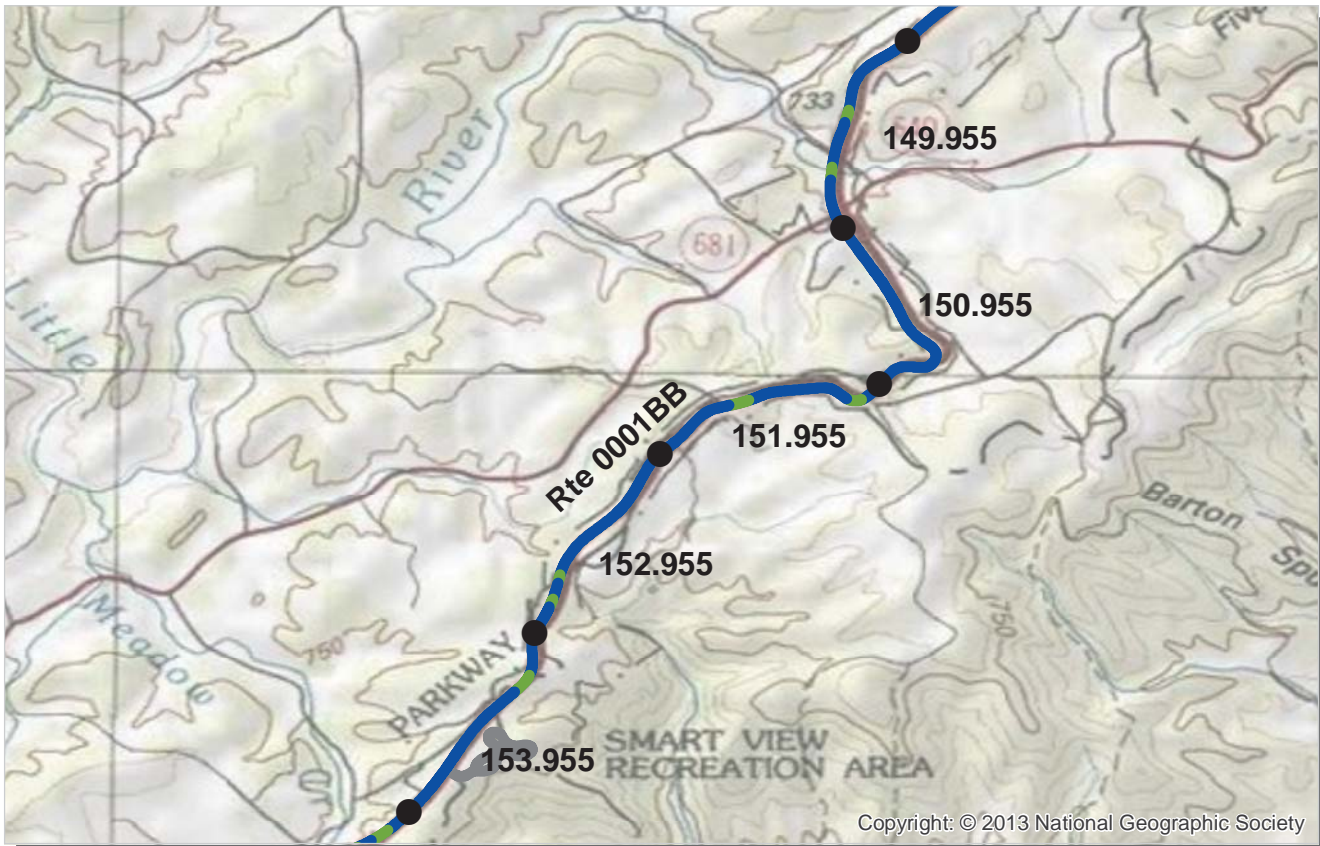
ROUTE: 0001BB BLUE RIDGE PARKWAY - ROCKY KNOB SUB-DISTRICT

PCR Poor ■ Fair ■ Good ■ Excellent ■ No Data ■
 (0 - 60) (61 - 84) (85 - 94) (95 - 100)

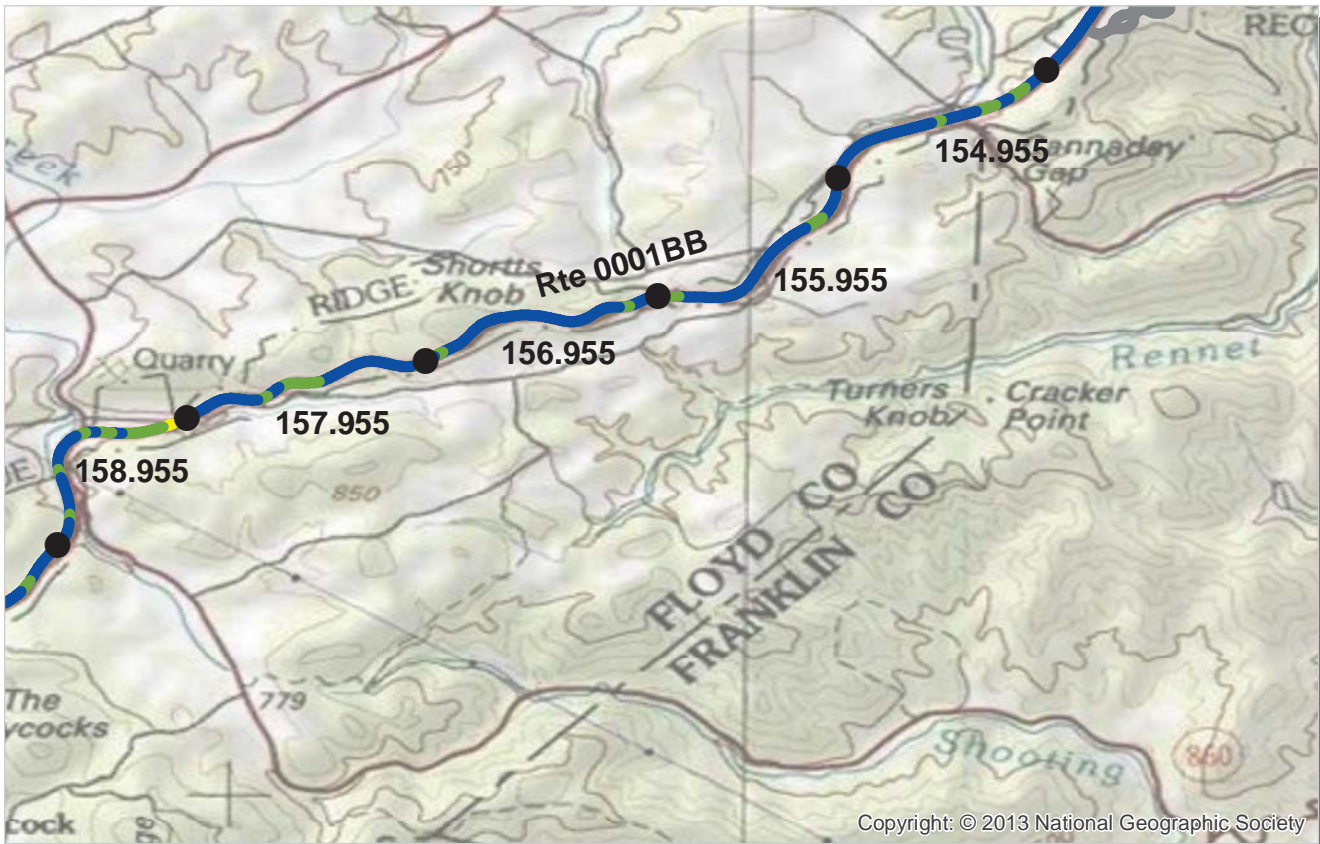
ROUTE: 0001BB BLUE RIDGE PARKWAY - ROCKY KNOB SUB-DISTRICT

PCR Poor ■ Fair ■ Good ■ Excellent ■ No Data ■
 (0 - 60) (61 - 84) (85 - 94) (95 - 100)

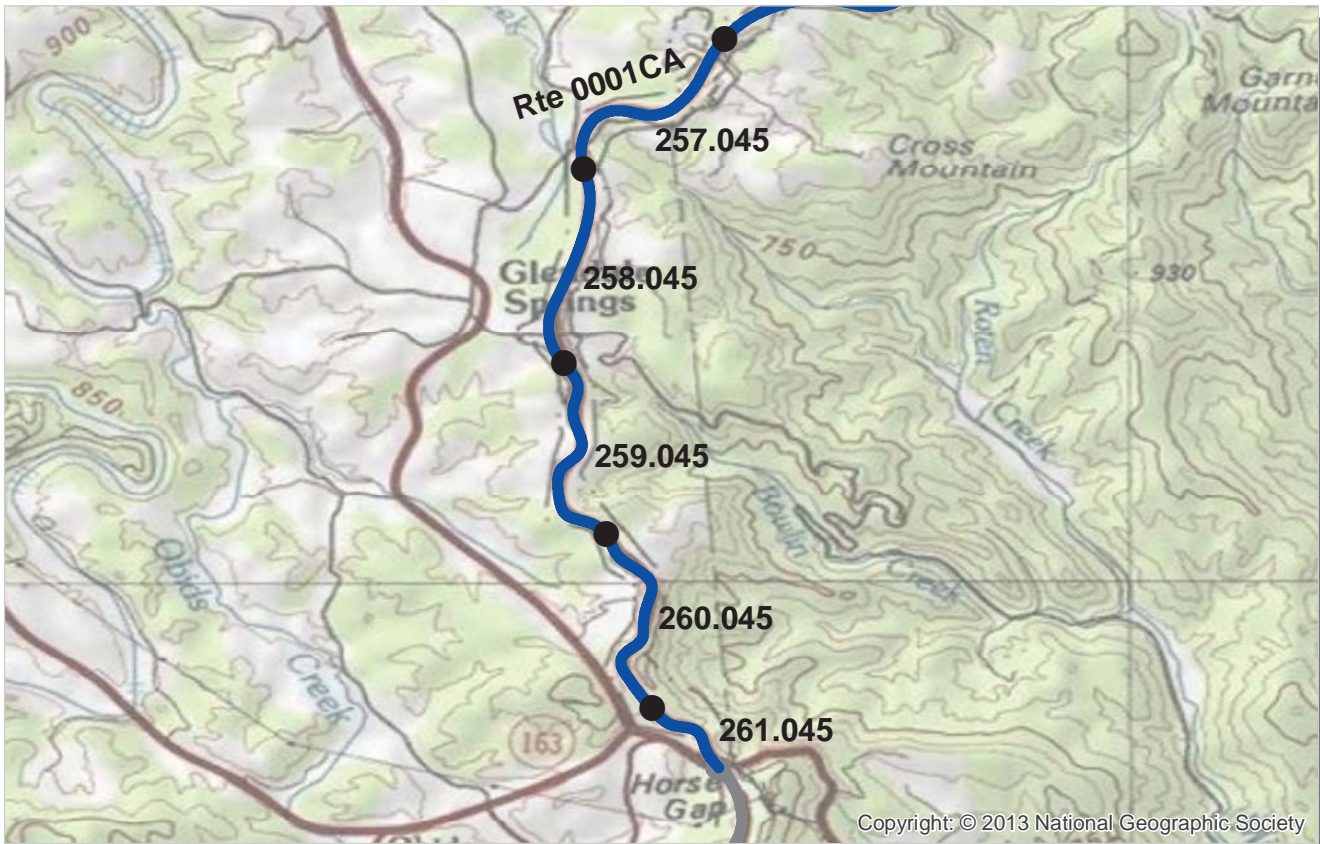
ROUTE: 0001CB BLUE RIDGE PARKWAY - SANDY FLATS SUB-DISTRICT

PCR Poor ■ Fair ■ Good ■ Excellent ■ No Data ■
 (0 - 60) (61 - 84) (85 - 94) (95 - 100)

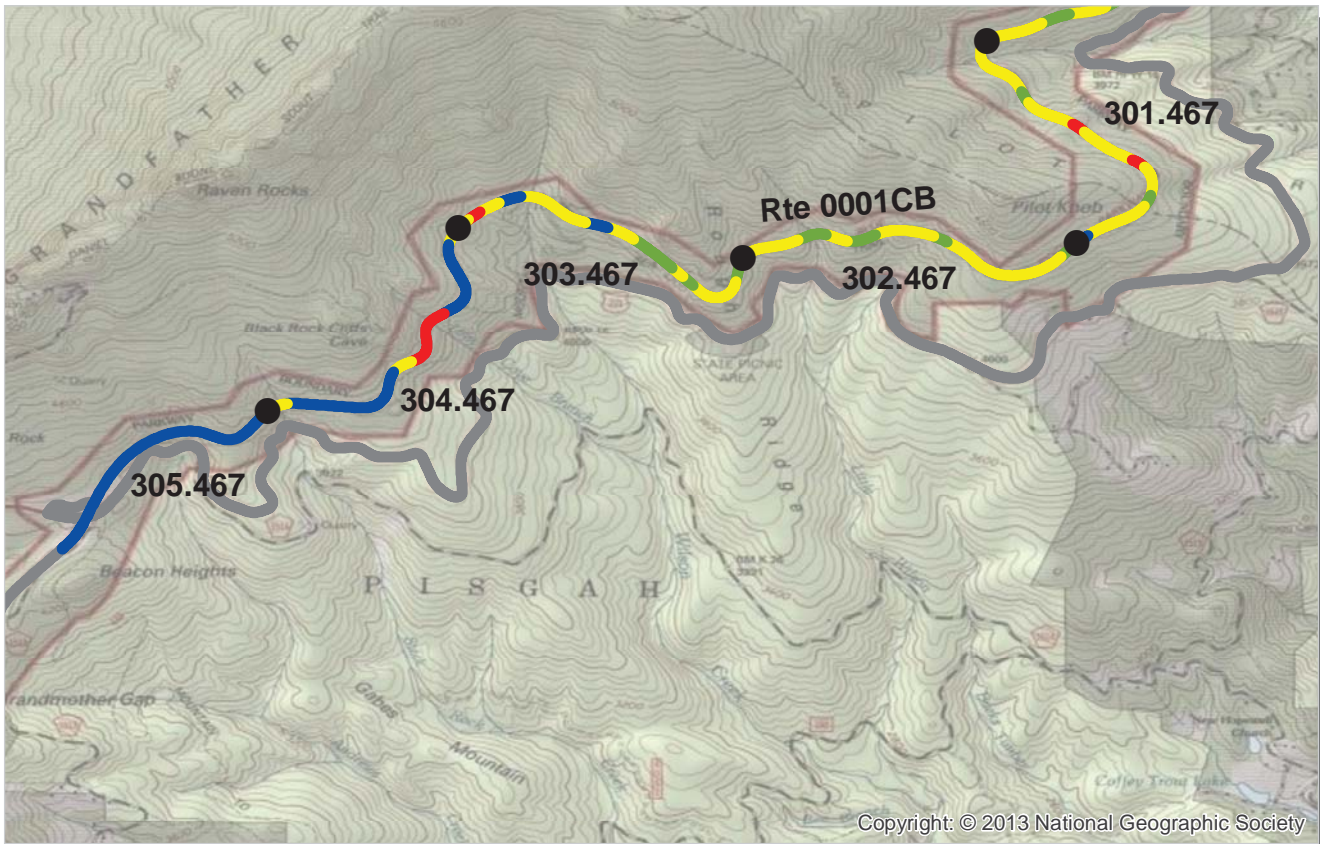
ROUTE: 0001CB BLUE RIDGE PARKWAY - SANDY FLATS SUB-DISTRICT

PCR	Poor	Fair	Good	Excellent	No Data
	(0 - 60)	(61 - 84)	(85 - 94)	(95 - 100)

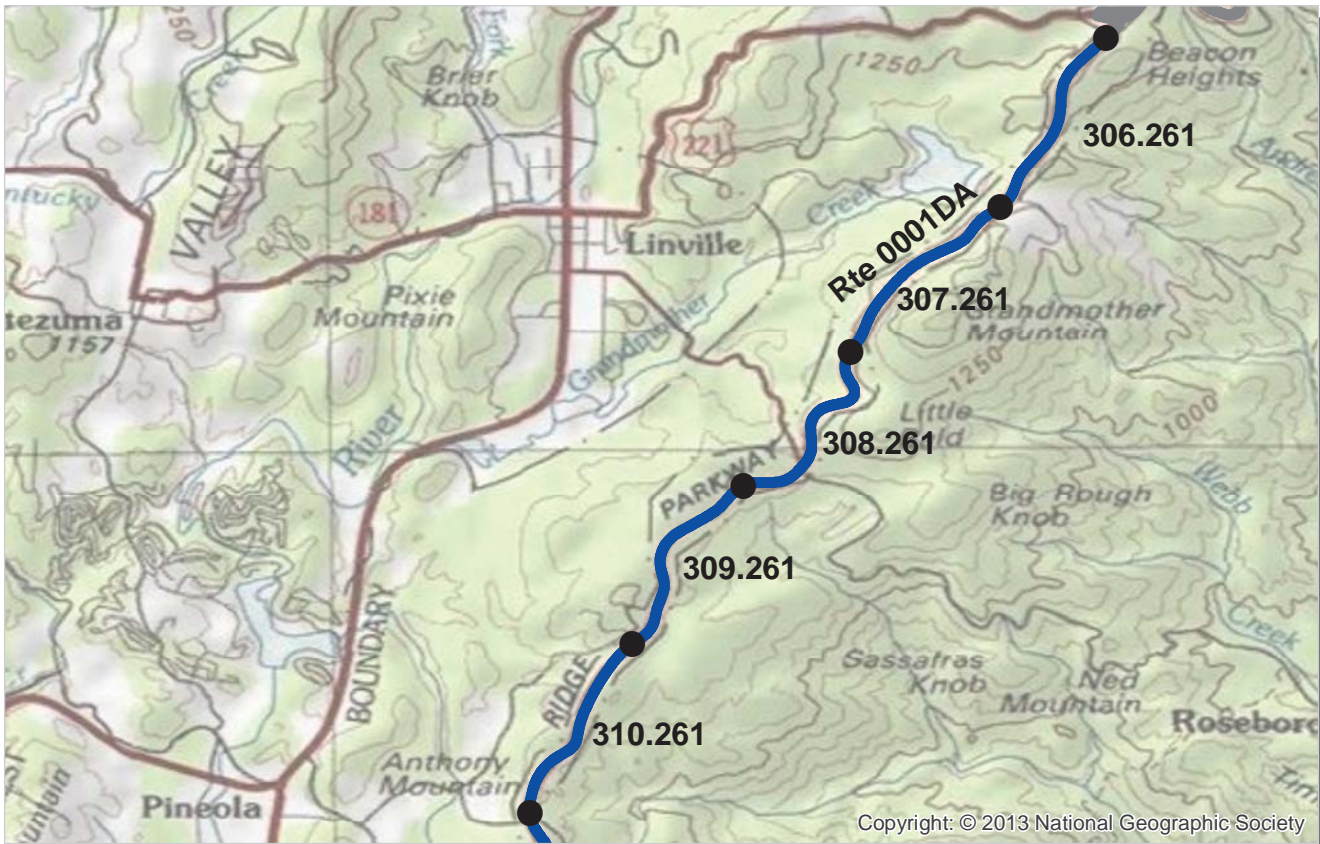
ROUTE: 0001DA BLUE RIDGE PARKWAY - GILLESPIE GAP SUB-DISTRICT

PCR Poor ■ Fair ■ Good ■ Excellent ■ No Data ■
 (0 - 60) (61 - 84) (85 - 94) (95 - 100)

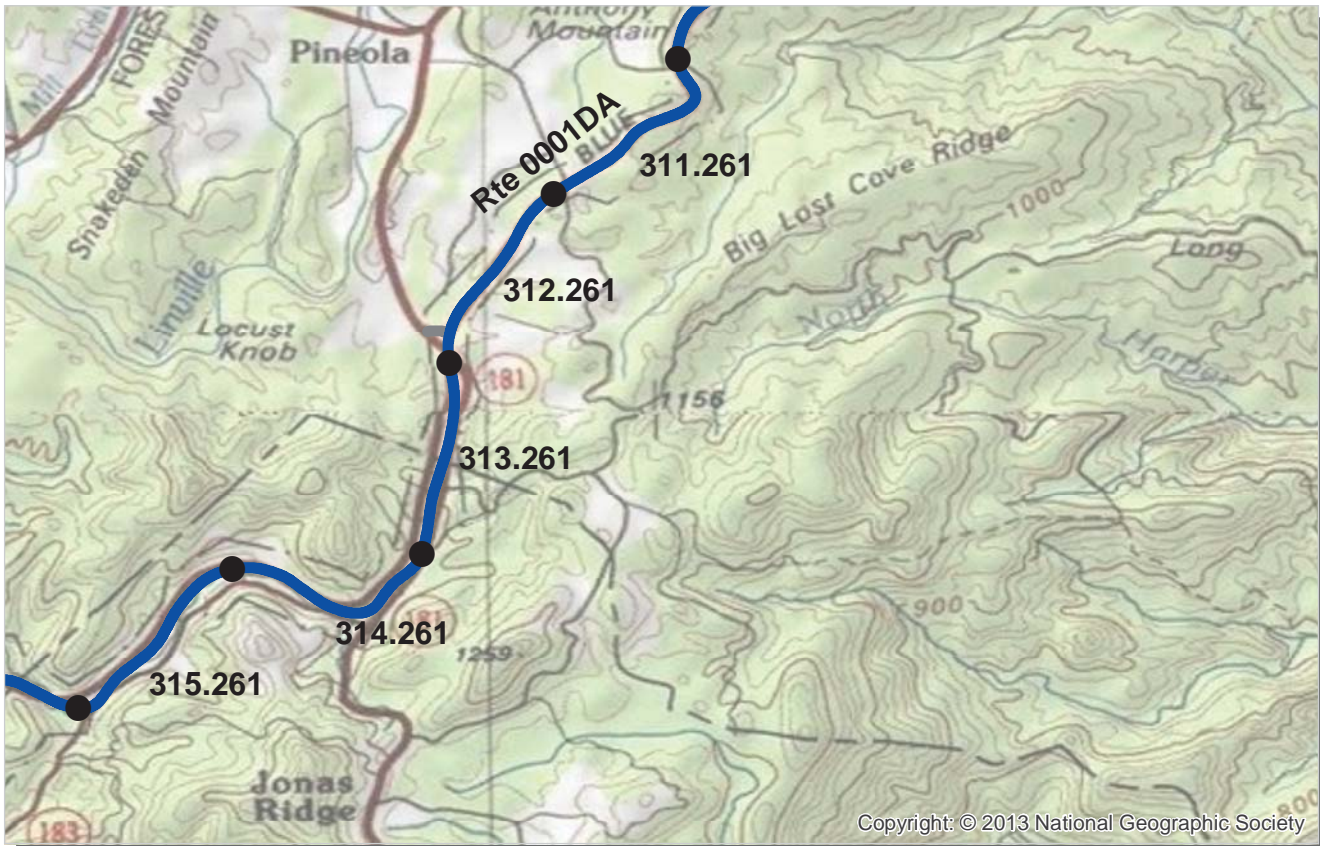
ROUTE: 0001DA BLUE RIDGE PARKWAY - GILLESPIE GAP SUB-DISTRICT

PCR Poor ■ Fair ■ Good ■ Excellent ■ No Data ■
 (0 - 60) (61 - 84) (85 - 94) (95 - 100)

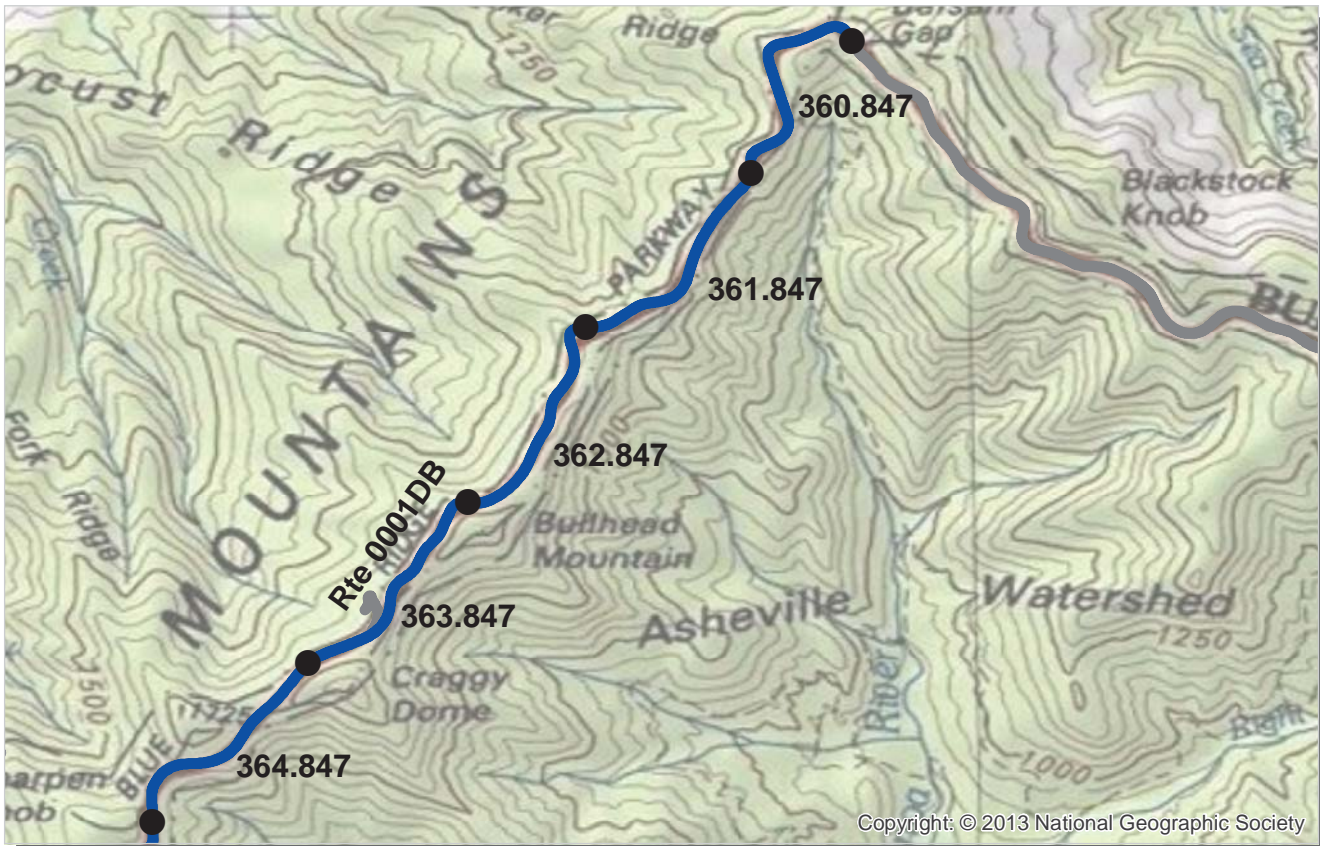
ROUTE: 0001DB BLUE RIDGE PARKWAY - OTEEN SUB-DISTRICT

PCR	Poor	Fair	Good	Excellent	No Data
	(0 - 60)	(61 - 84)	(85 - 94)	(95 - 100)

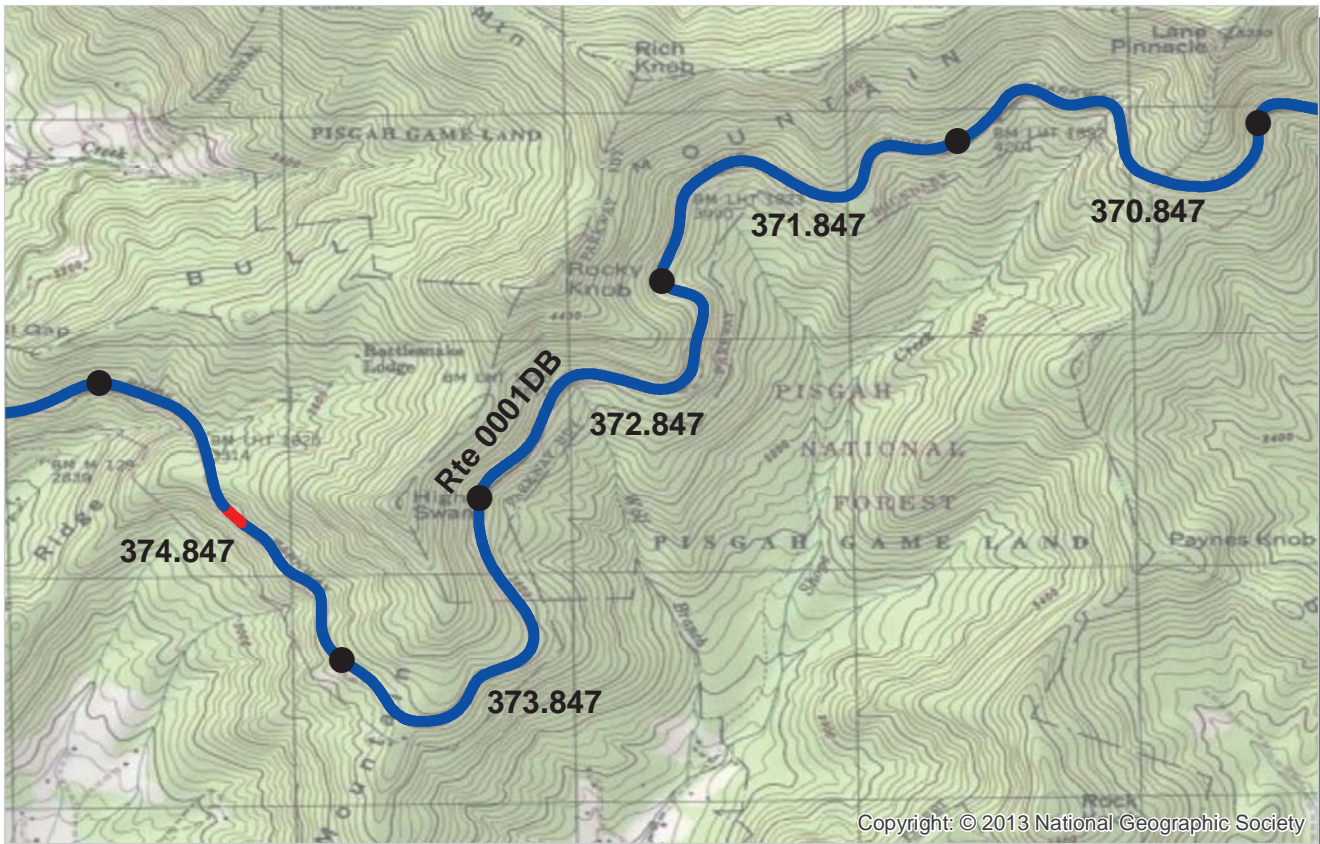
ROUTE: 0001DB BLUE RIDGE PARKWAY - OTEEN SUB-DISTRICT

PCR Poor ■ Fair ■ Good ■ Excellent ■ No Data ■
 (0 - 60) (61 - 84) (85 - 94) (95 - 100)

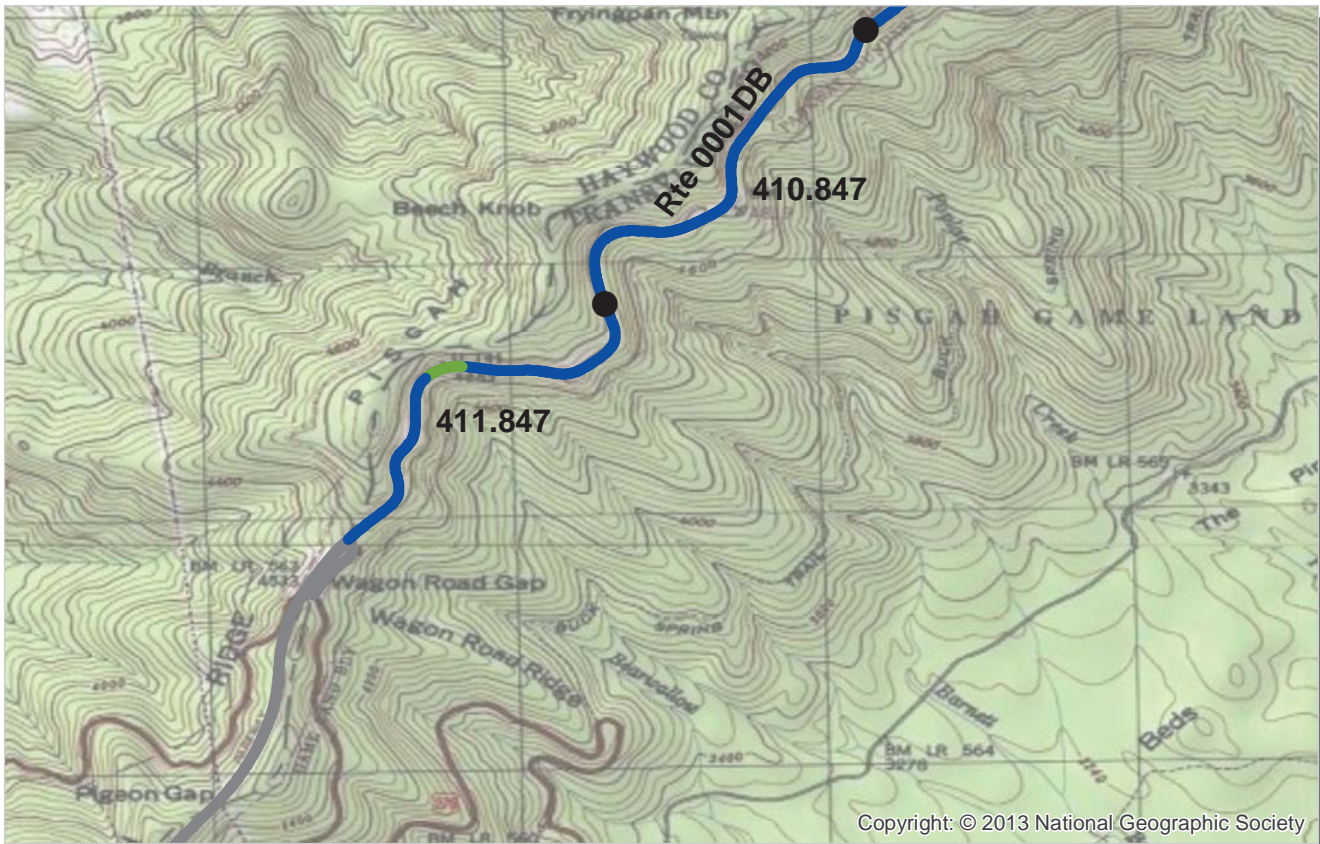
ROUTE: 0001DC BLUE RIDGE PARKWAY - BALSAM GAP SUB-DISTRICT

PCR Poor ■ Fair ■ Good ■ Excellent ■ No Data ■
 (0 - 60) (61 - 84) (85 - 94) (95 - 100)

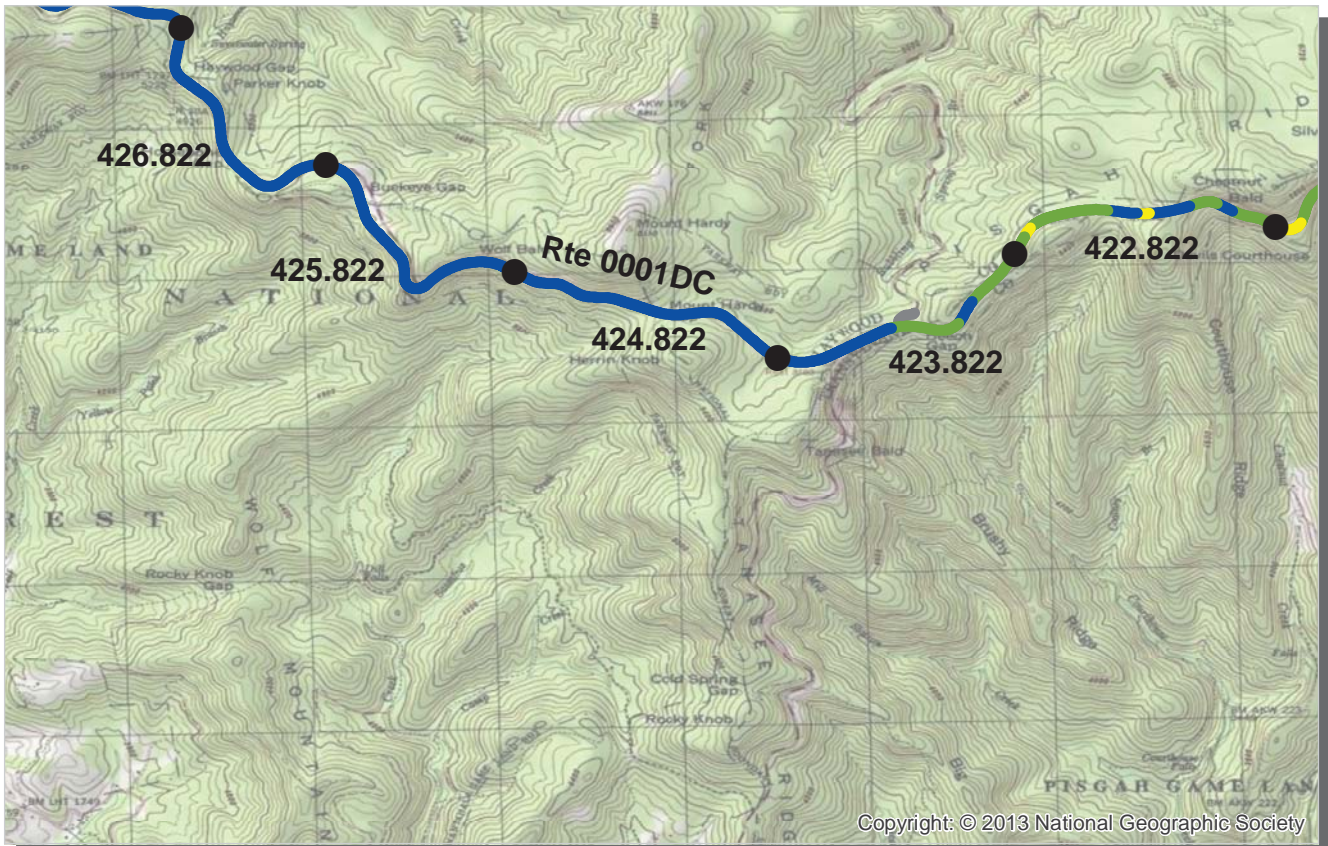
ROUTE: 0001DC BLUE RIDGE PARKWAY - BALSAM GAP SUB-DISTRICT

PCR	Poor	Fair	Good	Excellent	No Data
	(0 - 60)	(61 - 84)	(85 - 94)	(95 - 100)

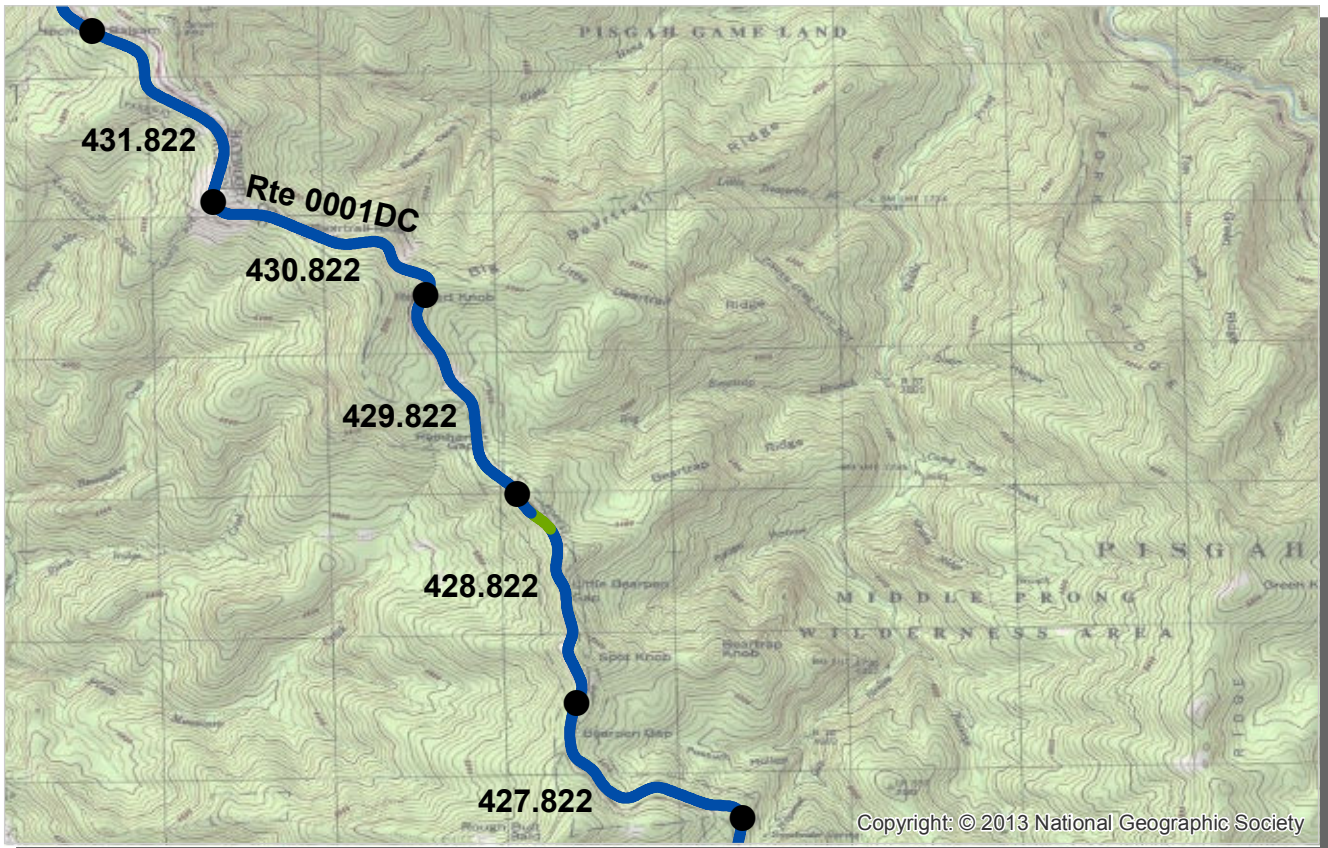
ROUTE: 0001DC BLUE RIDGE PARKWAY - BALSAM GAP SUB-DISTRICT

PCR Poor ■ Fair ■ Good ■ Excellent ■ No Data ■
 (0 - 60) (61 - 84) (85 - 94) (95 - 100)

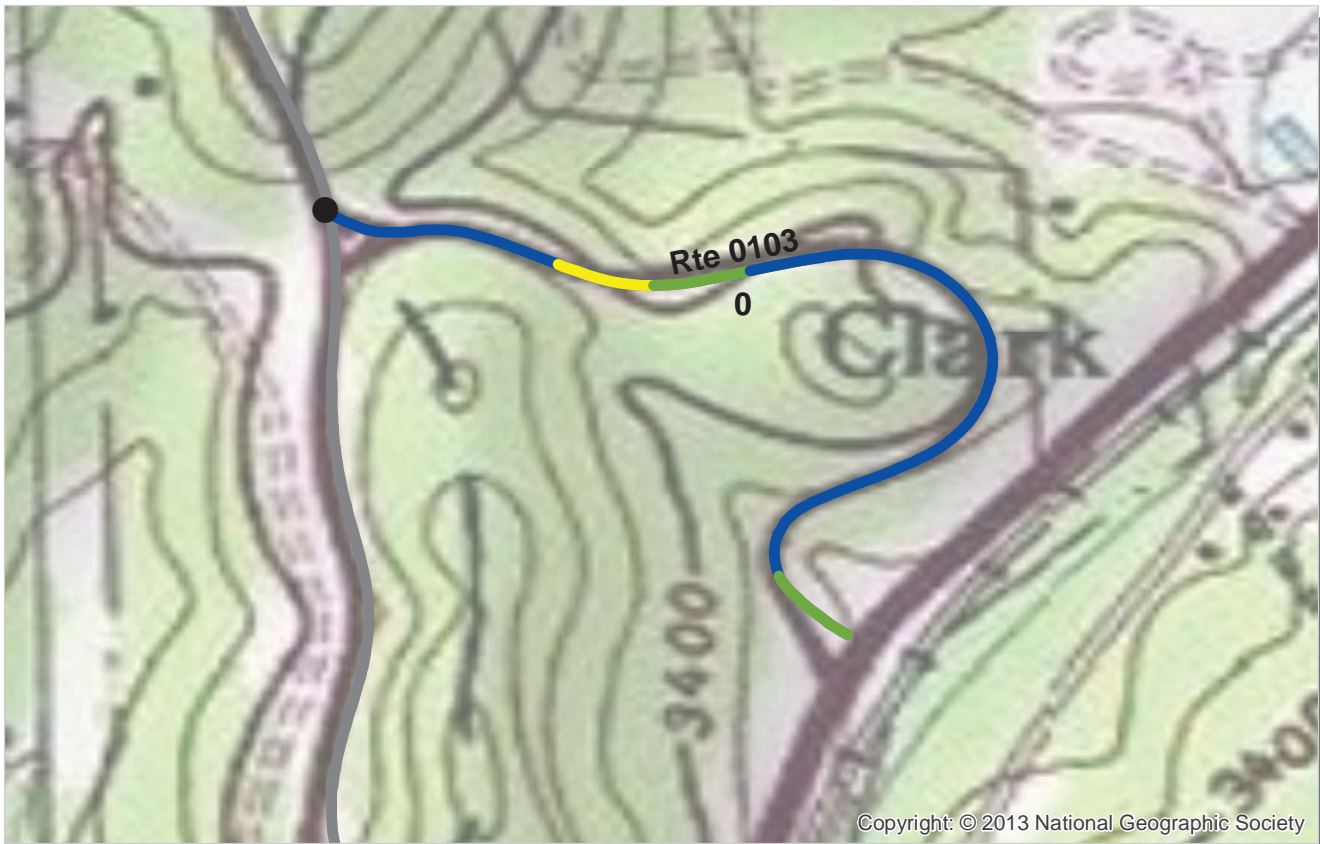
ROUTE: 0103 ACCESS RAMP TO U.S. ROUTE 23 AND U.S. 74

PCR	Poor		Fair		Good		Excellent		No Data	
	(0 - 60)		(61 - 84)	(85 - 94)	(95 - 100)

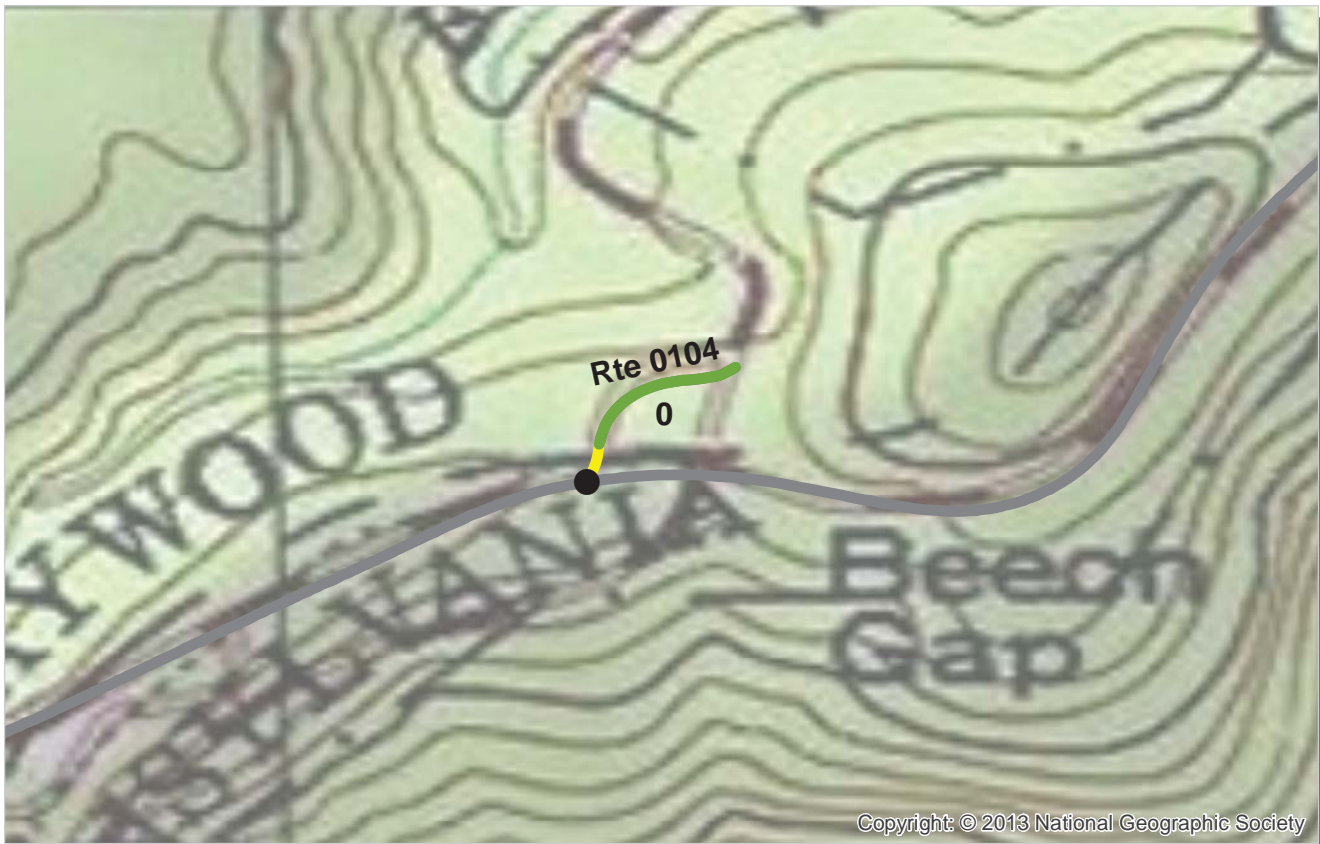
ROUTE: 0104 ACCESS RAMP TO NC ROUTE 215

PCR	Poor	Fair	Good	Excellent	No Data
	(0 - 60)	(61 - 84)	(85 - 94)	(95 - 100)
