Federal Lands Highway Road Inventory Program

Road Inventory and Condition Assessment

Blue Ridge Parkway BLRI

Cycle 5 Report

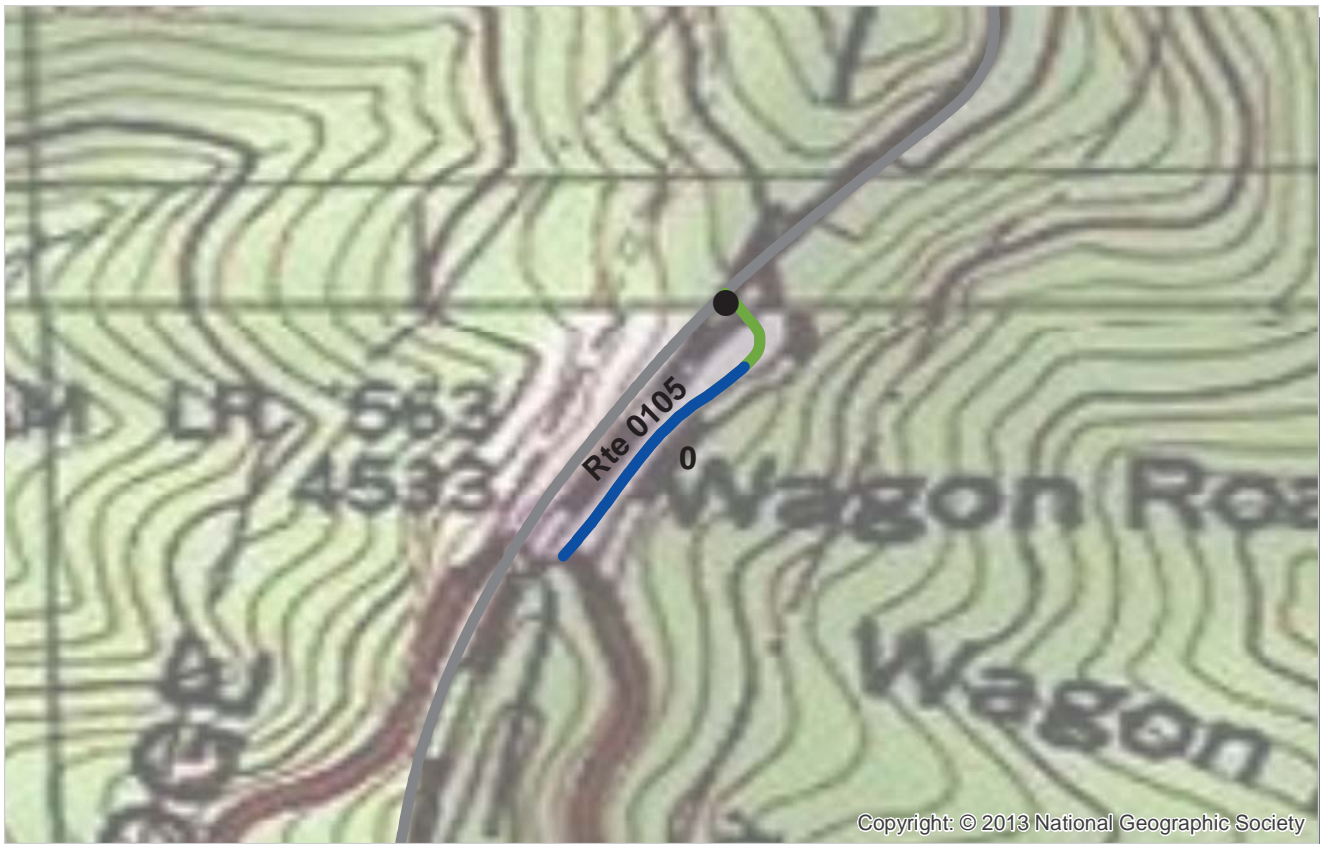
ROUTE: 0105 ACCESS RAMP TO U.S. ROUTE 276

PCR Poor ■ Fair ■ Good ■ Excellent ■ No Data ■
 (0 - 60) (61 - 84) (85 - 94) (95 - 100)

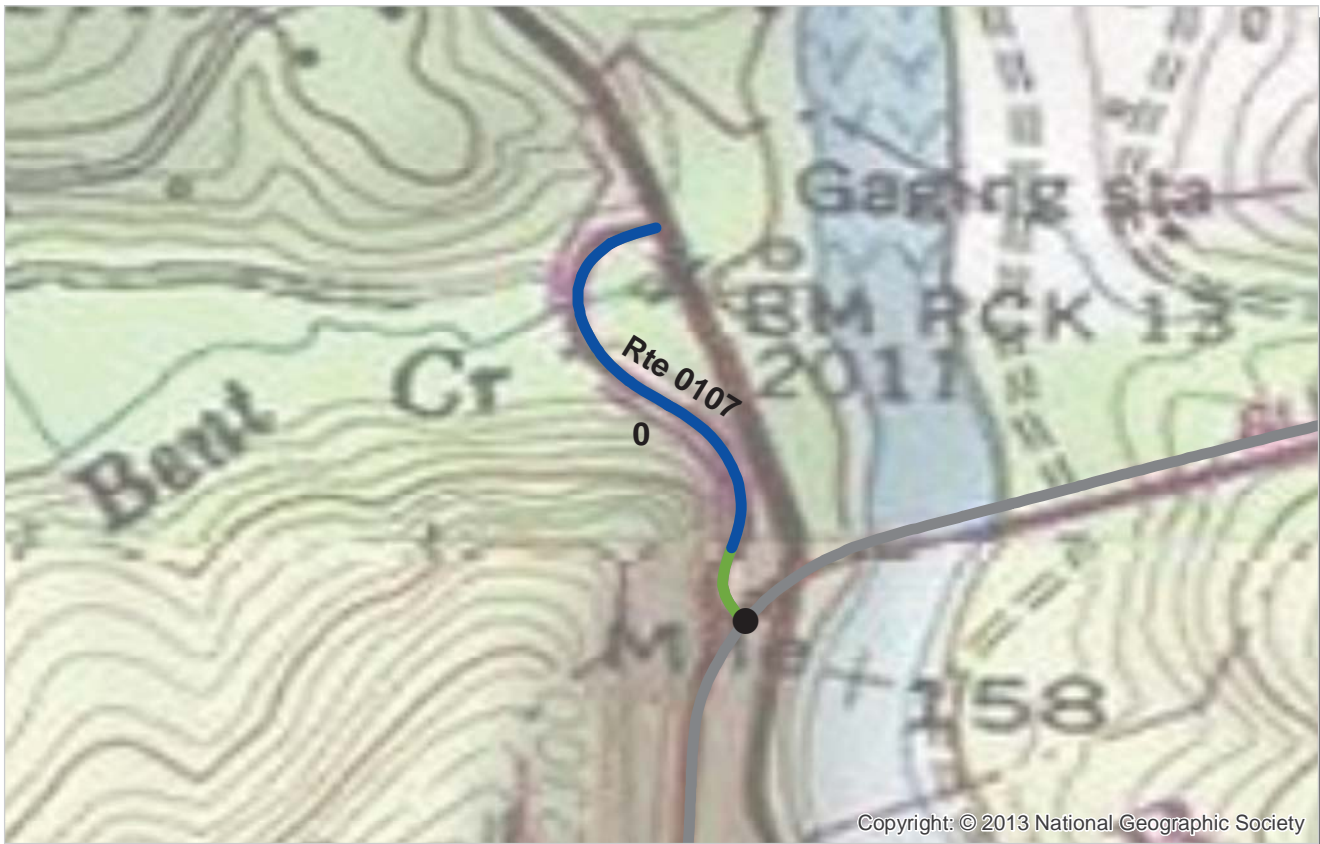
ROUTE: 0107 ACCESS RAMP TO NC ROUTE 191

PCR Poor ■ Fair ■ Good ■ Excellent ■ No Data ■
 (0 - 60) (61 - 84) (85 - 94) (95 - 100)

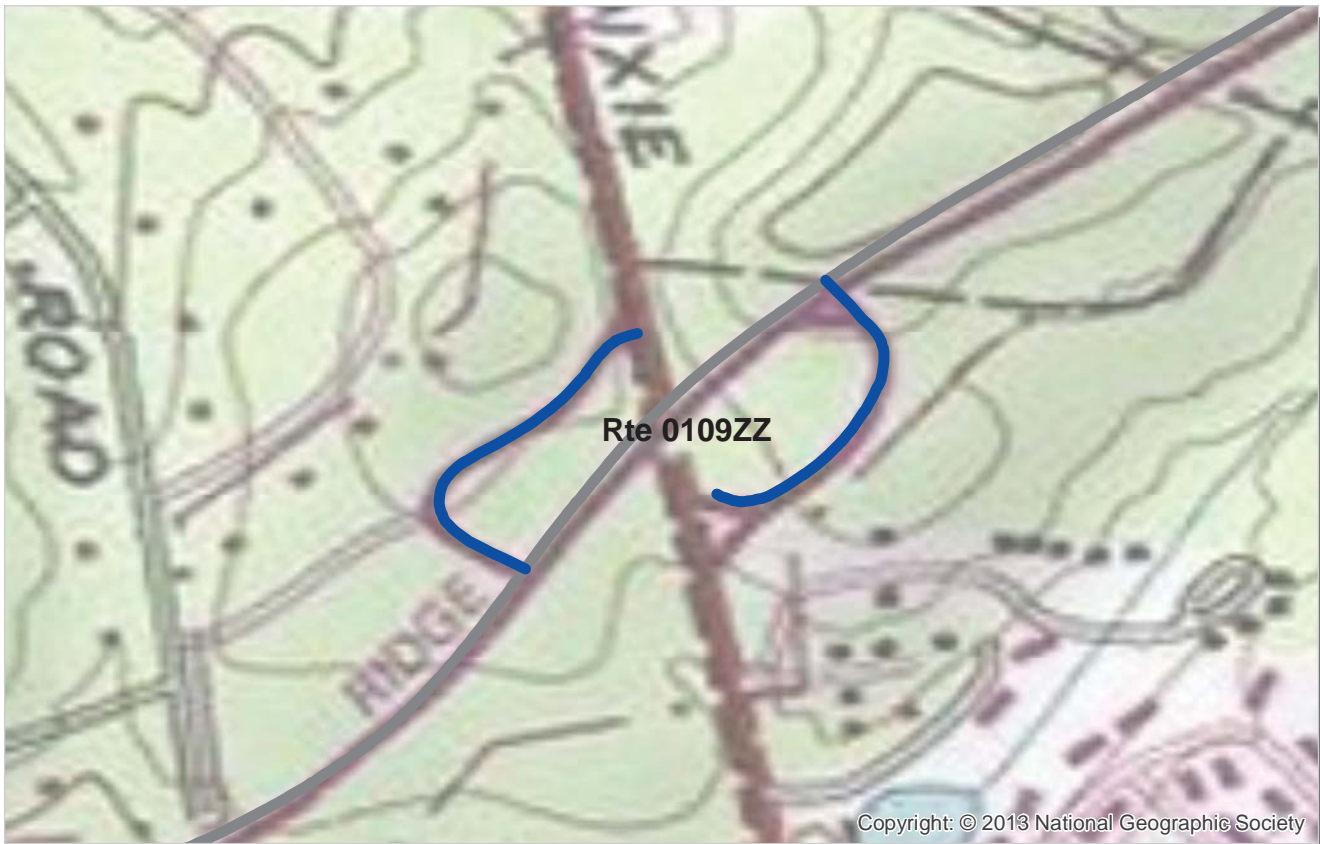
ROUTE: 0109ZZ ACCESS RAMPS TO U.S. ROUTE 25

PCR	Poor		Fair		Good		Excellent		No Data	
		(0 - 60)		(61 - 84)		(85 - 94)		(95 - 100)

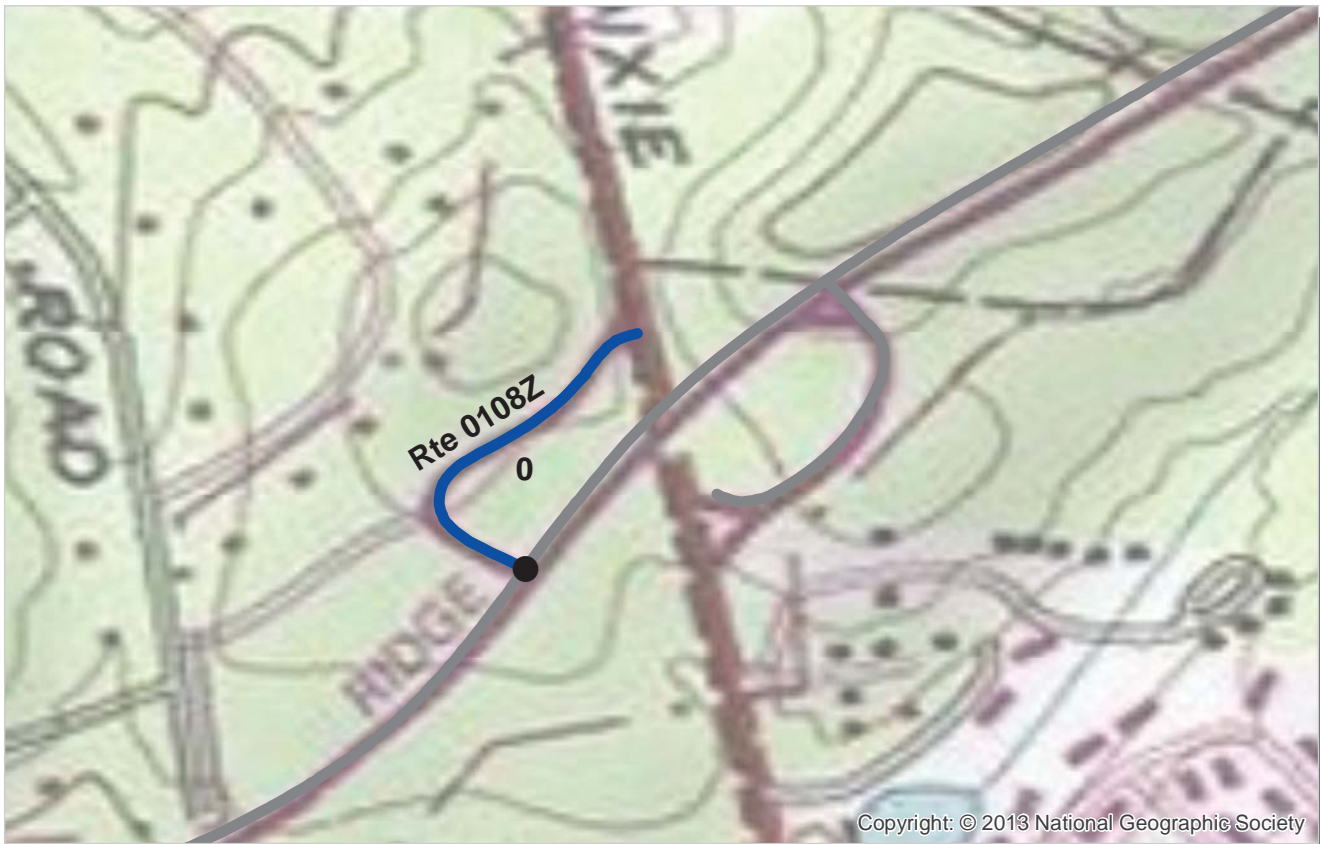
ROUTE: 0108Z ACCESS RAMP TO U.S. ROUTE 25 SOUTH

PCR Poor ■ Fair ■ Good ■ Excellent ■ No Data ■
 (0 - 60) (61 - 84) (85 - 94) (95 - 100)

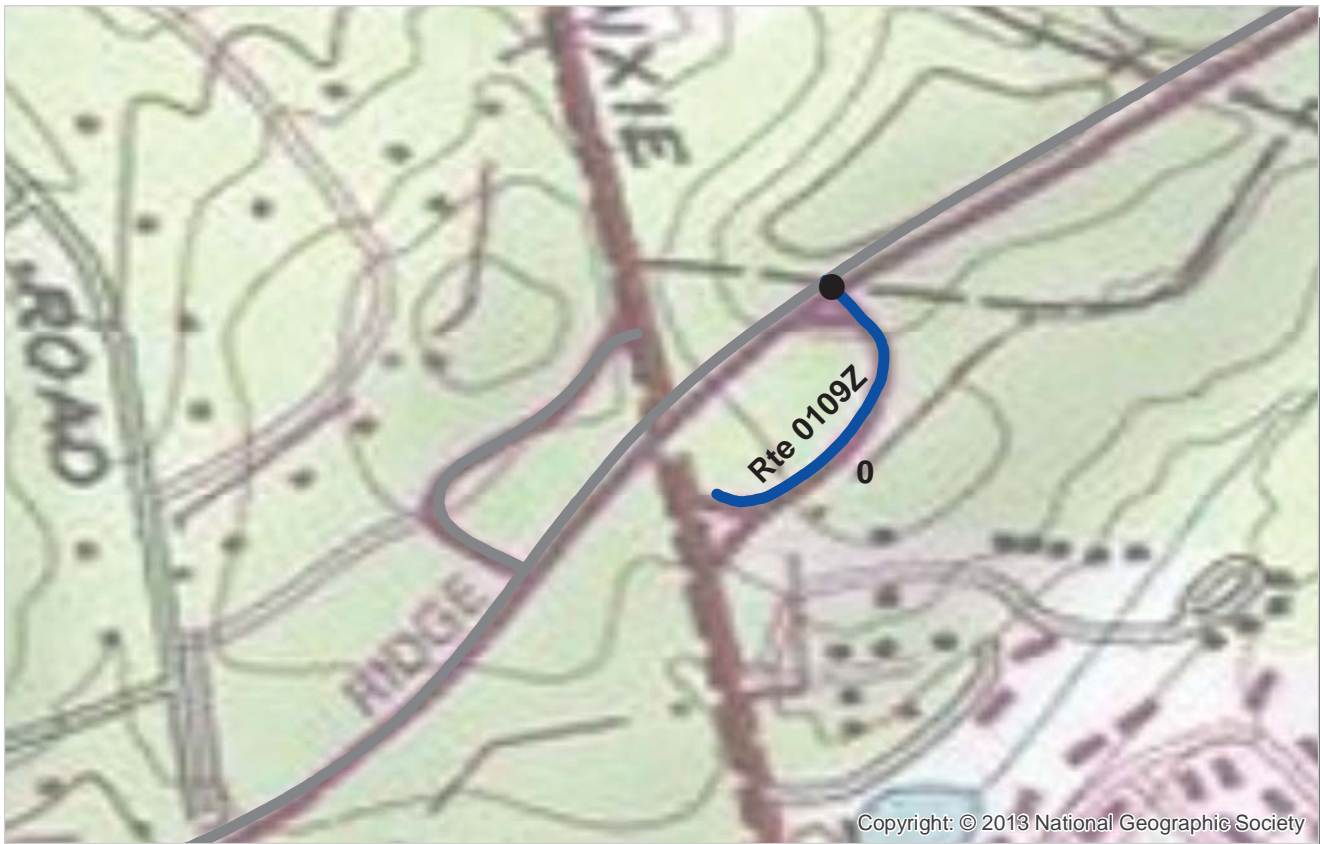
ROUTE: 0111ZZ ACCESS RAMPS TO U.S. ROUTE 74-A

PCR	Poor		Fair		Good		Excellent		No Data	
		(0 - 60)		(61 - 84)		(85 - 94)		(95 - 100)

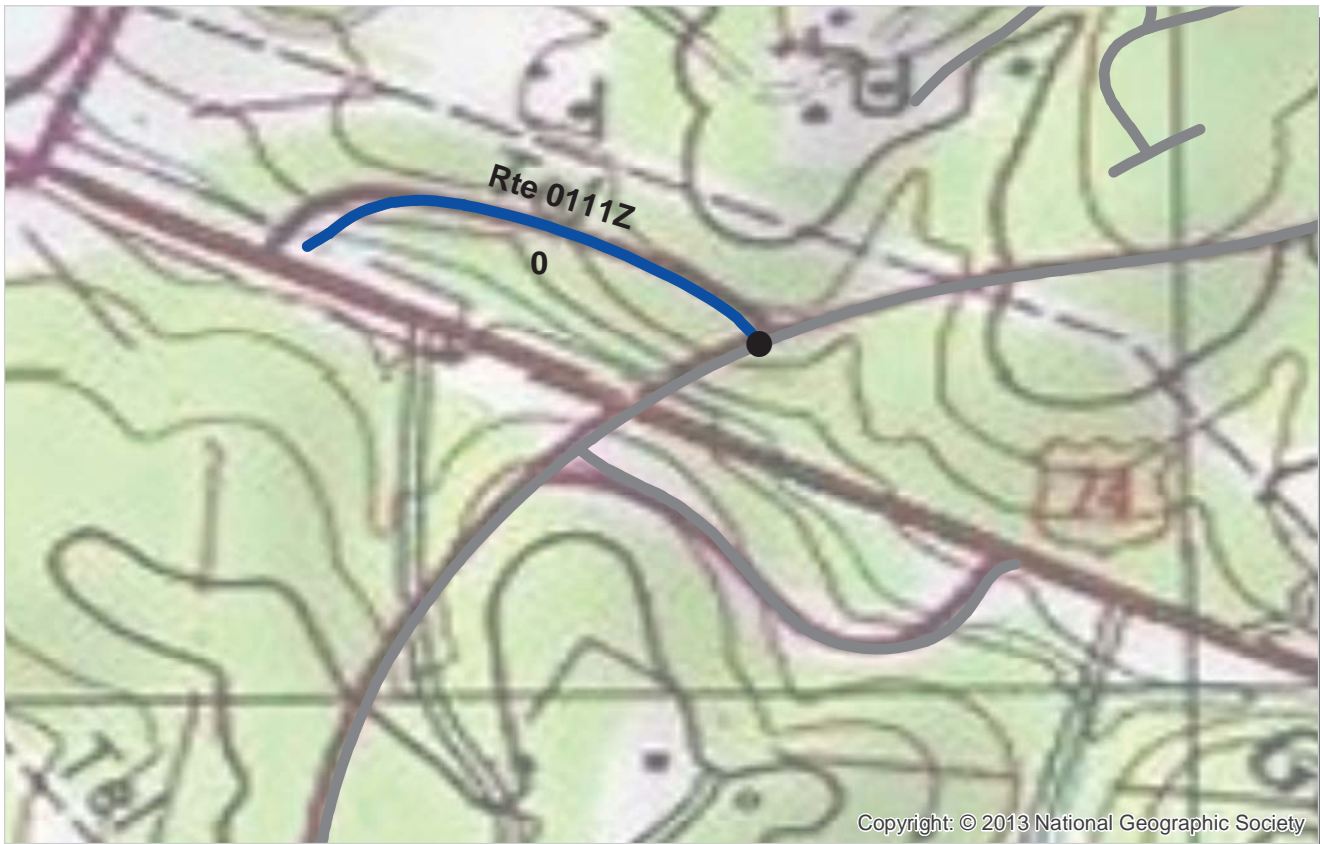
ROUTE: 0111Z ACCESS RAMP TO U.S. ROUTE 74-A WEST

PCR Poor ■ Fair ■ Good ■ Excellent ■ No Data ■
 (0 - 60) (61 - 84) (85 - 94) (95 - 100)

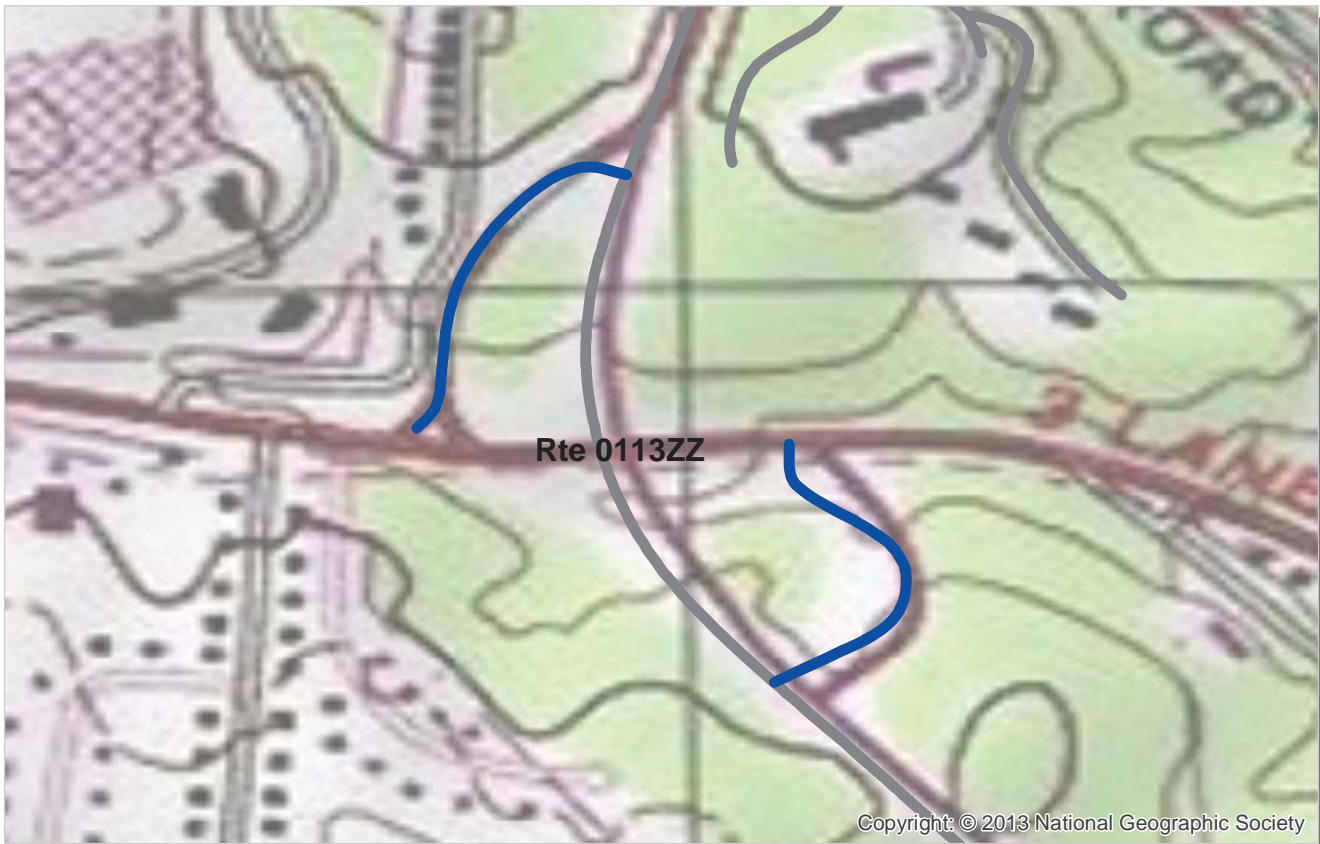
ROUTE: 0113ZZ ACCESS RAMPS TO U.S. ROUTE 70

NOTES:
 Structural Crack Index is a combination of the Longitudinal Cracking Index and Alligator Cracking Index.
 See Section 10 for explanation of SCR, PCR, & all Distress Index Values.
 NC - Not Collected N/A - Not Applicable

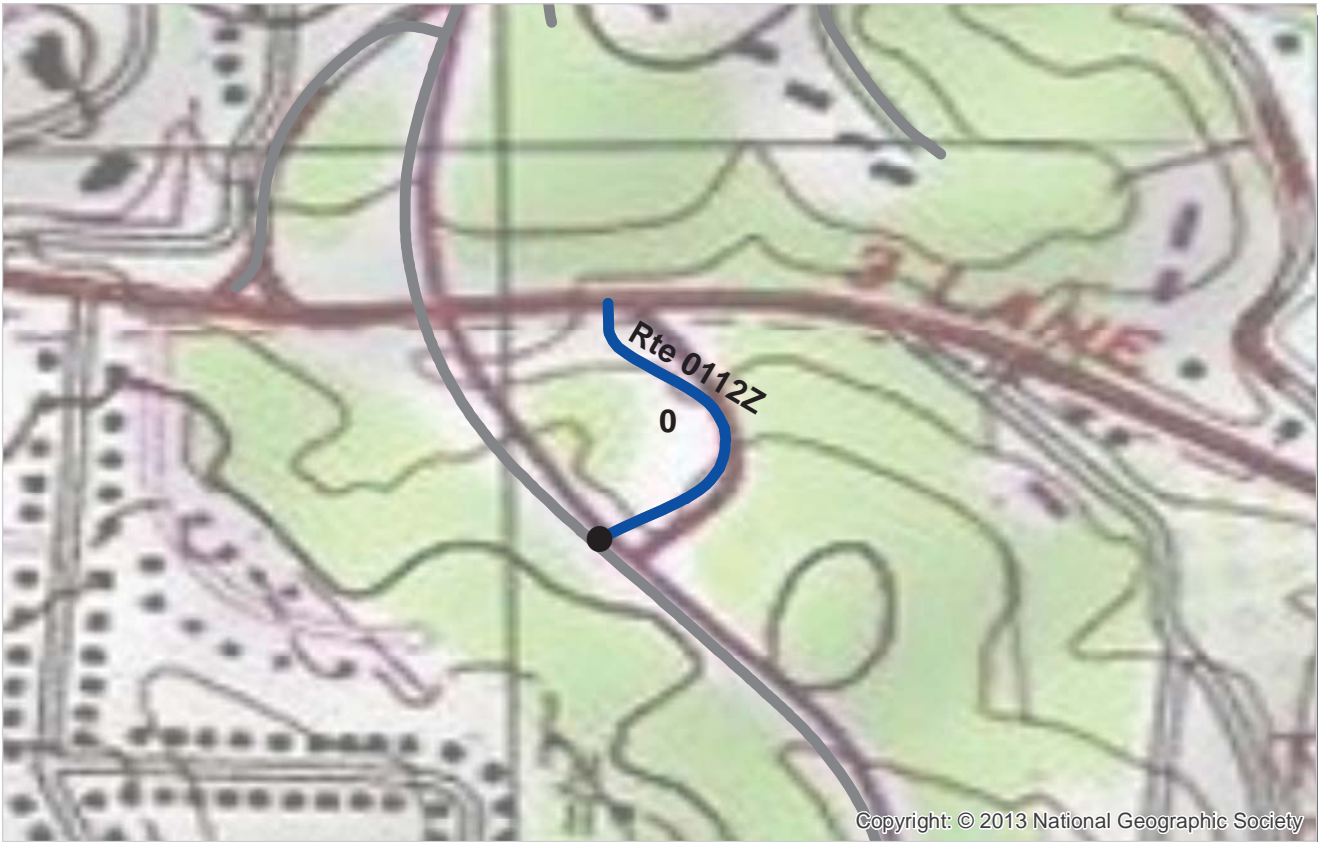
ROUTE: 0112Z ACCESS RAMP TO U.S. ROUTE 70 EAST

PCR Poor ■ Fair ■ Good ■ Excellent ■ No Data ■
 (0 - 60) (61 - 84) (85 - 94) (95 - 100)

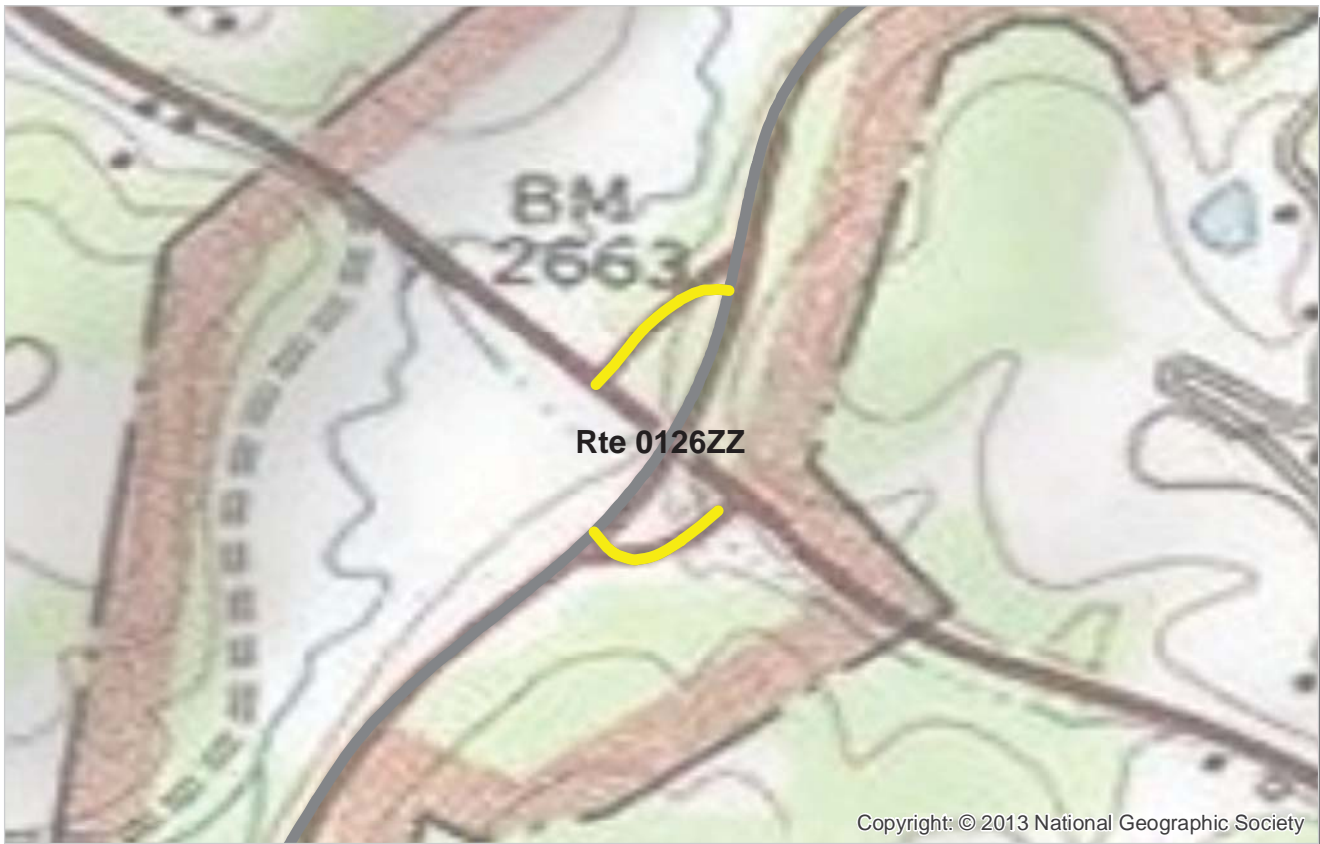
ROUTE: 0125Z ACCESS RAMP TO NC ROUTE 18 NORTH

Section Number					
Section Length (mi)					
Cross Section Information					
Number of Lanes	N/A				
Paved Width (ft)	N/A				
Lane Width (ft)	N/A				
Roadway Condition Information					
SCR (Surface Condition Rating)	79				
PCR (Pavement Condition Rating)	79				
Distress Index Values					
Structural Crack Index	N/A				
Transverse Cracking Index	N/A				
Patching Index	N/A				
Rutting Index	N/A				
Roughness Condition Index (RCI)	N/A

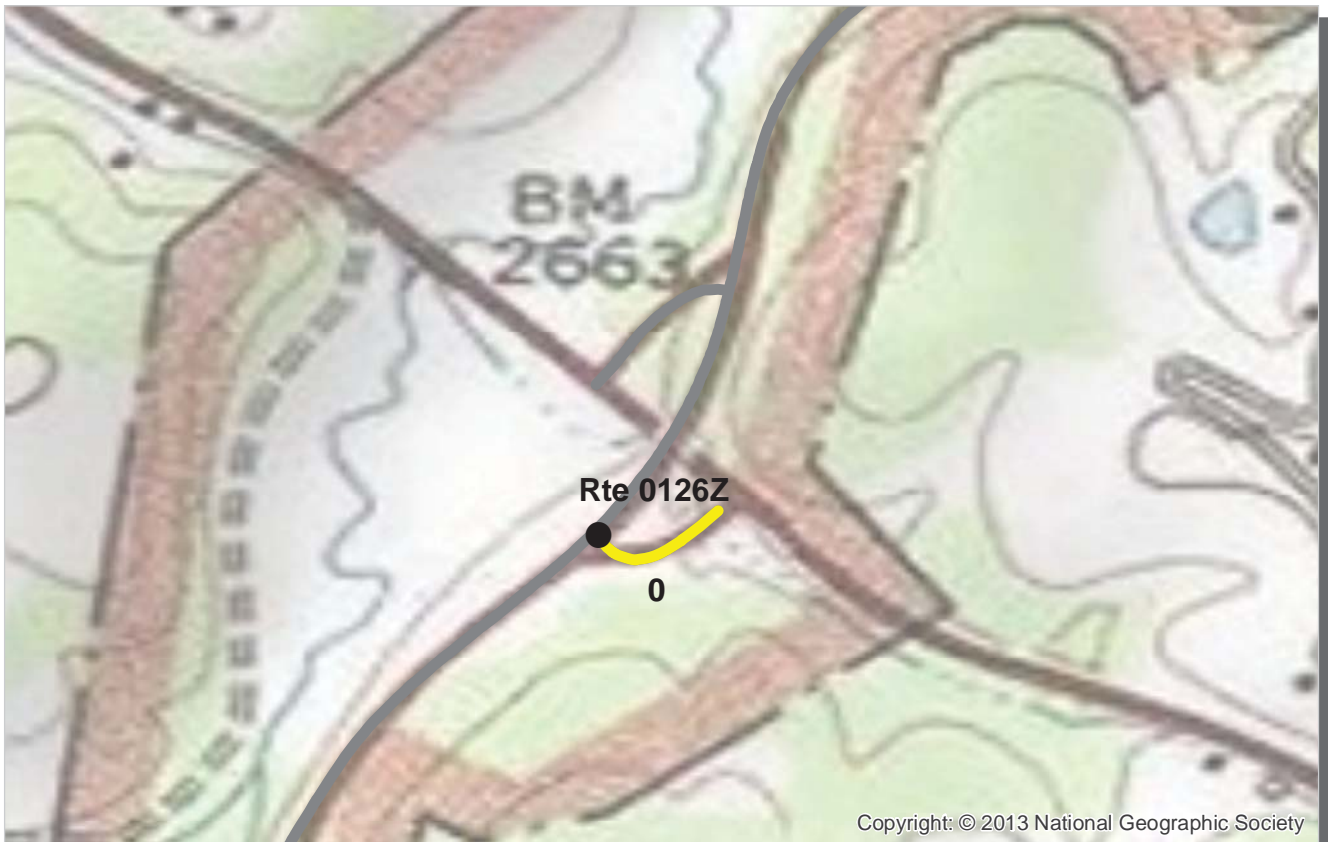
ROUTE: 0126ZZ ACCESS RAMPS TO U.S. ROUTE 21

<i>Section Number</i>	0				
<i>Section Length (mi)</i>	0.06				
<i>Cross Section Information</i>					
Number of Lanes	2				
Paved Width (ft)	22				
Lane Width (ft)	10				
<i>Roadway Condition Information</i>					
SCR (Surface Condition Rating)	70				
PCR (Pavement Condition Rating)	70				
<i>Distress Index Values</i>					
Structural Crack Index	83				
Transverse Cracking Index	70				
Patching Index	100				
Rutting Index	93				
Roughness Condition Index (RCI)	NC

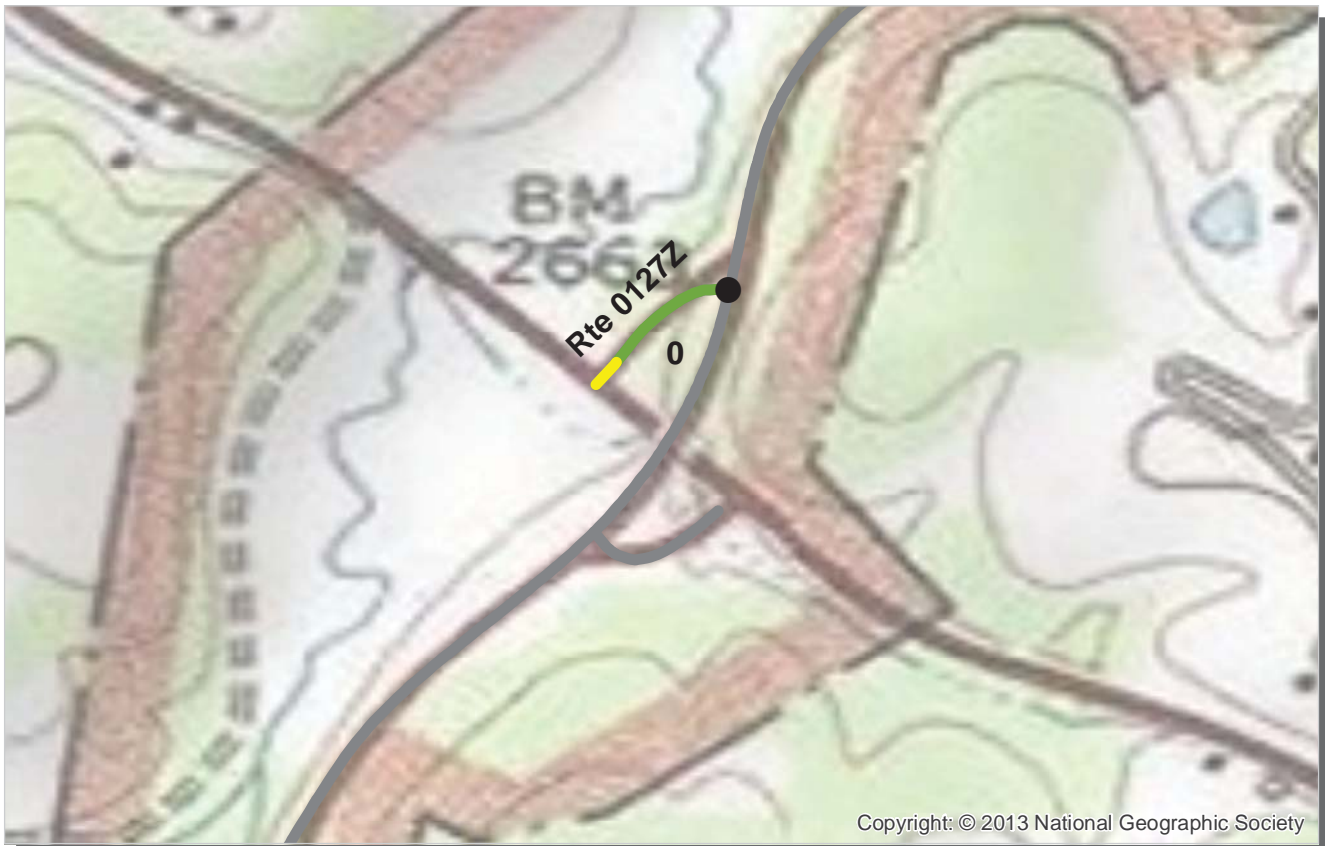
ROUTE: 0126Z ACCESS RAMP TO U.S. ROUTE 21 SOUTH

<i>Section Number</i>	0				
<i>Section Length (mi)</i>	0.07				
<i>Cross Section Information</i>					
Number of Lanes	2				
Paved Width (ft)	19				
Lane Width (ft)	9				
<i>Roadway Condition Information</i>					
SCR (Surface Condition Rating)	88				
PCR (Pavement Condition Rating)	88				
<i>Distress Index Values</i>					
Structural Crack Index	98				
Transverse Cracking Index	88				
Patching Index	100				
Rutting Index	96				
Roughness Condition Index (RCI)	NC

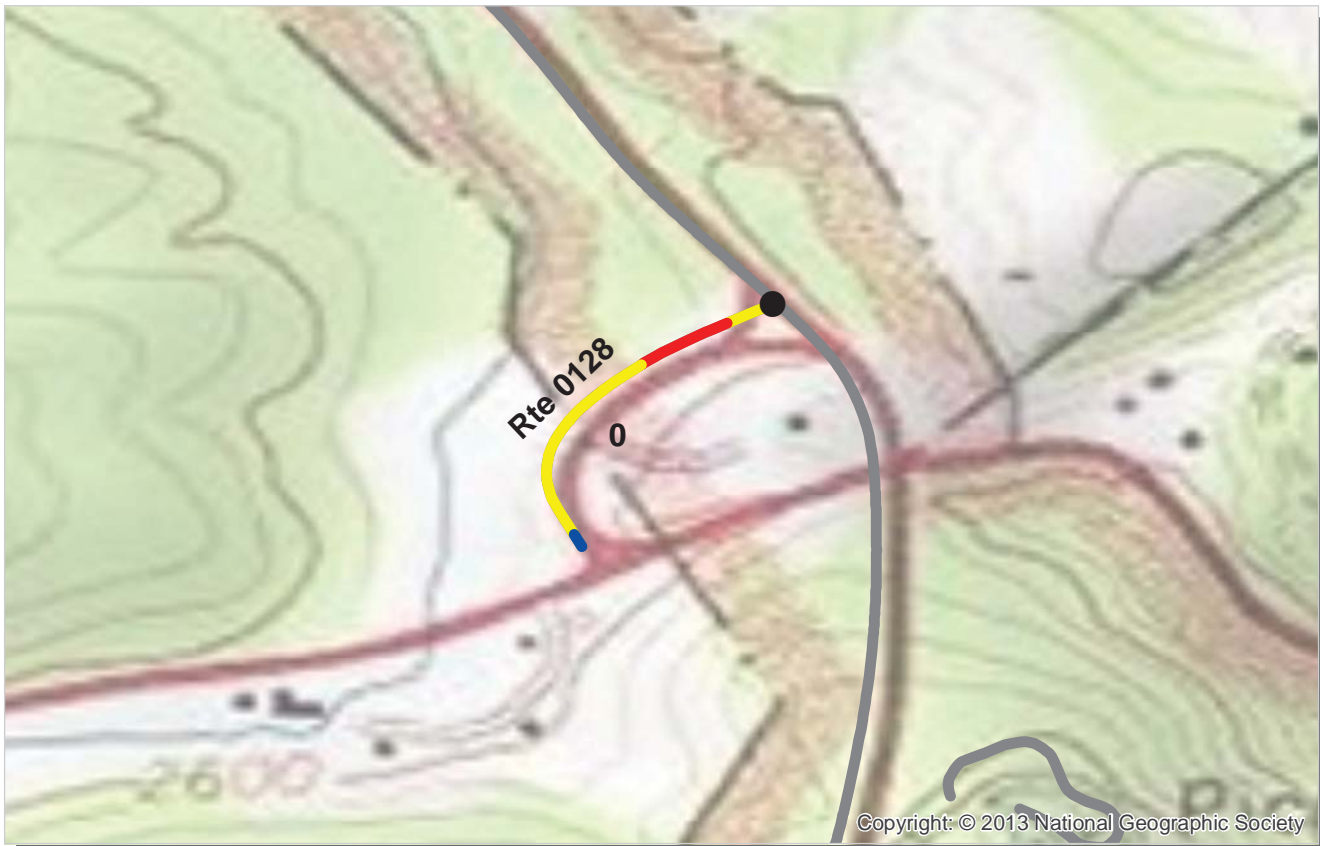
ROUTE: 0127Z ACCESS RAMP TO U.S. ROUTE 21 NORTH

Section Number	0				
Section Length (mi)	0.17				
Cross Section Information					
Number of Lanes	2				
Paved Width (ft)	24				
Lane Width (ft)	12				
Roadway Condition Information					
SCR (Surface Condition Rating)	77				
PCR (Pavement Condition Rating)	77				
Distress Index Values					
Structural Crack Index	77				
Transverse Cracking Index	82				
Patching Index	100				
Rutting Index	93				
Roughness Condition Index (RCI)	NC

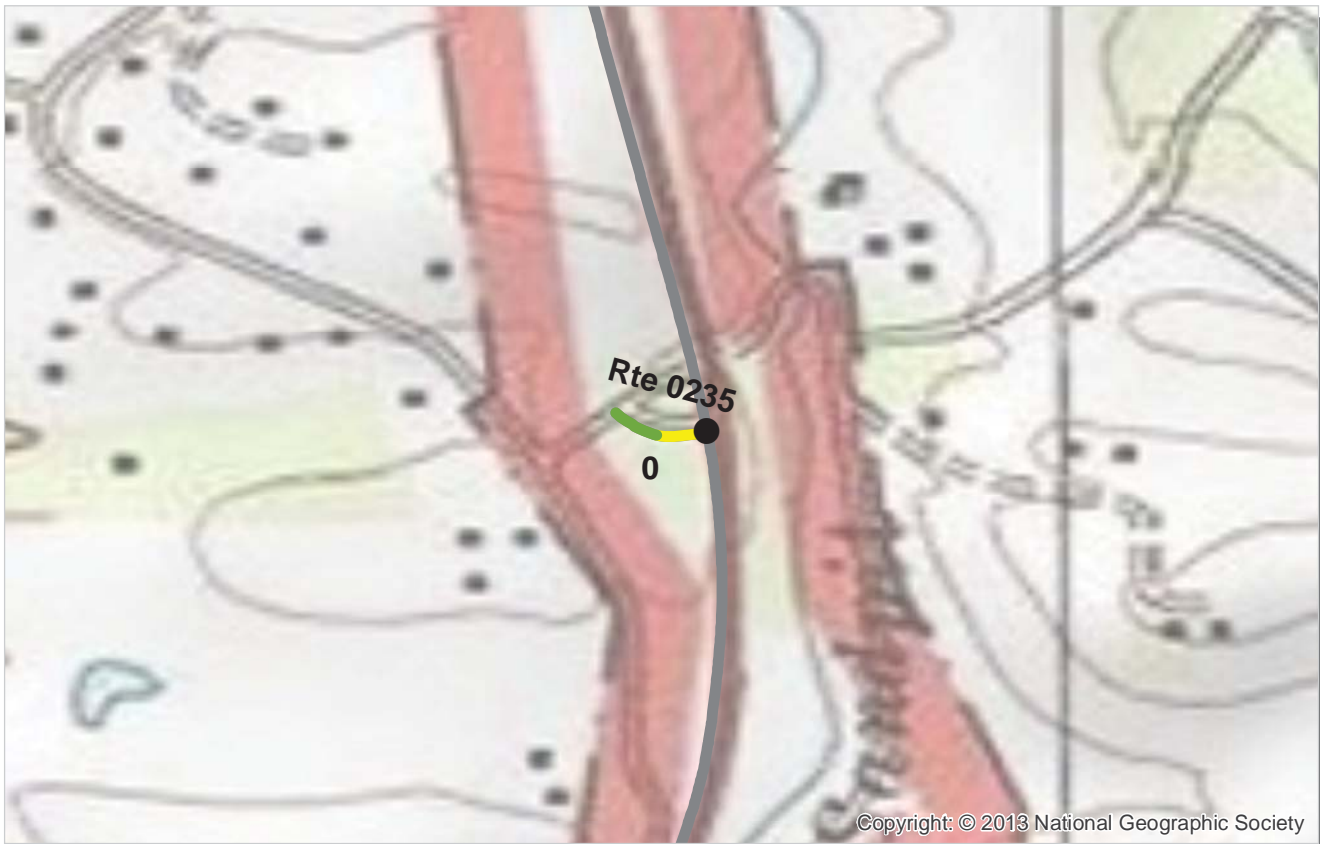
ROUTE: 0232 PIPERS GAP ACCESS ROAD

PCR Poor ■ Fair ■ Good ■ Excellent ■ No Data ■
 (0 - 60) (61 - 84) (85 - 94) (95 - 100)

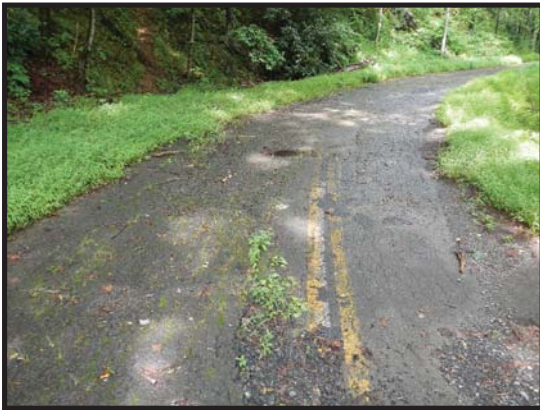
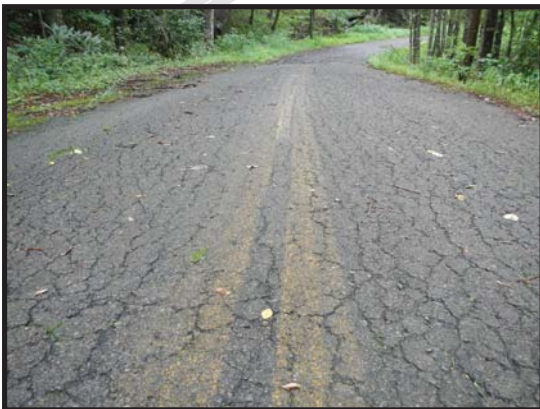
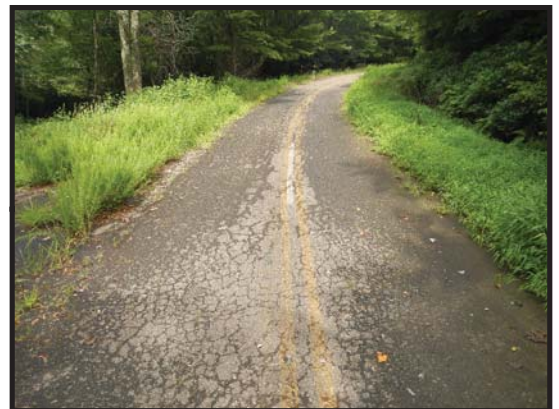
Route Number	Public / NonPublic	Date Visited	Area (sq ft)	Lane Miles *	Paved Length (mi)	Paved Width (ft)
0449	NONPUBLIC	8/13/2013	68,044	1.17	1.16	11.1
Culverts	Drop Inlets	Gates	Curb & Gutter	Curb	PCR	Surface Type
0	0	1	NO CURB AND GUTTER	NO CURB	POOR/45	AS

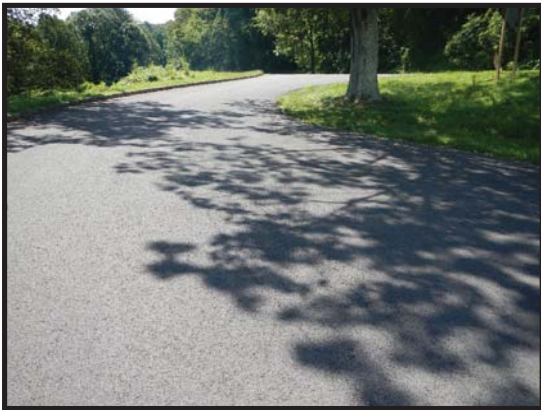
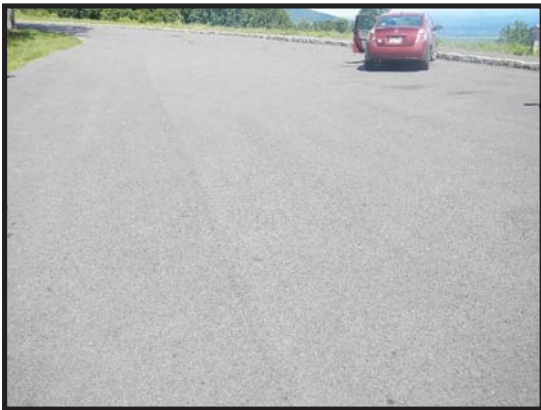
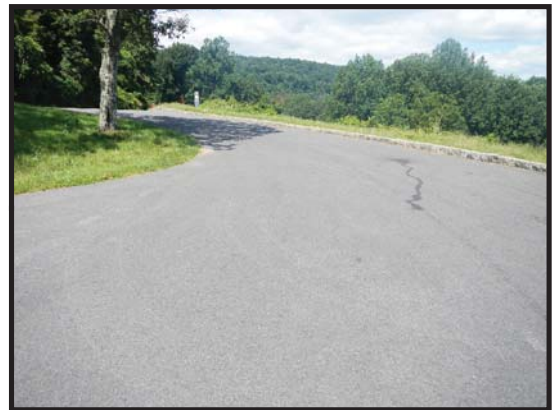
Route Number	Public / NonPublic	Date Visited	Area (sq ft)	Lane Miles *	Surface Type
0900	PUBLIC	8/15/2013	12,097	0.21	AS
Culverts	Drop Inlets	Gates	Curb & Gutter	Curb	PCR
0	1	0	NO CURB AND GUTTER	STONE CURB	EXCELLENT/97

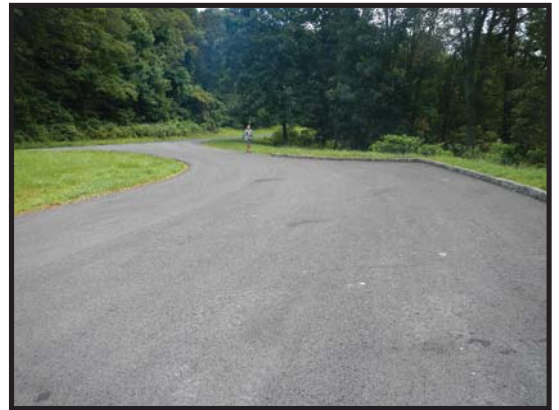
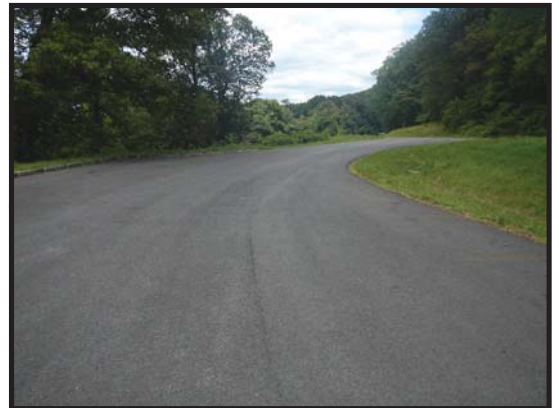
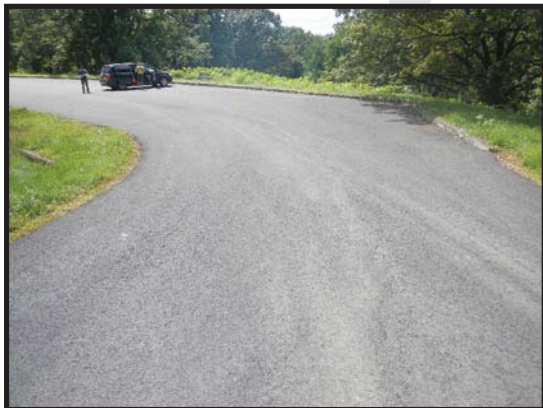
Route 0902

Route Number	Public / NonPublic	Date Visited	Area (sq ft)	Lane Miles *	Surface Type
0902	PUBLIC	8/15/2013	10,222	0.18	AS
Culverts	Drop Inlets	Gates	Curb & Gutter	Curb	PCR
0	1	0	NO CURB AND GUTTER	STONE CURB	EXCELLENT/97

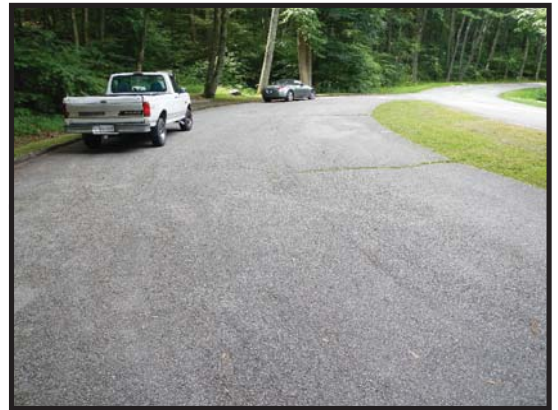
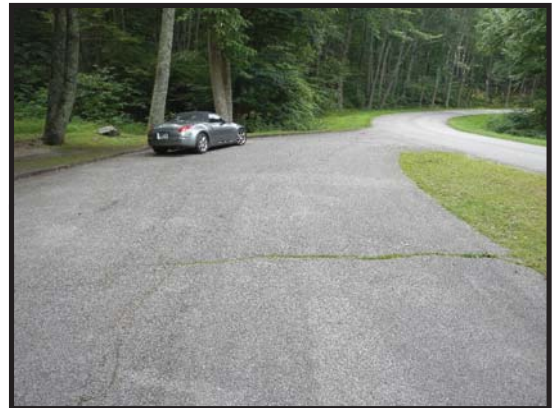
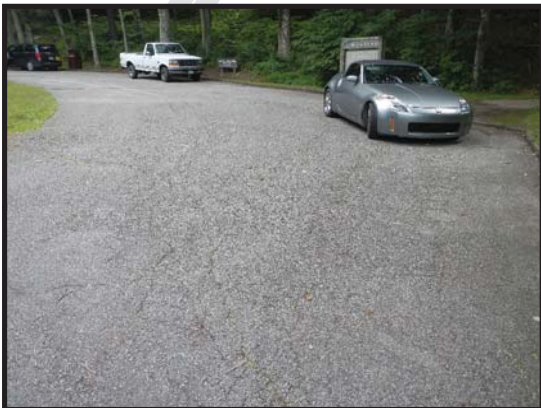
Route Number	Public / NonPublic	Date Visited	Area (sq ft)	Lane Miles *	Surface Type
0916	PUBLIC	8/15/2013	2,658	0.05	AS
Culverts	Drop Inlets	Gates	Curb & Gutter	Curb	PCR
0	1	0	NO CURB AND GUTTER	STONE CURB	POOR/45

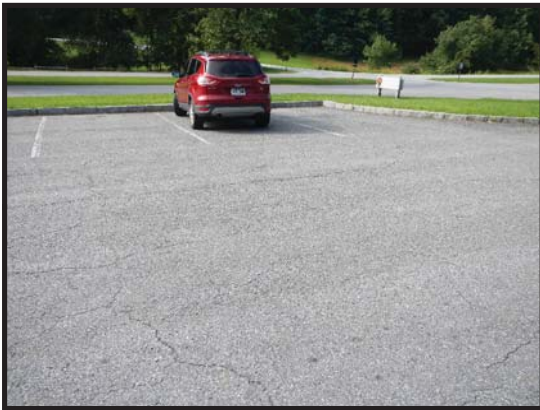
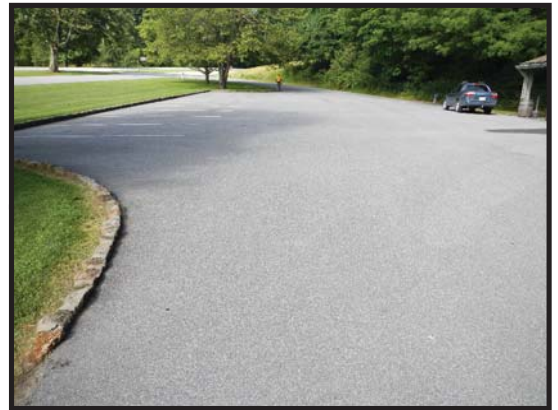
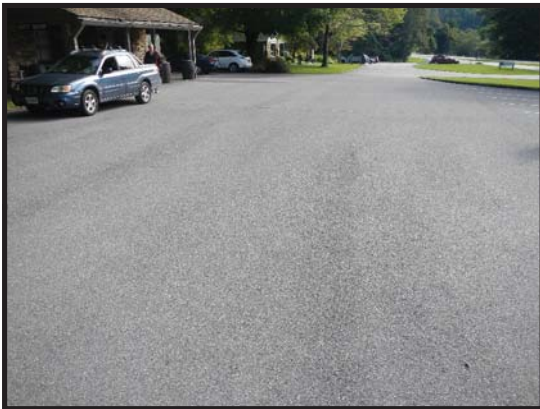
Route 0950

Route Number	Public / NonPublic	Date Visited	Area (sq ft)	Lane Miles *	Surface Type
0950	PUBLIC	8/15/2013	32,138	0.55	AS
Culverts	Drop Inlets	Gates	Curb & Gutter	Curb	PCR
1	3	0	NO CURB AND GUTTER	STONE CURB	FAIR/73

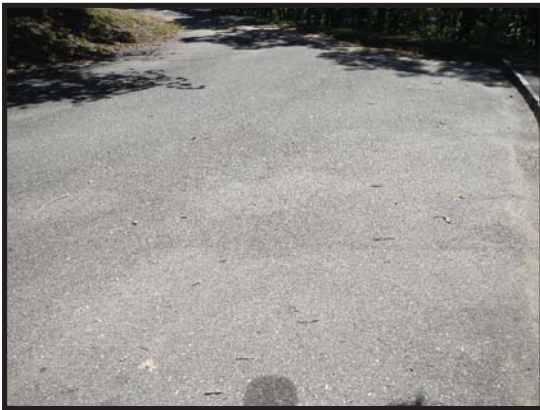
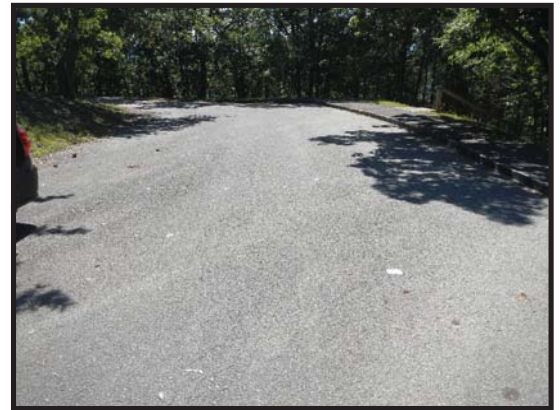
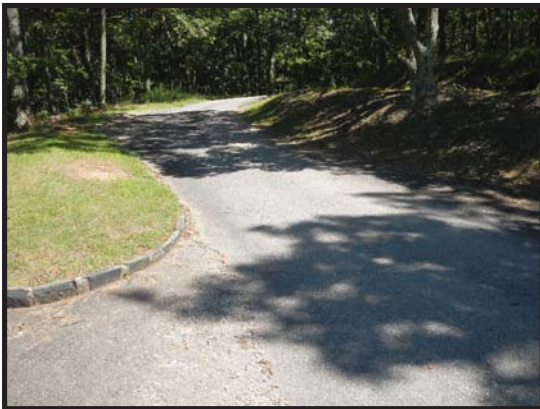
Route 0971

Route Number	Public / NonPublic	Date Visited	Area (sq ft)	Lane Miles *	Surface Type
0971	PUBLIC	8/14/2013	6,208	0.11	AS
Culverts	Drop Inlets	Gates	Curb & Gutter	Curb	PCR
0	0	0	NO CURB AND GUTTER	STONE CURB	FAIR/73

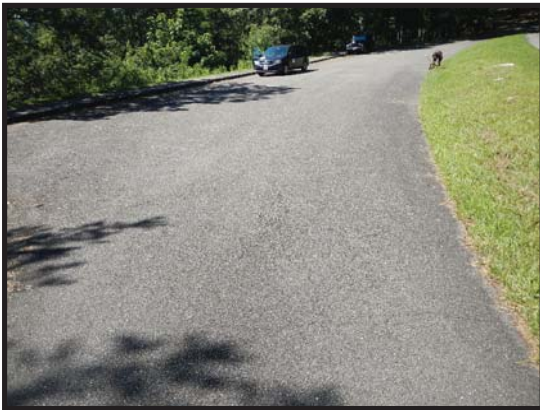
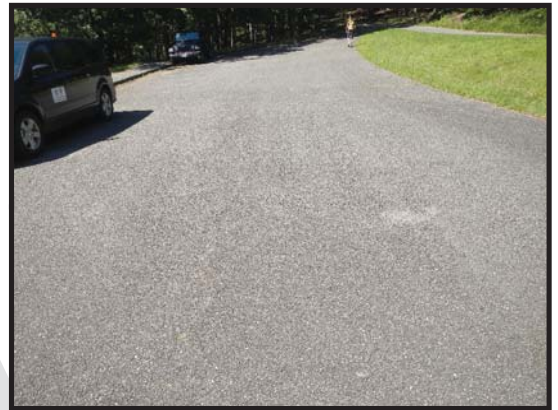
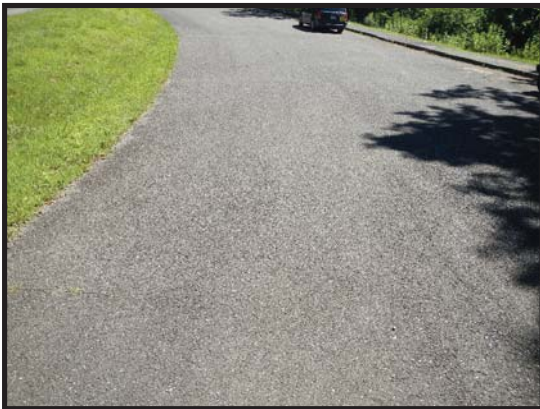
Route 0973

Route Number	Public / NonPublic	Date Visited	Area (sq ft)	Lane Miles *	Surface Type
0973	PUBLIC	8/14/2013	7,529	0.13	AS
Culverts	Drop Inlets	Gates	Curb & Gutter	Curb	PCR
0	0	0	NO CURB AND GUTTER	STONE CURB	FAIR/73

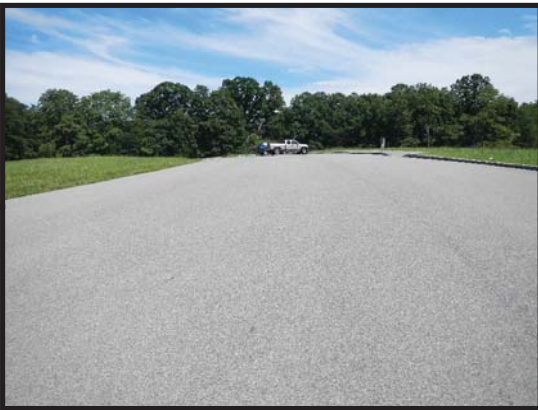
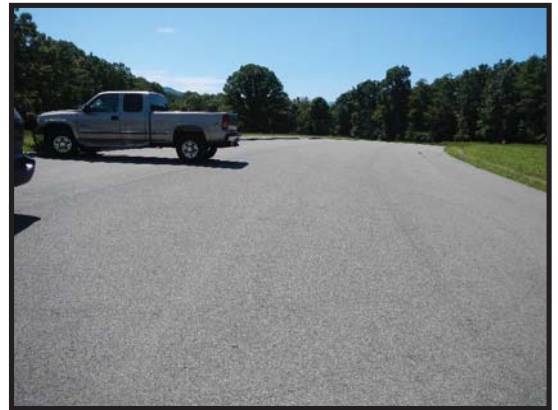
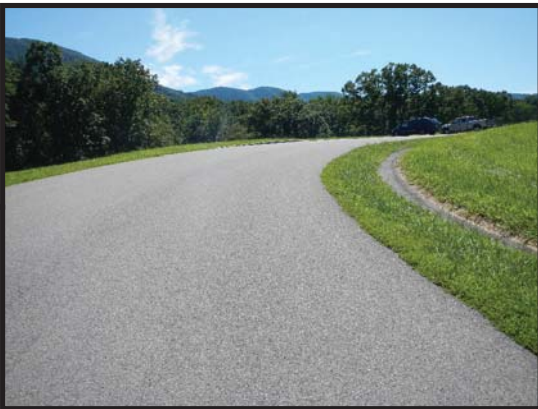
Route 0978

Route Number	Public / NonPublic	Date Visited	Area (sq ft)	Lane Miles *	Surface Type
0978	PUBLIC	8/14/2013	19,474	0.34	AS
Culverts	Drop Inlets	Gates	Curb & Gutter	Curb	PCR
1	1	0	NO CURB AND GUTTER	STONE CURB	GOOD/90

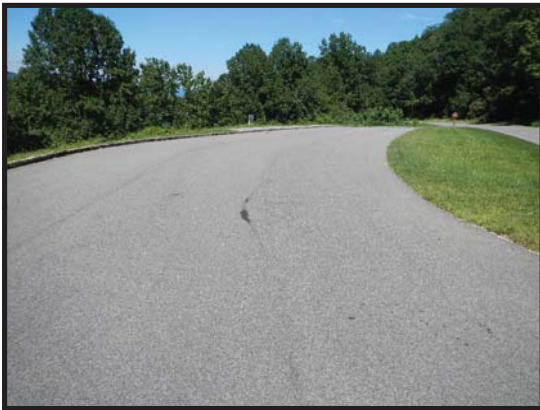
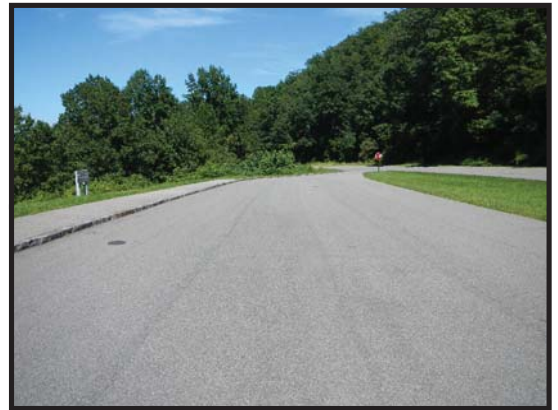
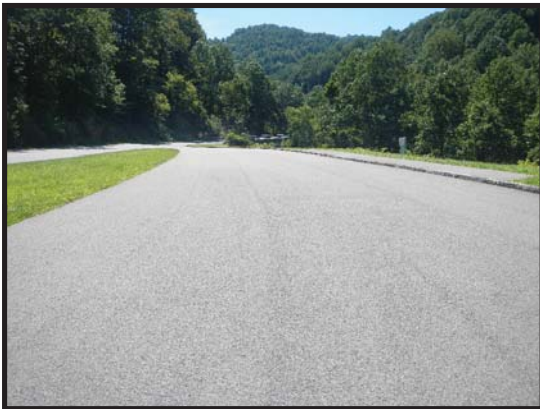
Route 0979

Route Number	Public / NonPublic	Date Visited	Area (sq ft)	Lane Miles *	Surface Type
0979	PUBLIC	8/14/2013	9,786	0.17	AS
Culverts	Drop Inlets	Gates	Curb & Gutter	Curb	PCR
0	1	0	NO CURB AND GUTTER	STONE CURB	GOOD/90

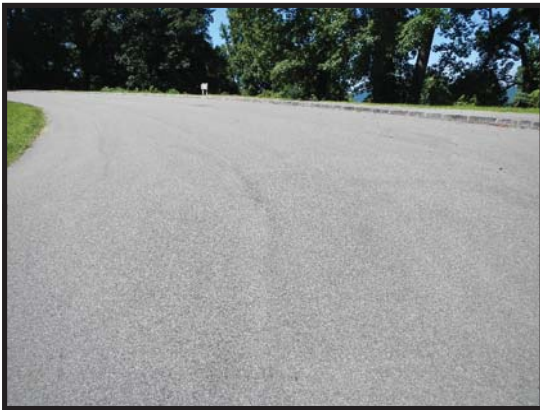
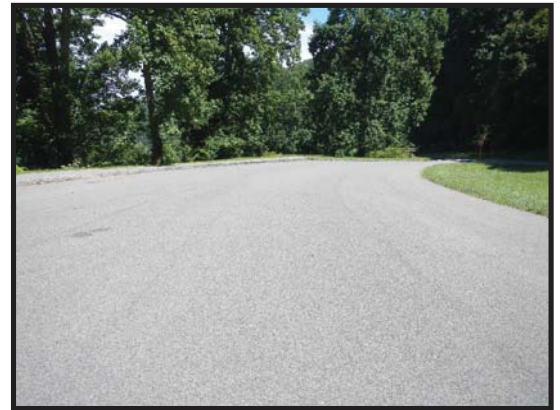
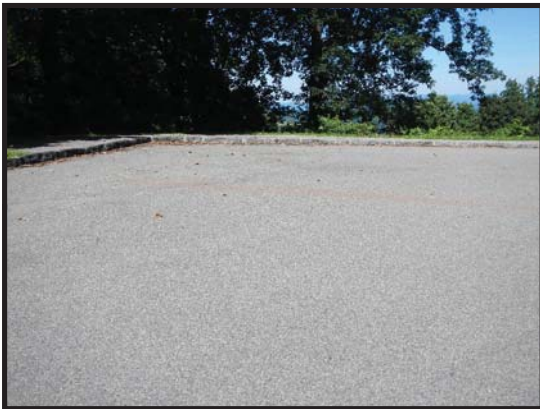
Route 0980

Route Number	Public / NonPublic	Date Visited	Area (sq ft)	Lane Miles *	Surface Type
0980	PUBLIC	8/14/2013	11,844	0.20	AS
Culverts	Drop Inlets	Gates	Curb & Gutter	Curb	PCR
0	2	0	NO CURB AND GUTTER	STONE CURB	GOOD/90
