Federal Lands Highway Road Inventory Program

Road Inventory and Condition Assessment

Blue Ridge Parkway BLRI

Cycle 5 Report

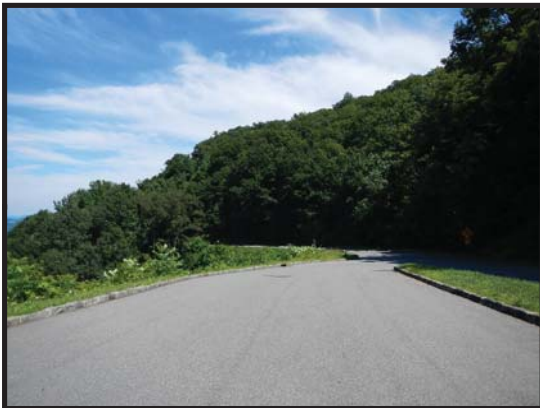
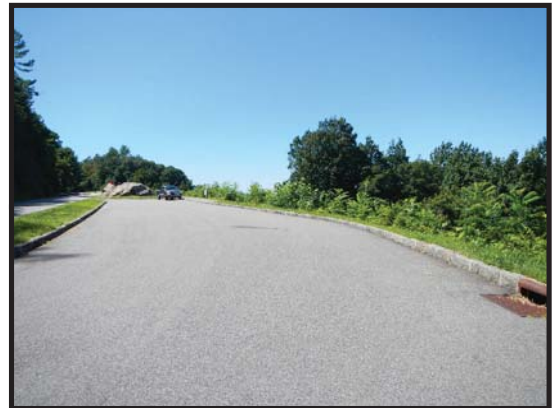
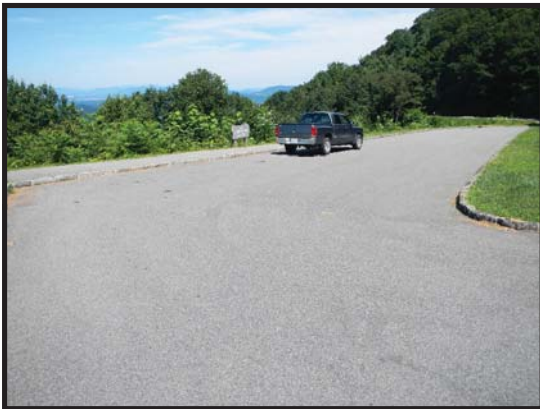
Route Number	Public / NonPublic	Date Visited	Area (sq ft)	Lane Miles *	Surface Type
0981	PUBLIC	8/14/2013	6,883	0.12	AS
Culverts	Drop Inlets	Gates	Curb & Gutter	Curb	PCR
0	1	0	NO CURB AND GUTTER	STONE CURB	GOOD/90

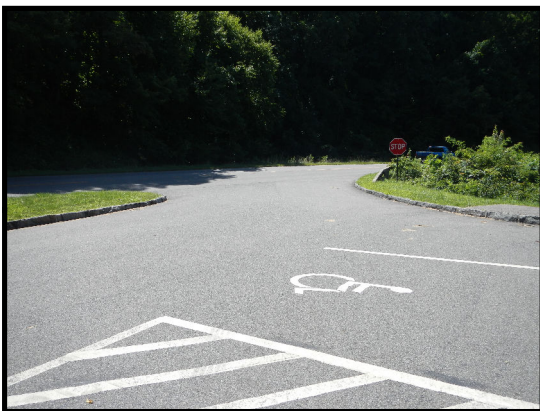
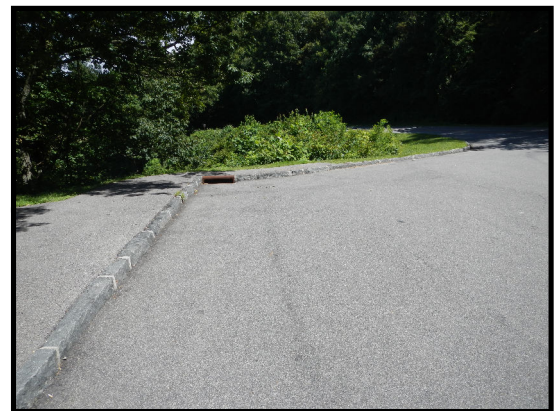
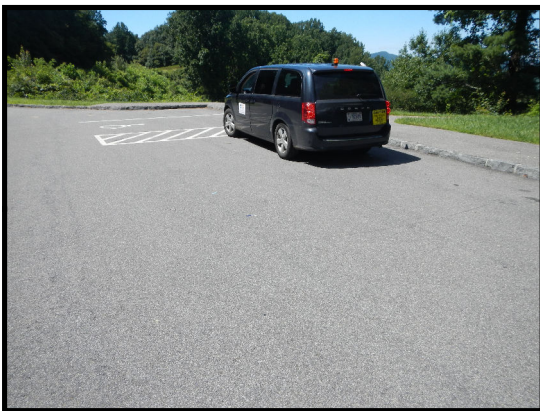
Route 0982

Route Number	Public / NonPublic	Date Visited	Area (sq ft)	Lane Miles *	Surface Type
0982	PUBLIC	8/14/2013	5,768	0.10	AS
Culverts	Drop Inlets	Gates	Curb & Gutter	Curb	PCR
0	2	0	NO CURB AND GUTTER	STONE CURB	GOOD/90

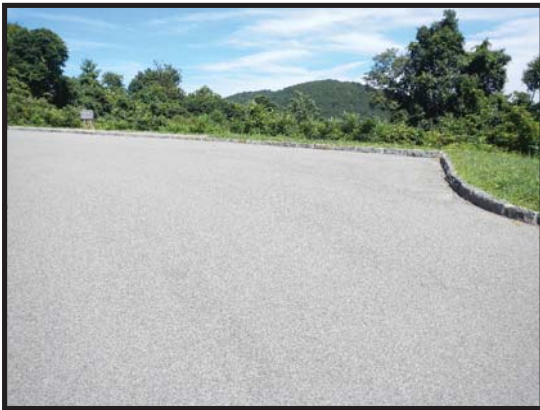
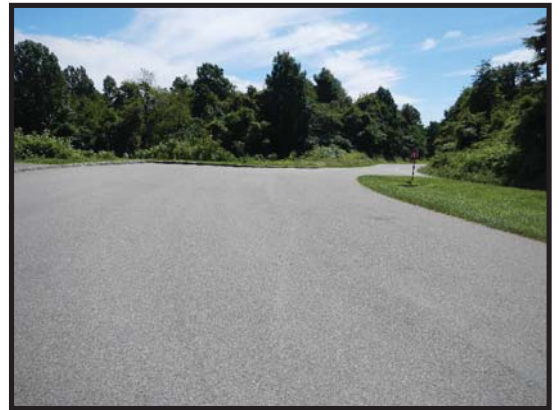
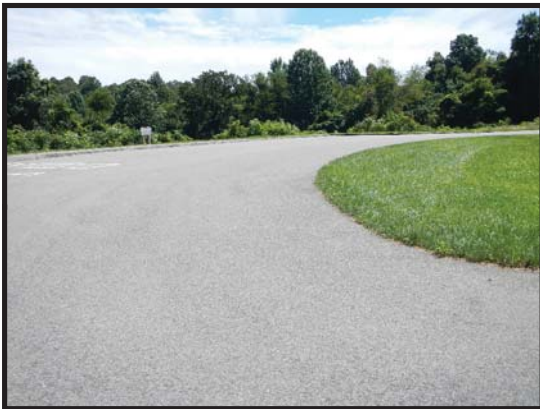
Route 0983

Route Number	Public / NonPublic	Date Visited	Area (sq ft)	Lane Miles *	Surface Type
0983	PUBLIC	8/14/2013	8,013	0.14	AS
Culverts	Drop Inlets	Gates	Curb & Gutter	Curb	PCR
0	1	0	NO CURB AND GUTTER	STONE CURB	GOOD/90

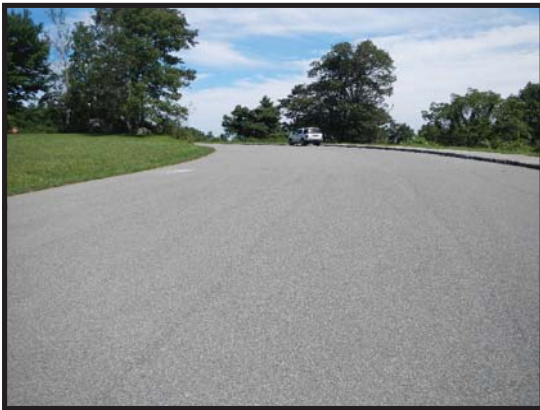
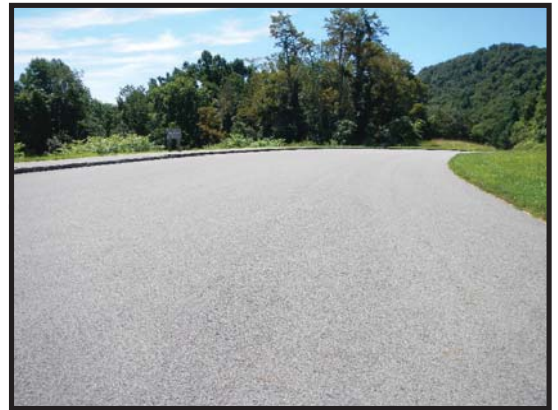
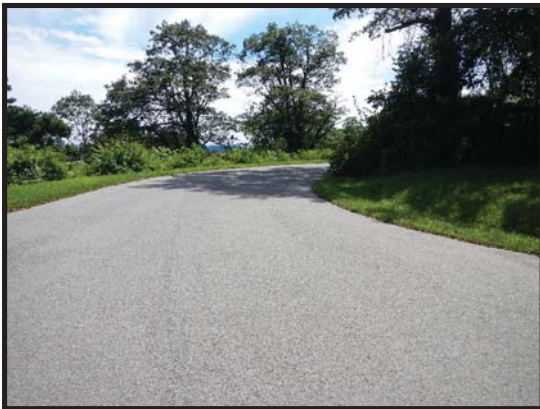
Route 0984

Route Number	Public / NonPublic	Date Visited	Area (sq ft)	Lane Miles *	Surface Type
0984	PUBLIC	8/14/2013	14,692	0.25	AS
Culverts	Drop Inlets	Gates	Curb & Gutter	Curb	PCR
0	1	0	NO CURB AND GUTTER	STONE CURB	GOOD/90

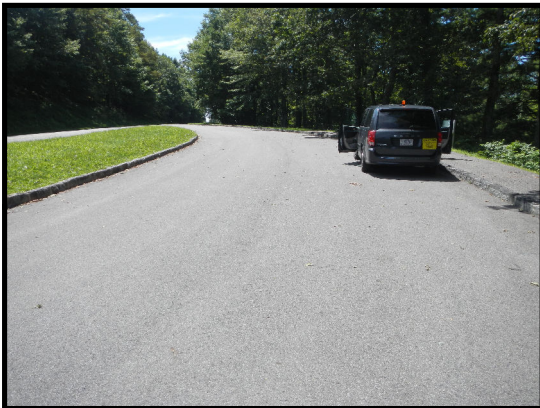
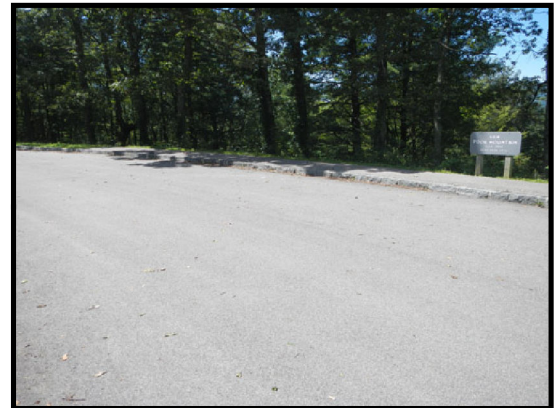
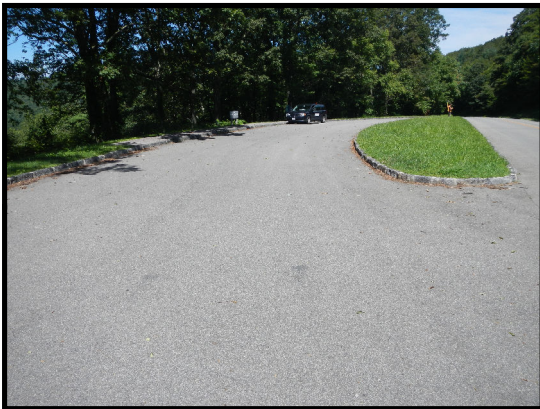
Route 0985

Route Number	Public / NonPublic	Date Visited	Area (sq ft)	Lane Miles *	Surface Type
0985	PUBLIC	8/14/2013	7,150	0.12	AS
Culverts	Drop Inlets	Gates	Curb & Gutter	Curb	PCR
0	0	0	NO CURB AND GUTTER	STONE CURB	GOOD/90

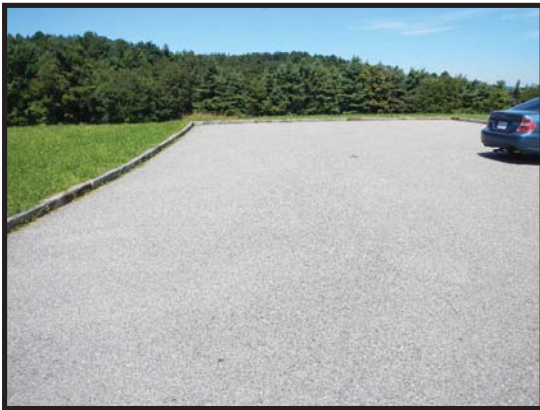
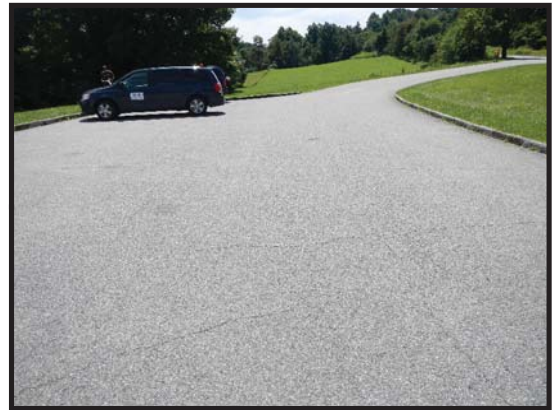
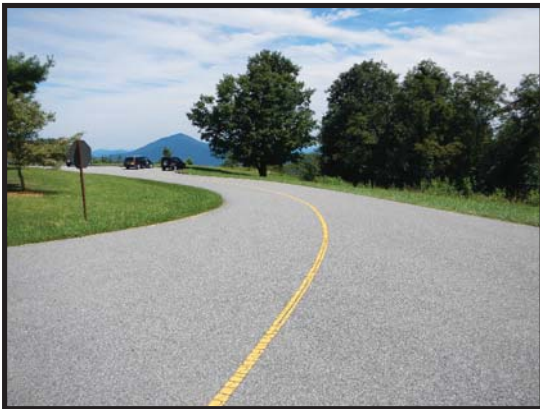
Route 0986

Route Number	Public / NonPublic	Date Visited	Area (sq ft)	Lane Miles *	Surface Type
0986	PUBLIC	8/14/2013	11,665	0.20	AS
Culverts	Drop Inlets	Gates	Curb & Gutter	Curb	PCR
2	1	0	NO CURB AND GUTTER	STONE CURB	GOOD/90

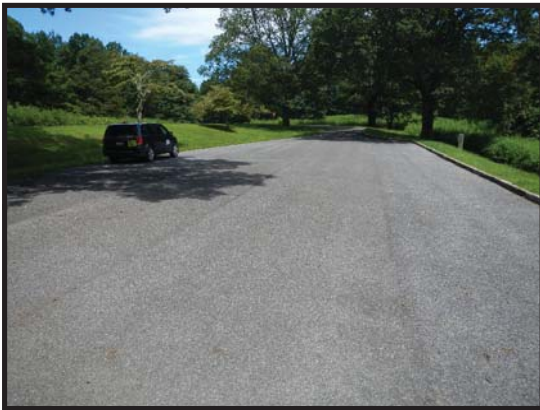
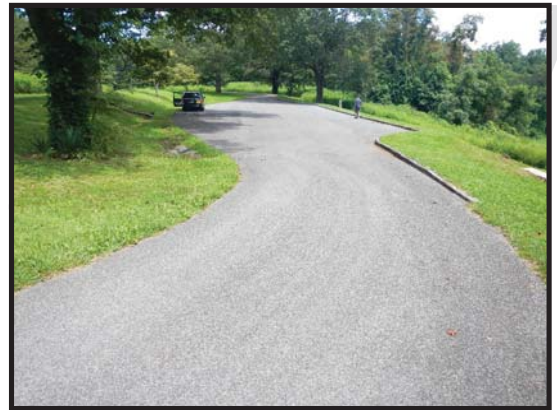
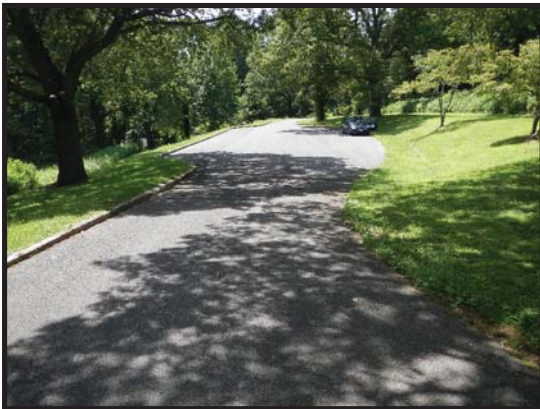
Route 0989

Route Number	Public / NonPublic	Date Visited	Area (sq ft)	Lane Miles *	Surface Type
0989	PUBLIC	8/14/2013	11,823	0.20	AS
Culverts	Drop Inlets	Gates	Curb & Gutter	Curb	PCR
1	1	0	NO CURB AND GUTTER	STONE CURB	GOOD/90

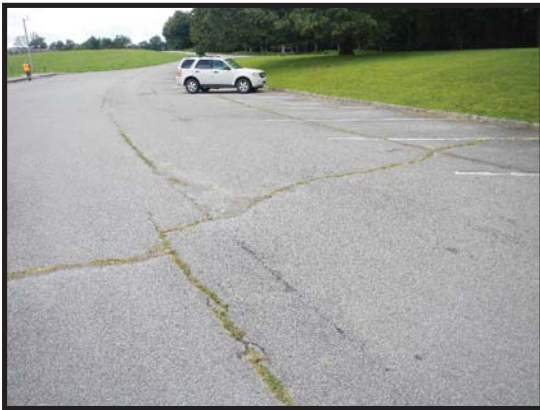
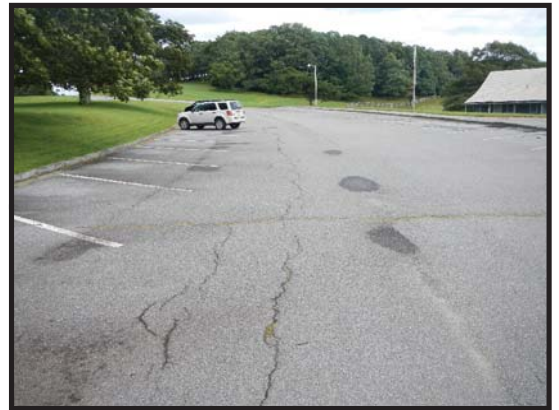
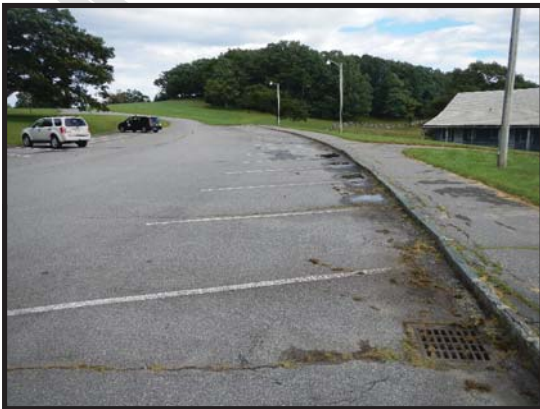
Route Number	Public / NonPublic	Date Visited	Area (sq ft)	Lane Miles *	Surface Type
1011AZ	PUBLIC	8/13/2013	19,324	0.33	AS
Culverts	Drop Inlets	Gates	Curb & Gutter	Curb	PCR
0	1	0	NO CURB AND GUTTER	STONE CURB	POOR/45

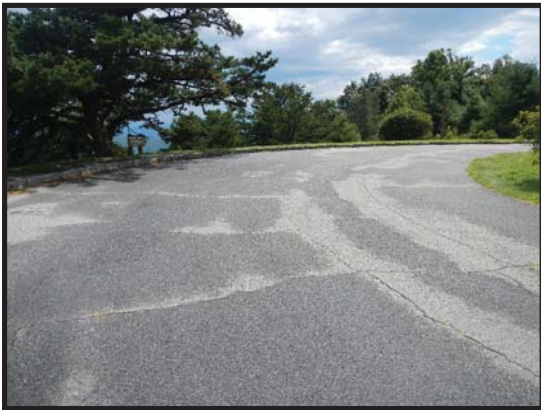
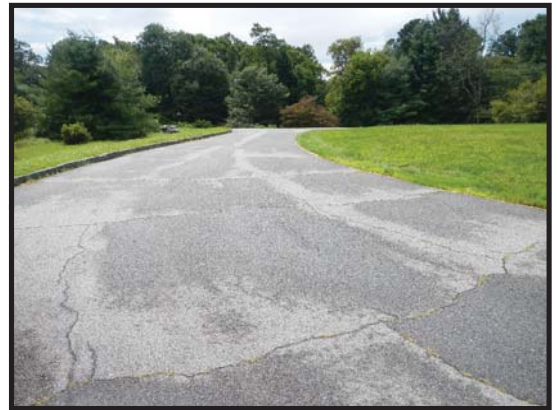
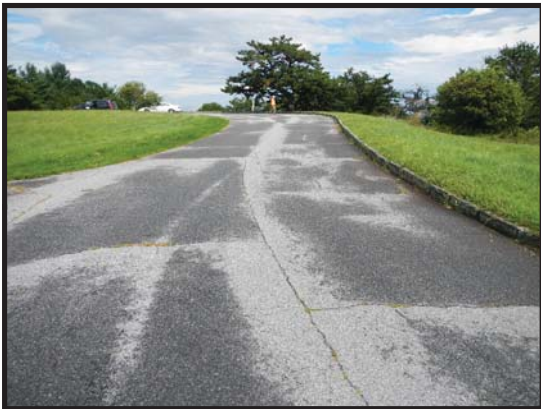
Route 1014

Route Number	Public / NonPublic	Date Visited	Area (sq ft)	Lane Miles *	Surface Type
1014	PUBLIC	8/13/2013	9,814	0.17	AS
Culverts	Drop Inlets	Gates	Curb & Gutter	Curb	PCR
0	0	0	NO CURB AND GUTTER	STONE CURB	POOR/45

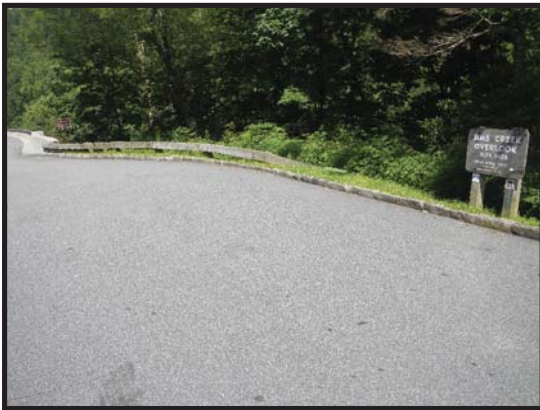
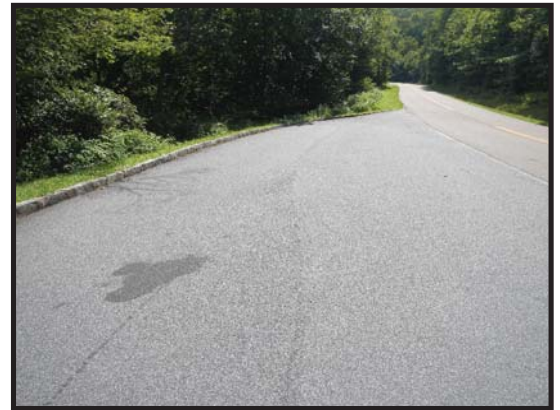
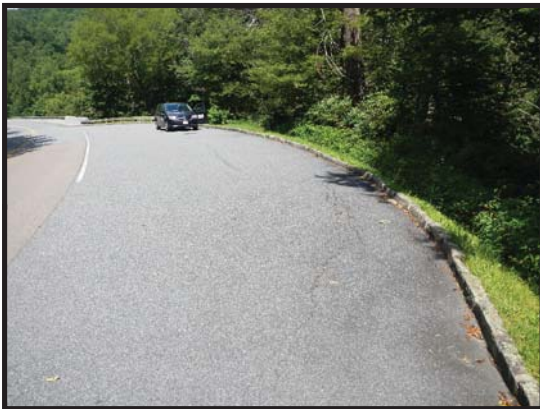
Route 1038

Route Number	Public / NonPublic	Date Visited	Area (sq ft)	Lane Miles *	Surface Type
1038	PUBLIC	8/13/2013	4,024	0.07	AS
Culverts	Drop Inlets	Gates	Curb & Gutter	Curb	PCR
0	0	0	NO CURB AND GUTTER	STONE CURB	GOOD/90

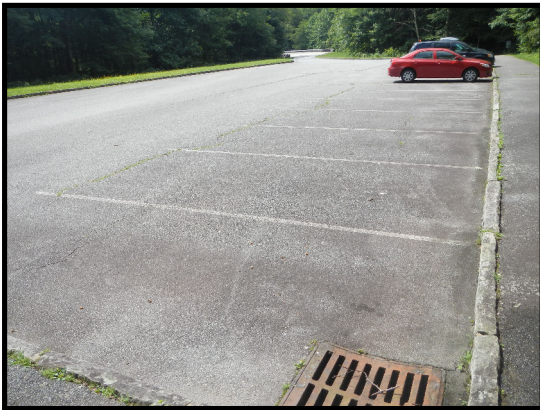
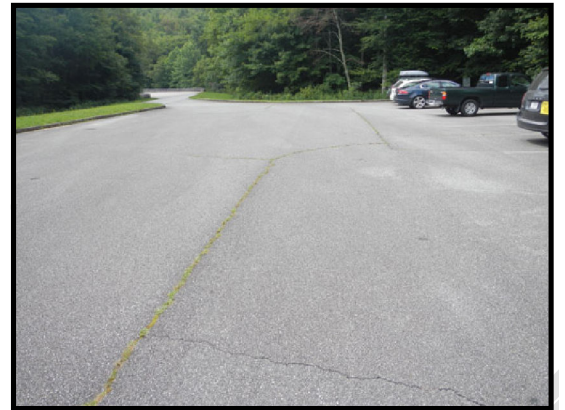
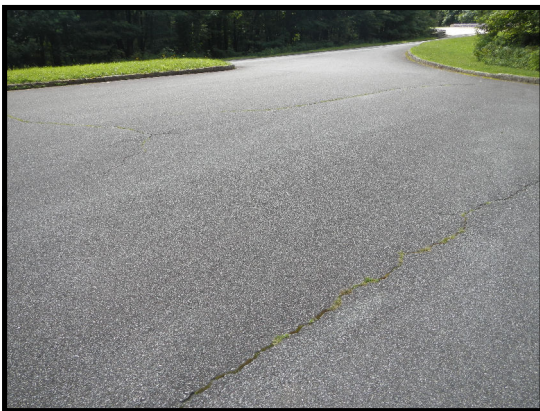
Route 1043

Route Number	Public / NonPublic	Date Visited	Area (sq ft)	Lane Miles *	Surface Type
1043	PUBLIC	8/13/2013	13,288	0.23	AS
Culverts	Drop Inlets	Gates	Curb & Gutter	Curb	PCR
1	1	0	NO CURB AND GUTTER	STONE CURB	POOR/45

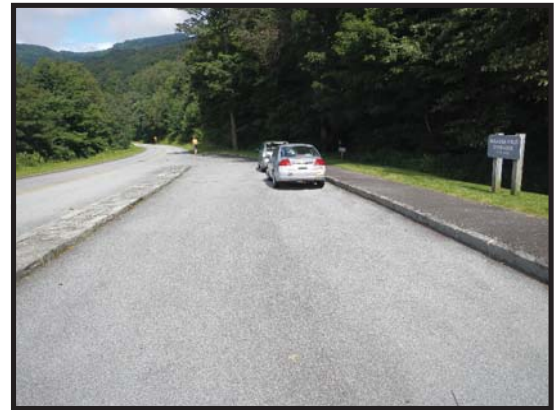
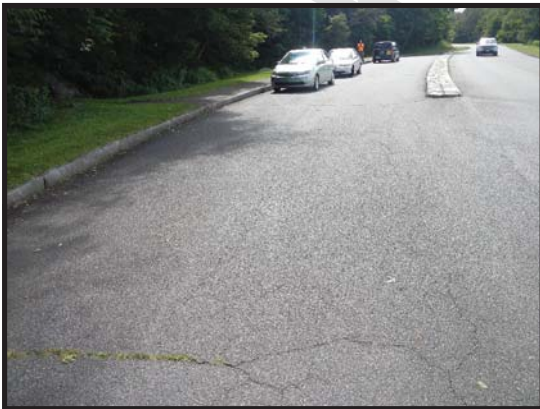
Route 1047

Route Number	Public / NonPublic	Date Visited	Area (sq ft)	Lane Miles *	Surface Type
1047	PUBLIC	8/13/2013	5,201	0.09	AS
Culverts	Drop Inlets	Gates	Curb & Gutter	Curb	PCR
1	0	0	NO CURB AND GUTTER	STONE CURB	POOR/45

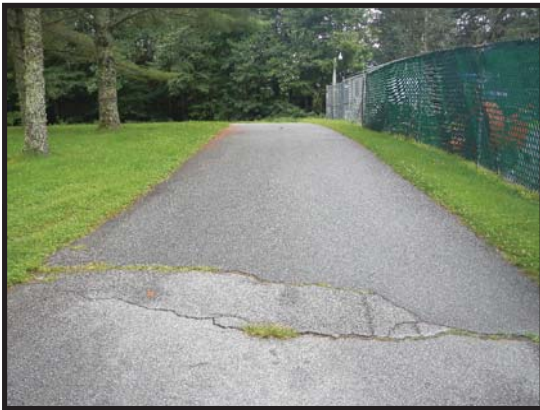
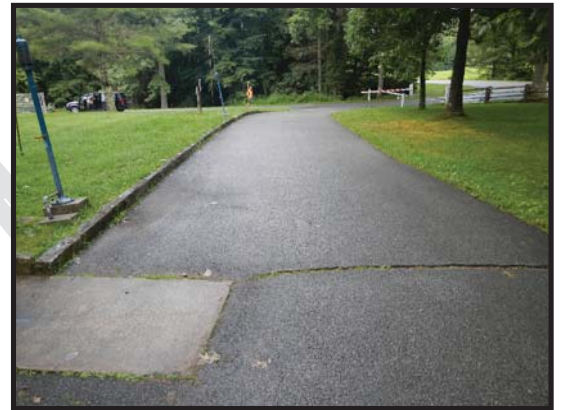
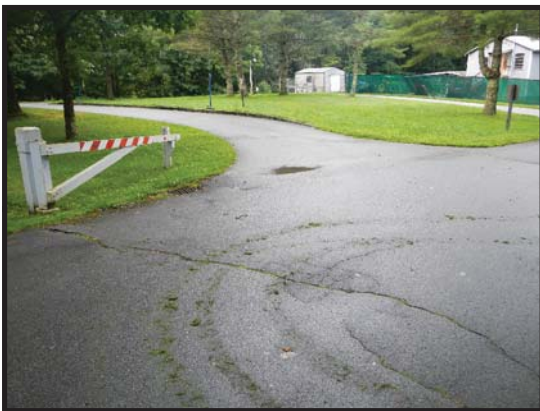
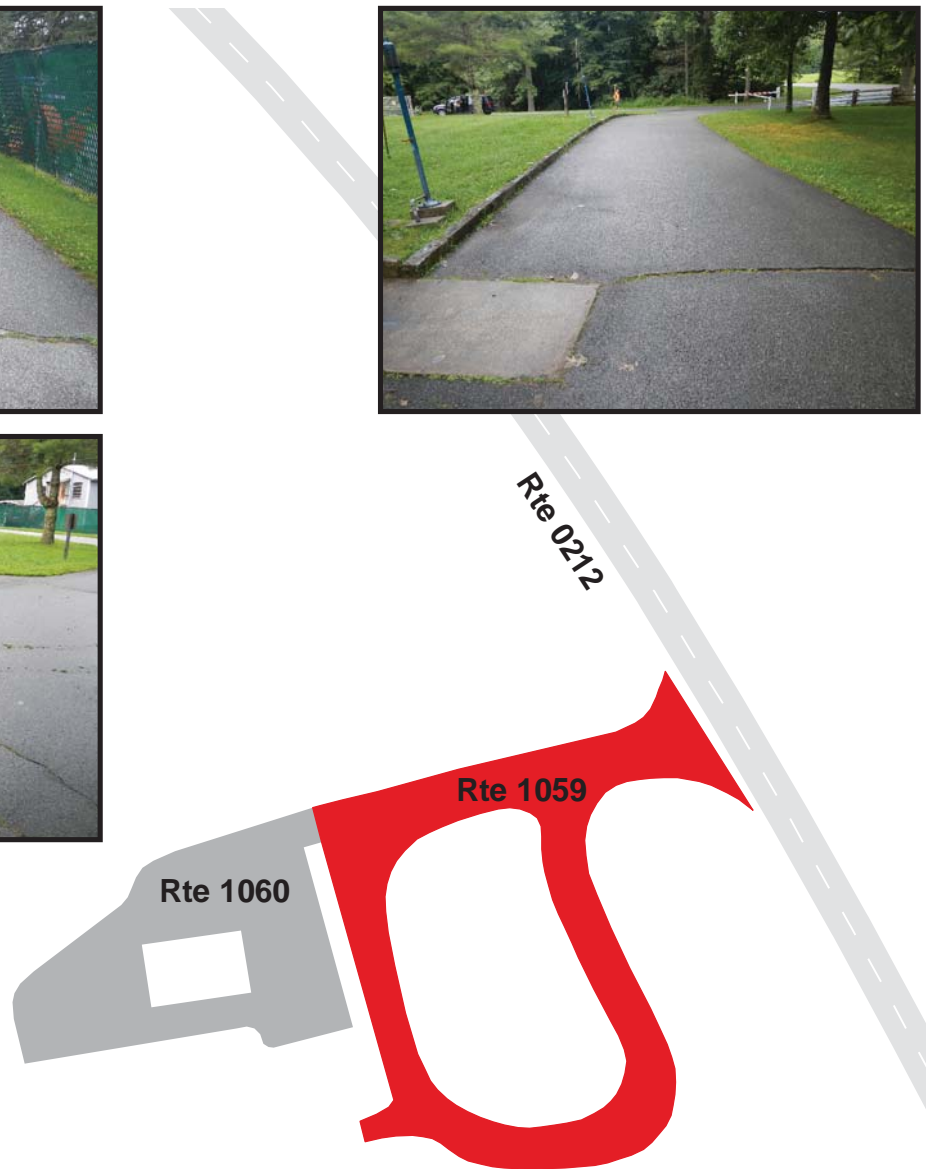
Route Number	Public / NonPublic	Date Visited	Area (sq ft)	Lane Miles *	Surface Type
1059	PUBLIC	8/13/2013	9,451	0.16	AS
Culverts	Drop Inlets	Gates	Curb & Gutter	Curb	PCR
0	1	1	NO CURB AND GUTTER	STONE CURB	FAIR/73

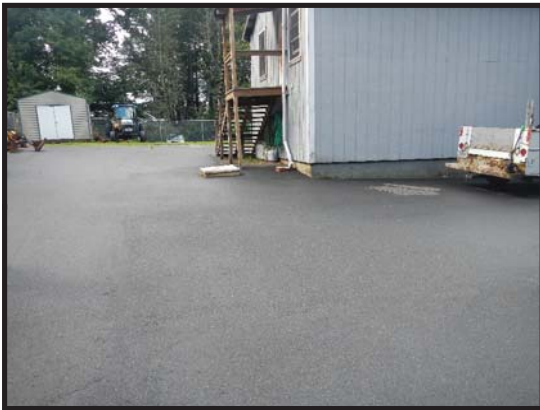
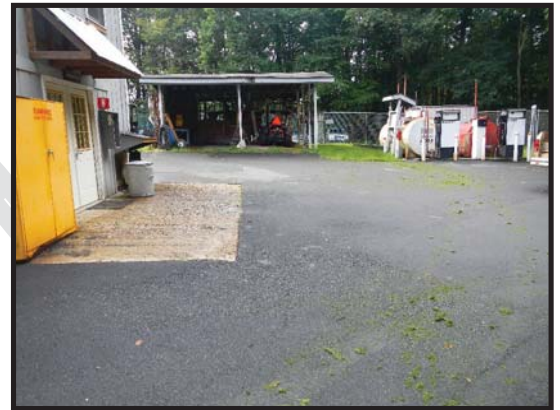
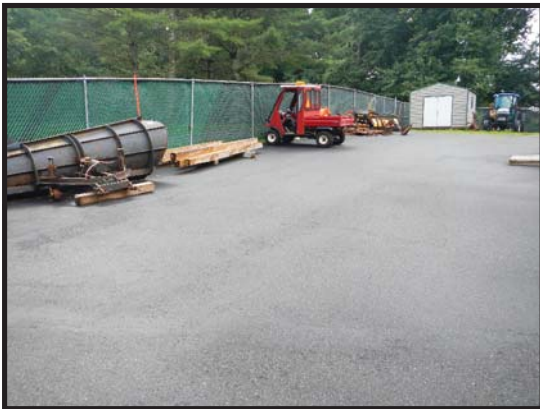
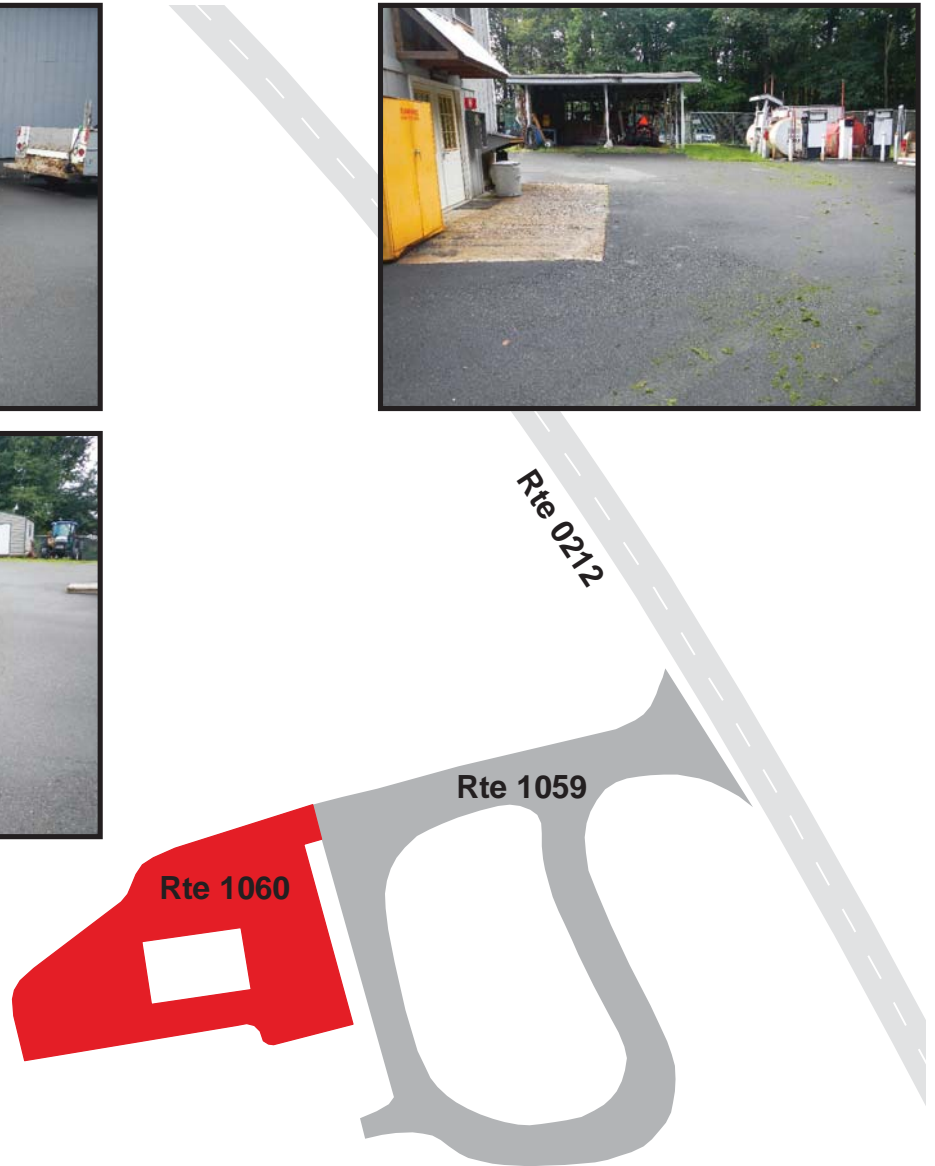
BLUE RIDGE PARKWAY
Route 1060
LINVILLE MAINTENANCE PARKING
FROM ROUTE 1059
TO PARKING

Route Number	Public / NonPublic	Date Visited	Area (sq ft)	Lane Miles *	Surface Type
1060	NONPUBLIC	8/13/2013	7,046	0.12	AS
Culverts	Drop Inlets	Gates	Curb & Gutter	Curb	PCR
0	0	3	NO CURB AND GUTTER	NO CURB	GOOD/90

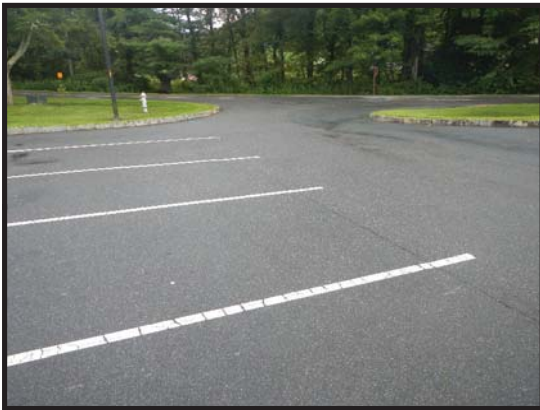
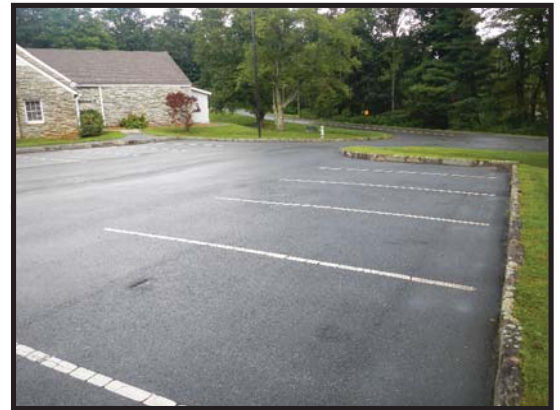
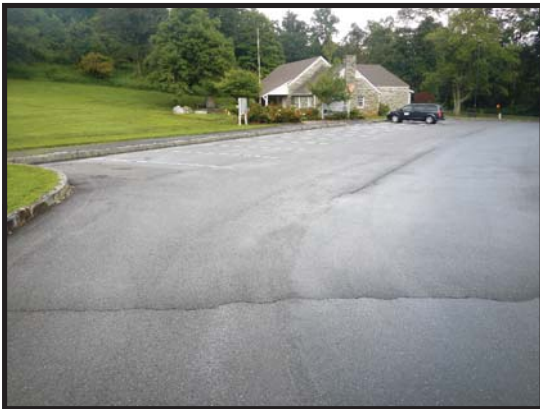
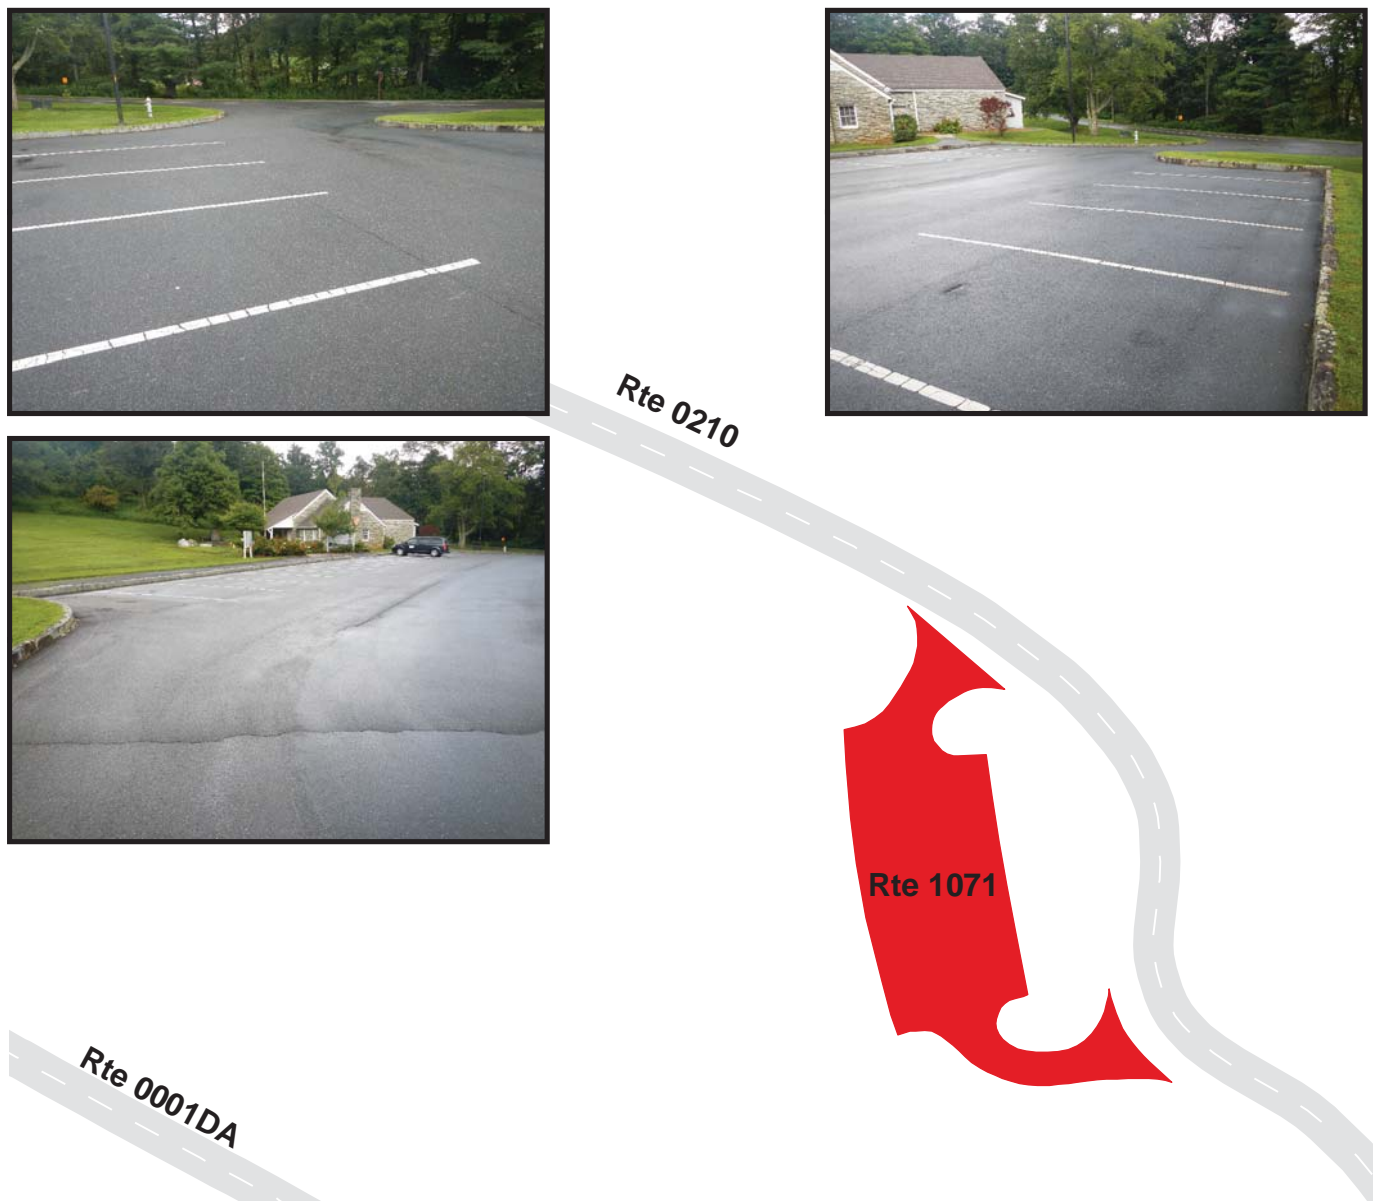
Route 1071

Route Number	Public / NonPublic	Date Visited	Area (sq ft)	Lane Miles *	Surface Type
1071	PUBLIC	8/13/2013	13,138	0.23	AS
Culverts	Drop Inlets	Gates	Curb & Gutter	Curb	PCR
1	1	0	NO CURB AND GUTTER	STONE CURB	GOOD/90

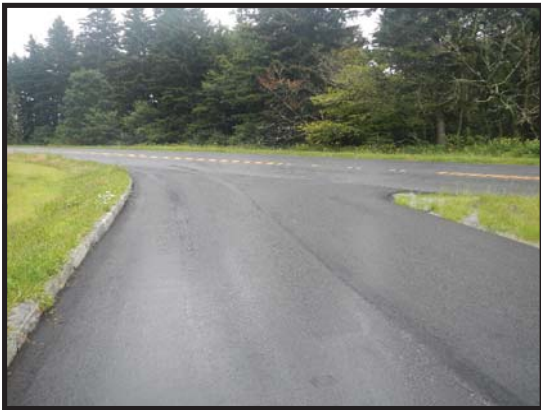
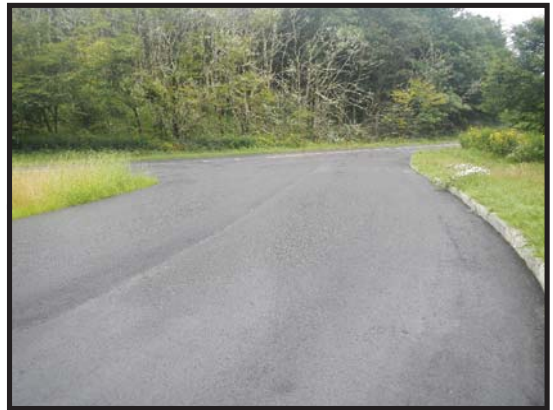
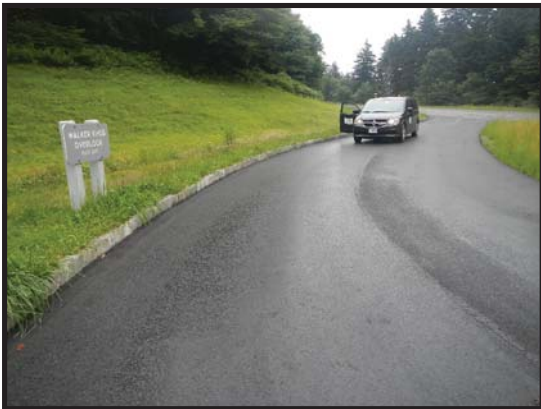
Route 1082

Route Number	Public / NonPublic	Date Visited	Area (sq ft)	Lane Miles *	Surface Type
1082	PUBLIC	8/12/2013	4,193	0.07	AS
Culverts	Drop Inlets	Gates	Curb & Gutter	Curb	PCR
0	0	0	NO CURB AND GUTTER	STONE CURB	GOOD/90

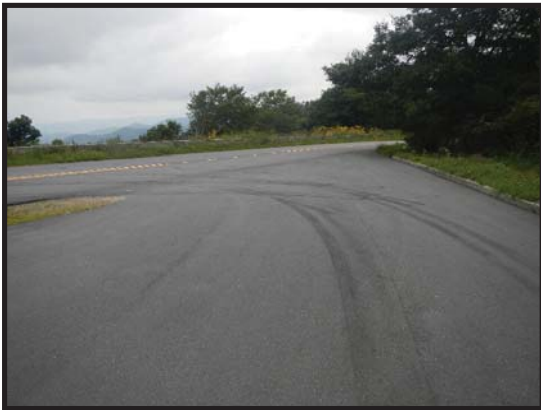
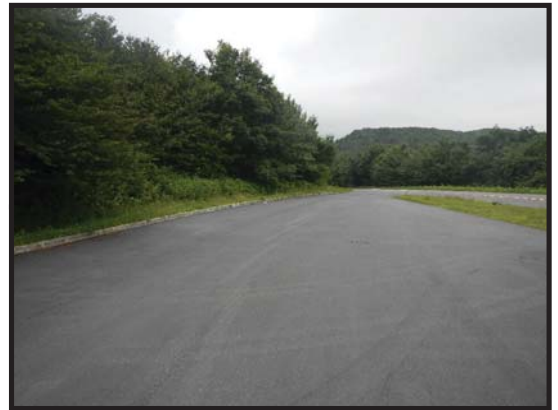
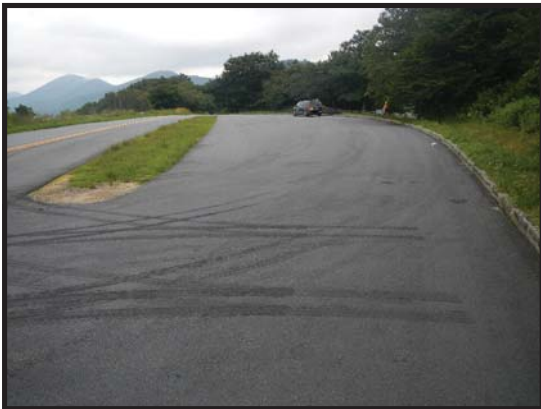
Route 1083

Route Number	Public / NonPublic	Date Visited	Area (sq ft)	Lane Miles *	Surface Type
1083	PUBLIC	8/12/2013	8,851	0.15	AS
Culverts	Drop Inlets	Gates	Curb & Gutter	Curb	PCR
1	0	0	NO CURB AND GUTTER	STONE CURB	GOOD/90

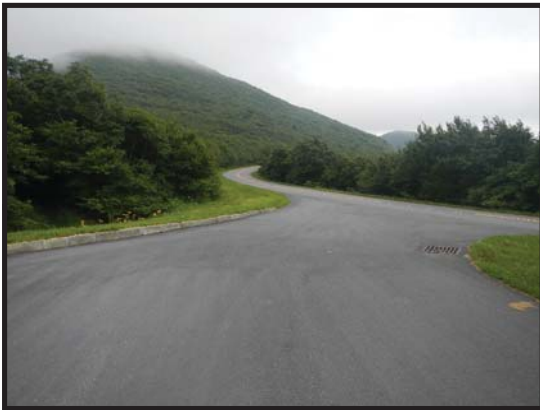
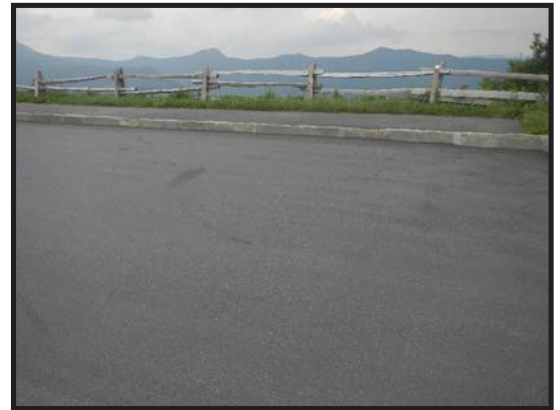
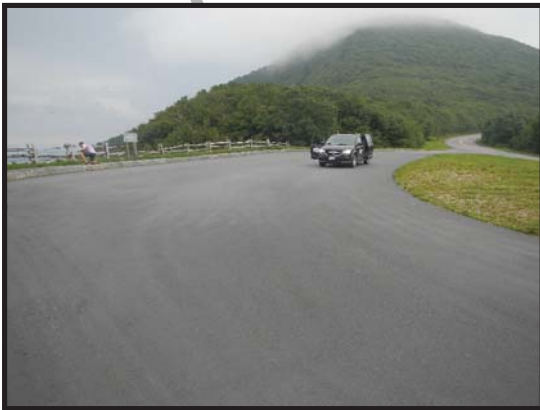
Route 1084

Route Number	Public / NonPublic	Date Visited	Area (sq ft)	Lane Miles *	Surface Type
1084	PUBLIC	8/12/2013	8,453	0.15	AS
Culverts	Drop Inlets	Gates	Curb & Gutter	Curb	PCR
0	1	0	NO CURB AND GUTTER	STONE CURB	GOOD/90

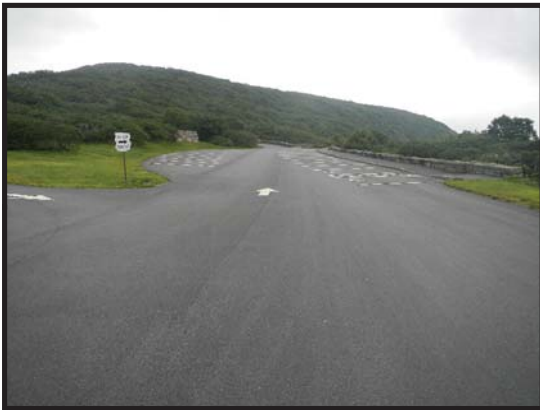
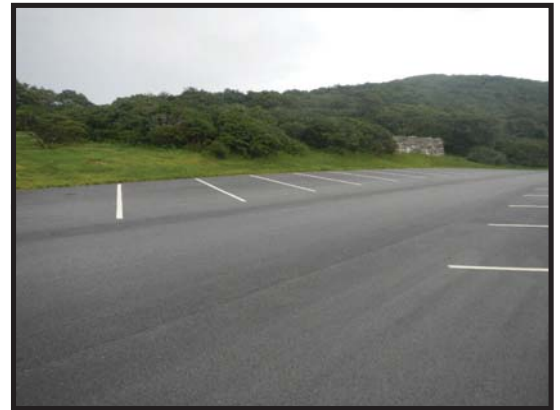
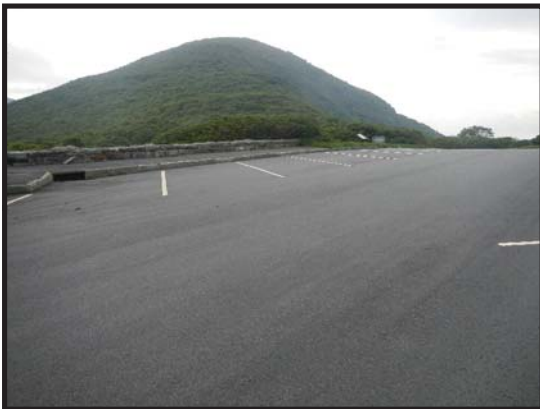
Route 1085

Route Number	Public / NonPublic	Date Visited	Area (sq ft)	Lane Miles *	Surface Type
1085	PUBLIC	8/12/2013	29,616	0.51	AS
Culverts	Drop Inlets	Gates	Curb & Gutter	Curb	PCR
0	5	0	NO CURB AND GUTTER	STONE CURB	GOOD/90

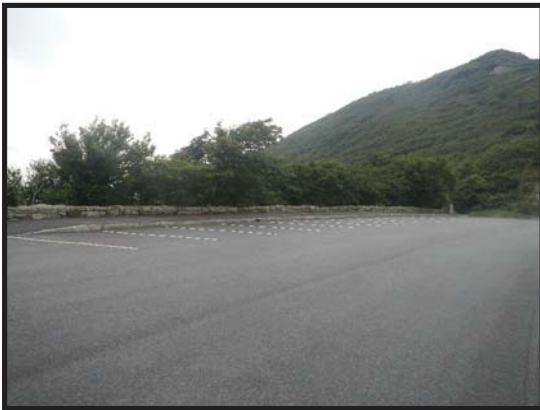
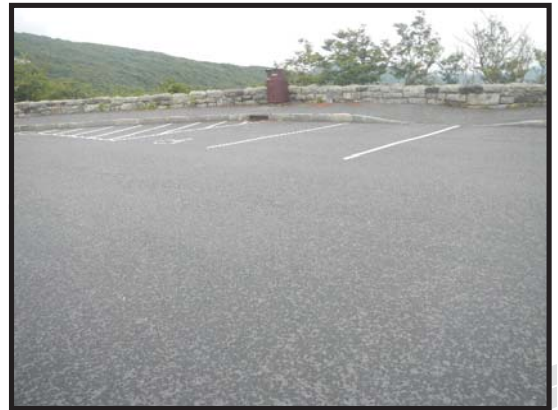
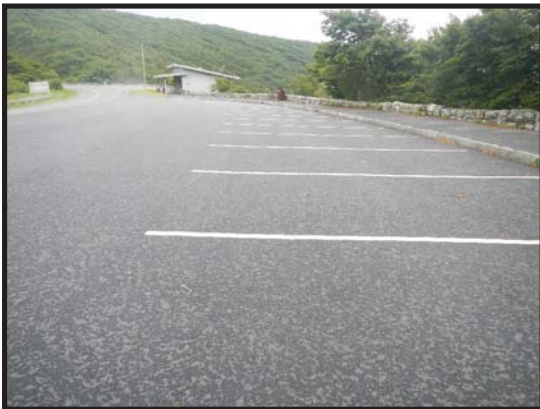
Route Number	Public / NonPublic	Date Visited	Area (sq ft)	Lane Miles *	Surface Type
1086AZ	PUBLIC	8/12/2013	9,820	0.17	AS
Culverts	Drop Inlets	Gates	Curb & Gutter	Curb	PCR
0	1	0	NO CURB AND GUTTER	STONE CURB	GOOD/90

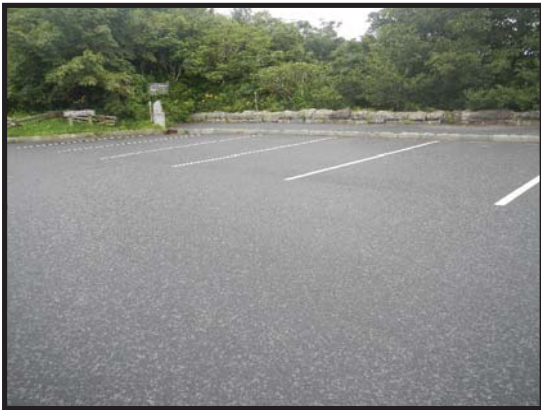
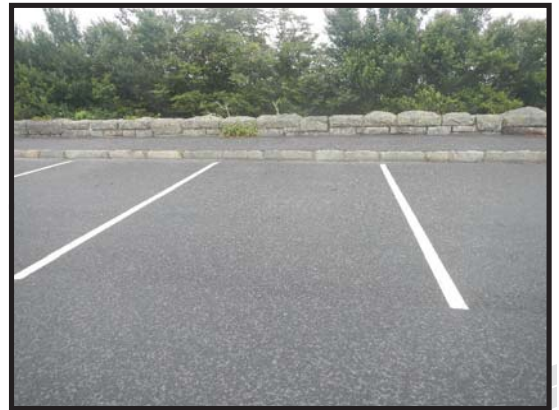
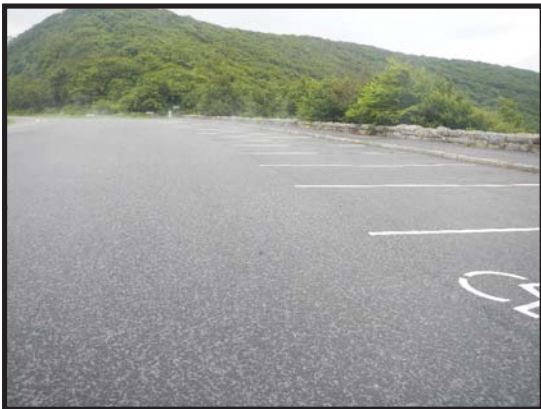
Route 1086BZ

Route Number	Public / NonPublic	Date Visited	Area (sq ft)	Lane Miles *	Surface Type
1086BZ	PUBLIC	8/12/2013	14,376	0.25	AS
Culverts	Drop Inlets	Gates	Curb & Gutter	Curb	PCR
0	1	0	NO CURB AND GUTTER	STONE CURB	GOOD/90

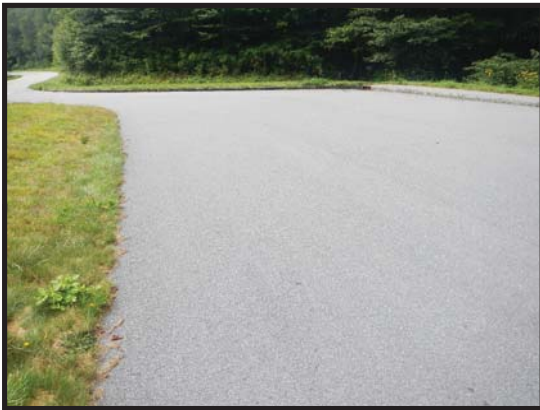
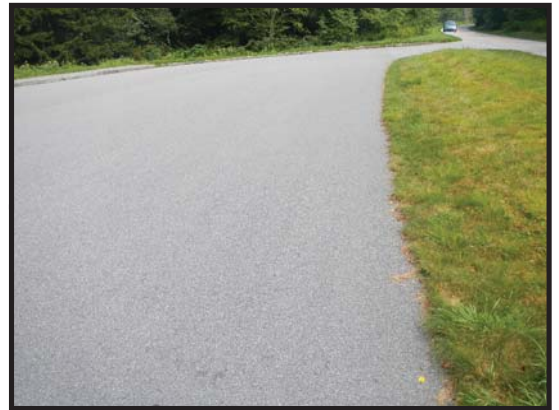
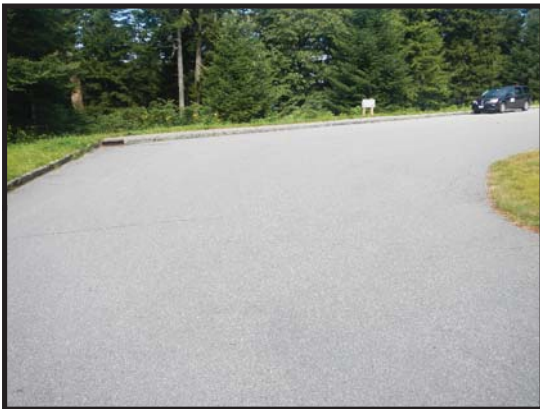
Route 1128

Route Number	Public / NonPublic	Date Visited	Area (sq ft)	Lane Miles *	Surface Type
1128	PUBLIC	8/12/2013	9,822	0.17	AS
Culverts	Drop Inlets	Gates	Curb & Gutter	Curb	PCR
0	1	0	NO CURB AND GUTTER	STONE CURB	GOOD/90

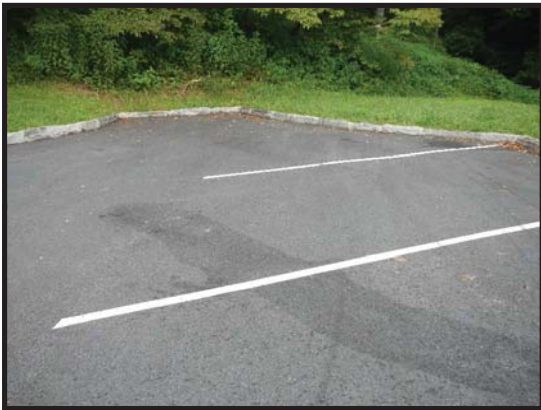
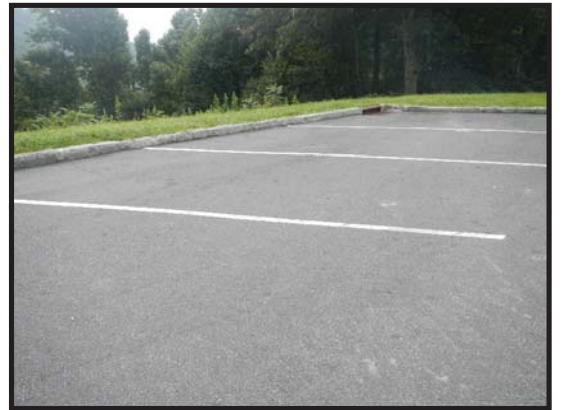
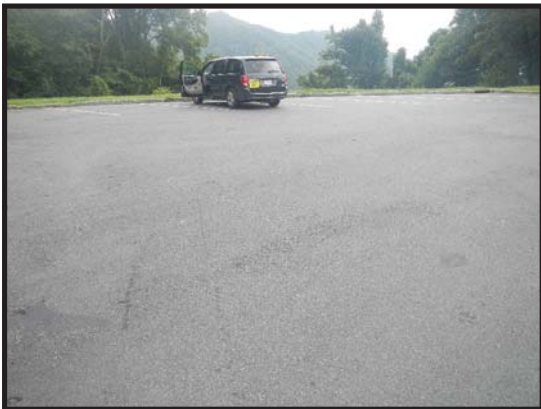
Route 1188

Route Number	Public / NonPublic	Date Visited	Area (sq ft)	Lane Miles *	Surface Type
1188	PUBLIC	8/12/2013	4,662	0.08	AS
Culverts	Drop Inlets	Gates	Curb & Gutter	Curb	PCR
0	2	0	NO CURB AND GUTTER	STONE CURB	GOOD/90

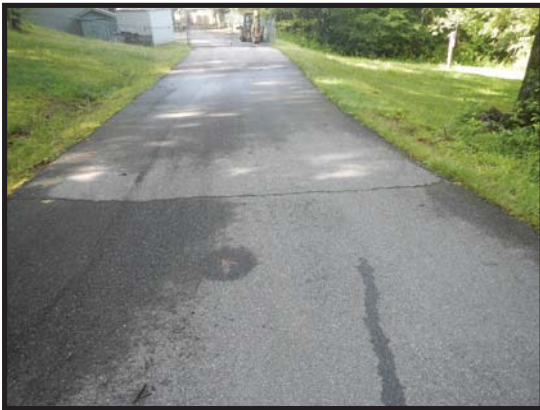
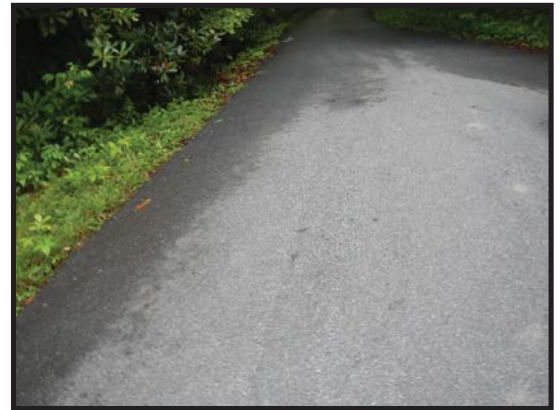
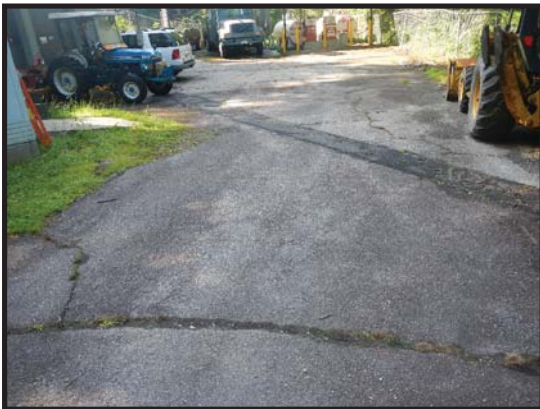
Route 1190

Route Number	Public / NonPublic	Date Visited	Area (sq ft)	Lane Miles *	Surface Type
1190	PUBLIC	8/12/2013	5,509	0.10	AS
Culverts	Drop Inlets	Gates	Curb & Gutter	Curb	PCR
0	0	1	NO CURB AND GUTTER	NO CURB	POOR/45

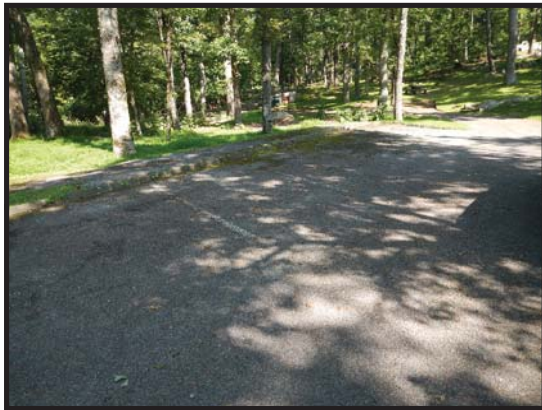
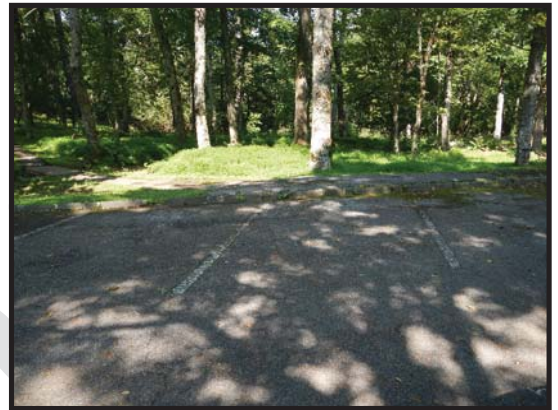
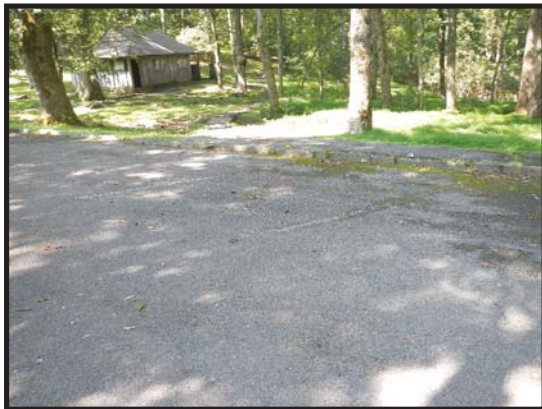
Route Number	Public / NonPublic	Date Visited	Area (sq ft)	Lane Miles *	Surface Type
1218FZ	PUBLIC	8/14/2013	1,265	0.02	AS
Culverts	Drop Inlets	Gates	Curb & Gutter	Curb	PCR
0	0	0	NO CURB AND GUTTER	STONE CURB	POOR/45

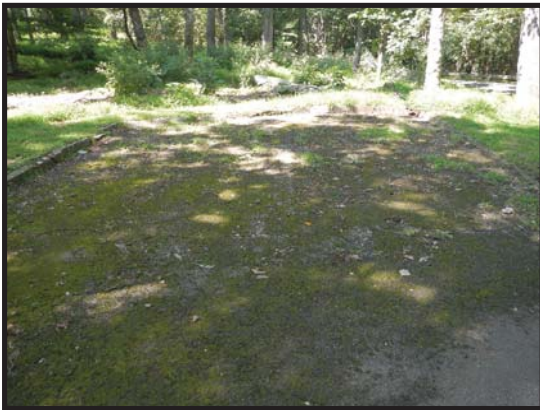
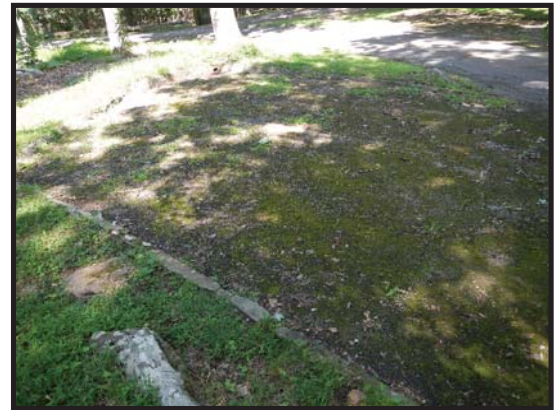
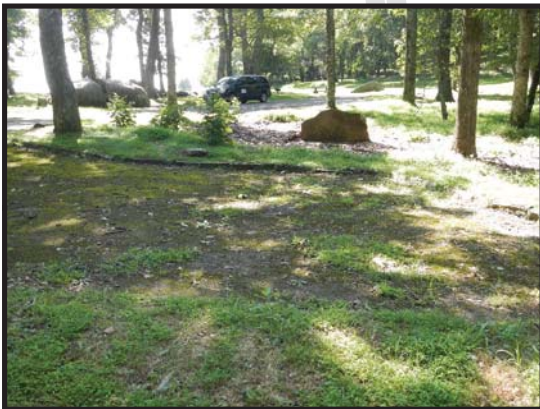
Rte 1218GZ

Route Number	Public / NonPublic	Date Visited	Area (sq ft)	Lane Miles *	Surface Type
1218GZ	PUBLIC	8/14/2013	392	0.01	AS
Culverts	Drop Inlets	Gates	Curb & Gutter	Curb	PCR
0	0	0	NO CURB AND GUTTER	STONE CURB	POOR/45
