Federal Lands Highway Road Inventory Program

Road Inventory and Condition Assessment

Blue Ridge Parkway BLRI

Cycle 5 Report

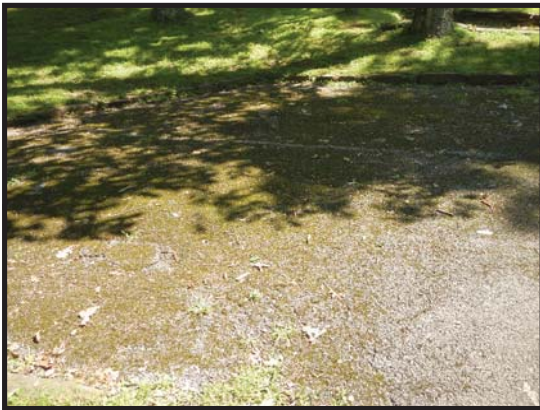
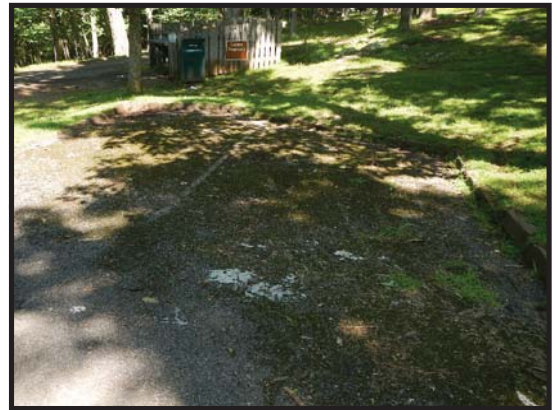
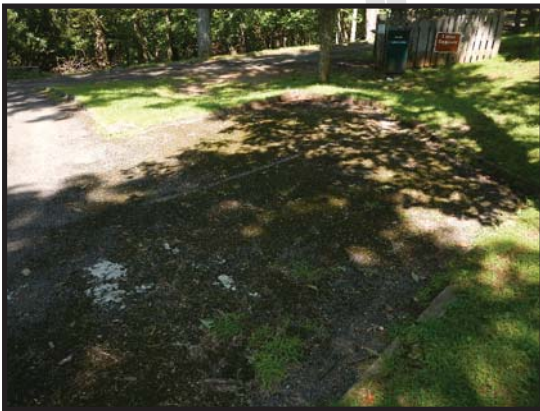
Route 1218HZ

Route Number	Public / NonPublic	Date Visited	Area (sq ft)	Lane Miles *	Surface Type
1218HZ	PUBLIC	8/14/2013	405	0.01	AS
Culverts	Drop Inlets	Gates	Curb & Gutter	Curb	PCR
0	0	0	NO CURB AND GUTTER	STONE CURB	POOR/45

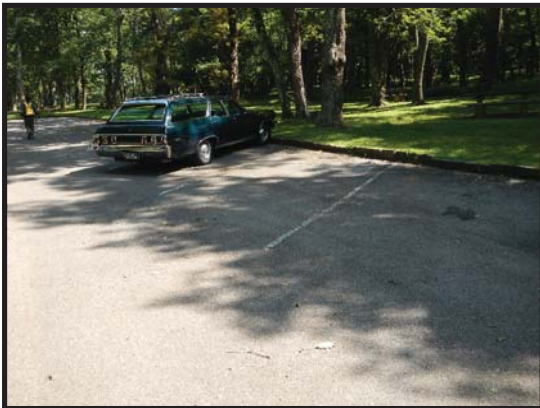
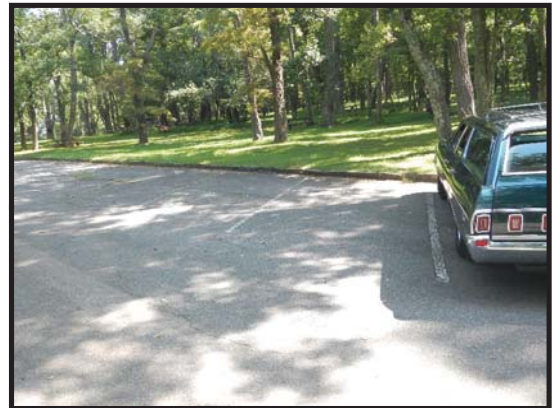
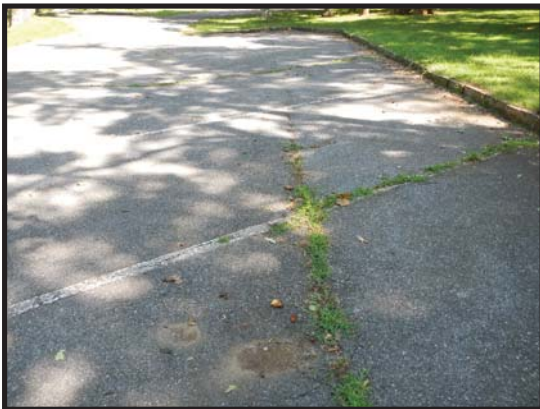
Route 1218IZ

Route Number	Public / NonPublic	Date Visited	Area (sq ft)	Lane Miles *	Surface Type
1218IZ	PUBLIC	8/14/2013	3,012	0.05	AS
Culverts	Drop Inlets	Gates	Curb & Gutter	Curb	PCR
0	0	0	NO CURB AND GUTTER	STONE CURB	POOR/45

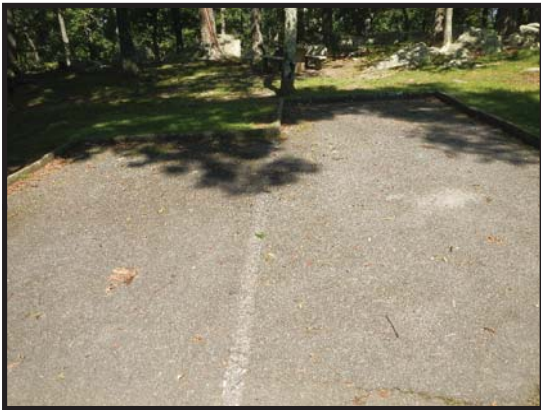
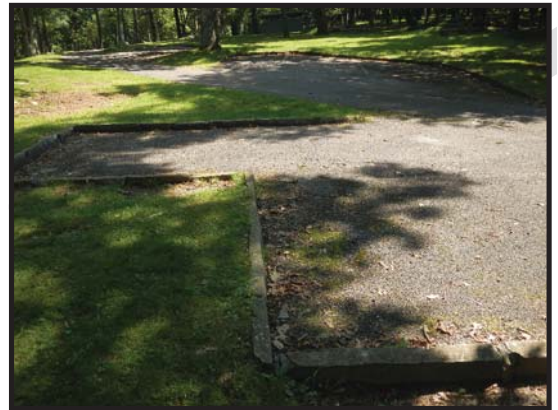
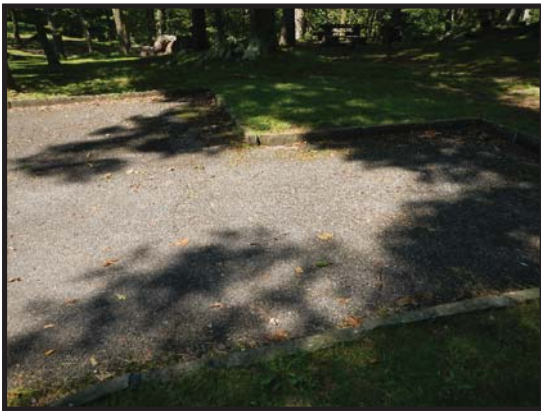
Route 1218JZ

Route Number	Public / NonPublic	Date Visited	Area (sq ft)	Lane Miles *	Surface Type
1218JZ	PUBLIC	8/14/2013	567	0.01	AS
Culverts	Drop Inlets	Gates	Curb & Gutter	Curb	PCR
0	0	0	NO CURB AND GUTTER	STONE CURB	FAIR/73

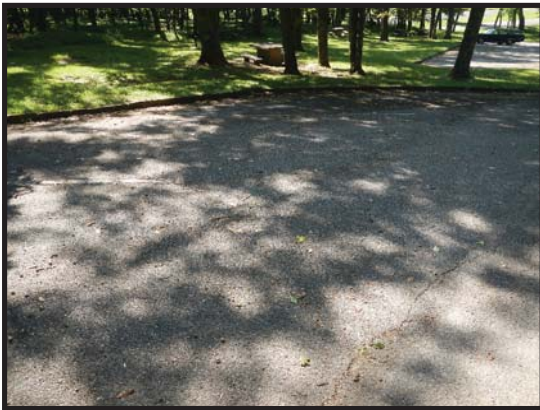
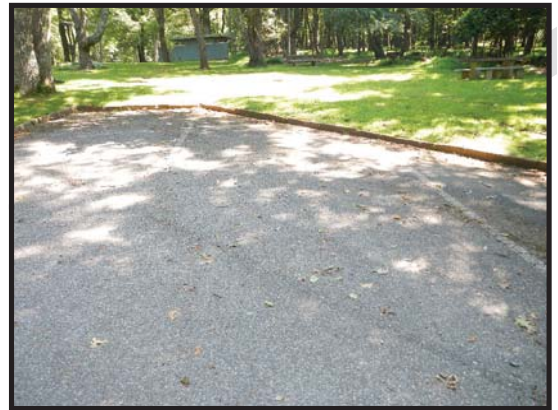
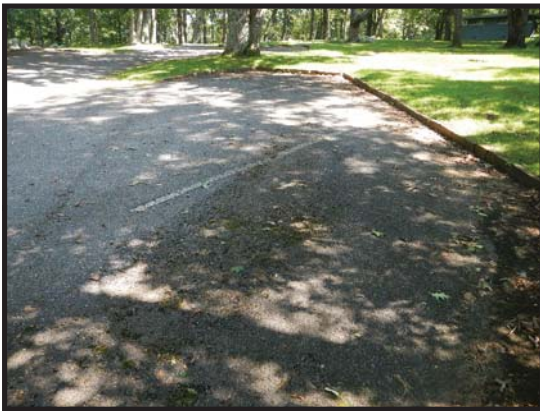
Route 1218KZ

Route Number	Public / NonPublic	Date Visited	Area (sq ft)	Lane Miles *	Surface Type
1218KZ	PUBLIC	8/14/2013	1,038	0.02	AS
Culverts	Drop Inlets	Gates	Curb & Gutter	Curb	PCR
0	0	0	NO CURB AND GUTTER	STONE CURB	FAIR/73

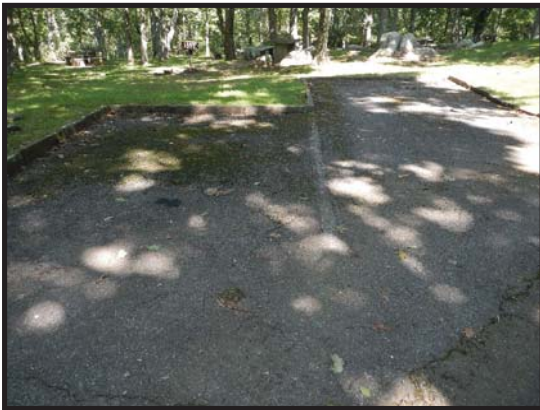
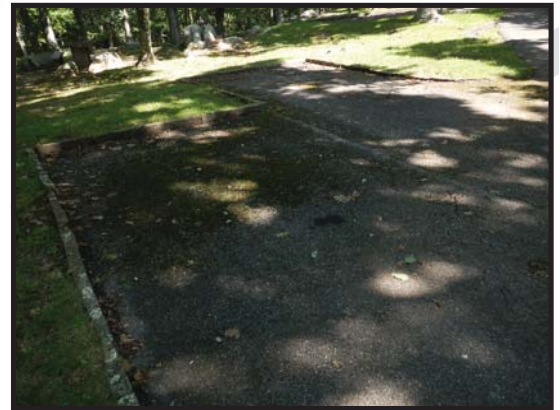
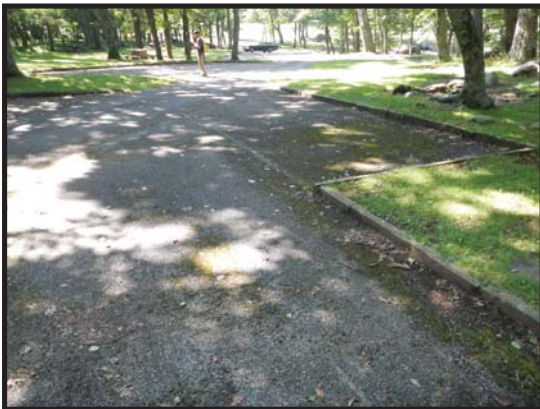
Route 1218LZ

Route Number	Public / NonPublic	Date Visited	Area (sq ft)	Lane Miles *	Surface Type
1218LZ	PUBLIC	8/14/2013	430	0.01	AS
Culverts	Drop Inlets	Gates	Curb & Gutter	Curb	PCR
0	0	0	NO CURB AND GUTTER	STONE CURB	POOR/45

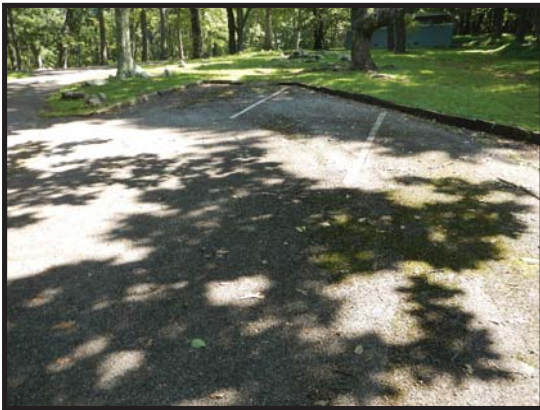
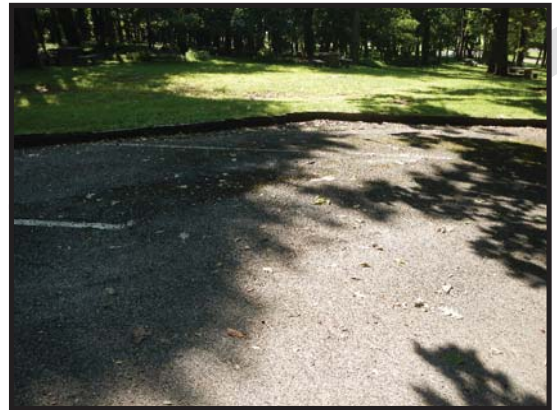
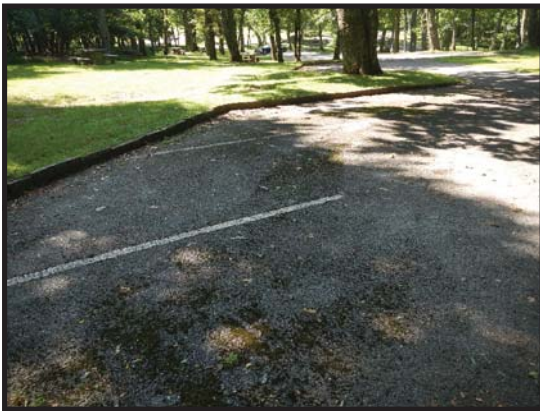
Route 1218MZ

Route Number	Public / NonPublic	Date Visited	Area (sq ft)	Lane Miles *	Surface Type
1218MZ	PUBLIC	8/14/2013	897	0.02	AS
Culverts	Drop Inlets	Gates	Curb & Gutter	Curb	PCR
0	0	0	NO CURB AND GUTTER	STONE CURB	FAIR/73

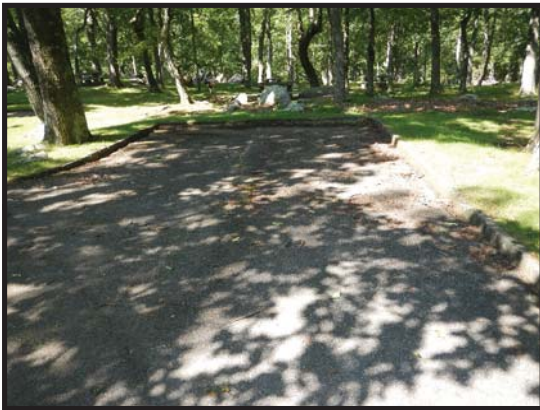
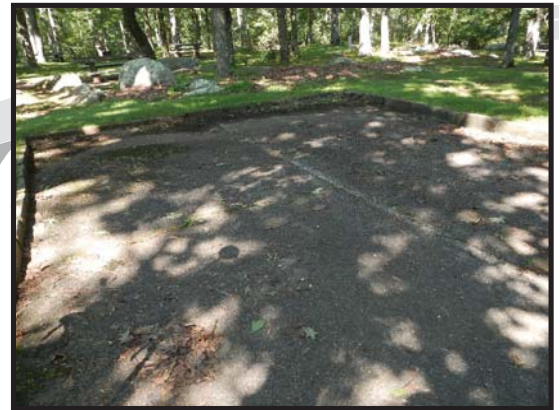
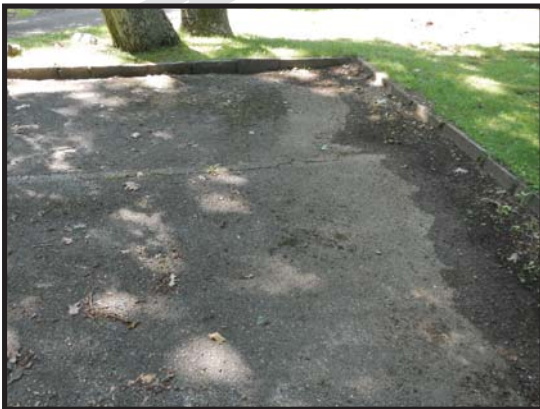
Route 1218NZ

Route Number	Public / NonPublic	Date Visited	Area (sq ft)	Lane Miles *	Surface Type
1218NZ	PUBLIC	8/14/2013	389	0.01	AS
Culverts	Drop Inlets	Gates	Curb & Gutter	Curb	PCR
0	0	0	NO CURB AND GUTTER	STONE CURB	POOR/45

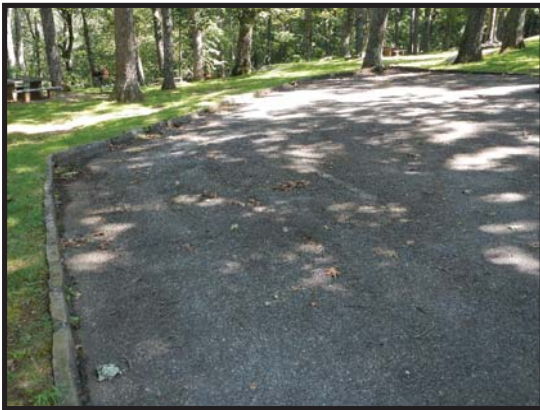
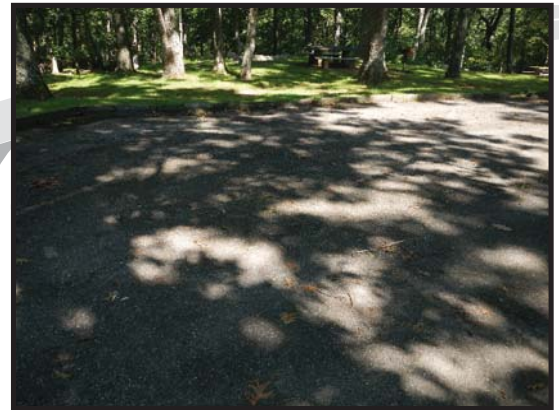
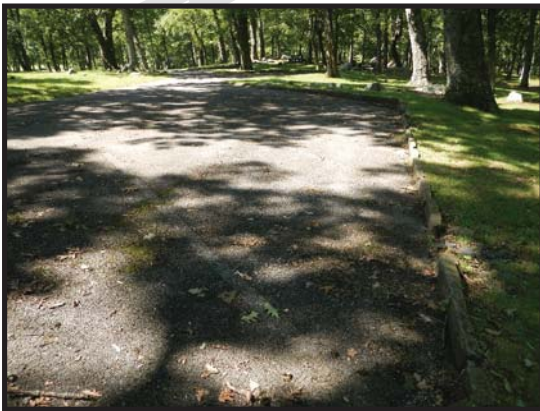
Route 1218OZ

Route Number	Public / NonPublic	Date Visited	Area (sq ft)	Lane Miles *	Surface Type
1218OZ	PUBLIC	8/14/2013	790	0.01	AS
Culverts	Drop Inlets	Gates	Curb & Gutter	Curb	PCR
0	0	0	NO CURB AND GUTTER	STONE CURB	POOR/45

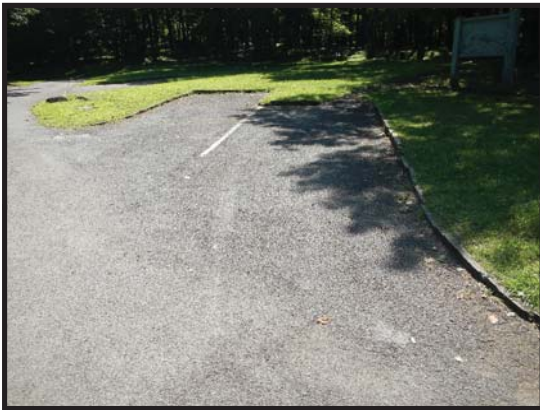
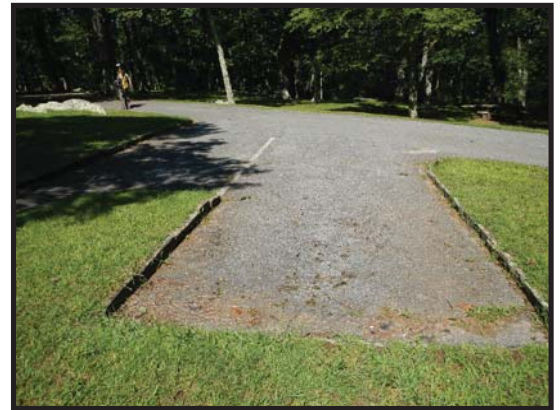
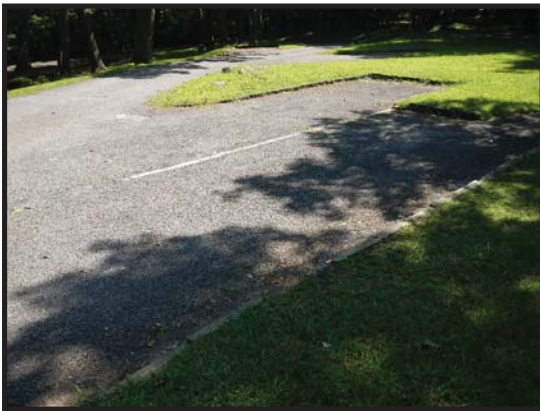
Route 1218PZ

Route Number	Public / NonPublic	Date Visited	Area (sq ft)	Lane Miles *	Surface Type
1218PZ	PUBLIC	8/14/2013	593	0.01	AS
Culverts	Drop Inlets	Gates	Curb & Gutter	Curb	PCR
0	0	0	NO CURB AND GUTTER	STONE CURB	FAIR/73

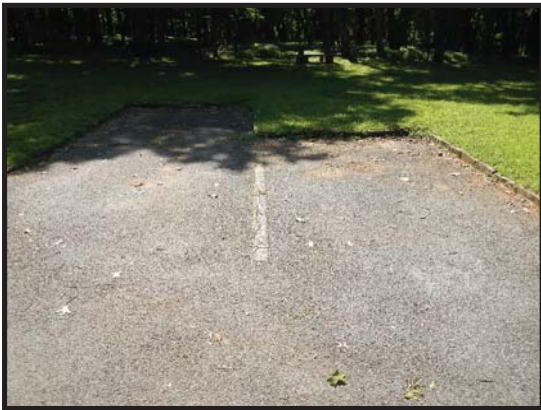
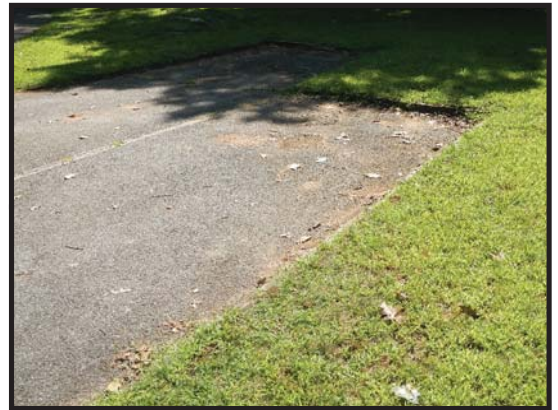
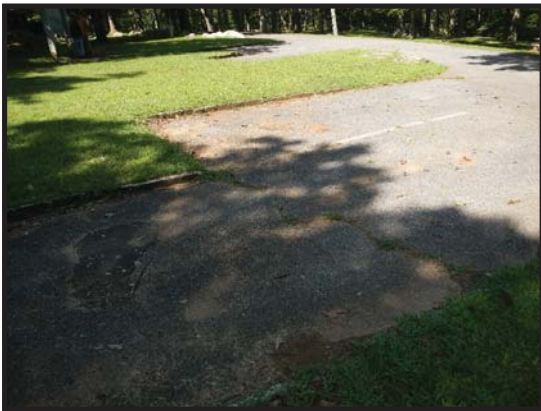
Route 1218QZ

Route Number	Public / NonPublic	Date Visited	Area (sq ft)	Lane Miles *	Surface Type
1218QZ	PUBLIC	8/14/2013	428	0.01	AS
Culverts	Drop Inlets	Gates	Curb & Gutter	Curb	PCR
0	0	0	NO CURB AND GUTTER	STONE CURB	POOR/45

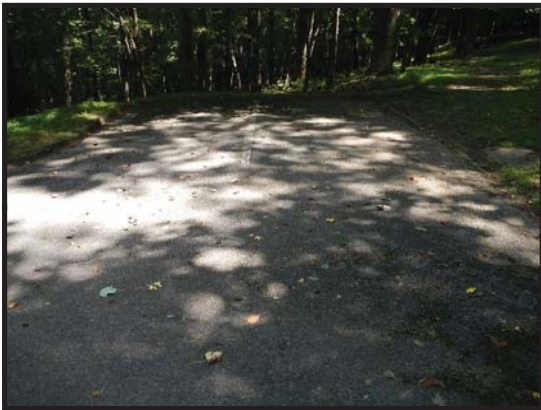
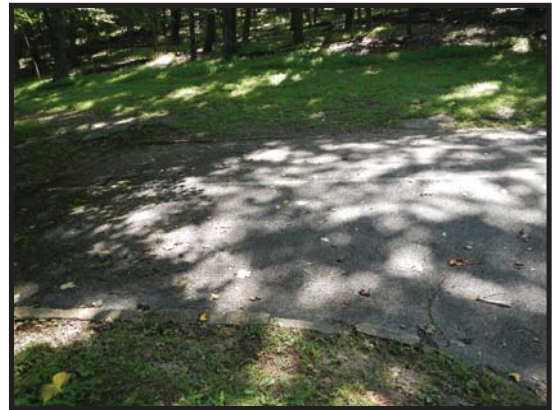
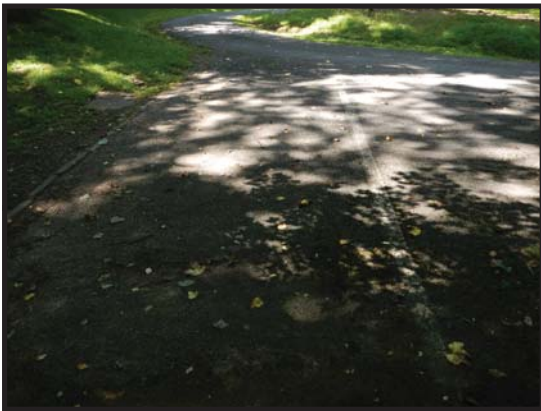
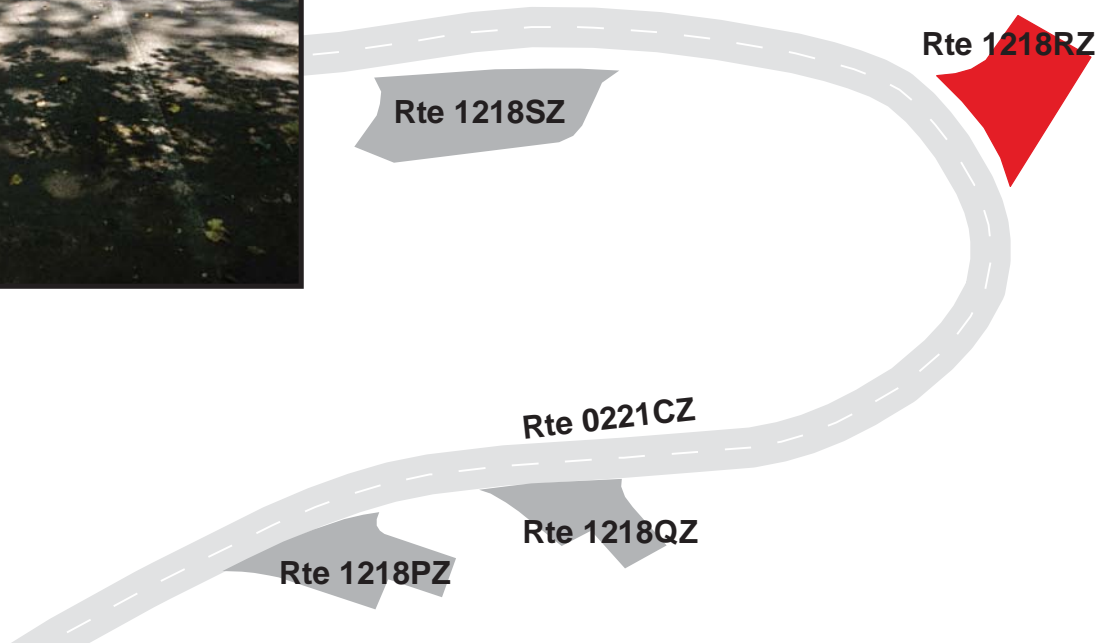
Route Number	Public / NonPublic	Date Visited	Area (sq ft)	Lane Miles *	Surface Type
1218RZ	PUBLIC	8/14/2013	609	0.01	AS
Culverts	Drop Inlets	Gates	Curb & Gutter	Curb	PCR
0	0	0	NO CURB AND GUTTER	STONE CURB	FAIR/73

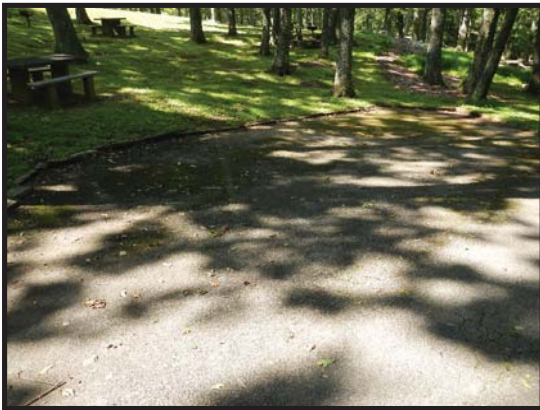
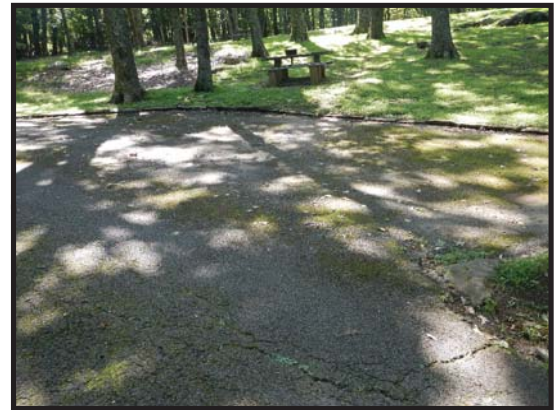
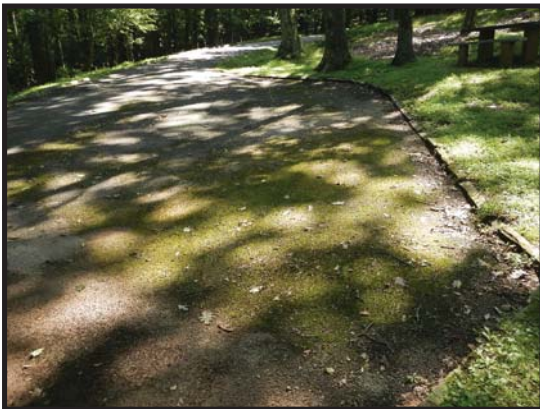
Route 1218SZ

Route Number	Public / NonPublic	Date Visited	Area (sq ft)	Lane Miles *	Surface Type
1218SZ	PUBLIC	8/14/2013	952	0.02	AS
Culverts	Drop Inlets	Gates	Curb & Gutter	Curb	PCR
0	0	0	NO CURB AND GUTTER	STONE CURB	FAIR/73

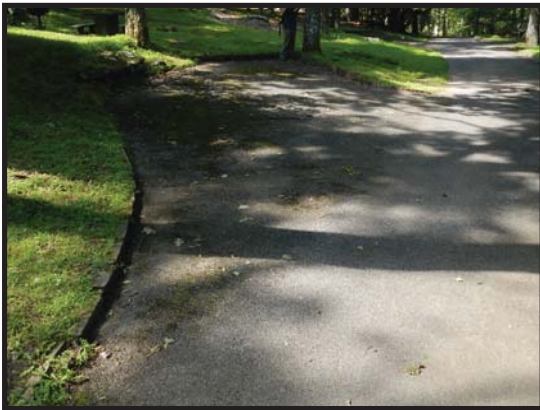
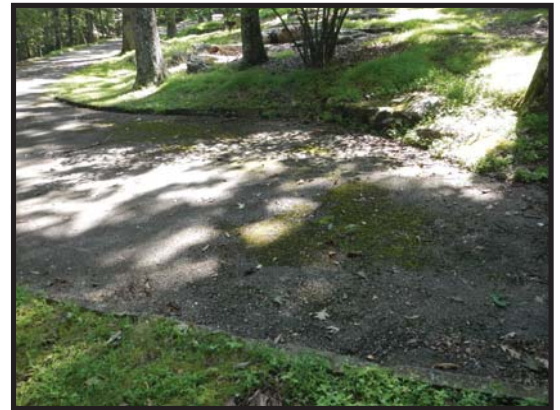
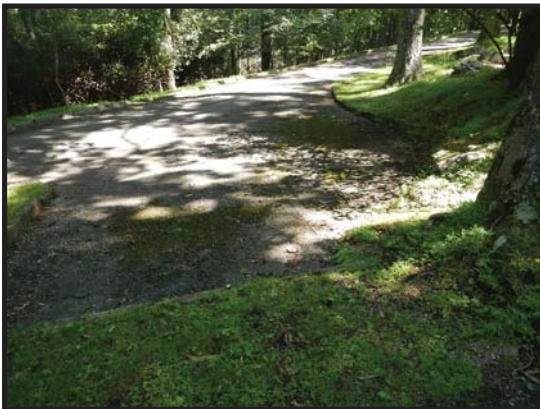
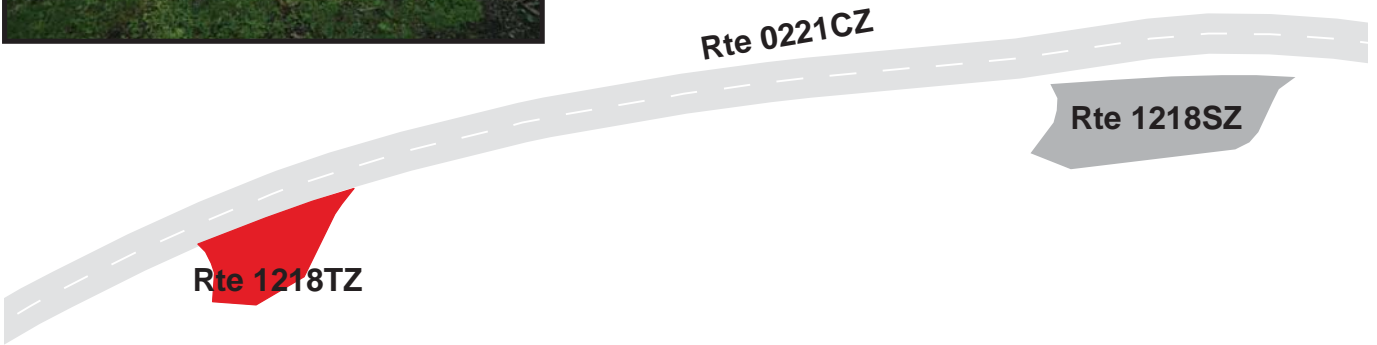
Route 1218TZ

Route Number	Public / NonPublic	Date Visited	Area (sq ft)	Lane Miles *	Surface Type
1218TZ	PUBLIC	8/14/2013	470	0.01	AS
Culverts	Drop Inlets	Gates	Curb & Gutter	Curb	PCR
0	0	0	NO CURB AND GUTTER	STONE CURB	FAIR/73

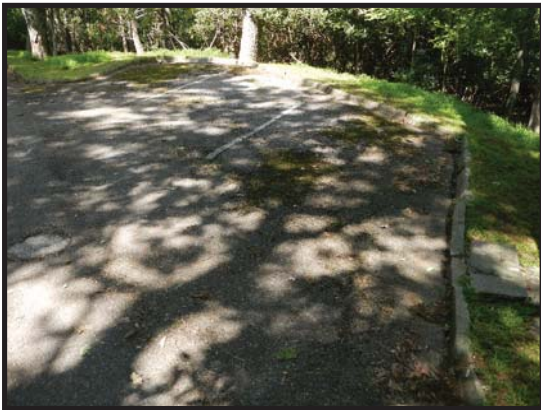
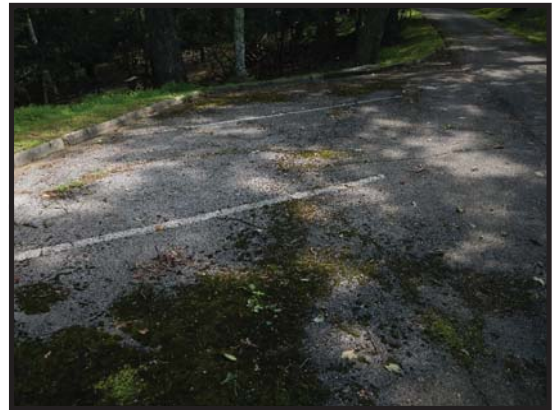
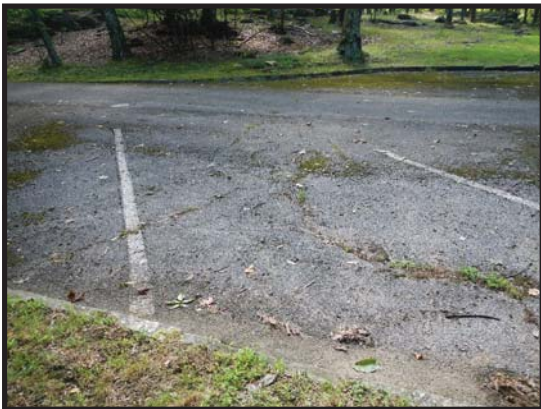
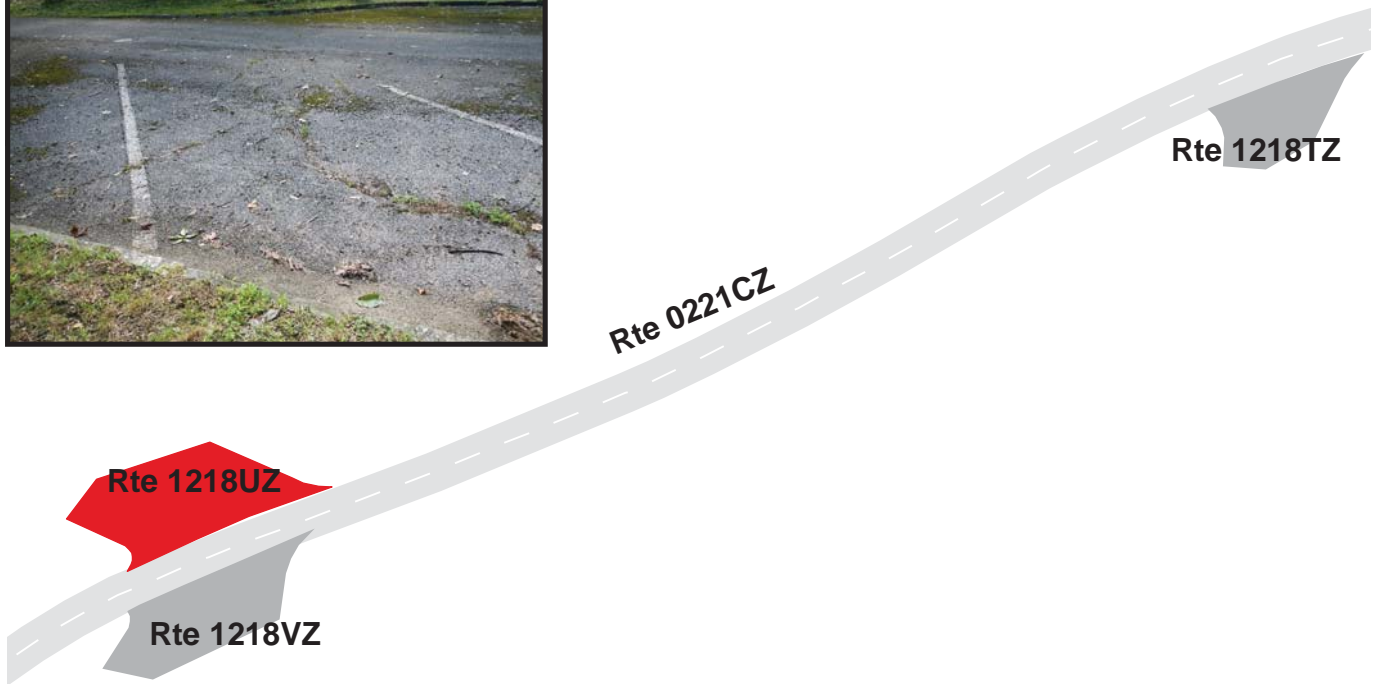
Route 1218UZ

Route Number	Public / NonPublic	Date Visited	Area (sq ft)	Lane Miles *	Surface Type
1218UZ	PUBLIC	8/14/2013	852	0.02	AS
Culverts	Drop Inlets	Gates	Curb & Gutter	Curb	PCR
0	0	0	NO CURB AND GUTTER	STONE CURB	POOR/45

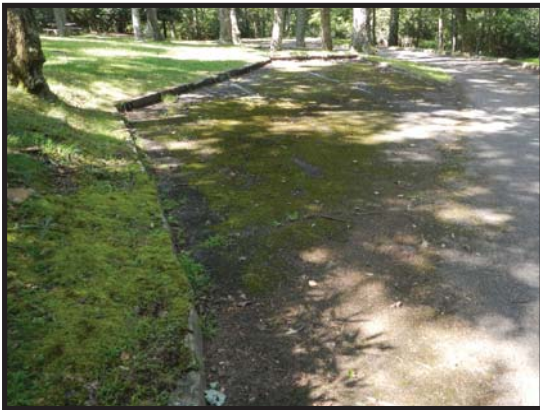
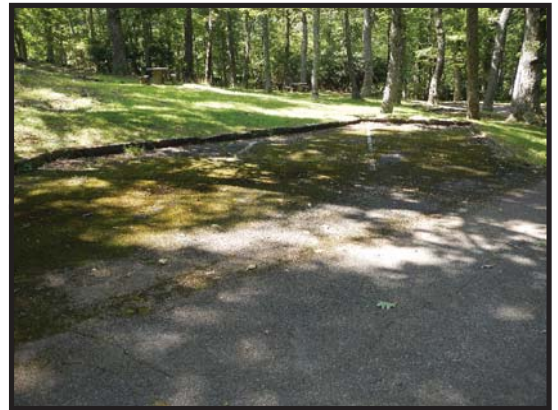
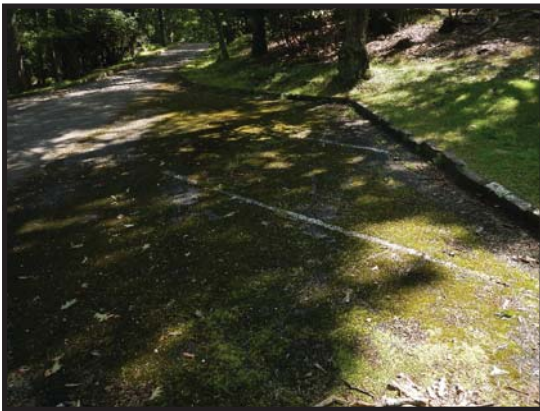
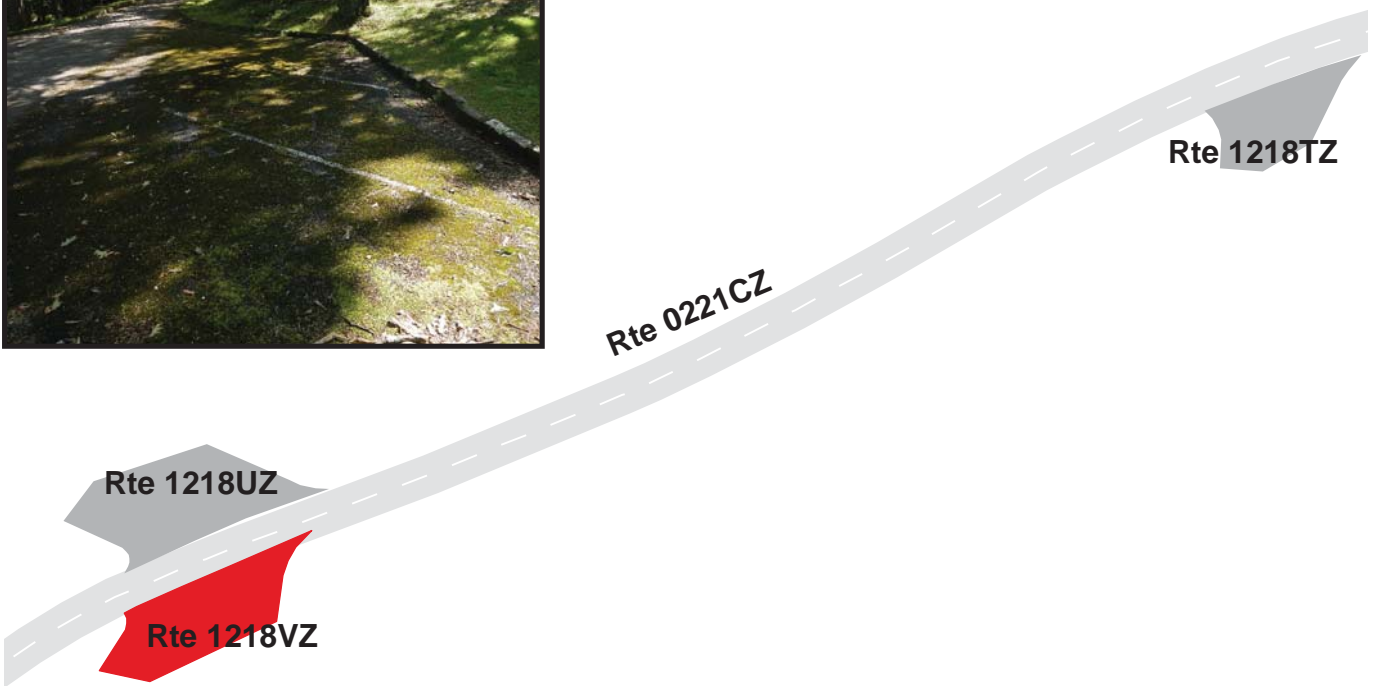
Route 1218VZ

Route Number	Public / NonPublic	Date Visited	Area (sq ft)	Lane Miles *	Surface Type
1218VZ	PUBLIC	8/14/2013	703	0.01	AS
Culverts	Drop Inlets	Gates	Curb & Gutter	Curb	PCR
0	0	0	NO CURB AND GUTTER	STONE CURB	POOR/45

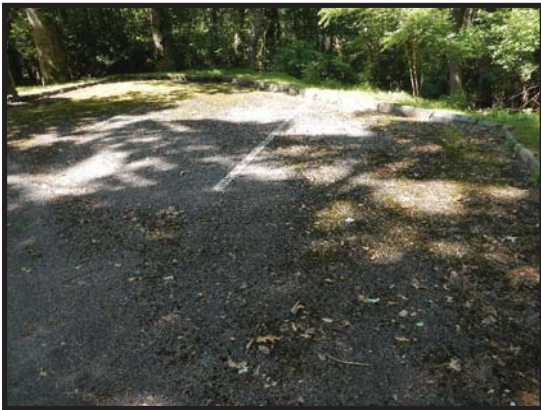
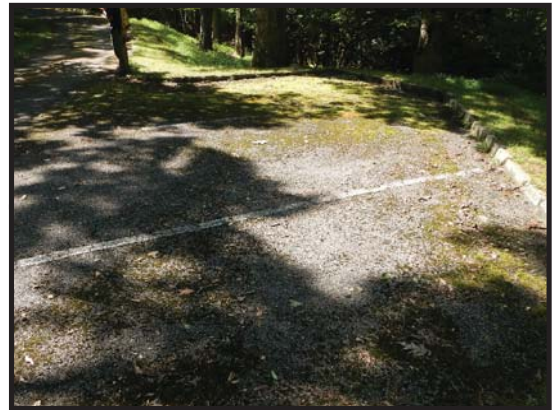
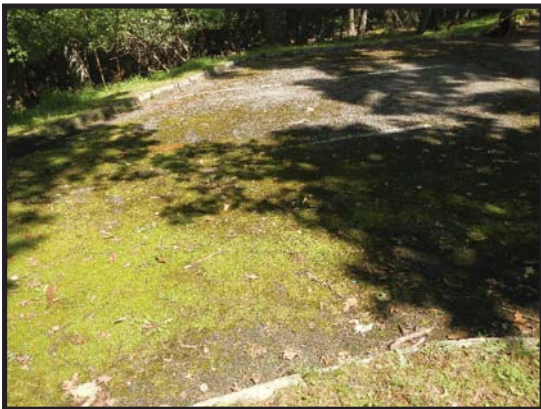
Route 1218WZ

Route Number	Public / NonPublic	Date Visited	Area (sq ft)	Lane Miles *	Surface Type
1218WZ	PUBLIC	8/14/2013	688	0.01	AS
Culverts	Drop Inlets	Gates	Curb & Gutter	Curb	PCR
0	0	0	NO CURB AND GUTTER	STONE CURB	POOR/45

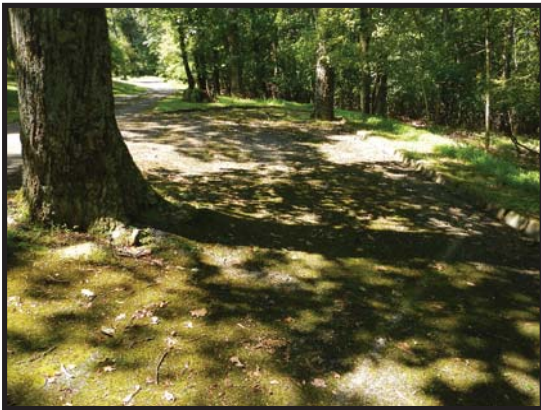
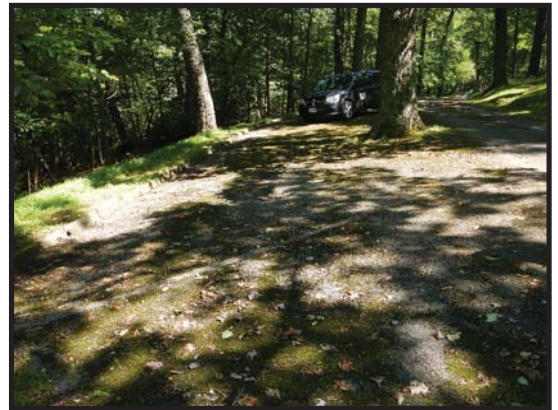
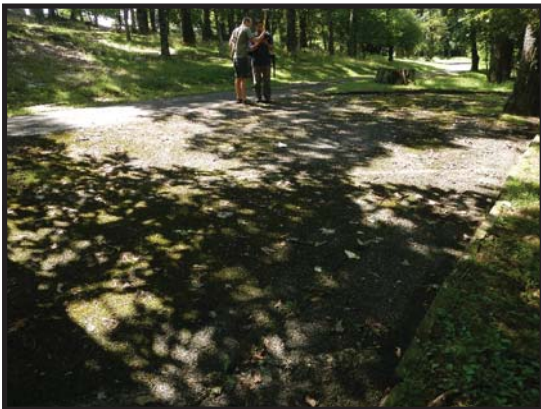
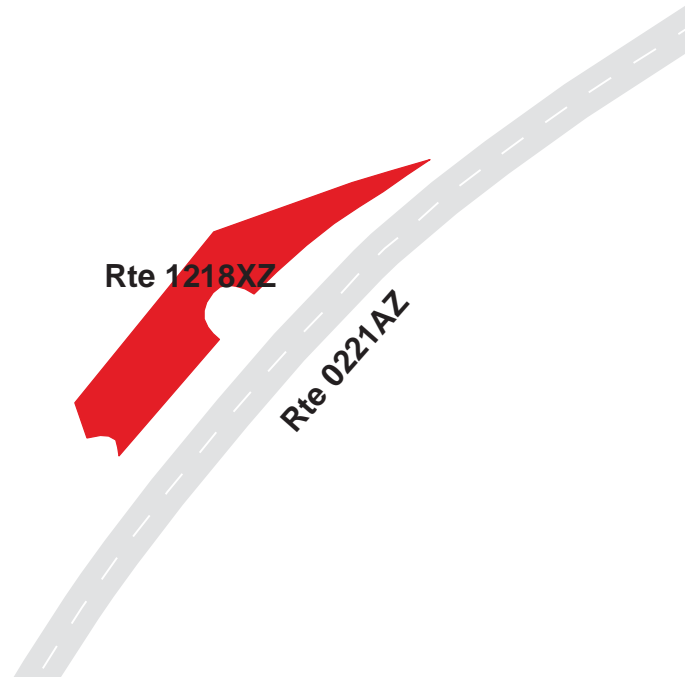
Route 1218XZ

Route Number	Public / NonPublic	Date Visited	Area (sq ft)	Lane Miles *	Surface Type
1218XZ	PUBLIC	8/14/2013	1,161	0.02	AS
Culverts	Drop Inlets	Gates	Curb & Gutter	Curb	PCR
0	0	0	NO CURB AND GUTTER	STONE CURB	POOR/45

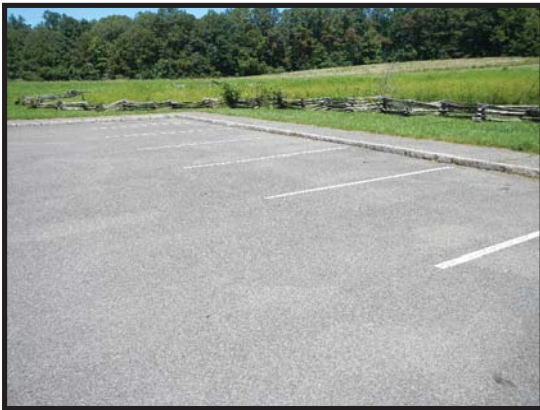
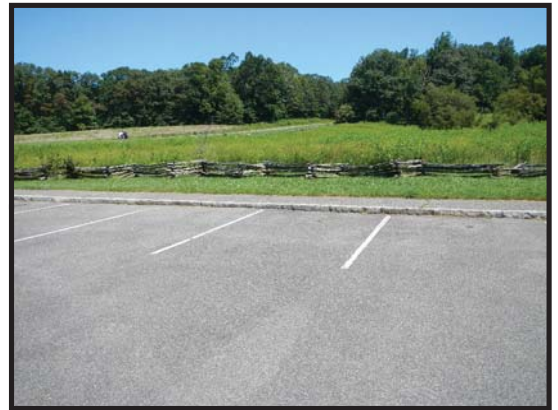
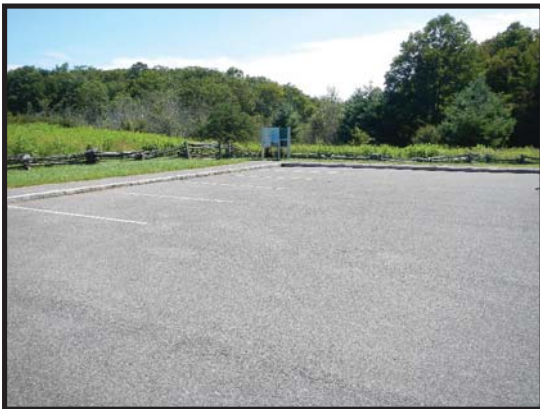
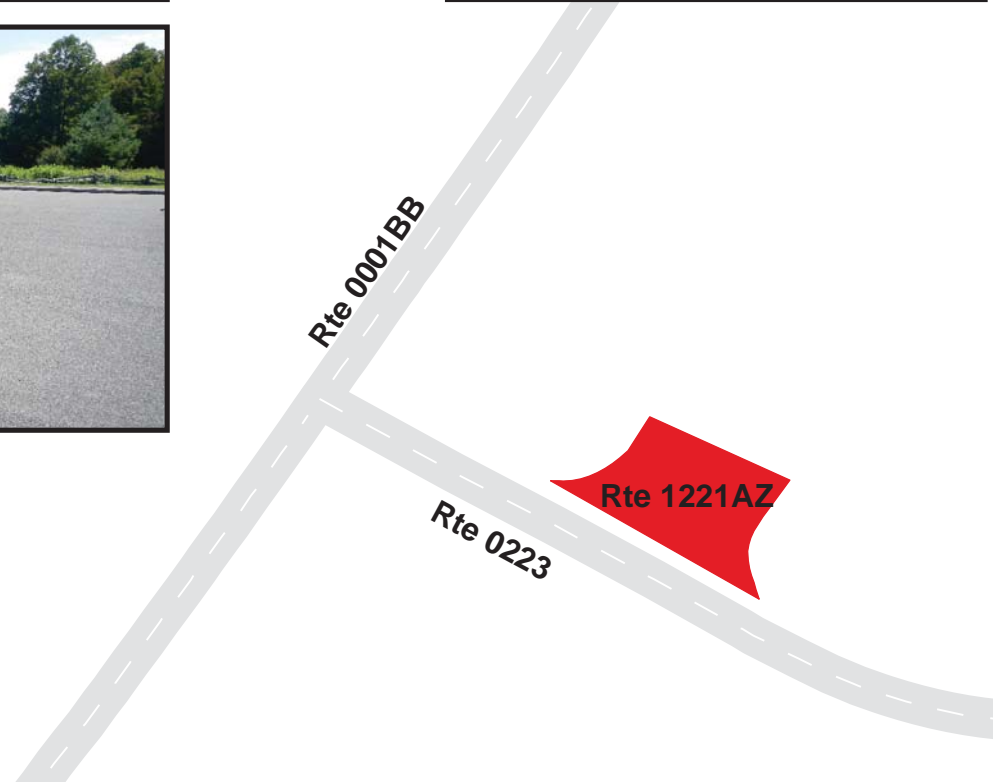
Route Number	Public / NonPublic	Date Visited	Area (sq ft)	Lane Miles *	Surface Type
1221AZ	PUBLIC	8/14/2013	4,381	0.08	AS
Culverts	Drop Inlets	Gates	Curb & Gutter	Curb	PCR
0	0	0	NO CURB AND GUTTER	STONE CURB	GOOD/90

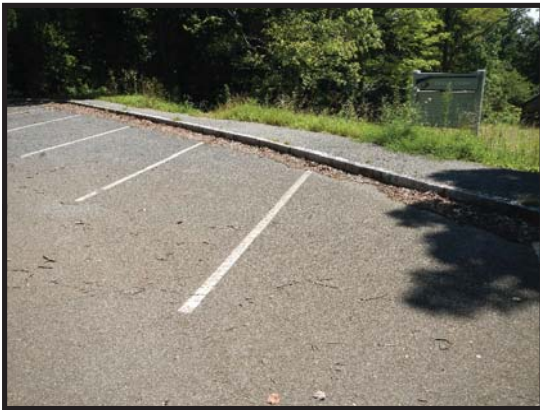
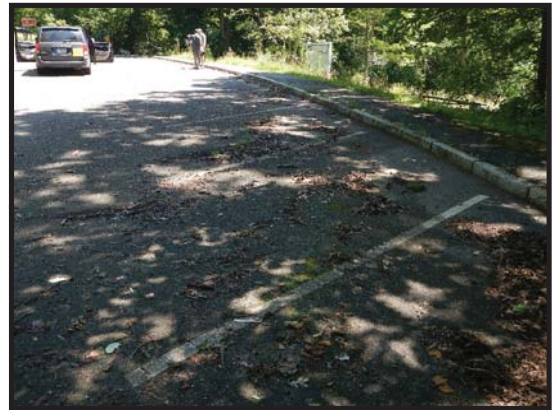
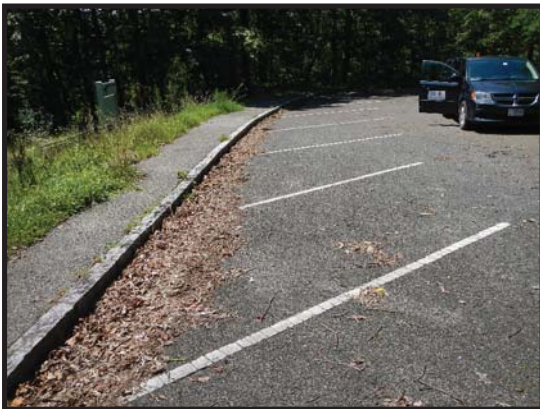
Route 1221BZ

Route Number	Public / NonPublic	Date Visited	Area (sq ft)	Lane Miles *	Surface Type
1221BZ	PUBLIC	8/14/2013	1,996	0.03	AS
Culverts	Drop Inlets	Gates	Curb & Gutter	Curb	PCR
0	0	0	NO CURB AND GUTTER	STONE CURB	GOOD/90

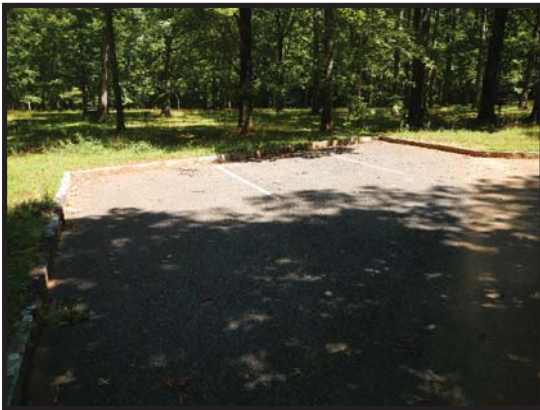
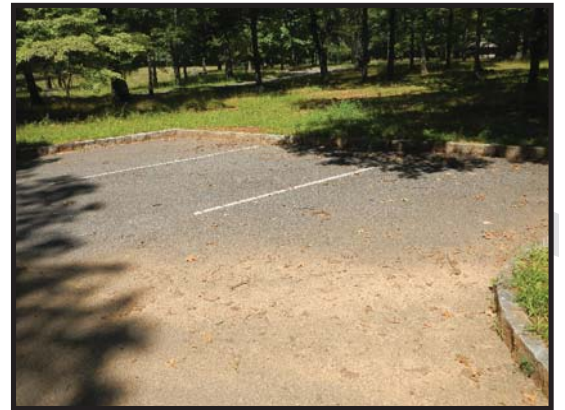
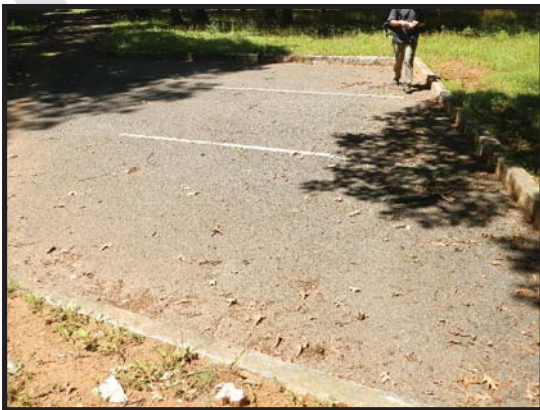
Route 1221CZ

Route Number	Public / NonPublic	Date Visited	Area (sq ft)	Lane Miles *	Surface Type
1221CZ	PUBLIC	8/14/2013	812	0.01	AS
Culverts	Drop Inlets	Gates	Curb & Gutter	Curb	PCR
0	0	0	NO CURB AND GUTTER	STONE CURB	GOOD/90

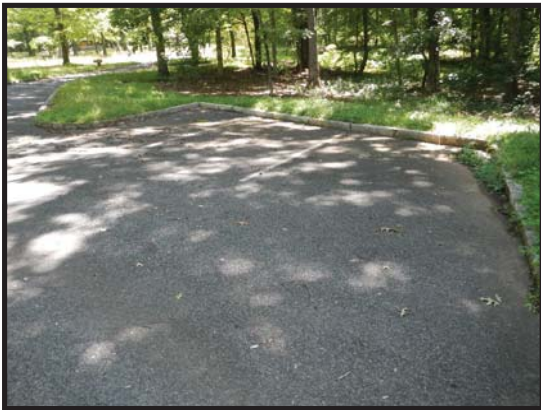
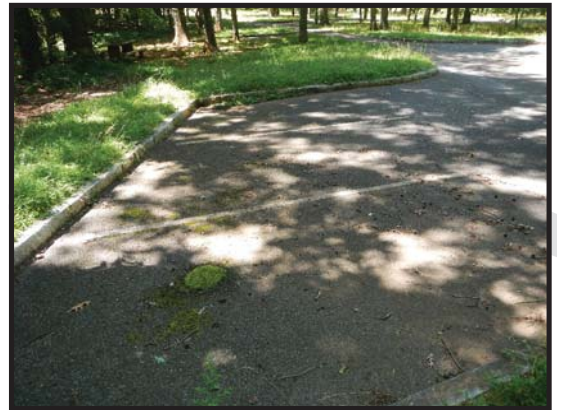
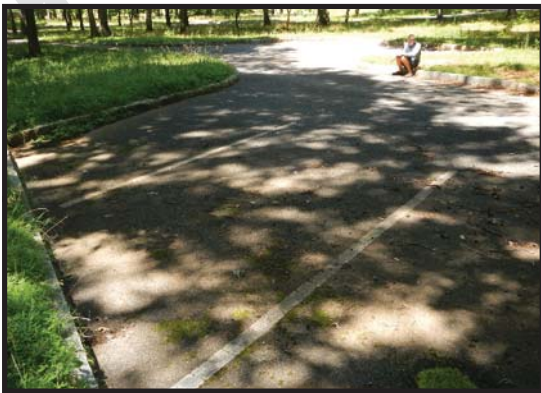
Route 1221DZ

Route Number	Public / NonPublic	Date Visited	Area (sq ft)	Lane Miles *	Surface Type
1221DZ	PUBLIC	8/14/2013	679	0.01	AS
Culverts	Drop Inlets	Gates	Curb & Gutter	Curb	PCR
0	0	0	NO CURB AND GUTTER	STONE CURB	GOOD/90

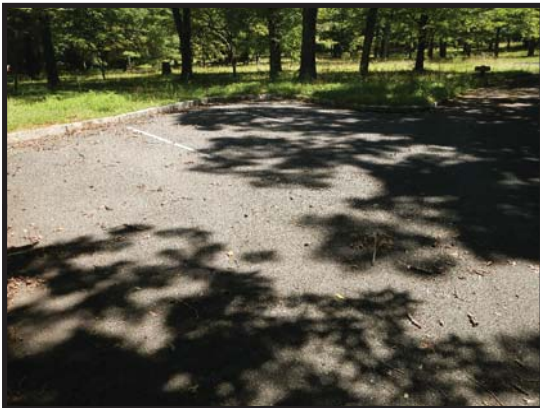
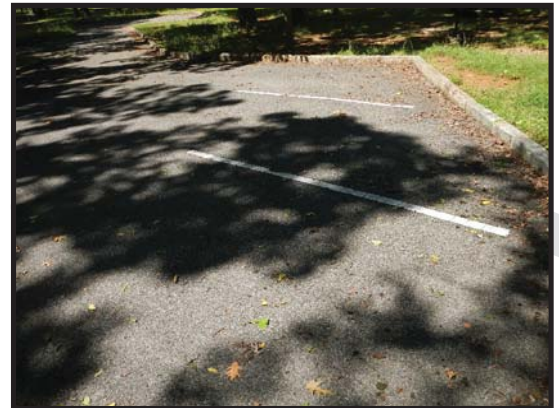
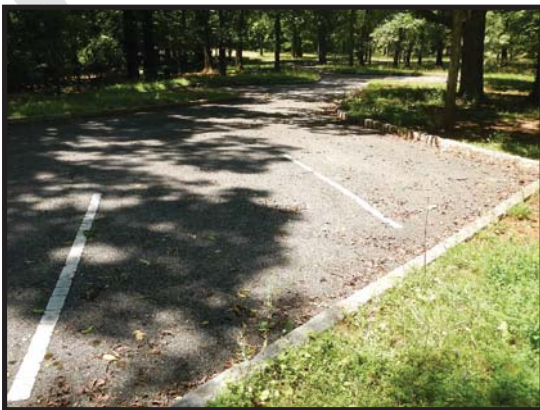
Route Number	Public / NonPublic	Date Visited	Area (sq ft)	Lane Miles *	Surface Type
1221EZ	PUBLIC	8/14/2013	890	0.02	AS
Culverts	Drop Inlets	Gates	Curb & Gutter	Curb	PCR
0	0	0	NO CURB AND GUTTER	STONE CURB	GOOD/90

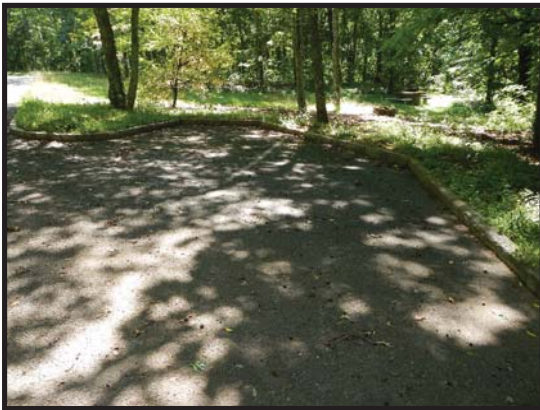
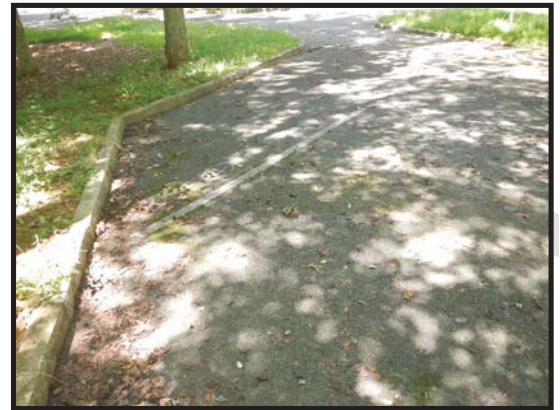
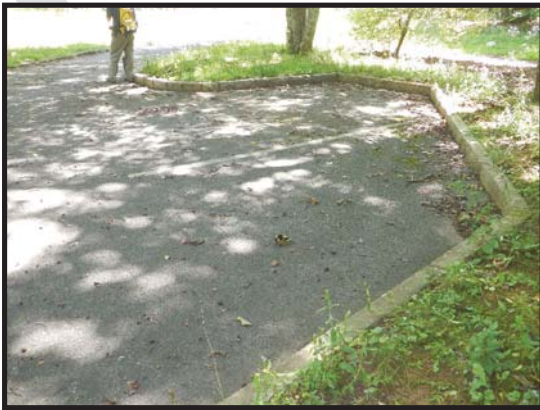
Route 1221FZ

Route Number	Public / NonPublic	Date Visited	Area (sq ft)	Lane Miles *	Surface Type
1221FZ	PUBLIC	8/14/2013	383	0.01	AS
Culverts	Drop Inlets	Gates	Curb & Gutter	Curb	PCR
0	0	0	NO CURB AND GUTTER	STONE CURB	GOOD/90

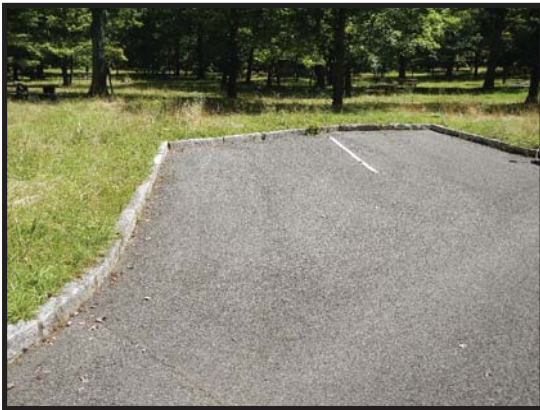
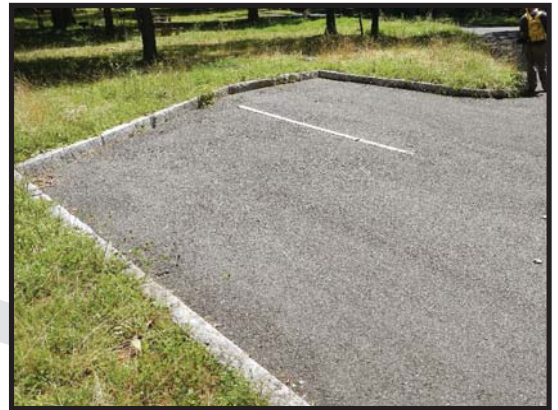
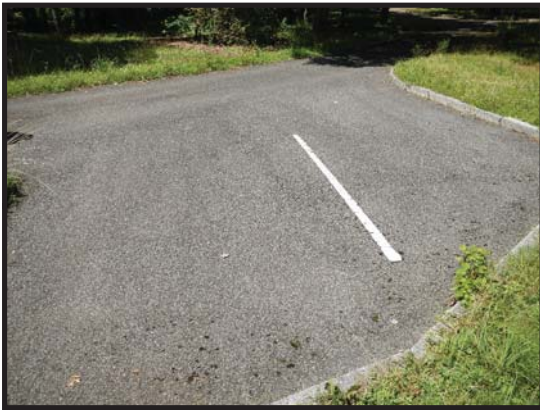
Route 1221GZ

Route Number	Public / NonPublic	Date Visited	Area (sq ft)	Lane Miles *	Surface Type
1221GZ	PUBLIC	8/14/2013	415	0.01	AS
Culverts	Drop Inlets	Gates	Curb & Gutter	Curb	PCR
0	0	0	NO CURB AND GUTTER	STONE CURB	GOOD/90

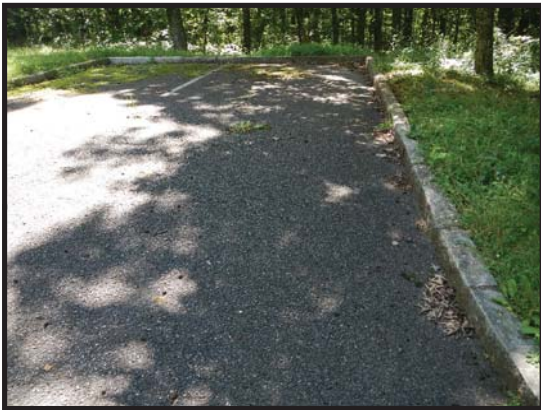
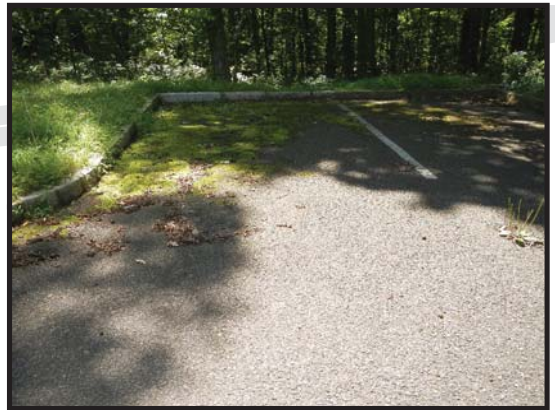
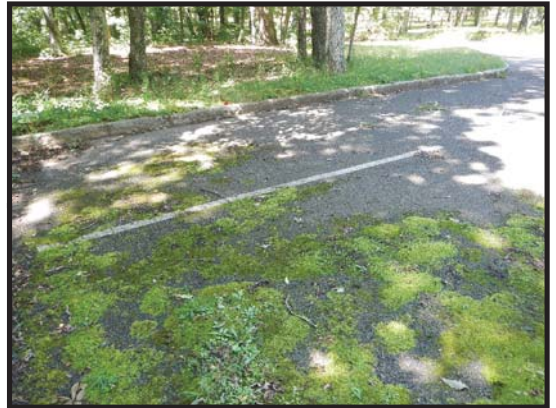
Route 1221HZ

Route Number	Public / NonPublic	Date Visited	Area (sq ft)	Lane Miles *	Surface Type
1221HZ	PUBLIC	8/14/2013	621	0.01	AS
Culverts	Drop Inlets	Gates	Curb & Gutter	Curb	PCR
0	0	0	NO CURB AND GUTTER	STONE CURB	GOOD/90
