Federal Lands Highway Road Inventory Program

Road Inventory and Condition Assessment

Blue Ridge Parkway BLRI

Cycle 5 Report

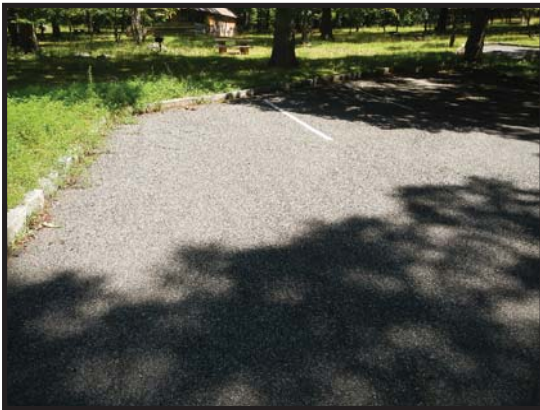
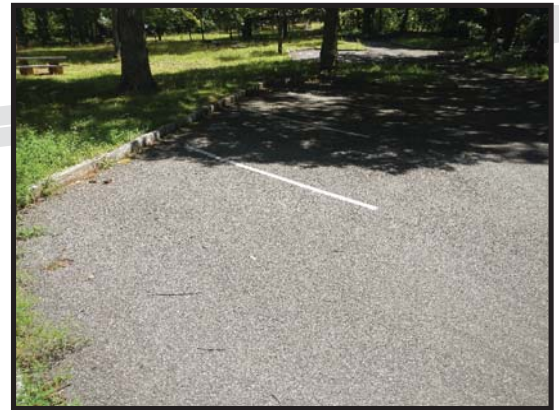
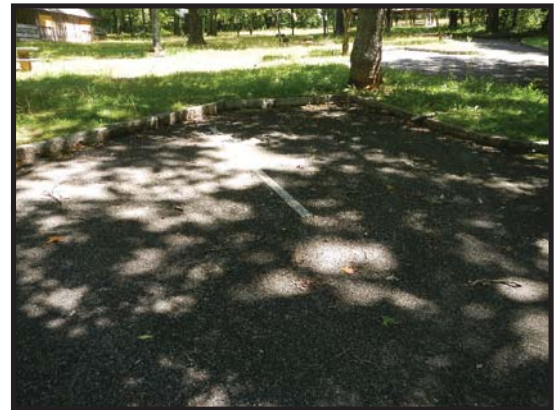
Route 1221IZ

Route Number	Public / NonPublic	Date Visited	Area (sq ft)	Lane Miles *	Surface Type
1221IZ	PUBLIC	8/14/2013	1,165	0.02	AS
Culverts	Drop Inlets	Gates	Curb & Gutter	Curb	PCR
0	0	0	NO CURB AND GUTTER	STONE CURB	GOOD/90

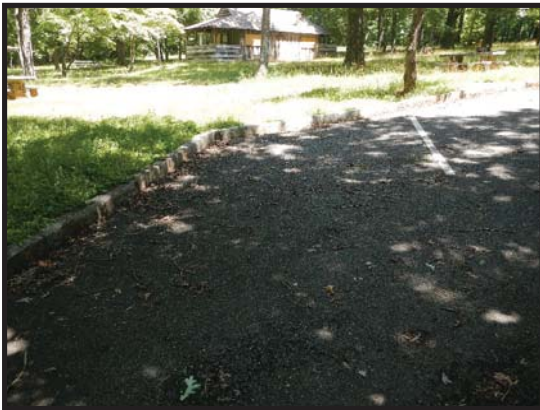
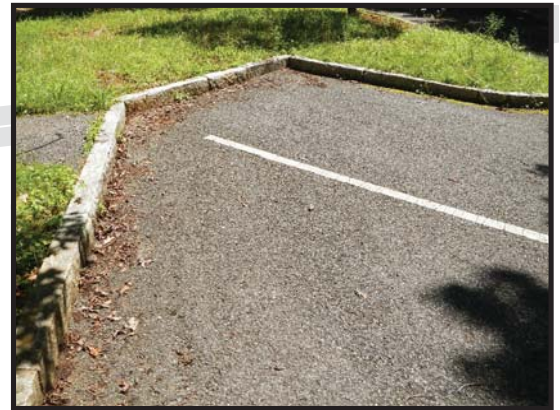
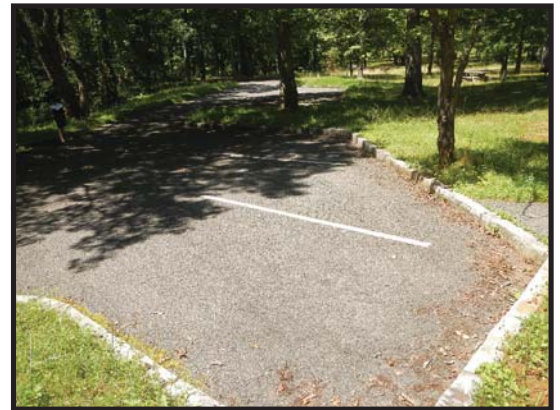
Route 1221JZ

Route Number	Public / NonPublic	Date Visited	Area (sq ft)	Lane Miles *	Surface Type
1221JZ	PUBLIC	8/14/2013	899	0.02	AS
Culverts	Drop Inlets	Gates	Curb & Gutter	Curb	PCR
0	0	0	NO CURB AND GUTTER	STONE CURB	GOOD/90

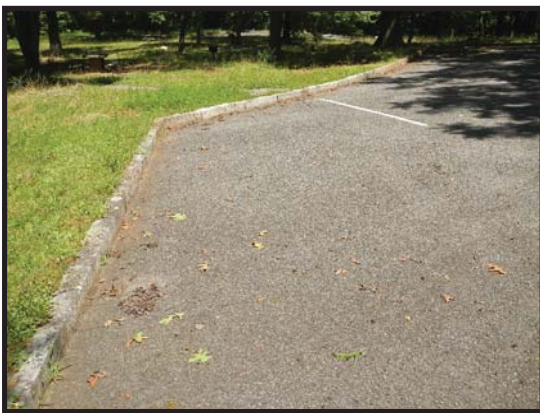
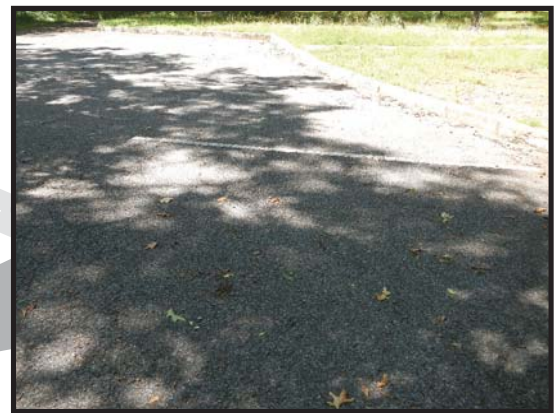
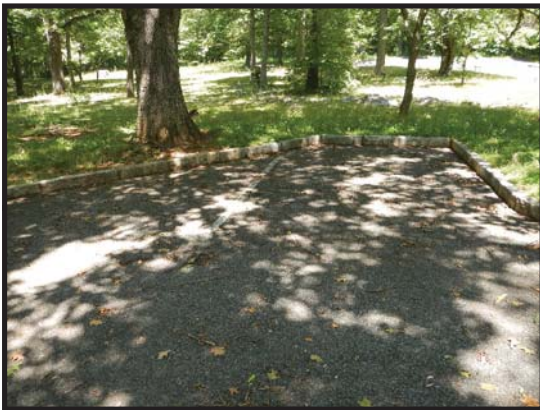
Route 1221KZ

Route Number	Public / NonPublic	Date Visited	Area (sq ft)	Lane Miles *	Surface Type
1221KZ	PUBLIC	8/14/2013	1,575	0.03	AS
Culverts	Drop Inlets	Gates	Curb & Gutter	Curb	PCR
0	0	0	NO CURB AND GUTTER	STONE CURB	GOOD/90

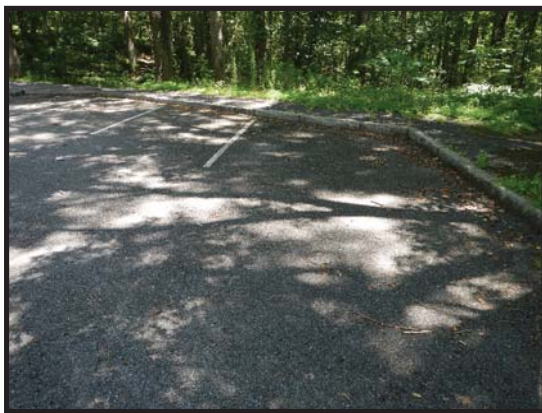
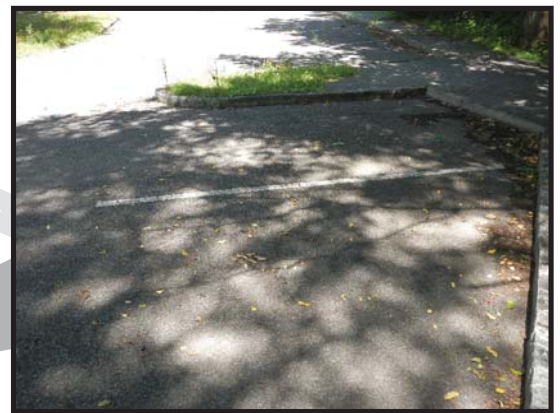
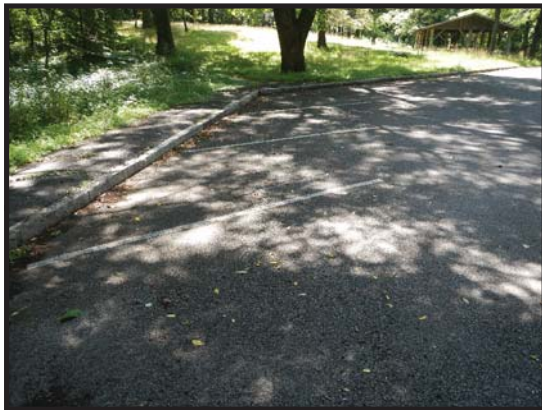
Route 1221LZ

Route Number	Public / NonPublic	Date Visited	Area (sq ft)	Lane Miles *	Surface Type
1221LZ	PUBLIC	8/14/2013	934	0.02	AS
Culverts	Drop Inlets	Gates	Curb & Gutter	Curb	PCR
0	0	0	NO CURB AND GUTTER	STONE CURB	GOOD/90

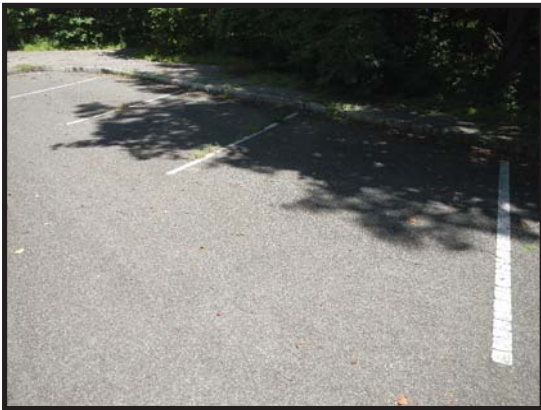
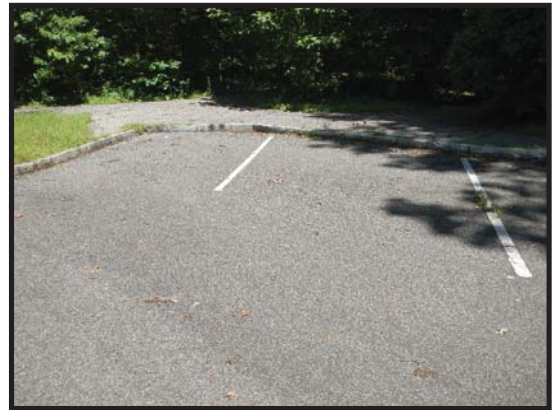
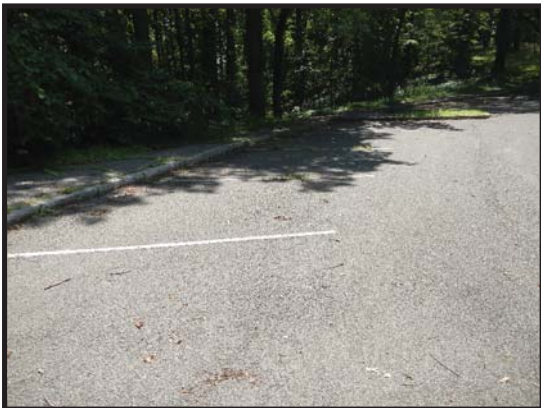
Route 1221MZ

Route Number	Public / NonPublic	Date Visited	Area (sq ft)	Lane Miles *	Surface Type
1221MZ	PUBLIC	8/14/2013	1,260	0.02	AS
Culverts	Drop Inlets	Gates	Curb & Gutter	Curb	PCR
0	0	0	NO CURB AND GUTTER	STONE CURB	GOOD/90

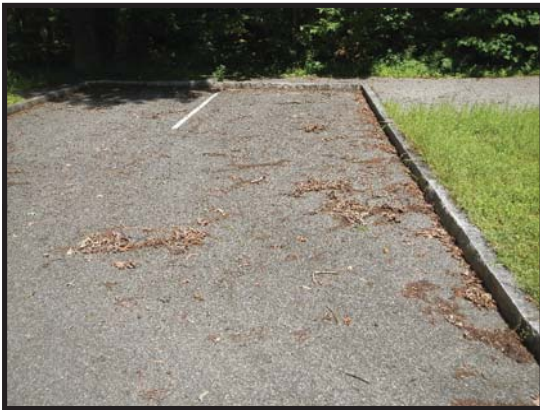
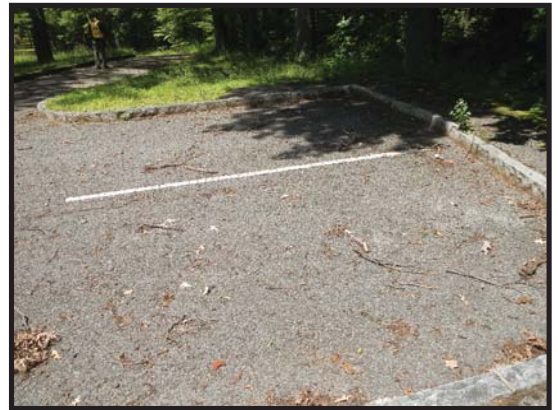
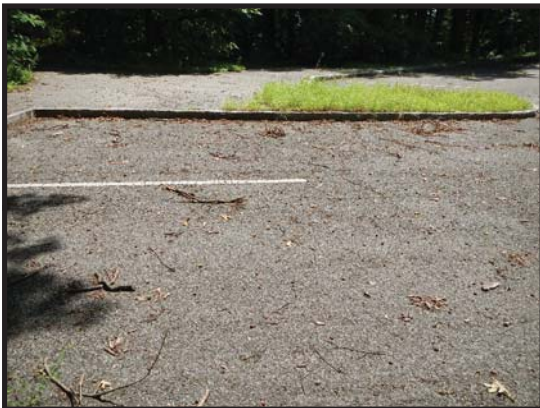
Route 1221NZ

Route Number	Public / NonPublic	Date Visited	Area (sq ft)	Lane Miles *	Surface Type
1221NZ	PUBLIC	8/14/2013	545	0.01	AS
Culverts	Drop Inlets	Gates	Curb & Gutter	Curb	PCR
0	0	0	NO CURB AND GUTTER	STONE CURB	GOOD/90

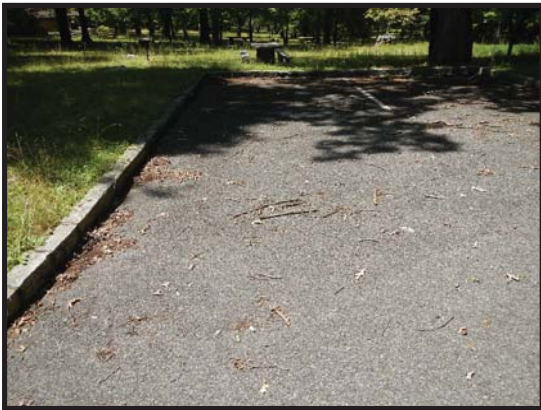
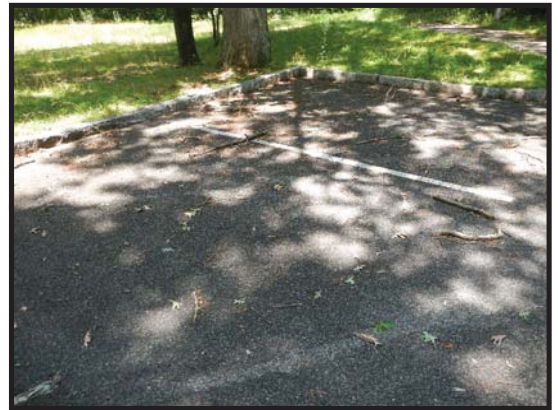
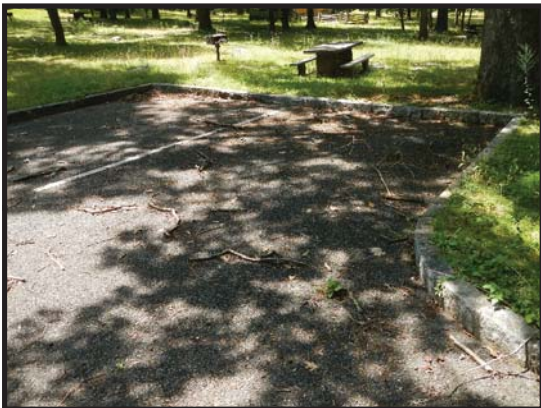
Route 1221OZ

Route Number	Public / NonPublic	Date Visited	Area (sq ft)	Lane Miles *	Surface Type
1221OZ	PUBLIC	8/14/2013	663	0.01	AS
Culverts	Drop Inlets	Gates	Curb & Gutter	Curb	PCR
0	0	0	NO CURB AND GUTTER	STONE CURB	GOOD/90

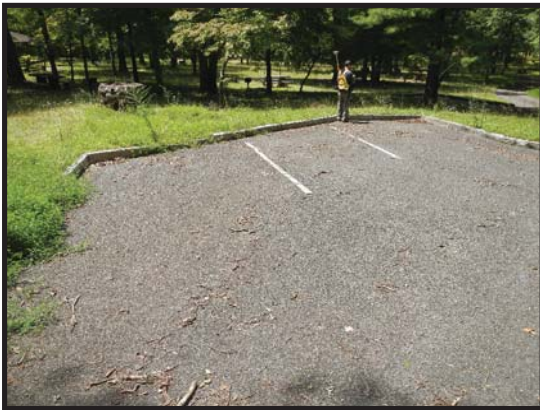
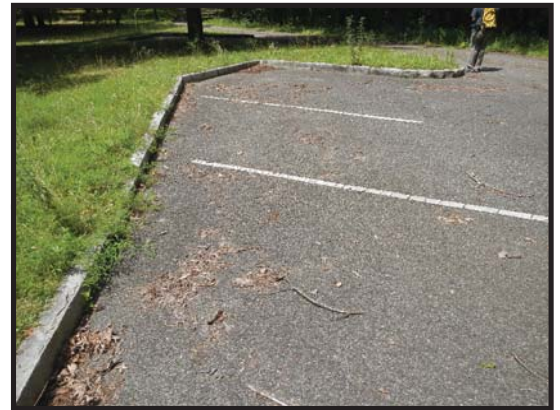
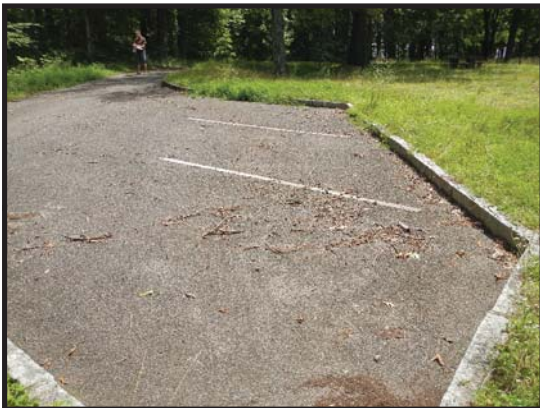
Route 1221PZ

Route Number	Public / NonPublic	Date Visited	Area (sq ft)	Lane Miles *	Surface Type
1221PZ	PUBLIC	8/14/2013	835	0.01	AS
Culverts	Drop Inlets	Gates	Curb & Gutter	Curb	PCR
0	0	0	NO CURB AND GUTTER	STONE CURB	GOOD/90

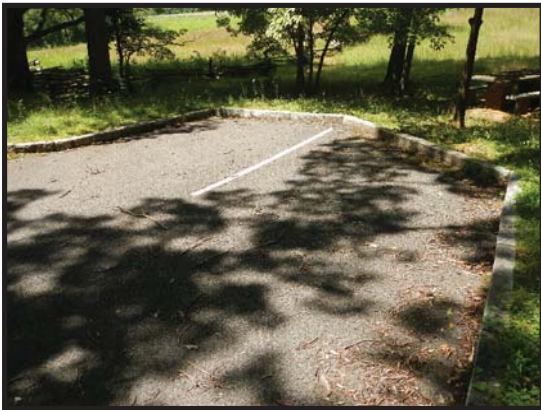
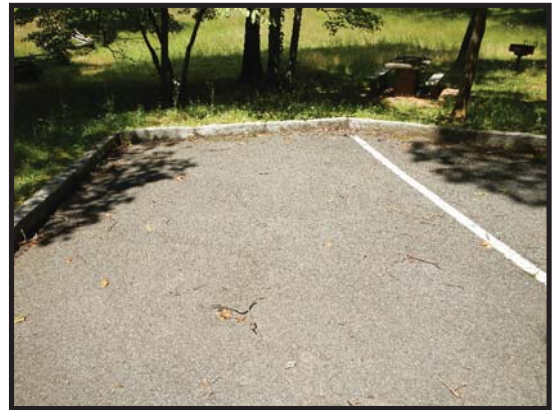
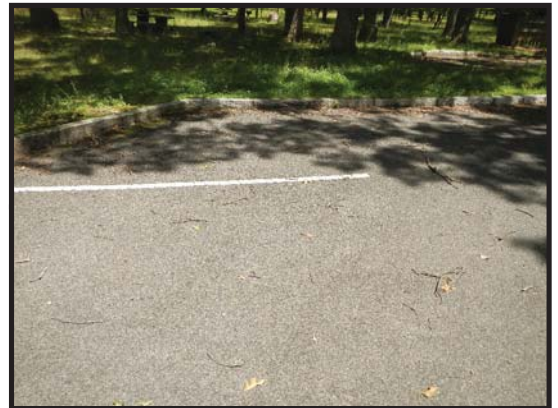
Route Number	Public / NonPublic	Date Visited	Area (sq ft)	Lane Miles *	Surface Type
1221YEZ	PUBLIC	8/14/2013	578	0.01	AS
Culverts	Drop Inlets	Gates	Curb & Gutter	Curb	PCR
0	0	0	NO CURB AND GUTTER	STONE CURB	GOOD/90

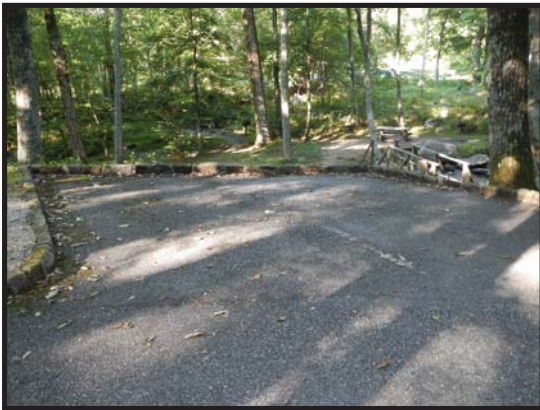
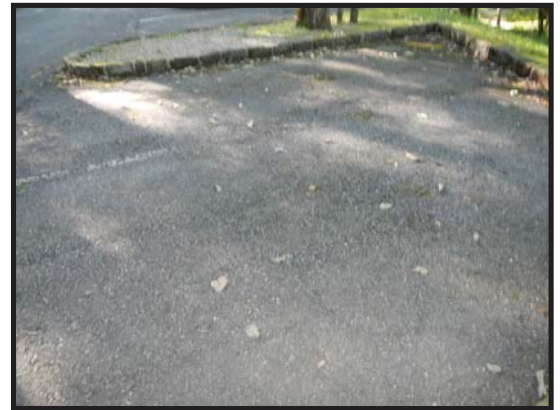
Route Number	Public / NonPublic	Date Visited	Area (sq ft)	Lane Miles *	Surface Type
1233HZ	PUBLIC	8/15/2013	480	0.01	AS
Culverts	Drop Inlets	Gates	Curb & Gutter	Curb	PCR
0	0	0	NO CURB AND GUTTER	STONE CURB	FAIR/73

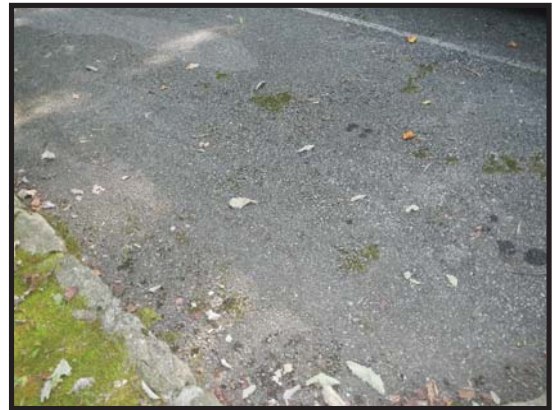
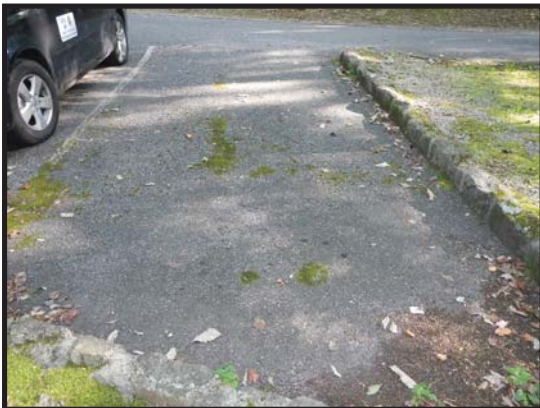
Route 1233IZ

Route Number	Public / NonPublic	Date Visited	Area (sq ft)	Lane Miles *	Surface Type
1233IZ	PUBLIC	8/15/2013	736	0.01	AS
Culverts	Drop Inlets	Gates	Curb & Gutter	Curb	PCR
0	0	0	NO CURB AND GUTTER	STONE CURB	FAIR/73

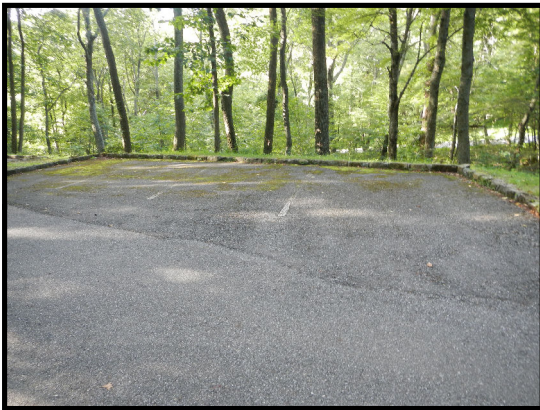
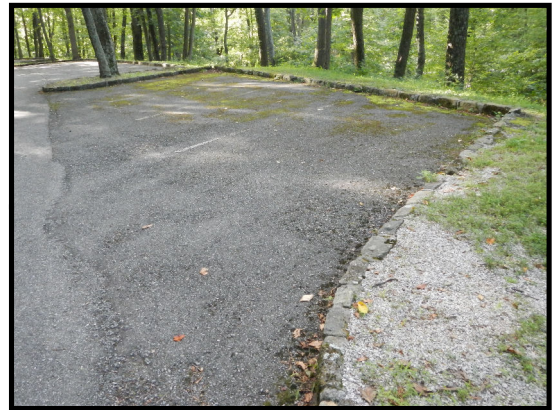
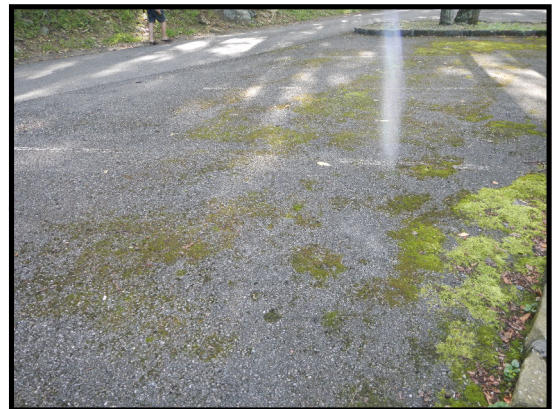
Route 1233JZ

Route Number	Public / NonPublic	Date Visited	Area (sq ft)	Lane Miles *	Surface Type
1233JZ	PUBLIC	8/15/2013	941	0.02	AS
Culverts	Drop Inlets	Gates	Curb & Gutter	Curb	PCR
0	0	0	NO CURB AND GUTTER	STONE CURB	FAIR/73

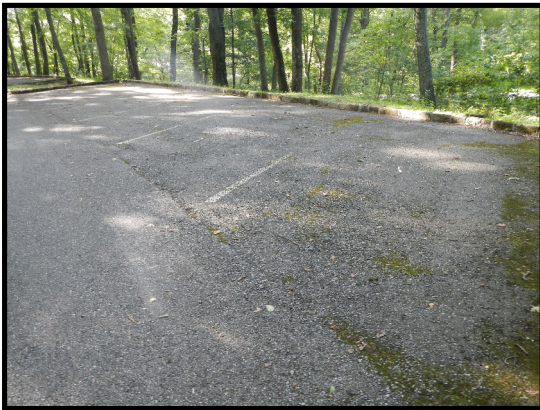
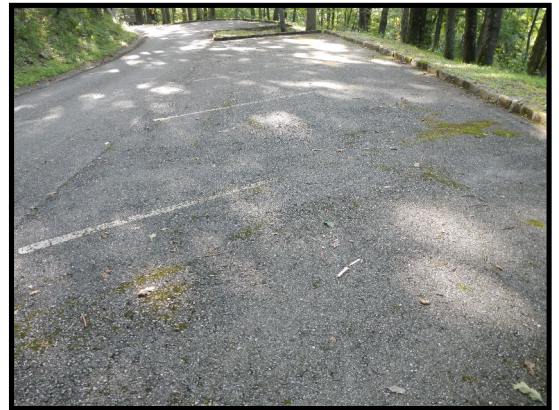
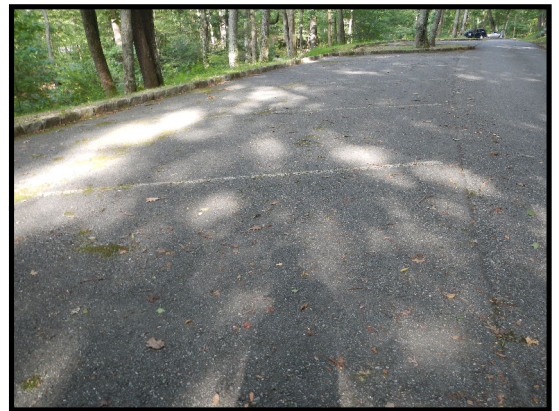
Route 1233KZ

Route Number	Public / NonPublic	Date Visited	Area (sq ft)	Lane Miles *	Surface Type
1233KZ	PUBLIC	8/15/2013	1,553	0.03	AS
Culverts	Drop Inlets	Gates	Curb & Gutter	Curb	PCR
0	0	0	NO CURB AND GUTTER	STONE CURB	GOOD/90

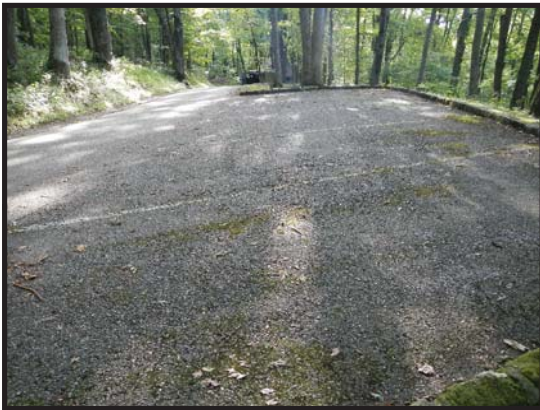
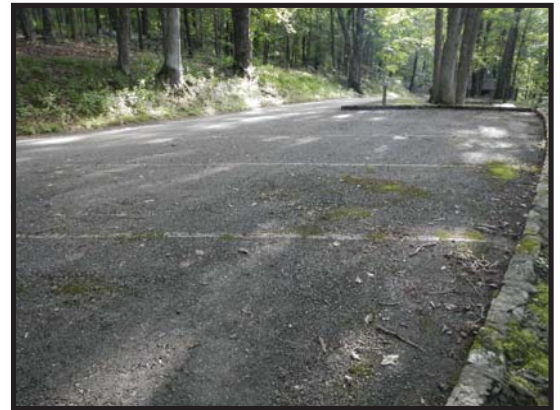
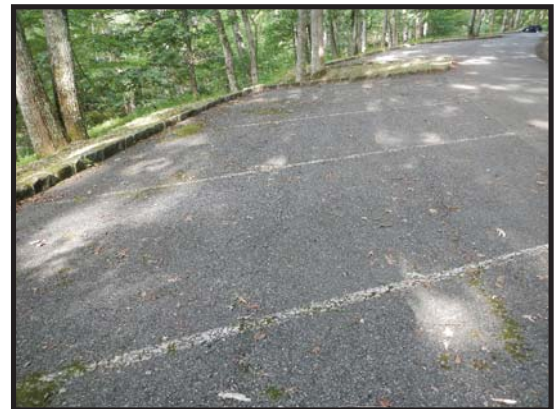
Route 1233LZ

Route Number	Public / NonPublic	Date Visited	Area (sq ft)	Lane Miles *	Surface Type
1233LZ	PUBLIC	8/15/2013	1,068	0.02	AS
Culverts	Drop Inlets	Gates	Curb & Gutter	Curb	PCR
0	0	0	NO CURB AND GUTTER	STONE CURB	FAIR/73

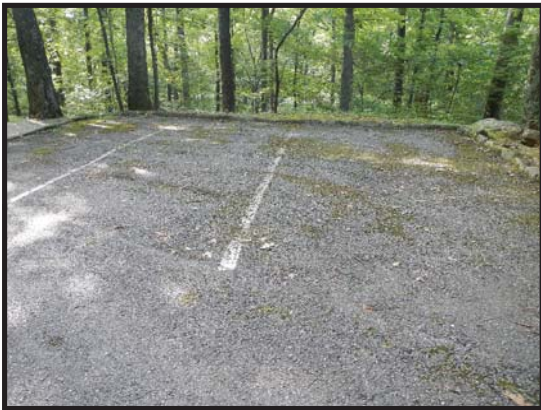
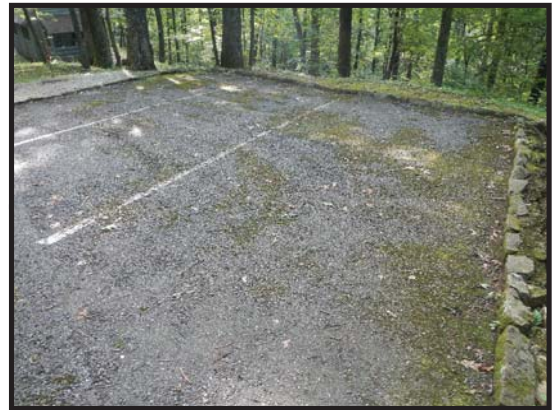
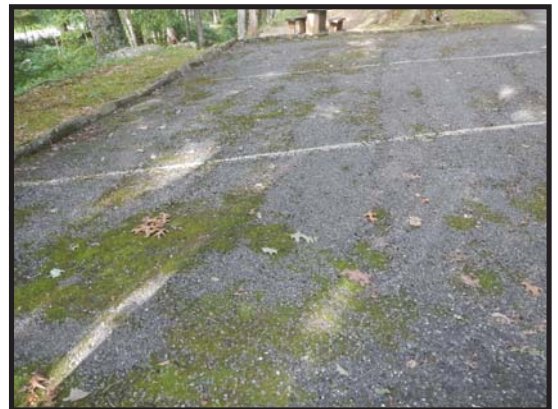
Route 1233MZ

Route Number	Public / NonPublic	Date Visited	Area (sq ft)	Lane Miles *	Surface Type
1233MZ	PUBLIC	8/15/2013	626	0.01	AS
Culverts	Drop Inlets	Gates	Curb & Gutter	Curb	PCR
0	0	0	NO CURB AND GUTTER	STONE CURB	FAIR/73

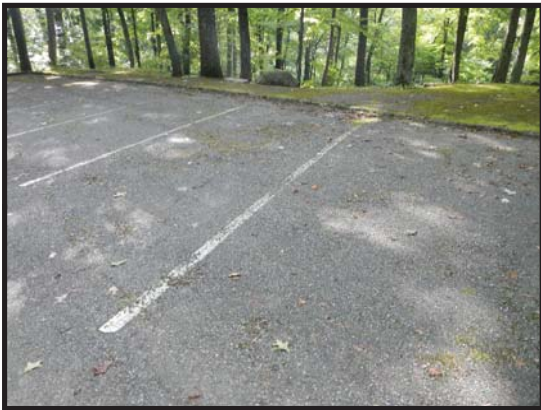
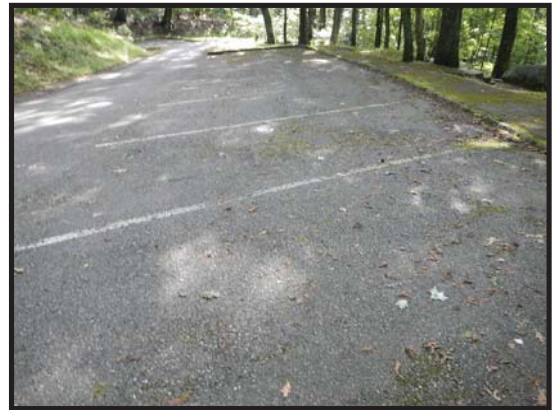
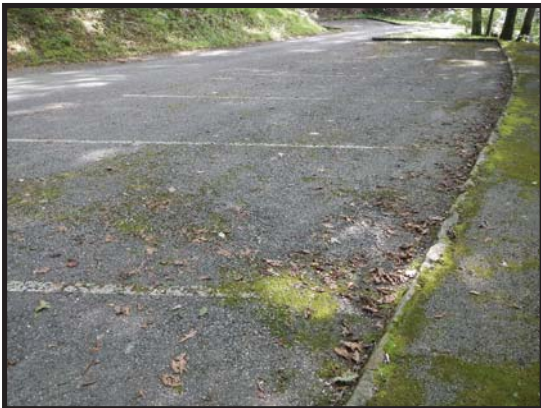
Route 1233NZ

Route Number	Public / NonPublic	Date Visited	Area (sq ft)	Lane Miles *	Surface Type
1233NZ	PUBLIC	8/15/2013	2,055	0.04	AS
Culverts	Drop Inlets	Gates	Curb & Gutter	Curb	PCR
0	0	0	NO CURB AND GUTTER	STONE CURB	FAIR/73

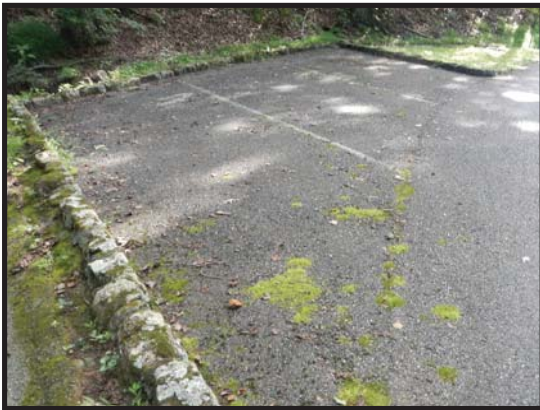
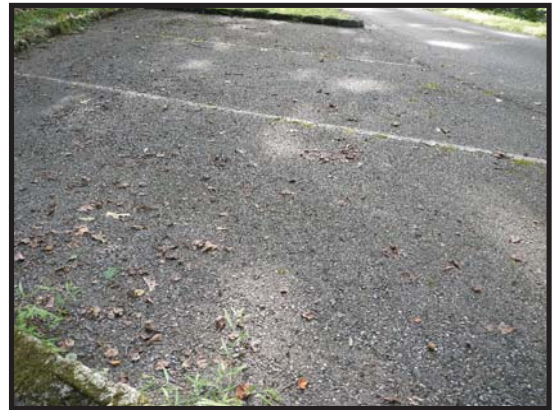
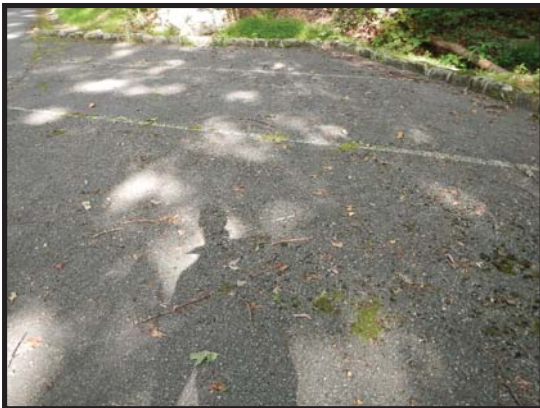
Route 1233OZ

Route Number	Public / NonPublic	Date Visited	Area (sq ft)	Lane Miles *	Surface Type
1233OZ	PUBLIC	8/15/2013	1,027	0.02	AS
Culverts	Drop Inlets	Gates	Curb & Gutter	Curb	PCR
0	0	0	NO CURB AND GUTTER	STONE CURB	FAIR/73

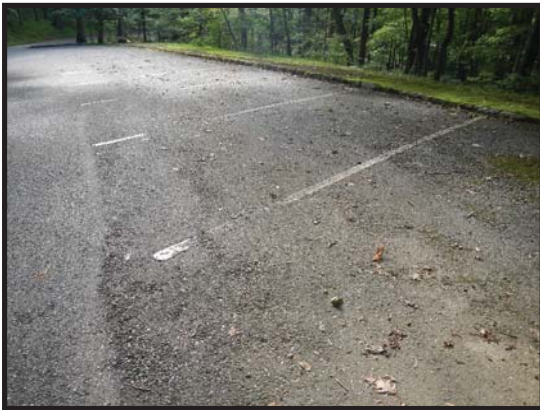
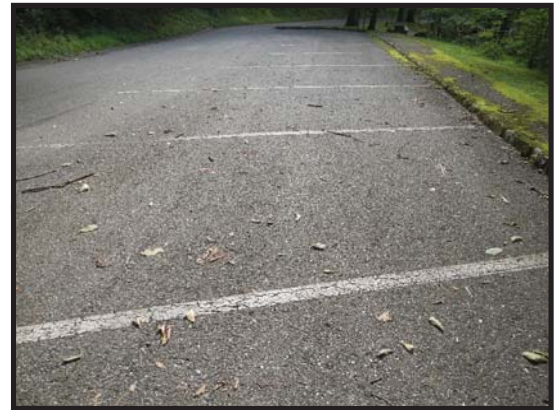
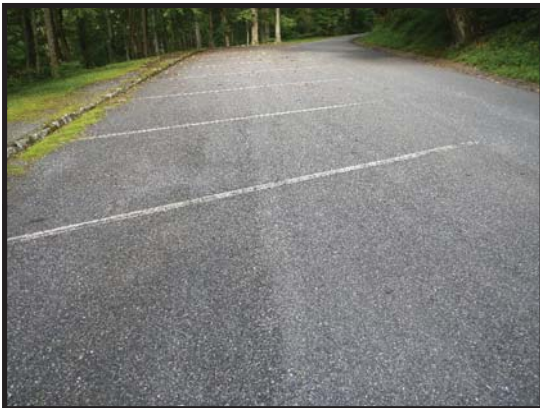
Route 1233PZ

Route Number	Public / NonPublic	Date Visited	Area (sq ft)	Lane Miles *	Surface Type
1233PZ	PUBLIC	8/15/2013	2,212	0.04	AS
Culverts	Drop Inlets	Gates	Curb & Gutter	Curb	PCR
0	0	0	NO CURB AND GUTTER	STONE CURB	GOOD/90

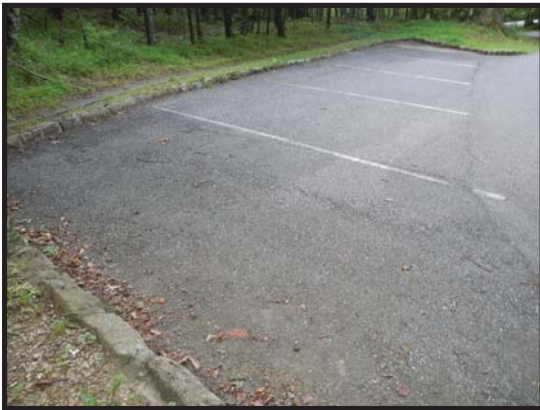
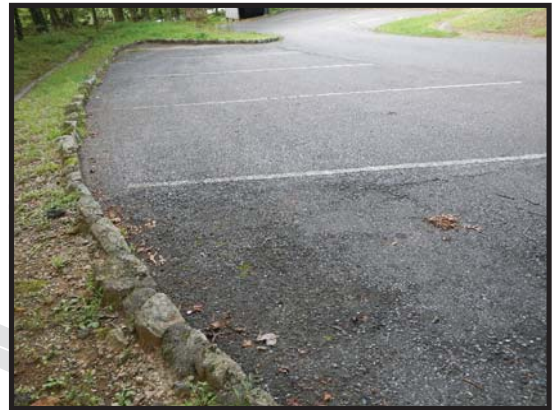
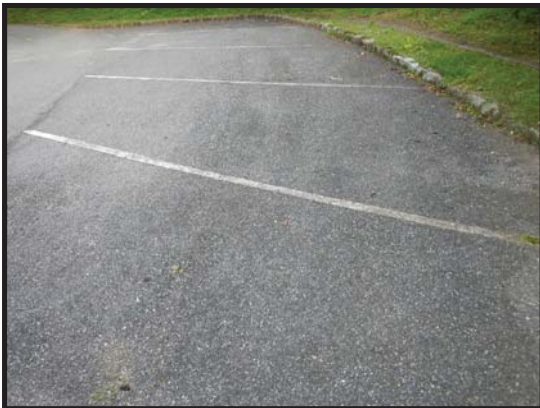
Route 1233QZ

Route Number	Public / NonPublic	Date Visited	Area (sq ft)	Lane Miles *	Surface Type
1233QZ	PUBLIC	8/15/2013	1,299	0.02	AS
Culverts	Drop Inlets	Gates	Curb & Gutter	Curb	PCR
0	0	0	NO CURB AND GUTTER	STONE CURB	GOOD/90

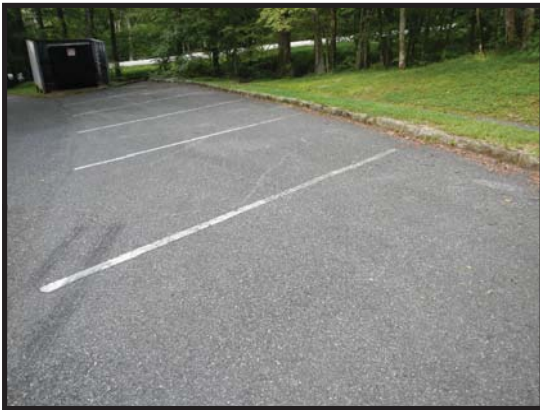
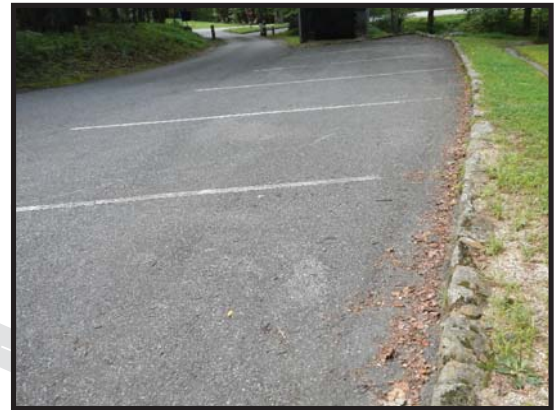
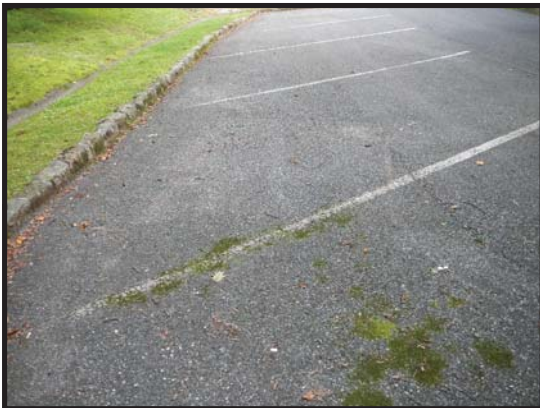
Route 1233RZ

Route Number	Public / NonPublic	Date Visited	Area (sq ft)	Lane Miles *	Surface Type
1233RZ	PUBLIC	8/15/2013	1,589	0.03	AS
Culverts	Drop Inlets	Gates	Curb & Gutter	Curb	PCR
0	0	0	NO CURB AND GUTTER	STONE CURB	GOOD/90

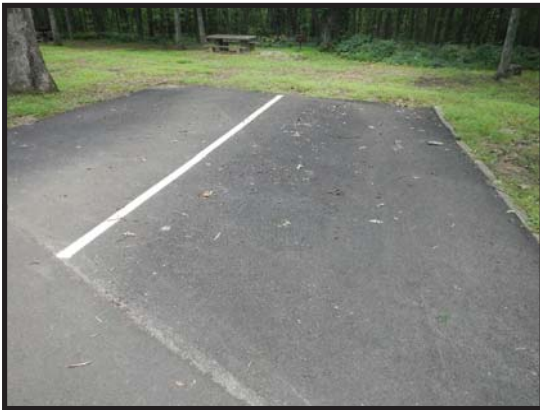
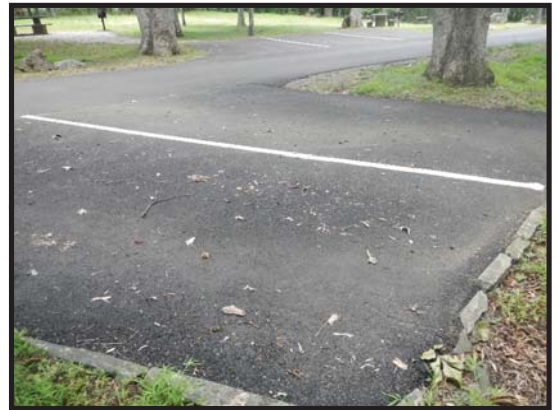
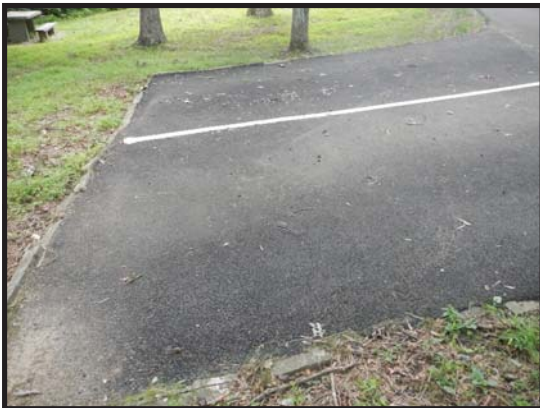
Route Number	Public / NonPublic	Date Visited	Area (sq ft)	Lane Miles *	Surface Type
1244AZ	PUBLIC	8/15/2013	390	0.01	AS
Culverts	Drop Inlets	Gates	Curb & Gutter	Curb	PCR
0	0	0	NO CURB AND GUTTER	STONE CURB	EXCELLENT/97

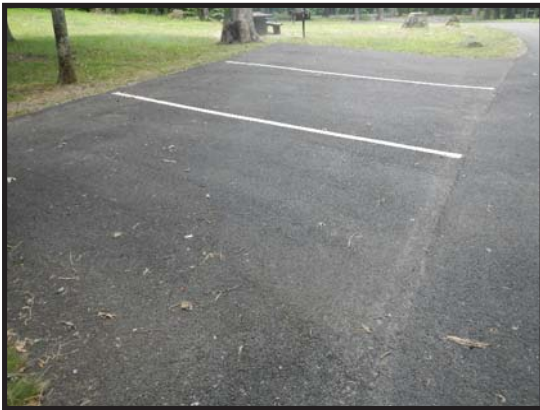
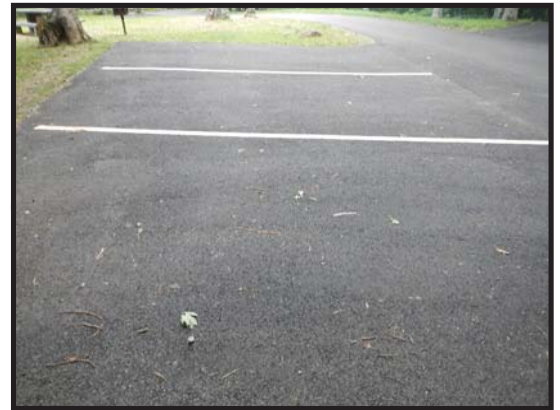
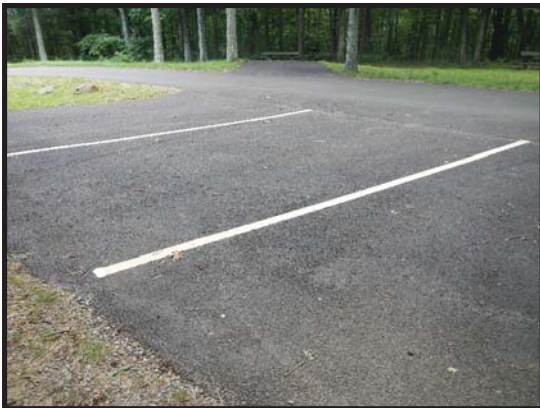
Route 1244BZ

Route Number	Public / NonPublic	Date Visited	Area (sq ft)	Lane Miles *	Surface Type
1244BZ	PUBLIC	8/15/2013	1,073	0.02	AS
Culverts	Drop Inlets	Gates	Curb & Gutter	Curb	PCR
0	0	0	NO CURB AND GUTTER	NO CURB	EXCELLENT/97

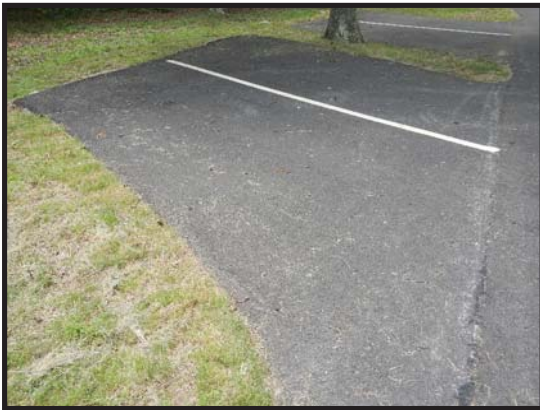
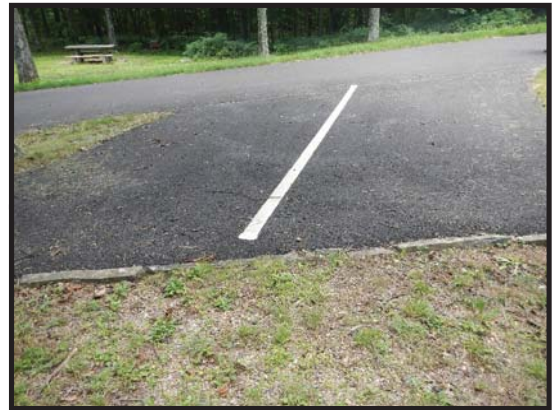
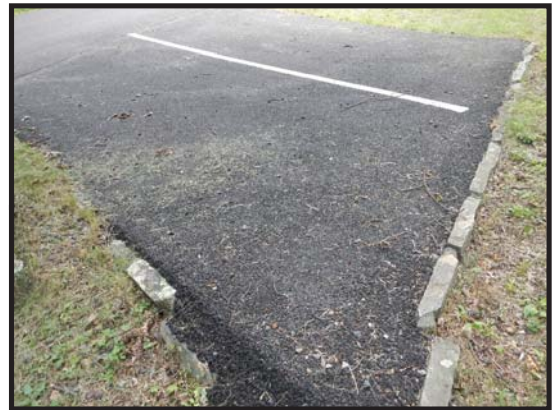
Route 1244CZ

Route Number	Public / NonPublic	Date Visited	Area (sq ft)	Lane Miles *	Surface Type
1244CZ	PUBLIC	8/15/2013	324	0.01	AS
Culverts	Drop Inlets	Gates	Curb & Gutter	Curb	PCR
0	0	0	NO CURB AND GUTTER	STONE CURB	EXCELLENT/97

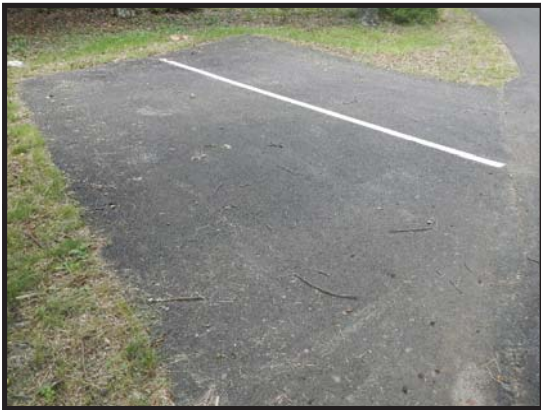
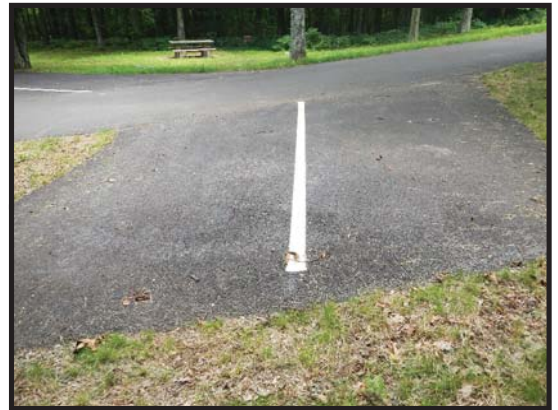
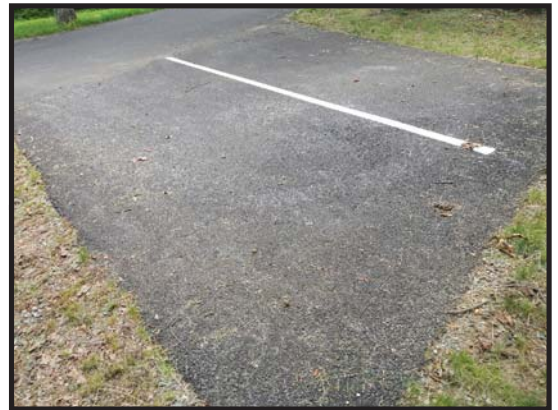
Route 1244DZ

Route Number	Public / NonPublic	Date Visited	Area (sq ft)	Lane Miles *	Surface Type
1244DZ	PUBLIC	8/15/2013	297	0.01	AS
Culverts	Drop Inlets	Gates	Curb & Gutter	Curb	PCR
0	0	0	NO CURB AND GUTTER	NO CURB	EXCELLENT/97

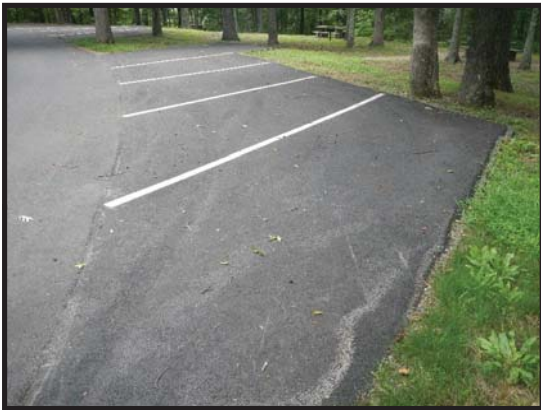
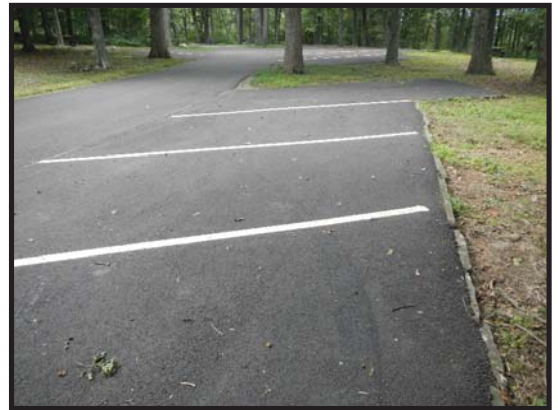
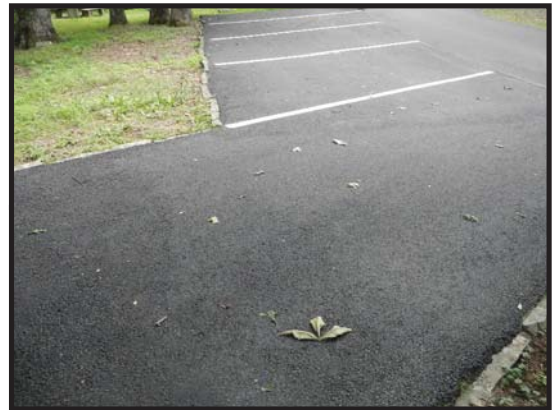
Route 1244EZ

Route Number	Public / NonPublic	Date Visited	Area (sq ft)	Lane Miles *	Surface Type
1244EZ	PUBLIC	8/15/2013	1,066	0.02	AS
Culverts	Drop Inlets	Gates	Curb & Gutter	Curb	PCR
0	0	0	NO CURB AND GUTTER	STONE CURB	EXCELLENT/97

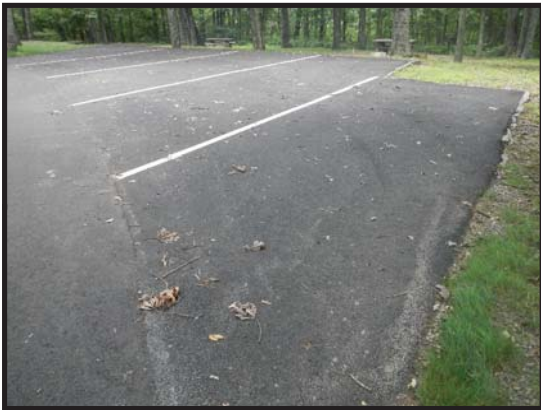
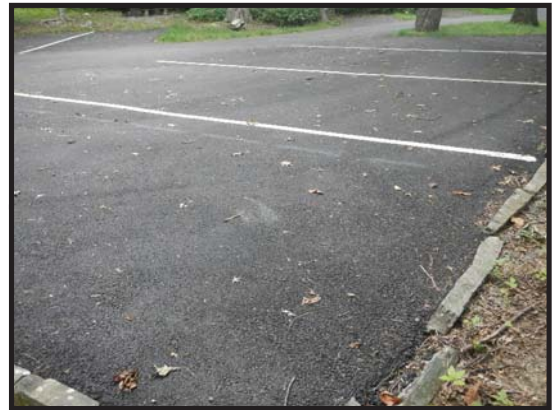
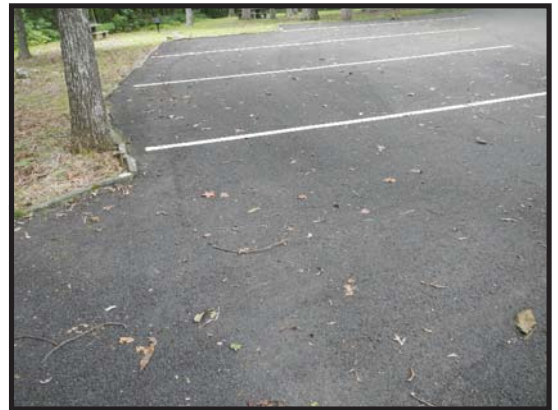
Route 1244FZ

Route Number	Public / NonPublic	Date Visited	Area (sq ft)	Lane Miles *	Surface Type
1244FZ	PUBLIC	8/15/2013	1,674	0.03	AS
Culverts	Drop Inlets	Gates	Curb & Gutter	Curb	PCR
0	0	0	NO CURB AND GUTTER	STONE CURB	EXCELLENT/97

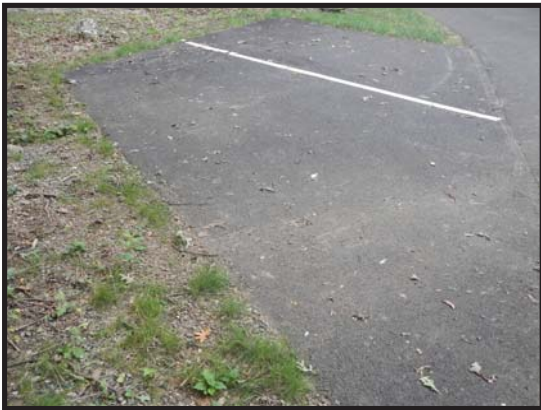
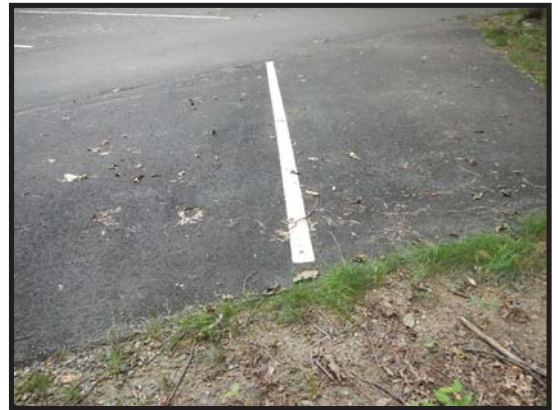
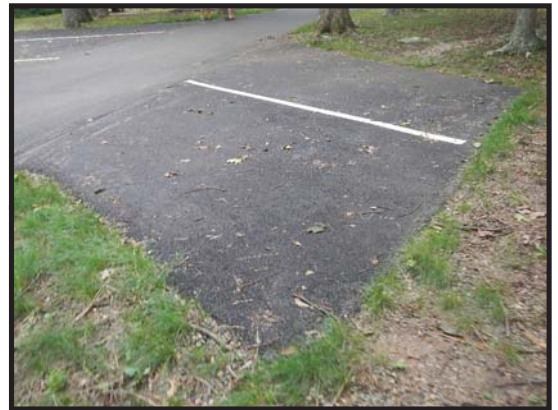
Route 1244GZ

Route Number	Public / NonPublic	Date Visited	Area (sq ft)	Lane Miles *	Surface Type
1244GZ	PUBLIC	8/15/2013	344	0.01	AS
Culverts	Drop Inlets	Gates	Curb & Gutter	Curb	PCR
0	0	0	NO CURB AND GUTTER	NO CURB	EXCELLENT/97

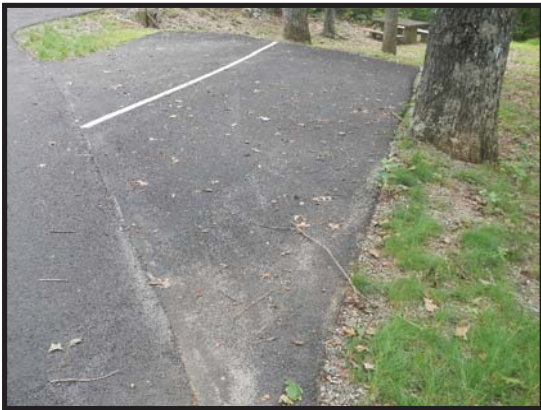
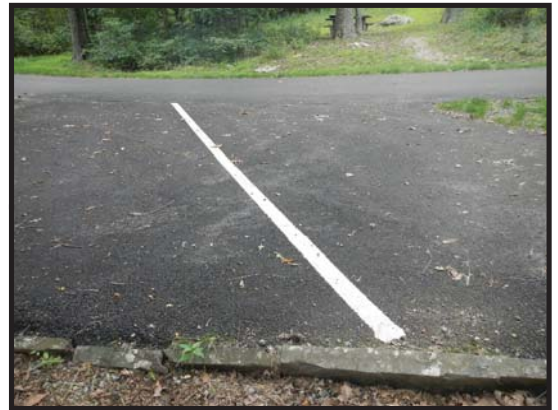
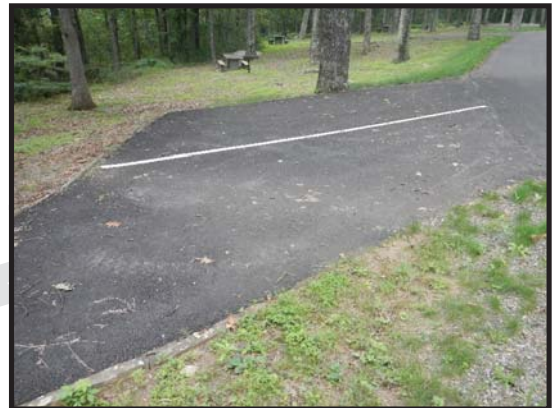
Route 1244HZ

Route Number	Public / NonPublic	Date Visited	Area (sq ft)	Lane Miles *	Surface Type
1244HZ	PUBLIC	8/15/2013	552	0.01	AS
Culverts	Drop Inlets	Gates	Curb & Gutter	Curb	PCR
0	0	0	NO CURB AND GUTTER	STONE CURB	EXCELLENT/97

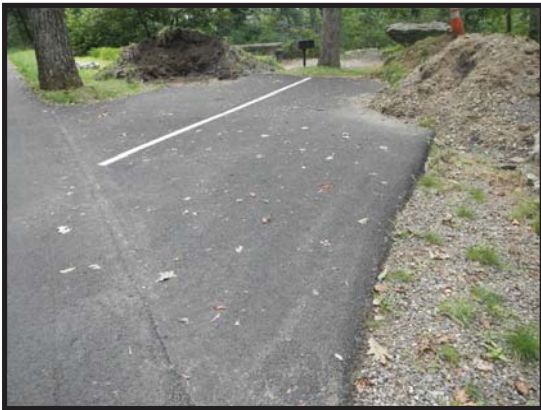
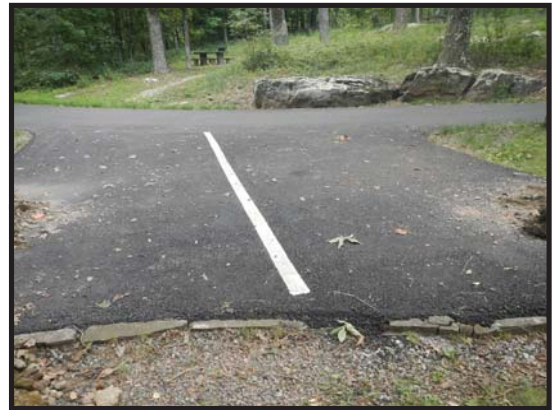
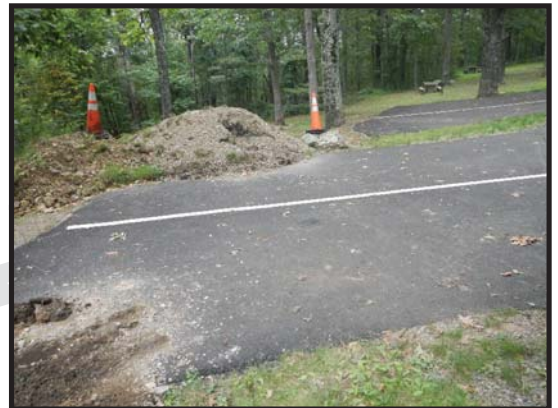
Route 1244IZ

Route Number	Public / NonPublic	Date Visited	Area (sq ft)	Lane Miles *	Surface Type
1244IZ	PUBLIC	8/15/2013	494	0.01	AS
Culverts	Drop Inlets	Gates	Curb & Gutter	Curb	PCR
0	0	0	NO CURB AND GUTTER	STONE CURB	EXCELLENT/97

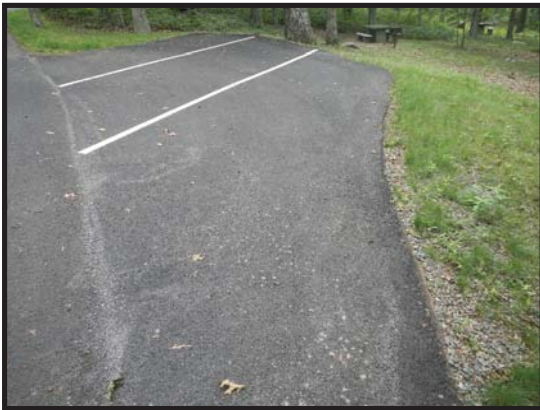
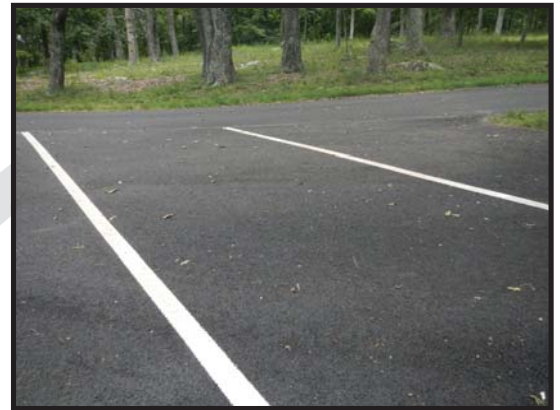
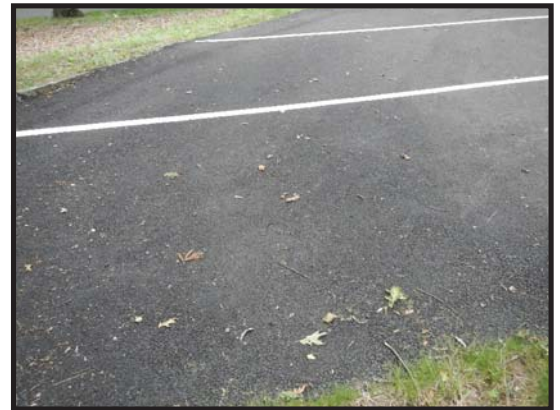
Route 1244JZ

Route Number	Public / NonPublic	Date Visited	Area (sq ft)	Lane Miles *	Surface Type
1244JZ	PUBLIC	8/15/2013	663	0.01	AS
Culverts	Drop Inlets	Gates	Curb & Gutter	Curb	PCR
0	0	0	NO CURB AND GUTTER	STONE CURB	EXCELLENT/97

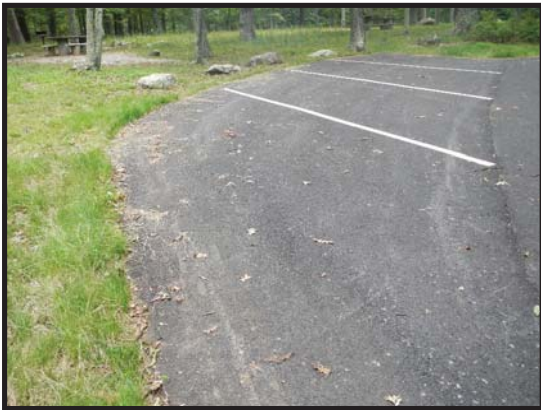
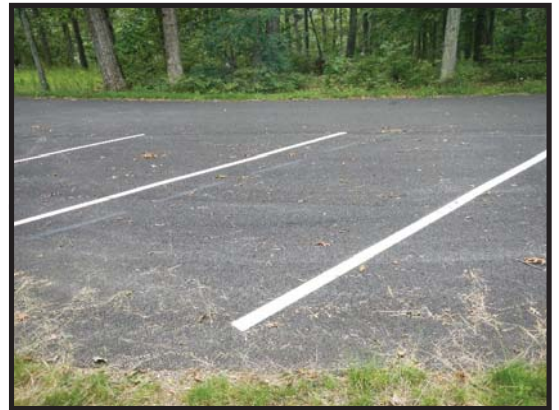
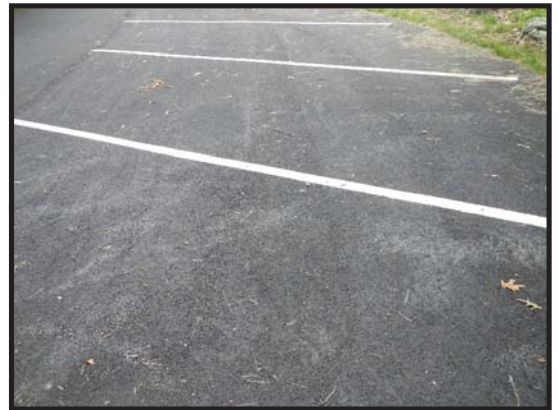
Route 1244KZ

Route Number	Public / NonPublic	Date Visited	Area (sq ft)	Lane Miles *	Surface Type
1244KZ	PUBLIC	8/15/2013	864	0.02	AS
Culverts	Drop Inlets	Gates	Curb & Gutter	Curb	PCR
0	0	0	NO CURB AND GUTTER	NO CURB	EXCELLENT/97

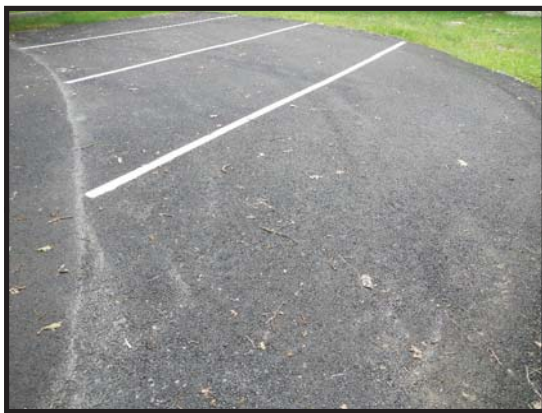
Route Number	Public / NonPublic	Date Visited	Area (sq ft)	Lane Miles *	Surface Type
1244LZ	PUBLIC	8/15/2013	949	0.02	AS
Culverts	Drop Inlets	Gates	Curb & Gutter	Curb	PCR
0	0	0	NO CURB AND GUTTER	STONE CURB	EXCELLENT/97
