# Federal Lands Highway Road Inventory Program

Road Inventory and Condition Assessment

## Boston National Historical Park BOST

### Cycle 5 Report

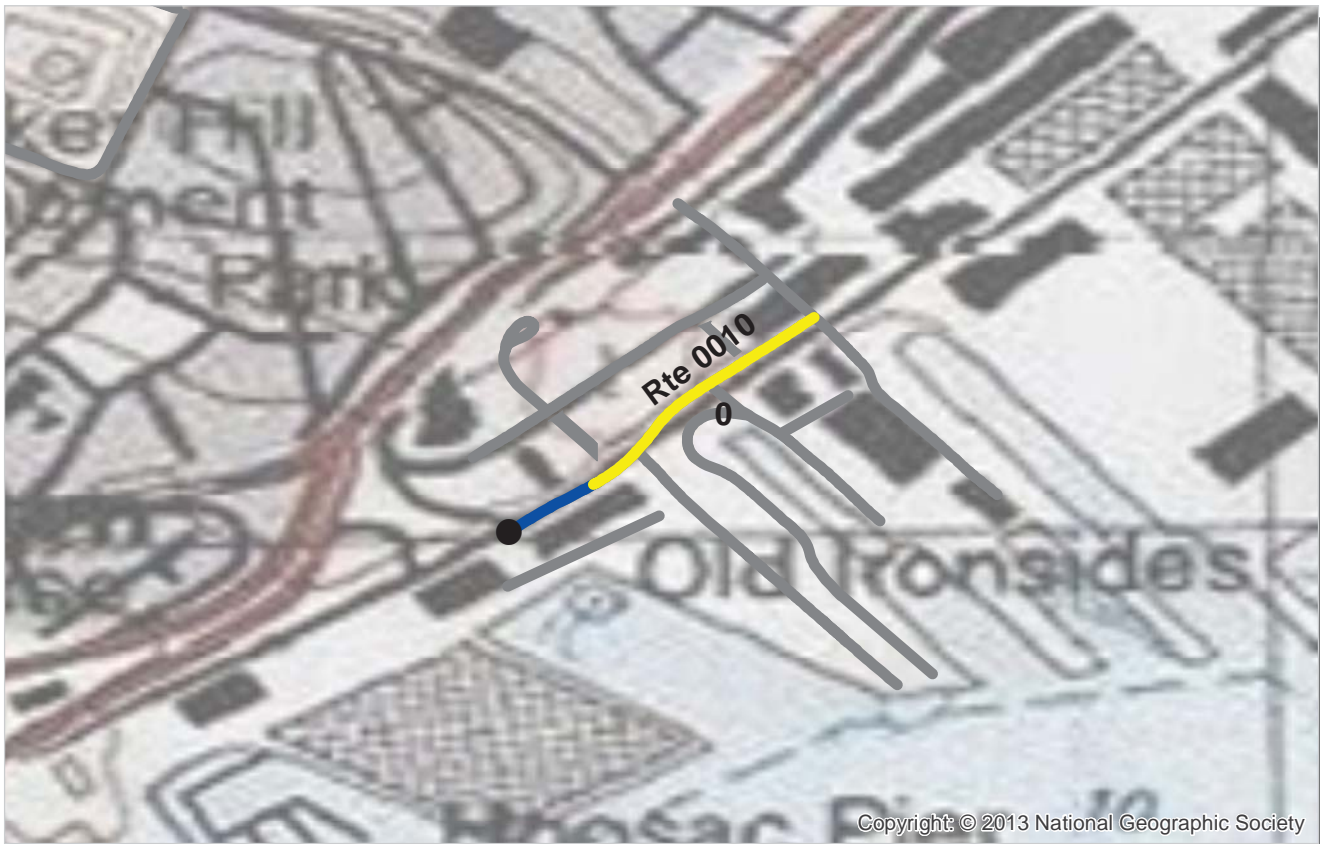
**ROUTE: 0010 FIRST AVENUE**

<b>Section Number</b>	0				
<b>Section Length (mi)</b>	0.15				
<b>Cross Section Information</b>					
Number of Lanes	2				
Paved Width (ft)	52				
Lane Width (ft)	26				
<b>Roadway Condition Information</b>					
SCR (Surface Condition Rating)	88				
PCR (Pavement Condition Rating)	88				
<b>Distress Index Values</b>					
Structural Crack Index	88				
Transverse Cracking Index	95				
Patching Index	99				
Rutting Index	97				
Roughness Condition Index (RCI)	NC

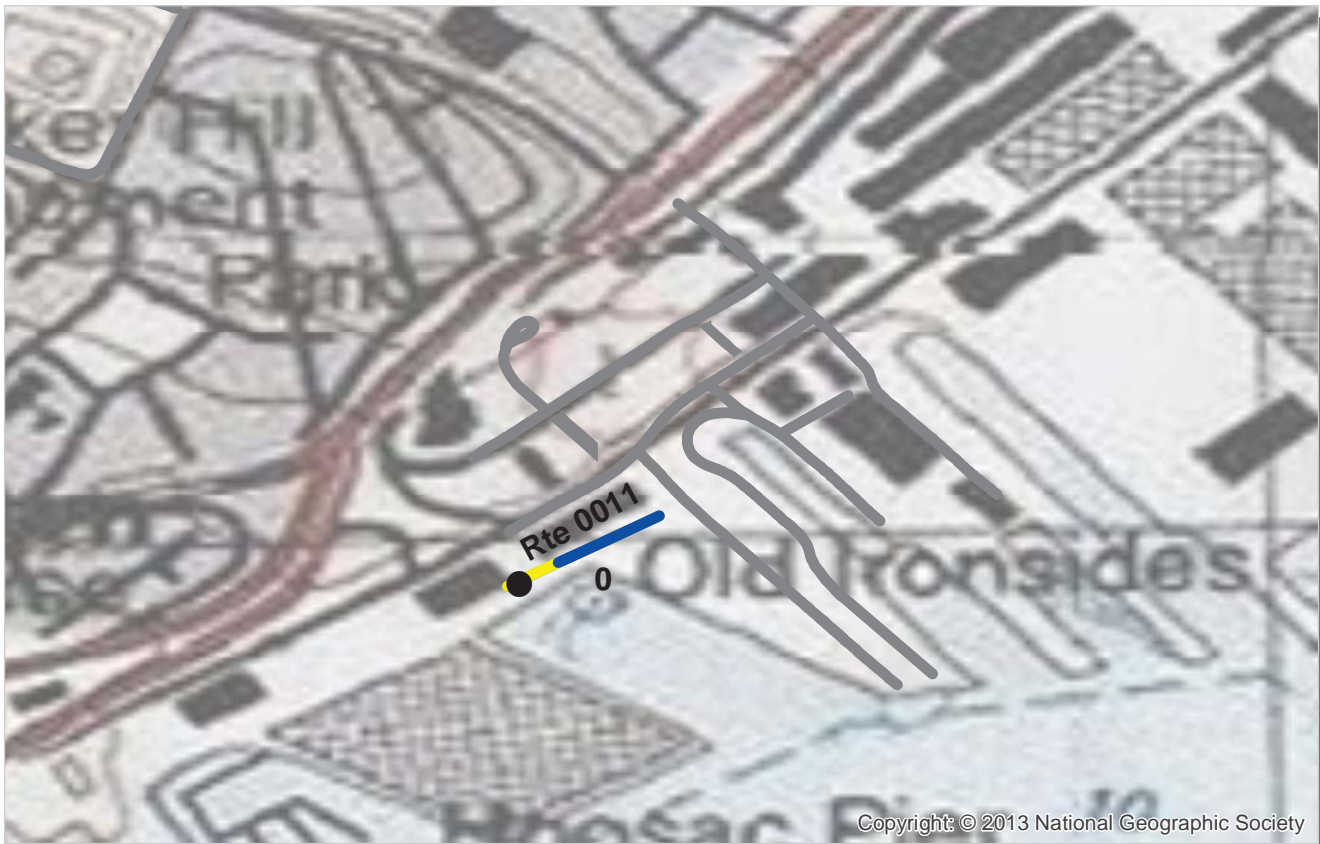
**ROUTE: 0011 LINCOLN AVENUE**

<b>Section Number</b>	0				
<b>Section Length (mi)</b>	0.06				
<b>Cross Section Information</b>					
Number of Lanes	2				
Paved Width (ft)	38				
Lane Width (ft)	19				
<b>Roadway Condition Information</b>					
SCR (Surface Condition Rating)	89				
PCR (Pavement Condition Rating)	89				
<b>Distress Index Values</b>					
Structural Crack Index	100				
Transverse Cracking Index	98				
Patching Index	100				
Rutting Index	89				
Roughness Condition Index (RCI)	NC

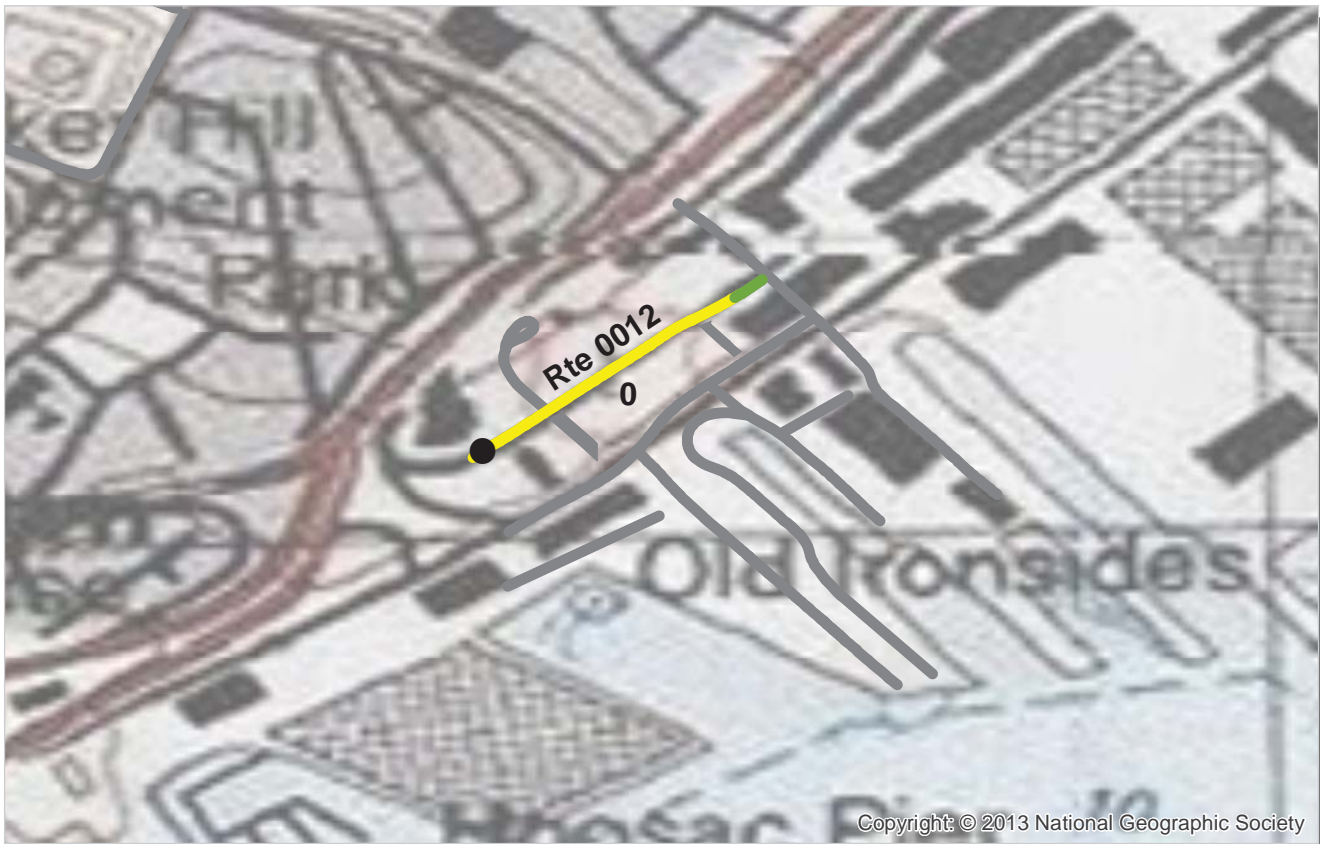
**ROUTE: 0012 SECOND AVENUE**

<b>Section Number</b>	0				
<b>Section Length (mi)</b>	0.13				
<b>Cross Section Information</b>					
Number of Lanes	2				
Paved Width (ft)	23				
Lane Width (ft)	12				
<b>Roadway Condition Information</b>					
SCR (Surface Condition Rating)	72				
PCR (Pavement Condition Rating)	72				
<b>Distress Index Values</b>					
Structural Crack Index	72				
Transverse Cracking Index	91				
Patching Index	100				
Rutting Index	99				
Roughness Condition Index (RCI)	NC

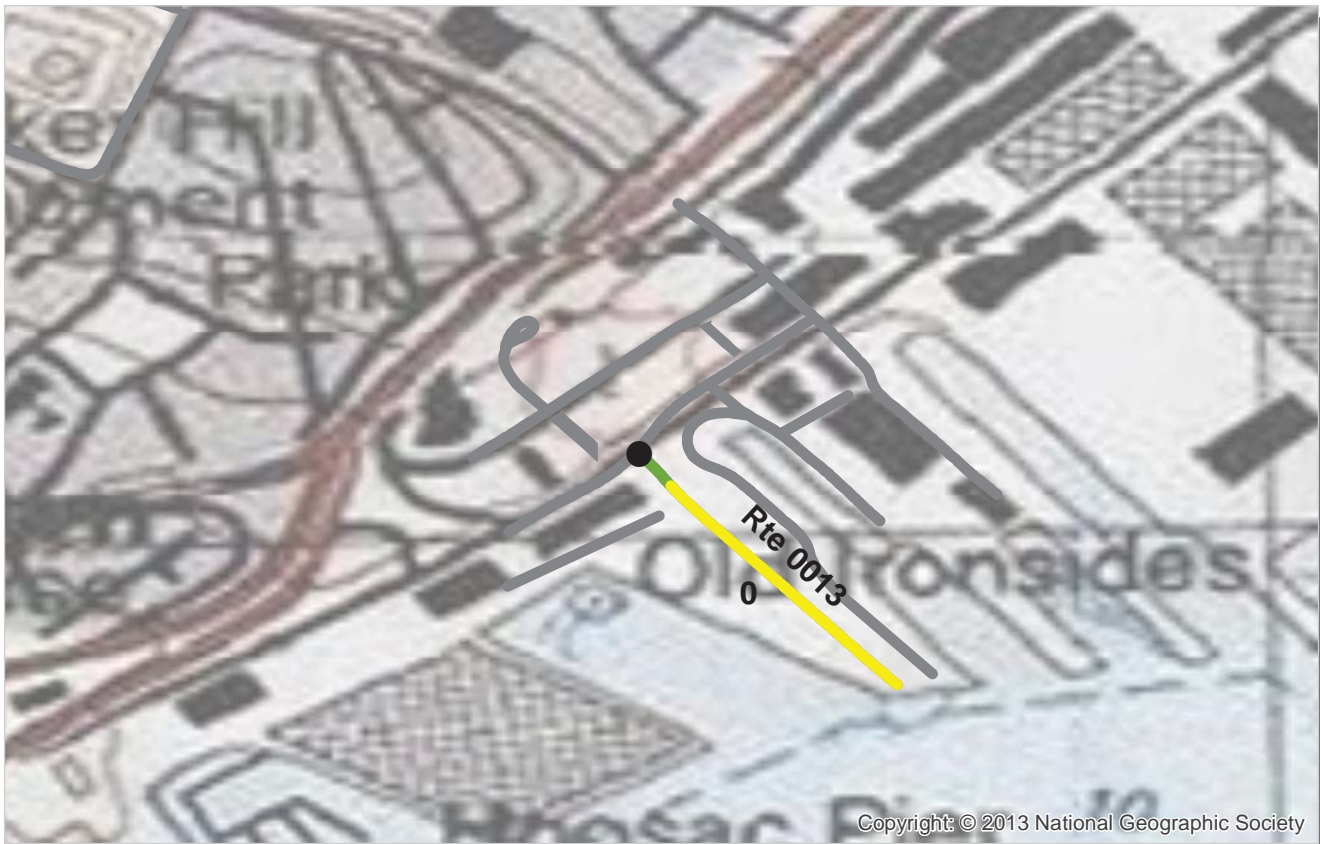
**ROUTE: 0013 THIRD STREET / PIER 1**

<b>Section Number</b>	0				
<b>Section Length (mi)</b>	0.15				
<b>Cross Section Information</b>					
Number of Lanes	2				
Paved Width (ft)	28				
Lane Width (ft)	14				
<b>Roadway Condition Information</b>					
SCR (Surface Condition Rating)	69				
PCR (Pavement Condition Rating)	69				
<b>Distress Index Values</b>					
Structural Crack Index	98				
Transverse Cracking Index	94				
Patching Index	100				
Rutting Index	69				
Roughness Condition Index (RCI)	NC

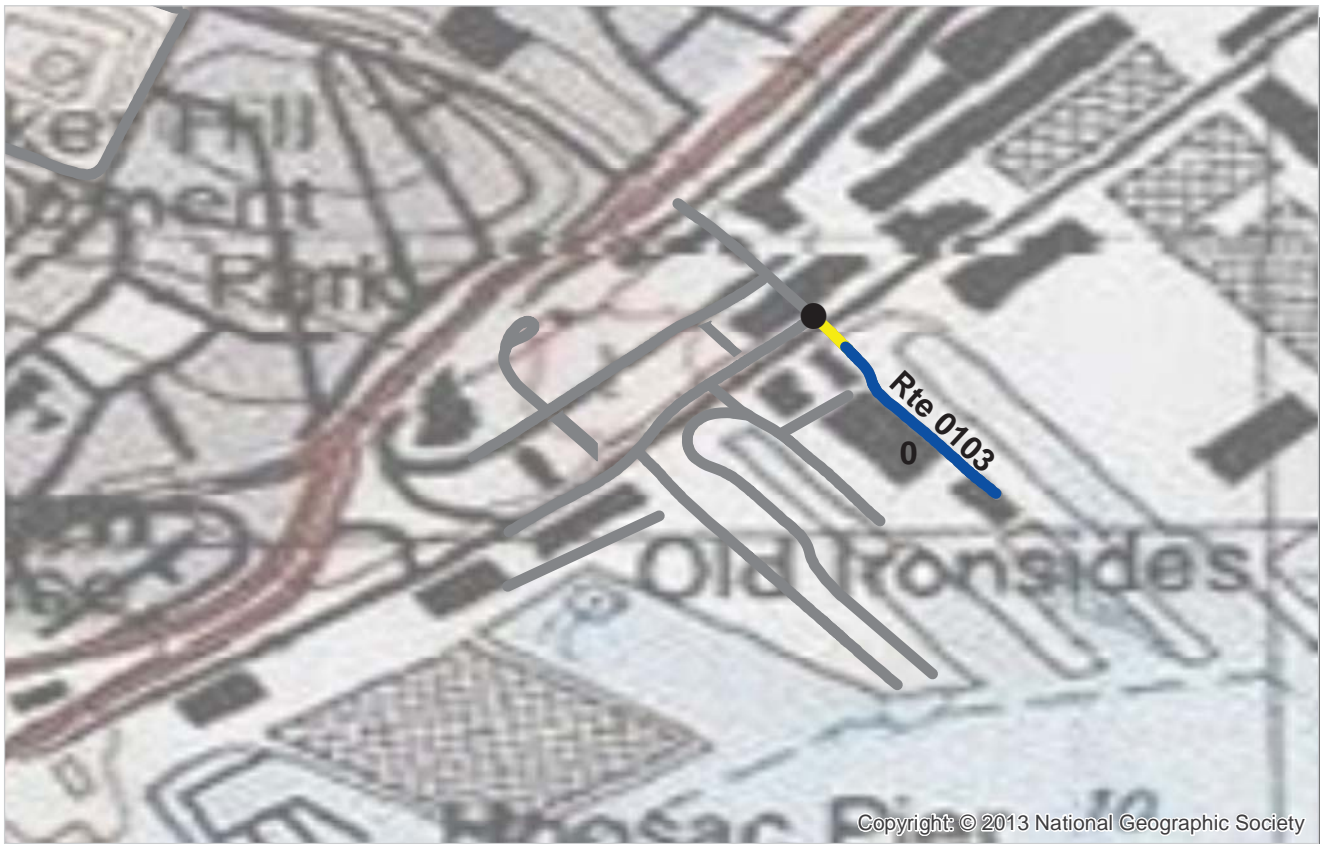
**ROUTE: 0103 BAXTER ROAD**

<b>Section Number</b>	0				
<b>Section Length (mi)</b>	0.11				
<b>Cross Section Information</b>					
Number of Lanes	2				
Paved Width (ft)	37				
Lane Width (ft)	18				
<b>Roadway Condition Information</b>					
SCR (Surface Condition Rating)	95				
PCR (Pavement Condition Rating)	95				
<b>Distress Index Values</b>					
Structural Crack Index	97				
Transverse Cracking Index	95				
Patching Index	100				
Rutting Index	96				
Roughness Condition Index (RCI)	NC

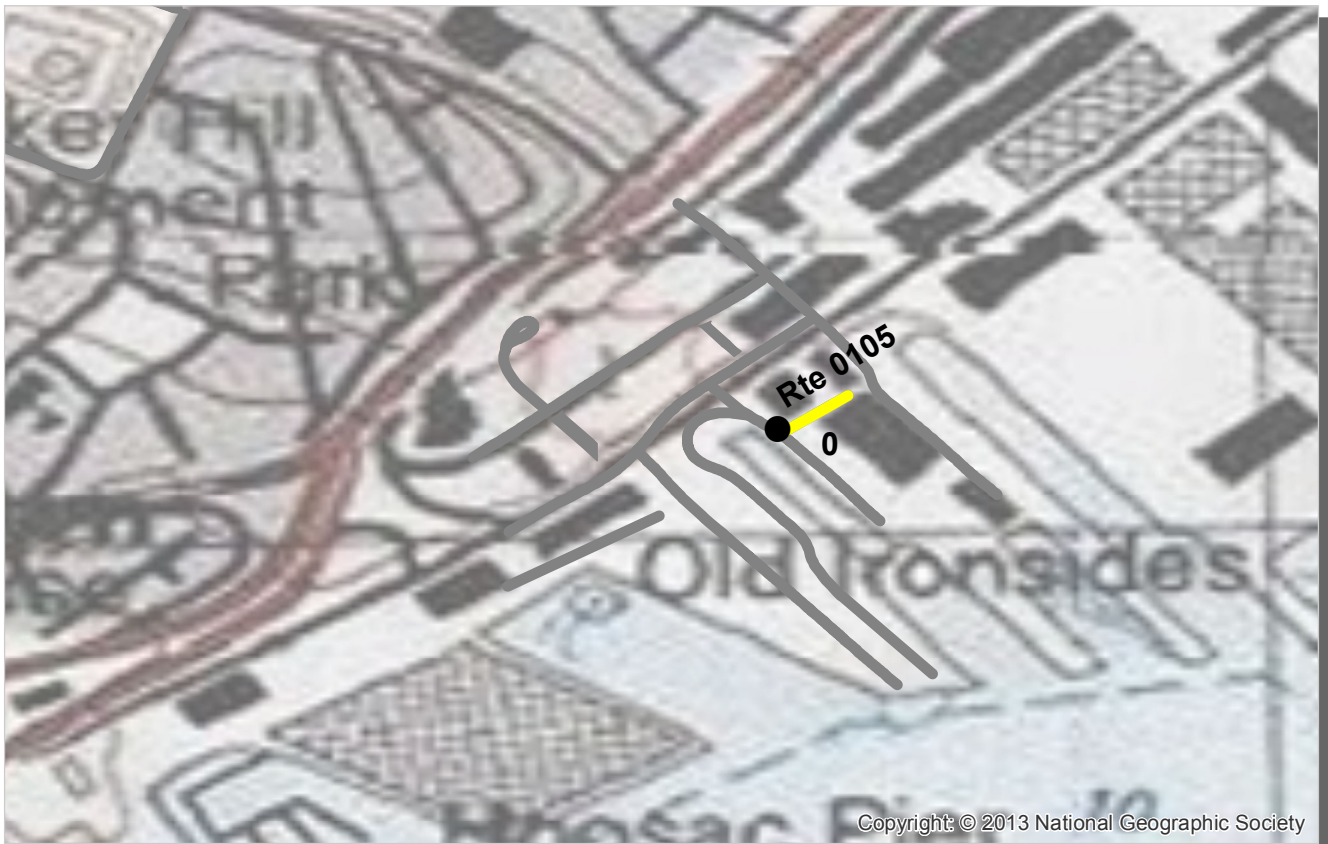
ROUTE: 0105 DRY DOCK 1 AND 2 CONNECTOR ROAD

<b>Section Number</b>	0				
<b>Section Length (mi)</b>	0.03				
<b>Cross Section Information</b>					
Number of Lanes	1				
Paved Width (ft)	24				
Lane Width (ft)	18				
<b>Roadway Condition Information</b>					
SCR (Surface Condition Rating)	83				
PCR (Pavement Condition Rating)	83				
<b>Distress Index Values</b>					
Structural Crack Index	100				
Transverse Cracking Index	98				
Patching Index	99				
Rutting Index	83				
Roughness Condition Index (RCI)	NC

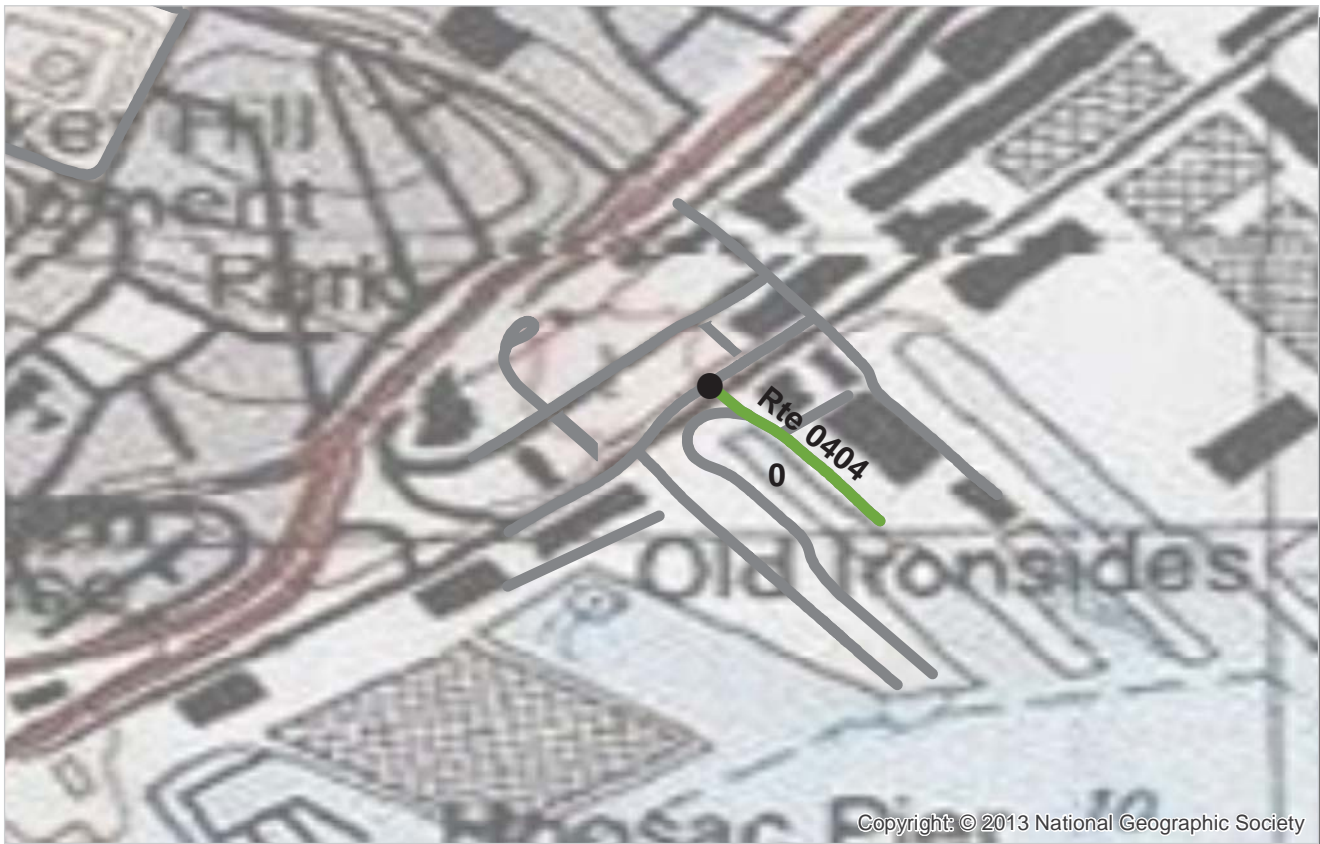
**ROUTE: 0404 DRY DOCK 1 EAST / BUILDING 24 ACCESS ROAD**

<b>Section Number</b>	0				
<b>Section Length (mi)</b>	0.09				
<b>Cross Section Information</b>					
Number of Lanes	1				
Paved Width (ft)	25				
Lane Width (ft)	18				
<b>Roadway Condition Information</b>					
SCR (Surface Condition Rating)	91				
PCR (Pavement Condition Rating)	91				
<b>Distress Index Values</b>					
Structural Crack Index	91				
Transverse Cracking Index	95				
Patching Index	100				
Rutting Index	91				
Roughness Condition Index (RCI)	NC

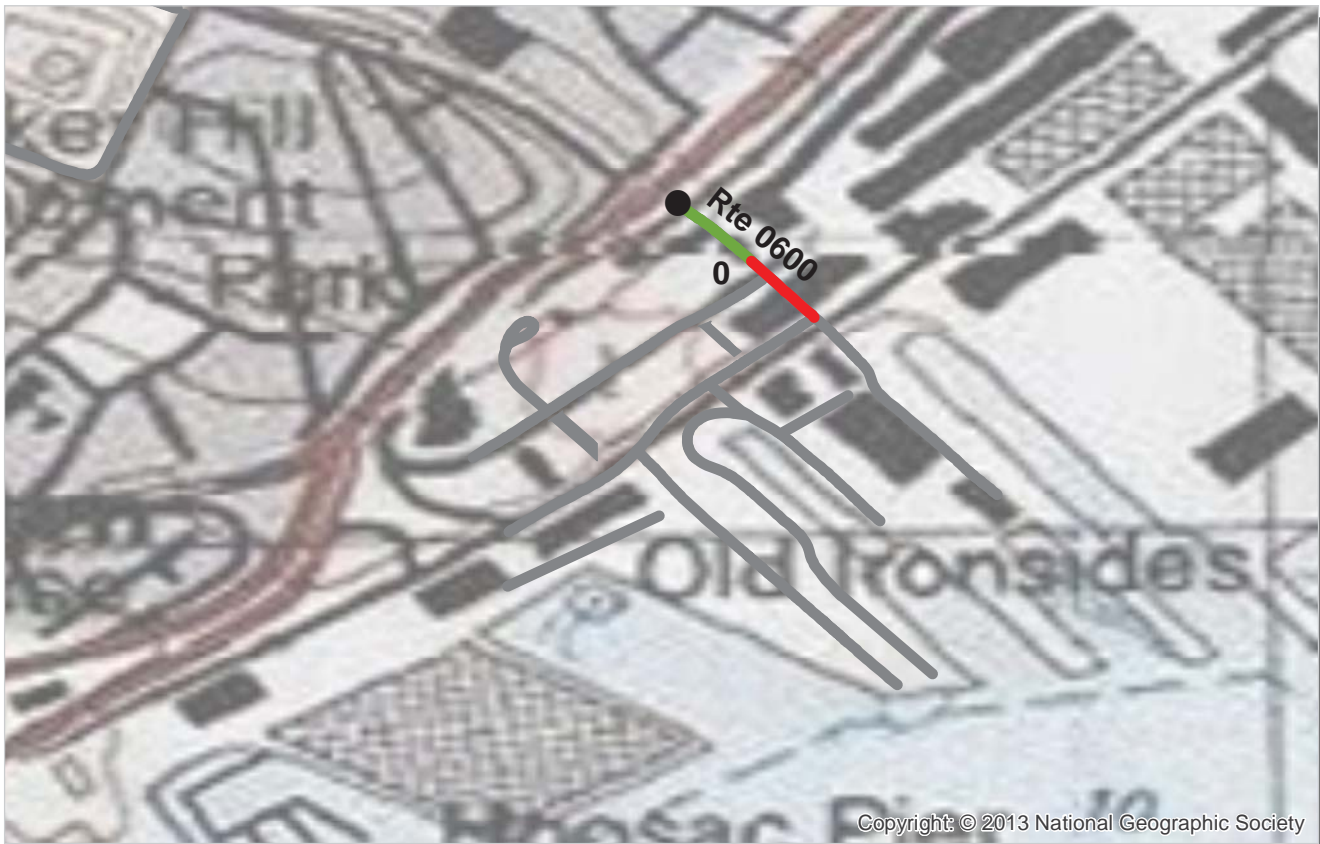
**ROUTE: 0600 FIFTH STREET**

<b>Section Number</b>	0				
<b>Section Length (mi)</b>	0.08				
<b>Cross Section Information</b>					
Number of Lanes	2				
Paved Width (ft)	27				
Lane Width (ft)	15				
<b>Roadway Condition Information</b>					
SCR (Surface Condition Rating)	66				
PCR (Pavement Condition Rating)	66				
<b>Distress Index Values</b>					
Structural Crack Index	83				
Transverse Cracking Index	91				
Patching Index	95				
Rutting Index	66				
Roughness Condition Index (RCI)	NC

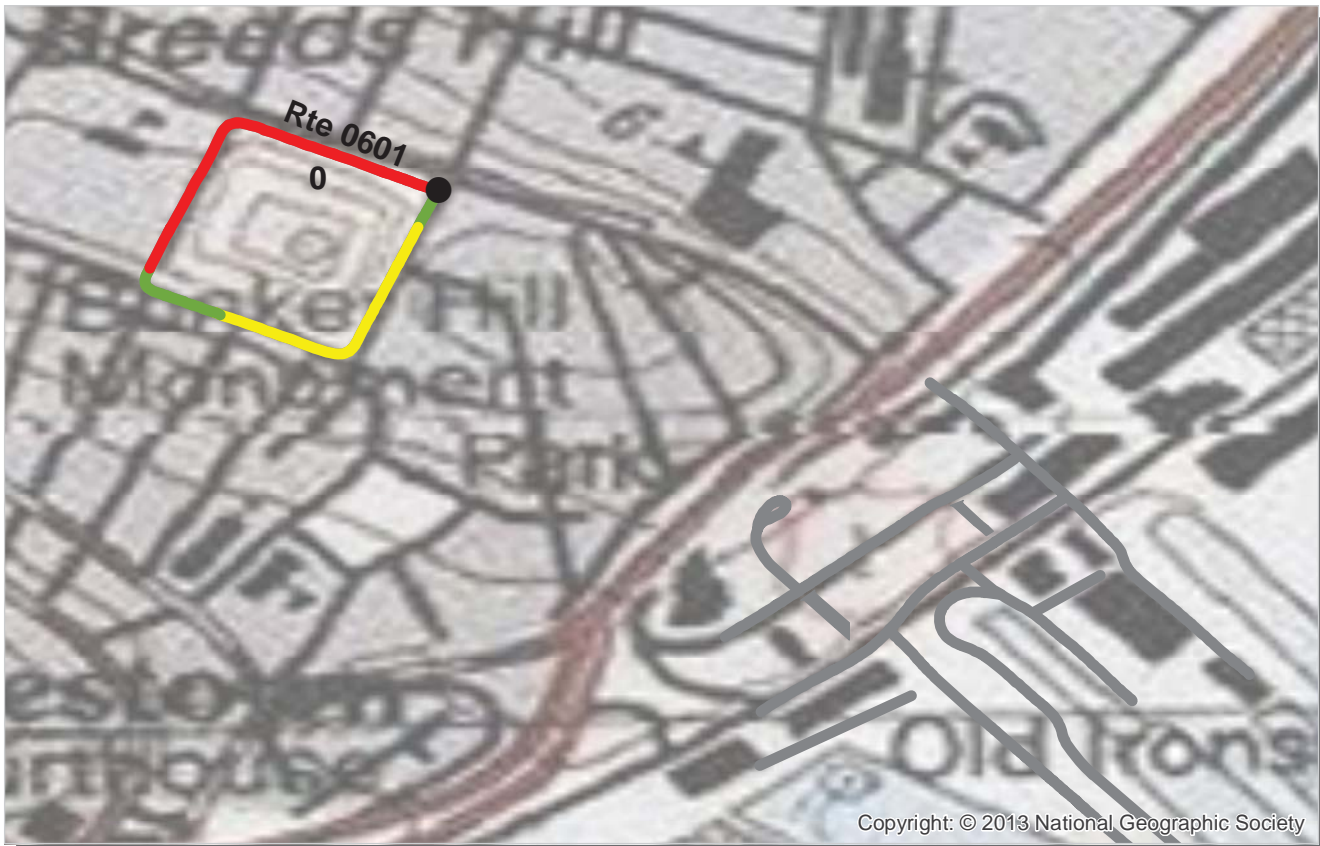
**ROUTE: 0601 MONUMENT SQUARE**

<b>Section Number</b>	0				
<b>Section Length (mi)</b>	0.34				
<b>Cross Section Information</b>					
Number of Lanes	2				
Paved Width (ft)	33				
Lane Width (ft)	16				
<b>Roadway Condition Information</b>					
SCR (Surface Condition Rating)	62				
PCR (Pavement Condition Rating)	62				
<b>Distress Index Values</b>					
Structural Crack Index	62				
Transverse Cracking Index	84				
Patching Index	99				
Rutting Index	97				
Roughness Condition Index (RCI)	NC

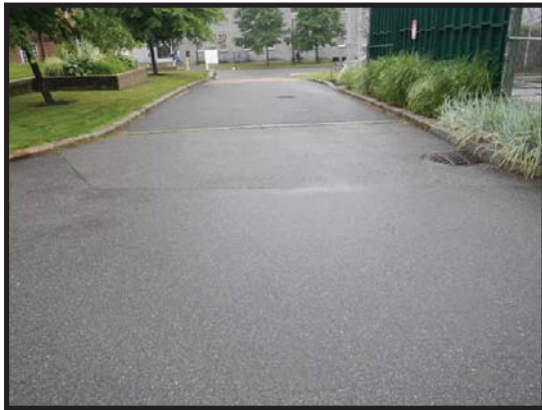
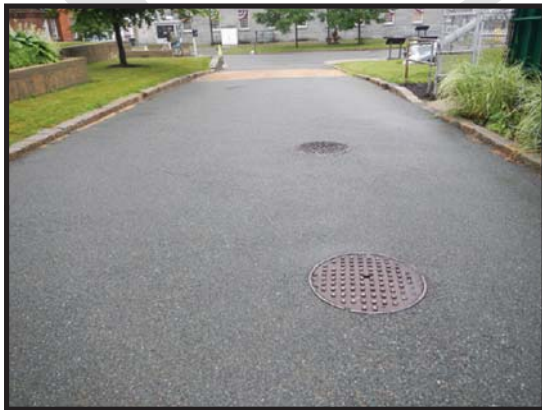
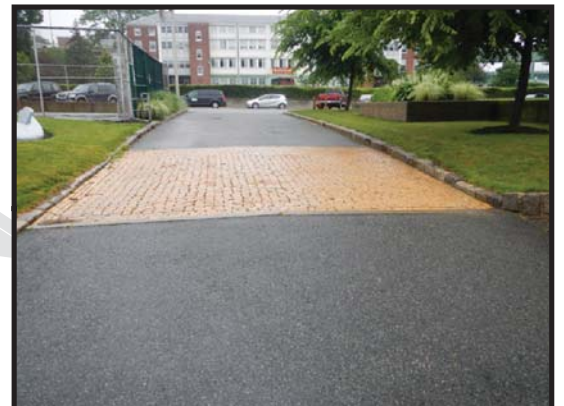
Route Number	Public / NonPublic	Date Visited	Area (sq ft)	Lane Miles *	Surface Type
0100	PUBLIC	6/28/2013	1,922	0.03	AS
Culverts	Drop Inlets	Gates	Curb & Gutter	Curb	PCR
0	1	0	NO CURB AND GUTTER	STONE CURB	POOR/45

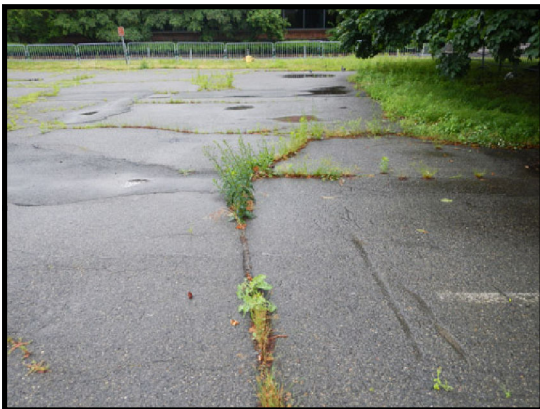
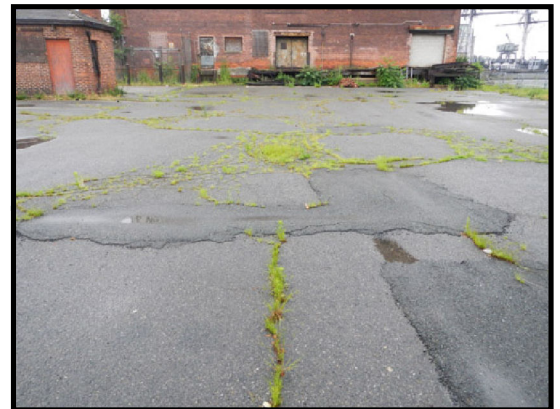
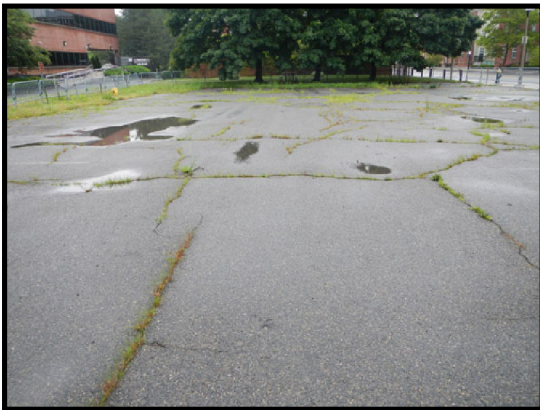
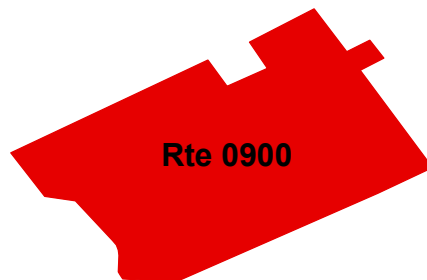
Route Number	Public / NonPublic	Date Visited	Area (sq ft)	Lane Miles *	Surface Type
0900	NONPUBLIC	6/28/2013	8,298	0.14	AS
Culverts	Drop Inlets	Gates	Curb & Gutter	Curb	PCR
0	0	1	NO CURB AND GUTTER	NO CURB	POOR/45

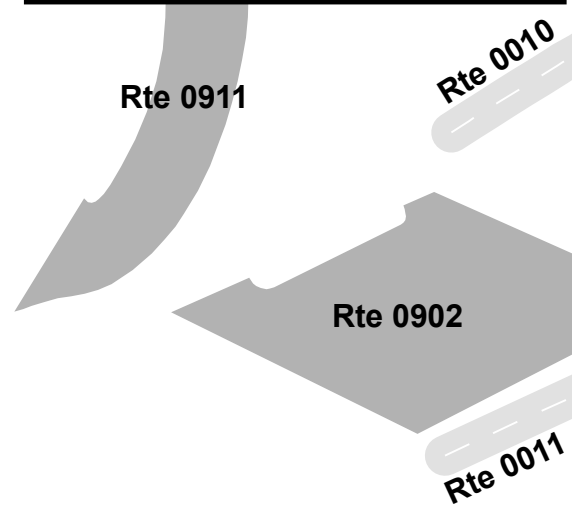
## Route 0902

Route Number	Public / NonPublic	Date Visited	Area (sq ft)	Lane Miles *	Surface Type
0902	NONPUBLIC	6/28/2013	14,987	0.26	AS
Culverts	Drop Inlets	Gates	Curb & Gutter	Curb	PCR
0	6	2	NO CURB AND GUTTER	STONE CURB	FAIR/73

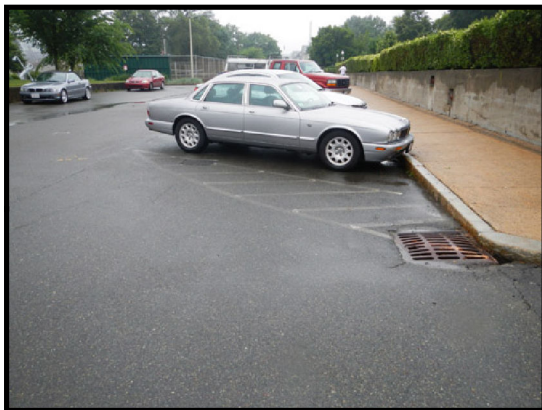
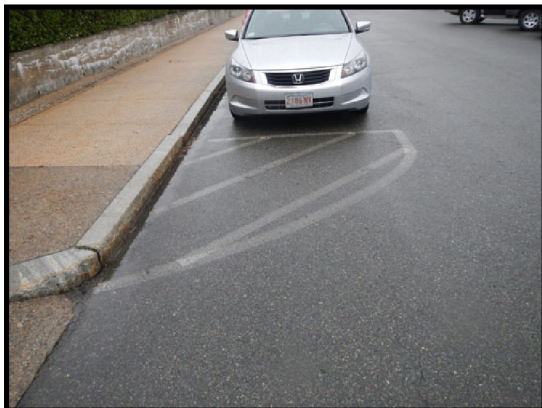
## Route 0903D

Route Number	Public / NonPublic	Date Visited	Area (sq ft)	Lane Miles *	Surface Type
0903D	NONPUBLIC	6/28/2013	2,354	0.04	AS
Culverts	Drop Inlets	Gates	Curb & Gutter	Curb	PCR
0	2	0	NO CURB AND GUTTER	STONE CURB	GOOD/90

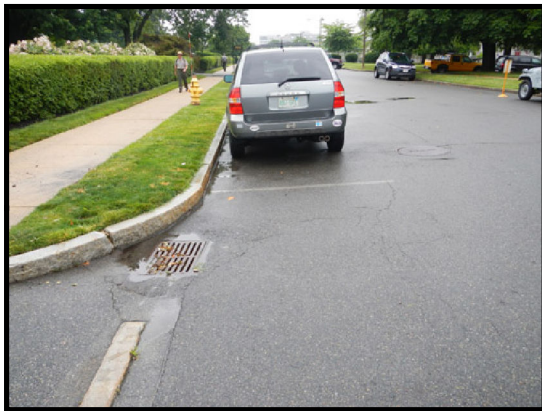
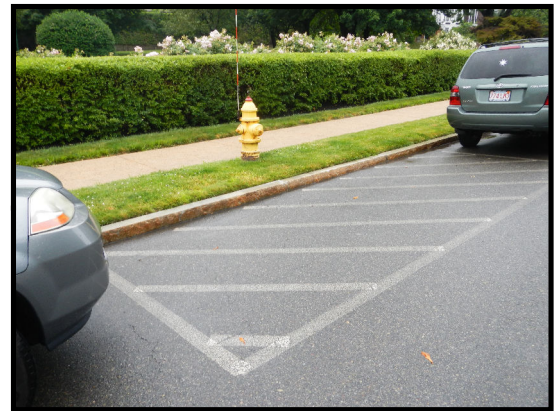
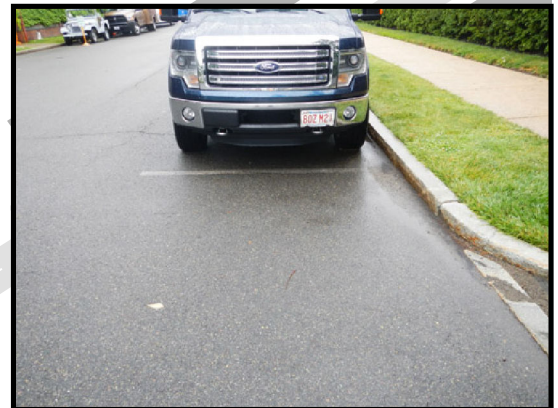
## Route 0903F

Route Number	Public / NonPublic	Date Visited	Area (sq ft)	Lane Miles *	Surface Type
0903F	NONPUBLIC	6/28/2013	908	0.02	AS
Culverts	Drop Inlets	Gates	Curb & Gutter	Curb	PCR
0	1	0	NO CURB AND GUTTER	STONE CURB	FAIR/73
