# Federal Lands Highway Road Inventory Program

Road Inventory and Condition Assessment

## Booker T. Washington National Monument BOWA

### Cycle 5 Report

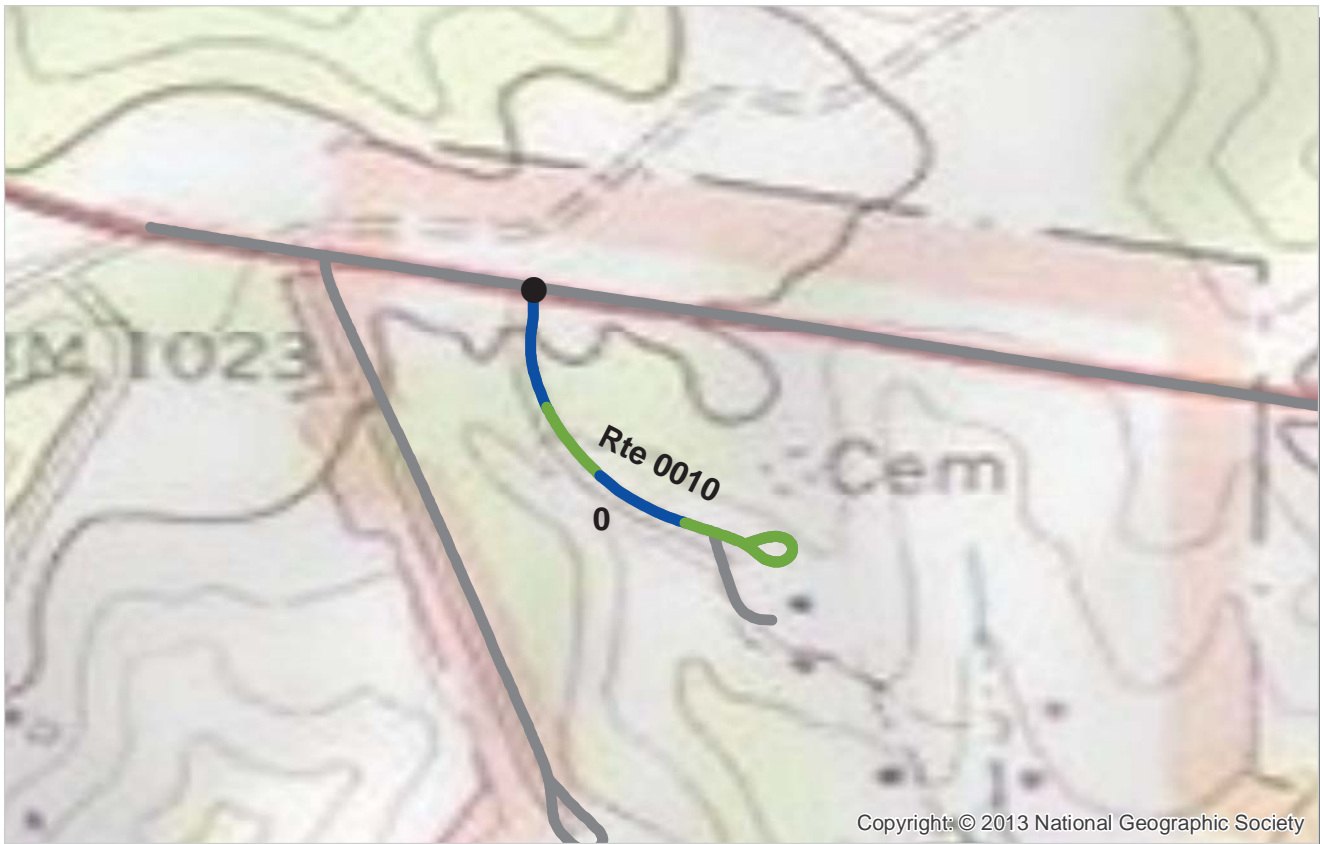
**ROUTE: 0010 VC ENTRANCE ROAD**

<b>Section Number</b>	0				
<b>Section Length (mi)</b>	0.21				
<b>Cross Section Information</b>					
Number of Lanes	2				
Paved Width (ft)	20				
Lane Width (ft)	10				
<b>Roadway Condition Information</b>					
SCR (Surface Condition Rating)	94				
PCR (Pavement Condition Rating)	94				
<b>Distress Index Values</b>					
Structural Crack Index	97				
Transverse Cracking Index	94				
Patching Index	100				
Rutting Index	97				
Roughness Condition Index (RCI)	NC

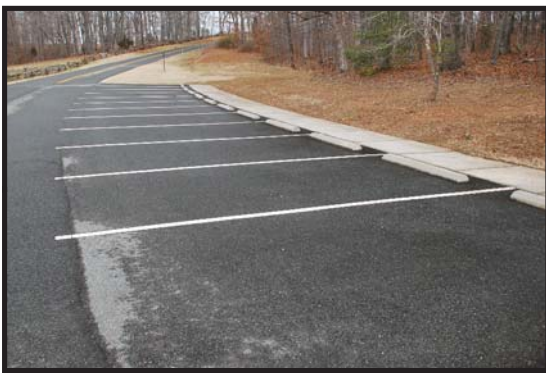
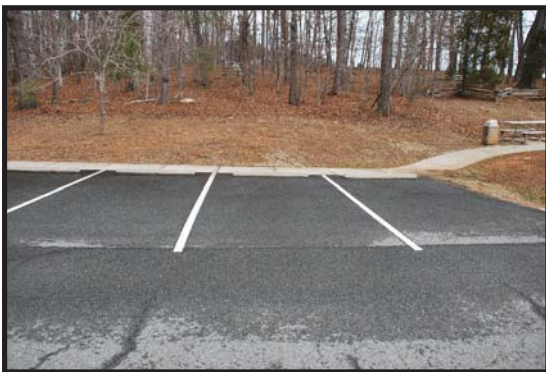
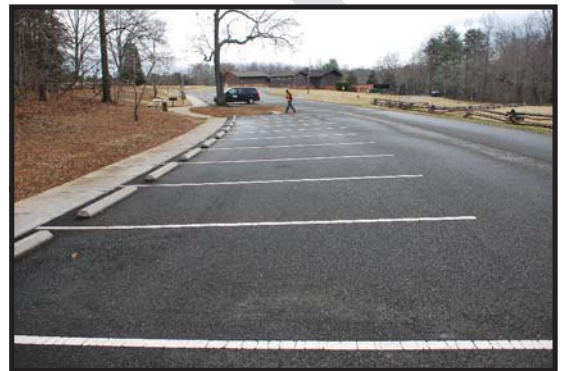
## Route 0900AZ

Route Number	Public / NonPublic	Date Visited	Area (sq ft)	Lane Miles *	Surface Type
0900AZ	PUBLIC	2/22/2013	2,222	0.04	AS
Culverts	Drop Inlets	Gates	Curb & Gutter	Curb	PCR
0	1	0	NO CURB AND GUTTER	NO CURB	FAIR/73

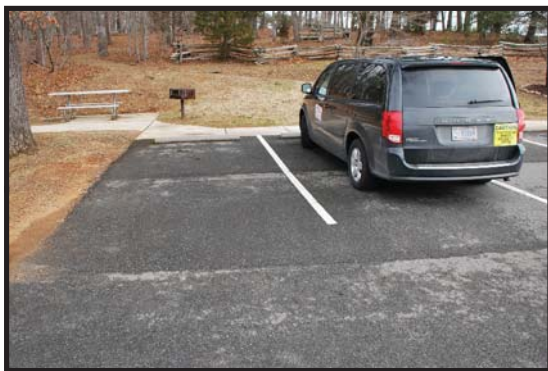
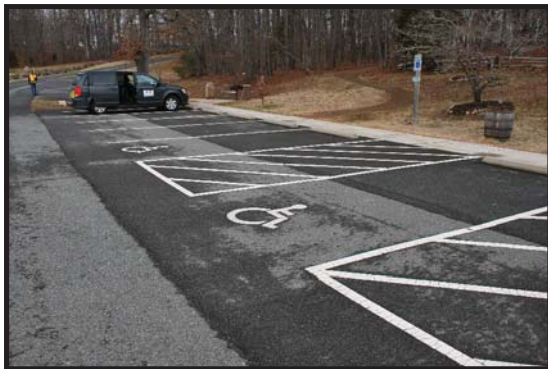
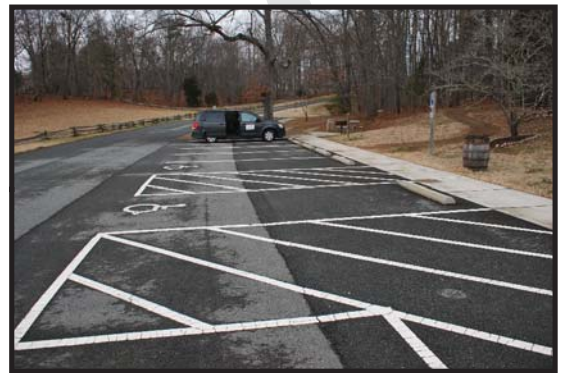
## Route 0900BZ

Route Number	Public / NonPublic	Date Visited	Area (sq ft)	Lane Miles *	Surface Type
0900BZ	PUBLIC	2/22/2013	3,439	0.06	AS
Culverts	Drop Inlets	Gates	Curb & Gutter	Curb	PCR
0	0	0	NO CURB AND GUTTER	NO CURB	FAIR/73

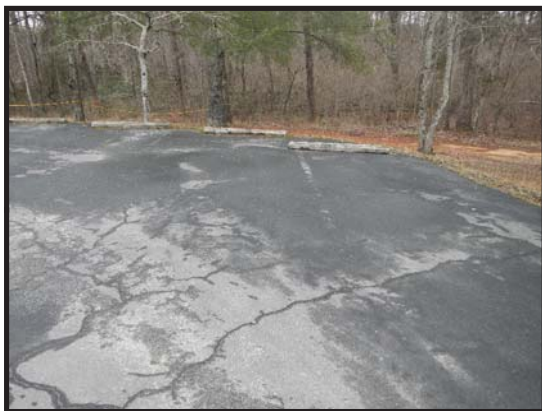
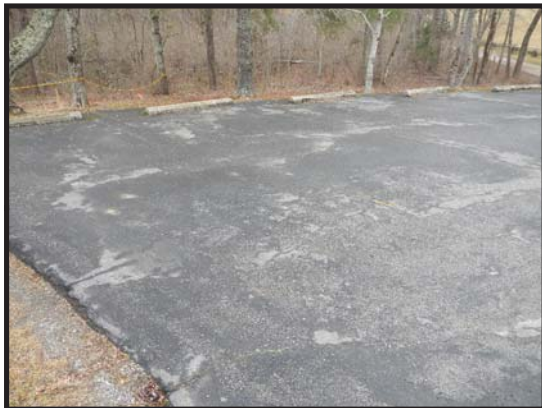
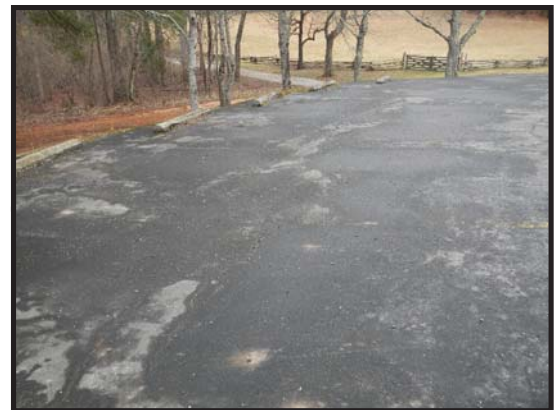
## Route 0901

Route Number	Public / NonPublic	Date Visited	Area (sq ft)	Lane Miles *	Surface Type
0901	NONPUBLIC	2/22/2013	1,377	0.02	AS
Culverts	Drop Inlets	Gates	Curb & Gutter	Curb	PCR
0	0	0	NO CURB AND GUTTER	NO CURB	POOR/45

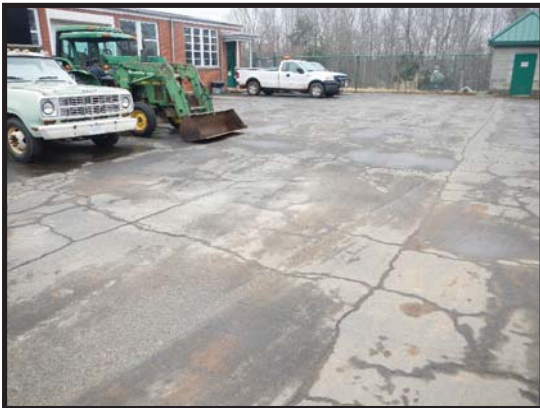
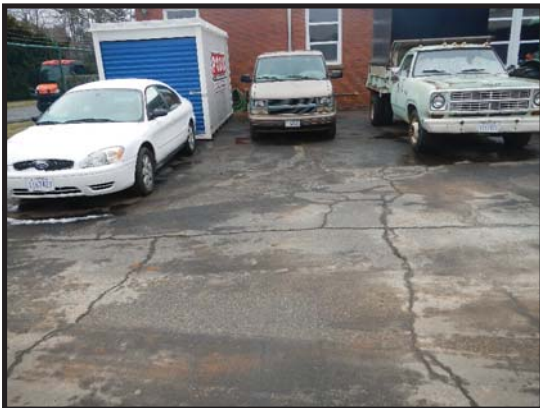
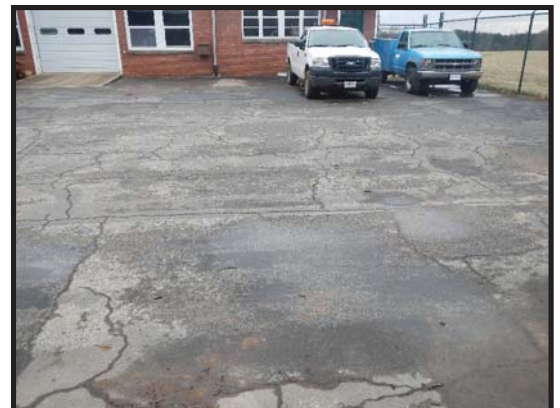
## Route 0903

Route Number	Public / NonPublic	Date Visited	Area (sq ft)	Lane Miles *	Surface Type
0903	NONPUBLIC	2/22/2013	7,699	0.13	AS
Culverts	Drop Inlets	Gates	Curb & Gutter	Curb	PCR
0	0	1	NO CURB AND GUTTER	NO CURB	POOR/45

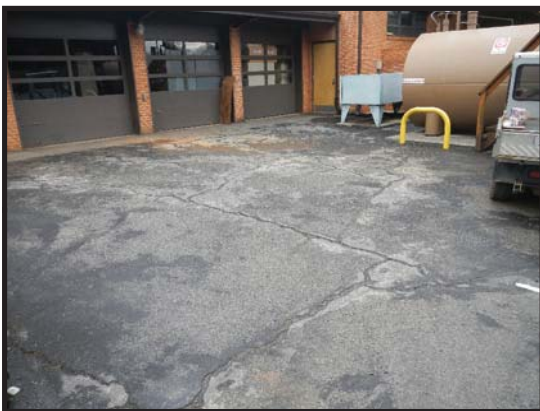
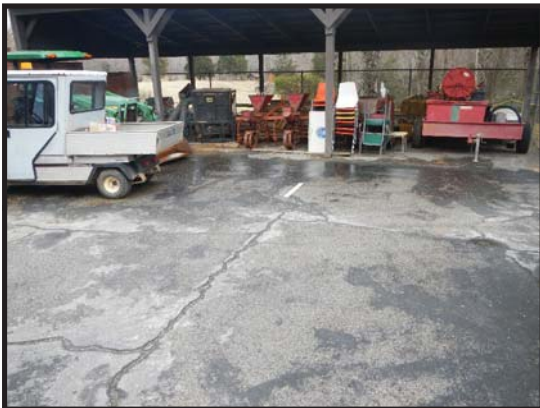
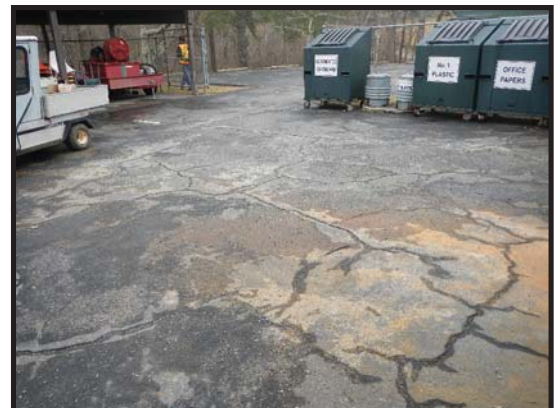
## Route 0904

Route Number	Public / NonPublic	Date Visited	Area (sq ft)	Lane Miles *	Surface Type
0904	NONPUBLIC	2/22/2013	1,429	0.03	AS
Culverts	Drop Inlets	Gates	Curb & Gutter	Curb	PCR
0	0	1	NO CURB AND GUTTER	NO CURB	POOR/45
