Federal Lands Highway Road Inventory Program

Road Inventory and Condition Assessment

Bryce Canyon National Park BRCA

Cycle 5 Report

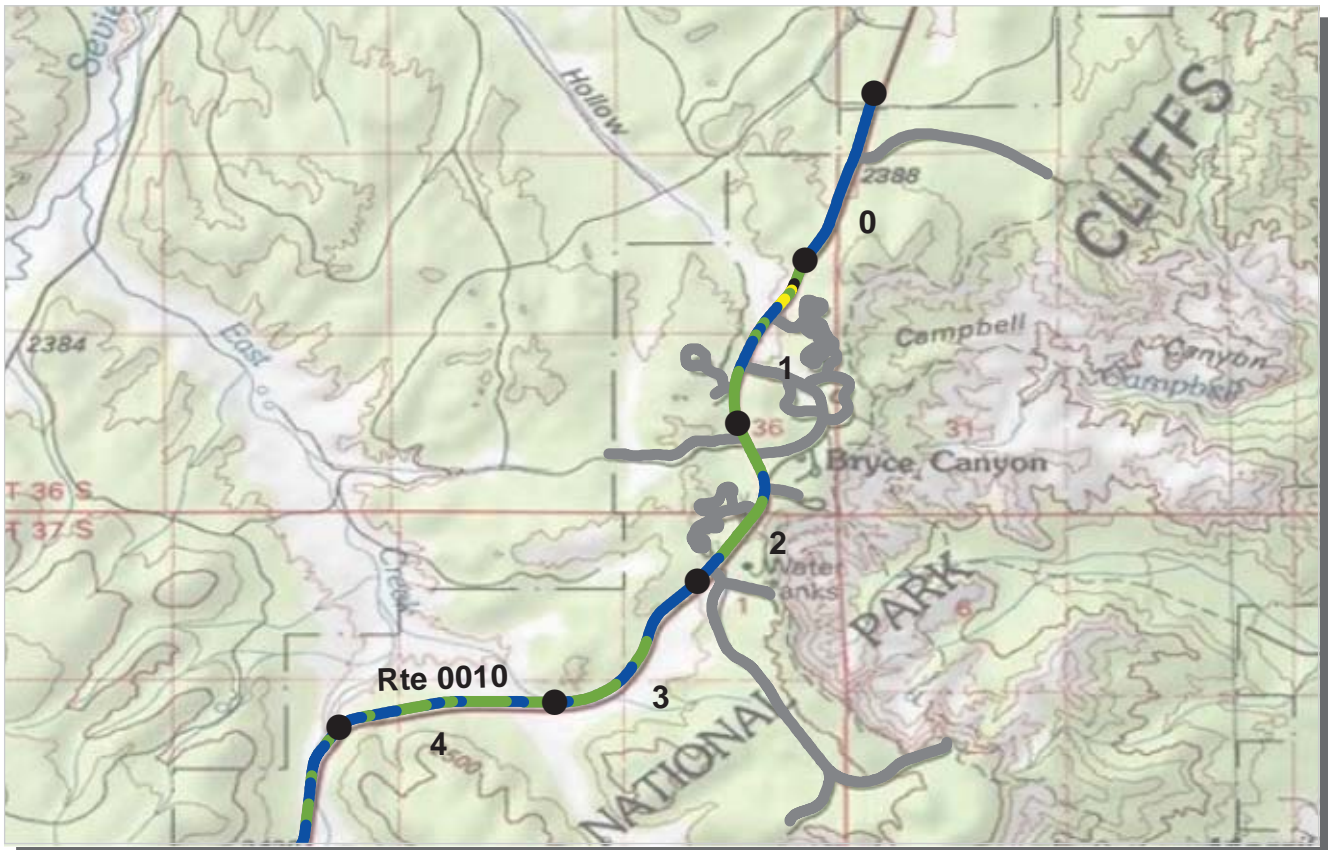
ROUTE: 0010 MAIN PARK ROAD

<i>Section Number</i>	0	1	2	3	4
<i>Section Length (mi)</i>	1.00	1.00	1.00	1.00	1.00
<i>Cross Section Information</i>					
Number of Lanes	2	2	2	2	2
Paved Width (ft)	30	39	31	26	27
Lane Width (ft)	11	13	11	11	11
<i>Roadway Condition Information</i>					
SCR (Surface Condition Rating)	95	93	90	95	91
PCR (Pavement Condition Rating)	97	94	94	97	95
<i>Distress Index Values</i>					
Structural Crack Index	100	99	100	100	100
Transverse Cracking Index	100	99	100	100	100
Patching Index	100	100	100	100	100
Rutting Index	95	93	90	95	91
Roughness Condition Index (RCI)	100	95	100	100	100

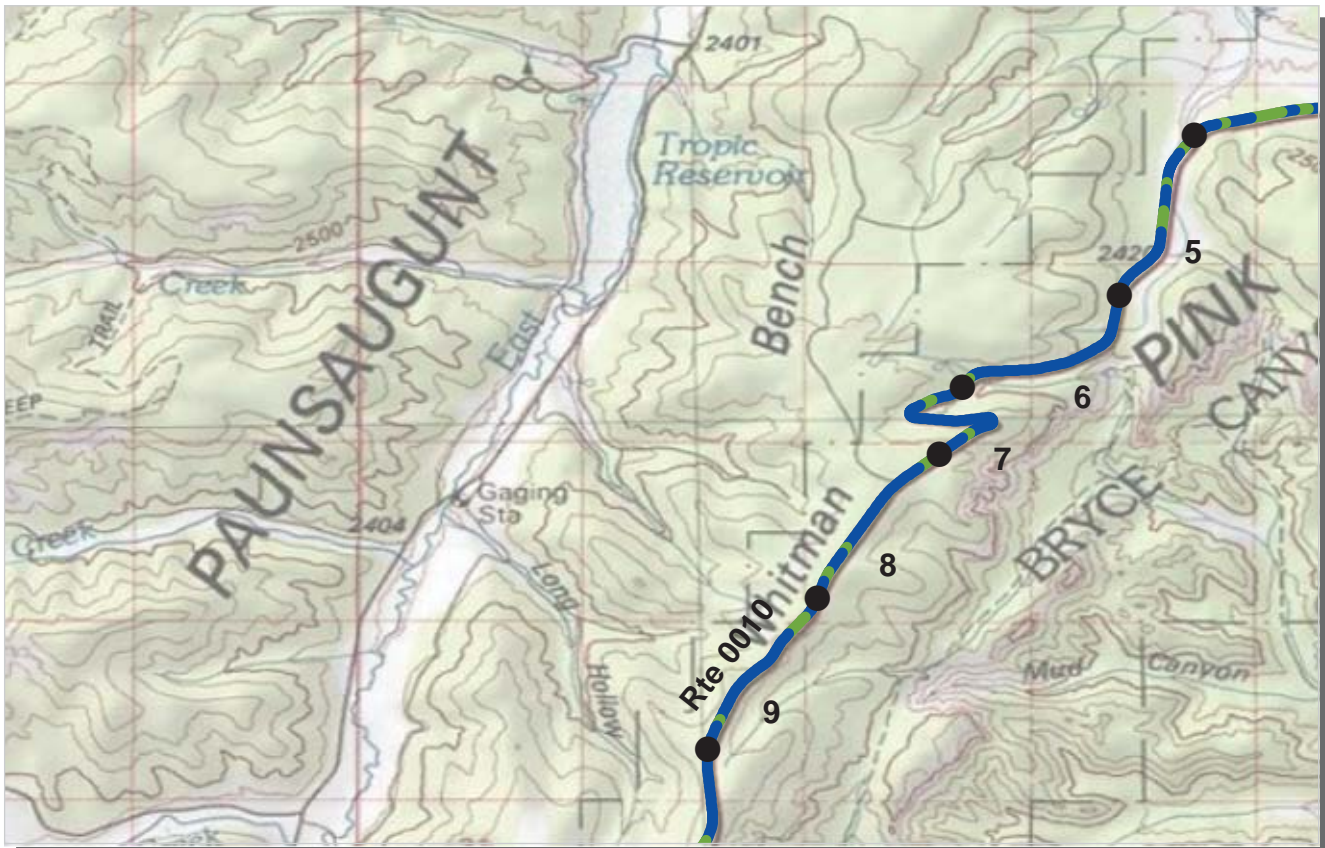
ROUTE: 0010 MAIN PARK ROAD

Section Number	5	6	7	8	9
Section Length (mi)	1.00	1.00	1.00	1.00	1.00
Cross Section Information					
Number of Lanes	2	2	2	2	2
Paved Width (ft)	29	31	32	27	27
Lane Width (ft)	11	11	11	11	10
Roadway Condition Information					
SCR (Surface Condition Rating)	94	97	98	93	94
PCR (Pavement Condition Rating)	96	98	99	96	96
Distress Index Values					
Structural Crack Index	100	100	100	100	100
Transverse Cracking Index	100	100	100	100	100
Patching Index	100	100	100	100	100
Rutting Index	94	97	98	93	94
Roughness Condition Index (RCI)	100	100	100	100	100

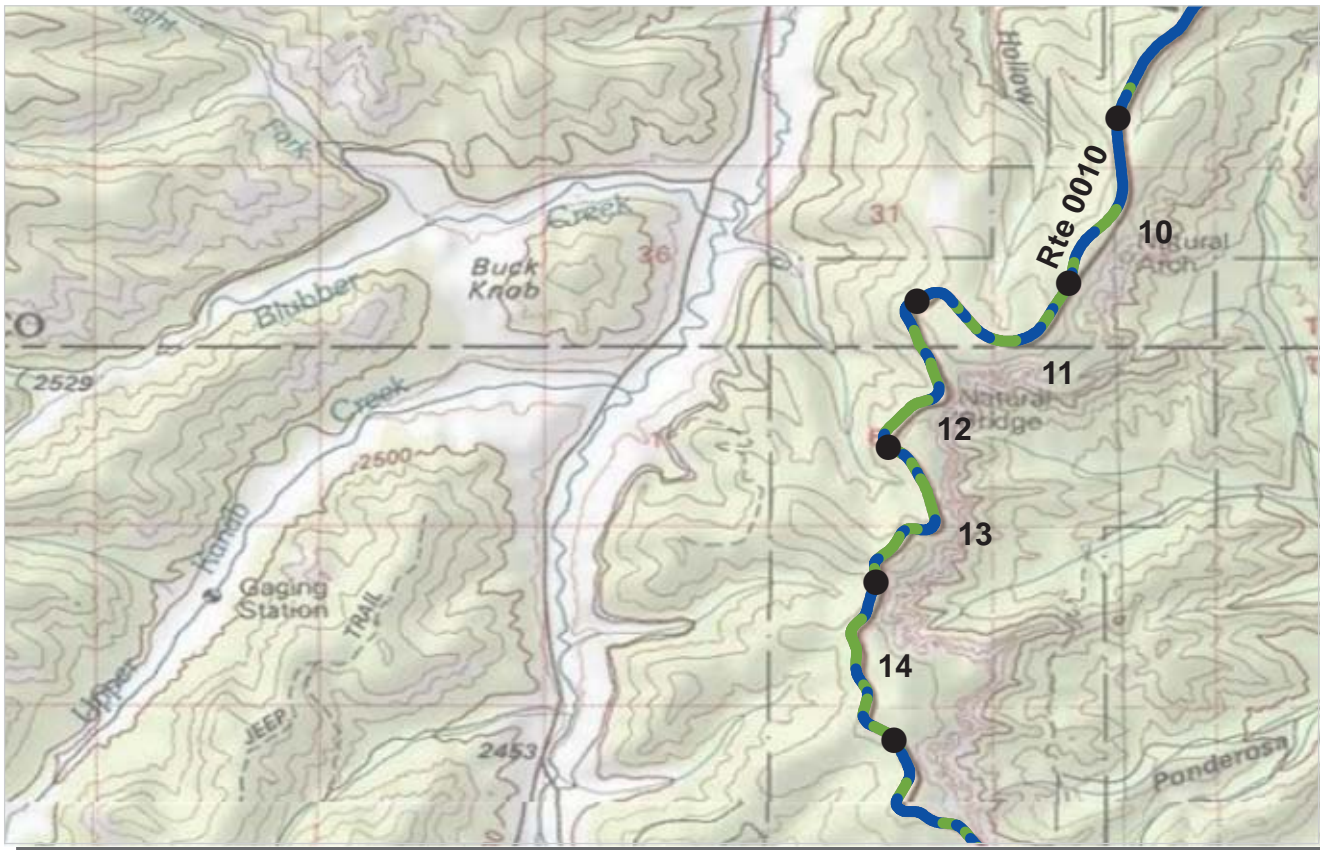
ROUTE: 0010 MAIN PARK ROAD

<i>Section Number</i>	10	11	12	13	14
<i>Section Length (mi)</i>	1.00	1.00	1.00	1.00	1.00
<i>Cross Section Information</i>					
Number of Lanes	2	2	2	2	2
Paved Width (ft)	27	25	33	28	30
Lane Width (ft)	11	10	11	11	11
<i>Roadway Condition Information</i>					
SCR (Surface Condition Rating)	94	91	91	91	92
PCR (Pavement Condition Rating)	96	95	95	95	95
<i>Distress Index Values</i>					
Structural Crack Index	100	100	98	99	98
Transverse Cracking Index	99	100	99	99	100
Patching Index	100	100	100	100	100
Rutting Index	94	91	91	91	92
Roughness Condition Index (RCI)	100	100	100	100	100

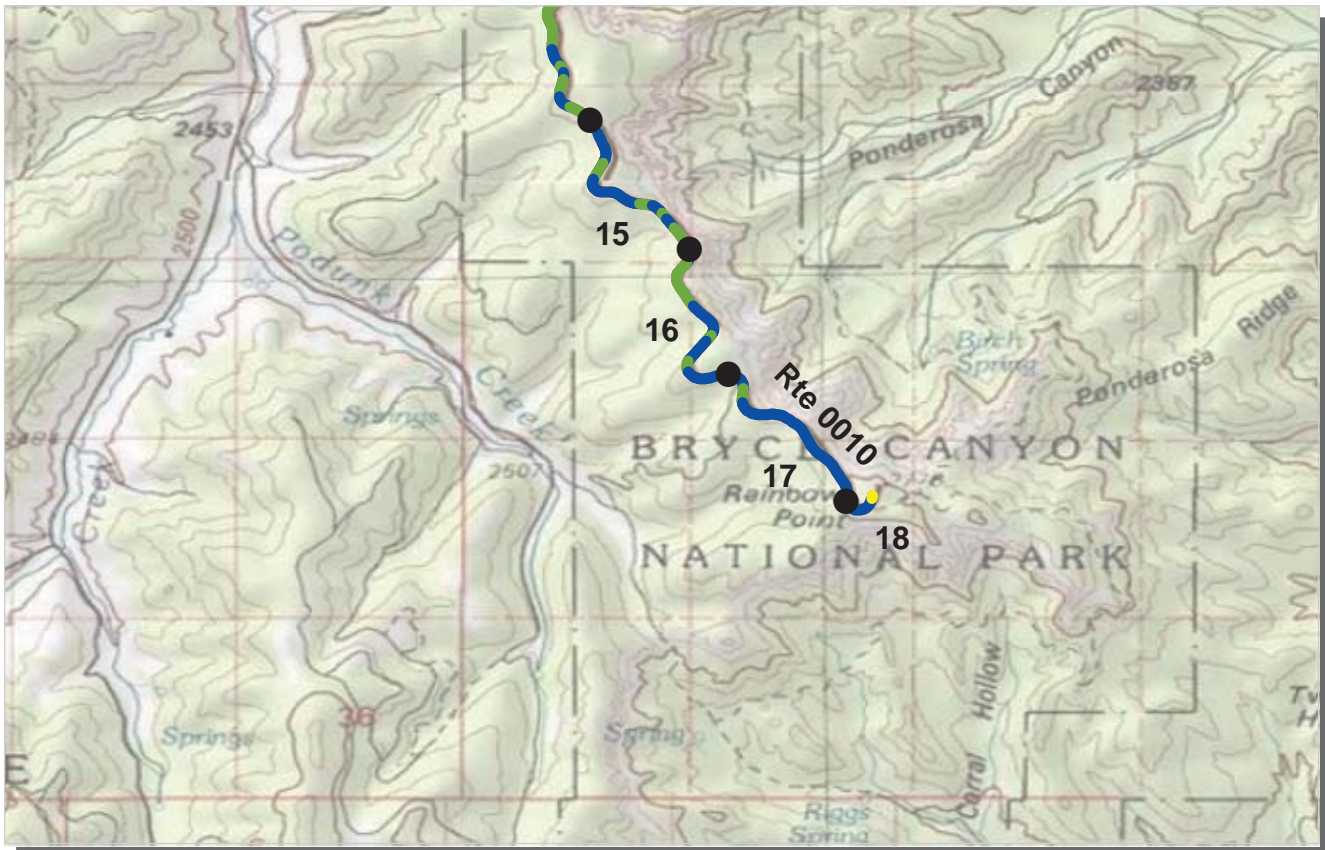
ROUTE: 0010 MAIN PARK ROAD

Section Number	15	16	17	18	
Section Length (mi)	1.00	1.00	1.00	0.20	
Cross Section Information					
Number of Lanes	2	2	2	2	
Paved Width (ft)	29	28	29	27	
Lane Width (ft)	11	11	11	10	
Roadway Condition Information					
SCR (Surface Condition Rating)	93	92	96	95	
PCR (Pavement Condition Rating)	96	95	98	97	
Distress Index Values					
Structural Crack Index	100	99	100	100	
Transverse Cracking Index	100	100	100	100	
Patching Index	100	100	100	100	
Rutting Index	93	92	96	95	
Roughness Condition Index (RCI)	100	100	100	100

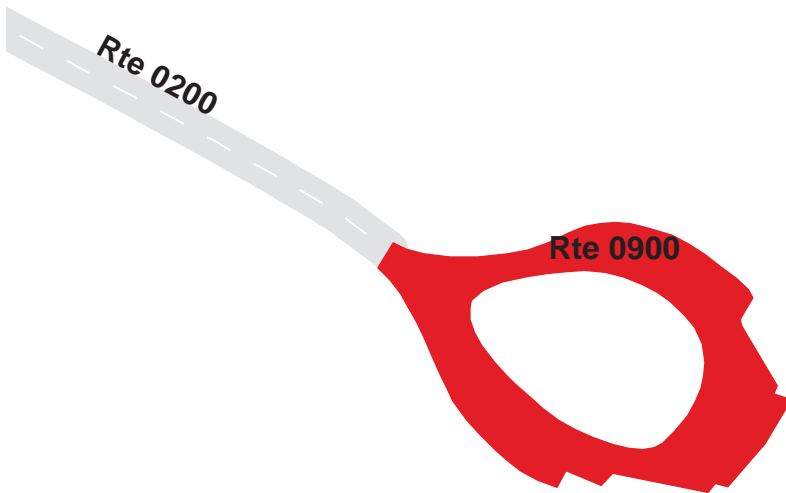
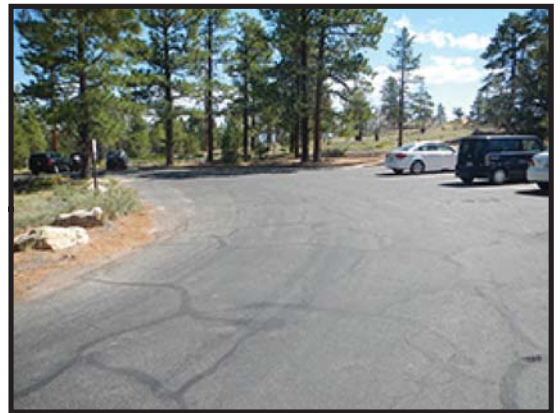
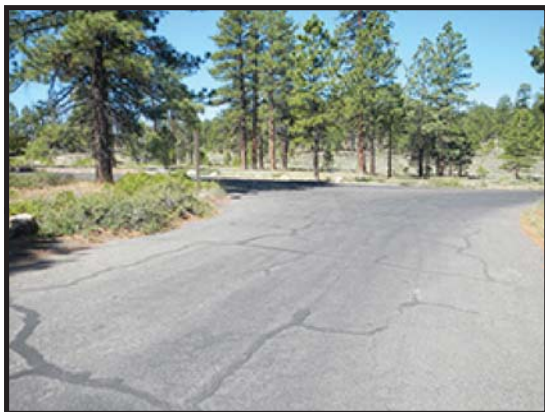
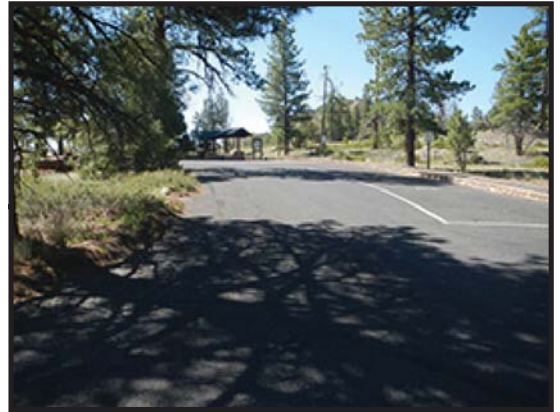
Route 0913

Route Number	Public / NonPublic	Date Visited	Area (sq ft)	Lane Miles *	Surface Type
0913	PUBLIC	6/15/2012	57,165	0.98	AS
Culverts	Drop Inlets	Gates	Curb & Gutter	Curb	PCR
1	0	0	NO CURB AND GUTTER	NO CURB	FAIR/73

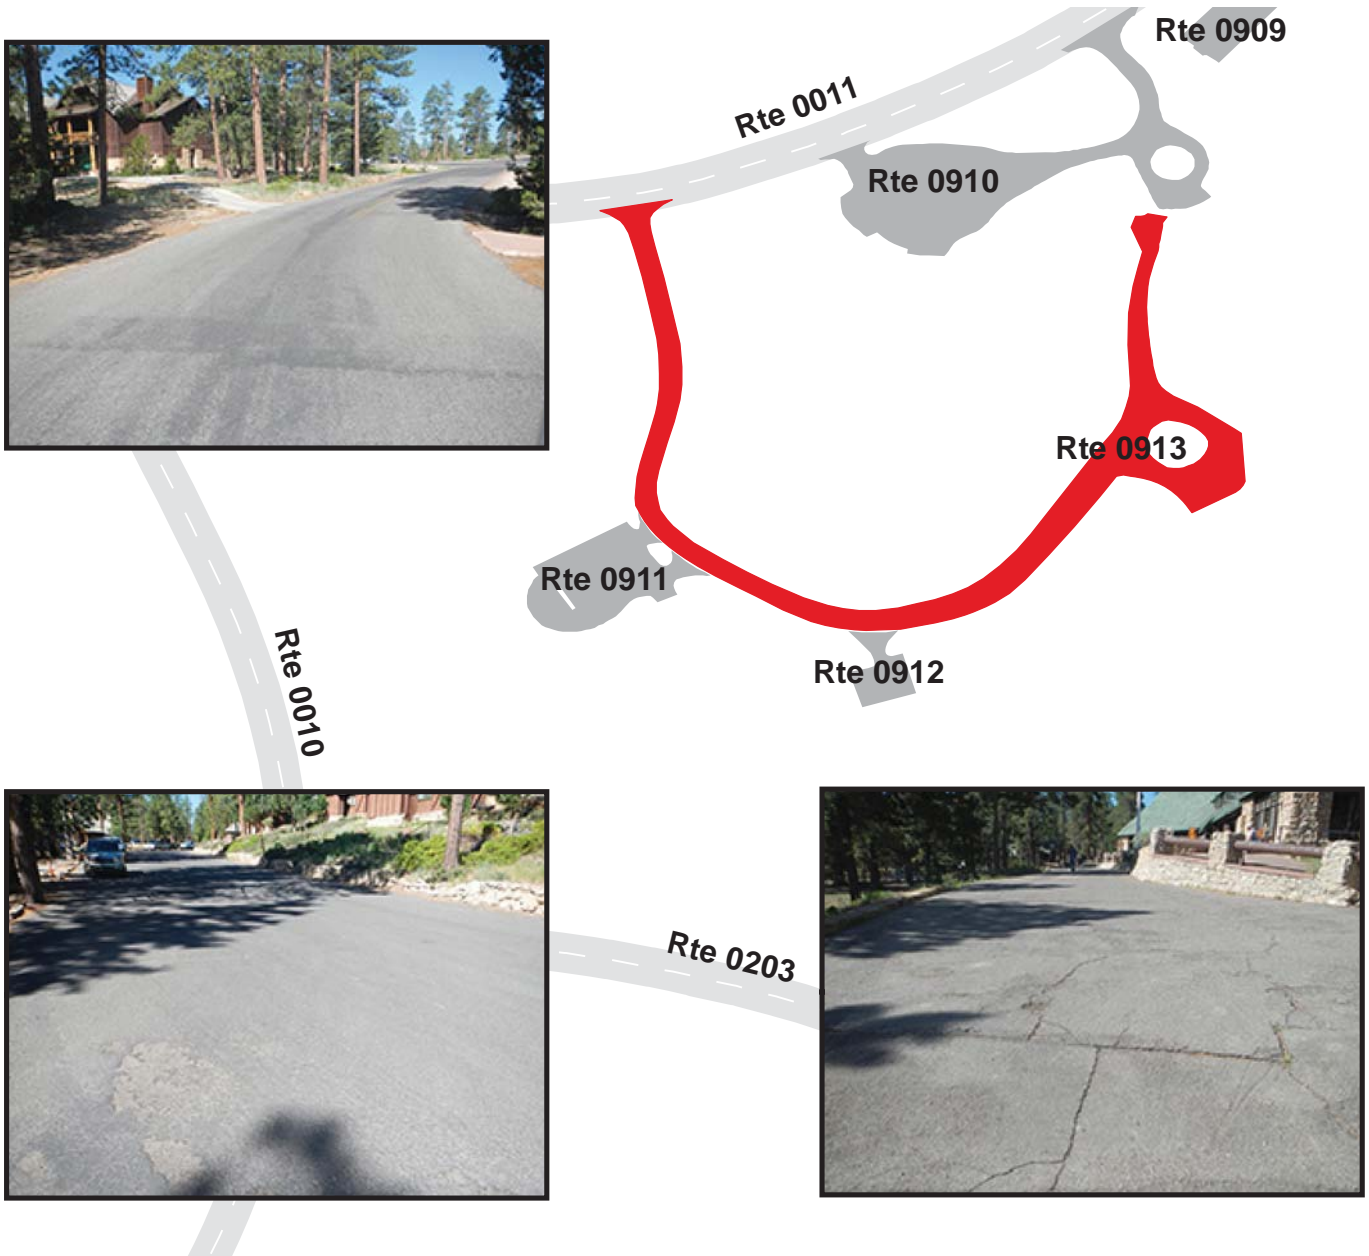
Route 0927

Route Number	Public / NonPublic	Date Visited	Area (sq ft)	Lane Miles *	Surface Type
0927	PUBLIC	6/15/2012	14,492	0.25	AS
Culverts	Drop Inlets	Gates	Curb & Gutter	Curb	PCR
0	0	0	NO CURB AND GUTTER	CONCRETE CURB	GOOD/90

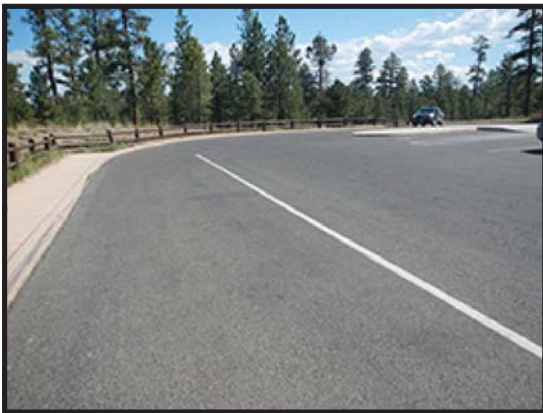
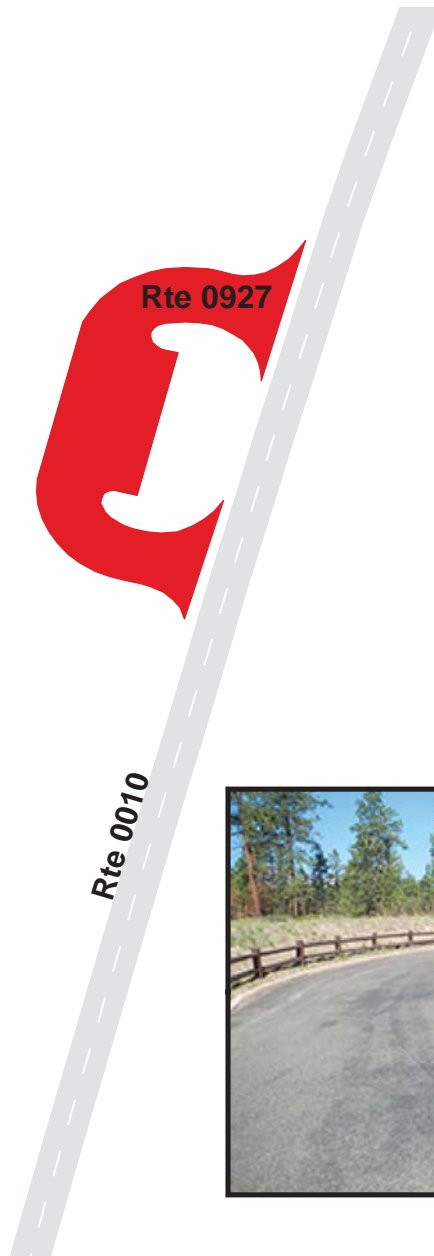
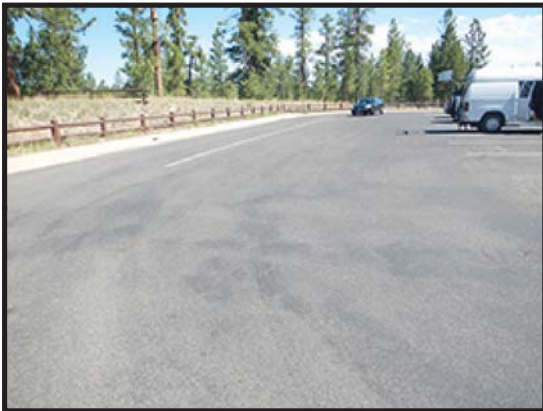
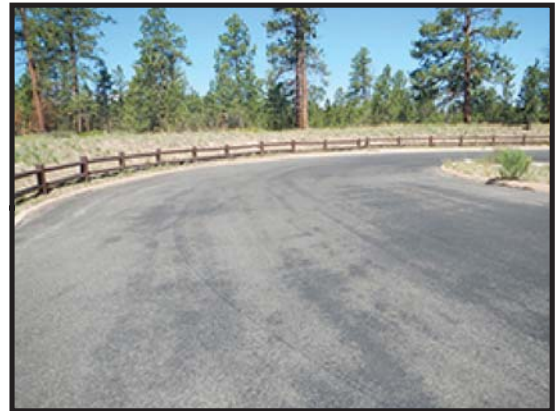
Route 0937

Route Number	Public / NonPublic	Date Visited	Area (sq ft)	Lane Miles *	Surface Type
0937	PUBLIC	6/15/2012	13,957	0.24	AS
Culverts	Drop Inlets	Gates	Curb & Gutter	Curb	PCR
0	0	0	NO CURB AND GUTTER	CONCRETE CURB	GOOD/90

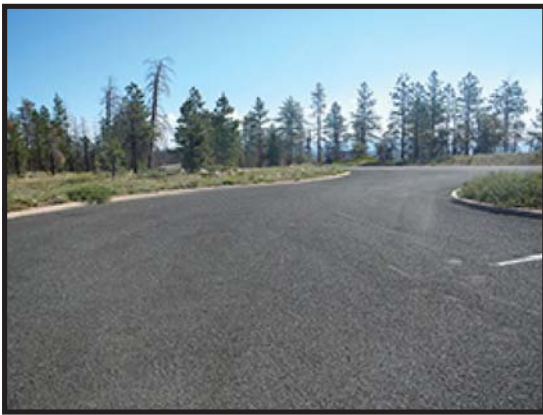
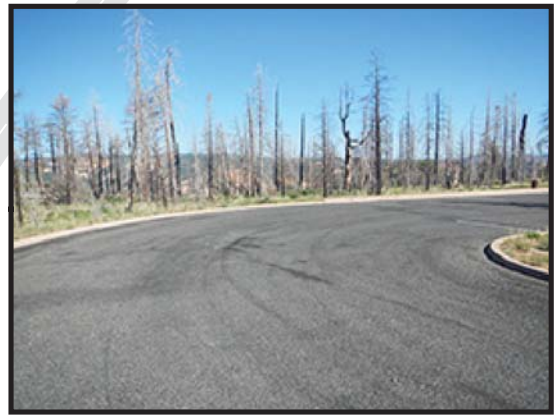
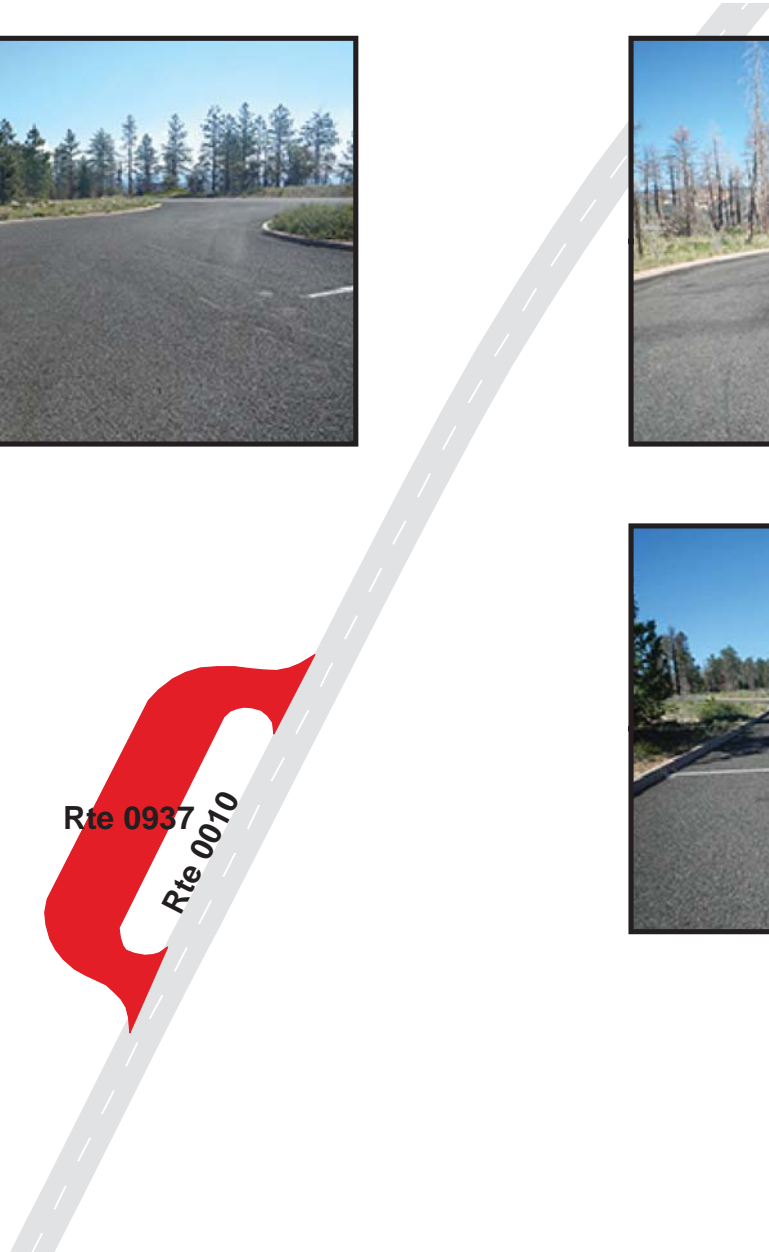
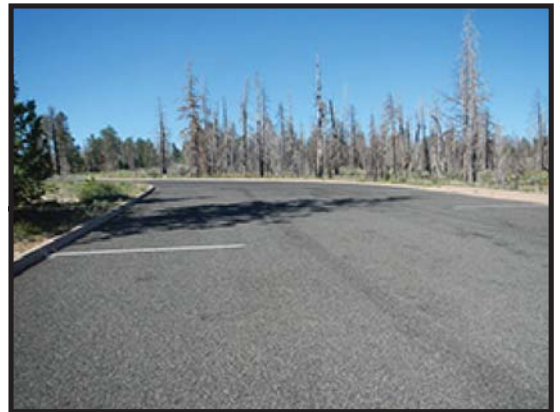
Route 0938

Route Number	Public / NonPublic	Date Visited	Area (sq ft)	Lane Miles *	Surface Type
0938	PUBLIC	6/15/2012	2,134	0.04	AS
Culverts	Drop Inlets	Gates	Curb & Gutter	Curb	PCR
0	0	0	NO CURB AND GUTTER	NO CURB	GOOD/90

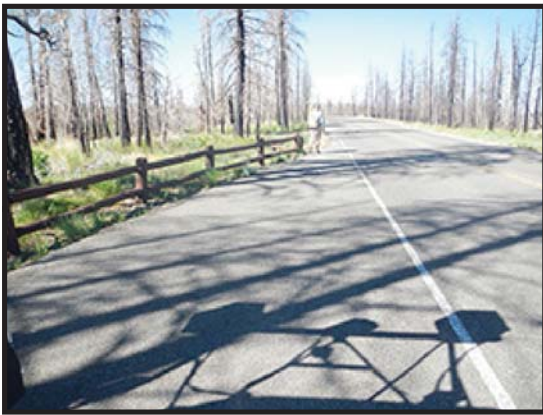
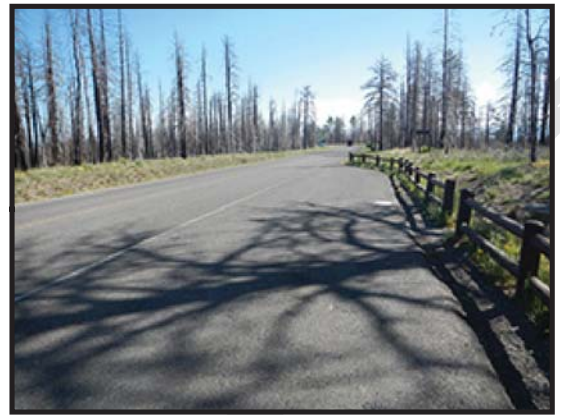
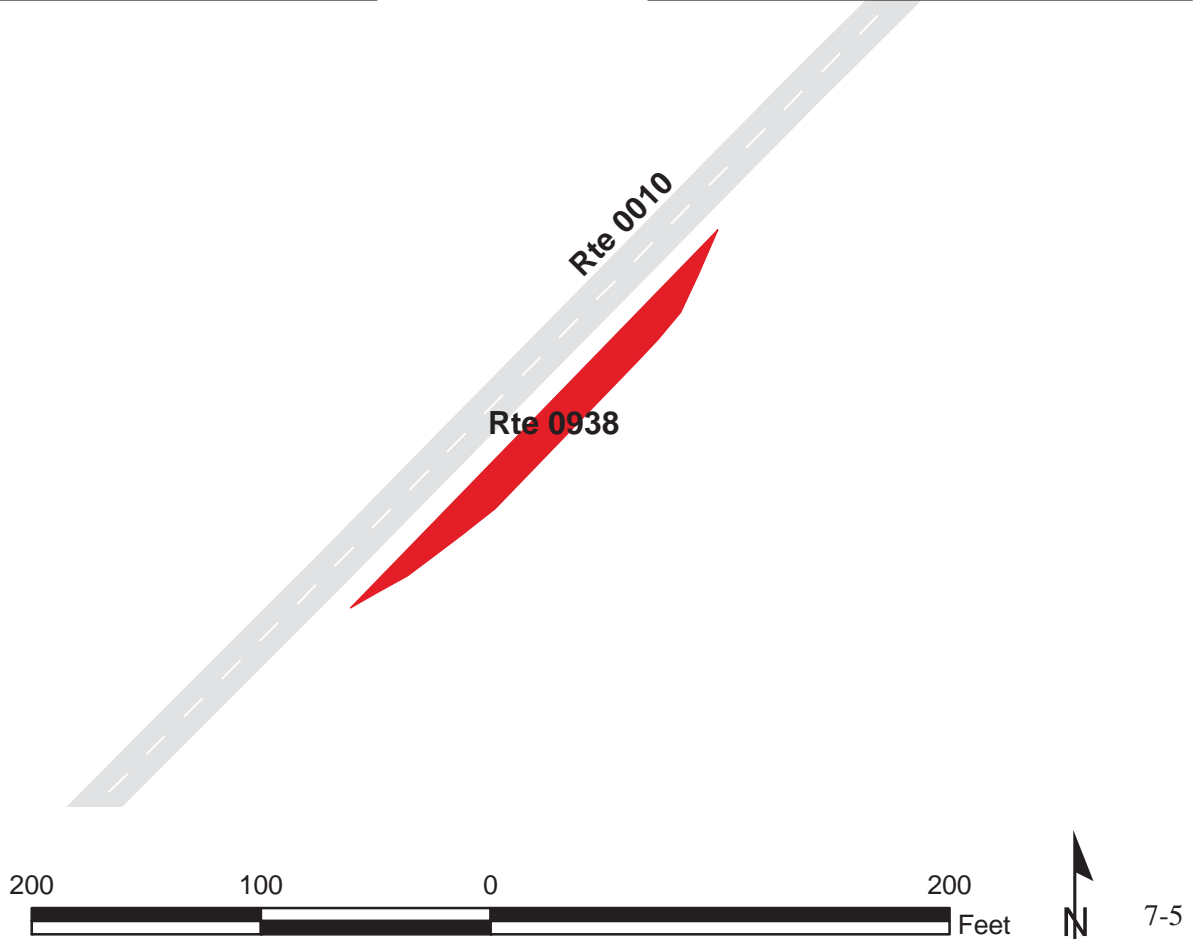
Route 0939

Route Number	Public / NonPublic	Date Visited	Area (sq ft)	Lane Miles *	Surface Type
0939	PUBLIC	6/15/2012	9,509	0.16	AS
Culverts	Drop Inlets	Gates	Curb & Gutter	Curb	PCR
0	0	0	NO CURB AND GUTTER	CONCRETE CURB	GOOD/90

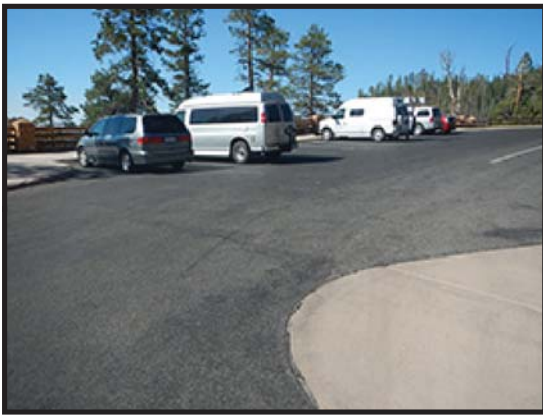
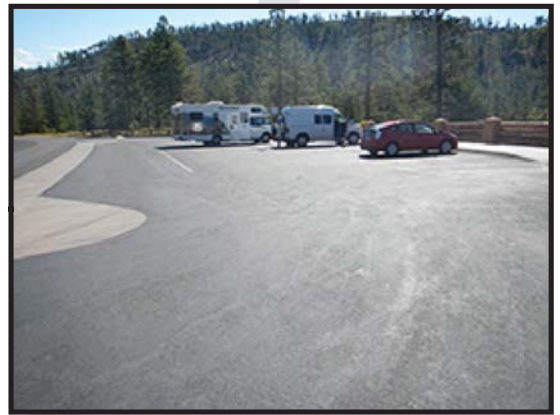
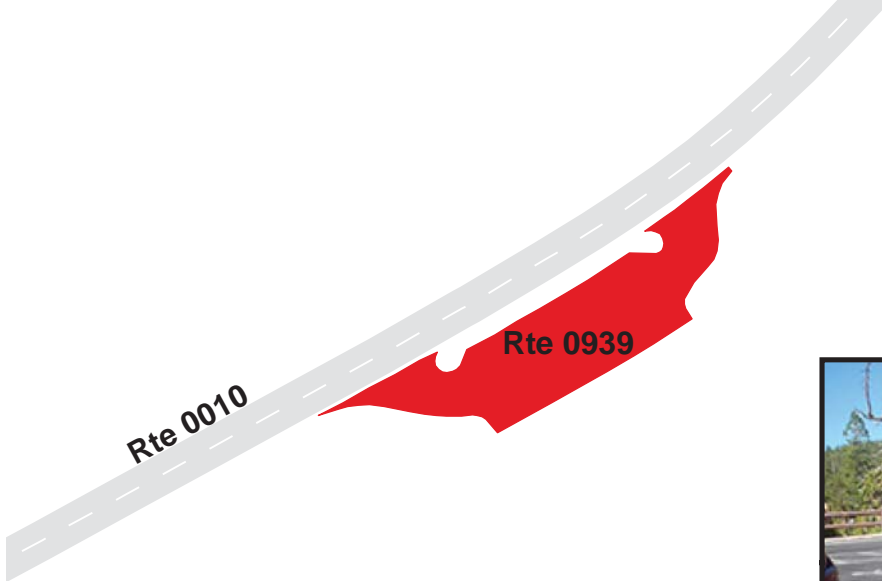
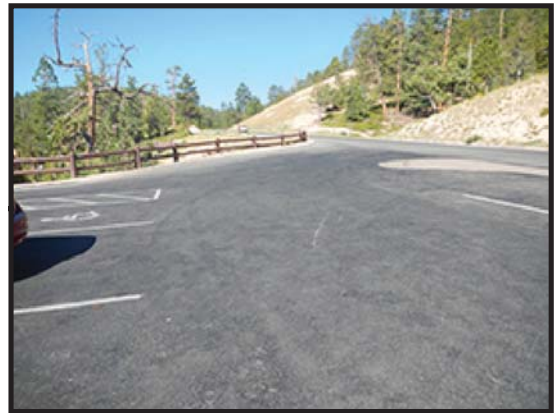
Route 0942

Route Number	Public / NonPublic	Date Visited	Area (sq ft)	Lane Miles *	Surface Type
0942	PUBLIC	6/15/2012	47,805	0.82	AS
Culverts	Drop Inlets	Gates	Curb & Gutter	Curb	PCR
0	0	0	NO CURB AND GUTTER	NO CURB	GOOD/90
