Federal Lands Highway Road Inventory Program

Road Inventory and Condition Assessment

Cabrillo National Monument CABR

Cycle 5 Report

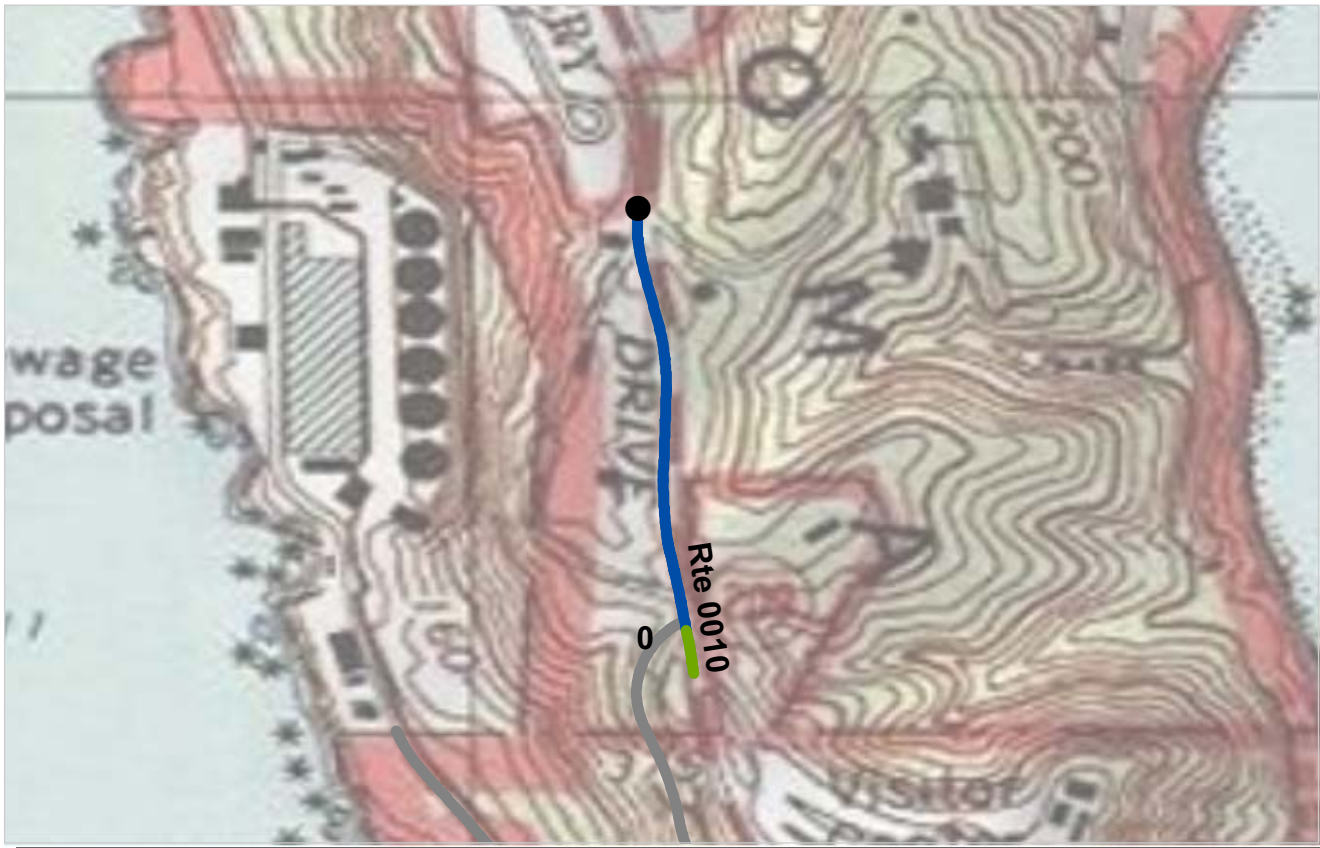
ROUTE: 0010 CABRILLO MEMORIAL DRIVE

Section Number	0				
Section Length (mi)	0.31				
Cross Section Information					
Number of Lanes	2				
Paved Width (ft)	32				
Lane Width (ft)	11				
Roadway Condition Information					
SCR (Surface Condition Rating)	97				
PCR (Pavement Condition Rating)	97				
Distress Index Values					
Structural Crack Index	100				
Transverse Cracking Index	100				
Patching Index	100				
Rutting Index	97				
Roughness Condition Index (RCI)	NC

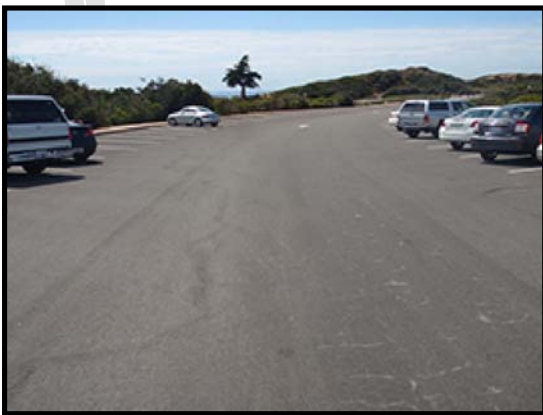
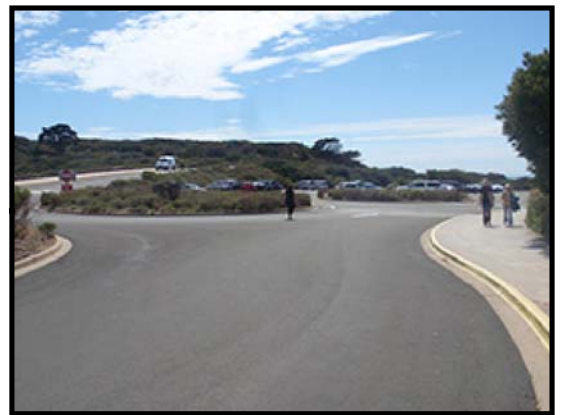
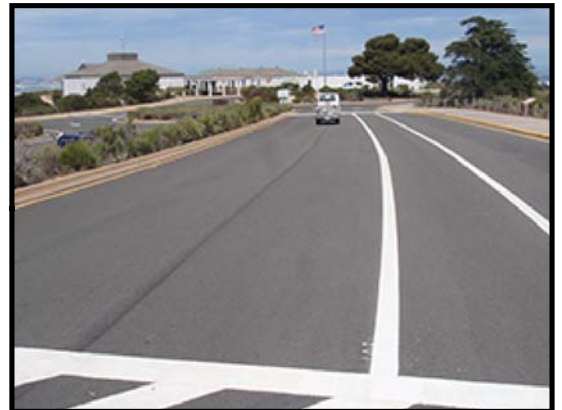
Route 0901

Route Number	Public / NonPublic	Date Visited	Area (sq ft)	Lane Miles *	Surface Type
0901	PUBLIC	4/25/2012	22,640	0.39	AS
Culverts	Drop Inlets	Gates	Curb & Gutter	Curb	PCR
0	0	1	NO CURB AND GUTTER	ASPHALT CURB	GOOD/90

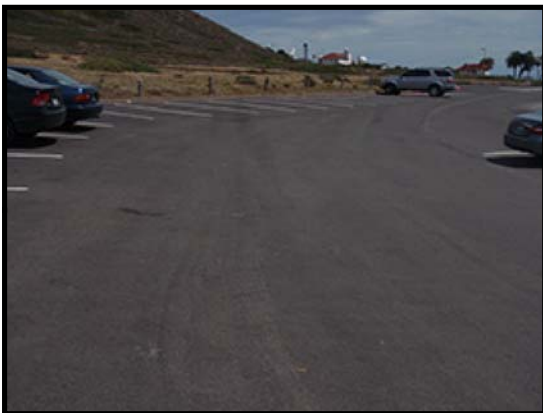
Route 0902

Route Number	Public / NonPublic	Date Visited	Area (sq ft)	Lane Miles *	Surface Type
0902	PUBLIC	4/25/2012	5,321	0.09	AS
Culverts	Drop Inlets	Gates	Curb & Gutter	Curb	PCR
0	0	0	CONCRETE CURB AND GUTTER	NO CURB	EXCELLENT/97

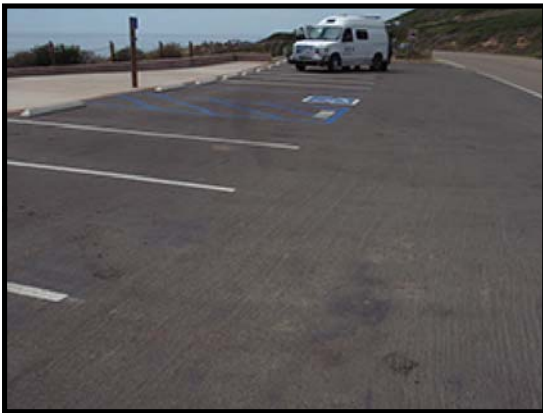
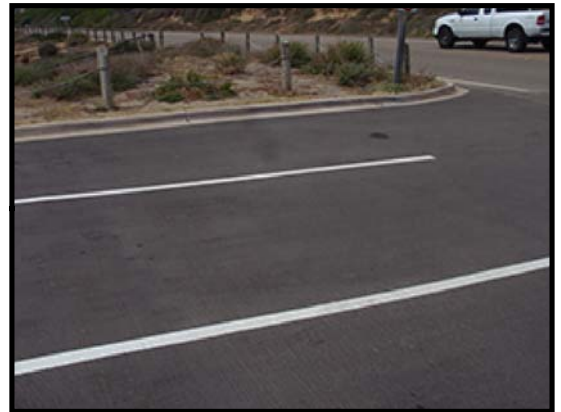
Route 0903

Route Number	Public / NonPublic	Date Visited	Area (sq ft)	Lane Miles *	Surface Type
0903	PUBLIC	4/25/2012	13,547	0.23	AS
Culverts	Drop Inlets	Gates	Curb & Gutter	Curb	PCR
0	2	0	CONCRETE CURB AND GUTTER	NO CURB	EXCELLENT/97

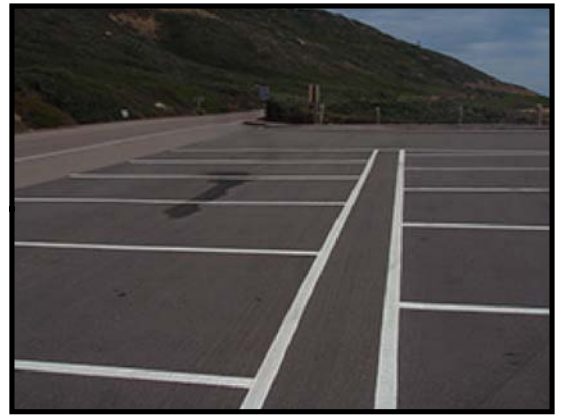
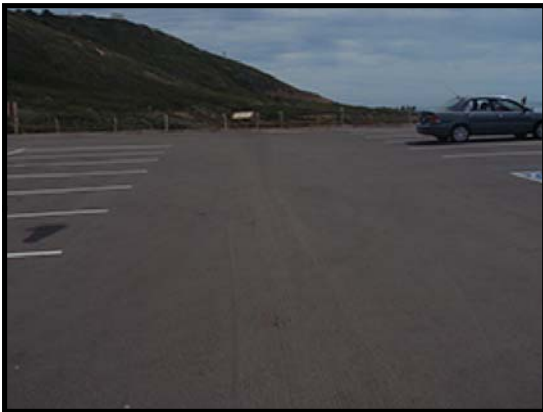
Route 0904

Route Number	Public / NonPublic	Date Visited	Area (sq ft)	Lane Miles *	Surface Type
0904	PUBLIC	4/25/2012	9,069	0.16	AS
Culverts	Drop Inlets	Gates	Curb & Gutter	Curb	PCR
0	1	0	CONCRETE CURB AND GUTTER	NO CURB	EXCELLENT/97

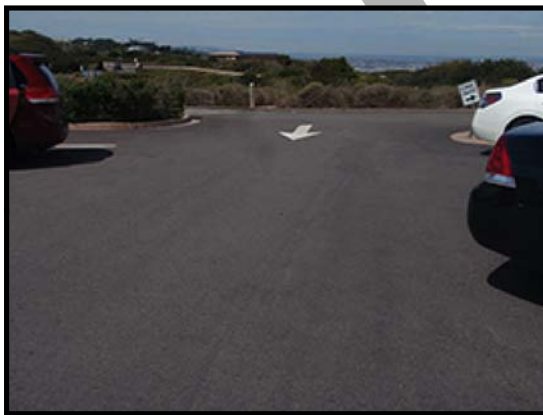
Route 0905

Route Number	Public / NonPublic	Date Visited	Area (sq ft)	Lane Miles *	Surface Type
0905	NONPUBLIC	4/25/2012	21,219	0.37	AS
Culverts	Drop Inlets	Gates	Curb & Gutter	Curb	PCR
0	1	2	NO CURB AND GUTTER	ASPHALT CURB	GOOD/90

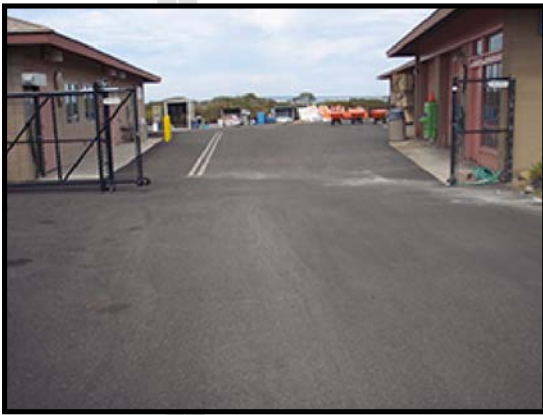
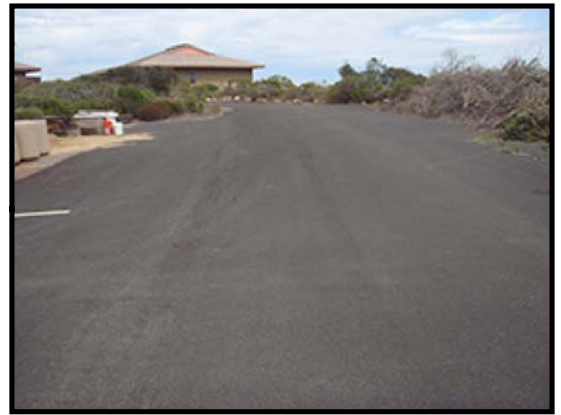
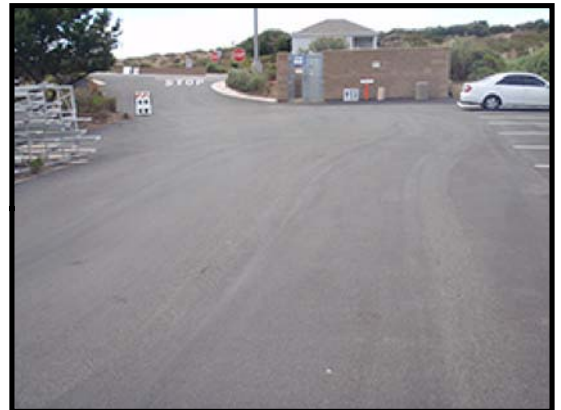
Route 0906

Route Number	Public / NonPublic	Date Visited	Area (sq ft)	Lane Miles *	Surface Type
0906	PUBLIC	4/25/2012	477	0.01	AS
Culverts	Drop Inlets	Gates	Curb & Gutter	Curb	PCR
0	0	0	CONCRETE CURB AND GUTTER	NO CURB	EXCELLENT/97
