Federal Lands Highway Road Inventory Program

Road Inventory and Condition Assessment

**Cape Cod National Seashore
CACO**

Cycle 5 Report

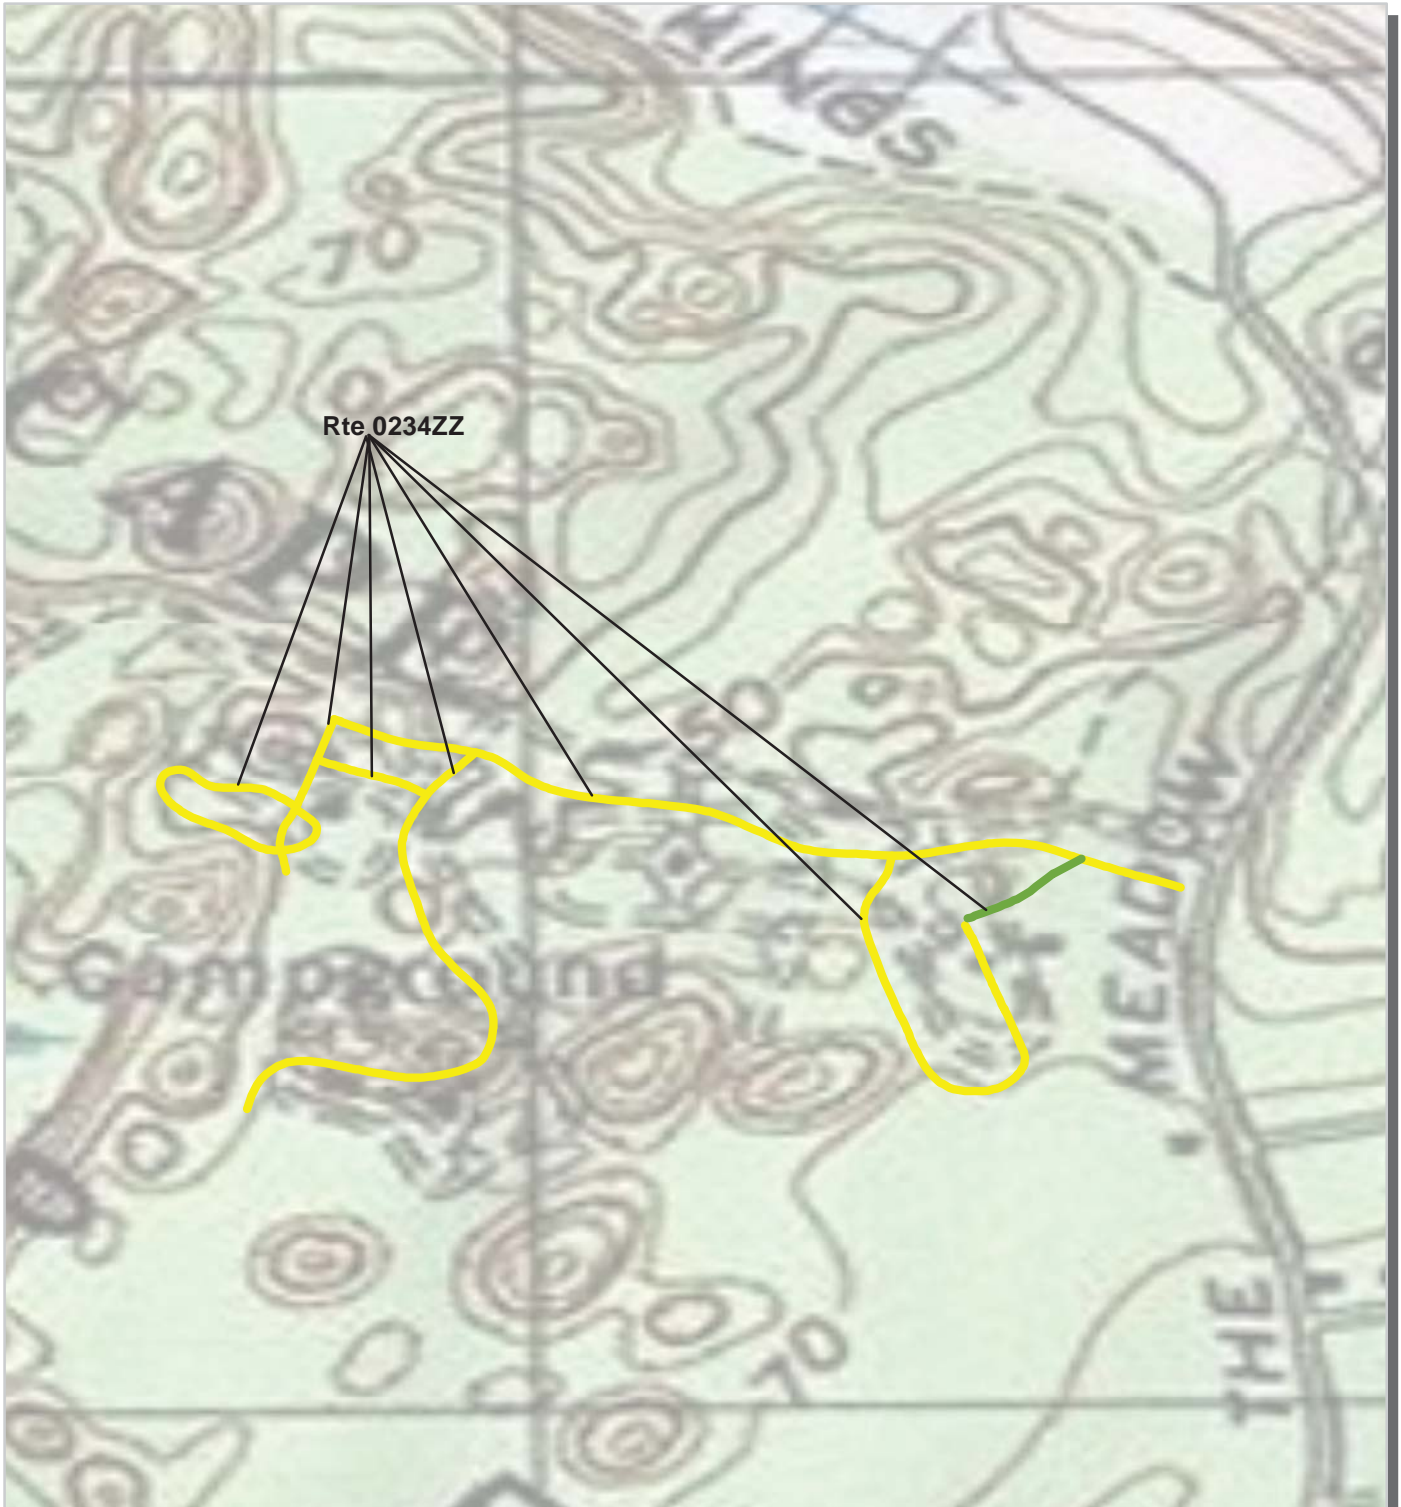
**Cape Cod National Seashore
Route Condition Map
PCR - Mile by Mile
Area 2**

PCR	Poor	Fair	Good	Excellent	No Data
	(0 - 60)	(61 - 84)	(85 - 94)	(95 - 100)

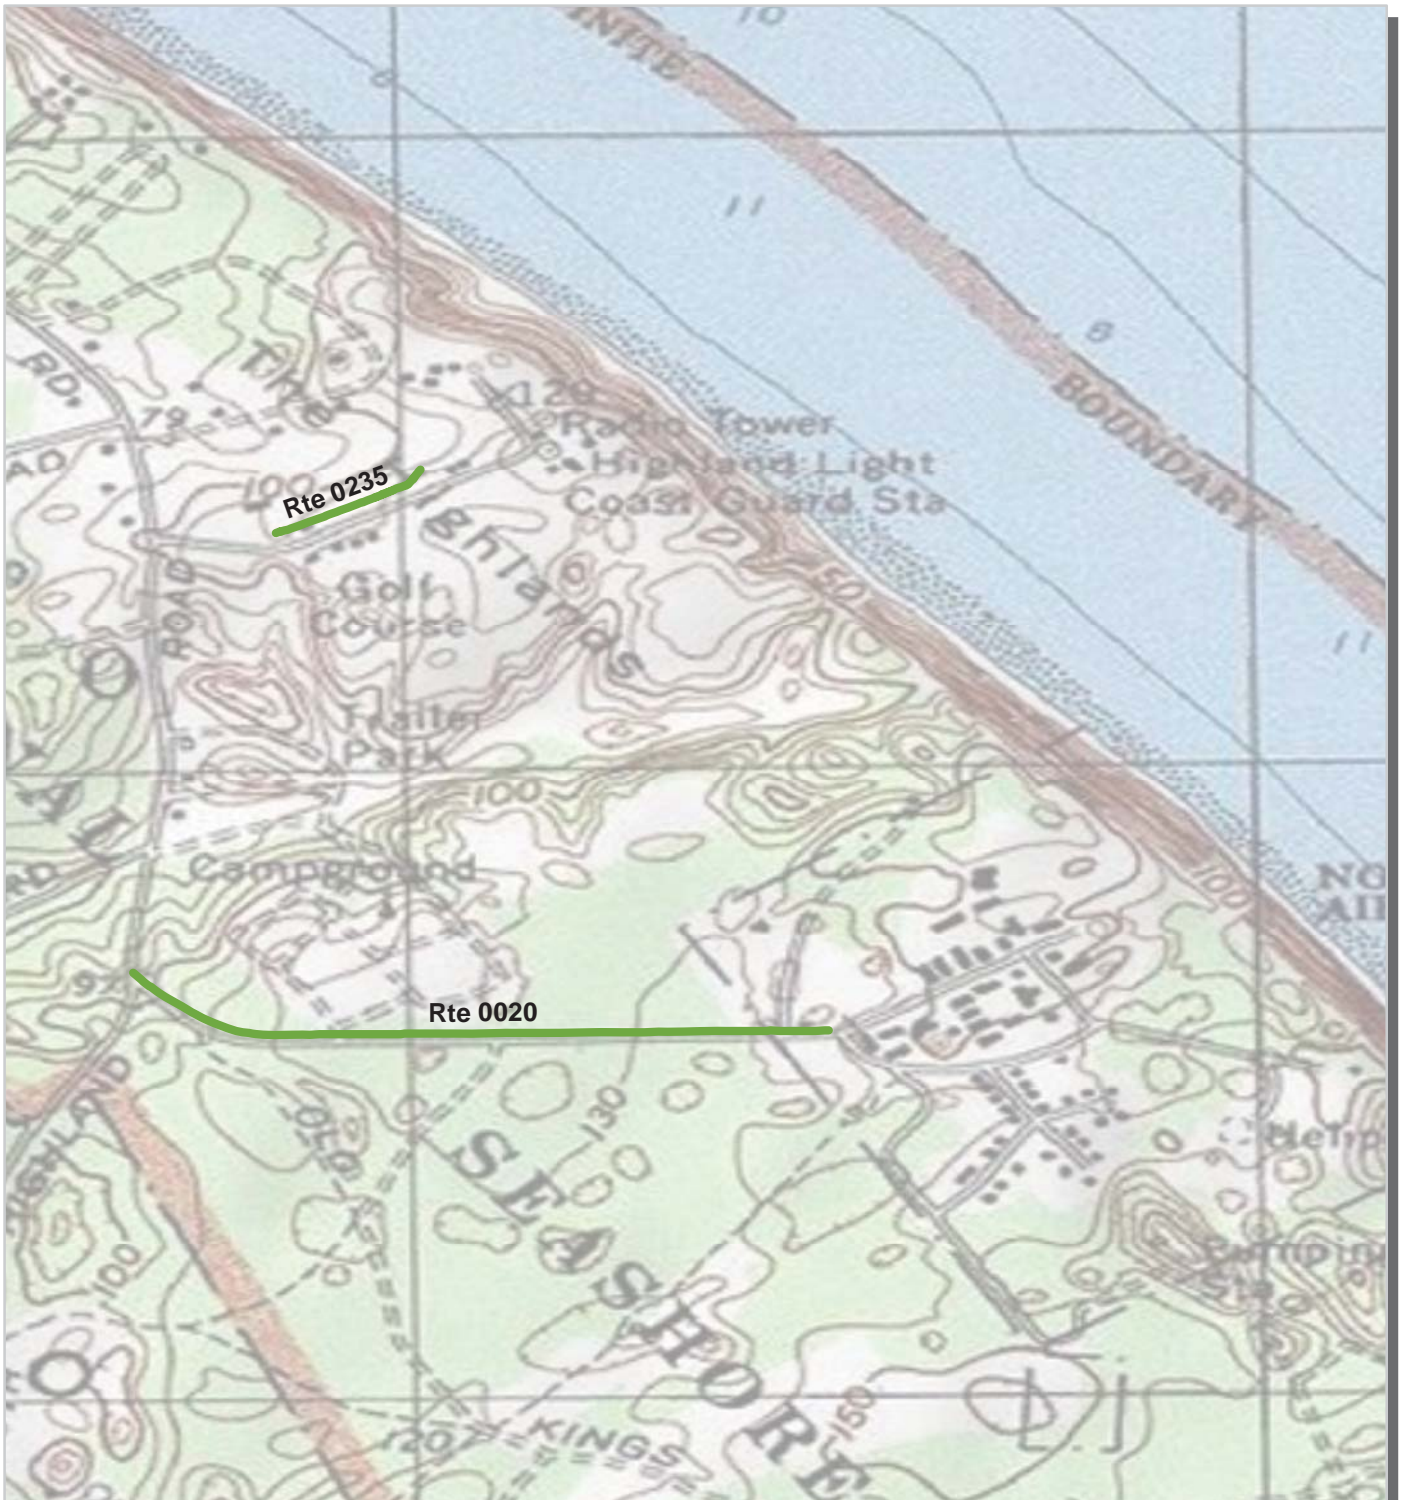
Cape Cod National Seashore Route Condition Map PCR - Mile by Mile Area 3

PCR	Poor	Fair	Good	Excellent	No Data
	█	█	█	█	█
	(0 - 60)	(61 - 84)	(85 - 94)	(95 - 100)

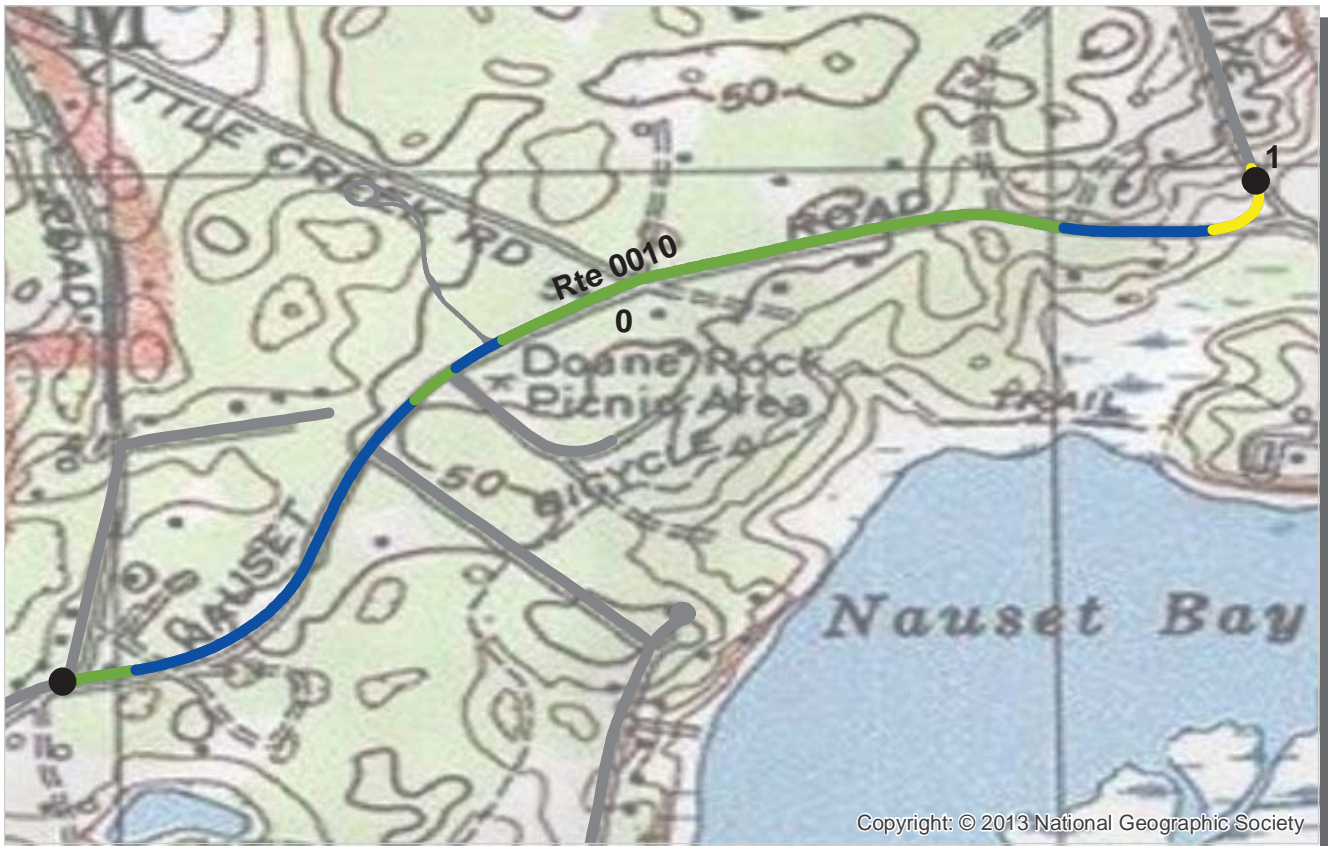
ROUTE: 0010 DOANE ROAD

Section Number	0	1			
Section Length (mi)	1.00	0.01			
Cross Section Information					
Number of Lanes	2	2			
Paved Width (ft)	24	26			
Lane Width (ft)	10	10			
Roadway Condition Information					
SCR (Surface Condition Rating)	92	75			
PCR (Pavement Condition Rating)	95	71			
Distress Index Values					
Structural Crack Index	99	95			
Transverse Cracking Index	99	75			
Patching Index	100	100			
Rutting Index	92	100			
Roughness Condition Index (RCI)	100	64

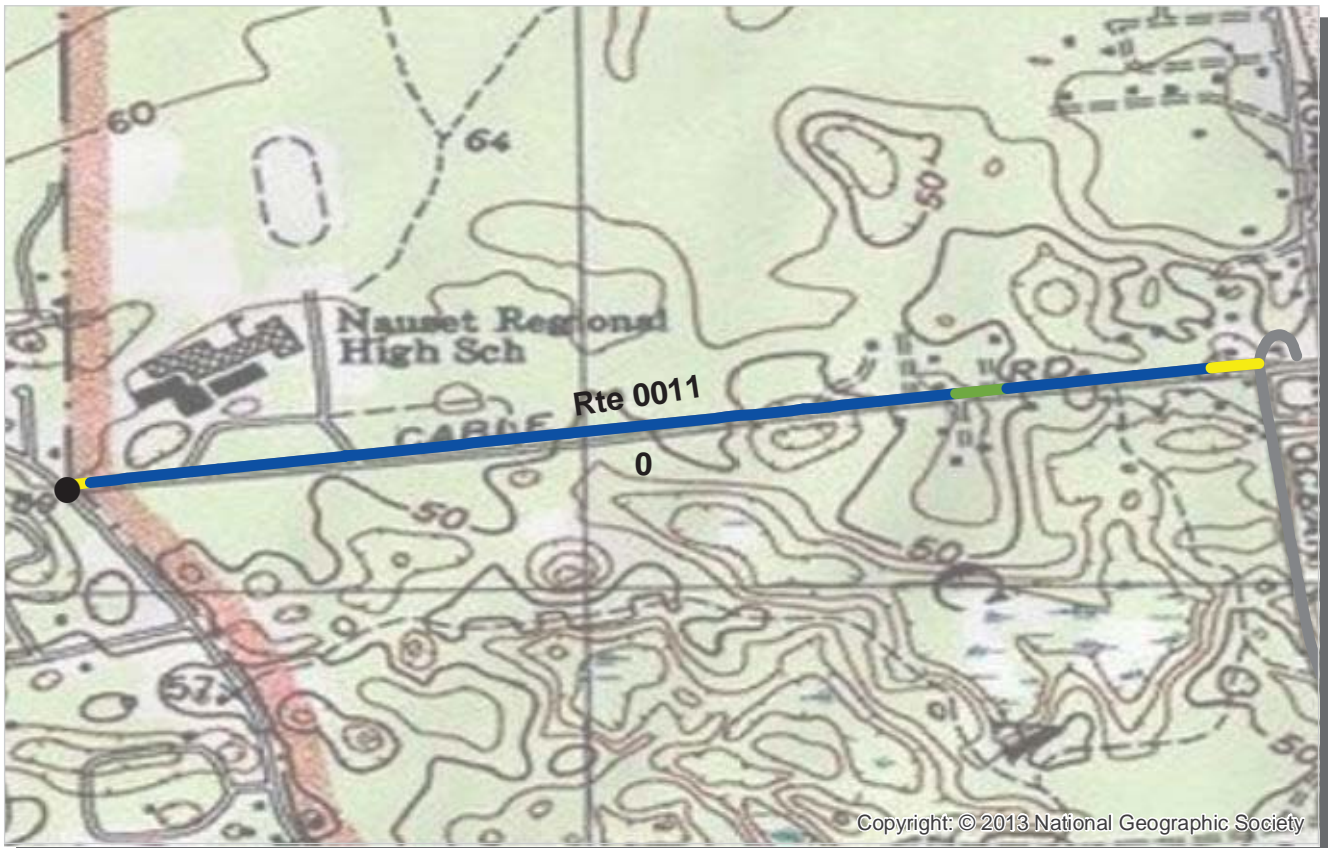
ROUTE: 0011 CABLE ROAD

<i>Section Number</i>	0				
<i>Section Length (mi)</i>	0.93				
<i>Cross Section Information</i>					
Number of Lanes	2				
Paved Width (ft)	23				
Lane Width (ft)	10				
<i>Roadway Condition Information</i>					
SCR (Surface Condition Rating)	98				
PCR (Pavement Condition Rating)	99				
<i>Distress Index Values</i>					
Structural Crack Index	100				
Transverse Cracking Index	99				
Patching Index	100				
Rutting Index	98				
Roughness Condition Index (RCI)	100

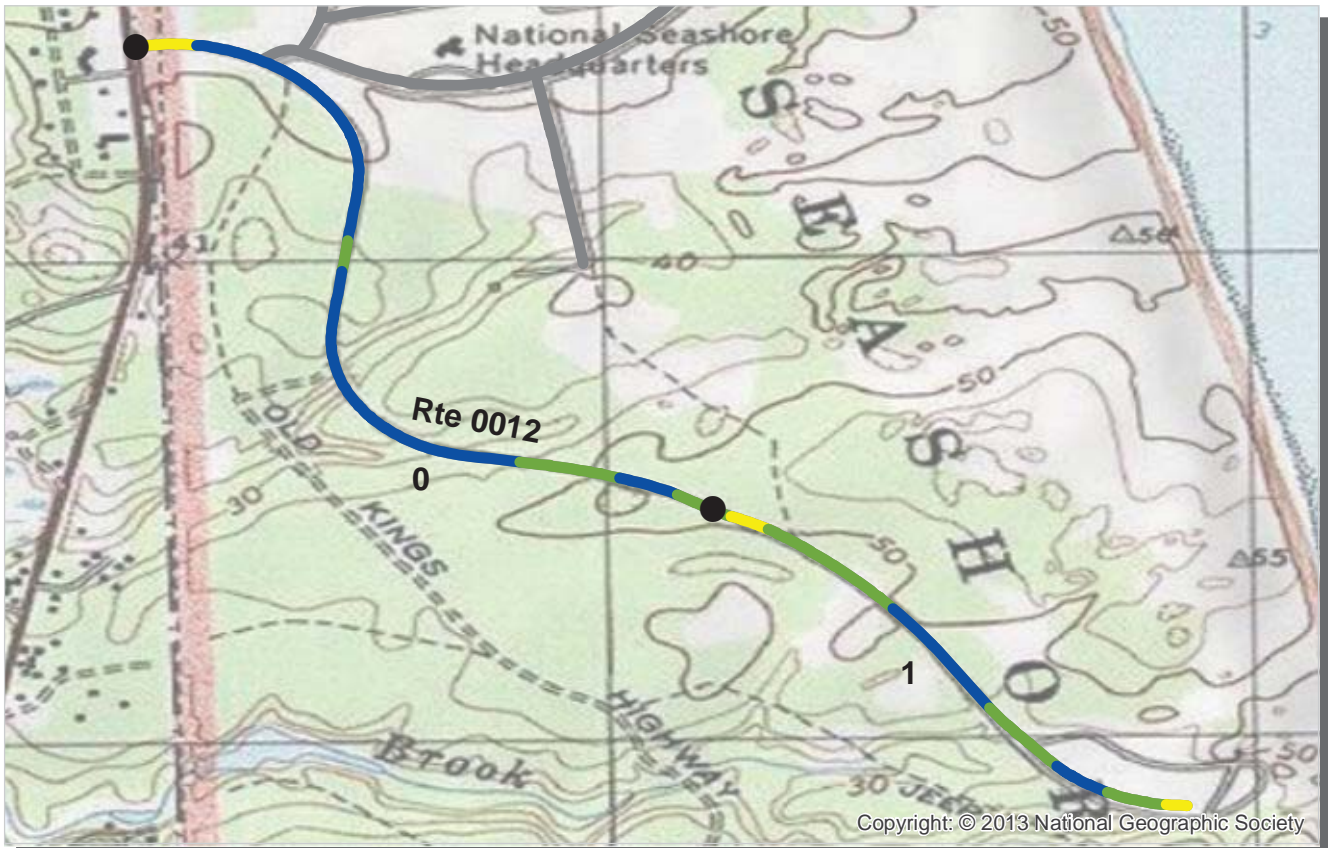
ROUTE: 0012 MARCONI BEACH ROAD

<i>Section Number</i>	0	1			
<i>Section Length (mi)</i>	1.00	0.62			
<i>Cross Section Information</i>					
Number of Lanes	2	2			
Paved Width (ft)	26	24			
Lane Width (ft)	10	11			
<i>Roadway Condition Information</i>					
SCR (Surface Condition Rating)	94	95			
PCR (Pavement Condition Rating)	95	94			
<i>Distress Index Values</i>					
Structural Crack Index	99	100			
Transverse Cracking Index	94	95			
Patching Index	100	100			
Rutting Index	99	96			
Roughness Condition Index (RCI)	96	93

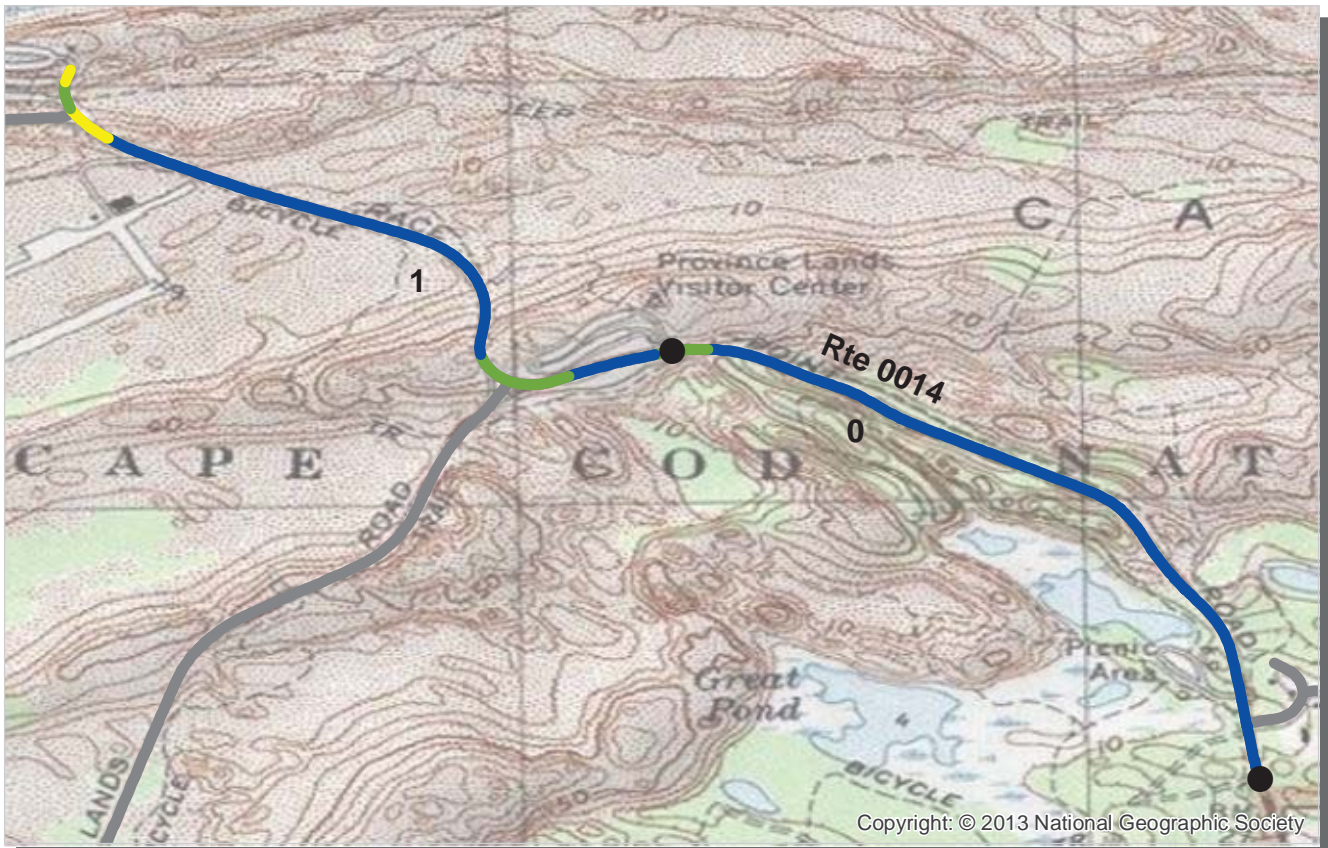
ROUTE: 0014 RACE POINT ROAD

<i>Section Number</i>	0	1			
<i>Section Length (mi)</i>	1.00	0.94			
<i>Cross Section Information</i>					
Number of Lanes	2	2			
Paved Width (ft)	23	27			
Lane Width (ft)	10	11			
<i>Roadway Condition Information</i>					
SCR (Surface Condition Rating)	100	98			
PCR (Pavement Condition Rating)	100	99			
<i>Distress Index Values</i>					
Structural Crack Index	100	99			
Transverse Cracking Index	100	98			
Patching Index	100	100			
Rutting Index	100	98			
Roughness Condition Index (RCI)	100	100

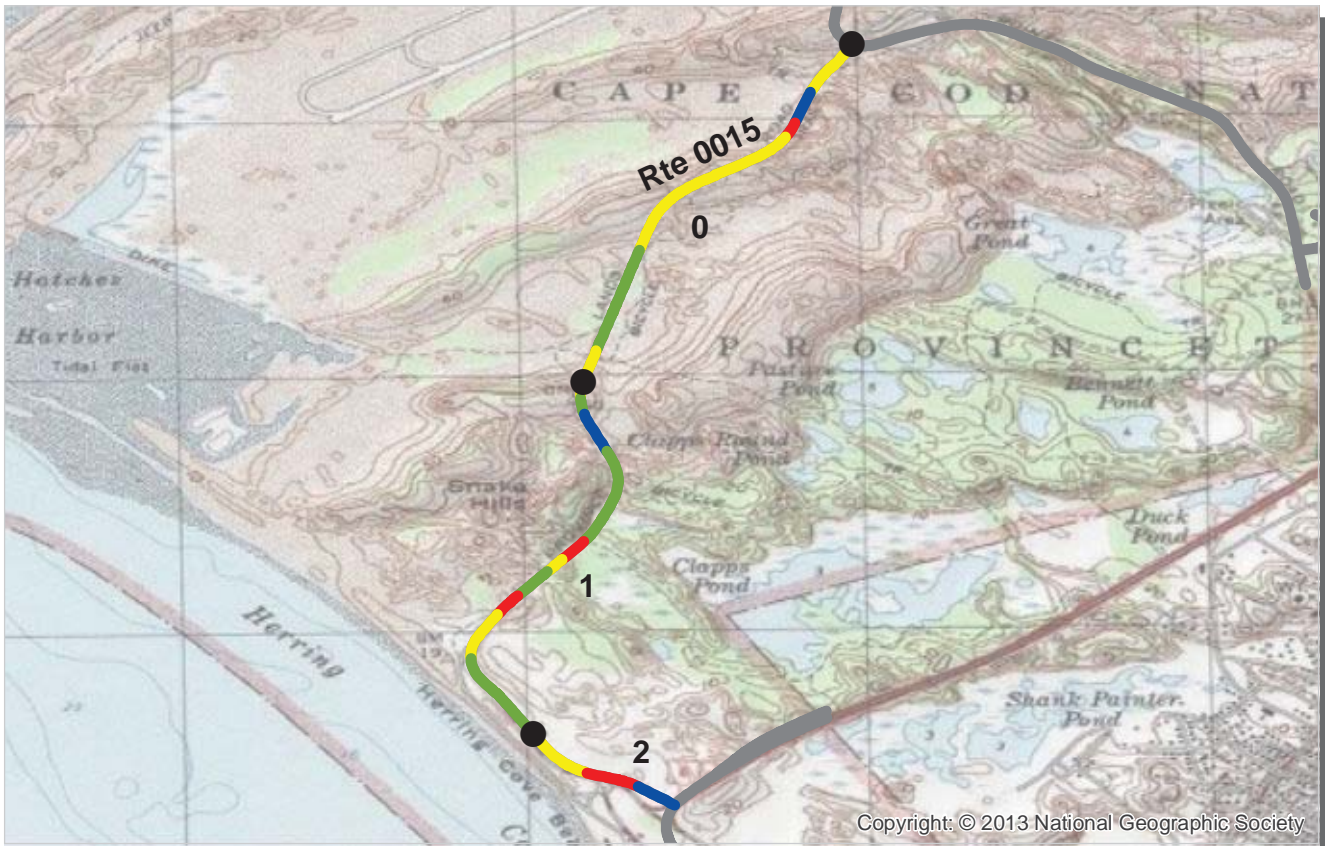
ROUTE: 0015 PROVINCE LANDS ROAD

Section Number	0	1	2		
Section Length (mi)	1.00	1.00	0.32		
Cross Section Information					
Number of Lanes	2	2	3		
Paved Width (ft)	24	24	31		
Lane Width (ft)	10	10	11		
Roadway Condition Information					
SCR (Surface Condition Rating)	74	74	60		
PCR (Pavement Condition Rating)	84	83	71		
Distress Index Values					
Structural Crack Index	74	74	60		
Transverse Cracking Index	85	86	67		
Patching Index	100	100	100		
Rutting Index	88	88	95		
Roughness Condition Index (RCI)	100	97	88

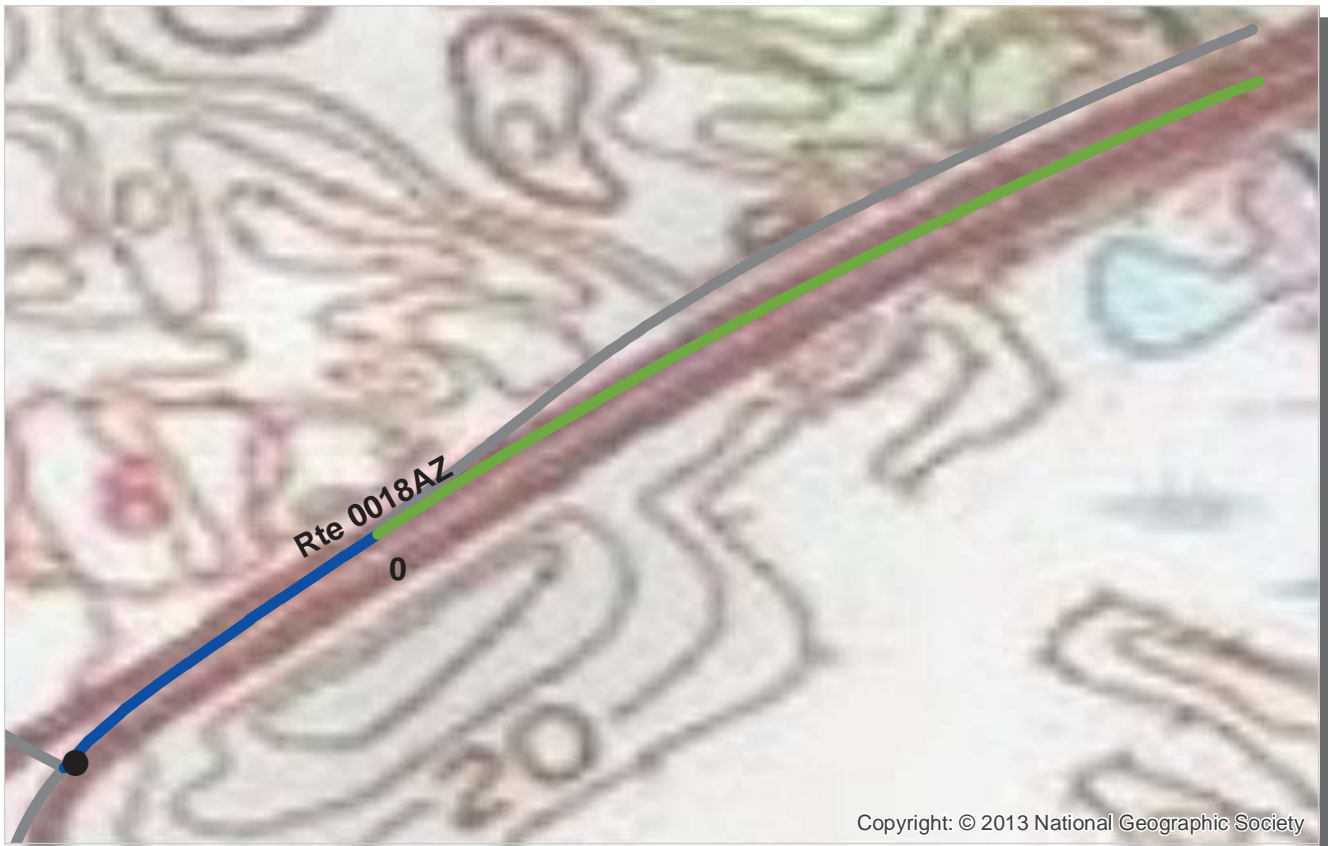
ROUTE: 0018ZZ STATE ROUTE 6

PCR	Poor	Fair	Good	Excellent	No Data
	■	■	■	■	■
	(0 - 60)	(61 - 84)	(85 - 94)	(95 - 100)

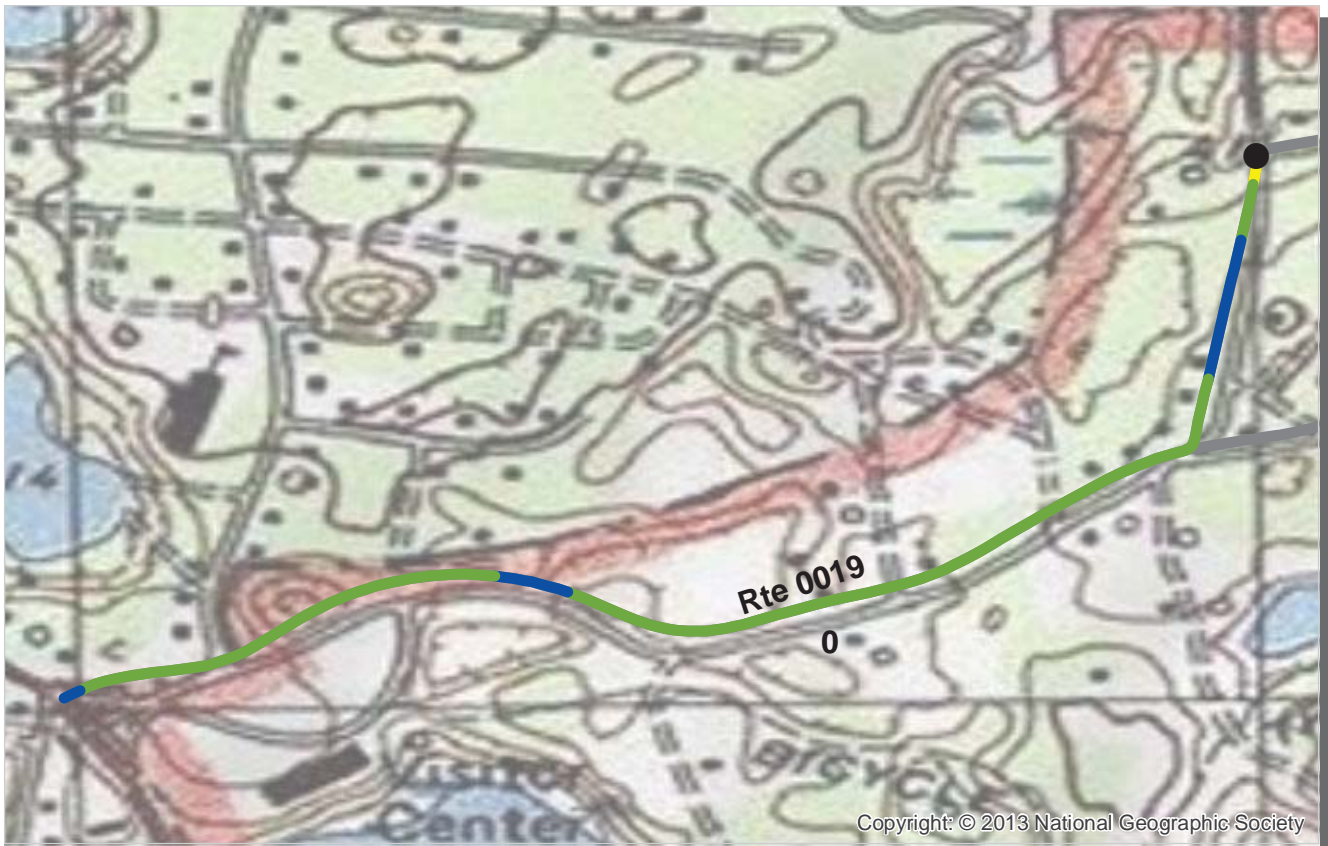
ROUTE: 0018BZ EASTBOUND STATE ROUTE 6

PCR	Poor	Fair	Good	Excellent	No Data
	(0 - 60)	(61 - 84)	(85 - 94)	(95 - 100)

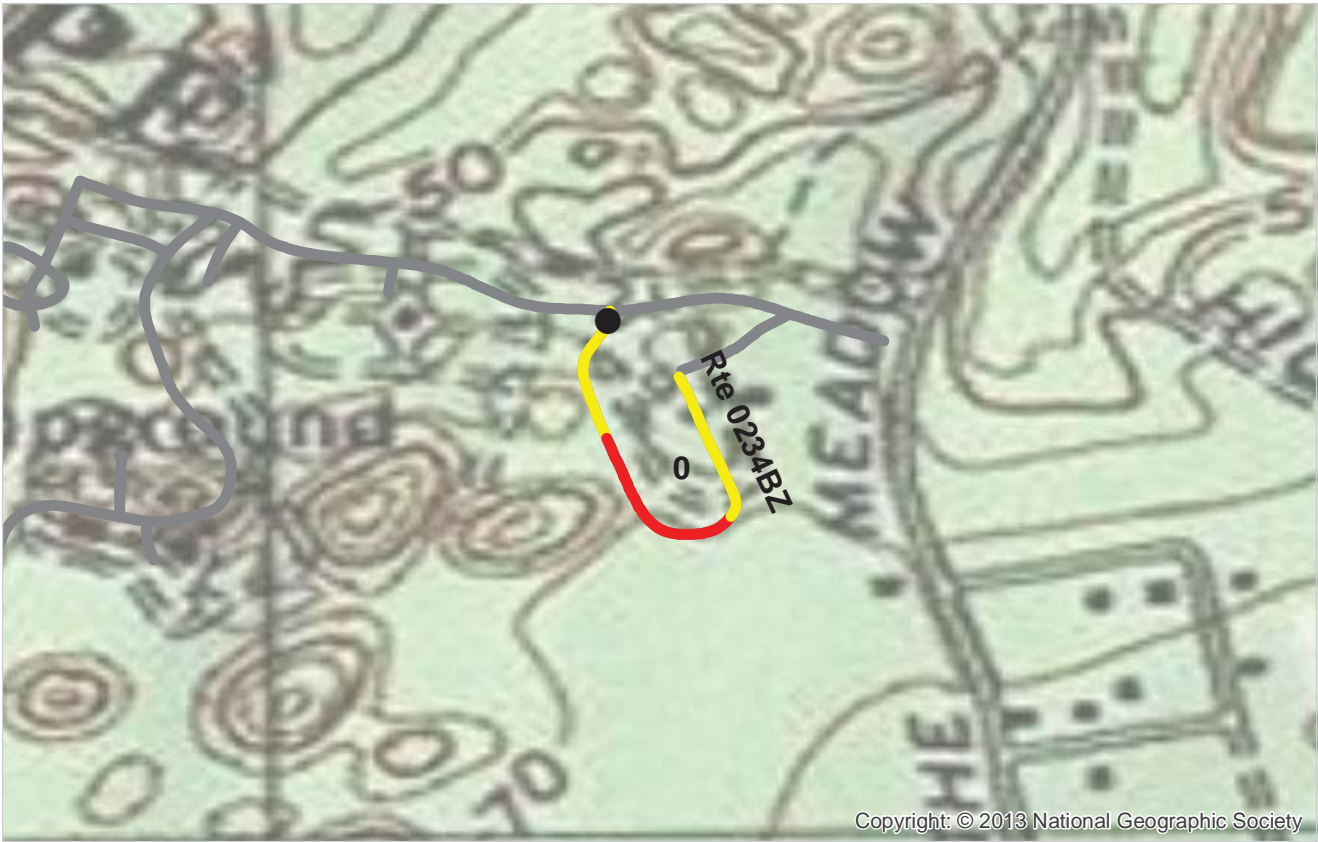
**ROUTE: 0234ZZ NORTH OF HIGHLAND CAMPGROUND
ROADS**

PCR	Poor	Fair	Good	Excellent	No Data
	(0 - 60)	(61 - 84)	(85 - 94)	(95 - 100)

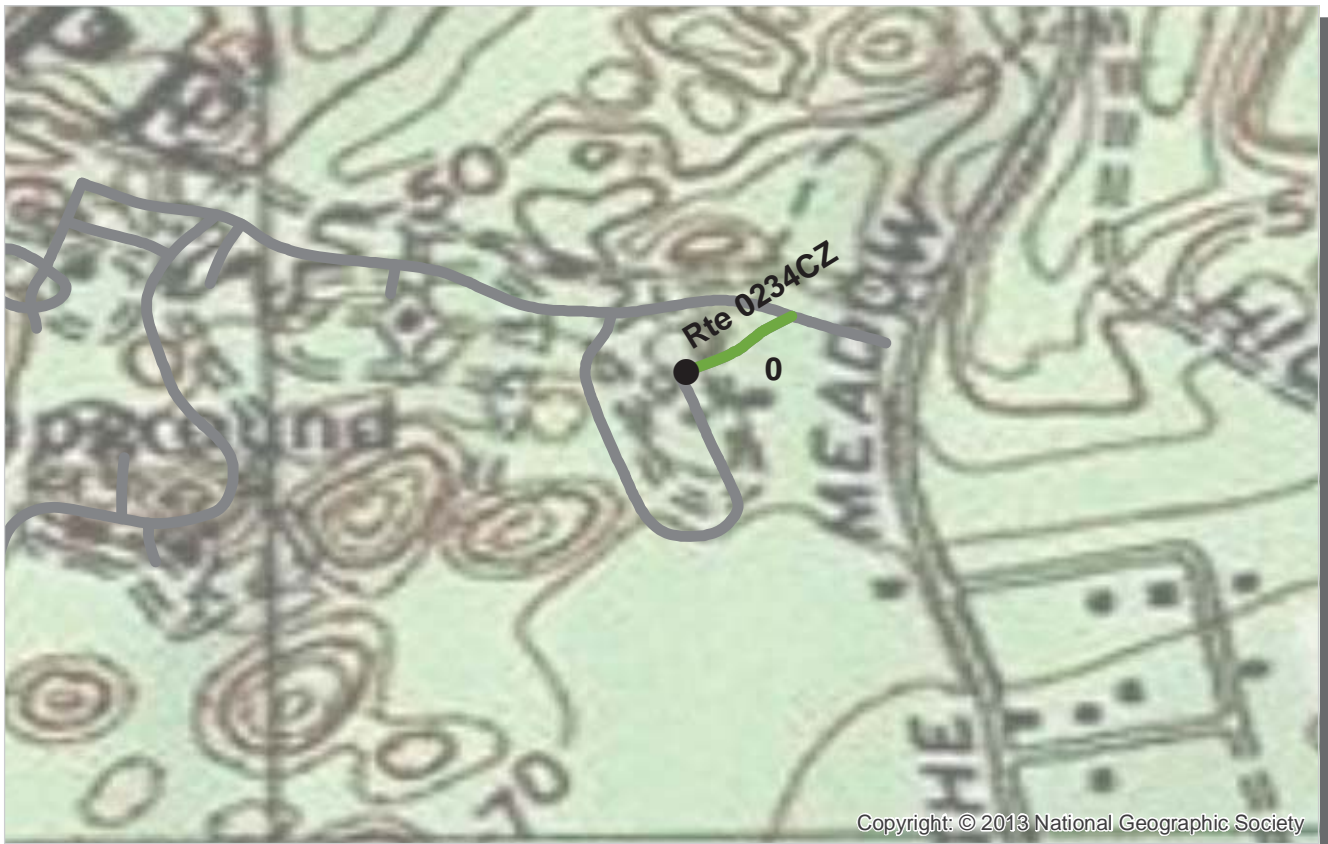
ROUTE: 0234BZ NORTH OF HIGHLAND CAMPGROUND ROAD B (AREA 1)

PCR	Poor	Fair	Good	Excellent	No Data
	(0 - 60)	(61 - 84)	(85 - 94)	(95 - 100)

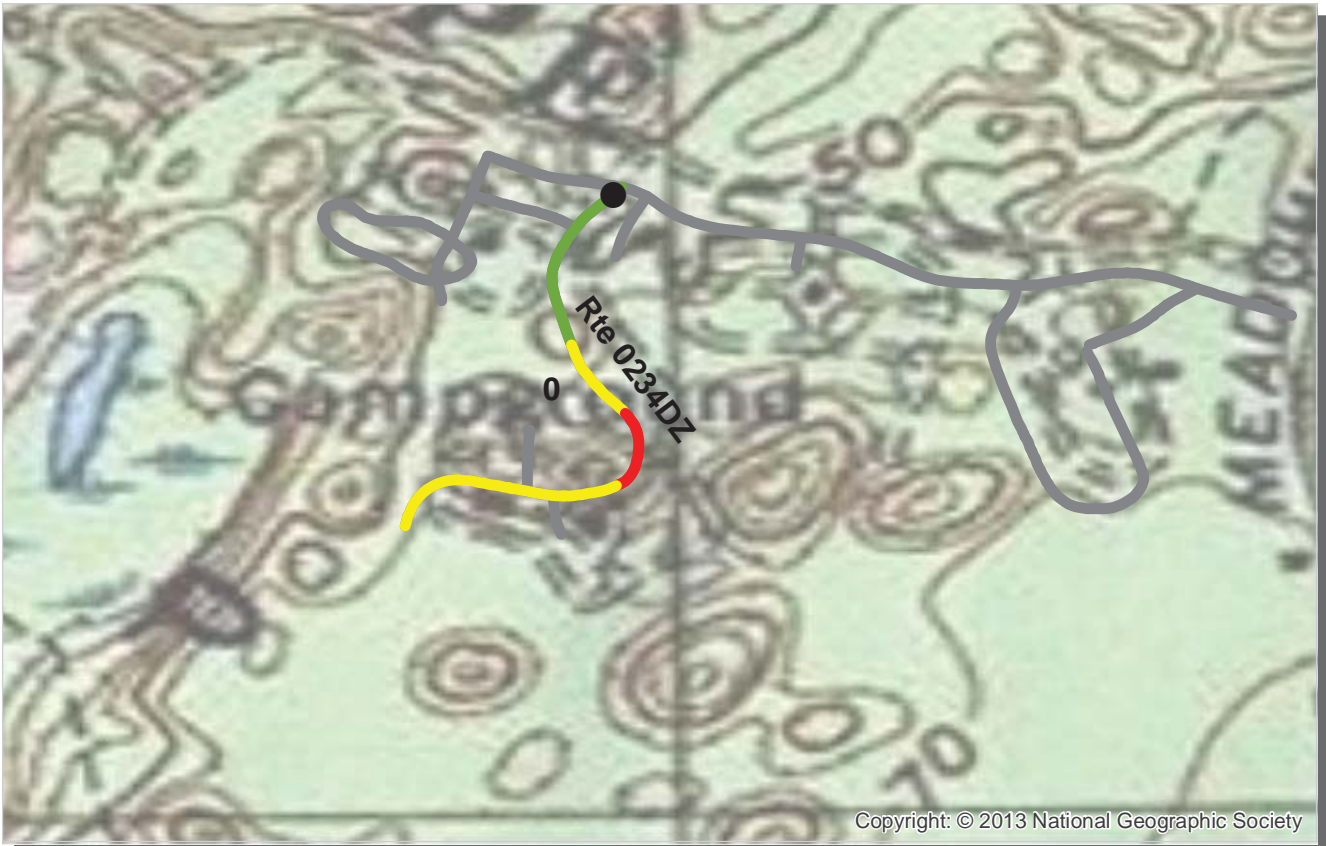
ROUTE: 0234CZ NORTH OF HIGHLAND CAMPGROUND ROAD C

PCR	Poor		Fair		Good		Excellent		No Data	
		(0 - 60)		(61 - 84)		(85 - 94)		(95 - 100)

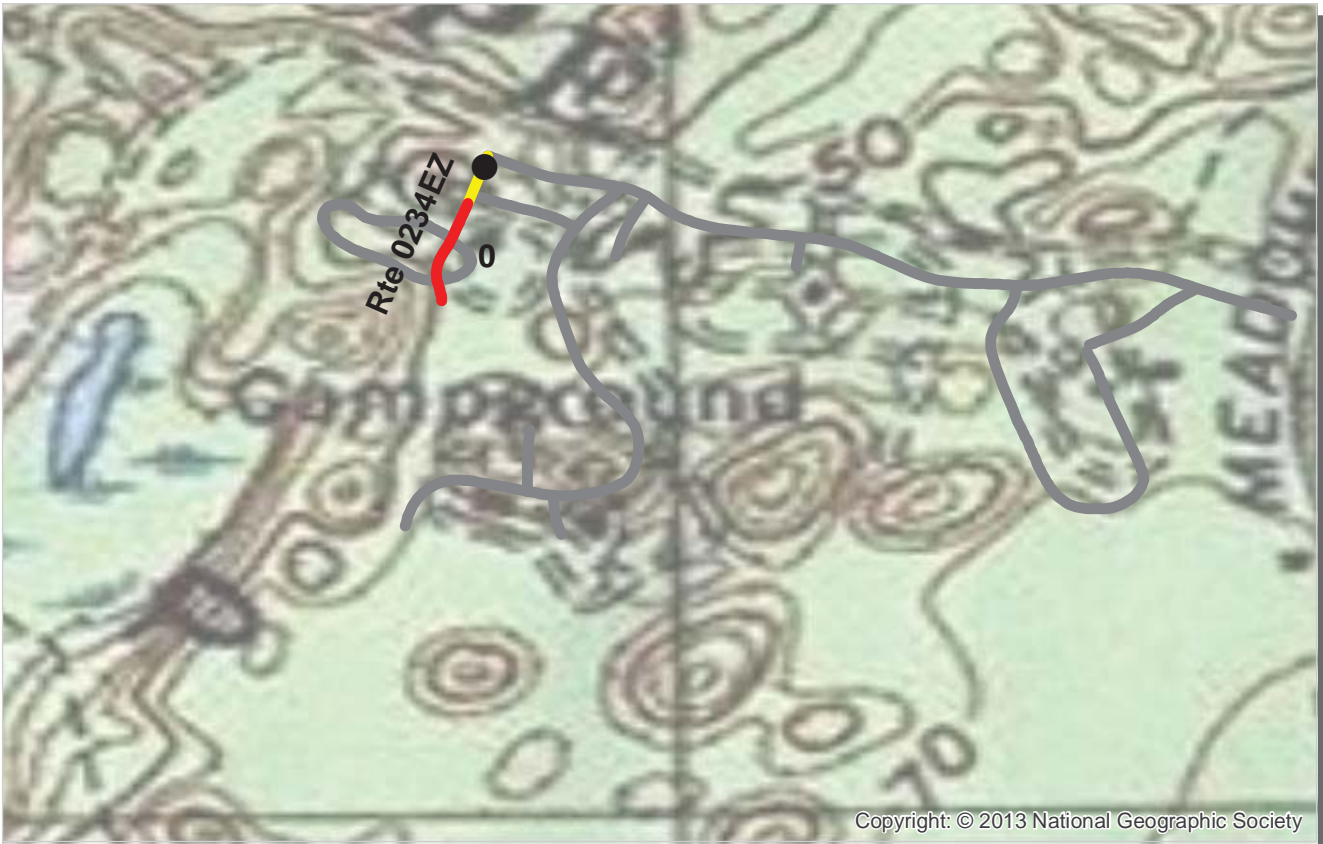
ROUTE: 0234DZ NORTH OF HIGHLAND CAMPGROUND ROAD D (AREA 4)

PCR	Poor	Fair	Good	Excellent	No Data
	(0 - 60)	(61 - 84)	(85 - 94)	(95 - 100)

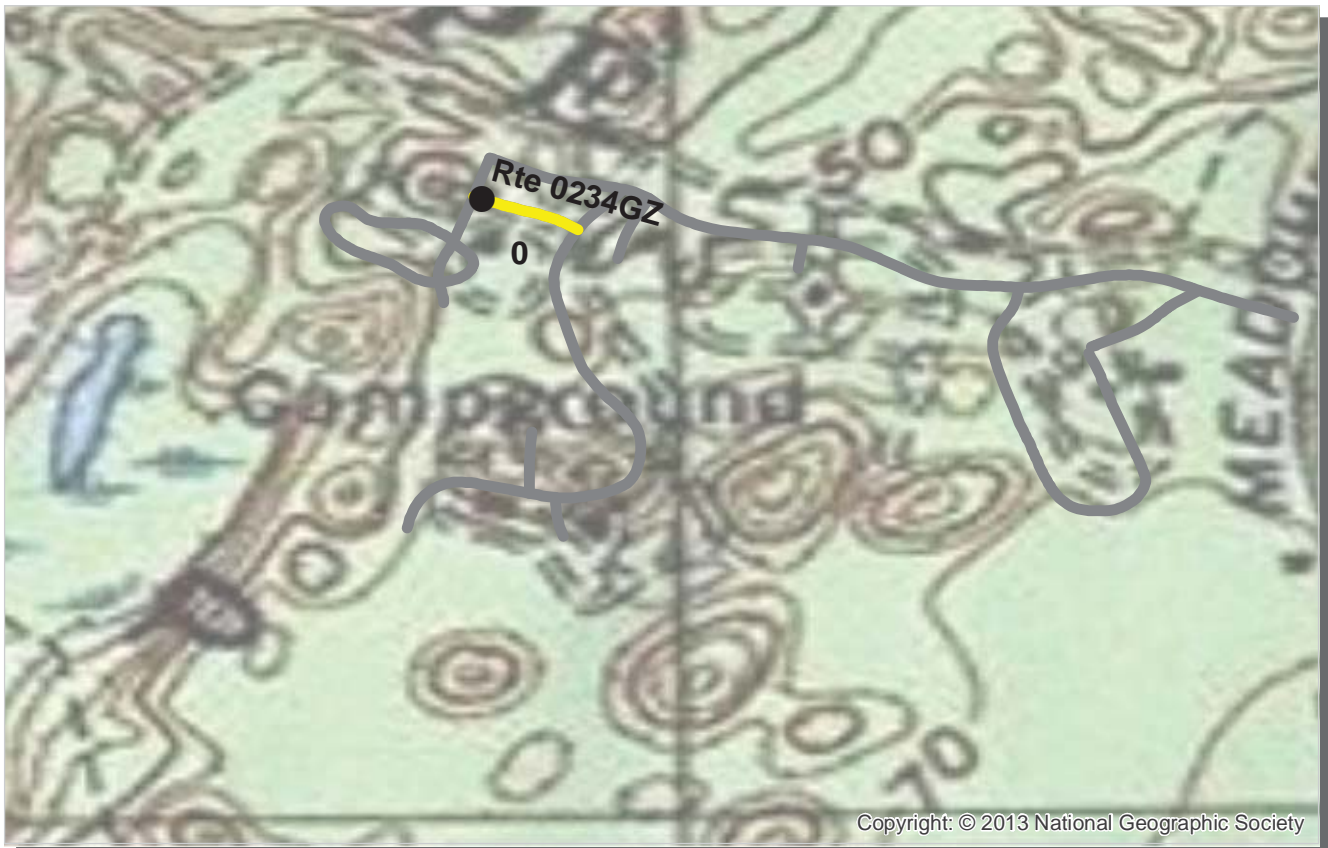
ROUTE: 0234EZ NORTH OF HIGHLAND CAMPGROUND ROAD E (AREA 3)

PCR	Poor	Fair	Good	Excellent	No Data
	(0 - 60)	(61 - 84)	(85 - 94)	(95 - 100)

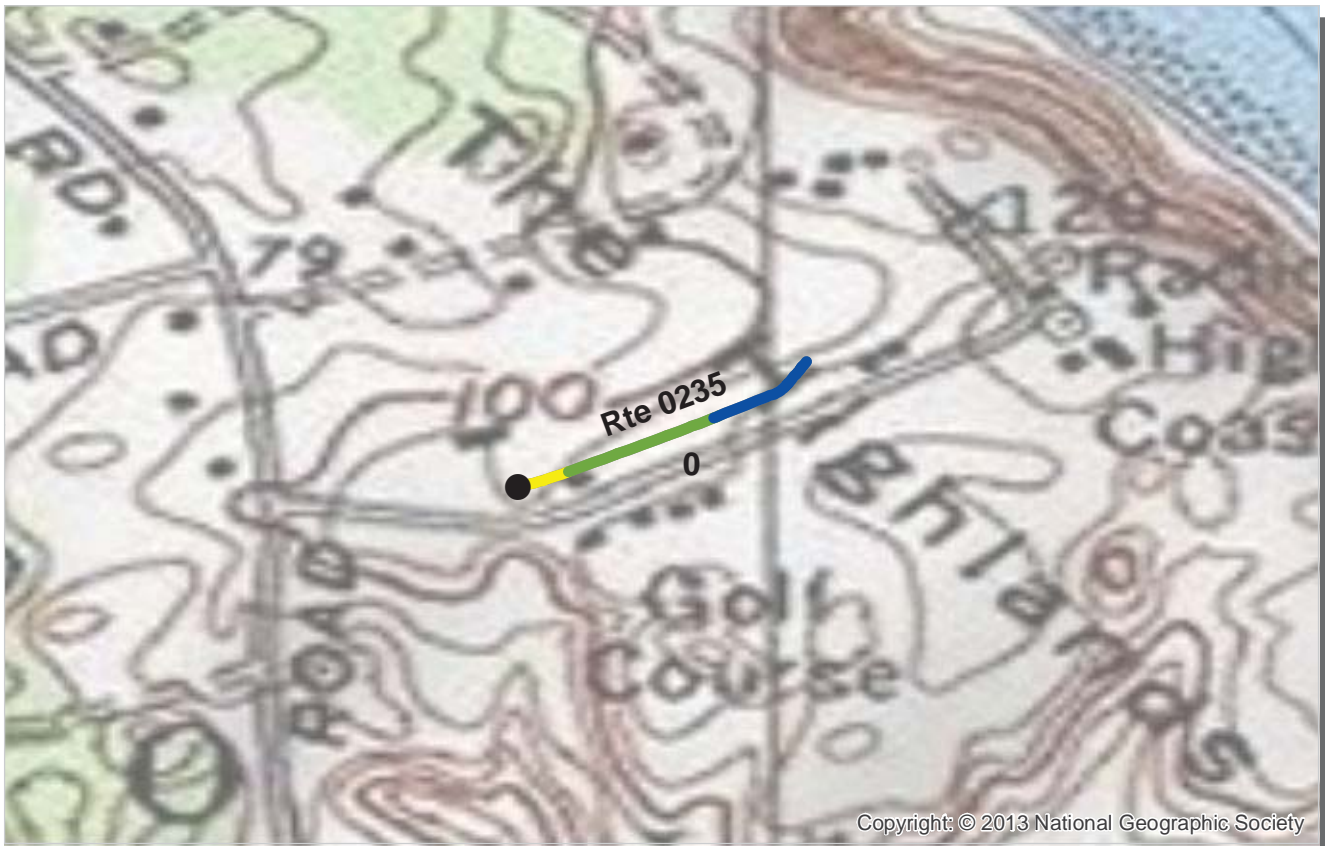
ROUTE: 0234GZ NORTH OF HIGHLAND CAMPGROUND ROAD G

PCR Poor ■ Fair ■ Good ■ Excellent ■ No Data ■
 (0 - 60) (61 - 84) (85 - 94) (95 - 100)

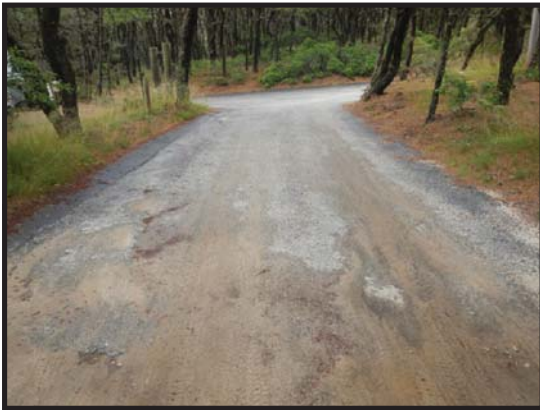
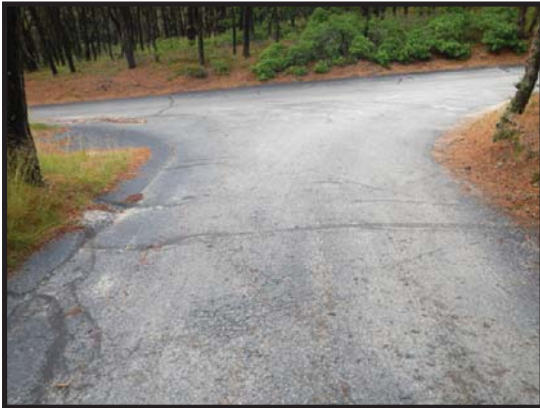
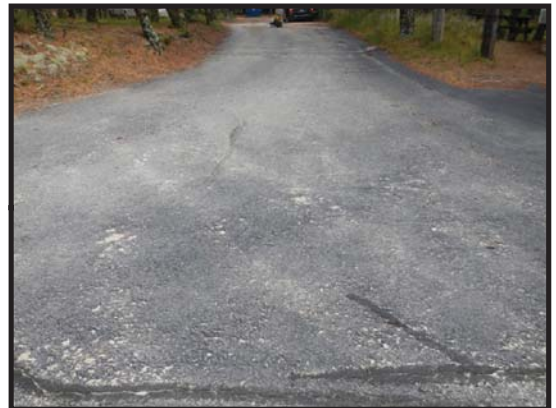
Route Number	Public / NonPublic	Date Visited	Area (sq ft)	Lane Miles *	Paved Length (mi)	Paved Width (ft)
0234HZ	PUBLIC	6/29/2013	805	0.01	0.01	12.7
Culverts	Drop Inlets	Gates	Curb & Gutter	Curb	PCR	Surface Type
0	0	0	NO CURB AND GUTTER	ASPHALT CURB	POOR/45	AS

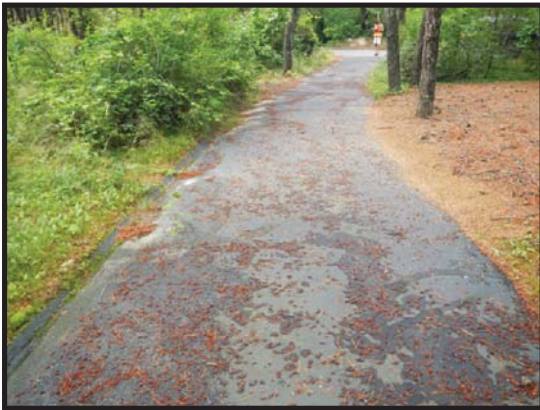
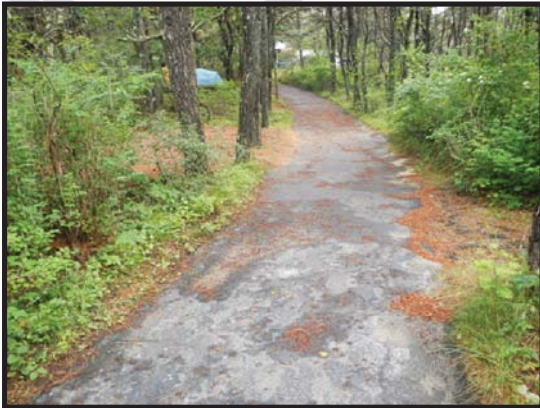
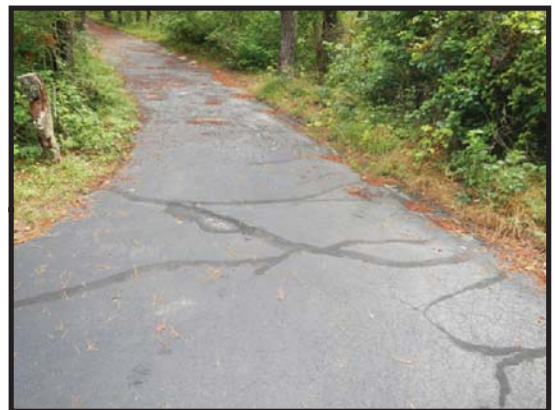
Route 0234IZ

Route Number	Public / NonPublic	Date Visited	Area (sq ft)	Lane Miles *	Paved Length (mi)	Paved Width (ft)
0234IZ	PUBLIC	6/29/2013	1,375	0.02	0.03	9.3
Culverts	Drop Inlets	Gates	Curb & Gutter	Curb	PCR	Surface Type
0	0	0	NO CURB AND GUTTER	ASPHALT CURB	POOR/45	AS

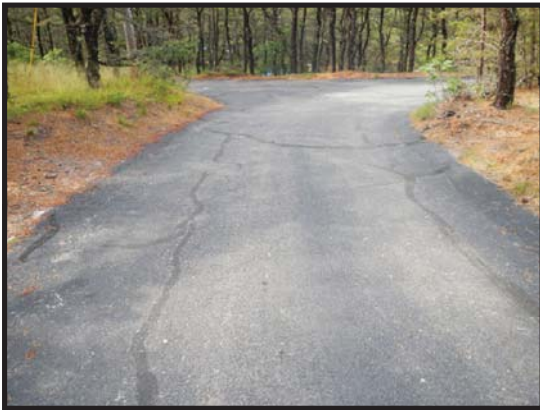
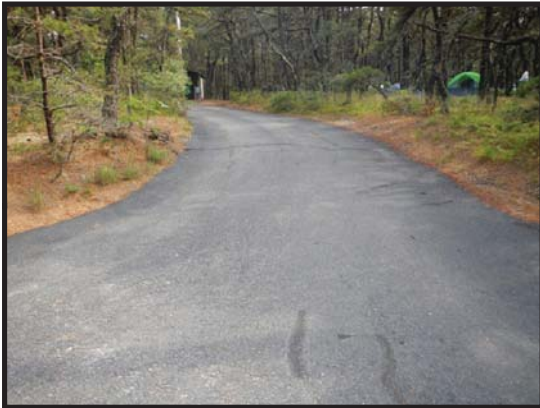
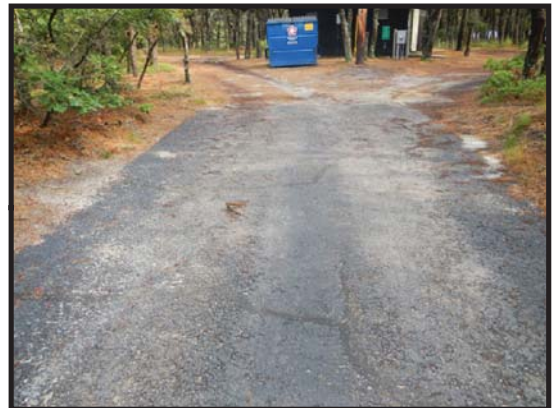
Route 0234JZ

Route Number	Public / NonPublic	Date Visited	Area (sq ft)	Lane Miles *	Paved Length (mi)	Paved Width (ft)
0234JZ	PUBLIC	6/29/2013	1,293	0.02	0.02	13.6
Culverts	Drop Inlets	Gates	Curb & Gutter	Curb	PCR	Surface Type
0	0	0	NO CURB AND GUTTER	ASPHALT CURB	POOR/45	AS

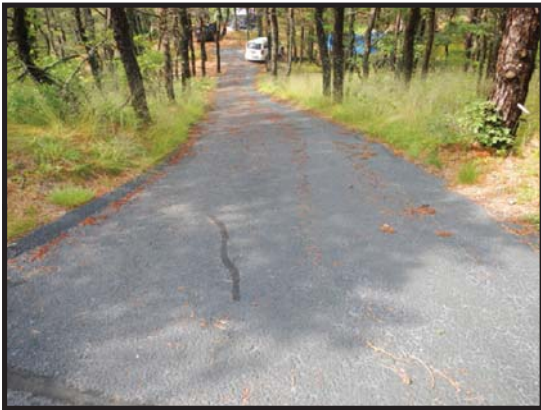
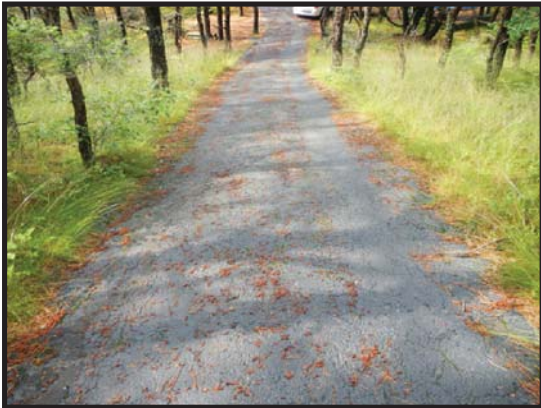
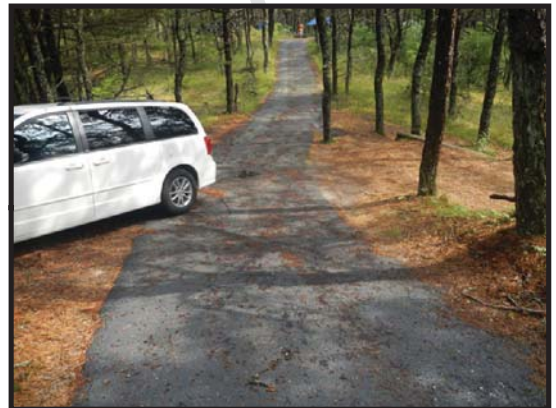
Route 0234KZ

Route Number	Public / NonPublic	Date Visited	Area (sq ft)	Lane Miles *	Paved Length (mi)	Paved Width (ft)
0234KZ	PUBLIC	6/29/2013	1,331	0.02	0.03	9
Culverts	Drop Inlets	Gates	Curb & Gutter	Curb	PCR	Surface Type
0	0	0	NO CURB AND GUTTER	ASPHALT CURB	POOR/45	AS
