Federal Lands Highway Road Inventory Program

Road Inventory and Condition Assessment

**Cape Cod National Seashore
CACO**

Cycle 5 Report

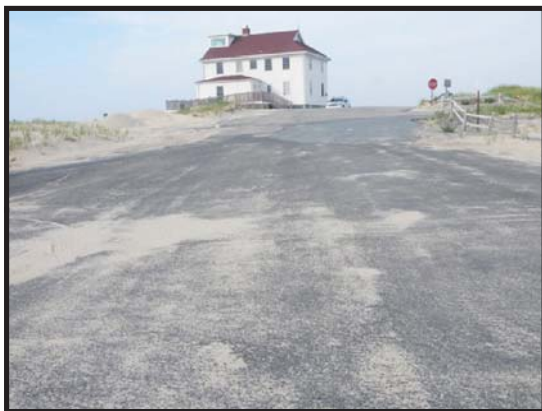
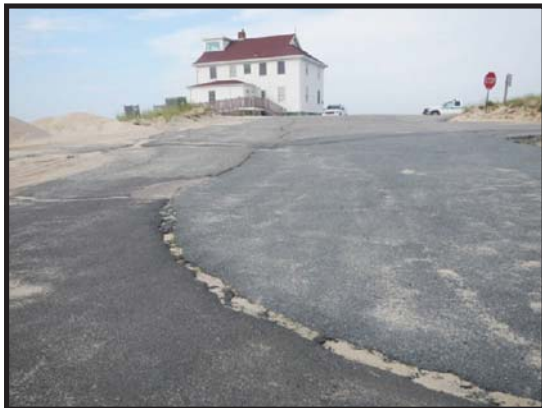
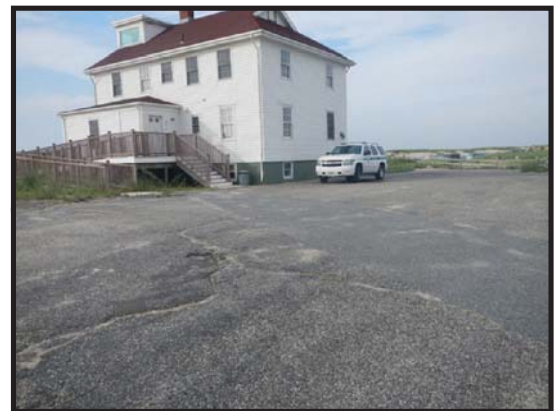
Route Number	Public / NonPublic	Date Visited	Area (sq ft)	Lane Miles *	Surface Type
0928	PUBLIC	6/29/2013	19,408	0.33	AS
Culverts	Drop Inlets	Gates	Curb & Gutter	Curb	PCR
0	0	1	NO CURB AND GUTTER	NO CURB	POOR/45

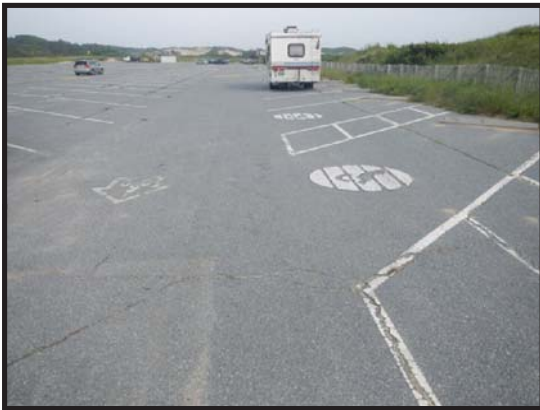
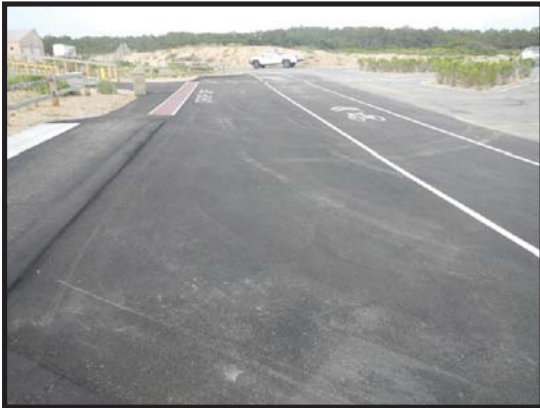
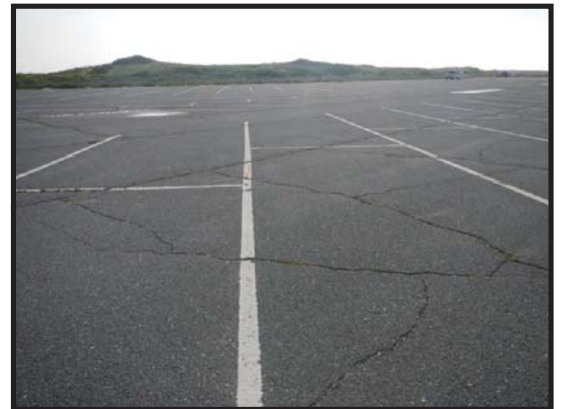
Route 0929

Route Number	Public / NonPublic	Date Visited	Area (sq ft)	Lane Miles *	Surface Type
0929	PUBLIC	6/29/2013	210,865	3.63	AS
Culverts	Drop Inlets	Gates	Curb & Gutter	Curb	PCR
0	2	2	NO CURB AND GUTTER	ASPHALT & STONE CURB	POOR/45

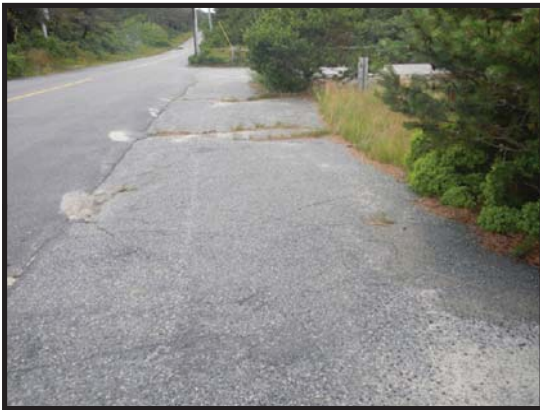
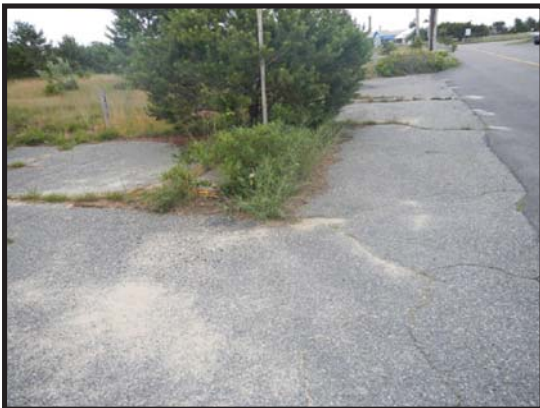
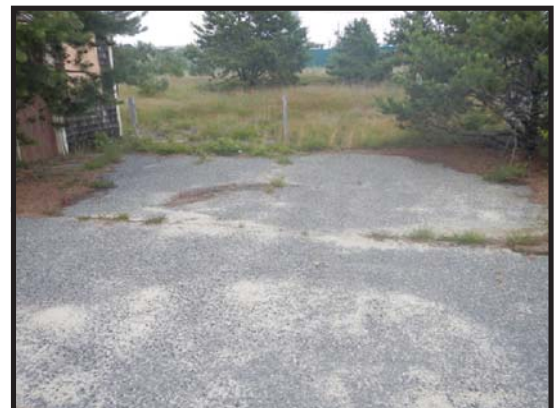
Route Number	Public / NonPublic	Date Visited	Area (sq ft)	Lane Miles *	Surface Type
0935B	PUBLIC	6/29/2013	1,520	0.03	AS
Culverts	Drop Inlets	Gates	Curb & Gutter	Curb	PCR
0	0	0	NO CURB AND GUTTER	NO CURB	POOR/45

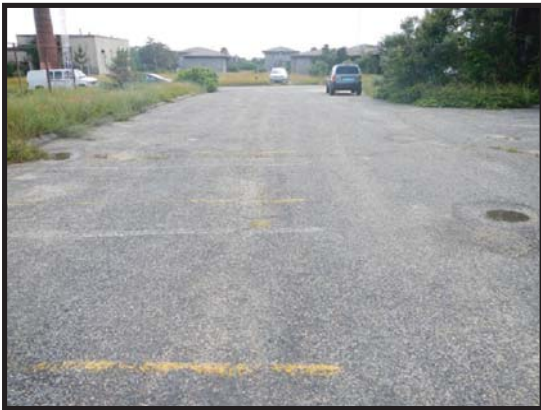
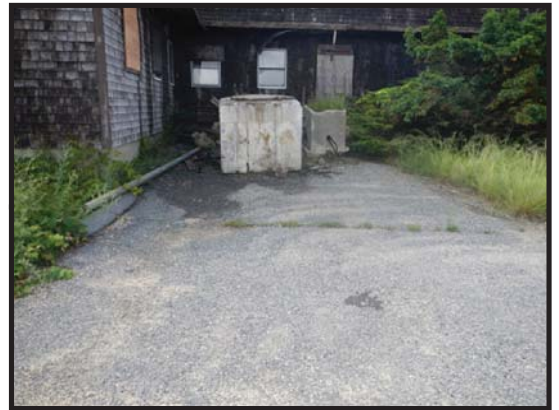
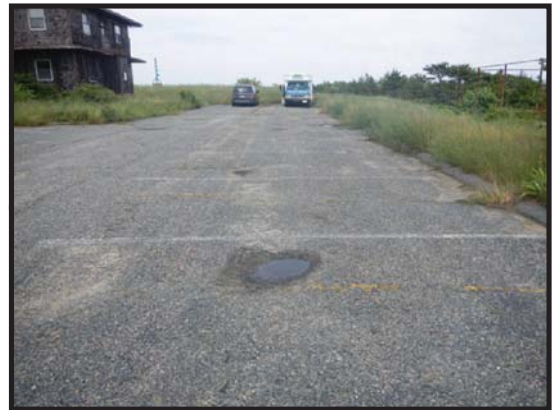
Route 0939C

Route Number	Public / NonPublic	Date Visited	Area (sq ft)	Lane Miles *	Surface Type
0939C	PUBLIC	6/29/2013	6,059	0.10	AS
Culverts	Drop Inlets	Gates	Curb & Gutter	Curb	PCR
0	0	0	NO CURB AND GUTTER	ASPHALT & CONCRETE	POOR/45

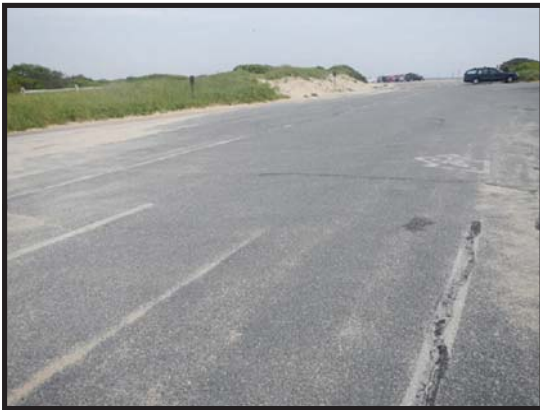
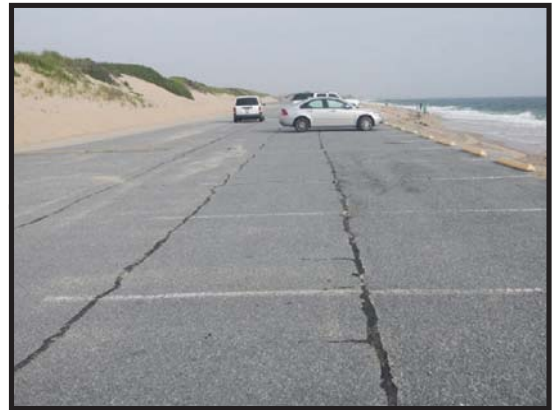
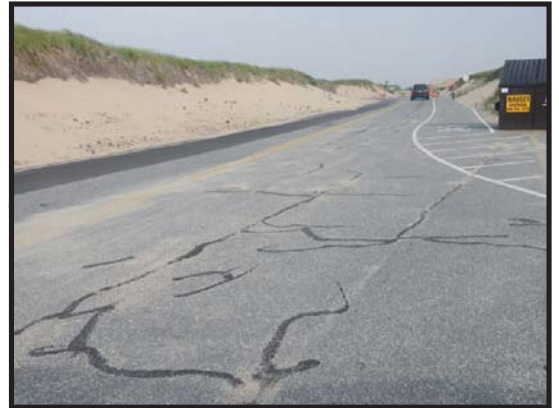
Route 0946

Route Number	Public / NonPublic	Date Visited	Area (sq ft)	Lane Miles *	Surface Type
0946	PUBLIC	6/29/2013	112,603	1.94	AS
Culverts	Drop Inlets	Gates	Curb & Gutter	Curb	PCR
0	0	1	NO CURB AND GUTTER	NO CURB	POOR/45

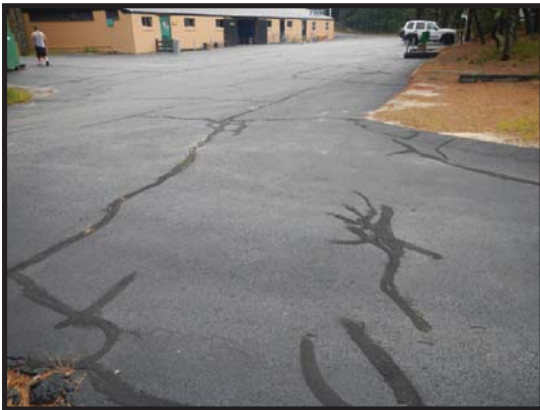
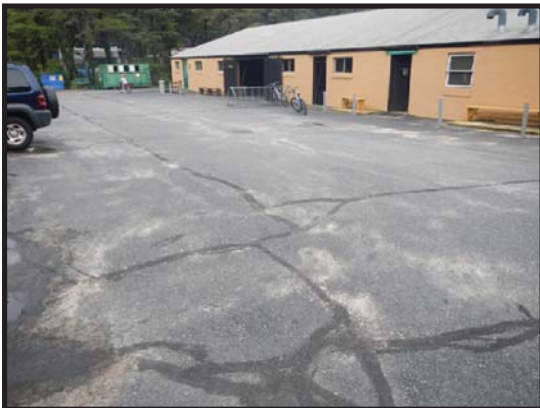
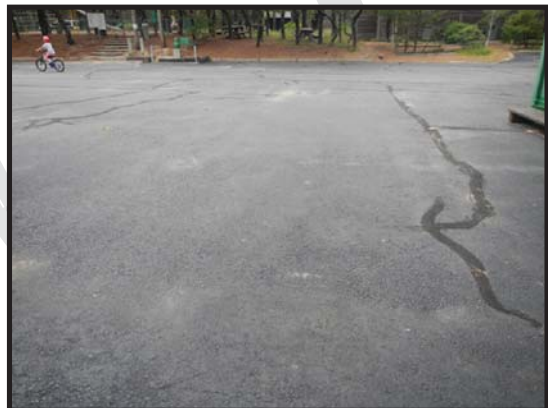
Route Number	Public / NonPublic	Date Visited	Area (sq ft)	Lane Miles *	Surface Type
0948BZ	PUBLIC	6/29/2013	10,042	0.17	AS
Culverts	Drop Inlets	Gates	Curb & Gutter	Curb	PCR
0	0	0	NO CURB AND GUTTER	ASPHALT & CONCRETE	POOR/45

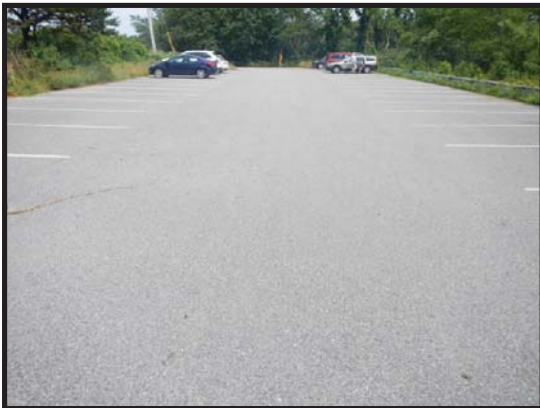
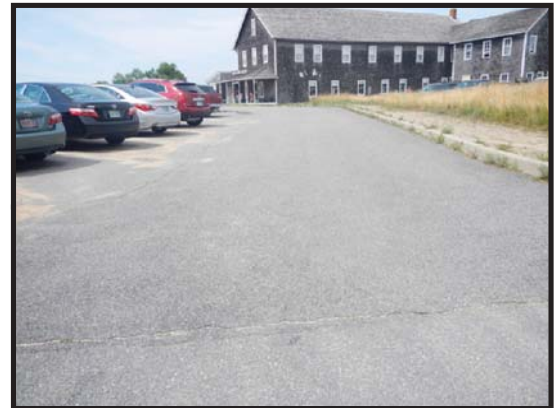
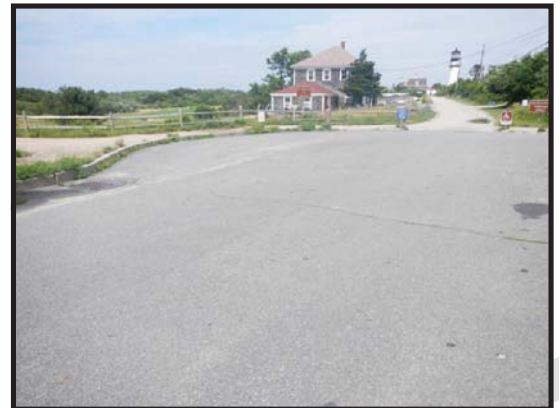
Route Number	Public / NonPublic	Date Visited	Area (sq ft)	Lane Miles *	Surface Type
0949	PUBLIC	6/29/2013	47,289	0.81	AS
Culverts	Drop Inlets	Gates	Curb & Gutter	Curb	PCR
0	1	0	NO CURB AND GUTTER	CONCRETE CURB	FAIR/73

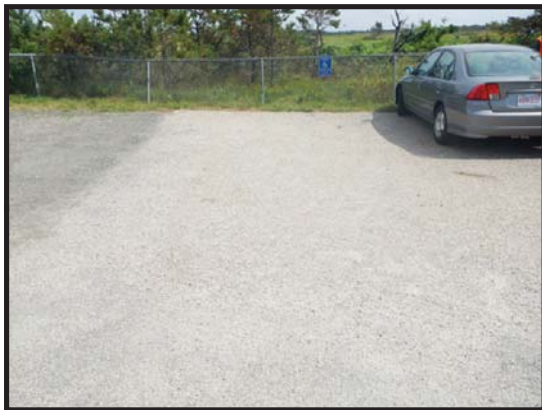
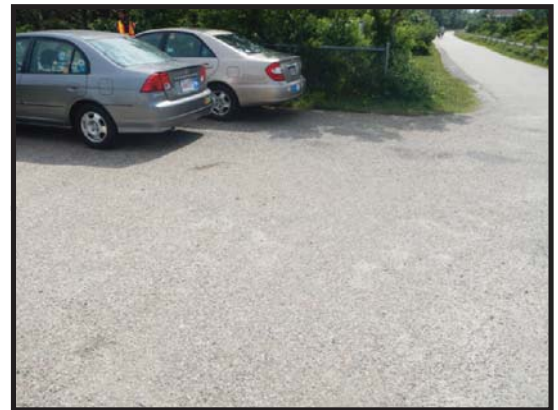
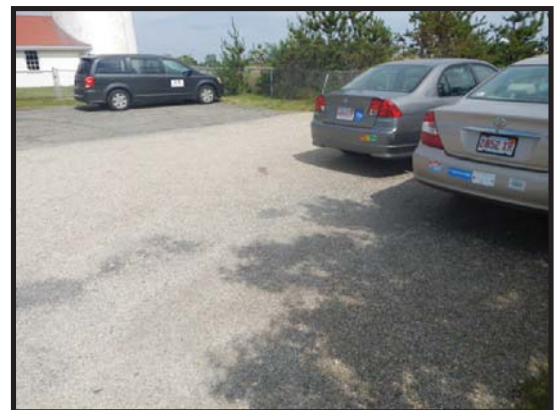
Note: Route 0950 is paved, but it has a layer of gravel to make it look unpaved, so condition data was not reported because the asphalt was not visible.

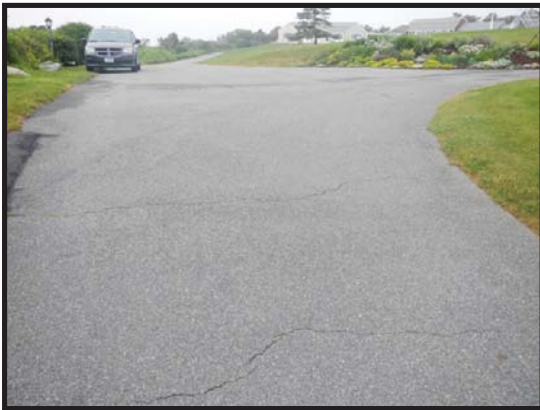
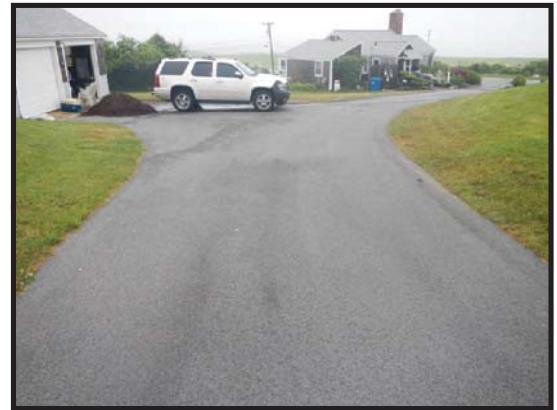
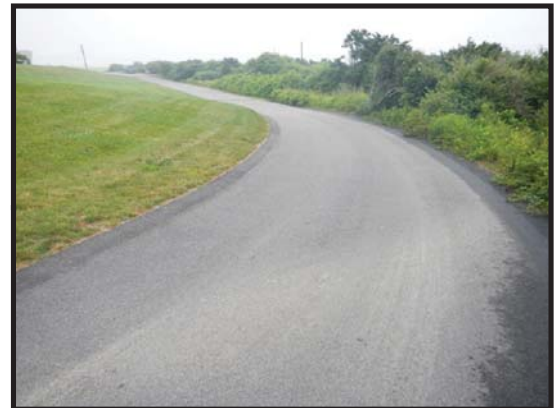
Route Number	Public / NonPublic	Date Visited	Area (sq ft)	Lane Miles *	Surface Type
0951	PUBLIC	6/29/2013	17,284	0.30	AS
Culverts	Drop Inlets	Gates	Curb & Gutter	Curb	PCR
0	0	0	NO CURB AND GUTTER	ASPHALT CURB	GOOD/90
