Federal Lands Highway Road Inventory Program

Road Inventory and Condition Assessment

Cape Lookout National Seashore CALO

Cycle 5 Report

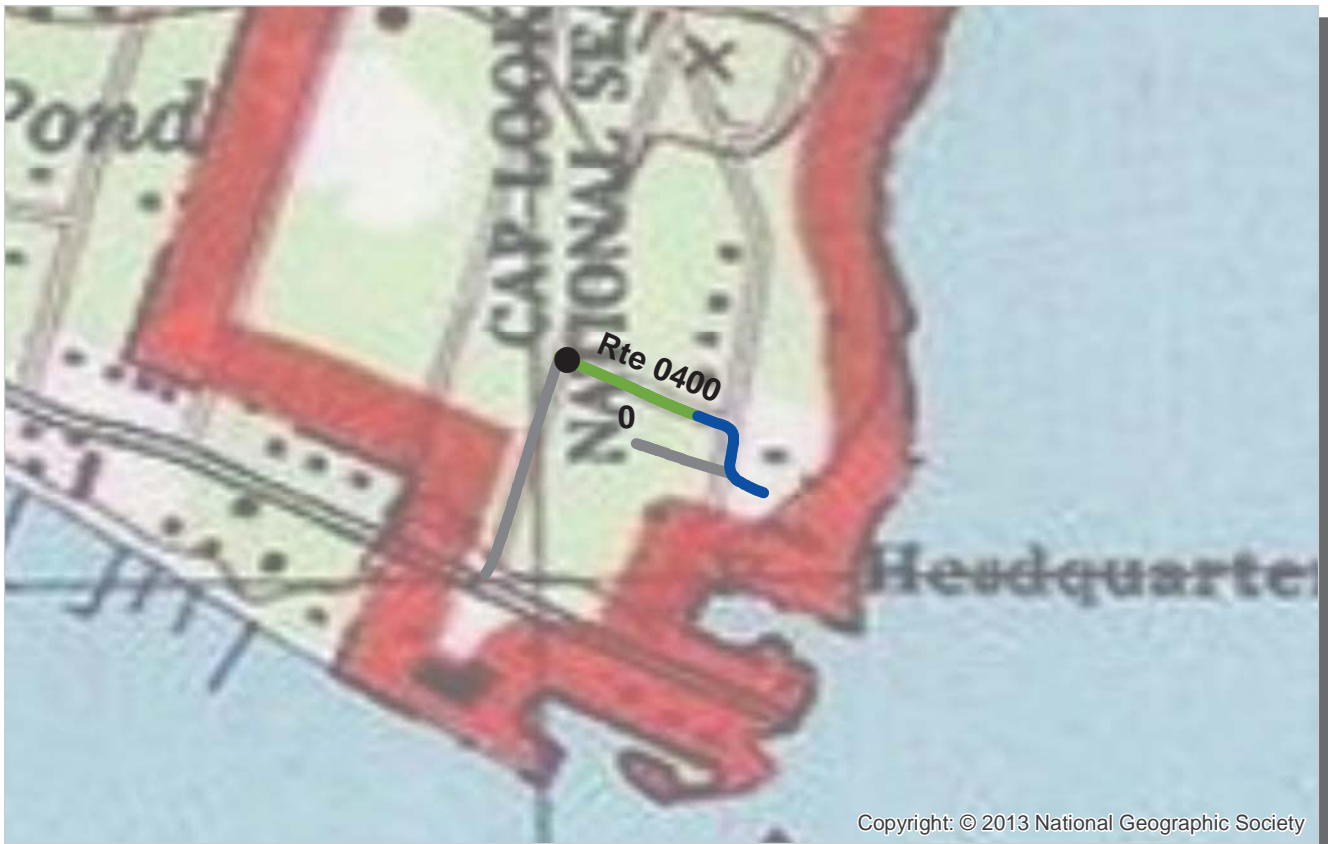
ROUTE: 0400 CHARLES STREET

Section Number	0				
Section Length (mi)	0.11				
Cross Section Information					
Number of Lanes	1				
Paved Width (ft)	14				
Lane Width (ft)	13				
Roadway Condition Information					
SCR (Surface Condition Rating)	93				
PCR (Pavement Condition Rating)	93				
Distress Index Values					
Structural Crack Index	93				
Transverse Cracking Index	98				
Patching Index	98				
Rutting Index	96				
Roughness Condition Index (RCI)	NC

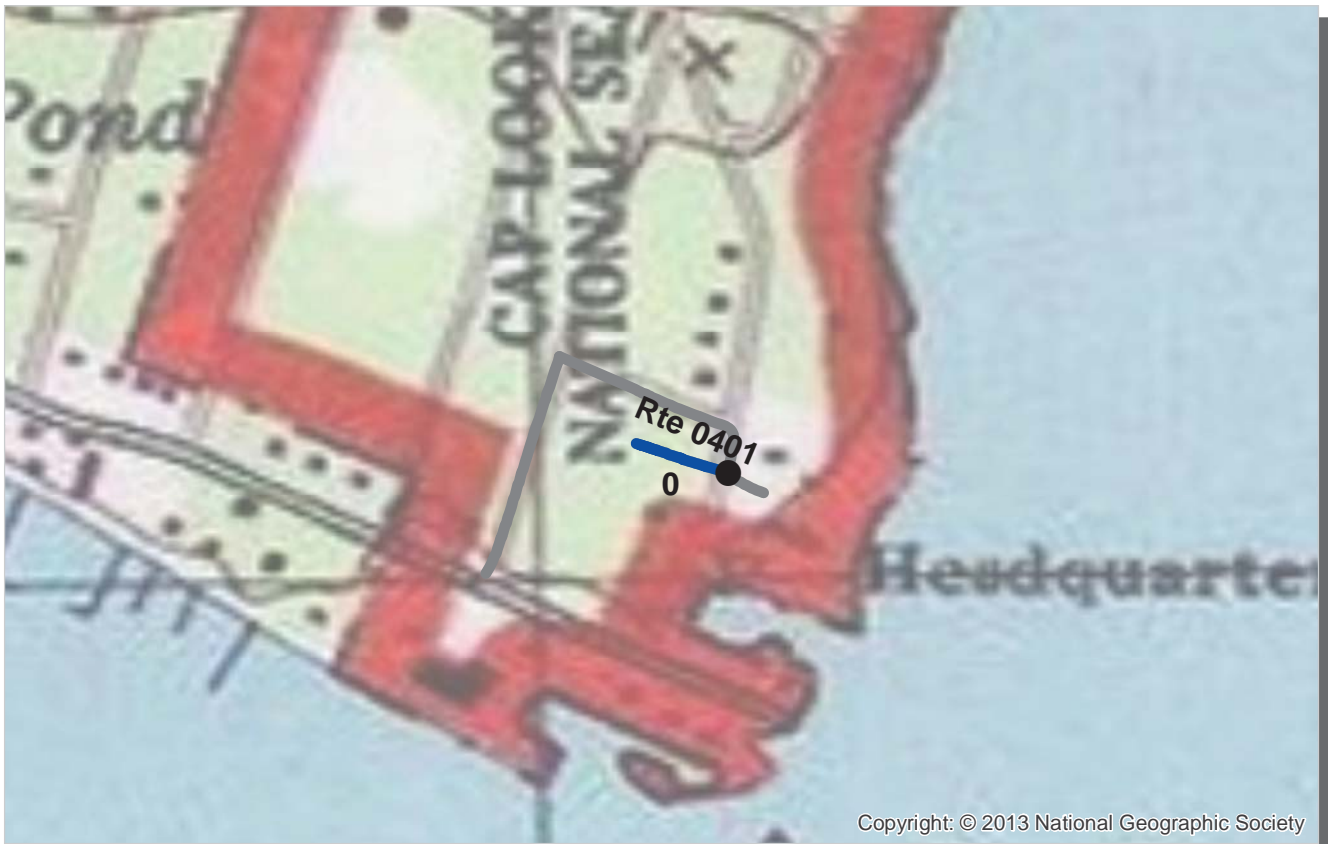
ROUTE: 0401 FUEL FARM ROAD

Section Number	0				
Section Length (mi)	0.04				
Cross Section Information					
Number of Lanes	1				
Paved Width (ft)	11				
Lane Width (ft)	11				
Roadway Condition Information					
SCR (Surface Condition Rating)	95				
PCR (Pavement Condition Rating)	95				
Distress Index Values					
Structural Crack Index	100				
Transverse Cracking Index	100				
Patching Index	100				
Rutting Index	95				
Roughness Condition Index (RCI)	NC

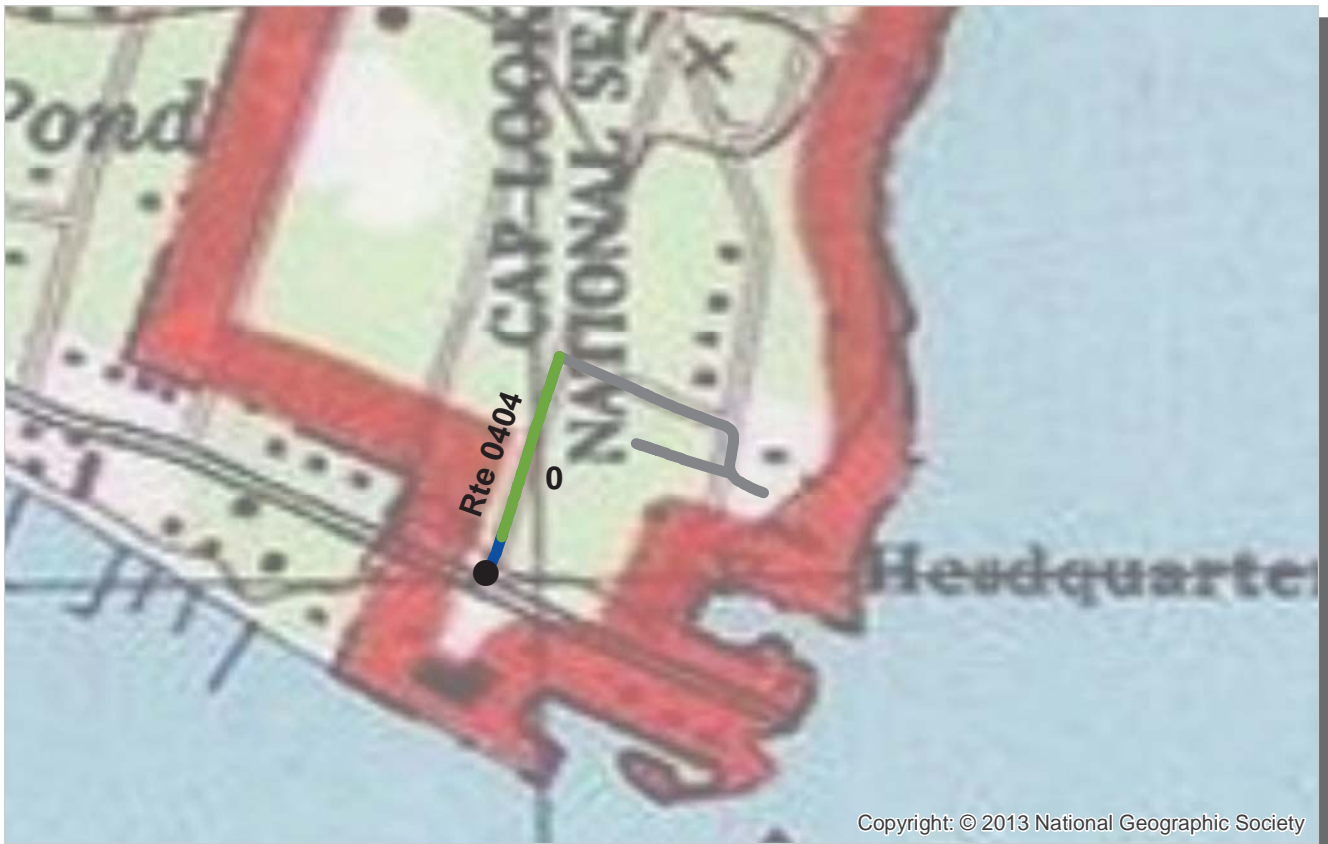
ROUTE: 0404 CAPE POINT DRIVE

Section Number	0				
Section Length (mi)	0.12				
Cross Section Information					
Number of Lanes	2				
Paved Width (ft)	18				
Lane Width (ft)	9				
Roadway Condition Information					
SCR (Surface Condition Rating)	94				
PCR (Pavement Condition Rating)	94				
Distress Index Values					
Structural Crack Index	94				
Transverse Cracking Index	96				
Patching Index	96				
Rutting Index	96				
Roughness Condition Index (RCI)	NC

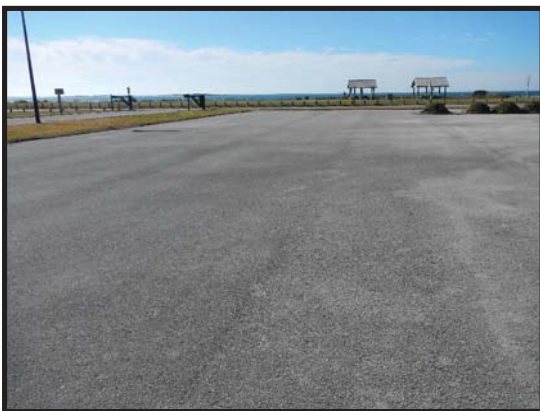
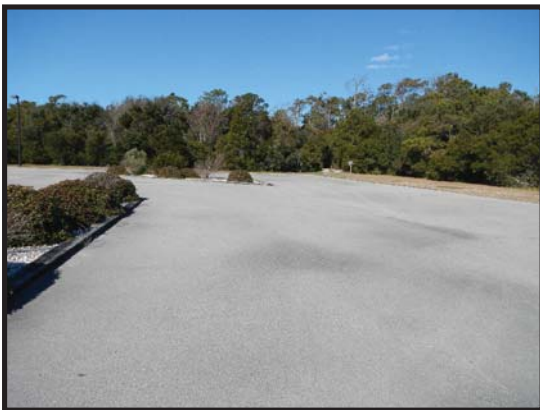
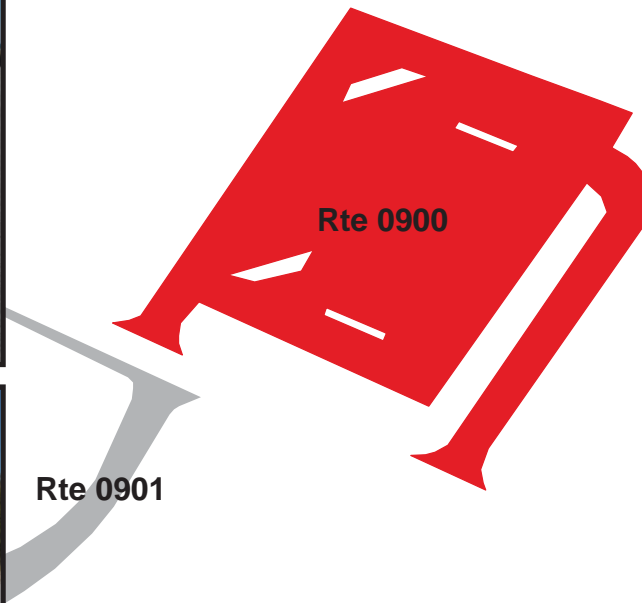
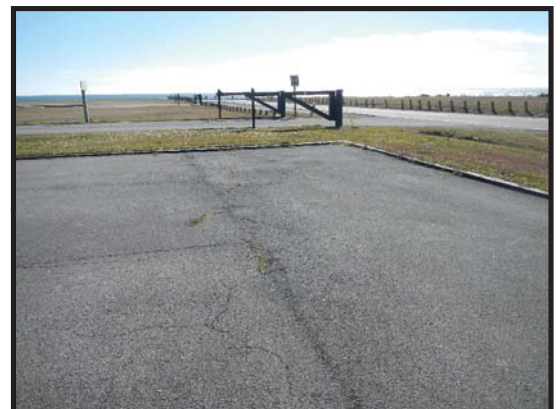
Route 0901

Route Number	Public / NonPublic	Date Visited	Area (sq ft)	Lane Miles *	Surface Type
0901	PUBLIC	2/5/2013	21,390	0.37	AS
Culverts	Drop Inlets	Gates	Curb & Gutter	Curb	PCR
0	0	1	NO CURB AND GUTTER	NO CURB	POOR/45

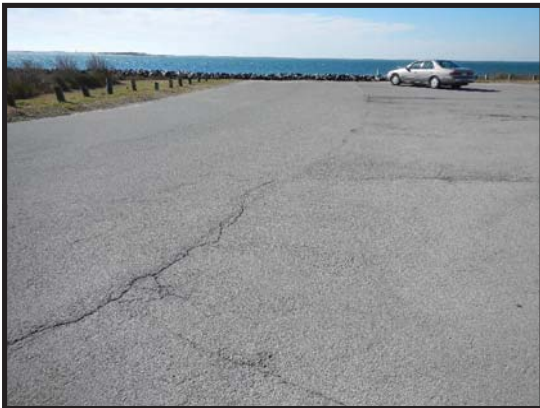
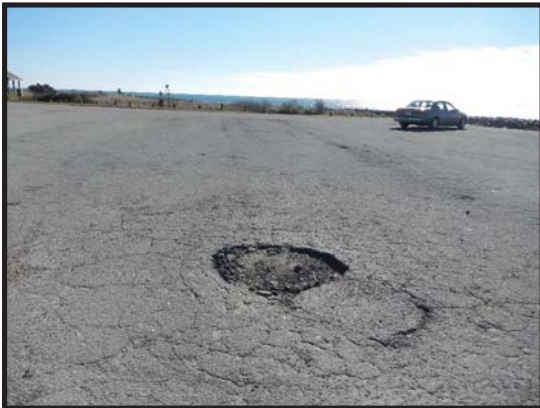
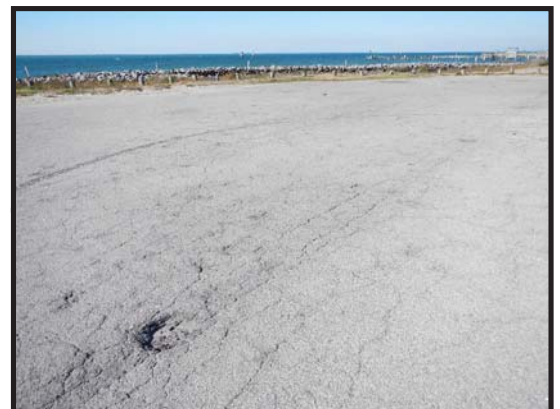
Route 0902

Route Number	Public / NonPublic	Date Visited	Area (sq ft)	Lane Miles *	Surface Type
0902	NONPUBLIC	2/5/2013	7,857	0.14	AS
Culverts	Drop Inlets	Gates	Curb & Gutter	Curb	PCR
0	0	0	NO CURB AND GUTTER	NO CURB	GOOD/90

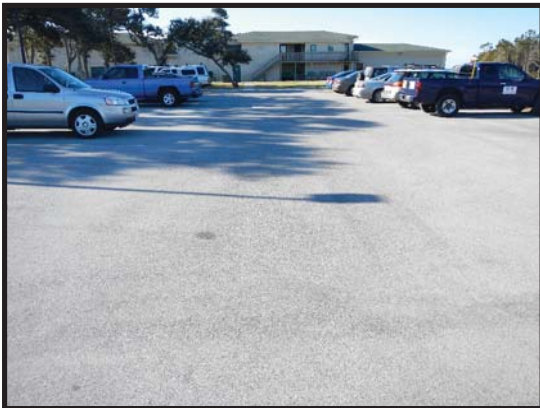
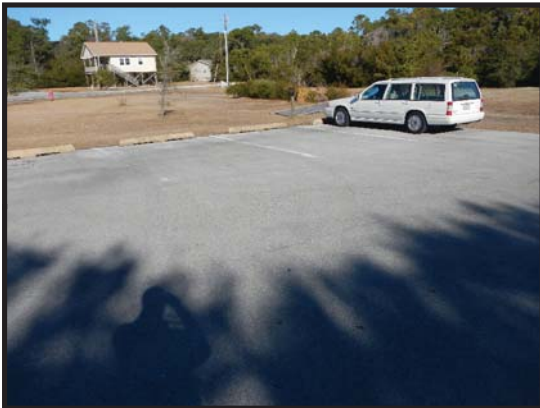
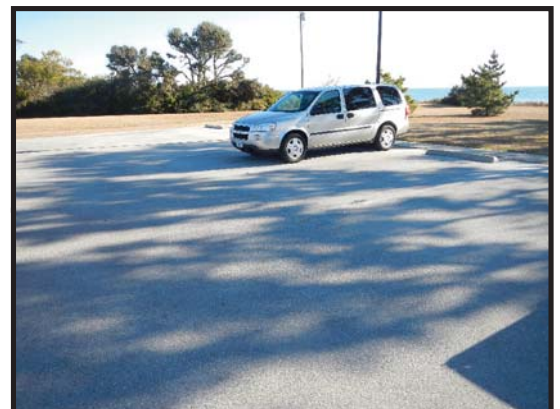
Route 0903

Route Number	Public / NonPublic	Date Visited	Area (sq ft)	Lane Miles *	Surface Type
0903	NONPUBLIC	2/5/2013	23,501	0.41	AS
Culverts	Drop Inlets	Gates	Curb & Gutter	Curb	PCR
1	0	0	NO CURB AND GUTTER	NO CURB	FAIR/73

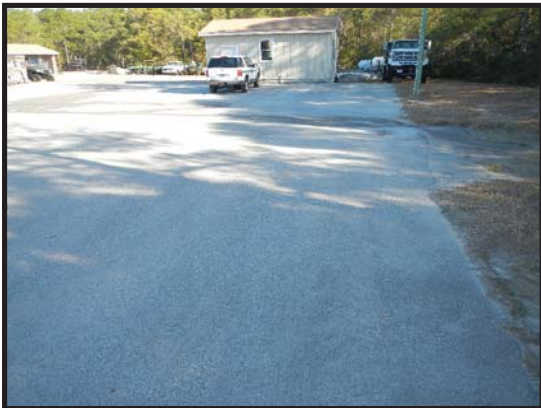
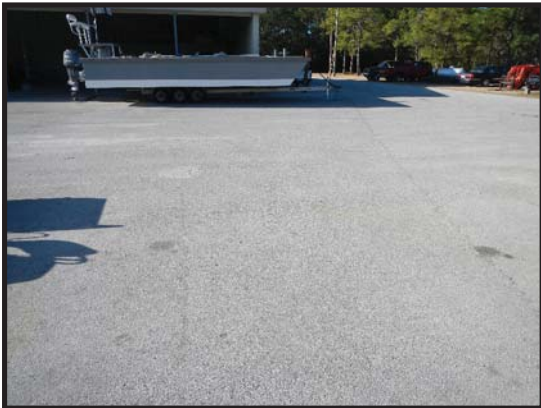
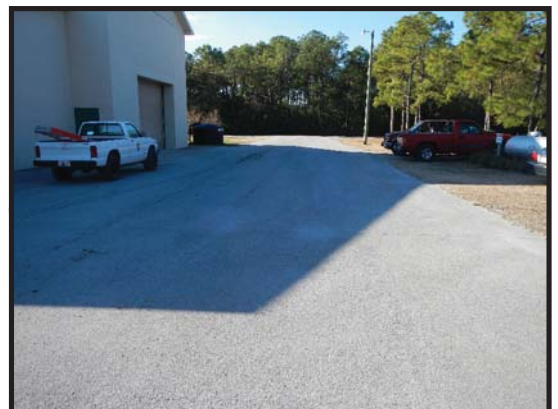
Route 0904

Route Number	Public / NonPublic	Date Visited	Area (sq ft)	Lane Miles *	Surface Type
0904	PUBLIC	2/5/2013	75,112	1.29	AS
Culverts	Drop Inlets	Gates	Curb & Gutter	Curb	PCR
1	0	0	NO CURB AND GUTTER	NO CURB	GOOD/90
