# Federal Lands Highway Road Inventory Program

Road Inventory and Condition Assessment

## Canyonlands National Park CANY - 1340

### Cycle 5 Report

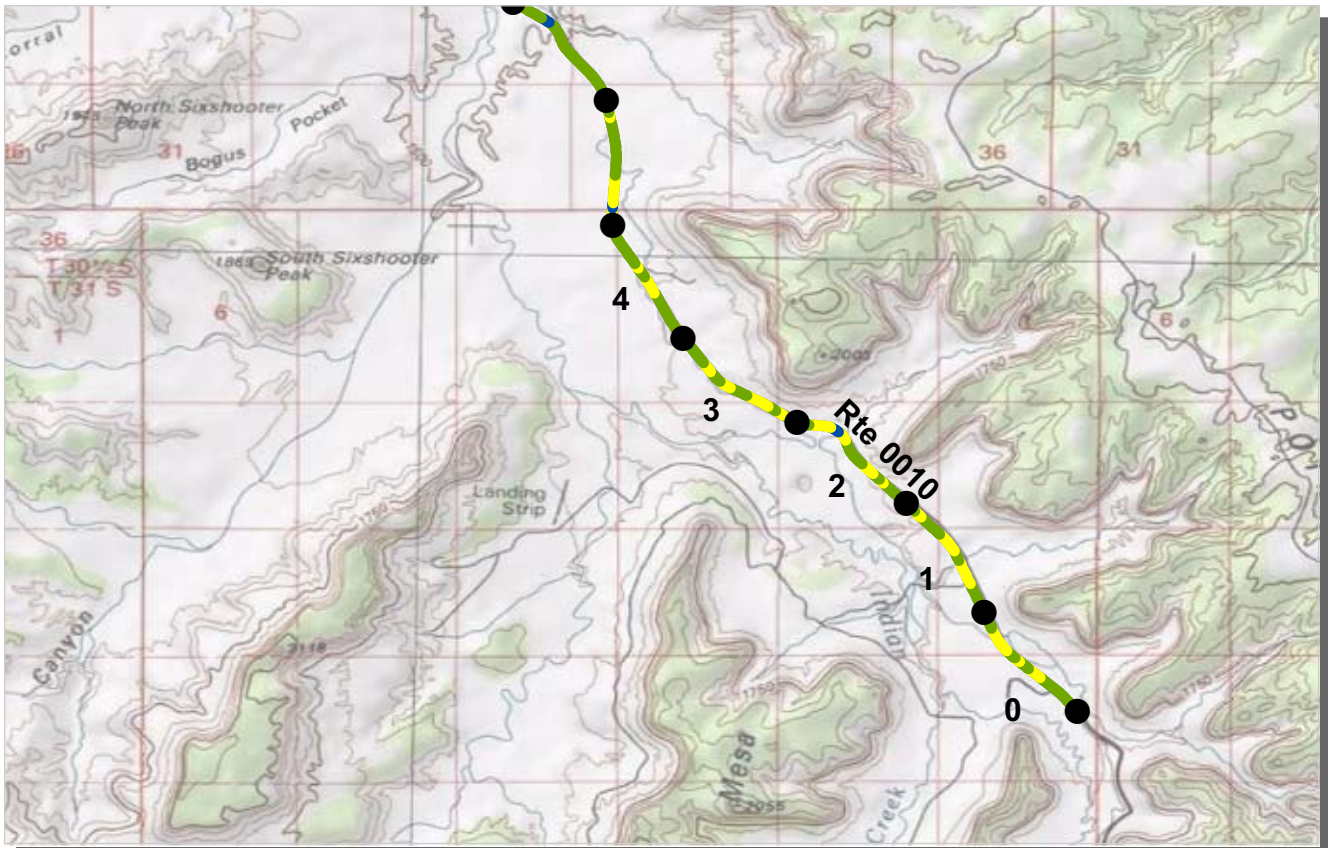
**ROUTE: 0010 NEEDLES ACCESS ROAD**

<i>Section Number</i>	0	1	2	3	4
<i>Section Length (mi)</i>	1.00	1.00	1.00	1.00	1.00
<i>Cross Section Information</i>					
Number of Lanes	2	2	2	2	2
Paved Width (ft)	29	30	29	29	29
Lane Width (ft)	10	11	11	11	11
<i>Roadway Condition Information</i>					
SCR (Surface Condition Rating)	87	91	92	92	91
PCR (Pavement Condition Rating)	86	86	85	87	87
<i>Distress Index Values</i>					
Structural Crack Index	89	92	98	95	95
Transverse Cracking Index	87	92	96	93	92
Patching Index	100	100	100	100	100
Rutting Index	93	91	92	92	91
Roughness Condition Index (RCI)	84	79	75	80	82

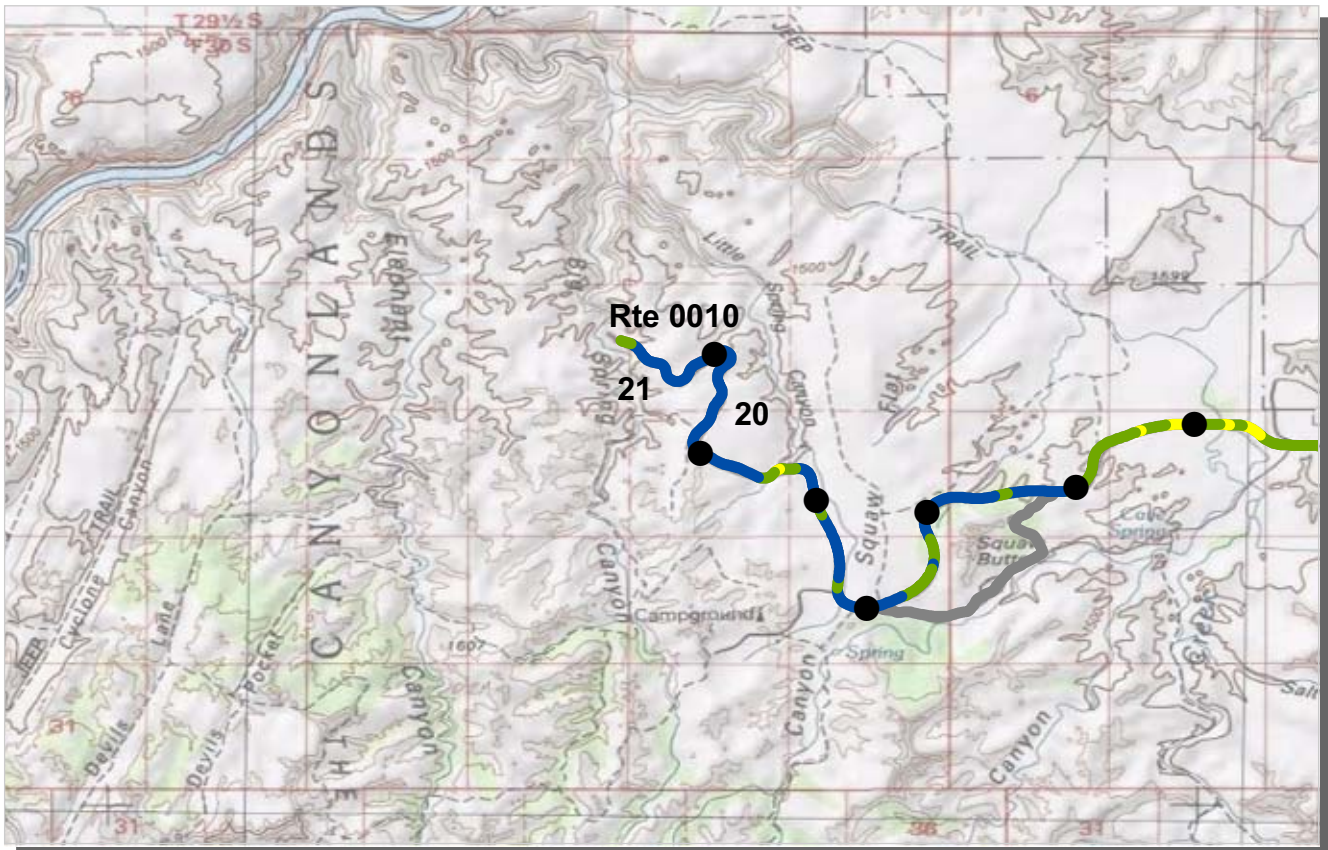
**ROUTE: 0010 NEEDLES ACCESS ROAD**

<i>Section Number</i>	20	21			
<i>Section Length (mi)</i>	1.00	0.85			
<i>Cross Section Information</i>					
Number of Lanes	2	2			
Paved Width (ft)	28	28			
Lane Width (ft)	11	11			
<i>Roadway Condition Information</i>					
SCR (Surface Condition Rating)	98	98			
PCR (Pavement Condition Rating)	99	99			
<i>Distress Index Values</i>					
Structural Crack Index	100	100			
Transverse Cracking Index	100	100			
Patching Index	100	100			
Rutting Index	98	98			
Roughness Condition Index (RCI)	100	100

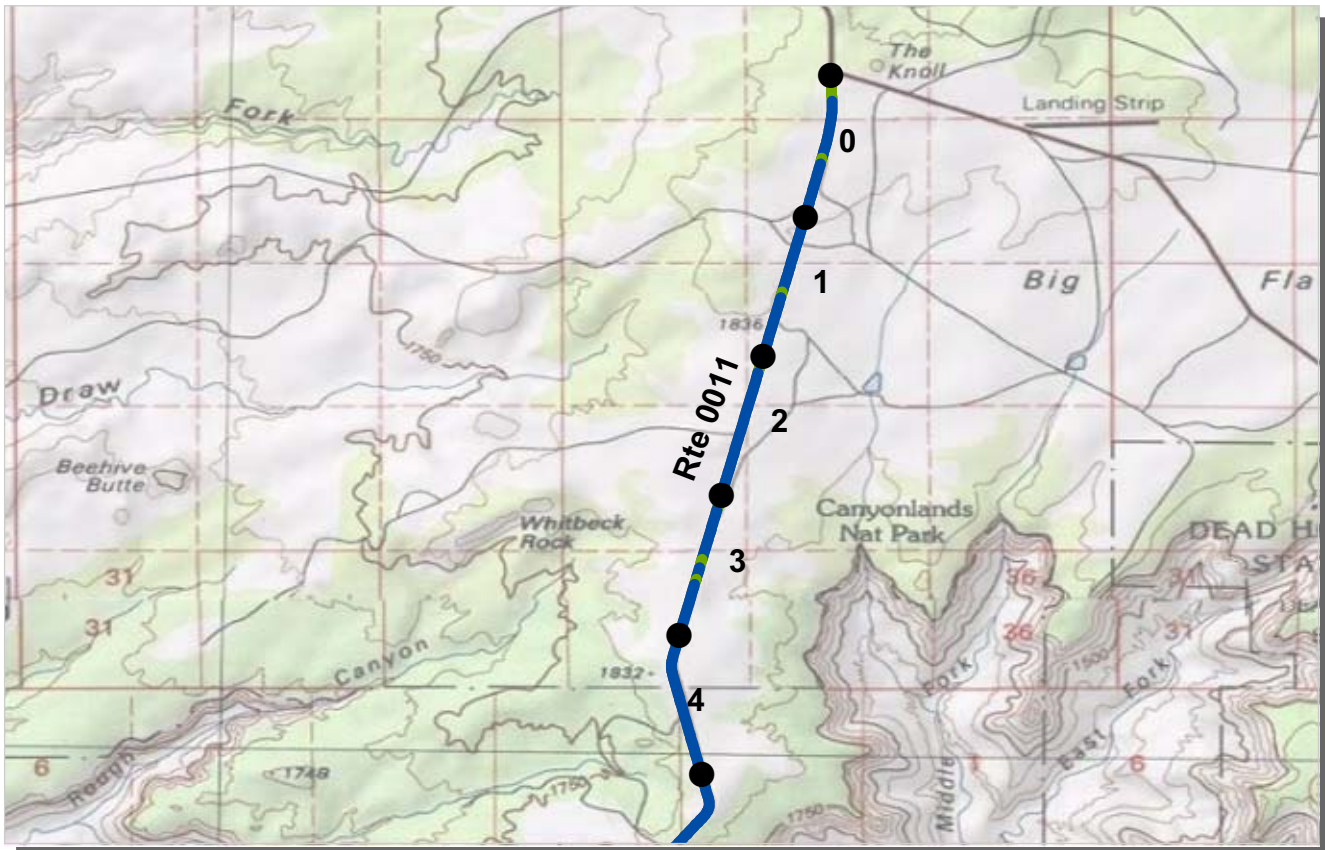
**ROUTE: 0011 ISLAND IN THE SKY ROAD**

<i>Section Number</i>	0	1	2	3	4
<i>Section Length (mi)</i>	1.00	1.00	1.00	1.00	1.00
<i>Cross Section Information</i>					
Number of Lanes	2	2	2	2	2
Paved Width (ft)	33	32	33	34	30
Lane Width (ft)	11	11	11	11	11
<i>Roadway Condition Information</i>					
SCR (Surface Condition Rating)	95	96	95	96	97
PCR (Pavement Condition Rating)	97	98	97	98	98
<i>Distress Index Values</i>					
Structural Crack Index	98	99	97	98	100
Transverse Cracking Index	99	100	99	99	99
Patching Index	100	100	100	100	100
Rutting Index	95	96	95	96	97
Roughness Condition Index (RCI)	100	100	100	100	100

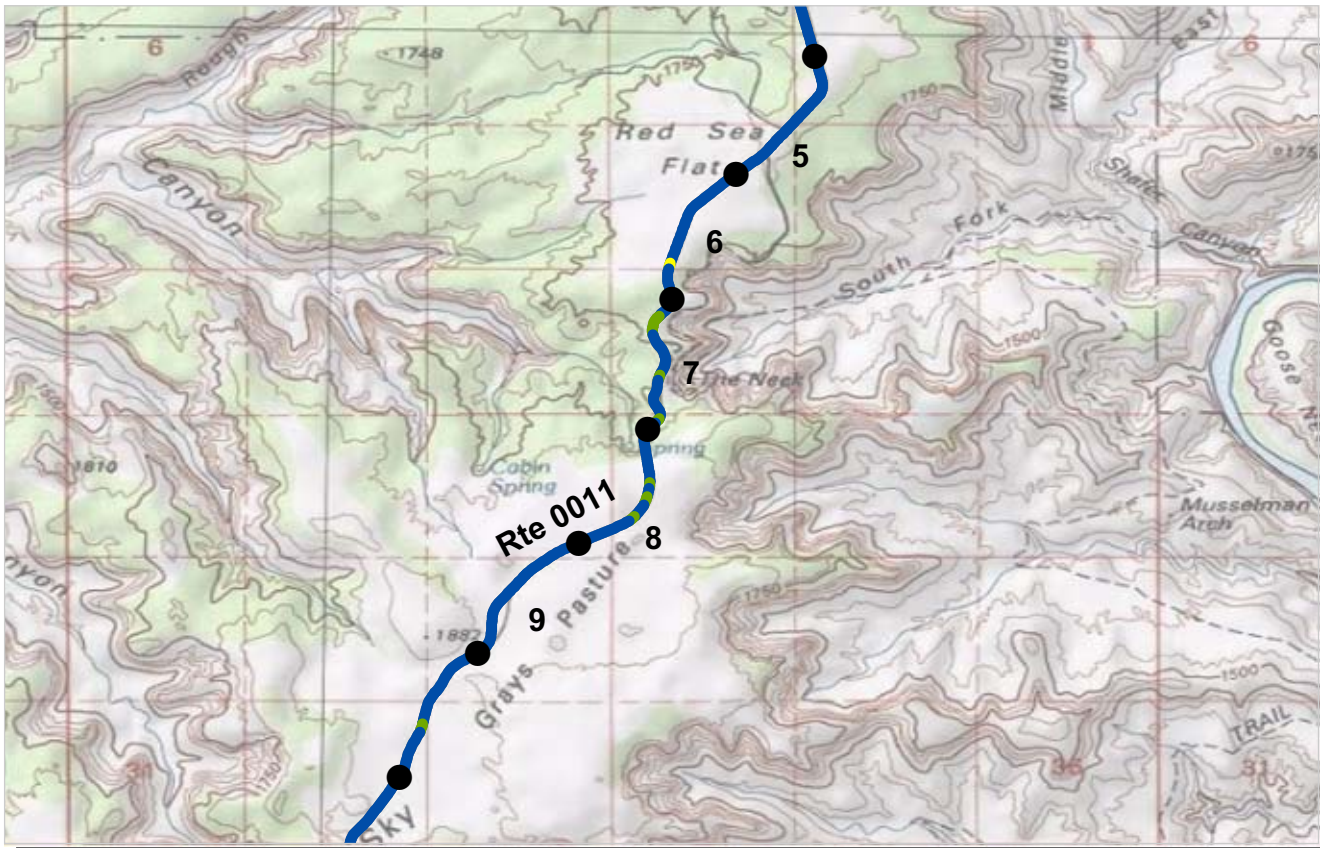
**ROUTE: 0011 ISLAND IN THE SKY ROAD**

<i>Section Number</i>	5	6	7	8	9
<i>Section Length (mi)</i>	1.00	1.00	1.00	1.00	1.00
<i>Cross Section Information</i>					
Number of Lanes	2	2	2	2	2
Paved Width (ft)	30	28	33	28	26
Lane Width (ft)	11	11	11	11	11
<i>Roadway Condition Information</i>					
SCR (Surface Condition Rating)	98	97	95	96	95
PCR (Pavement Condition Rating)	99	98	97	98	97
<i>Distress Index Values</i>					
Structural Crack Index	99	97	95	96	99
Transverse Cracking Index	99	98	97	99	100
Patching Index	100	100	100	100	100
Rutting Index	98	98	99	97	95
Roughness Condition Index (RCI)	100	100	100	100	100

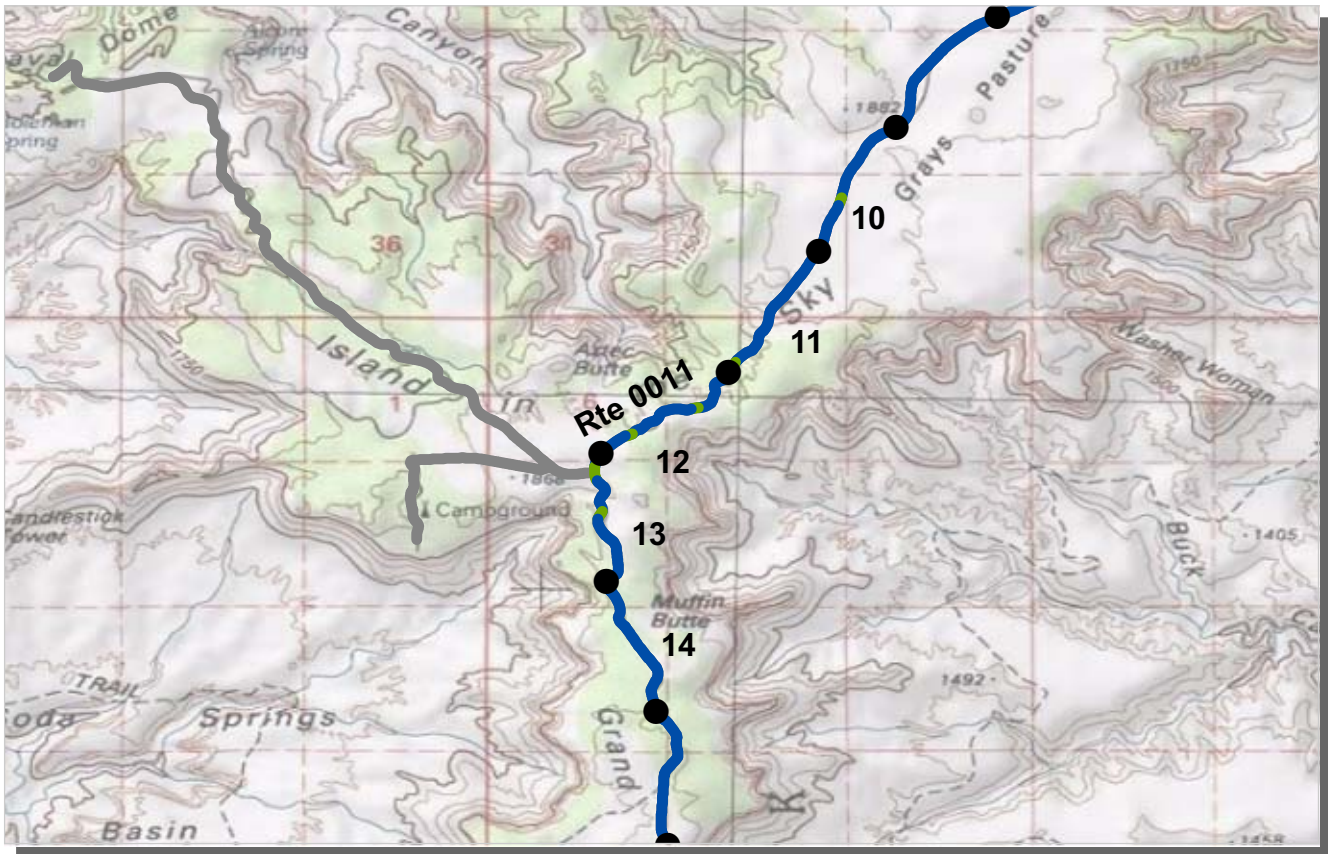
**ROUTE: 0011 ISLAND IN THE SKY ROAD**

<i>Section Number</i>	10	11	12	13	14
<i>Section Length (mi)</i>	1.00	1.00	1.00	1.00	1.00
<i>Cross Section Information</i>					
Number of Lanes	2	2	2	2	2
Paved Width (ft)	27	26	28	30	26
Lane Width (ft)	11	11	11	11	10
<i>Roadway Condition Information</i>					
SCR (Surface Condition Rating)	95	96	98	97	98
PCR (Pavement Condition Rating)	97	98	99	98	99
<i>Distress Index Values</i>					
Structural Crack Index	99	100	98	99	99
Transverse Cracking Index	99	100	98	99	99
Patching Index	100	100	100	100	100
Rutting Index	95	96	98	97	98
Roughness Condition Index (RCI)	100	100	100	100	100

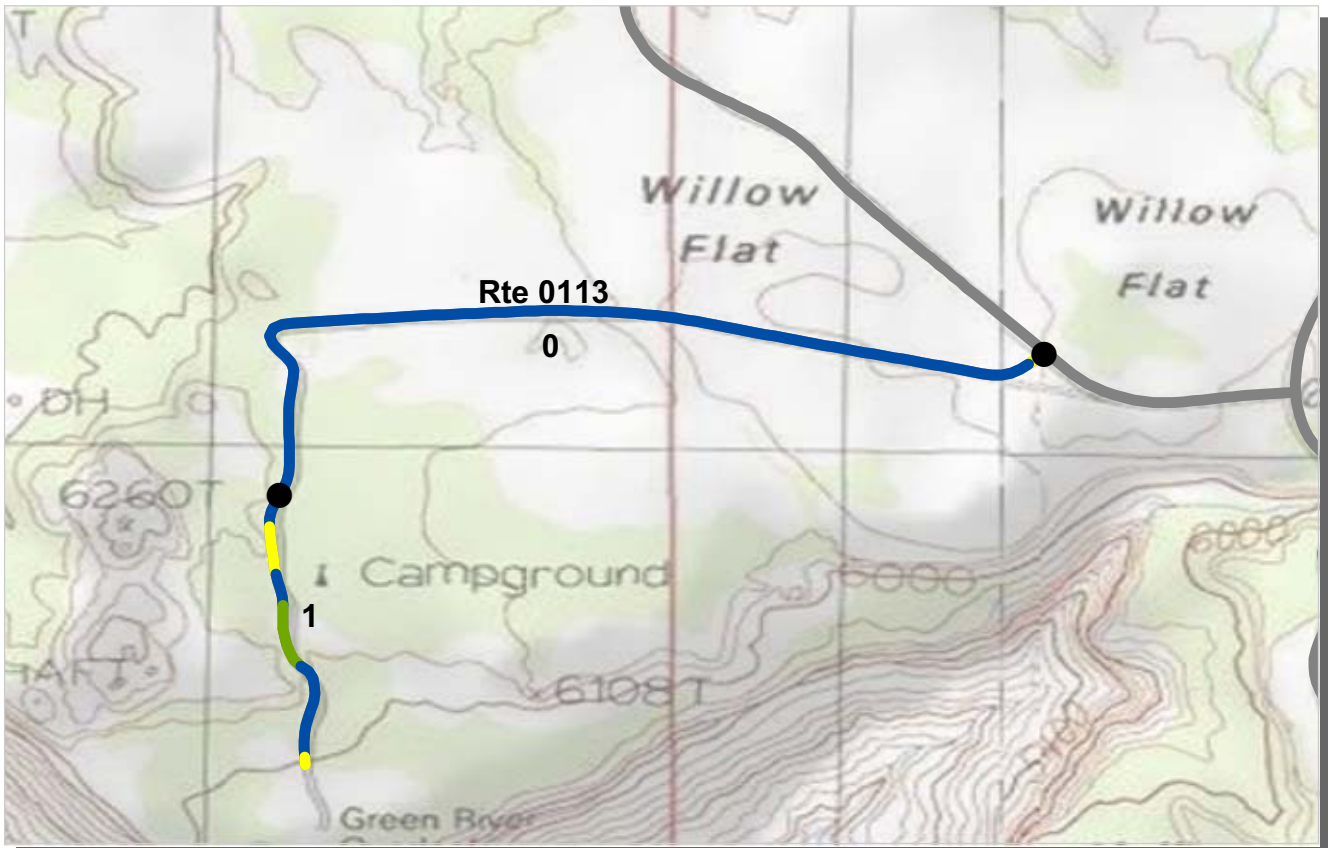
**ROUTE: 0113 GREEN RIVER OVERLOOK ROAD**

<i>Section Number</i>	0	1			
<i>Section Length (mi)</i>	1.00	0.35			
<i>Cross Section Information</i>					
Number of Lanes	2	2			
Paved Width (ft)	22	23			
Lane Width (ft)	10	10			
<i>Roadway Condition Information</i>					
SCR (Surface Condition Rating)	96	94			
PCR (Pavement Condition Rating)	98	94			
<i>Distress Index Values</i>					
Structural Crack Index	100	100			
Transverse Cracking Index	99	100			
Patching Index	100	100			
Rutting Index	96	94			
Roughness Condition Index (RCI)	100	93

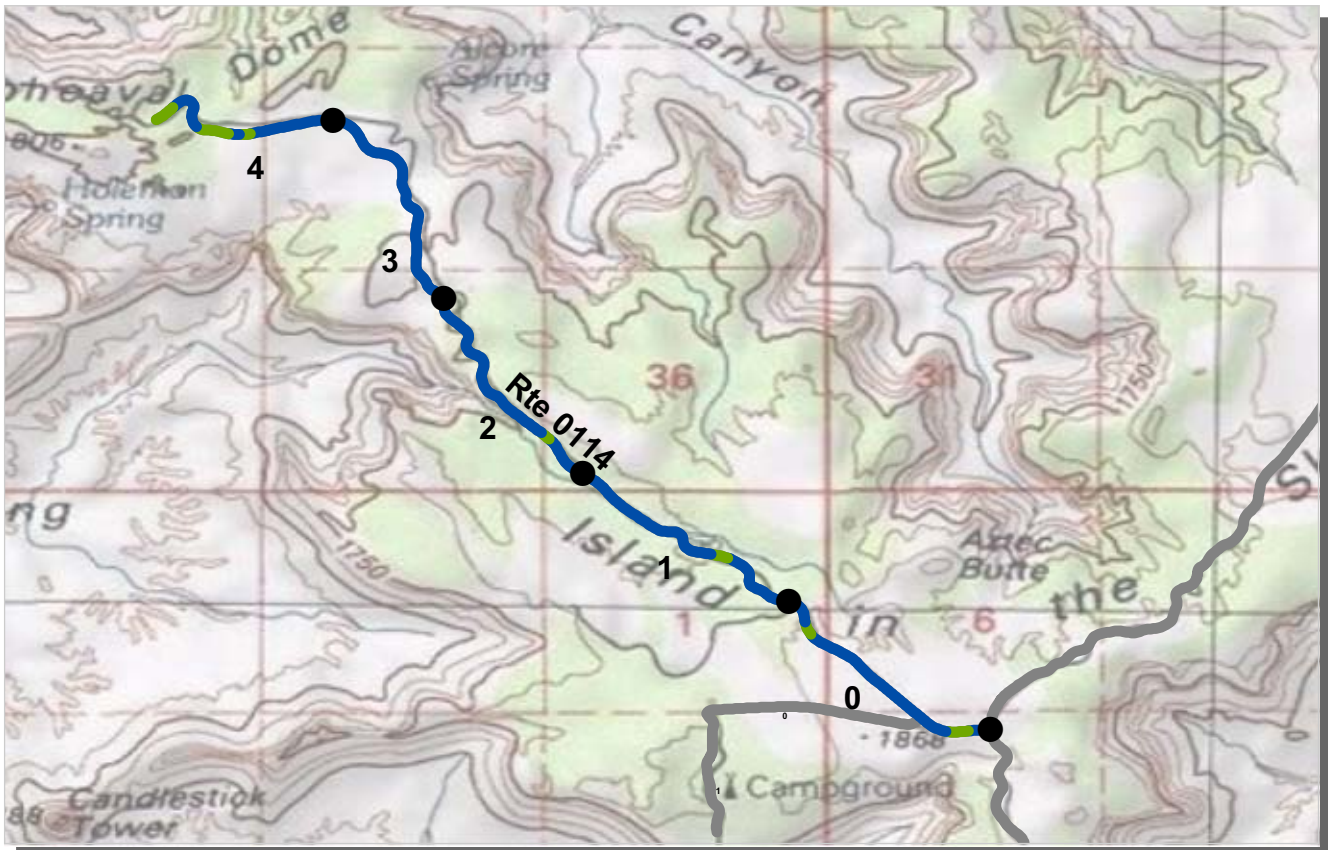
**ROUTE: 0114 UPHEAVAL DOME ROAD**

<i>Section Number</i>	0	1	2	3	4
<i>Section Length (mi)</i>	1.00	1.00	1.00	1.00	0.78
<i>Cross Section Information</i>					
Number of Lanes	2	2	2	2	2
Paved Width (ft)	26	27	26	27	27
Lane Width (ft)	11	10	10	10	10
<i>Roadway Condition Information</i>					
SCR (Surface Condition Rating)	98	97	97	98	96
PCR (Pavement Condition Rating)	99	98	98	99	98
<i>Distress Index Values</i>					
Structural Crack Index	99	98	99	99	96
Transverse Cracking Index	98	97	97	98	98
Patching Index	100	100	100	100	100
Rutting Index	98	99	99	99	98
Roughness Condition Index (RCI)	100	100	100	100	100

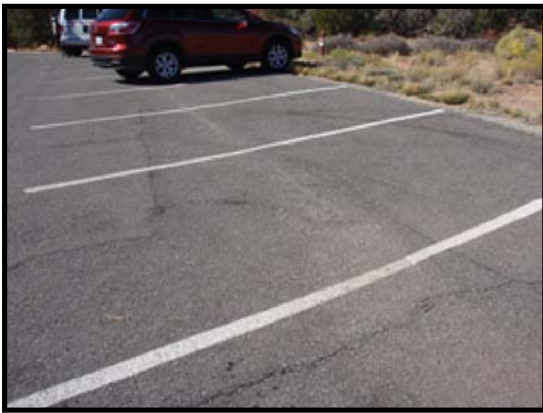
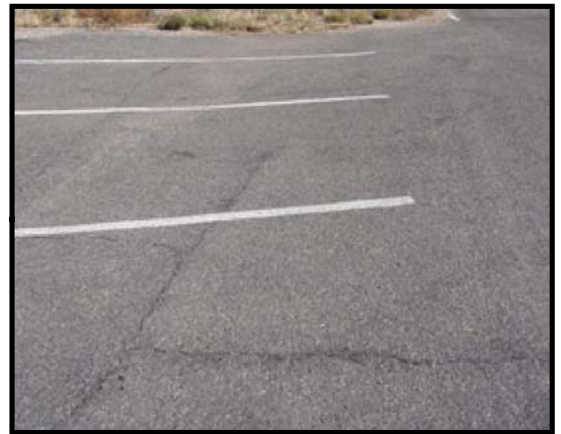
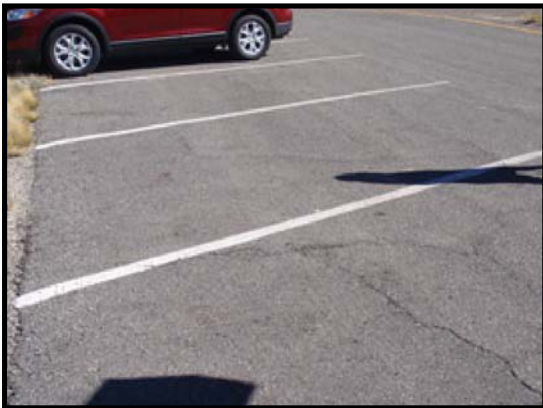
Route Number	Public / NonPublic	Date Visited	Area (sq ft)	Lane Miles *	Surface Type
0925	PUBLIC	10/14/2011	2,520	0.04	AS
Culverts	Drop Inlets	Gates	Curb & Gutter	Curb	PCR
0	0	0	NO CURB AND GUTTER	NO CURB	POOR/45
