Federal Lands Highway Road Inventory Program

Road Inventory and Condition Assessment

Capitol Reef National Park CARE

Cycle 5 Report

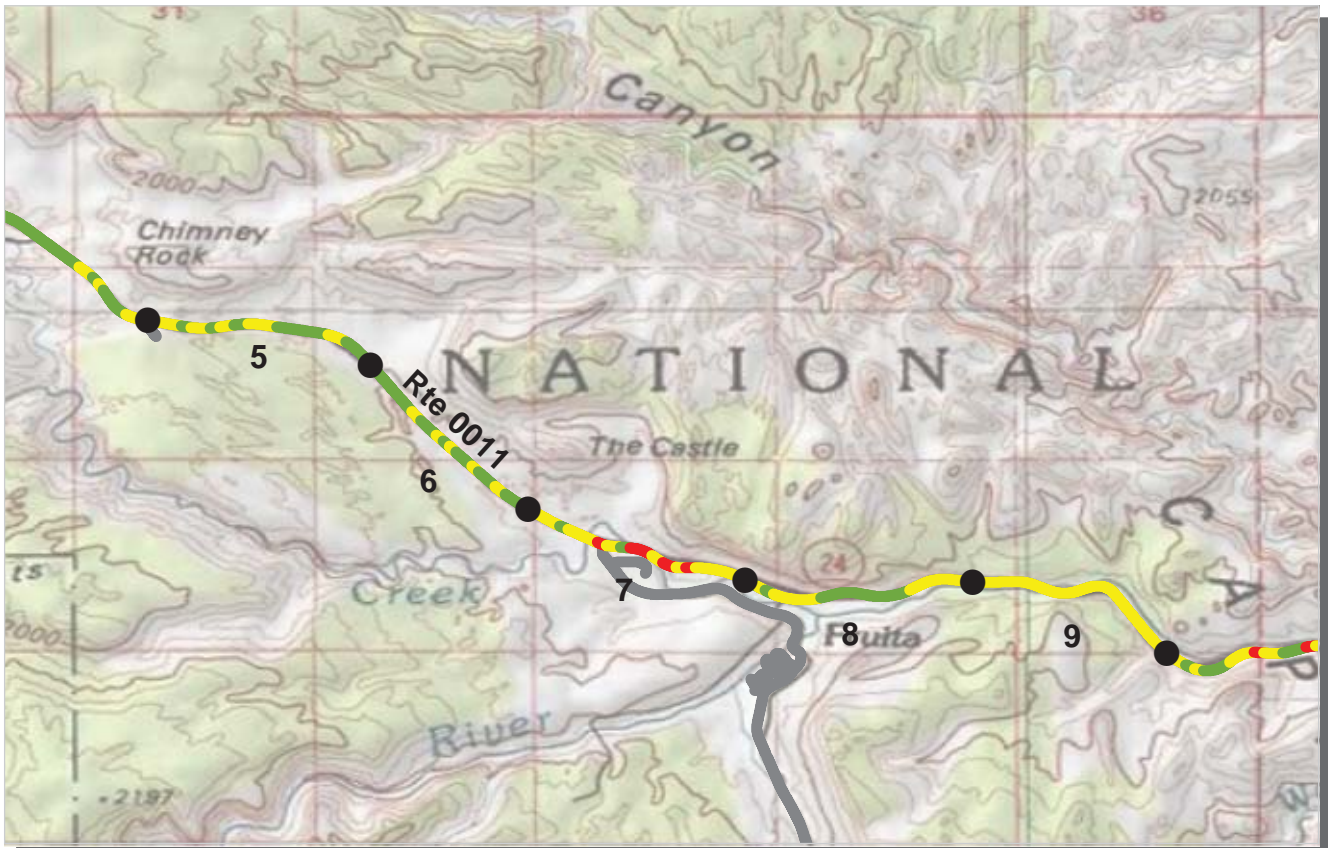
ROUTE: 0011 STATE HIGHWAY 24

<i>Section Number</i>	5	6	7	8	9
<i>Section Length (mi)</i>	1.00	1.00	1.00	1.00	1.00
<i>Cross Section Information</i>					
Number of Lanes	2	2	2	2	2
Paved Width (ft)	24	23	31	25	30
Lane Width (ft)	10	10	11	11	11
<i>Roadway Condition Information</i>					
SCR (Surface Condition Rating)	85	86	56	82	84
PCR (Pavement Condition Rating)	85	86	64	80	79
<i>Distress Index Values</i>					
Structural Crack Index	92	93	56	96	95
Transverse Cracking Index	85	86	81	82	84
Patching Index	100	100	100	100	100
Rutting Index	97	97	93	95	95
Roughness Condition Index (RCI)	84	87	75	78	71

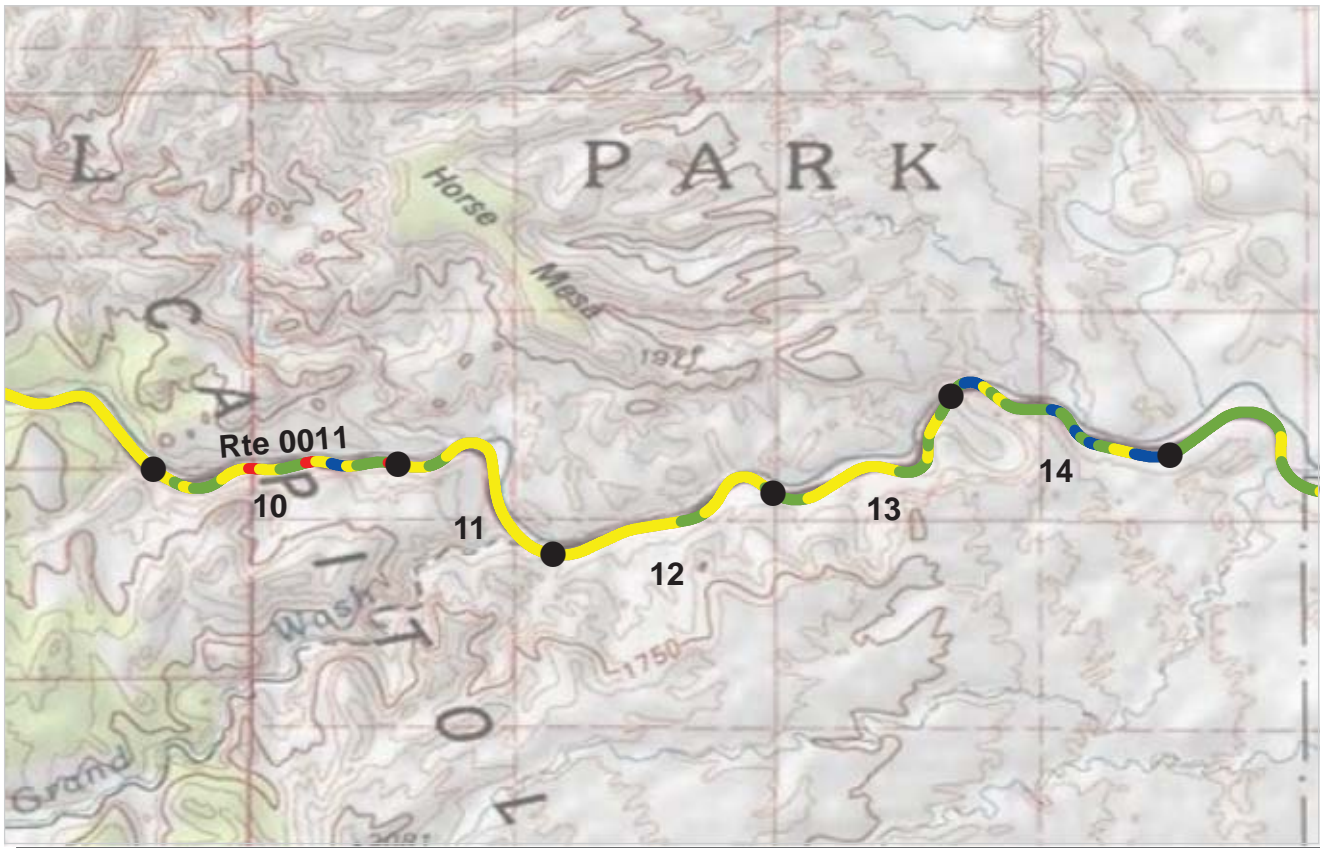
ROUTE: 0011 STATE HIGHWAY 24

<i>Section Number</i>	10	11	12	13	14
<i>Section Length (mi)</i>	1.00	1.00	1.00	1.00	1.00
<i>Cross Section Information</i>					
Number of Lanes	2	2	2	2	2
Paved Width (ft)	27	27	28	29	29
Lane Width (ft)	10	11	10	11	11
<i>Roadway Condition Information</i>					
SCR (Surface Condition Rating)	87	84	82	89	95
PCR (Pavement Condition Rating)	81	79	76	85	90
<i>Distress Index Values</i>					
Structural Crack Index	89	91	90	95	100
Transverse Cracking Index	87	84	82	89	99
Patching Index	100	100	100	100	100
Rutting Index	94	95	96	91	95
Roughness Condition Index (RCI)	72	71	68	80	82

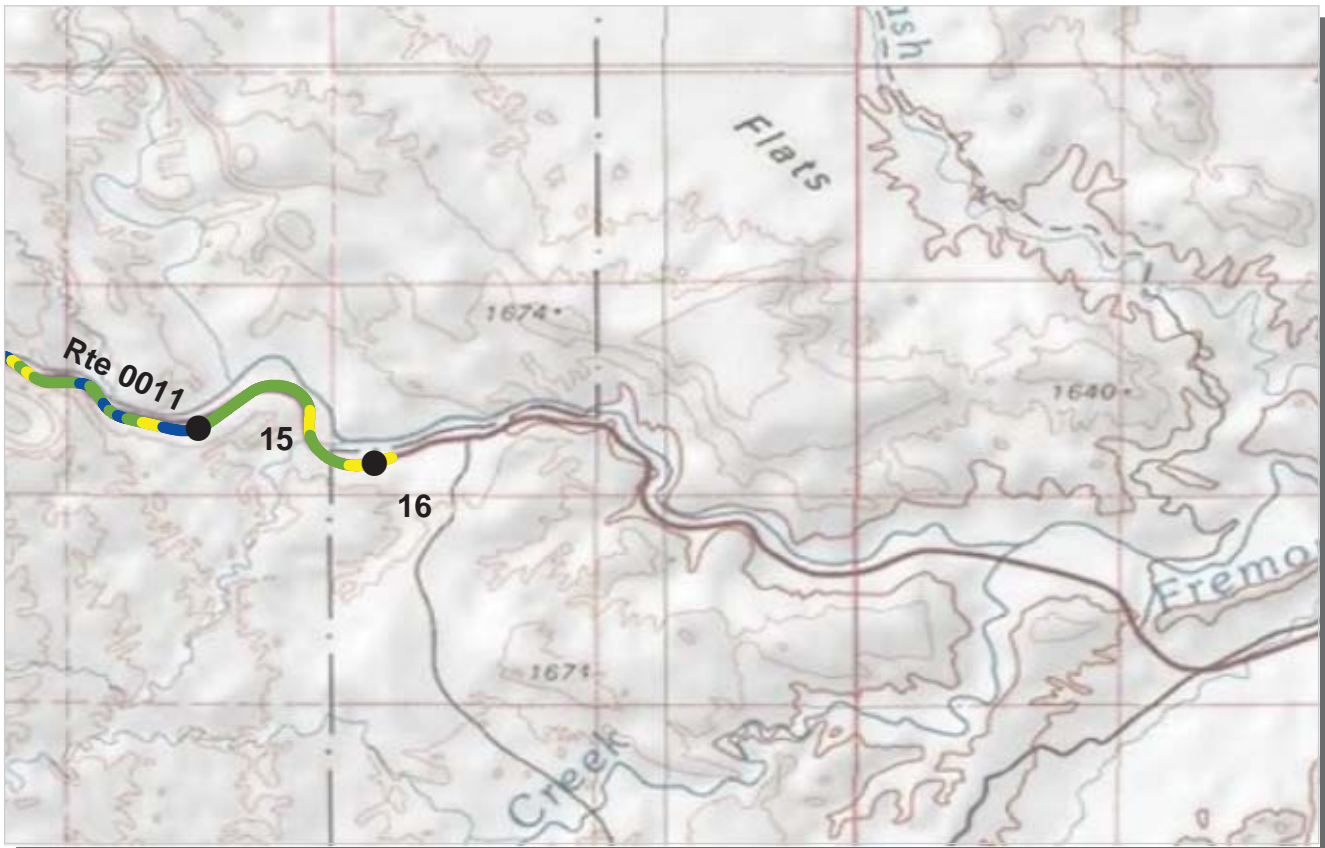
ROUTE: 0011 STATE HIGHWAY 24

<i>Section Number</i>	15	16			
<i>Section Length (mi)</i>	1.00	0.07			
<i>Cross Section Information</i>					
Number of Lanes	2	2			
Paved Width (ft)	28	28			
Lane Width (ft)	11	11			
<i>Roadway Condition Information</i>					
SCR (Surface Condition Rating)	96	96			
PCR (Pavement Condition Rating)	87	75			
<i>Distress Index Values</i>					
Structural Crack Index	100	100			
Transverse Cracking Index	99	100			
Patching Index	100	100			
Rutting Index	96	96			
Roughness Condition Index (RCI)	74	43

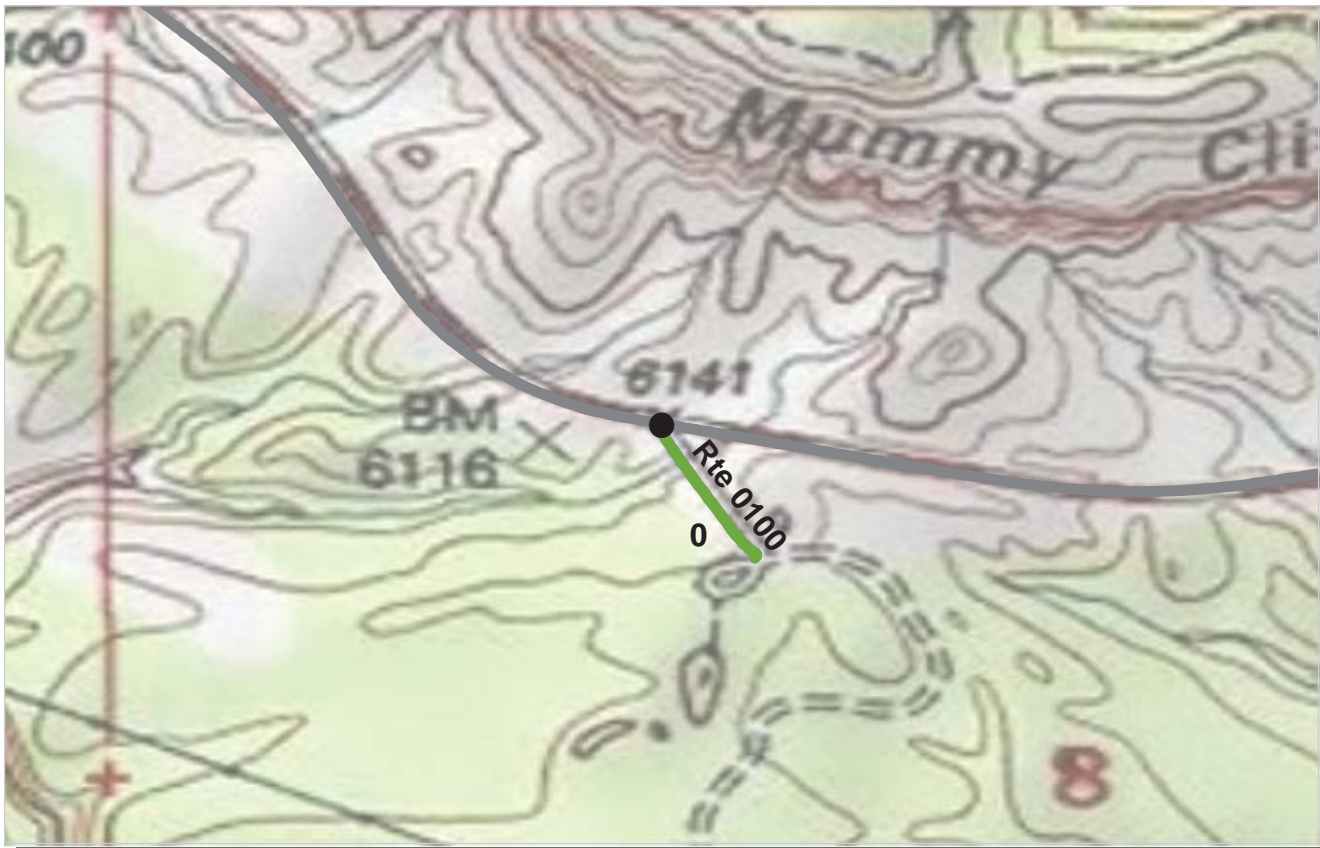
ROUTE: 0100 GOOSENECKS ROAD

Section Number	0				
Section Length (mi)	0.10				
Cross Section Information					
Number of Lanes	2				
Paved Width (ft)	19				
Lane Width (ft)	10				
Roadway Condition Information					
SCR (Surface Condition Rating)	91				
PCR (Pavement Condition Rating)	91				
Distress Index Values					
Structural Crack Index	91				
Transverse Cracking Index	95				
Patching Index	100				
Rutting Index	92				
Roughness Condition Index (RCI)	NC

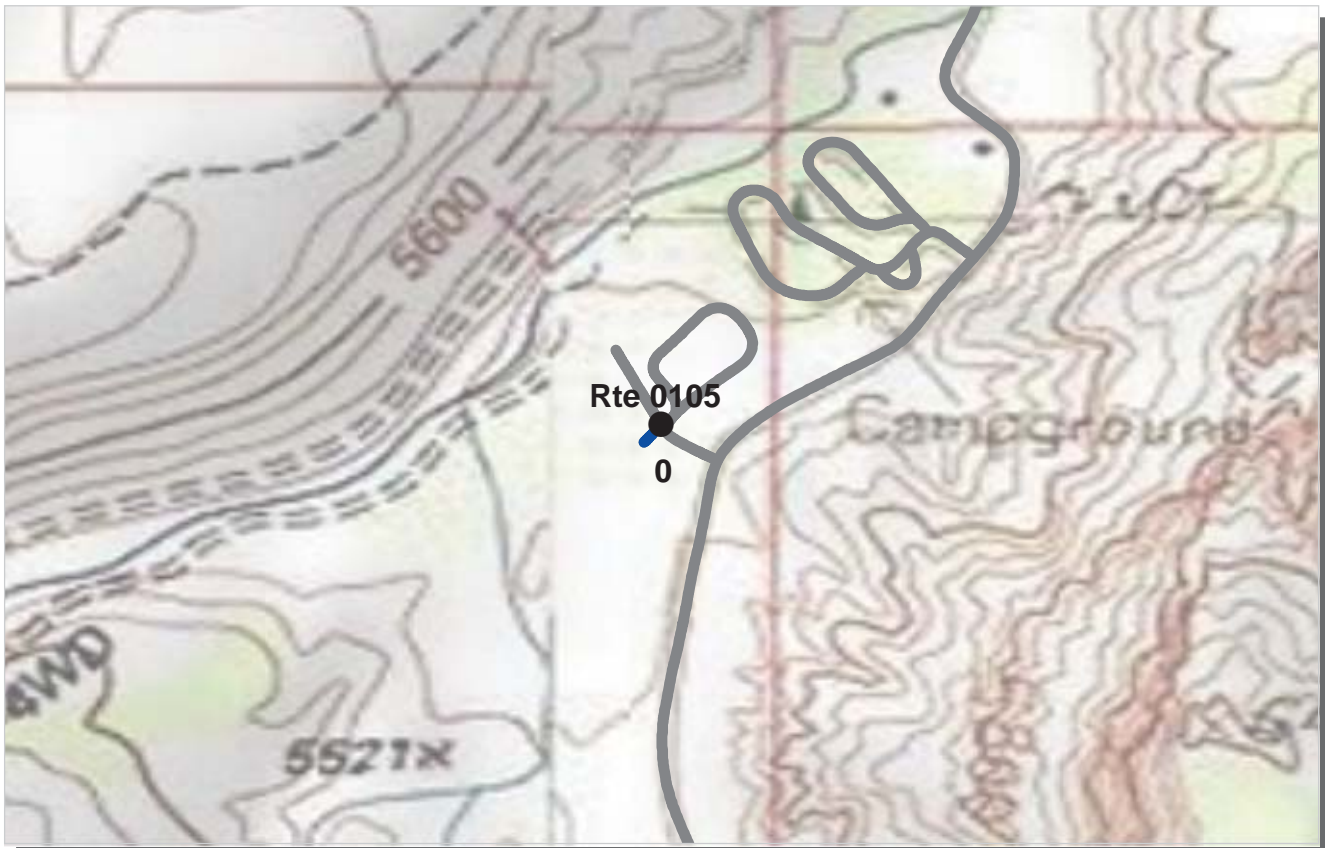
ROUTE: 0105 GROUP CAMP SITE ACCESS ROAD

Section Number	0				
Section Length (mi)	0.02				
Cross Section Information					
Number of Lanes	2				
Paved Width (ft)	21				
Lane Width (ft)	11				
Roadway Condition Information					
SCR (Surface Condition Rating)	99				
PCR (Pavement Condition Rating)	99				
Distress Index Values					
Structural Crack Index	100				
Transverse Cracking Index	100				
Patching Index	100				
Rutting Index	99				
Roughness Condition Index (RCI)	NC

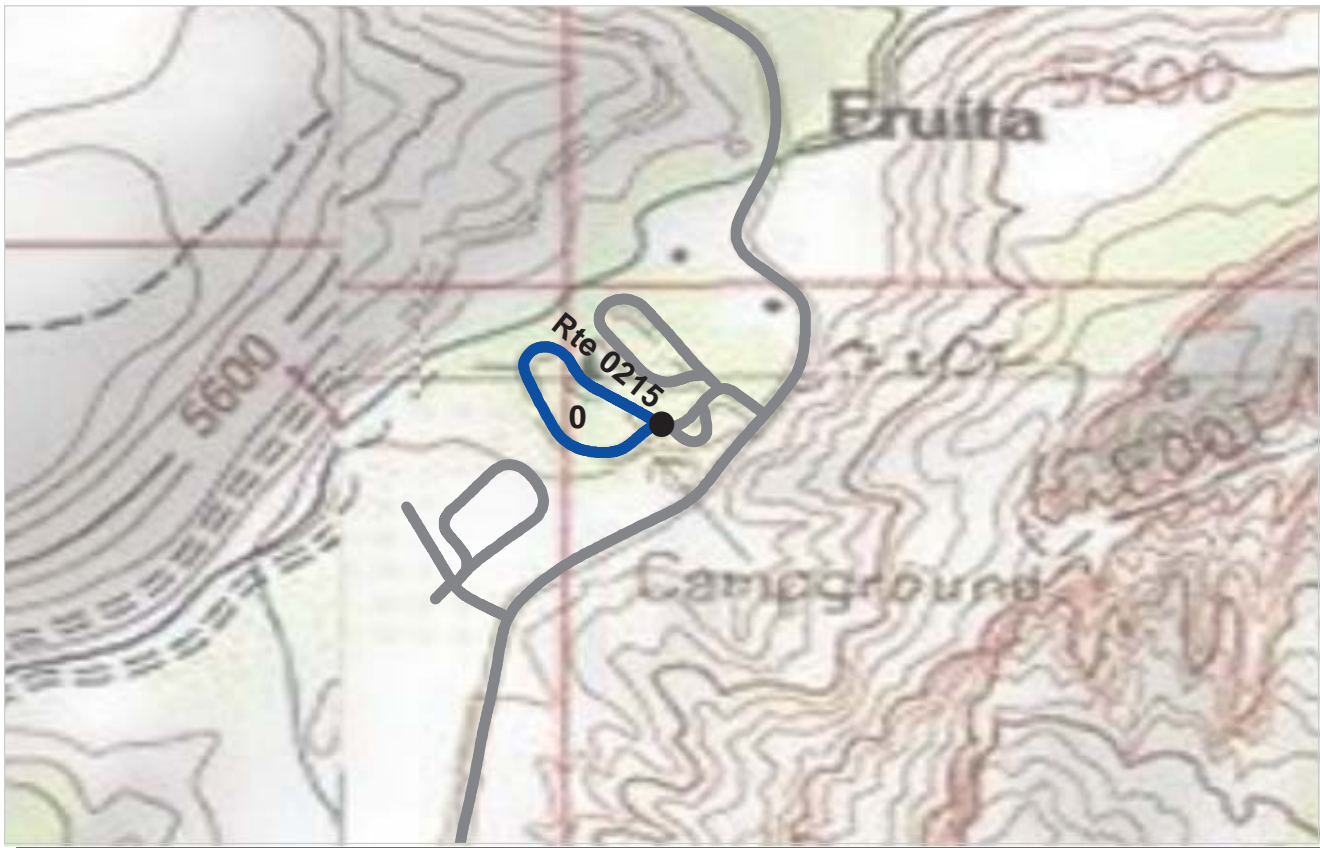
ROUTE: 0215 CAMPGROUND LOOP B

Section Number	0				
Section Length (mi)	0.21				
Cross Section Information					
Number of Lanes	1				
Paved Width (ft)	13				
Lane Width (ft)	13				
Roadway Condition Information					
SCR (Surface Condition Rating)	98				
PCR (Pavement Condition Rating)	98				
Distress Index Values					
Structural Crack Index	100				
Transverse Cracking Index	100				
Patching Index	100				
Rutting Index	98				
Roughness Condition Index (RCI)	NC

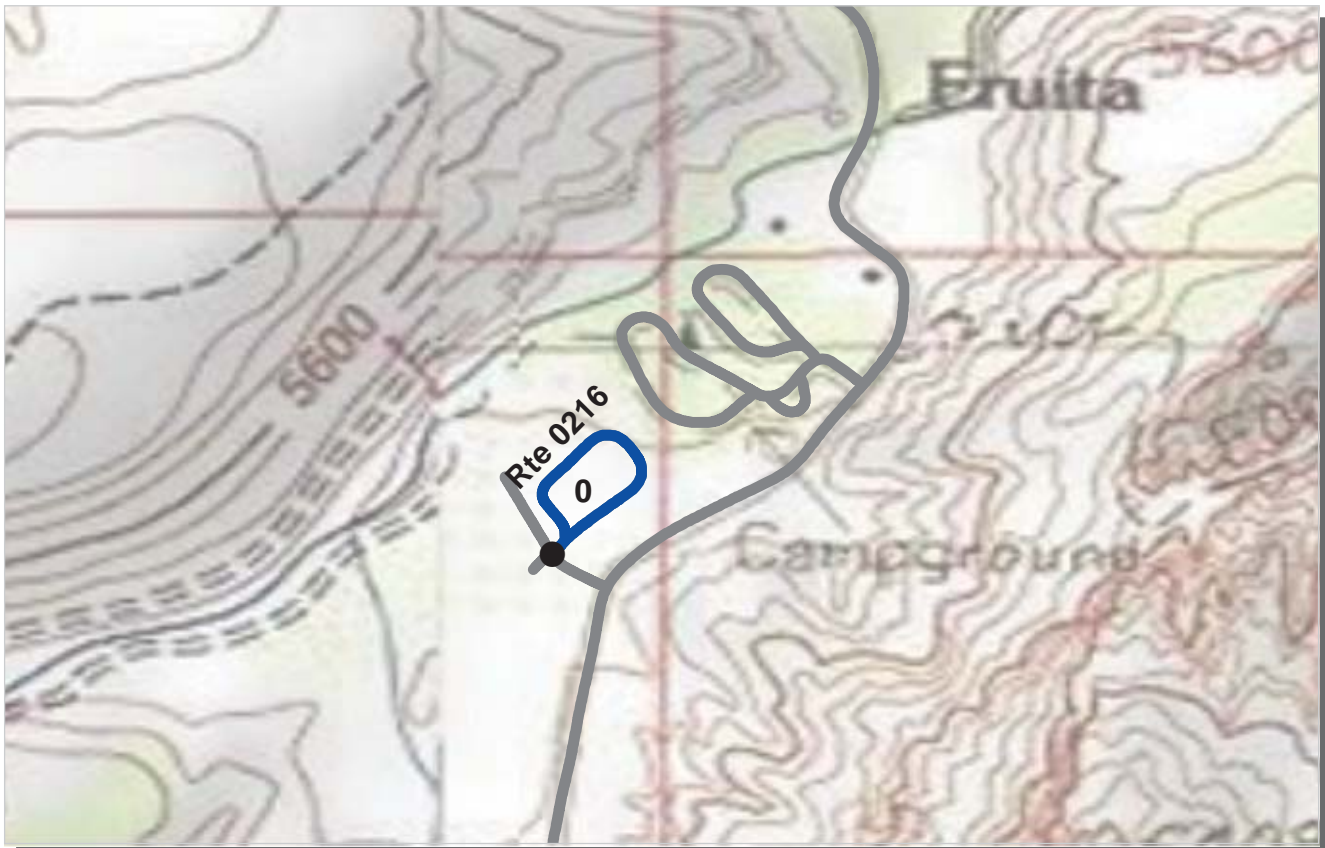
ROUTE: 0216 CAMPGROUND LOOP C

Section Number	0				
Section Length (mi)	0.18				
Cross Section Information					
Number of Lanes	1				
Paved Width (ft)	15				
Lane Width (ft)	15				
Roadway Condition Information					
SCR (Surface Condition Rating)	99				
PCR (Pavement Condition Rating)	99				
Distress Index Values					
Structural Crack Index	100				
Transverse Cracking Index	100				
Patching Index	100				
Rutting Index	99				
Roughness Condition Index (RCI)	NC

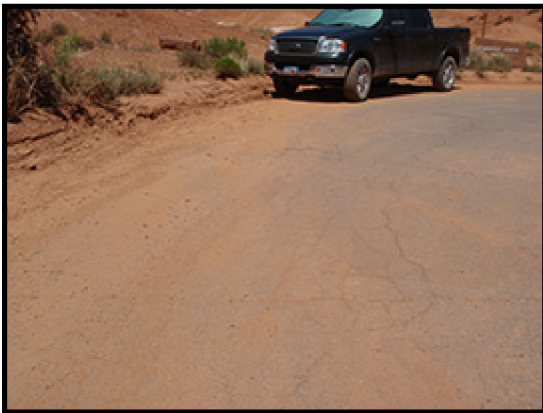
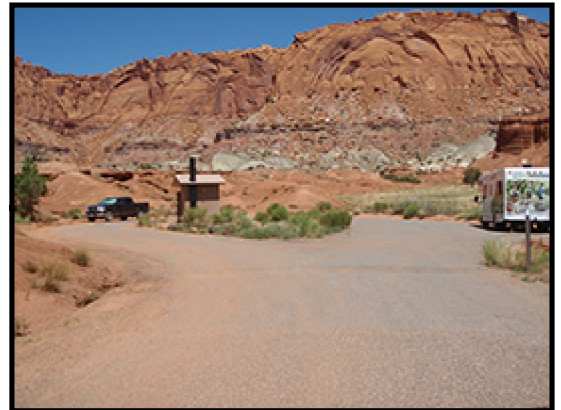
Route Number	Public / NonPublic	Date Visited	Area (sq ft)	Lane Miles *	Surface Type
0900	PUBLIC	8/11/2011	7,968	0.14	AS
Culverts	Drop Inlets	Gates	Curb & Gutter	Curb	PCR
1	0	0	NO CURB AND GUTTER	NO CURB	POOR/45

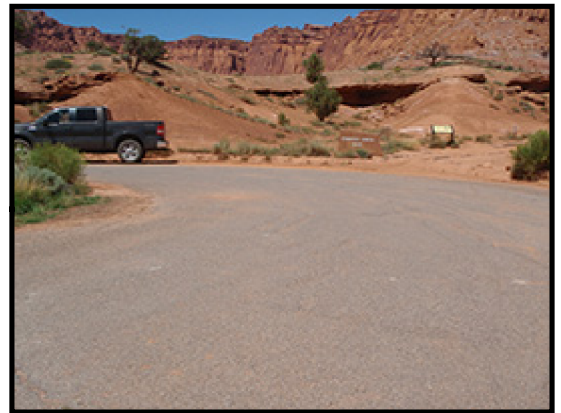
Route 0901

Route Number	Public / NonPublic	Date Visited	Area (sq ft)	Lane Miles *	Surface Type
0901	PUBLIC	8/11/2011	9,543	0.16	AS
Culverts	Drop Inlets	Gates	Curb & Gutter	Curb	PCR
0	0	0	NO CURB AND GUTTER	NO CURB	FAIR/73

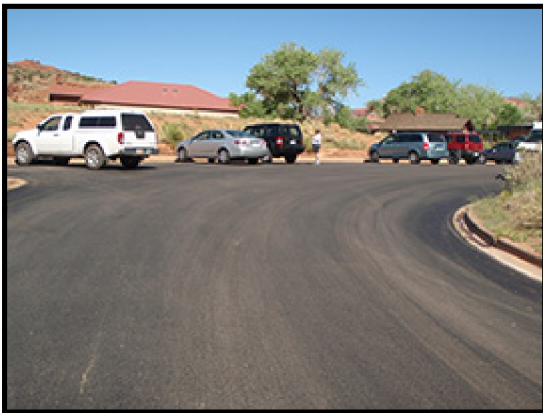
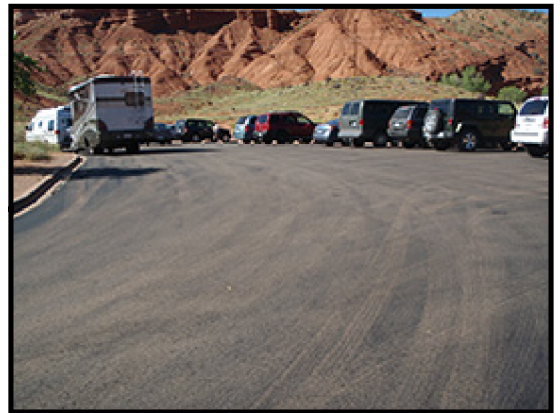
Route 0902

Route Number	Public / NonPublic	Date Visited	Area (sq ft)	Lane Miles *	Surface Type
0902	PUBLIC	8/11/2011	14,277	0.25	AS
Culverts	Drop Inlets	Gates	Curb & Gutter	Curb	PCR
0	0	0	CONCRETE CURB AND GUTTER	NO CURB	GOOD/90

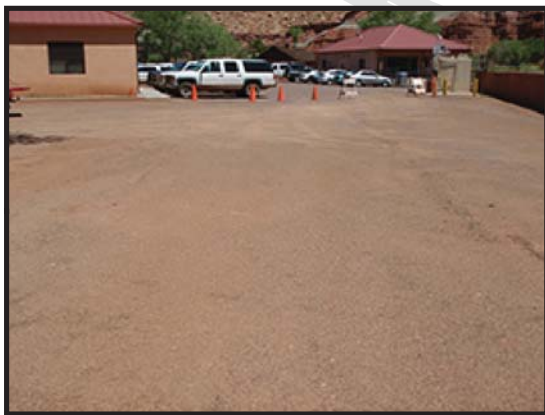
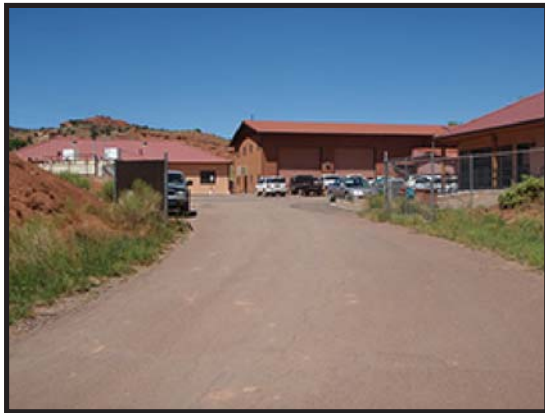
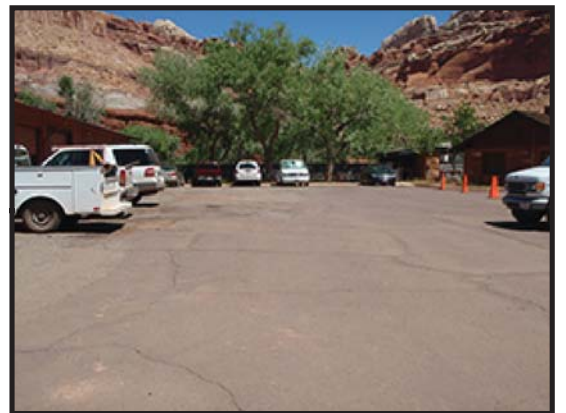
Route 0903

Route Number	Public / NonPublic	Date Visited	Area (sq ft)	Lane Miles *	Surface Type
0903	NONPUBLIC	8/11/2011	41,109	0.71	AS
Culverts	Drop Inlets	Gates	Curb & Gutter	Curb	PCR
0	1	1	CONCRETE CURB AND GUTTER	CONCRETE CURB	POOR/45

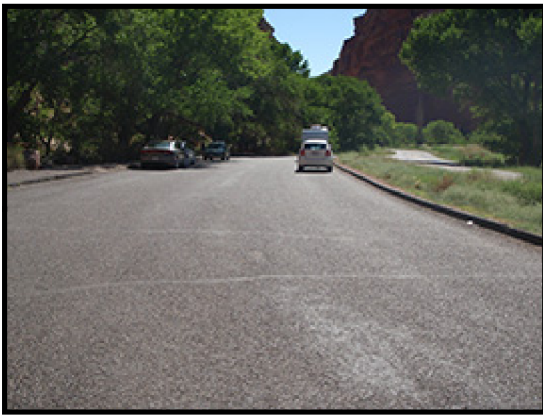
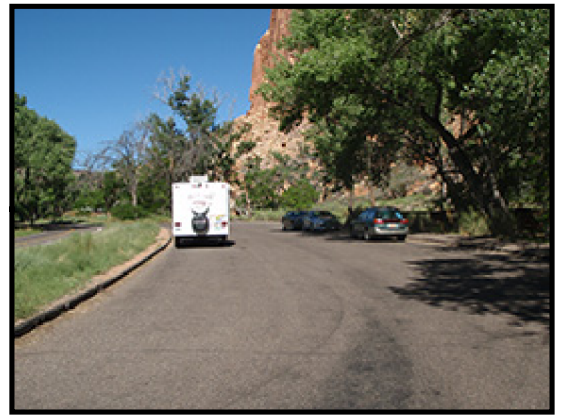
Route 0904

Route Number	Public / NonPublic	Date Visited	Area (sq ft)	Lane Miles *	Surface Type
0904	PUBLIC	8/11/2011	11,367	0.20	AS
Culverts	Drop Inlets	Gates	Curb & Gutter	Curb	PCR
0	0	0	NO CURB AND GUTTER	ASPHALT CURB	FAIR/73

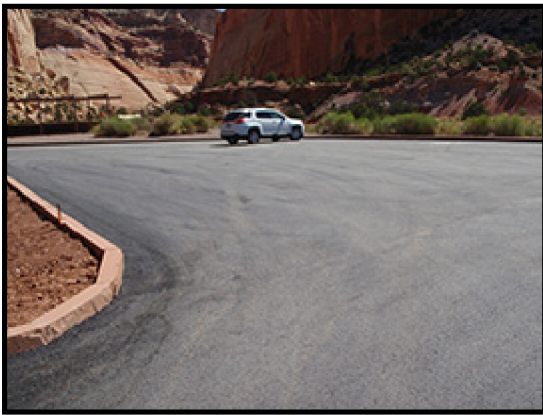
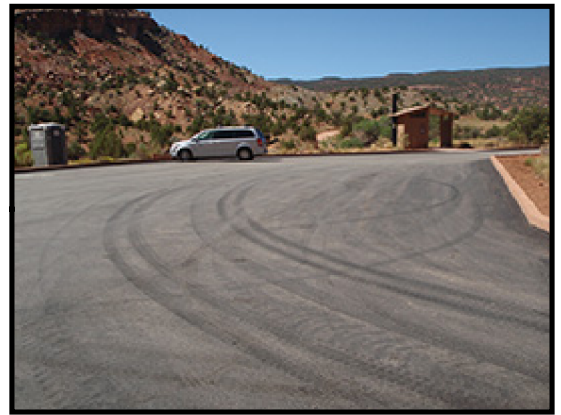
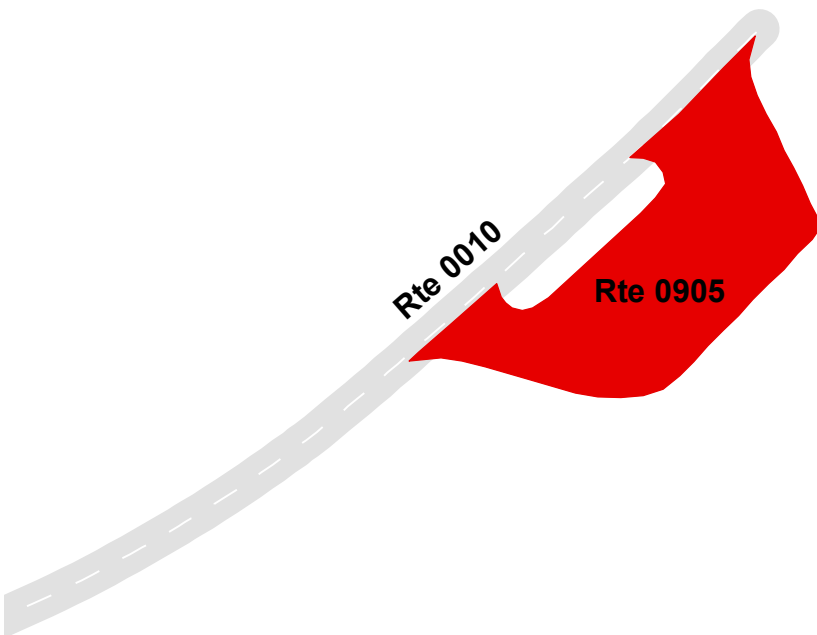
Route 0905

Route Number	Public / NonPublic	Date Visited	Area (sq ft)	Lane Miles *	Surface Type
0905	PUBLIC	8/11/2011	8,259	0.14	AS
Culverts	Drop Inlets	Gates	Curb & Gutter	Curb	PCR
0	0	0	NO CURB AND GUTTER	STONE CURB	EXCELLENT/97

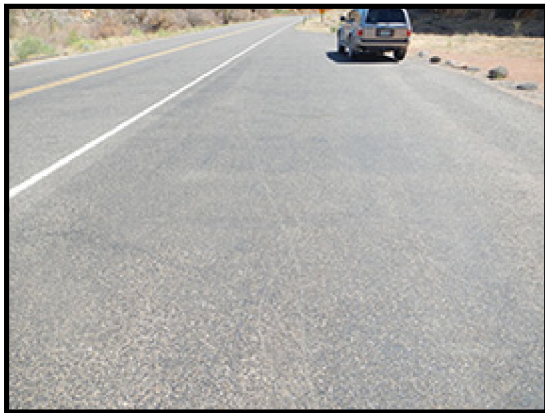
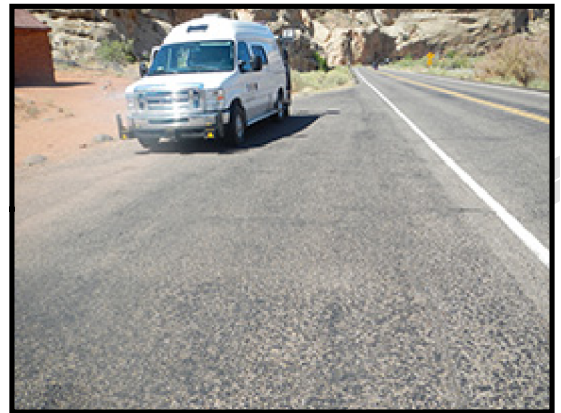
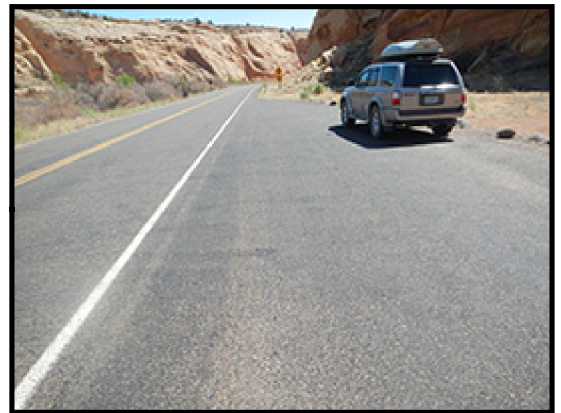
Route 0913

Route Number	Public / NonPublic	Date Visited	Area (sq ft)	Lane Miles *	Surface Type
0913	PUBLIC	6/16/2012	3,067	0.05	AS
Culverts	Drop Inlets	Gates	Curb & Gutter	Curb	PCR
0	0	0	NO CURB AND GUTTER	NO CURB	GOOD/90

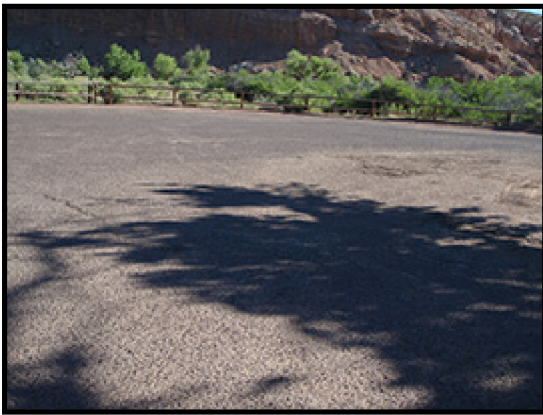
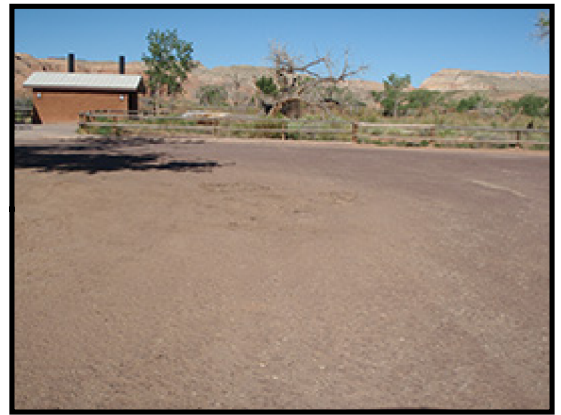
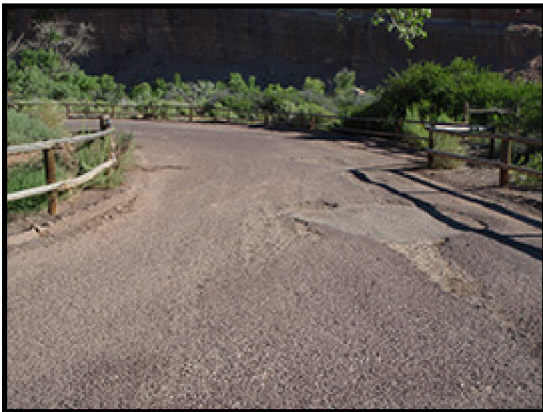
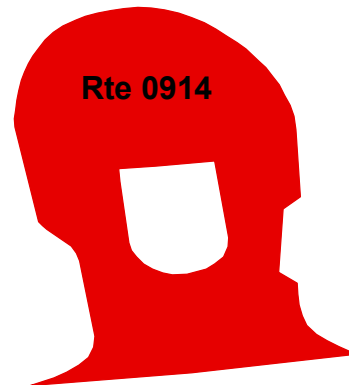
Route 0914

Route Number	Public / NonPublic	Date Visited	Area (sq ft)	Lane Miles *	Surface Type
0914	PUBLIC	8/11/2011	13,286	0.23	AS
Culverts	Drop Inlets	Gates	Curb & Gutter	Curb	PCR
0	0	0	NO CURB AND GUTTER	CONCRETE CURB	POOR/45

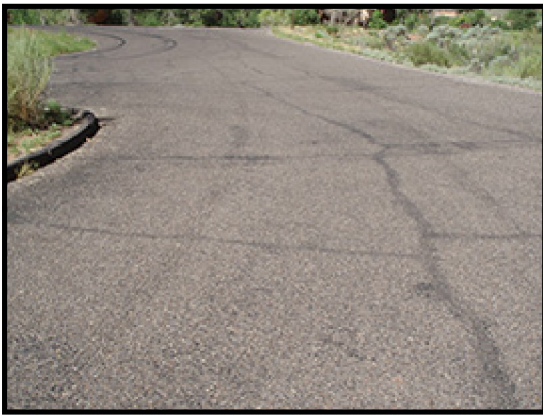
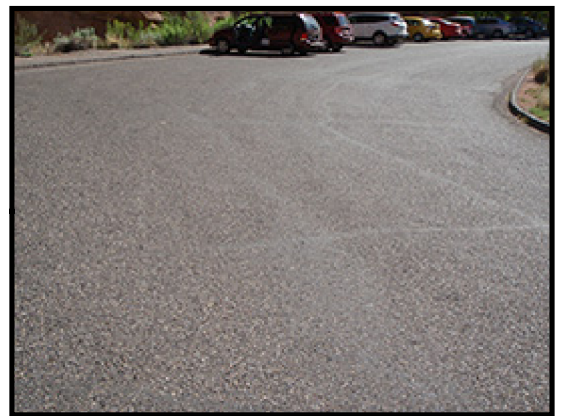
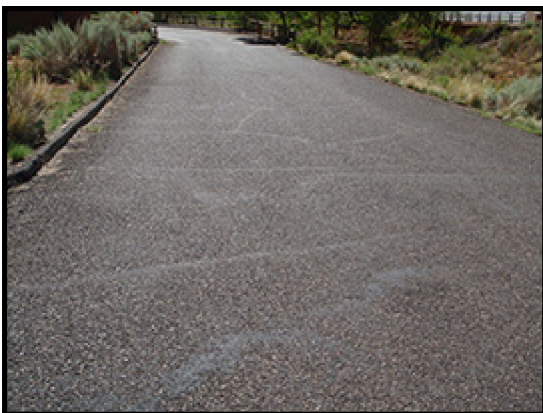
Route 0915

Route Number	Public / NonPublic	Date Visited	Area (sq ft)	Lane Miles *	Surface Type
0915	PUBLIC	8/11/2011	19,022	0.33	AS
Culverts	Drop Inlets	Gates	Curb & Gutter	Curb	PCR
0	0	0	NO CURB AND GUTTER	ASPHALT CURB	FAIR/73

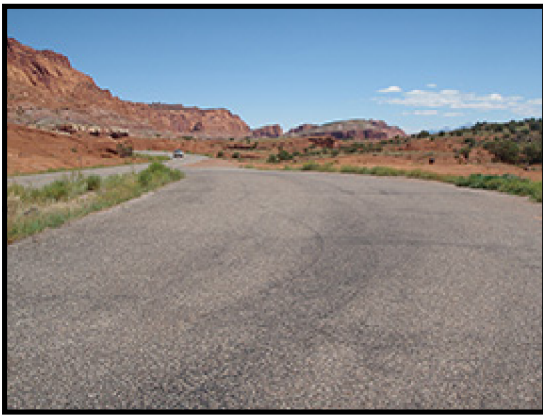
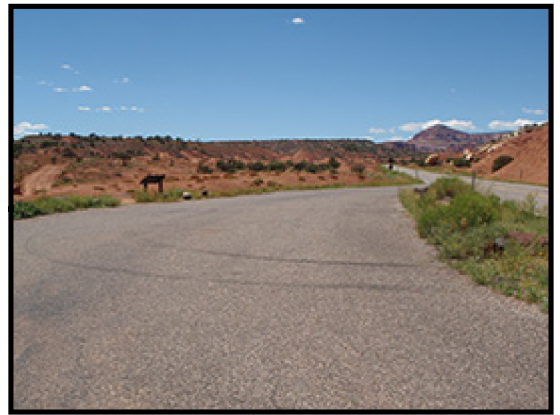
Route 0916

Route Number	Public / NonPublic	Date Visited	Area (sq ft)	Lane Miles *	Surface Type
0916	PUBLIC	8/11/2011	5,484	0.09	AS
Culverts	Drop Inlets	Gates	Curb & Gutter	Curb	PCR
0	0	0	NO CURB AND GUTTER	NO CURB	FAIR/73

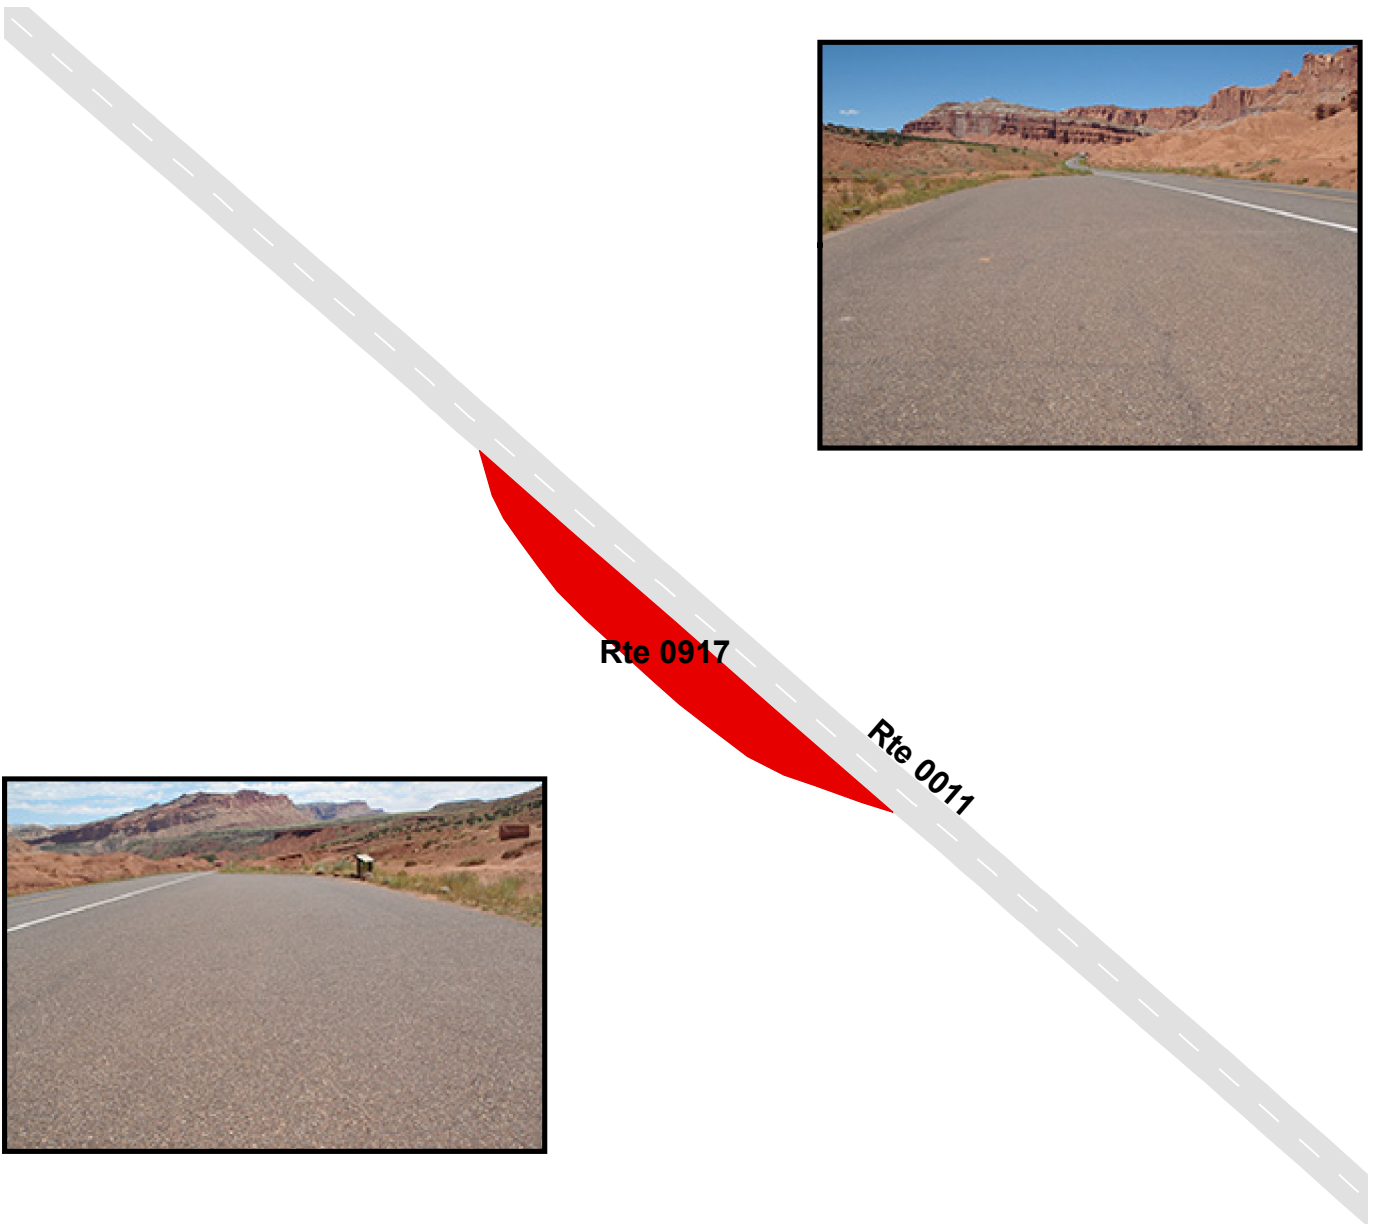
Route 0917

Route Number	Public / NonPublic	Date Visited	Area (sq ft)	Lane Miles *	Surface Type
0917	PUBLIC	8/11/2011	6,927	0.12	AS
Culverts	Drop Inlets	Gates	Curb & Gutter	Curb	PCR
0	0	0	NO CURB AND GUTTER	NO CURB	FAIR/73

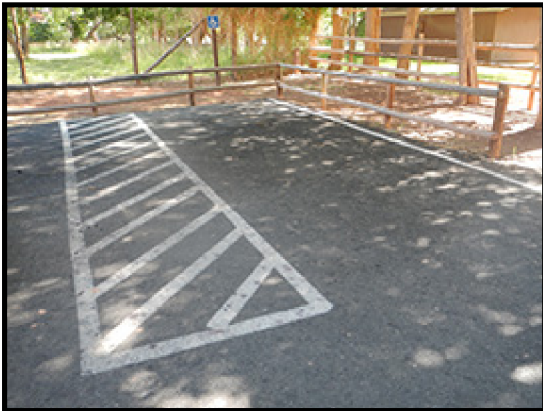
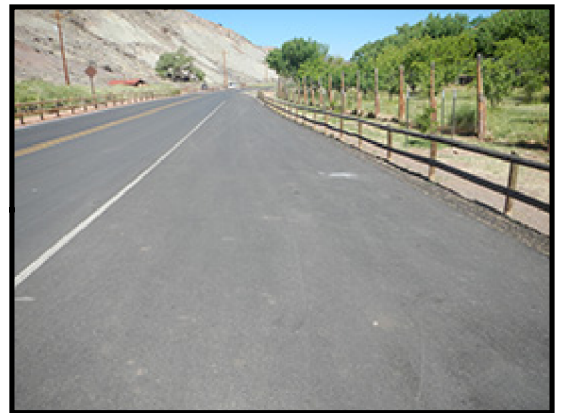
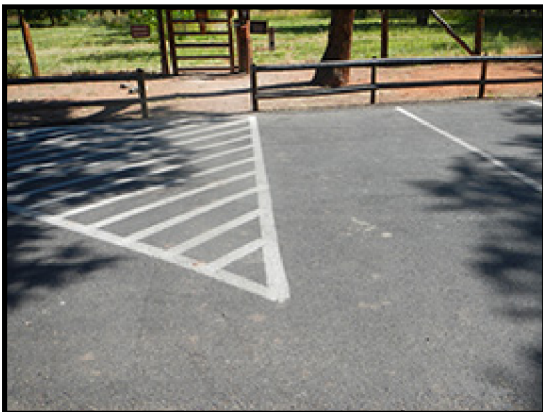
Route 0920

Route Number	Public / NonPublic	Date Visited	Area (sq ft)	Lane Miles *	Surface Type
0920	PUBLIC	6/16/2012	5,957	0.10	AS
Culverts	Drop Inlets	Gates	Curb & Gutter	Curb	PCR
0	0	0	NO CURB AND GUTTER	NO CURB	EXCELLENT/97

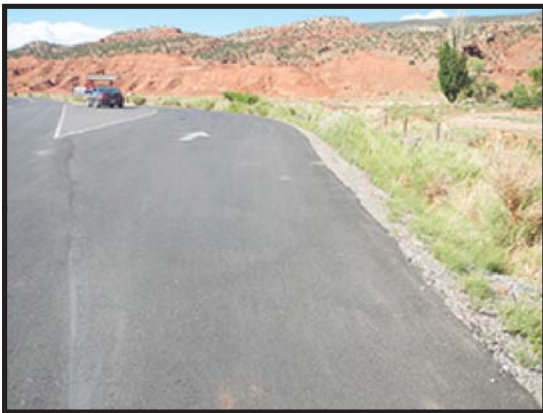
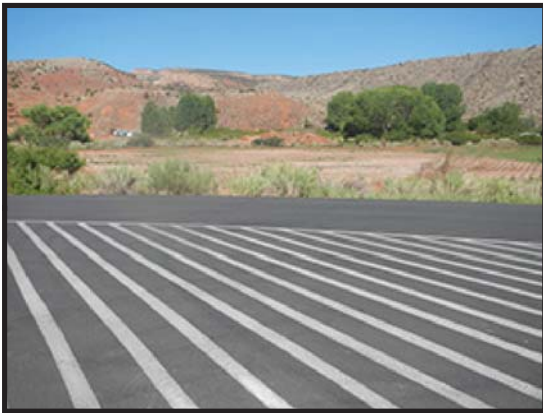
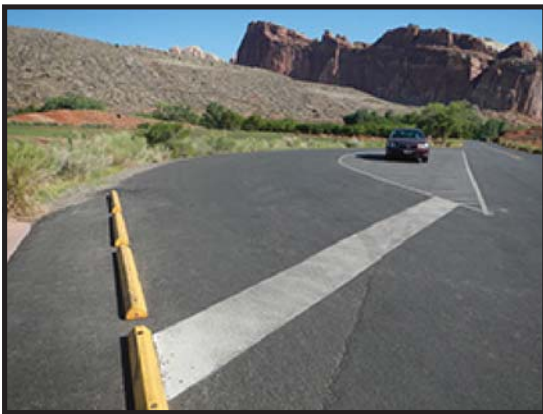
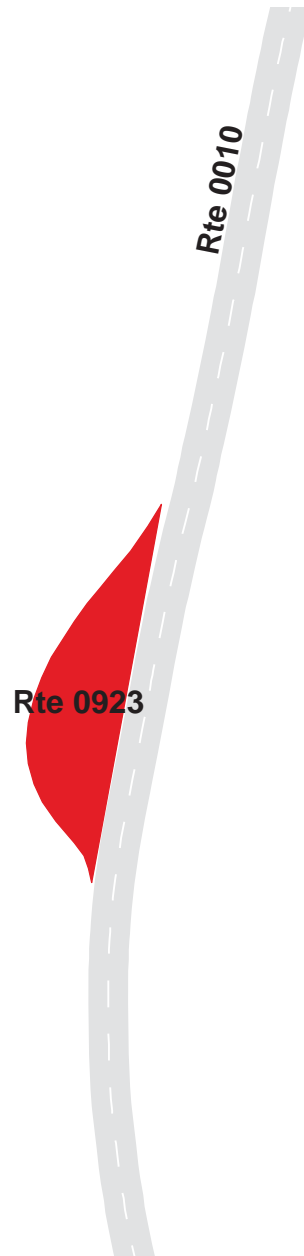
Route Number	Public / NonPublic	Date Visited	Area (sq ft)	Lane Miles *	Surface Type
0923	PUBLIC	6/16/2012	6,147	0.11	AS
Culverts	Drop Inlets	Gates	Curb & Gutter	Curb	PCR
0	0	0	NO CURB AND GUTTER	NO CURB	EXCELLENT/97

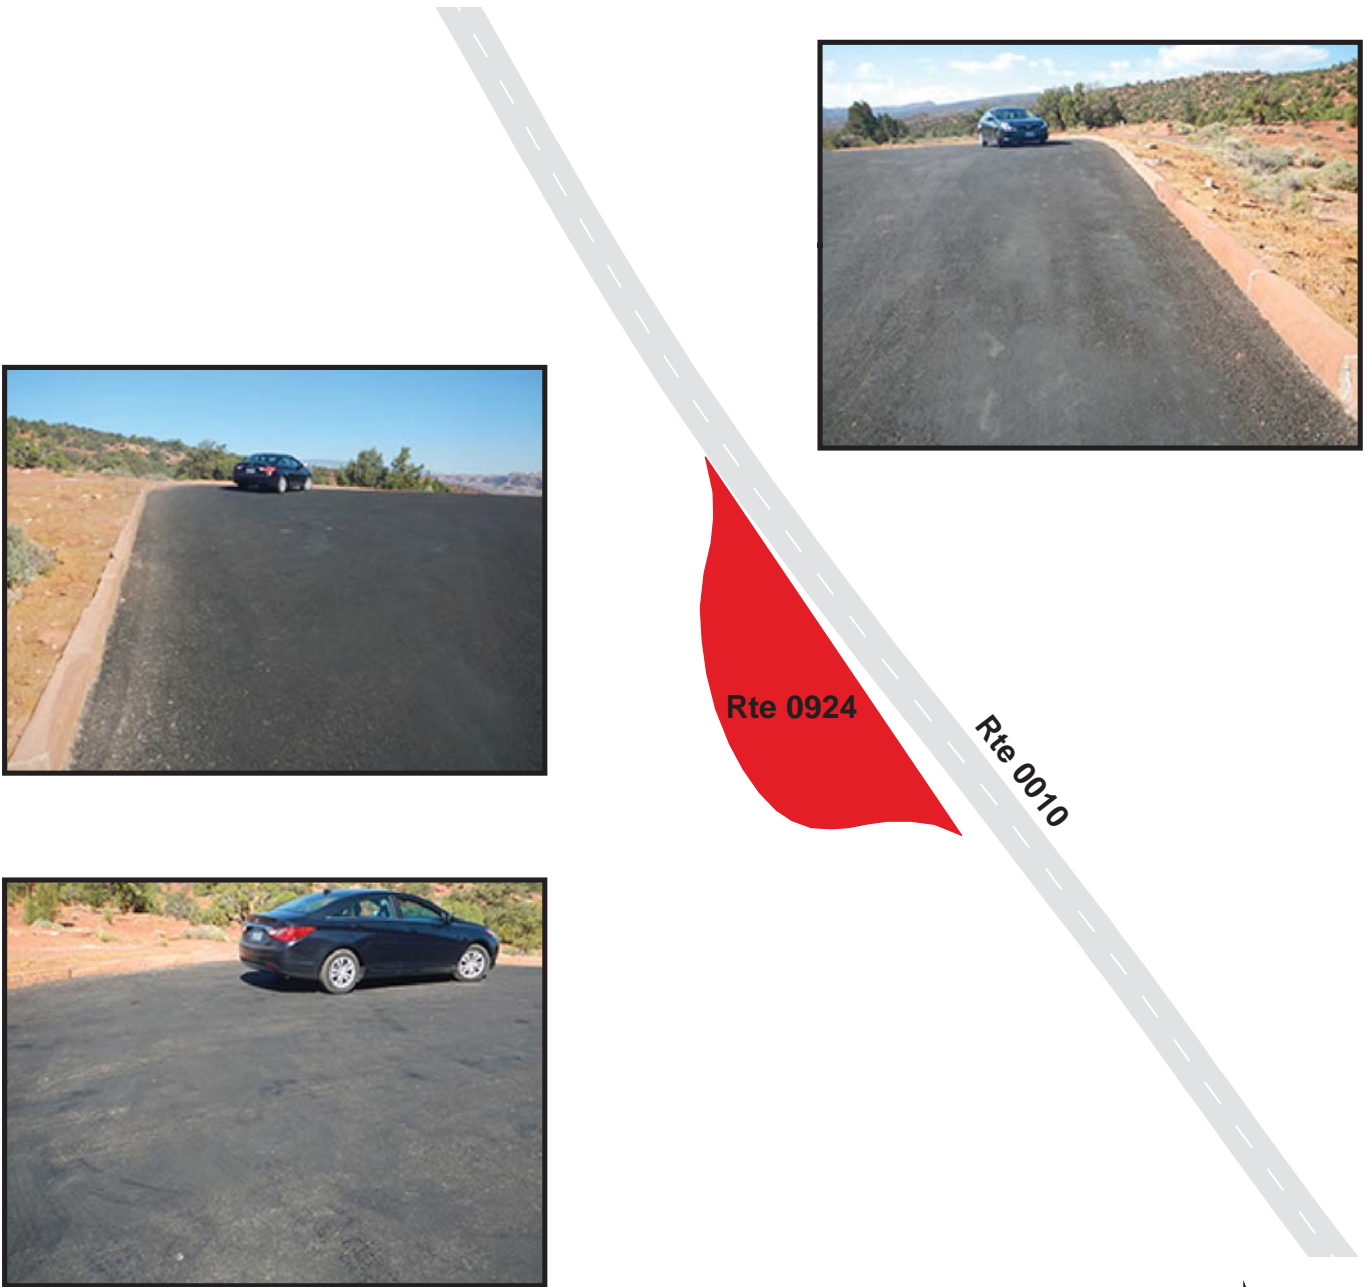
Route 0924

Route Number	Public / NonPublic	Date Visited	Area (sq ft)	Lane Miles *	Surface Type
0924	PUBLIC	6/16/2012	3,041	0.05	AS
Culverts	Drop Inlets	Gates	Curb & Gutter	Curb	PCR
0	0	0	NO CURB AND GUTTER	STONE CURB	GOOD/90

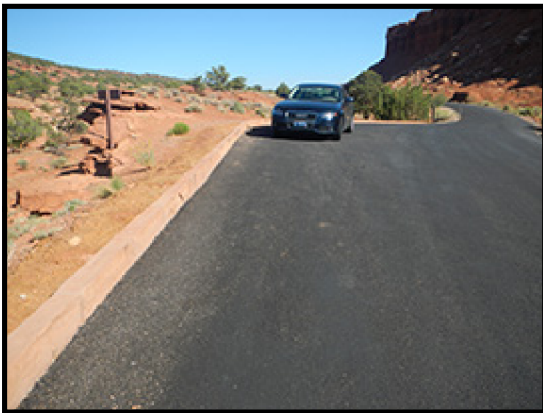
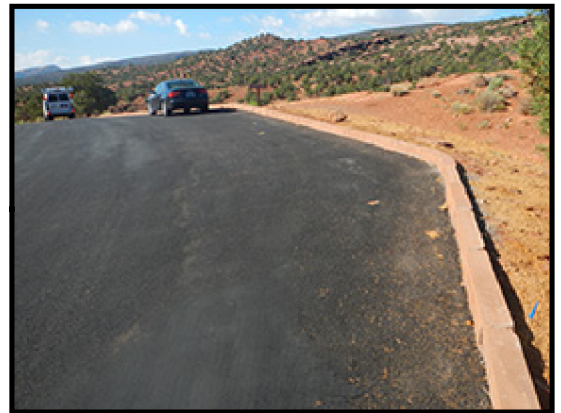
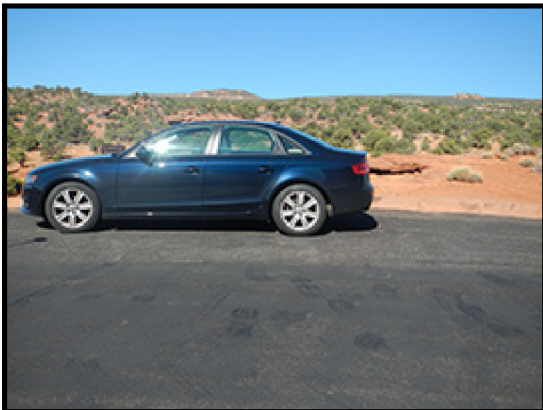
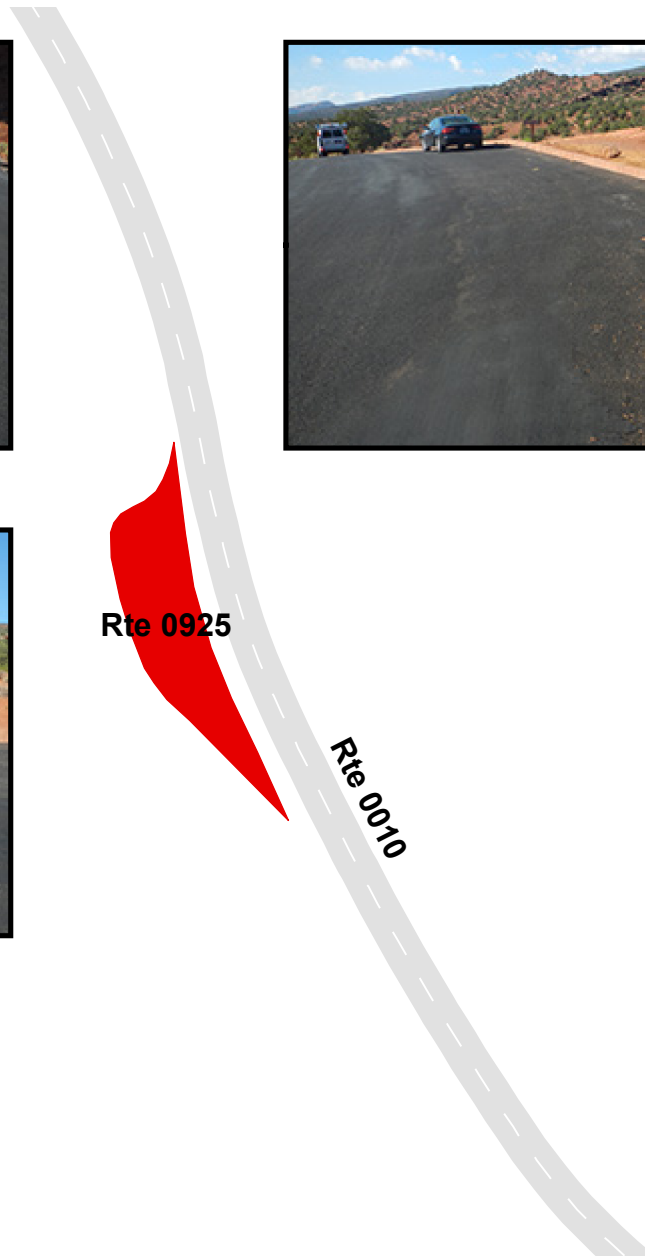
Route 0925

Route Number	Public / NonPublic	Date Visited	Area (sq ft)	Lane Miles *	Surface Type
0925	PUBLIC	6/16/2012	1,720	0.03	AS
Culverts	Drop Inlets	Gates	Curb & Gutter	Curb	PCR
0	0	0	NO CURB AND GUTTER	STONE CURB	GOOD/90

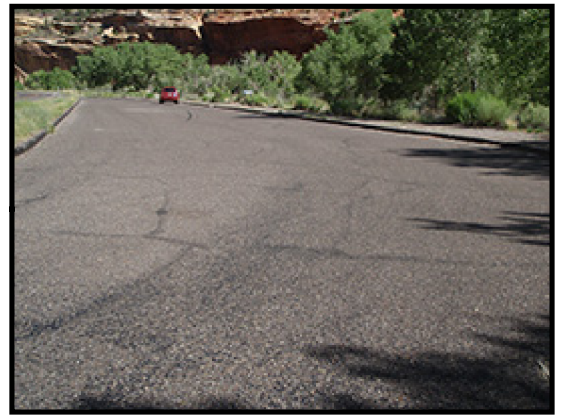
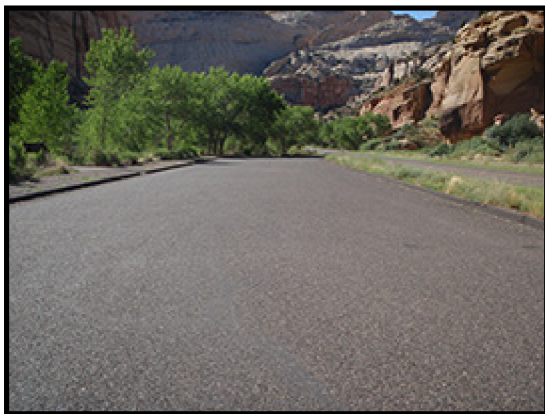
Route Number	Public / NonPublic	Date Visited	Area (sq ft)	Lane Miles *	Surface Type
0930	PUBLIC	8/11/2011	11,202	0.19	AS
Culverts	Drop Inlets	Gates	Curb & Gutter	Curb	PCR
0	0	0	NO CURB AND GUTTER	ASPHALT CURB	FAIR/73
