Federal Lands Highway Road Inventory Program

Road Inventory and Condition Assessment

**Catoctin Mountain Park
CATO**

Cycle 5 Report

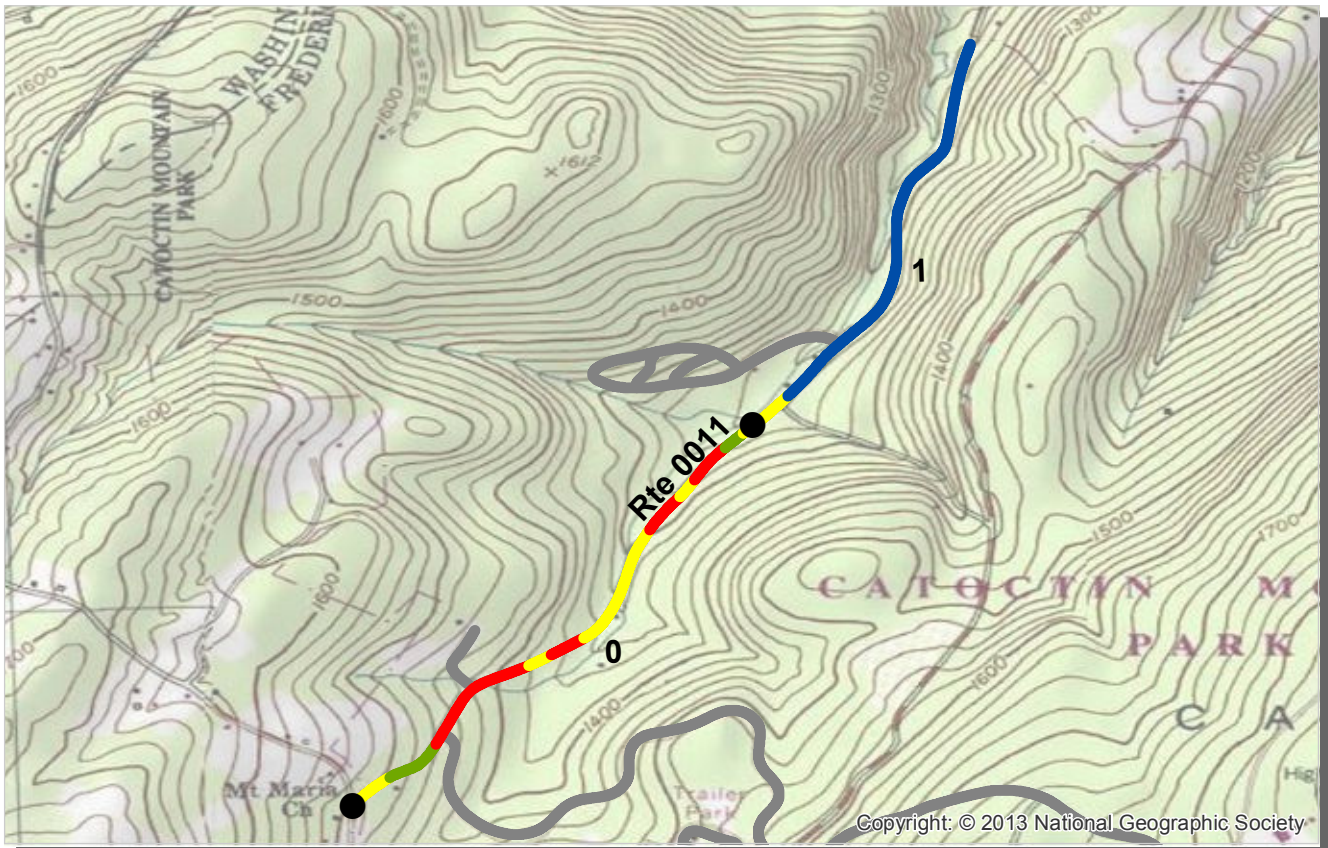
ROUTE: 0011 FOXVILLE - DEERFIELD ROAD

<i>Section Number</i>	0	1			
<i>Section Length (mi)</i>	1.00	0.86			
<i>Cross Section Information</i>					
Number of Lanes	2	2			
Paved Width (ft)	18	18			
Lane Width (ft)	8	8			
<i>Roadway Condition Information</i>					
SCR (Surface Condition Rating)	52	98			
PCR (Pavement Condition Rating)	59	99			
<i>Distress Index Values</i>					
Structural Crack Index	52	98			
Transverse Cracking Index	98	100			
Patching Index	100	100			
Rutting Index	97	100			
Roughness Condition Index (RCI)	69	100

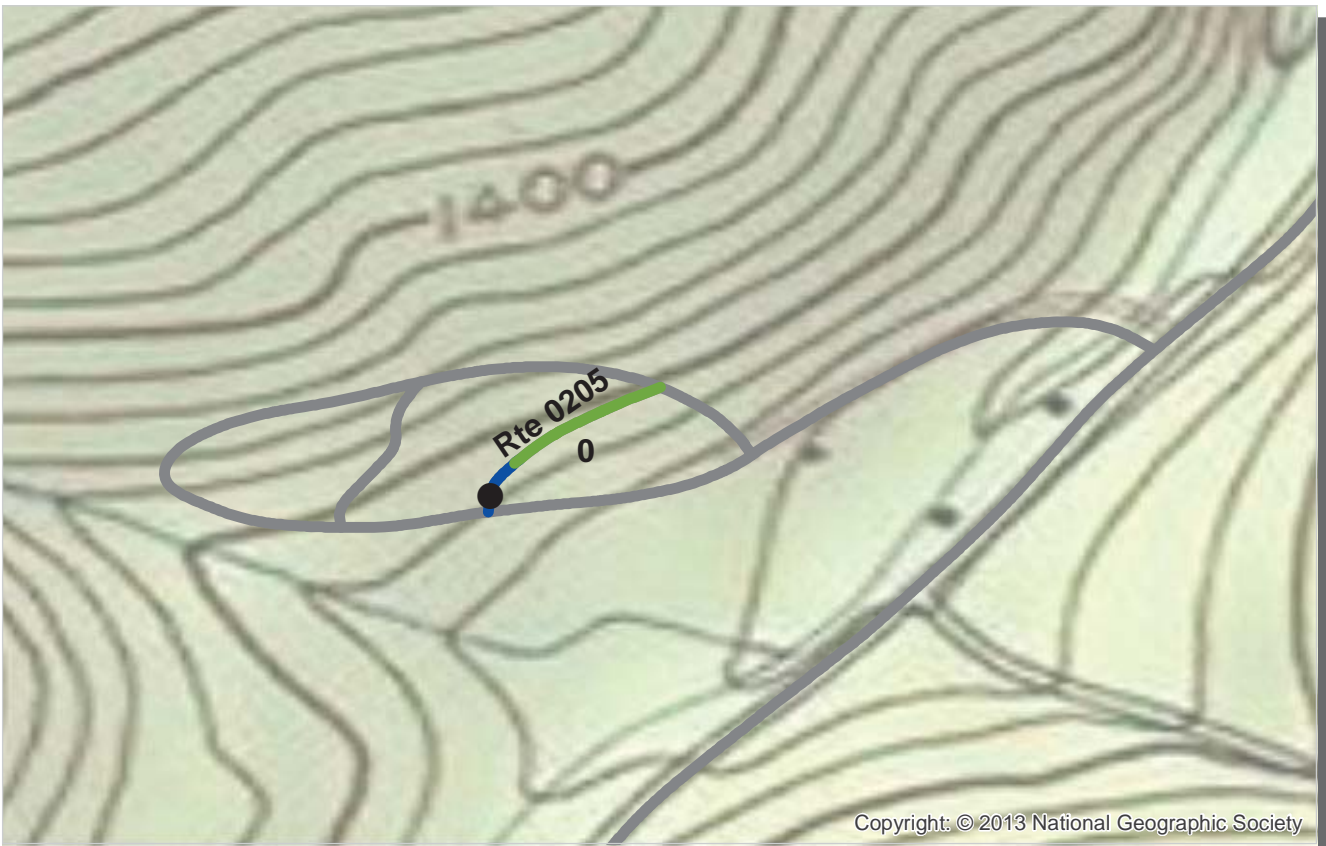
ROUTE: 0204 OWENS CREEK CAMPGROUND

Section Number	0				
Section Length (mi)	0.67				
Cross Section Information					
Number of Lanes	1				
Paved Width (ft)	15				
Lane Width (ft)	11				
Roadway Condition Information					
SCR (Surface Condition Rating)	90				
PCR (Pavement Condition Rating)	90				
Distress Index Values					
Structural Crack Index	98				
Transverse Cracking Index	99				
Patching Index	99				
Rutting Index	90				
Roughness Condition Index (RCI)	NC

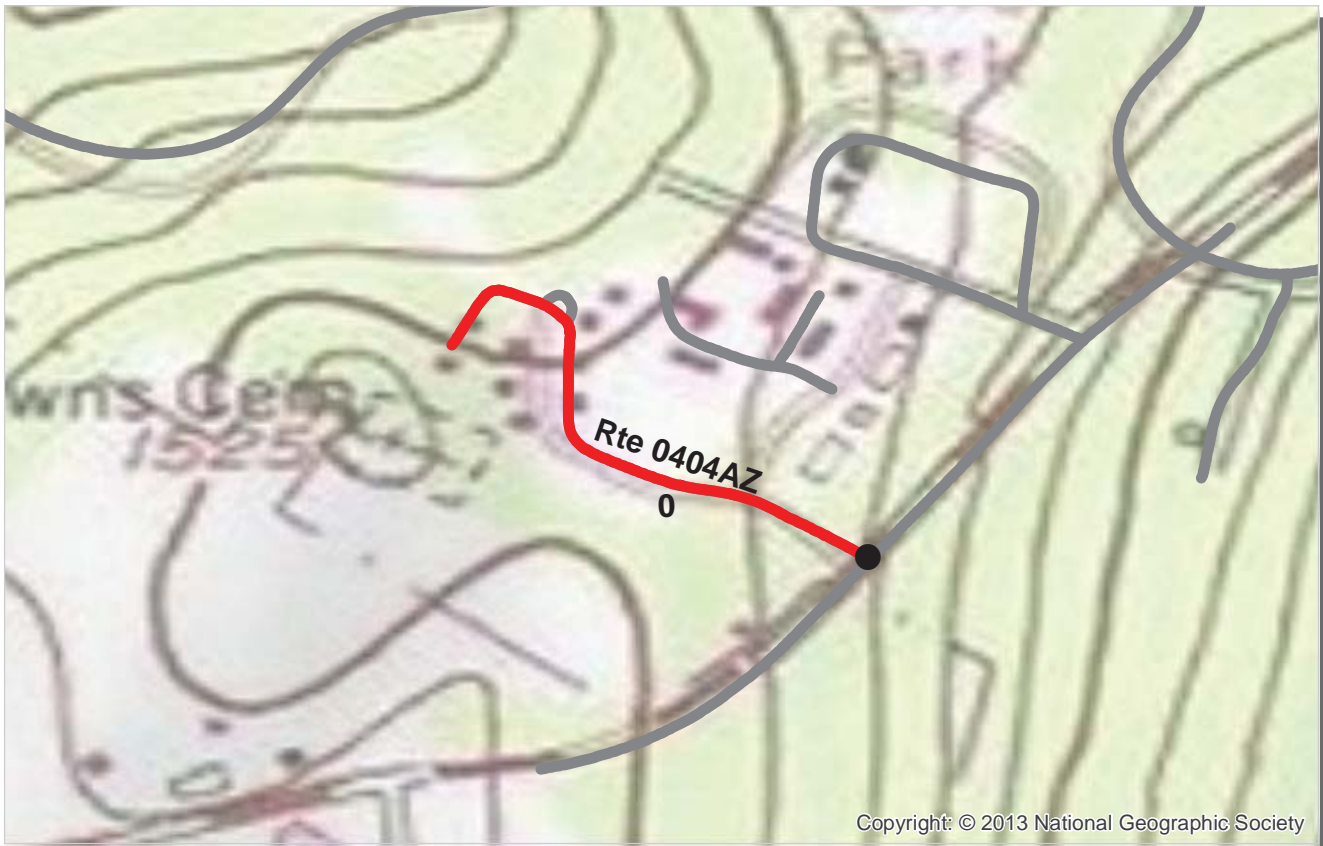
ROUTE: 0404AZ ROUND MEADOW ROAD

Section Number	0				
Section Length (mi)	0.25				
Cross Section Information					
Number of Lanes	2				
Paved Width (ft)	17				
Lane Width (ft)	11				
Roadway Condition Information					
SCR (Surface Condition Rating)	41				
PCR (Pavement Condition Rating)	41				
Distress Index Values					
Structural Crack Index	41				
Transverse Cracking Index	86				
Patching Index	98				
Rutting Index	91				
Roughness Condition Index (RCI)	NC

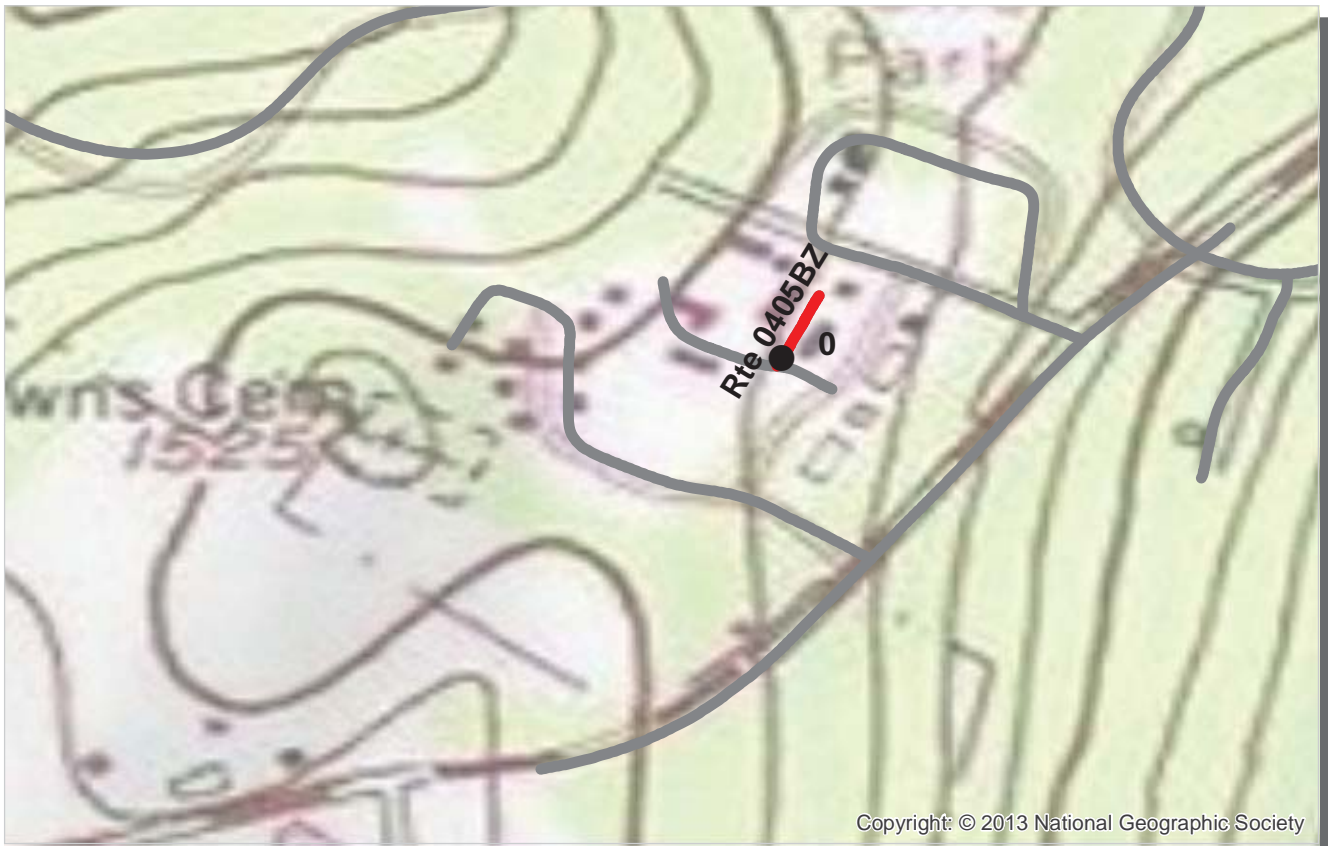
Section Number	0				
Section Length (mi)	0.03				
Cross Section Information					
Number of Lanes	2				
Paved Width (ft)	16				
Lane Width (ft)	8				
Roadway Condition Information					
SCR (Surface Condition Rating)	17				
PCR (Pavement Condition Rating)	17				
Distress Index Values					
Structural Crack Index	17				
Transverse Cracking Index	68				
Patching Index	97				
Rutting Index	93				
Roughness Condition Index (RCI)	NC

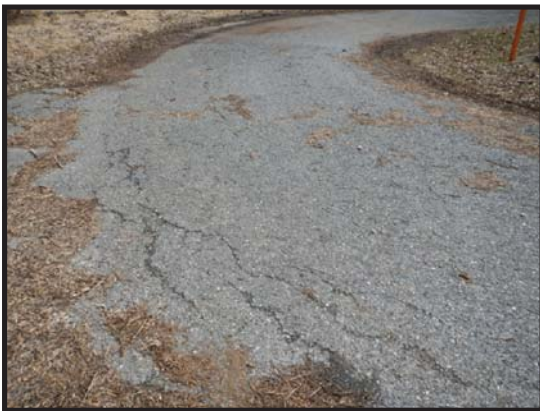
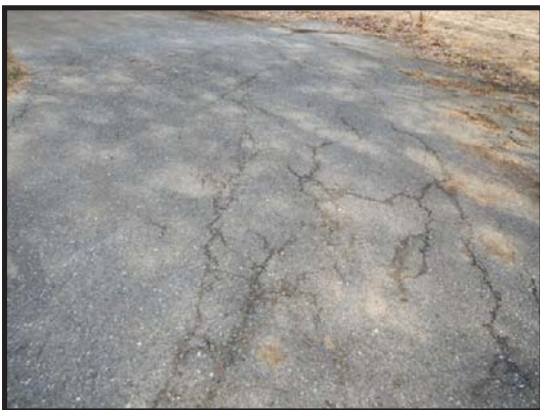
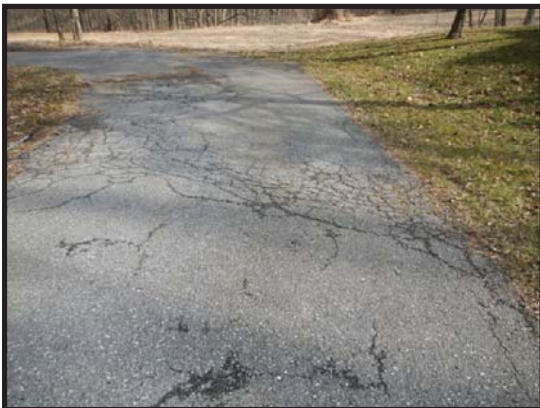
Route Number	Public / NonPublic	Date Visited	Area (sq ft)	Lane Miles *	Paved Length (mi)	Paved Width (ft)
0404BZ	PUBLIC	4/2/2013	1,331	0.02	0.02	12
Culverts	Drop Inlets	Gates	Curb & Gutter	Curb	PCR	Surface Type
0	0	0	NO CURB AND GUTTER	NO CURB	POOR/45	AS

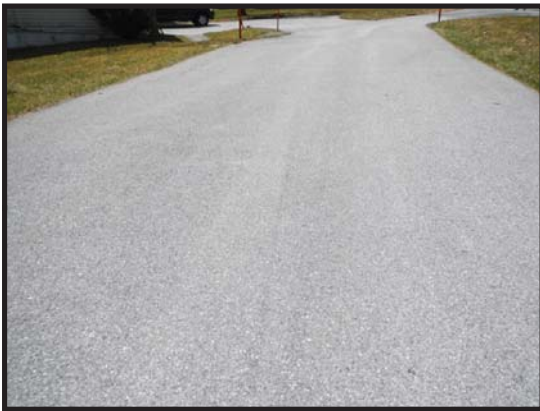
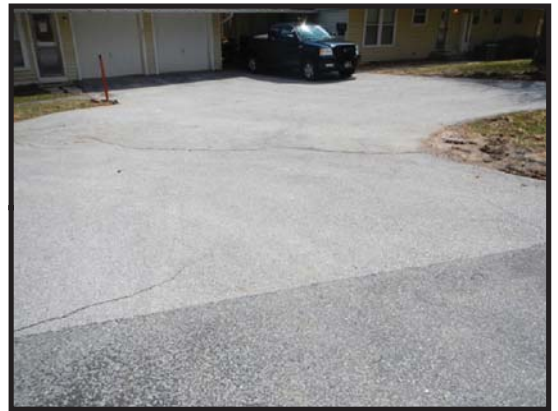
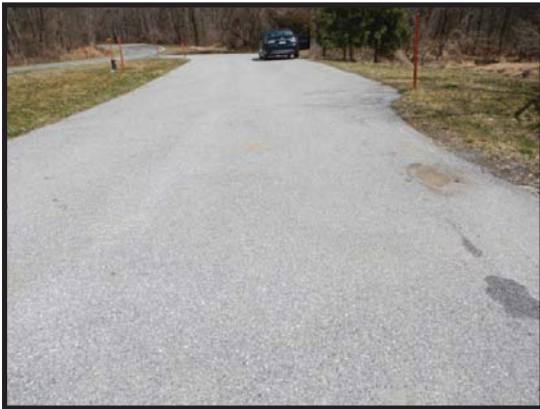
Route 0406

Route Number	Public / NonPublic	Date Visited	Area (sq ft)	Lane Miles *	Surface Type
0406	PUBLIC	4/2/2013	4,912	0.09	AS
Culverts	Drop Inlets	Gates	Curb & Gutter	Curb	PCR
0	1	0	NO CURB AND GUTTER	NO CURB	GOOD/90

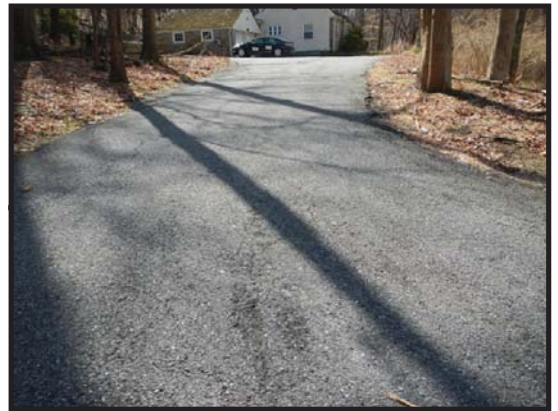
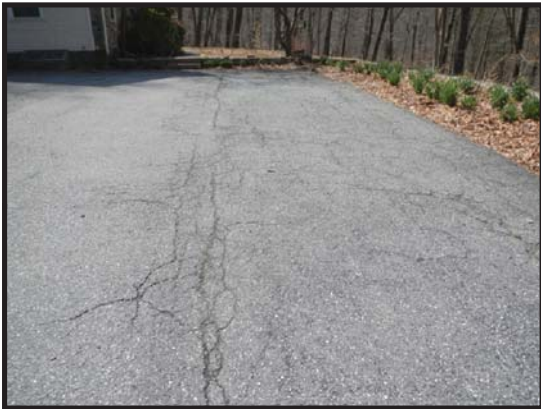
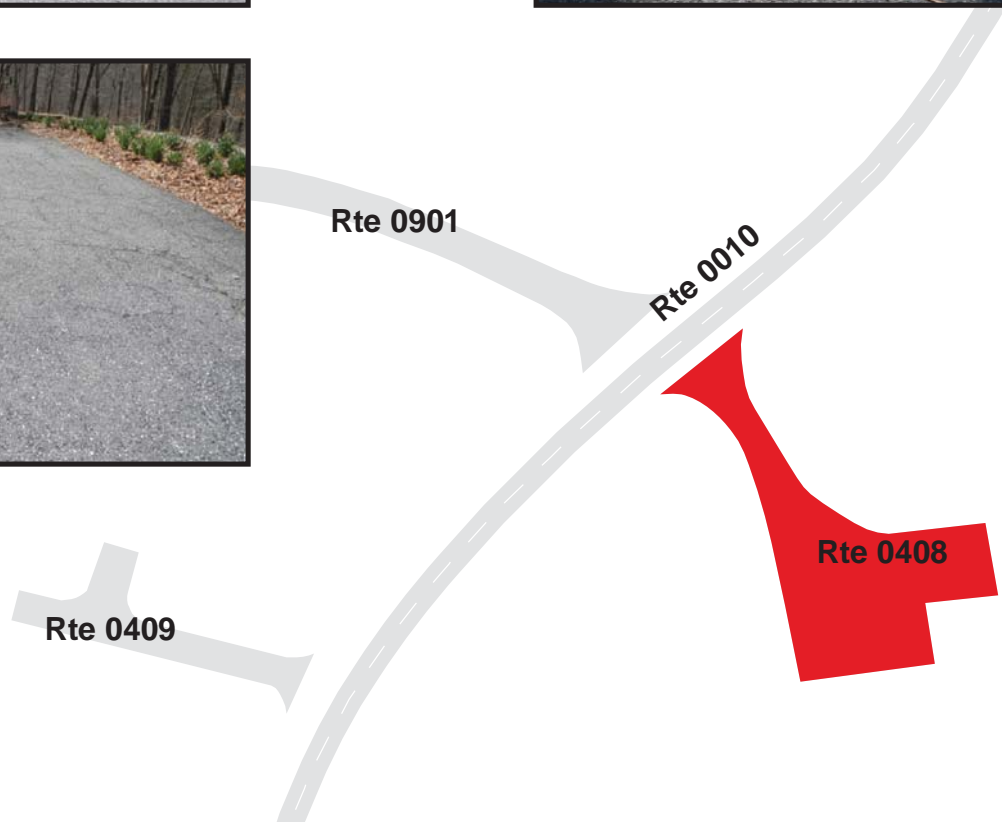
Route 0408

Route Number	Public / NonPublic	Date Visited	Area (sq ft)	Lane Miles *	Surface Type
0408	PUBLIC	4/2/2013	4,526	0.08	AS
Culverts	Drop Inlets	Gates	Curb & Gutter	Curb	PCR
0	0	1	NO CURB AND GUTTER	NO CURB	POOR/45

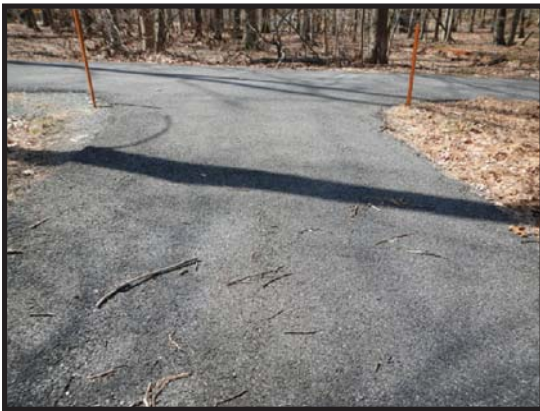
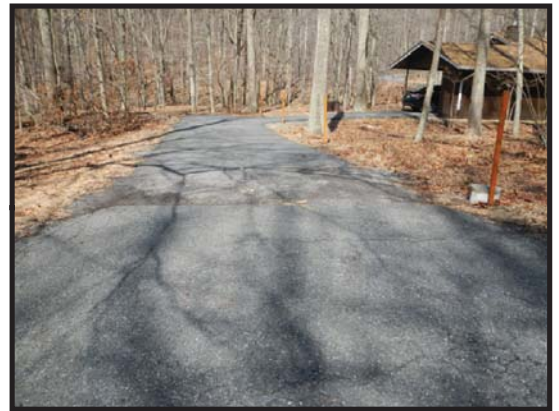
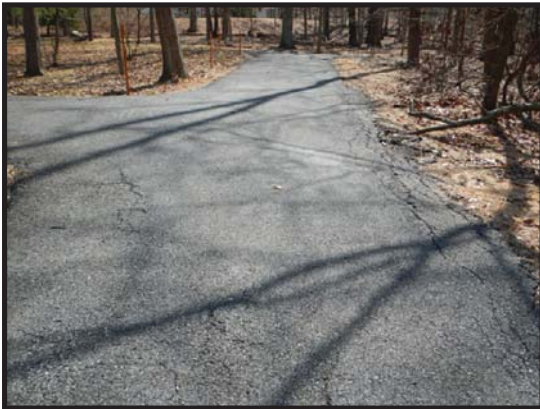
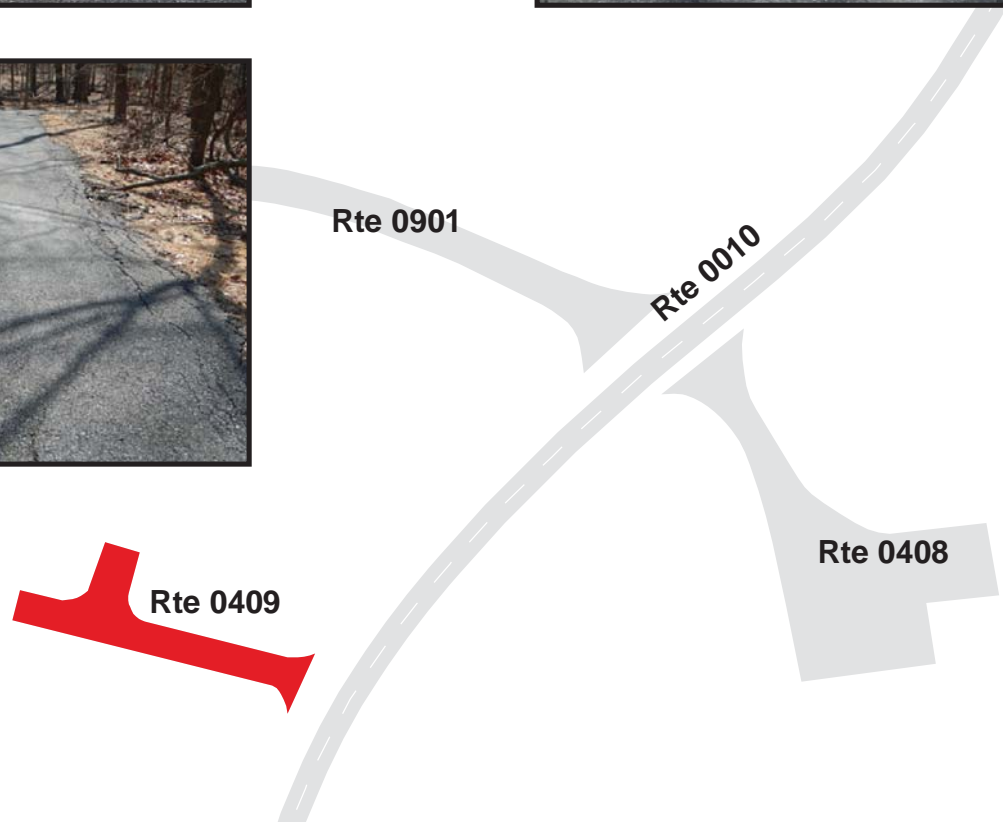
Route 0409

Route Number	Public / NonPublic	Date Visited	Area (sq ft)	Lane Miles *	Surface Type
0409	PUBLIC	4/2/2013	1,600	0.03	AS
Culverts	Drop Inlets	Gates	Curb & Gutter	Curb	PCR
0	0	0	NO CURB AND GUTTER	NO CURB	POOR/45

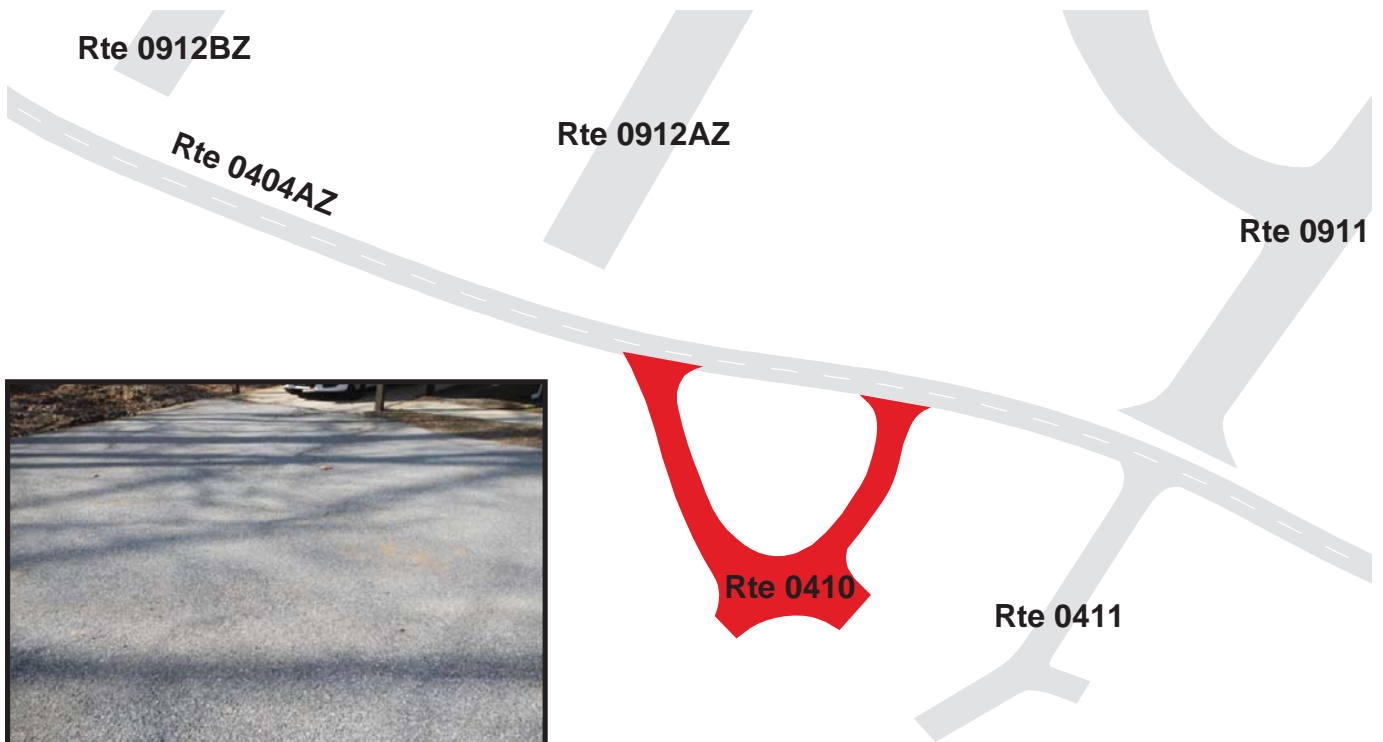
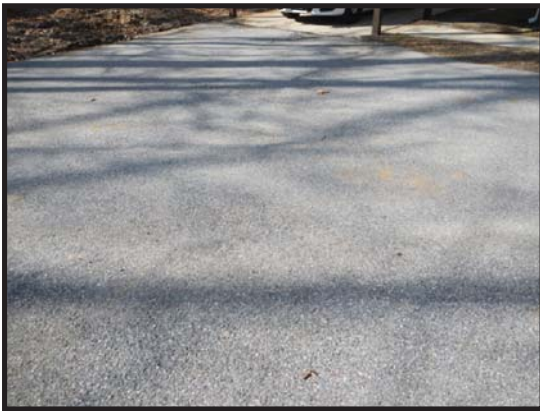
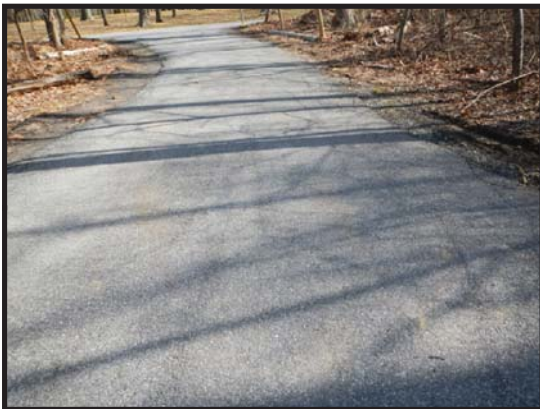
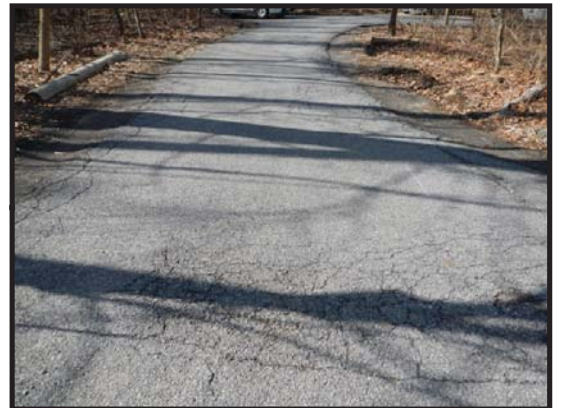
Route 0410

Route Number	Public / NonPublic	Date Visited	Area (sq ft)	Lane Miles *	Surface Type
0410	PUBLIC	4/2/2013	2,732	0.05	AS
Culverts	Drop Inlets	Gates	Curb & Gutter	Curb	PCR
0	0	0	NO CURB AND GUTTER	NO CURB	POOR/45

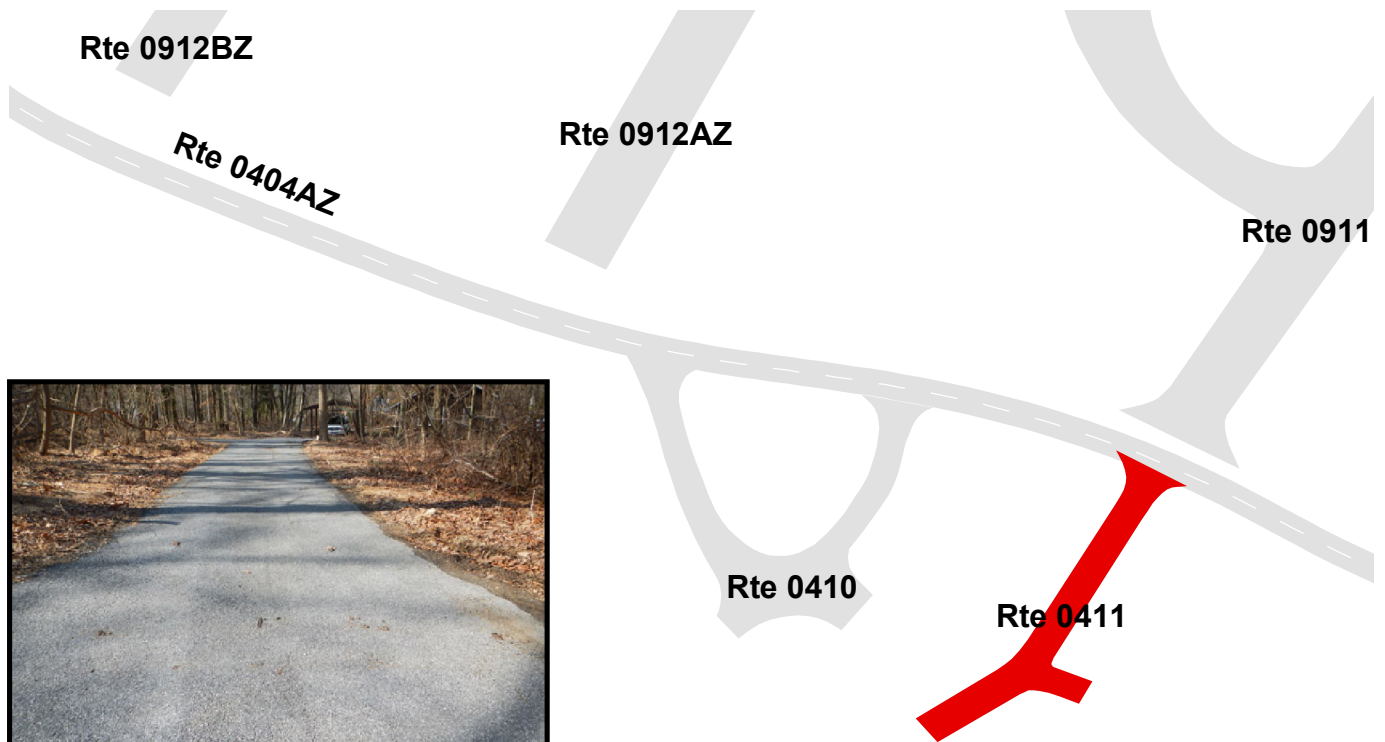
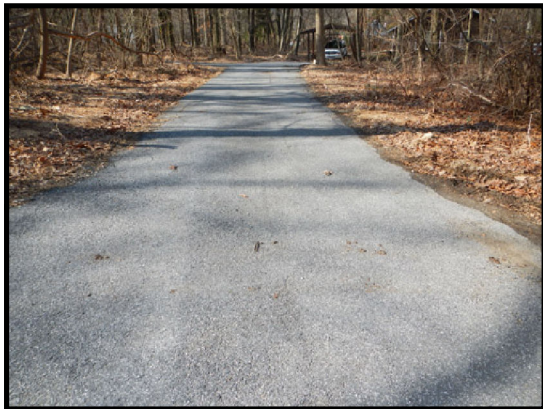
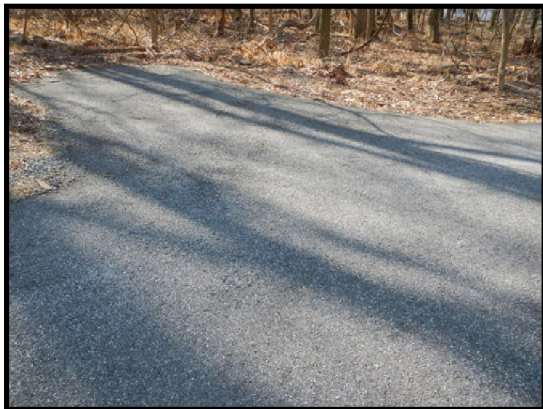
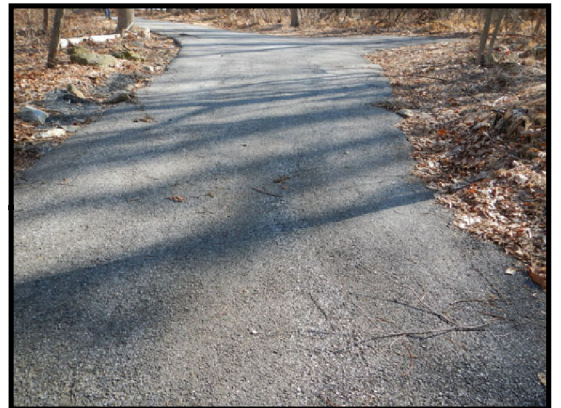
Route 0411

Route Number	Public / NonPublic	Date Visited	Area (sq ft)	Lane Miles *	Surface Type
0411	PUBLIC	4/2/2013	1,585	0.03	AS
Culverts	Drop Inlets	Gates	Curb & Gutter	Curb	PCR
0	0	0	NO CURB AND GUTTER	NO CURB	FAIR/73

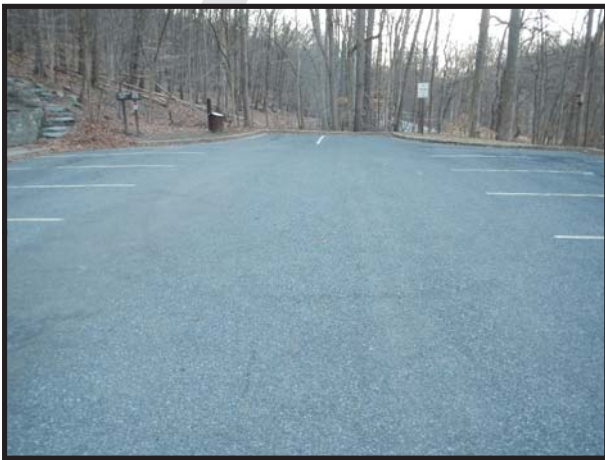
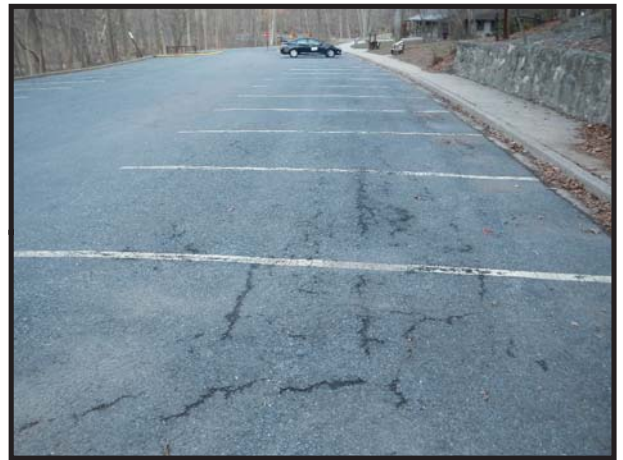
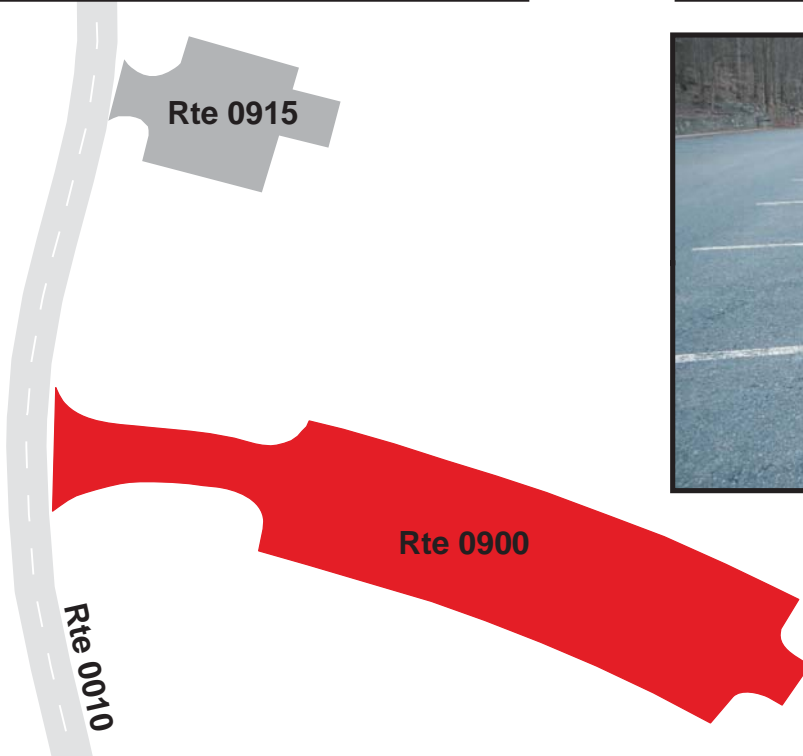
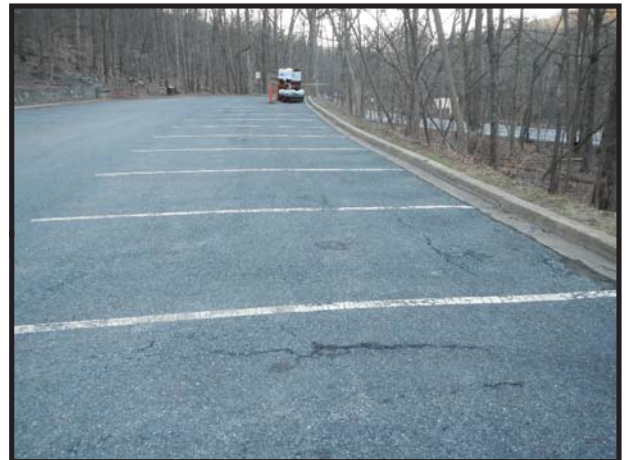
Route Number	Public / NonPublic	Date Visited	Area (sq ft)	Lane Miles *	Surface Type
0900	PUBLIC	4/2/2013	12,997	0.22	AS
Culverts	Drop Inlets	Gates	Curb & Gutter	Curb	PCR
0	1	0	CONCRETE CURB AND GUTTER	NO CURB	FAIR/73

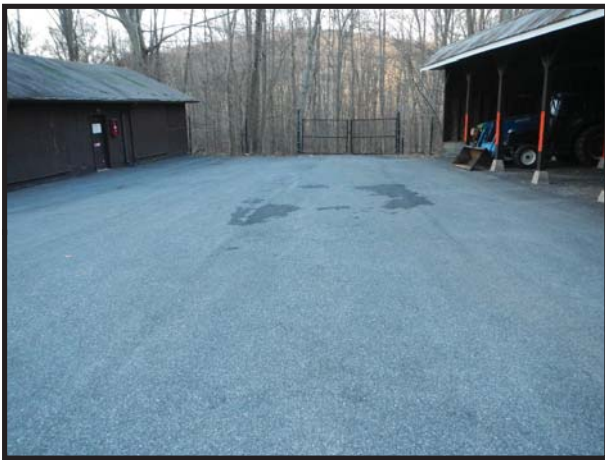
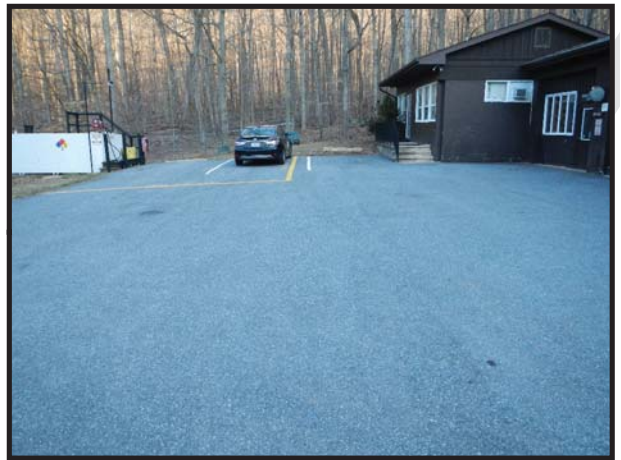
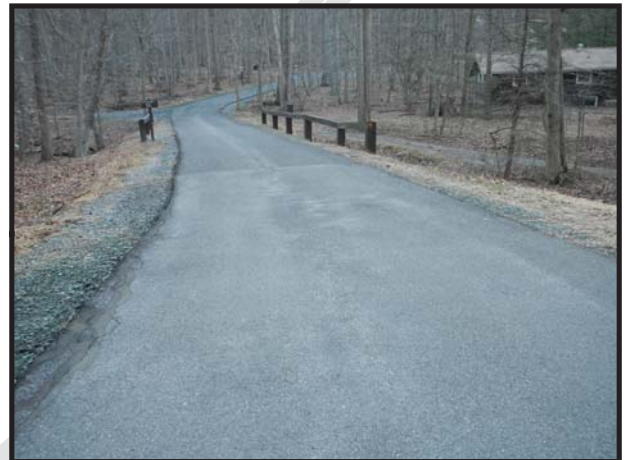
Route 0901

Route Number	Public / NonPublic	Date Visited	Area (sq ft)	Lane Miles *	Surface Type
0901	NONPUBLIC	4/2/2013	16,988	0.29	AS
Culverts	Drop Inlets	Gates	Curb & Gutter	Curb	PCR
2	0	3	NO CURB AND GUTTER	NO CURB	GOOD/90

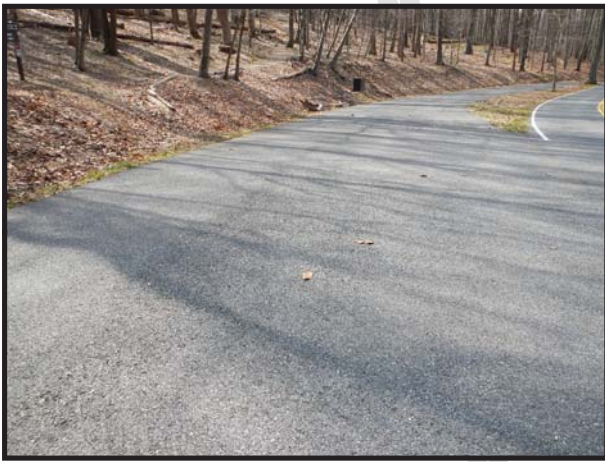
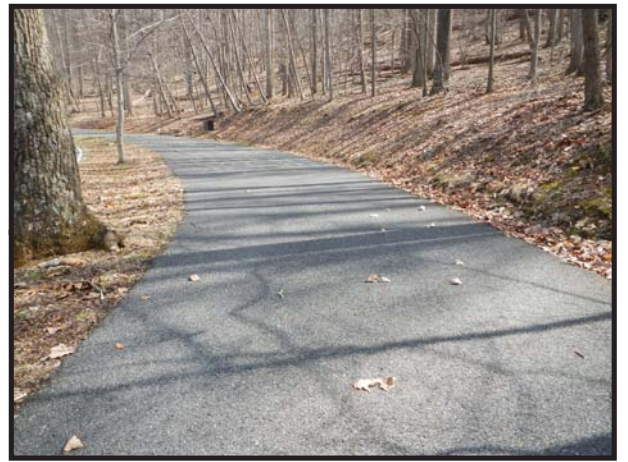
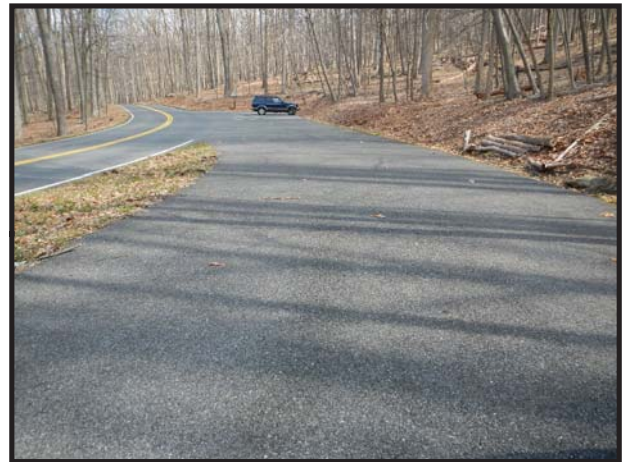
Route 0903

Route Number	Public / NonPublic	Date Visited	Area (sq ft)	Lane Miles *	Surface Type
0903	PUBLIC	4/2/2013	7,439	0.13	AS
Culverts	Drop Inlets	Gates	Curb & Gutter	Curb	PCR
1	3	0	NO CURB AND GUTTER	NO CURB	GOOD/90

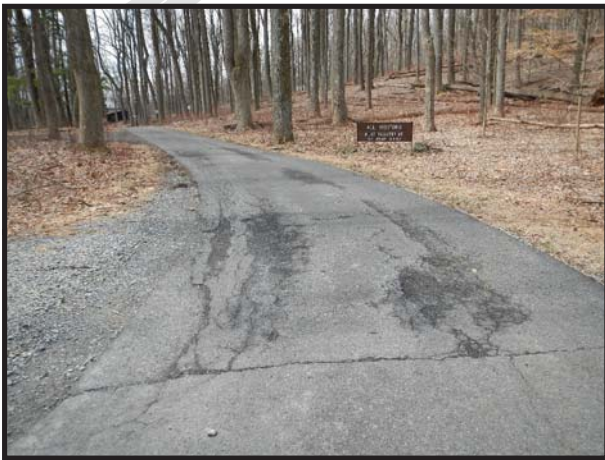
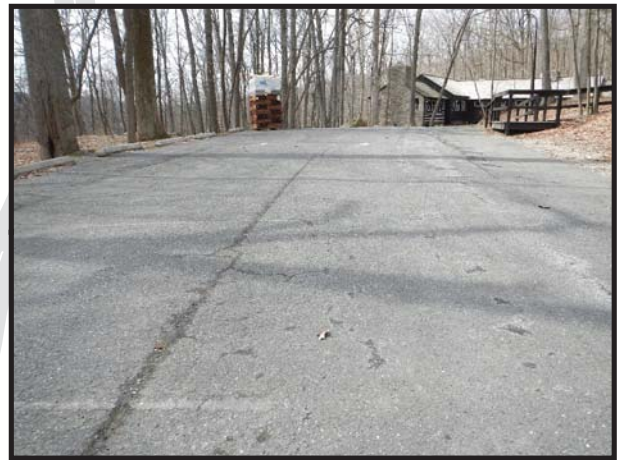
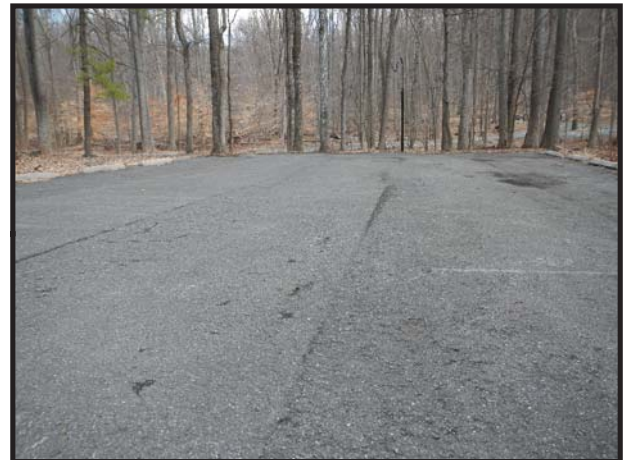
Route 0904

Route Number	Public / NonPublic	Date Visited	Area (sq ft)	Lane Miles *	Surface Type
0904	PUBLIC	4/2/2013	27,743	0.48	AS
Culverts	Drop Inlets	Gates	Curb & Gutter	Curb	PCR
4	1	1	NO CURB AND GUTTER	NO CURB	POOR/45

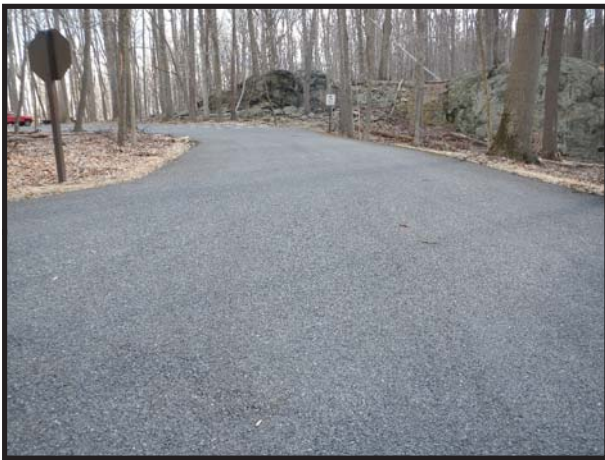
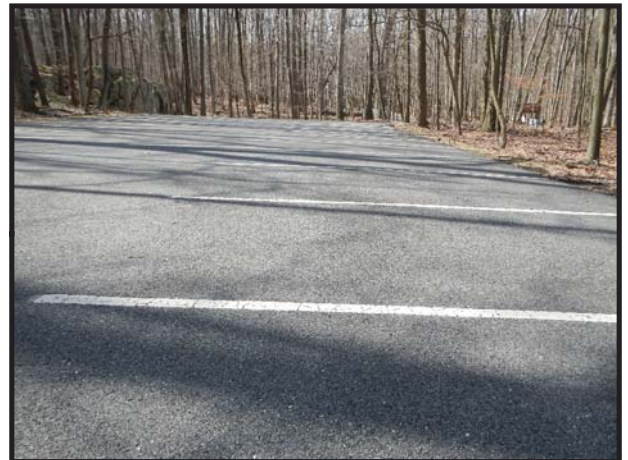
Route 0905

Route Number	Public / NonPublic	Date Visited	Area (sq ft)	Lane Miles *	Surface Type
0905	PUBLIC	4/2/2013	13,360	0.23	AS
Culverts	Drop Inlets	Gates	Curb & Gutter	Curb	PCR
1	0	0	NO CURB AND GUTTER	NO CURB	GOOD/90

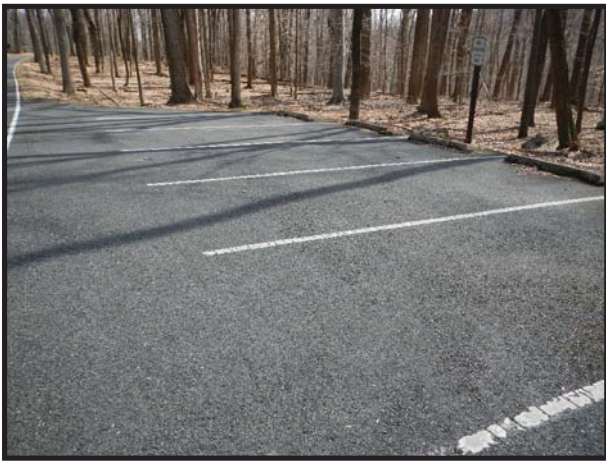
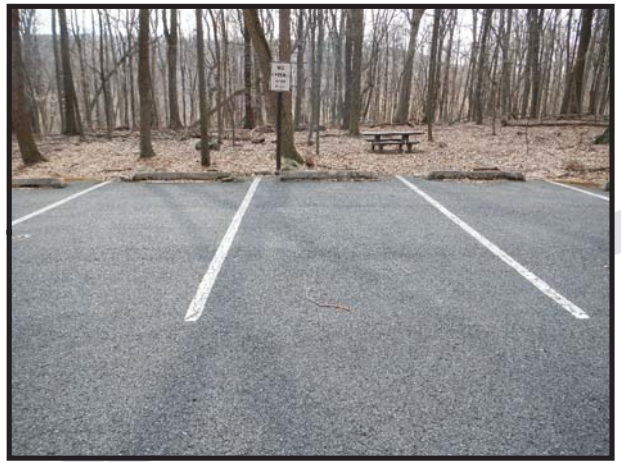
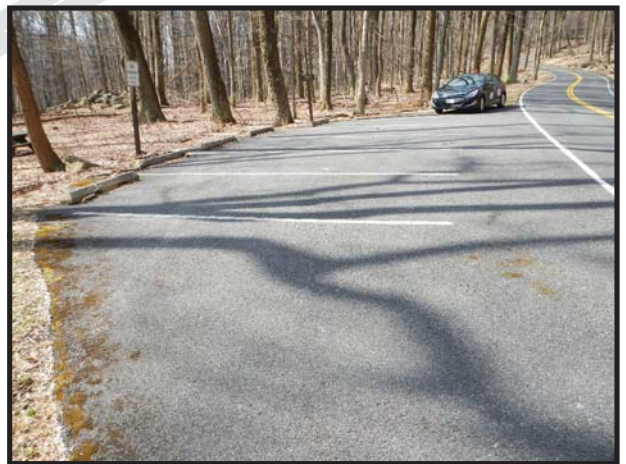
Route 0906

Route Number	Public / NonPublic	Date Visited	Area (sq ft)	Lane Miles *	Surface Type
0906	PUBLIC	4/2/2013	2,535	0.04	AS
Culverts	Drop Inlets	Gates	Curb & Gutter	Curb	PCR
0	0	0	NO CURB AND GUTTER	NO CURB	GOOD/90

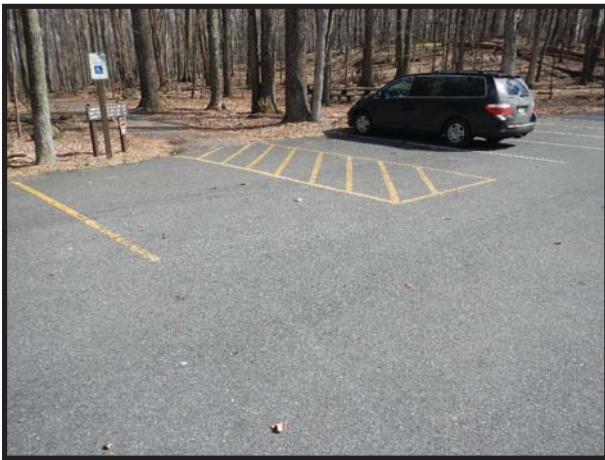
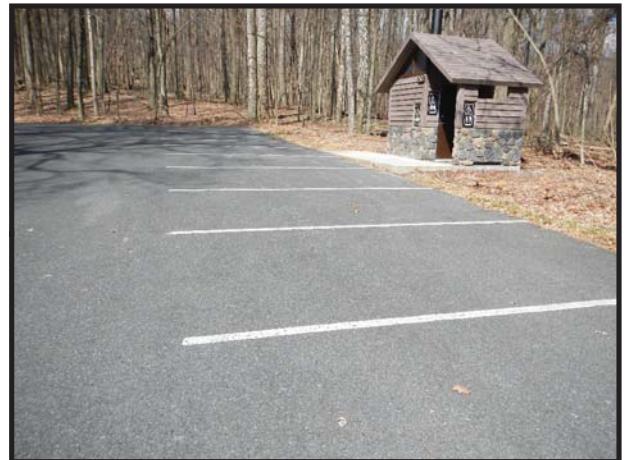
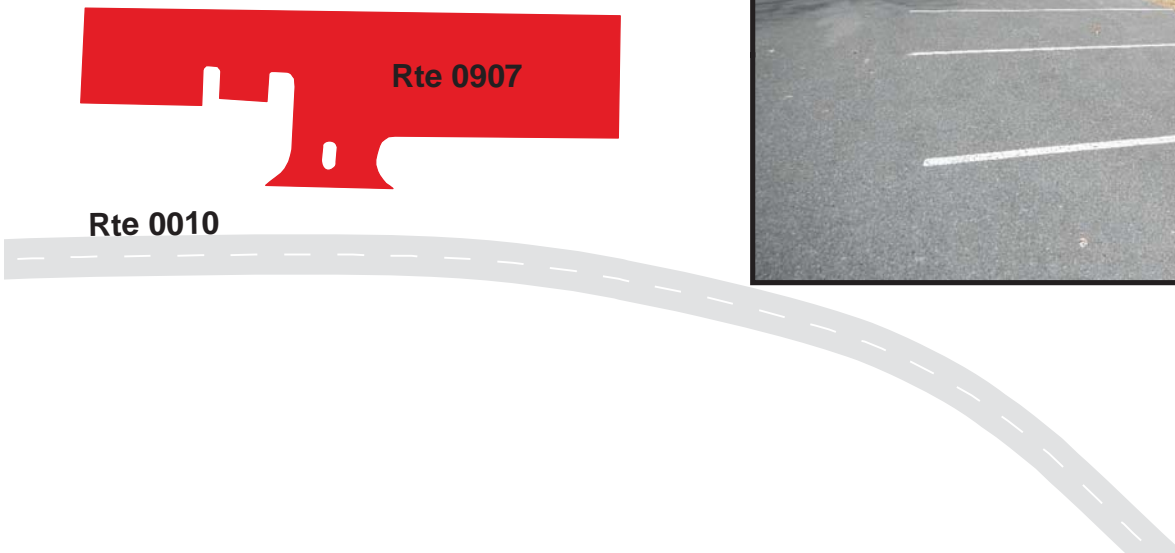
Route 0907

Route Number	Public / NonPublic	Date Visited	Area (sq ft)	Lane Miles *	Surface Type
0907	PUBLIC	4/2/2013	20,477	0.35	AS
Culverts	Drop Inlets	Gates	Curb & Gutter	Curb	PCR
1	0	0	NO CURB AND GUTTER	NO CURB	GOOD/90

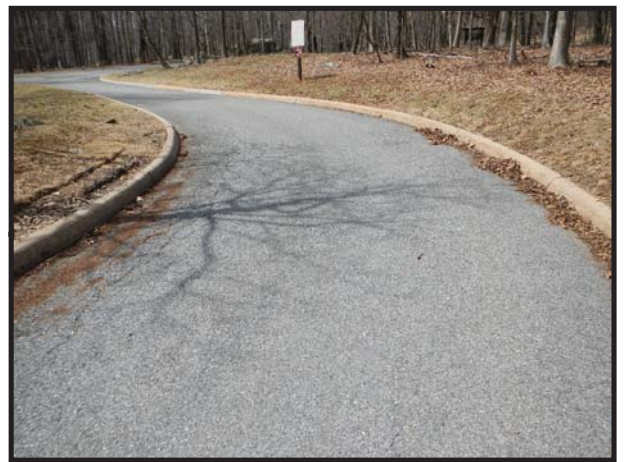
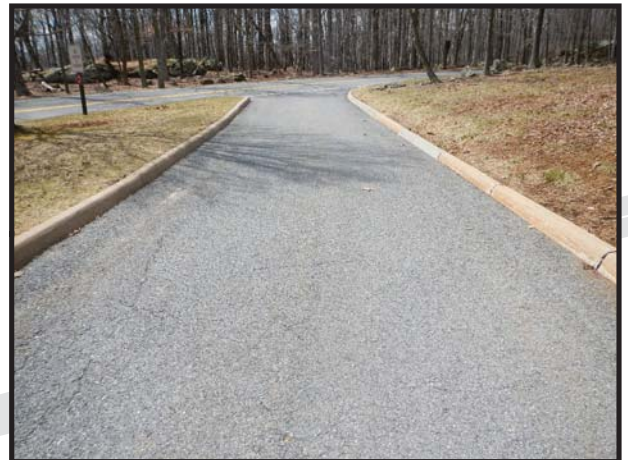
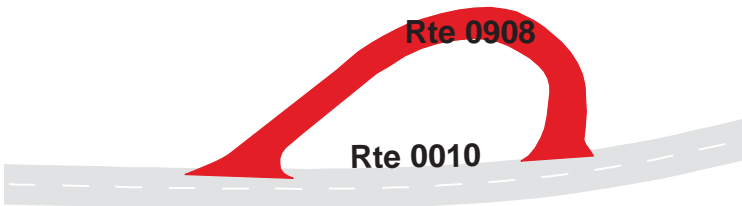
Route 0908

Route Number	Public / NonPublic	Date Visited	Area (sq ft)	Lane Miles *	Surface Type
0908	PUBLIC	4/2/2013	2,349	0.04	AS
Culverts	Drop Inlets	Gates	Curb & Gutter	Curb	PCR
0	1	1	NO CURB AND GUTTER	CONCRETE CURB	GOOD/90

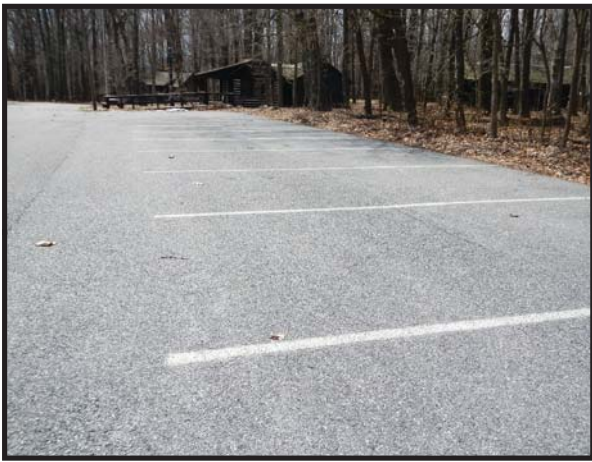
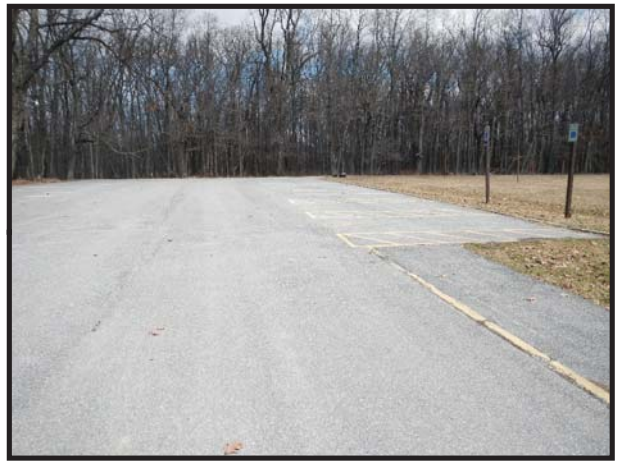
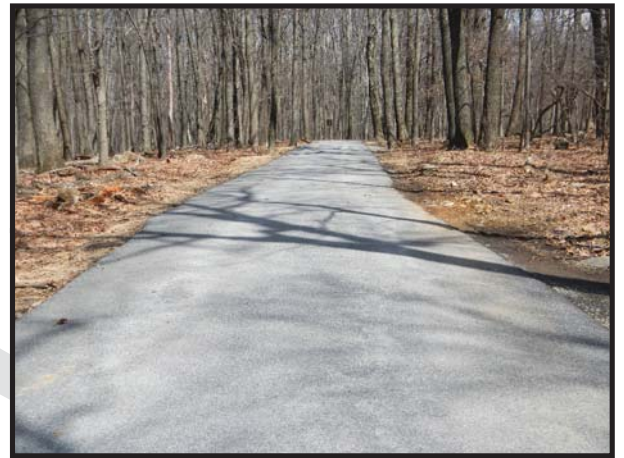
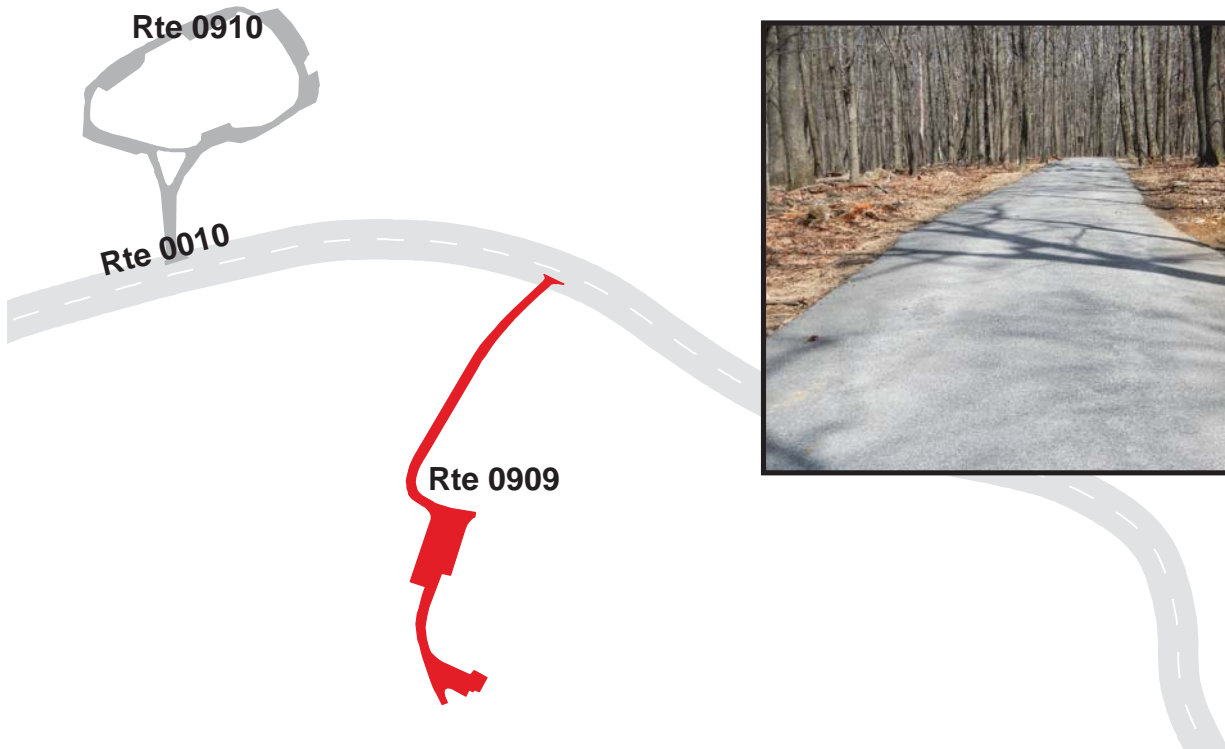
Route 0909

Route Number	Public / NonPublic	Date Visited	Area (sq ft)	Lane Miles *	Surface Type
0909	PUBLIC	4/2/2013	26,806	0.46	AS
Culverts	Drop Inlets	Gates	Curb & Gutter	Curb	PCR
0	1	1	NO CURB AND GUTTER	CONCRETE CURB	GOOD/90
