Federal Lands Highway Road Inventory Program

Road Inventory and Condition Assessment

**Catoctin Mountain Park
CATO**

Cycle 5 Report

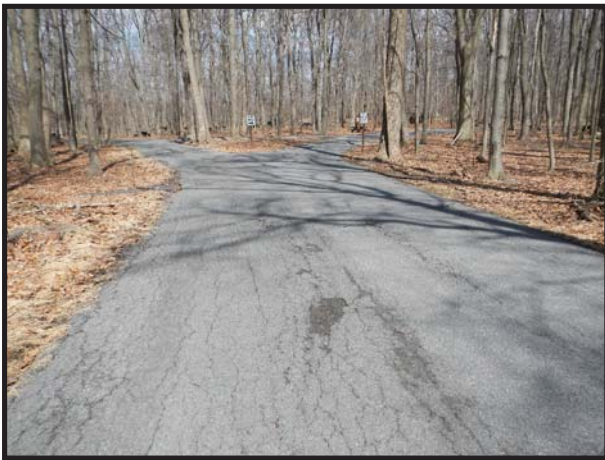
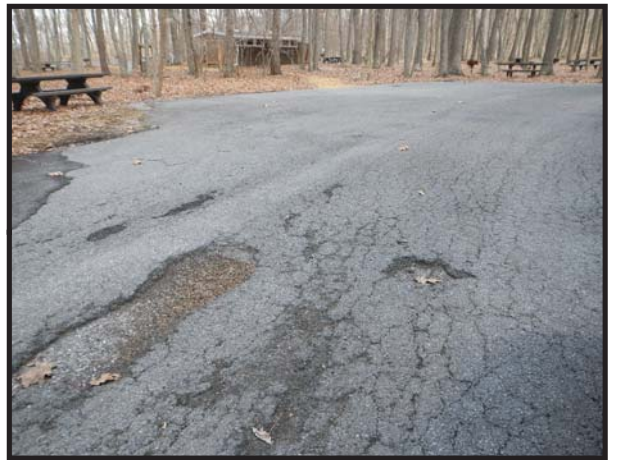
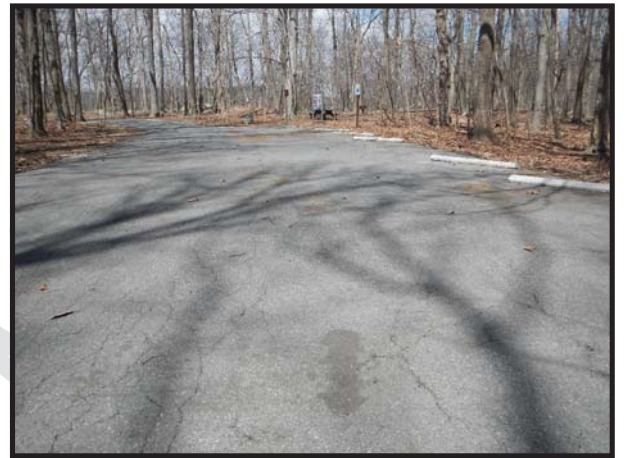
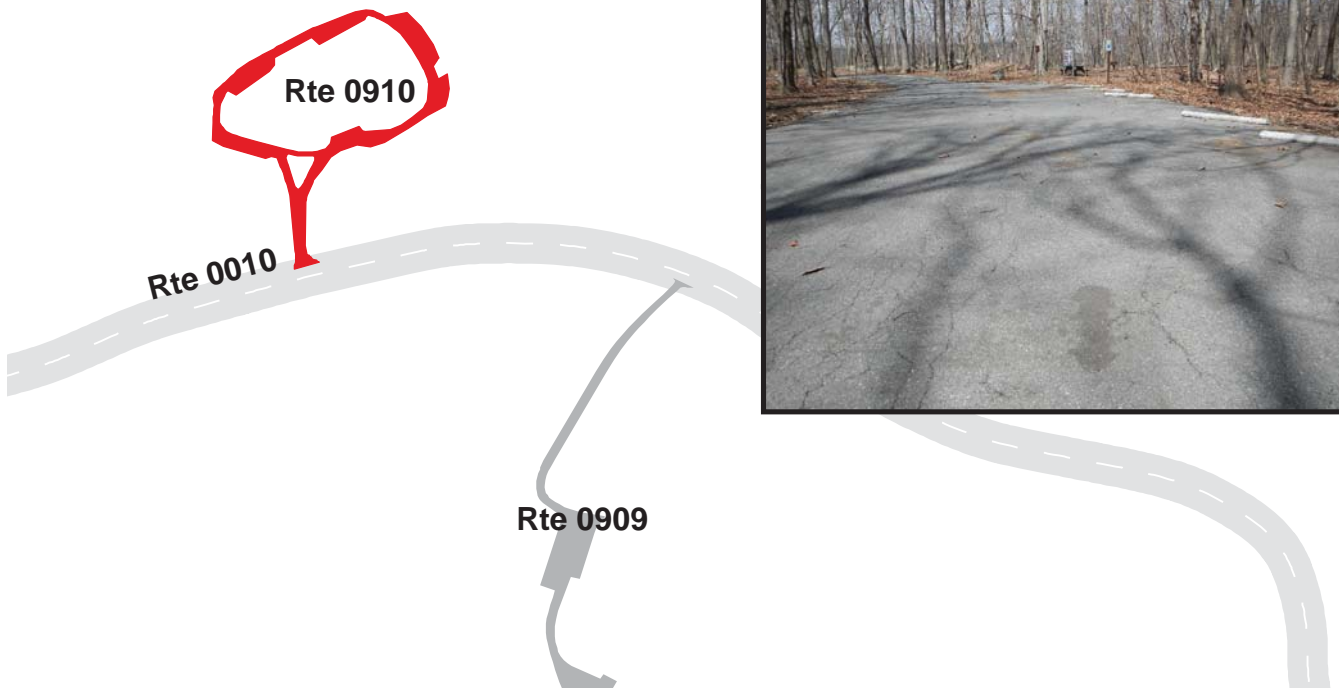
Route 0910

Route Number	Public / NonPublic	Date Visited	Area (sq ft)	Lane Miles *	Surface Type
0910	PUBLIC	4/2/2013	32,398	0.56	AS
Culverts	Drop Inlets	Gates	Curb & Gutter	Curb	PCR
0	0	1	NO CURB AND GUTTER	NO CURB	POOR/45

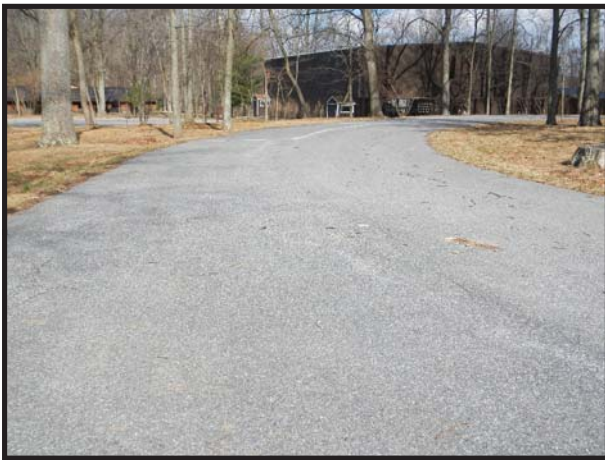
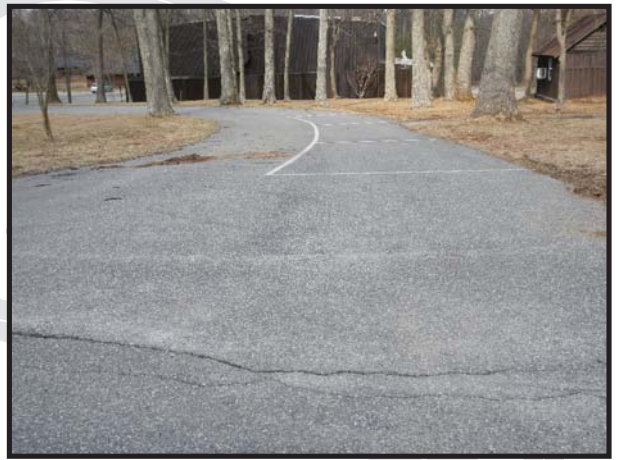
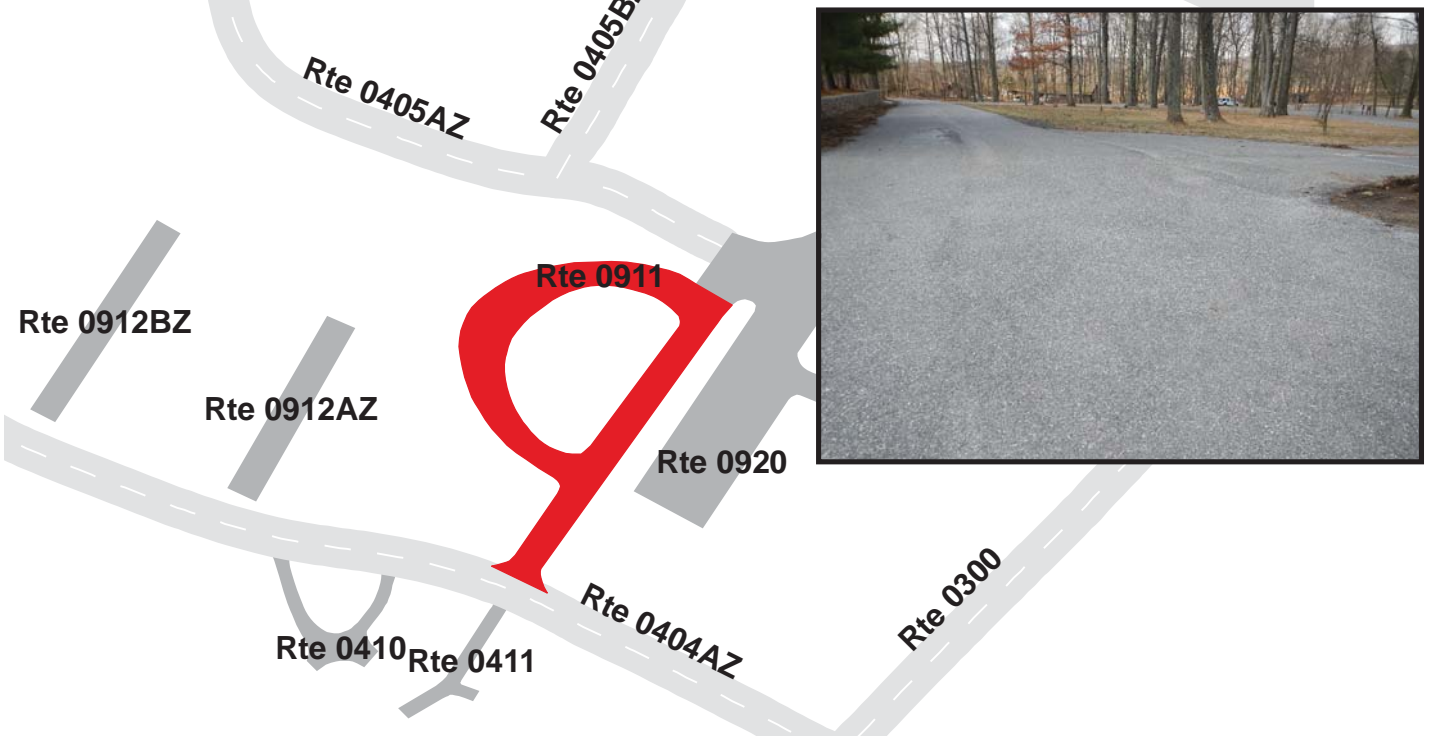
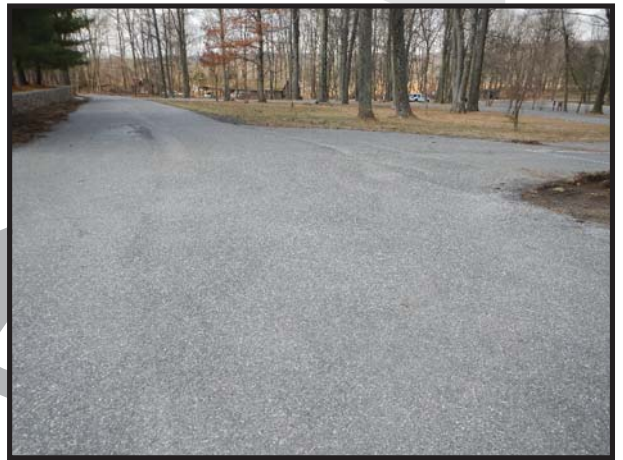
Route 0911

Route Number	Public / NonPublic	Date Visited	Area (sq ft)	Lane Miles *	Surface Type
0911	PUBLIC	4/2/2013	14,244	0.25	AS
Culverts	Drop Inlets	Gates	Curb & Gutter	Curb	PCR
0	0	0	NO CURB AND GUTTER	NO CURB	FAIR/73

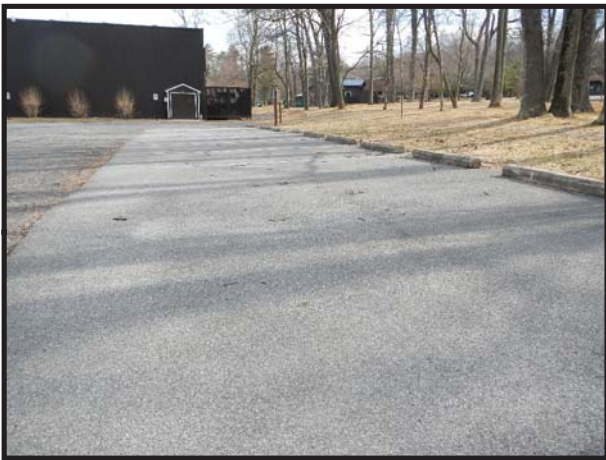
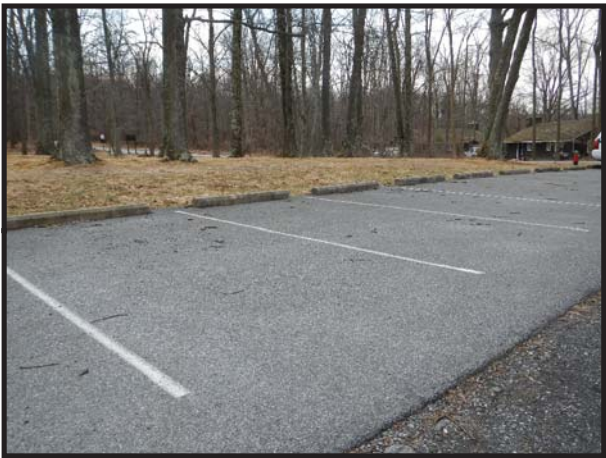
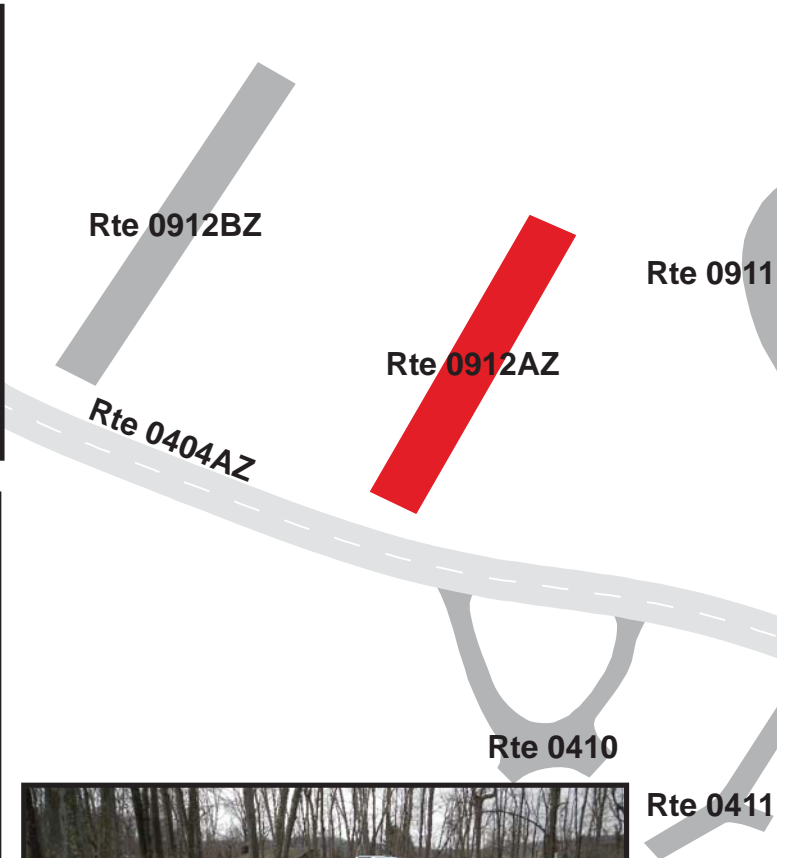
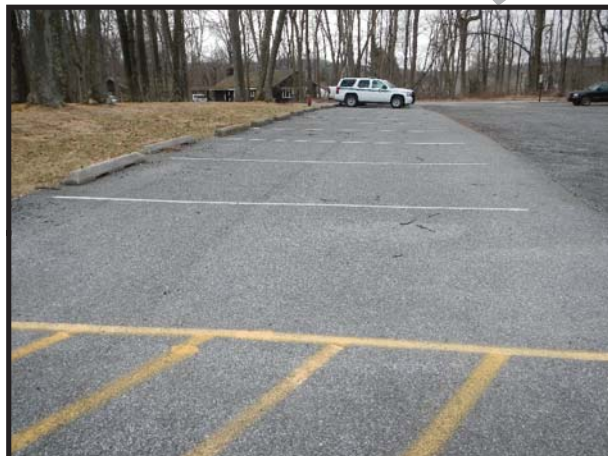
Route Number	Public / NonPublic	Date Visited	Area (sq ft)	Lane Miles *	Surface Type
0912AZ	PUBLIC	4/2/2013	3,615	0.06	AS
Culverts	Drop Inlets	Gates	Curb & Gutter	Curb	PCR
0	0	0	NO CURB AND GUTTER	NO CURB	GOOD/90

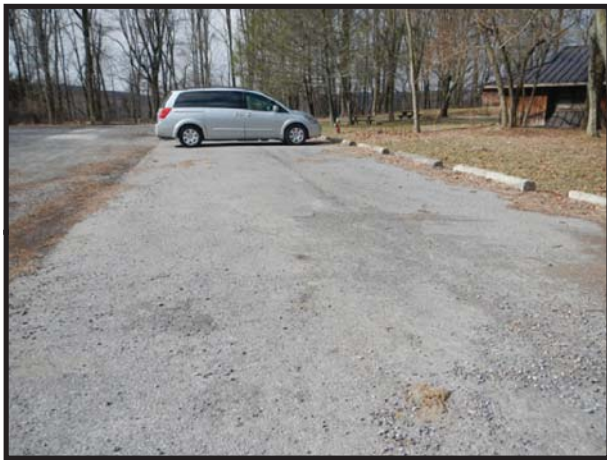
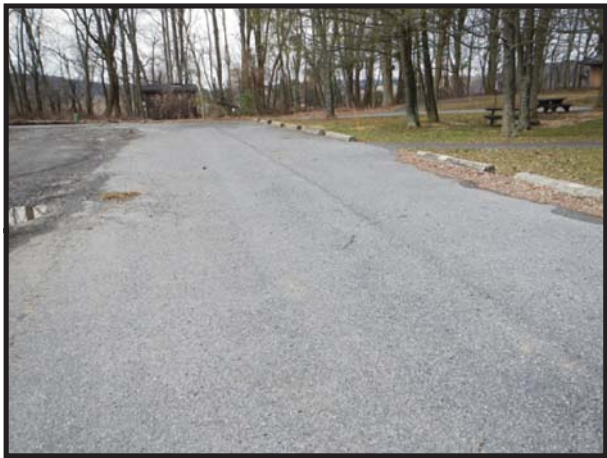
Route Number	Public / NonPublic	Date Visited	Area (sq ft)	Lane Miles *	Surface Type
0912BZ	PUBLIC	4/2/2013	3,649	0.06	AS
Culverts	Drop Inlets	Gates	Curb & Gutter	Curb	PCR
0	0	0	NO CURB AND GUTTER	NO CURB	GOOD/90

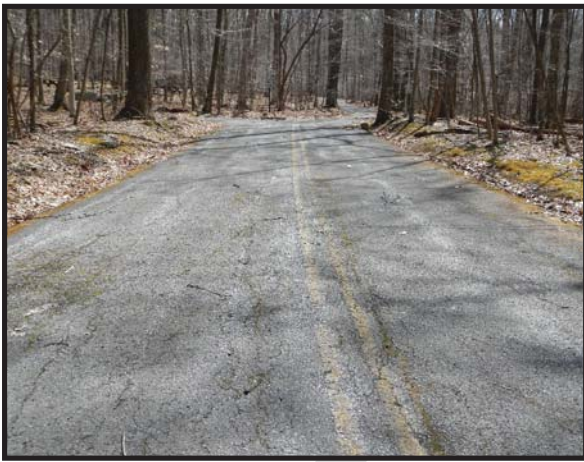
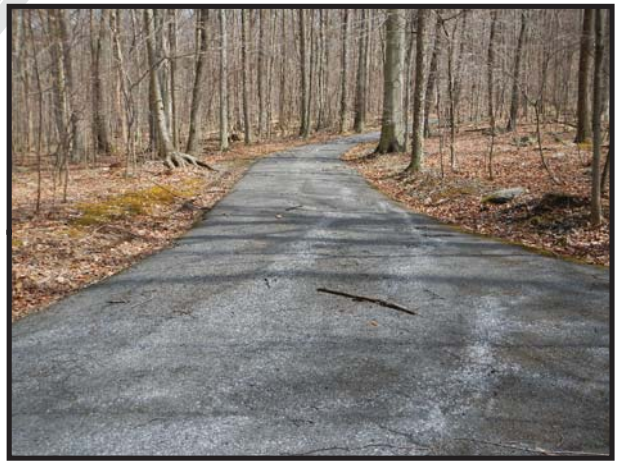
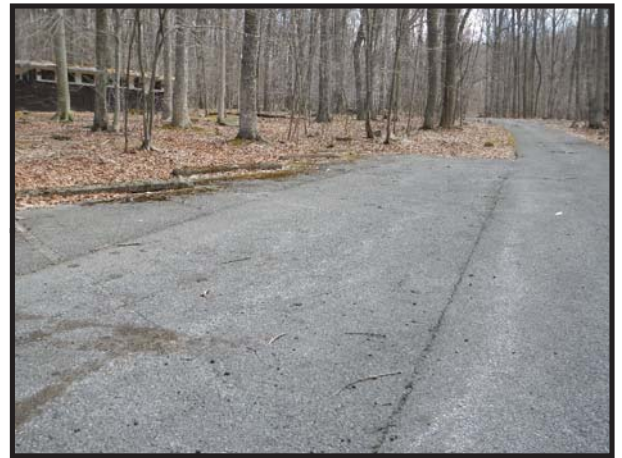
Route 0913

Route Number	Public / NonPublic	Date Visited	Area (sq ft)	Lane Miles *	Surface Type
0913	PUBLIC	4/2/2013	33,901	0.58	AS
Culverts	Drop Inlets	Gates	Curb & Gutter	Curb	PCR
1	0	1	NO CURB AND GUTTER	NO CURB	FAIR/73

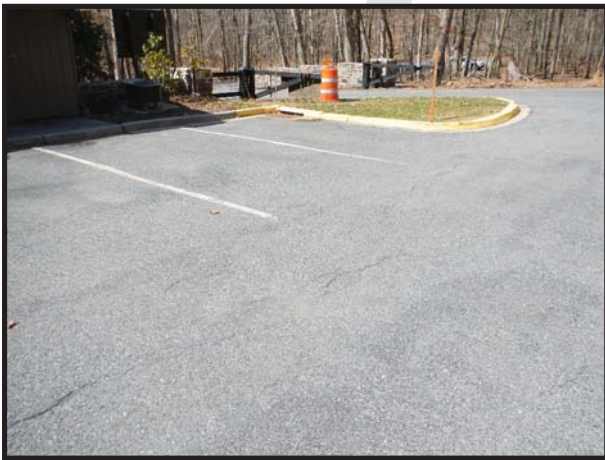
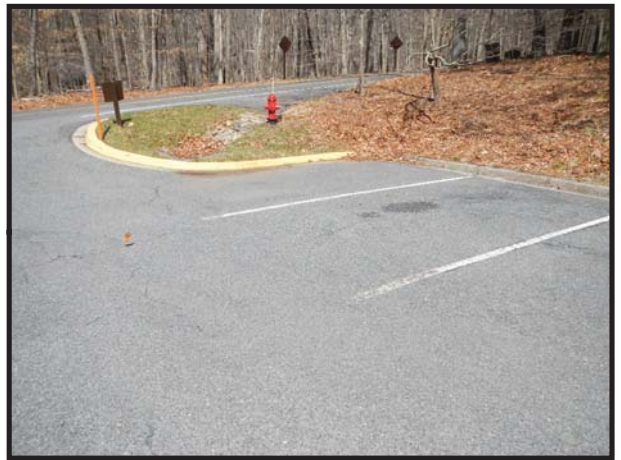
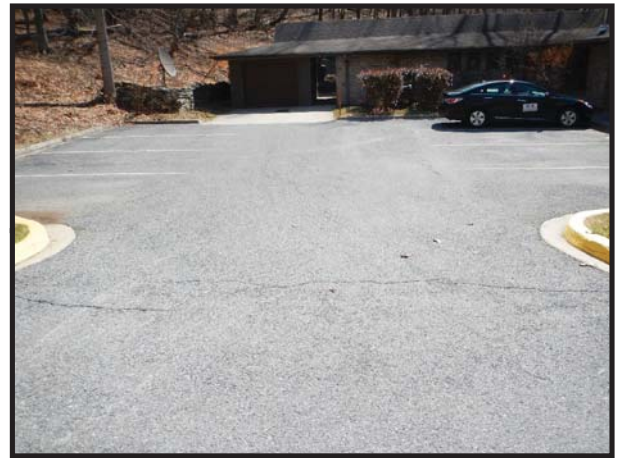
Route 0915

Route Number	Public / NonPublic	Date Visited	Area (sq ft)	Lane Miles *	Surface Type
0915	NONPUBLIC	4/2/2013	2,997	0.05	AS
Culverts	Drop Inlets	Gates	Curb & Gutter	Curb	PCR
0	4	0	CONCRETE CURB AND GUTTER	NO CURB	FAIR/73

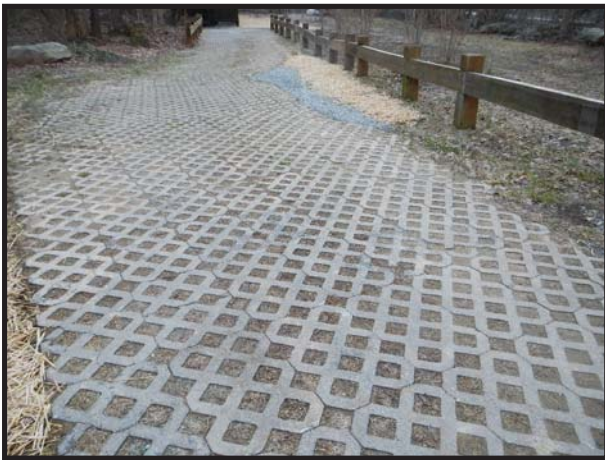
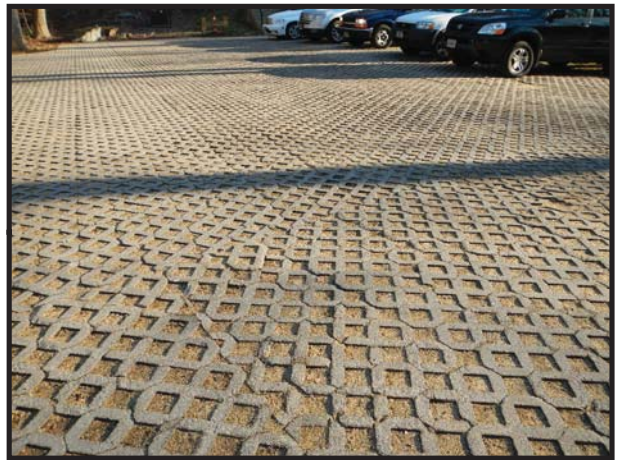
Route 0917

Route Number	Public / NonPublic	Date Visited	Area (sq ft)	Lane Miles *	Surface Type
0917	NONPUBLIC	4/2/2013	10,830	0.19	BR
Culverts	Drop Inlets	Gates	Curb & Gutter	Curb	PCR
1	0	1	NO CURB AND GUTTER	NO CURB	GOOD/90

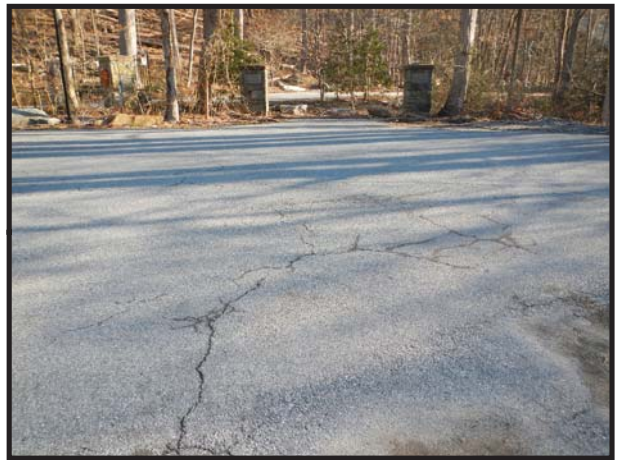
Route 0918

Route Number	Public / NonPublic	Date Visited	Area (sq ft)	Lane Miles *	Surface Type
0918	PUBLIC	4/2/2013	3,150	0.05	AS
Culverts	Drop Inlets	Gates	Curb & Gutter	Curb	PCR
0	0	0	NO CURB AND GUTTER	NO CURB	POOR/45

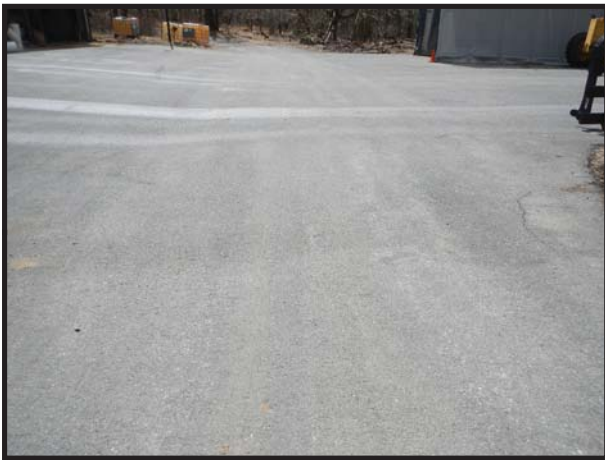
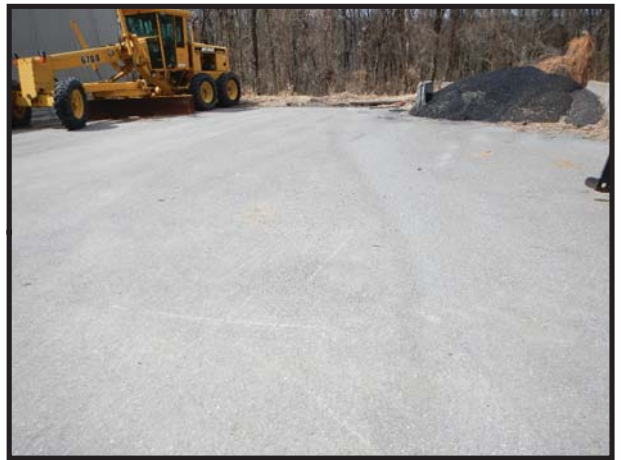
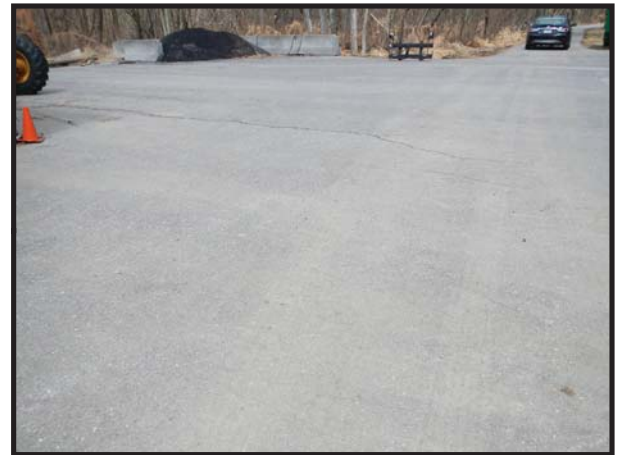
Route 0919

Route Number	Public / NonPublic	Date Visited	Area (sq ft)	Lane Miles *	Surface Type
0919	NONPUBLIC	4/2/2013	6,540	0.11	AS
Culverts	Drop Inlets	Gates	Curb & Gutter	Curb	PCR
0	0	0	NO CURB AND GUTTER	NO CURB	FAIR/73

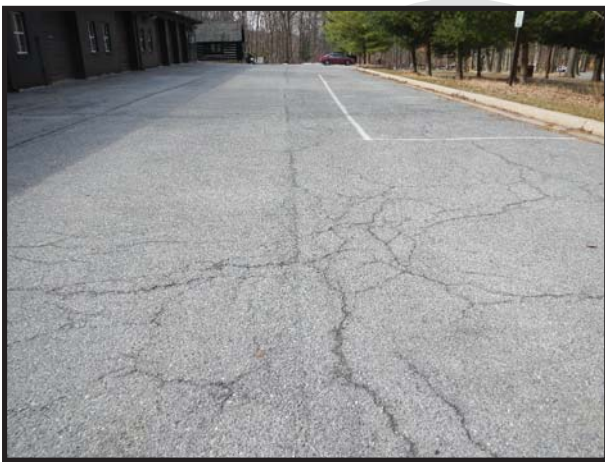
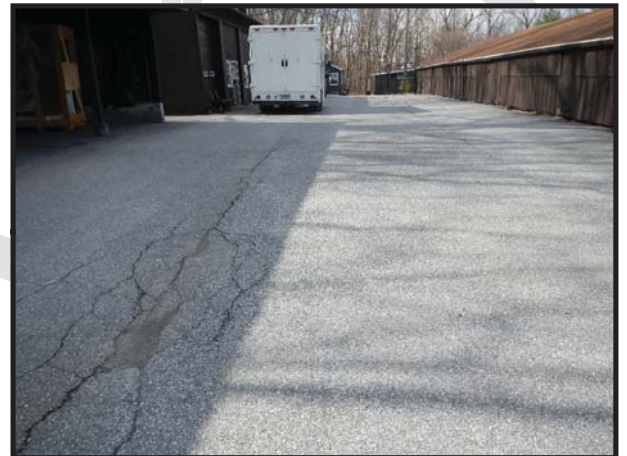
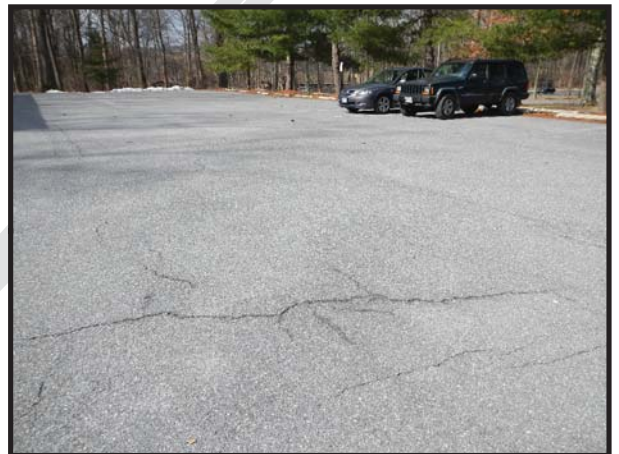
Route 0920

Route Number	Public / NonPublic	Date Visited	Area (sq ft)	Lane Miles *	Surface Type
0920	NONPUBLIC	4/2/2013	32,385	0.56	AS
Culverts	Drop Inlets	Gates	Curb & Gutter	Curb	PCR
0	1	2	CONCRETE CURB AND GUTTER	NO CURB	FAIR/73

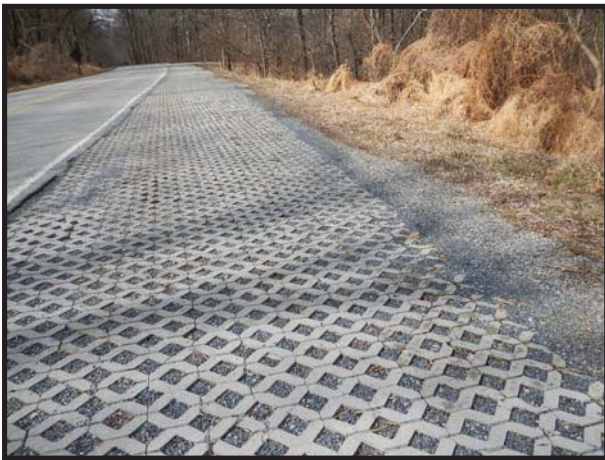
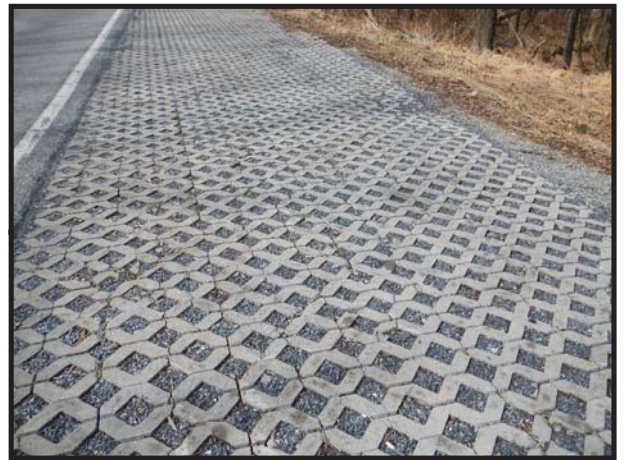
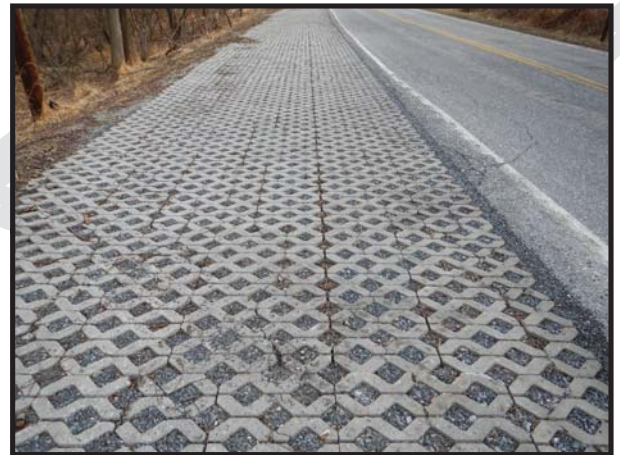
Route 0921

Route Number	Public / NonPublic	Date Visited	Area (sq ft)	Lane Miles *	Surface Type
0921	PUBLIC	4/2/2013	2,267	0.04	BR
Culverts	Drop Inlets	Gates	Curb & Gutter	Curb	PCR
0	0	0	NO CURB AND GUTTER	NO CURB	FAIR/73

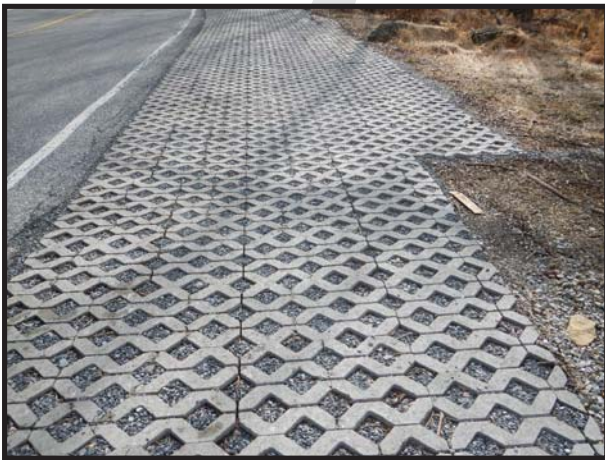
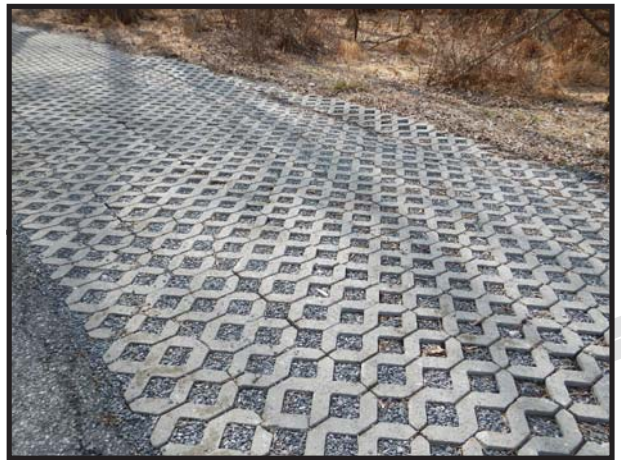
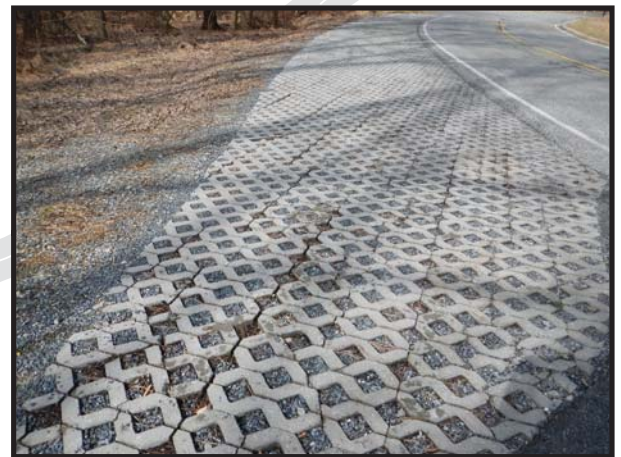
Route 0922

Route Number	Public / NonPublic	Date Visited	Area (sq ft)	Lane Miles *	Surface Type
0922	PUBLIC	4/2/2013	1,099	0.02	BR
Culverts	Drop Inlets	Gates	Curb & Gutter	Curb	PCR
0	0	0	NO CURB AND GUTTER	NO CURB	FAIR/73
